# CONWY QUAY REDEVELOPMENT PROGRAMME

## ARCHAEOLOGICAL RECORD & WATCHING BRIEF

### Photographic survey and watching brief

GAT Project No. 2070

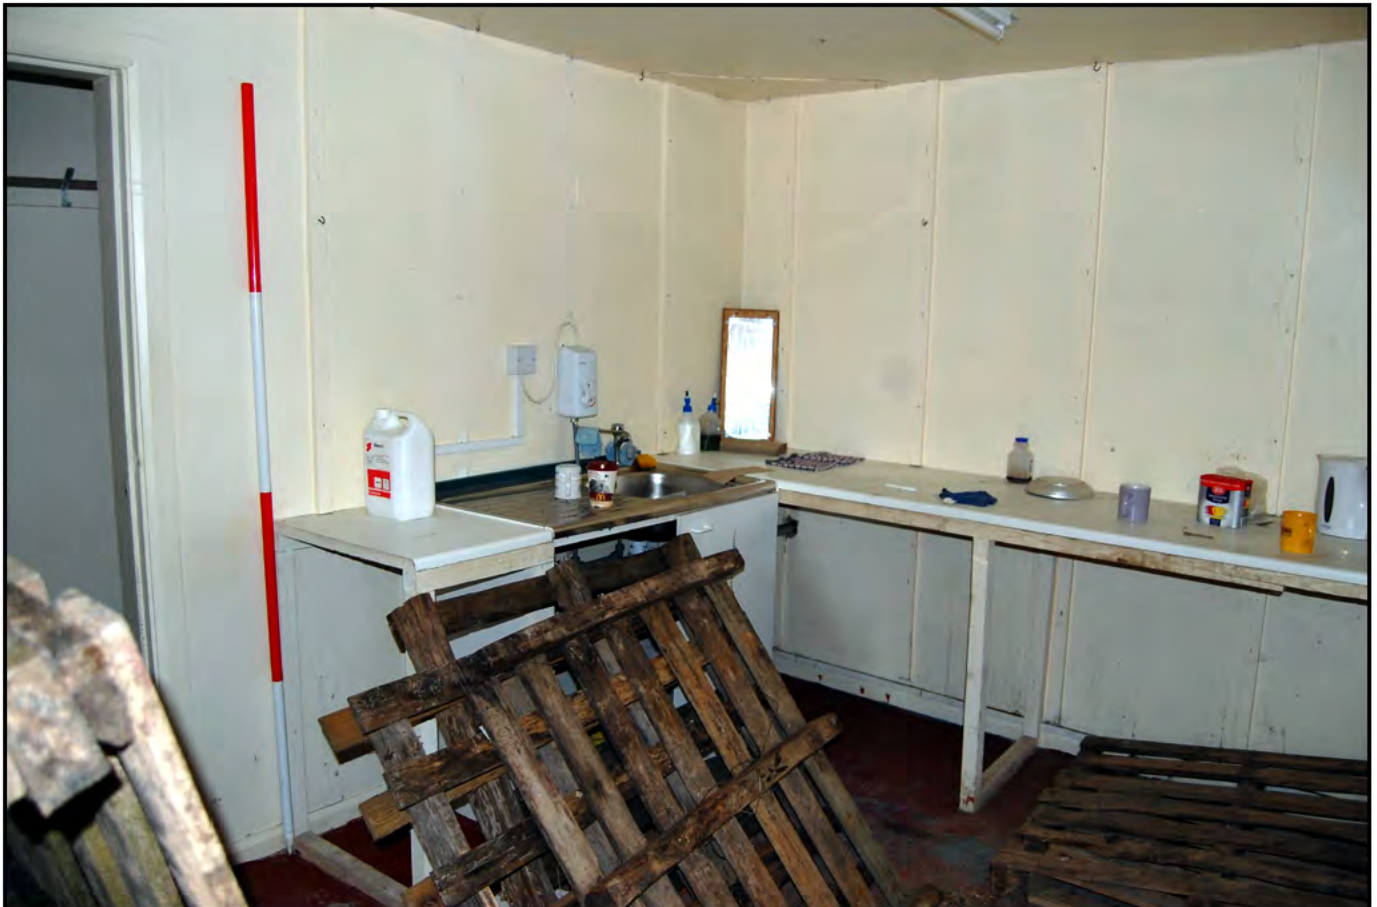
**Plate 17: YARD 02 (PRN 30454): Building 02 (PRN 30455)(Internal):** Building 02 had been converted into an office space, with internal drywall partitions and drywall cladding on all walls except for the south elevation (Ranging pole: 2.0m)

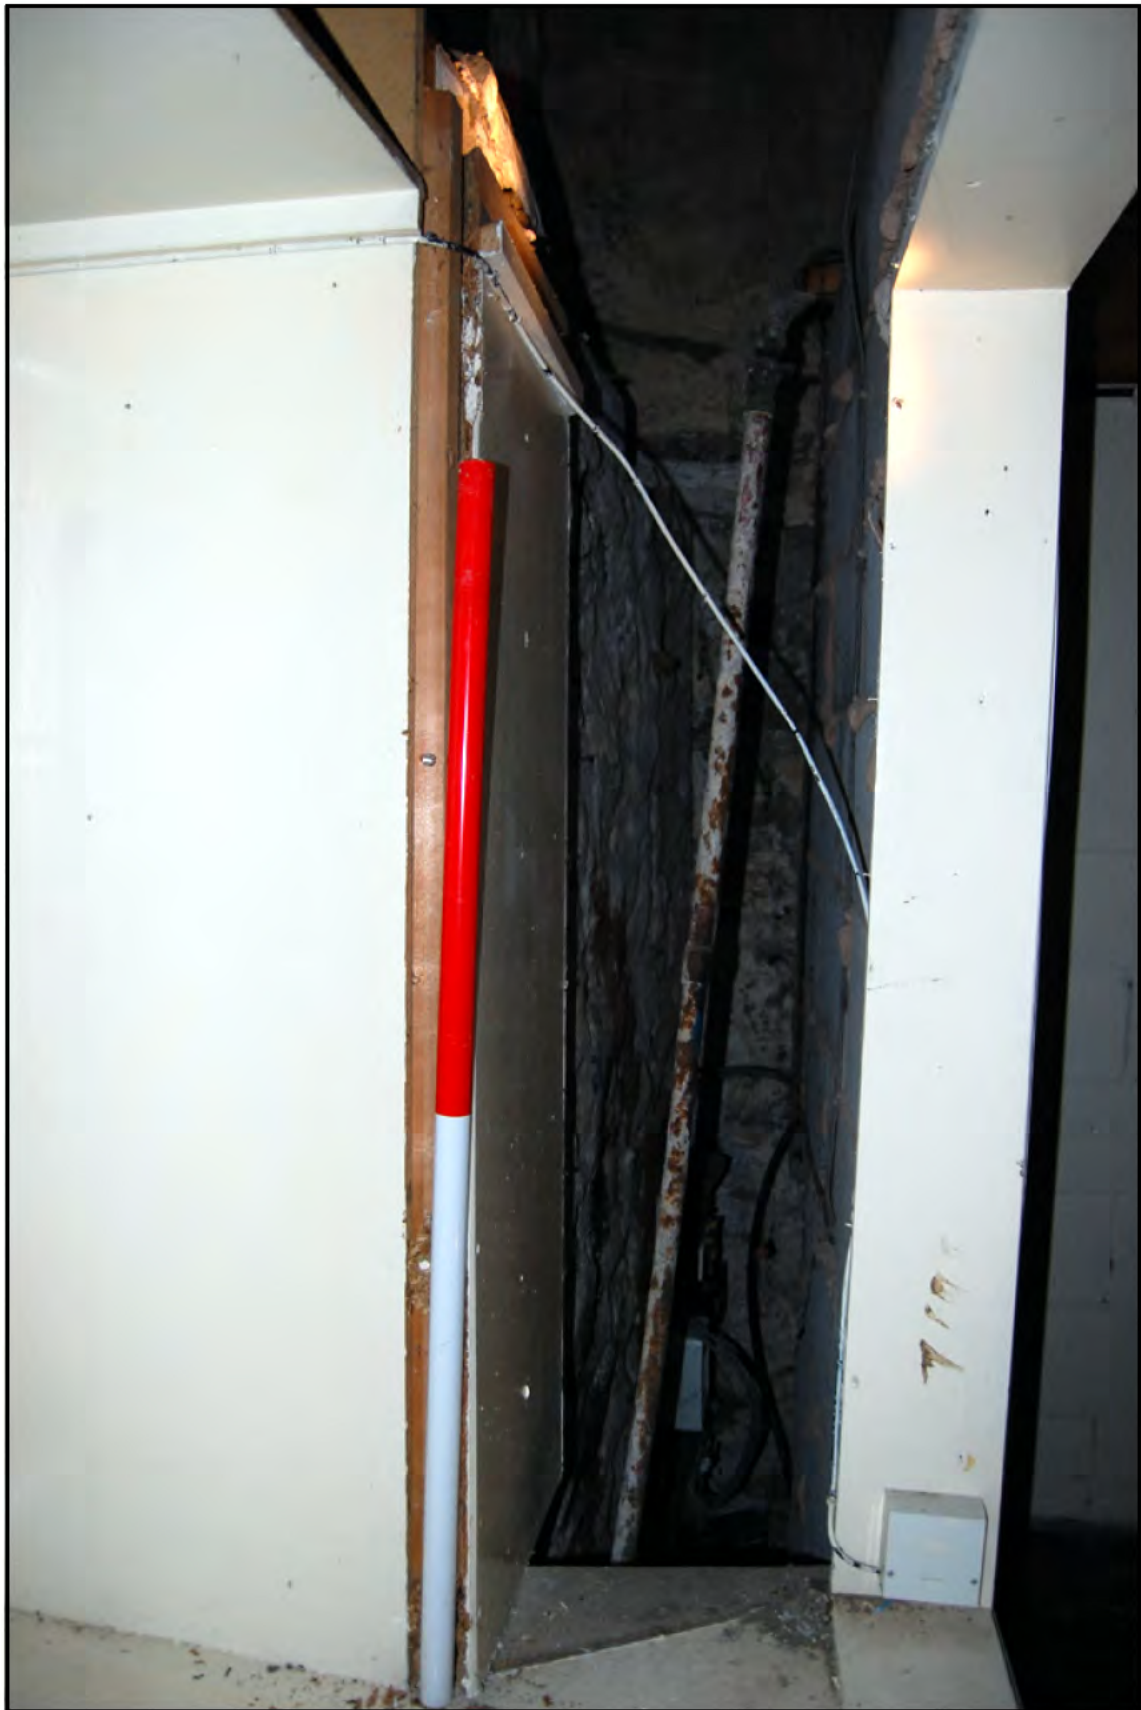
**Plate 18: YARD 2 (PRN 30454): Building 02 (PRN 30455) (Internal):** The east elevation window was identified internally as a recessed bay window. An inspection of this feature revealed that a thermal block wall had been built as a false wall parallel to the original elevation. The latter was partially visible where drywall from the bay window had been removed, exposing whitewashed stone walling .  
(Ranging pole: 1.0m)

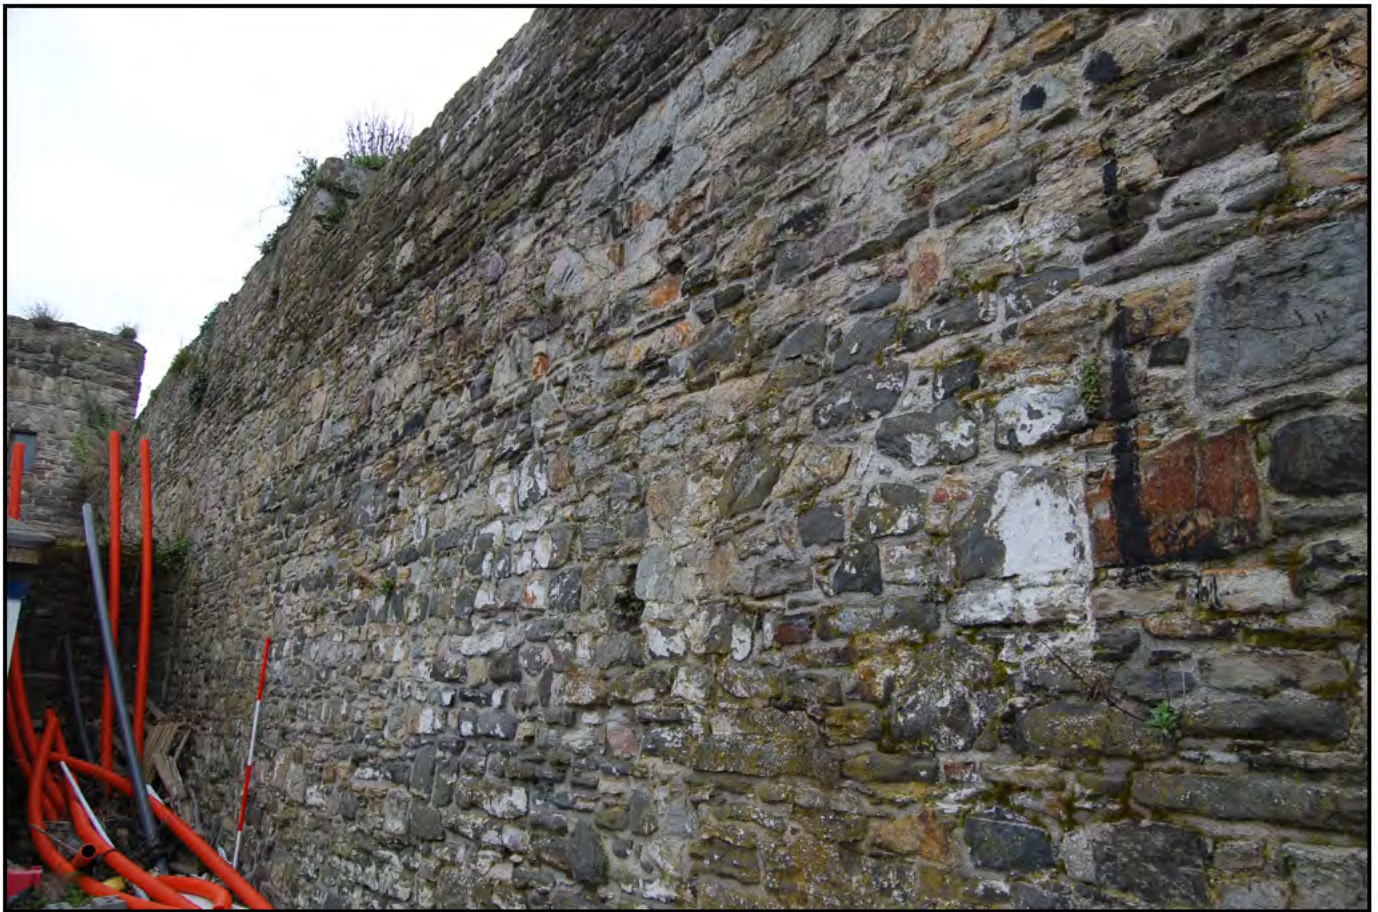
**Plate 20: YARD 2 (PRN 30454): Building 11 (PRN 30456):** in addition to the archival evidence (cf. plate 19), Building 11 was identified from paint marks on the town wall with two vertical and one horizontal lines of paint enclosing patches of white lime wash (Ranging pole: 2.0m)

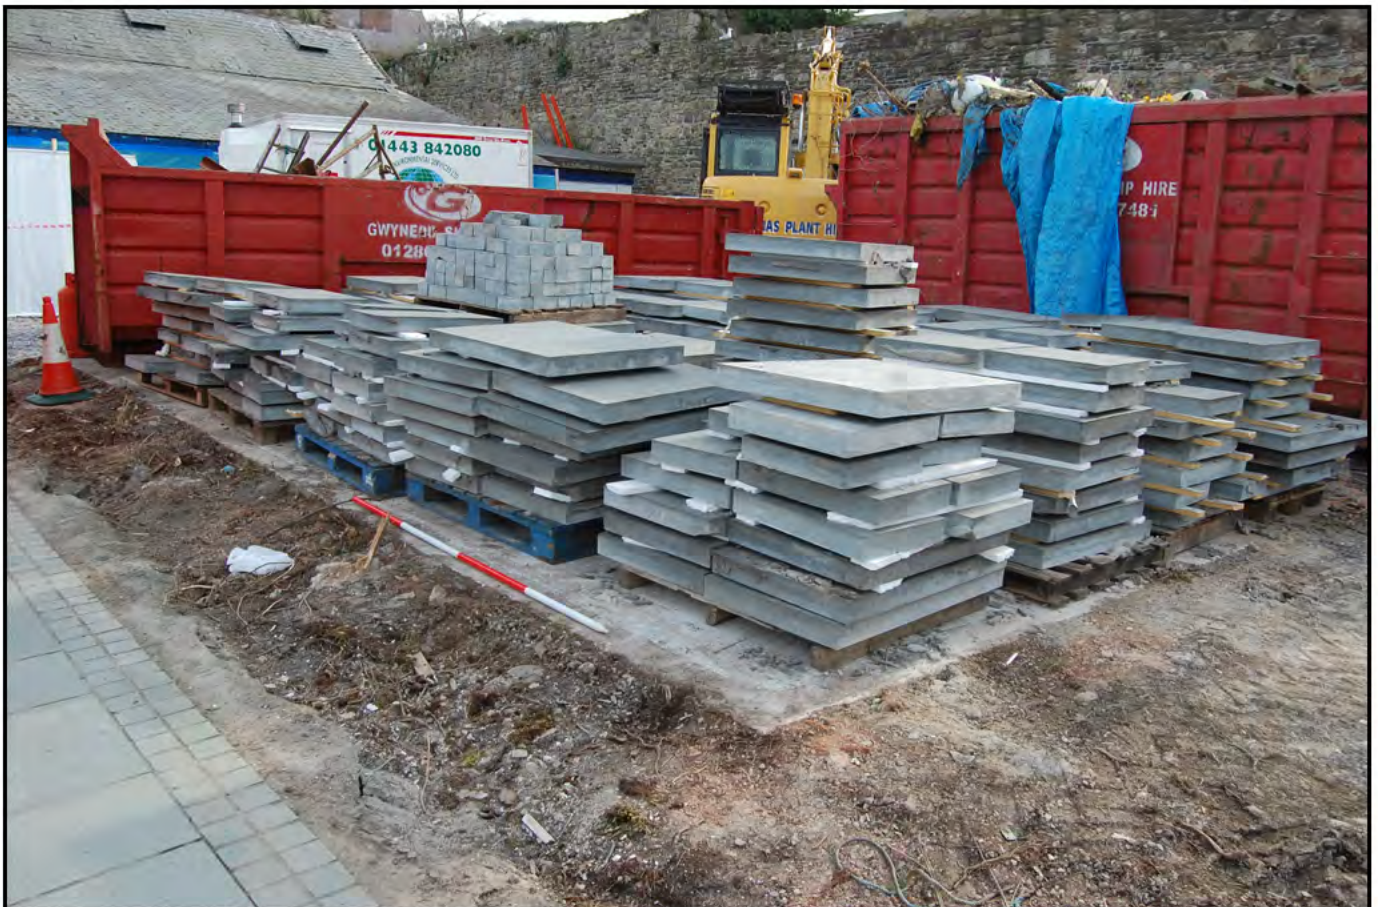
**Plate 21: Yard 3 (PRN 30457): Building 09 (PRN 30459):** this was demolished in the 1980's when the Yards between Buildings 02 (PRN 30455) and 04 (PRN 30464) were cleared and used for boat storage. This building was the engineering machine workshop and part of Reliance Engineering. It lay against the west wall with its long axis parallel to the Quay. It was identified as a concrete floor pad measuring 9.2m x 6m (Ranging pole: 2.0m).

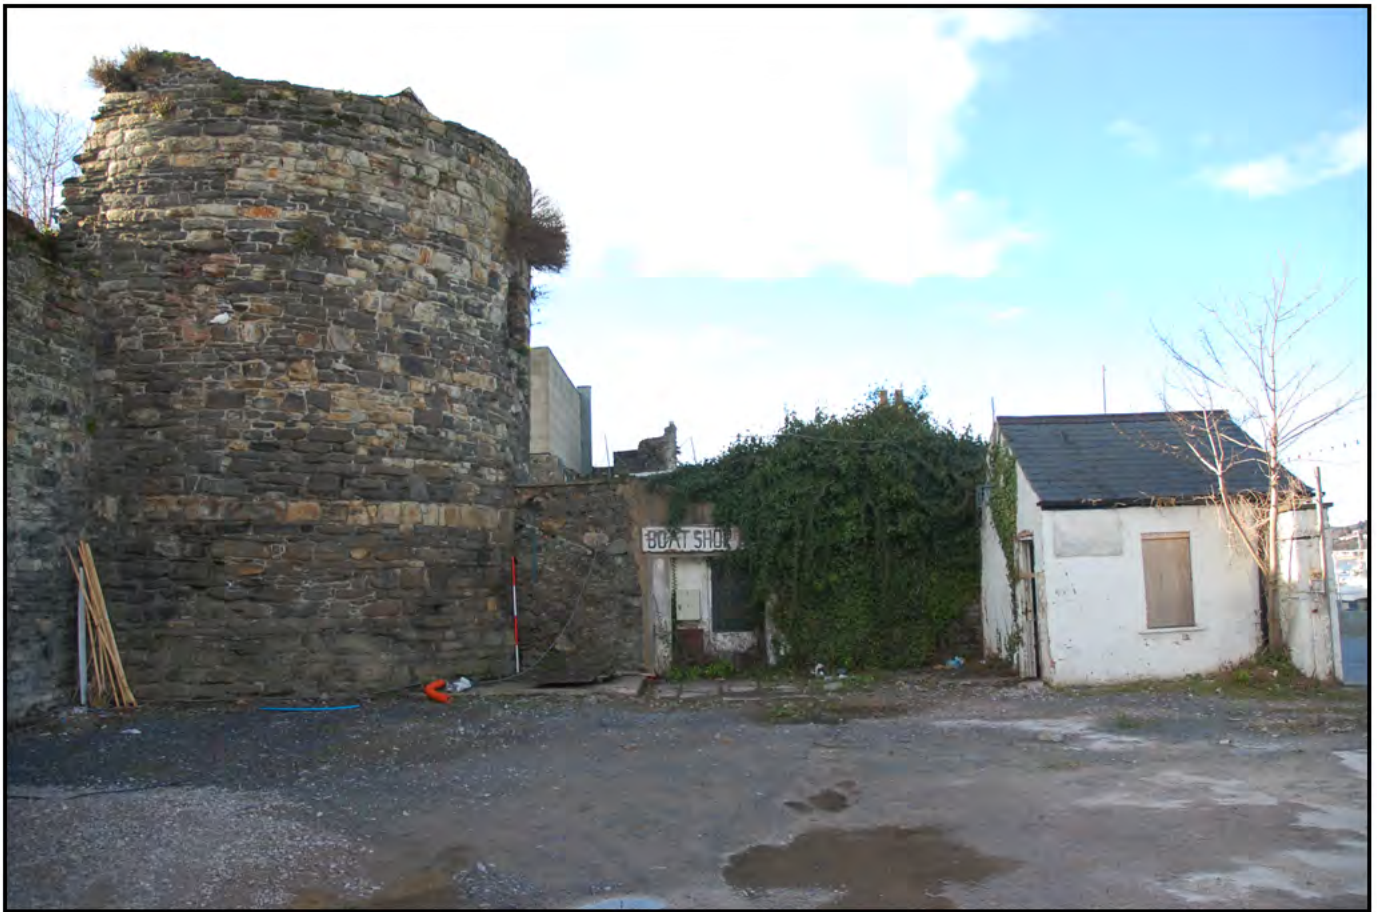
**Plate 22: YARD 3 (PRN 30457): Building 13 (PRN 30462):** a small building in the north-east corner of Yard 3 PRN . Last use was as a seafood stall in the 1980's. First appears on OS maps in 1900 Figure 07, where it is seen as part of the small complex of buildings built against the cross-wall between Yards 3 and 4. This single storey building measured approximately 4.2 m square. The south and west walls were of brick, whilst the north and east walls were formed by the pre-existing yard walls of stone. The roof was of slate. (Ranging pole: 2.0m)

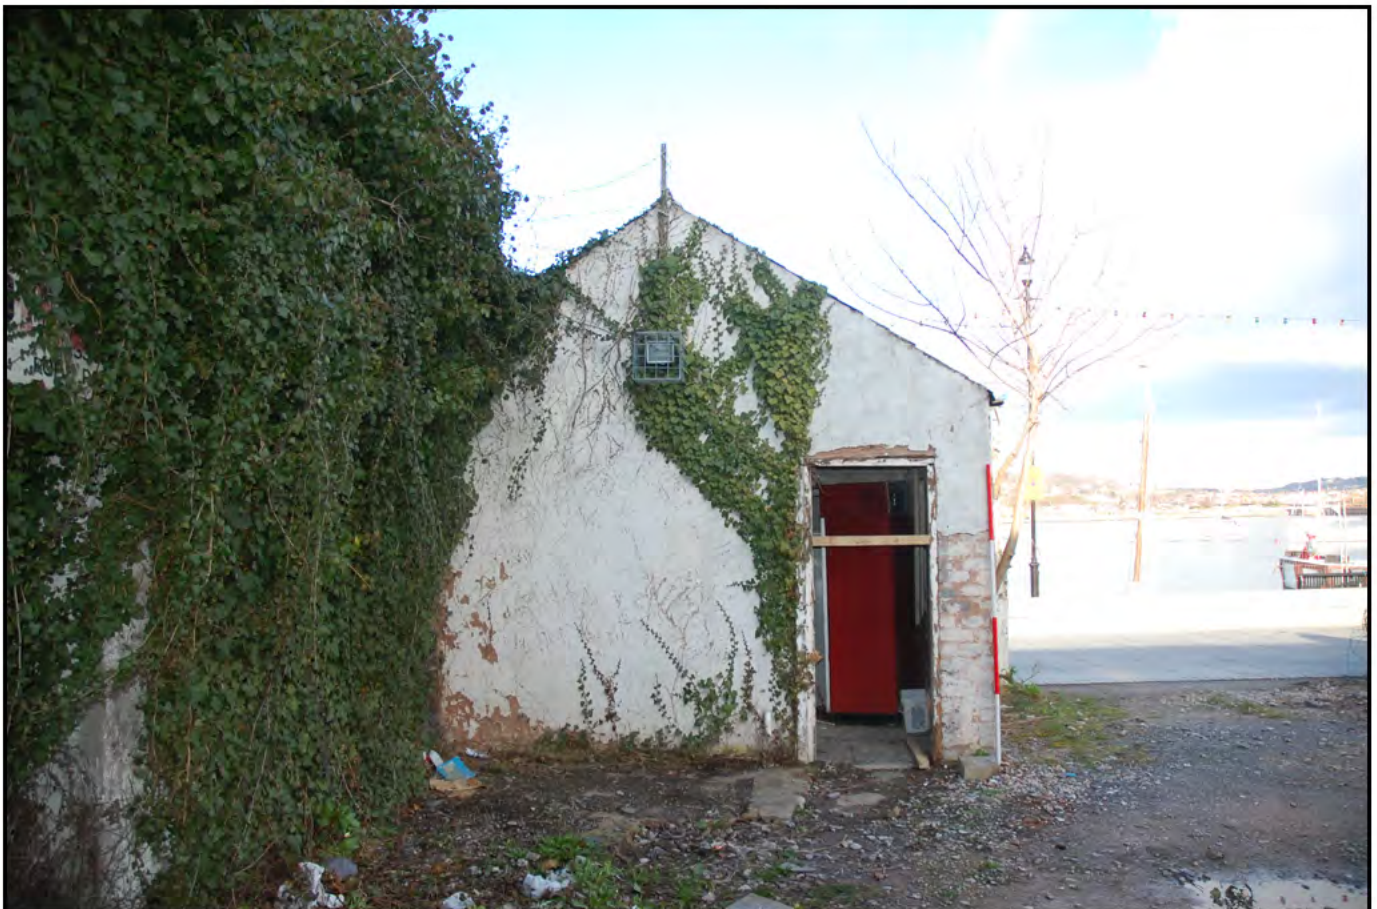
**Plate 23: YARD 3 (PRN 30458): Building 13:** west facing access door. Note, Building 13 (PRN 30462) constructed from brick. (Ranging pole: 2.0m)

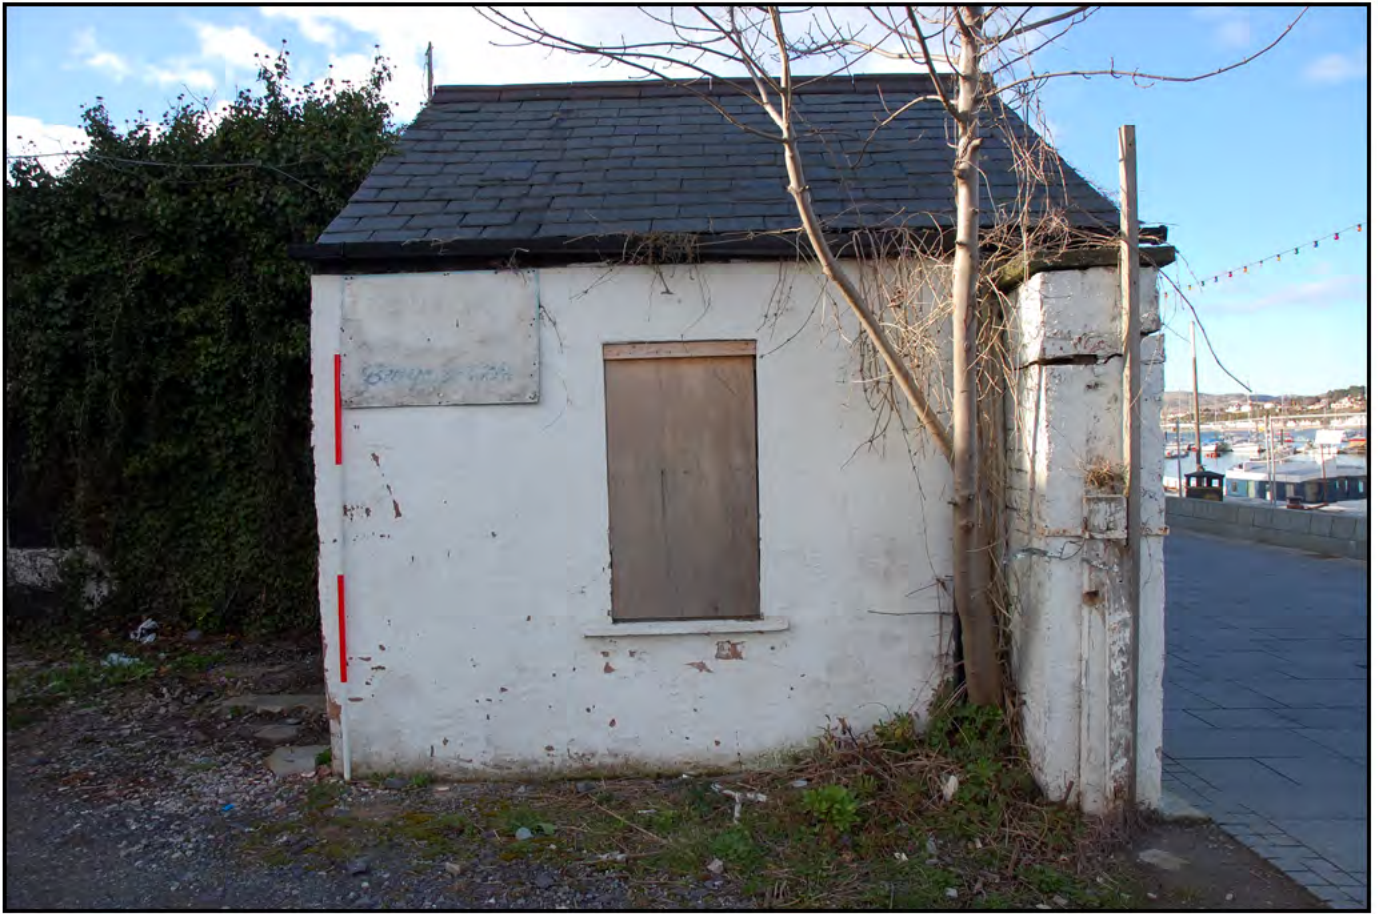
**Plate 24: YARD 3 (PRN 30457): Building 13 (PRN 30430462): south-facing elevation detailing signage for seafood stall and serving hatch. Note also the entrance through Wall A at right of image allowing access to Yard 3 (Ranging pole: 2.0m)**

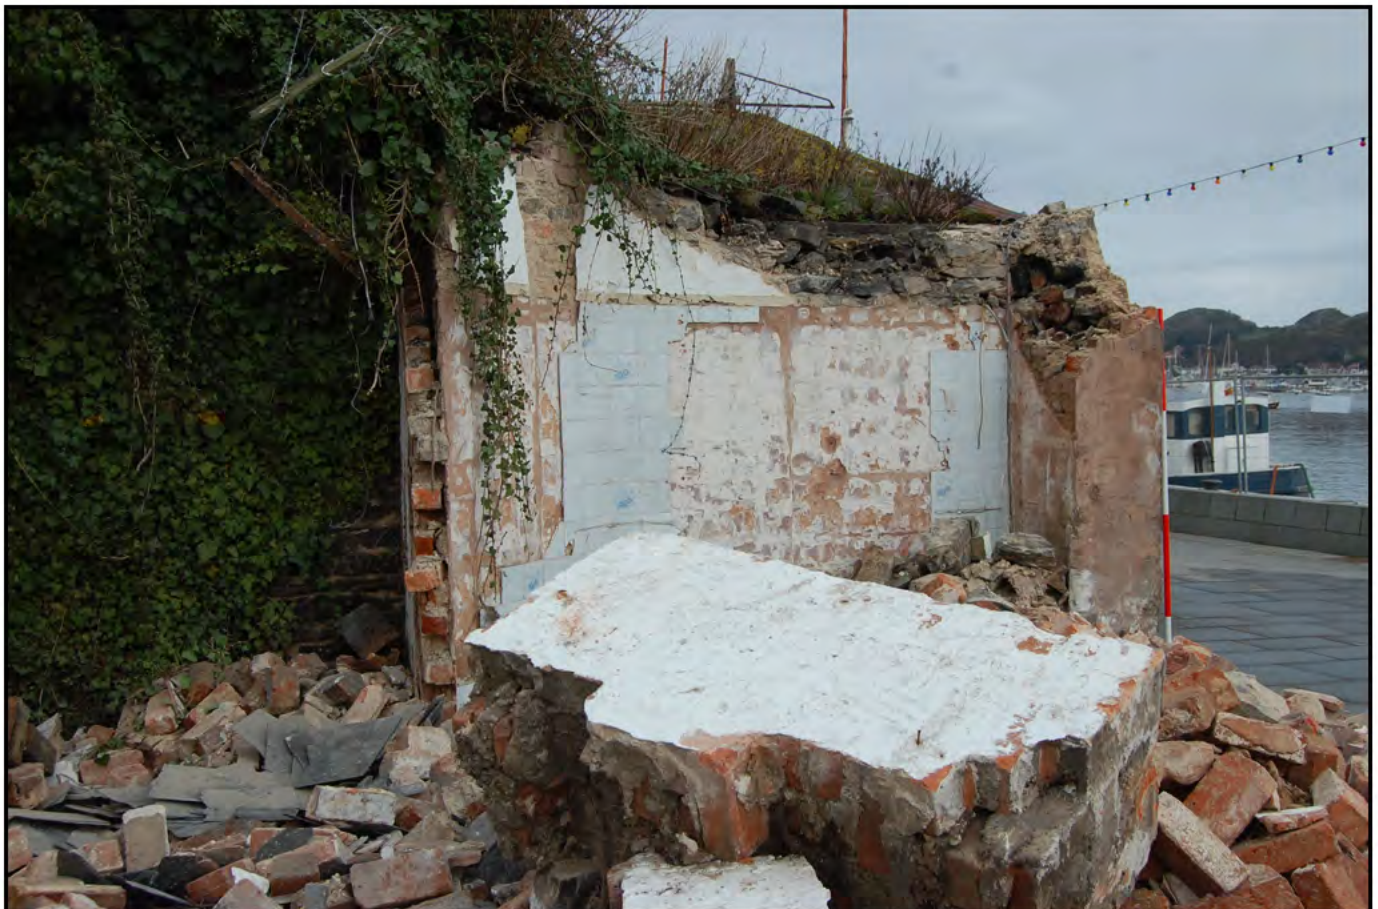
**Plate 25: YARD 3 (PRN 30457): Building 13 (PRN 30430462): removal of south-facing elevation during demolition phase, detailing rendered and tiled internal elevations. (Ranging pole: 2.0m)**

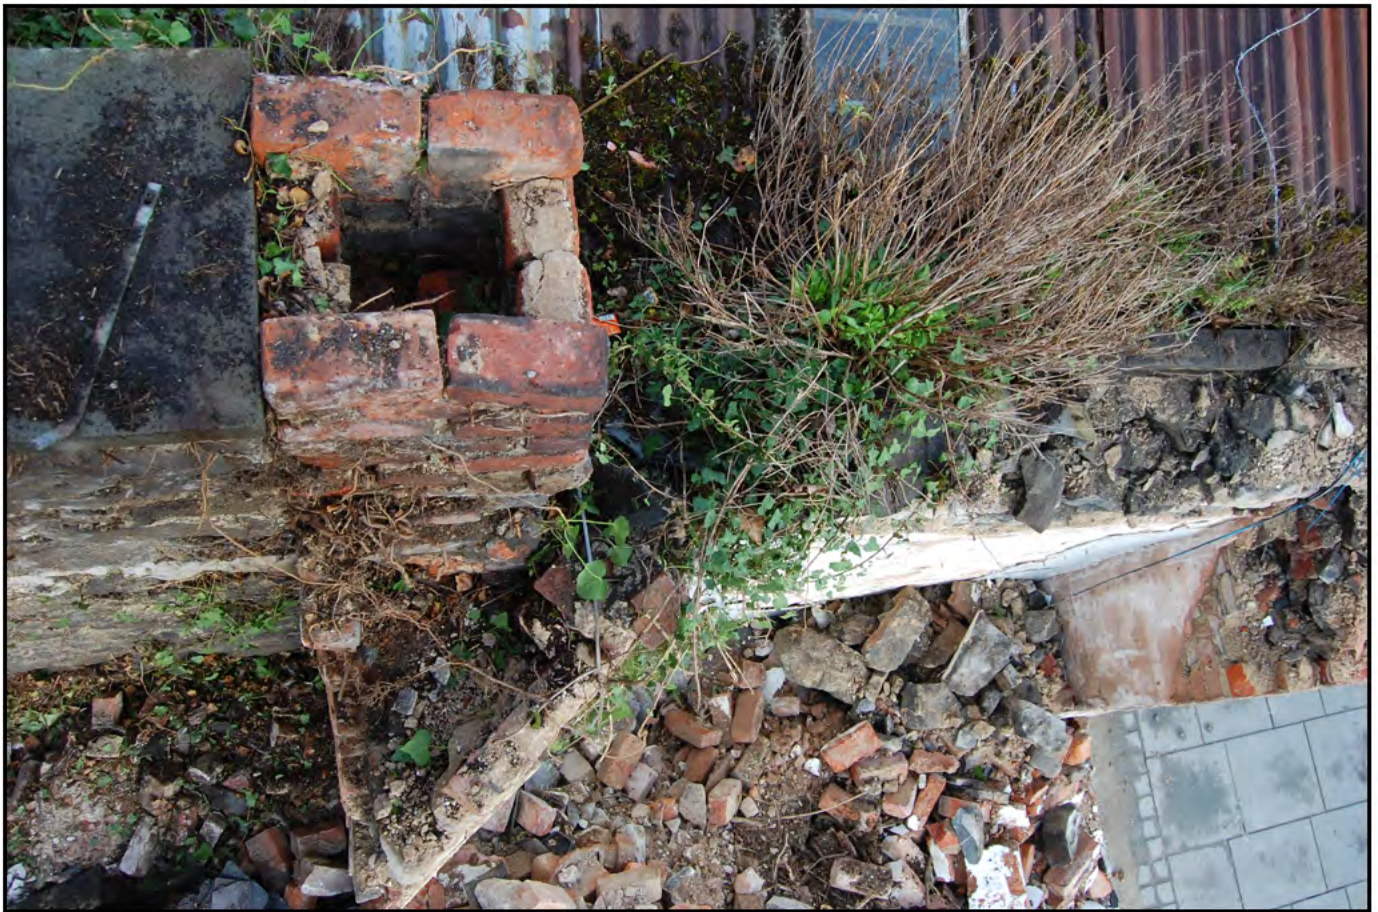
**Plate 26: YARD 3 (PRN 30457): Building 13 (PRN 30462): during demolition a brick built chimney was identified built into the stone cross-wall (Cross Wall B) against which Building 13 was built. Birds' eye view during demolition detailing brick-built chimney and stone-built cross wall. (Ranging pole: 2.0m)**

There was an angled wall built into the west corner of **Building 13**. During demolition a brick built chimney was found built into the stone cross-wall (Cross Wall B; plate 26). After removal of the modern internal tiles from the angled wall a fire place was found (plate 27). It became clear that the once free standing chimney which served the fireplace in **Building 13** had become incorporated into the cross-wall when that wall was raised. The wooden wall plate for the roof of **Building 13** had been built onto the top of wall B at its original height.

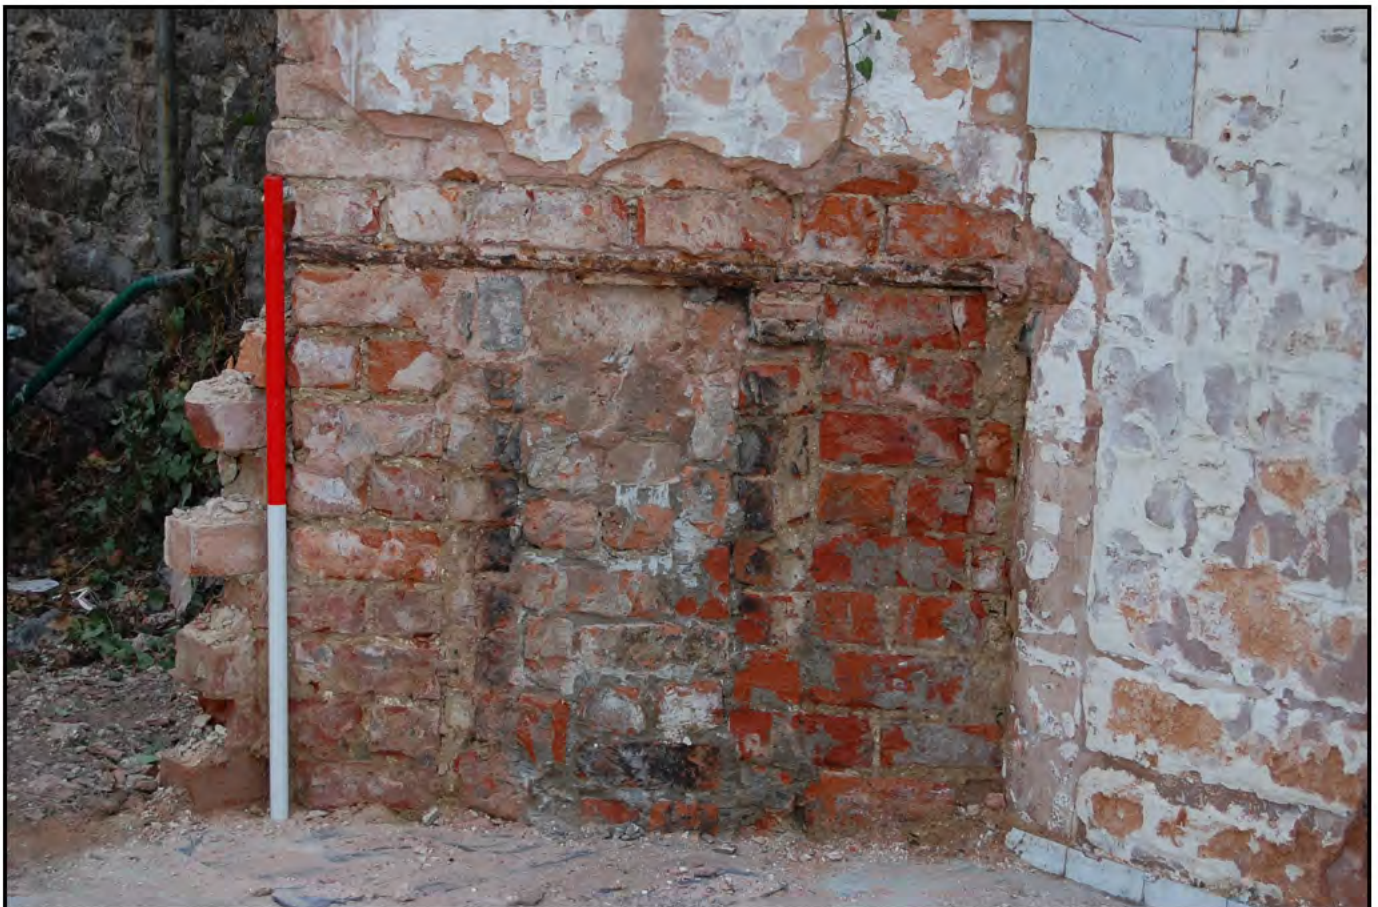
**Plate 27: YARD 3 (PRN 30457): Building 13 (PRN 30462): internal fireplace associated with chimney (plate 26), identified during demolition phase (Ranging pole: 2.0m).**

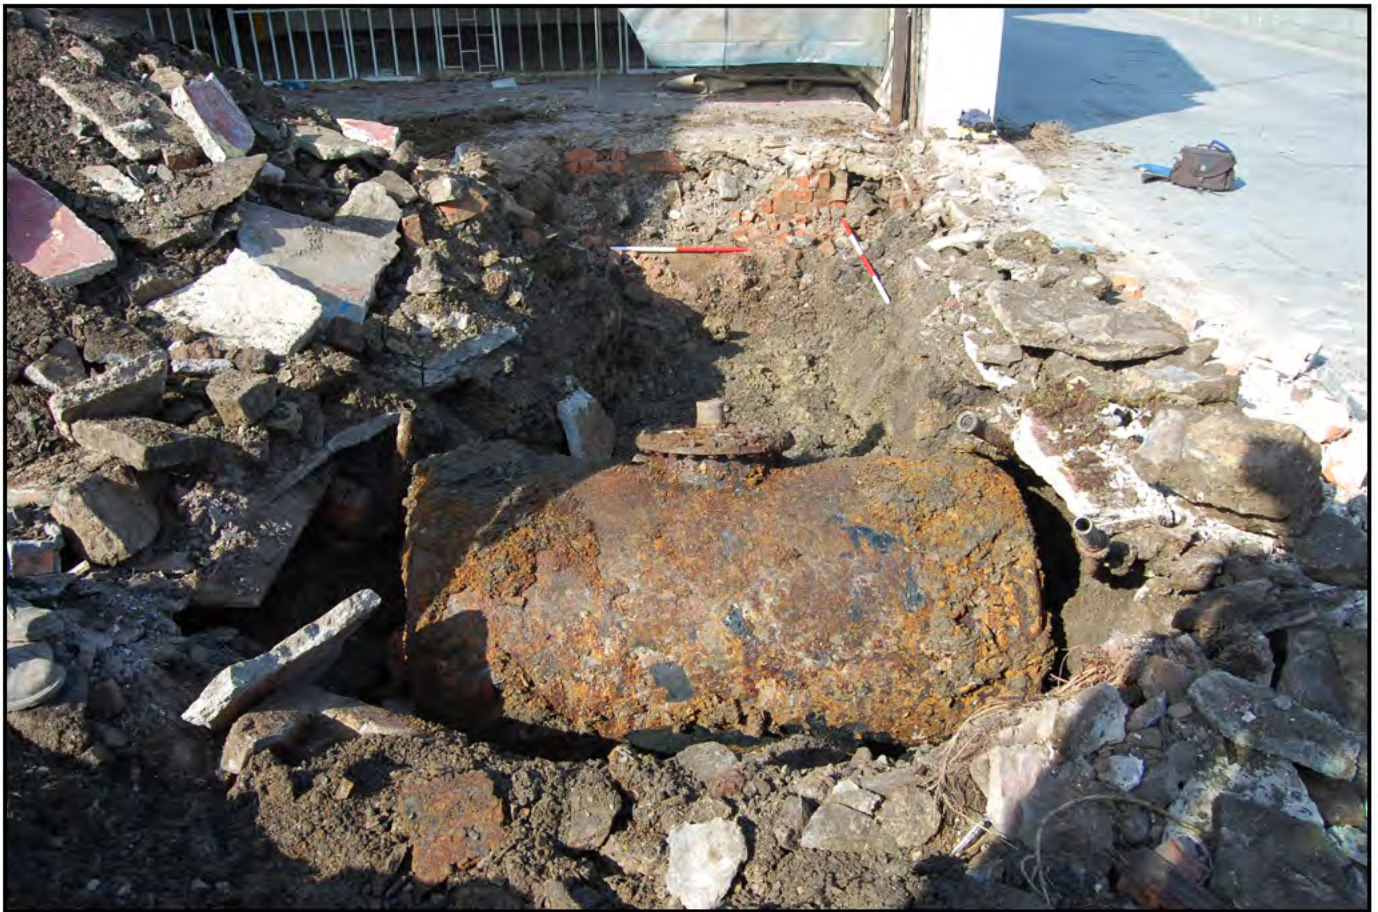
**Plate 28: YARD 4 (PRN 30463):** A series of redundant buried fuel tanks were identified withn Yard 4 during the demolition phase. The fuel tanks had been installed underground just inside the frontage of the garage (the central building within Building 04 (PRN 30464); cf. plate 26). A total of four tanks were found during the demolition.  
(Ranging poles: 1 x 1.0m and 1x 2.0m)

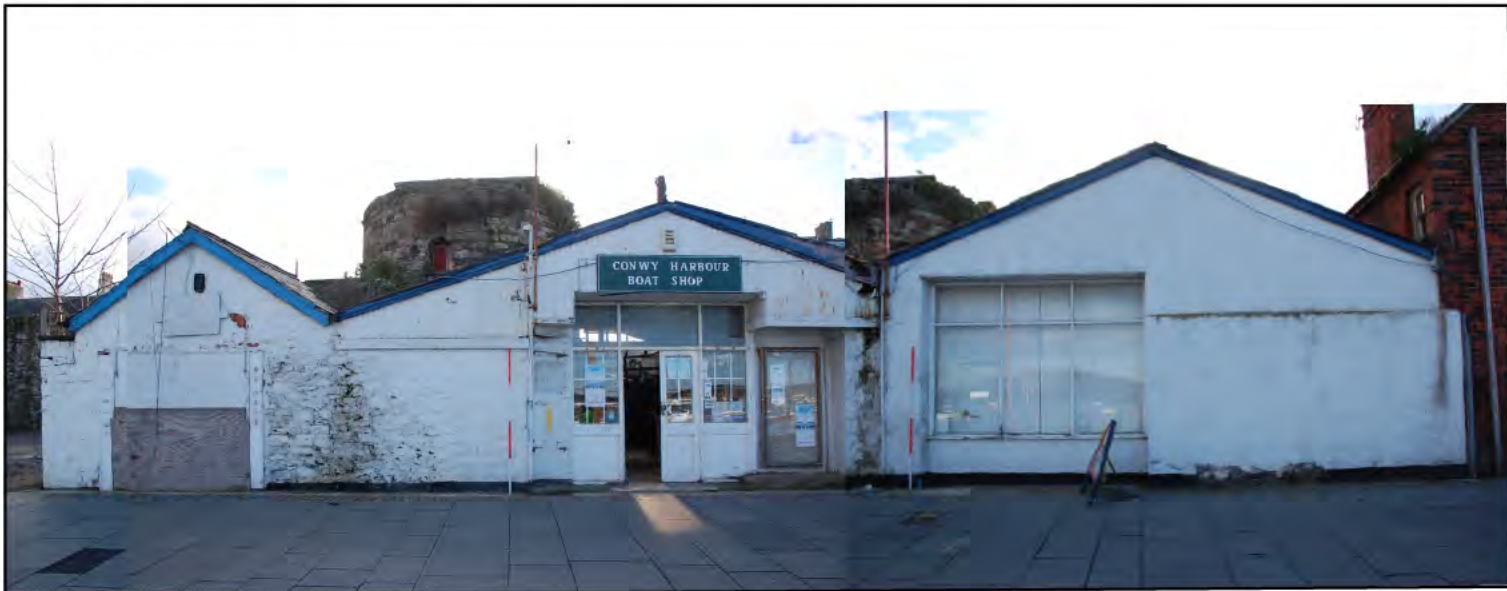
**Plate 29: YARD 4 (PRN 30463): Building 04 (30464):** composite image detailing the east facing elevation of Building 04. This building occupied the full width of Yard 4 and was extant as three bays. These lay north and in front of an earlier stone building that lay on a north-south axis against the town wall (Building 14 (PRN 30465): plate 33). The north, east and south walls of Building 04 also formed the yard walls, whilst the west wall used the existing east wall of Building 14. Each bay was roofed with a pitched roof running east-west, so the front onto the quay was made up of three gables. The wall fronting the quay partly made use of the earlier Wall A (the enclosure), though parts were rebuilt in brick plate 29. The east and west cross-walls (B and C) between Wall A and the town wall also partly survived in their original form, though had been raised in height from approximately 2.0m to 3.35m plate 22. The cross-walls were seen to abut Wall A. Access into the building was both from the quay and from Yard 3 to the east through wide doors (cf. plate 22)

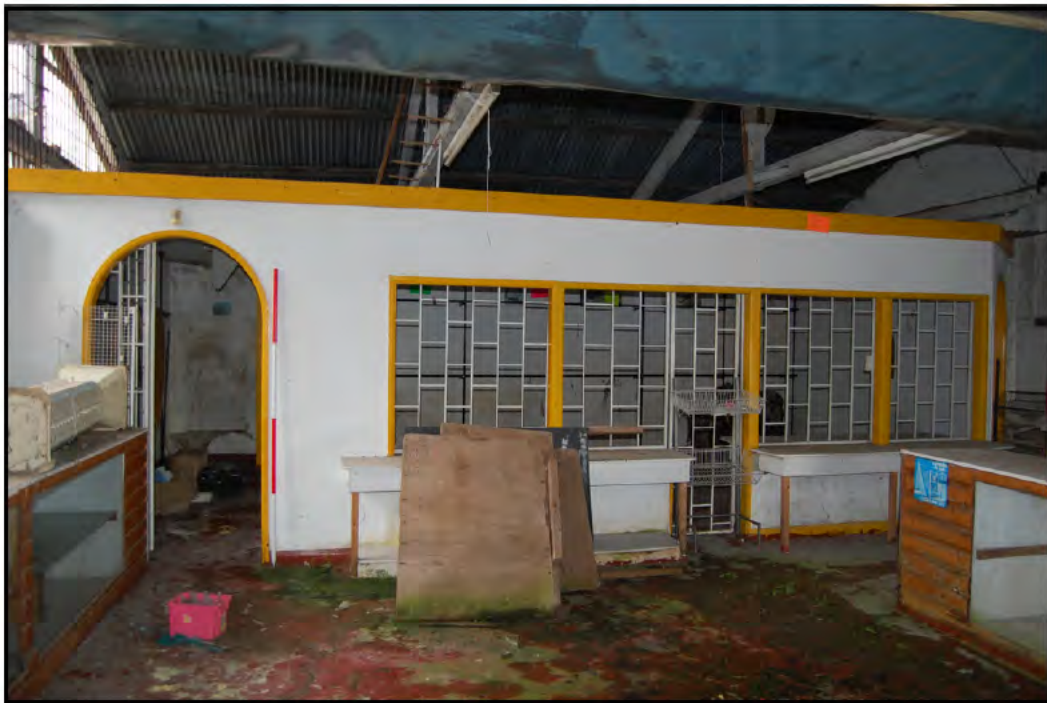
**Plate 30: YARD 4 (PRN 30464): Building 14 (PRN 30465):** The interior of Building 04 (PRN 30464) comprised a large open space partitioned into smaller areas, reflecting its final use as the *Chandlery Shop*.  
(Ranging pole: 2.0m)

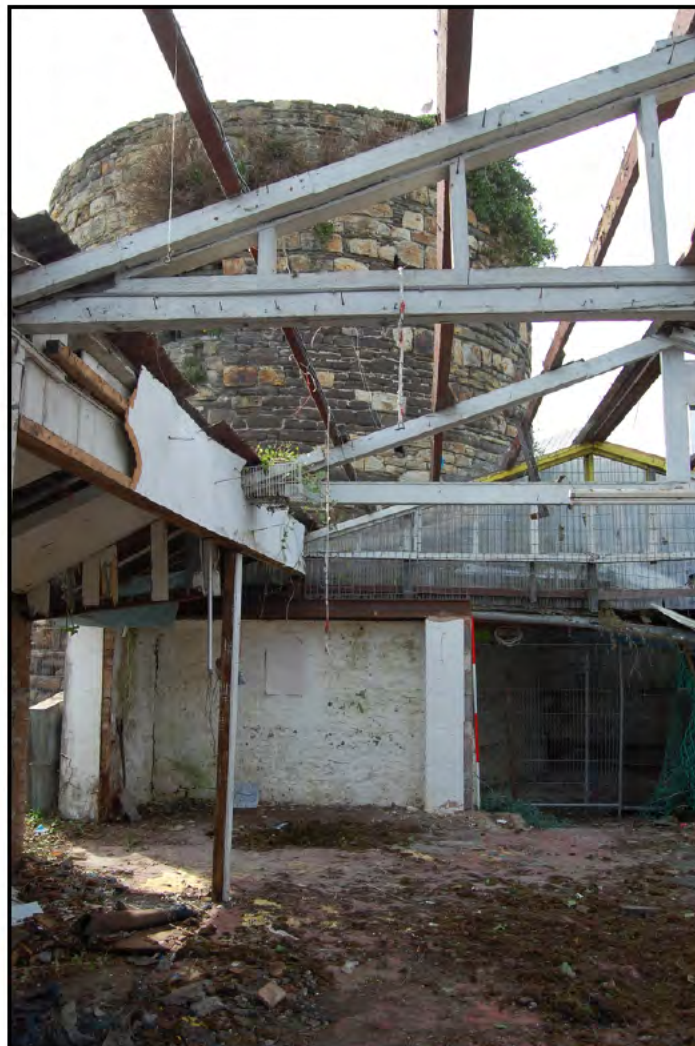
**Plate 31: YARD 4 (PRN 30463): Building 14 (PRN 30465):** The rear of the building included the town wall (whitewashed) and the interior of Building 14.  
(Ranging pole: 2.0m)

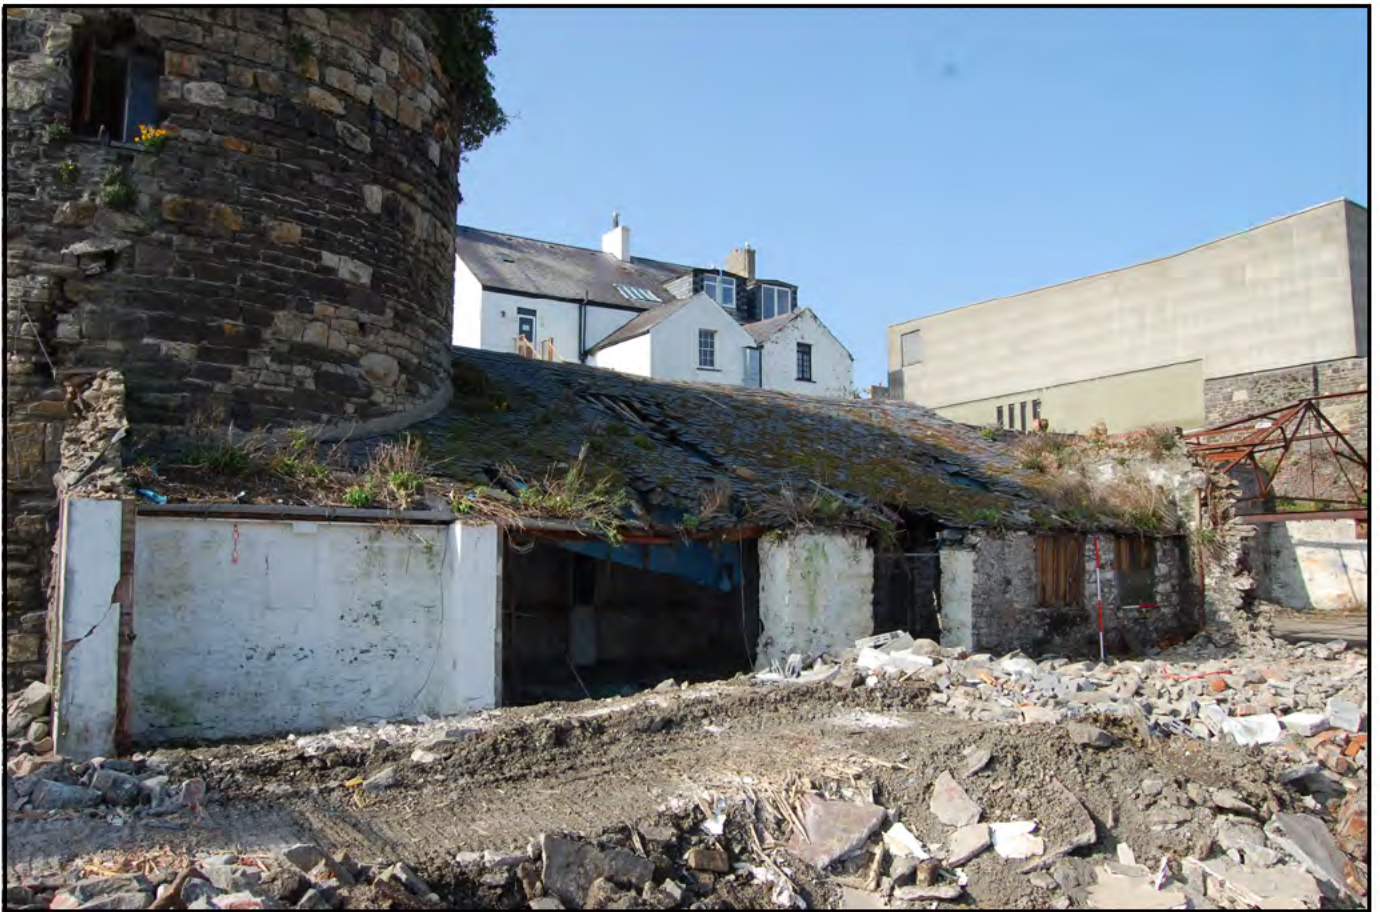
**Plate 32: YARD 4 (PRN 30463): Building 14 (PRN 30465): east facing front wall. Structure was encompassed by Building 04 (PRN 30464). (Ranging poles: 1 x 2.0m and 1 x 1.0m)**

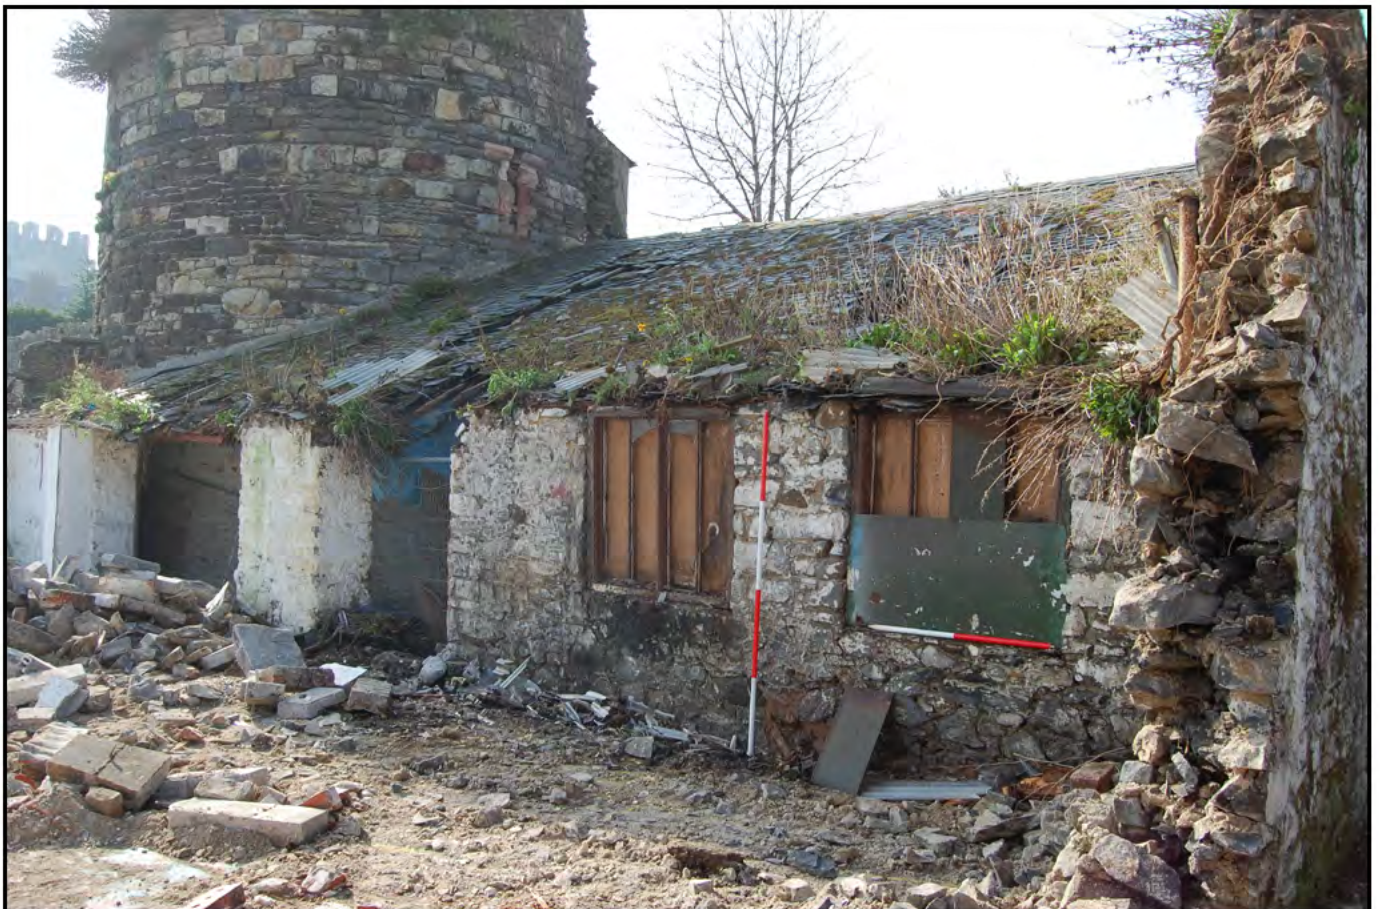
**Plate 33: YARD 4 (PRN 30463): Building 14 (PRN 30465): east facing front wall. Structure was encompassed by Building 04 (PRN 30464). (Ranging poles: 1 x 2.0m and 1 x 1.0m)**

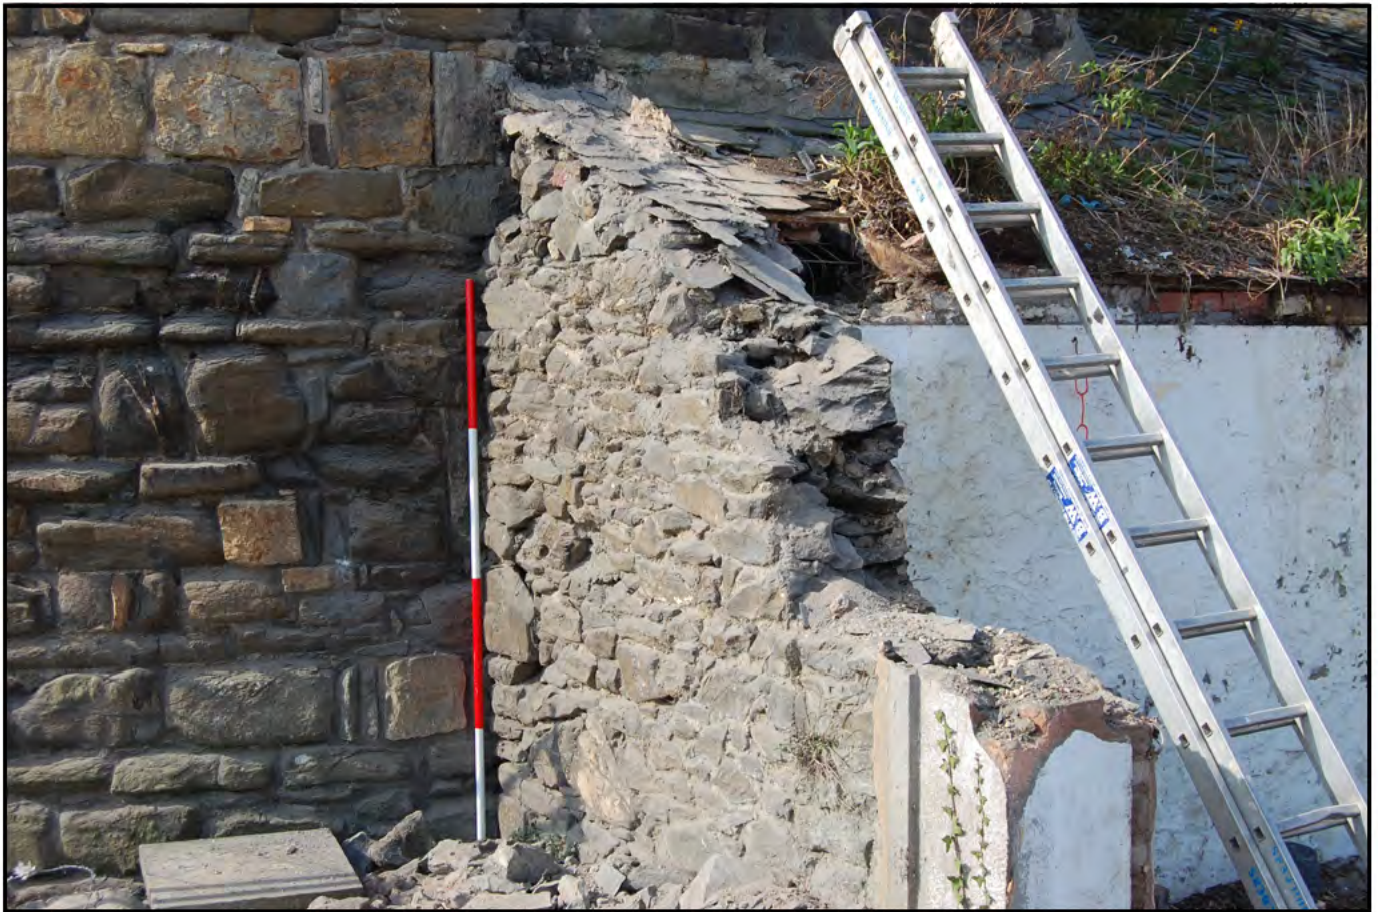
**Plate 34: YARD 4 (PRN 30463): Building 14 (PRN 30465): during demolition: the roof of Building 14 was supported on half kingpost trusses of mid 19th century date. The king-posts lay against the town wall, supported on pillars built against the wall. The only part of this build that had insertions into the medieval wall was where the roof structure wrapped around tower 3, where timbers had been inserted into the tower wall.  
(Ranging poles: 1 x 2.0m and 1 x 1.0m)**
