# CONWY QUAY REDEVELOPMENT PROGRAMME

## ARCHAEOLOGICAL RECORD & WATCHING BRIEF

### Photographic survey and watching brief

GAT Project No. 2070

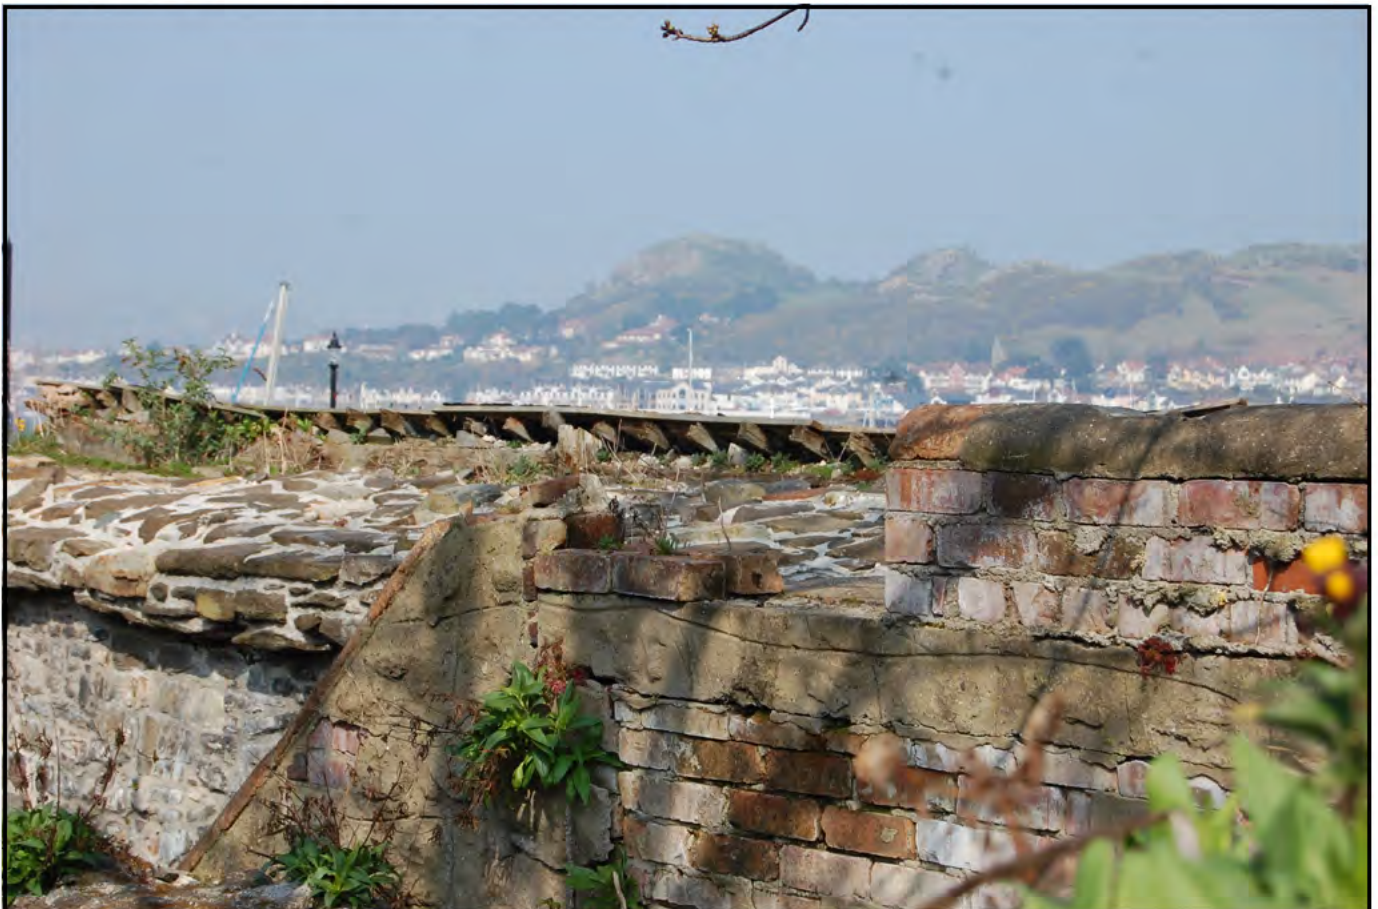
**Plate 35: YARD 4 (PRN 30463): Building 14 (PRN 30465): during demolition: example of roof rising slightly above the top of the town wall (view north)**

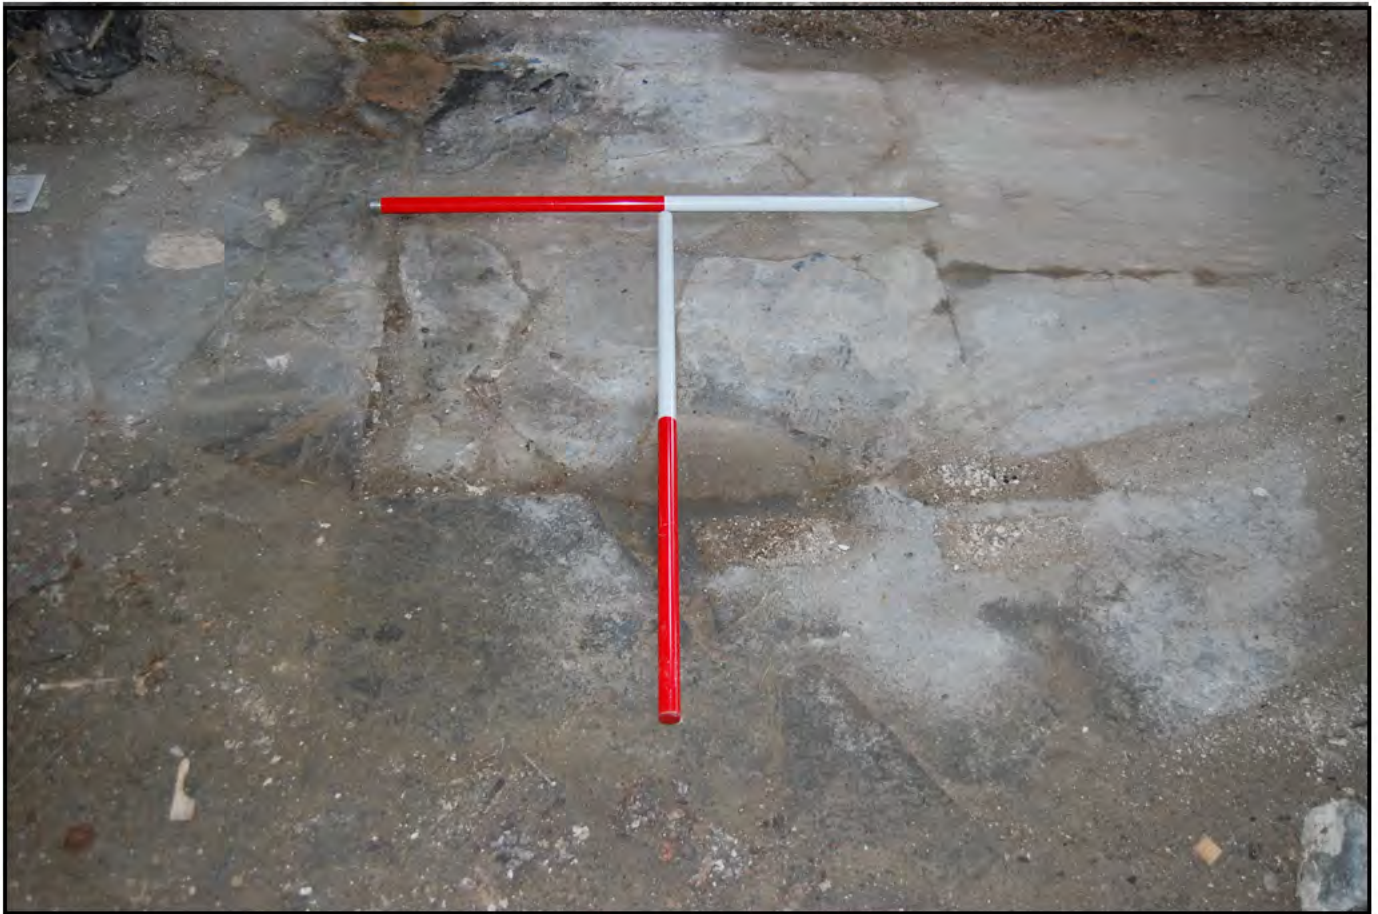
**Plate 36: YARD 4 (PRN 30463): Building 14 (PRN 30465): during demolition: the floor was made of large (up to 1.0m<sup>2</sup>) slate slabs. (Ranging poles: 2 x 1.0m)**

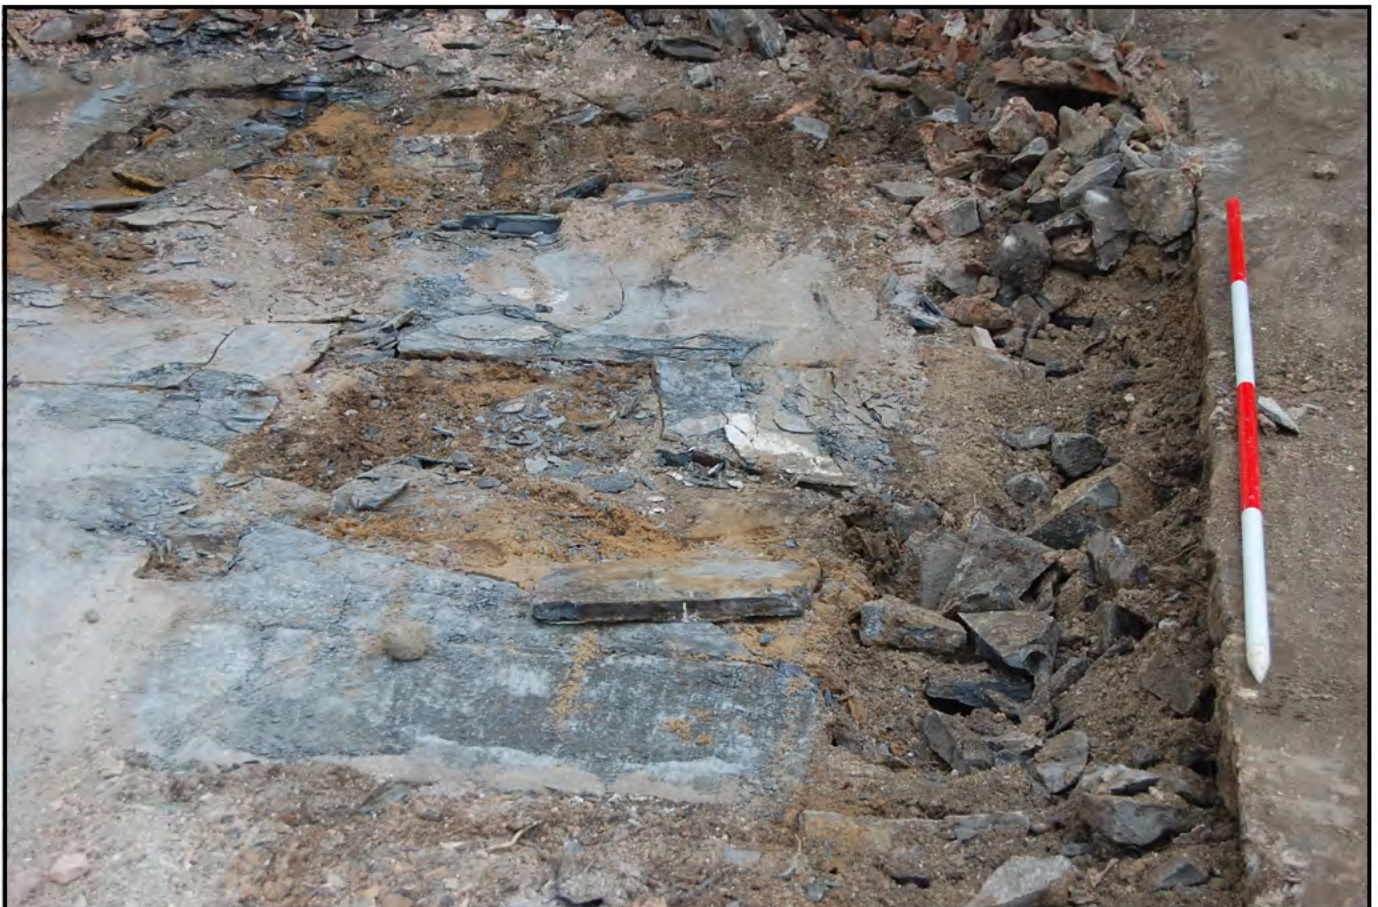
**Plate 37: YARD 4 (PRN 30463): Building 14 (PRN 30465): during demolition: the floor was made of large (up to 1.0m<sup>2</sup>) slate slabs plate 36 laid on yellow sand. The floor level within Building 14 was some 0.25m lower than the modern concrete floors of Building 04 (PRN 30464) and probably represented the original floor/yard levels.**

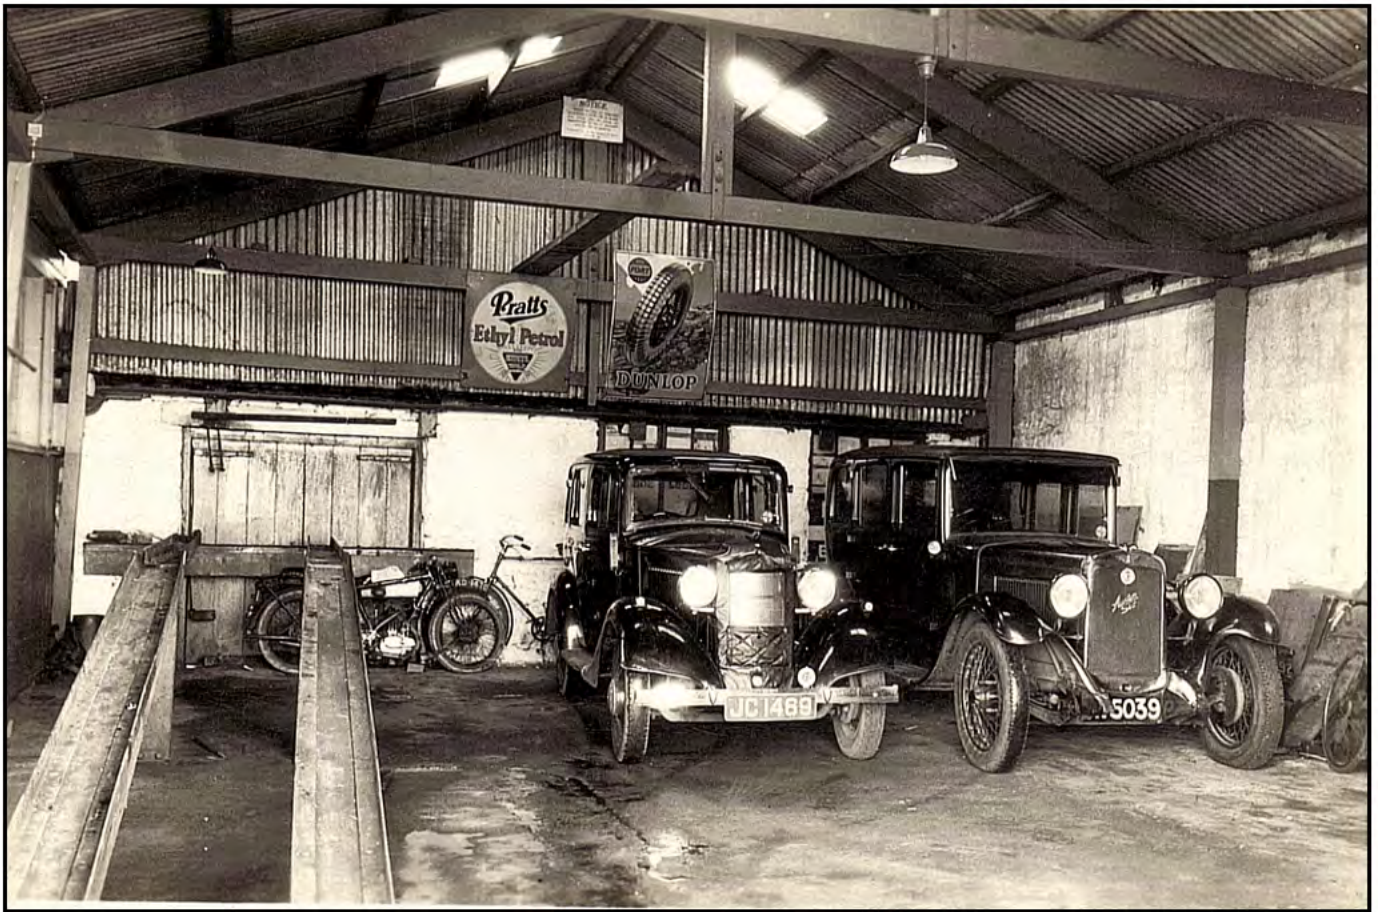
Plate 38: YARD 4 (PRN 30463) Building 04 (PRN 30464): reproduction of archive image CP 341/2 detailing former use. Business owned and operated by Mr. Higginbottom as a garage.

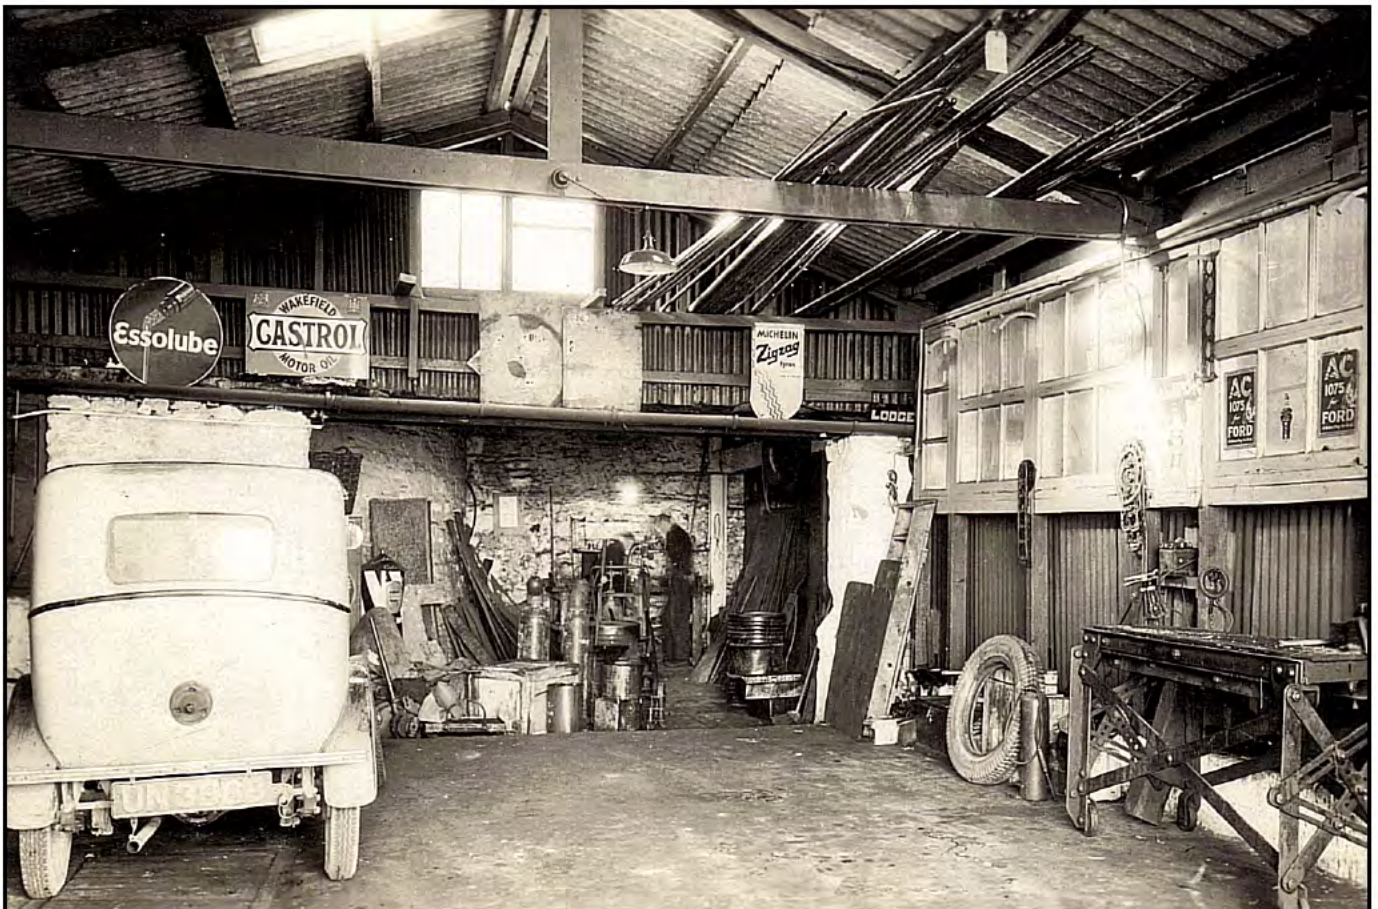
Plate 39: YARD 4 (PRN 30463): Building 14 (PRN 30465): reproduction of archive image CP 341/3 detailing former use. Business owned and operated by Mr. Higginbottom as a garage. Former front of Building 14 can be seen towards right of image.

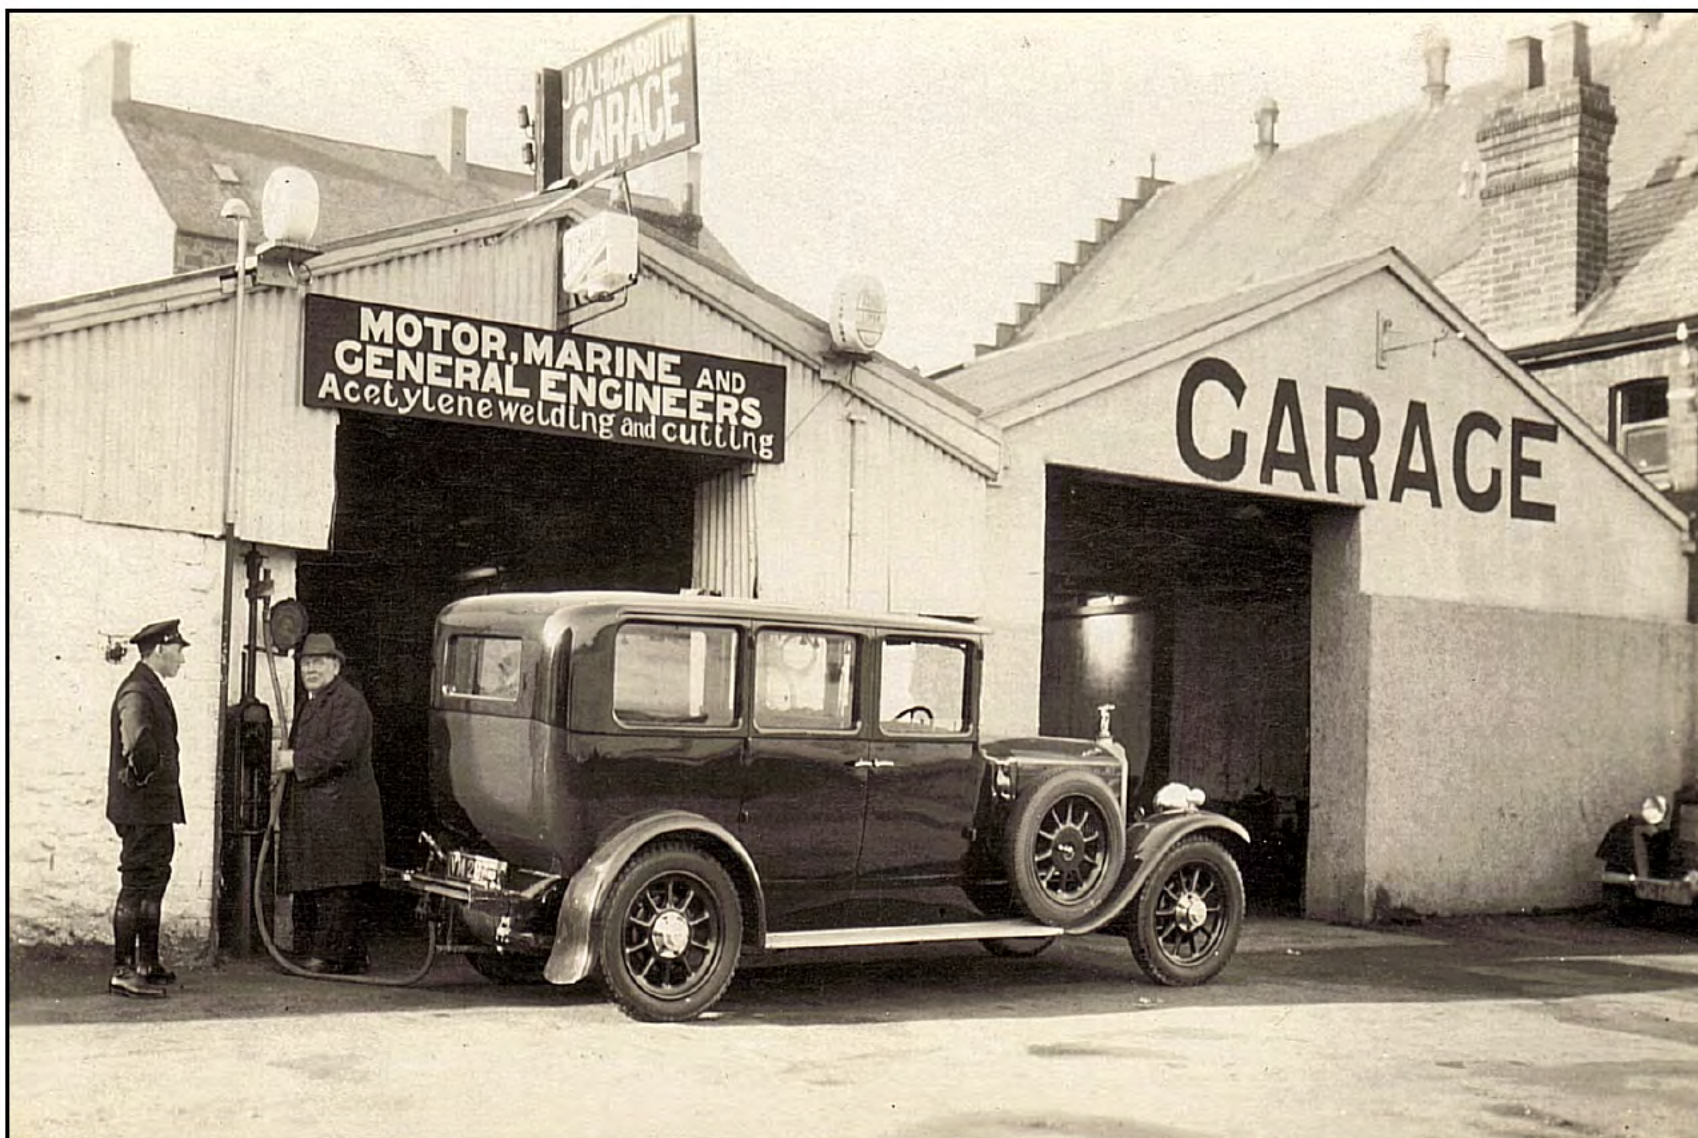
Plate 40: Plate 38: YARD 4 (PRN 30463) Building 04 (PRN 30464): reproduction of archive image CP 341/1 detailing former use. Business owned and operated by Mr. Higginbottom as a garage. Mr. A. Higginbottom can be seen fuelling a car at a petrol pump

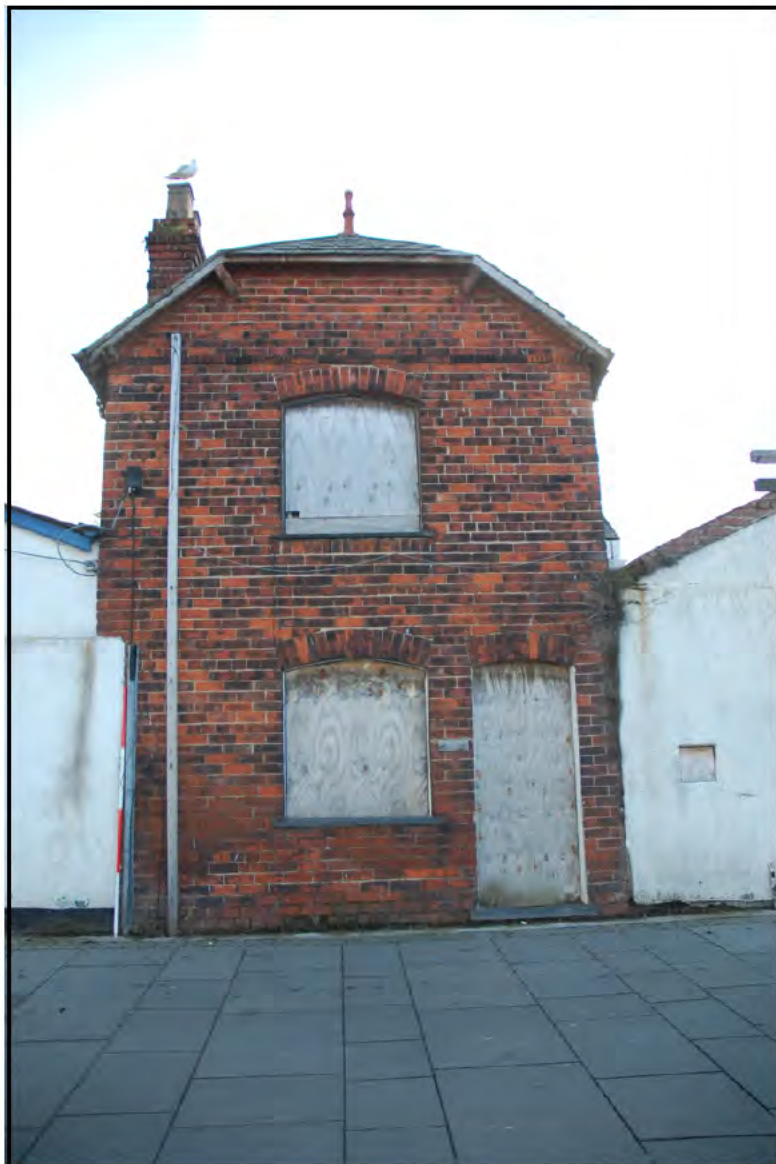
**Plate 42: YARD 5 (PRN 30468): Building 05 (PRN 30469): east-facing elevation (quay side): a small two storey building in red brick (English Garden Bond) with a hipped roof of slate with ceramic ridge tiles.  
(Ranging pole: 1.0m)**

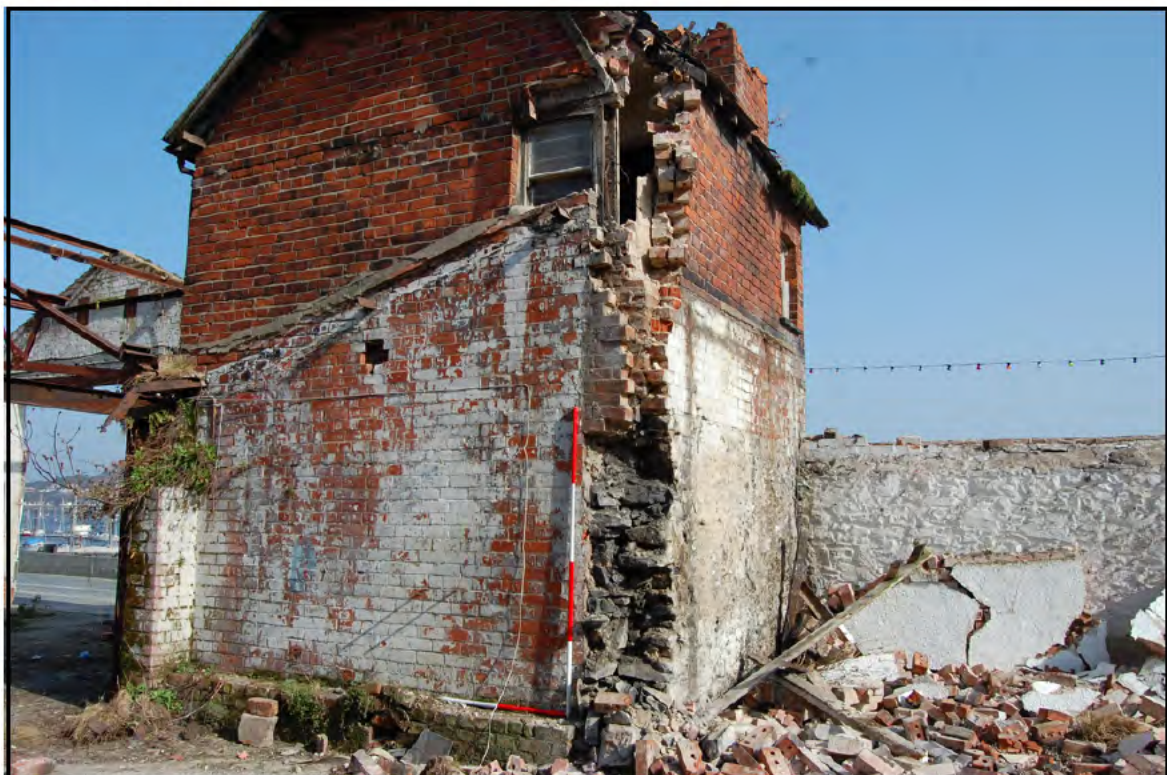
**Plate 43: YARD 5 (PRN 30468): Building 05 (PRN 30469): image taken within YARD 5 during demolition phase: the original stone cross-wall (Cross Wall C) that formed the southern boundary of the yard, had been incorporated into the southern elevation of Building 05, with the upper floor built of brick. The former outline of Building 15 (PRN 30471) is visible along the west facing elevation of Building 05.**

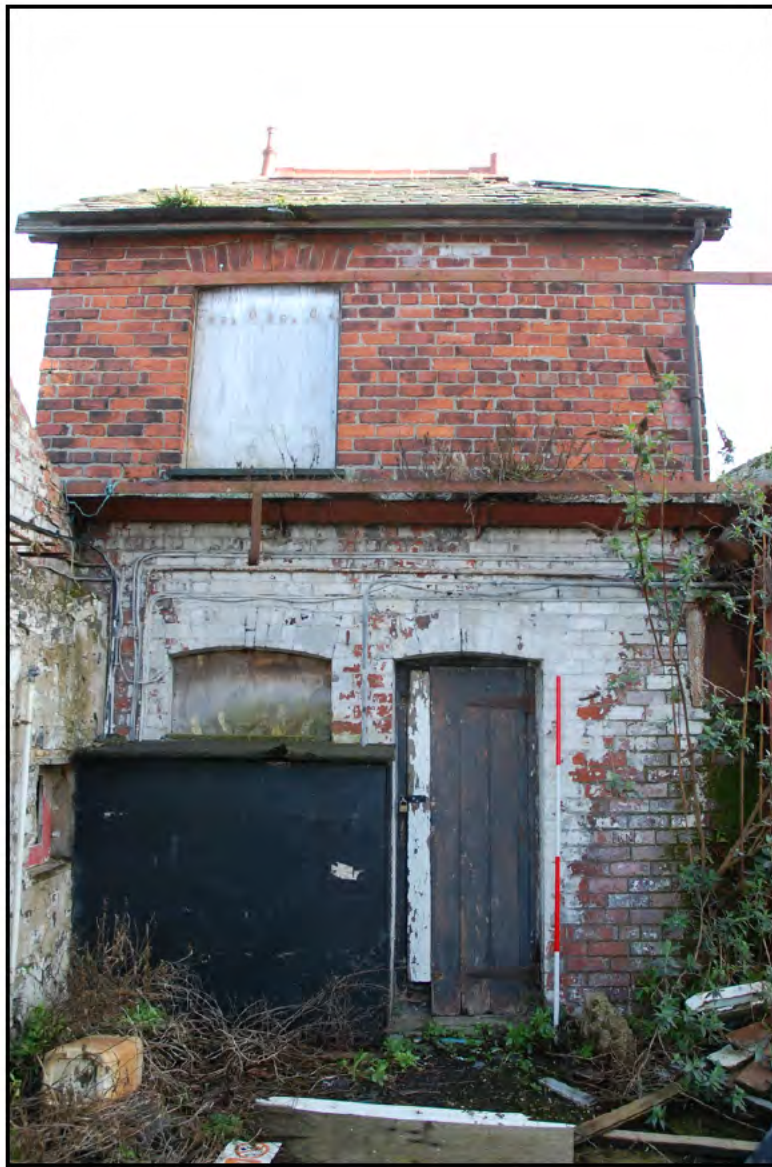
**Plate 44: YARD 5 (PRN 30468): Building 05 (PRN 30469): north facing elevation: detailing entrance into structure. This elevation is visible in Plate 41 on the architects elevation drawing from 1882 (CM&P 23/1/55). The metal roof frame covering YARD 5 is also visible. (Ranging pole: 2.0m)**

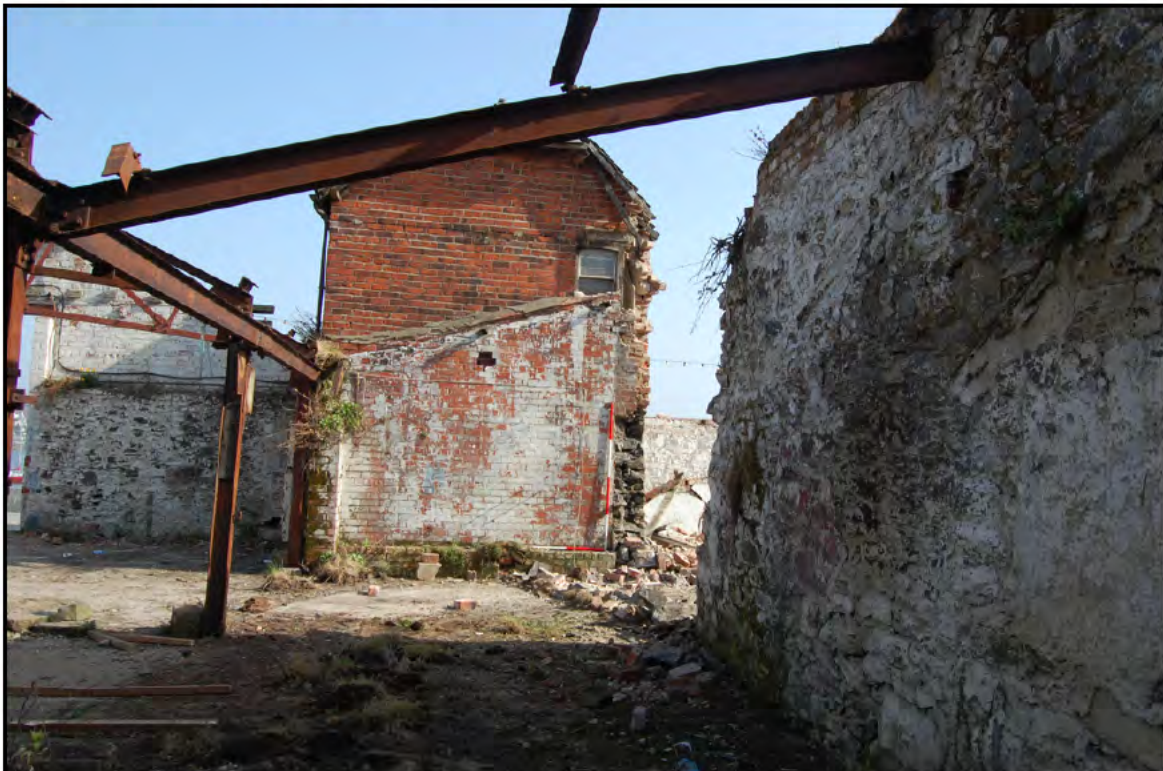
**Plate 45: YARD 5 (PRN 30468): Building 05 (PRN 30469): west-facing elevation detailing former location of Building 15, as well as Cross Wall C and the roof supports for YARD 5 (Ranging pole: 2.0m)**

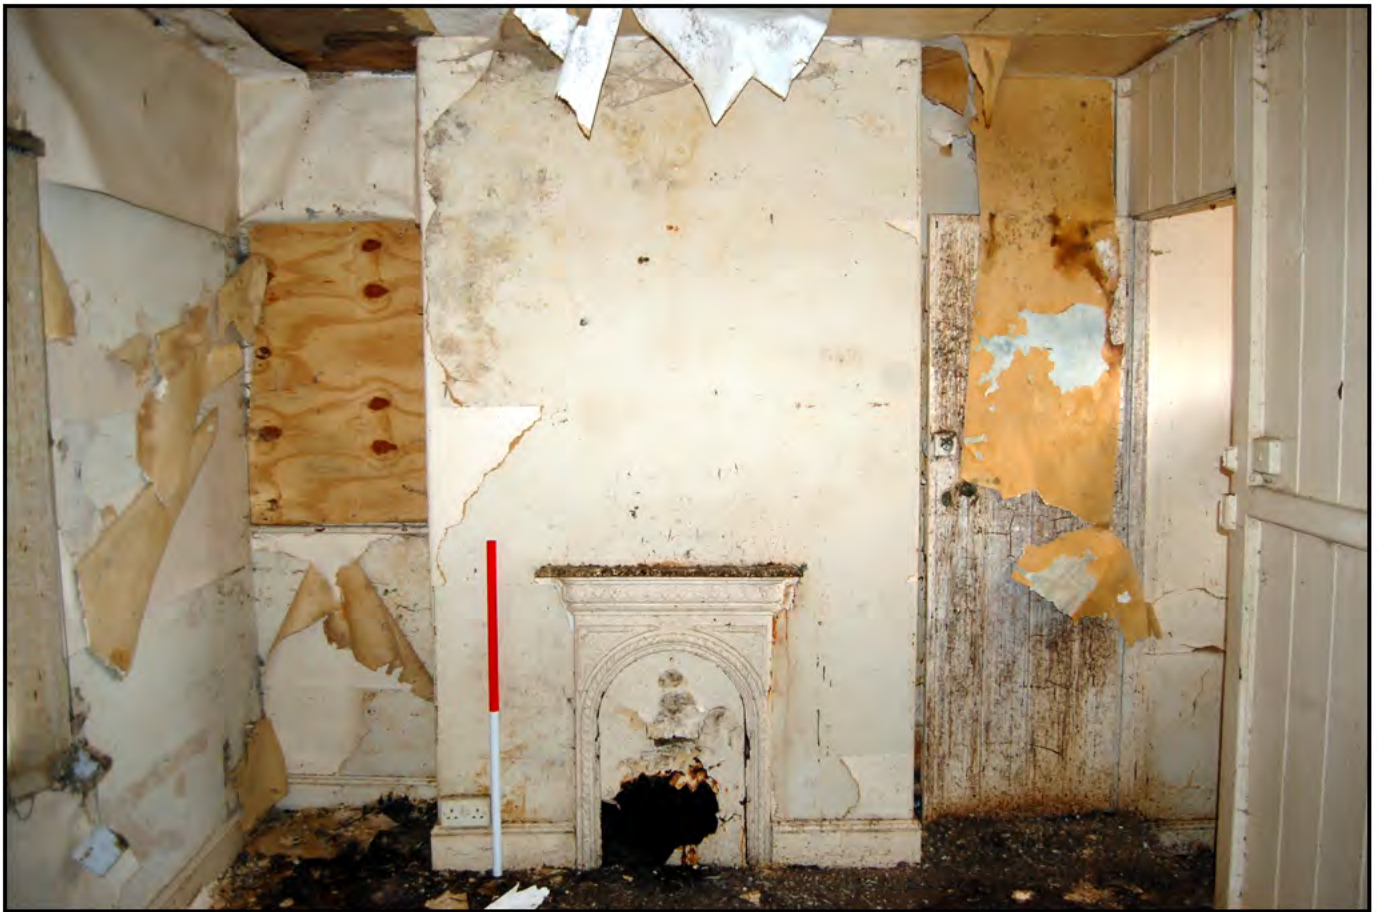
**Plate 46: YARD 5 (PRN 30468): Building 05 (PRN 30469) (internal):**The first floor comprised a single room , with three single-hung sash windows. A small cast iron Victorian arched fireplace remained in situ.

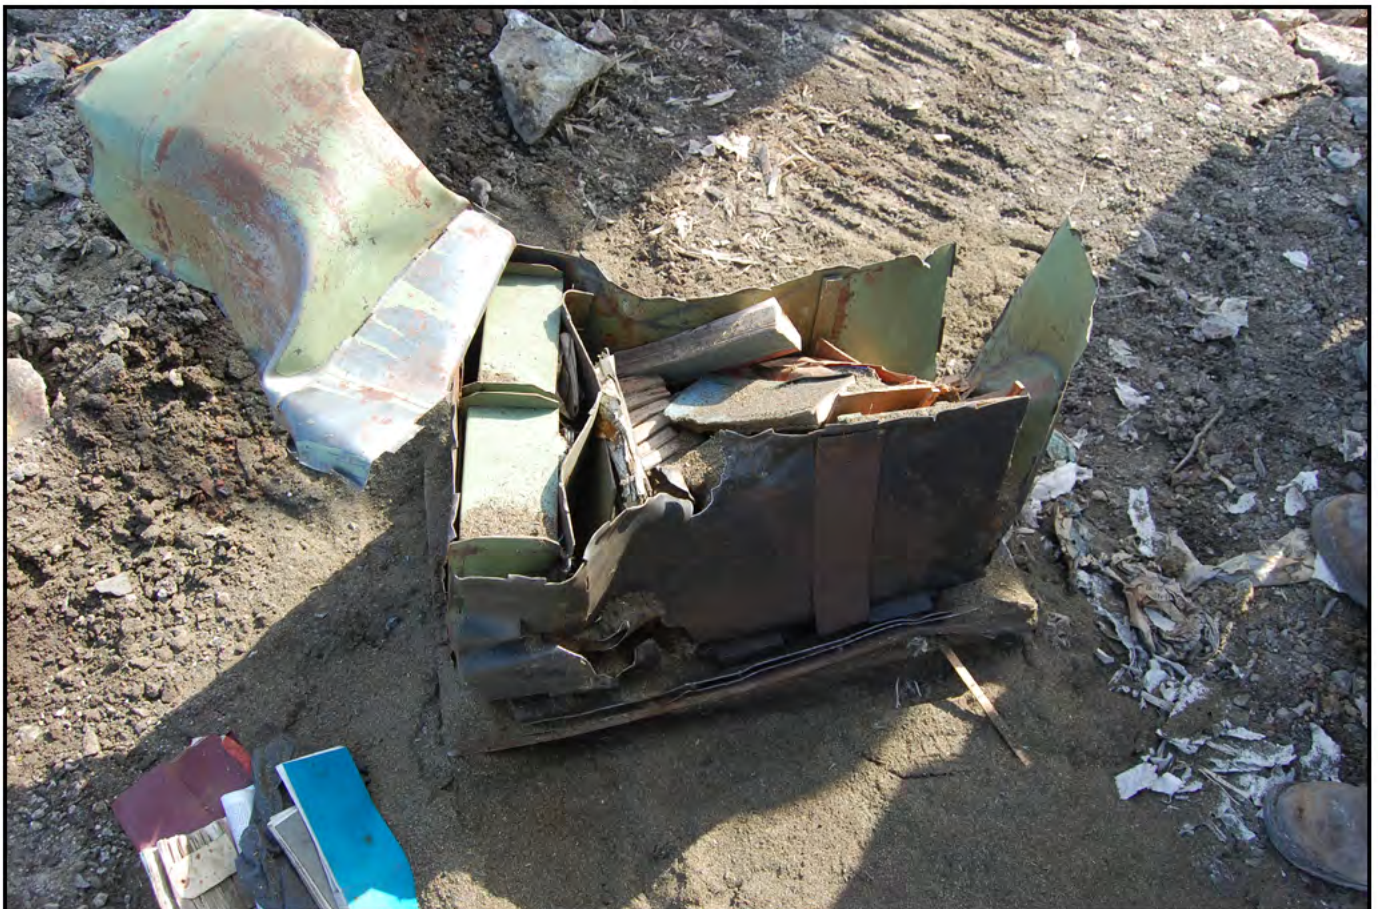
**Plate 47: YARD 5 (PRN 30468): Building 05 (PRN 30469):** A safe found under the stairs of Building 05 during the watching brief was full of papers and cheque book stubs belonging to Higginbottom's dating from the late 1930's to the 1970's. The Higginbottom's took over the property in the 1950's.

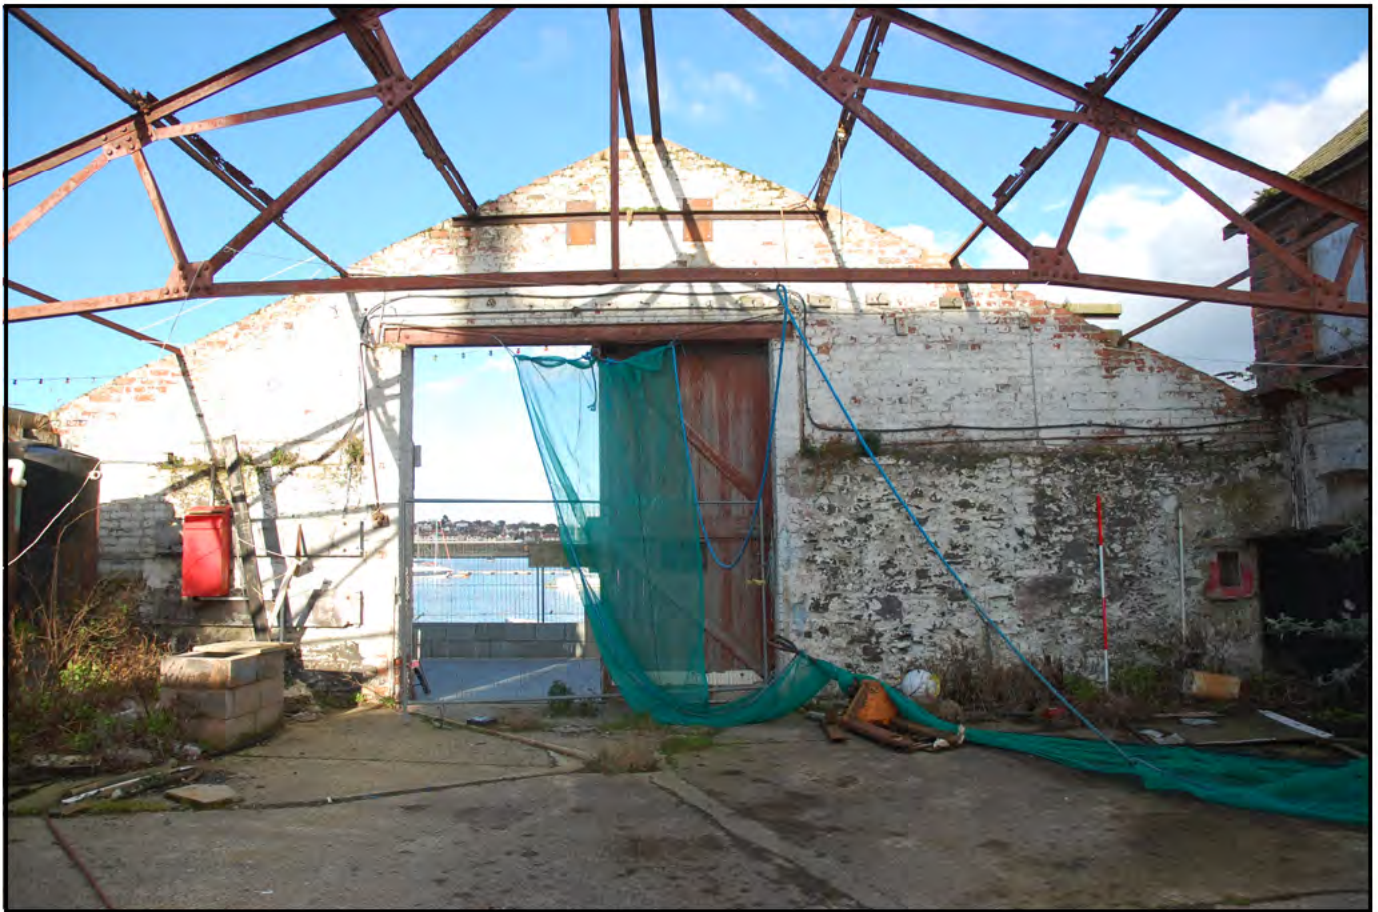
**Plate 48: YARD 5 (PRN 30468): Building 06 (PRN 30470):** this building was, in effect, Yard 5 with a roof on. The building/yard measured 16.4m x 16.0m (l x w), but excluded the south-east corner occupied by Building 05. Wall A (quay enclosure wall) is visible forming part of the east (quay) wall surmounted by brick.  
(Ranging pole: 2.0m)

**Building 06** was, in effect, **Yard 5** with a roof on, measuring 16.4m x 16.0m, but excluding the south-east corner occupied by **Building 05**. The cross walls C (plate 50) and D (plate 51) reached a total height of 2.6m including a 0.4m brick rebuild on the top, which on wall D held the roof supports. Steel girders had also been inserted into the town wall as part of the roof structure. There was also a 0.40 m high dwarf brick wall built against the bottom of Cross Wall D but the function was unknown (plate 51). Cross Wall D had been partly repaired in brick at the east end (plate 51).

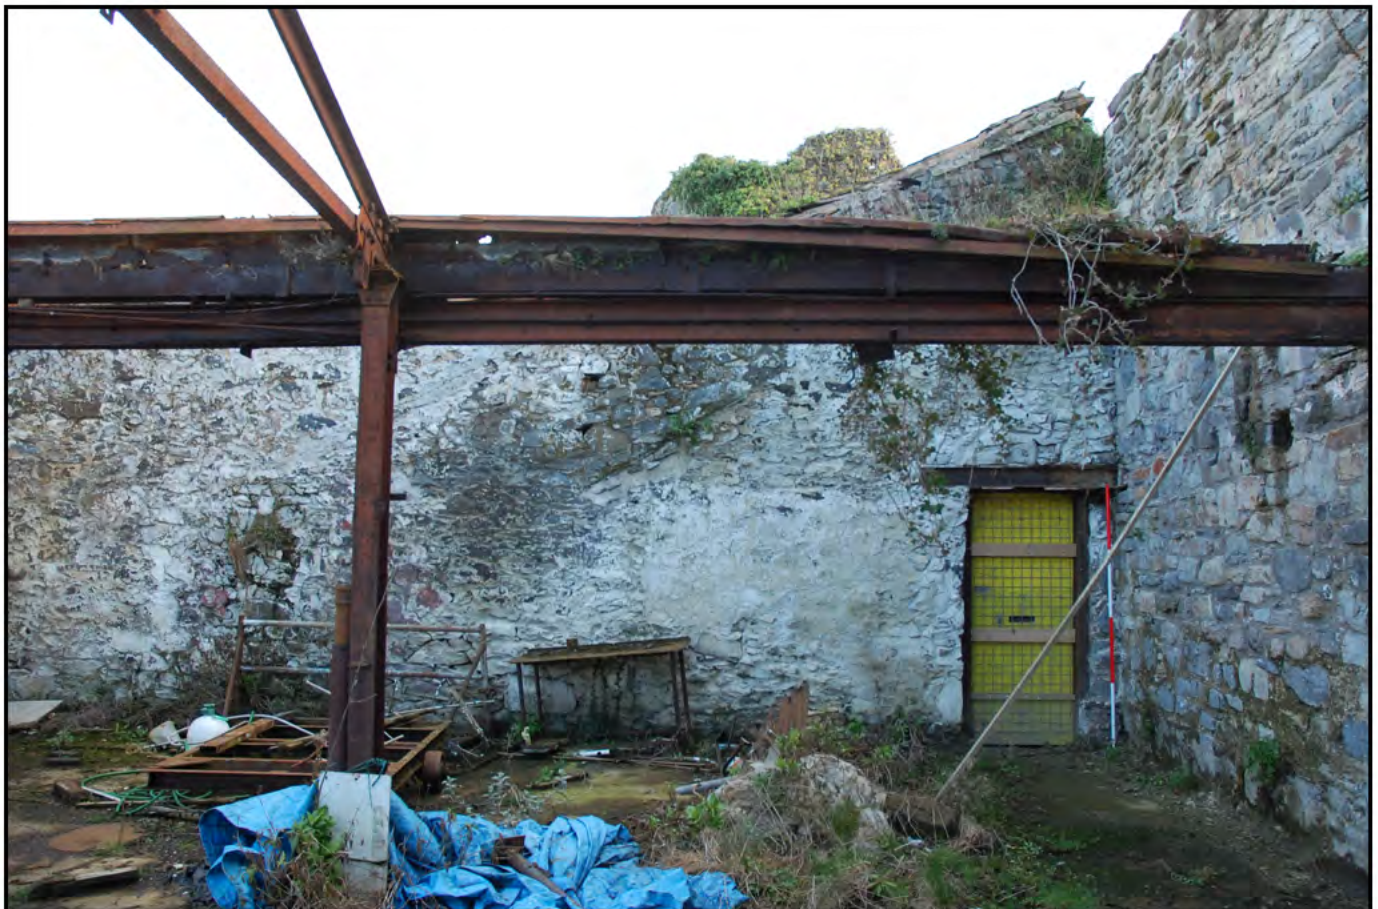
**Plate 49: YARD 5 (PRN 30468): north facing elevation (formerly Cross Wall C).** A door leading to Building 04/14 is visible, which was inserted in the 1970s. the former roofline of Building 16 (30472) is visible as is Building 04 (PRN 30464).  
(Ranging pole: 2.0m)

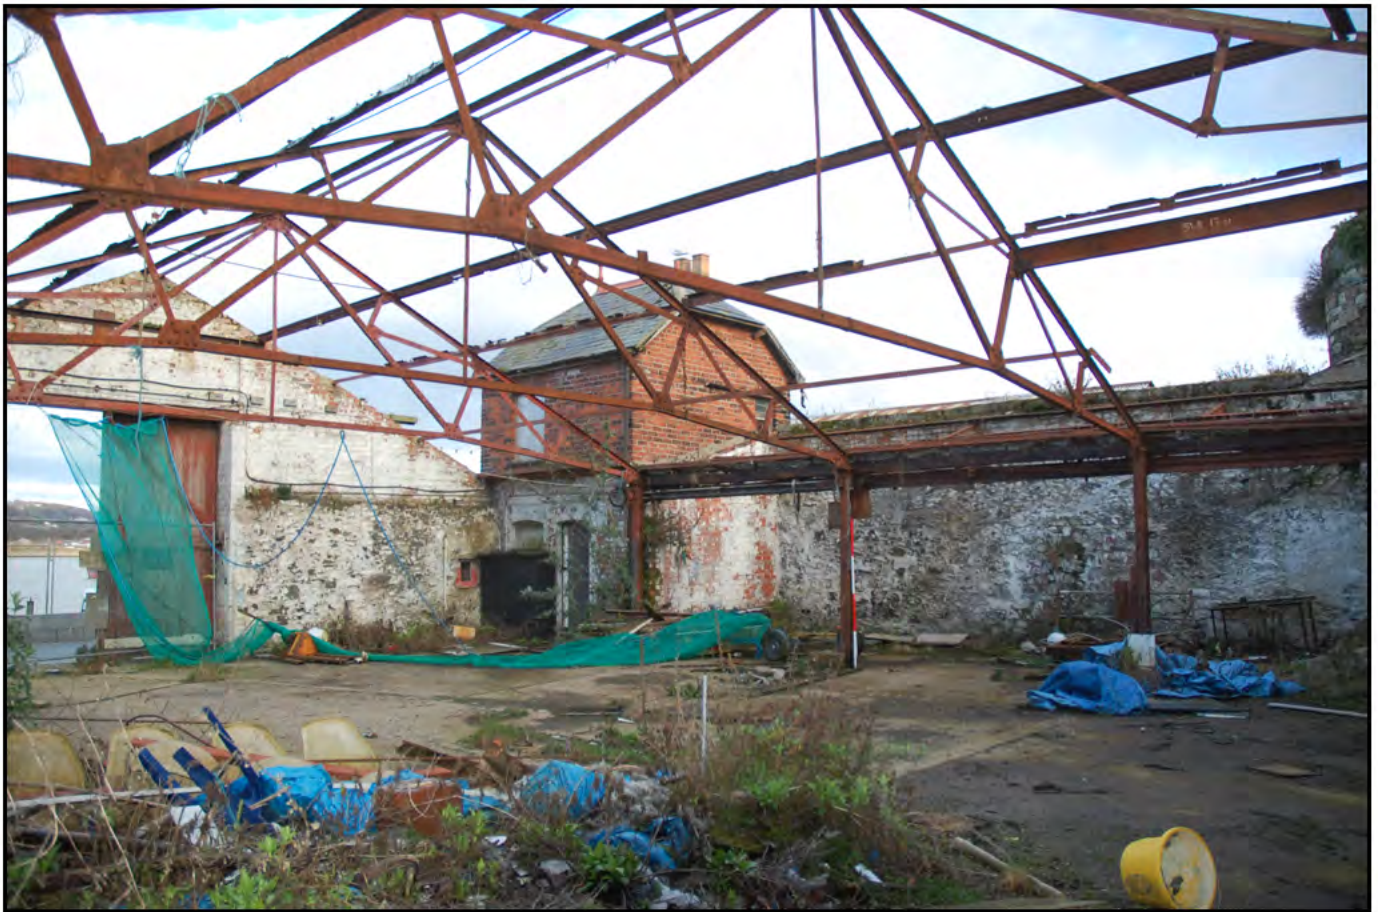
**Plate 50: YARD 5 (PRN 30468): general view of the yard, including Buildings 05 (PRN 30469) and 06 (PRN 30470), former location of Building 15 (PRN 30471) and Cross Wall C. The most recent usage of the yard was as a welding yard for Higginbottom's, who took over in the late 1950's, by which time the steel girder and corrugated tin roof was already in place. (Ranging pole: 2.0m)**

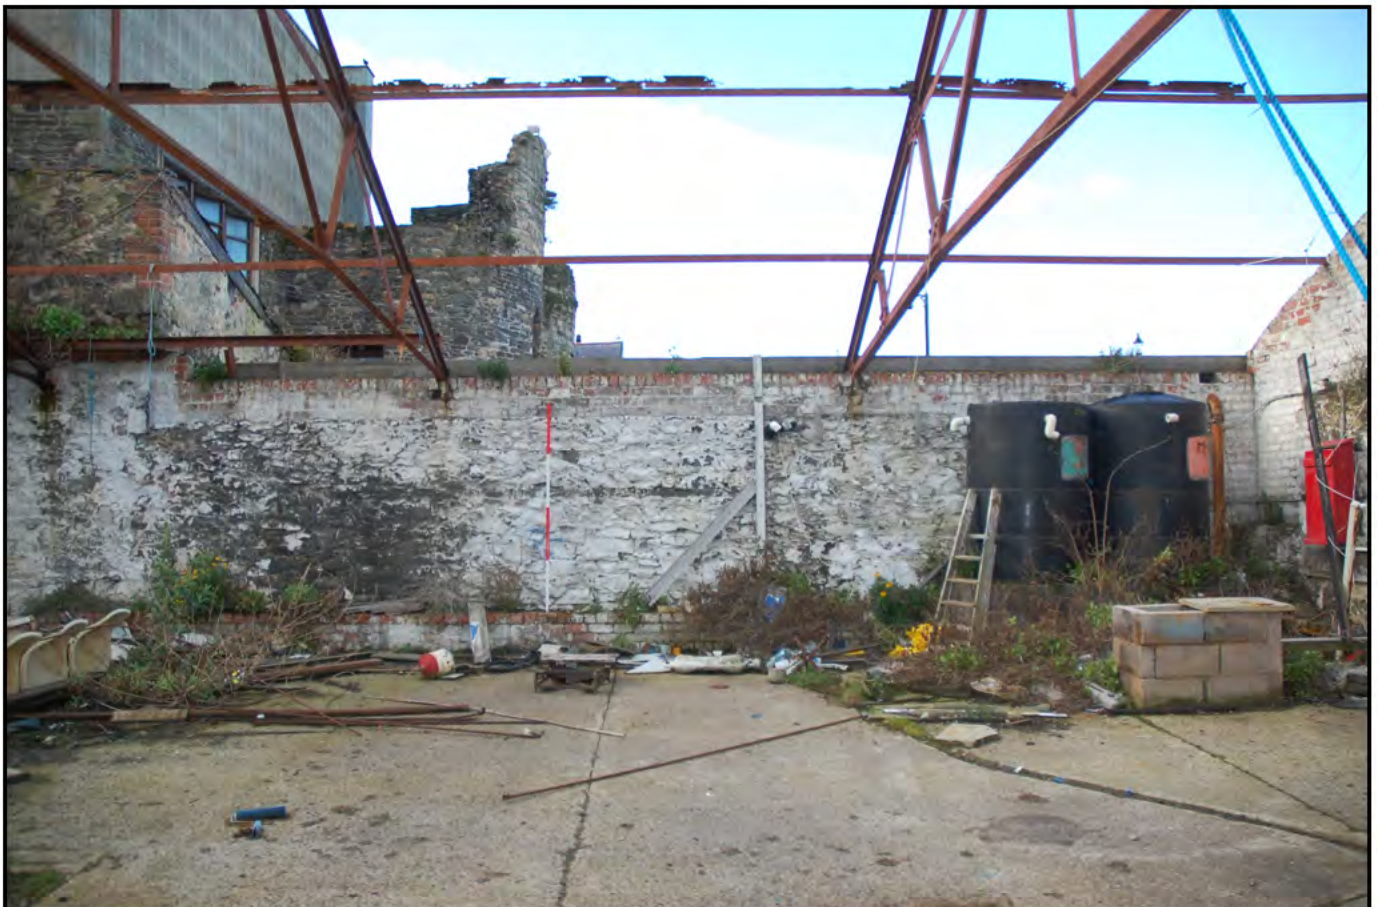
**Plate 51: YARD 5 (PRN 30468): Cross Wall D: view north of elevation, which formed the northern boundary of YARD 5. The wall reached a total height of 2.6m including a 0.4m brick rebuild on the top that held the roof supports. Steel girders had also been inserted into the town wall as part of the roof structure. There was also a 0.40 m high dwarf brick wall built against the bottom of Cross Wall D but the function was unknown. Cross Wall D had been partly repaired in brick at the east end plate 51.**

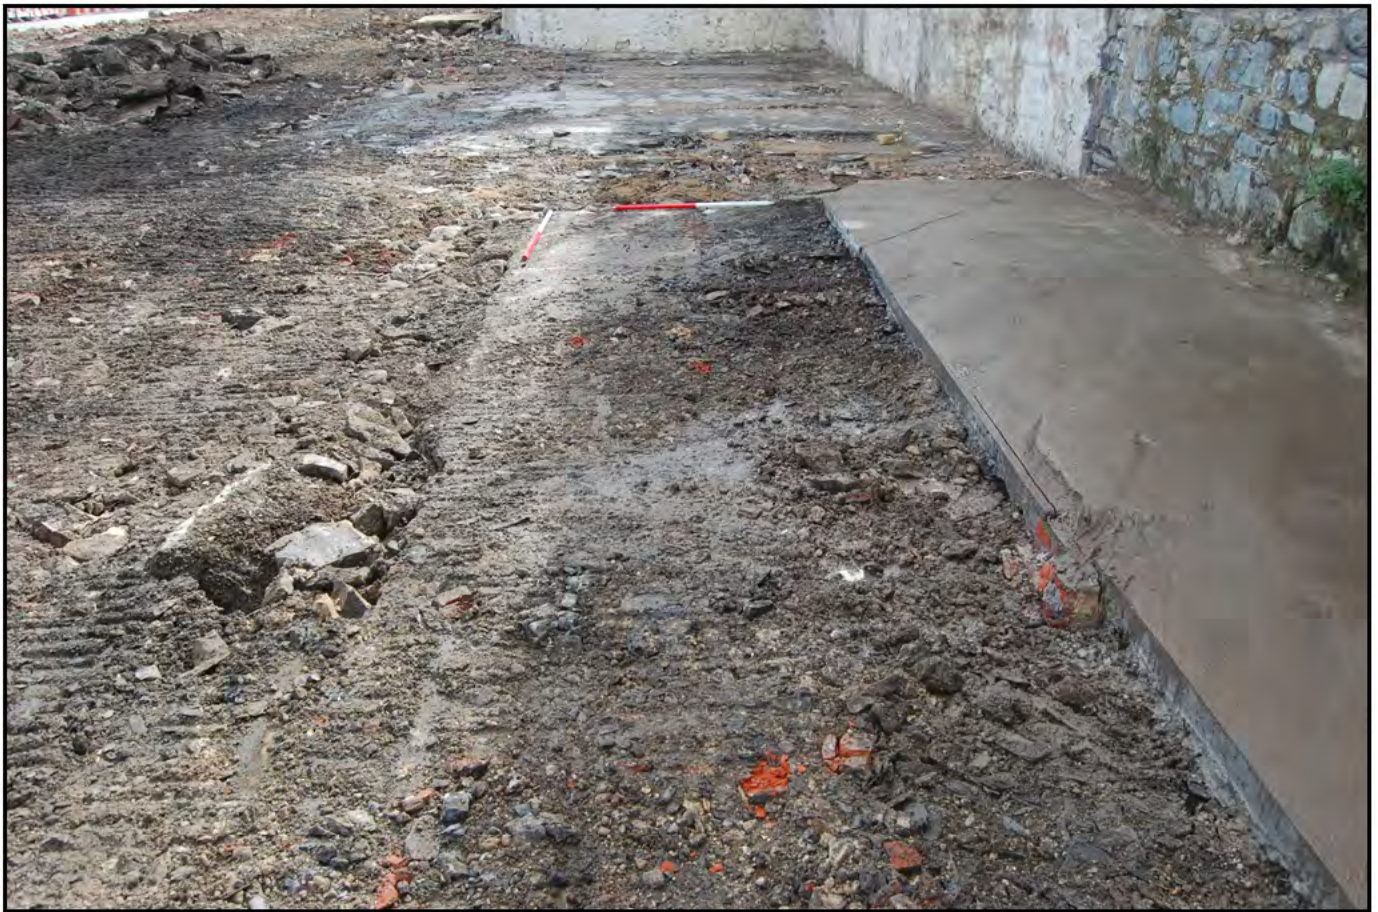
**Plate 52: YARD 5 (PRN 30468): Building 16 (PRN 30472): possible redundant floor surface identified during demolition/watching brief phase.  
(Ranging pole: 2 x 1.0m)**
