# CONWY QUAY REDEVELOPMENT PROGRAMME

## ARCHAEOLOGICAL RECORD & WATCHING BRIEF

### Photographic survey and watching brief

GAT Project No. 2070

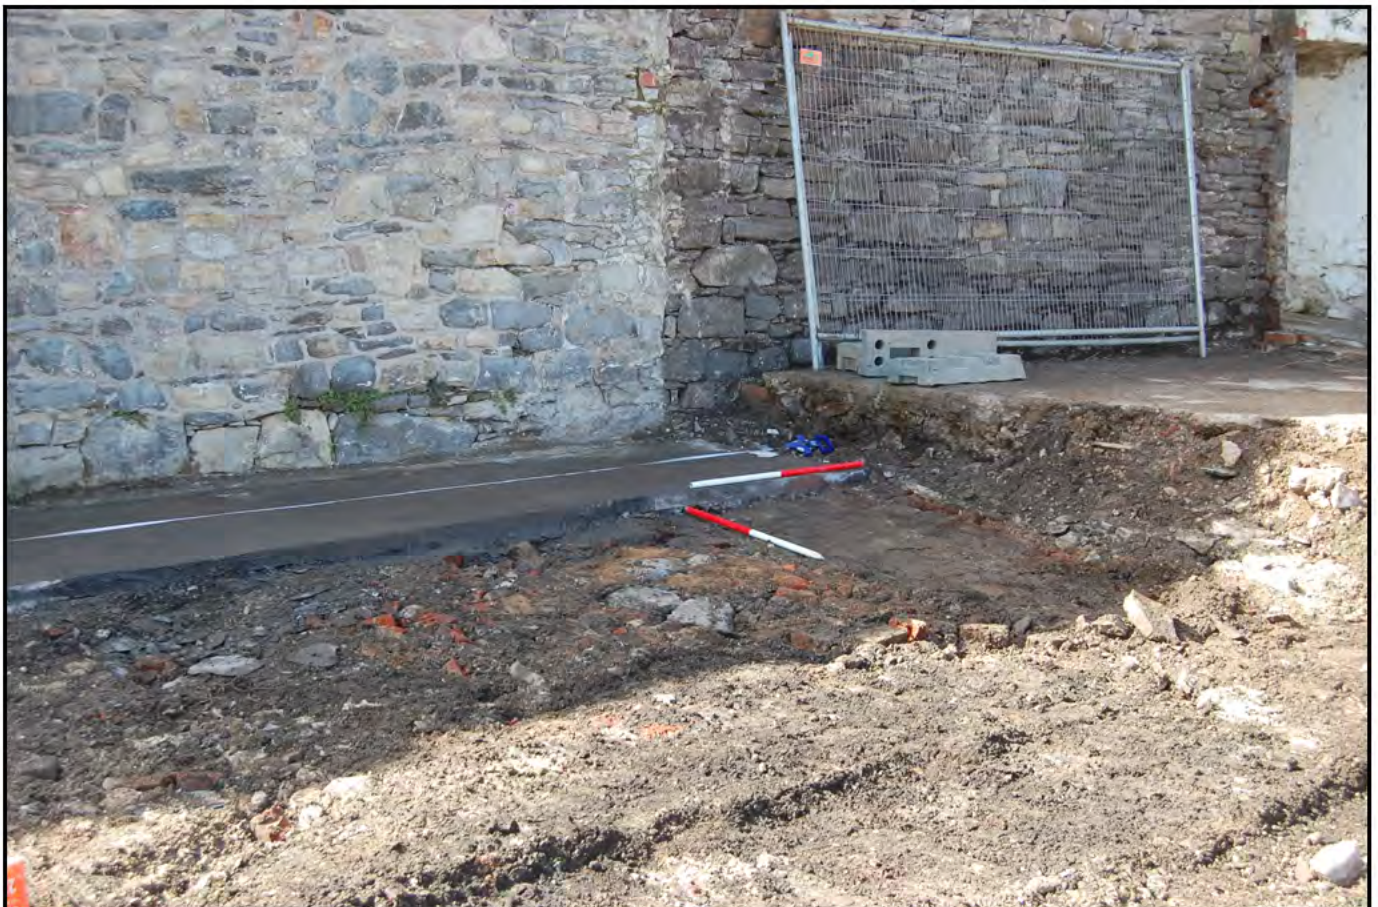
**Plate 53: YARD 5 (PRN 30468): Building 17 (PRN30473): a redundant brick floor surface was identified during the demolition/watchng brief phase and the removal of the modern floor for Building 06 (PRN 30470)/Yard 5 (PRN 30468). This was thought to be the smithy shown occupying the NW corner of Yard 5 on the 1901 plan for the slaughterhouse (CMP23/2/44). No surviving roof line was seen but the town wall within Building 06/Yard 5 has been repaired by Cadw.**

During the process of removing the modern floor (as above) in the NW corner of **Building 06/Yard 5**, a brick floor surface was found (plate 53). The bricks were worn smooth and rounded (plate 54) and although the floor was fragmentary enough was found and cleaned to suggest a floor plan of approx. 3.6m along the axis of the town wall and 4.15m along the axis of Cross Wall D (if it continued under the modern concrete to the town

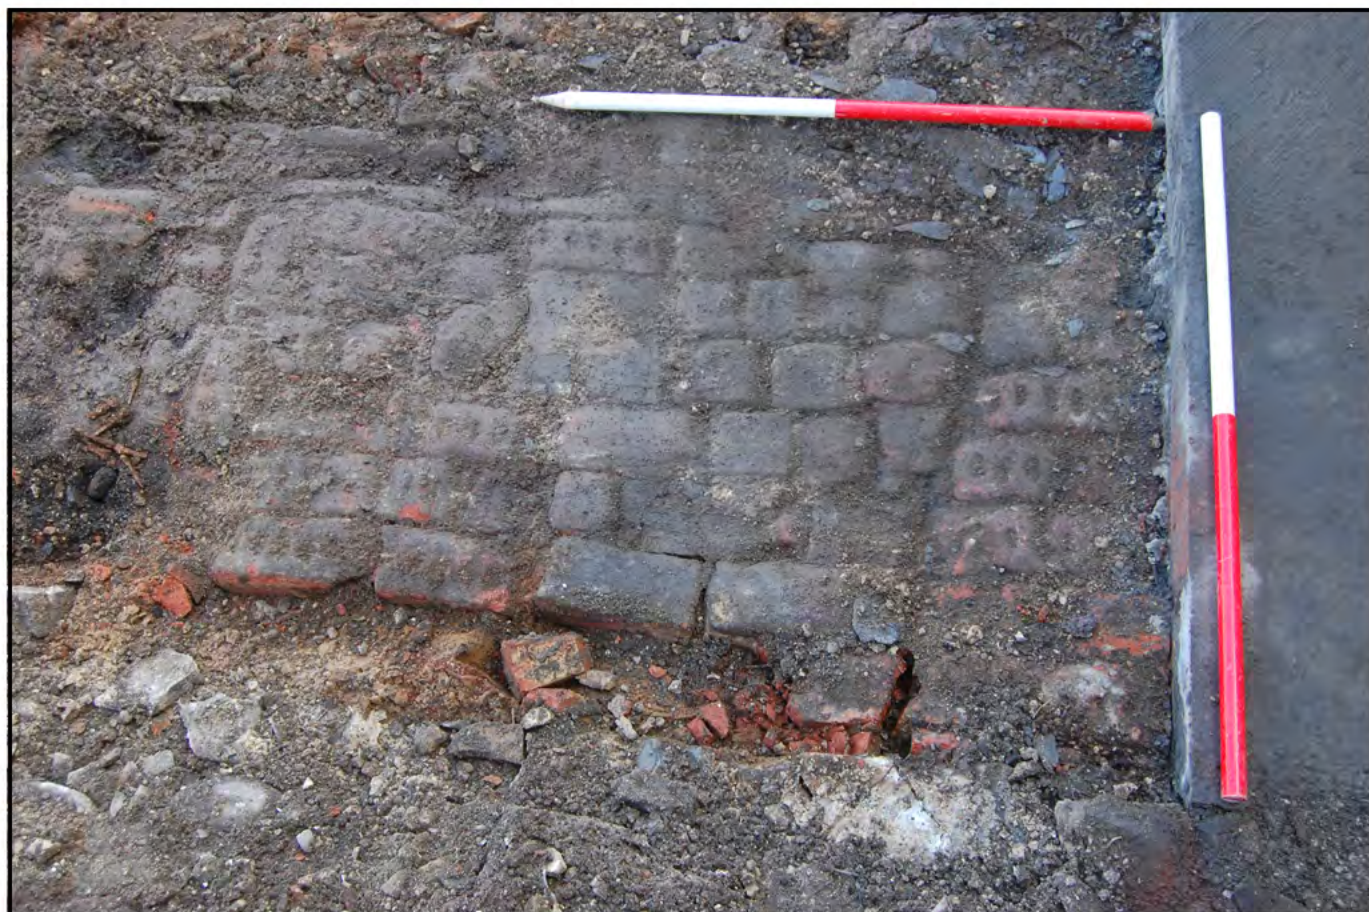
**Plate 54: YARD 5 (PRN 30468): Building 17 (PRN 30473):** a redundant brick floor surface identified during the demolition/watching brief phase and the removal of the modern floor for Building 06/Yard 5. This was thought to be the smithy shown occupying the NW corner of Yard 5 on the 1901 plan for the slaughterhouse (CMP23/2/44). A floor plan of approx. 3.6m along the axis of the town wall and 4.15m along the axis of Cross Wall D (if it continued under the modern concrete to the town wall). A small sample of coal and rusted nails was recovered from a deposit on the brick floor.

wall). This was thought to be the smithy shown occupying the NW corner of **Yard 5** on the 1901 plan for the slaughterhouse (**CMP23/2/44**). A small sample of coal and rusted nails was recovered from a deposit on the brick floor. No surviving roof line was seen but the town wall within **Building 06/Yard 5** has been repaired by Cadw. There was a 4.4 m gap between the north end of the floor of **Building 16** and the south extent of **Building 17**, with disturbed ground between. It is not known if it continued between these points, but OS maps seem to indicate a continuous roof line along the town wall for the full width of **Yard 5** (Figures 07 and 08). Both of these floors (**Buildings 16 and 17**) were, at the time of writing preserved in-situ below the membrane and crushed slate temporary surface (as is the slate floor of **Building 14**) and more information may be gained from a watching brief when this and the remaining concrete is lifted for the new permanent re-surfacing.

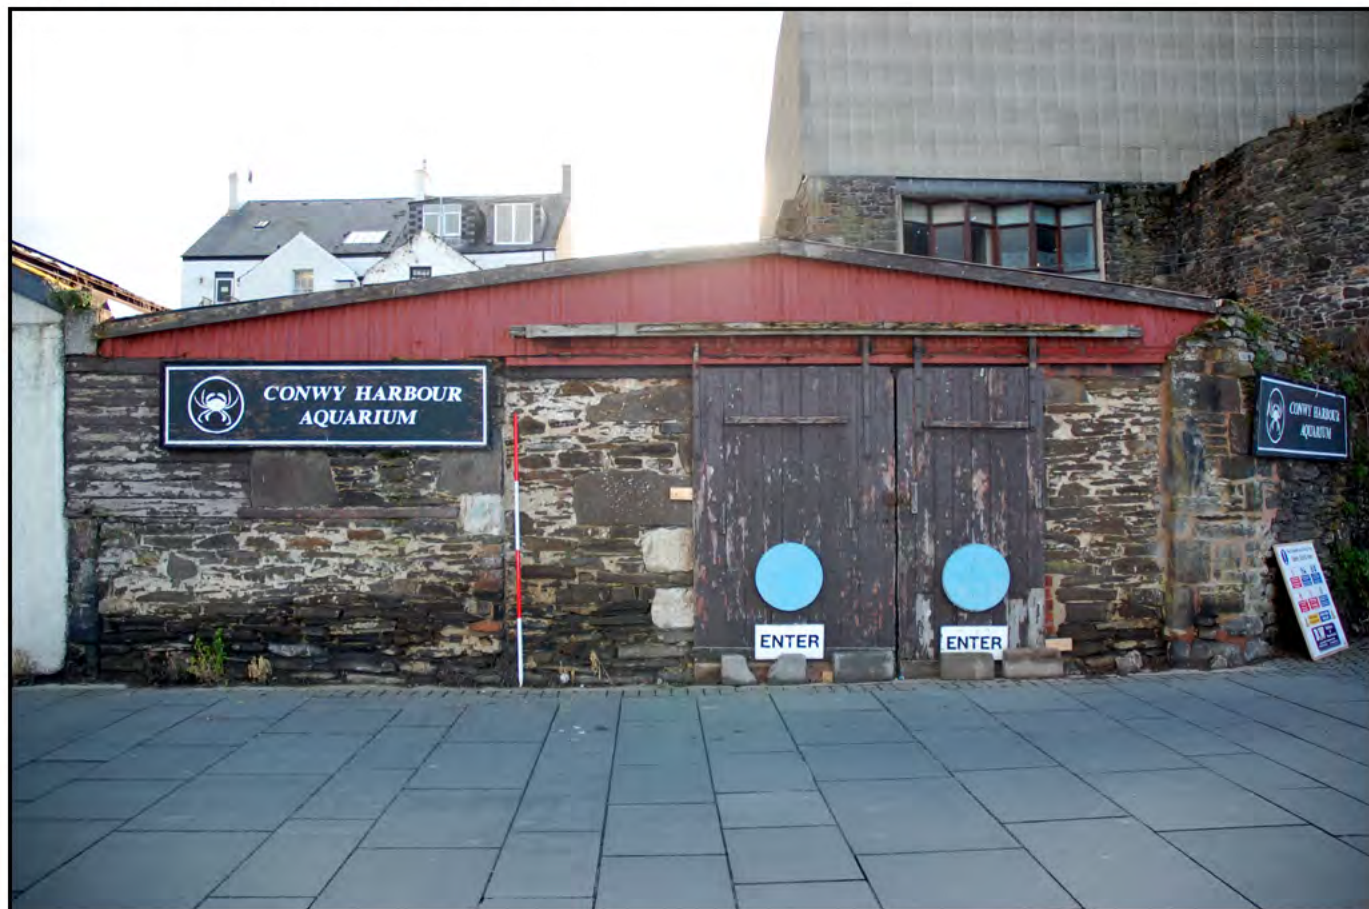
**Plate 55: YARD 6 (PRN 30474): Building 07 (PRN 30475):** east facing elevation: this yard was occupied by a single large building, Building 07 (PRN 30475), the last use of which was as the Conwy Aquarium. This elevation incorporated Wall A (quay enclosure wall)

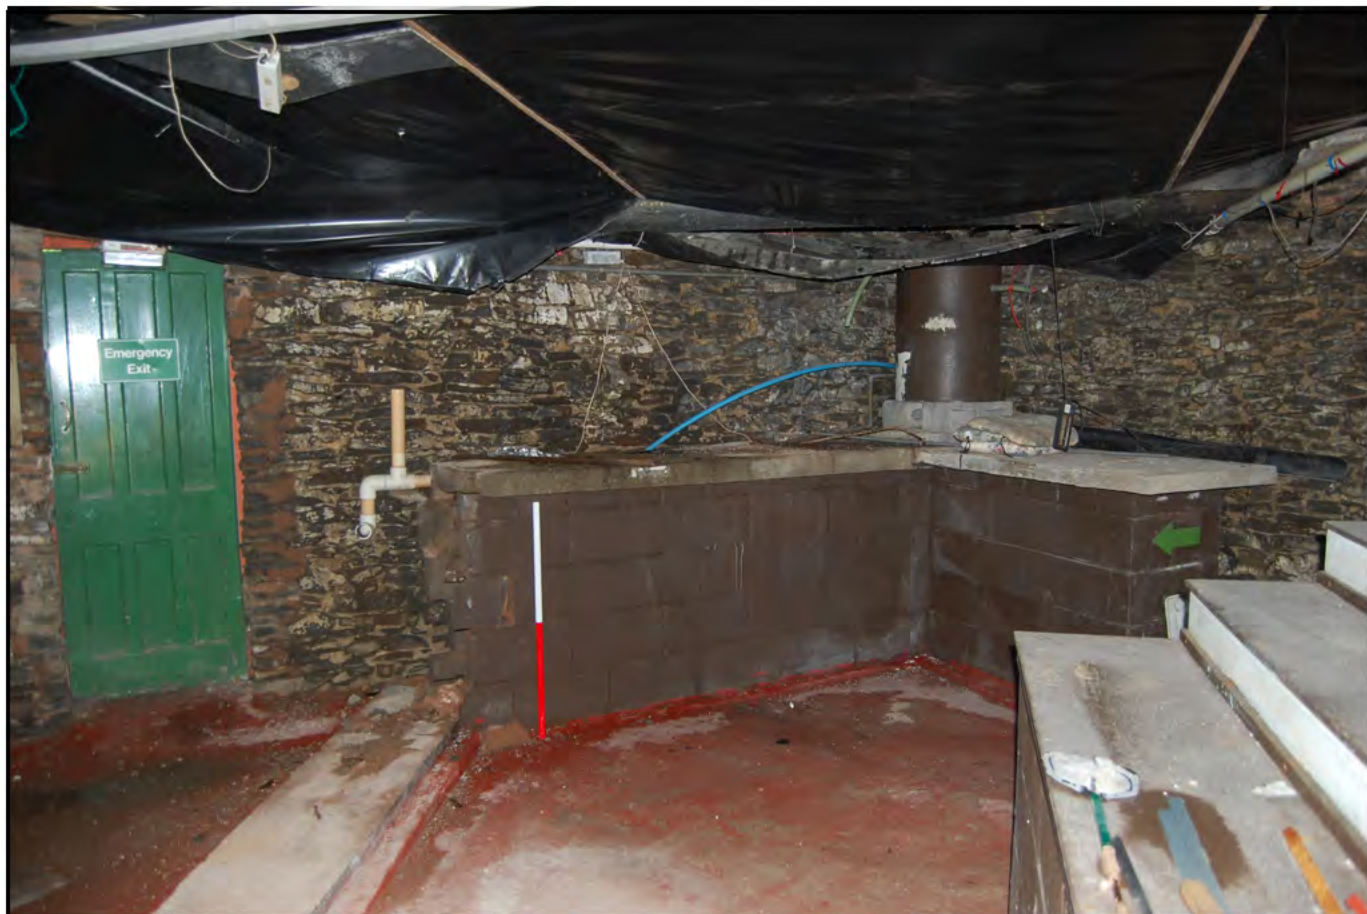
Plate 56: YARD 6 (PRN 30474): Building 07 (PRN 30475): internal view of final usage as aquarium (Ranging pole: 1.0m)

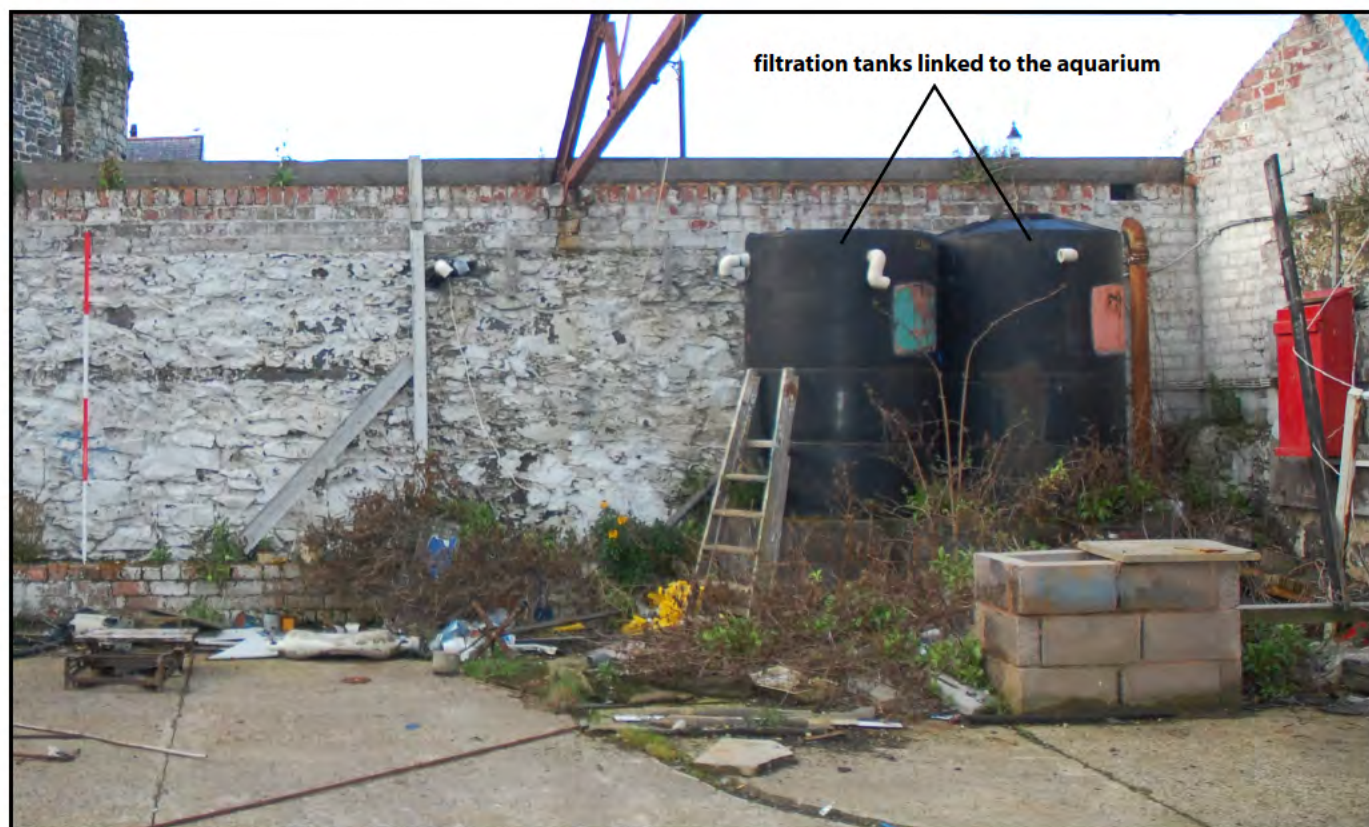
Plate 57: YARD 6 (PRN 30474) Building 07 (PRN 30475): view from YARD 5 (PRN 30468) of location of the two modern filtration tanks linked to the aquarium. Located at right of image. (Ranging pole: 2.0m)

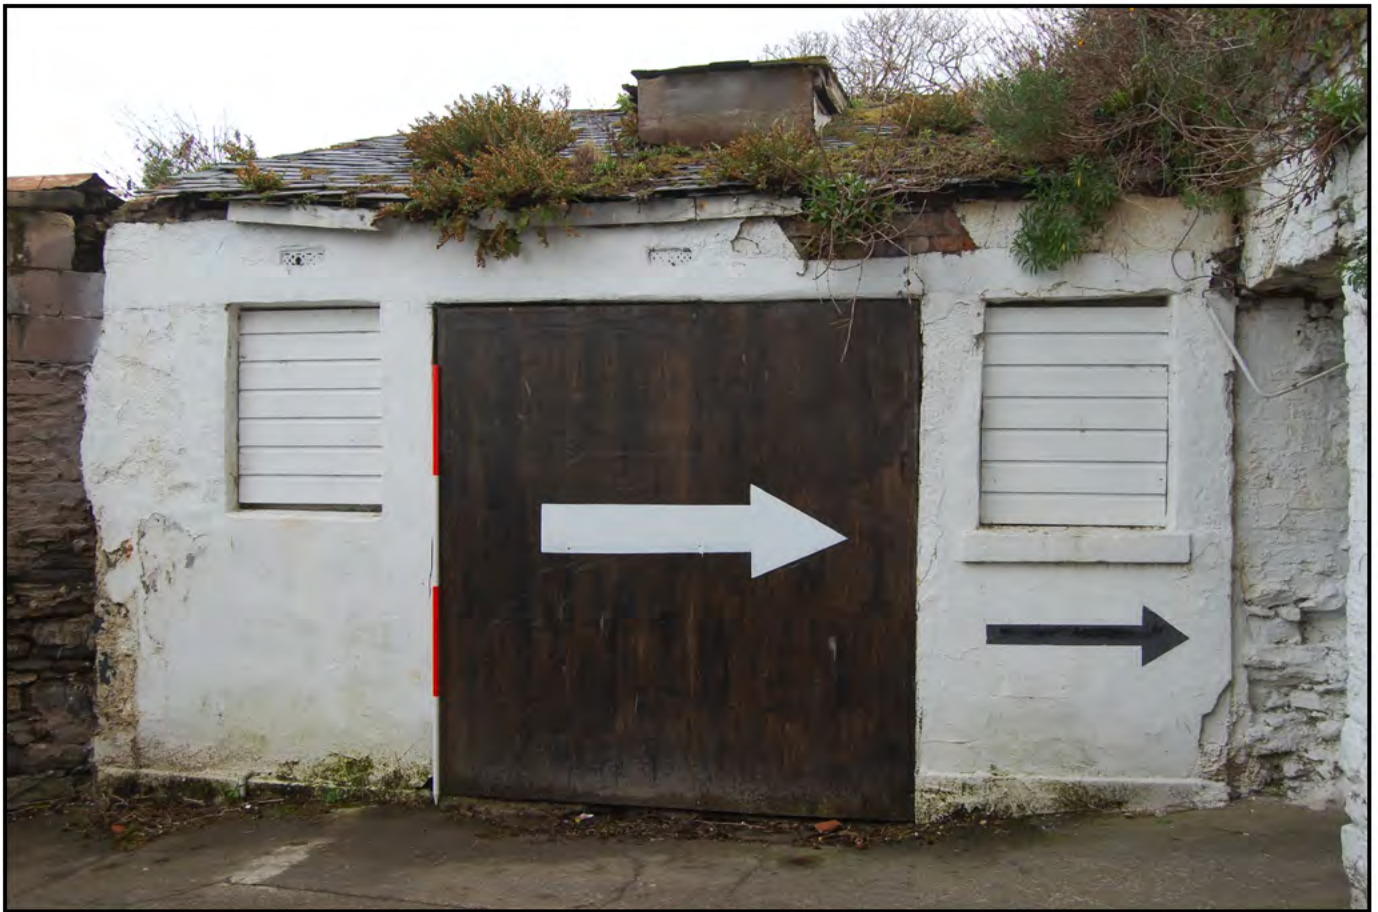
**Plate 58: YARD 6 (PRN 30474): Building 08 (PRN 30476): north facing external elevation. Built as a slaughterhouse but final use was as a boatman/fisherman store.  
(Ranging pole: 2.0m)**

The building was recently used as a casual boatman/fisherman store and floats and various items were found inside, but was essentially, still in its original condition (plate 58). Internally, there was a range of metal rails with sliding hooks on all elevations, except the front (plate 59). There was a large metal hand winch set on the NE wall, and various work benches (plate 60). One of the few variations from the plan was a large iron ring that was to be affixed through the SW wall into the town wall behind. The only iron ring was actually found in the SE (rear elevation) through **Cross Wall D**, and held by a metal cross member seen in the wall in **Building 06/Yard 5**. Internally, there was also a large square sectioned wooden beam with an arrangement of rails and hooks attached.

Single storey structure described on Conwy Quay Redevelopment Drawing CEU901.09/01 02 as “Small Store”. The NW elevation was the only visible/accessible elevation (plate 58). This elevation measured 5.20m in width and 3.00m in height. This was surmounted by a hip roof, built from slate. The elevation was rendered but an exposed path of brick was visible (plate 58). A 2.40m wide and high entrance was located in the centre of the elevation, with a 1.00m high and wide window on either side. Brick vents (two) and a roof vent were also visible (plate 58).

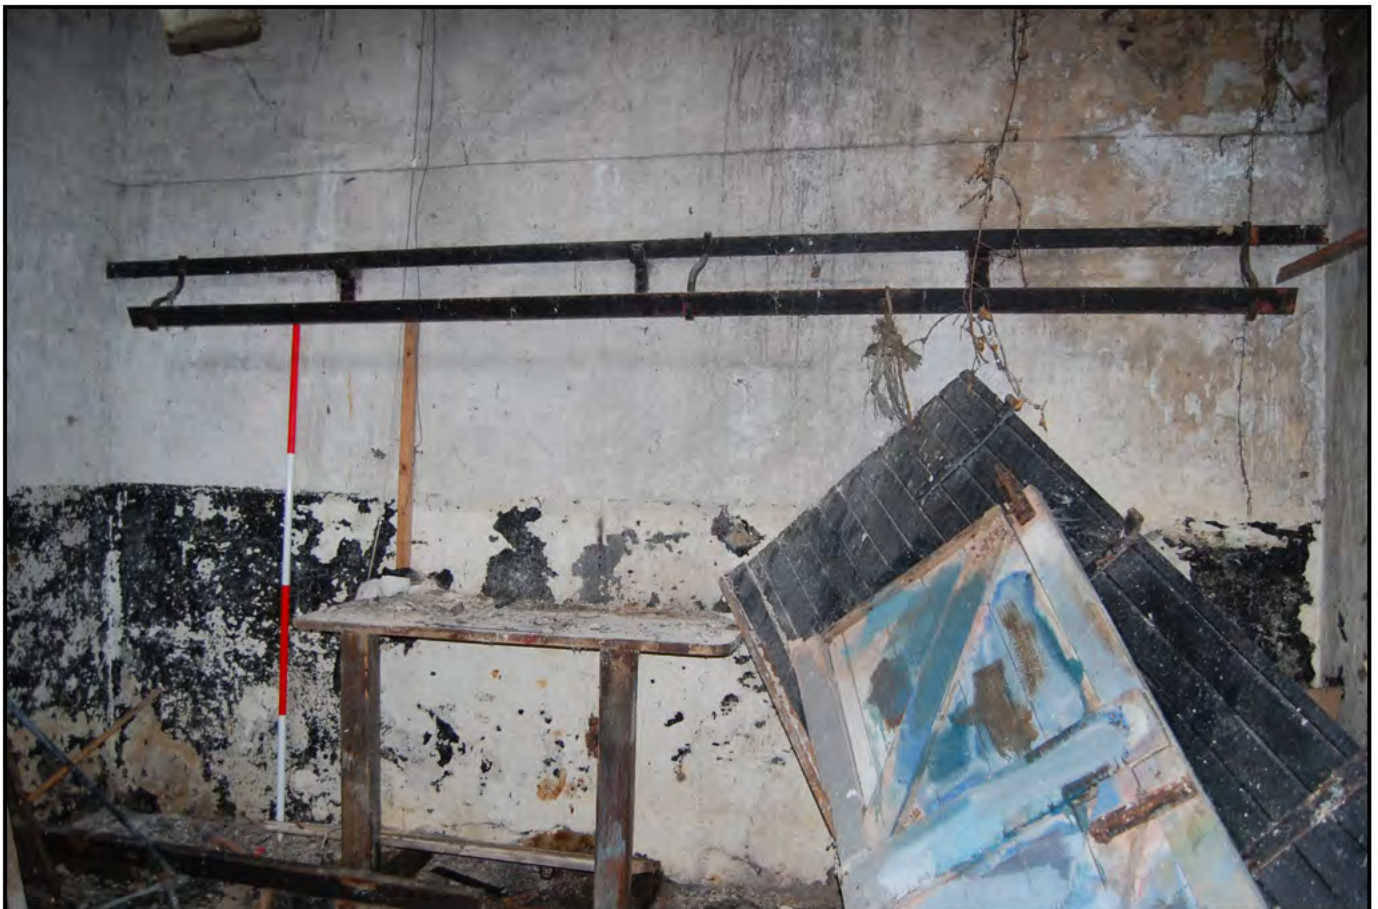
**Plate 59: YARD 6 (PRN 30474): Building 08 (PRN 30476): internal view of former slaughterhouse, a range of metal rails with sliding hooks that were extant on all elevations except the front entrance.  
(Ranging pole: 2.0m)**

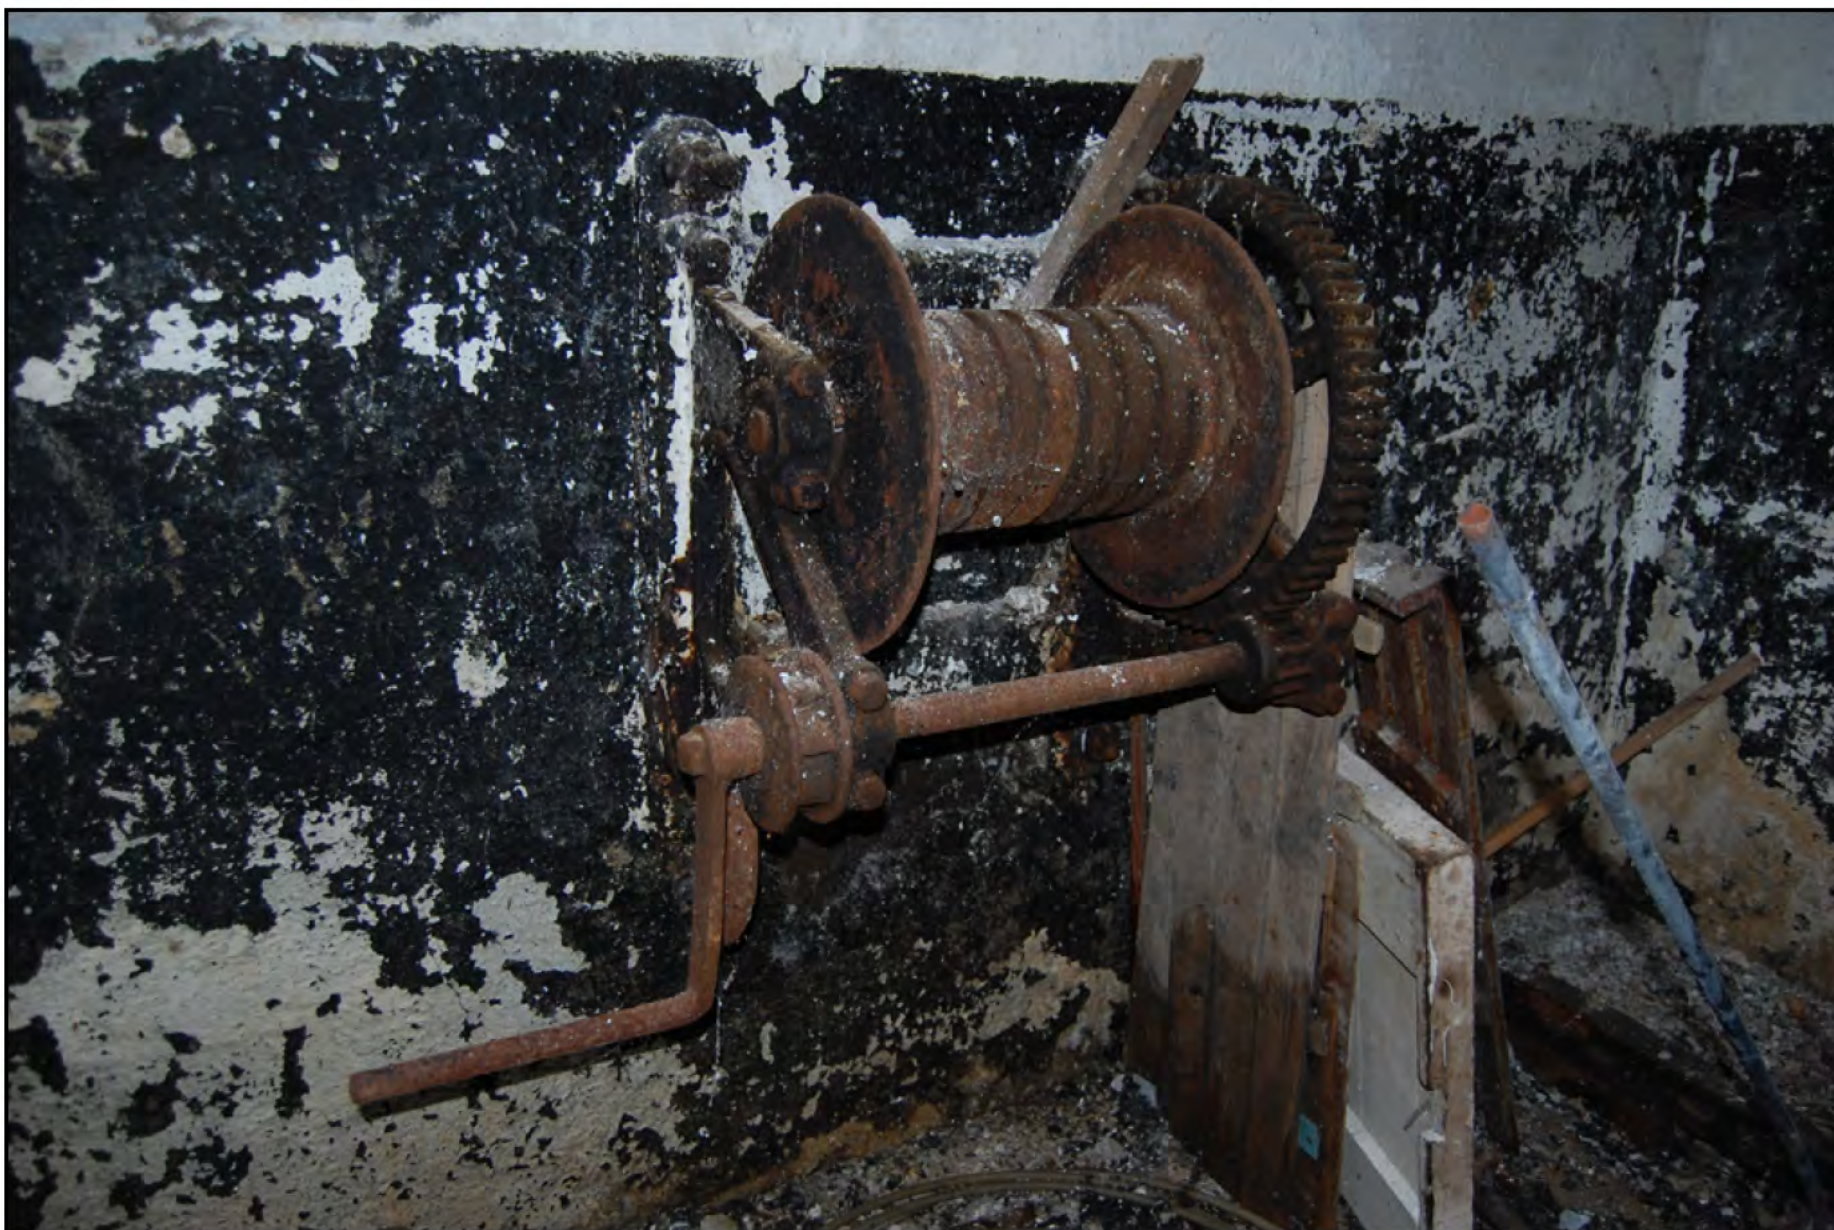
Plate 60: YARD 6 (PRN 30474): Building 08 (PRN 30476) (internal): detail of a large metal hand winch set on the NE wall

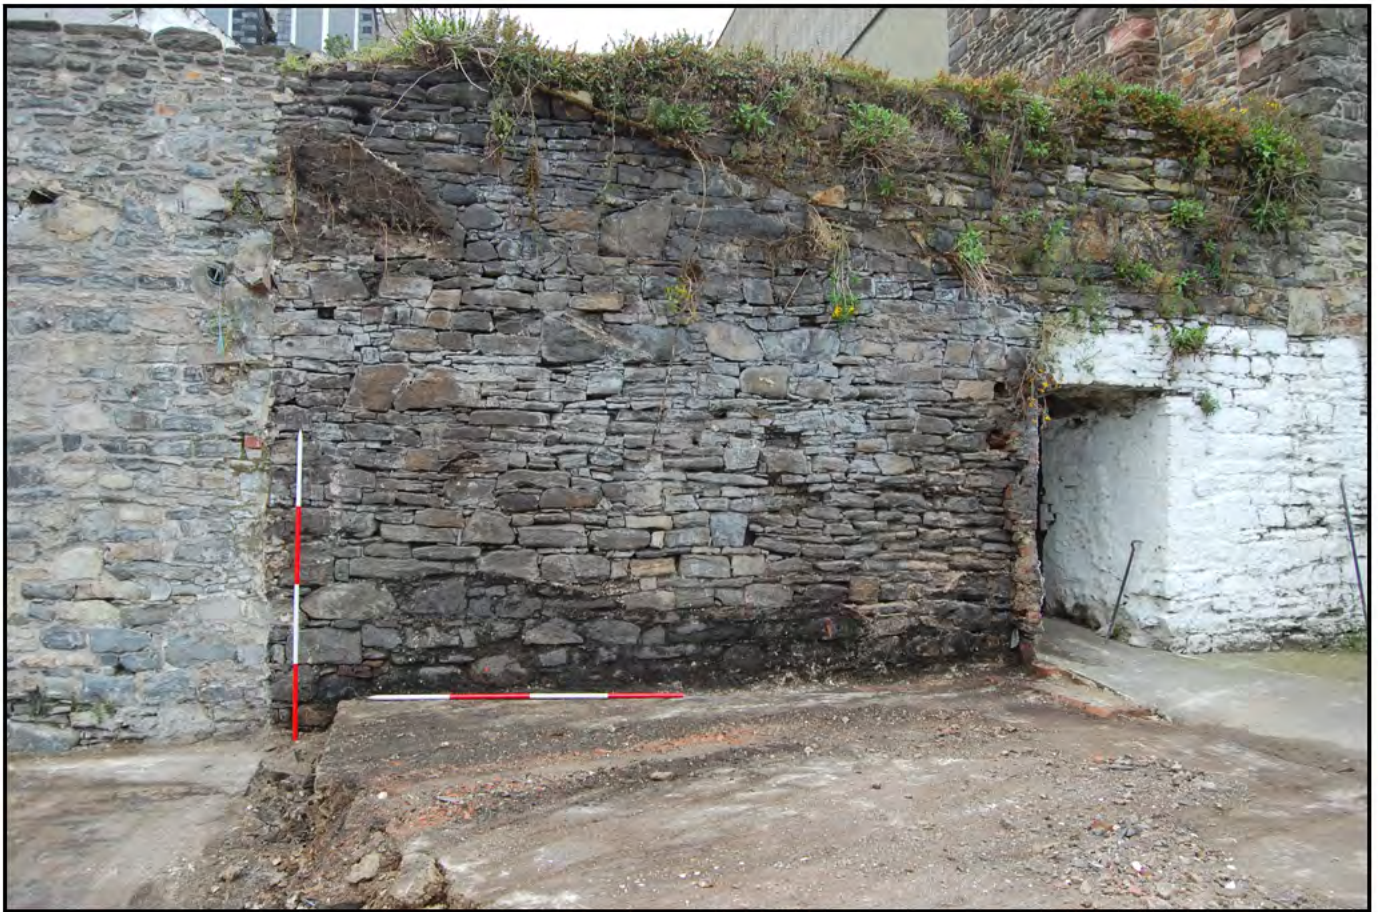
**Plate 62: YARD 6 (PRN 30474): Building 08 (PRN 30476): raised floor associated with Building 08 identified during demolition/watching brief phase. The original architects' plans (CMP 23/2/44 plate 61) specified a nine-inch thick concrete floor, which appeared to slope down slightly from SE to NW (from back to front) presumably to help drainage and sluicing of the floor. This slope is visible in this image. (Ranging poles: 2 x 2.0m)**

**CMP 23/2/44** (plate 61) specified a nine-inch thick concrete floor, which appeared to slope down slightly from SE to NW (from back to front) presumably to help drainage and sluicing of the floor. This raised floor was identified during the archaeological watching brief after demolition of the surrounding walls and was clearly higher than any other intact floors (plate 62). The building utilised the existing short length of stone wall forming the rear elevation of **Building 07**, **Cross Wall D** and **Wall A**, forming, as a result, a small yard into which the slaughterhouse was built. **Cross Wall D** formed the lower part of the SE (rear elevation), with the upper levels built of brick. The town wall itself was not used and the SW elevation was built entirely of brick with a distinct gap between it and the town wall (plate 63). It is not known when the property changed hands, but in the 1926-1927 rate book, the occupier is shown as J.H. Dewhurst Ltd. How long the building operated as a slaughterhouse is not certain, but it would have ceased to operate long before the butchers shop became a chip shop (late 20<sup>th</sup> century), as it is doubtful if health, noise, and pollution regulations would have allowed it to continue much beyond the mid 20<sup>th</sup> century. This building with its sloping roof and raised air vent is just visible below the old town hall, and rising above **Building 07**, in *The Spirit of Conwy* vol.2 (E.M. Pattinson, 2003, p.20, bottom).

After the demolition of **Building 08**, the brick SW elevation of which had been built slightly away from the town wall, a roofline preserved as a diagonal line of cement flashing, sealing the roof against the town wall, was seen (plate 62). This indicated a building against the north side of **Cross Wall D** at the angle where **Cross Wall D** joined the town wall. The flashing indicated a building with a sloping roof with the dimensions of 3.4m high (against **Cross Wall D**, 1.8m (at the lowest point of the flashing and, presumably the front) x 3.4m deep (horizontal measurement from wall D to lowest point of flashing). Length was unknown but there does appear to a building shown in this position on the 1889 and 1900 OS maps, which by 1901/1902 has become **Building 08** (Figures 06 to 08). The building on the 1889 map seems larger than that on the 1900 map, and would seem to be a better fit. A very small length of a horizontal band of cement ‘flashing’ was seen below the diagonal line, which might indicate the position of the smaller building seen on the 1900 map. If so it was very short lived, and there is not enough evidence to firmly identify this as the remains of another building.

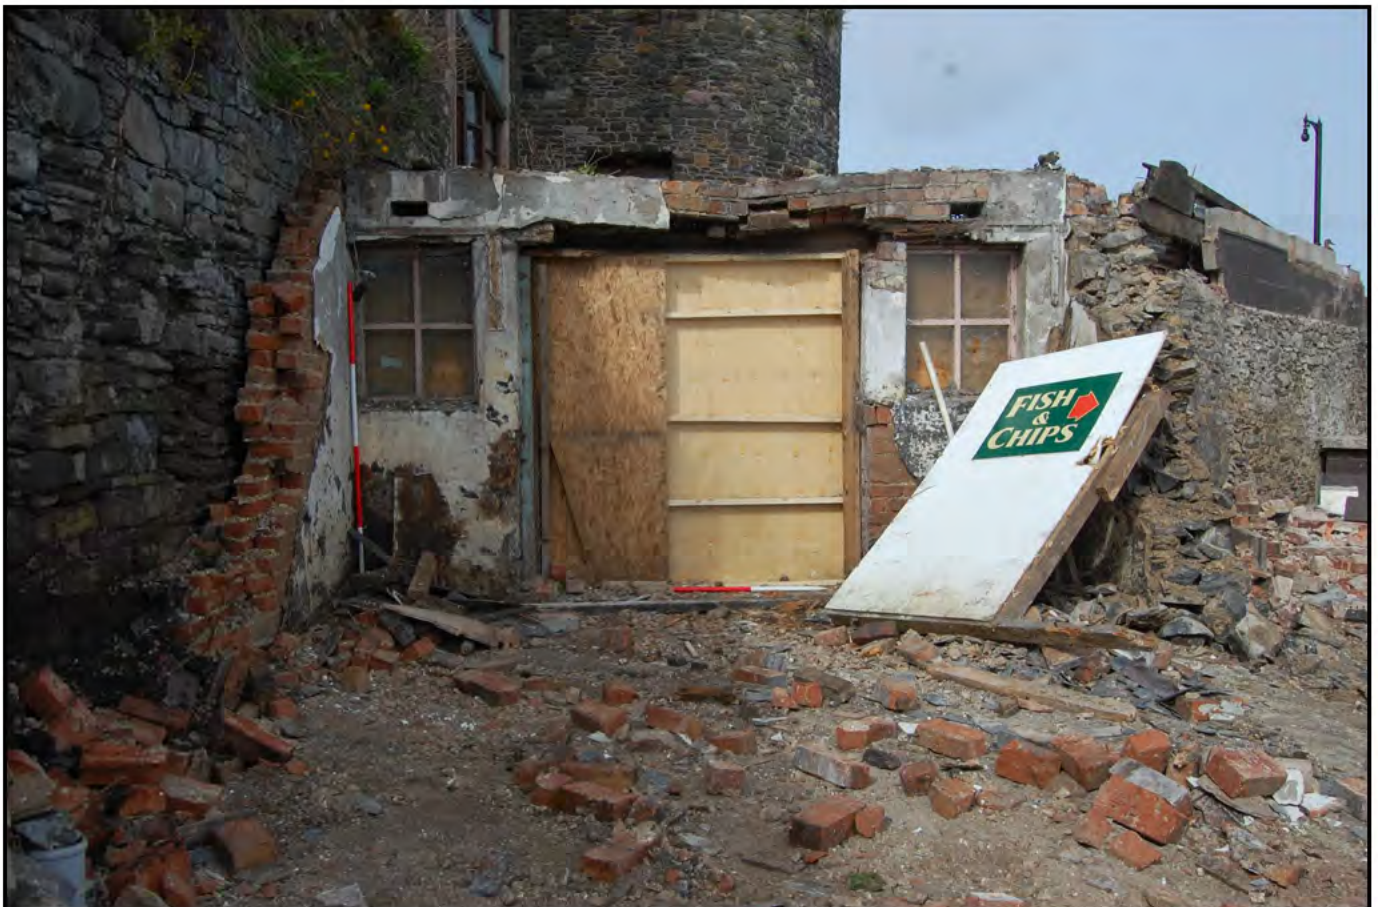
**Plate 63: YARD 6 (PRN 30474): Building 08 (PRN 30476): demolition/watching brief phase: Building 08 utilised the existing short length of stone wall forming the rear elevation of Building 07 (PRN 30475), Cross Wall D and Wall A, forming, as a result, a small yard into which the slaughterhouse was built. Cross Wall D formed the lower part of the rear elevation with the upper levels built of brick. The town wall itself was not used and the SW elevation was built entirely of brick with a distinct gap between it and the town wall. (Ranging pole: 2.0m)**

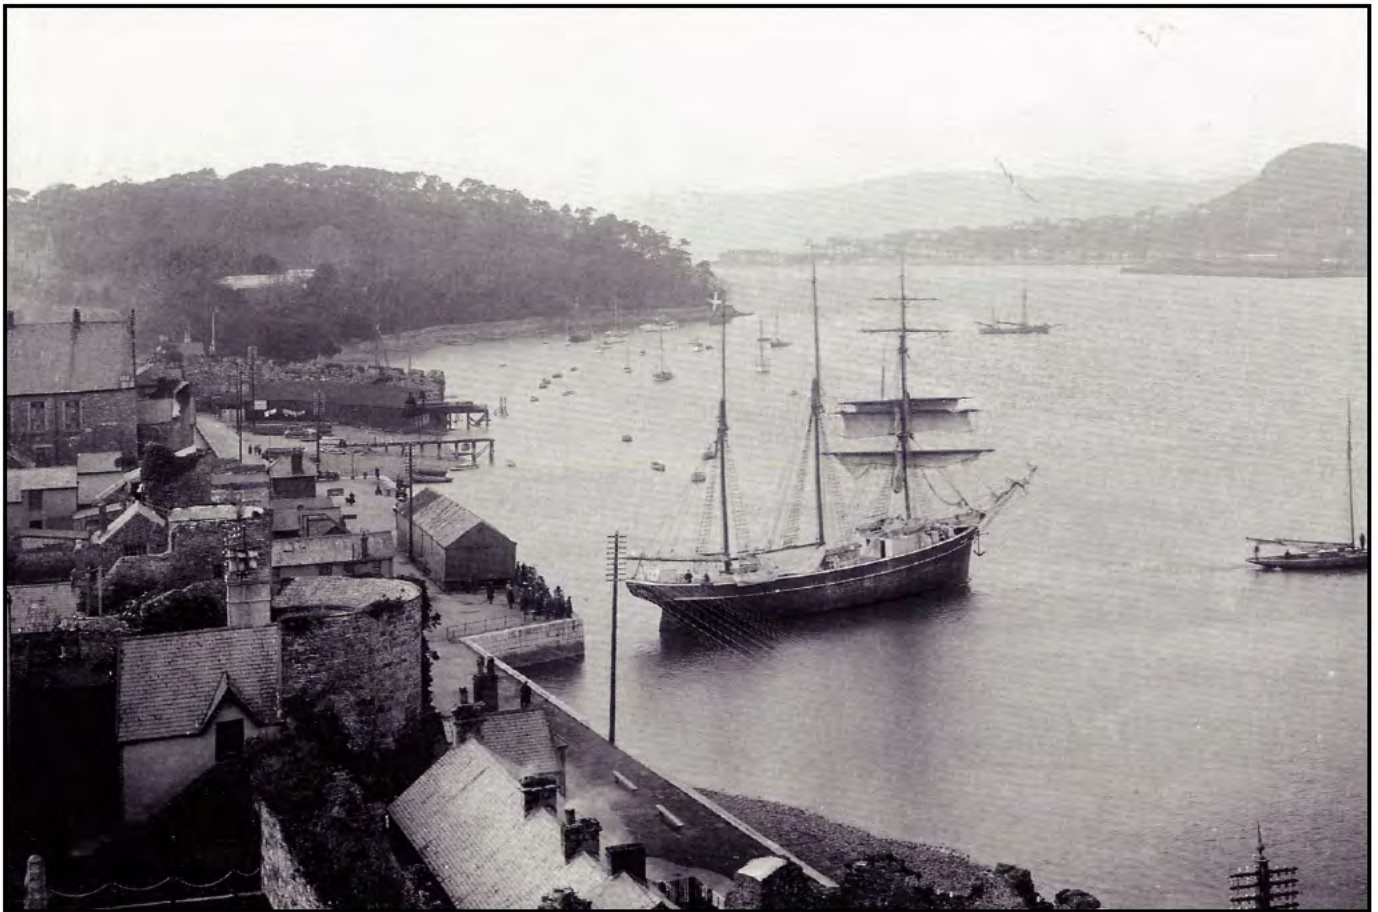
**Plate 64: The Quay (PRN 19750): Building 20 (PRN 30478): early twentieth century view of the quay reproduced from Pattinson, 2003. Building 20 is the detached building along the quay front. The L-shape within the quay was subsumed within a quay redevelopment during the late twentieth century.**

Although it lay outside the area of the site, **Building 20** looms large in the map, documentary, and photographic records of the Quay. **Building 20** is the large shed close to the front of the Quay, seen on all early photographs (plates 64 and 65). In at least one of the photographs the signage above the door in the NW elevation, says Manchester, Liverpool and North Wales Steamship Co. Ltd. It was in fact built for W.S. Caine Company. Plans for proposed goods warehouse were received by the council engineer’s office on the 26<sup>th</sup> of November

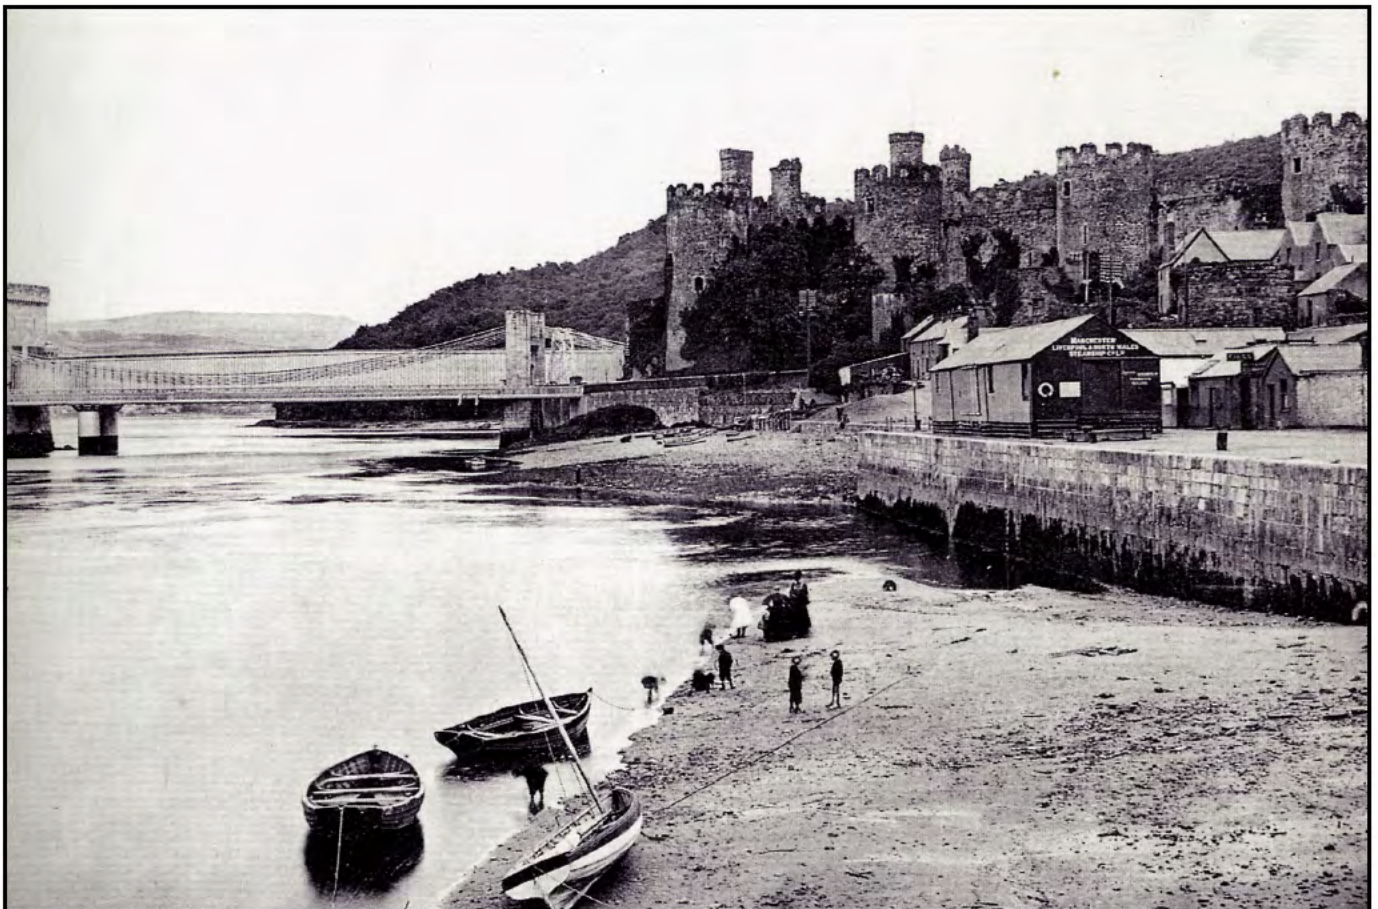
**Plate 65: The Quay (PRN 19750): Building 20 (PRN 30478): early twentieth century view of the quay reproduced from Pattinson, 2003. Building 20 is the detached building along the quay front. Building 20 was situated opposite YARD 03 (PRN 30457)/Building 09 (PRN 30459)**
