Alternative Site for the Proposed Pumping Station, Rhiwgoch, Harlech

Report on watching brief

GAT Project No. 2064.4
Report No. 817
June 2009

REPORT ON AN ARCHAEOLOGICAL WATCHING BRIEF

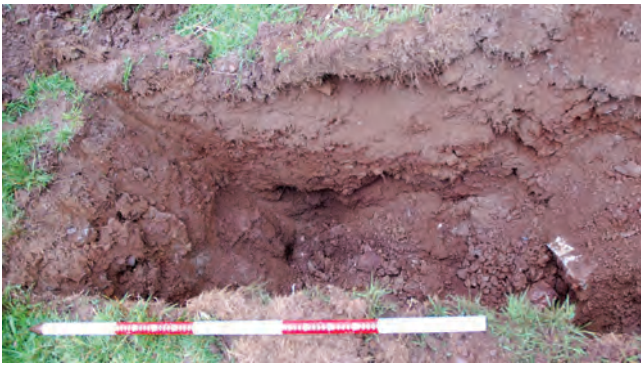
Plate 1. Test pit 1 from north-west

Test pit 1 (plate 1)

Size: 2.7m by 0.7m, 0.8m deep max.

0-0.3m: Dark grey loam with occasional stones. Topsoil.

0.3-0.8m: Friable dark red-brown loam with c.40% sub-rounded stones up to 300mm in length. Main soil horizon developed on the boulder clay, probably largely of colluvial origin. No traces of mixing due to ploughing.

0.8m+: Large boulders stopped further excavation of test pit. Unclear whether these were the top of bedrock or glacial boulders.

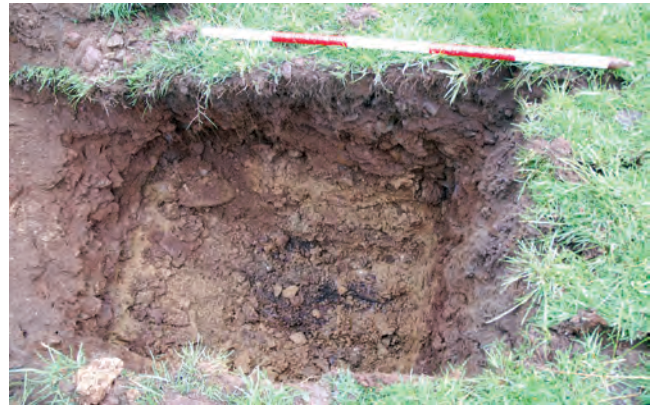
Plate 2. Test pit 2 from south

Test pit 2 (plate 2)

Size: 1.5m by 0.7m, 1.1m deep max.

0-0.3m: Dark grey loam with occasional stones. Topsoil.

0.3-0.8m: Friable dark red-brown loam with c.40% sub-rounded stones up to 300mm in length. Main soil horizon developed on the boulder clay.

0.8m+: Yellow-brown clay loam with some stone. Boulder clay.

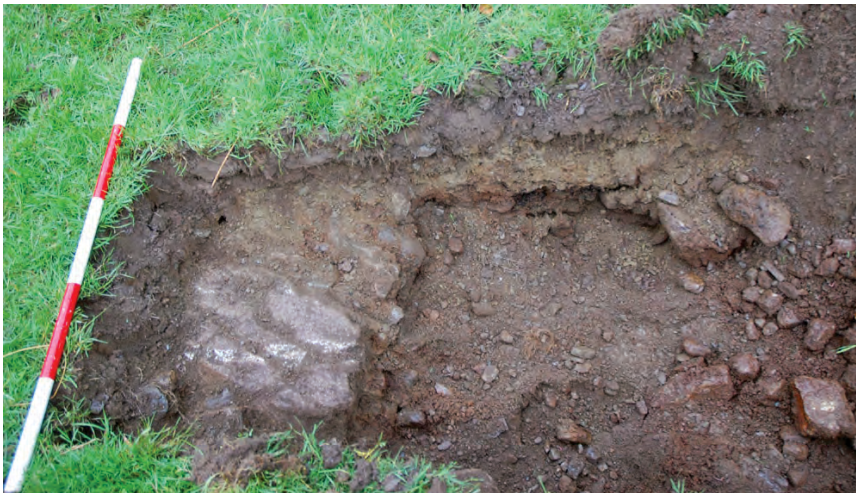
Plate 3. Test pit 3 from north, showing possible surface

Test pit 3 (plate 3)

Size: 1.9m by 0.7m, 0.5m deep max.

0-0.1m: Layer 301: Topsoil.

0.1-0.2m: Layer 302: Yellow gritty silt with occasional stones.

0.2-0.3m: Layer 303: Stones laid flat under and with layer 302. Largest stone up to 0.45m in length with traces of wear on the surface.
0.3-0.5m: Layer 304: Friable dark red-brown loam with c.40% sub-rounded stones up to 300mm in length.
0.5m+: Large boulders stopped further excavation of test pit. Unclear whether these were the top of bedrock or glacial boulders.

In test pit 3 an area of stones, that appeared to have been deliberately laid, was noticed in association with a 0.1m thick deposit of yellow gritty silt. Together these seemed to form a man-made surface. Only a small area of this was seen in the trench so its function and date are difficult to determine, but a 19th century yard or road surface seems to be a possible interpretation. This could indicate the presence of other related archaeology and may suggest the presence of the remains of a building, although one is not indicated here on any of the early maps.

The watching brief allowed the depth and nature of the deposits on the site to be inspected. In addition the possible surface seen in test pit 3 indicates that there is archaeology present on site. The strip, map and sample evaluation of the whole development area recommended in the assessment will enable the full extent of this feature to be established and any related archaeology to be identified. It is important to carry out this work prior to the start of the construction works so that any archaeology can be adequately recorded without holding up construction.

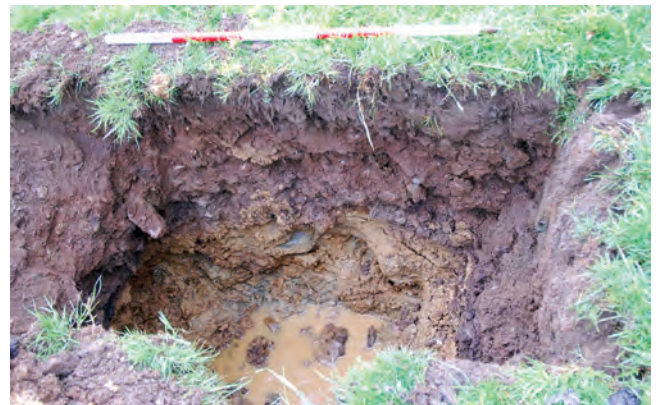
Plate 4. Test pit 4 from south

Test pit 4 (plate 4)

Size: 1.6m by 0.7m, 1.5m deep max.
0-0.3m: Topsoil.
0.3-0.9m: Friable dark red-brown loam with c.40% sub-rounded stones up to 300mm in length. Main soil horizon developed on the boulder clay.
0.9m+: Yellow-brown clay loam with some stone. Boulder clay.

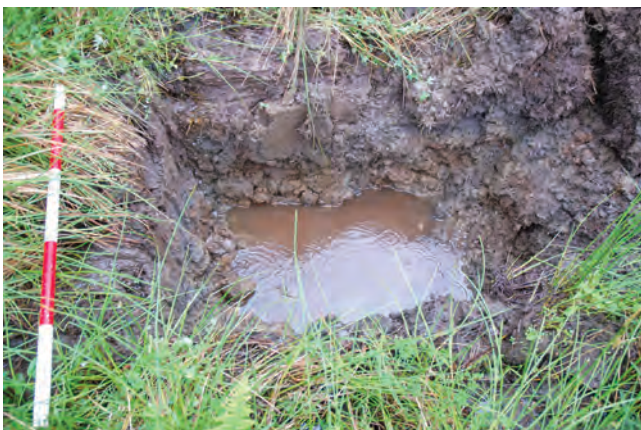
Plate 5. Test pit 5 from north

Test pit 5 (plate 5)

Size: 1.2m by 0.7m, 0.7m deep max.
0-0.3m: Topsoil.
0.3-0.5m: Fairly clean and stone-free grey silt.
0.5m+: Yellow-brown clay loam with some stone. Boulder clay. Very wet and waterlogged.

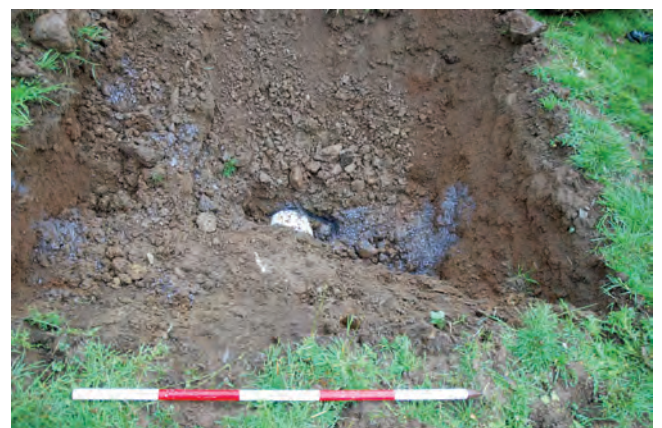
Plate 6. Test pit 7 from east
showing water pipe

Test pit 7 (plate 6)

Size: 2.2m by 2.0m, 0.9m deep max.
0-0.3m: Topsoil.
0.3->0.7m: Friable dark red-brown loam with c.40% sub-rounded stones up to 300mm in length. Main soil horizon developed on the boulder clay.
Cut by pipe trench. Pipe at c.0.7m below surface.
