No.2, Manod, Llanbeblig Road **Caernarfon**

Archaeological Assessment

GAT Project No. G 40

Report No. 818

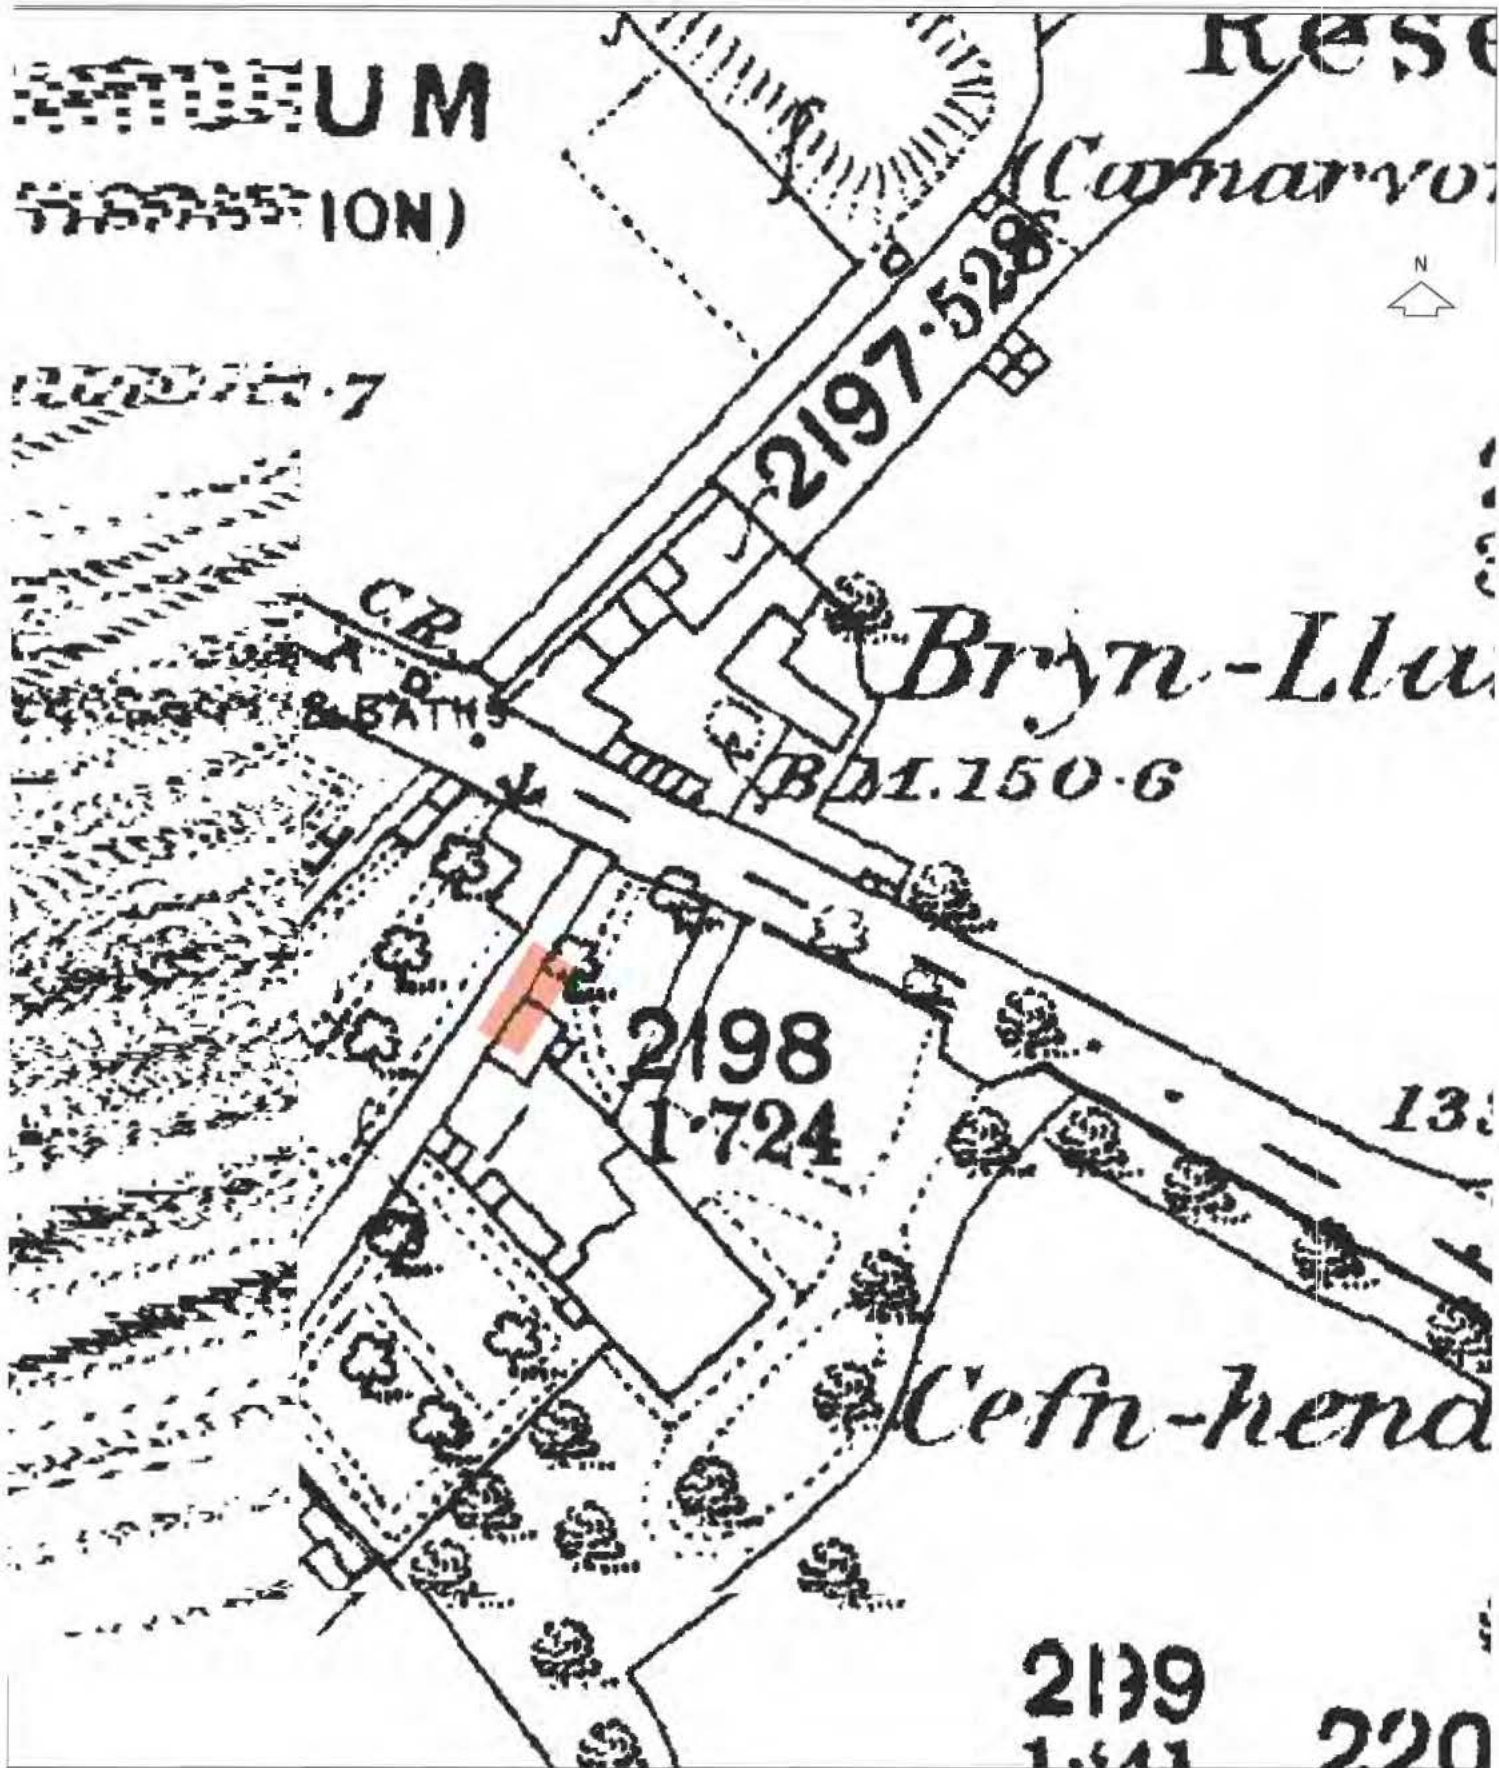
Figure 2: 1889 OS Map
Scale 1:750

In 1918 the eastern spread of the town of Caernarfon had only just reached the Roman fort, however to the south-east of the study area the first edition 1889 OS map depicts a farmstead labeled as *Cefn-hendre* (PRN 29718 (*see figure 2*) at SH485622. This map shows the surrounding area as being very rural, with open field systems and tree plantations, as well as depicting a moderately sized ancillary building to the farm located in very close proximity to the study area. Indeed, the structure was orientated north-east to south-

west and the north-eastern and north-western walls appear to be directly within the study area and measuring approximately 7.0m by 5.0m.

The wall comprising the north-western side of the ancillary structure is depicted as being a wall of substantial length, measuring approximately 65.0m and running from Llanbeblig road in the north-east to open fields in the south-west where it abruptly terminates. Moreover, a second wall appears to run parallel to this wall, forming a road or track way measuring approximately 4.5m in width which also curiously terminates at open fields to the south-west.

When the location of stone walls (03) and (09) are compared with both the first and third edition OS maps, 1889 and 1910 respectively, it can be seen that they correspond with the locations of the ancillary building to the farmstead *Cefn-hendre*. It appears that the north-eastern to south-western wall (03) represents the external wall to the road/track way depicted on both maps, and the south-east to north-west wall (09) corresponds with the north-eastern wall of the ancillary building. It is not clear whether this structure was a barn, workshop, or building of some other function, however it does seem clear that the cobbled surface (10) located to the south-east of the trench does in fact represent the internal floor surface of this ancillary structure. This hypothesis is supported by the fact that the cobbled surface terminates at the face of wall (09).

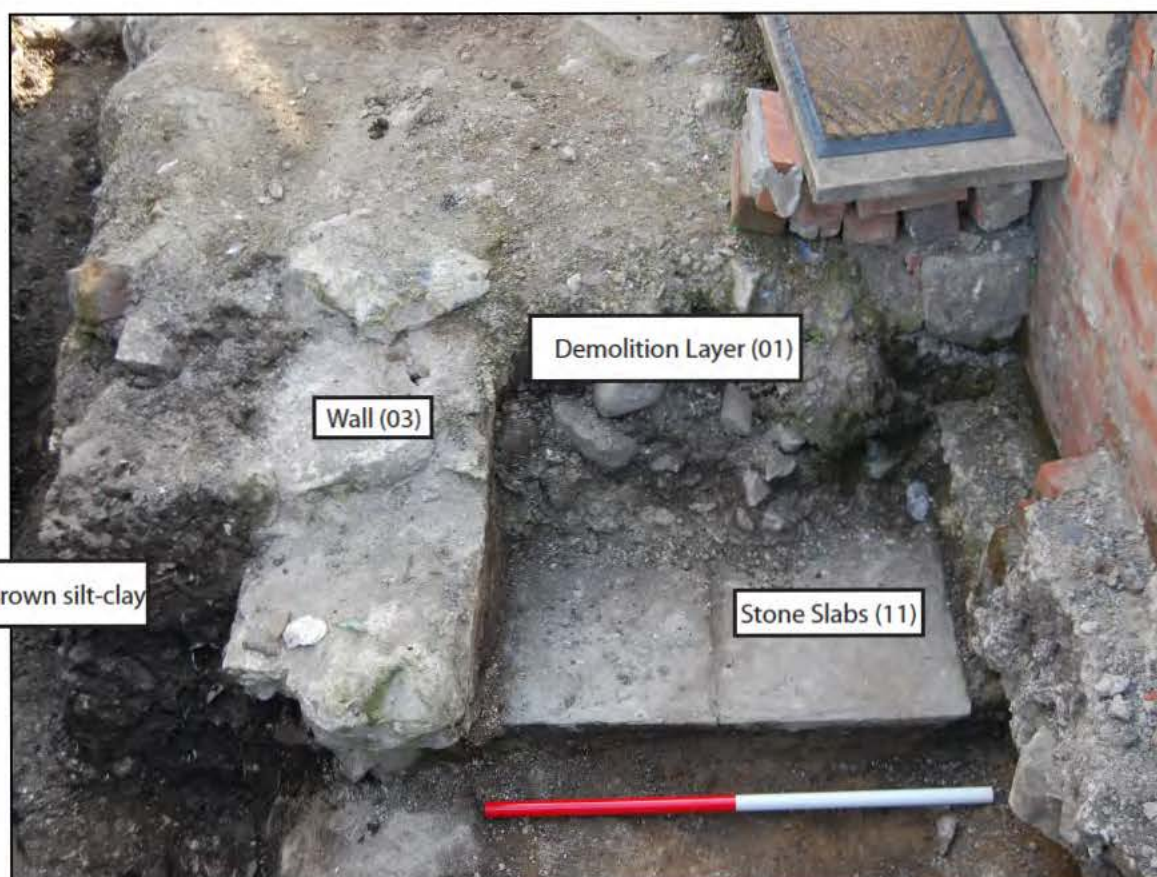
Butting up against wall (03) and thus chronologically later in the phase of construction, however most probably contemporary was a cobbled surface (02) and a stone slab surface (11). The cobbled surface comprised a medium compacted mid red-brown silt-clay, with 90% medium sized rounded cobble inclusions measuring 1.2m by 0.13m in depth, the length was unknown; while the stone slab surface (11) comprised two light grey stone slabs measuring 0.4m by >0.3m by 0.05m in dimensions. Both these surface layers physically lie above sand-silt deposit (07) and chronologically above wall (03), however despite probably being contemporary the excavated foundation trench had destroyed any relationship between the two layers.

Plate 4: South facing stone slabs (11).

The relationship between stone slabs (11) and cobbled layer (02) is not clear due to disturbance during the excavation of the trench. However, it does appear that both layers are contemporary and represent the surface of the road/track way depicted on the 1889 and 1910 OS maps. Indeed, despite there being no existing earlier deposits beneath the portion of the road/track way uncovered, it is certainly possible that the track is in fact of Roman origin and has been reused over time. This theory is supported by the fact that the OS maps depict the track as terminating in such a curious manner, however this merely stands as conjecture at present.

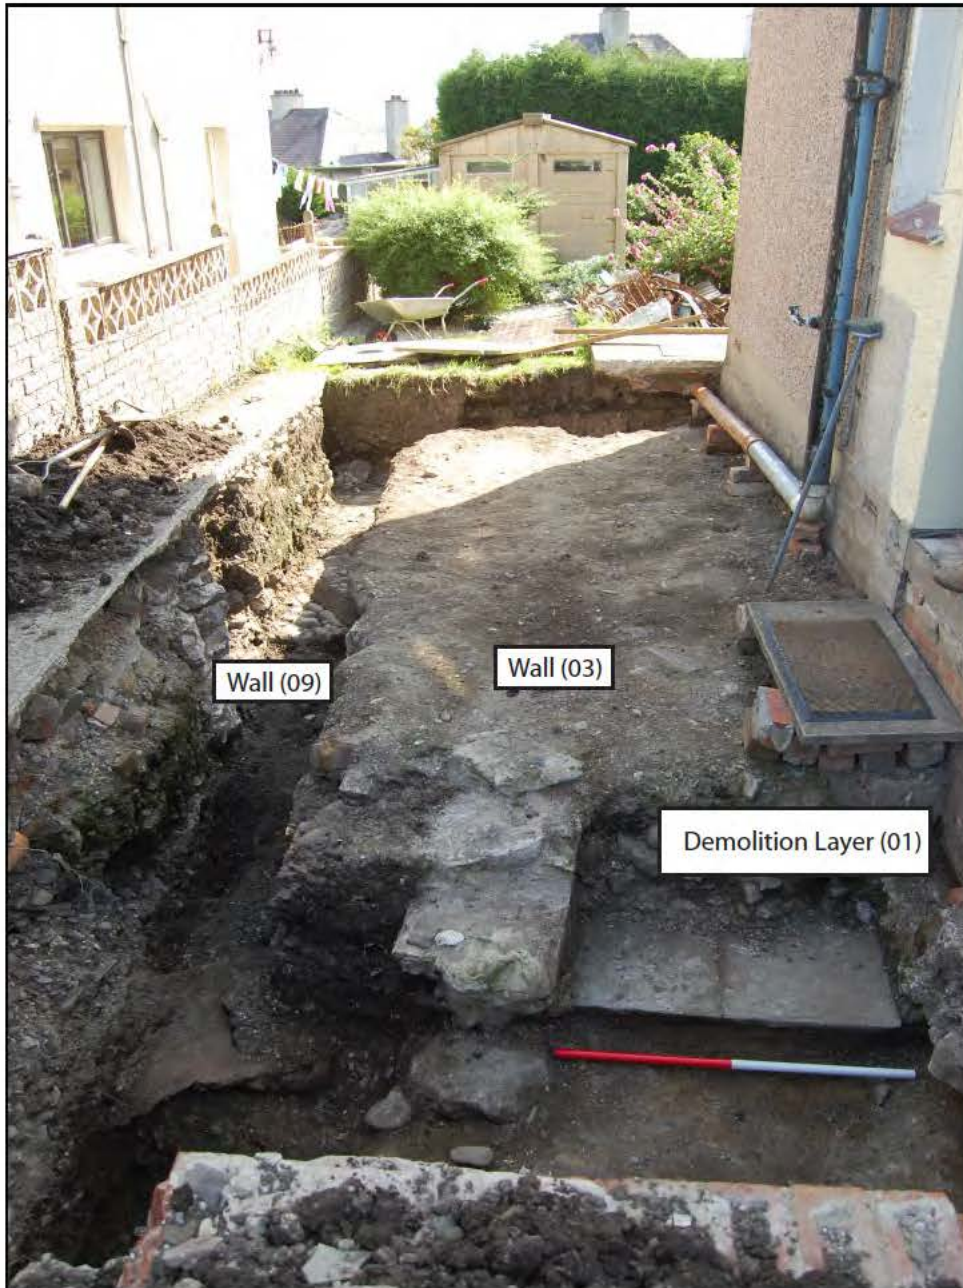
Plate 5: North facing trench

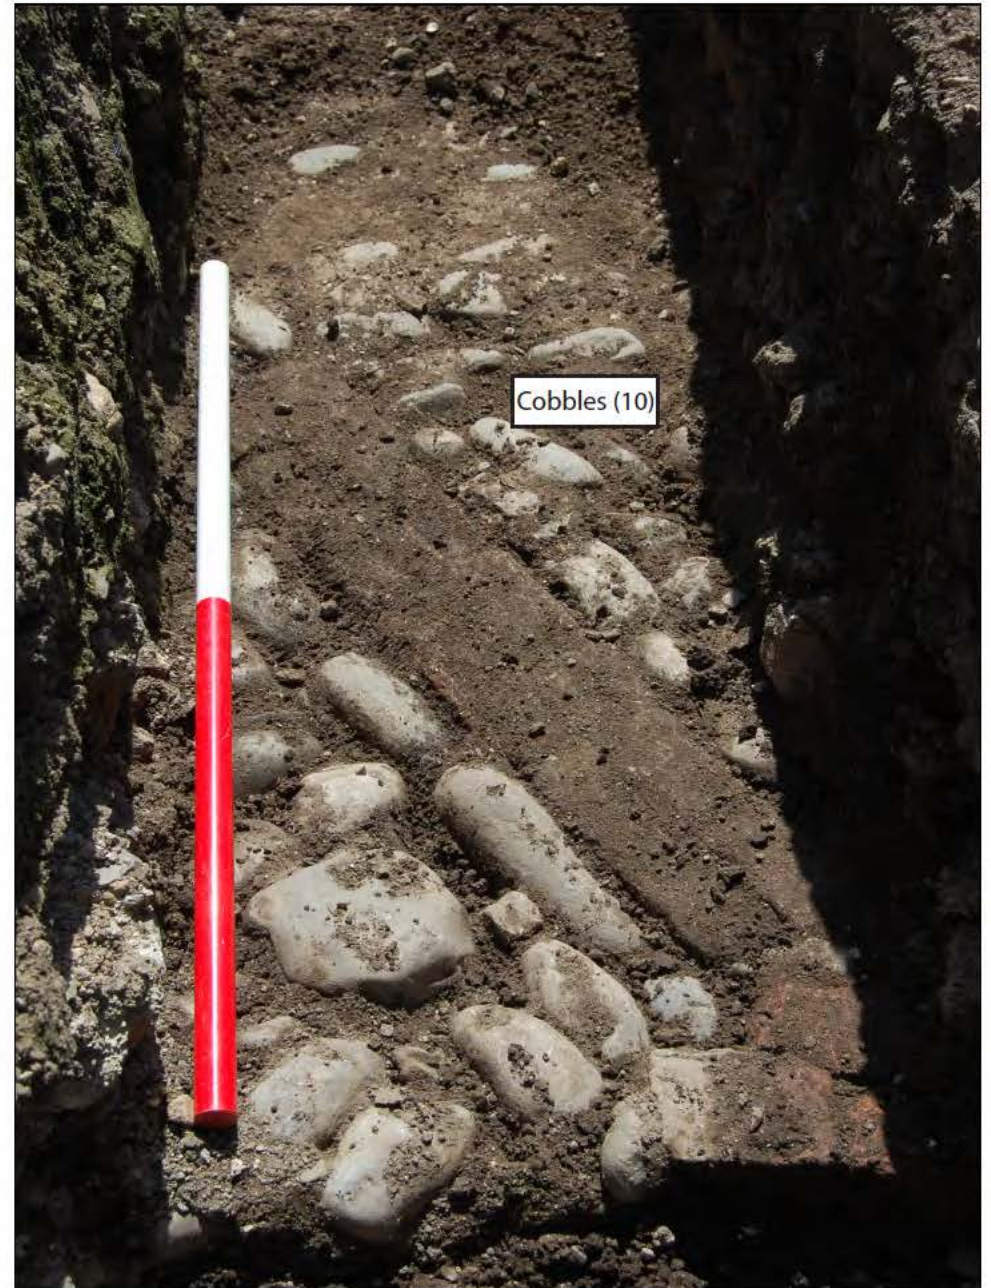
In the south-eastern section of the trench a cobbled surface (10) existed measuring >3.8m by >0.9m by 0.1m in depth, which physically lay immediately above the natural silt-clay (06), but which butted up against wall (09) to the north-east. This layer was not present north of wall (09) and faded out at the south-western section of the trench. The deposit was a moderately firm dark red-brown silt-clay, with 80-90% rounded and sub-rounded small to medium sized cobble inclusions.

Plate 6: North facing cobble Layer (10)
