# Rhiwgoch Pumping Station **Harlech**

## **Archaeological Field Evaluation 2009**

**GAT Project No. G 2064.5**

**Report No. 819**

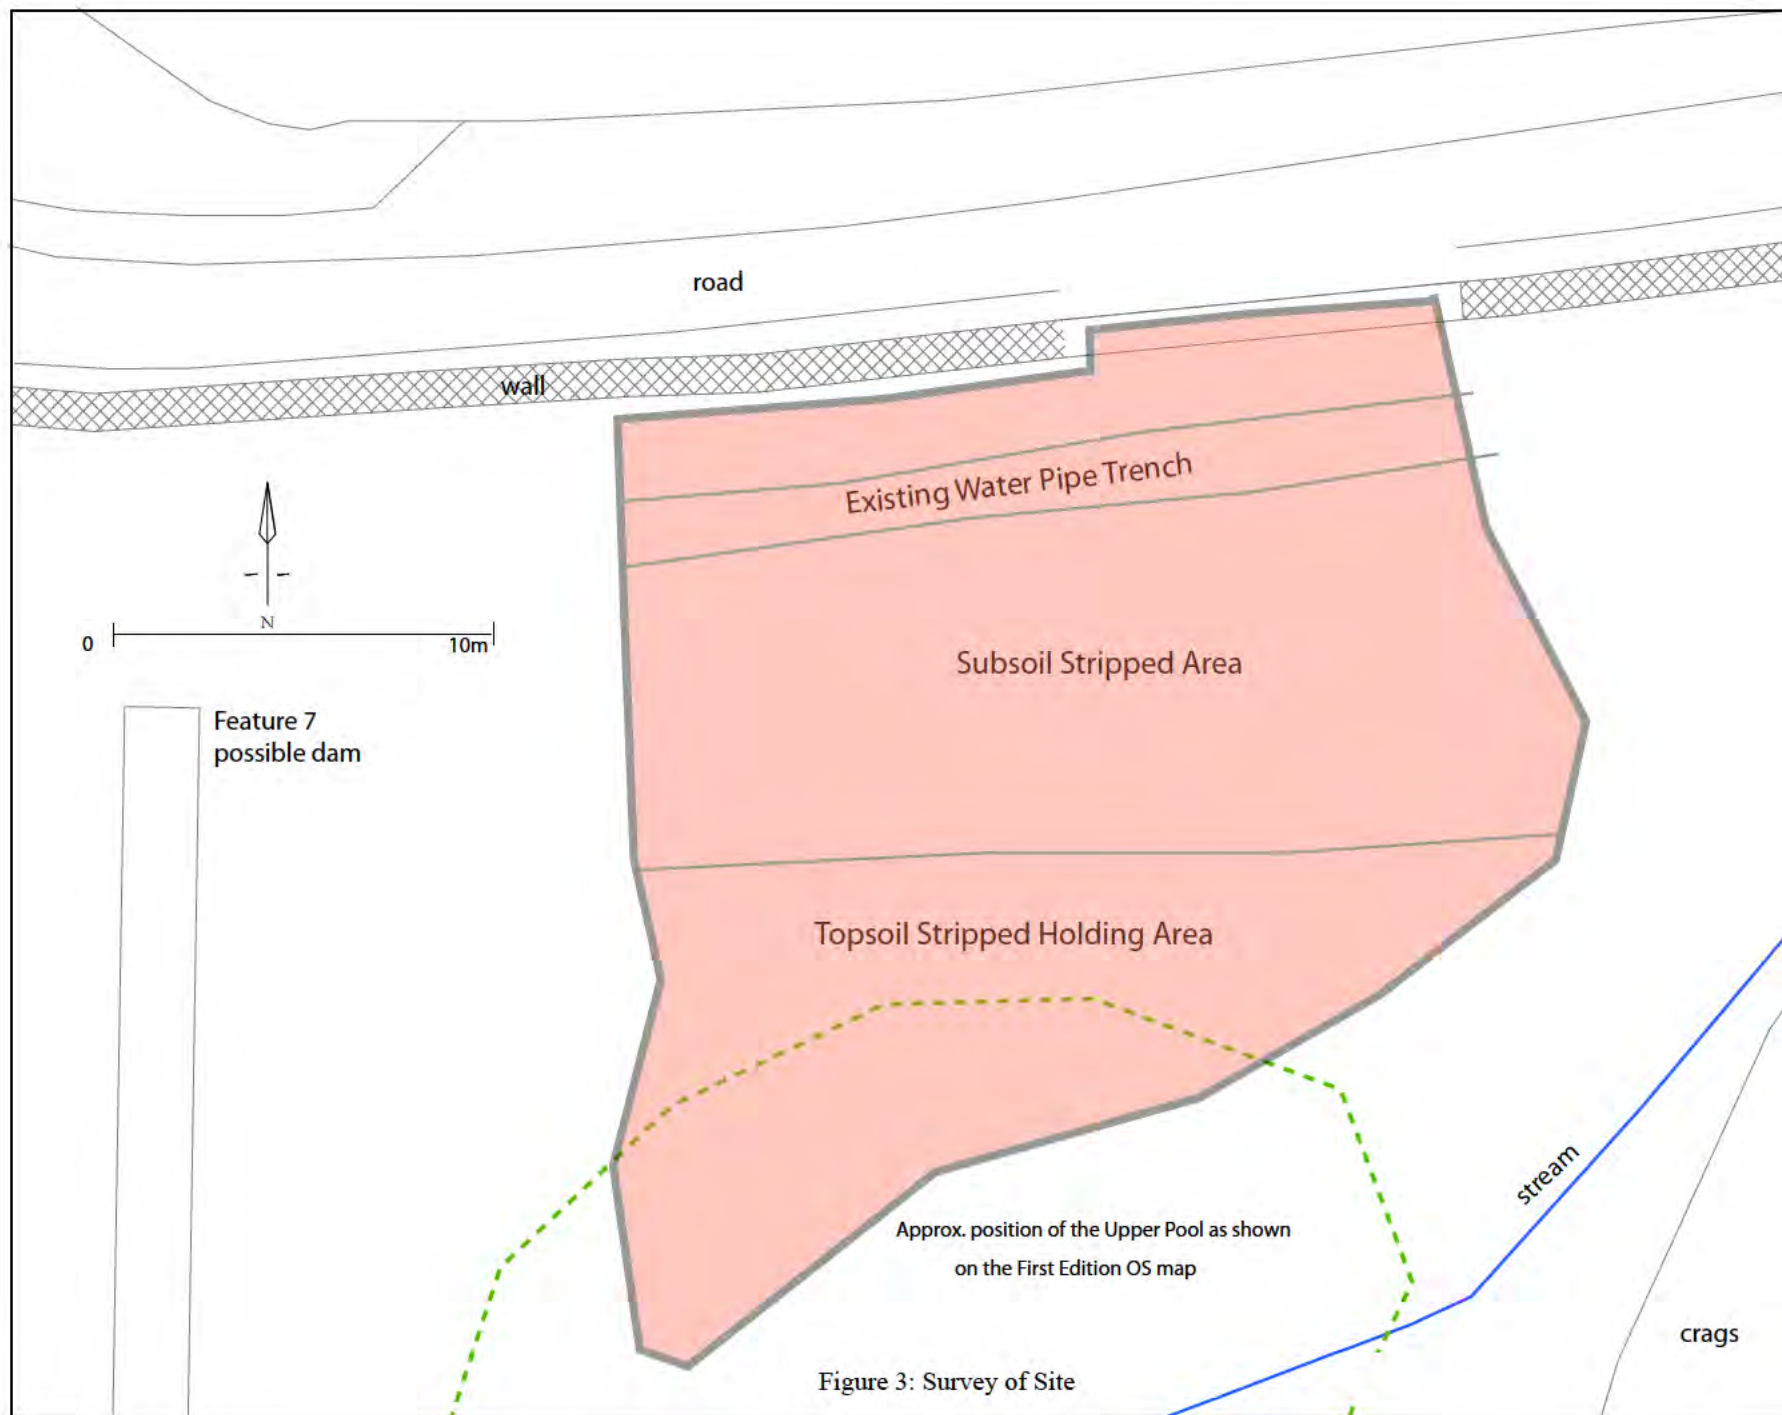
Figure 3: Survey of Site

Due to the logistics of spoil management, it was decided by the engineer for Dŵr Cymru Welsh Water that an additional area located directly to the south of the development area would be topsoil stripped to provide a holding area for the subsoil obtained when the study area was stripped (figure 3). Thus a triangular area measuring 23.0m in length, 12.5m in width at its western end and 1.0m in length at its eastern end was stripped of its topsoil (plate 2). No archaeological features or artefacts were located in the holding area, however due to the subsoil having not been removed it is impossible to be certain as to whether the area was archaeologically sterile, although due to the area not being built upon or infringed in any further way, the strategy was deemed acceptable.

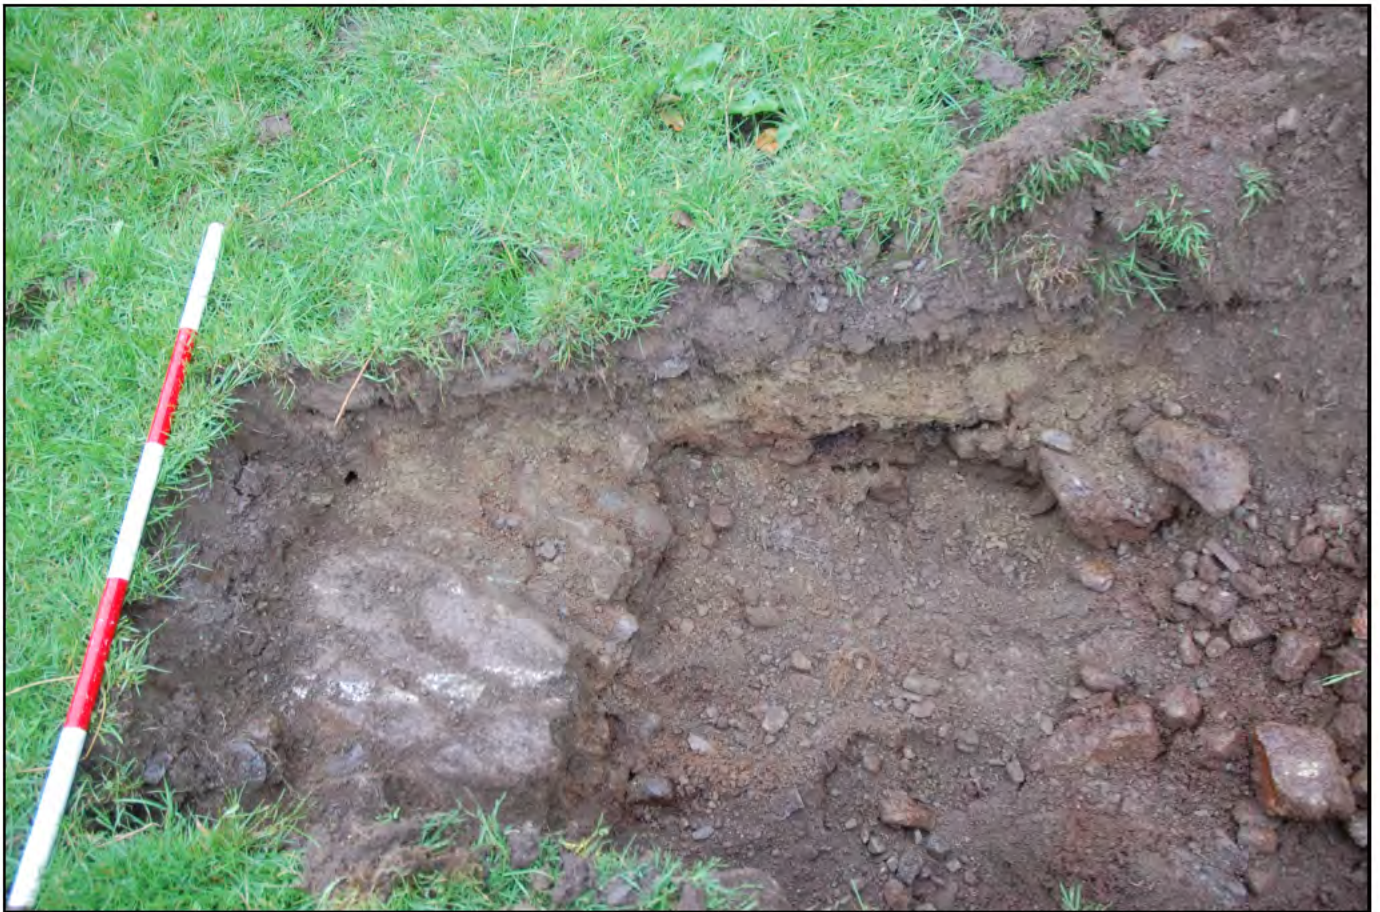
**Plate 1: Test Pit Three, from the North.**

Additional care was taken with the stripping around the possible surface layer identified during the watching brief phase in trial trench three (plate 1), identified by the presence of potentially deliberately laid stones associated with a 0.1m thick deposit of yellow gritty-silt. However upon the removal of top and sub

strata around the feature, it became clear that it was limited to only two large sub-rounded cobbles which were well fixed into the natural silt-clay, and some small rounded cobbles resting upon the natural. These stones were clearly glacial in origin, with the yellow gritty-silt deposit spreading as a natural colluvial layer to the south. No other features or artefacts of archaeological value were located.

The strip, map and sample strategy enabled a clear view of the study area, and provided the opportunity to prove that the area was archaeologically sterile prior to development. The identification of a potential surface layer during the watching brief phase created the requirement for further archaeological works, however in this case the evidence has been proven to be merely glacial deposits of stone and silt-clays.

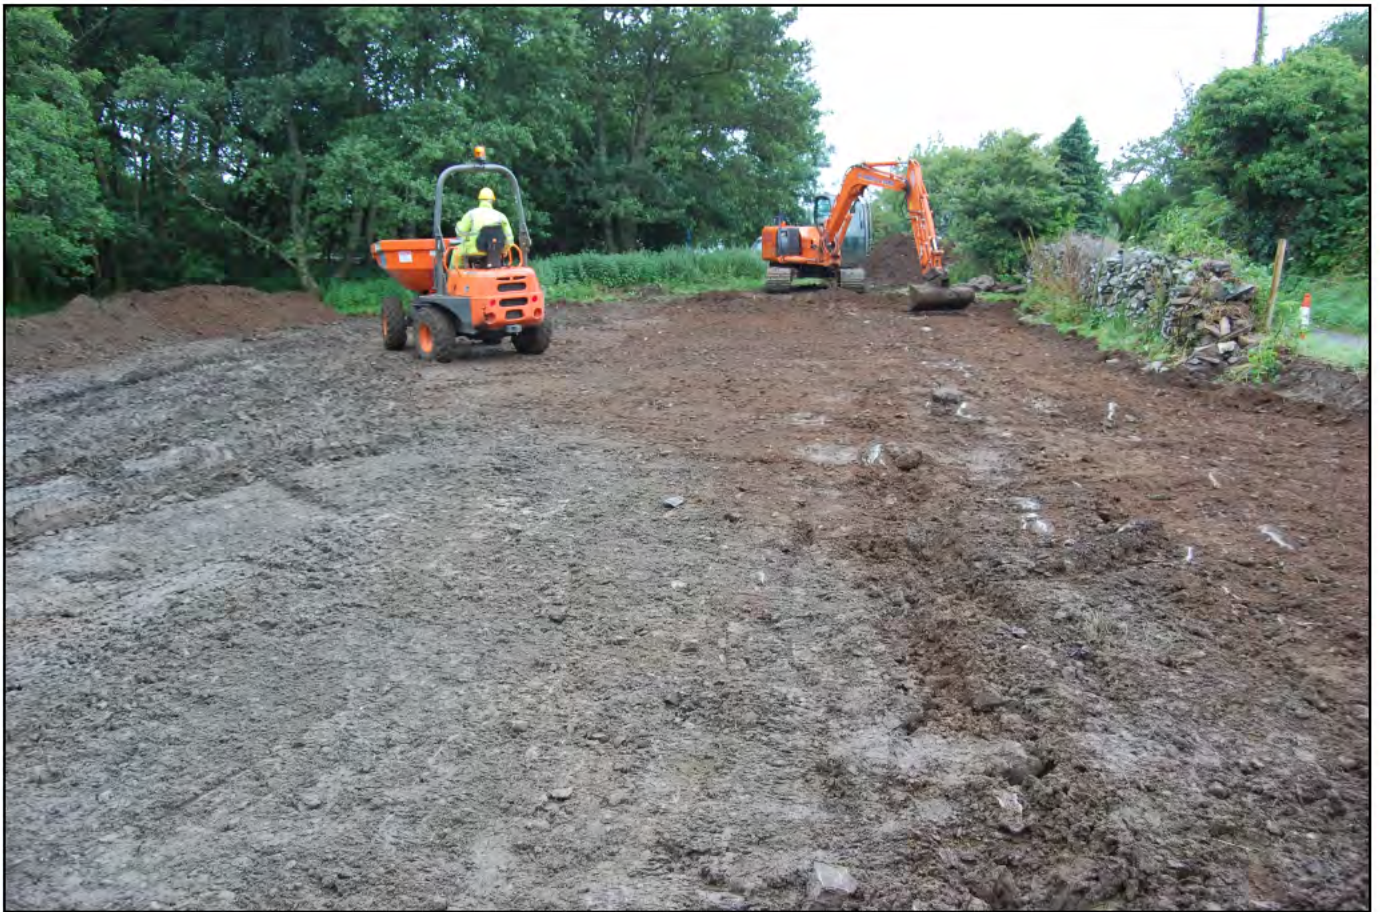
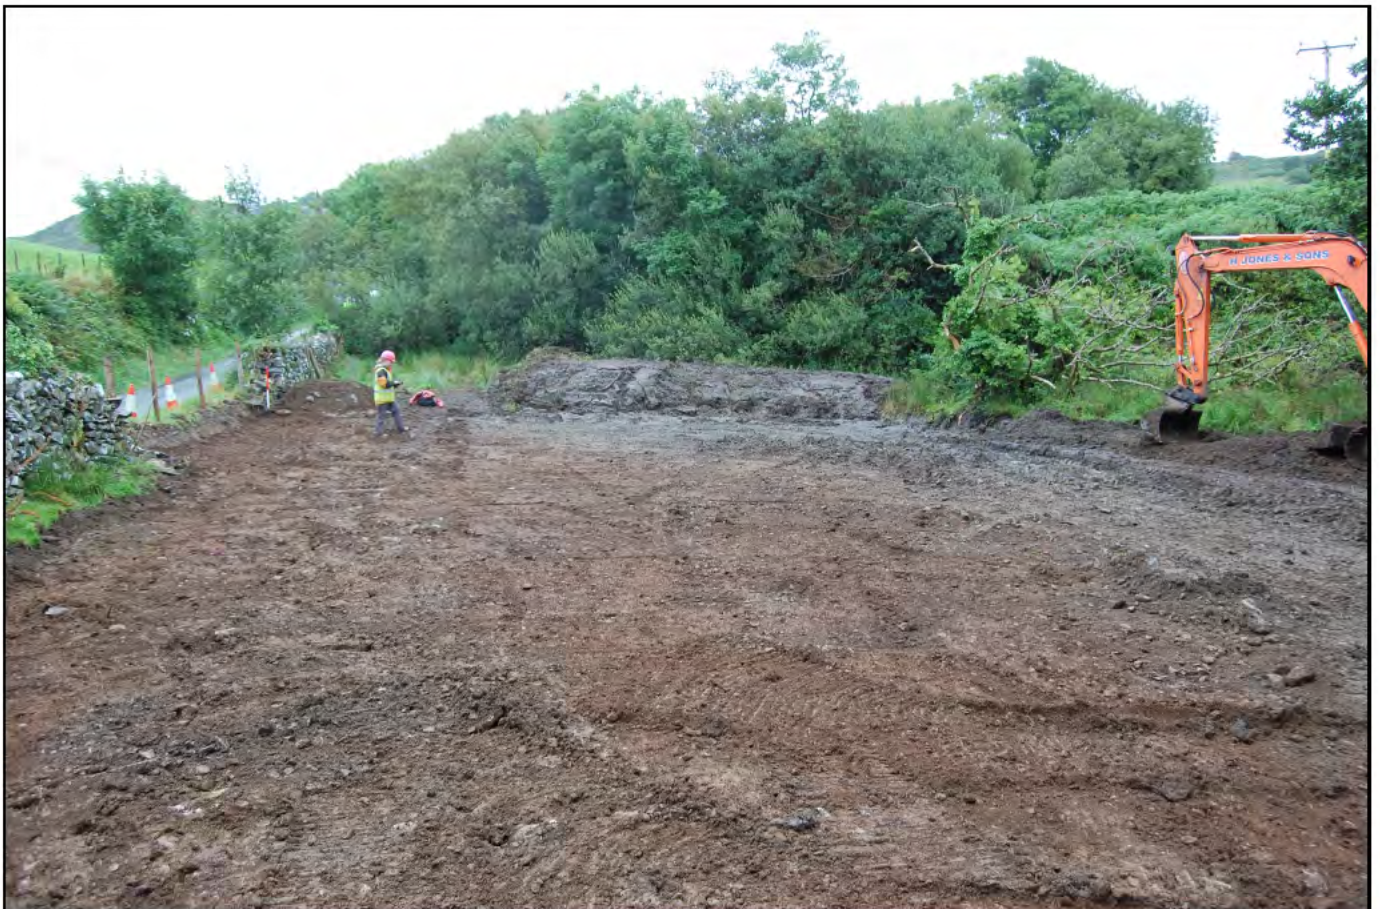
The main development area was initially stripped of its topsoil, which was consolidated in a load located to the south-west of the site avoiding stone-faced bank feature 7 (figure 1). No archaeological features or artefacts were located at this stage, and subsequently the subsoil was also stripped away onto a natural glacial colluvium (plates 3 and 4). The topsoil averaged a regular 0.17m in depth and was a dark, red-brown silt-clay with moderately frequent medium sized sub-rounded pebble inclusions. The subsoil layer was very thin and non-existent in places, composed of a mixture of colluvium silts with occasional modern pottery fragments included. The natural colluvium layer was a mixture of dark red-brown, orange, yellow and grey clays and silt-clays resulting from glacial deposition. To the south of the development area the natural clay became more pronounced and darker in colour due to the progression into waterlogged ground in the catchment area of the streams.

**Plate 3: Subsoil Stripped Area, from the East.**

**Plate 4: Subsoil Stripped Area, from the West.**

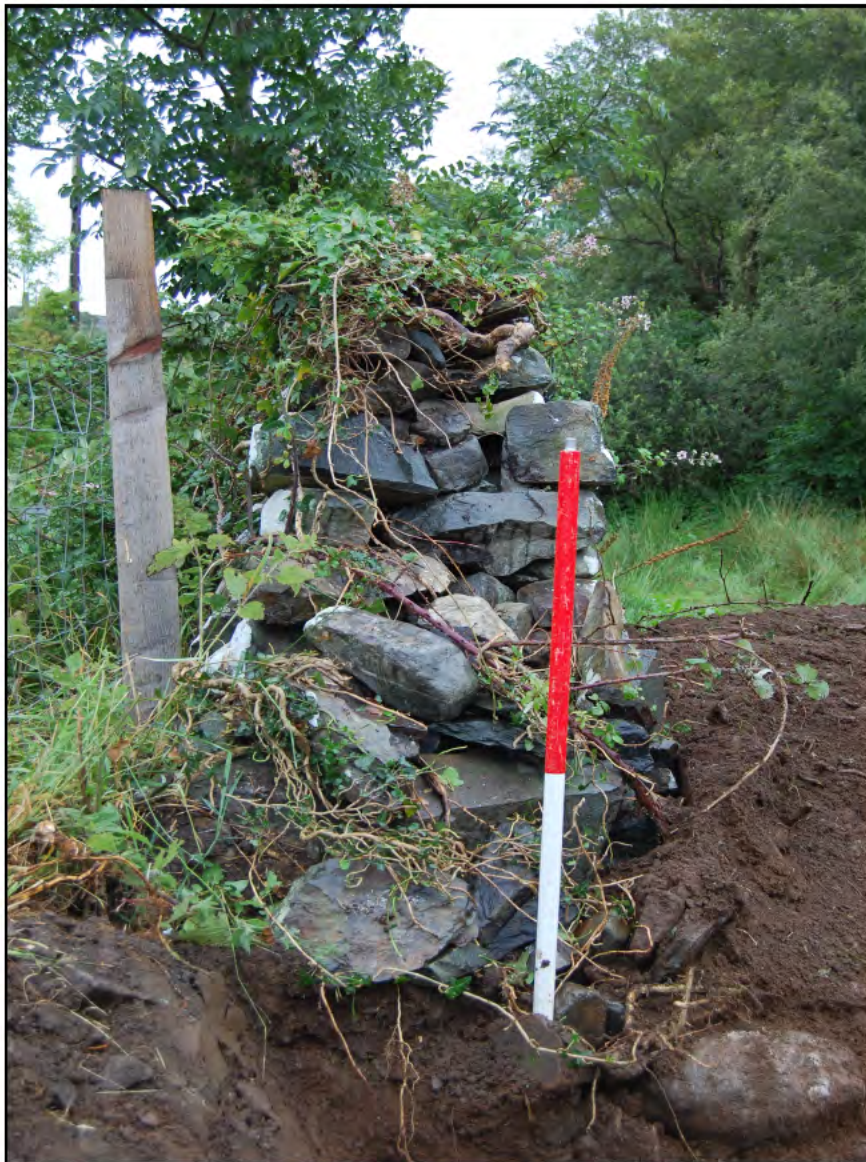
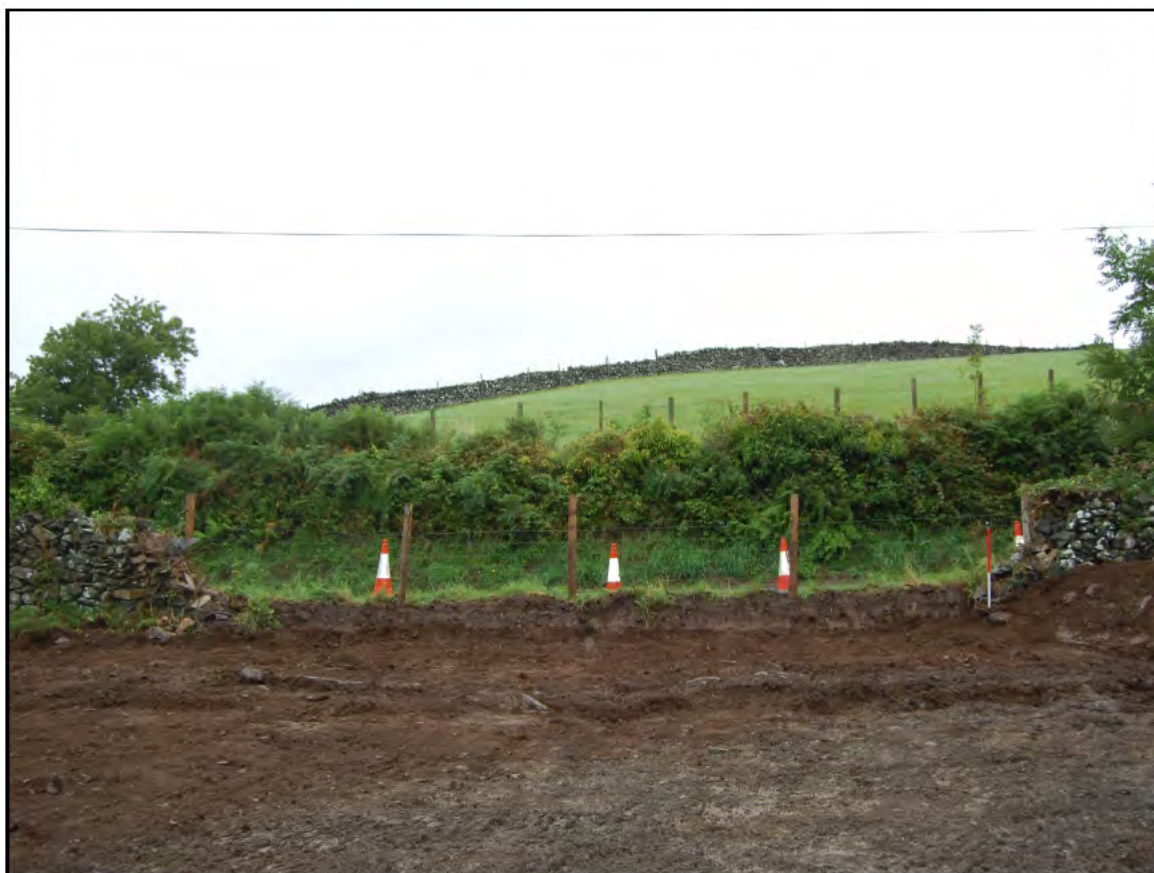
A 10.0m stretch of the field boundary wall forming the northern limit of the development area was breached (plates 5 and 6), and the stone deposited in an approved area to the south-west. The breached section was cleaned and inspected for any indication of earlier deposits beneath the wall, or indeed any suggestion of an earlier construction form to the wall, however no such evidence was found.

The programme of works also provided the opportunity to inspect the field boundary wall to the north of the site, once it was breached. However, in this case no evidence could be found to suggest any earlier deposits or phases of the wall.

**Plate 5: Breached Field Boundary, from the West.**

**Plate 6: Breached Field Boundary, from the South.**
