# Proposed Development at Glynllifon College: **Llandwrog, Gwynedd (Area A)**

## Archaeological Assessment

GAT Project No. 2092.2

Report No. 826

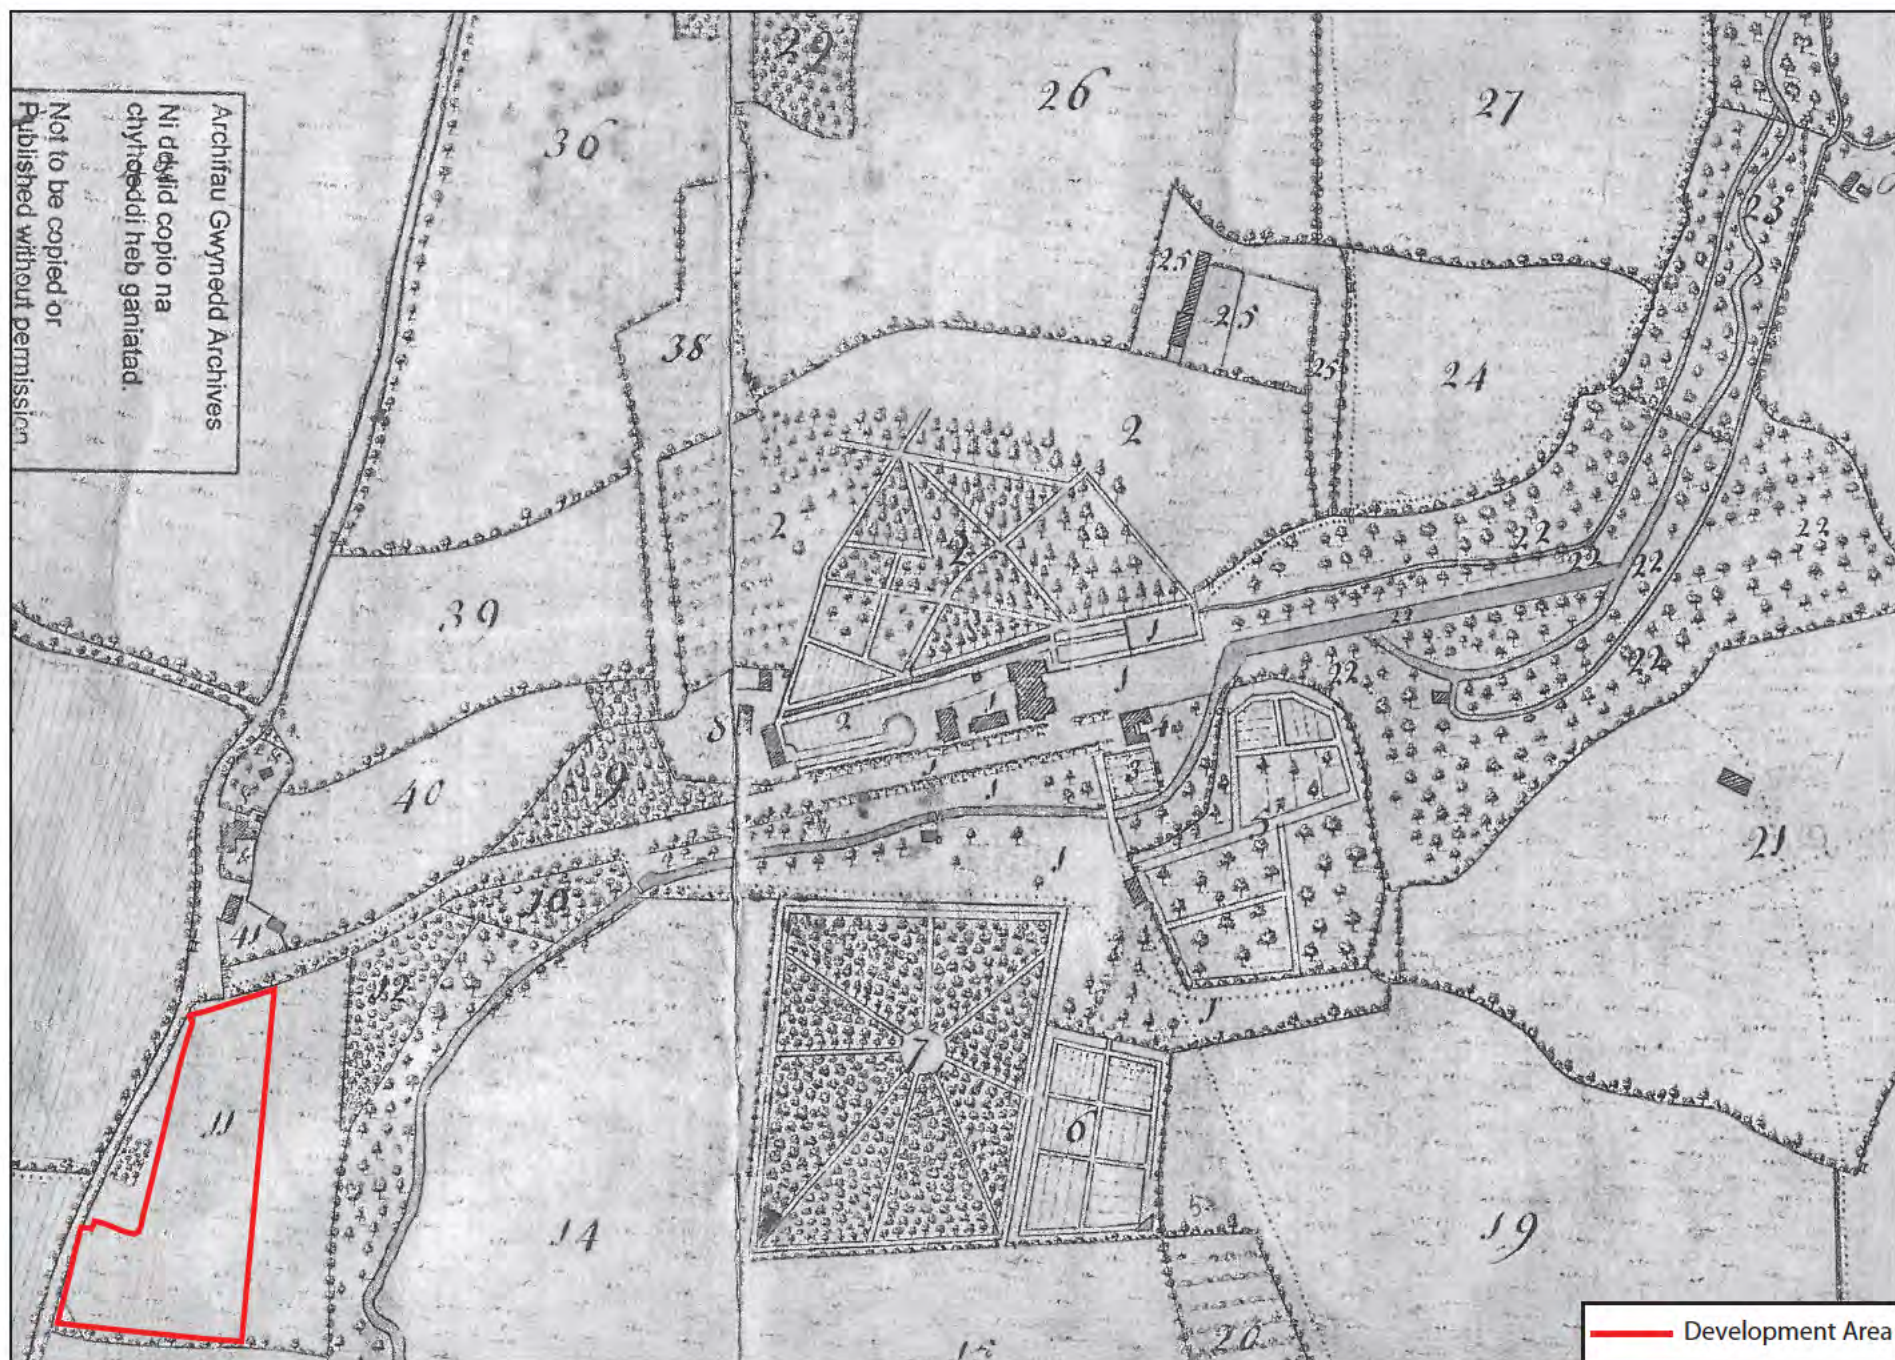
Figure 3. Map of Glynllifon Demesne with schedule of lands (1751) (XD2A/1580). Development area shown approximately in red.

The 1751 estate map (Gwynedd RO, XD2A/1580) (figure 3) marks a house near what is now the main gate as 'Bettws house and garden', this has an adjacent cowshed (beudy) and yard (buarth) and a nearby field is called Cae Tan y Bettws. The Bettws name is then applied to the woodland that covered part of the development area and the name appears on OS maps through to the present day. 'Betws' is a loan word from the Old English 'bed-hus' meaning an oratory. It is a common place name in Wales and first occurs at the beginning of the 13<sup>th</sup> century (Roberts 1992, 44). The name is suggestive of a chapel in this location, of which nothing but the name remained by the 18<sup>th</sup> century. On the 1790 estate map (National Library Ms Maps vol. 95 094/8/2) (figure 4) the house was still there but the name is applied to a farm to the south, so there must be some doubt about the exact location of the chapel site. Wherever it was located it would have lain next to one of the principle medieval routes from Caernarfon to Nefyn or Pwllheli (Williams-Jones 1977a, 78), along which, in 1284, Edward I marched to a tournament held at Nefyn to celebrate his conquest of Wales (Williams-Jones 1977b, 82, 84).

The north-western part of the development area has been at least partly under woodland for most of the time since at least 1751 (figure 3) and it is probable that this scarp represents a boundary marking the woodland edge. Overlaying the OS maps with the field visit data shows that the scarp runs close to but not on quite the same alignment as the 19<sup>th</sup> century woodland edge. The discrepancy may be resolved with more detailed and accurate survey, but it could indicate that the scarp relates to the 18<sup>th</sup> century woodland. There are hints of the scarp continuing to the west of the curving driveway, and it seems to change alignment where it passes under the drive. This change of alignment fits well with the 18<sup>th</sup> century boundaries and the fact that the driveway seems to have been built over the scarp also indicates a pre-nineteenth century date.

The 1751 map (figure 3) shows a house named as Bettws in approximately this location. The name suggests that this may have been the site of a medieval chapel or oratory but this is not certain.

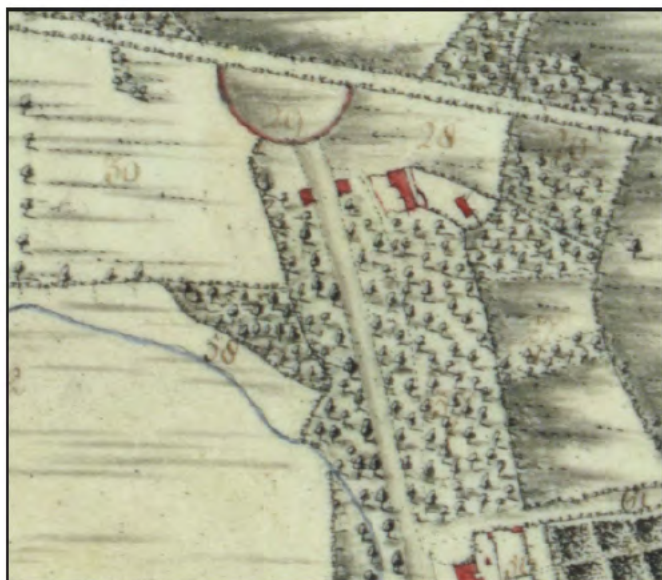
Figure 4. Glynllifon Demesne and Penbryn Bwlan (1790)  
(Ms Maps vol. 95 p32).  
Development area shown approximately in red  
and detail of development area as inset.

The 1790 map (figure 4) shows a lodge or gate way with a double structure at approximately this location. This seems to have been built around this date and to have been replaced by the present Grand Lodge. There was

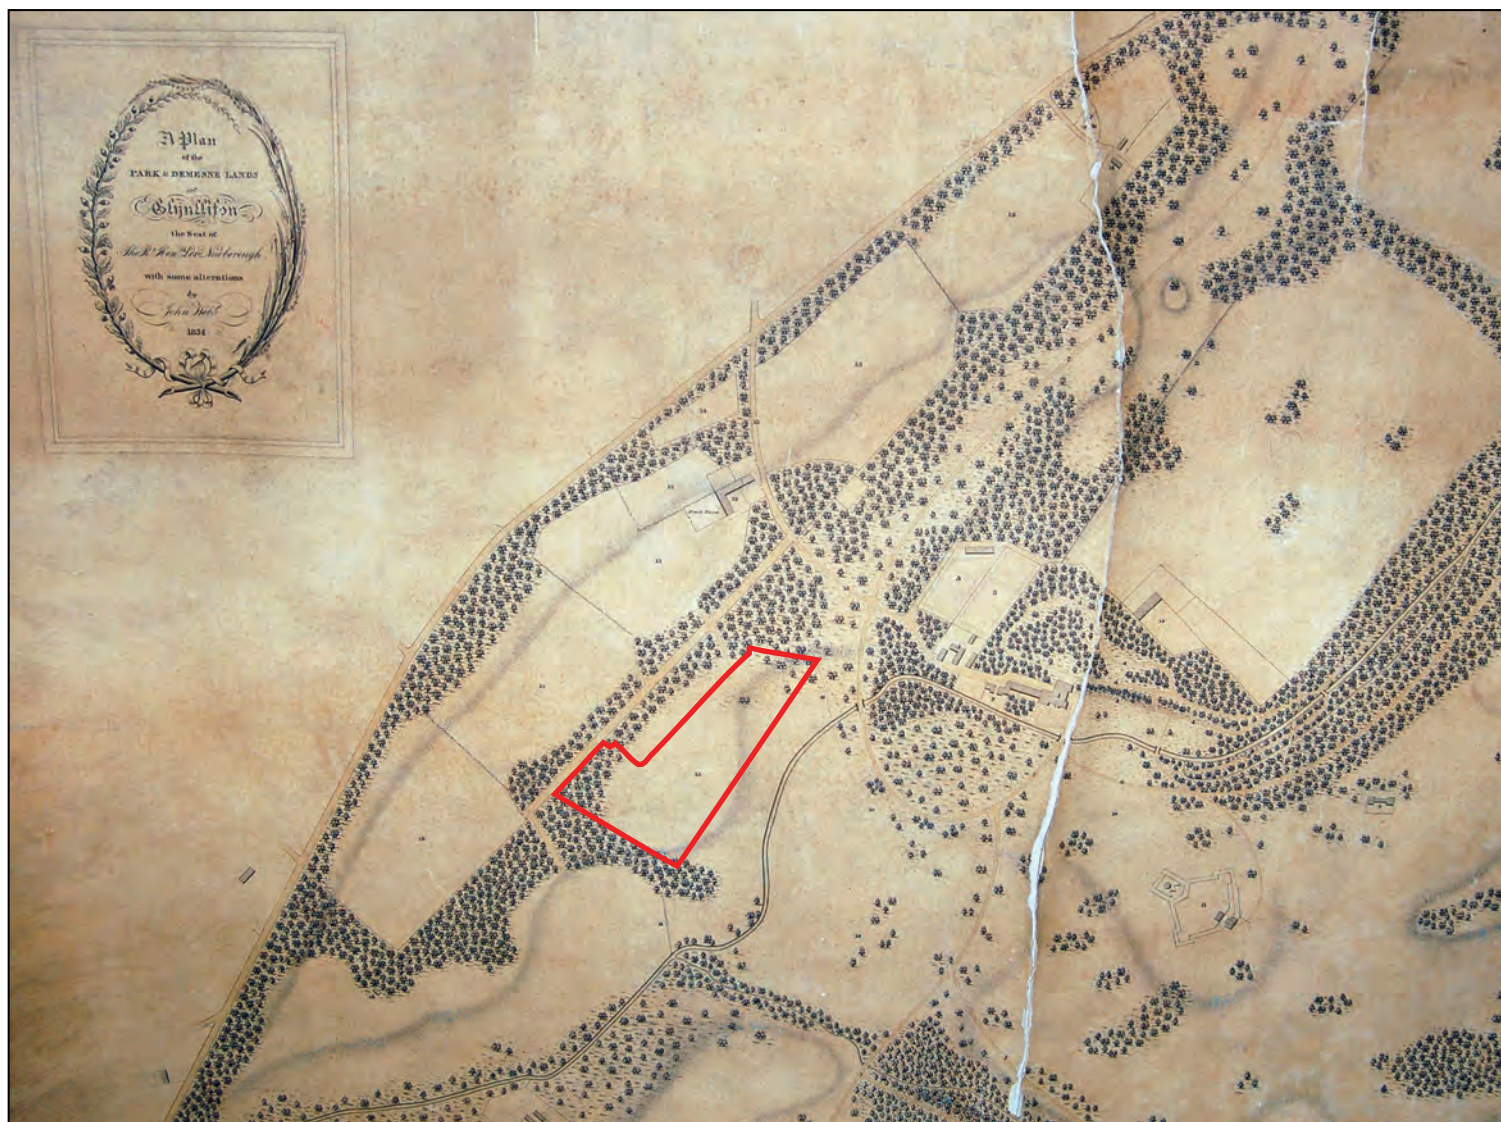
Figure 5. Map of park and demesne lands at Glynllifon (1824) (Gwynedd Record Office:XD2A/857). Development area shown approximately in red.

The development area consists of one field running northeast to southwest located to the southwest of the agricultural college, Coleg Meirion-Dwyfor (figure 2). It is defined by the estate wall (PRN 11,262) (feature 20) on its north-eastern side and by fencing on its south-eastern, south-western, and north-eastern sides. An irregular scarp between 2m and 4m in height runs southwest to northeast across the south-western edge of the development area close to the fence (figure 11). It appears that this scarp does not define a field edge but is a terrace cut into the drift and alluvial deposits by the river probably during the early Holocene. An estate map dating to 1824 gives a good representation of this river terrace (figure 5).

The first Lord Newborough built a lodge at the west gate, possibly in the 1790s (Cadw 1998, 209), but this seems to have been on a slightly different site to the present Grand Lodge. The 1790 map shows a double structure marking the gateway; however, this is to the east of the present lodge. An estate map of 1824 (Gwynedd RO XD2A/857) (figure 5) shows a single small building just to the north of the site of the present entrance but no lodges. The map of 1828 (Gwynedd RO XD2A/858) (figure 6) shows the present double structure in the current position with the entrance area in its current layout. The evidence is further confused by the tithe map (figure 7) that shows a single building to the south side of the drive. It appears from the map evidence that the first Lord Newborough built a double gateway structure but that this was demolished and the gate relocated as new driveways were built. The 1828 map has had additions made to it and if the tithe map can be trusted this suggests that the lodge was one of these additions and that it was not constructed until after 1849. The listed building record comments that the Classical detail of the present lodges and linking archway suggest that it is contemporary with the house built in the 1840s, with remodelling about 1900. The lion on top of the archway originally stood on the stable block and was moved in the late 19<sup>th</sup> century (Cadw 1998, 208).

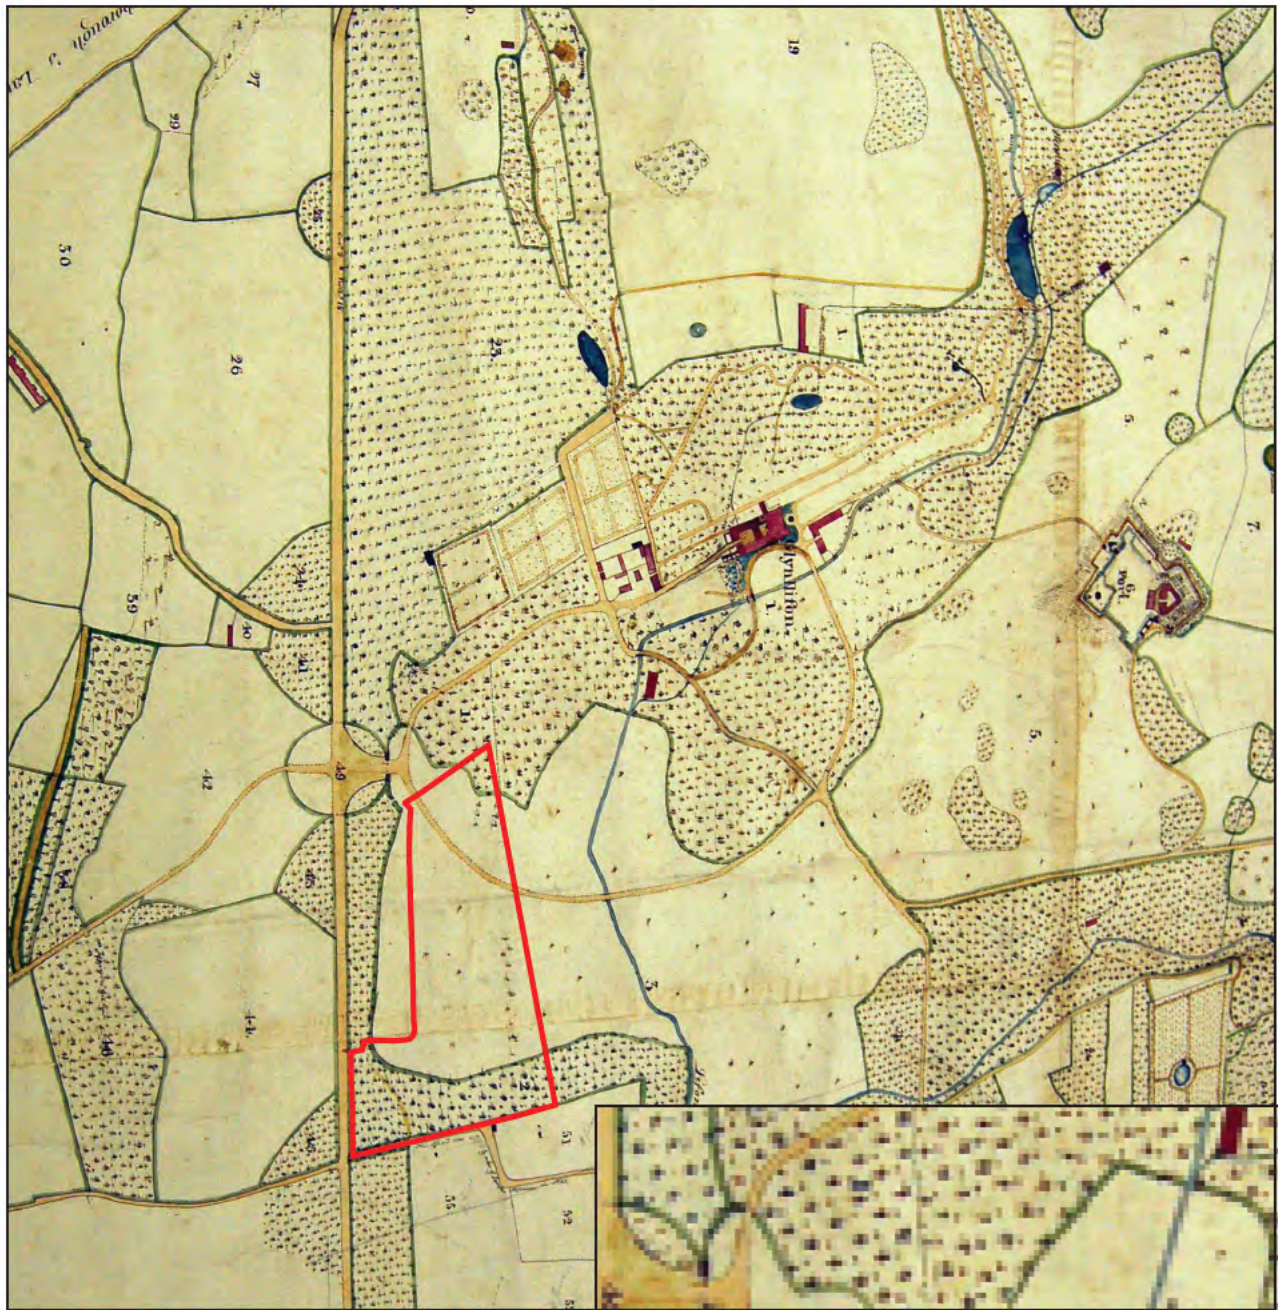
Figure 6. Map of Glynllifon Demesne  
in the parish of Llandwrog  
(1828-1840)  
(Gwynedd Record Office:XD2A/858).  
Development area shown approximately  
in red and detail of development area  
as inset.

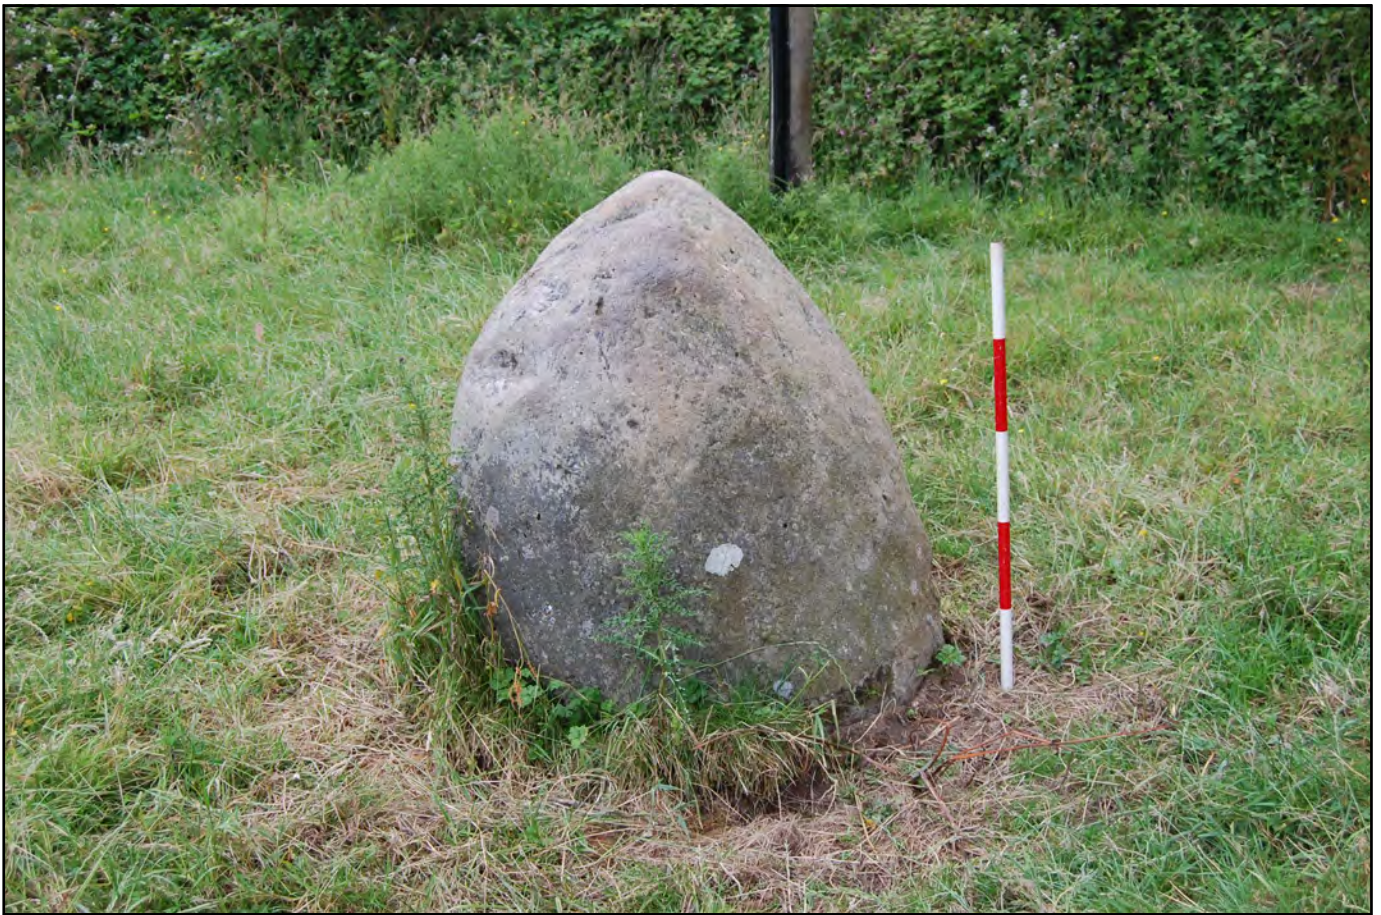
**Plate 1: South facing view of Standing stone**

This standing stone is a large rounded glacial boulder about 1.2m high set securely in the ground on one end. The top is rather pointed and is polished by rubbing. The wear does not seem to be consistent with cattle rubbing, as this would be expected down the sides, but cattle have been kept in the field and may have caused the wear. Lichen growth on the stone is fairly sparse. It is not marked on any of the County Series OS maps unlike other prehistoric standing stones in the vicinity, and the boulder is of a type that can be found in the local glacial boulder clays. It is notable that a covered reservoir is marked nearby on the modern map and such stones would be expected to be encountered while digging out the reservoir. The evidence therefore suggests that this stone was put in place during the 20<sup>th</sup> century, however this is by no means certain.

The stone is located outside of the proposed development area, however if it needs to be removed or moved to a new location it is recommended that an evaluation trench be dug against it to recover any available dating evidence to test the assumption that it is a recent feature. Its exact location should also be determined by including it in a survey of the area.

**Recommendations for further assessment:** Evaluation trench and survey

**Recommendations for mitigatory measures:** Dependant on further assessment
