# Eithinfynydd Water Treatment Works: **Tal-y- Bont, Gwynedd**

## Archaeological Assessment

GAT Project No. 2099

Report No. 831

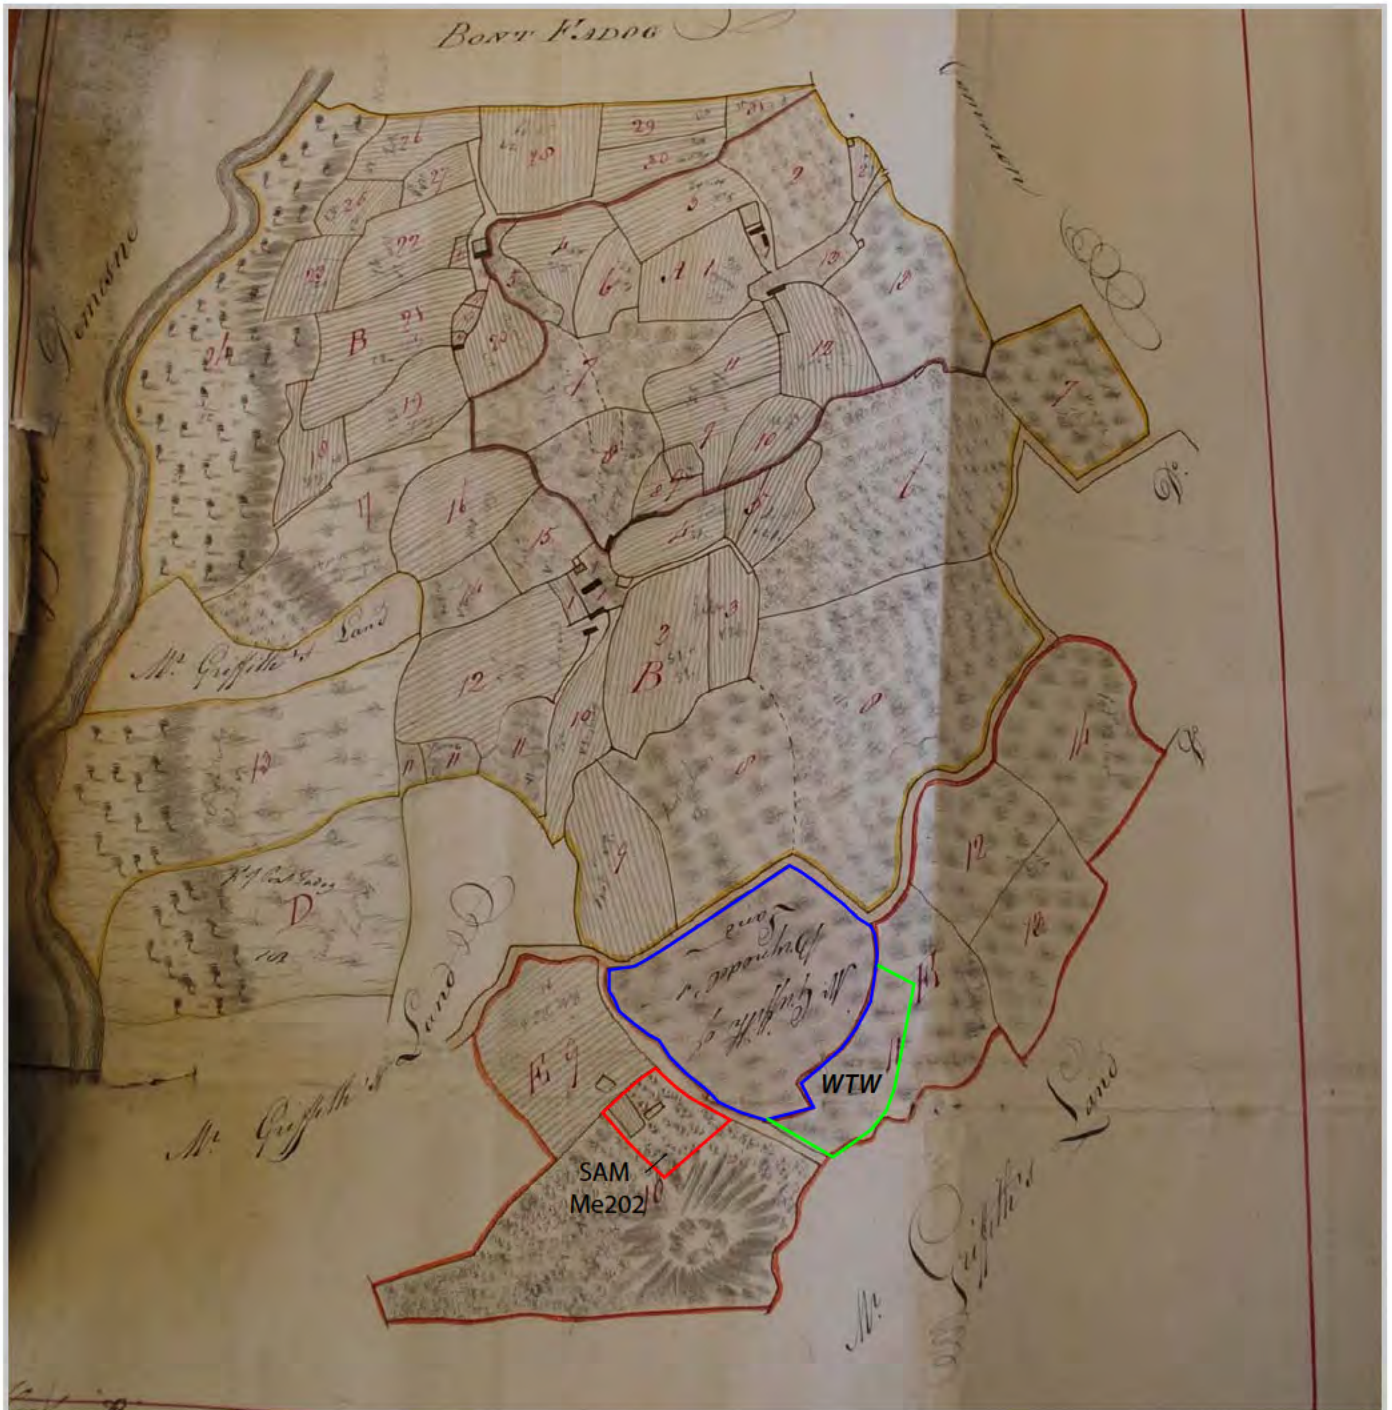
Figure 4. Corys-y-Gedol Estate Map c. 1770 (Bangor University Archives, Mostyn MSS S8678). Development Area outlined in blue, Scheduled Ancient Monument in red and Water Treatment Works in Green.

A possible field barn, located on the c.1770 Cors y Gedol estate plan within field E9 (Figure. 4) and the 1<sup>st</sup> and 2<sup>nd</sup> editions 25 inch Ordnance Survey maps (Figures. 7 & 8). On the Ordnance Survey maps, small enclosure walls are noted leading up to it. It is likely to be post medieval in date. This feature no longer exists, but would have once stood where the opening now lies to the road in the southern wall.

A trackway noted on the c.1770 Cors Y Gedol Estate map (figure 4) and the c.1800 Brynodol estate map (figure 5) to the west, north and continuing to the east of the study area. It currently survives in part as a track and part as an access route to the fields.

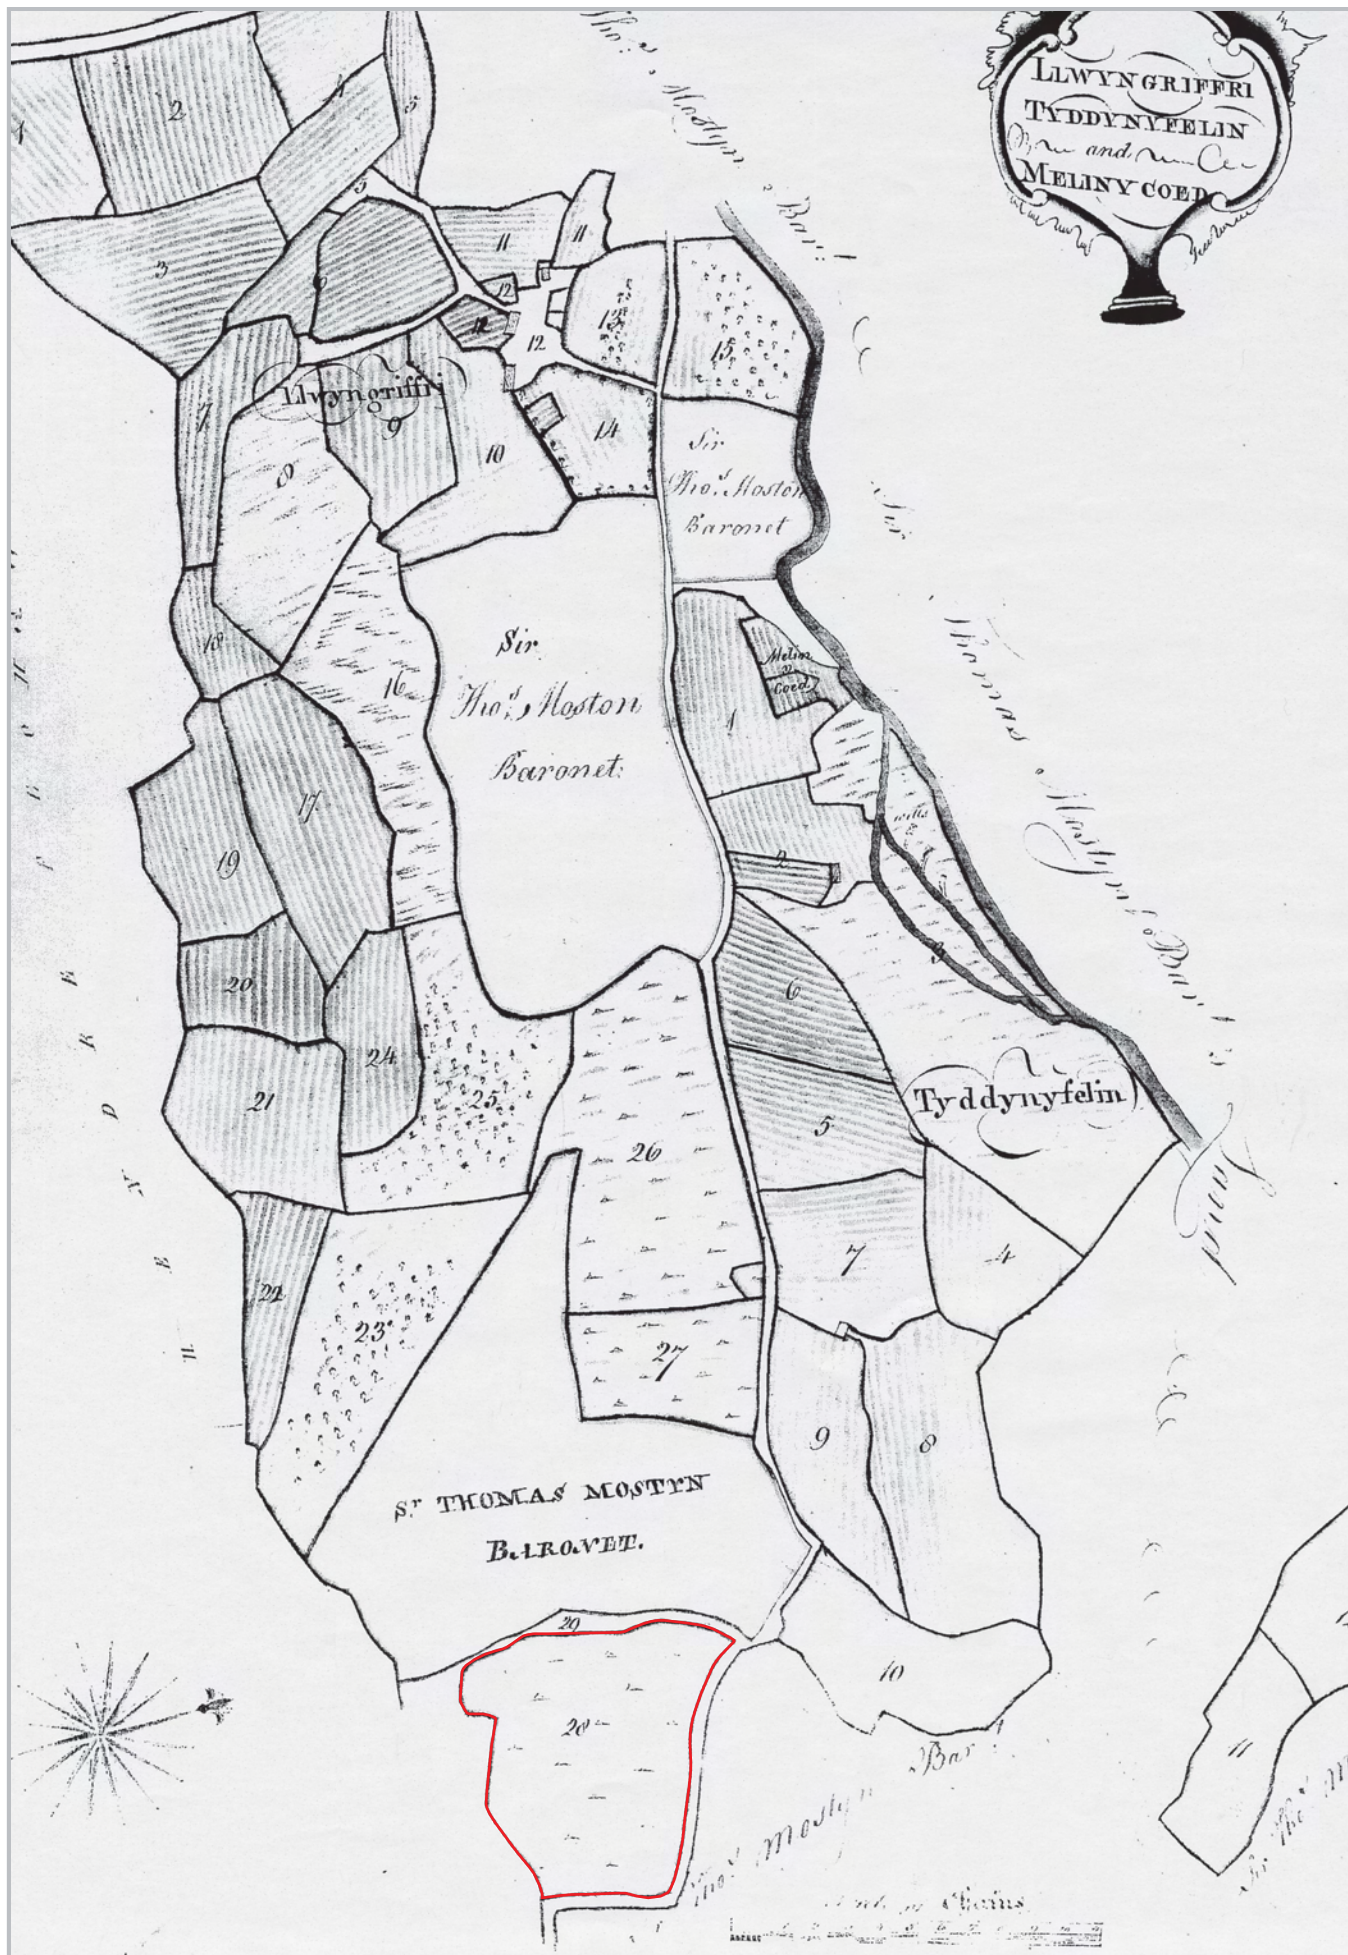
Figure 5. A plan of Brynodyn and Llanfair estates, in the county of caernarfon, also Taltreyddyn estate, in the county of Merioneth: the property of John Griffith Esq. by Richard Owen 1800.

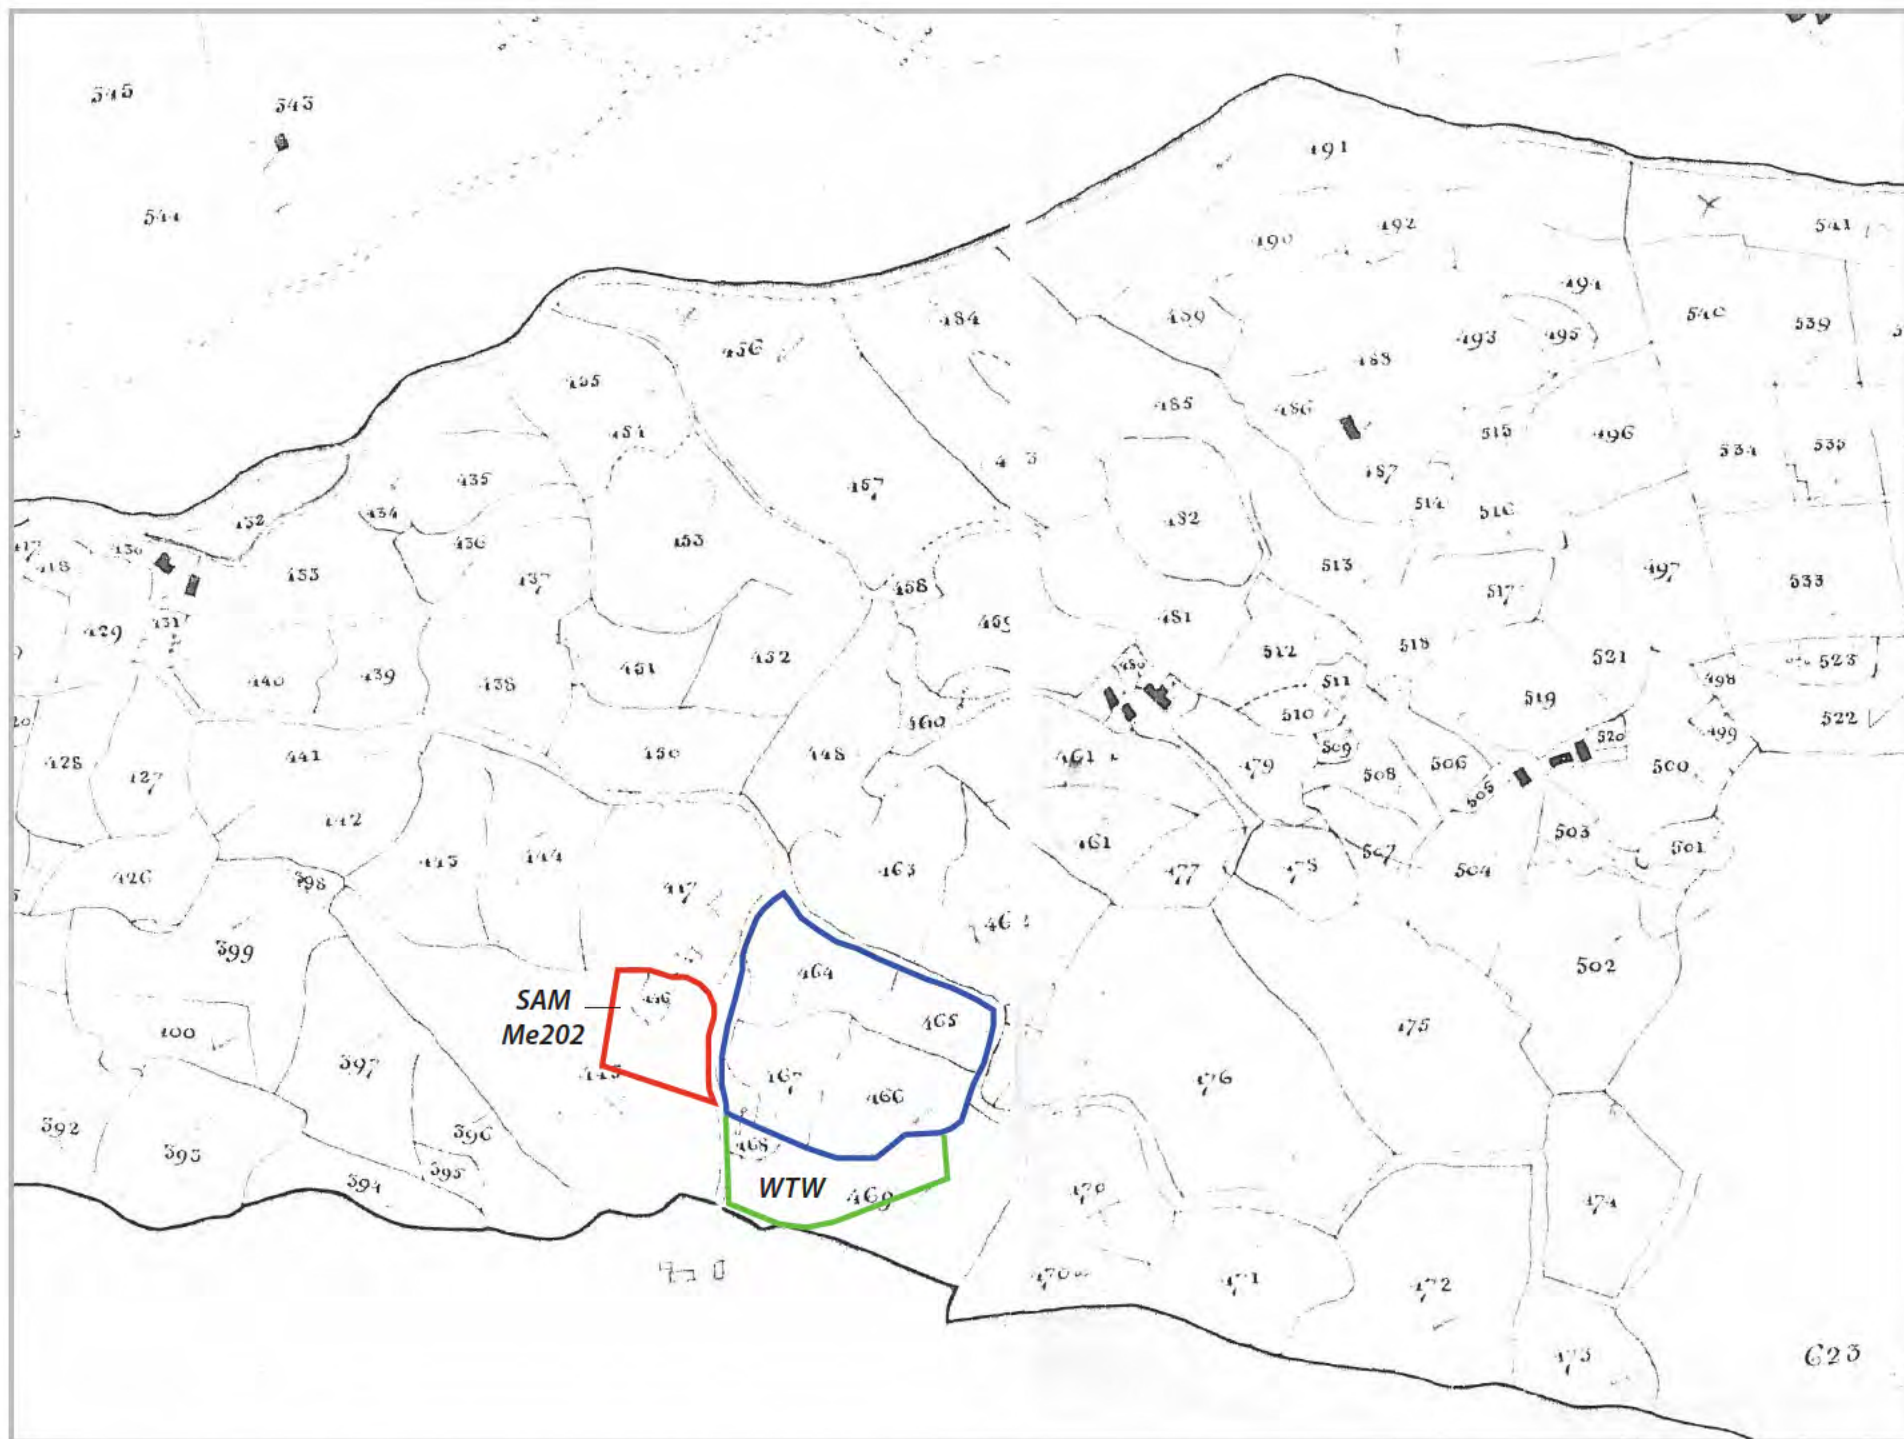
Figure 6. Tithe Map of the Parish of Llanddwye 1840 with assessment area outlined in blue, WTW in Green and SAM in red

A relict field wall which runs east-west across the study area. This, with feature 8, divided the area into four fields. The wall is noted on the tithe map of 1842 (figure. 6), but is absent on the 1770 Cors y Gedol estate map (UWB Mostyn MSS S8678 figure. 4), and the 1800 Brynodol estate map (NLW Vol 094/9/2 figure. 5). The tithe schedule refers to the four fields as being part of *Cae Erwerth*, suggesting that the sub-division of the fields was a relatively recent event in 1840. The wall was divided in the centre to create an access track 3m wide during the development of the present water treatment works in 1985.

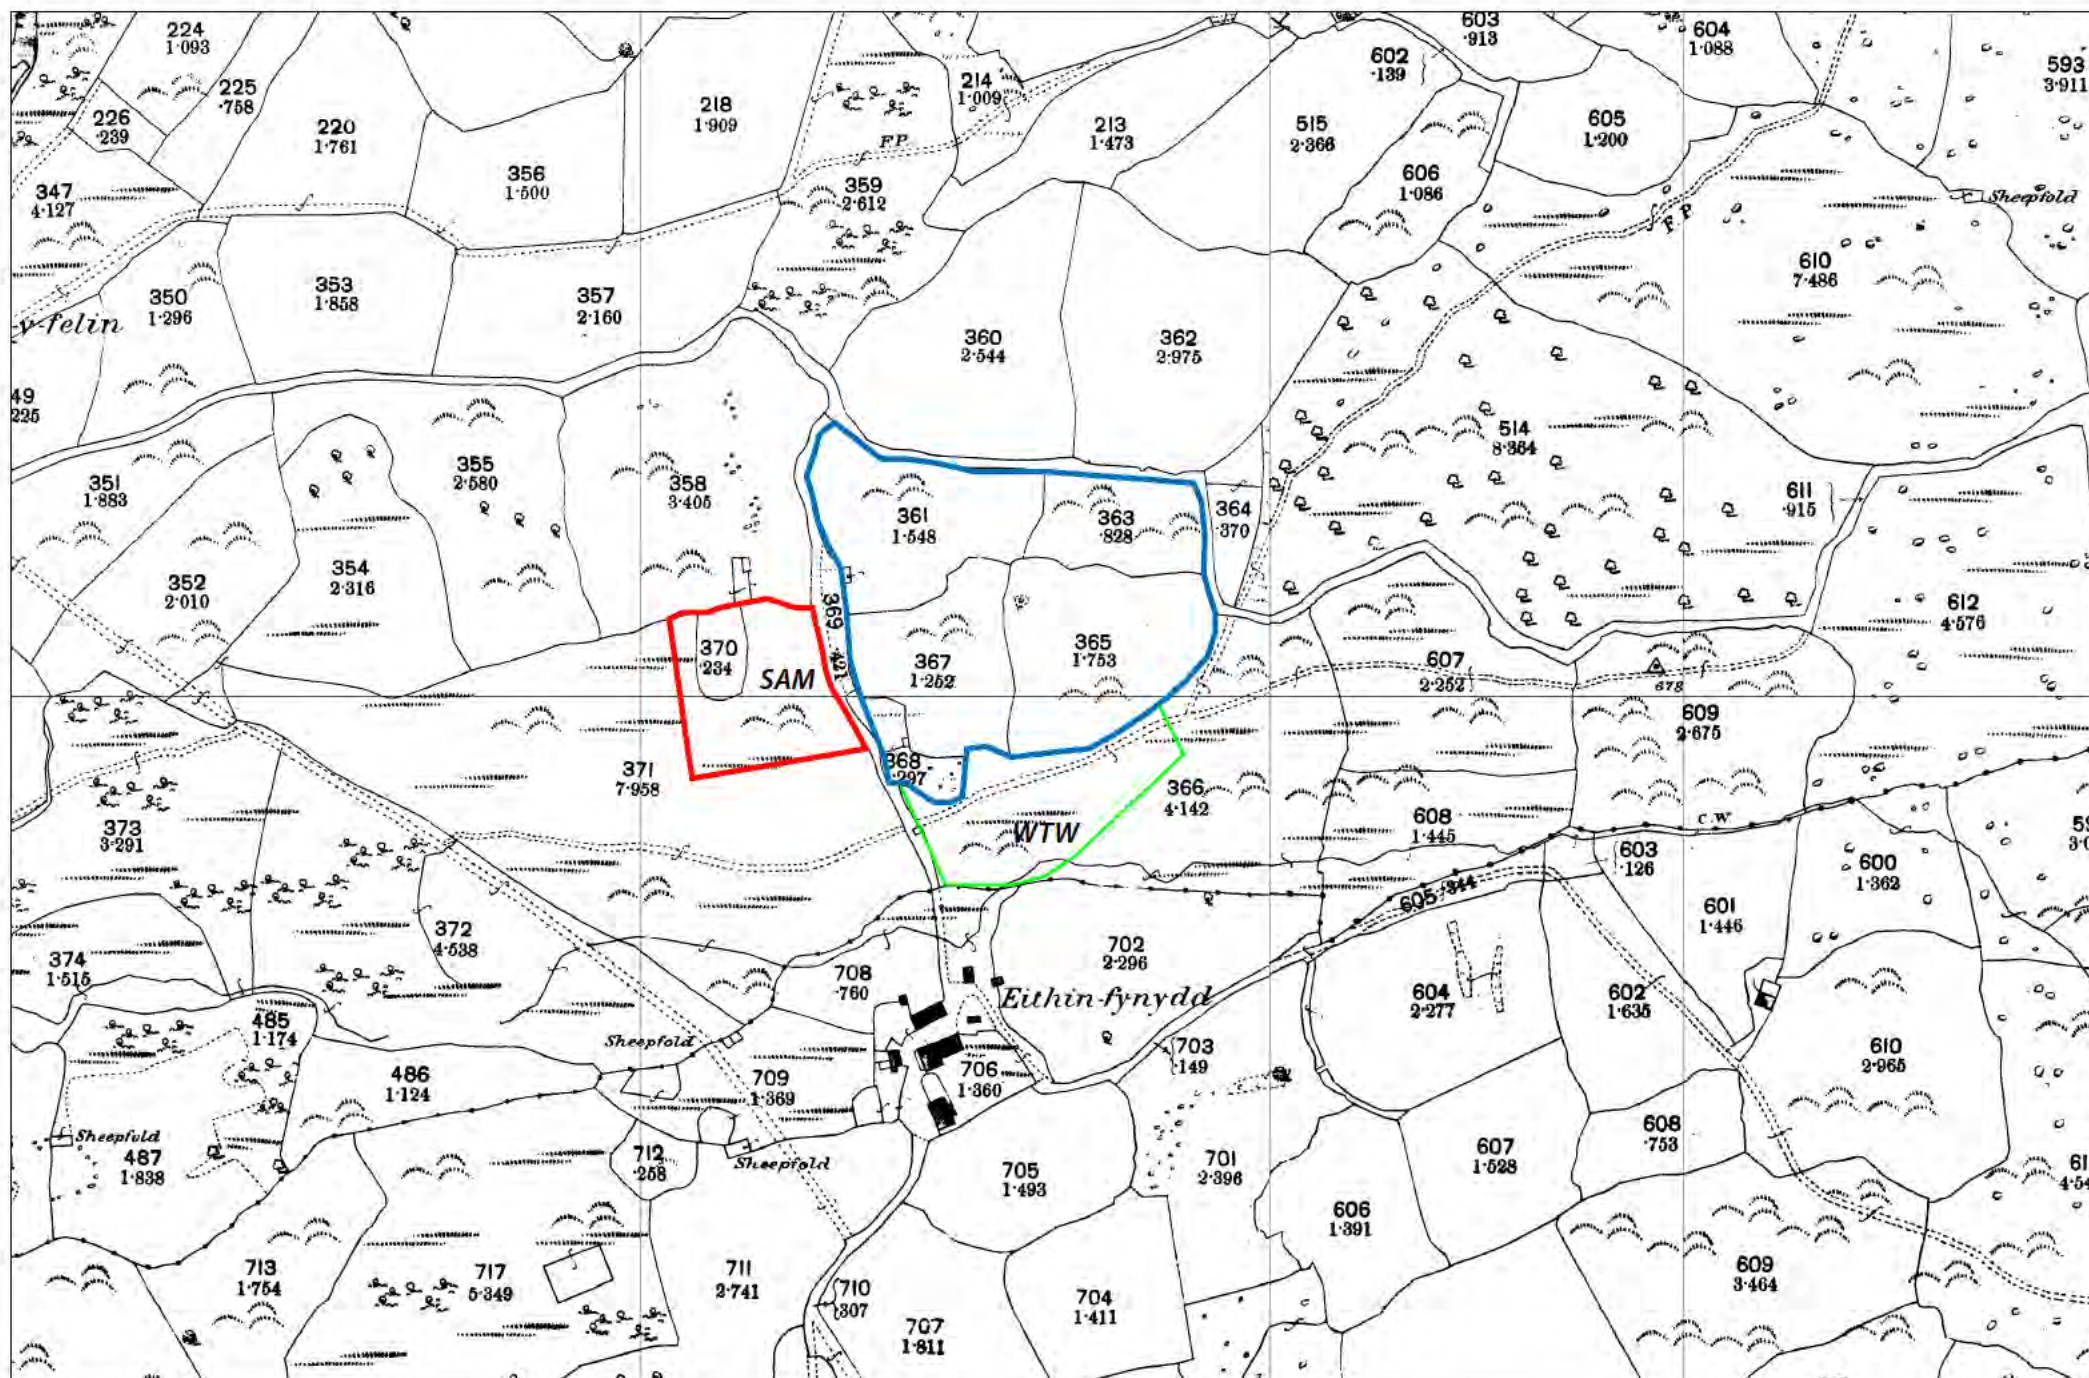
Figure 7. 1st edition 25 inch Merioneth Ordnance Survey Map of 1889. Sheets XXXII.5 and XXXII.6. Scale 1:3000. Development area outlined in blue, water treatment works in green and Scheduled Ancient Monument in red.

A farm trackway is noted on the 1889 25 inch 1<sup>st</sup> edition Ordnance Survey map (Figure. 7), heading east and northwards through the current water treatment works site with a northwards fork towards

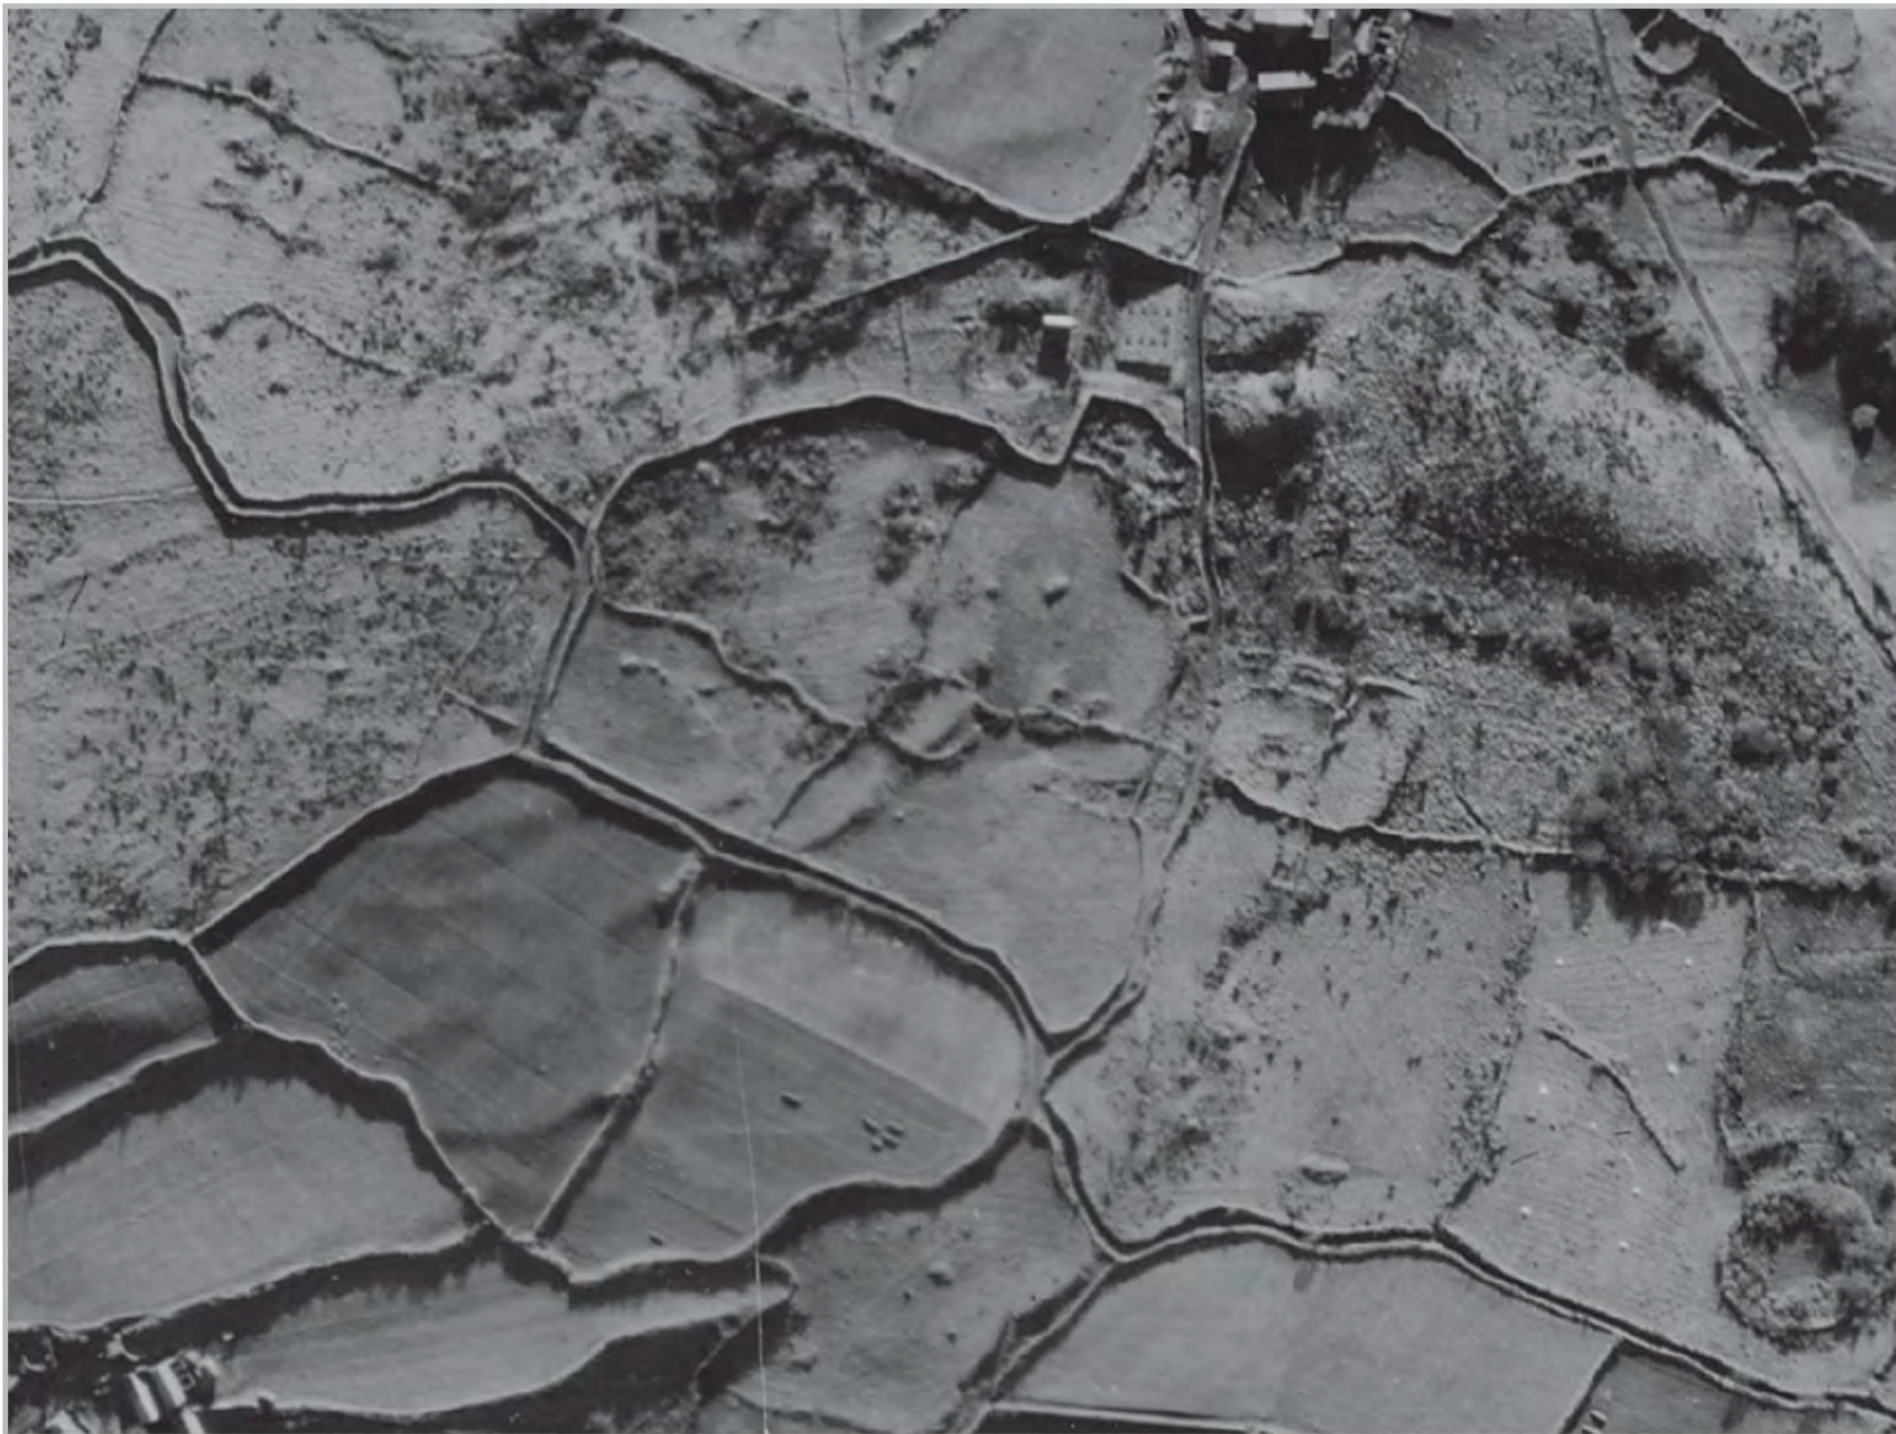
Figure 9. Aerial photograph RAF Vetic. CPE/UK 1939 F20 Frame 4026 Taken 19th January 1947

Two cairns of boulders and smaller loose stone about 2.8 x 4.5m and 1.8 x 2.3m in diameter. The feature is visible on the aerial photographs (CPE/UK 1939 and ZEIS 054 71-234 1971), where it appears to extend further to the west than at present. The appearance of the cairn suggests it is the result of relatively modern clearance, though it may contain remains of an earlier cairn or structure within it.

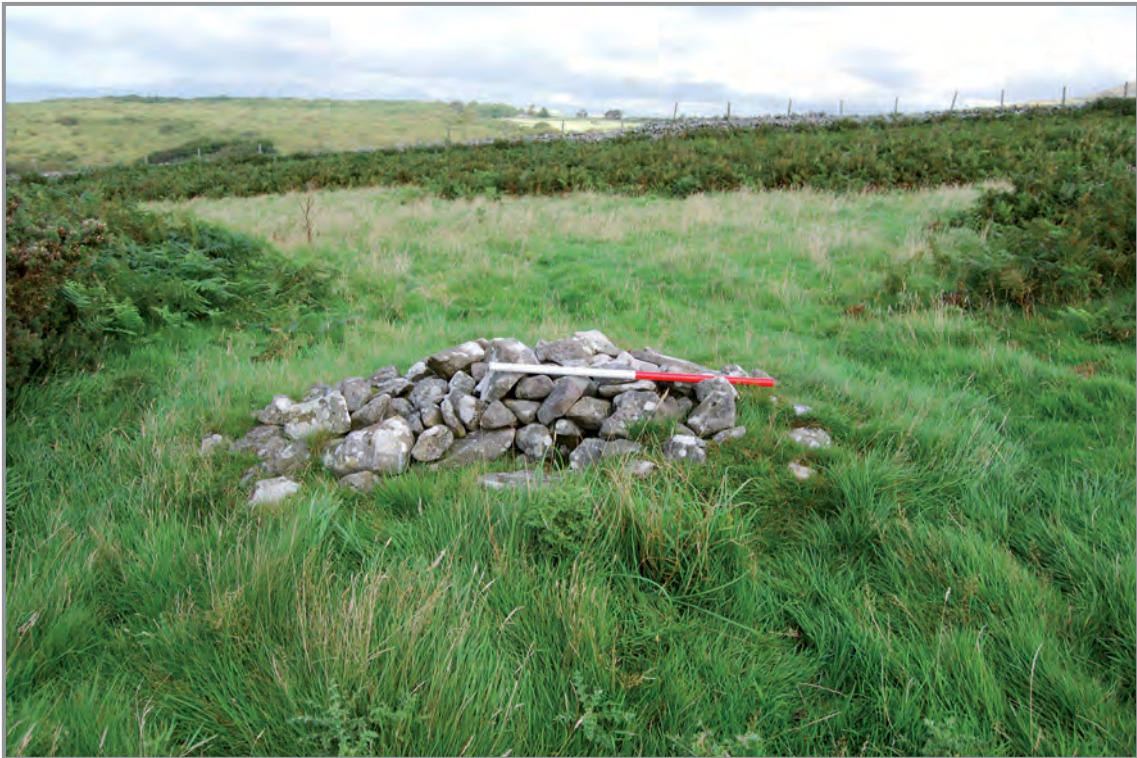
A mound of boulders and smaller loose stone, covering an area of about 5.5 x 3.8m. This may represent field clearance and later agricultural activity, or even construction activity from the first phase of works. However, some burnt stones are present, and therefore it may be, at least in part, a prehistoric burnt mound.

**Plate 1:** *Feature 2. Possible prehistoric cairn, field clearance or construction activity from the first phase of works. View taken from the north-west.*

**Recommendations for further assessment:** None

**Recommendations for mitigatory measures:** None

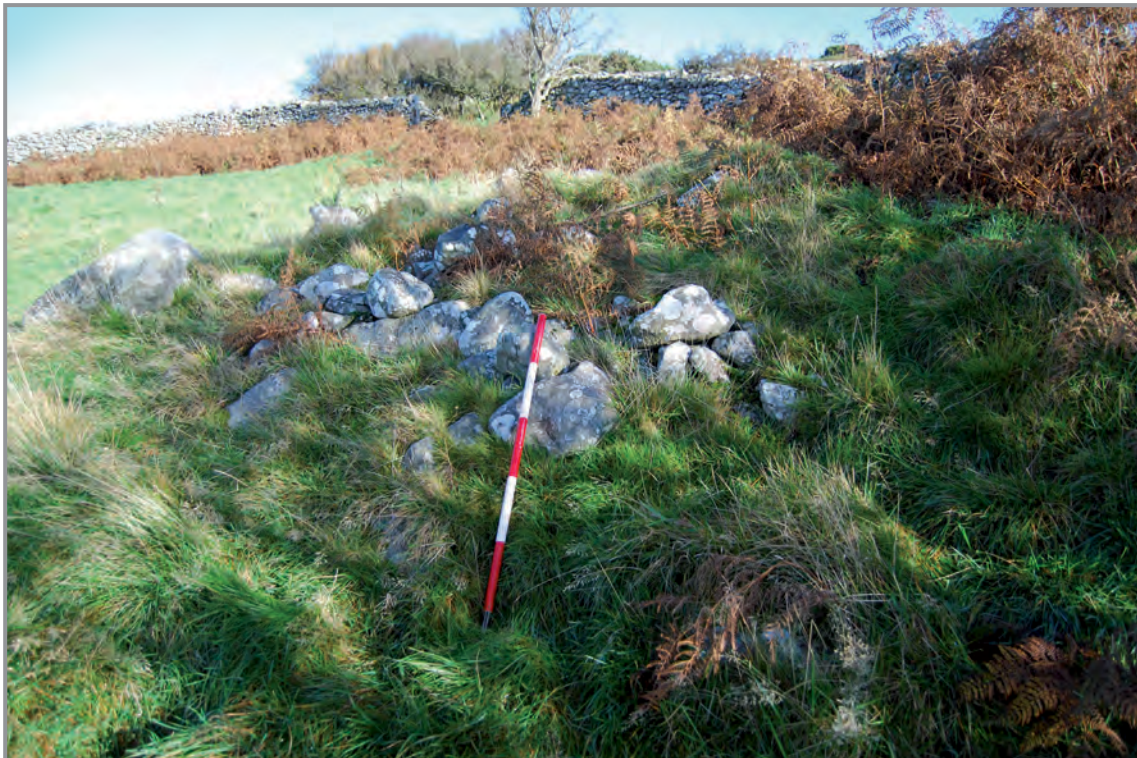
**Plate 2:** *Feature 3. Possible remains of a rectangular building. View taken from the south-east.*

**Recommendations for further assessment:** Trial Excavation

**Recommendations for mitigatory measures:** Await results of evaluation.

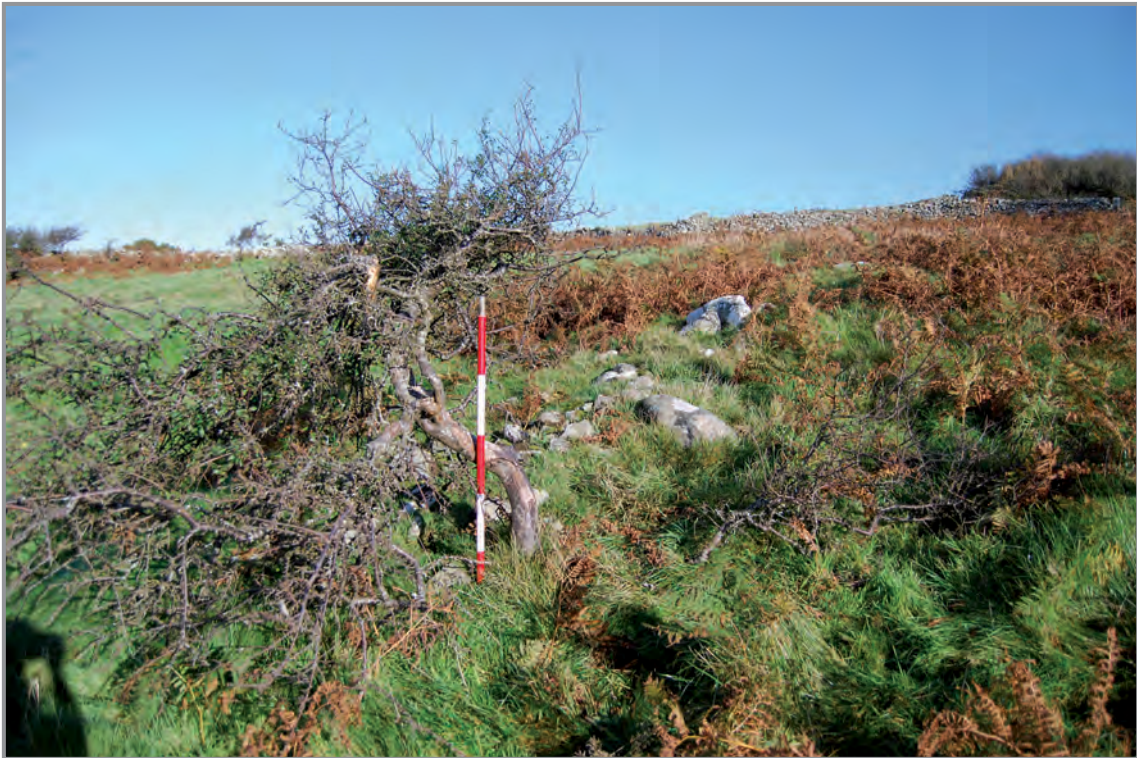
**Plate 3:** *Feature 5. Possible wall. View taken from the south-east.*

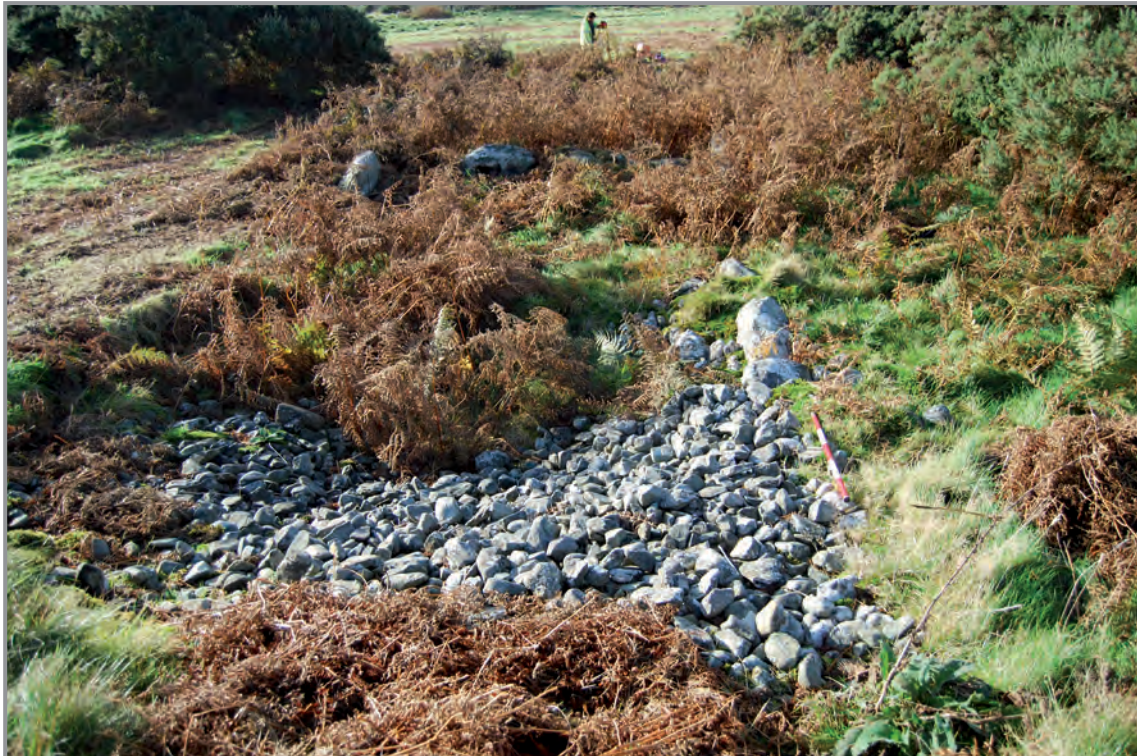
**Plate 4:** *Feature 6. Remains of a rectangular building, possible medieval long house or field barn. View taken from the south-west.*

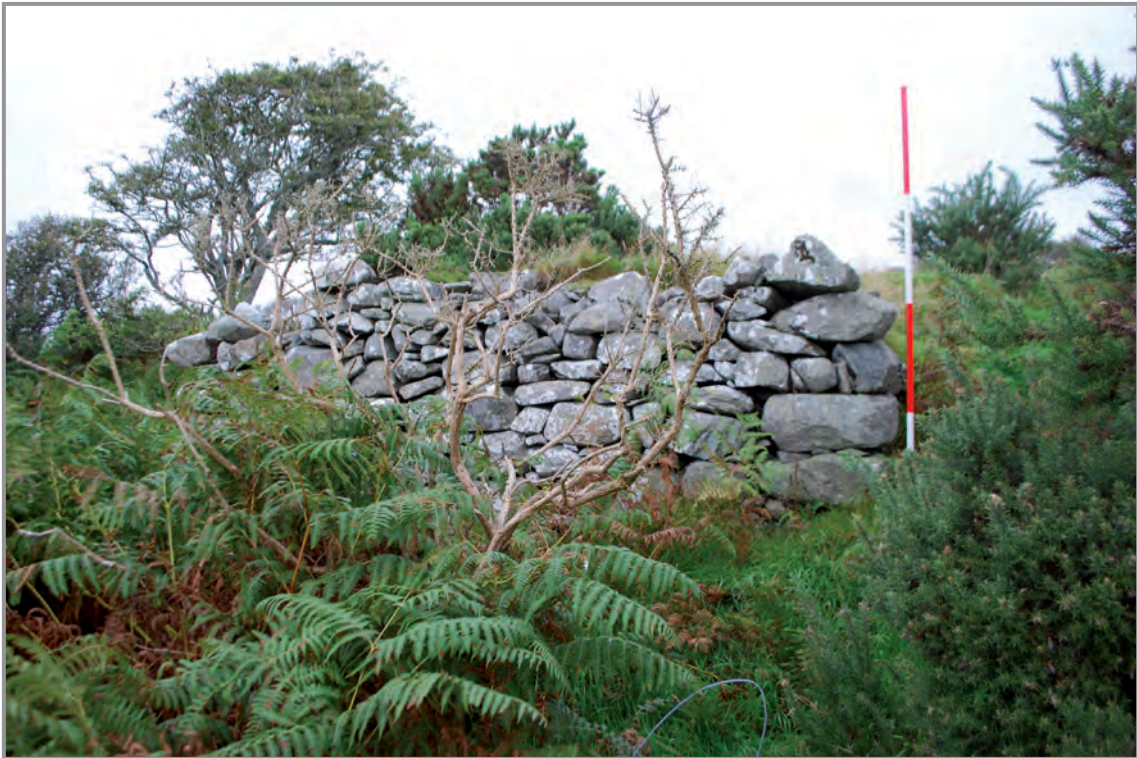
**Plate 5:** *Feature 10. Possible medieval enclosure, platform and long hut. View taken from the south-west.*

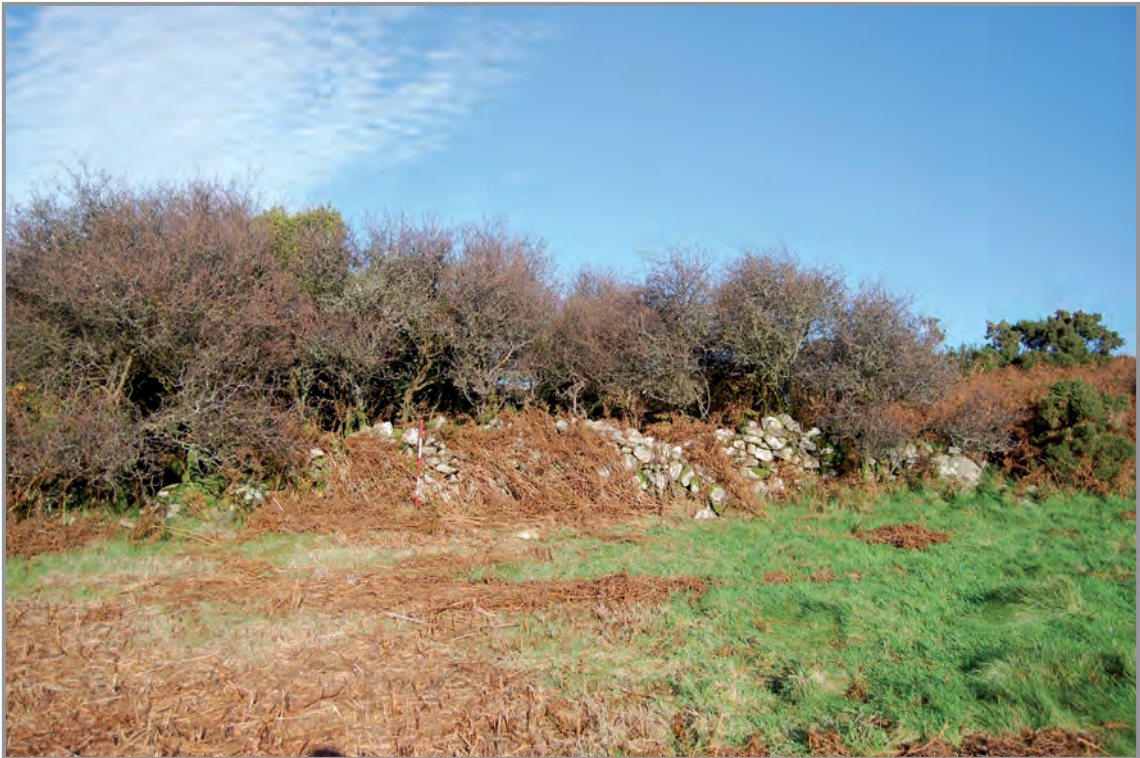
A relict field wall which runs north-south across the study and, with feature 7, divides the assessment area into four fields. It is noted on the tithe map of 1842 in its current form, but is absent on the 1770 Cors y Gedol estate map (UCNWB Mostyn MSS S8678 figure. 4) and the 1800 Brynodol Estate map (NLW Vol.094/9/2 figure. 5). The tithe schedule refers to the four fields as being part of *Cae Erwerth*, suggesting that the sub-division of the fields was a relatively recent event in 1842. The wall was divided in the centre to create an access track 3m wide during the development of the present water treatment works in 1985.

**Plate 7:** *Feature 8. Relict feild wall. View taken from the south-west.*

**Recommendations for further assessment:** None

**Recommendations for mitigatory measures:** None

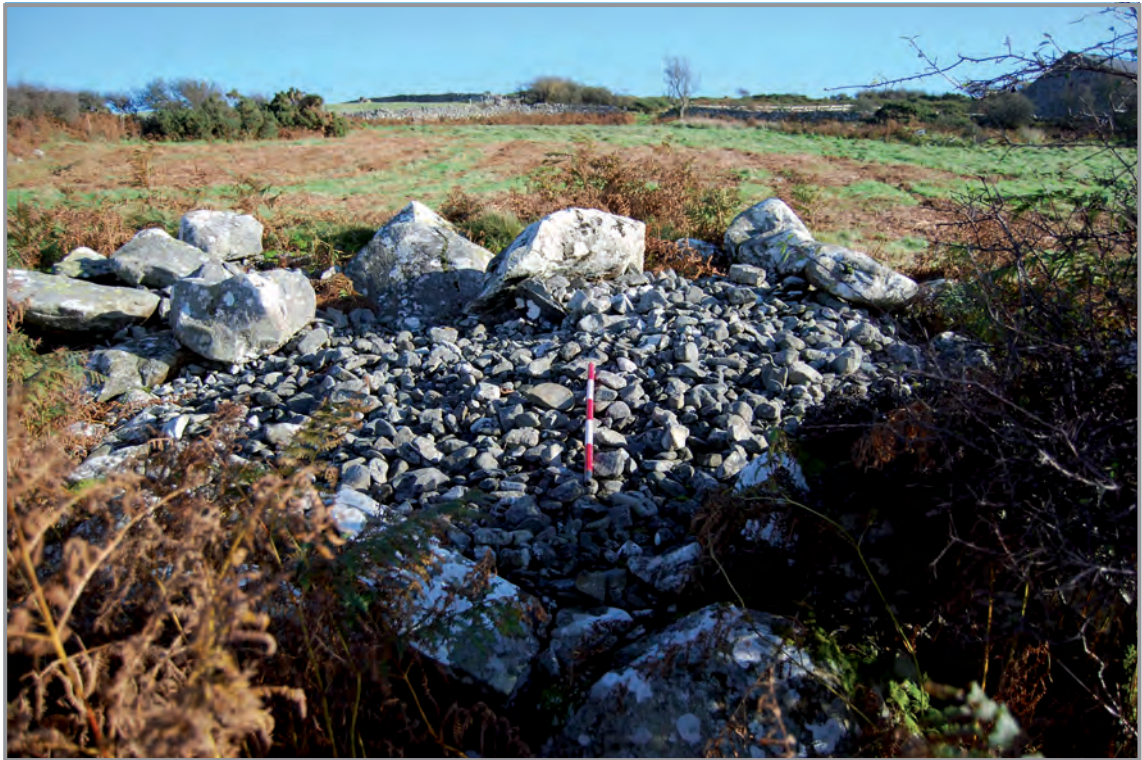
**Plate 8:** *Feature 15. Possible Bronze Age cairn. View taken from the East.*

**Recommendations for further assessment:** None**Recommendations for mitigatory measures:** None**Feature 16 Trackway***SH6008 2166**Period: Post medieval**Category: D Impact: None*
