CONWY QUAY REDEVELOPMENT PROGRAMME

SERVICE TRENCH WATCHING BRIEF

Archaeological Watching Brief

GAT Project No. 2070

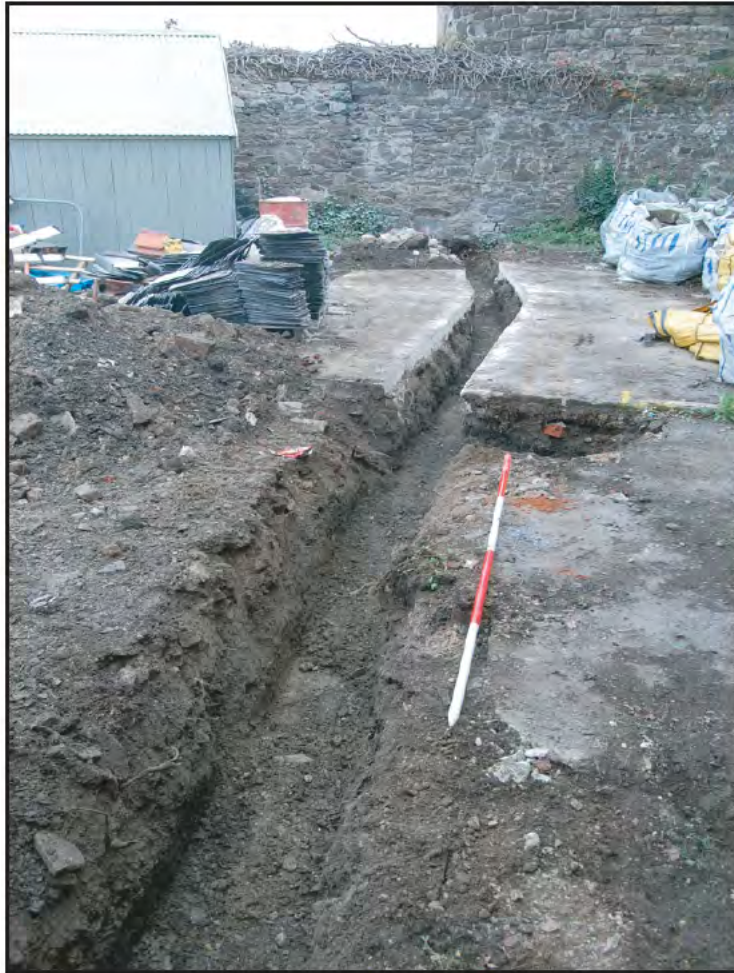
The service trench within Zone 1/Yard 1 measured 14.0m in length, 0.70m in width and 0.50m depth and was excavated through an existing concrete pad (located within the southeast corner of Zone 1/Yard 1) and through the levelling layer deposited after the demolition of **Building 01 (PRN 30452)**.

Plate 01: Zone 1/YARD 1 (PRN 30451): view southeast of service trench excavation (14.0m in length, 0.70m in width and 0.50m depth). Note enclosure wall A in the background, which defined the original quay layout and was retained as part of the redevelopment programme and concrete pad at former location of Building 18 (PRN 30453). (Ranging pole: 2.0m)

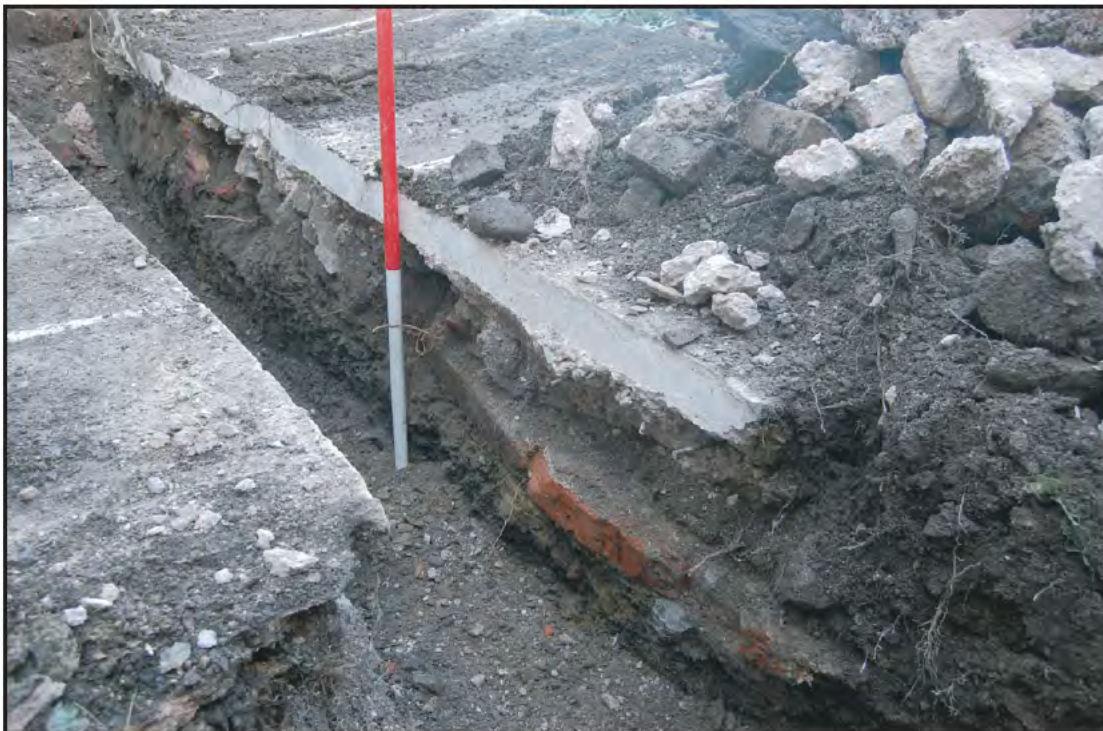
This concrete pad sealed a mixed demolition layer comprising loose red brick infill and a truncated section of walling/foundation, loose within the fill. This feature measured 0.30m in depth, made up of red brick with a covering of white/cream plaster (plate 02) (approximate brick sizes 0.21m by 0.10m, depth 0.09m). The concrete pad was laid during the twentieth century. This suggested that the truncated section of walling/foundation was a remnant of **Building 18 (PRN 30453)**, identified in GAT Report **815** as occupying the full width of **Yard 1**, lying against the town wall. The building was extant in the First to Third Edition OS 25" maps (cf. figure 03 for a reproduction of the Third Edition OS 25" map).

The demolition deposit containing the truncated section of walling/foundation sealed a deposit of crushed slate extant to the limit of excavation. This deposit was interpreted as a levelling layer associated with the construction of the quay.

Plate 02: Zone 1/YARD 1 (PRN 30451): service trench excavation detailing concrete pad within Zone 1/YARD 1 that was extant prior to the redevelopment programme, but was formerly the location of Building 18 (PRN 30453) (GAT report 815). Potential demolition remains relating to Building 18 were identified within the exposed section. (Ranging pole: 1.0m)

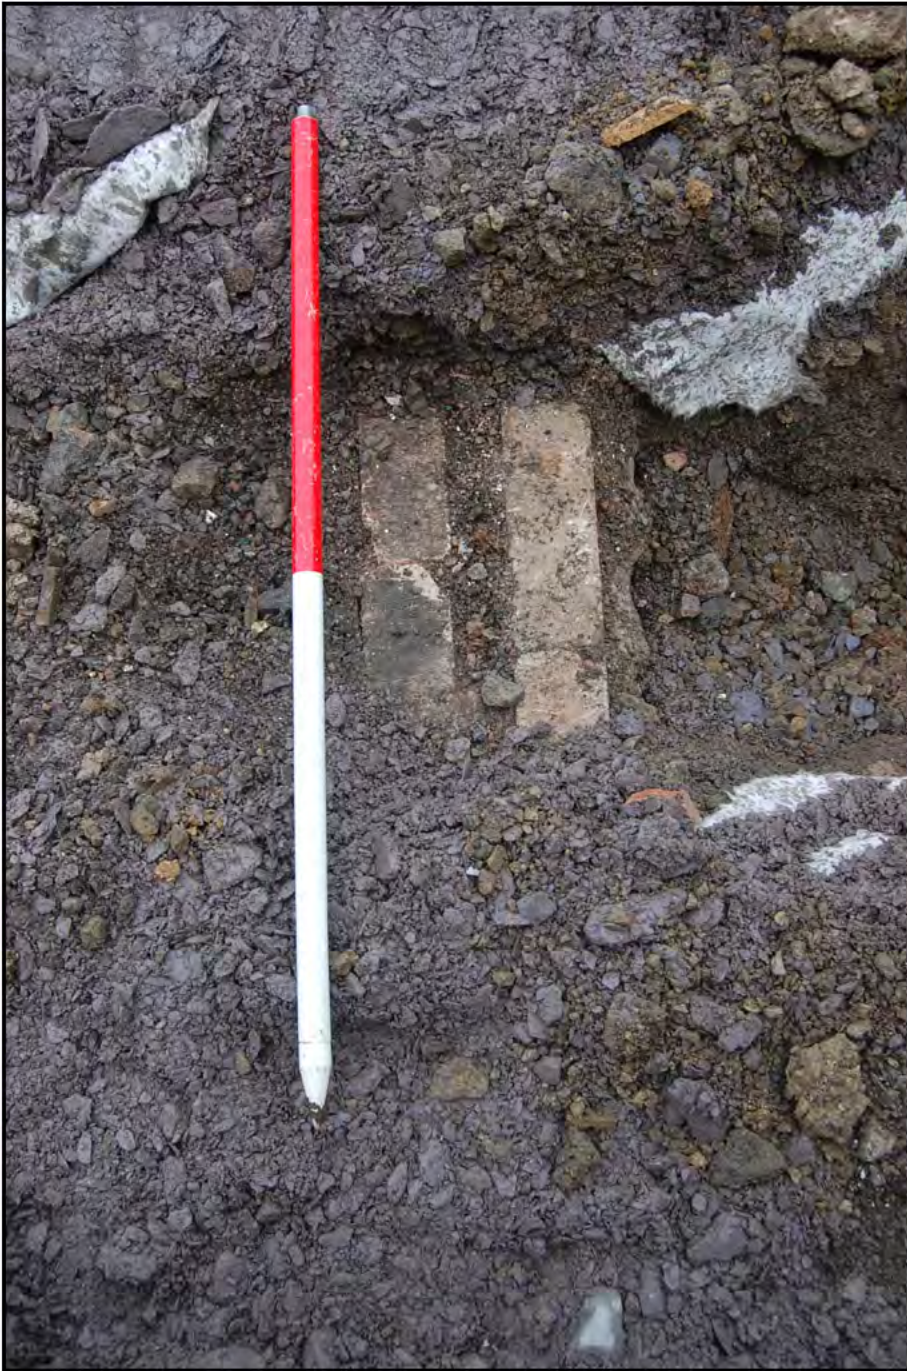
- 3.80m northwest of cross wall A were the remains of a modern wall foundation. The remains consisted of two *in-situ* pink-grey bricks (approximate brick sizes 0.21m by 0.10m, depth 0.09m), set 0.08m, overall width 0.28m apart on a rough concrete pad 0.12m deep and 0.71m wide, on a north east south west axis (plate 03). It is likely that this wall is associated with the development of **Building 02 (PRN 30455)**.

Plate 03: Zone 2/Yard 2 (PRN 30454): service trench excavation - detail of Building 02 foundation level (Ranging pole: 1.0m).

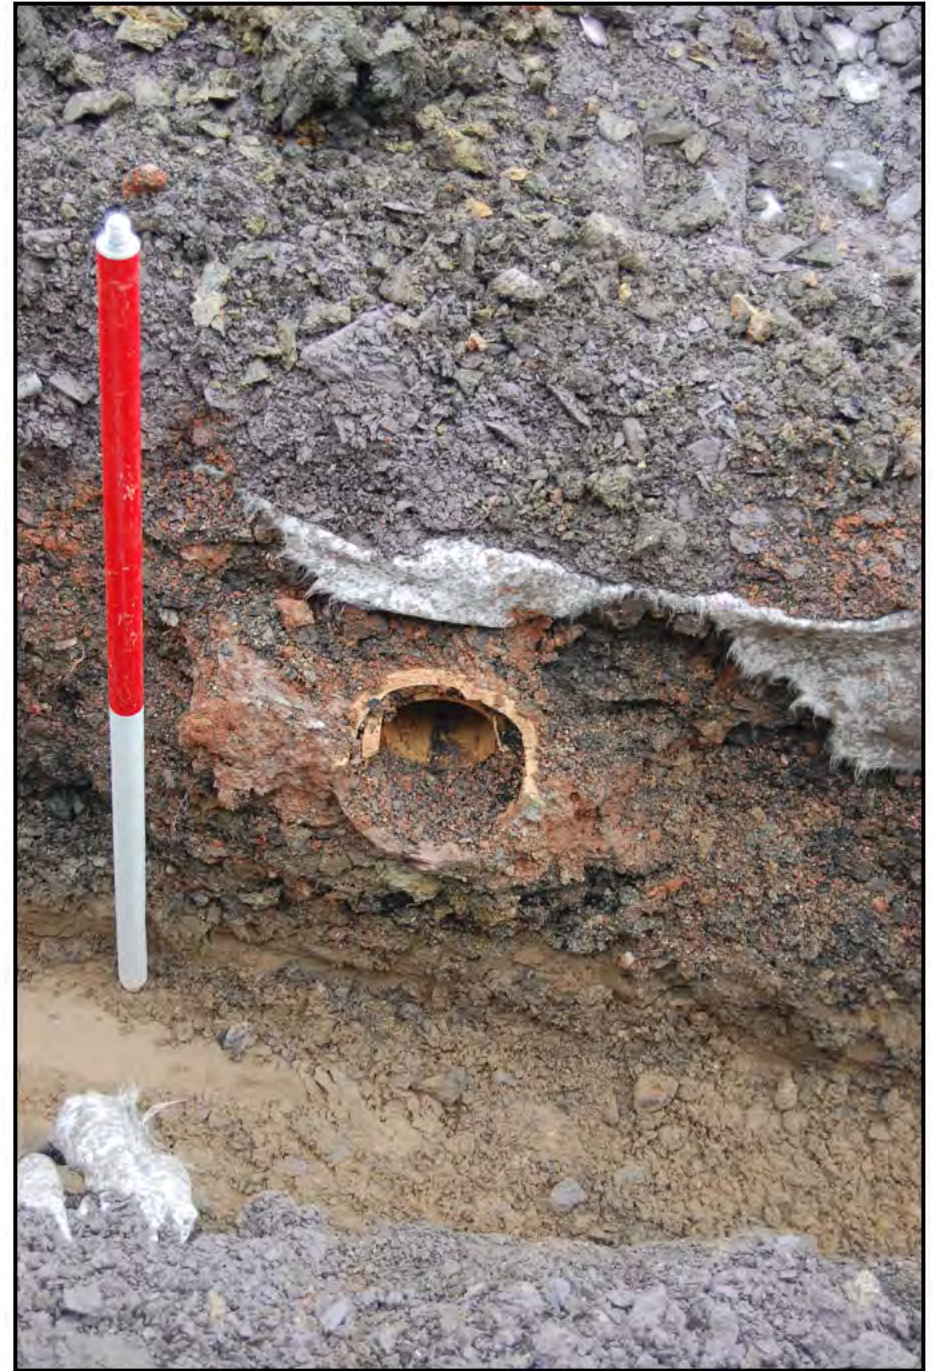
- 4.80m northwest of cross wall A, there was a disused water pipe held in a red brick and concrete mixed covering. This pipe will be used for the placement of a modern water pipe connection joining with the service trench (plate 04).

Plate 04: Zone 2: service trench excavation - detail of disused water pipe held in a red brick and concrete mixed covering (Ranging pole: 1.0m).

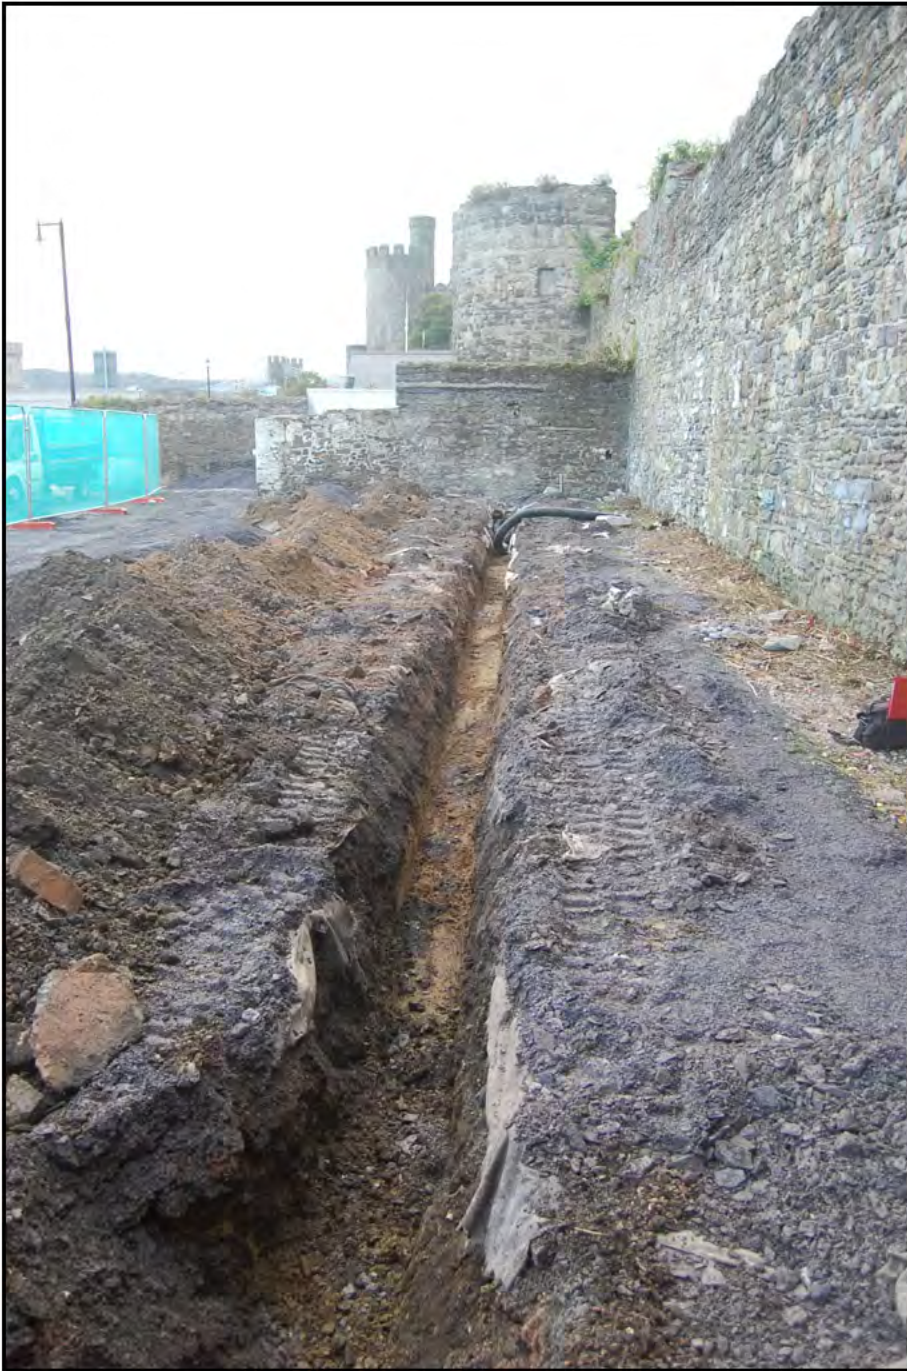
The discussion of the deposits will run from the southeast to the northwest. The trench depth varied between 0.70m to 1.0m with a width range of 0.70m to 0.80m with a length of c.70.0m.

Plate 05: Zone 2: service trench excavation - detail of full excavation depth

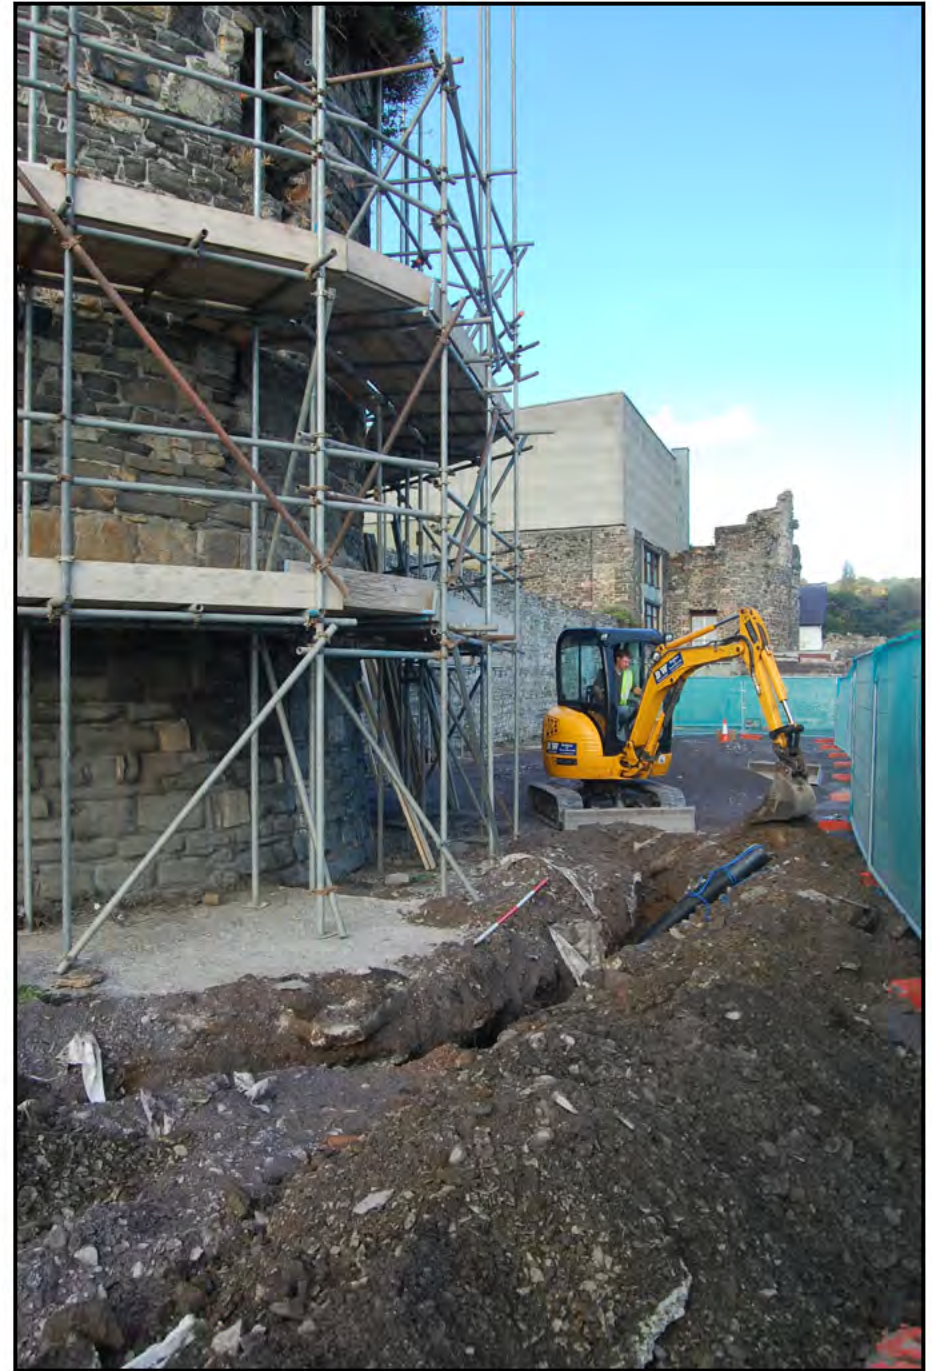
- 8.10m northwest of cross wall A, where the remains of a concrete pad visible in the northwest section: length 2.0m, the end of which was undamaged so it was clear that the pad didn't extend towards the town wall. This deposit was held in a mixed yellow-clay silt soil matrix with rare crushed slate and gravels with a depth of 0.15m. Below this was a mixed brownish sand with a depth range of 0.14m to 0.23m heading towards Tower 3 (plate 06)

Plate 06: Zone 2/Yard 3 (PRN 30457): service trench excavation - detail of excavation surrounding Tower 3 with concrete pad associated with Building 12 (PRN 30461) towards left of image (Ranging pole: 2.0m)

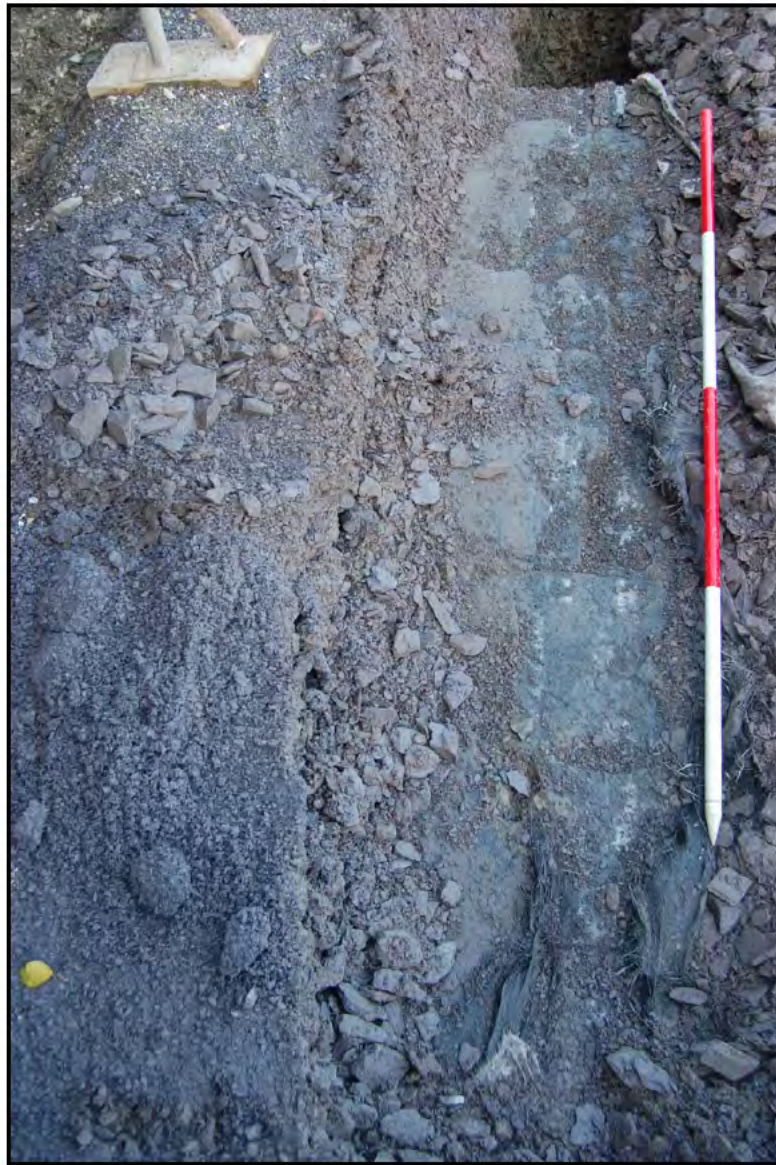
- c.5.50m northwest of Tower 3 where the remains of the slate floor identified within **Building 14 (PRN 30465)** during the building record/watching brief phase (GAT Report **815**) (plate 07) directly under the modern crushed slate layer at a depth of 0.34m. The slate flooring had a foundation layer of mixed yellowy sand with black staining 0.04 deep this sat on a thicker grey sandy layer 0.09m deep. Below this was a mixed gravel and crushed slate deposit excavated to a depth of 0.25m (plate 07).

Plate 07: Zone 2/Yard 4 (PRN 30463): service trench excavation - detail of slate floor associated with Building 14 (PRN 30465). (Ranging pole: 2.0m)

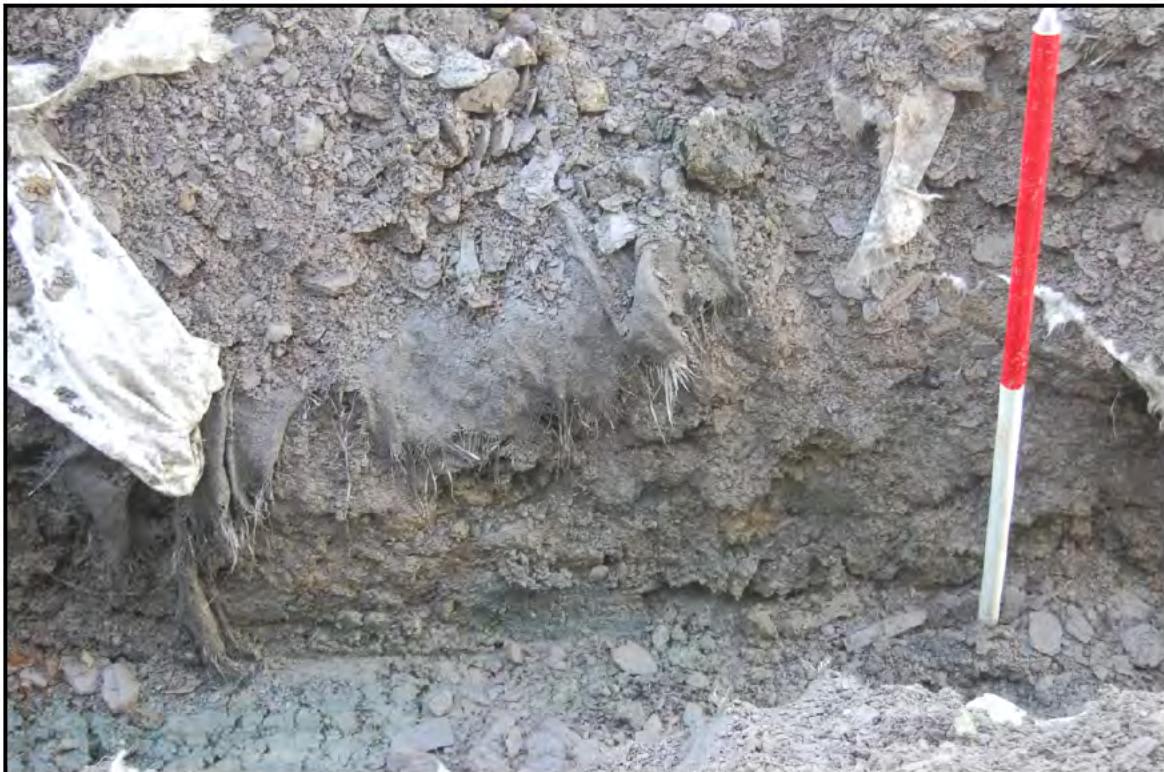
- Northwest of Tower 3, within the former location of **Yard 4** below the modern crushed slate layer was a mixed clay-silt layer with occasional pick gravels this layer had a distinguishable

greenish shade and a strong smell of diesel this can be associated with Garage which once occupied Yard 4 (GAT Report **815**) (plate 08).

Plate 08: Zone 2/Yard 4 (PRN 30463): service trench excavation - detail of full excavation depth and contaminated soil associated with former garage

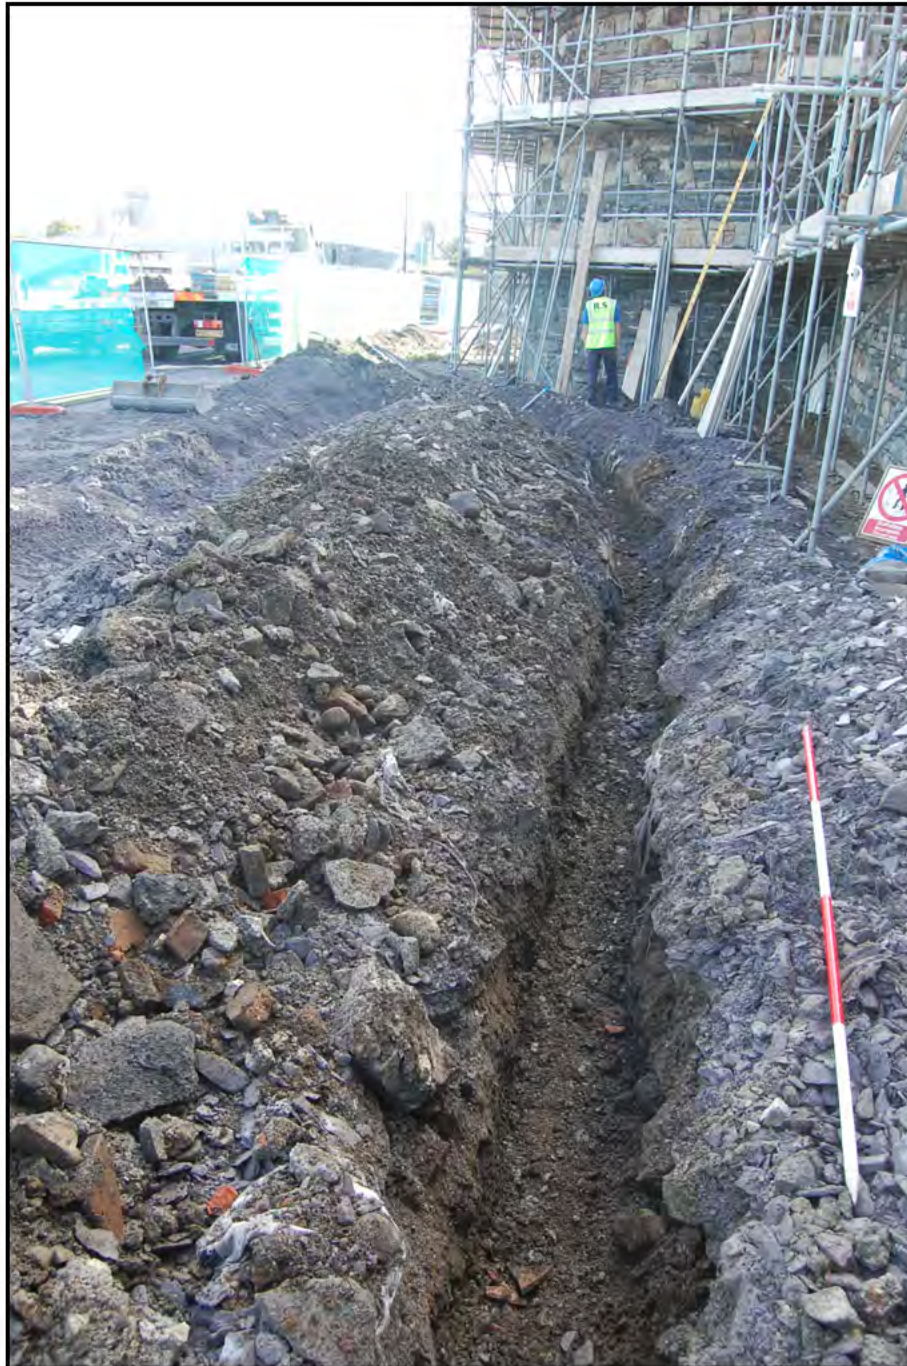
The whole of this area had been covered in a deposit of dark grey crushed slate after the clearing of the buildings carried out in 2009, its depth varied though out the length of the trench ranging from 0.20m to 0.40m. The slate deposit sealed a protective *Terram* membrane.

**Plate 09: Zone 2/Yard 4 (PRN 30463) to Yard 5 (PRN 30468): service trench excavation - completed length with Tower 3 in the background.
(Ranging pole: 2.0m)**
