# PROPOSED QUARRY REALIGNMENT, PENRHYN QUARRY, BETHESDA

## **Archaeological Assessment**

GAT Project No. 2098

Report No. 837

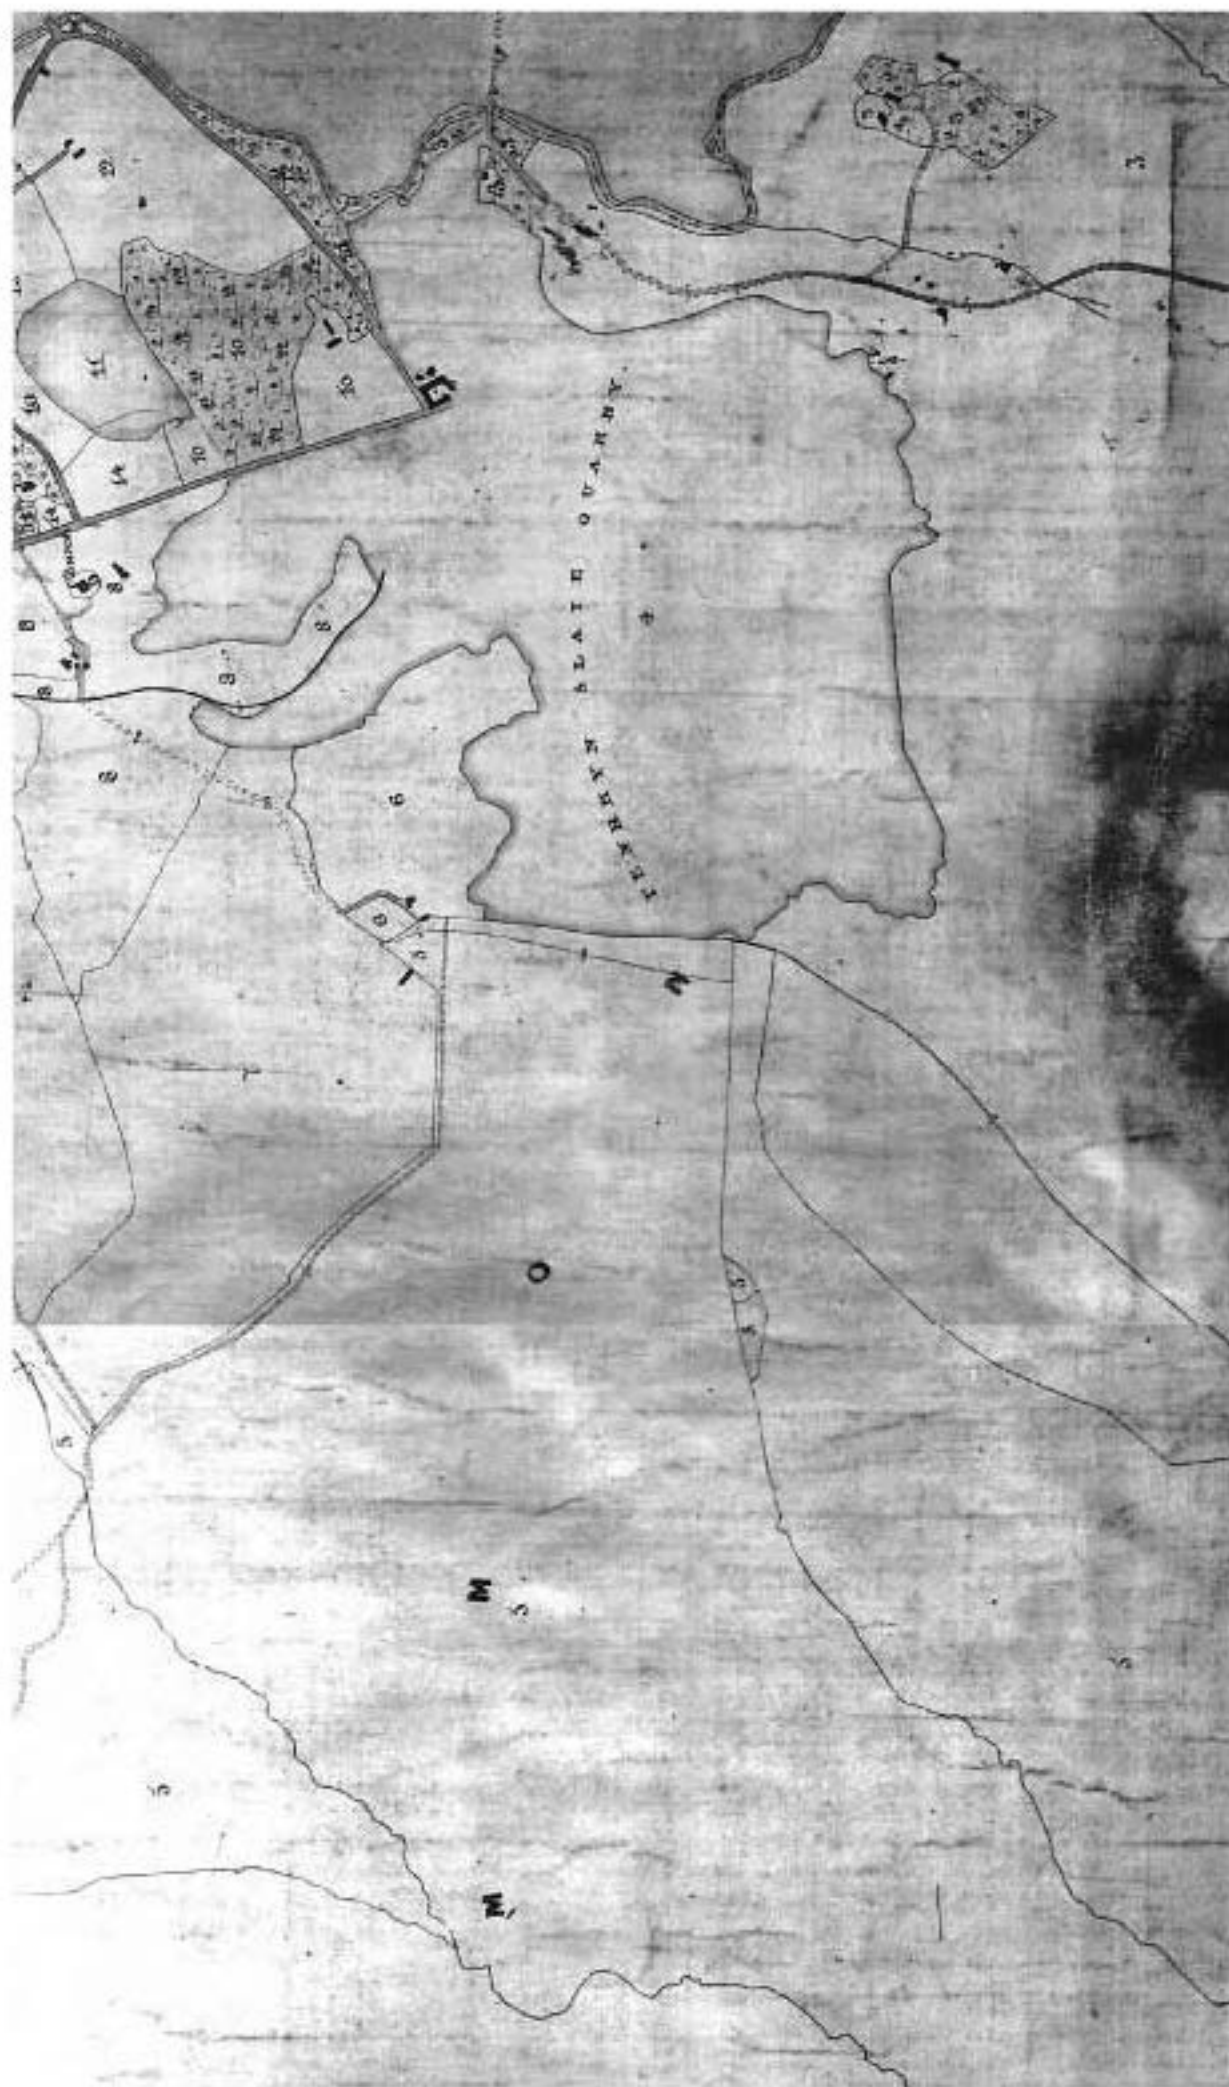
Fig. 5 Part of the 1841 tithe map of the parish of Landegai

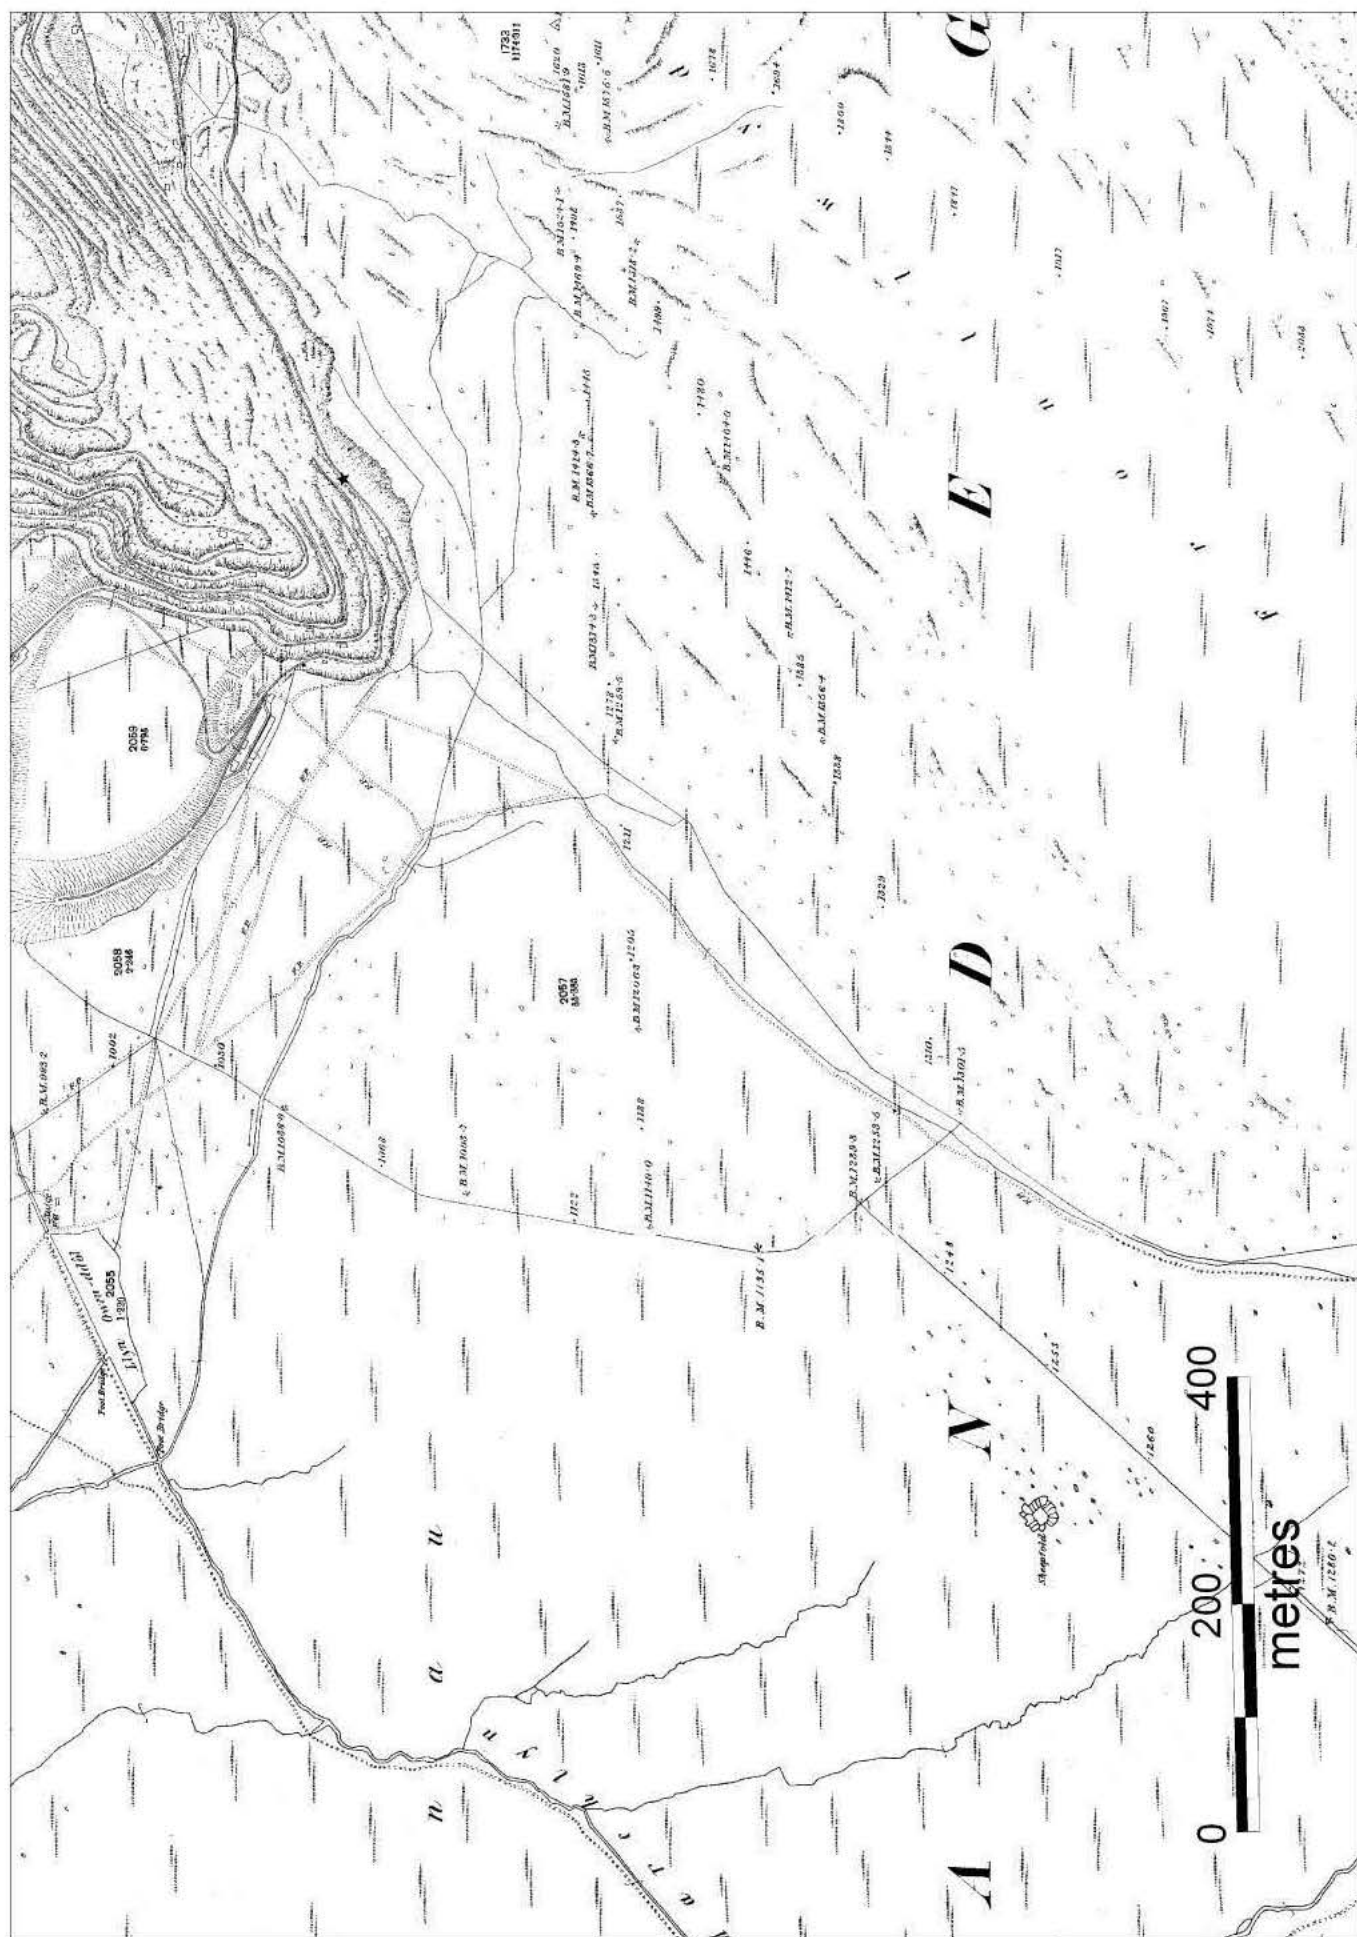
Fig. 6 25 inch to the mile Ordnance Survey map 1889

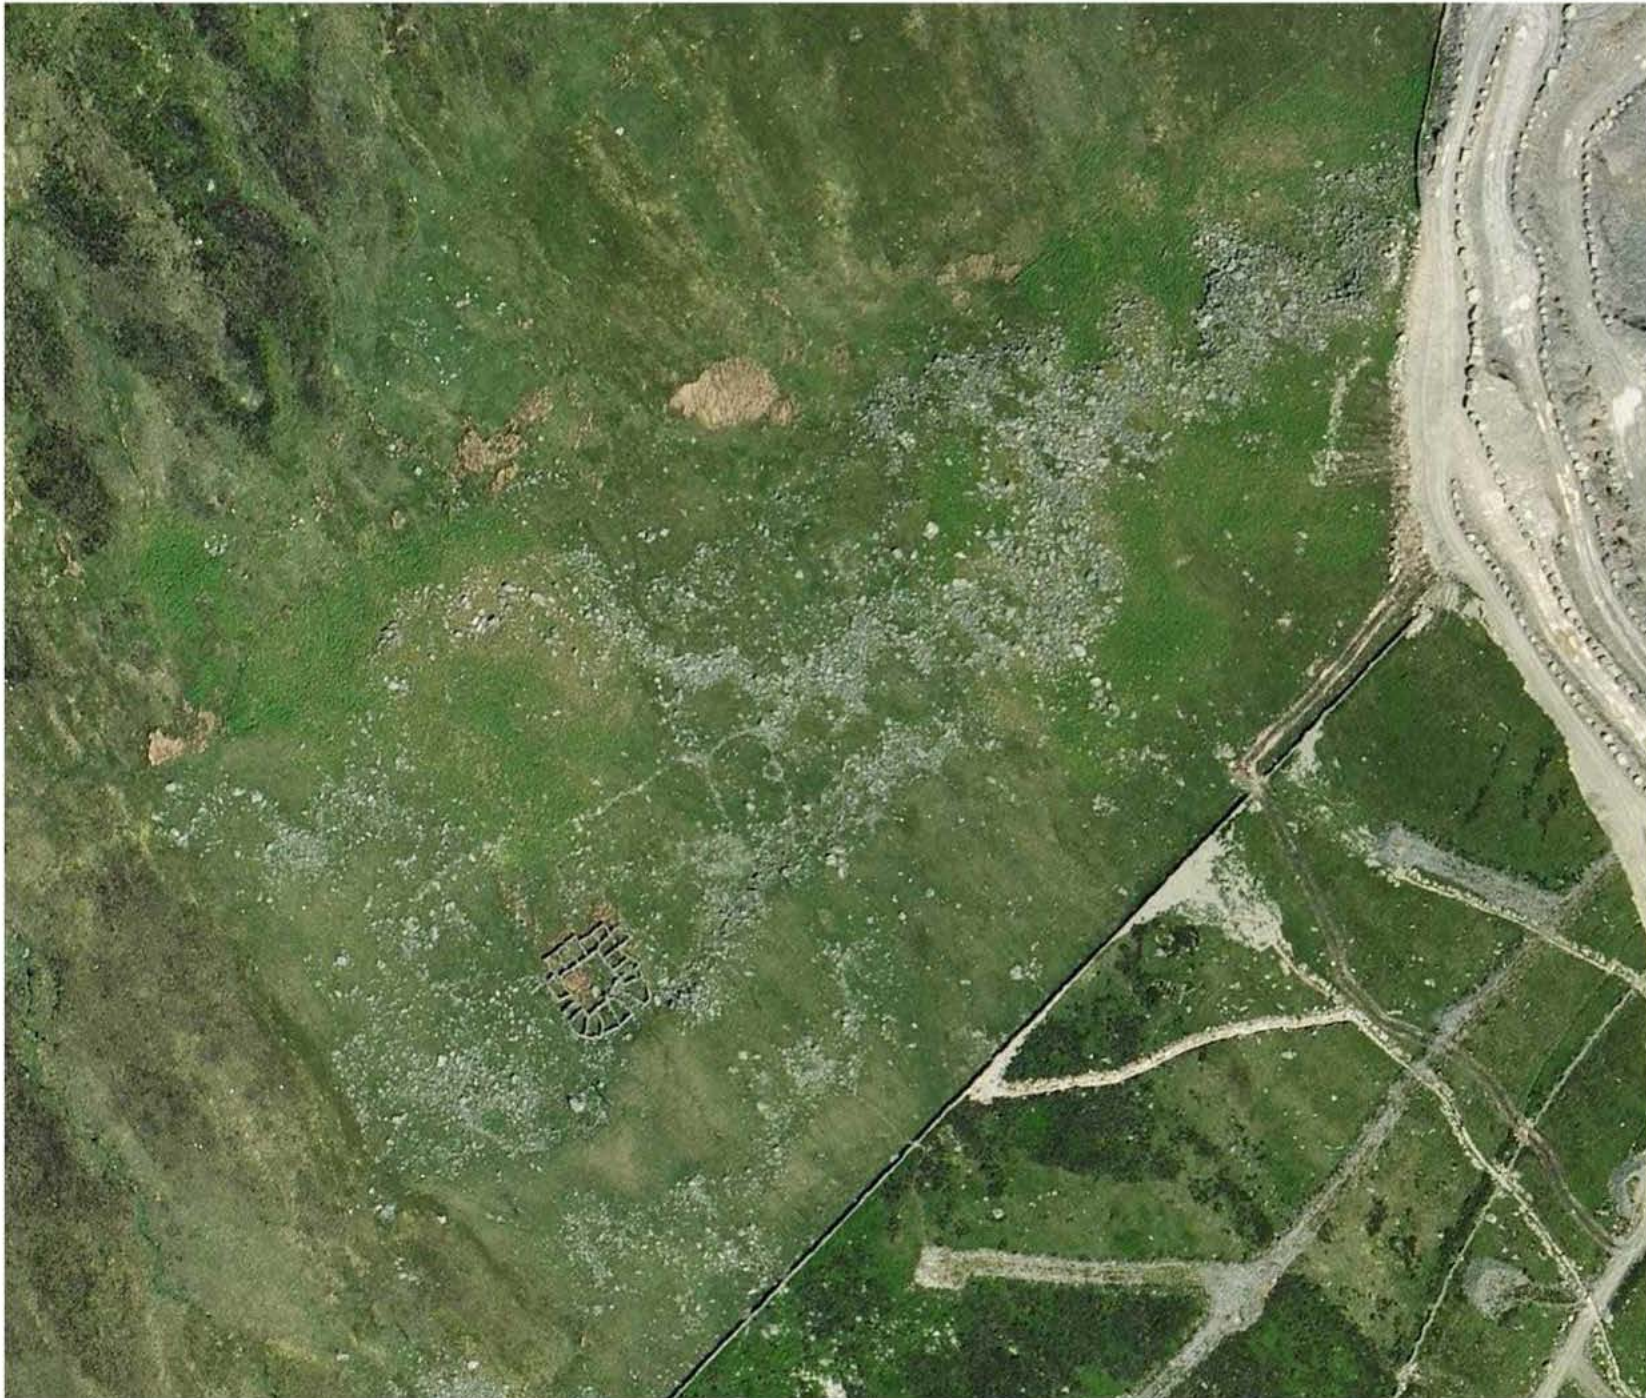
Plate 1 Aerial photograph of the proposed realignment area ( © GeoPerspectives and COWI A/S 2006)

The most informative aerial photograph is Bluesky 2006 which shows the area of the proposed realignment and the settlement in detail (Plate 1). A transcription of this image was used as the basis for the site plan (Fig. 3). Getmapping aerial photography from 1999 was also examined.

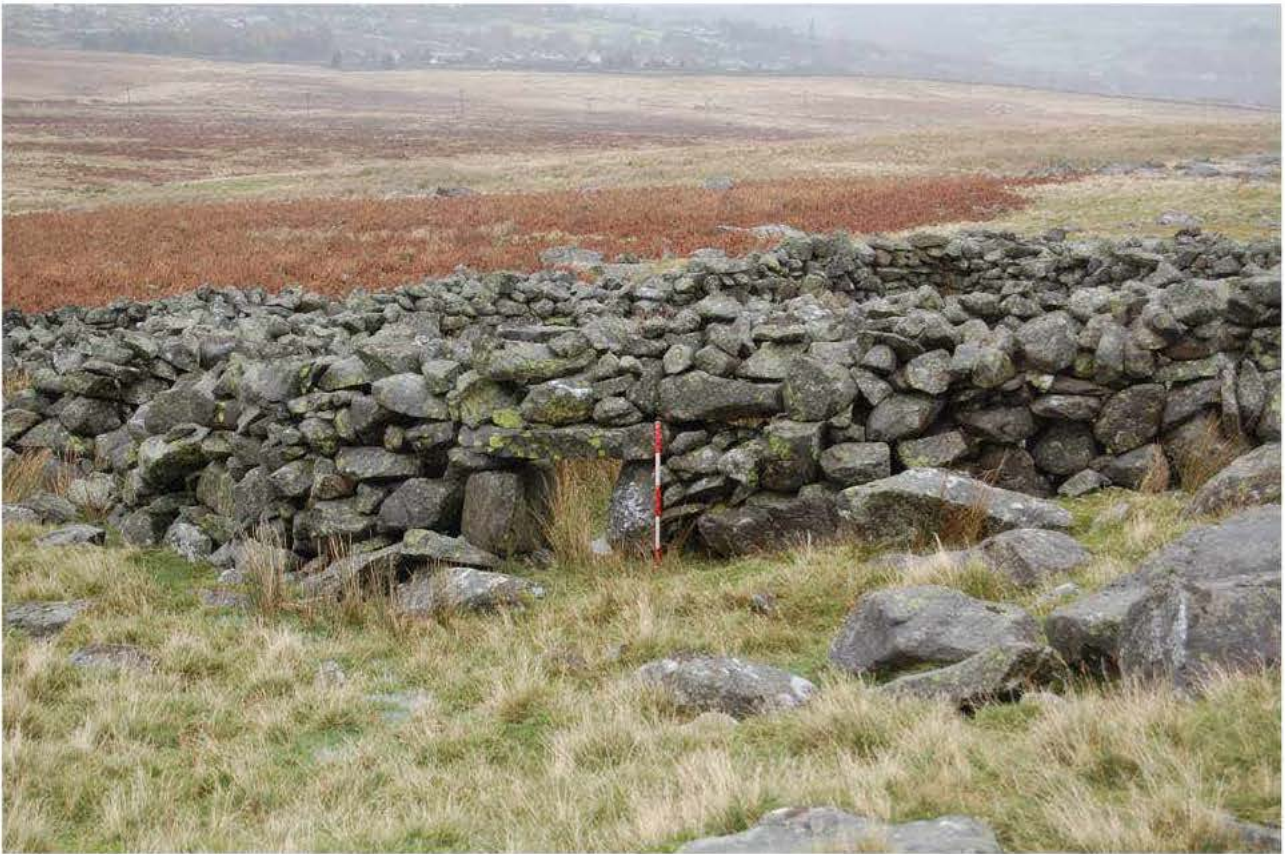
<b>1</b>	<b>Multicellular Sheepfold</b>		<b>PRN 29989</b>
<b>Assessment of Importance</b>	<b>C</b>	<b>Impact:</b> Major	<b>Mitigation:</b> Avoidance or detailed recording
<p><b>Description:</b> The most obvious site in the area is a large well-preserved multicellular sheepfold (Plate 2). This is 29m in diameter and typically stands to a height of 1.5m. It consists of 18 cells arrayed around a central larger cell. There are entrances running into the central cell from the west and east but access between the cells is often solely by means of sheep creeps (i.e. low entrances c.0.8m high with a lintel carrying the wall over the top). This presumably facilitated dividing up the flocks and the entrances could be closed with a flat stone. Overlies part of PRN 1707</p>			
<b>NGR</b>	SH6089 6385

The multicellular sheepfold is a good example of a monument that is a characteristic part of the uplands in Gwynedd. It is well preserved and retains most of its original features.

Plate 2 Multicellular sheepfold (Site 1)

A detailed photographic, written and drawn record should be made of the sheepfold ensuring that its full three dimensional structure and functionality is recorded.

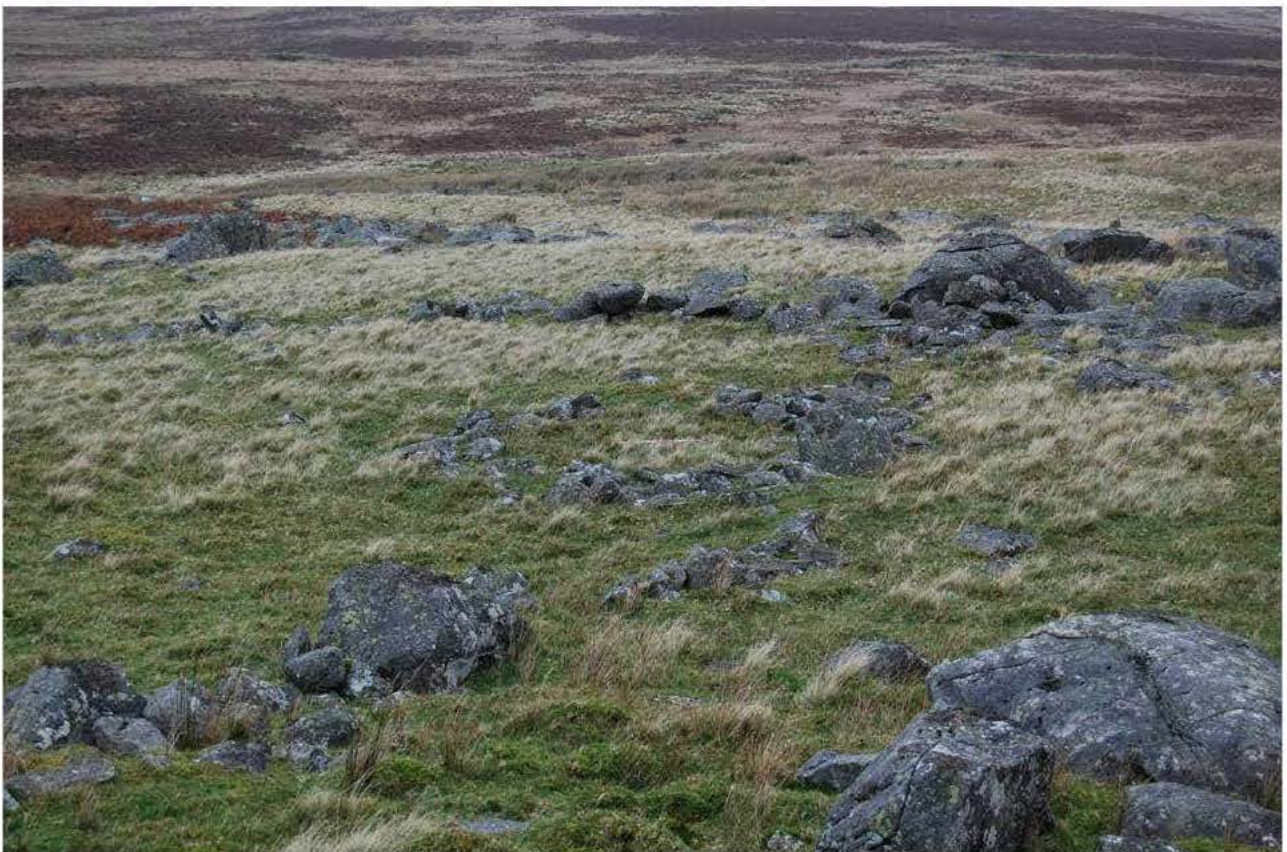
<b>2 to 11</b>	<b>Prehistoric Settlement and Enclosures</b>		<b>PRN 5380 (Individual PRNs Below)</b>
<b>Assessment of Importance</b>	<b>A/B</b>	<b>Impact:</b> Major	<b>Mitigation:</b> Avoidance or detailed recording including a comprehensive programme of excavation
<p><b>Description:</b> Prehistoric settlement consisting of several elements:  Five enclosures or paddocks (PRNs 60373-7) (Sites 2-6) defined by wandering walls (Plate 3) typical of prehistoric settlement in this area. The walls are no more than 0.3m high and consist of roughly piled small stones linking, probably <i>in situ</i>, natural boulders. The interior of the enclosures are partially cleared of stone.  In the eastern corner of enclosure 4 are two linked, roughly built, small pens with dimensions of 9.0 x 5.0m and 2.5m x 2.0m (Plate 4). A narrow passage leads into enclosure 4.  A small hut circle (PRN 60378) (Site 7) with an overall diameter of 5.5m is built into the north-eastern wall of enclosure 5 (Plate 3). The hut circle is well defined with piled rubble walls 1.0m thick and an entrance on the north-west.  Two probable outlying paddocks (PRNs 60379 and 60380) (Sites 8-9) to the north-west are defined by natural scarps. There appears to have some clearance here, with stones piled among the natural boulders on the edge of the scarp. There may also have been some clearance (PRN 60381) (Site 10) to the north-east although the stone appears to have been dumped among the natural boulders as opposed to have been made into wandering walls. A 1.5m wide meandering trackway (PRN 12305) (Site 11) approaches the settlement from the north and runs into enclosure 3 and then passes through the south-eastern wall. It is not clear if this is contemporary with the settlement or a later path.  The settlement occupies a natural terrace within the boulder fields on the edge of the bogs to the north-west and west. The area is well-drained and sheltered by the higher ground to the south and south-east. The site was presumably partially cleared during the construction of the multicellular sheepfold.</p>

The area of the proposed realignment contains a well-preserved prehistoric settlement. The site is in unimproved uplands and has probably had some stone cleared from it in order to construct a later sheepfold. There has however been no widespread clearance or ploughing and below ground survival is probably good. Also nearby peat bogs have a good potential for the preservation of environmental remains. This type of site has rarely been excavated in Wales and therefore has a high potential for enhancing our understanding of prehistoric upland settlement in the area.

Plate 3 Roundhouse (Site 7) and meandering walls of enclosure 5

If the realignment is to affect the complete proposed area, preservation by record is the recommended mitigation. This would involve recording the remains to an appropriate level. In the case of the settlement and possibly the hafod and cairn, depending on further evaluation, this would involve a comprehensive programme of excavation. All major features such as the roundhouse should be fully excavated and lesser features such as the enclosures should be sampled in sufficient detail to record their character and function.

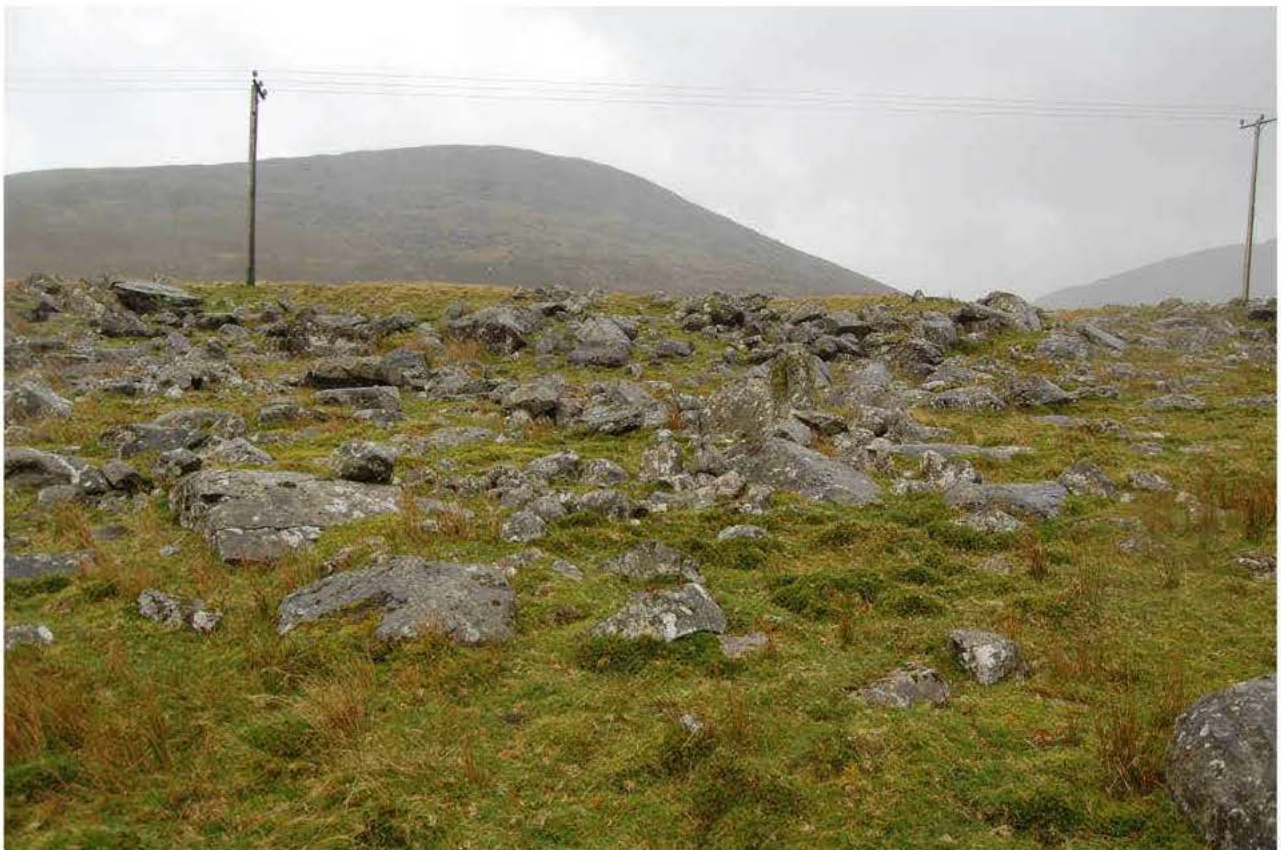
Plate 4 Pens in enclosure 4

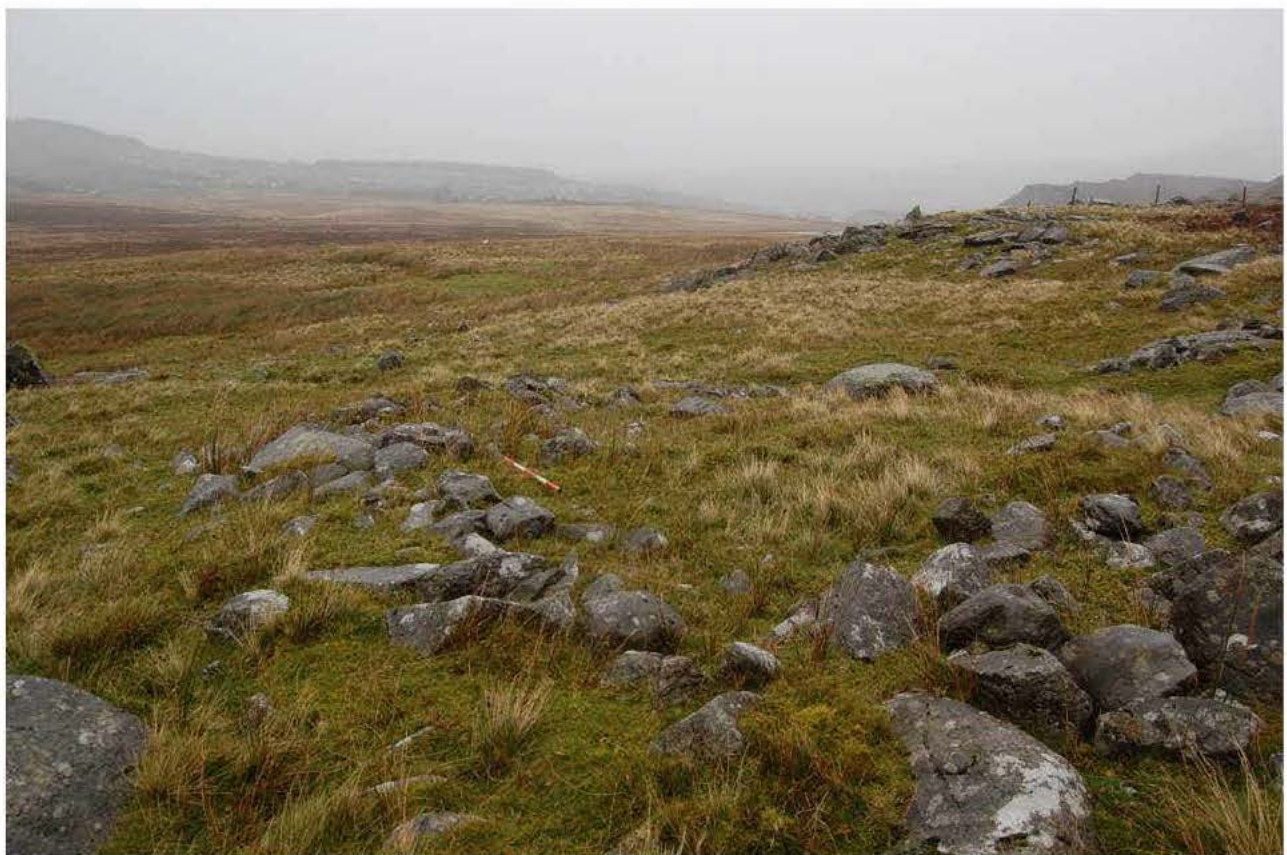
<b>13</b>	<b>Possible Hafod</b>		<b>PRN 12327</b>
<i>Assessment of Importance</i>	<b>E</b>	<i>Impact:</i> Major	<i>Mitigation:</i> Avoidance or detailed recording including a comprehensive programme of excavation
<i>Description:</i> The remains of a rectangular enclosure or building (Plate 5) lie in stony ground just to the west of trackway 11. The structure is defined by spread rubble walls and has external dimensions of 6.0m x 2.5m. The eastern wall is almost destroyed. The interior is on two levels with the north end about 0.5m lower than the south. The original form of the structure is unclear. It could be a long hut or hafod but could also be interpreted as a simple shelter or animal pen.			
<b>NGR</b>	SH60976398

A trackway and possible hafod are probably medieval but require further assessment. Below ground preservation is again likely to be good.

Plate 5 Possible Hafod (Site 13)

A basic record should be made of the rectangular shelter, trackway and the stone pile and possible hafod if further assessment shows them to be minor sites.
