Rhiwgoch Raw Water Main Replacement Works Near Harlech

Report on archaeological mitigation works

GAT Project No. 2055
Report No. 857
November 2010

Prepared for United Utilities
on behalf of Dŵr Cymru/Welsh Water

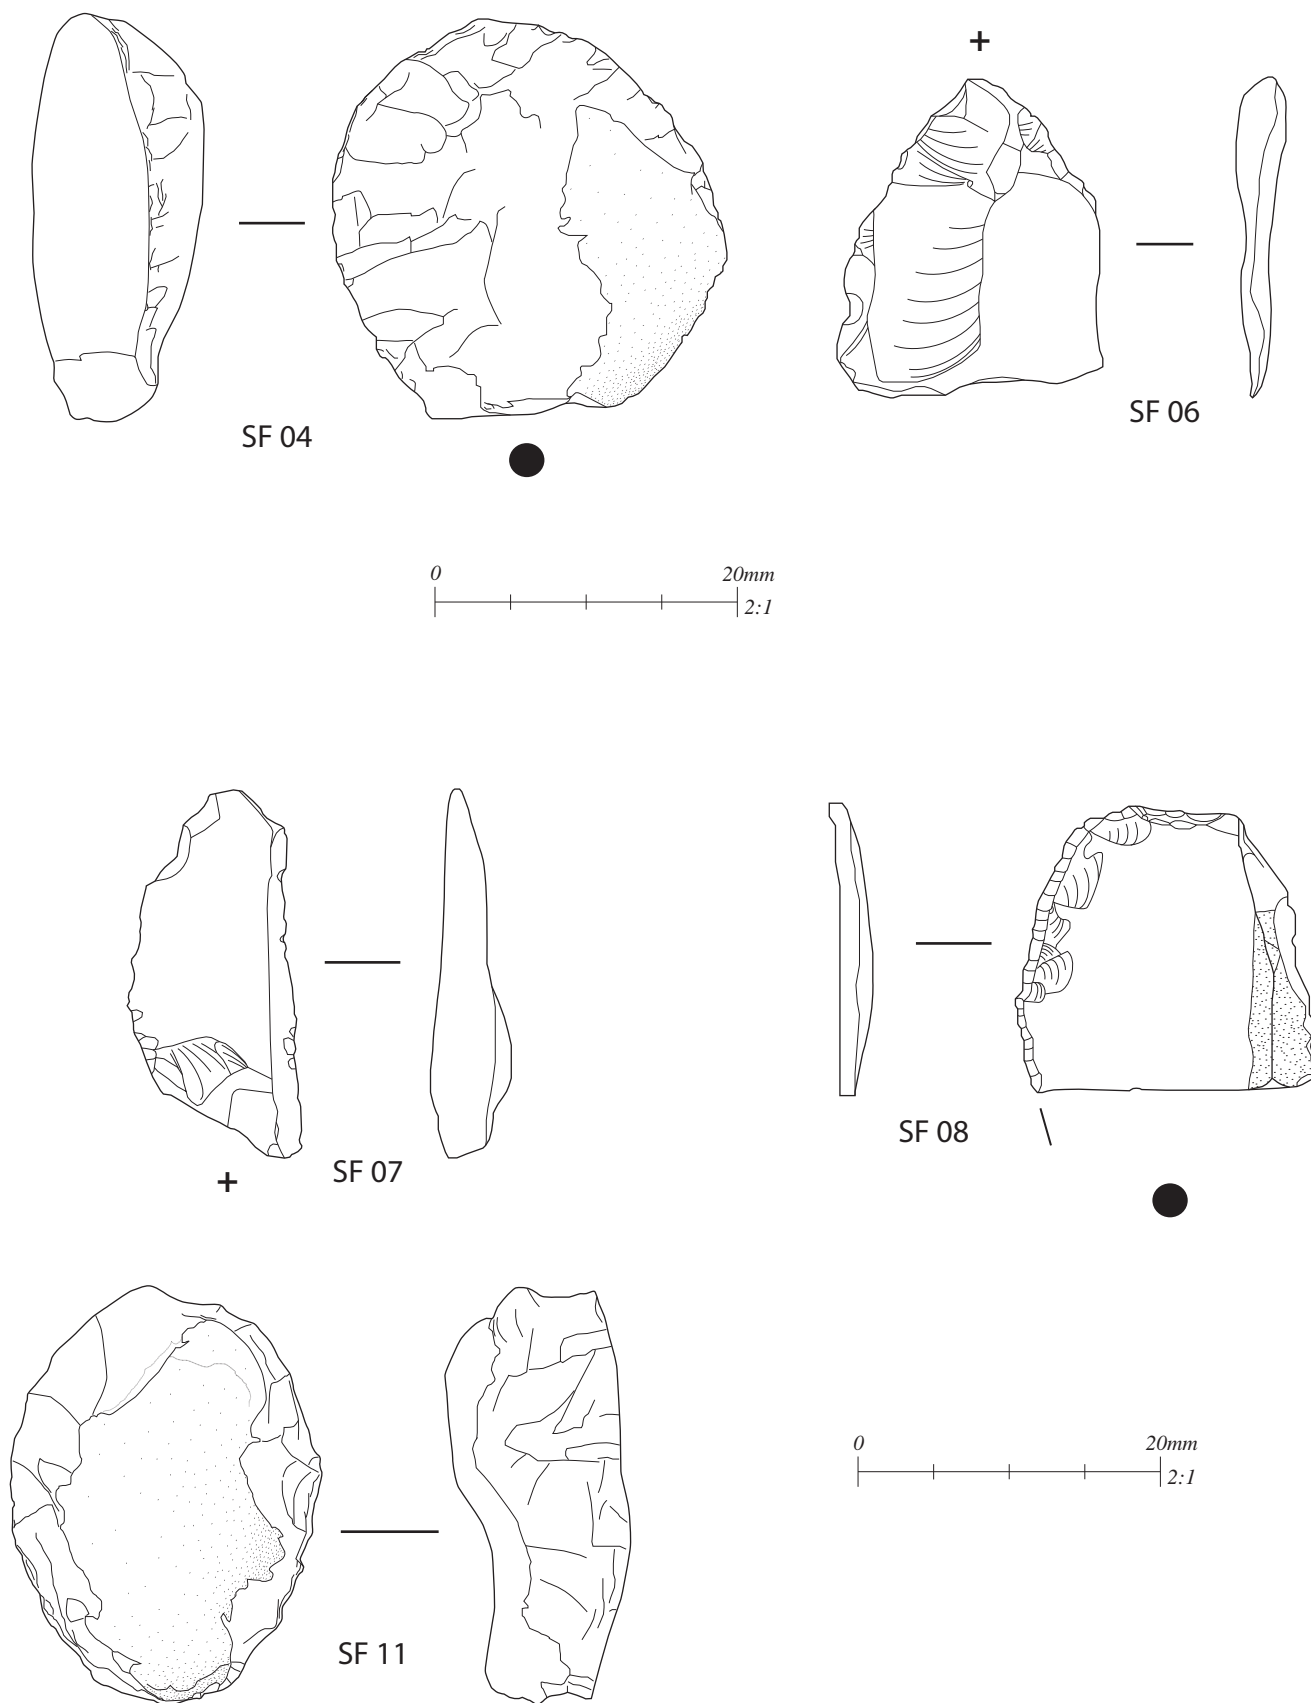
Small thick scraper retouched all round its circumference and with abrasion wear around most of it too. Worked around a fossil sponge inclusion in the flint, probably deliberately for decorative value.

Figure IV.1: Flint and chert tools from the Rhiwgoch pipeline

SF 04: a small convex end scraper found close to the northern boundary of field A5

SF 08: an end and side scraper, possibly Mesolithic, from field E8

SF 11: a small poor quality thumbnail scraper from field J1

No artefacts were found within the wall but a flint flake (SF 05) was found 13m to the north and a small convex end scraper (SF 04) was located close to the northern boundary of field A5. Both were found during machine watching and were not related to any features. See appendix IV for detailed descriptions of finds, and figure IV.1 for drawing of SF 04.

Other hints of prehistoric activity in the area are two flint flakes found during stripping. SF 01 from 55m north-east of feature 011, and SF 07 from 95m to the north-east. SF 01 is a small, broad secondary flake from a fluvio-glacial pebble and SF 07 is a casually retouched piece, which is possibly a graver. See appendix IV for full descriptions of finds and figure IV.1 for drawing of SF 07.

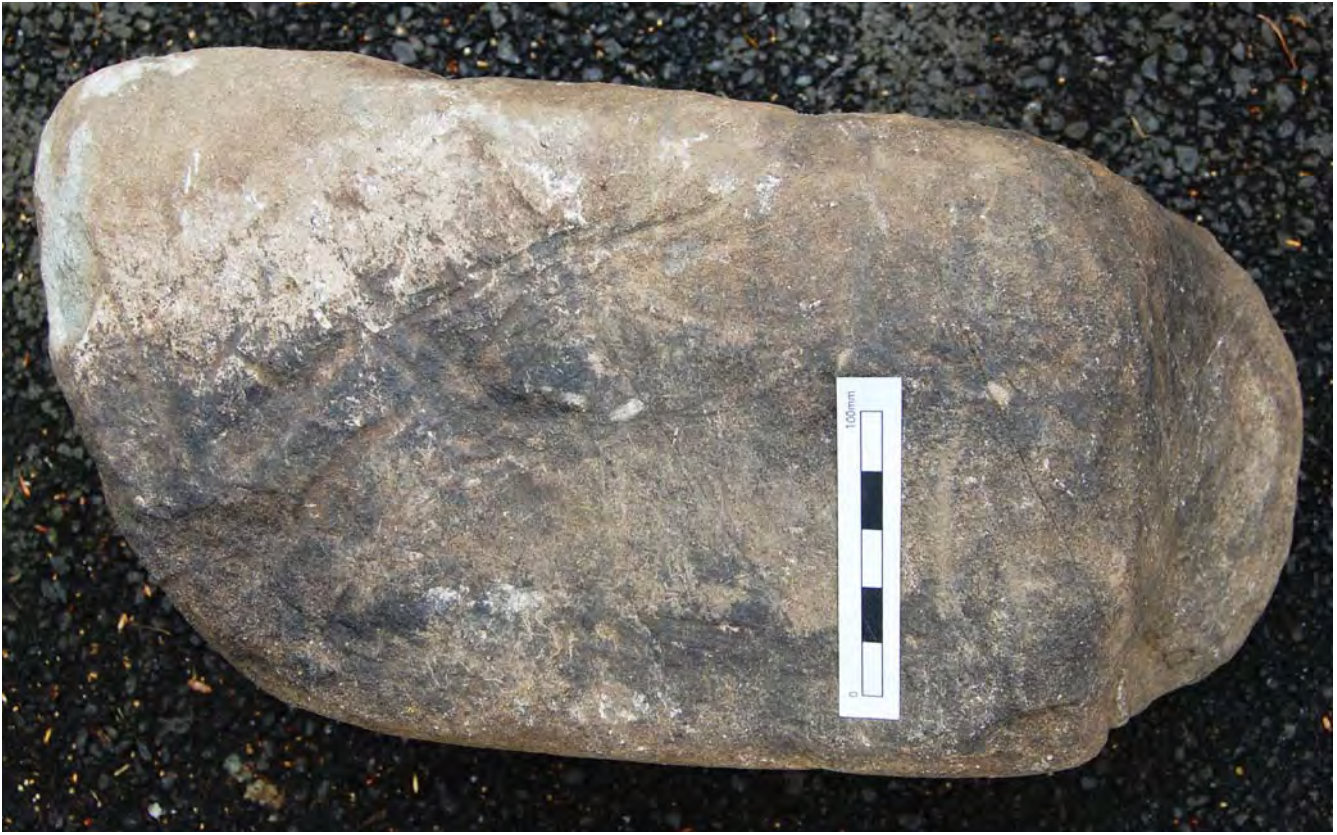
Figure IV.2: small glacial boulder with straight scratches on one face
Rubbing (left) and photograph of scratched face at same scale

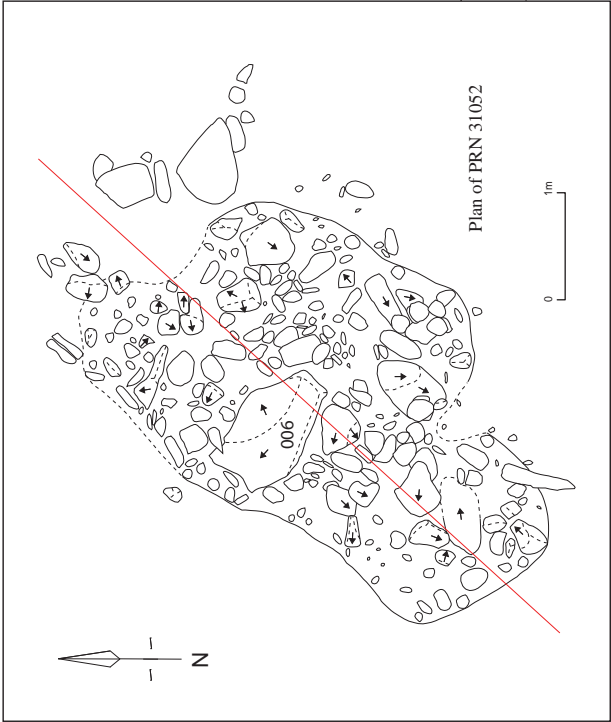
Figure 9. Plan of field clearance cairns in field B3, with inset showing detailed plan of cairn PRN 31052

Further to the north-east and within the contractors' compound, a fourth clearance cairn was located (006). This feature measured 5.7m by 2.9m and comprised an abundance of medium to large sized rounded, sub-rounded, and sub-angular boulders. Some of the stones were well embedded into the natural and clearly glacial in origin. The feature appears to have been created by the deposition of stones upon a naturally stony area, thus the upper layers of the feature were rather loose and had a lot of voids. This feature was planned in detail and fully excavated to test whether there were any features, such as cists below. There was nothing to suggest that this was any other than a very casual field clearance cairn.

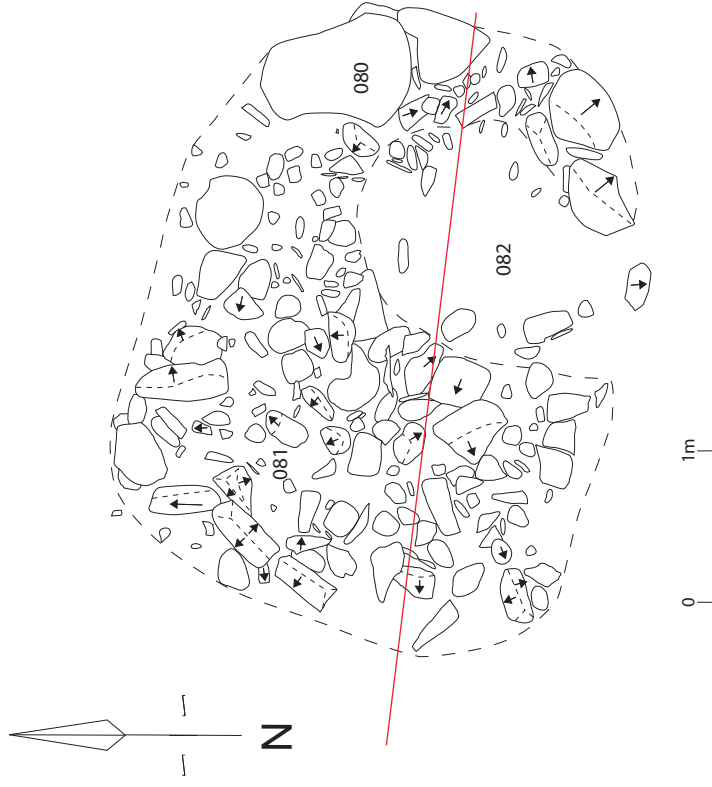
Figure 12. Plan and section of cairn PRN 31058

A cairn (081/082) measuring 4.2m by 3.2m was located in field E13 terraced into a fairly steep slope. This was a fairly regular, near circular shape with some large boulders placed around the eastern, down slope edge, so there was the possibility that it might be a burial cairn. The cairn was therefore recorded in plan, half sectioned and the section was drawn. The remainder of the cairn was then removed to search for any cists or burial remains that might have been beneath it. No such remains were found.

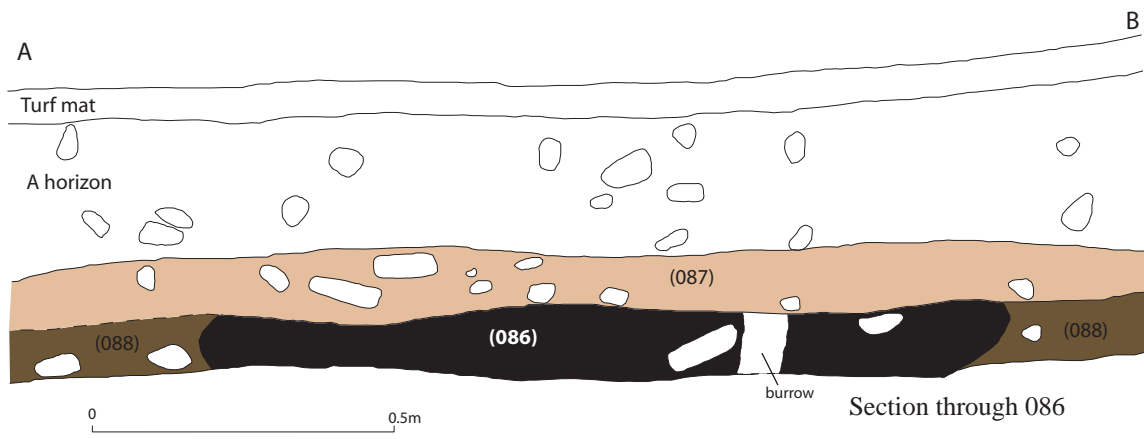
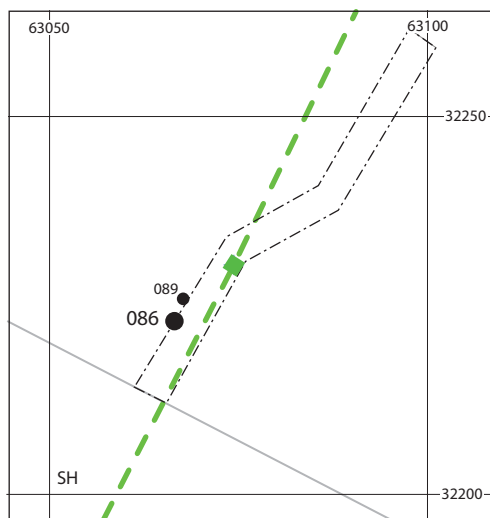
Figure 14. Plan of burnt patch 086 (PRN 31067) with location and section as insets

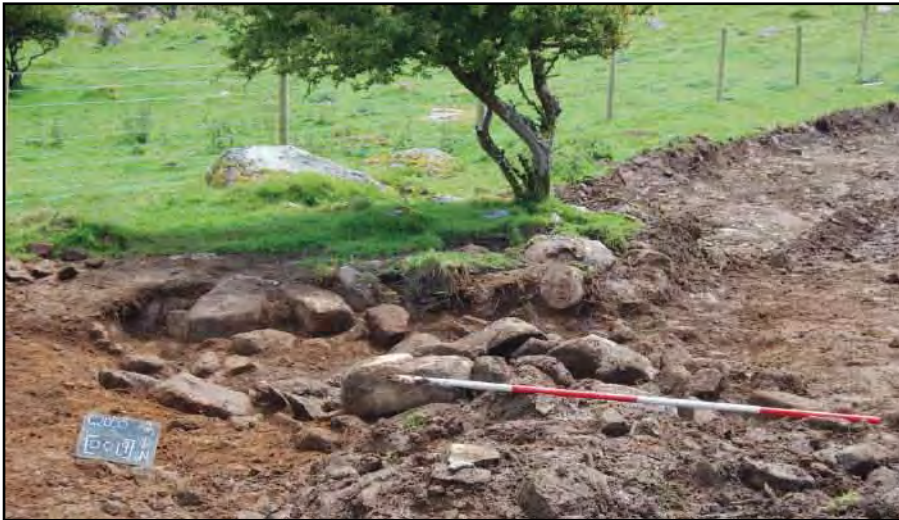
Plate 1. Boulders (0023) in linear hollow [019], from the north.

This feature was first believed to be a wall boundary, as the boulders in its fill resembled a rough wall. Upon further investigation it became clear that the stone inclusions did not appear to have a real structure. The glacial deposits in the area were particularly stony and natural glacial boulders lay in concentrations on the ground surface, visible even before the topsoil was stripped. It is probable that [019] was not a foundation cut for a field boundary wall, but a natural linear hollow containing natural boulders.

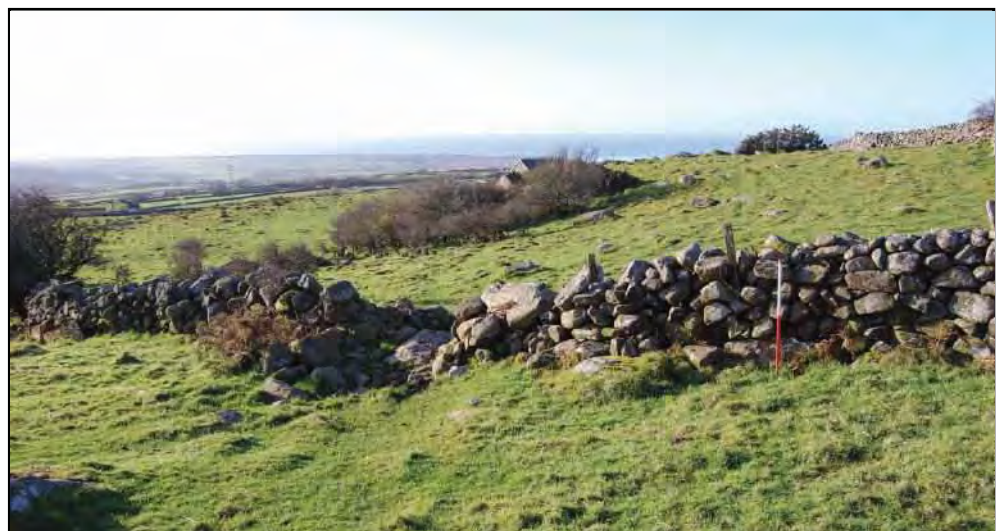
Plate 2. Wall PRN 29253, from the east.

This is a fairly well-built dry-stone wall of mixed local stone. It has larger stones 0.5-1.3m in length at its base with smaller stones no longer than 0.5m higher up. The larger stones run through the wall with no distinction between facing stones and core. The wall is 1-1.5m in height and between 0.6m and 1m wide. The section through the wall was recorded where a particularly massive stone set on edge formed the foundation of the wall. The wall rested directly on the mixed B-horizon with no trace of a buried soil.

The wandering line of the wall suggests it has an early origin and the massive foundation stones may have been part of the early version of this wall, but no dating evidence was recovered.

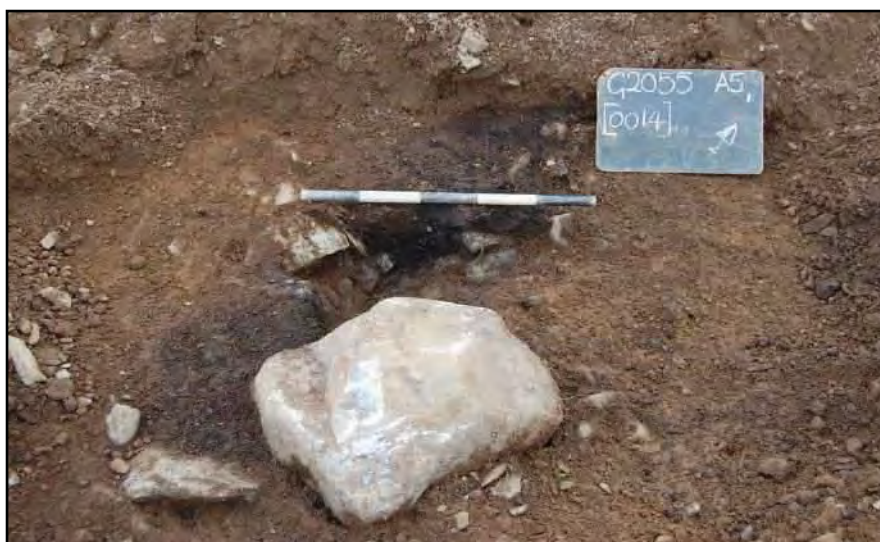
Plate 3. Gully [014] from south-east.

In field A5 a shallow gully [014] was discovered. This projected 0.9m beyond the north-western baulk of the trench. The feature, 0.5m wide and 0.15m deep, had shallow sides that curved gradually into a rounded base. It was orientated north-west to south-east and was filled by a loose dark grey-brown-black clay-silt, with less than 10% sub-rounded and angular large pebbles (015). This feature contained no archaeological finds or charcoal inclusions, and the cut was of an irregular form. Therefore it is not certain whether this feature was a gully of archaeological importance, or simply a natural feature such as a stone-hole or glacial scar.

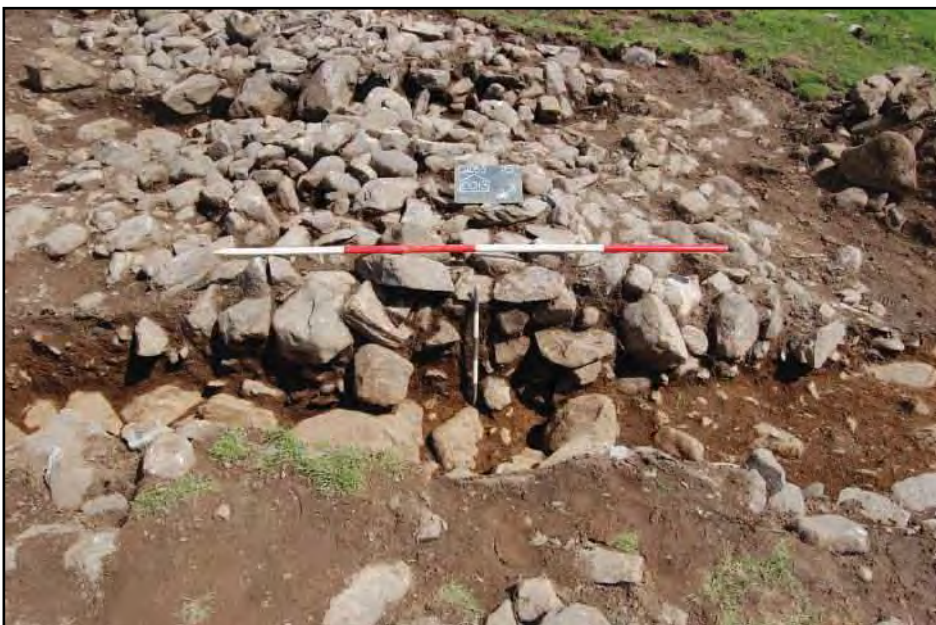
Plate 6. Section through wall (013)

Two exploratory slots were excavated across the wall, the first at the eastern end and the second towards the centre of the feature. The relationships were confused by variations in the deposits that initially resembled cut features until further investigated. A possible cut [029] to the north side of the wall, seen in one section but not others, seems to have been one of these illusory features caused by variations in the tumble from the wall. There were hints that the ground might have been levelled prior to wall construction [035], but reconsideration of the evidence suggested that there was no foundation cut. Beneath the wall was a thin layer (0.07-0.1m deep) of mid yellow-brown clayey-silt (038), which may have been a fragmentary relict soil. On the northern side of the wall was a firm mid brown-orange clayey-silt (031) up to 0.35m deep. This depth probably indicates an accumulation of soil due to ploughing on this side. Sealed beneath the relict soil was a feature [036] filled with firm dark grey-brown clay-silt (037). This feature was initially thought to be a pit but on removal of the wall stones it could be seen to be a natural fissure, probably of peri-glacial origin. This cut through a firm dark orange-brown clay-silt, with occasional small sub-angular and sub-rounded cobbles (recorded in different places as 032, 034 and 039), which formed the undisturbed B-horizon directly above the glacial deposits.

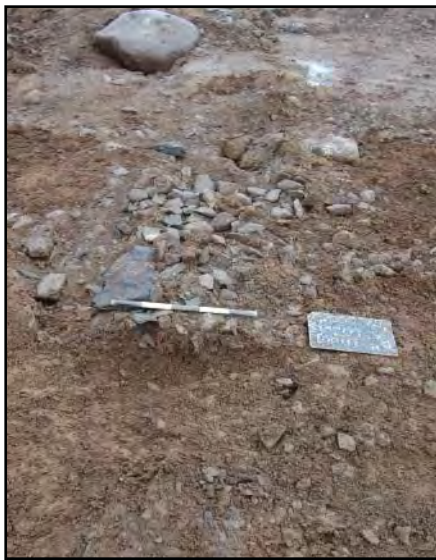
Plate 7. Drain [016] from the north-east (PRN 31048)

In field B1 the very shallow cut of a probable drain [016] was discovered. The feature curved slightly from the south-west to the north, measuring 0.45m in breadth, over 5.0m in length and 0.15m in depth. The feature had concave sides, a slightly rounded base, and was filled with stones in a loose mid grey-brown silt-clay matrix (017). This feature was in close proximity to a similarly constructed drain to the north-east which yielded modern pottery fragments and iron objects, suggesting this feature is of a similar modern age.

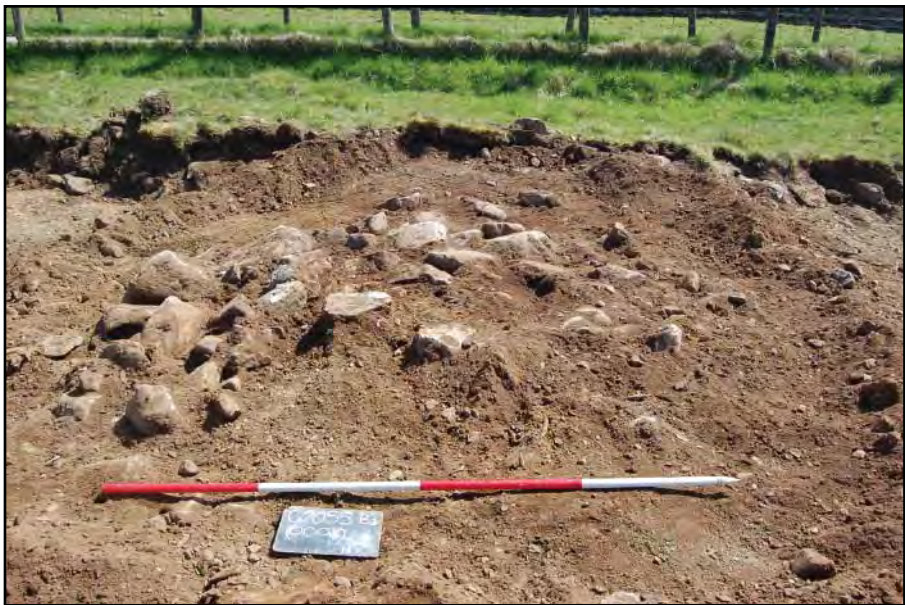
Plate 9. Cairn (08) from the north (PRN 31050)

Cairn (008) was situated near (007), and was similar in appearance although rather more regular in shape. It measured 3.0m by 2.15m, was 0.3m high and contained up to 80% sub-rounded and sub-angular cobbles, ranging from small to very large, bonded by a red-brown silt-clay, filling a natural hollow. No dating evidence was found.

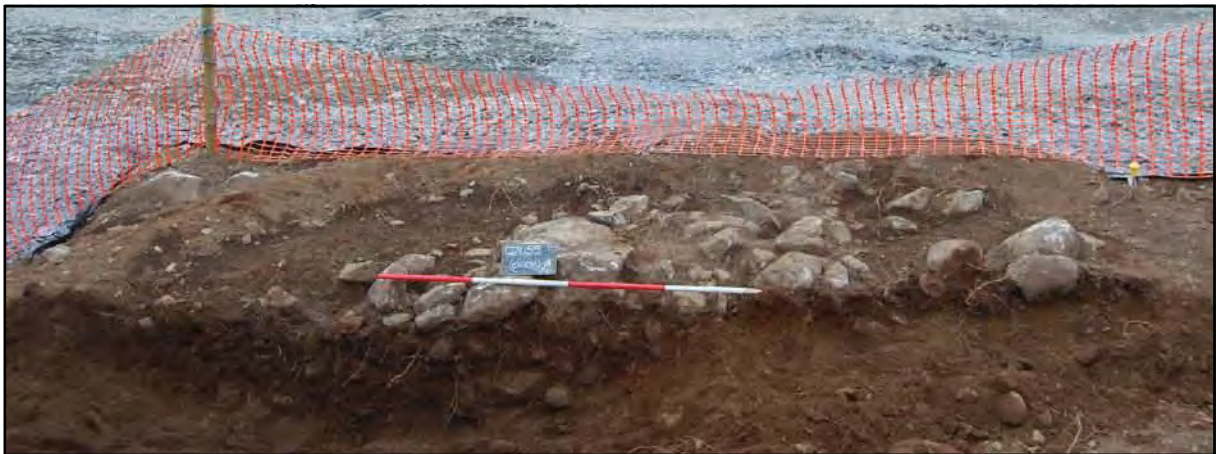
Plate 12. South-east facing section through cairn (06) (PRN 31052)

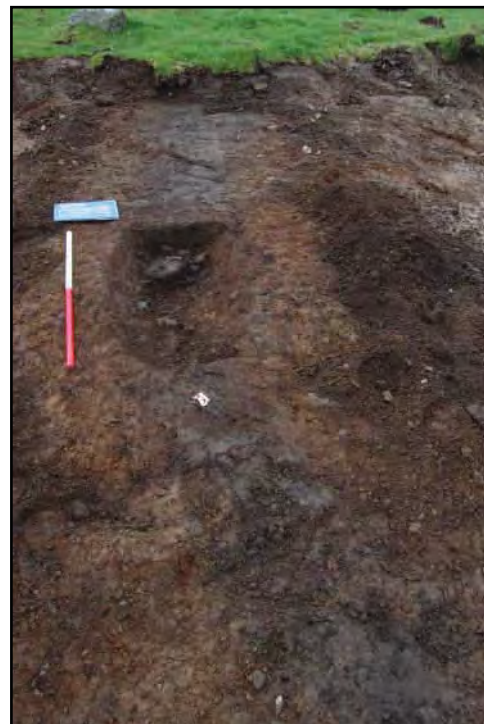
Plate 13. Gully [027] (PRN 31054) from the south

In field B4 a meandering linear gully [027] was discovered which had fairly steep sides and a concave base. The feature ran north to south, originating from the edges of a small stream in the north and running into the baulk in the south after 12.0m. The feature measured 0.6m in breadth and averaged 0.15m in depth, and was filled by a soft black-brown silt with medium sized sub-angular cobbles. This deposit appeared to have been water-borne. No dating evidence was found. It ran downhill from the stream and it seems possible that it is an overflow channel for this stream.

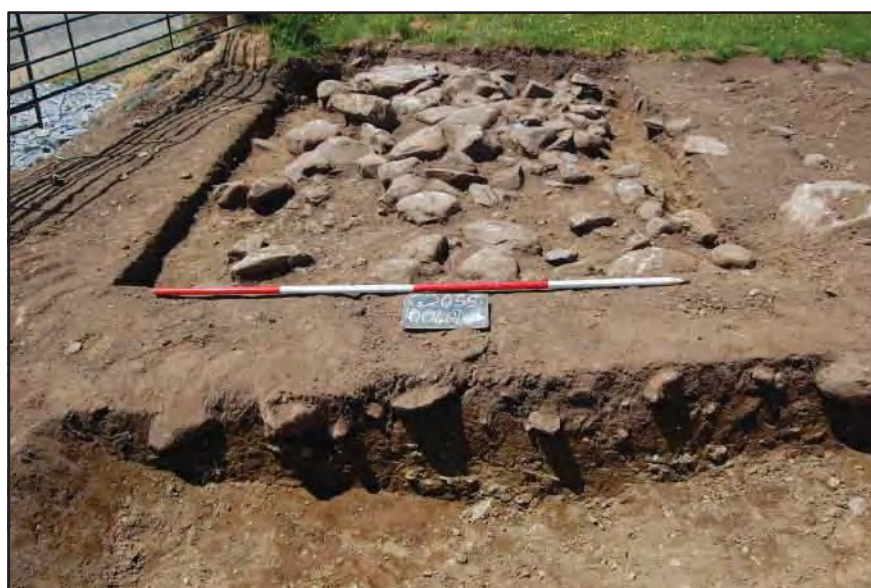
Plate 15. North-east facing section through field boundary [040] (PRN 29289)

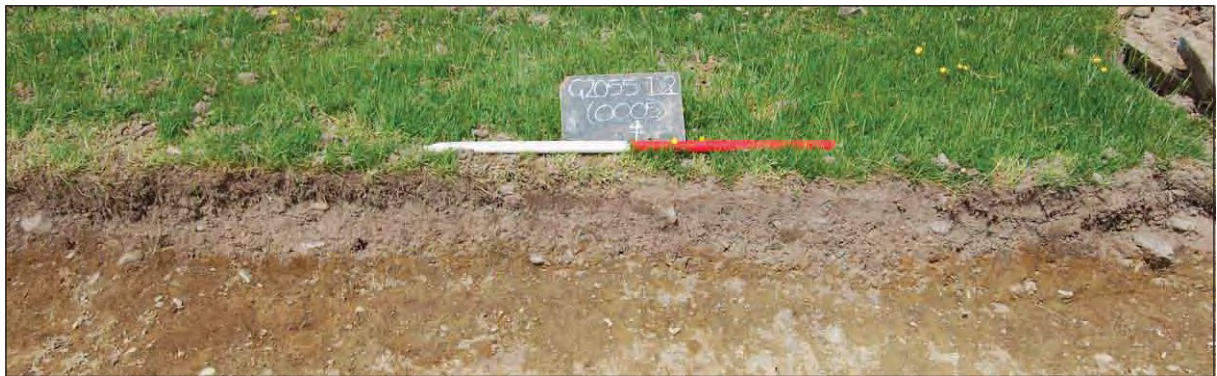
Plate 17: Section through ridge and furrow PRN 29271, from south

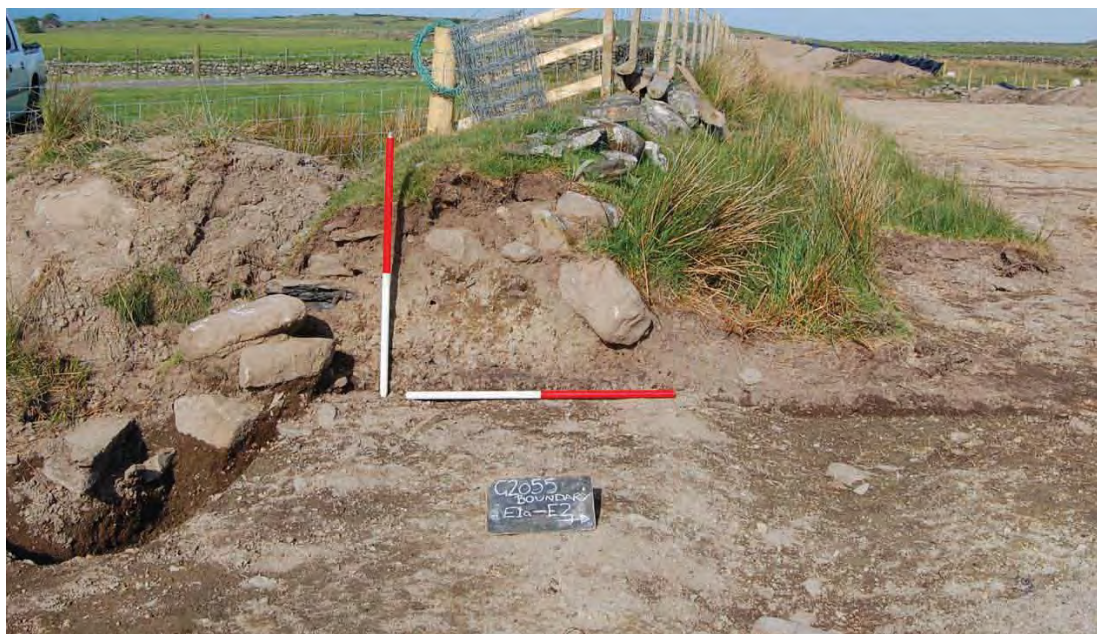
Plate 18: Section through clawdd boundary PRN 31055, from east

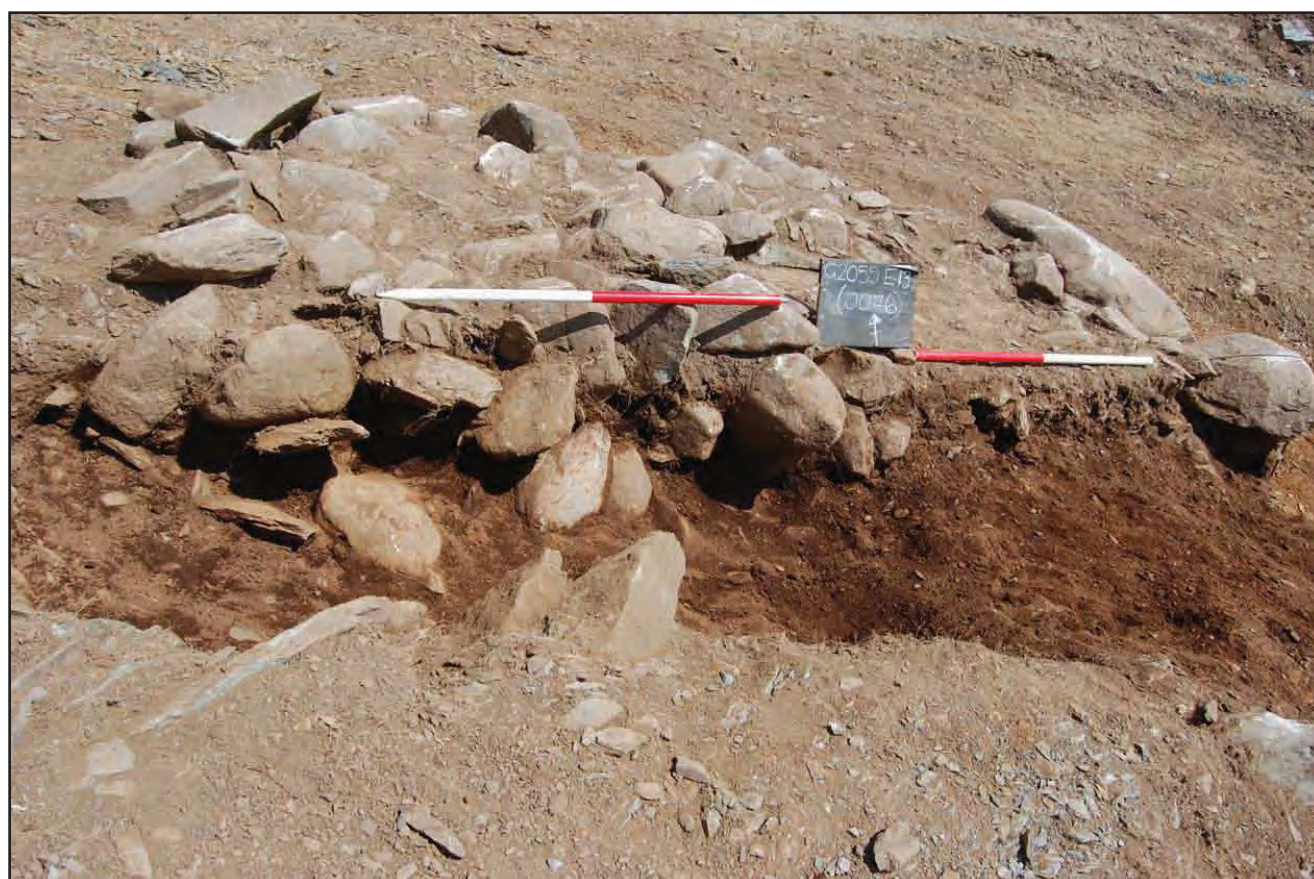
Plate 20. Section through cairn 081 (PRN 31058) from the south-west

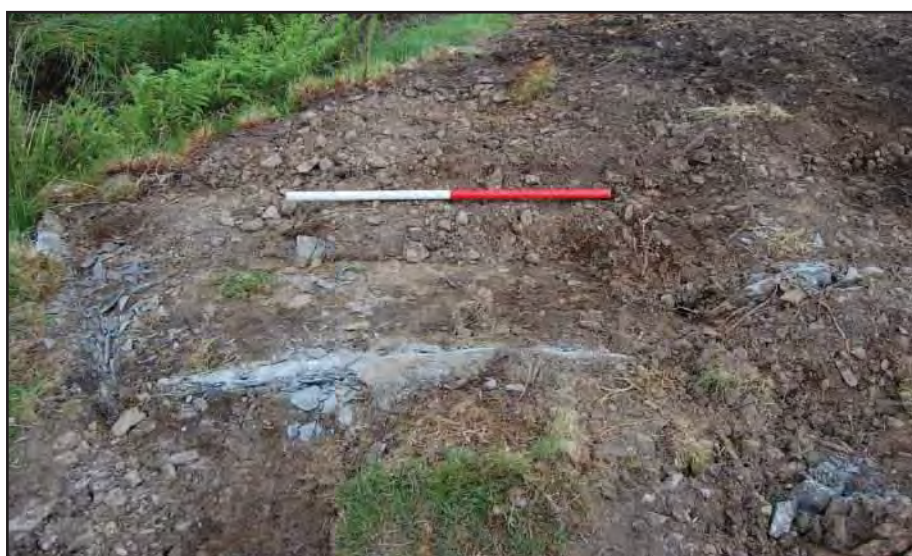
Plate 23. Burnt mound PRN 31061
showing stone slabs, probably a trough
from the south-east

The mound is roughly oval and measures c.17m by 14m. It is not more than 1m high. The removal of a small area of turf showed that the mound was composed of small heat-shattered stones with charcoal fragments and dust. Most of the stone seen was small in size, between 70-30mm in length, suggesting that it had been used many times and reduced to a small size. However some heat-fractured stones visible in the stream bank were larger than 200 mm in length, so there may be some sorting within the mound with small stones on top and larger stones towards the base. A fairly substantial amount of charcoal was present around the exposed stones.

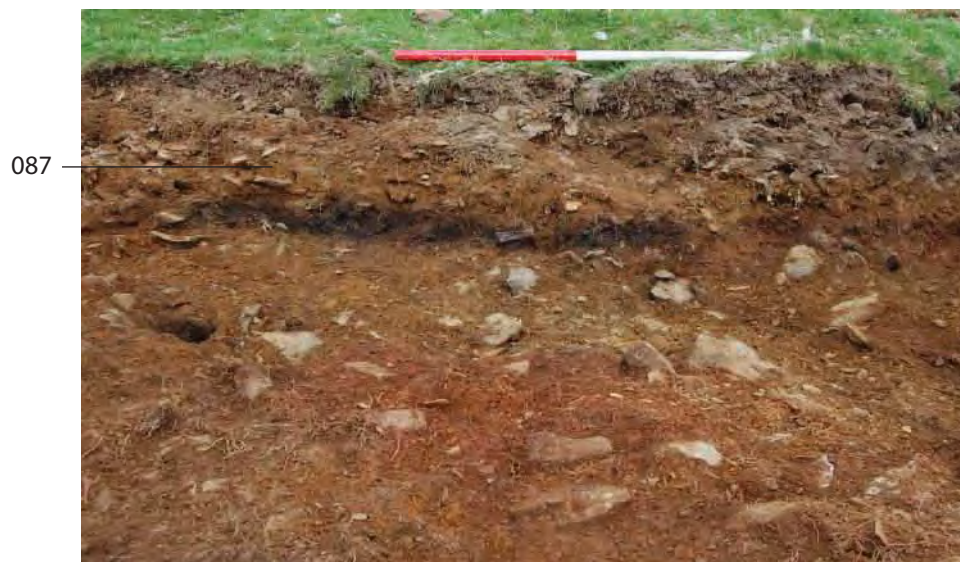
Plate 34. Charcoal deposit 086 in section and showing heat altered natural under 086 PRN 31067, from the south-east

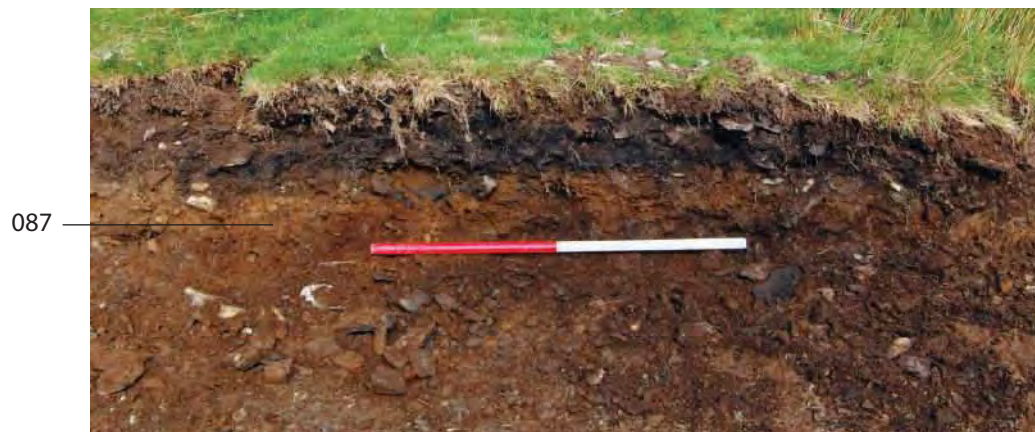
Plate 35. Section through burnt deposit 089 (PRN 31067), from the south-east

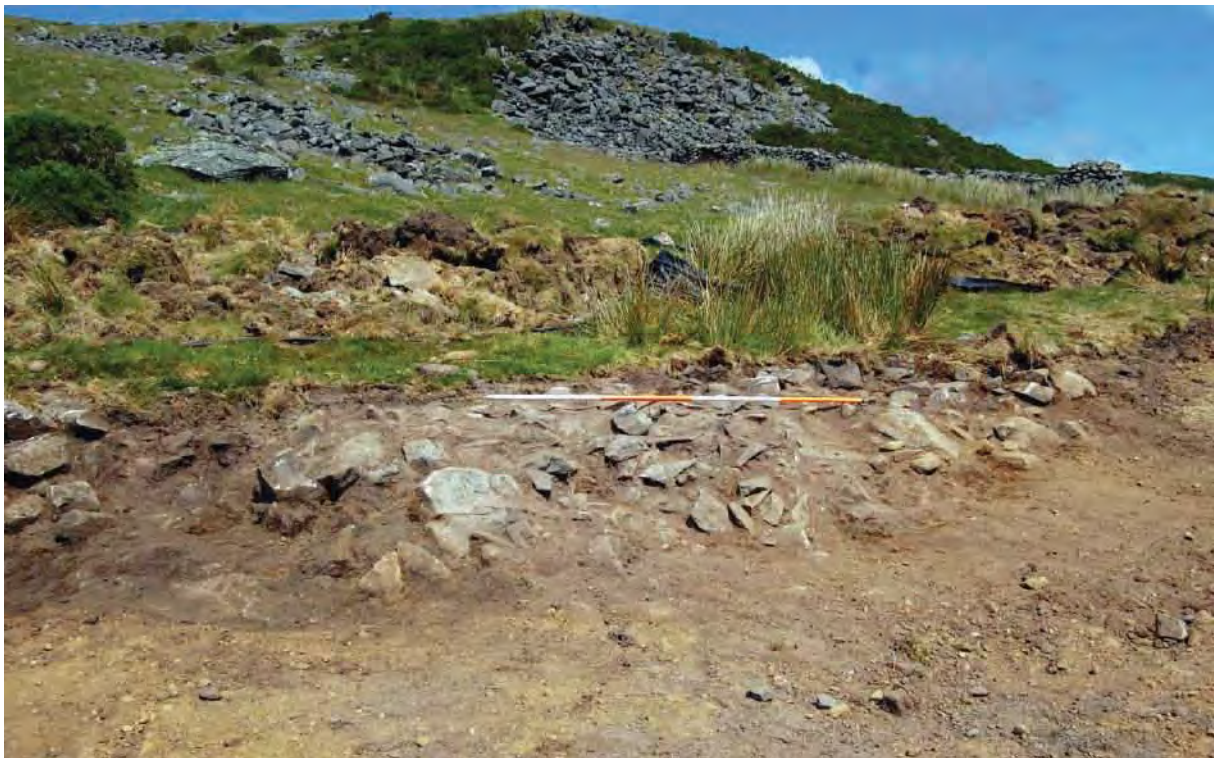
Plate 37. Scree patch (090) initially thought to be a cairn (PRN 31069), from the south.
Note other areas of clearly natural scree in background
