Industrial Recording:  
**Parys Mountain 2009-2010**

Report No. 859

Prepared for  
CADW

By  
Tanya Berks

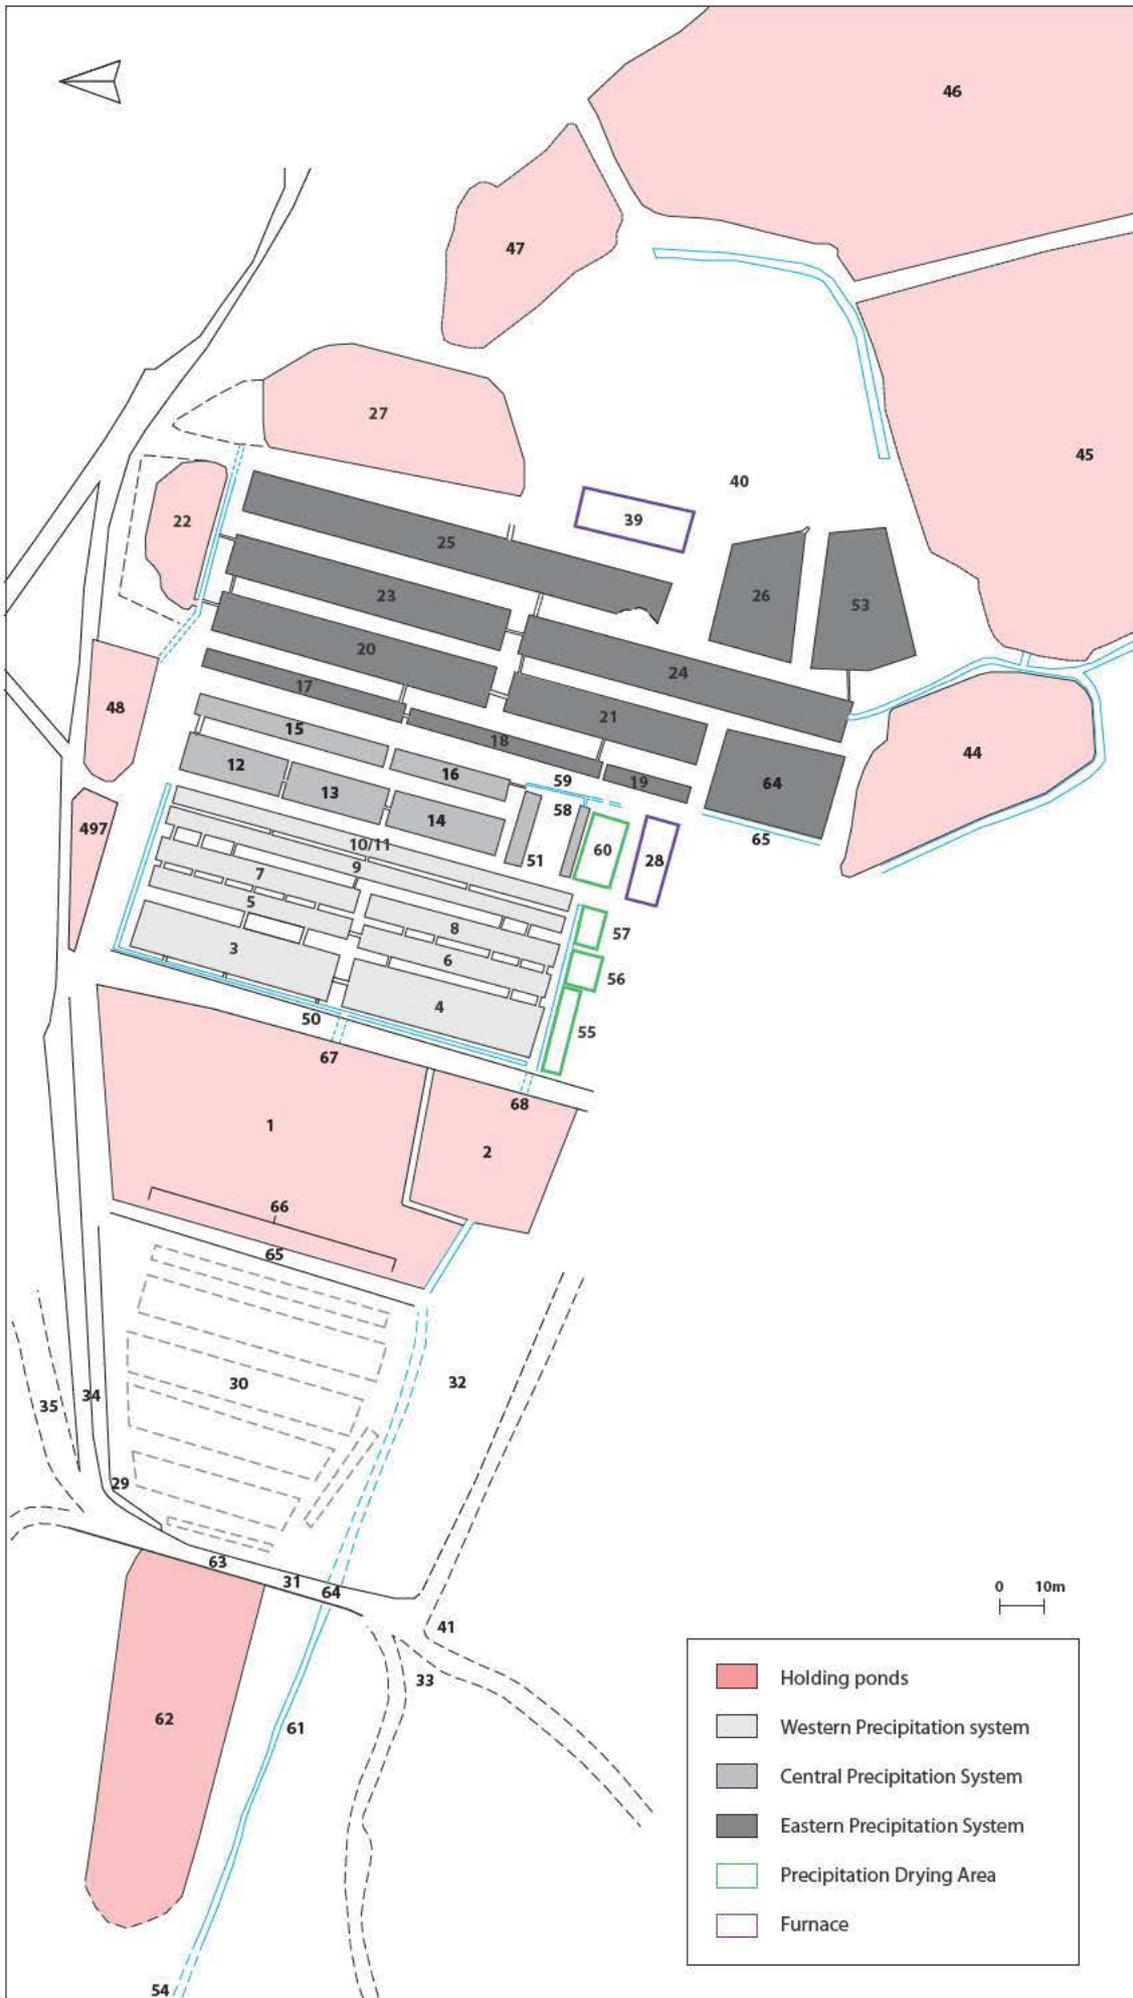
Figure 5: Feature location at Henwaith Precipitation pits

The Henwaith pits, as mentioned above, consist of a small group of western pits (feature 30) which are now overgrown, a large storage pond which is now divided into two (features 1 and 2) and a larger system of some 27 pits. East again were large ponds (44, 45, 46, 47) where ochre was extracted after the precipitation process had been completed.

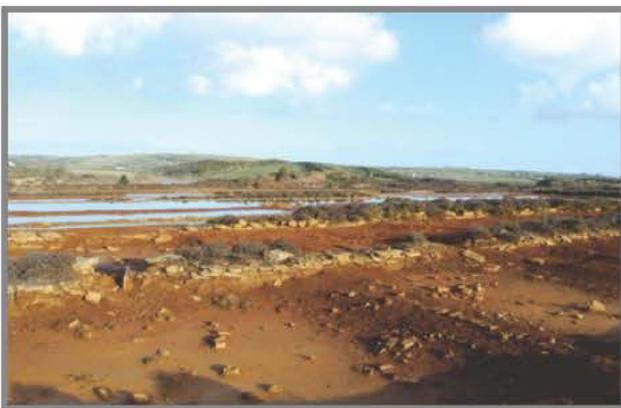
Plate 6: Ponds 3, 5 and 7 facing south. Pond 3 shows evidence of an undulating base and well preserved sluice gates

Ponds 3, 5 and 7 contain undulating bases of blocks of stone or burnt clay. The reason for this is described in the Mining Journal 1878;

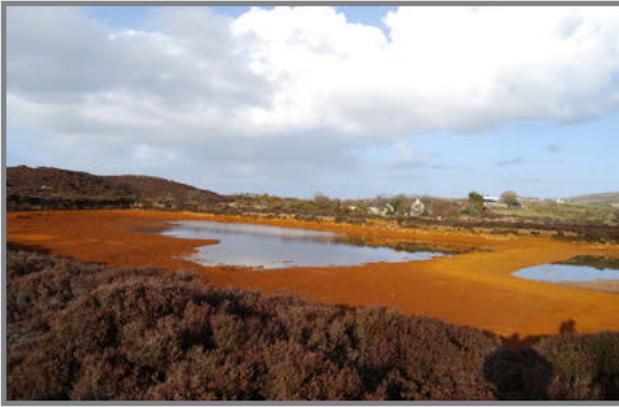
Plate 8: Pond 1 facing north

This feature is separated from feature 2 by a bund, probably of stone or brick, which is currently obscured by sediment. A retaining wall some 1.0m high surrounds the pond, with at least three integrated culverts on the western side so as to be fed from precipitation pits (30) to the west (plate 8)

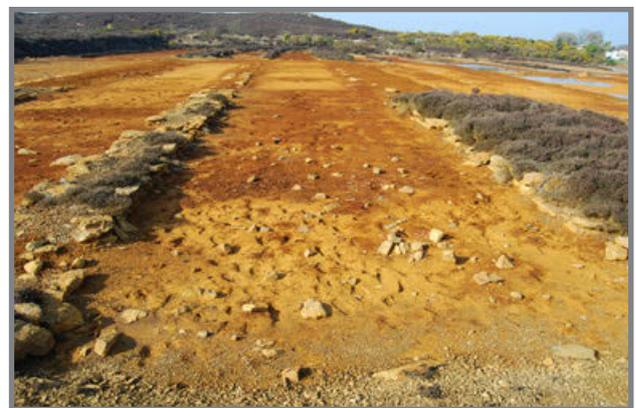
Plate 9: Ponds 7 and 8 facing north

This pit has the same dimensions as precipitation pit 5, and is fed by six culverts from pit 5 all with surviving wooden sluice gates. It is

This pit is identical in dimensions to pits 5, 6, and 7. The stone built retaining wall is in poor condition and survives only to two courses high. There is some evidence of a possible stone block base, however the vast majority is obscured by sediment. The pit is fed by five culverts from pit 6 to the west, three with surviving wooden sluices and likewise feeds into pit 9 by at least three culverts to the east (plate 9).

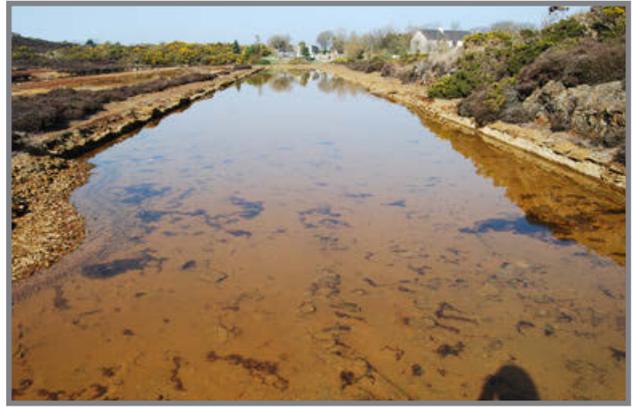
Plate 12: Pond 25 facing north

base. The pit appears to have been fed via culverts from pit 21, has wooden sluice gate remains with pit 23. There are the remains of a wooden sluice gate to the south, leading into a meandering stone built channel which drains into a large settling reservoir to the southeast (plate 12).

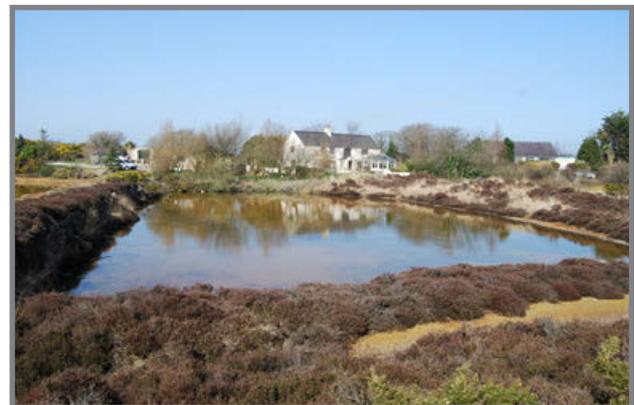
Plate 13: Pond 27 facing north

A sub-circular settling reservoir to the east of the precipitation pits. The western edge of the feature consists of a 1.5m high revetment wall. There is no evidence of a culvert in the western wall from pond 25 and it is also fed by holding pond 22 to the north-west. This pond drains east into reservoir 71 (plate 13).

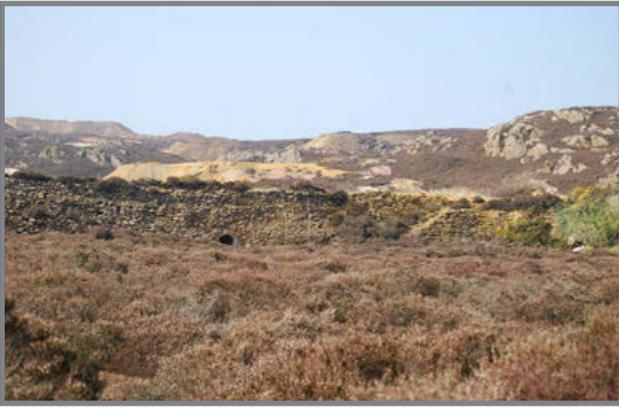
Plate 14: Embankment 31 facing west.

A substantial stone-built embankment carrying cart road 35 north to south across the hillside precipitation systems. It stands 4.0m high and has a stone built stairway 1.5m wide at its north-eastern side, presumably to give access to precipitation pits feature 30 below. The embankment has two brick built arches, the southern (64) of which feeds water into holding pond 2 via a stone built leat. The northern (63) arch is larger and almost certainly fed into precipitation system feature 30 to the east (plate 14).

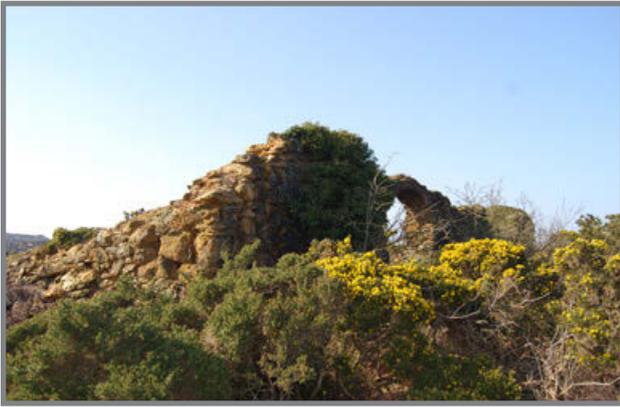
Plate 15: Furnace 39 facing west

A roofless and dilapidated stone building orientated north to south, heavily overgrown, with traces of burning on the internal walls on the south side. The building measures 27.0m by 8.0m in plan. A flattened brick arch doorway in the east facing longitudinal wall is large enough to accommodate a cart (plate 15).

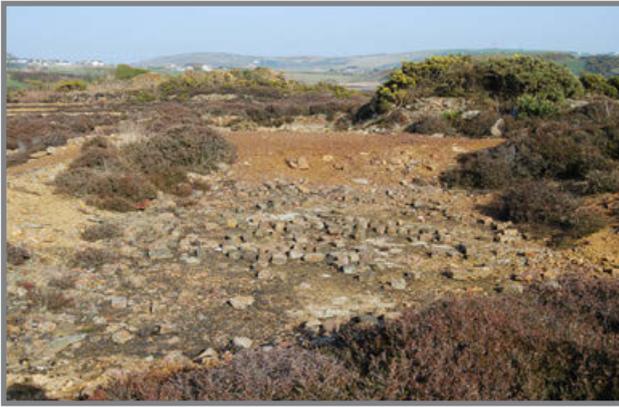
Plate 16: Drying area 55, 56 and 57

north; however this structure does not appear to have a water feed, suggesting it is not a precipitation tank. It seems likely that this structure is actually a precipitate drying room, and the leat structure is to return excess water back to the precipitation tanks. The structure has a poorly surviving stone wall to the north, with the southern and gable walls being obstructed by industrial tipping and vegetation encroachment (plate 16).

This structure is rectangular and very similar to structure 55 and 57, and may well be part of the same feature. It has a poorly surviving wall to the north, and the southern and gable walls are obstructed by debris. The structure has a very well preserved stone block floor, and has a stone leat in its northern wall which appears to run onto the walkway between precipitation pits 8 and 9, possibly having originally fed into a second leat (plate 16).

This structure is very similar to structures 55 and 56, but is smaller and square in plan. It also has a very well preserved stone block floor, and also lies at a higher level than the precipitation pits located to the north. The northern wall survives as much as three courses high and has a stone built leat which feeds into pit 11 to the north. The gable walls and southern wall is obscured by debris (plate 16).

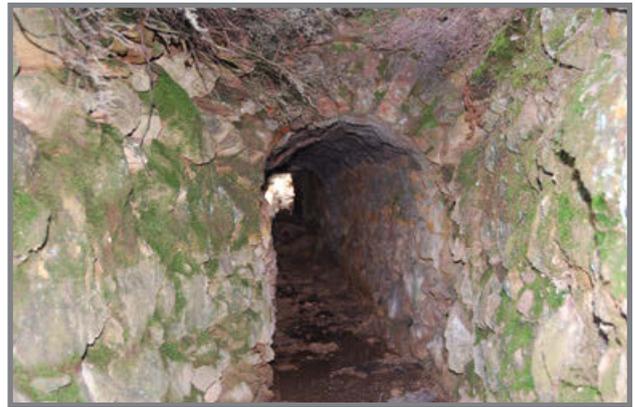
Plate 18: Culvert 64 facing west

Copper enriched water from the main Mona adit flows in this leat to the south of holding pond 62 through culvert 64 in embankment 31 and continues to the south of the first precipitation system 30 into pond 2.

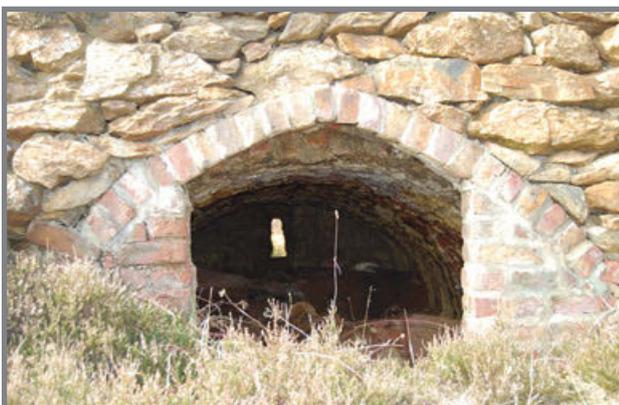
Plate 17: Culvert 63 facing west

Culvert in embankment 31, which feeds water from pond 1 into the western precipitation system through drain 50. On the eastern side the culvert is of re-pointed red brick 200cm in width and 180cm in height. On its west side the culvert is much narrower at 20cm in width and 180cm in height which

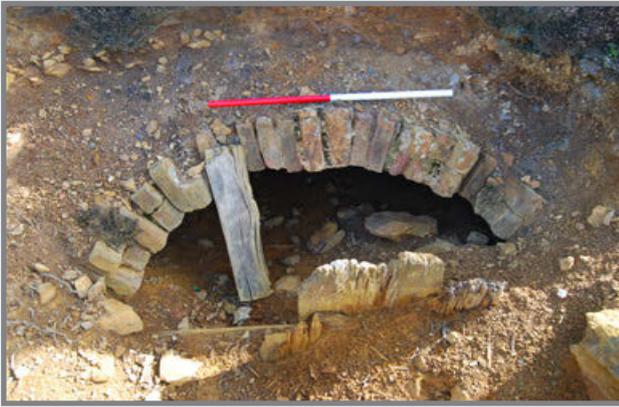
Plate 20: Culvert 67 facing west

Stone lined shallow curved arched culvert 100cm in width and 40cm in height with a surviving wooden culvert to the west consisting of both upright wooden posts and a vertical board which would have controlled the flow of water (plate 20).

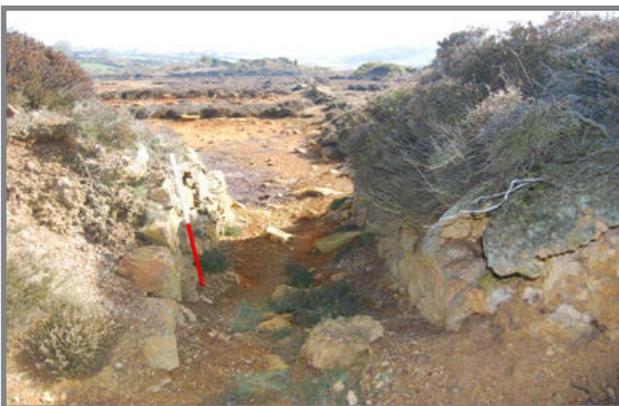
Plate 21: Culvert 68 facing east

This culvert has been totally destroyed and only exists as a gap in embankment 69 and 100cm in width (plate 21).

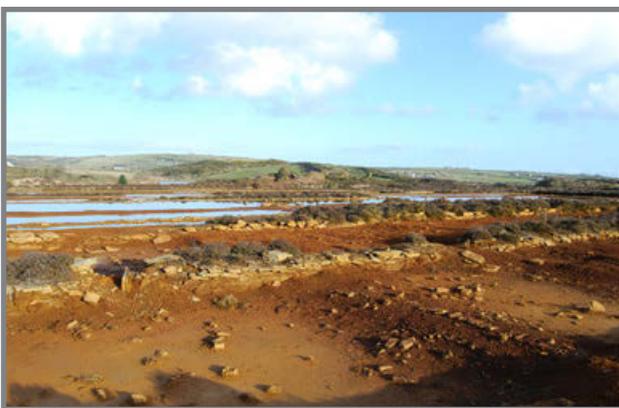
Plate 23: Sluice gates 77 and 78 facing south east

Evidence of wooden sluice gate. Both of the vertical posts survive dimensions 20x15x-

15cm and 20x15x15cm. The sluice gate measures in total 30cm in length, 15cm in width and a maximum of 20cm in height (plate 23).

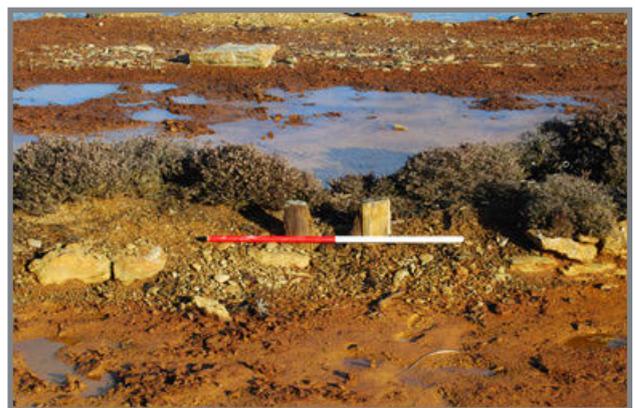
Plate 24: Sluice gate 81 facing east

Evidence of a wooden sluice gate. Only one vertical post survives dimensions 10x10x-2cm (plate 24).

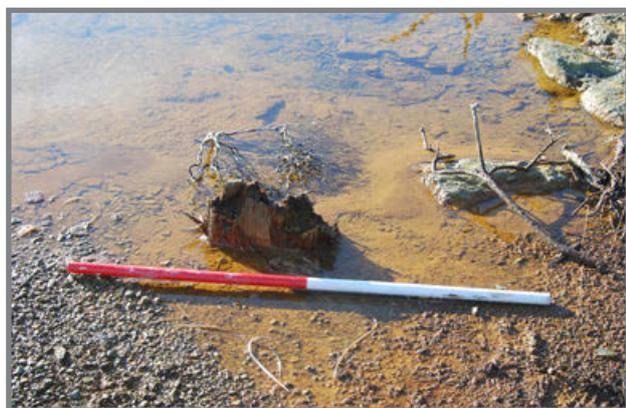
Plate 25: Sluice gate 88 facing east

Evidence of a wooden sluice gate. Only one vertical post survives dimensions 25x10x-2cm (plate 25).

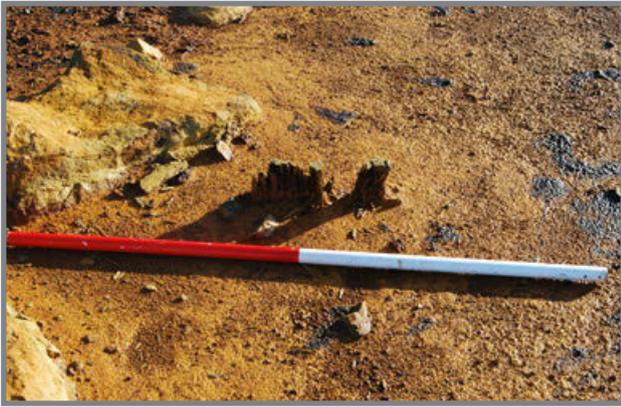
Plate 26: Sluice gate 90 facing east

Evidence of a wooden sluice gate. Only one vertical post in poor condition survives dimensions 25x10x1cm (plate 26).

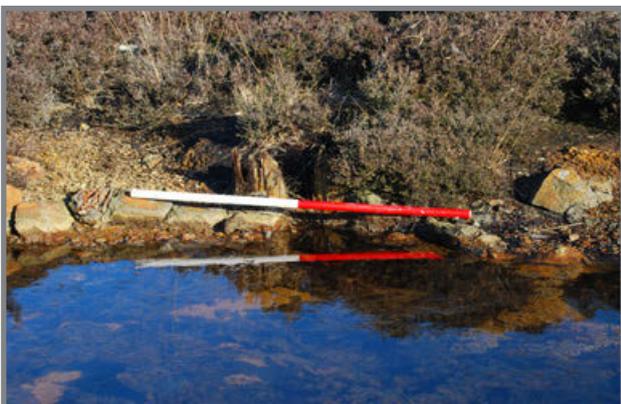
Plate 27: Sluice gate 92 facing west

2cm and 20x20x2cm. The sluice gate measures in total 50cm in length, 2cm in width and a maximum of 20cm in height (plate 27).

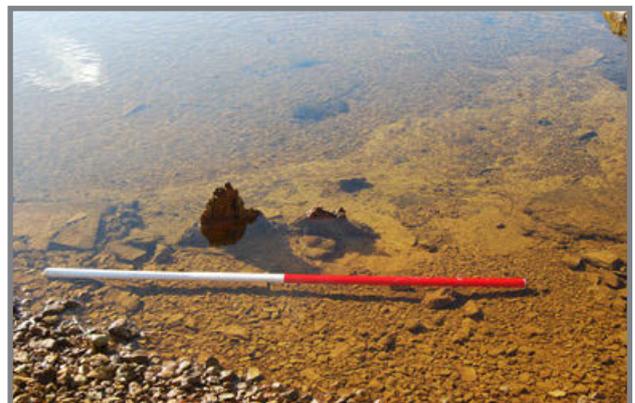
Plate 29: Sluice gate 95 facing east

Evidence of wooden sluice gate. Both of the vertical posts survive dimensions 20x20x-2cm and 20x4x2cm. The sluice gate measures to 50 cm in length, 2 cm in width and a maximum of 20cm in height (plate 29).

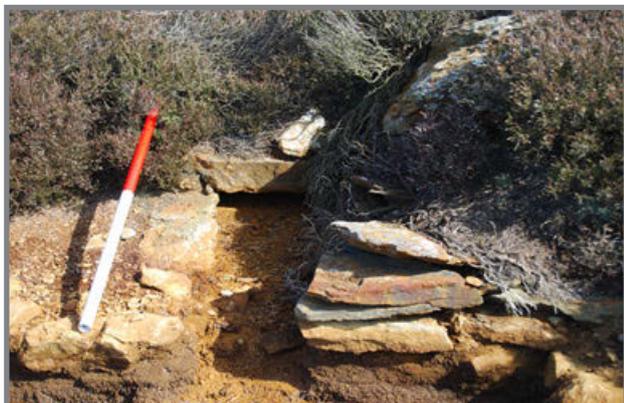
Plate 30: Stone capped drain 100 facing west

Stone capped drain flowing east to west from pond 58 into drain 59. The drain has one stone course and a capping stone of 60 x 10cm (plate 30).

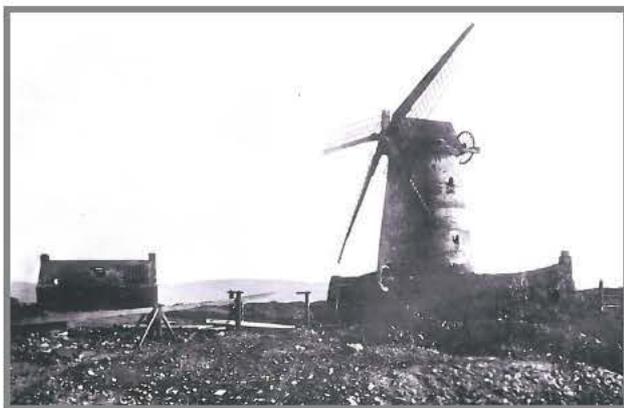
Plate 32: Windmill and Cairns engine house complex 19th century

The site of a flatrod system which connected the Cairn's shaft (107) with the windmill (74) and the steam engine (109). Photographs shows (plate 32) that this was operated on dolly posts, of which no trace was observed, but a substantial balance-box pit, stone-lined, survives immediately to the south-east of the shaft.

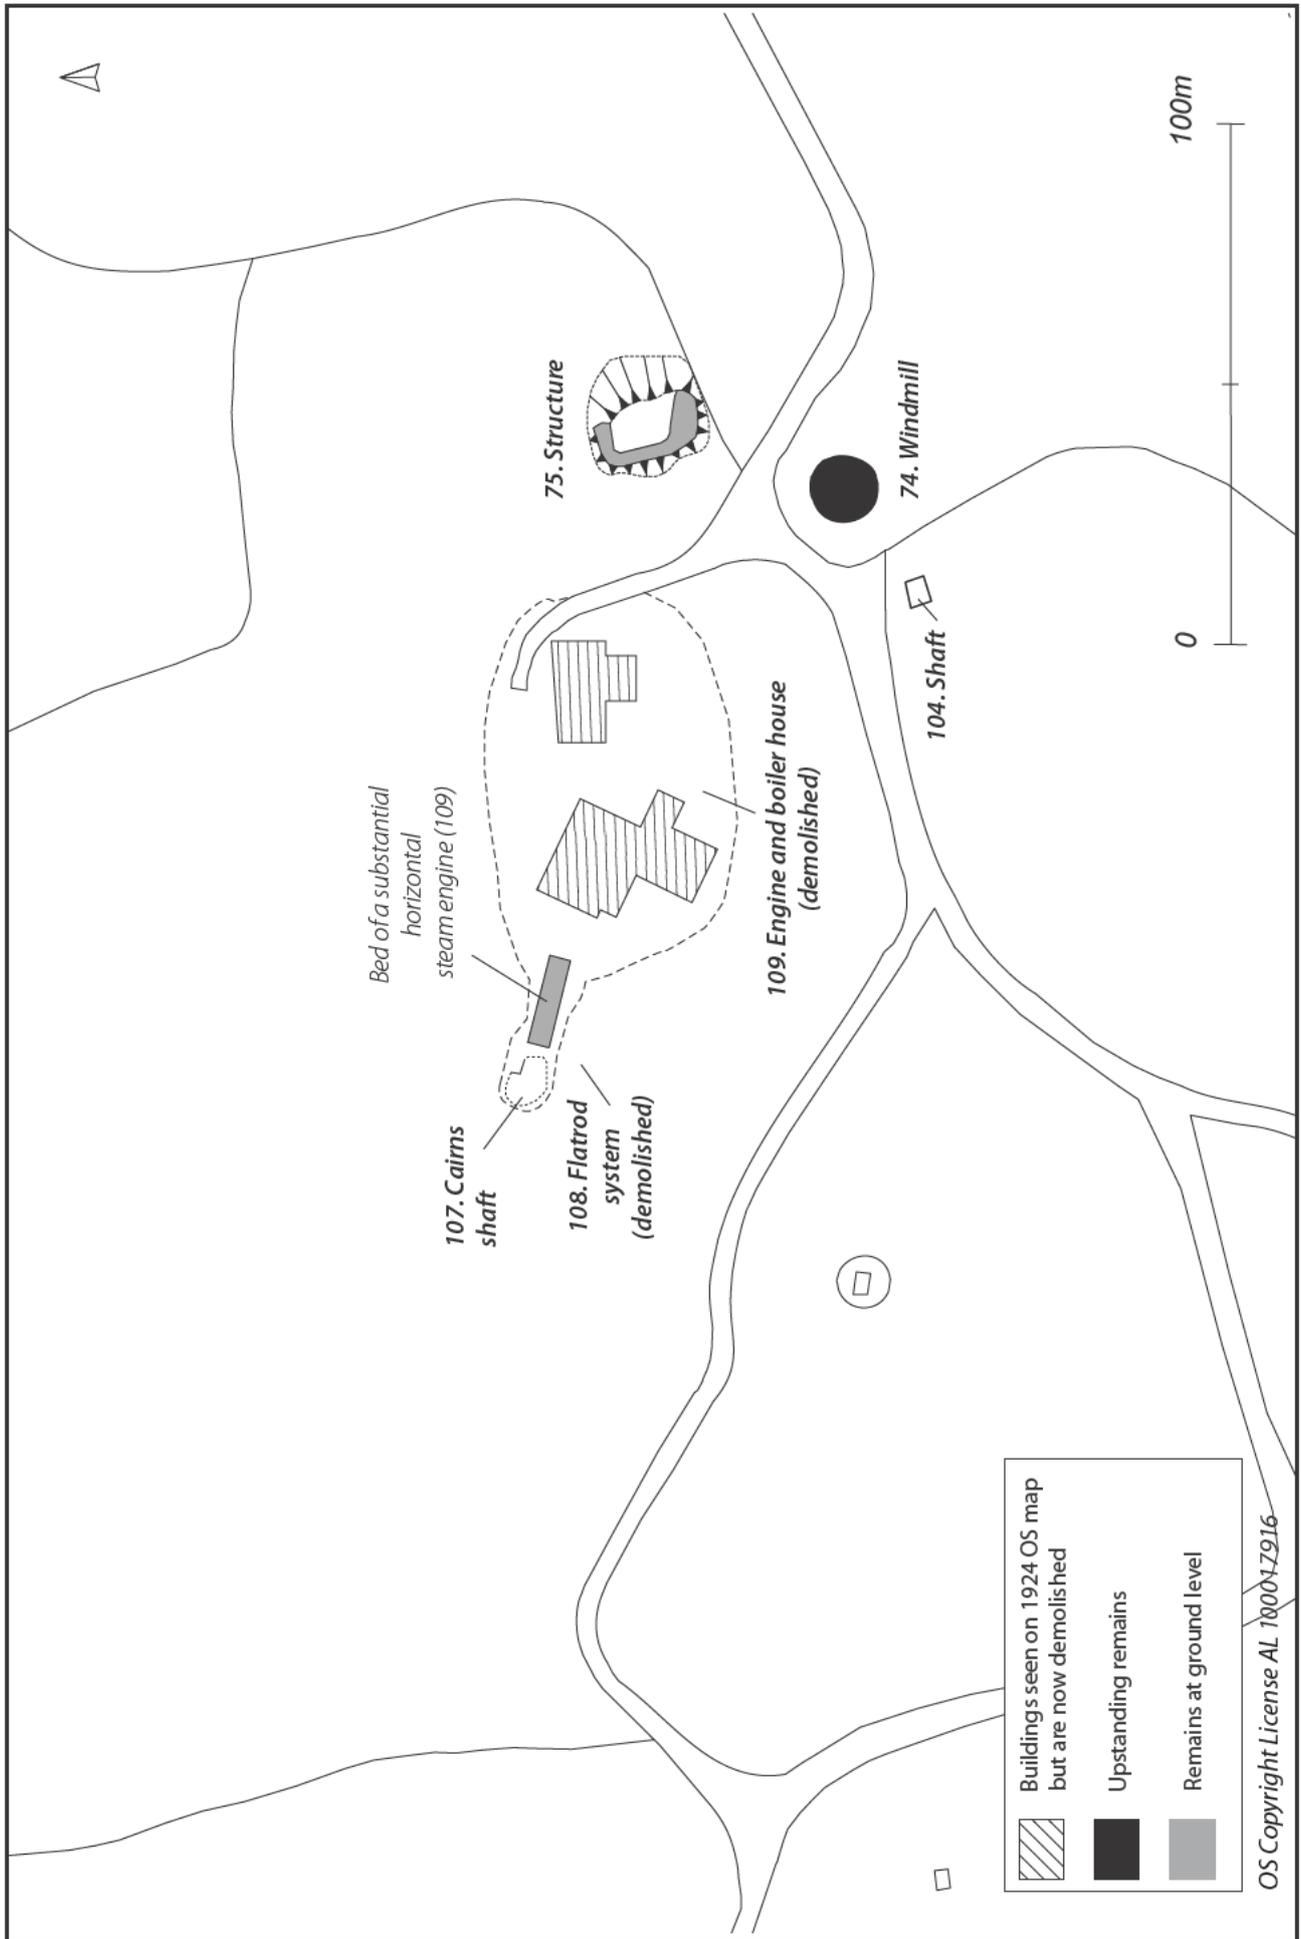
Figure 12: Windmill and associated features.

The windmill is the most prominent landmark on the mountain, and is visible from a considerable distance. It is a stone-built conical tower mill, which measures 8m in diameter across the base and stands approximately 20m high. Uniquely for Anglesey, it was a five-sailed mill; the cap and all the machinery are missing, but it is believed to have contained an upright shaft driven by bevel-gearing from the sail-shaft, which in turn operated 200' of flat-rods by means of a crank in its foot. The flat-rods operated a pump in Cairns' shaft, and were supported on intermediate dolly-posts.

There is little remaining of the engine house and associated features apart from a small rubble mound and small foundations to the north of the windmill, but the

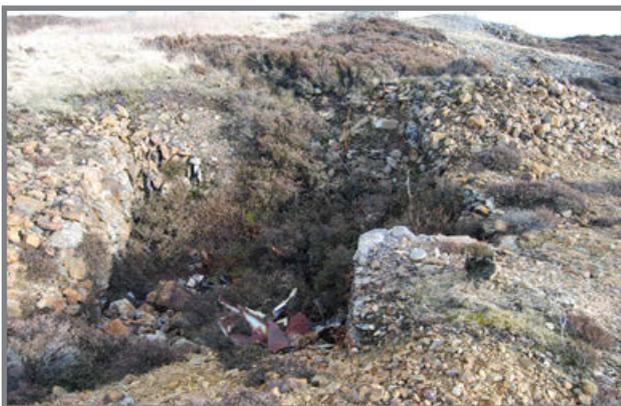
Plate 34: Cairns shaft and balance box, associated with the flatrod system pit facing south east

structures can be seen in the OS 1889-1924 maps. All that remains is the substantial stone base and twisted holding-down bolts of the engine itself which are found at the foot of the Cairns shaft.

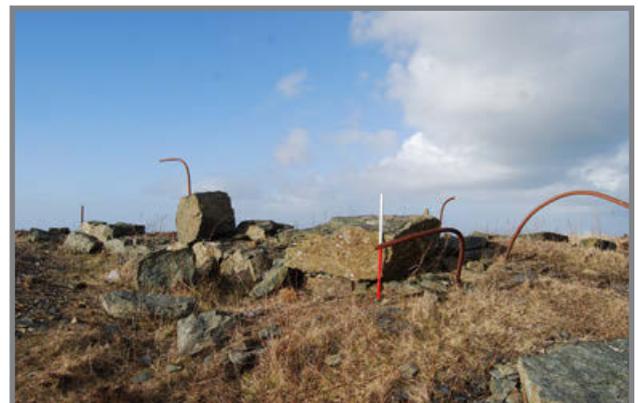
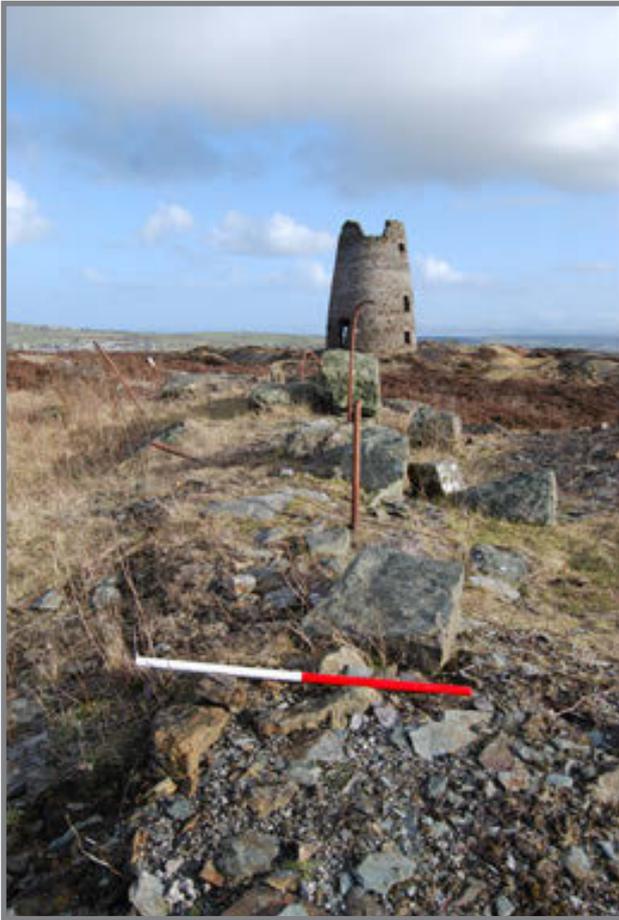
Plate 35: remains of engine house facing north east

Plate 36: Windmill and remains of engine house facing south east

The remains of a once-substantial engine-house and boiler-room. The buildings themselves have left practically no visible trace, though the stone bed of a substantial horizontal steam engine is apparent, and a number of holding-down bolts are apparent, much twisted. A photograph in Owen Griffith's book shows that the buildings were constructed of stone and roofed with slate. (Griffith O: *Mynydd Parys* (Caernarfon 1897) plate 31) (plate 35 and 36)

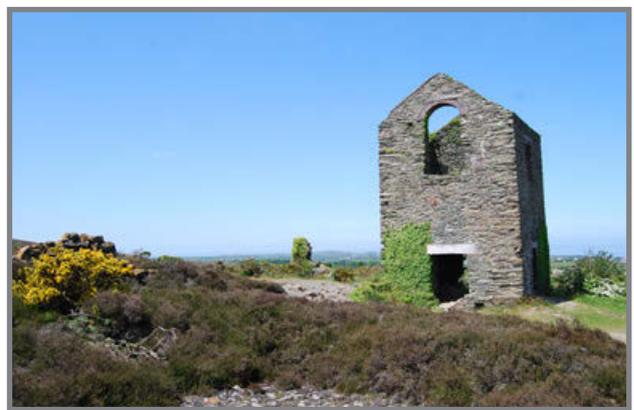
Plate 38: Pearl engine 122 house facing north

The Pearl engine-house; believed to have housed a beam engine pumping engine constructed by the Neath Abbey Ironworks in 1819, and later to have housed a beam engine of 1853 built by the Perran Foundry through the consulting engineers Messrs Hocking and Loam. An unusual feature is the hooded cowl over the beam, of which traces remain in the stonework. This is believed to be the oldest beam-engine house in Wales. It has recently been consolidated with grant-aid from Cadw. It is a Scheduled Ancient Monument.

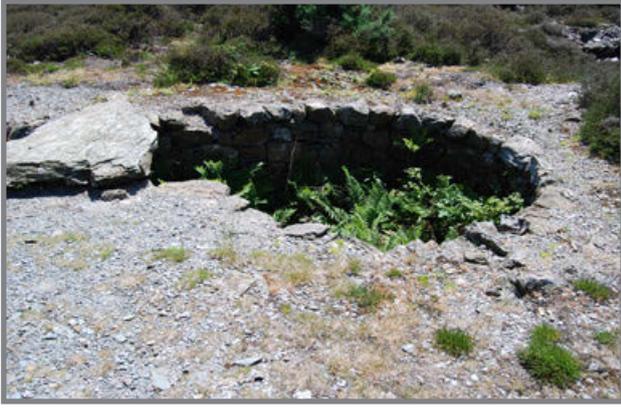
Plate 39: Capstan pit 123 facing east

A pit for a manually-operated capstan to haul pump-rods up and down the shaft for repair and renewal (124); recently (Novem-

ber 1997) consolidated with grant-aid from Cadw.

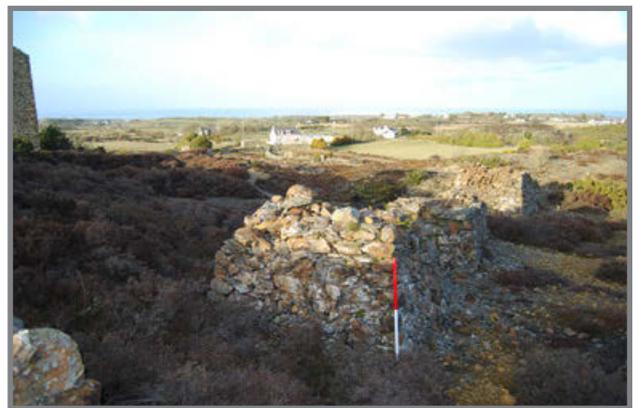
Plate 40: Pillars 131 facing north

A row of five stone-built tapering, pillars, measuring (maximum) 3m by 3m at the base and reaching to a maximum height of 2m. They appear to be too substantial to be launder pillars, and may possibly have carried a flatrod system, possibly from (140), or from (122) by means of a fend-off bob to turn it through an acute angle, to (127).

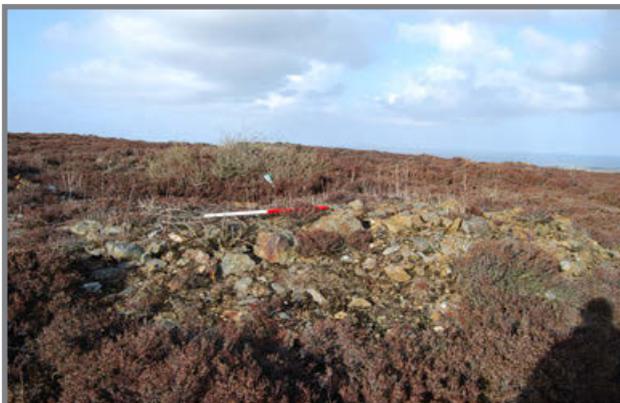
Plate 41: Structure 140, possible engine house facing north

The ruins of a Substantial stone-built structure, very seriously dilapidated and overgrown. It appears to have gone through several phases of use, including an office, which survives as a roofless structure in the western part of the building, and the 1900 25" ordnance survey map shows a cluster of small buildings around an enclosed area. This structure, or set of structures, may, be associated with the pillars (131) that line up with one of the perimeter walls, these are suggested as being, supports for a flat-rod system, in which case it is possible that this structure may have been an engine house of some description.
