Conwy Valley Flood Alleviation Scheme: **Trefriw Borrow Pit**

Archaeological Excavation

Report No. 864

CONWY VALLEY FLOOD ALLEVIATION SCHEME TREFRIW BORROW PIT

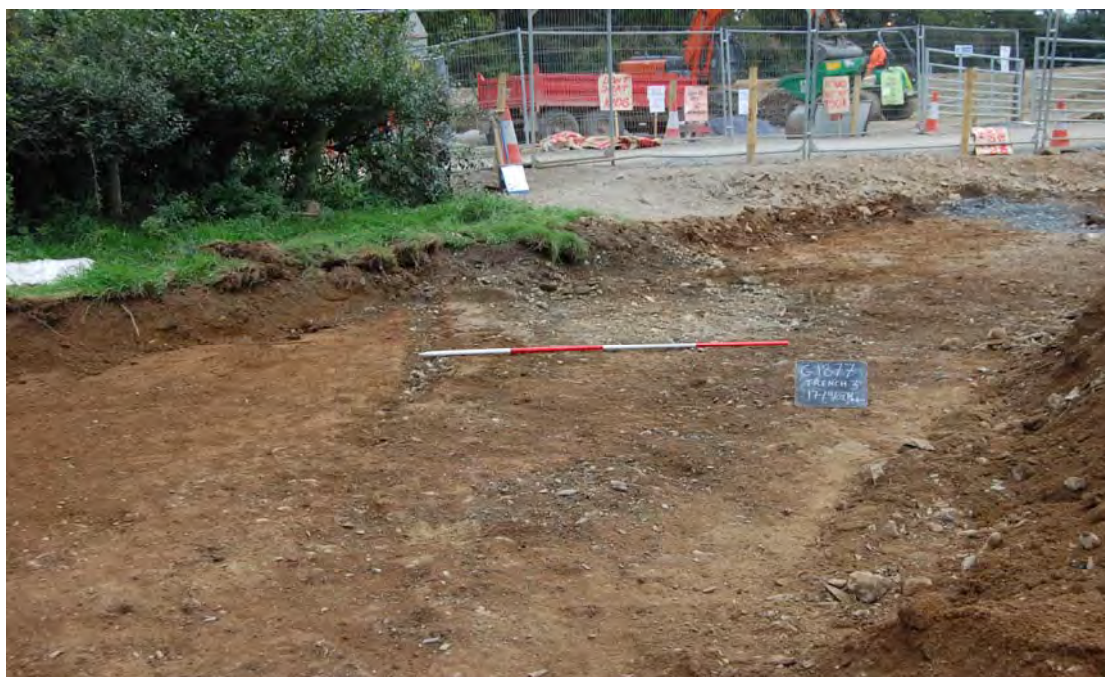
Plate 1 Pre-excitation image showing surviving stretch of road to north-east of borrow pit

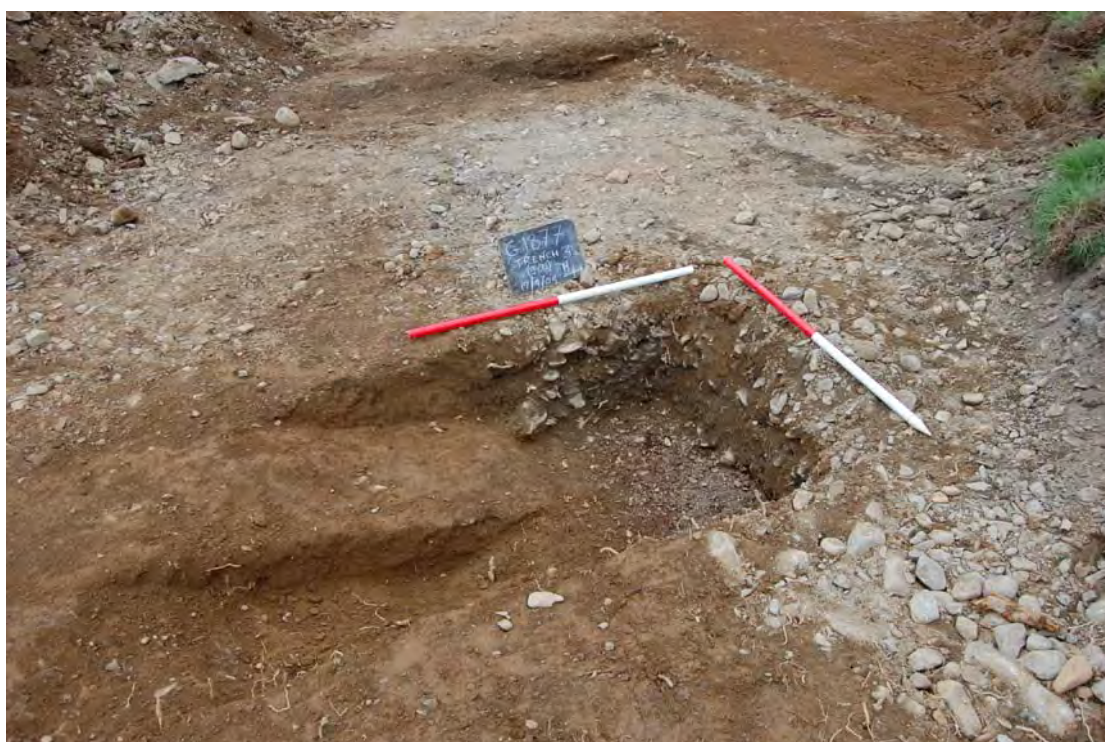
Plate 2 Post-excitation view of Trench 3a from the south-east

In Trench 3a (Fig.4, Plate 2) iron pan (307) was observed in the base of the hollow way. This lay below a compacted gravel fill (306). This probably represents a period of consolidation of the hollow way surface. This was overlain by a mid greyish brown silty clay fill (304), which in turn was overlain by a mid orangy brown silty clay (314). This lay beneath the mid orangy brown silty clay topsoil (301).

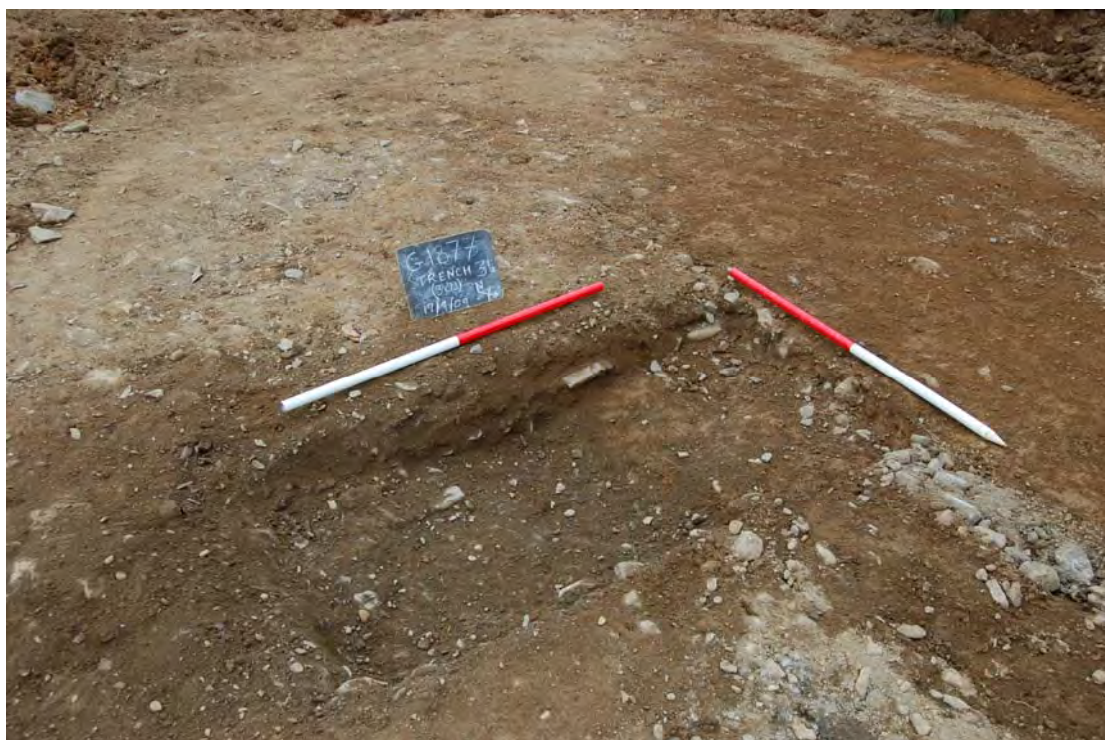
Plate 3 Post-excavation view of Trench 3b from the south east
