# Egryn: Llanaber

## Archaeological Building Survey

GAT Project No. 1879

Report No. 865

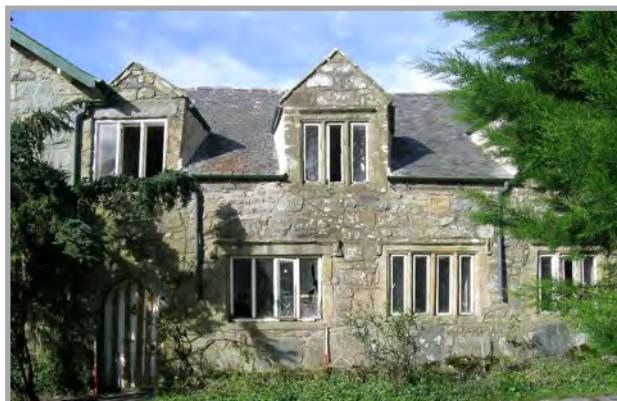
The south elevation exhibits all the major phases of construction. The centre part consists of the medieval hall, with its cross-passage and later mullioned windows. The hall is flanked by the gable end of the 19th century parlour wing to the west and the 18th

Plate 3: South elevation

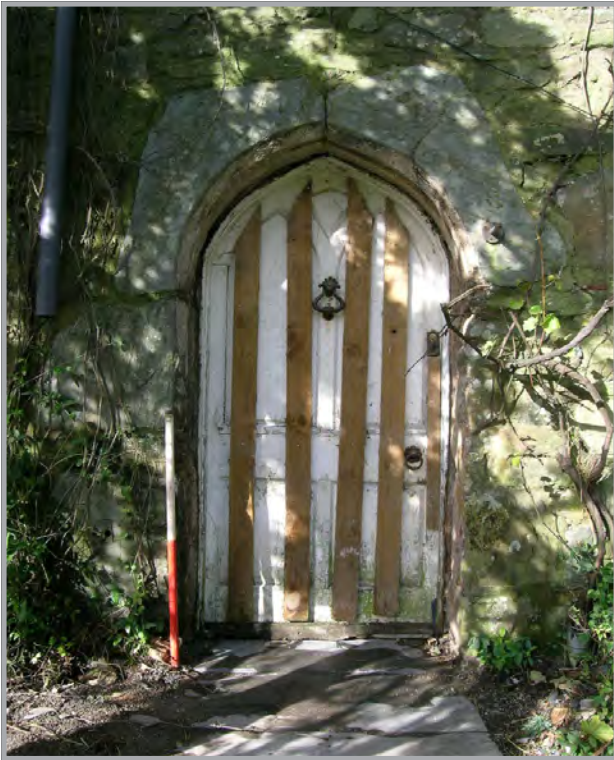
*Plate 4: The south door*

The doorway to the cross-passage has a pointed gothic arch, the arch being formed from two large chamfered slabs. The arch springs from jambs of the same stone on the west side, though not on the east, where the chamfer is continued down in a rougher form, and is presumably a replacement of the original. There are two rectangular hall windows; the western one retains only its original jambs and a rectangular moulded label with squared returns but no stops. The sill and lintel are concrete, and the window is of four wooden lights. The second window is a four light mullioned window with ovolo mouldings and a rectangular label, again with no stops. The next window, which lit the inner room behind the dais, is the same, but of three lights only. One mullion has been replaced, and the label is a simple horizontal string with no returns. A small square stone with an illegible inscription lies above the east hall window.

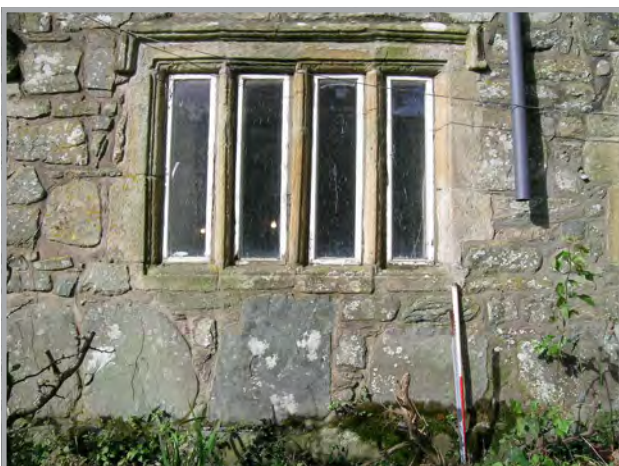
*Plate 5: Ovolo moulded windows on the south side of the hall*

Three gabled dormer windows light the first floor. The two eastern windows are of three lights with ovolo moulded jambs and mullions and a moulded label, again with no returns. A third dormer sited above the door is of similar size, but with no mouldings or stone mullions, and a large stone lintel. This window may be of later date, or the window has been completely rebuilt at a later date, perhaps when the 19th century wing was built.

In the south wall two windows light the hall and one window lights the inner room. These are large horizontal windows with ovolo moulded mullions and jambs. This decorative style only reached Wales later in the 16th century, so in their present form they belong to the second phase of the house. The ex-

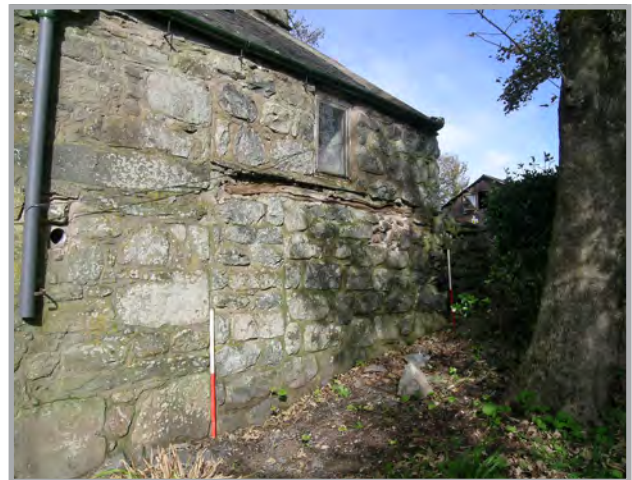
*Plate 6: The eastern extension*

The east end of the medieval house is marked by a vertical straight joint in the masonry, where the later building starts. A long horizontal timber lintel runs over a former large blocked opening, almost of cart shed size. This was subsequently part blocked to create a smaller door, and later fully blocked. A small single-light rectangular window lights the first floor, and there is a small iron rooflight.

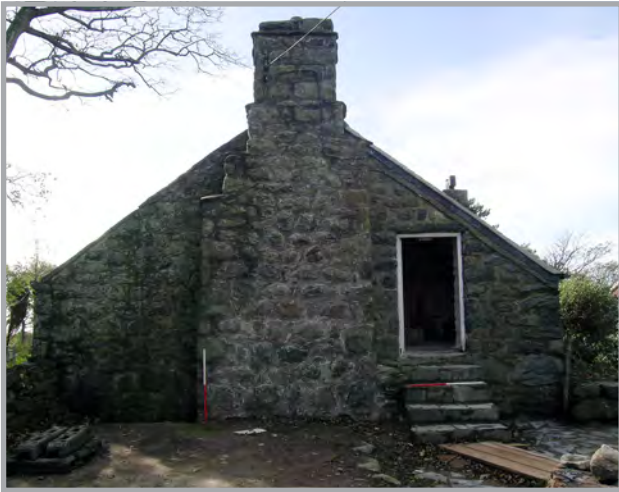
*Plate 7: The east gable*

here, where the east end of the house is built into the slope, and entry is into the first floor. A large chimney, projecting some 0.5m east of the wall line, occupies the centre part of the gable. It narrows in steps towards the top, and finishes above a horizontal string course. Right of the chimney is a door with five steps up which leads into the first floor room.

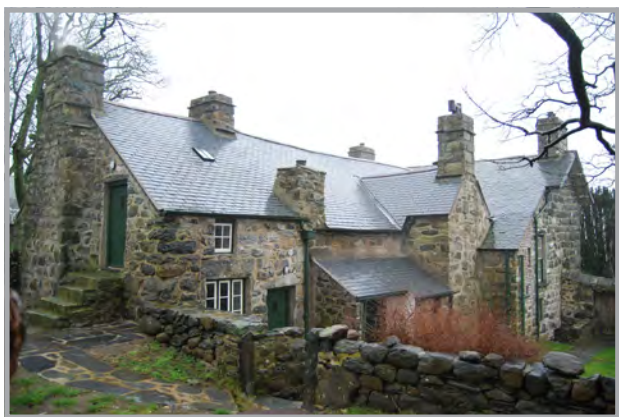
The north elevation, though not necessarily originally, certainly became the back of the house. Examining this side from east to west, at the east end is the 18th century extension, with a large 9-pane fixed window on the ground floor, and a door to the right, both with single slab lintels. A small single light window lights the first floor. There is a straight joint in the masonry above and in line with the right door jamb, indicating the end of the medieval house, though it carries up to form the left side of a small square chimney stack. This may be a later insertion, as the other side of the chimney is also visible as a straight joint in the upper part of the wall. The lower part of the wall is obscured by a later lean-to extension. This small extension with mono-pitch roof continues to, and is on the same alignment as, the projecting lateral hall

*Plate 8: The north elevation*

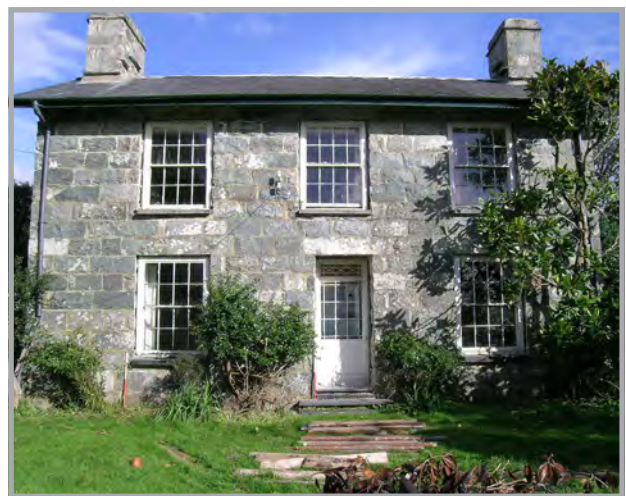
Built in the first part of the 19th century, the cross-wing was built to resemble the late Georgian/early Victorian houses of the area. The walls are of dark-grey quarried stone, regularly coursed. The roof is

*Plate 10: The west elevation*

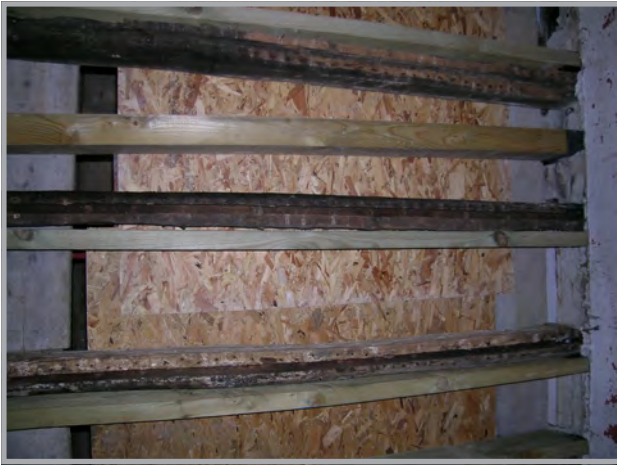
*Plate 11: Re-used timbers used as ceiling joists in the cross-passage*

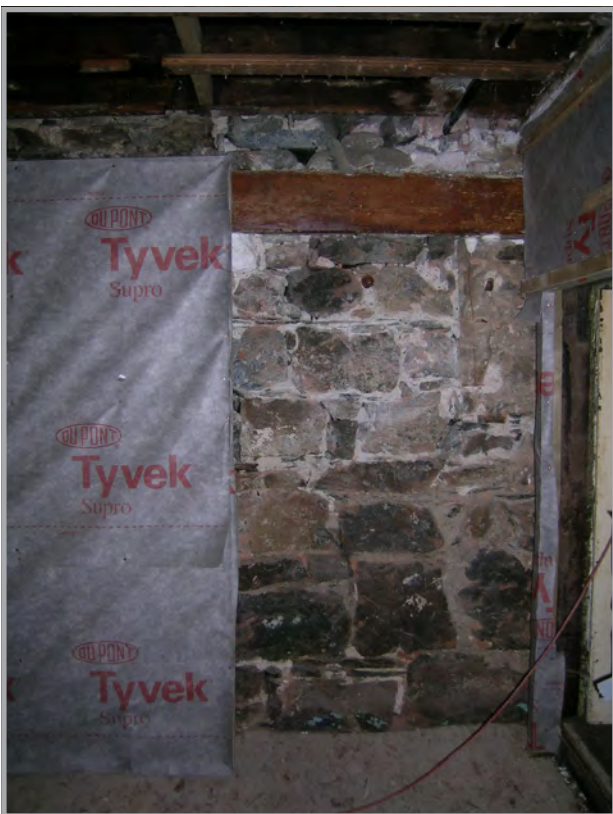
*Plate 20: Blocked window in the north wall of the hall*

The blocked north window in the hall is more problematic. It is crossed by the horizontal beam above the fireplace, and the corbel supporting the beam lies within the blocking, so the timber and corbel certainly post-date the opening. On the outside face of the wall the window appears to have simple chamfered jambs and a central chamfered mullion. The west jamb is tight in the corner between the wall and lateral chimney, and could possibly pre-date the chimney. In which case the horizontal beam could form part of the second (c. 1620) work, put in partly to help support the wall whilst the fireplace was inserted, and partly to help support the first floor. However its lack of decoration (the horizontal beam between the aisle posts is chamfered with decorative stops) would argue for a later insertion – essentially it looks too clumsy given the care with which the fireplace and windows were built.

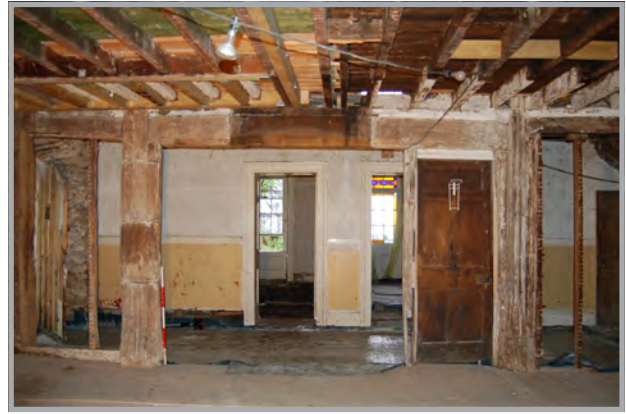
*Plate 21: The aisle truss ground floor looking west. The two aisle posts are linked by a later horizontal timber at ceiling height*

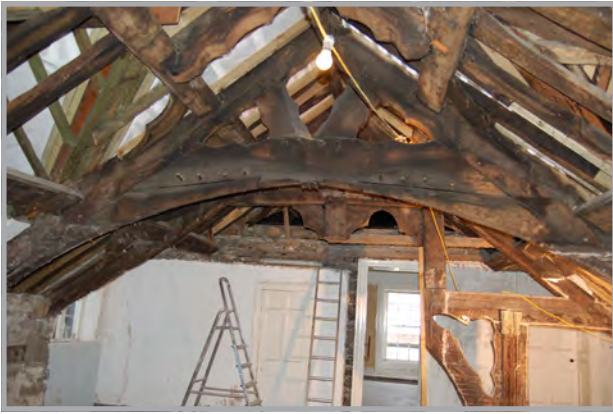
*Plate 23: The aisle truss before renovation can be seen behind the collar-beam truss. The south aisle post is missing*

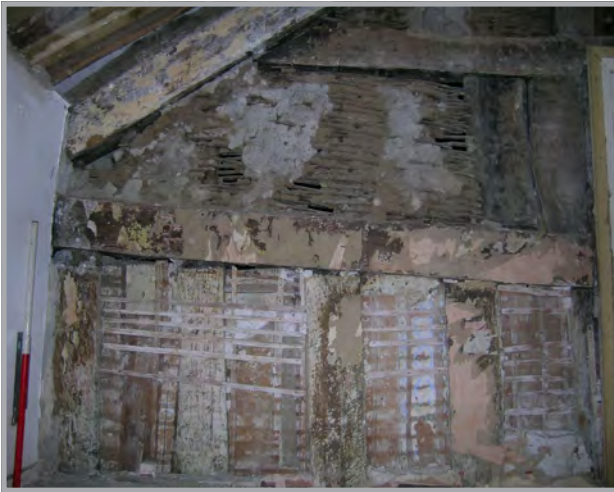
*Plate 28: The dais partition first floor inner room south side*

cupping above the collar beam. Part of the upper rail, one post and a number of panels are missing on the north side, perhaps to create a door (see 5.2 below).

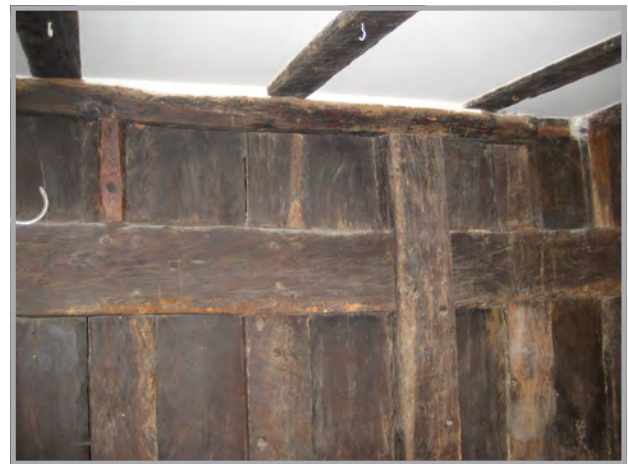
*Plate 31: The dais partition ground floor inner room. The vertical upright supports the plate for the joists*

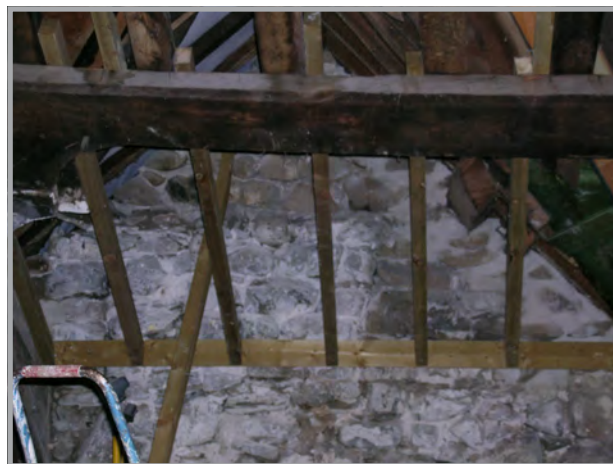
*Plate 33: The discolouration co-incides with straight joints in the masonry which could indicate blocking or an earlier structure*

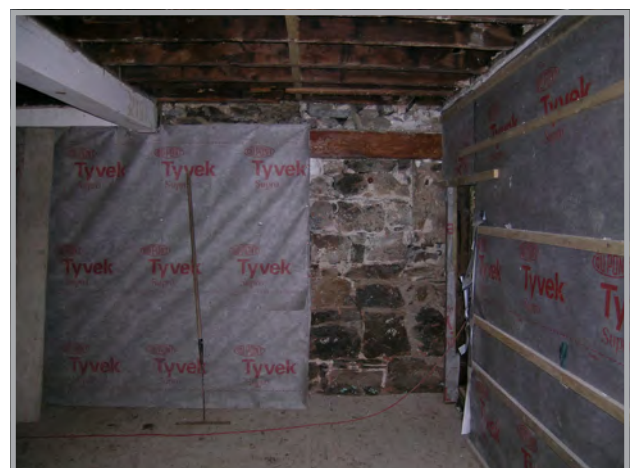
Plate 38: Blocked window in north wall of hall

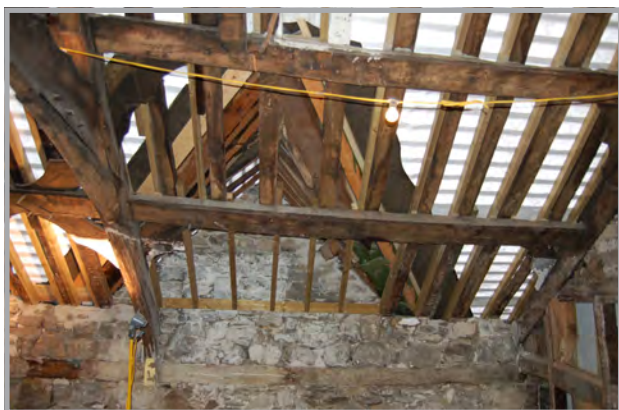
Plate 39: Straight joint in masonry of inner gable of lateral chimney

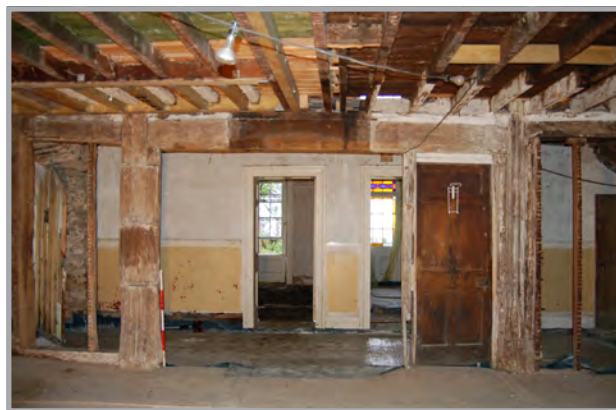
Plate 40: Ground floor aisle truss in hall. The upper central horizontal beam dated c. 1620

The present hall ceiling dates from the 19th century, and there is little evidence remaining for an earlier ceiling. The date of 1620 is derived from a horizontal beam across the aisle posts which is assumed to have been inserted to support the new ceiling joists. A central transverse beam would have crossed in the approximate location of the present 19th century beam. This is a perfectly reasonable supposition, however there is a 19th century description recalling the building in the 18th century before the new ceiling and cross-wing were built. The description is by the lexicographer William Owen Pughe (1759 – 1835) who wrote the account in 1830 (Pughe 1830, 10). In his 70's he was describing the house as he remembered it in his childhood. He says 'The inside is curious; the roof is supported by pointed arches, of fine Irish oak, springing from the basement, and dividing the building into three compartments. Over half of the middle one, which is the largest, there was till lately a gallery of communication between the apartments in each end, and protected by a balustrade, as if intended for an audience to hear and see what occurs below'. This would certainly imply that a first floor was never inserted in the hall, but that the two storeyed inner and outer bays were linked across the hall by a passage way at first floor level. The principal argument against this is the presence of the dormer window over the hall. It is difficult to see why this should be inserted if not to light an upper chamber. There are, however, two other factors to take into account. The first is the unusual horizontal timber above the fireplace. The purpose of this is unknown, but it may have helped support such a passageway. The second factor is a break in the post and panel partition at first floor level on the north side where one post and the upper rail of the panelling have been removed. This effectively creates a door through the partition. The presence of this door need not, of course, argue for the exist-

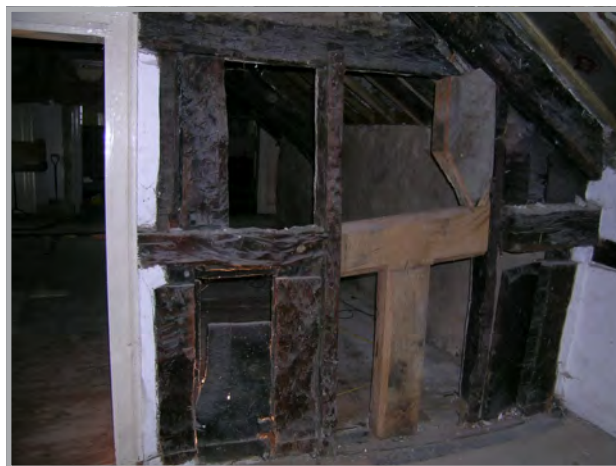
Plate 41: Dais partition first floor inner room. The upper rail and one post has been removed

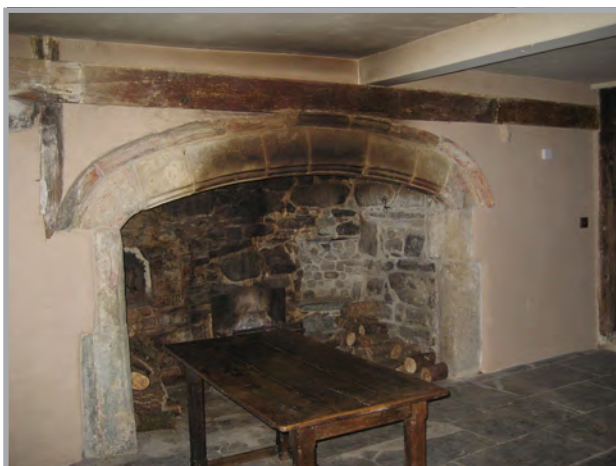
second phase c. 1620. An inserted long horizontal timber beam lies somewhat uncomfortably above the fireplace. The present ceiling cross-beam rests on it. The west end of the beam rests on a rounded corbel, and a second smaller one lies east of the fireplace. This timber crosses the blocked opening east of the fireplace, so must be later than it. A vertical timber which runs from the ceiling down the west side of the fireplace, crossing the horizontal beam, marks the position of a former internal partition, when the west end of the hall was divided into two small store rooms. The lateral fireplace has a segmental arch of large stone voussoirs with a quarter round moulding

Plate 42: The hall fireplace with horizontal timber in the wall above

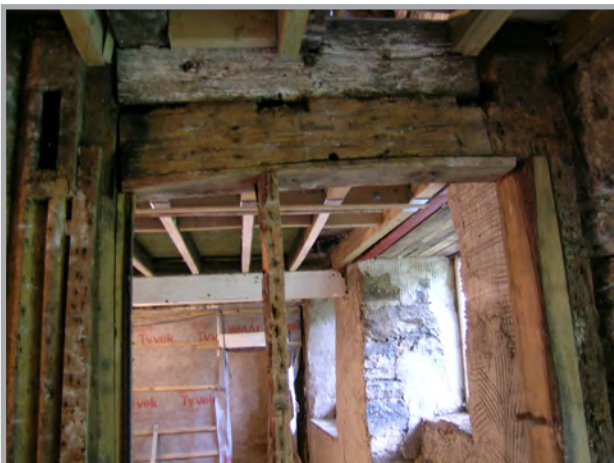
*Plate 43: Mortise in aisle truss and notches for joists on the cross-passage side*
