# MINFFORDD HOSPITAL, BANGOR GWYNEDD: ARCHAEOLOGICAL BUILDING RECORD

## Archaeological Building Record: Level 2/3

GAT Project No. 2125

Report No. 872

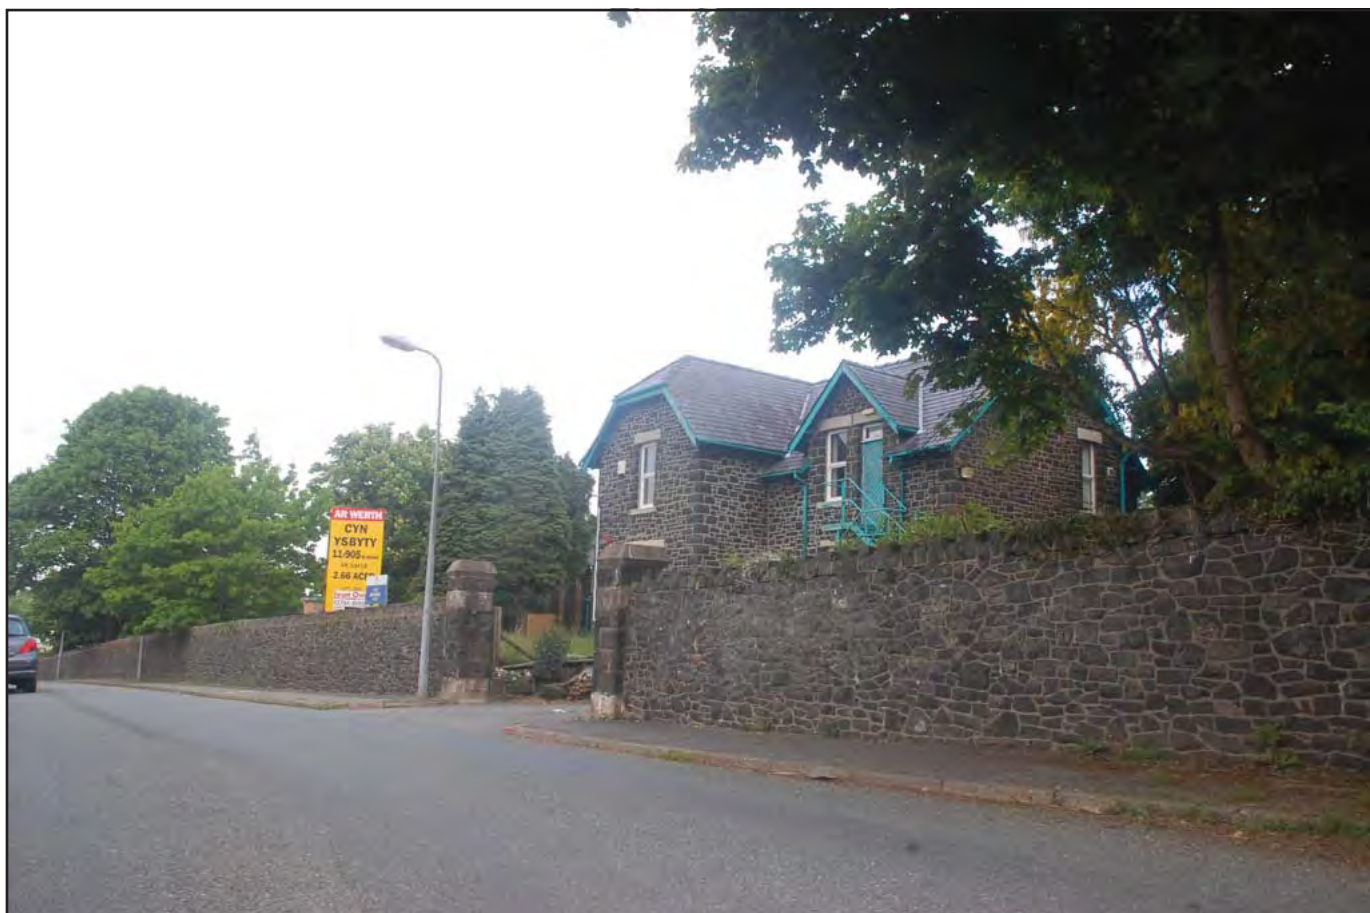
Plate 01: View west of main entrance and boundary wall along Hendrewen Road. The administration block is visible behind the boundary wall.

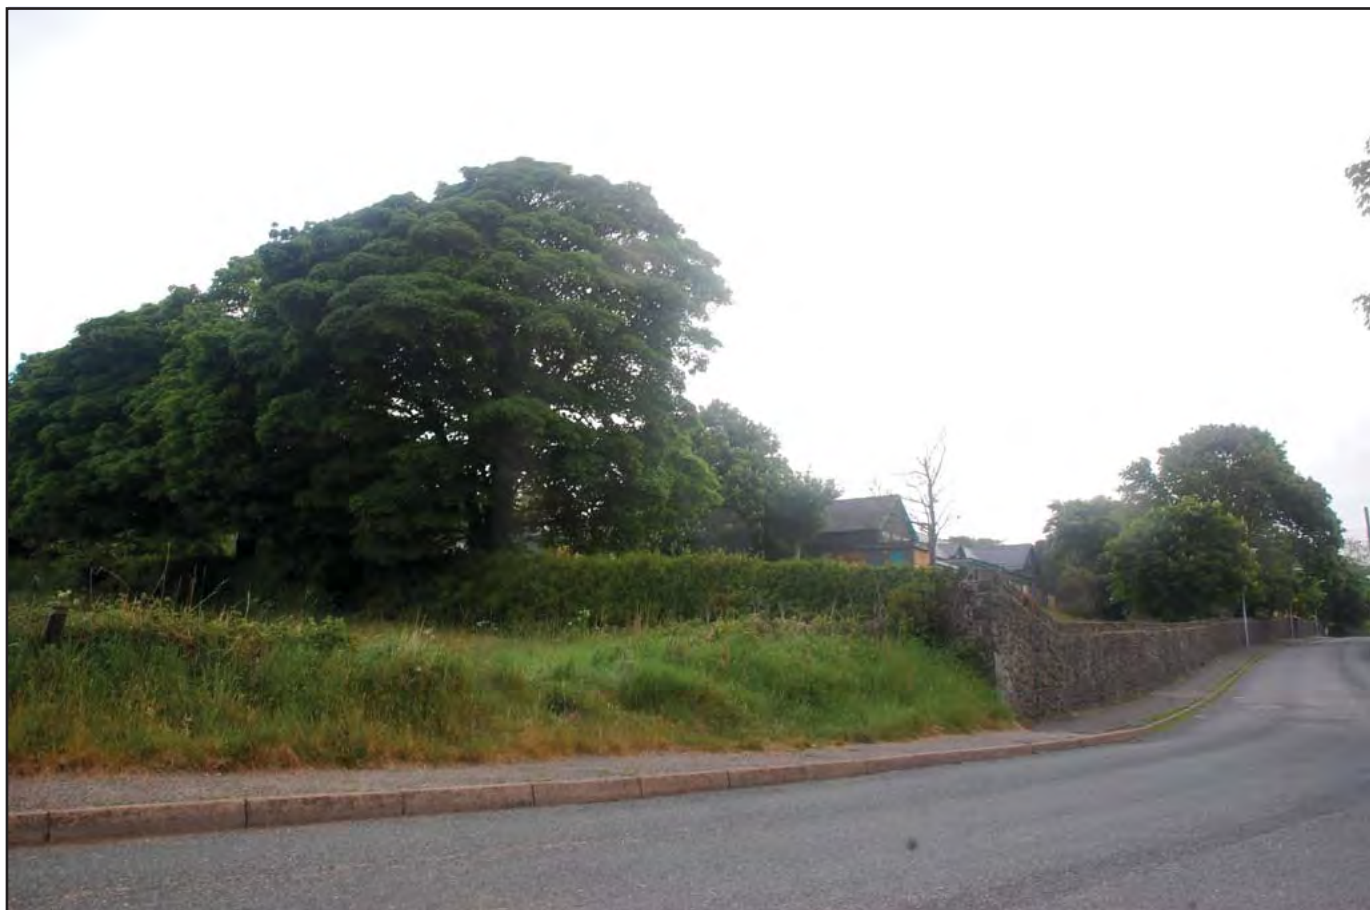
Plate 02: View east of Minffordd Hospital from Hendrewen Road, detailing the boundary wall that surrounds the complex. The Long Stay Unit is visible in the background.

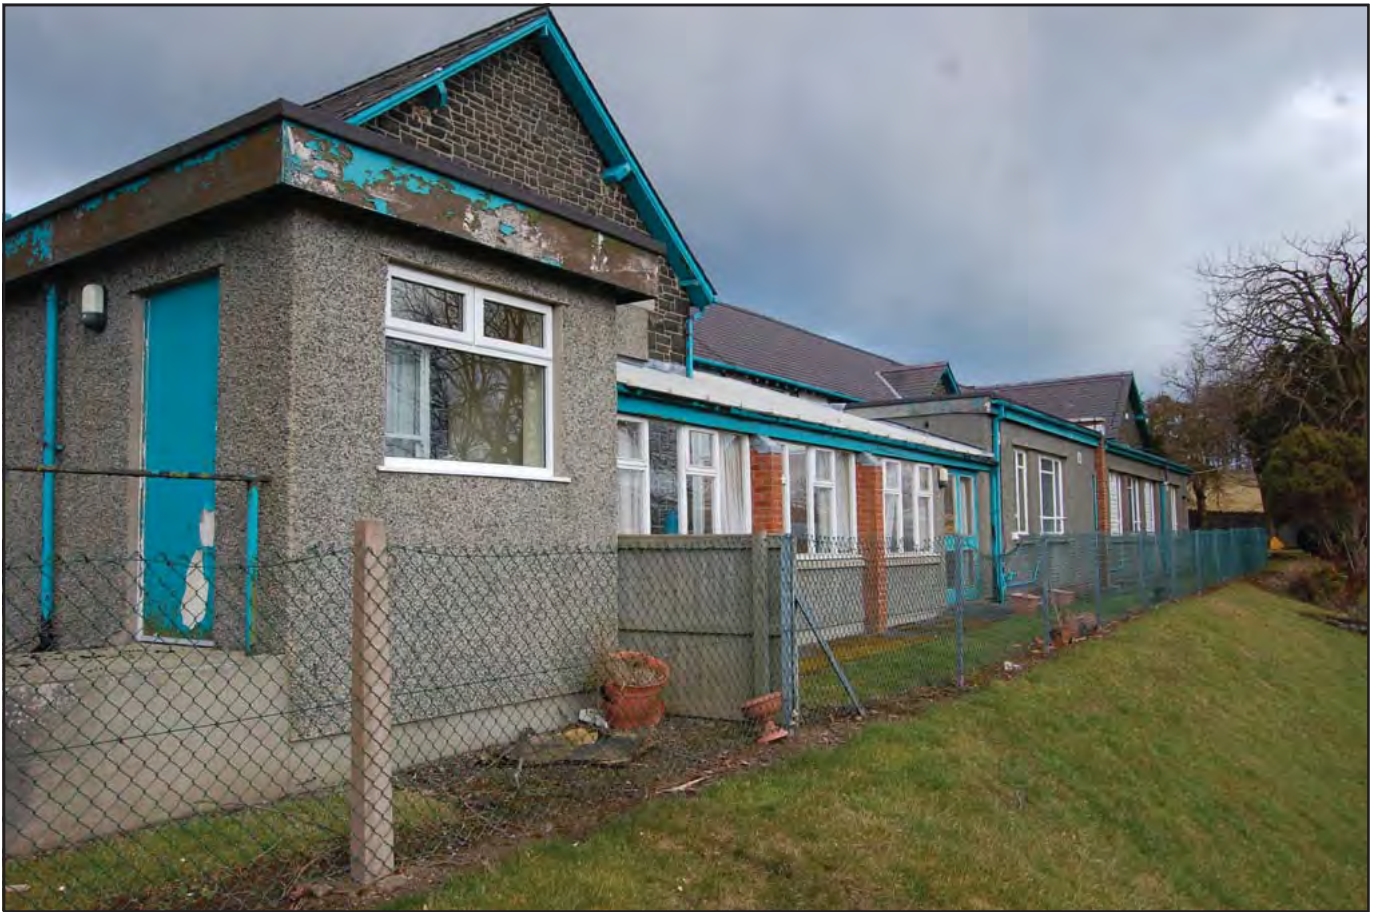
Plate 03: Long Stay Unit (External): Southeast facing elevation detailing late twentieth century veranda extension and flat roof extensions to the original structure. The Link Corridor is in the left foreground of image. The gable end of the male wing is also visible in the foreground, detailing original structural style.

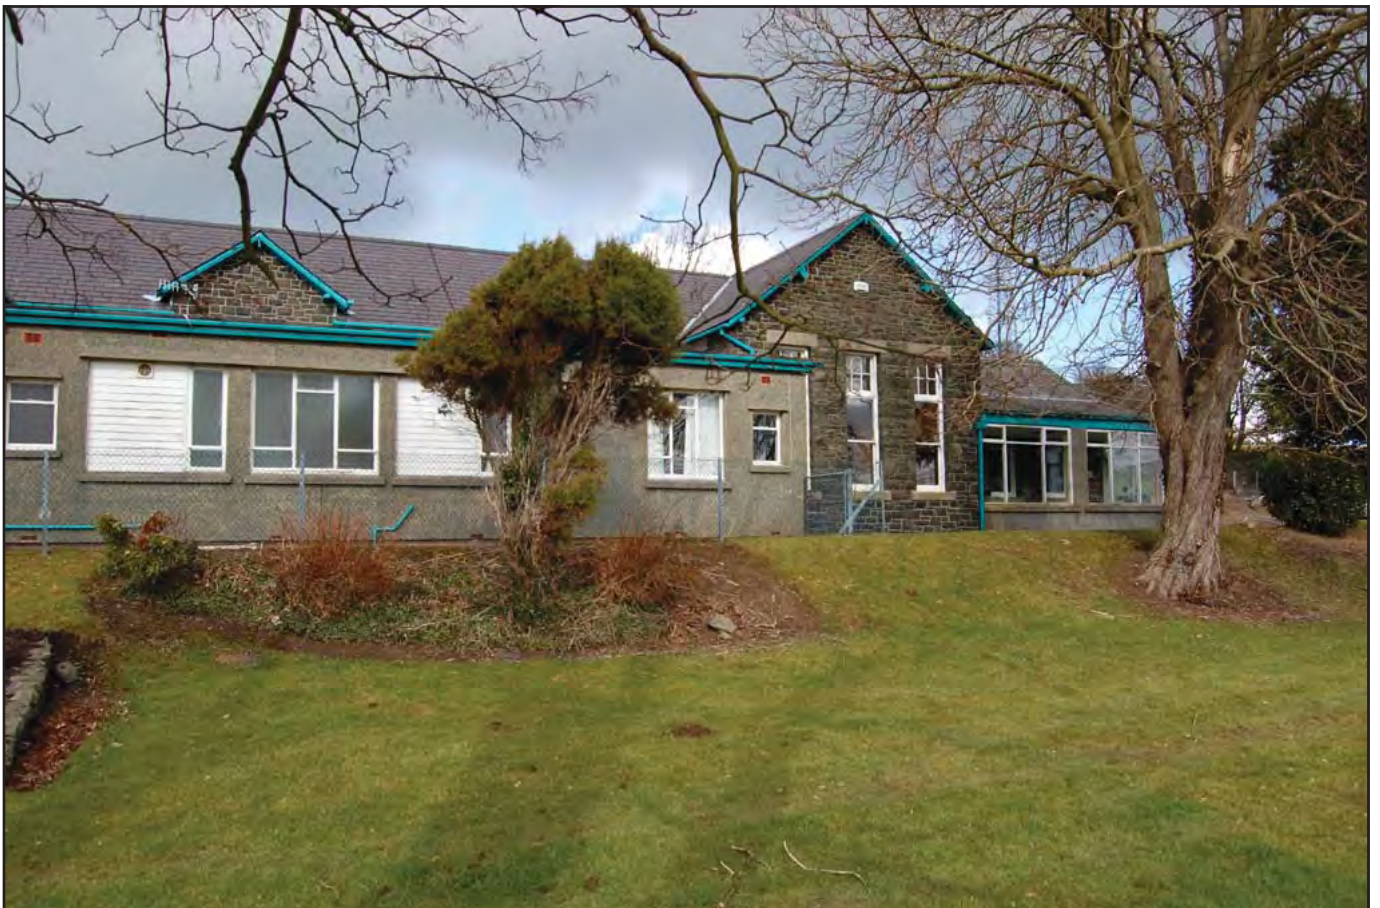
Plate 04: Long Stay Unit (External): Southeast facing elevation detailing late twentieth century flat roof extensions to the original structure. The Link Corridor is in the left foreground of image. The gable end of the female wing is also visible, detailing original structural style.

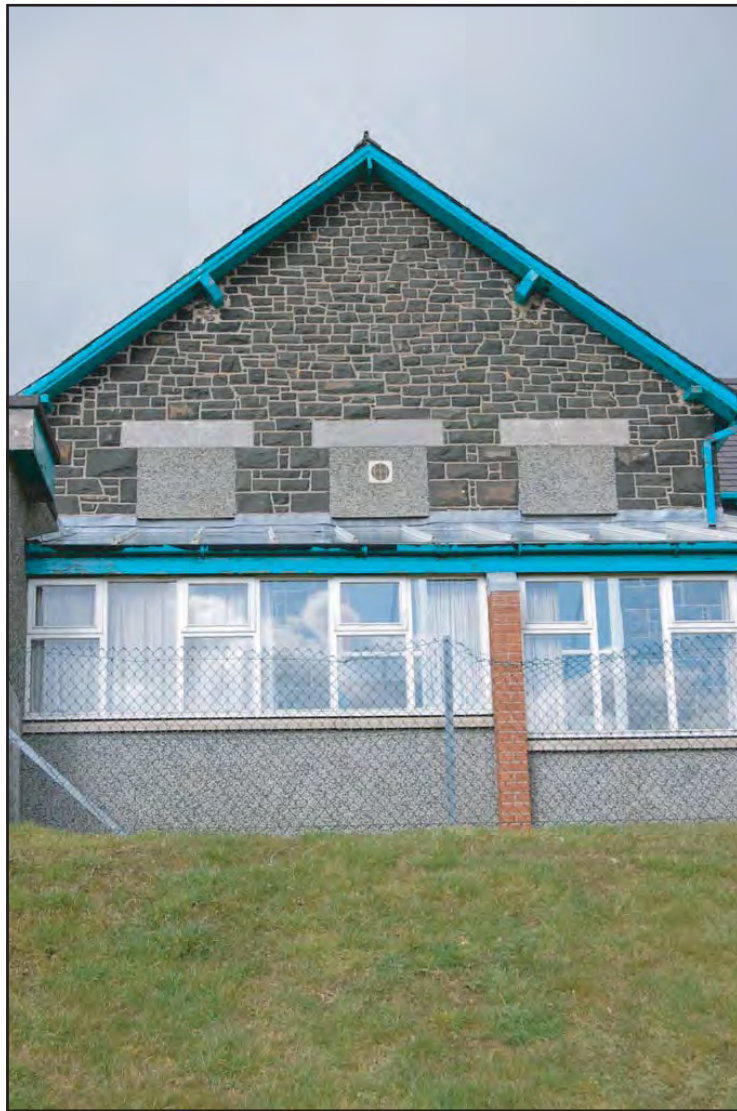
Plate 05: Long Stay Unit (External): Southeast facing elevation detailing late twentieth century veranda extension to the original structure (Rooms G03 and G07). The gable end of the male wing (Room G01) is also visible, detailing original structural style and blocked windows.

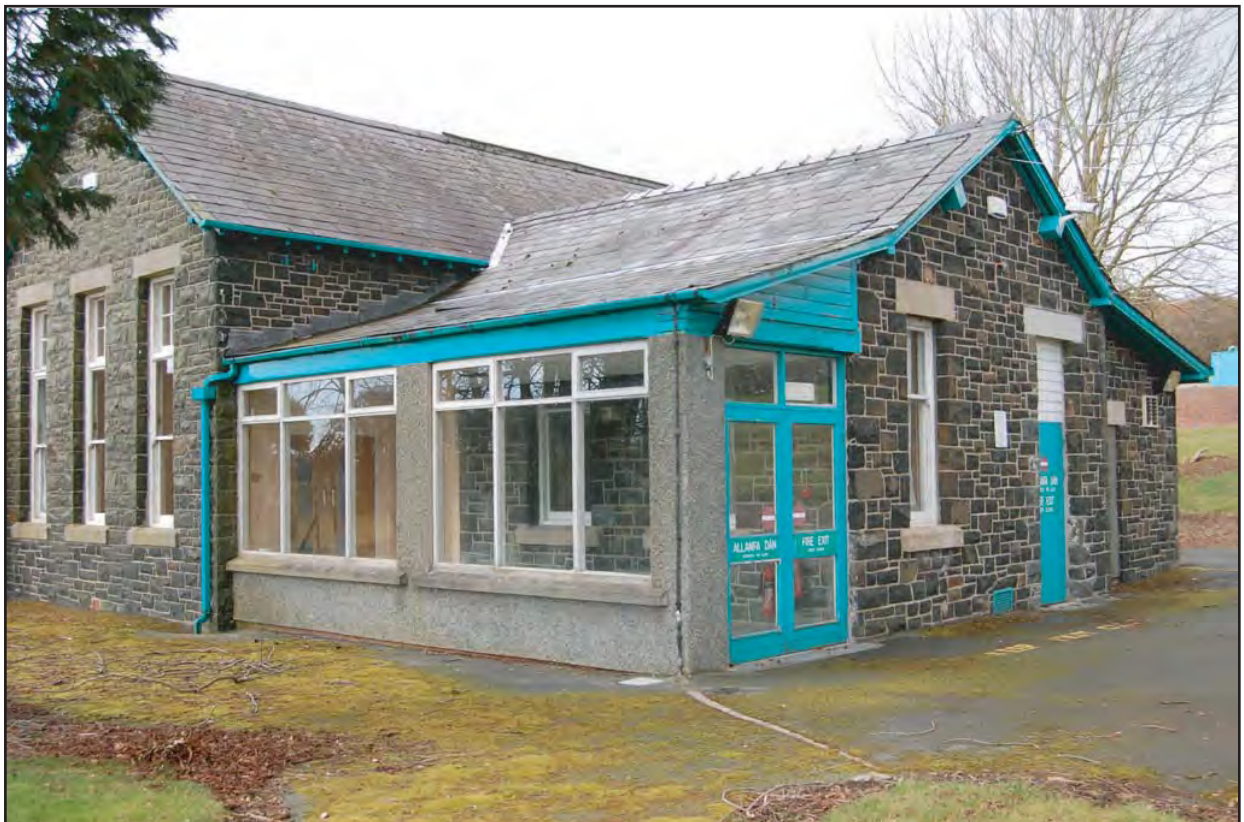
Plate 06: Long Stay Unit (External): Southeast and northeast facing elevations detailing original female wing (Room G11) and later extension (Room G12). The later extension was constructed between 1900 and 1914.

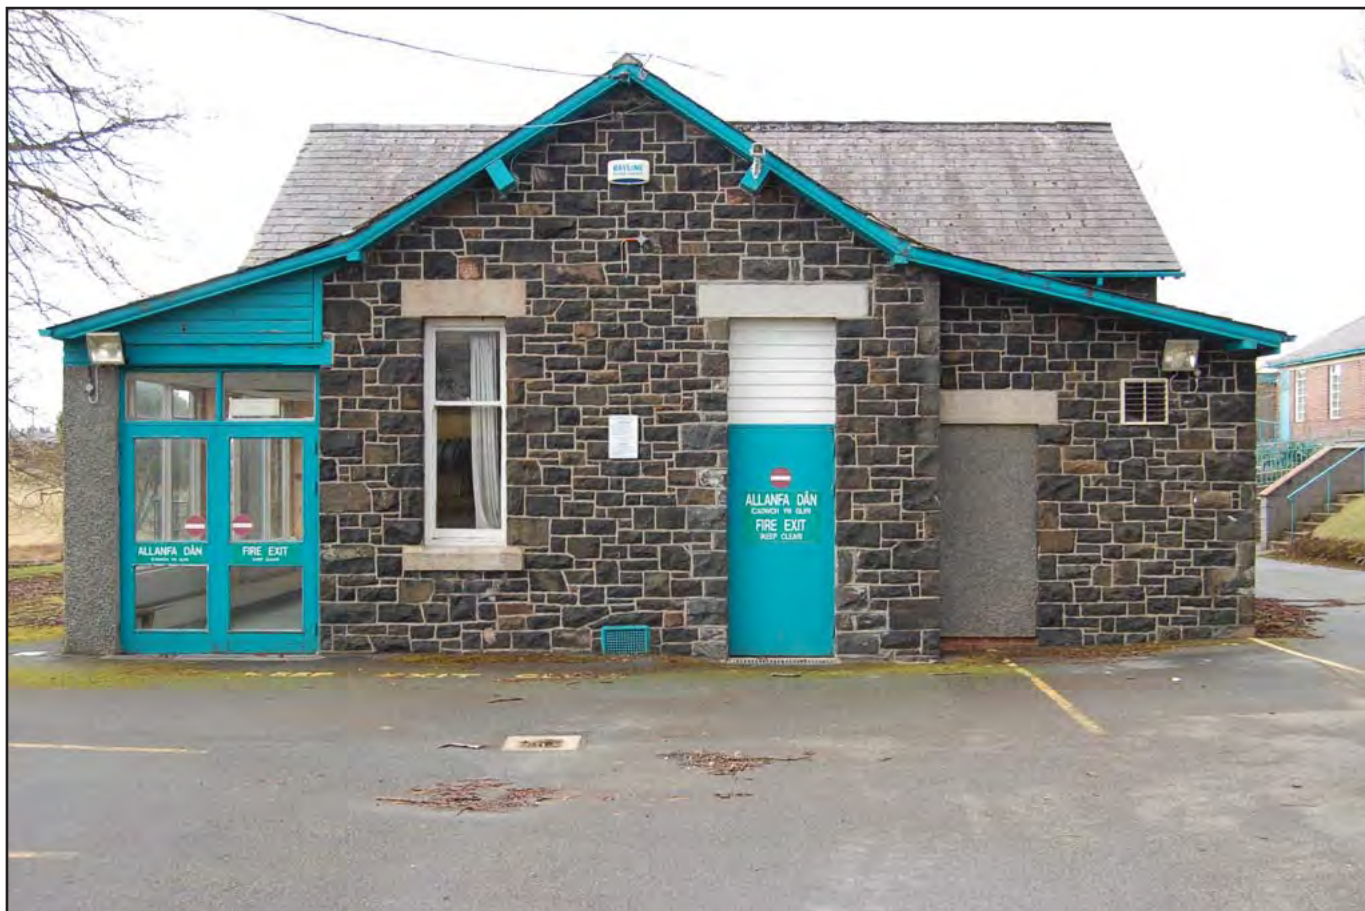
Plate 07: Long Stay Unit (External): Northeast facing elevation of early twentieth extension (Room G12), detailing the use of sub-rectangular stonework and quoin edging. The roof of the female wing (Room G11) is in the background.

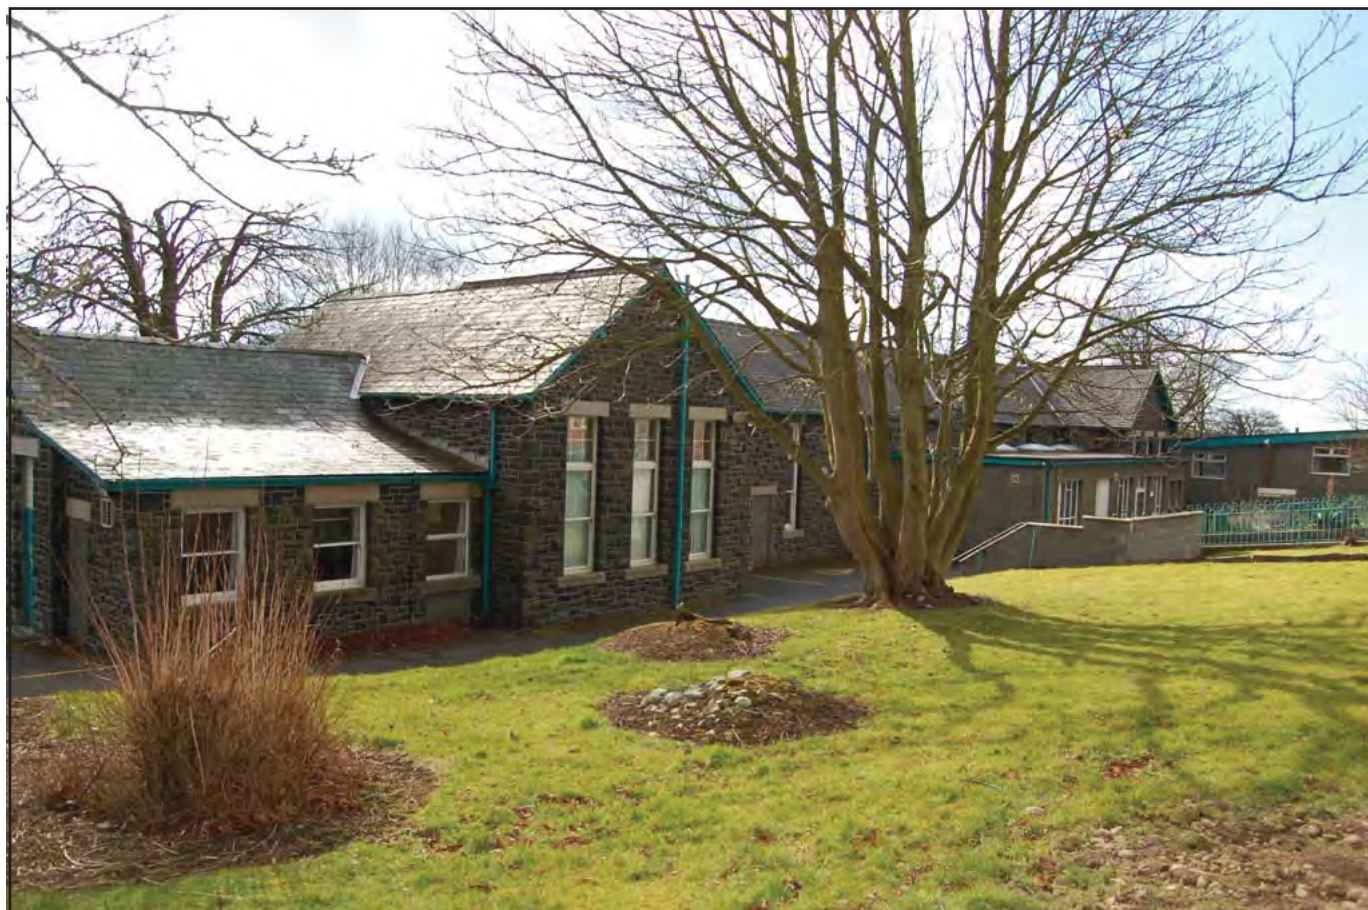
Plate 08: Long Stay Unit (External): Northwest facing elevation. The female wing (Room G11) and an extension (Room G12) are visible in the foreground. A flat-roofed extension and the link corridor can be seen towards the right of the image.

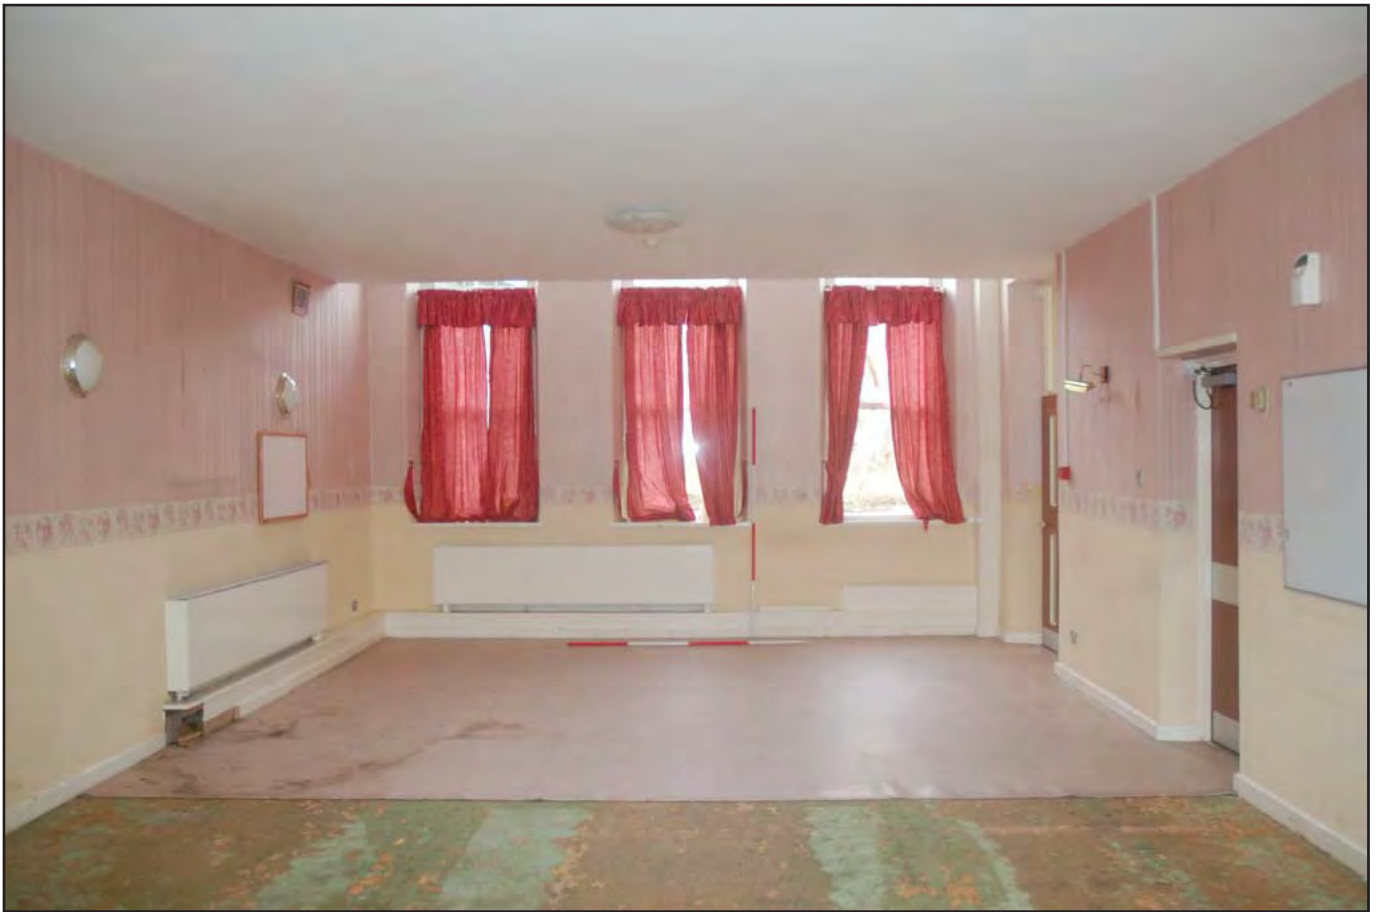
Plate 09: Long Stay Unit (Internal): Room G01 - view northwest detailing extant windows and entrance points as well as current decorative styles and features. All doors are fire doors. Bullnose skirting boards are visible.

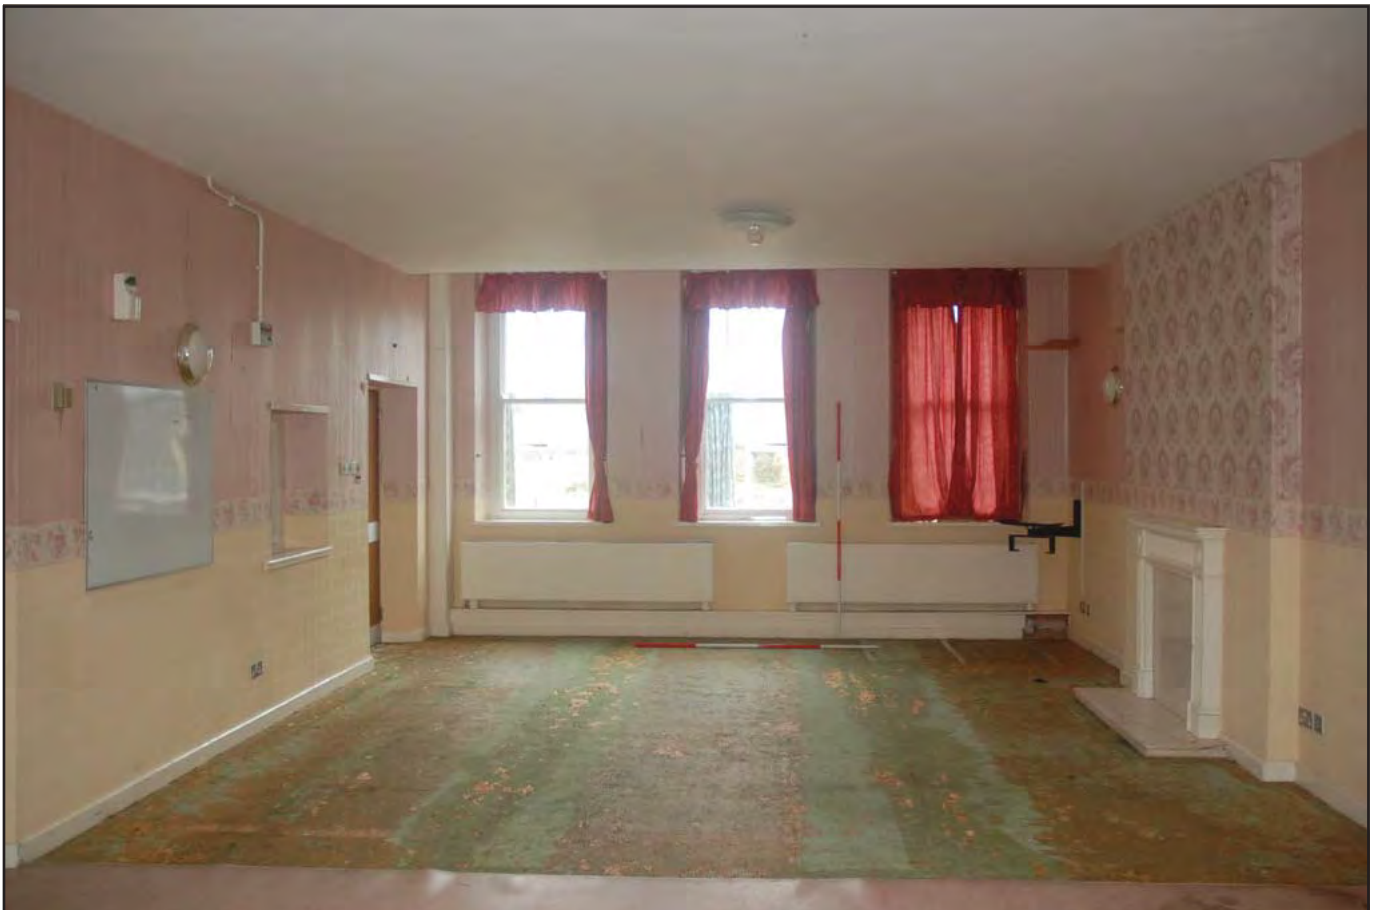
Plate 10: Long Stay Unit (Internal): Room G01 - view southeast detailing opposite view to Plate 09. Note disused fireplace to right of image.

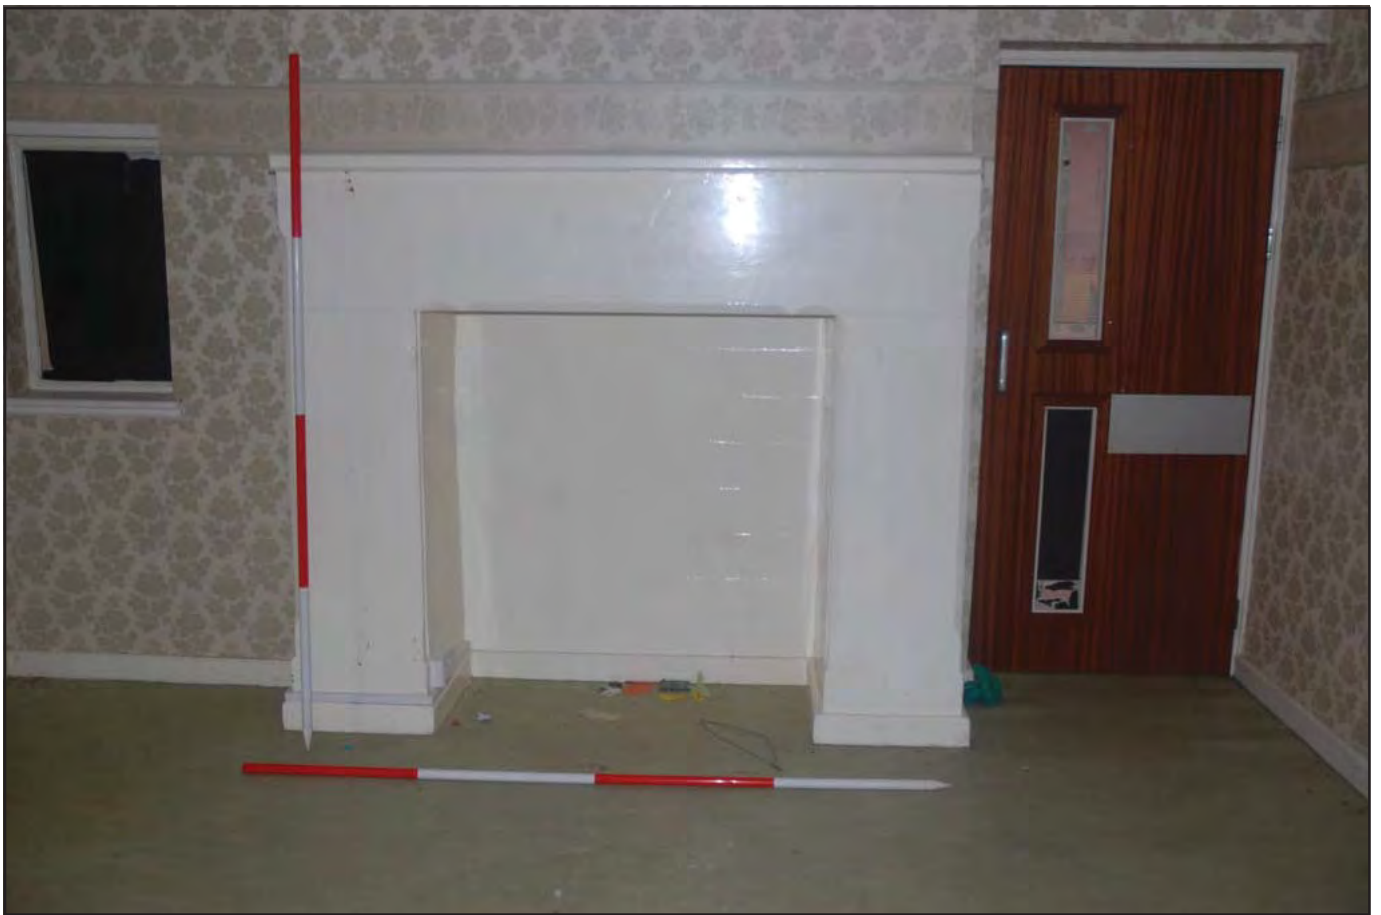
Plate 11: Long Stay Unit (Internal): Room G02 - view southwest detailing former ward kitchen fireplace current decorative styles and features. All doors are fire doors. Bullnose skirting boards are visible.

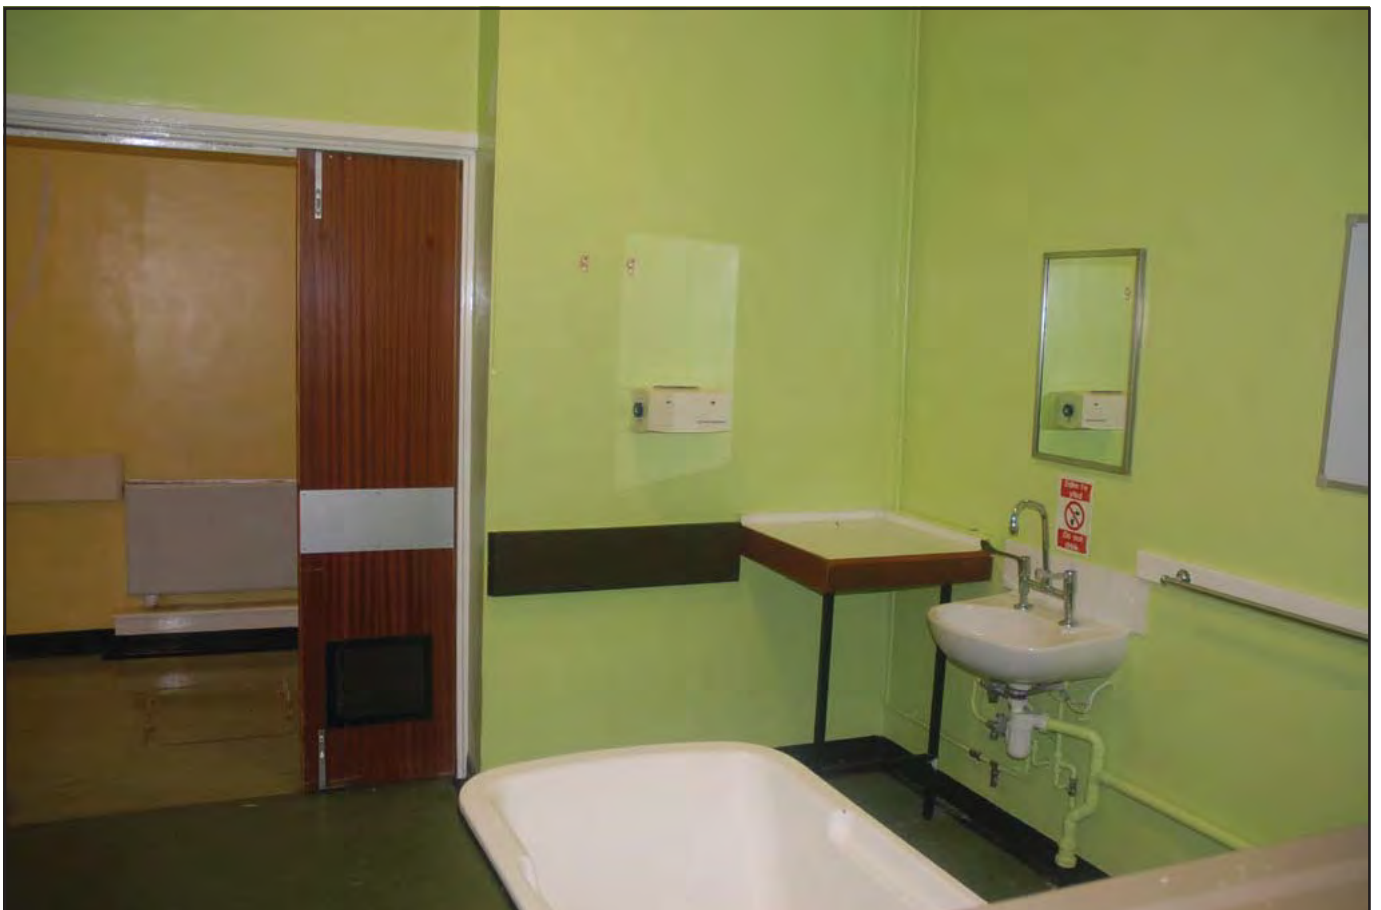
Plate 12: Long Stay Unit (Internal): Room G04 - view southwest detailing former female ward. This room was converted into a bathroom space for it's final use. Note large fire door entrance and bath in foreground.

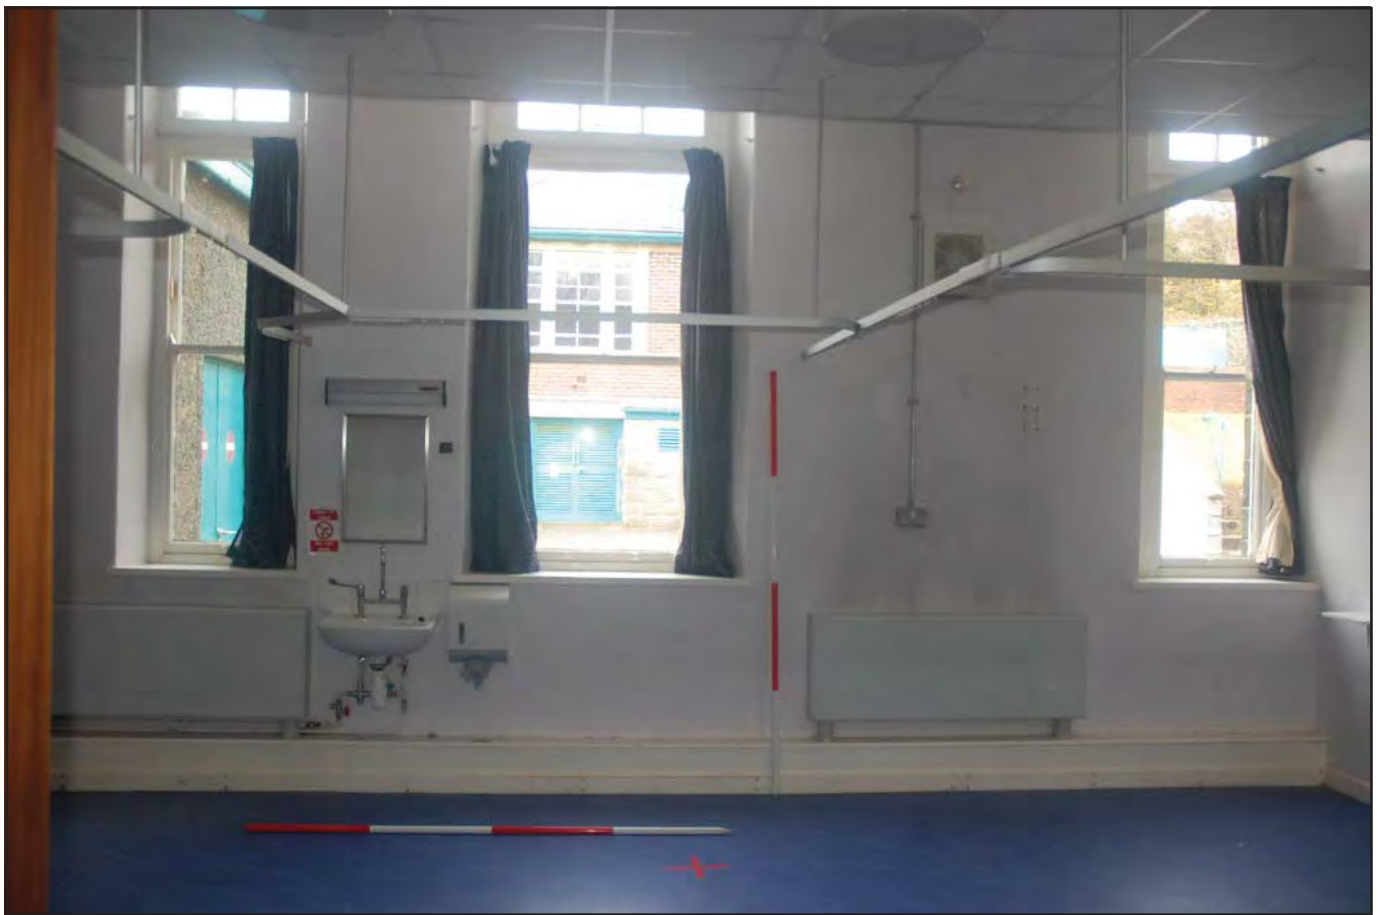
Plate 13: Long Stay Unit (Internal): Room G05 - view northwest detailing former male ward. All doors are fire doors. Bullnose skirting boards are visible. Note the Short Stay Unit visible through the windows as a brick-built structure (Scales: 2 x 2.0m)

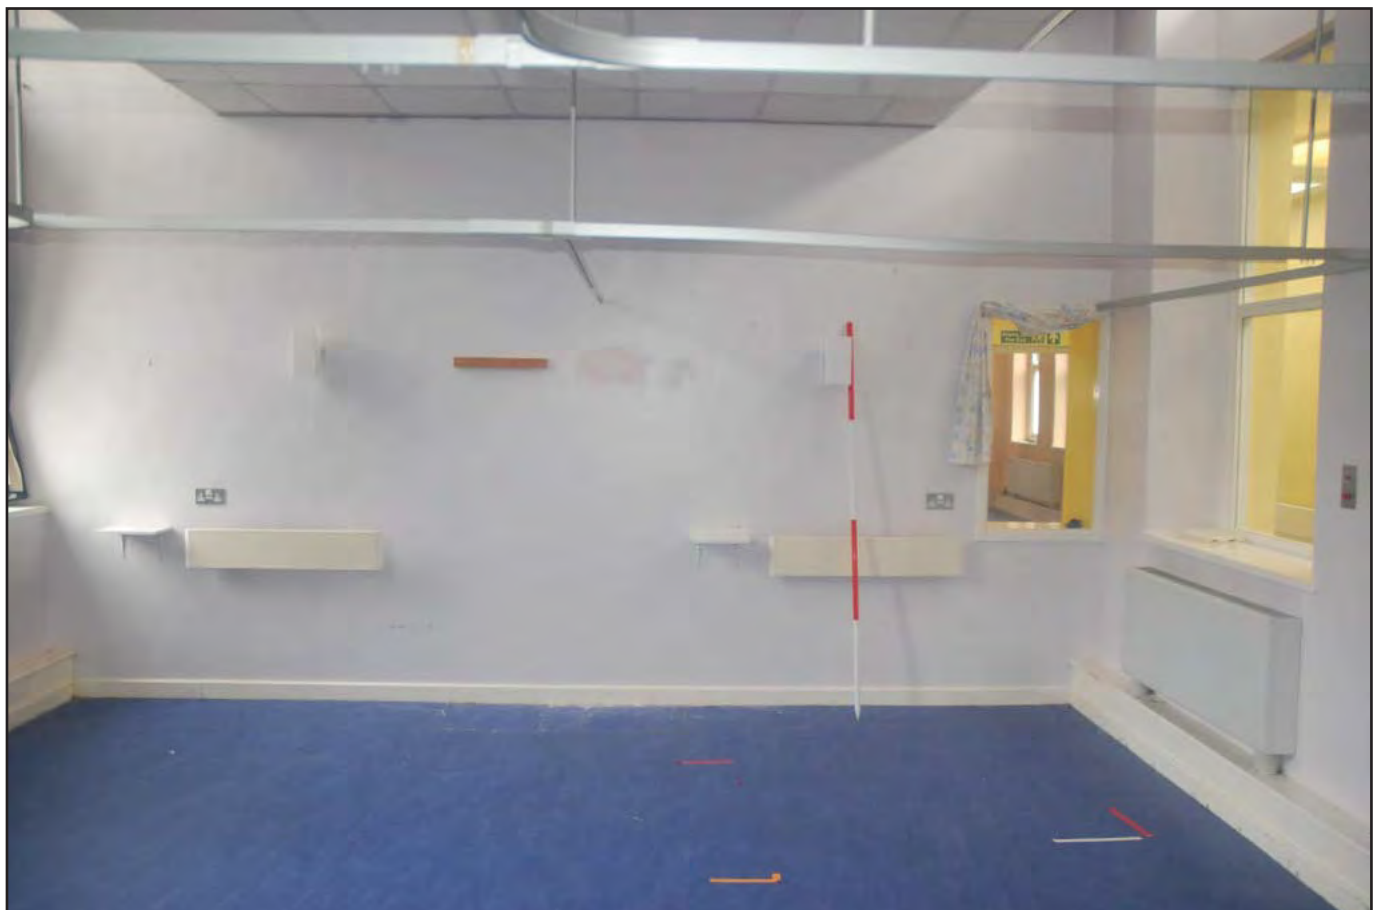
Plate 14: Long Stay Unit (Internal): Room G05 - view southeast detailing former male ward. All doors are fire doors. Bullnose skirting boards are visible. Note: internal corridor visible through openings (Scales: 2 x 2.0m)

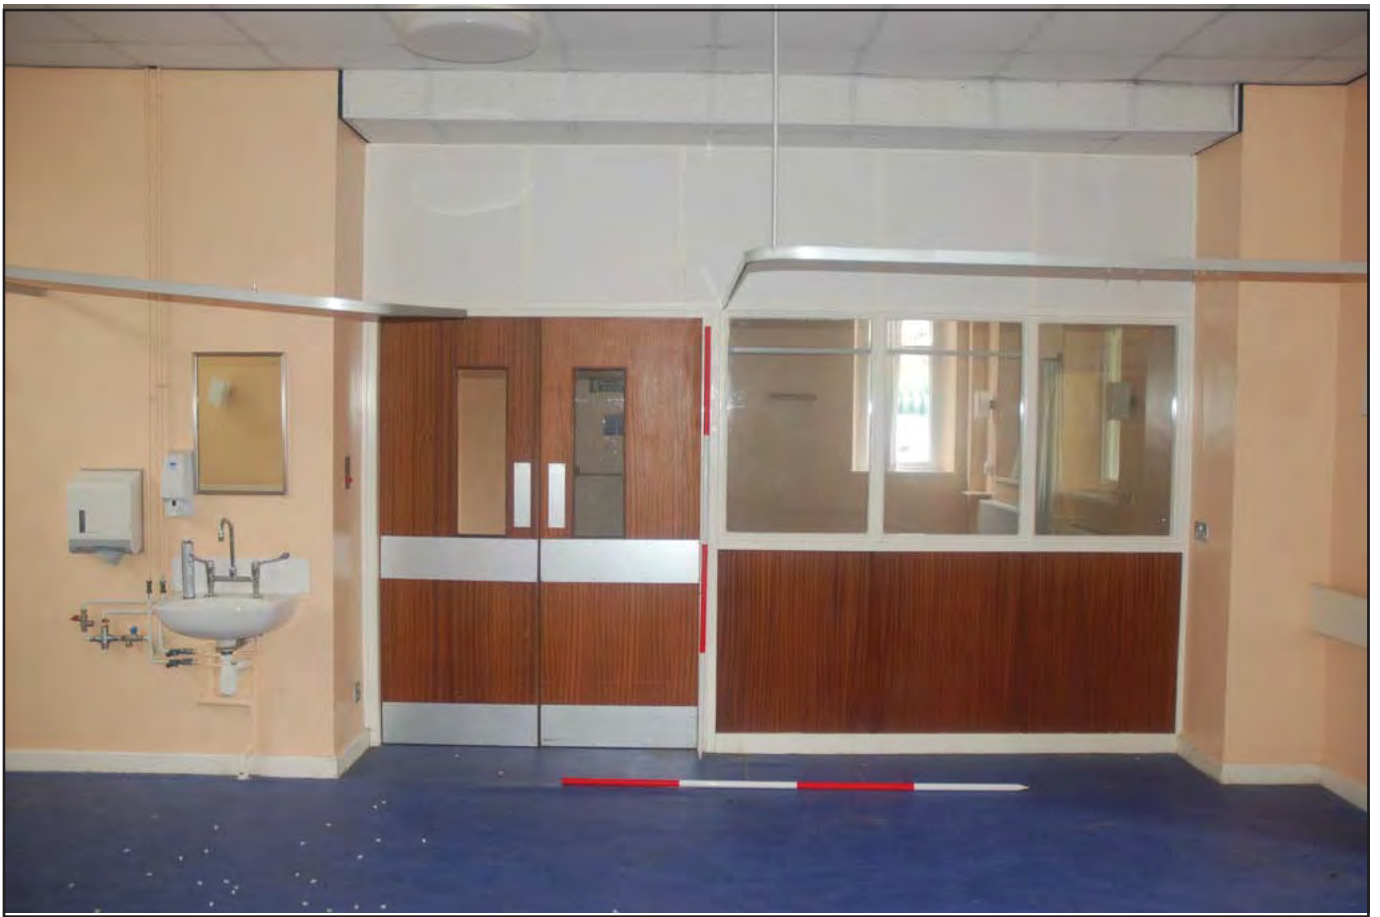
Plate 15: Long Stay Unit (Internal): Room G11 - view northeast of former female ward, detailing entrance via fire doors. Bullnose skirting boards are visible. Note Room G12 visible through the doors and screen (Scales: 2 x 2.0m)

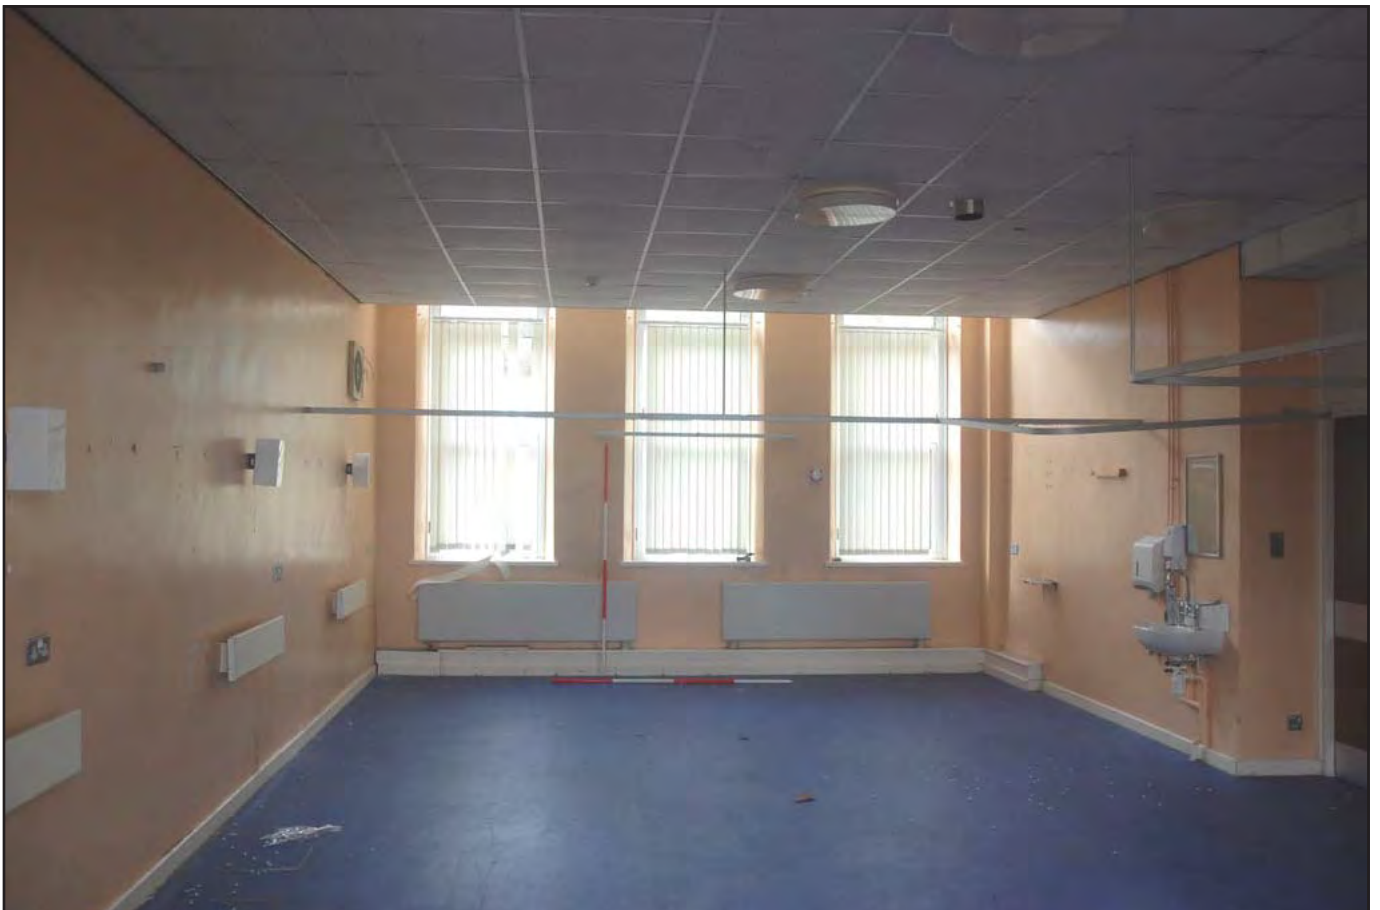
Plate 16: Long Stay Unit (Internal): Room G11 - view southeast of former female ward, detailing window fittings and bullnose skirtings. Original ceiling is disguised by a suspended ceiling (Scales: 2 x 2.0m)

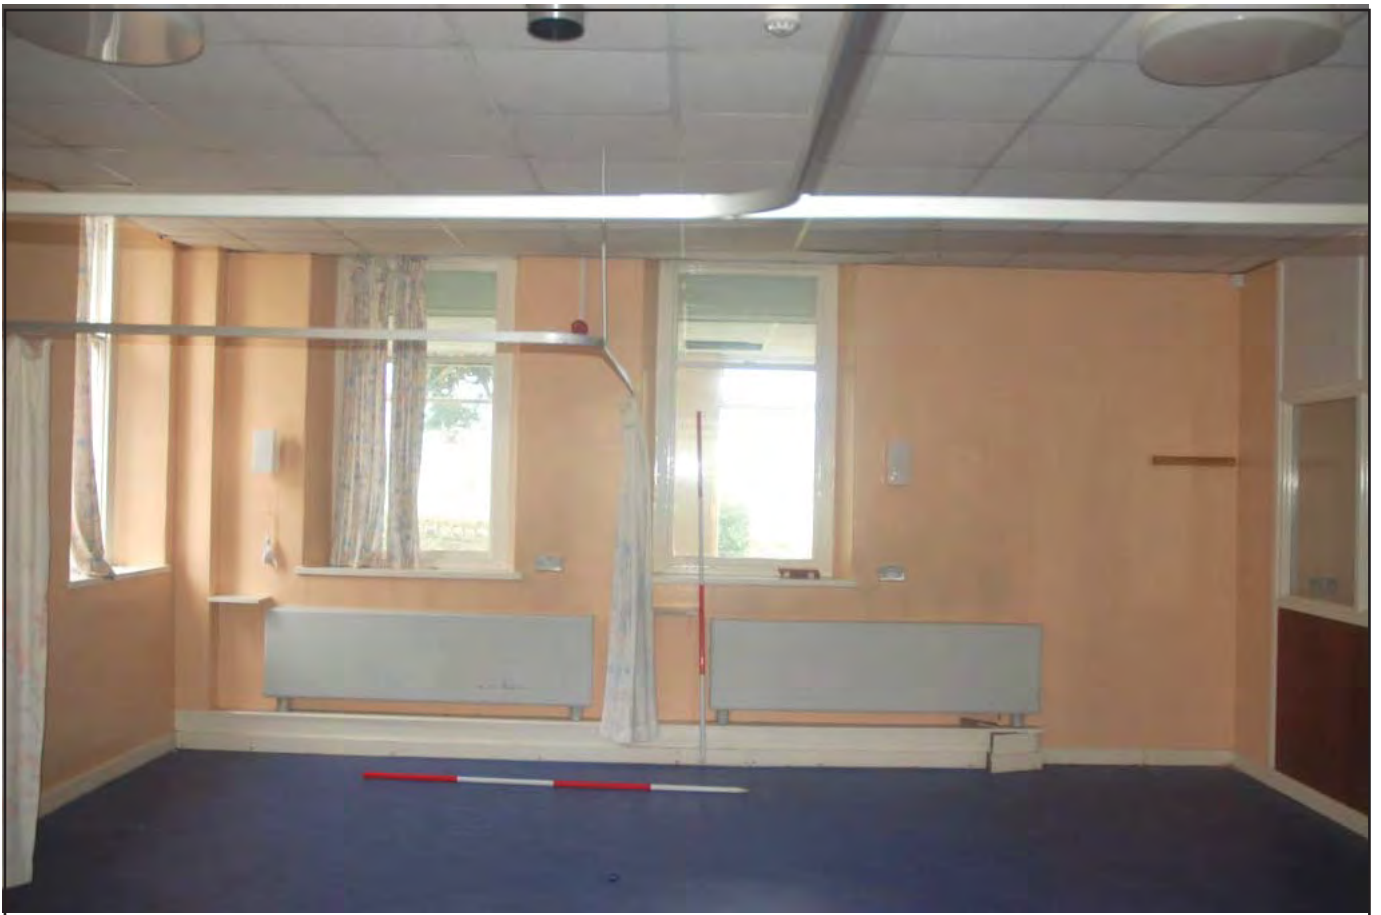
Plate 17: Long Stay Unit (Internal): Room G12 - view southeast of former female ward annexe. This room was created from the conversion and alteration of the former sewing, treatment and linen rooms into one room; therefore, most of the original internal structural elements have been altered and/or disguised. A suspended ceiling is in place and the screen separating Rooms G12 & G11 can be seen to the right of the image (Scales: 2 x 2.0m)

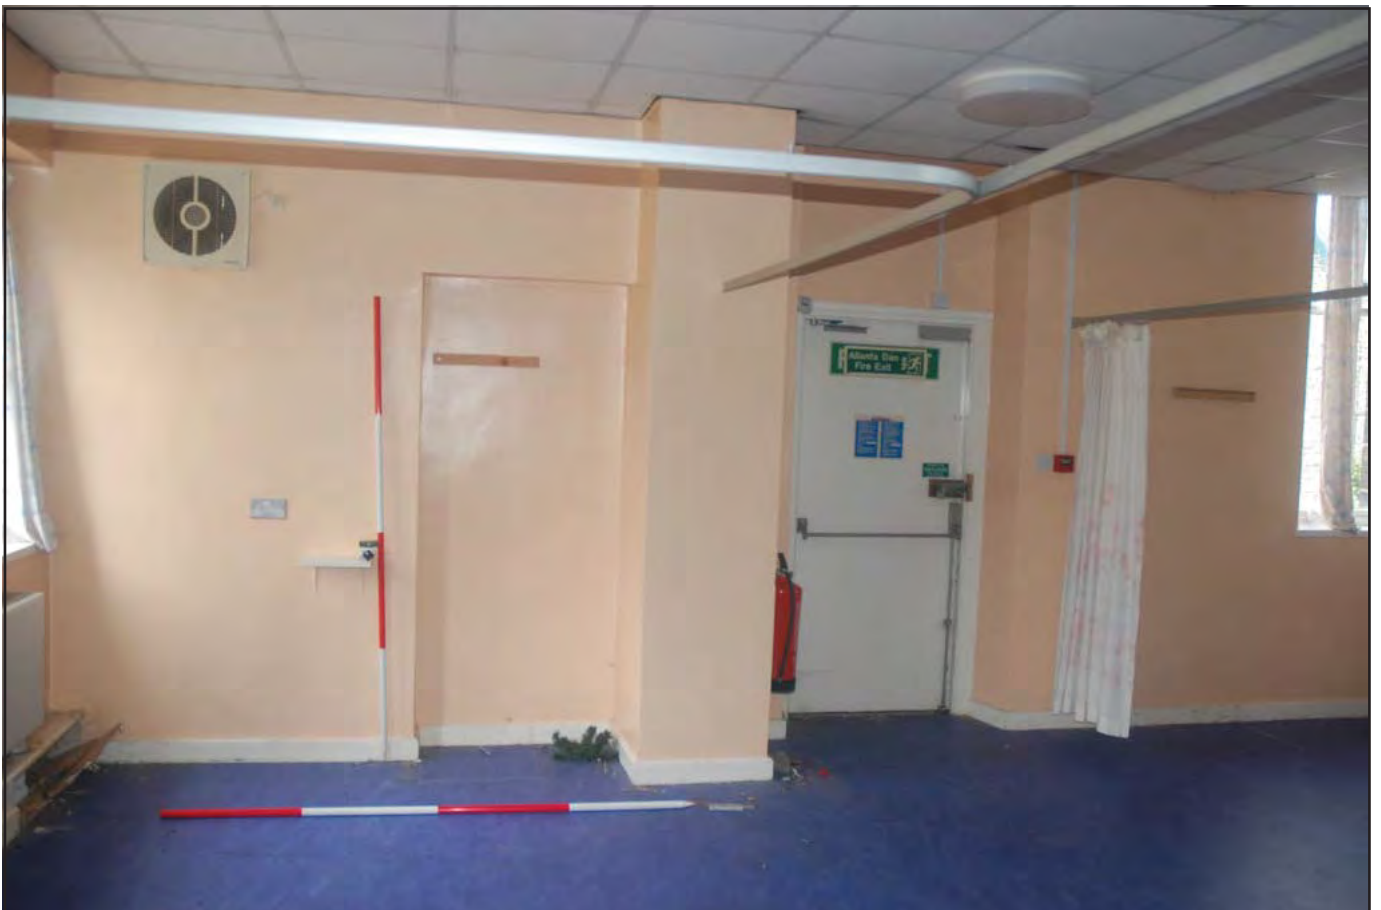
Plate 18: Long Stay Unit (Internal): Room G12 - view northeast of former female ward annexe. This room was created from the conversion and alteration of the former sewing, treatment and linen rooms into one room; therefore, most of the original internal structural elements have been altered and/or disguised. The partition wall separating the sewing and linen rooms can still be seen as a truncated stub; the entrance into the sewing room from outside can be seen as a blocked door. The alterations were completed after 1984 (Scales: 2 x 2.0m)
