# MINFFORDD HOSPITAL, BANGOR GWYNEDD: ARCHAEOLOGICAL BUILDING RECORD

## Archaeological Building Record: Level 2/3

GAT Project No. 2125

Report No. 872

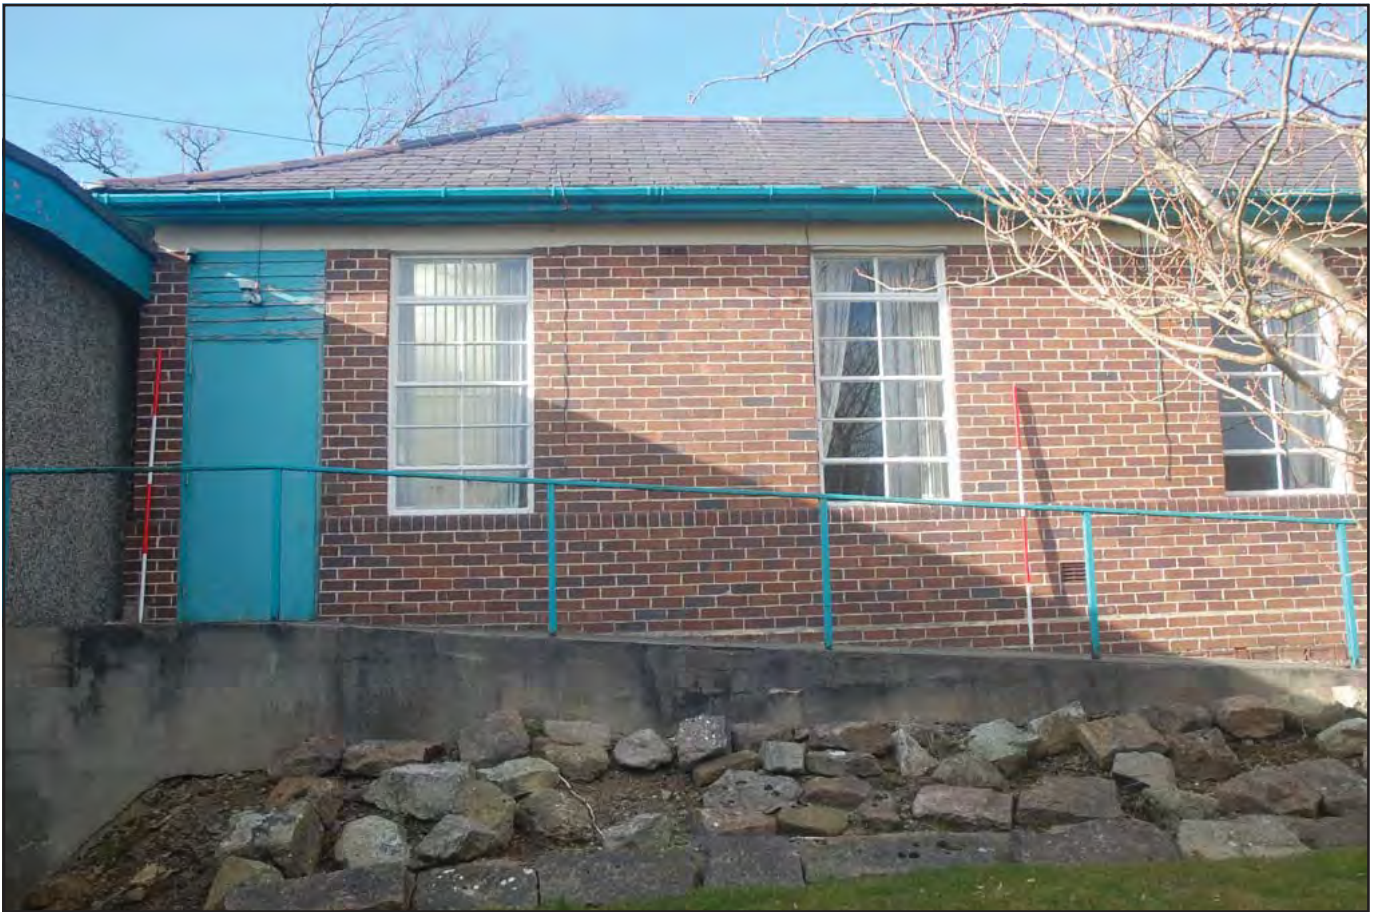
Plate 19: Short Stay Unit : Southeast facing elevation. Built from brick and not stone as the original buildings. Hip gable roof visible along with casement windows (Rooms G09, G10 & G13) and disabled access into G13. The courtyard separating the Long and Short Stay Units are visible in the foreground; the Link Corridor is visible to the left of the image (Scales: 2 x 2.0m)

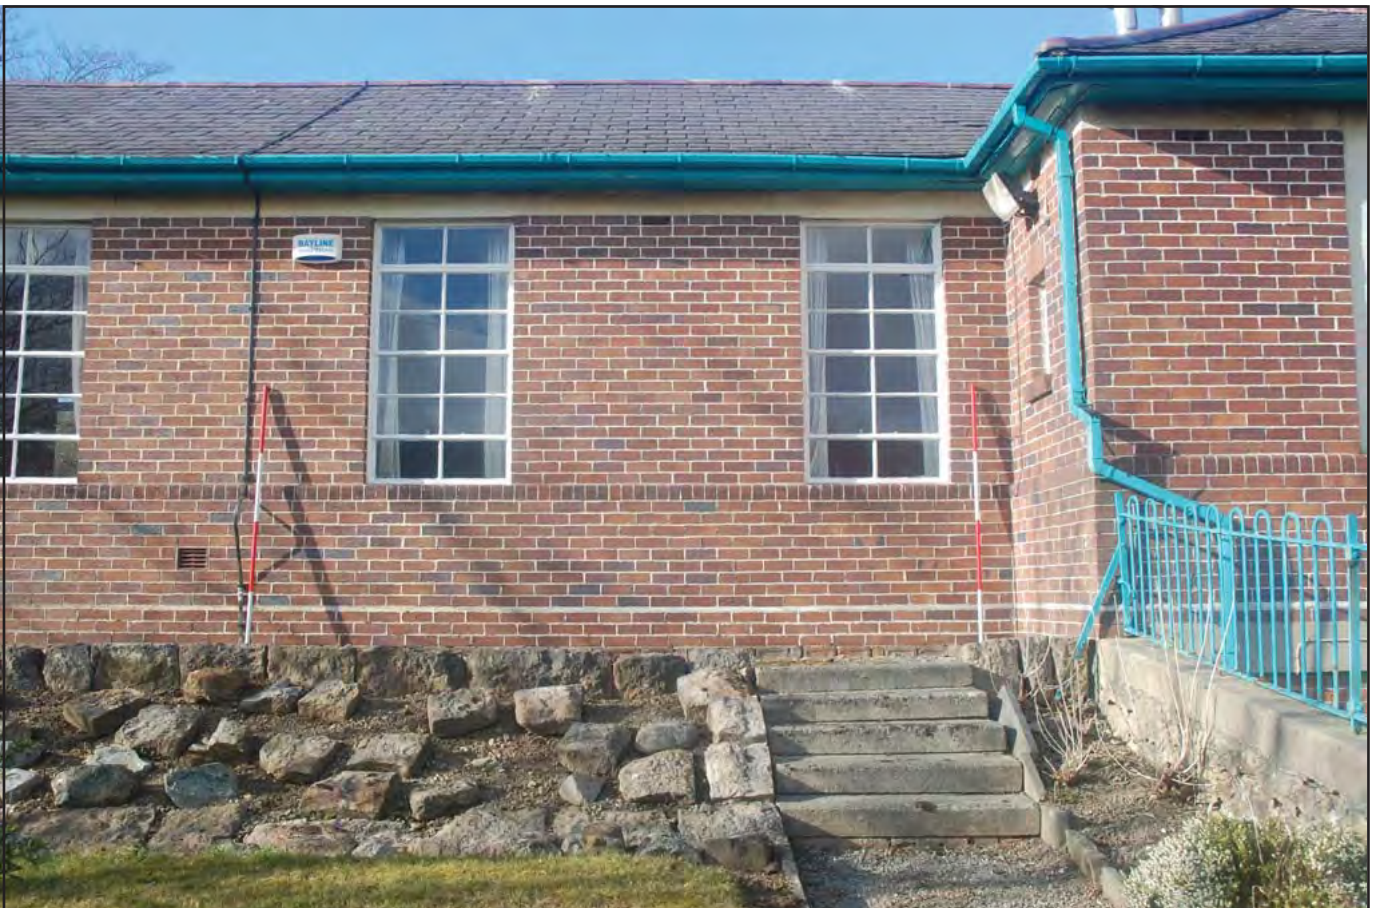
Plate 20: Short Stay Unit : Southeast facing elevation. Built from brick and not stone as the original buildings. Hip gable roof visible along with casement windows (Rooms G06 to G8). The courtyard separating the Long and Short Stay Units are visible in the foreground; the day room wing (Room G01) is visible to the right of the image (Scales: 2 x 2.0m)

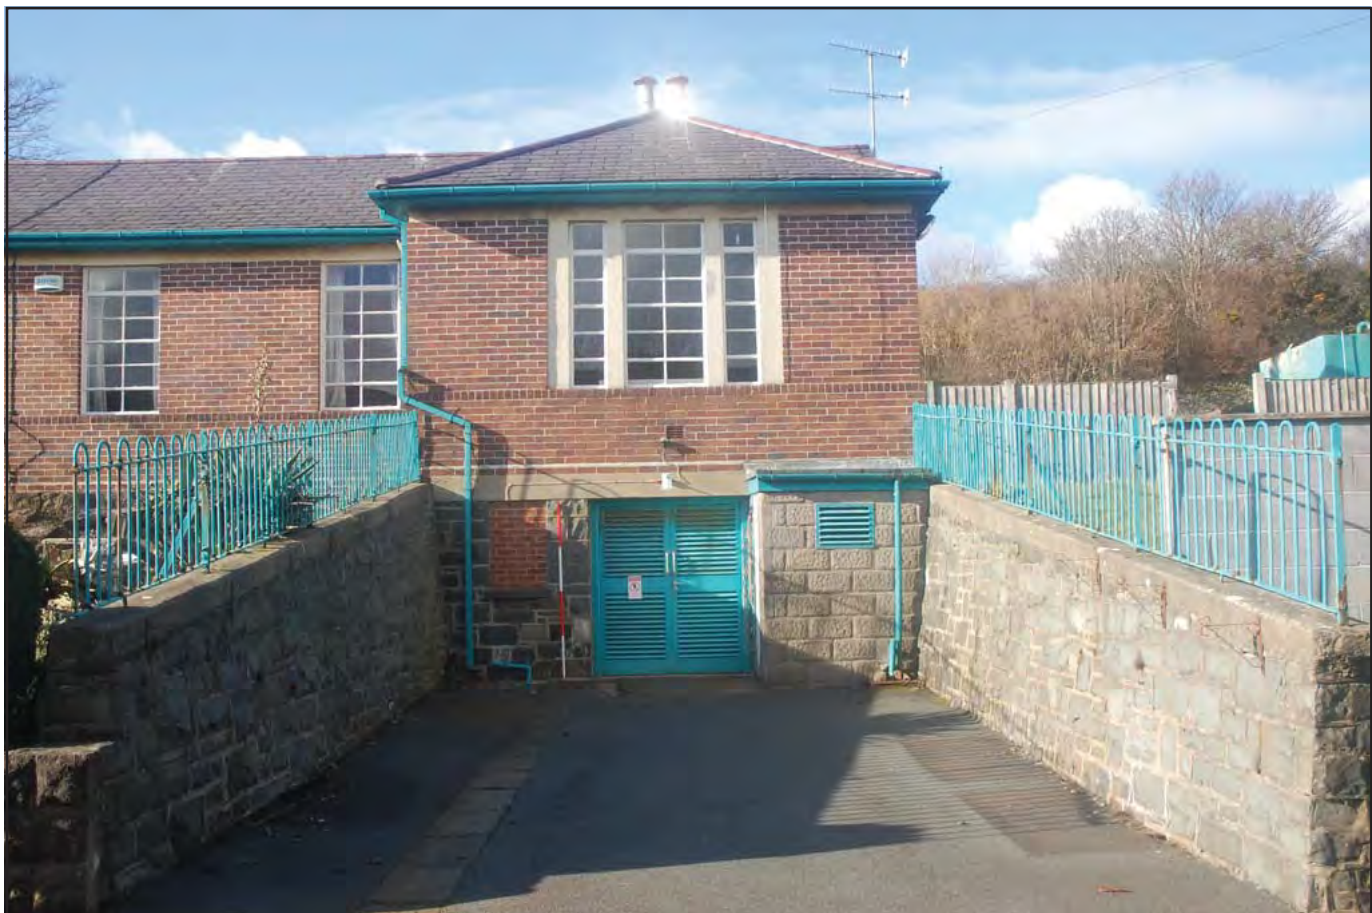
Plate 21: Short Stay Unit : Southeast facing elevation - Former Day Room (Room G01) and basement level boiler house; the latter includes a lean to annexe with a louvered window. The courtyard separating the Long and Short Stay Units is to the left of the image (Scale: 1x 2.0m)

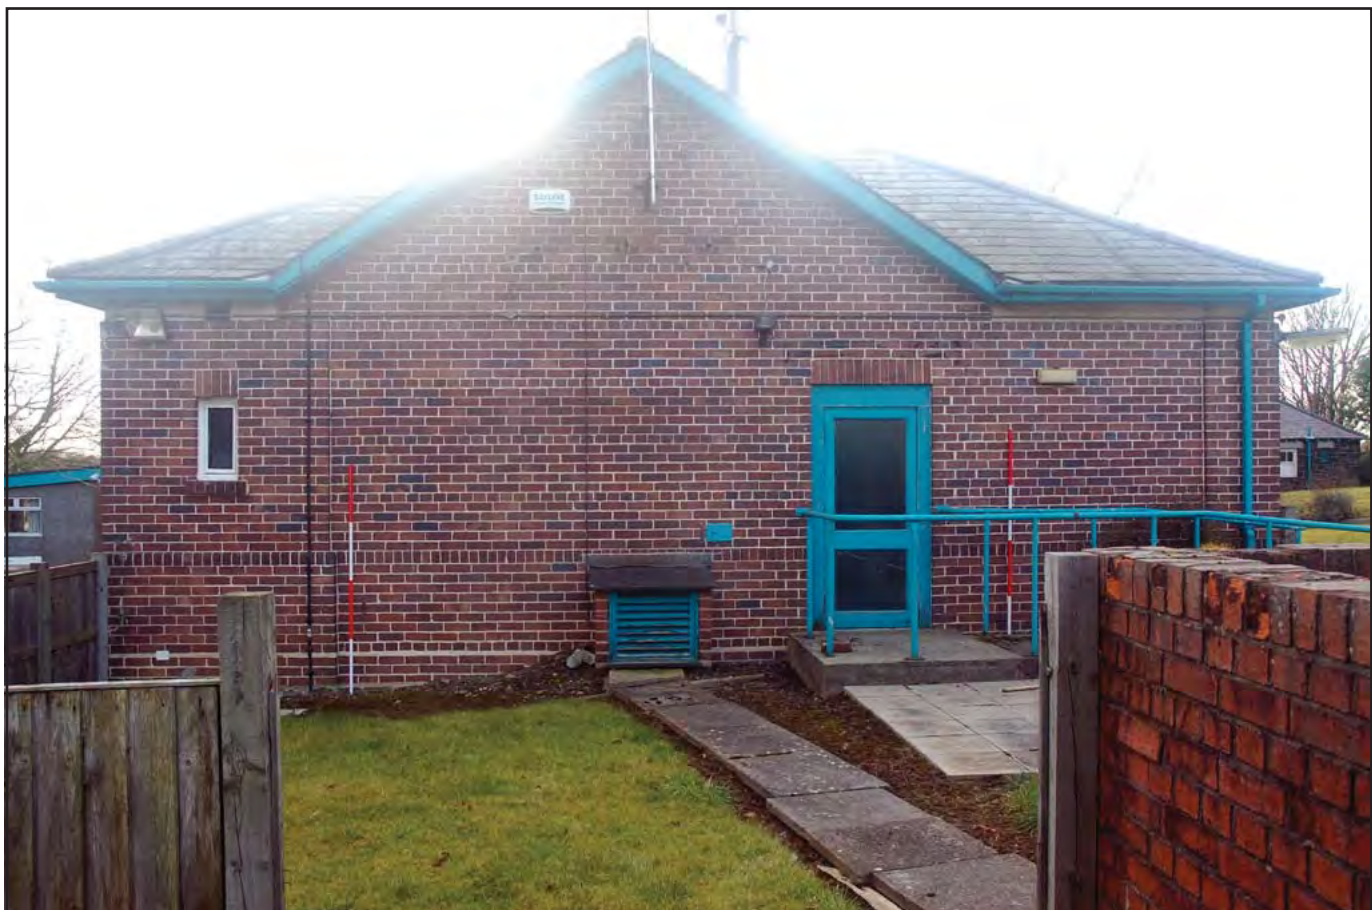
Plate 22: Short Stay Unit: Northeast facing elevation with gable end of the former Day Room (Room G01) visible. The door towards the right of image provides access to the central corridor of the building (Scales: 2 x 2.0m)

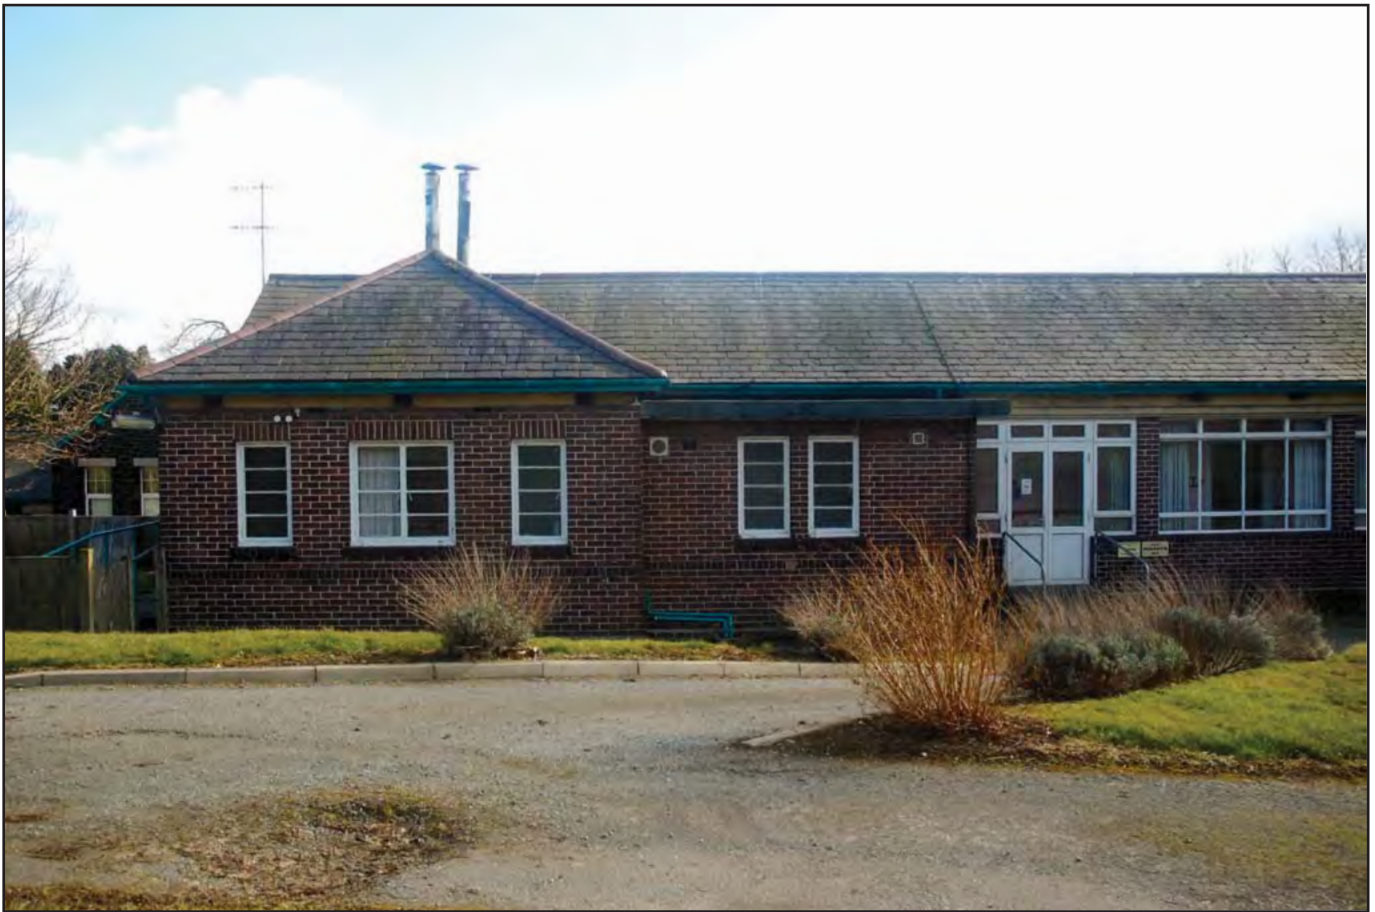
Plate 23: Short Stay Unit: Northwest facing elevation - Rooms G02 to G05 and main entrance; detailing English Garden Wall bond brick style and casement windows

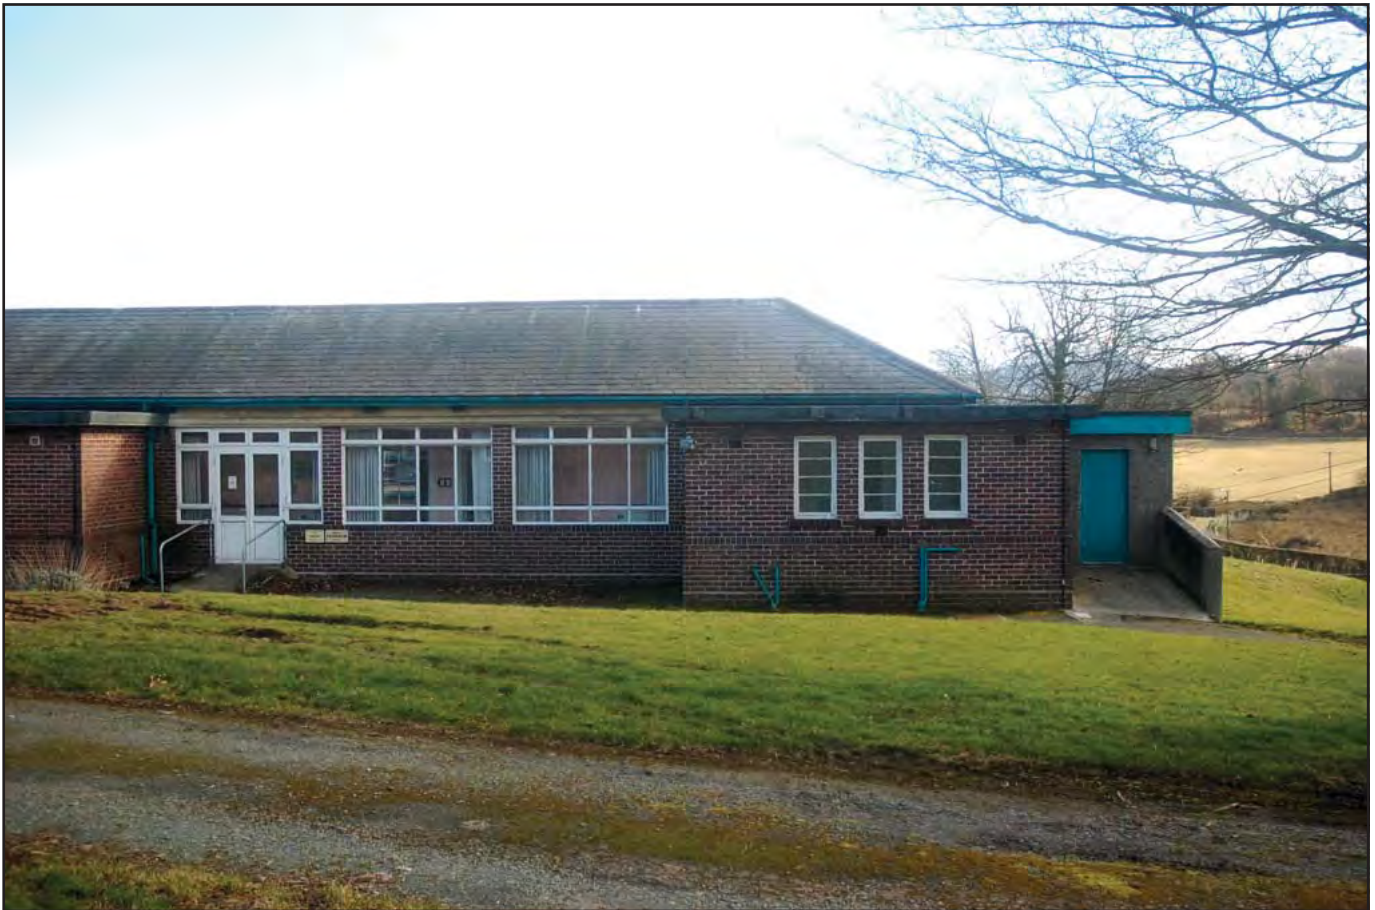
Plate 24: Short Stay Unit: Northwest facing elevation - main entrance and Room G11 (Kitchen); detailing English Garden Wall bond brick style and casement windows. Note the link corridor attached to the southwest facing elevation towards right of image

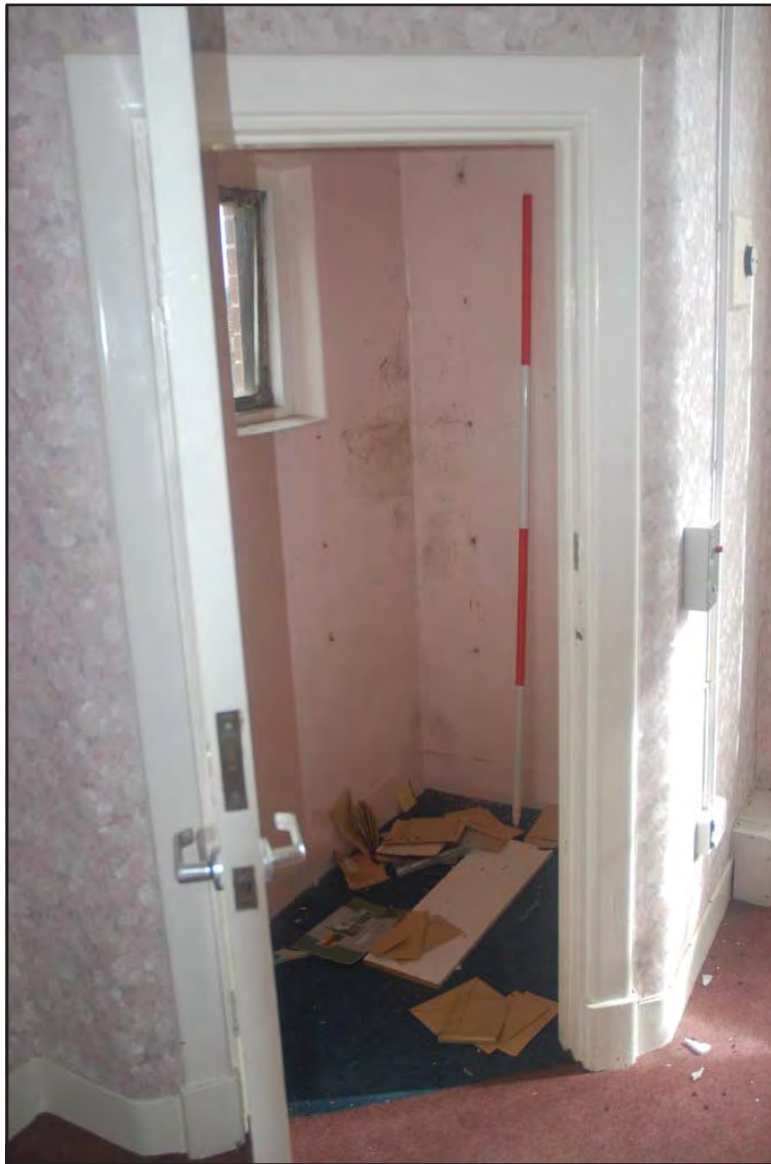
Plate 25: Short Stay Unit (Internal): view southeast of Room G01, detailing cubby within room (function unknown) that appears to be an original feature (Scale: 1 x 2.0m)

##### G01 (Plates 25 and 26)

Square shaped room (5.30m in width and length) accessed from central corridor within Short Stay Unit; entrance via six panel moulded wooden door (top panel frosted glaze), attached to moulded frame. Large casement window on northwest facing internal elevation (aspect onto courtyard separating Long and Short Stay Unit); windows frame measures 2.00m in width and height. Walls are papered; 0.10m bullnose skirtings at ground level; floor is carpeted. Storage heater below window. Two corner boxed in niches are present on the northwest facing internal elevation, either side of window, that appear to have functioned as storage spaces. Both examples have 0.50m high and 0.30m wide awning windows and are painted rather than wallpapered.

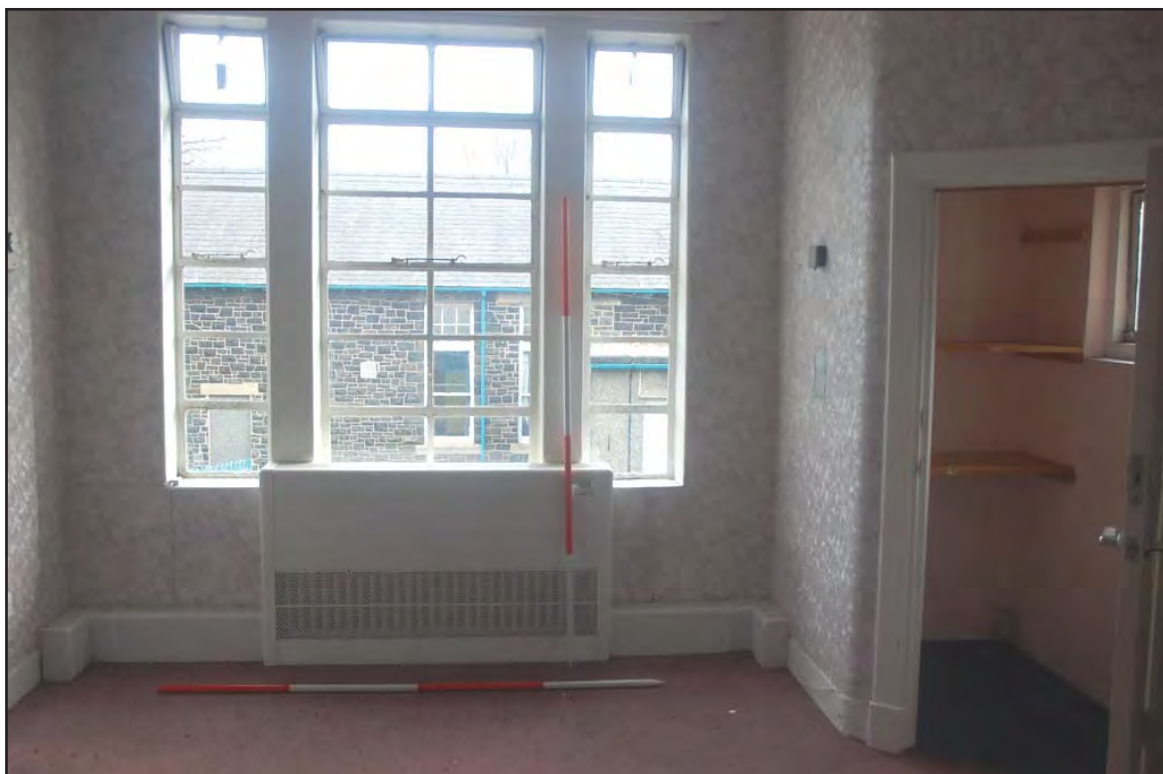
Plate 26: Short Stay Unit (Internal): view south of Room G01, detailing large casement window and internal structural and decorative features, including storage cubby (cf. Plate 25), door moulding and bullnose skirtings. Note the rear elevation of the Long Stay Unit visible through the window

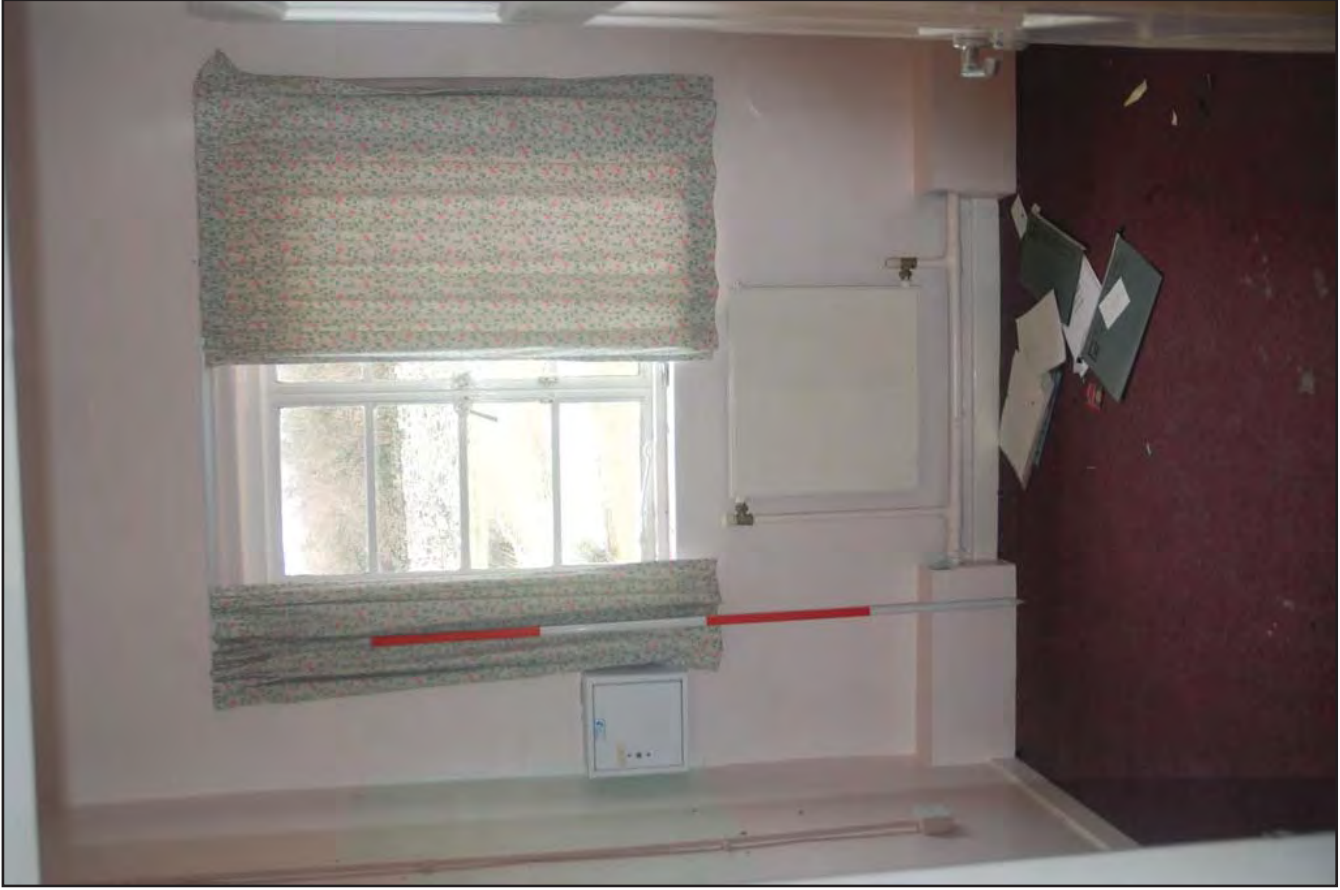
Plate 27: Short Stay Unit (Internal): view northwest of Room G03, detailing casement window and bullnose skirtings. Note moulded panel entrance door and not fire door as used in the Long Stay Unit (Scale: 1 x 2.0m)

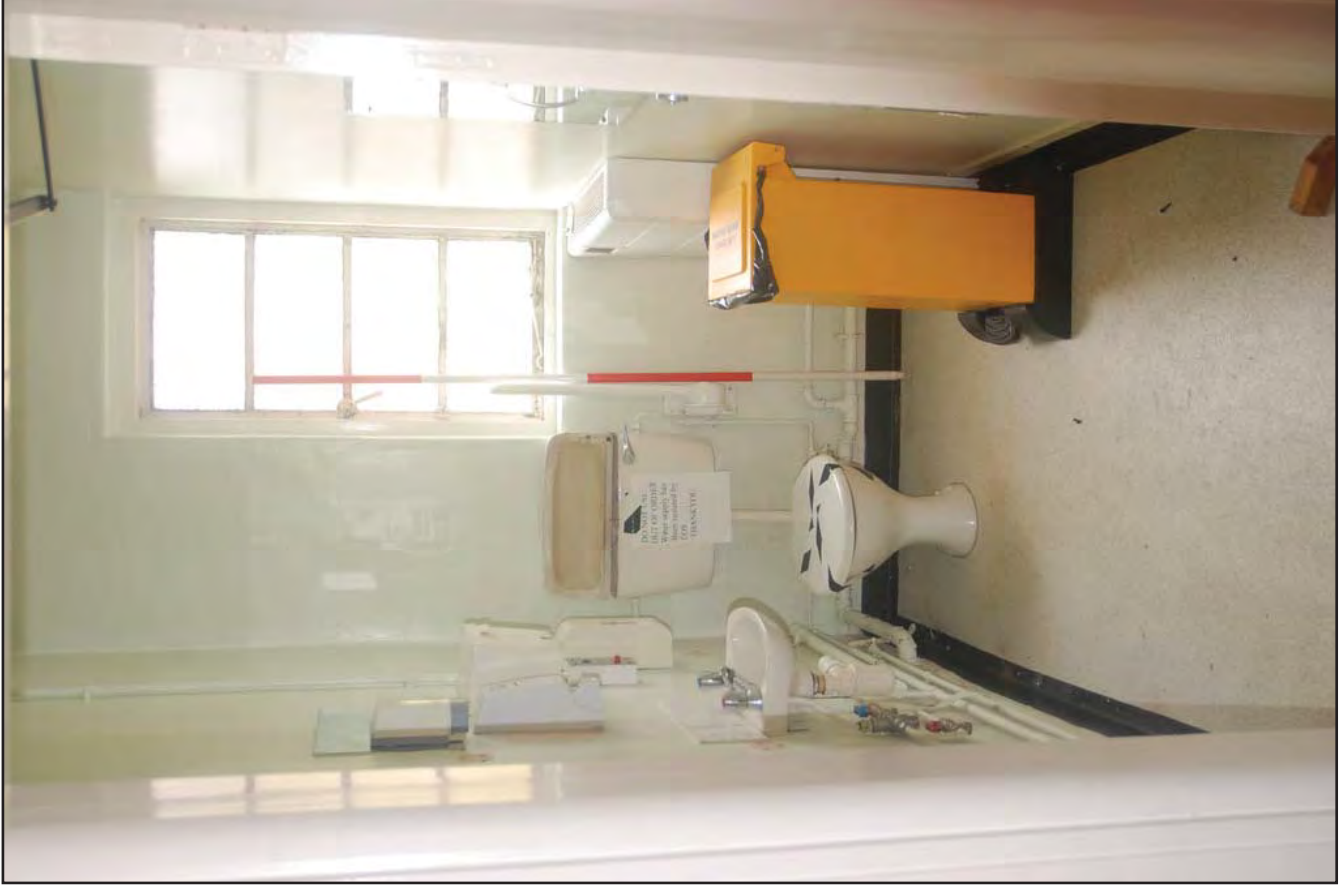
Plate 28: Short Stay Unit (Internal): view northwest of Room G04, detailing current usage as a staff WC. Casement window is visible (Scale: 1 x 2.0m).

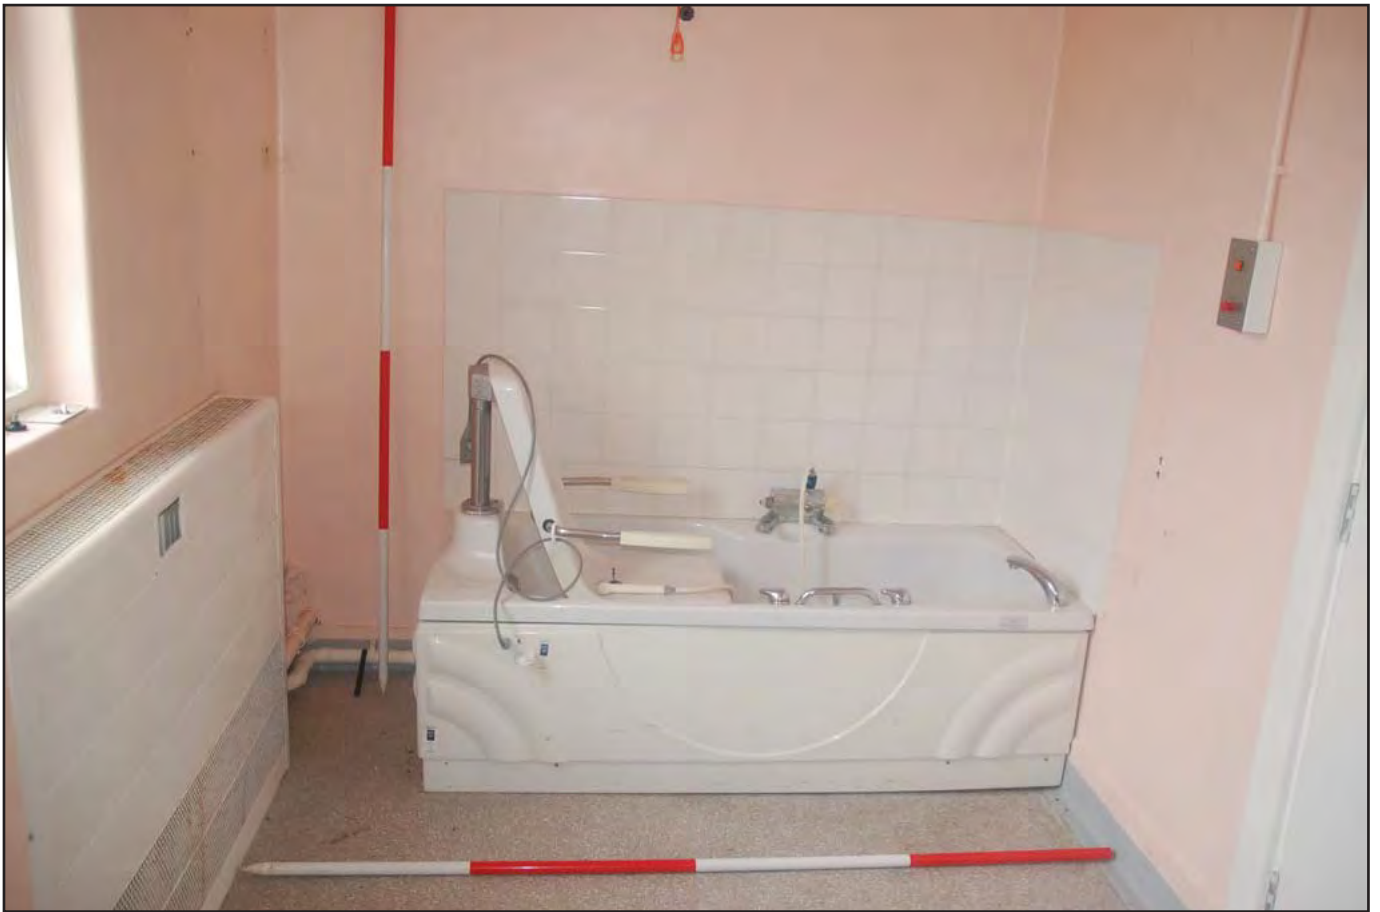
Plate 29: Short Stay Unit (Internal): View northeast of Room G05 detailing current use as a bathroom. Originally two rooms: sluice and bathroom, which were combined into a single room; original visible fittings limited to the casement window (left of image) (Scales: 2 x 2.0m)

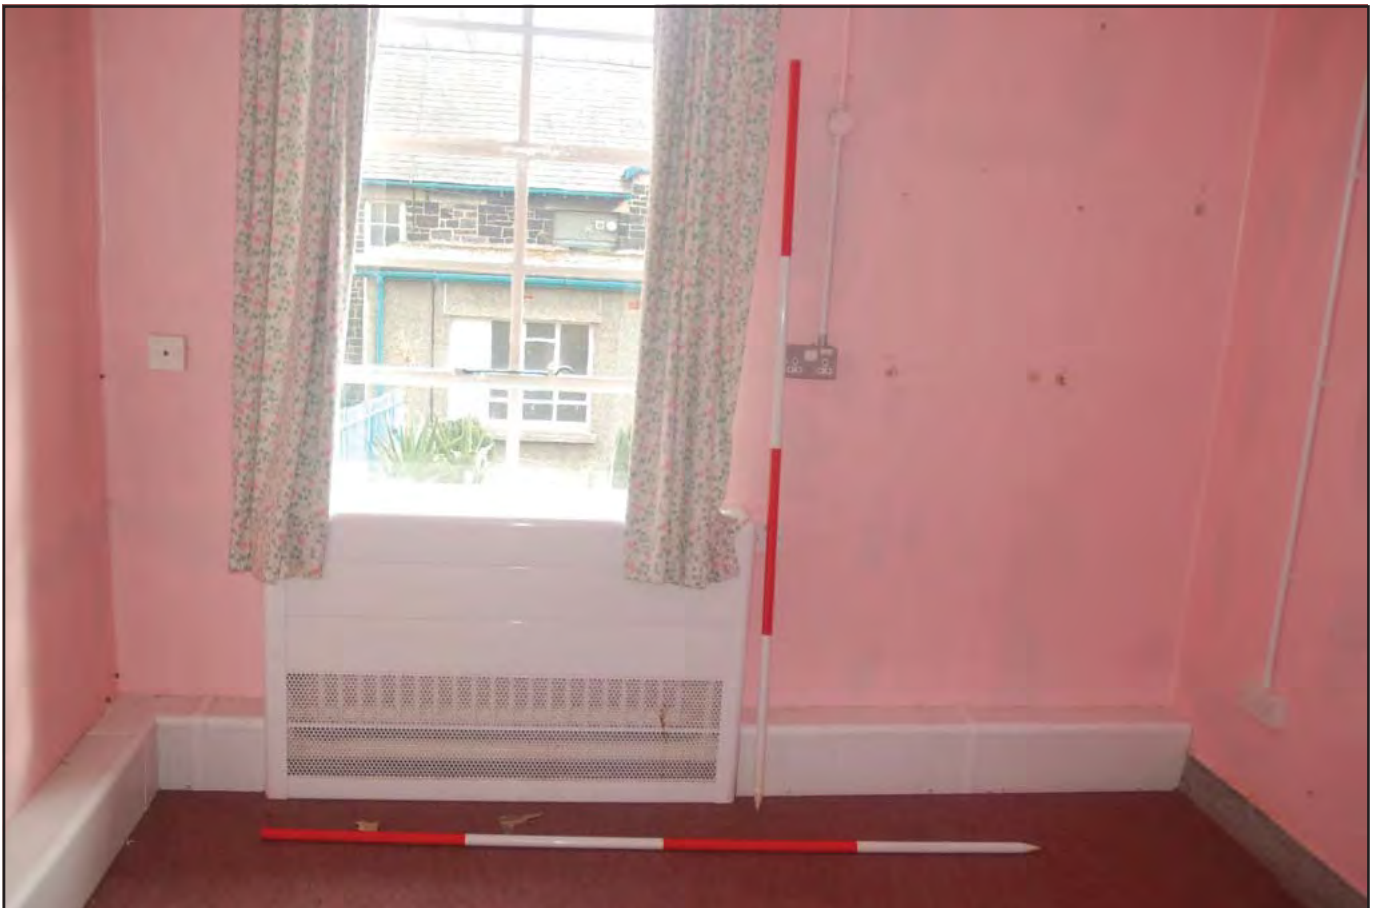
Plate 30: Short Stay Unit (Internal): View south of Room G06 detailing current use as a ward. Storage heater visible below original casement window, with boxed in plumbing (Scales: 2 x 2.0m)

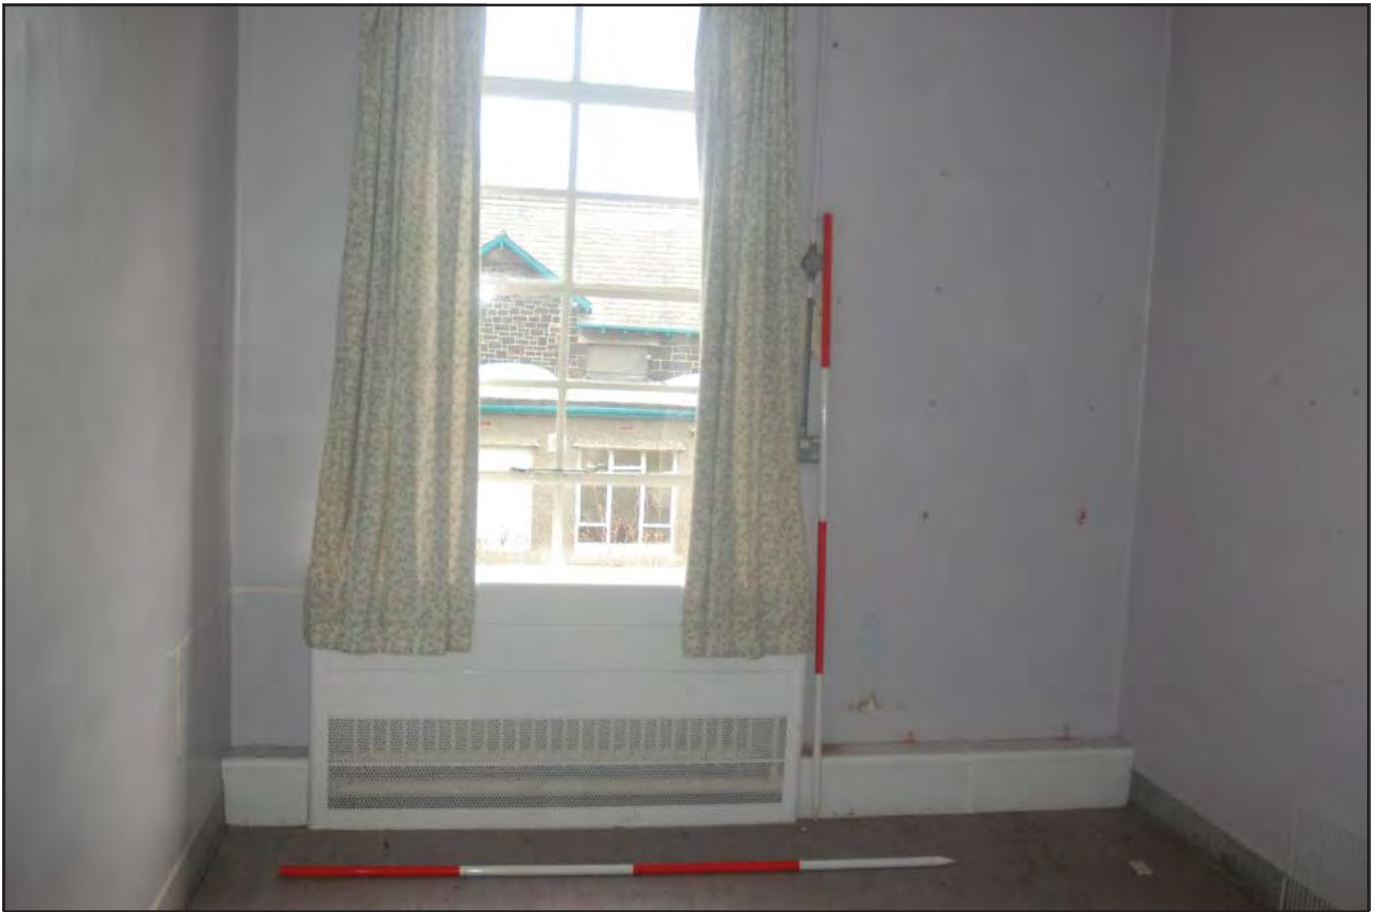
Plate 31: Short Stay Unit (Internal): View southeast of Room G07 detailing former use as a ward. Storage heater visible below original casement window, with boxed in plumbing (Scales: 2 x 2.0m)

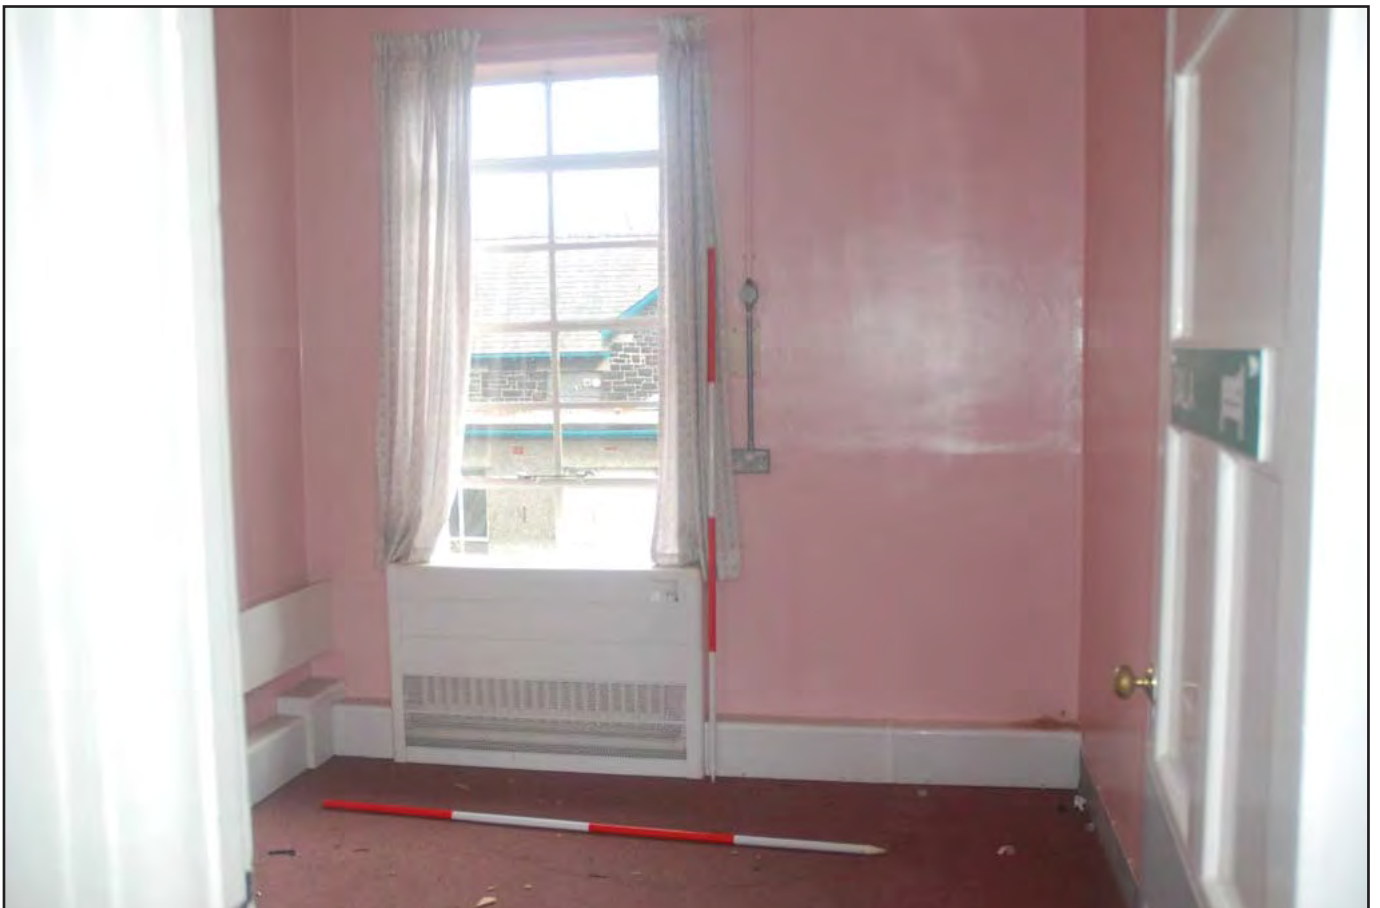
Plate 32: Short Stay Unit (Internal): View southeast of Room G08 detailing current use as a ward. Storage heater visible below original casement window, with boxed in plumbing. Panelled and moulded entrance door visible in image foreground. Rear of Long Stay Unit through window (Scales: 2 x 2.0m)

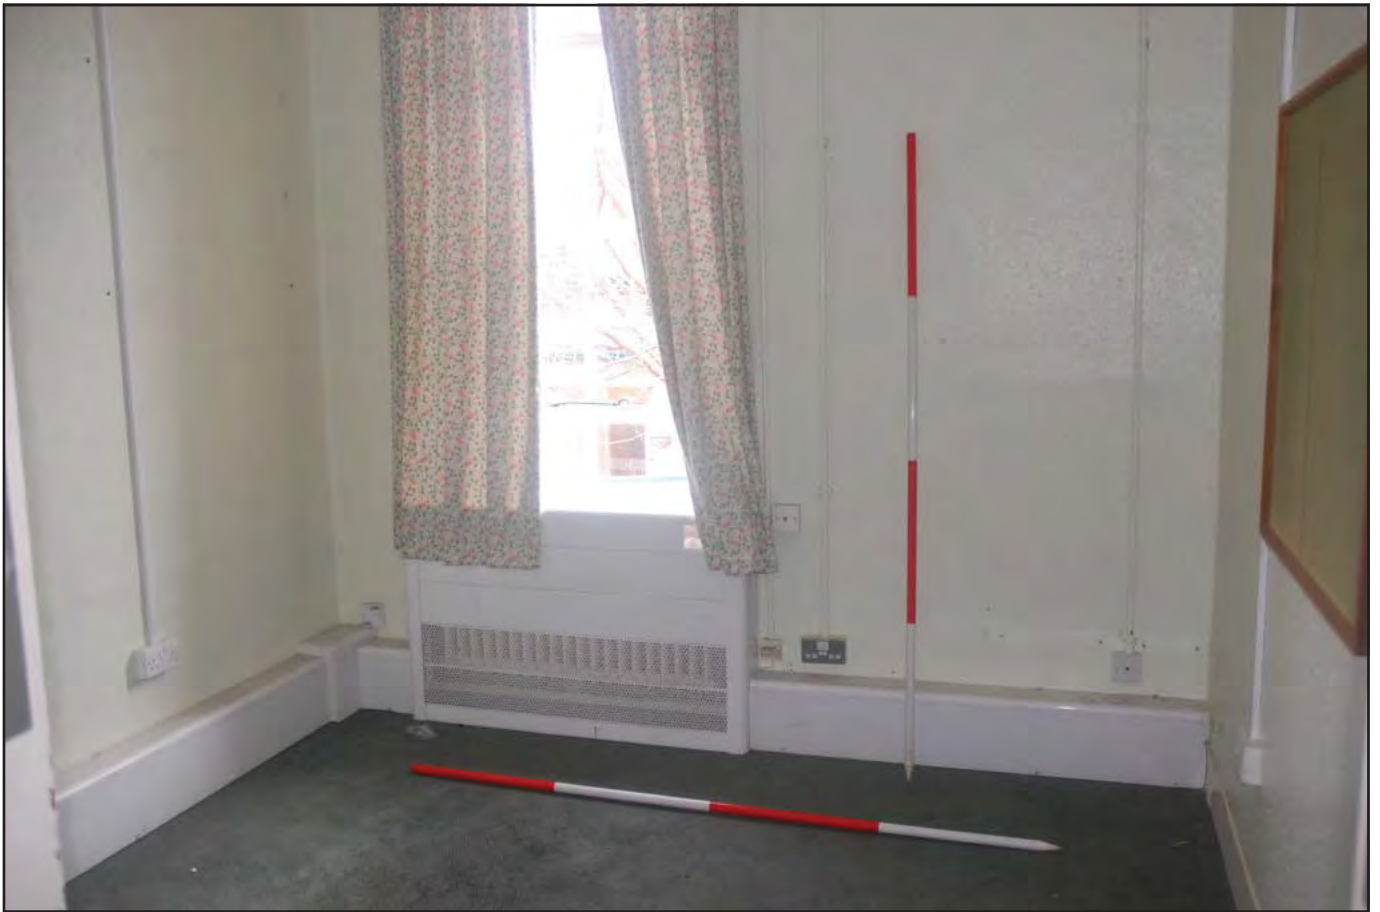
Plate 33: Short Stay Unit (Internal): View southeast of Room G09 detailing former use as a ward. Storage heater visible below original casement window, with boxed in plumbing (Scales: 2 x 2.0m)

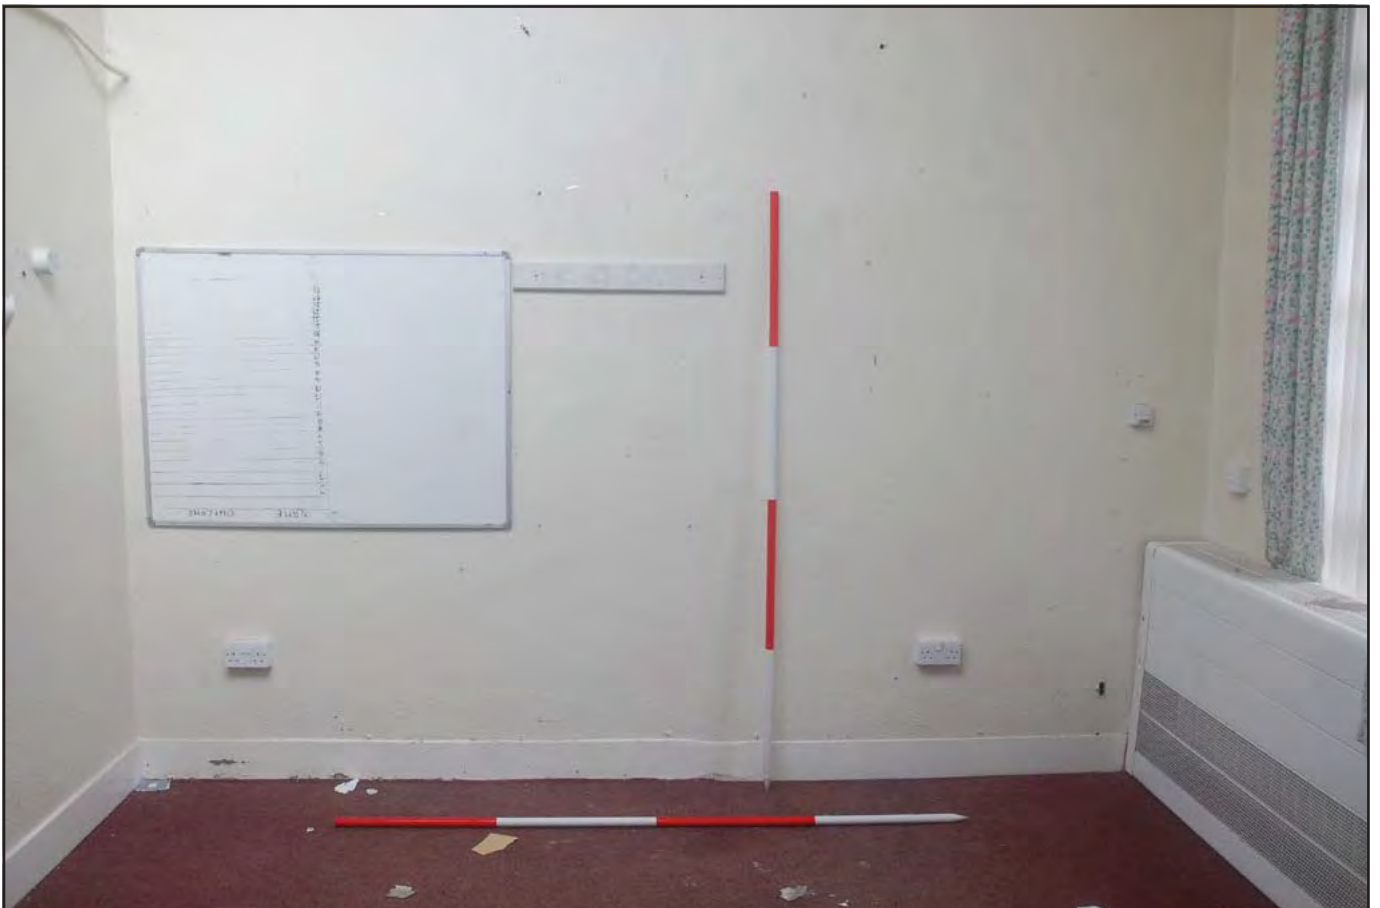
Plate 34: Short Stay Unit (Internal): View east of Room G10 detailing current use. Storage heater visible below original casement window, bullnose skirtings extant. (Scales: 2 x 2.0m)

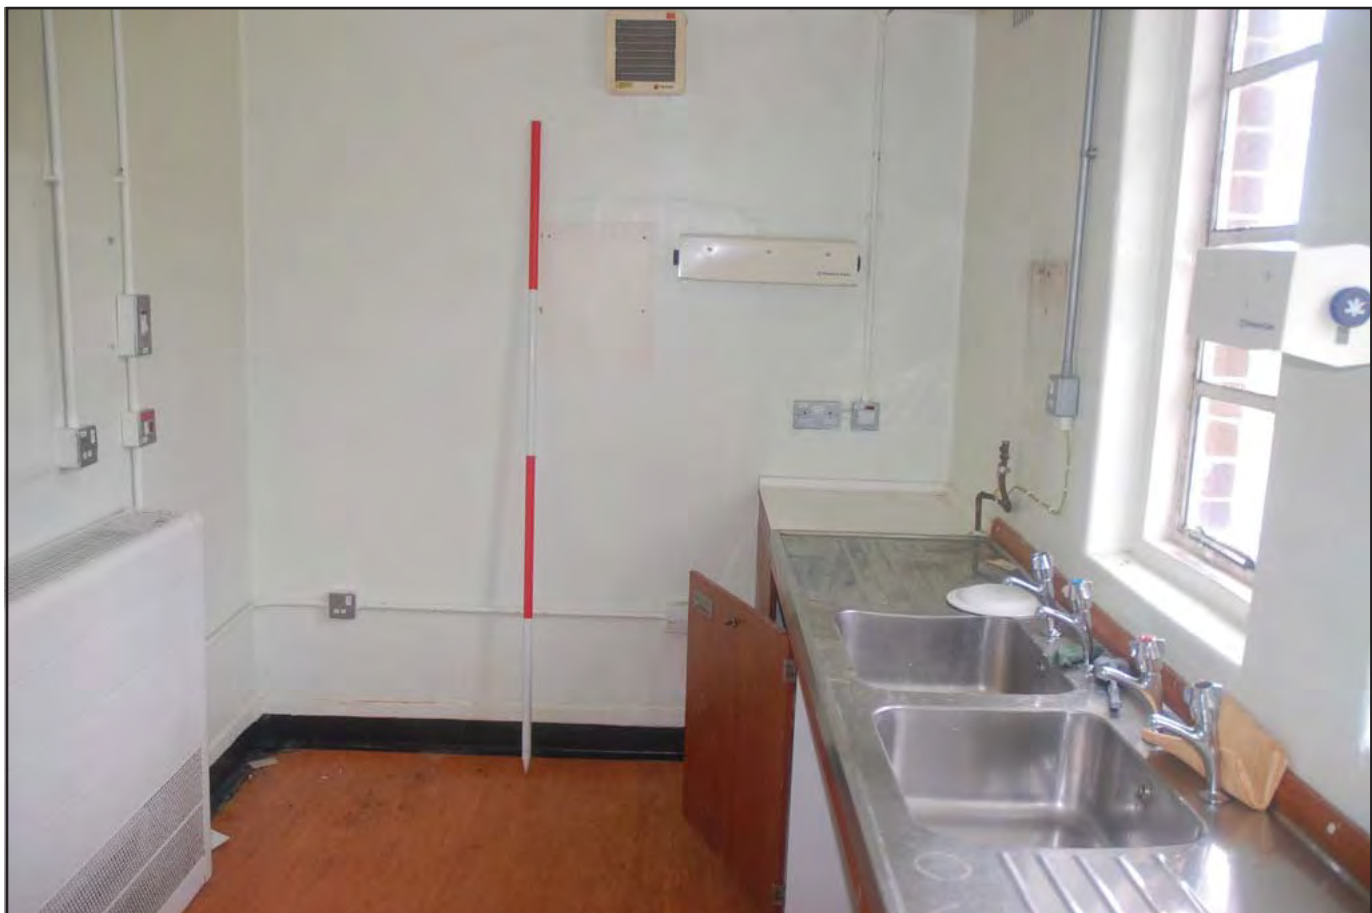
Plate 35: Short Stay Unit (Internal): View southeast of Room G11 detailing current use as kitchen. Originally two rectangular rooms, converted into a single larger rectangular room (Scale: 1 x 2.0m)

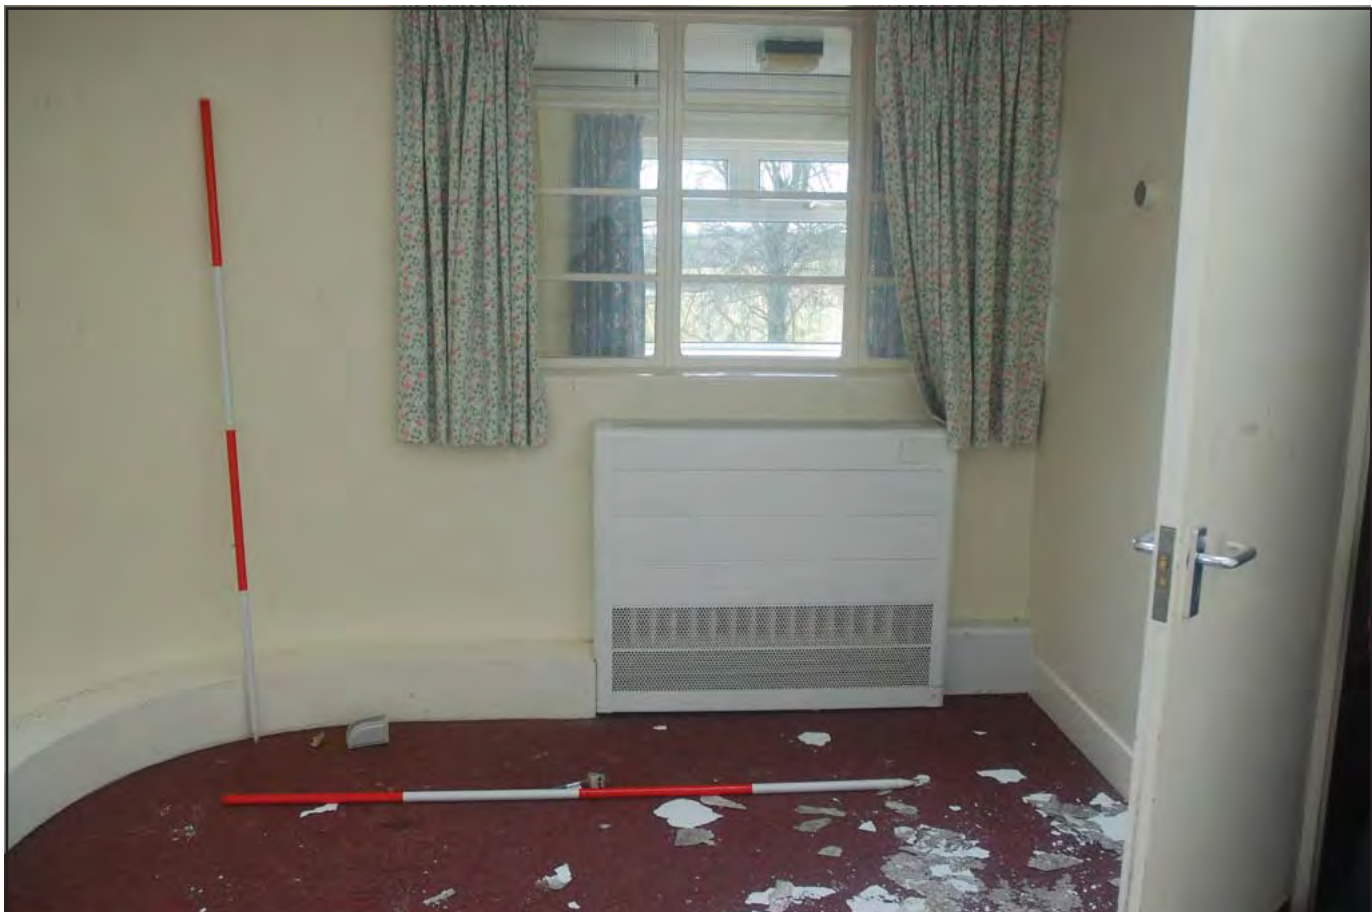
Plate 36: Short Stay Unit (Internal): View southwest of Room G12 detailing current use and original casement window fitting. Formerly a treatment room. Curved floor plan indicates former shape of the southwestern end of the building now disguised by the link corridor (visible through the casement window). Particleboard door in use rather than original panelled door seen elsewhere within the structure as room size was reduced and a new partition fitted. (Scales: 2 x 2.0m)
