# MINFFORDD HOSPITAL, BANGOR GWYNEDD: ARCHAEOLOGICAL BUILDING RECORD

## Archaeological Building Record: Level 2/3

GAT Project No. 2125

Report No. 872

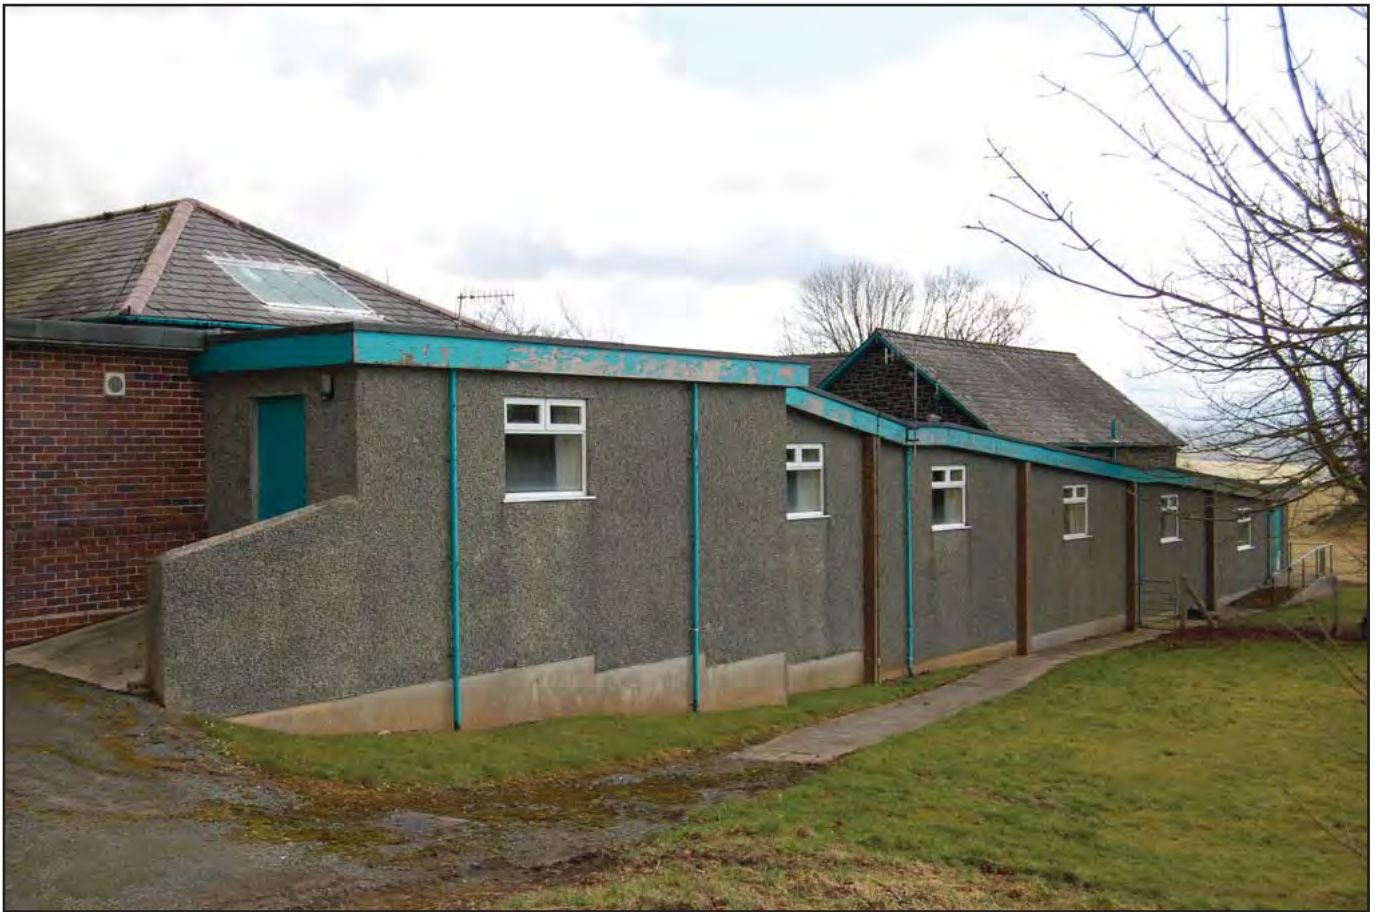
Plate 37: Link Corridor connecting Long and Short Stay Units: View south. Built 1991. Pebbledashed fronted with a box gutter and awning windows. Provides access to respective units; effectively masks the southwest facing elevations of both.

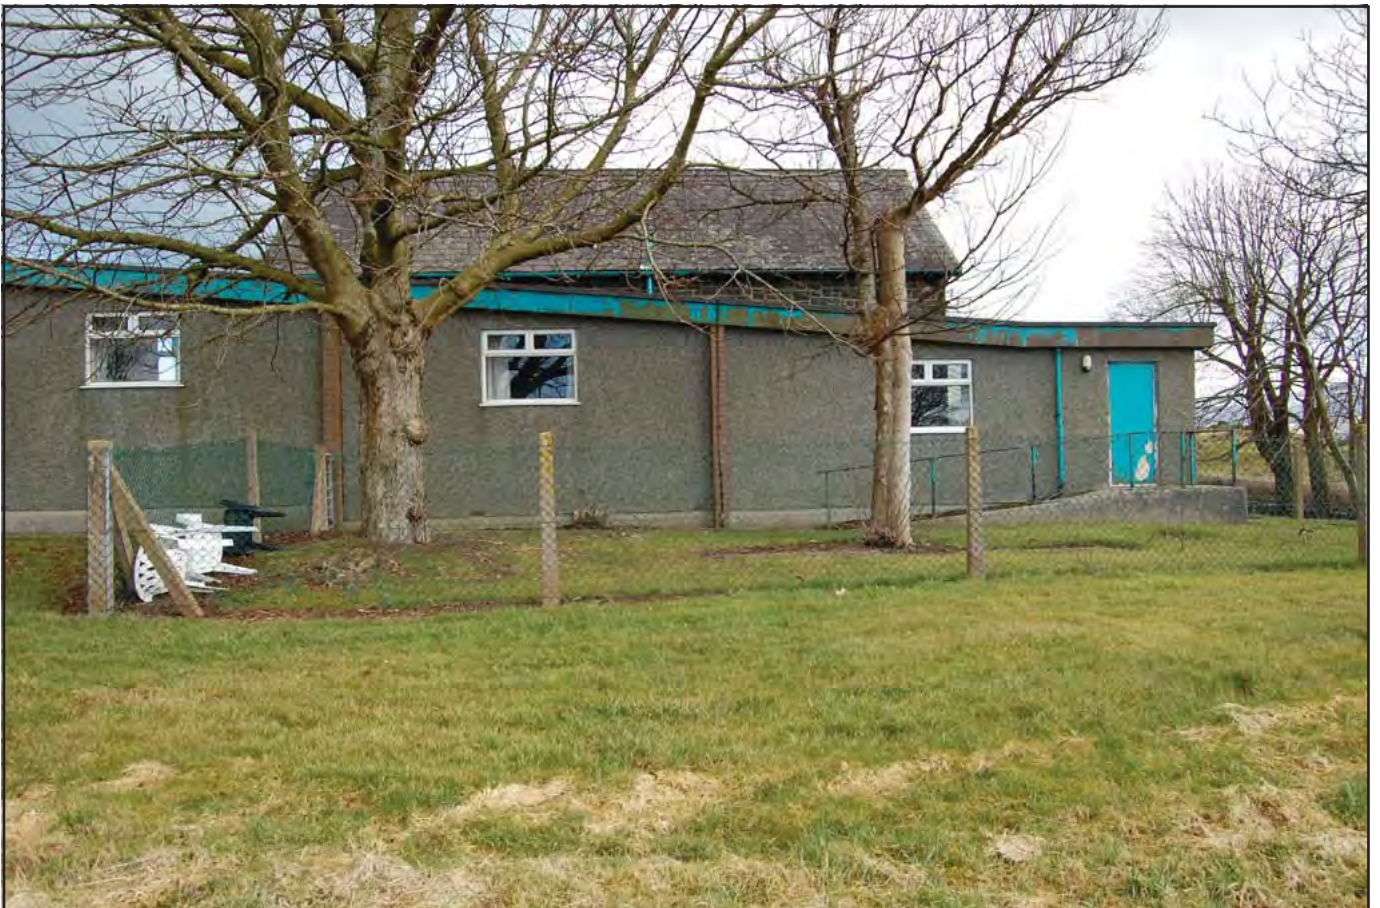
Plate 38: Link Corridor connecting Long and Short Stay Units: View east. Built 1991. Pebbledashed fronted with a box gutter and awning windows. Provides access to respective units; effectively masks the southwest facing elevations of both. Male ward wing of the Long Stay Unit is visible in the background as a slated pitched roof

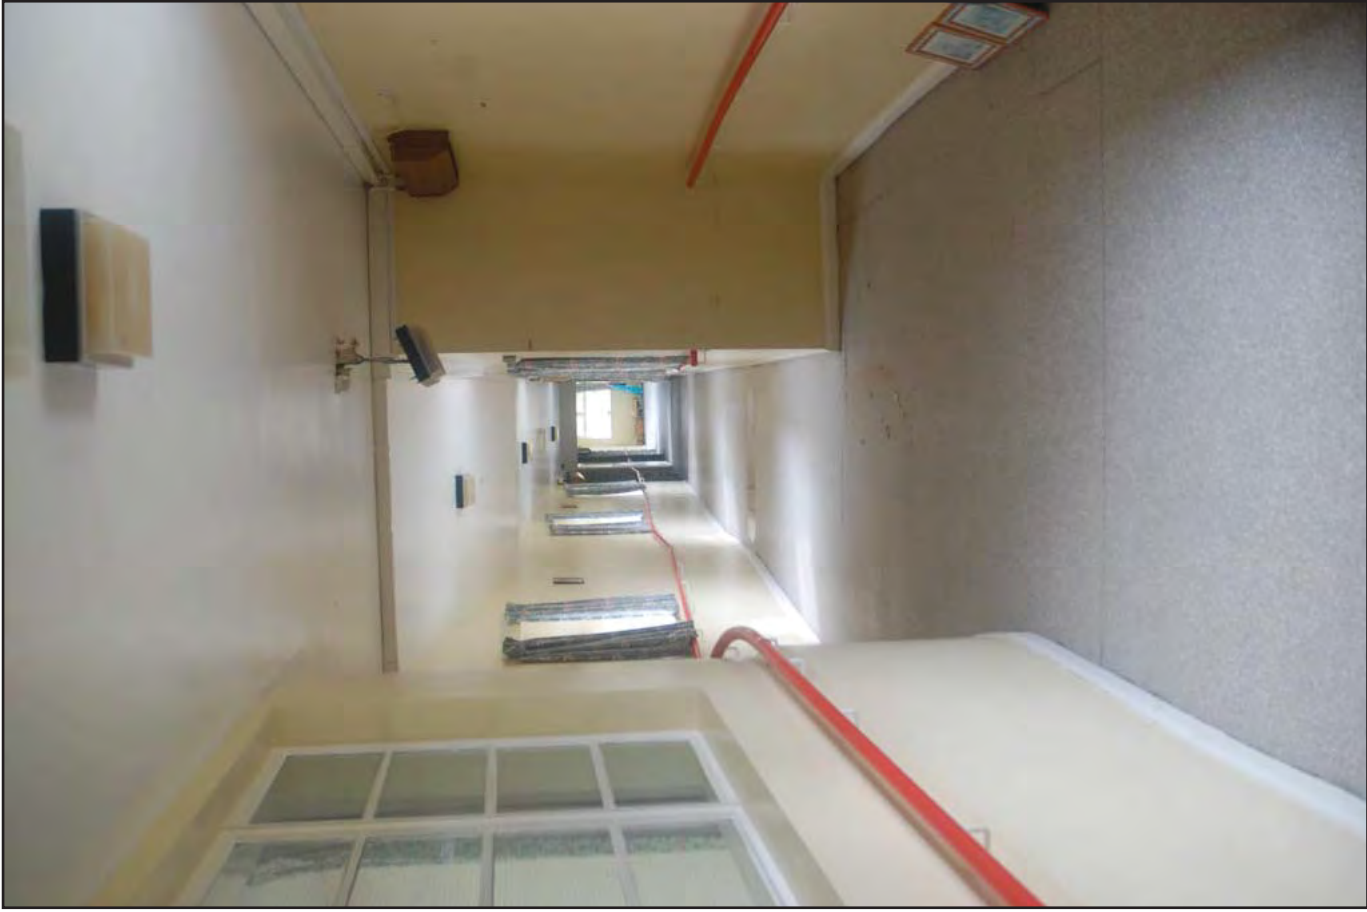
Plate 39: Link Corridor connecting Long and Short Stay Units (Internal): View southeast. Former exterior window of Room G12 visible in left foreground.

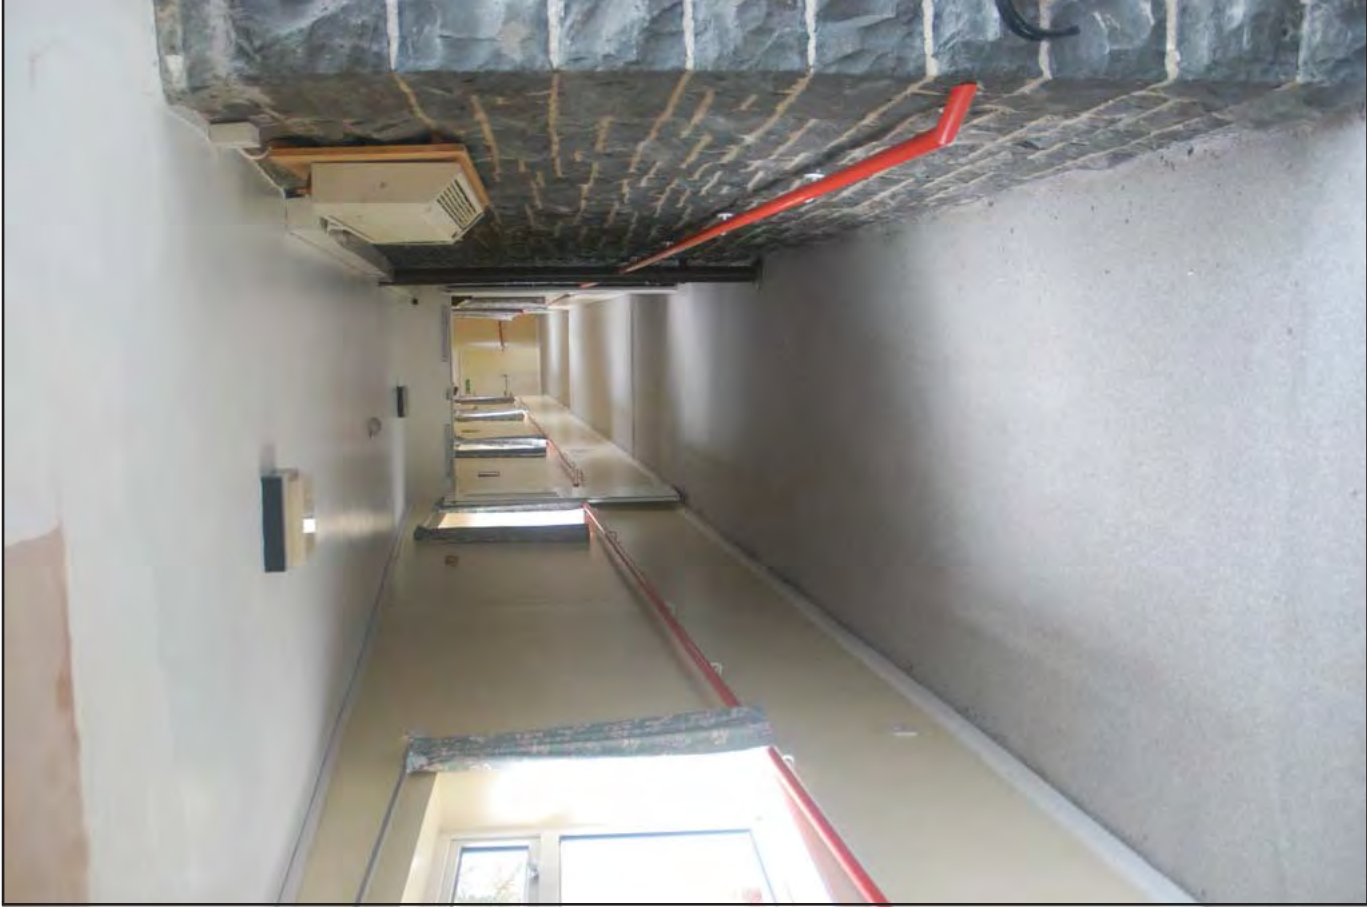
Plate 40: Link Corridor connecting Long and Short Stay Units (Internal): View northwest. Former building exterior visible in right foreground, now an internal wall.

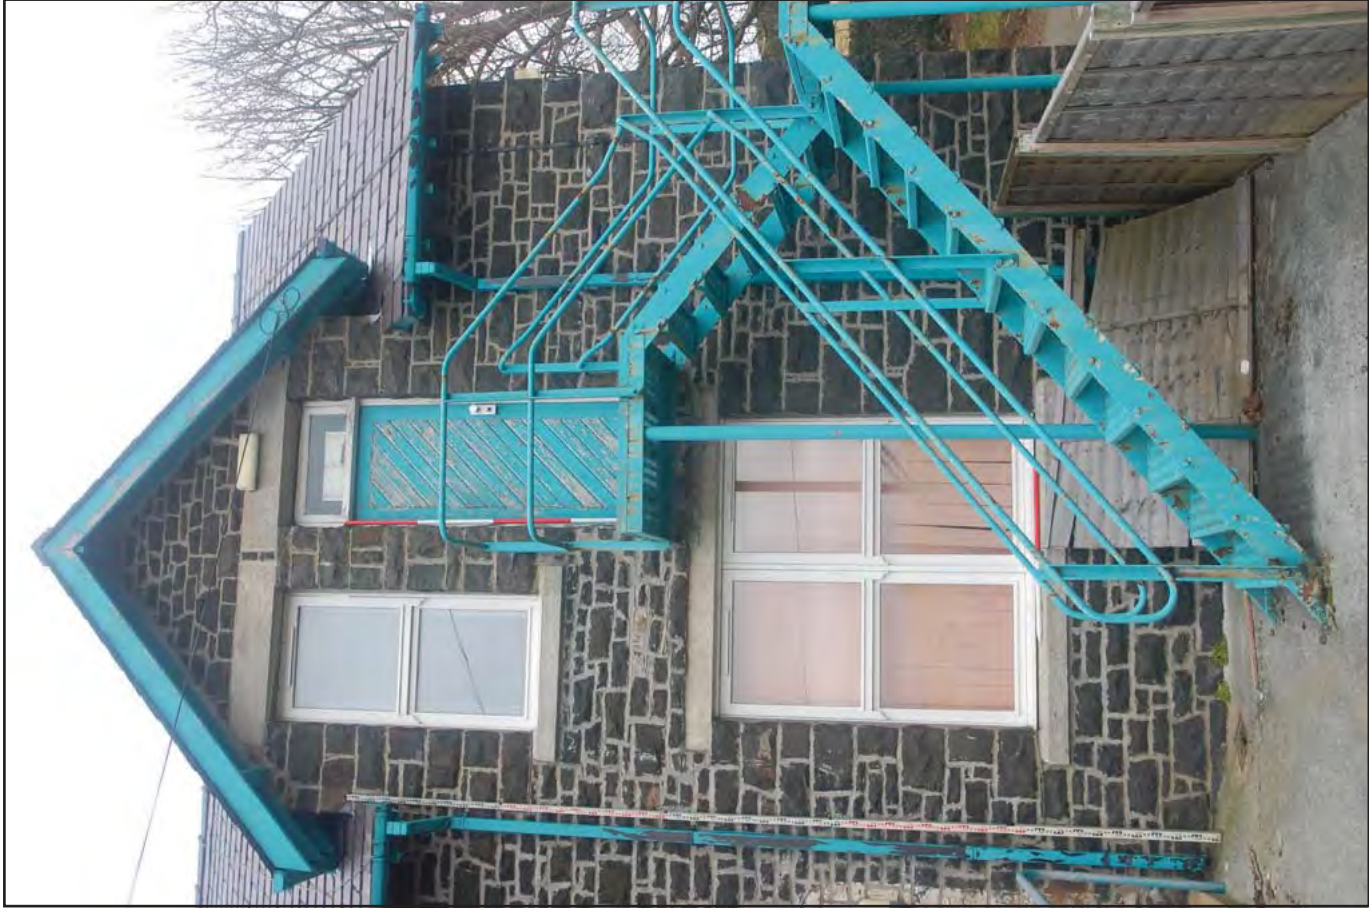
Plate 41: Administration Block: Southeast facing elevation. Ground floor Room G02 and first floor Room F04 are visible; Room F04 includes a fire exit, which is a converted window space. Stone voussoirs and sills in use. Original main entrance (cf. Plate 42) is to left of image (out of shot). Scales: 2 x 2.0m and 1 x 5.0m.

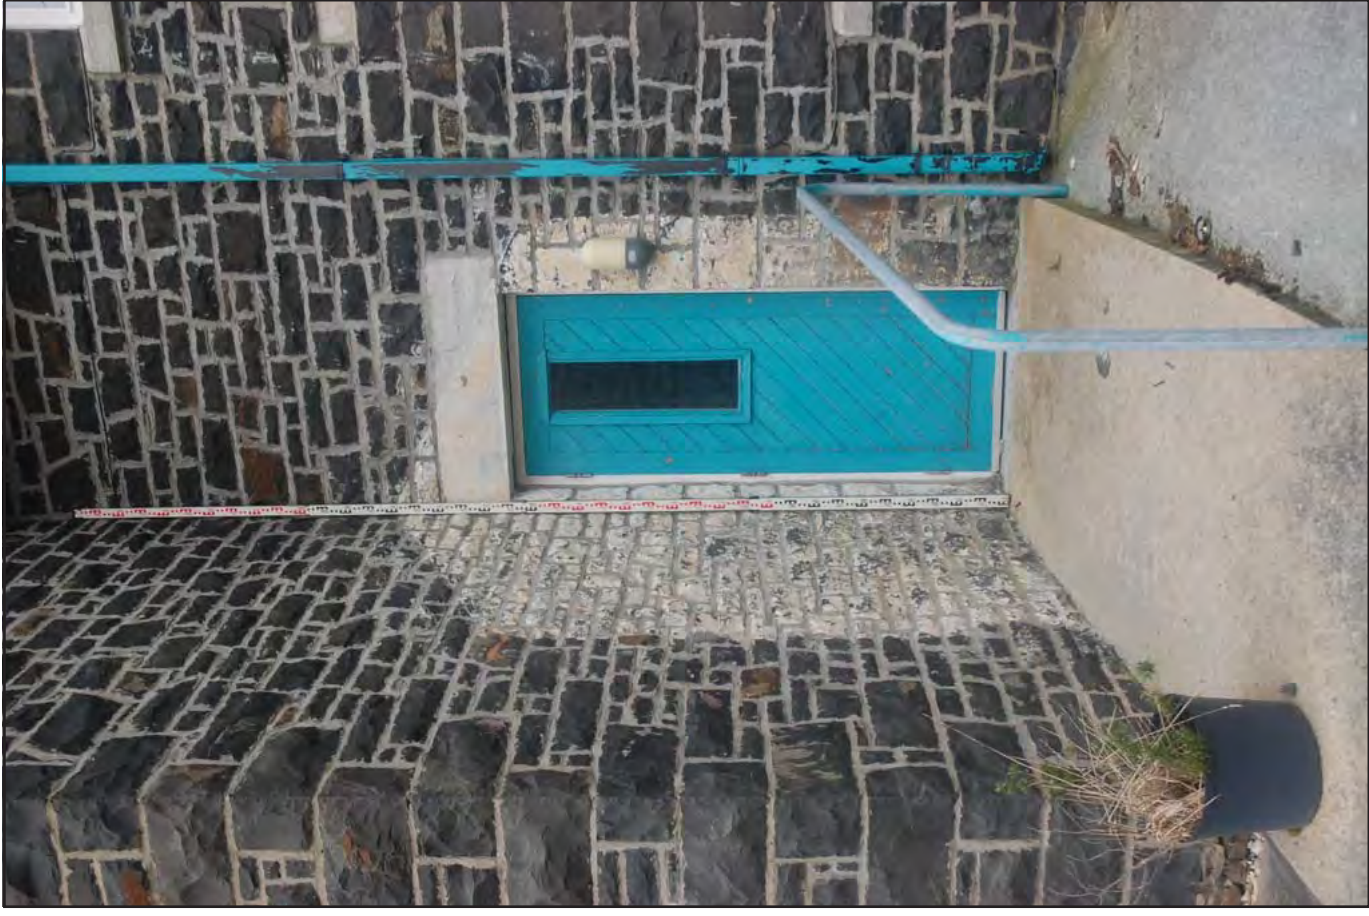
Plate 42: Administration Block: Southeast facing elevation. Ground floor former main entrance (now a fire exit) with a panelled door. Original porch has been removed, but outline is still visible. (Scale 1 x 5.0m).

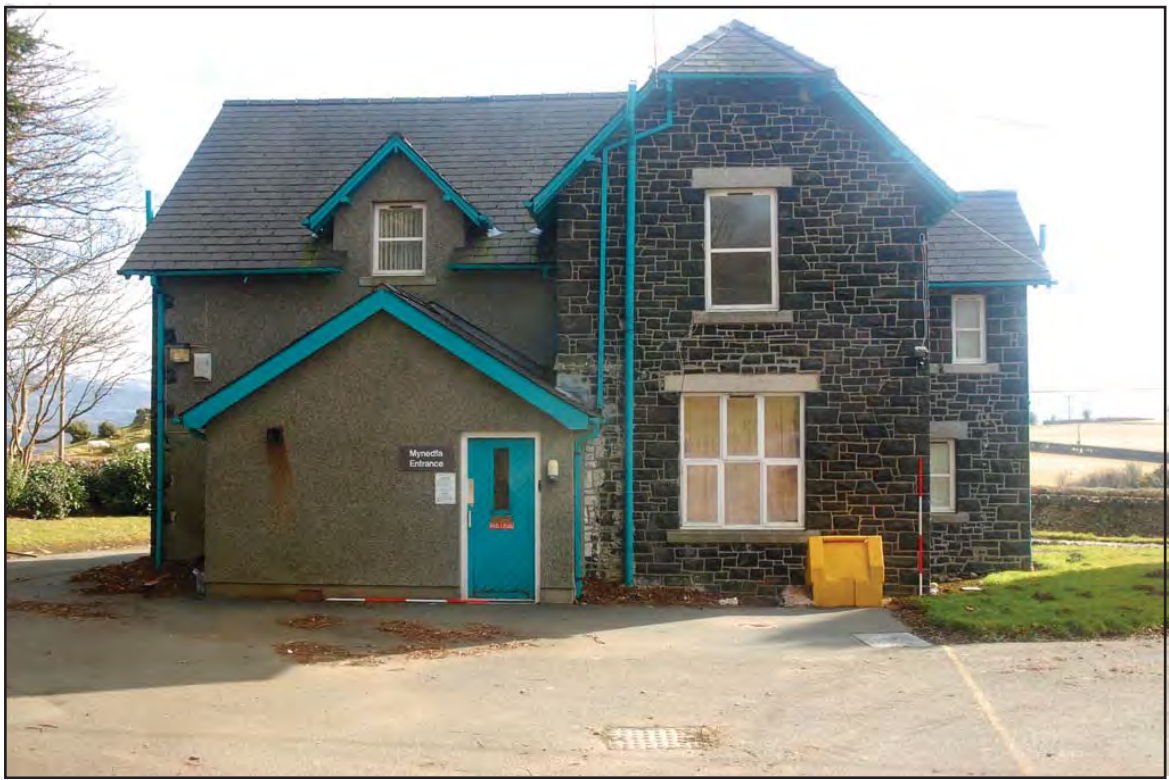
Plate 43: Administration Block: Northwest facing elevation detailing ground floor Room G04 and first floor Rooms F03 to F05. The rear of the property was altered c.1991, with the removal of a ground floor wing that included a kitchen, prep room and store. The kitchen was reduced in size to create the pebbledashed gabled main entrance/photocopy room visible in the image. Remnants of the alteration work can be seen where the main entrance is keyed into the original build. (Scales: 2 x 2.0m)

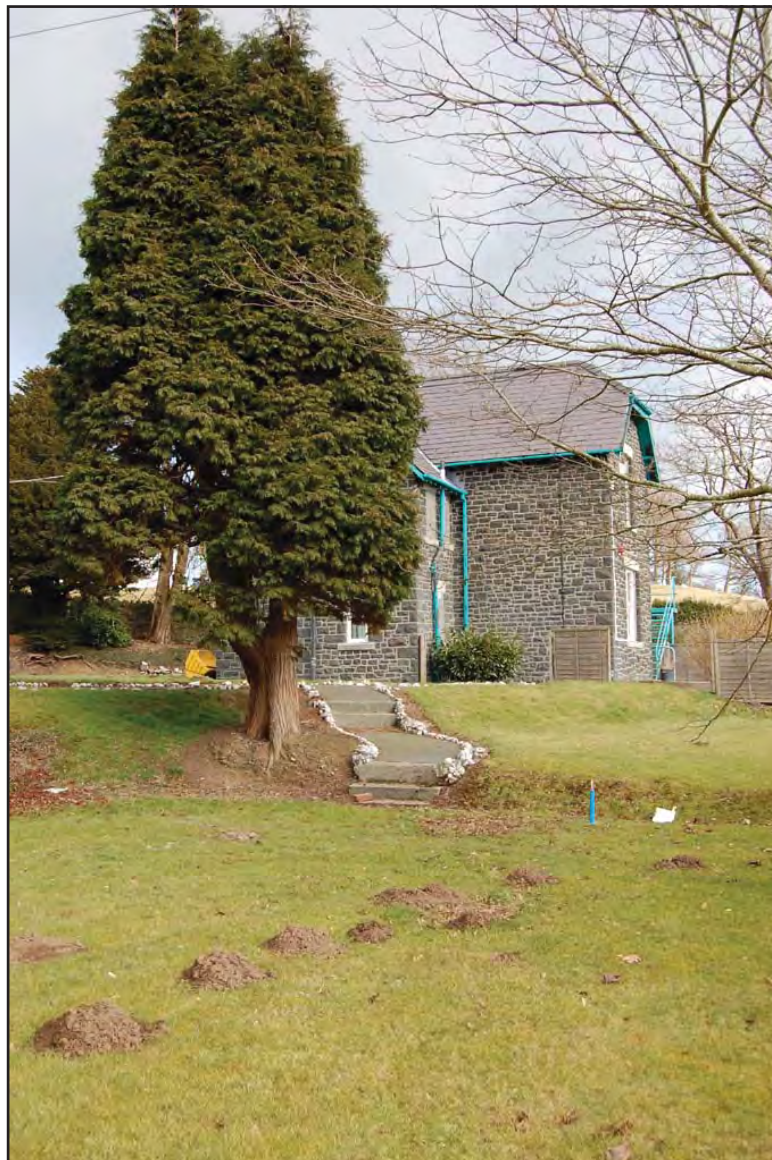
Plate 44: Administration Block: Southwest facing elevation detailing a path leading to the grounds of the complex.

#### Southwest facing elevation (Plate 44)

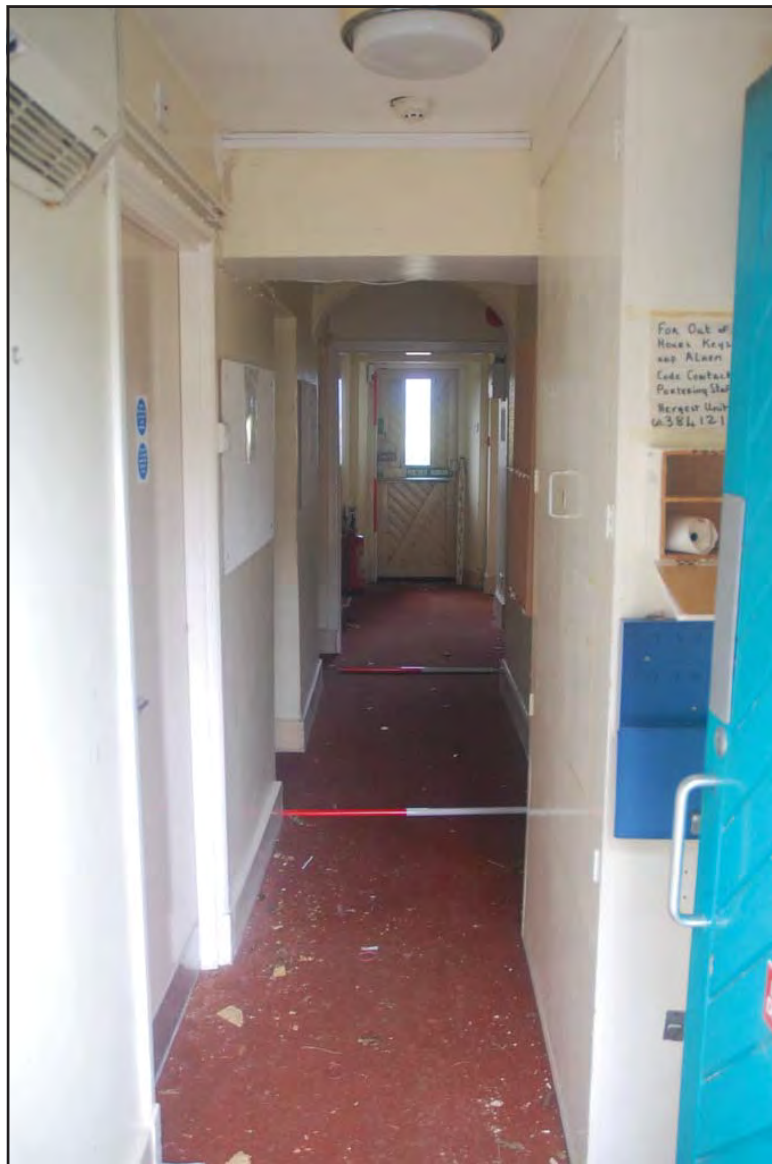
Plate 45: Administration Block (Internal): View northwest detailing main corridor through the building, with current main entrance in the background. This would have been the original building entrance prior to alterations in 1991. Scales: 2 x 1.0m

wooden door (with glass panel insert), leading onto a 9.32m long and 1.0m wide corridor (Plate 45) that runs the length of the building, allowing access to all ground floor rooms and to the first floor rooms via a staircase. The corridor walls are painted and plastered; the floor is linoleum. An archway is located towards the centre of the corridor: no decorative details visible. Modern light fittings present. Skirtings are 0.13m high bullnose. The staircase to the first floor is located between rooms G03 and G04 and opens onto a narrow first floor landing that provides access to rooms G06 to G09. The staircase has a simple moulded handrail, turned balusters, with a turned and decorated newel (no cap). The treads and risers are carpeted (Plate 49).

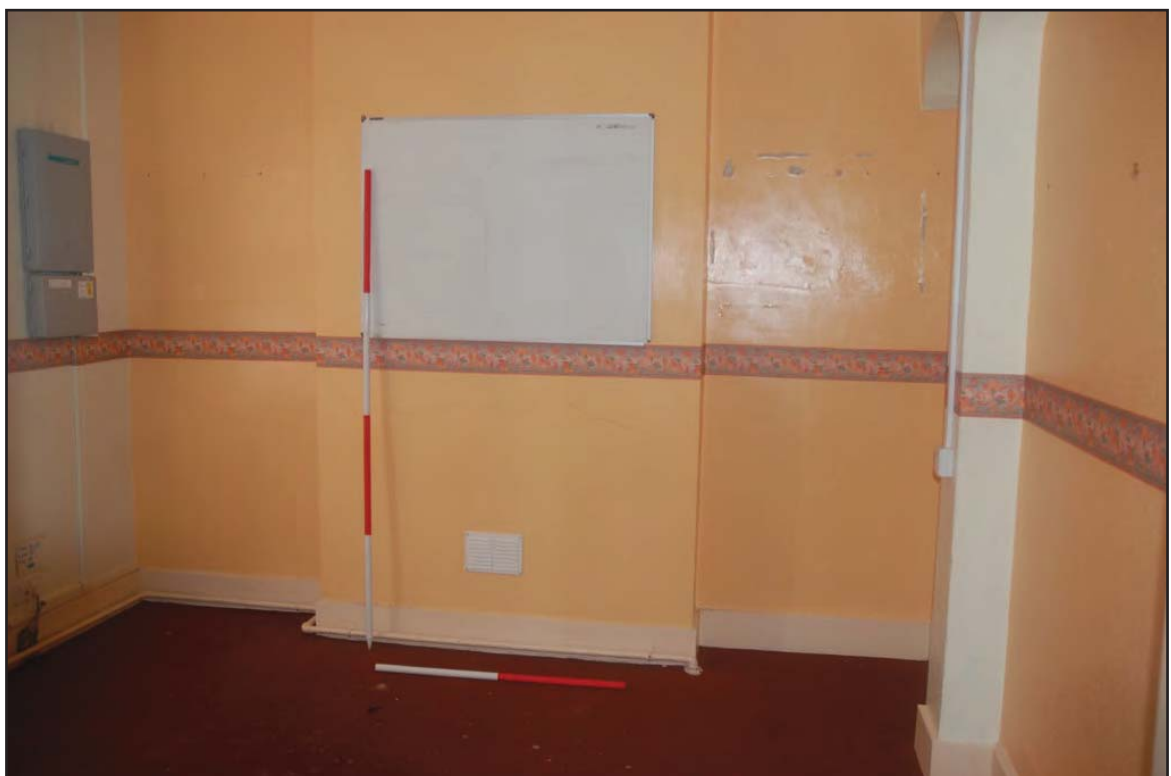
Plate 46: Administration Block (Internal): View southwest of former matron's office (Room G03) detailing redundant fireplace and current decor. Scales: 1 x 2.0m and 1 x 1.0m

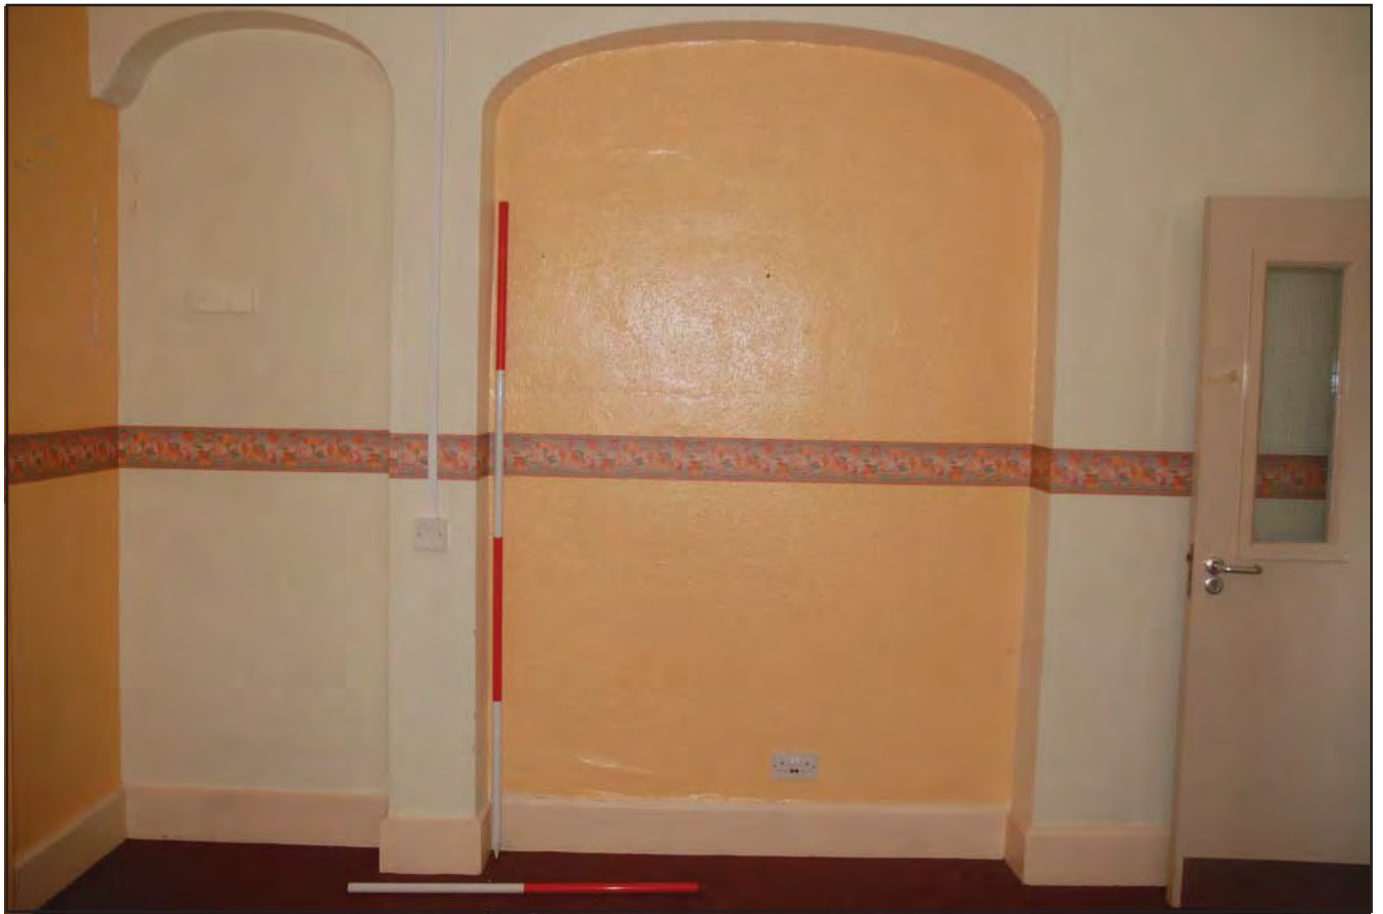
Plate 47: Administration Block (Internal): View northeast of former matron's office (Room G03) detailing redundant archways and modern fire door. Scales: 1 x 2.0m and 1 x 1.0m.

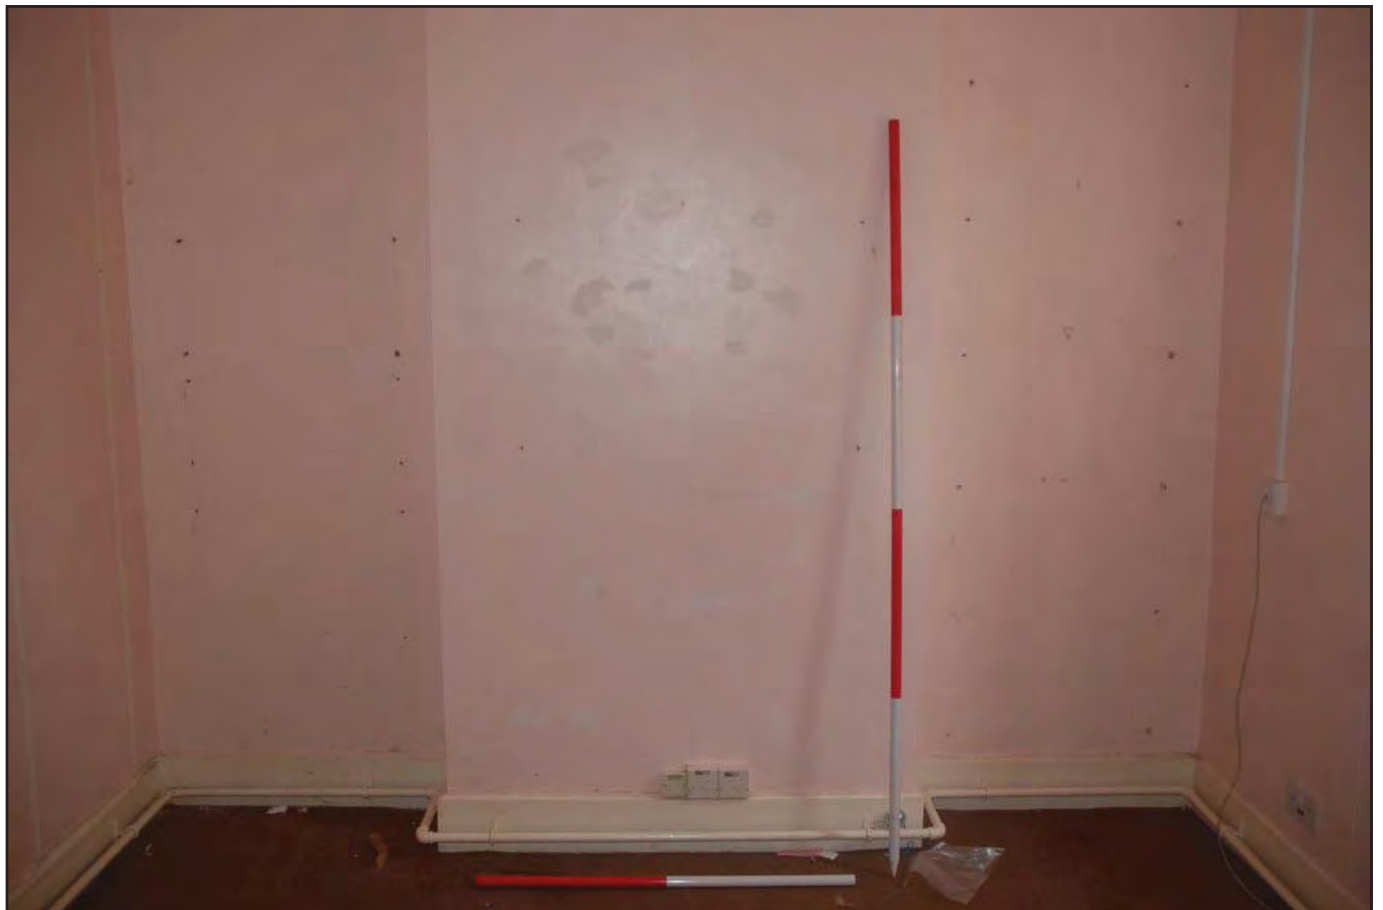
Plate 48: Administration Block (Internal): View northeast of former maid's sitting room (Room G04) detailing redundant fireplace. Scales: 1 x 2.0m and 1 x 1.0m.

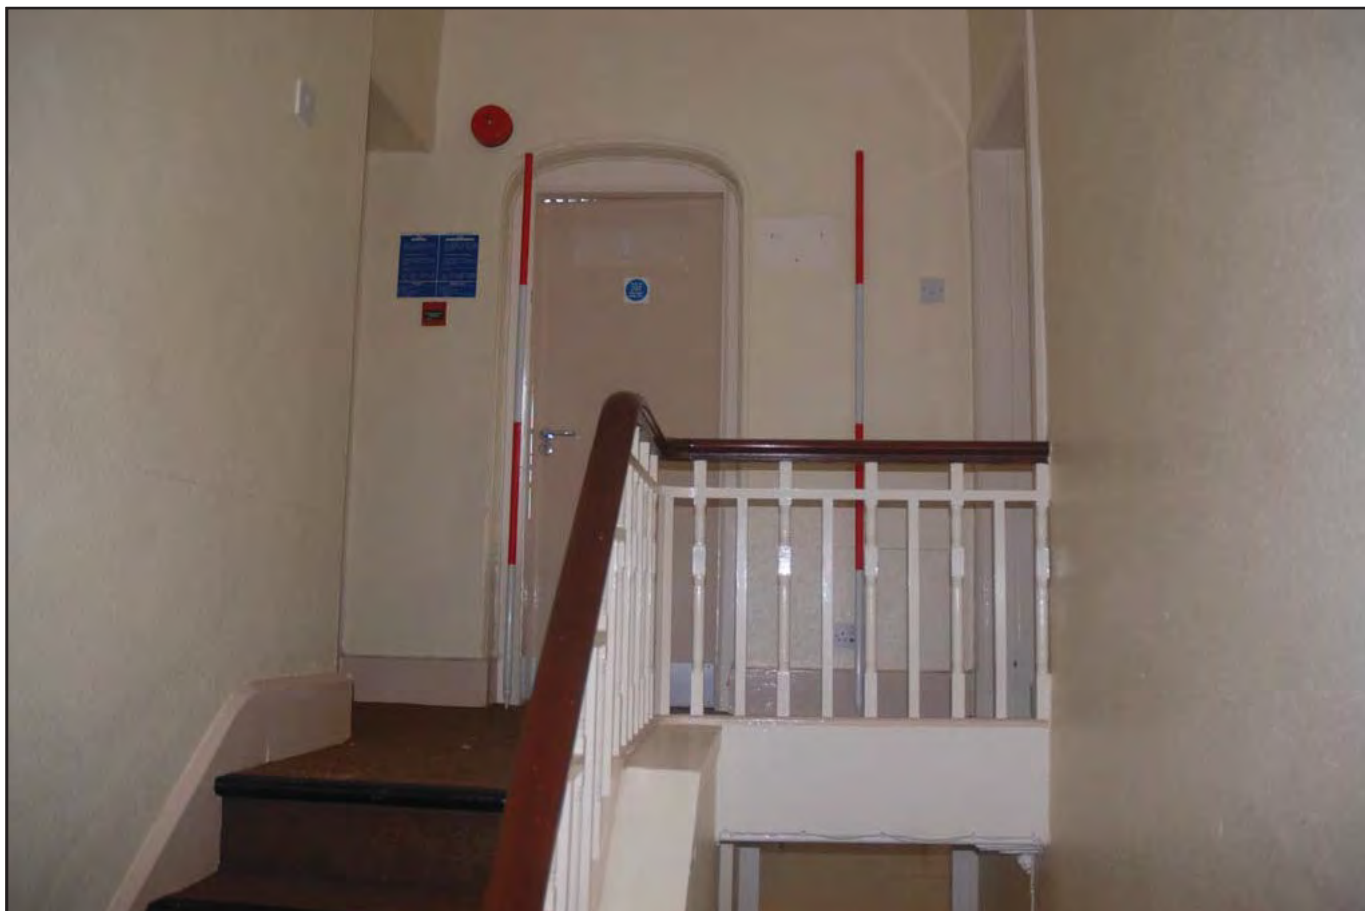
Plate 49: Administration Block (Internal): View northeast of first floor stairs leading to Rooms F02, F03 and F05. Room F03 is located at the centre of the image: the curved door arch is clearly visible. The staircase has a moulded rail with turned balusters; the tread and risers are carpeted.  
(Scales: 2 x 2.0m).

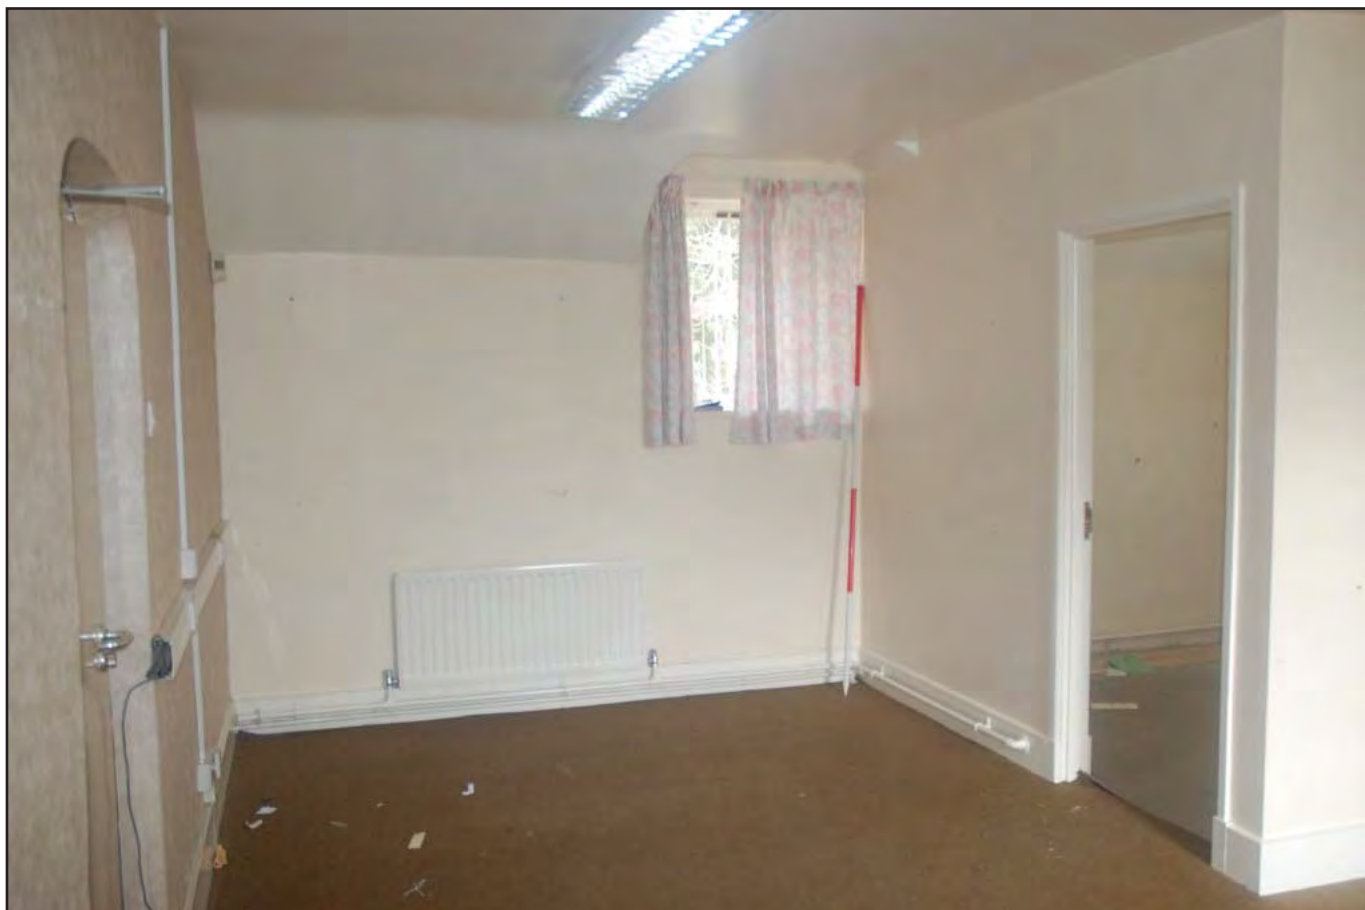
Plate 50: Administration Block (Internal): View northeast of former nurses changing room (Room F03) with the former sister's changing room (Room F04) as a boxed partition at right of image. Room F03 was converted from four rooms into two rooms (F03 and F04), with the removal of a sister's bedroom and a cook's bedroom. The original corridor entrance has been converted into the main entrance for F03 and is approached via a staircase and small landing (cf. Plate 48)  
(Scales: 1 x 2.0m).

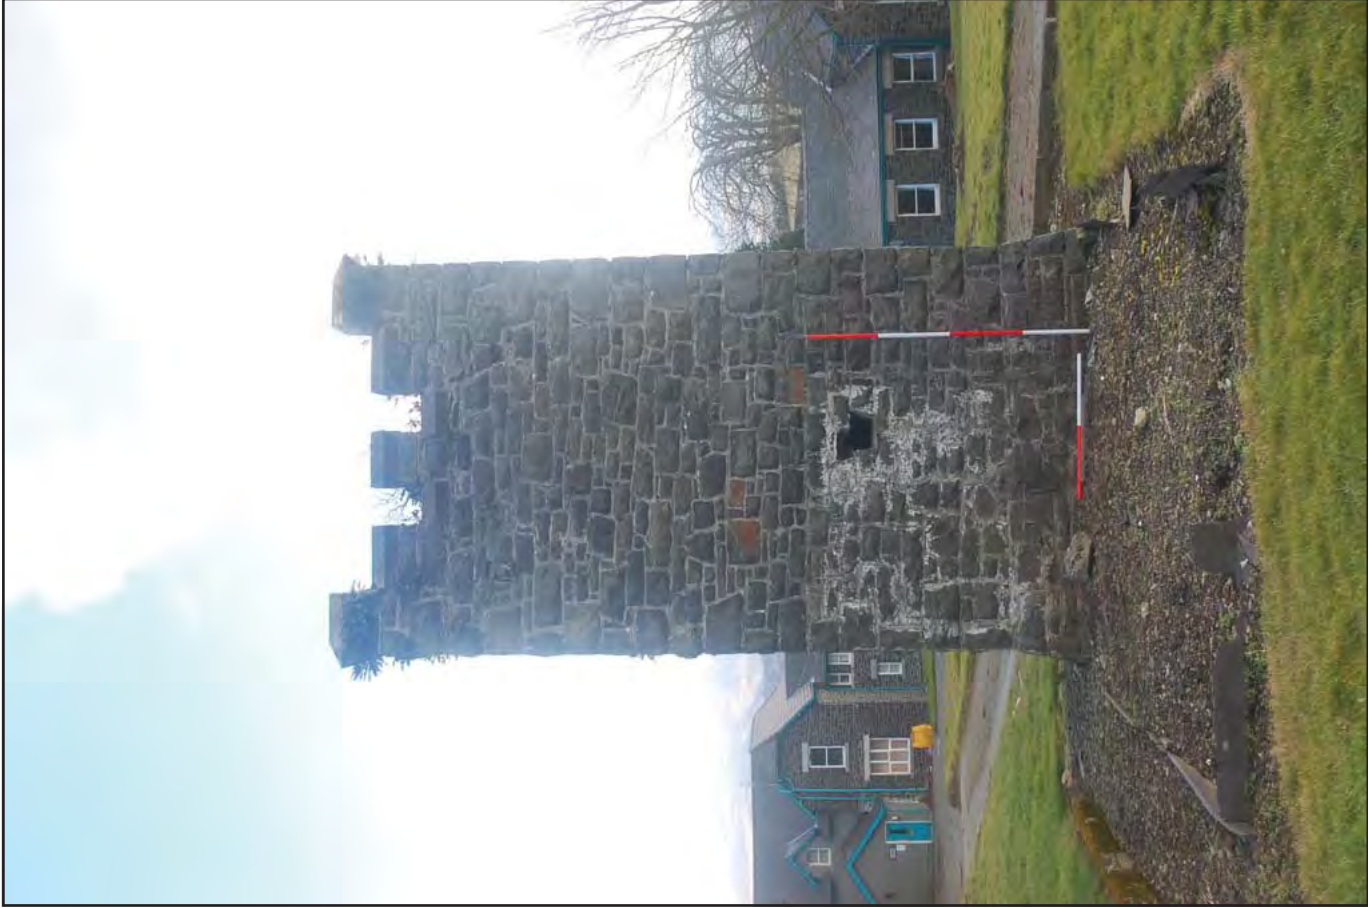
Plate 51: Water Tower - Northwest facing elevation detailing construction form, including crenellated capping and an internal buttress. Note the external slate defined area that appears to have functioned as a possible small garden area; note also the administration block in the left background and the Long Stay Unit in the right background (Scales: 2 x 2.0m).

As GAT was unable to access the inside of the water tower during the recording phase, it is recommended that a brief opportunity is made to inspect the interior during any development, where a photographic and written record could be completed as an addendum to the existing report.

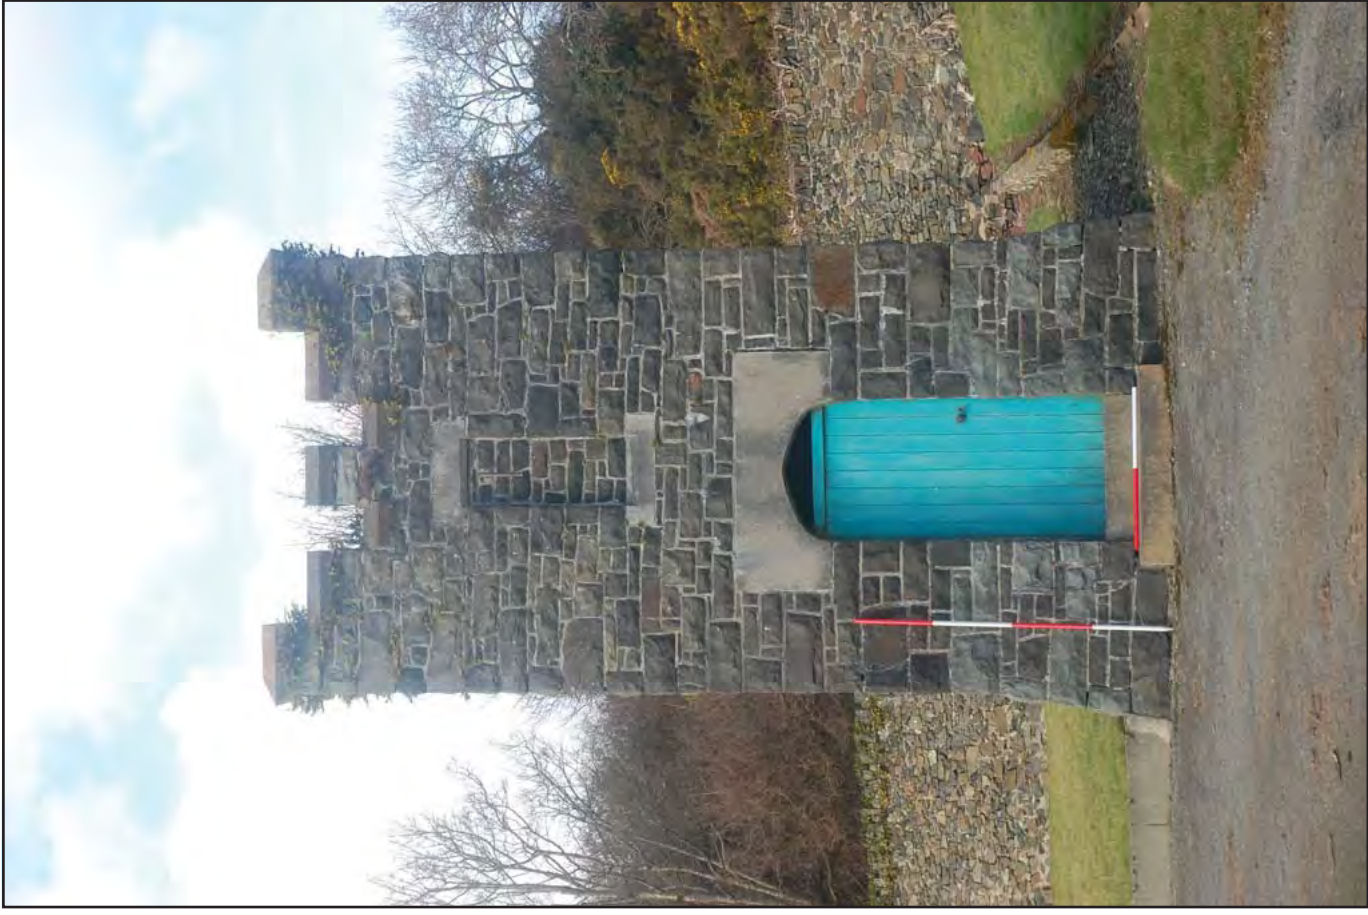
Plate 52: Water Tower - Southeast facing elevation detailing construction form, including crenellated capping, internal buttress and main entrance via pannelled door. Note the boundary wall at rear of image (Scales: 2 x 2.0m).

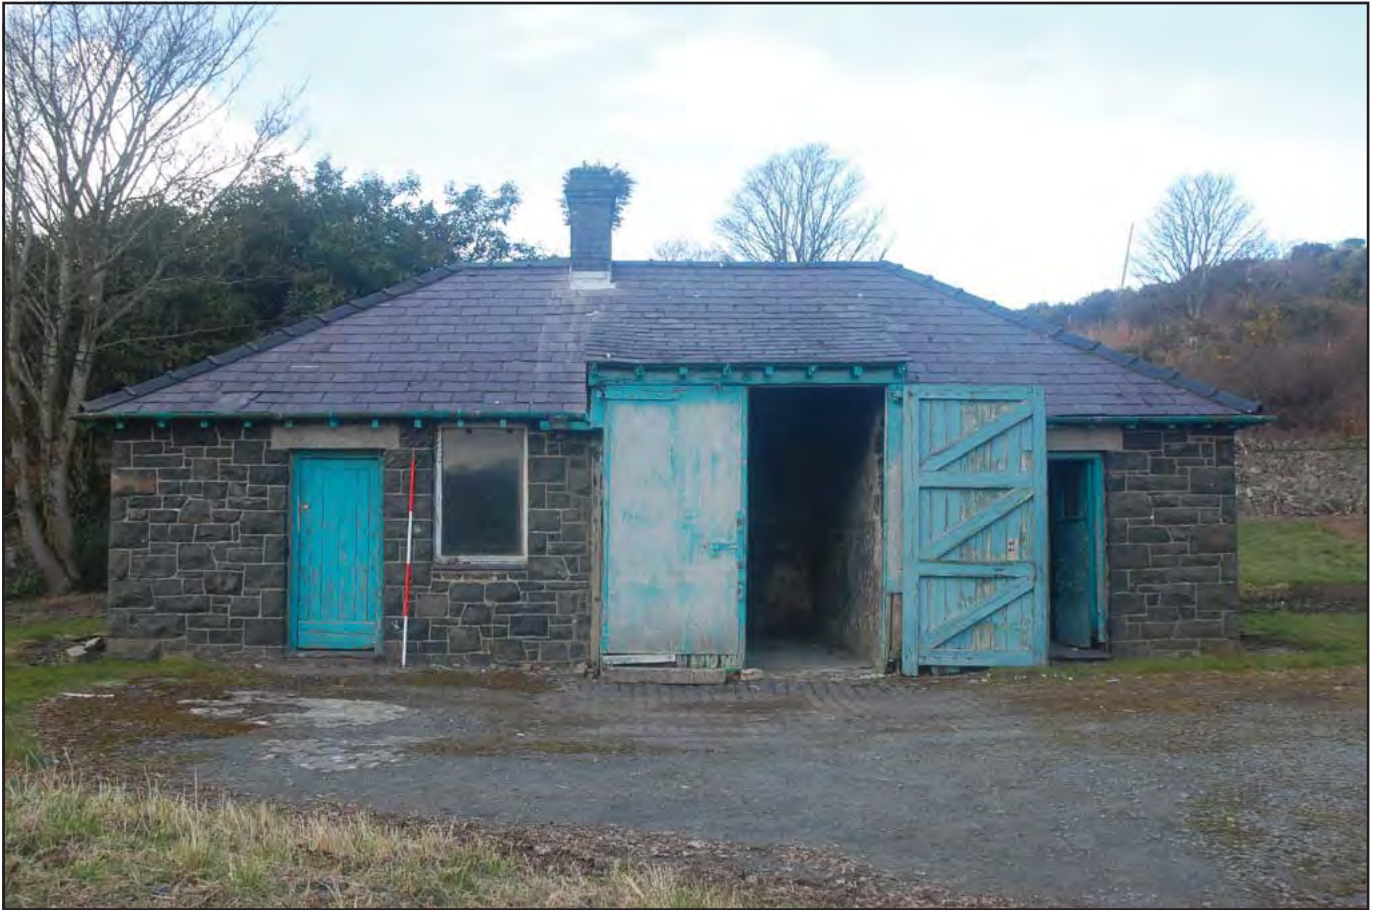
Plate 53: Garage - Southeast facing elevation; detailing main entrance via large panel and brace doors and two side entrances. Part of the original construction phase along with Long Stay Unit, Water Tower and Administration Block, with similar building detail including sub-rectangular stonework, stone lintel and quoin edging.  
(Scale: 1 x 2.0m)

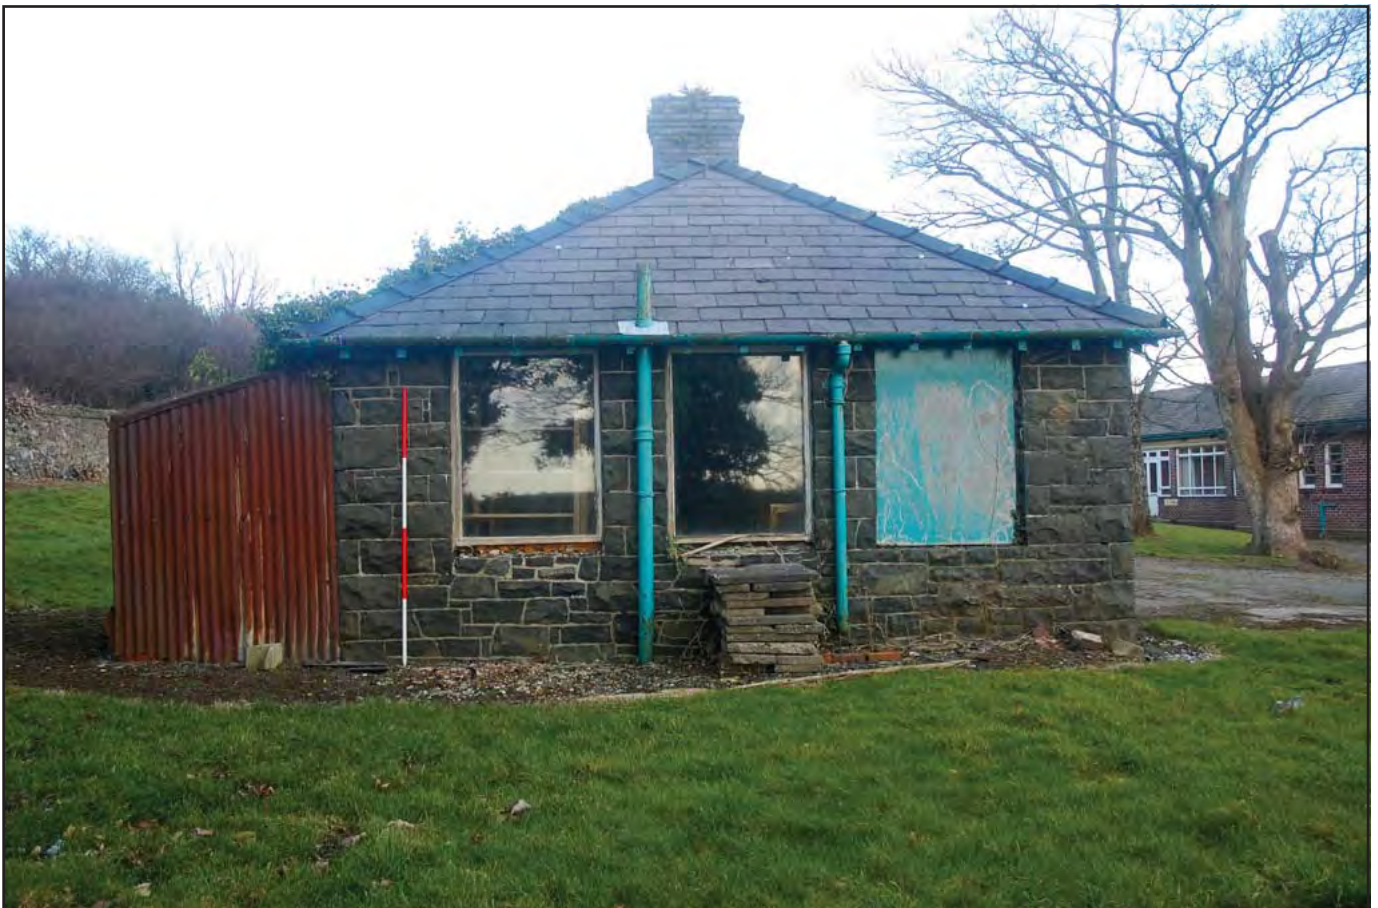
Plate 54: Garage - Southwest facing elevation detailing three fixed windows, hip gable roof and brick built chimney. The corrugated lean to is a later addition  
(Scale 1 x 2.0m)
