# MINFFORDD HOSPITAL, BANGOR GWYNEDD: ARCHAEOLOGICAL BUILDING RECORD

## Archaeological Building Record: Level 2/3

GAT Project No. 2125

Report No. 872

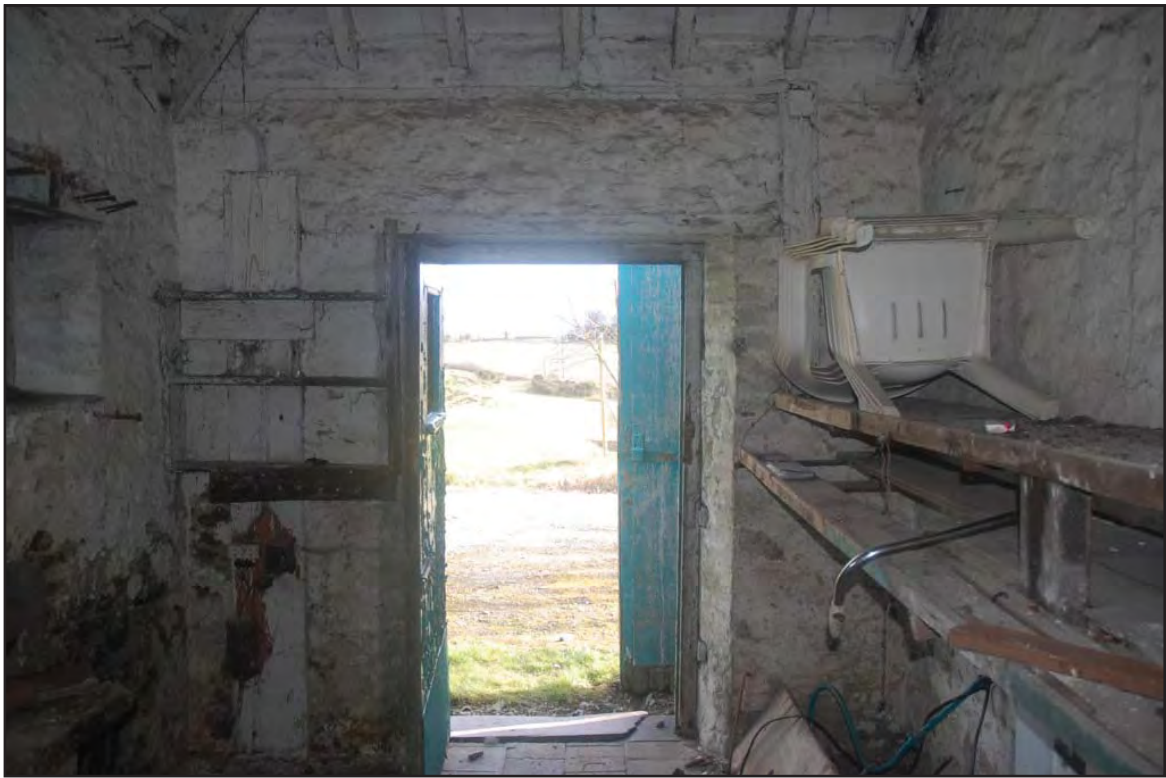
Plate 55: Garage (Internal): View south of side entrance room (cf. external view Plate 50) detailing interior finish and usage. Roughcast walls, whitewashed and exposed rafters visible. Various fittings also present facilitating it's use as a store.

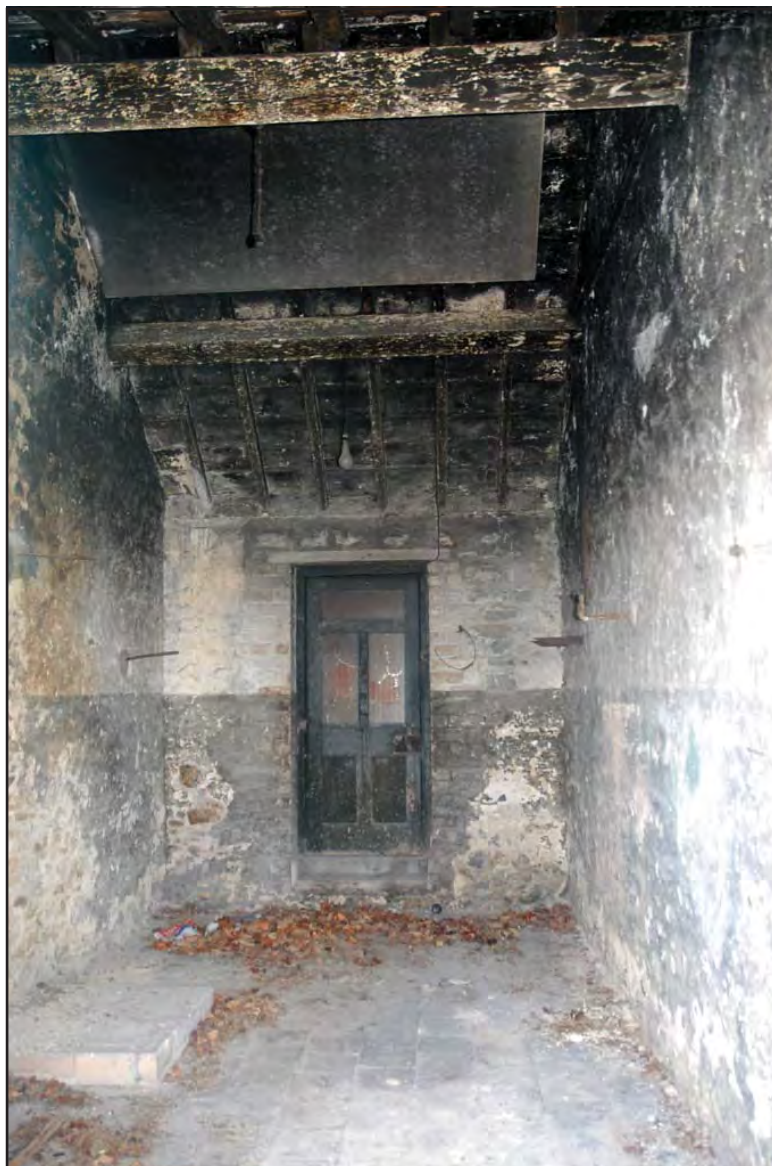
Plate 56: Garage (Internal): View northwest of main room interior detailing decor and usage: quarry tile floor, fireplace (?) plinth and roughcast walls. Rear door visible brick repair surround suggesting the door/entrance has been rebuilt or reused.

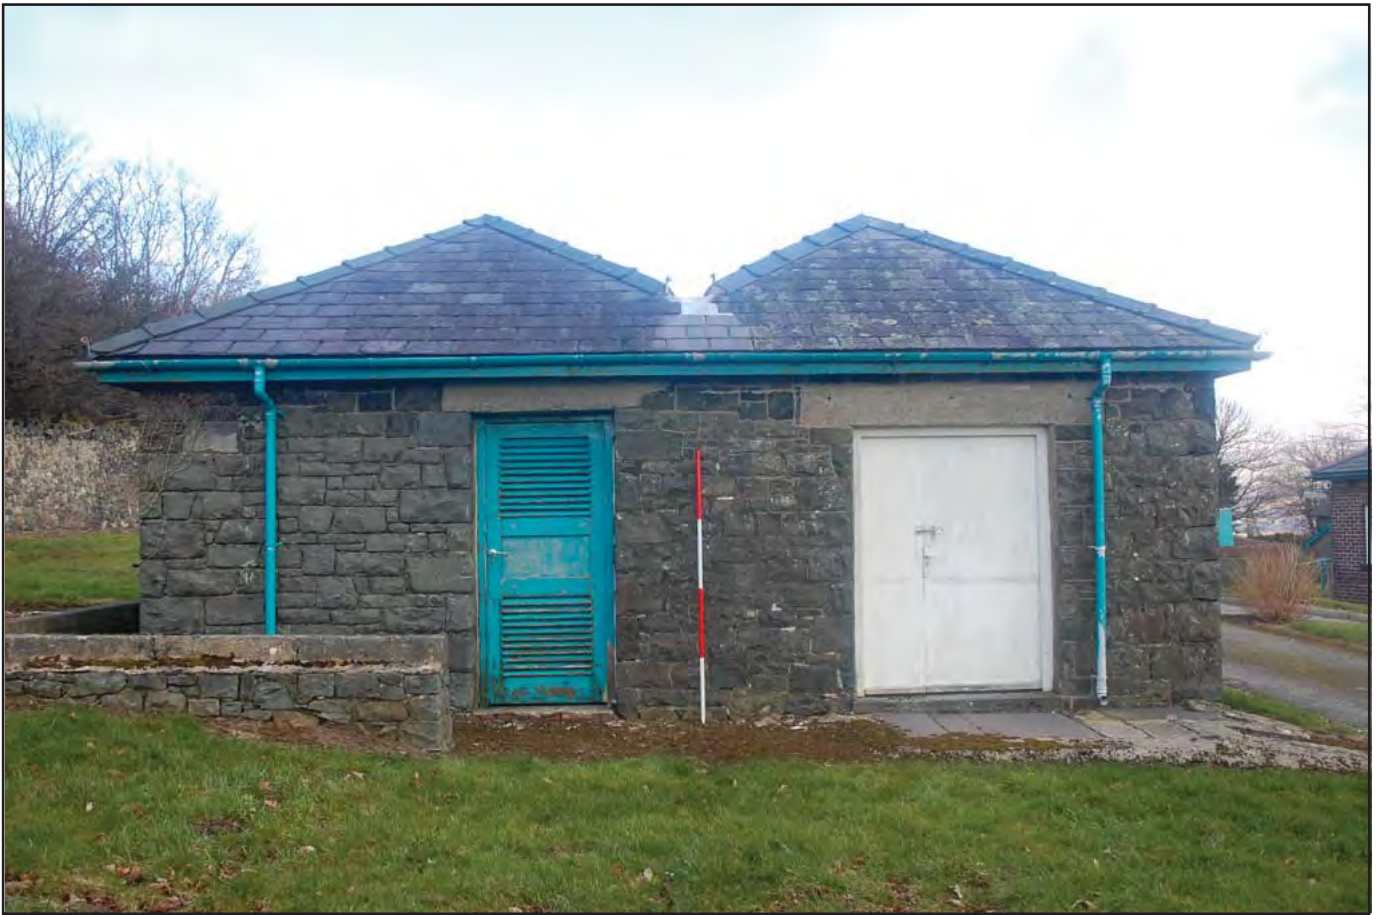
Plate 57: Generator Room: Northwest facing elevation detailing main entrance (large door) and louvered entrance. Double hip gable roof. The generator room was built between 1900 and 1914. An extension was later added, indicated by where the gables meet in the middle. The stonework on the left side of image is slightly different in appearance to the right side, indicating the extended portion. (Scale: 1 x 2.0m)

##### Northwest facing elevation (Plate 57)

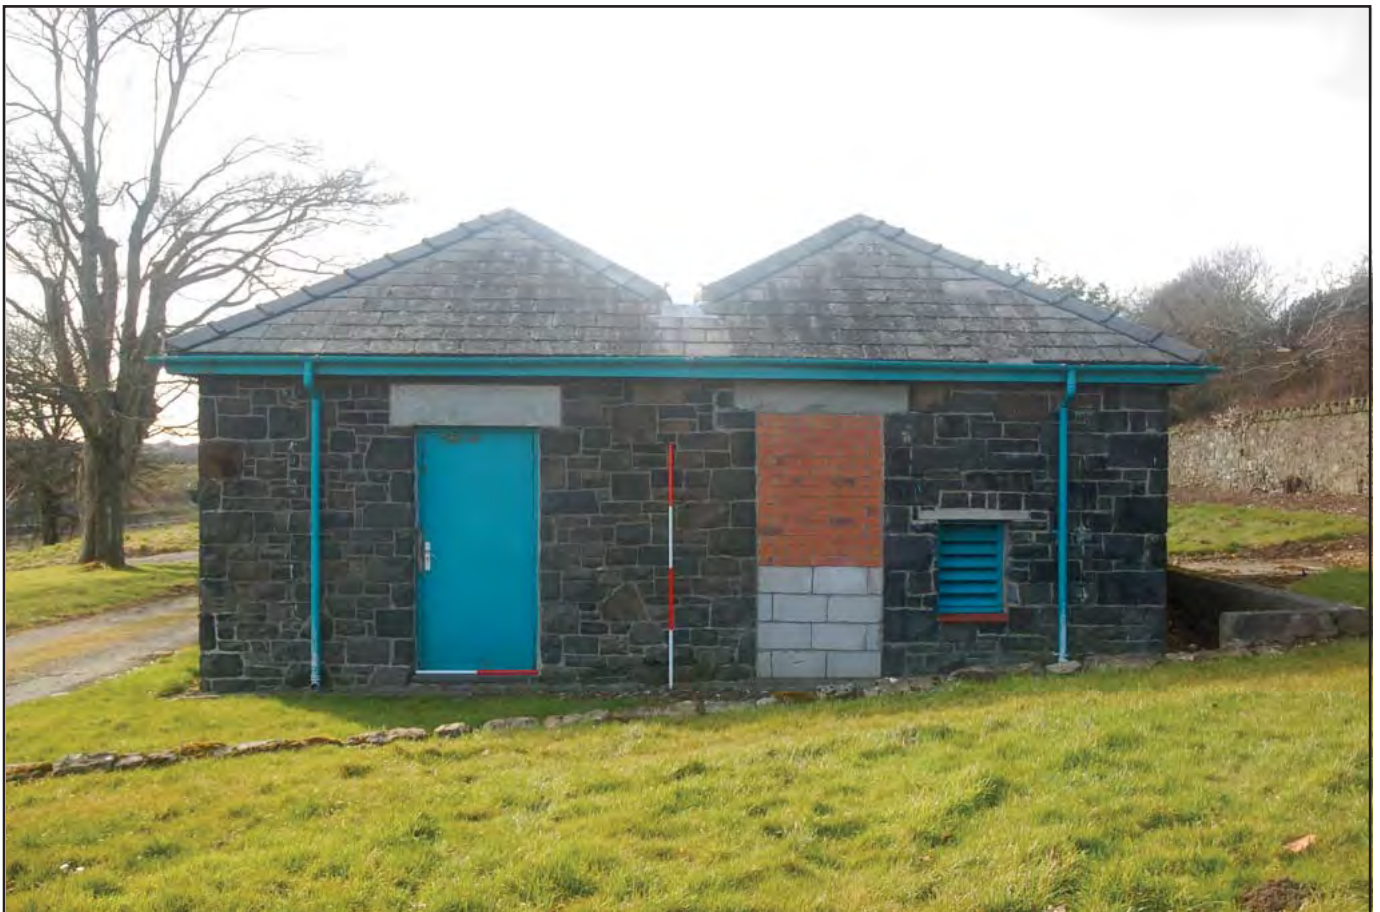
Plate 58: Generator Room: Southeast facing elevation detailing side entrance (blue door) and blocked entrance next to louvered vent. Double hip gable roof. The generator room was built between 1900 and 1914. The extension is indicated where the gables meet in the middle. (Scale: 1 x 2.0m; 1 x 1.0m)

##### Southwest facing elevation (Plate 58)

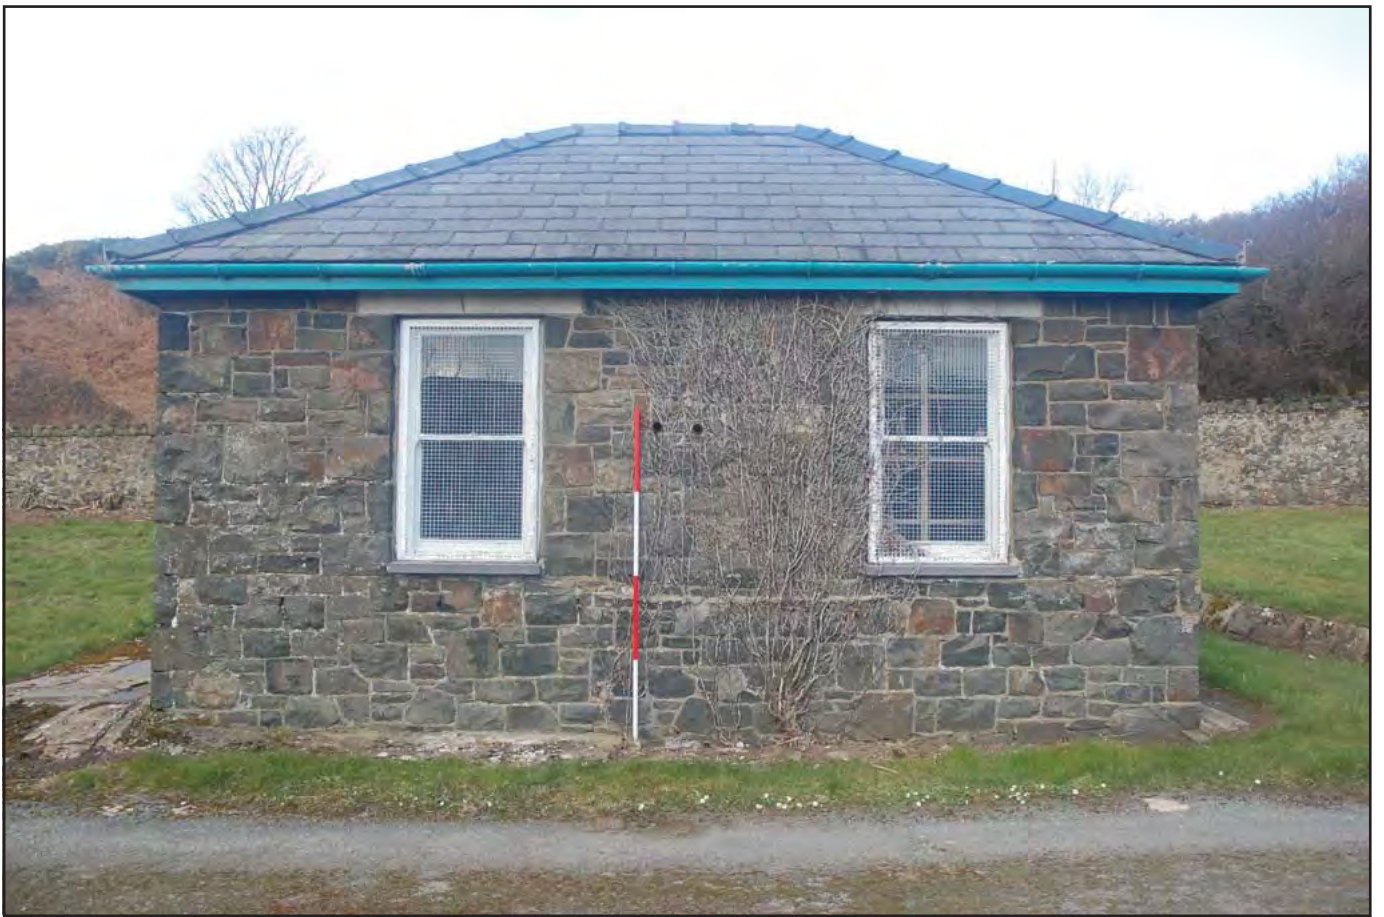
Plate 59: Generator Room: Southeast facing elevation detailing hip gable roof. The generator room was built between 1900 and 1914. An extension was later added (not visible). Stone lintel and quoins are present reflecting original building style for the hospital complex.  
(Scale: 1 x 2.0m)

##### Southeast facing elevation (Plate 59)

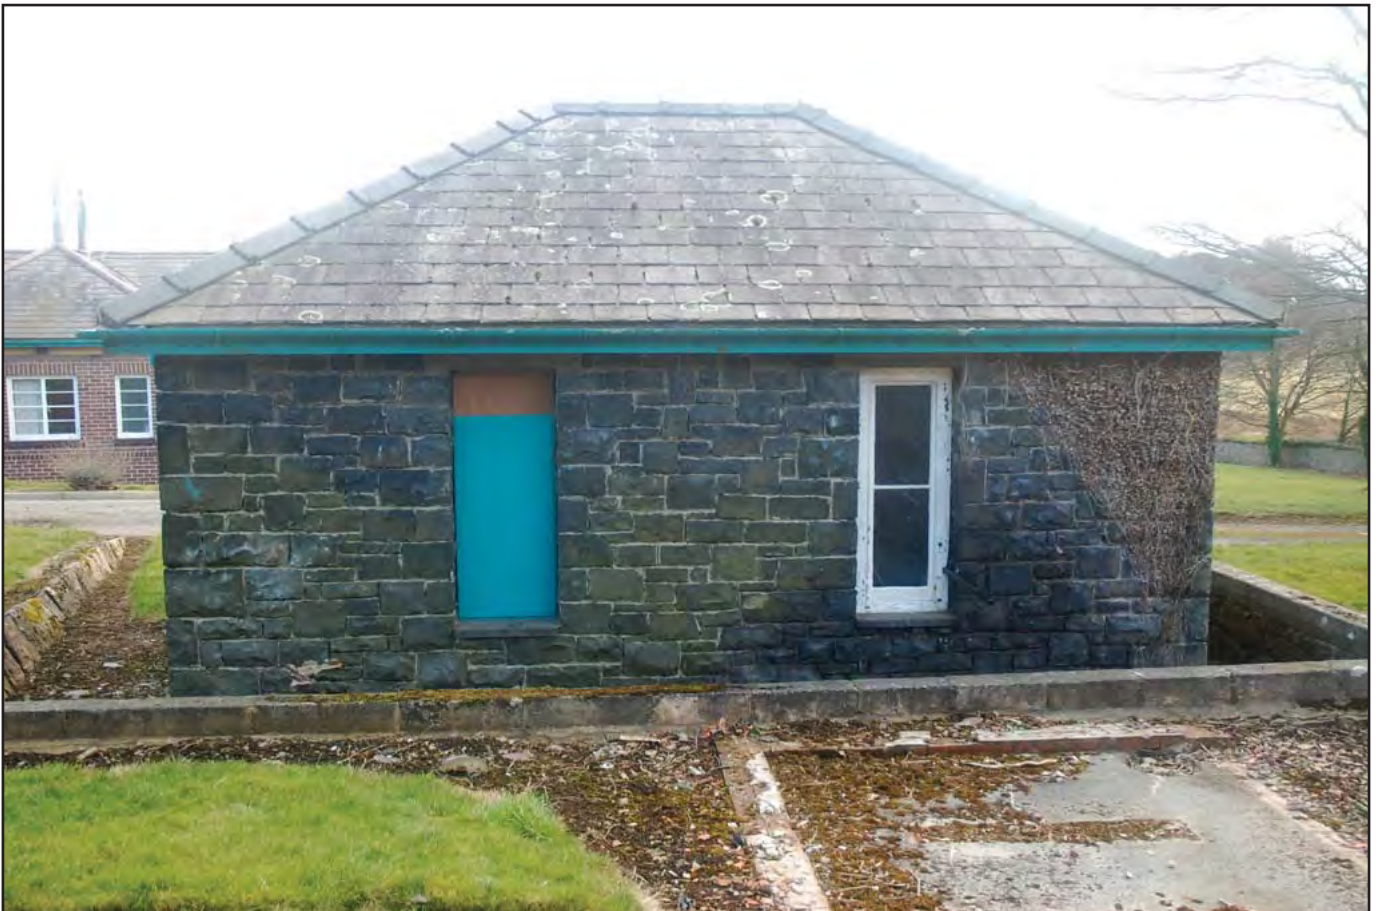
Plate 60: Generator Room: Northwest facing elevation detailing rear. This elevation represents the post-1914 extension, which has been benched into the slope. A later external platform has been built (bottom right of image), with brick surround that may have supported an upstanding piece of equipment. Note the rear of the Short Stay Unit to centre left of image.

##### Northeast facing elevation (Plate 60)

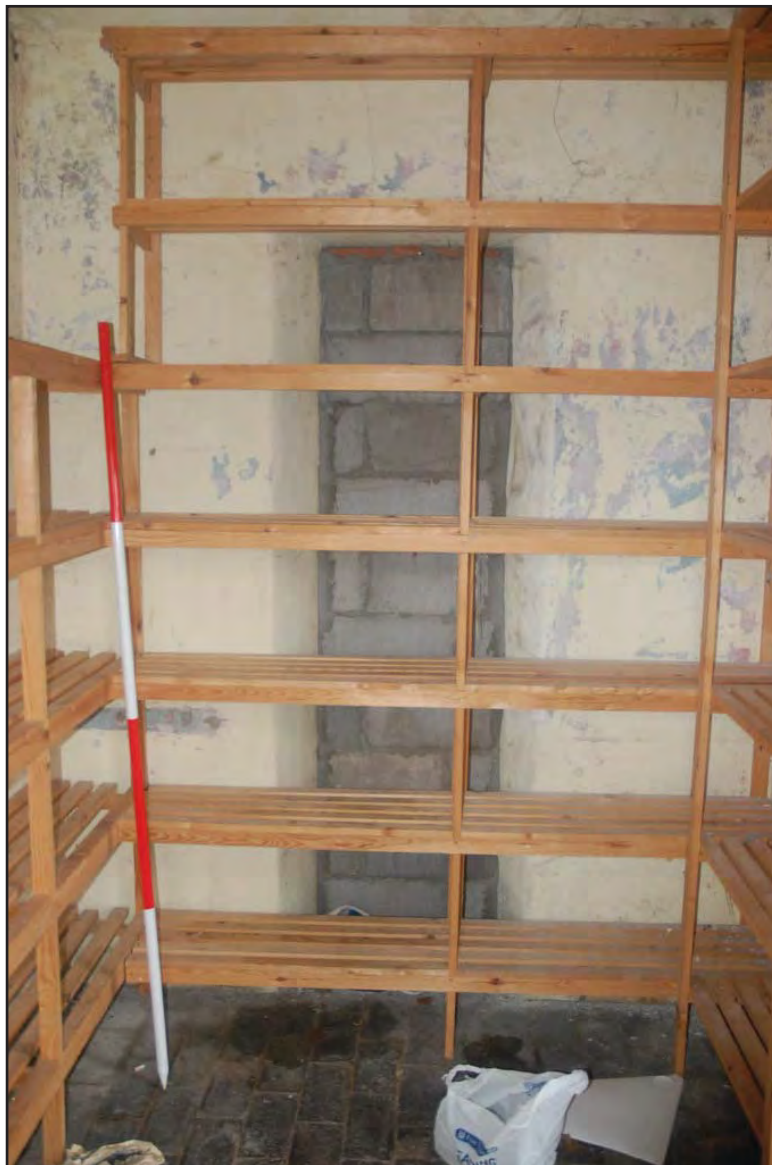
Plate 61: Generator Room (Internal) - View northeast of interior room, detailing decor and usage. Interior view of extension room. Note blocked window, visible from the outside in Plate 59. The floors are quarry tiles; the walls are rendered. Wooden shelving throughout room. (Scale: 1 x 2.0m)

##### G01 (Plate 61)

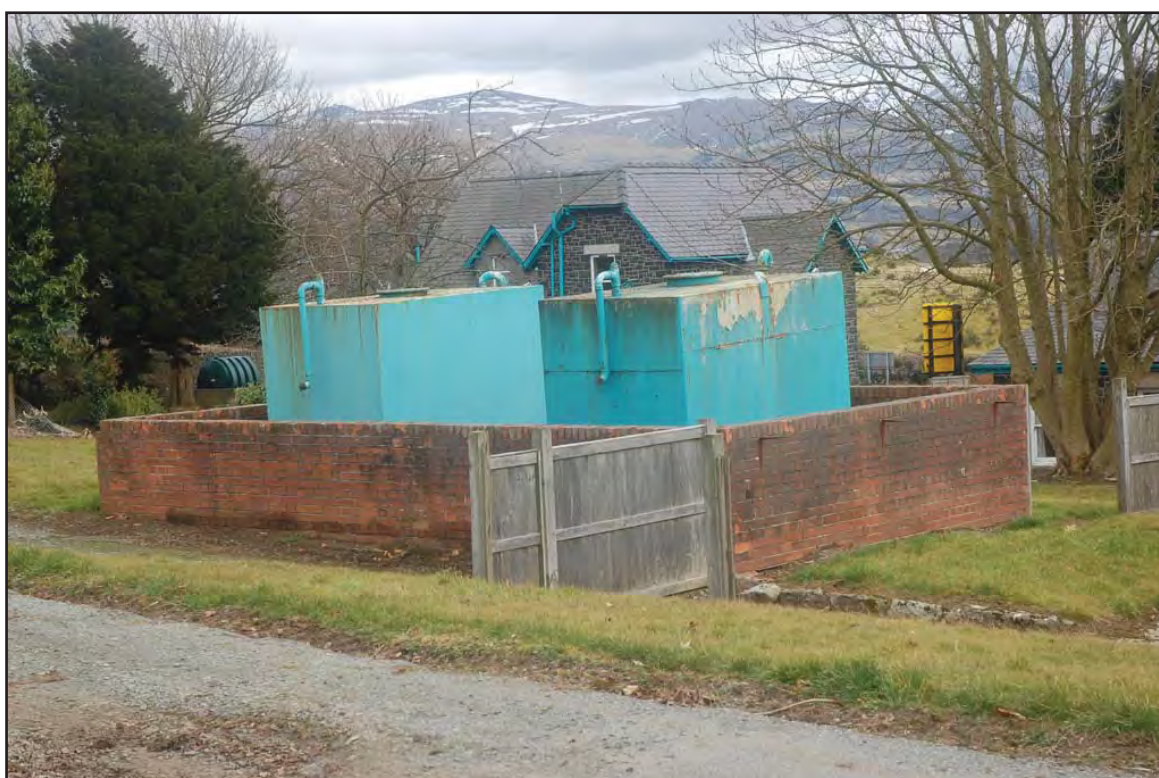
Plate 62: Oil Tanks: View southeast of oil tanks located towards rear of property. Enclosed by a low brick wall (Dearnies/Rat trap Bond). Accessed via site road that links all buildings within complex. Note administration block towards centre of image and views from the hospital site towards Snowdownia.

Two oil storage tanks (Plate 62) are located 10.97m to the northeast of the Short Stay Unit. The tanks are metal boxes enclosed by a 1.20m high Rat Trap bonded brick wall. The tanks are connected to the rest of the property via a tarmacadam path.

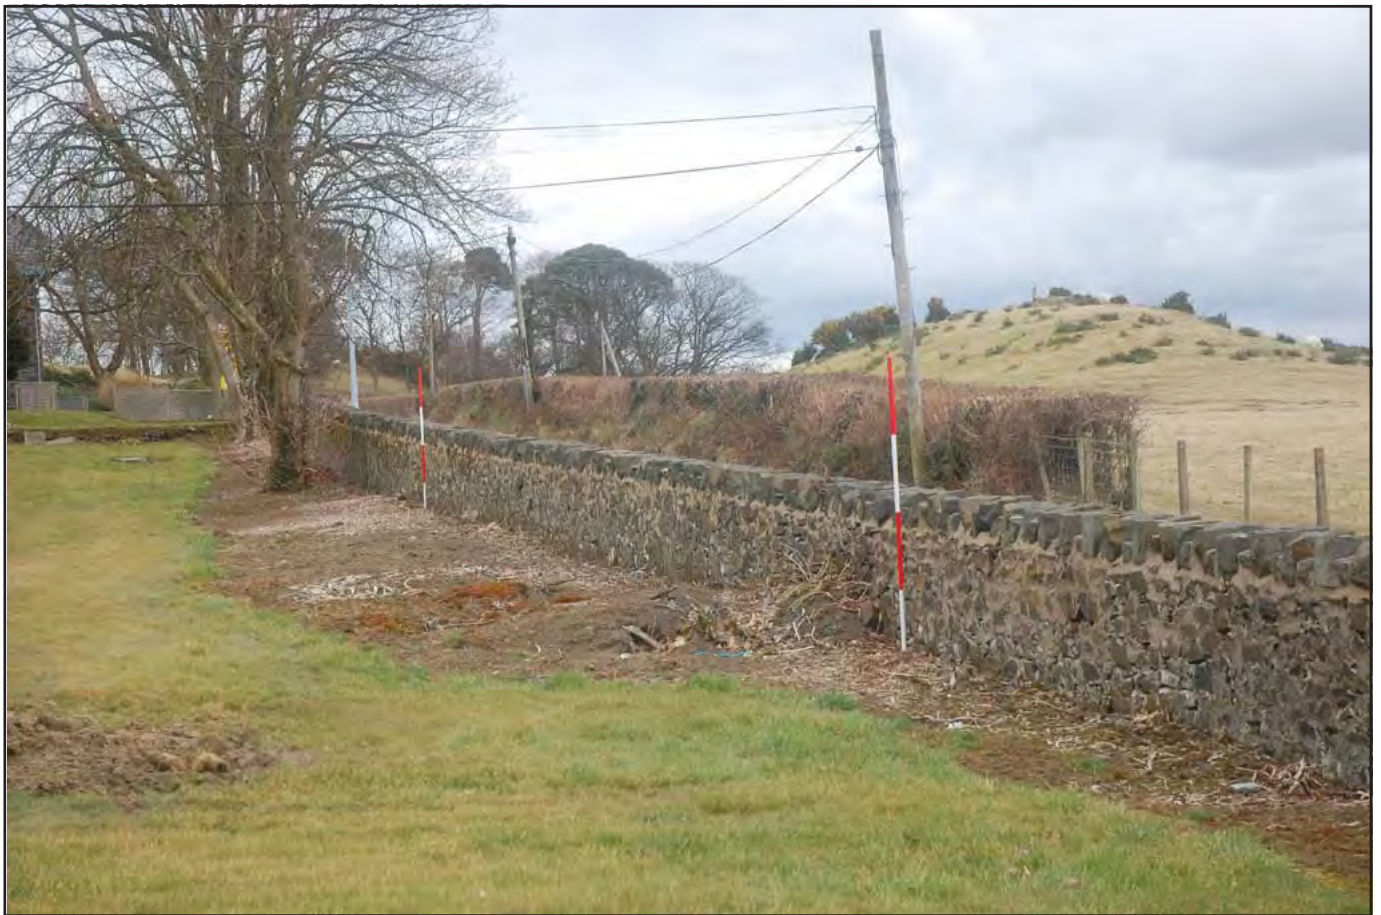
Plate 63: Boundary Wall - view south of portion running parallel to Hendrewen Road. Built from irregular shaped stone with a crenellated surmount. (Scale: 1 x 2.0m)

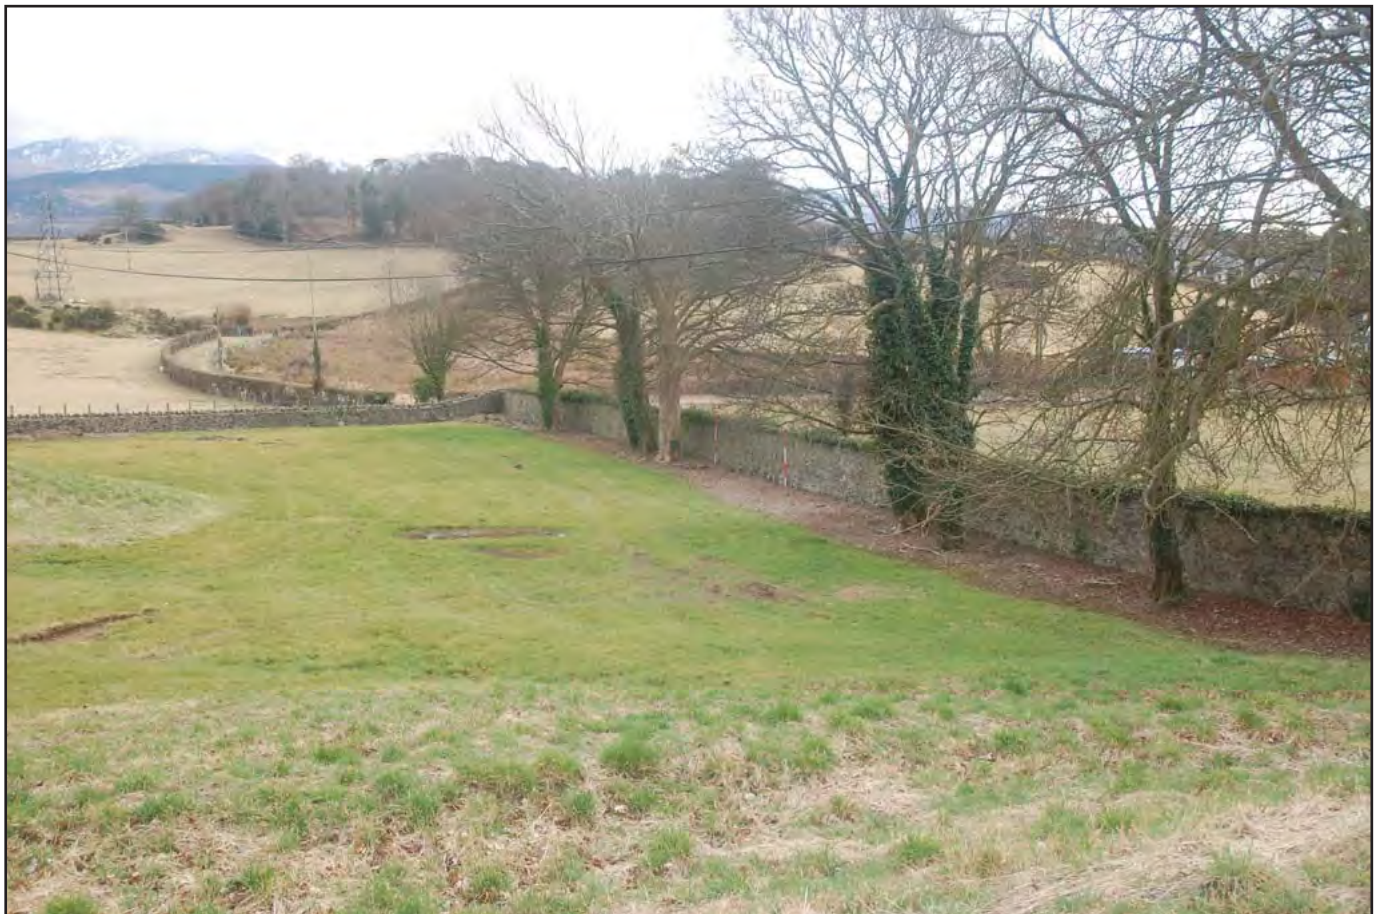
Plate 64: Boundary Wall - View southwest of southern and western boundary walls, detailing also the local views from the hospital complex and the hospital grounds. (Scale: 2 x 2.0m)

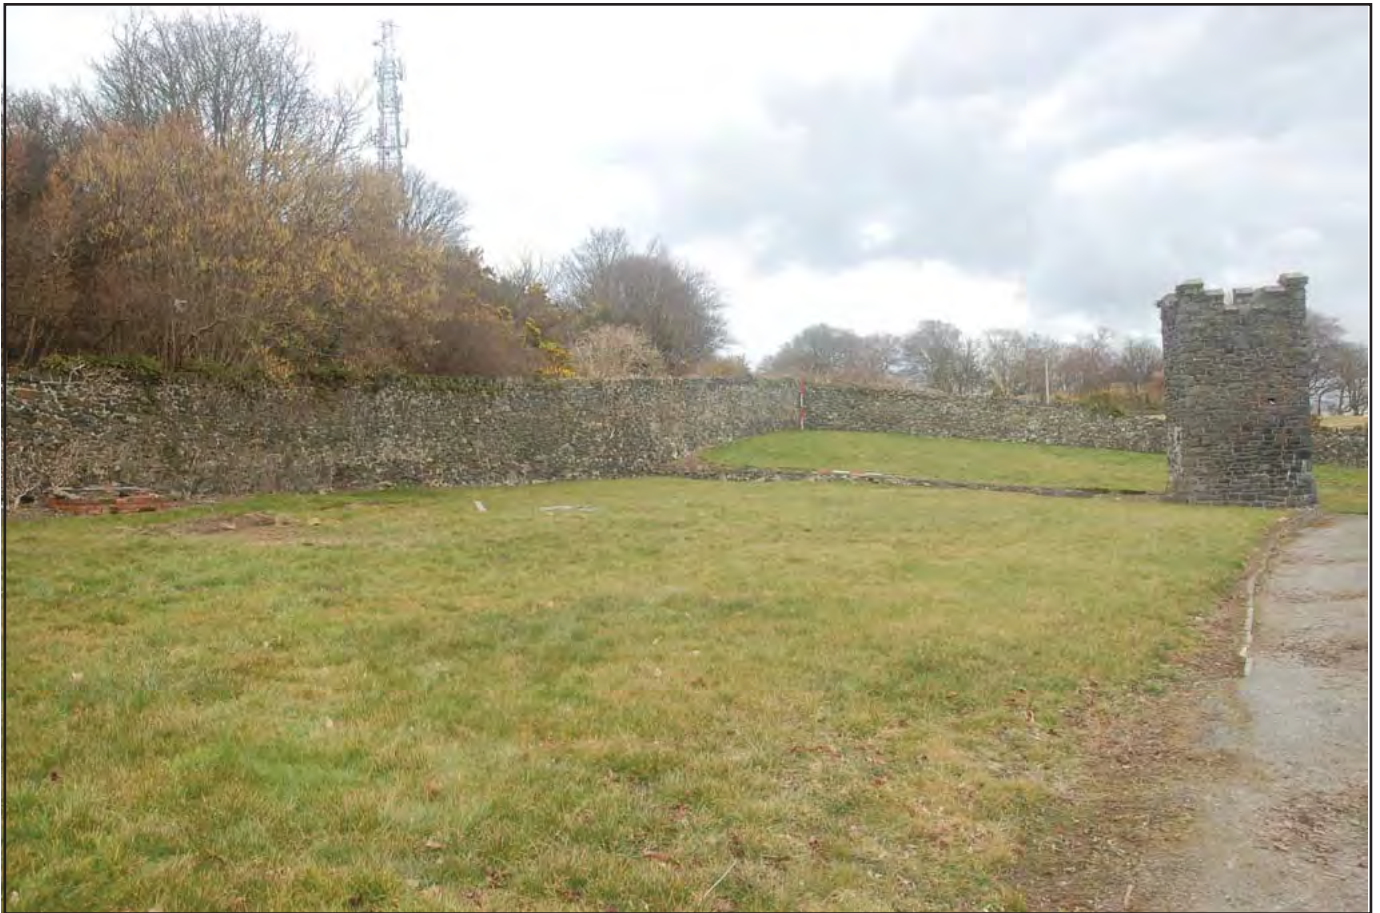
Plate 65: Boundary Wall - View east of rear portion including the former water tower. Note also the low-lying enclosed space between the wall and tower indicating a presumed garden space.  
(Scale: 1 x 2.0m)

As GAT was unable to access the inside of the water tower during the recording phase, it is recommended that a brief opportunity is made to inspect the interior during any development, where a photographic and written record could be completed as an addendum to the existing report.

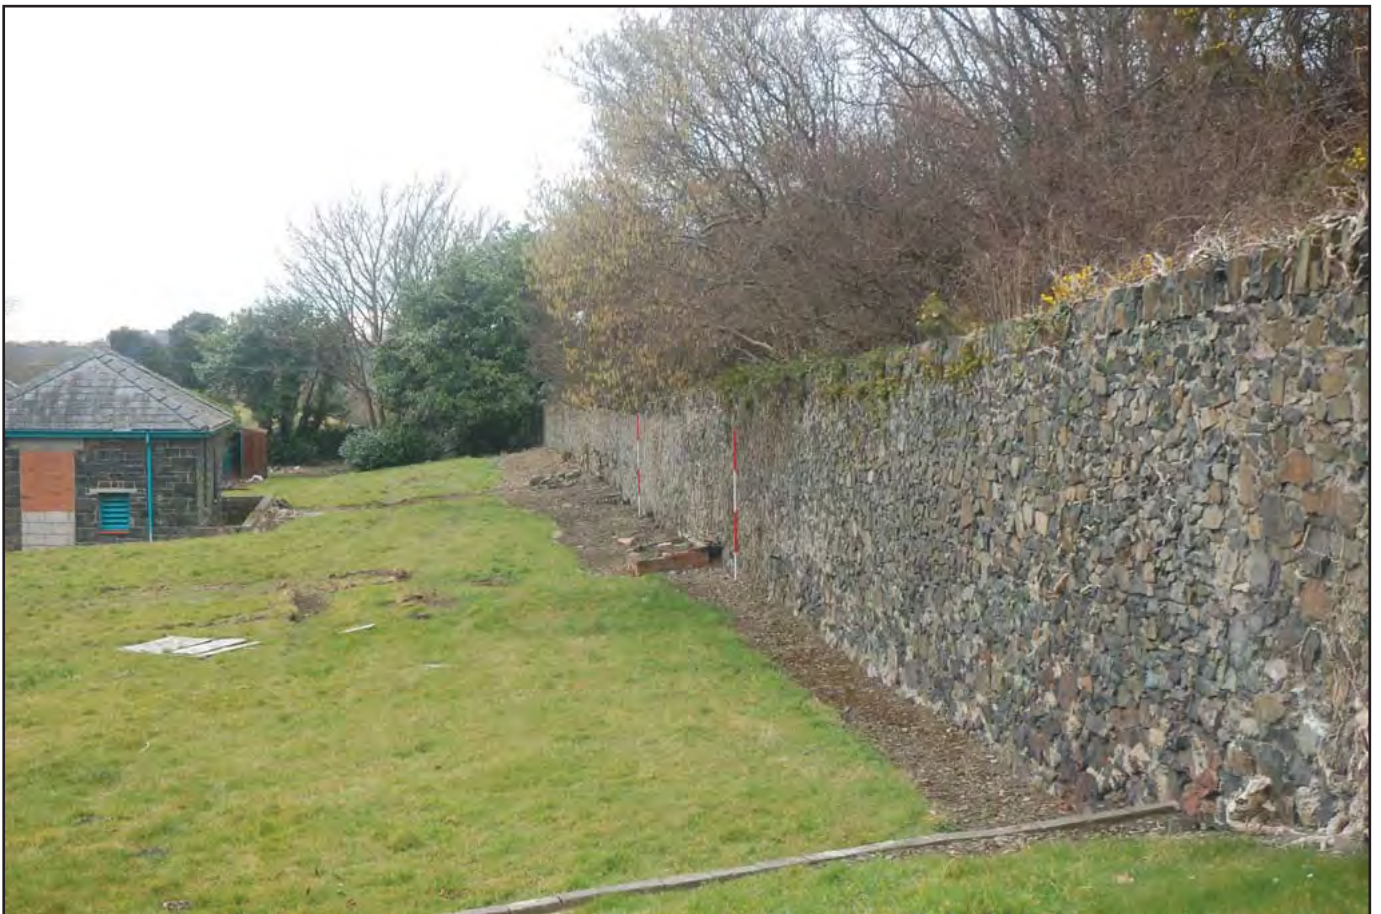
Plate 66: Boundary Wall - View west of rear portion, detailing construction (irregular stones and crenellated surmount) and height (2.50m max). Note the generator in image left and gravel path running along the base of the wall.  
(Scale: 2 x 2.0m)

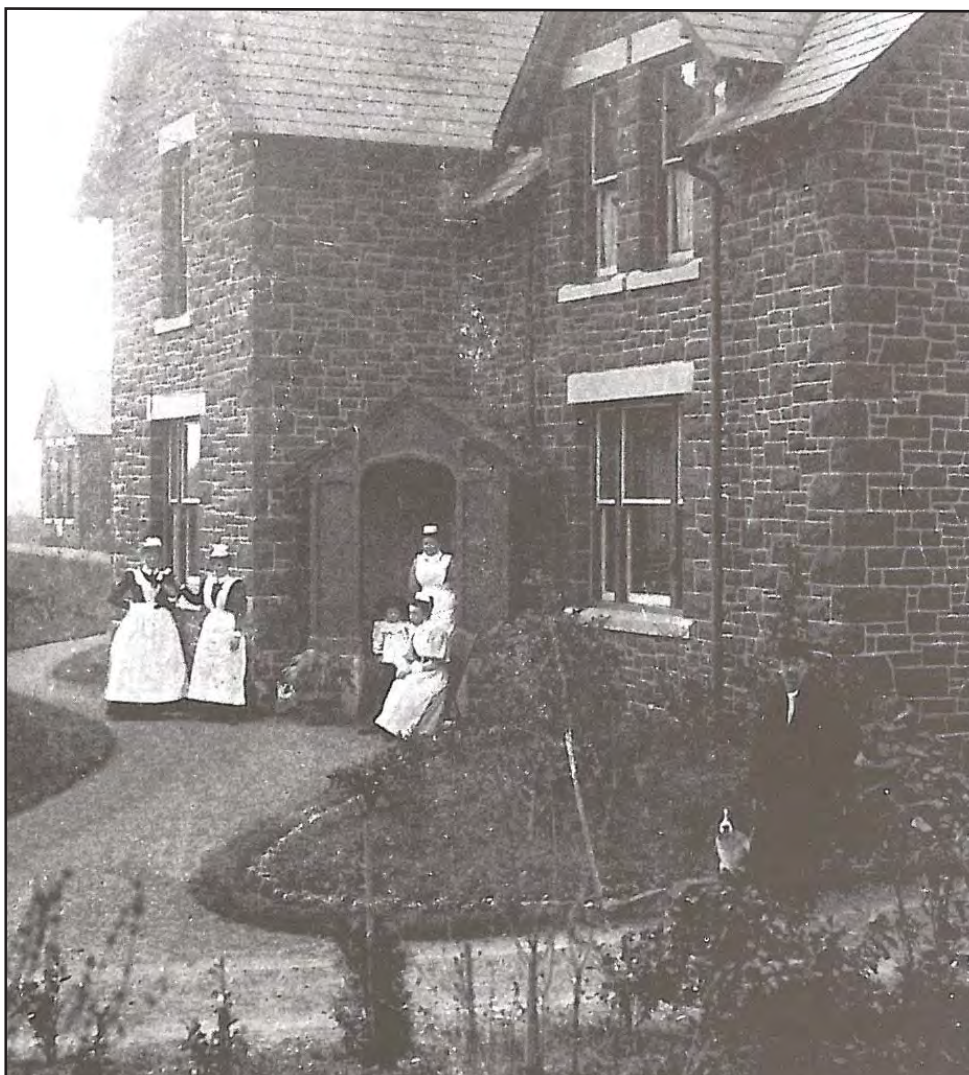
Plate 67: Administration Block - archive image from the nineteenth/early twentieth century detailing main entrance. The entrance porch has since been removed (cf. Plate 42); the front garden and path have been replaced with tarmacadam; the windows with modern sash replicas. A modern fire escape stairwell is now present linking the first floor parallel sash windows to the ground level; one of the two windows is now a fire escape door (Source: Roberts & Evans, 1995)

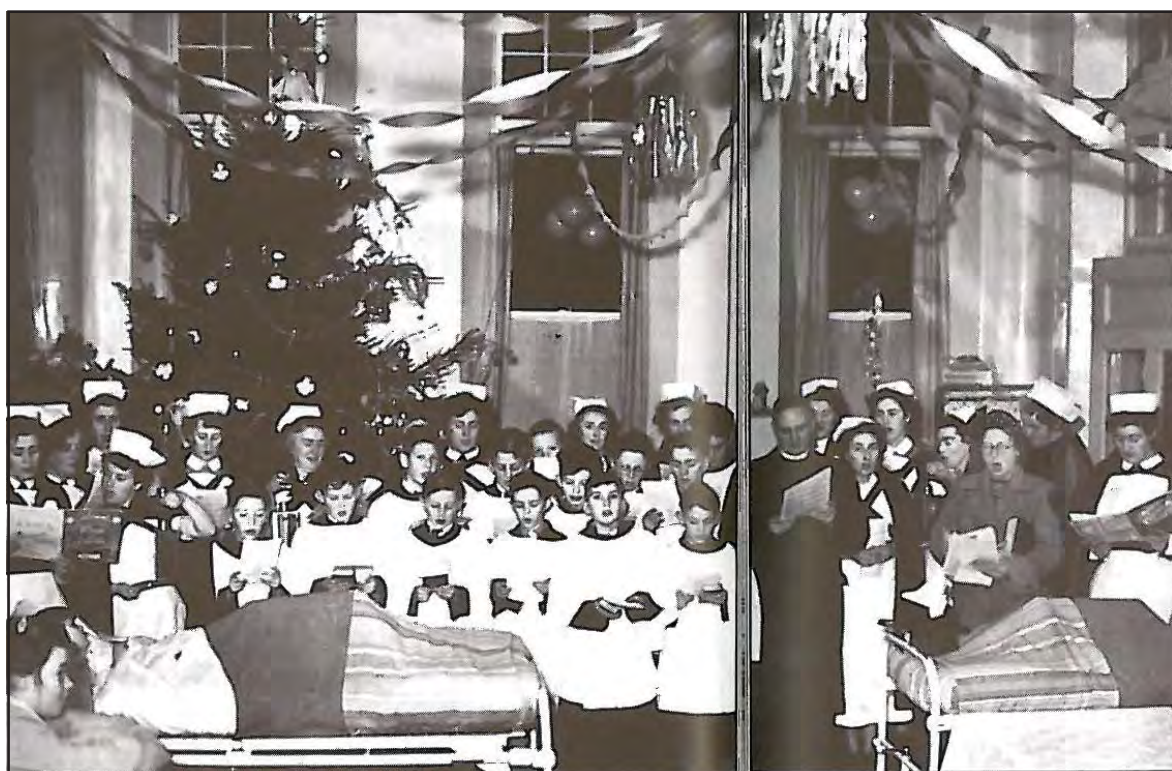
Plate 68: Long Stay Unit - archive image from the mid-twentieth century detailing one of the main wards during a Christmas celebration. Possibly Room G01 (q.v.; Plates 09 & 10) as room entrance is from the right of image, as with Plate 09. The original ceiling height is visible in this image, with the full height of the three sash windows exposed. The ceiling height was subsequently reduced and a suspended ceiling installed. The Georgian bar style upper portion of the sash windows were subsequently blocked (cf. Plate 05), with the remainder of the windows looking into a veranda style extension. (Source: Roberts & Evans, 1995)
