Conwy Valley Flood Alleviation Scheme: **Llanrwst, Gwynedd**

Archaeological Excavation:
Demountable Trenches 1-3 Llanrwst

CONWY VALLEY FLOOD ALLEVIATION SCHEME LLANRWST DEMOUNTABLE TRENCHES 1-3

Gwynedd Archaeological Trust Report No. 873

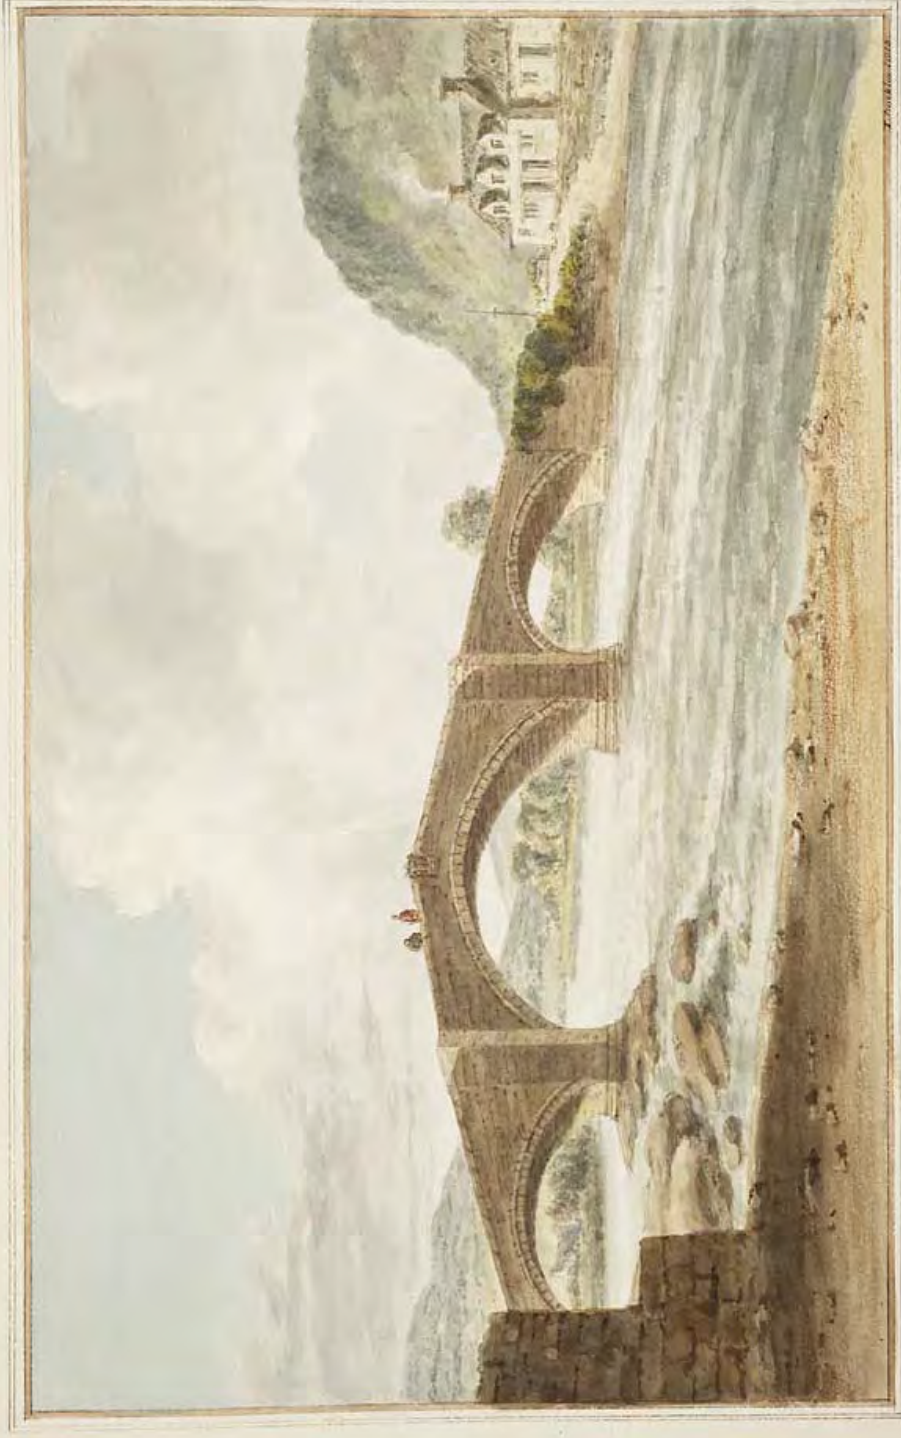
Llanrwst Bridge.

Fig. 3 Print of Llanrwst Bridge by John Buckler (NLW Drawing Volume 85)

The road, later turnpiked, into the town from the south (Mostyn MSS 8534; Mostyn MSS S8535; Figs. 4 and 5) had a metalled cobbled surface in the 18th century, and rose steeply as it approached the Bridge, and Bridge Street leading into the town, which is shown on the late 18th century print (Fig. 3).

The identification of the parapet of the 1636 Bont Fawr indicates that there has been significant survival of the original angled bridged parapet, which is shown on the Buckler print (Fig. 3), and many other late 18th century images. Archaeological evidence for the raising of the river bank and the revetment wall in 1794 was also evidenced.

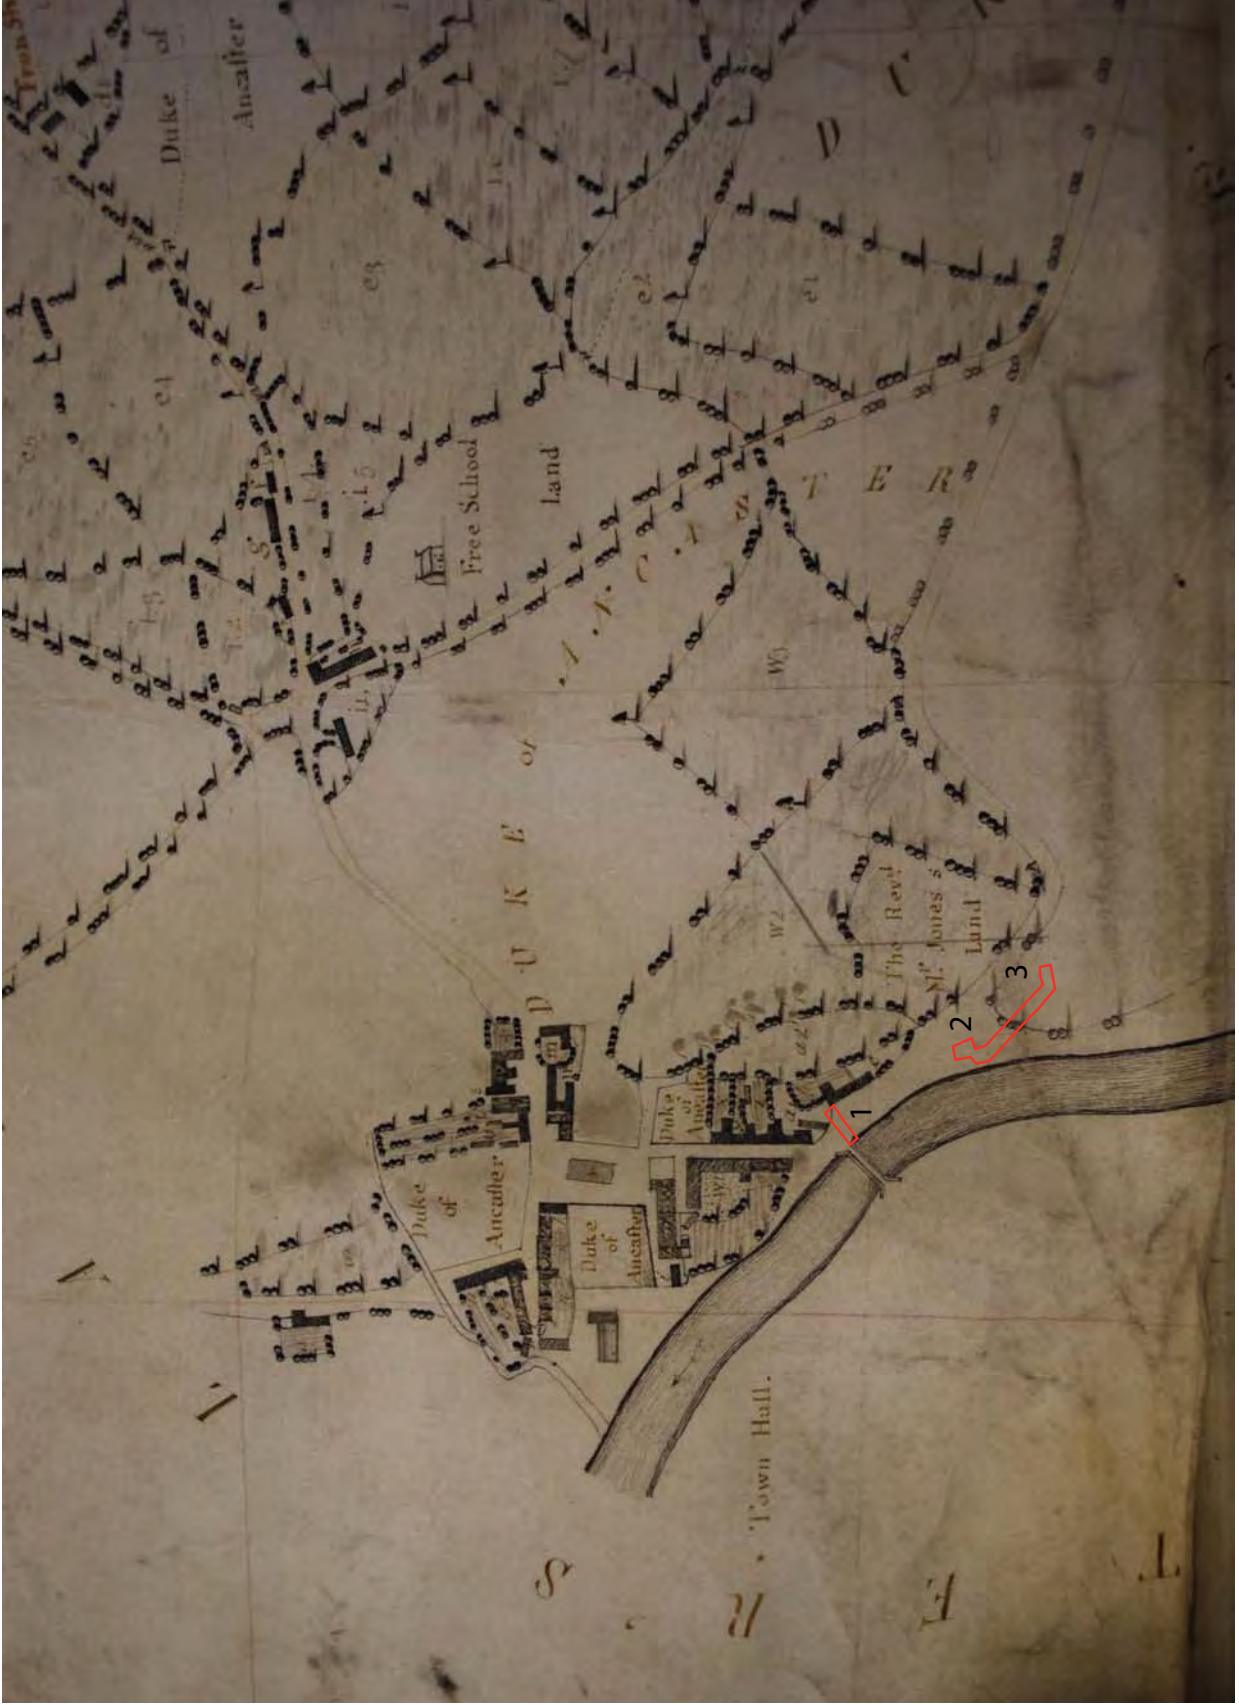
Fig. 5 Location of demountables 1-3 overlain on Mostyn estate maps of the 1770s (Mostyn MSS S8535)

The lack of other archaeological features in trench 4 (Demountable 3) can be explained by the fact that the area was an open field, as shown on figs. 5 and 6, and there is no evidence for development in this area until the garage and other services arrived in the mid 20th century.

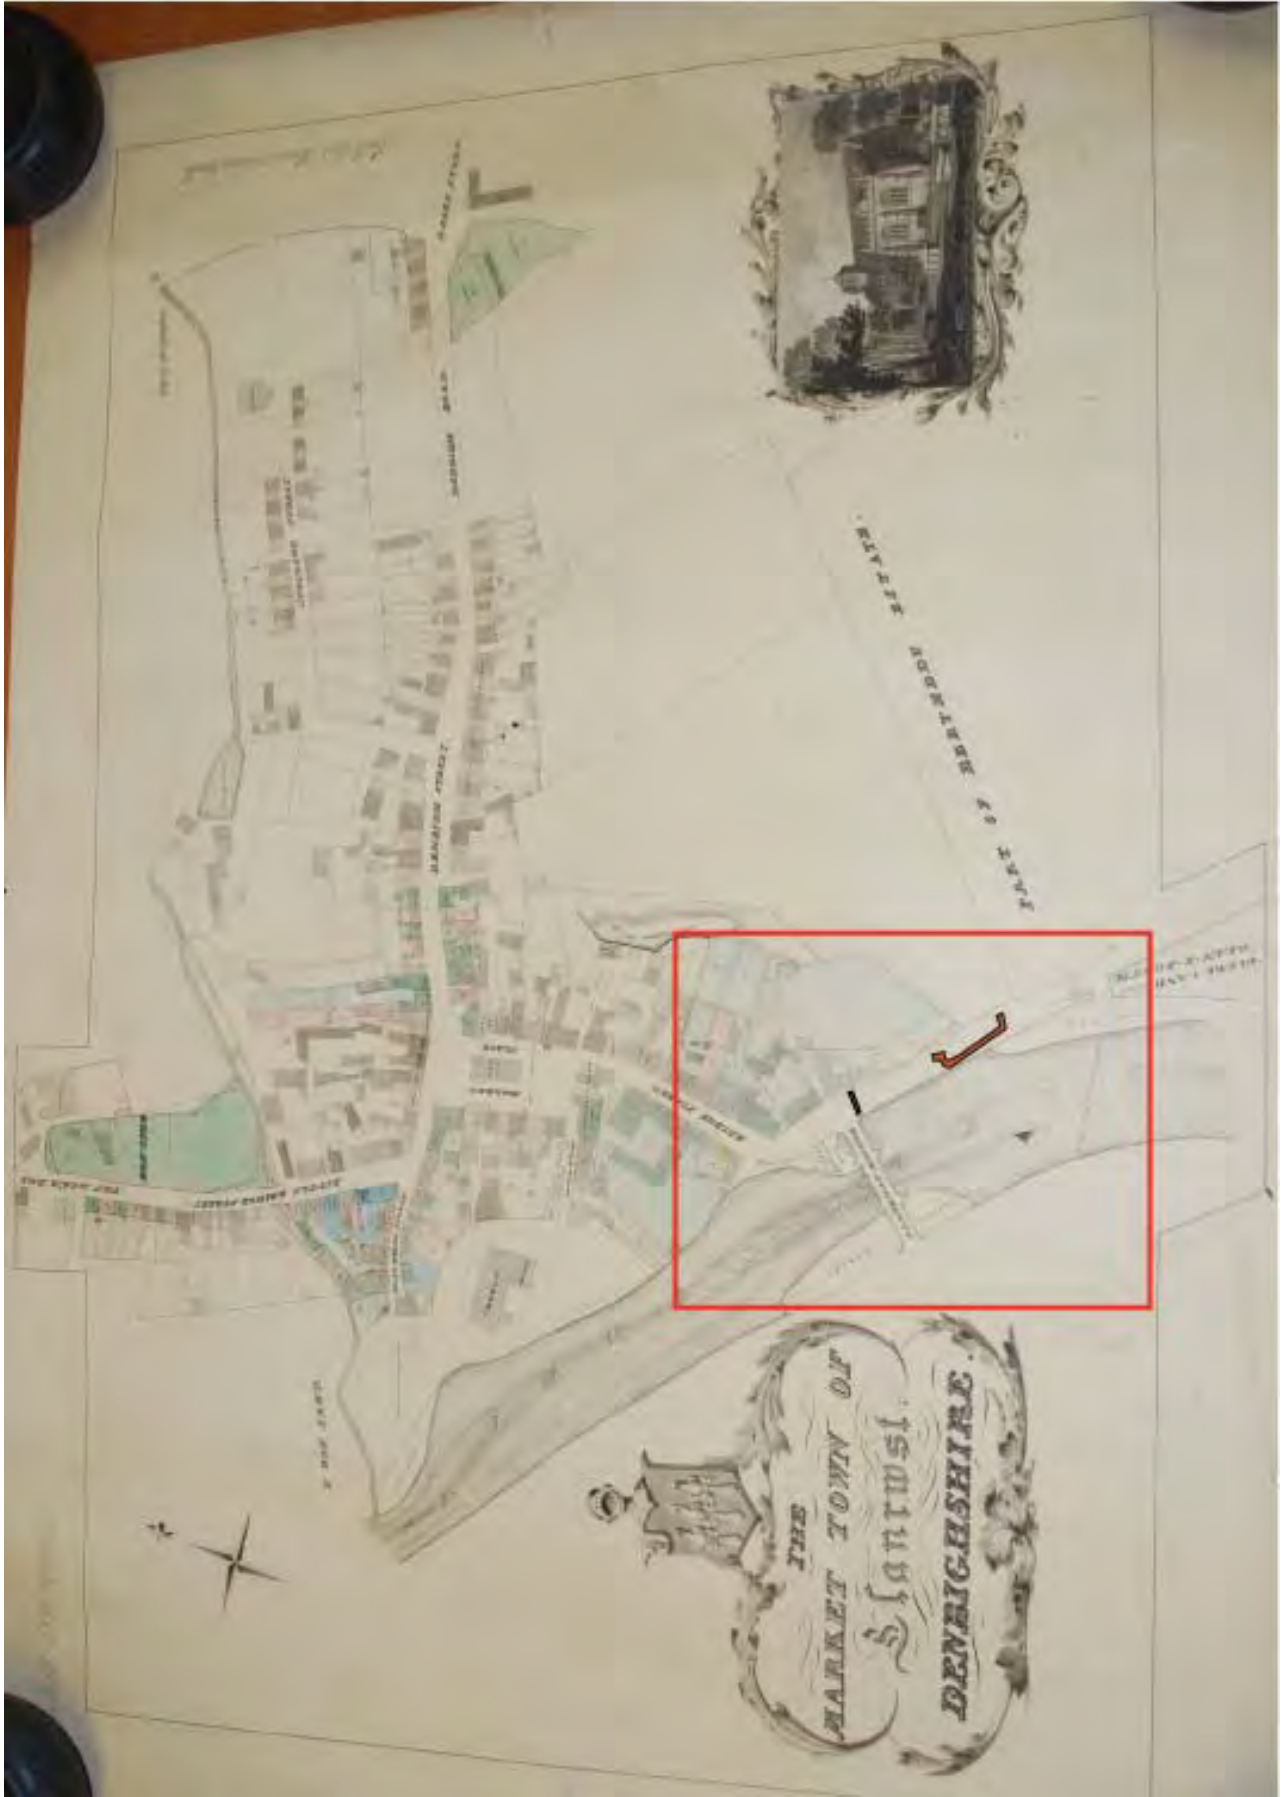
Fig. 6 Demountable Trenches overlain on Mostyn MSS 8534 The Market Town of Llanrwst, Denbighshire. Area of town discussed in text outlined in red

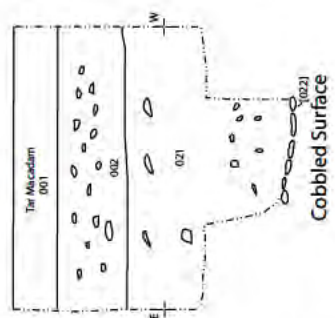
Fig. 8 Trench 3, Demountable 2 Cobbled road surface

Below a grey gravel sub surface (002), a make-up deposit, 0.6m thick, a dark orangey brown silty clay with medium rounded and sub angular stones (021), which had been removed by the contractors overlay a cobbled floor surface (022), made of rounded stones up to 0.4m across (Fig. 8; Plates 7-8). The extent of the cobbled surface was difficult to determine as it extended over the full open area of the trench, however it was cut by the construction cut of the building to the east, currently a solicitor's office. The cobbled surface was laid on a bed of sand (039) on a make-up layer of dark brownish grey silty clay (040), 0.68m deep, with small to large rounded and sub angular stones. This overlay mid orangey brown silty clay, probably caused by alluvial silting, which is of unknown depth (041). It is likely that this was caused by periodic flooding of the Afon Conwy.

A cobbled road surface (022) was noted below a substantial make-up layer (021). This is likely to be the same road surface seen in the demountable 1 trench, and shown on the mid 18th century estate map (Fig. 3). To the south in demountable 3 the area was open fields until into the 20th century (Fig. 4) and no archaeological deposits were encountered. This overlay a deep make-up clay deposit where the bottom of the deposit was not seen (041). This would appear to have been created by a long period of alluvial silting, as suggests that prior to the construction of the road the river was wider at this southern part of the town.

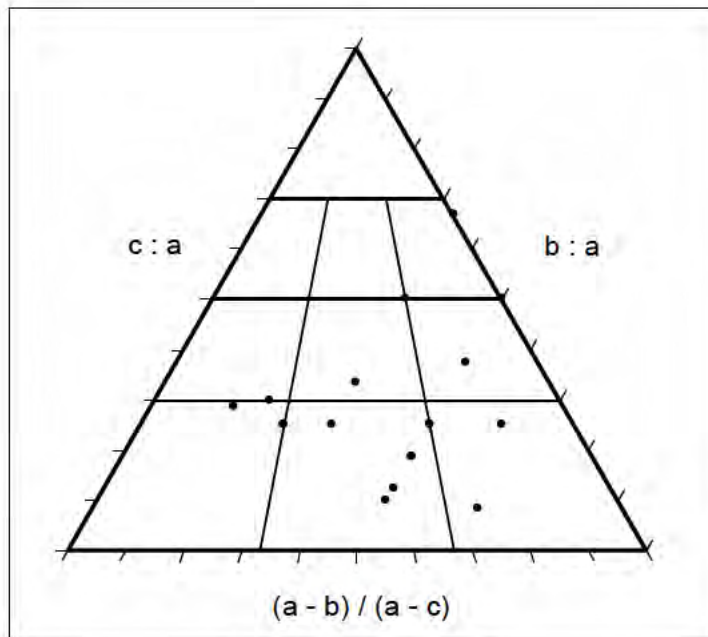
Sample 1001: sphericity

6 Assessment of the sphericity of the Gravel and Pebble grades based on the Wentworth Scale

Sneed and Folk classes	Sample 1001		Sample 1002	
	Count	Percent	Count	Percent
Compact	0	0.00	0	0.00
Compact-Platy	0	0.00	0	0.00
Compact-Bladed	0	0.00	1	5.88
Compact-Elongate	2	11.11	0	0.00
Platy	0	0.00	2	11.76
Bladed	2	11.11	2	11.76
Elongate	2	11.11	4	23.53
Very-Platy	2	11.11	2	11.76
Very-Bladed	8	44.44	5	29.41
Very-Elongate	2	11.11	1	5.88

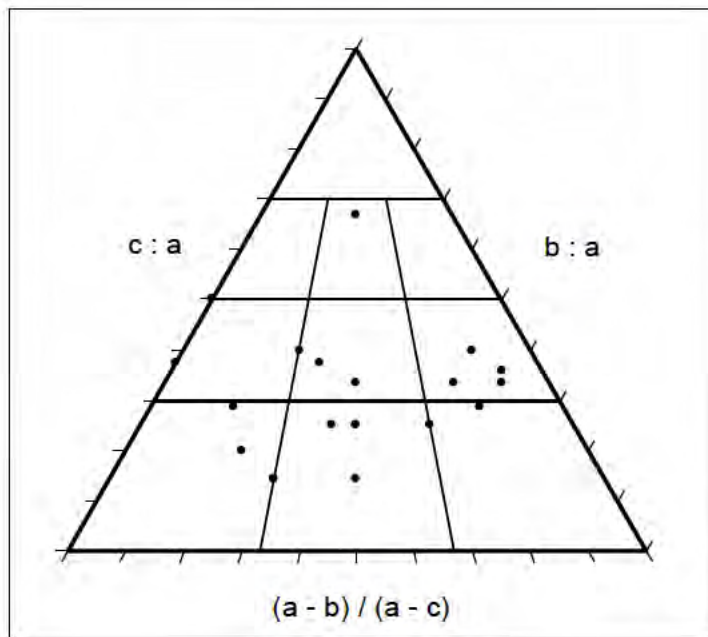
Sample 1002: sphericity
