FAIRBOURNE FLOOD ALLEVIATION SCHEME: Ground Investigation Programme

Archaeological Watching Brief

GAT Project No. 2127

Report No. 877

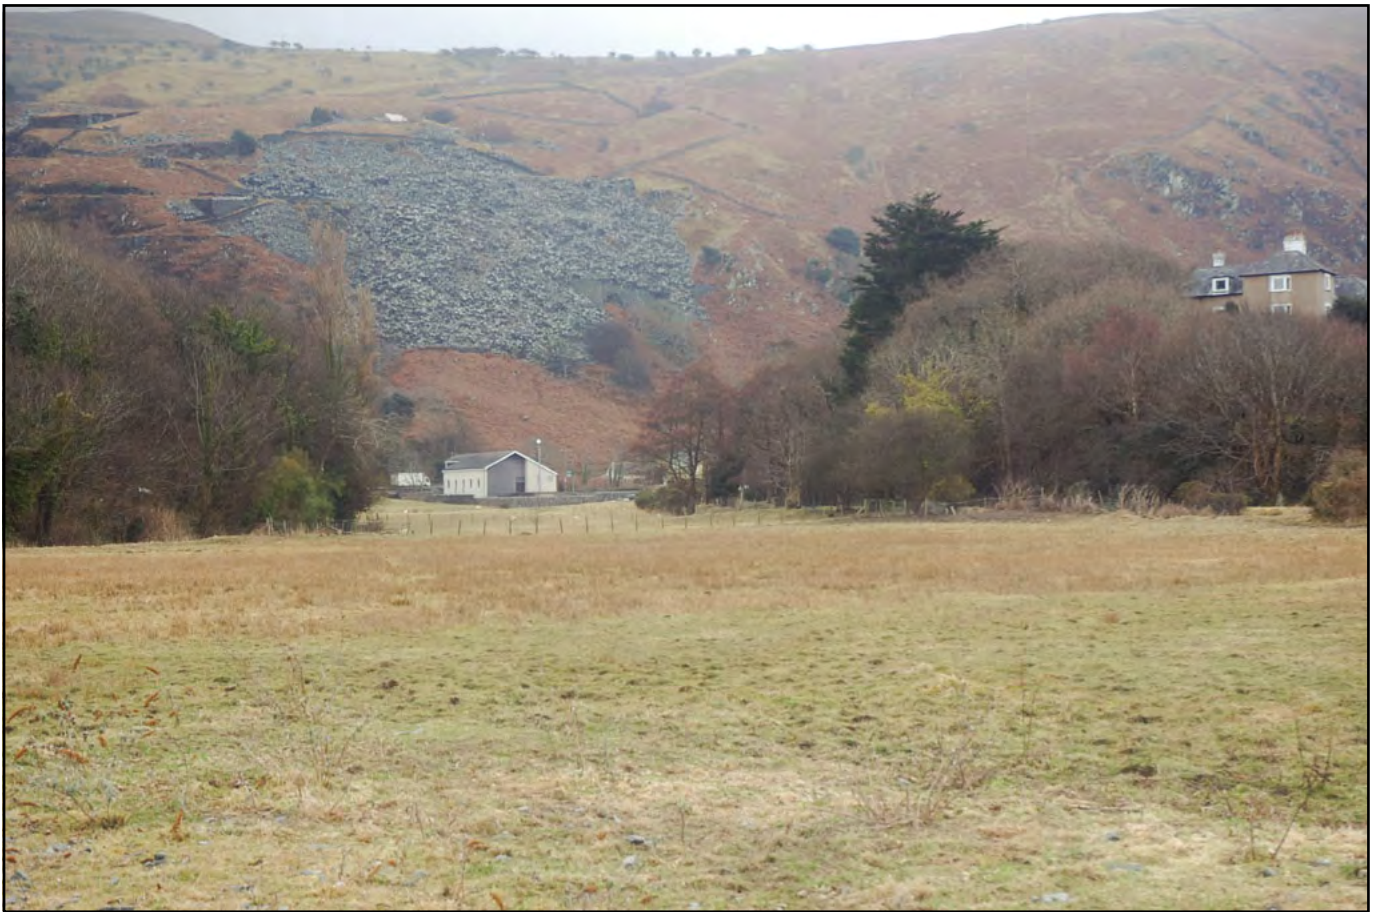
Plate 01 - General view of the location areas for TP01 to TP05: positioned along the flood plain from the building in the distance. The outcrop with the house is called Ynys y Bugail. Photo taken from the NW

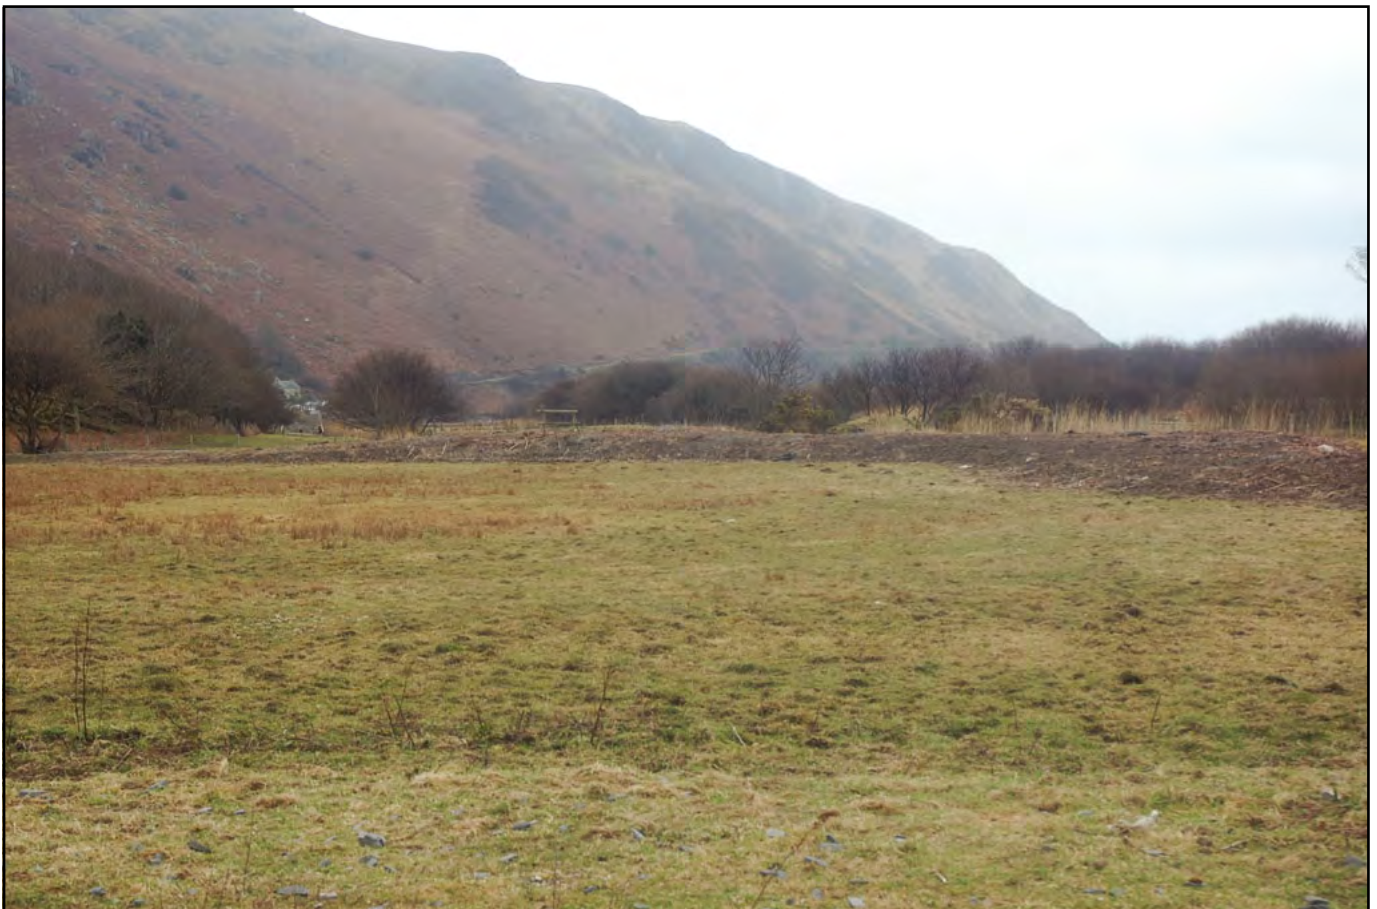
Plate 02 - General view of the location areas for TP06 to TP08, Ynys y Bugail can be seen to the left of the photo.

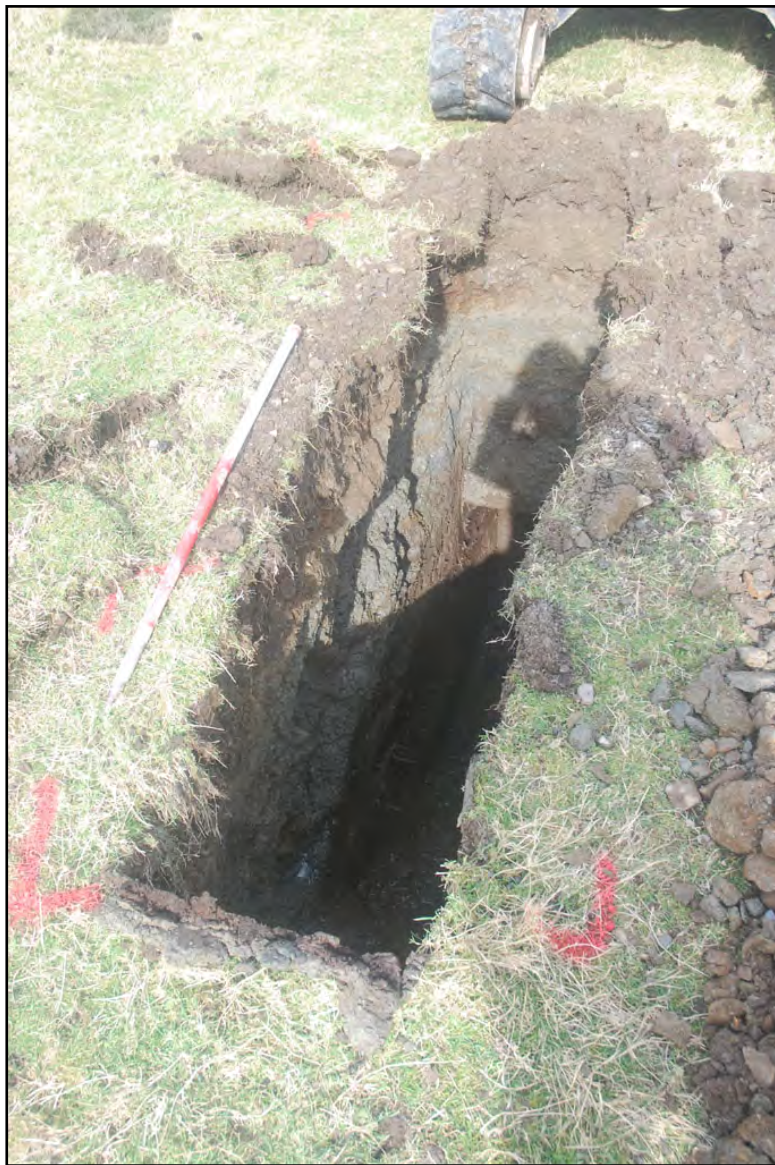
Dark greyish brown topsoil with a depth of 0.15m, underlain by a brownish grey silty sand with very frequent inclusions of river cobbles and shales, depth of 0.45m. Mid brownish grey sandy, clayey silt with a similar amount of stone inclusions as the above, water seepage between these horizons, depth of 0.50m. Below was a layer of silt-sand, peat-rich with frequent organics and depth of 1.40m, a slightly more clayey deposit below, although generally quite similar.

Thin topsoil deposit identified here followed by some made up ground above the organic layer, followed by alluvial activity at the base. No archaeological activity within confines of the trial pit.

Plate 03 - test pit 01: exposed section on completion. A 0.40m thick layer of silt-sand, peat-rich with frequent organics was identified @1.00m below ground level

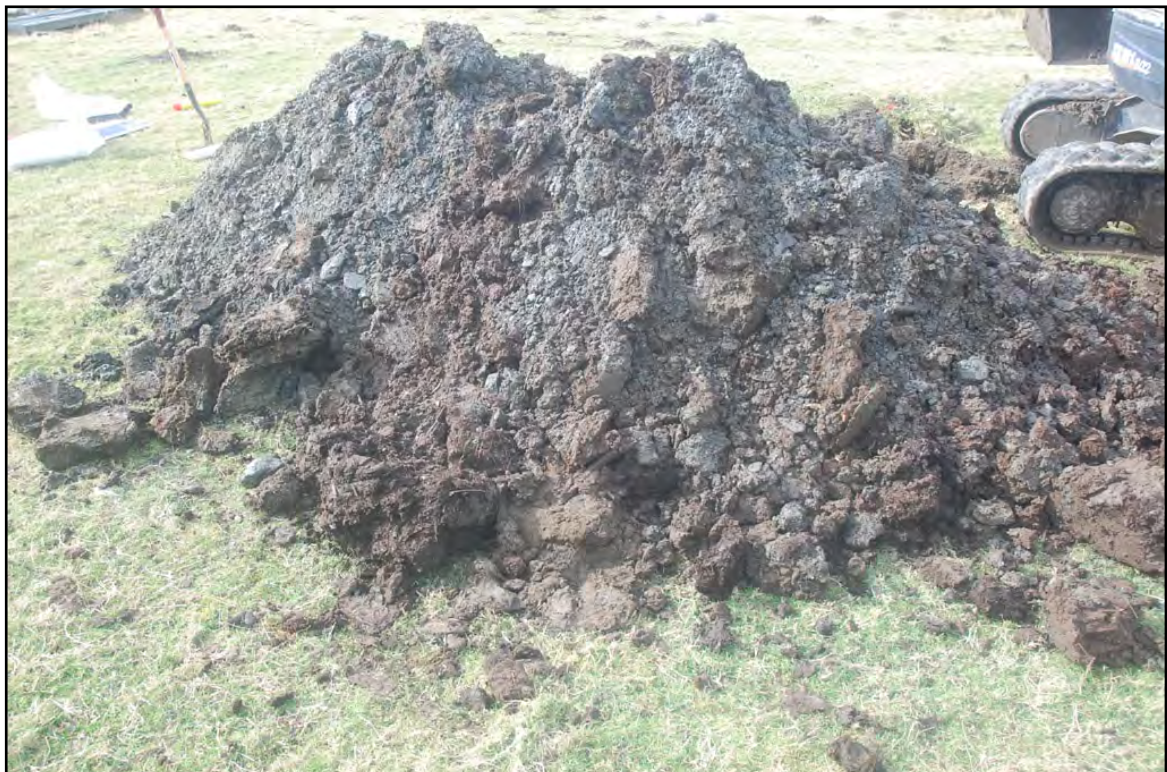
Plate 04- test pit/01: spoil heap detailing upcast material from test pit. The silt-sand, peat-rich is visible along with a clay-rich deposit located beneath the peat-rich layer that continued to limit of excavation (3.00m below ground level)

Plate 04 - deposit located beneath the peat-rich layer that continued to limit of excavation (3.00m below ground level)

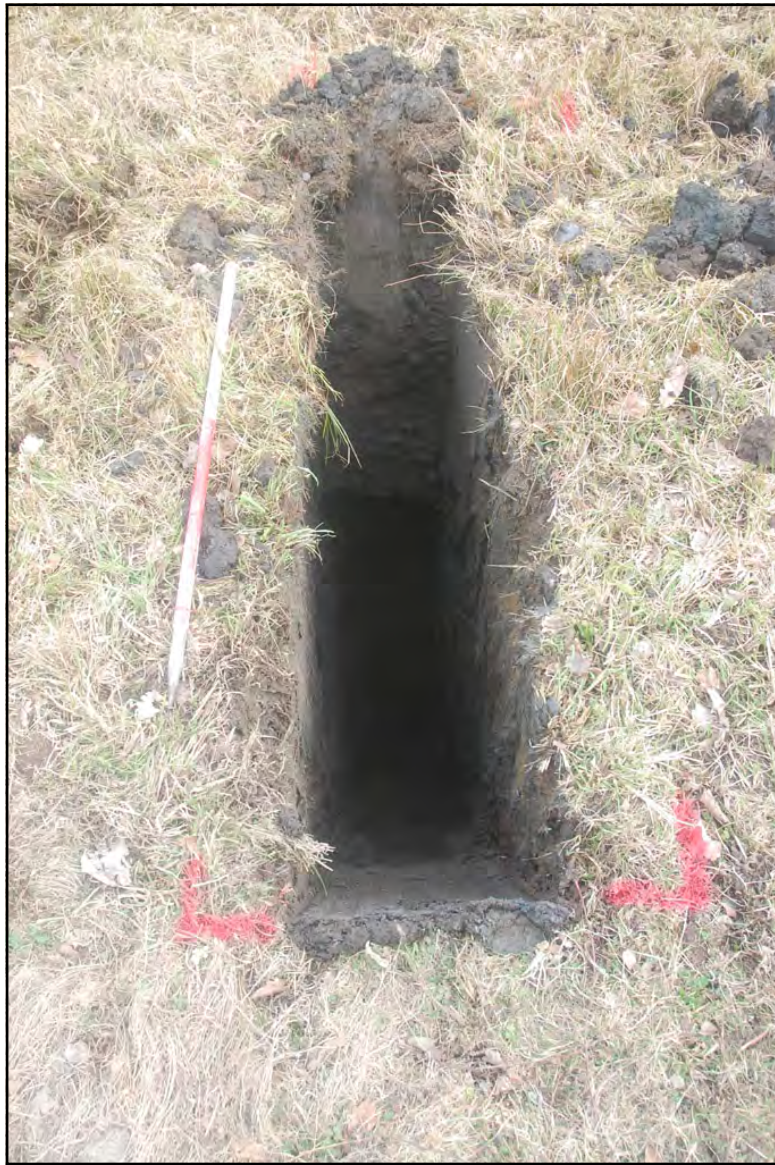
The topsoil was a mid greyish brown sandy silt with very occasional stone and depth of 0.25m. Upper subsoil of a mid orangey grey clayey silty sand with depth of 0.30m. The lower layer was a dark greyish brown and slightly organic peaty sandy silt, as the trench progressed the soil became more clayey with inclusions of fairly large shaley stone.

No archaeology. The organic deposit may have been material that had washed into this area from either or both the two wooded, rocky outcrops that are located either side of the trench, although test pits TP01-TP04 were also close to the outcrops and they produced significantly less organic material.

Plate 05 - test pit 05 post-excitation, Similar to test pit 01, peat-rich organic deposits were identified @0.55m below ground level, continuing towards the limit of excavation where the deposit became clay-rich

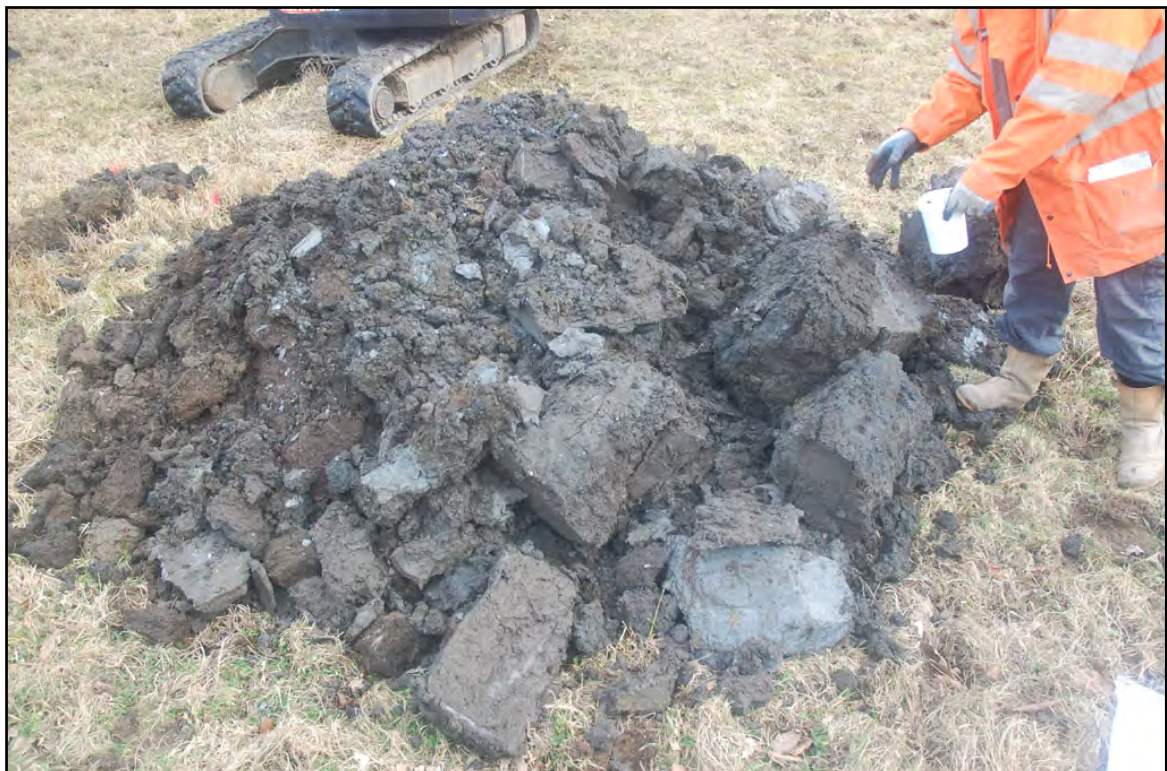
Plate 06 - test pit 05 spoil heap detailing upcast material, including the peat-rich organic deposits also identified in test pit 01 (located c.190.0m to the south).

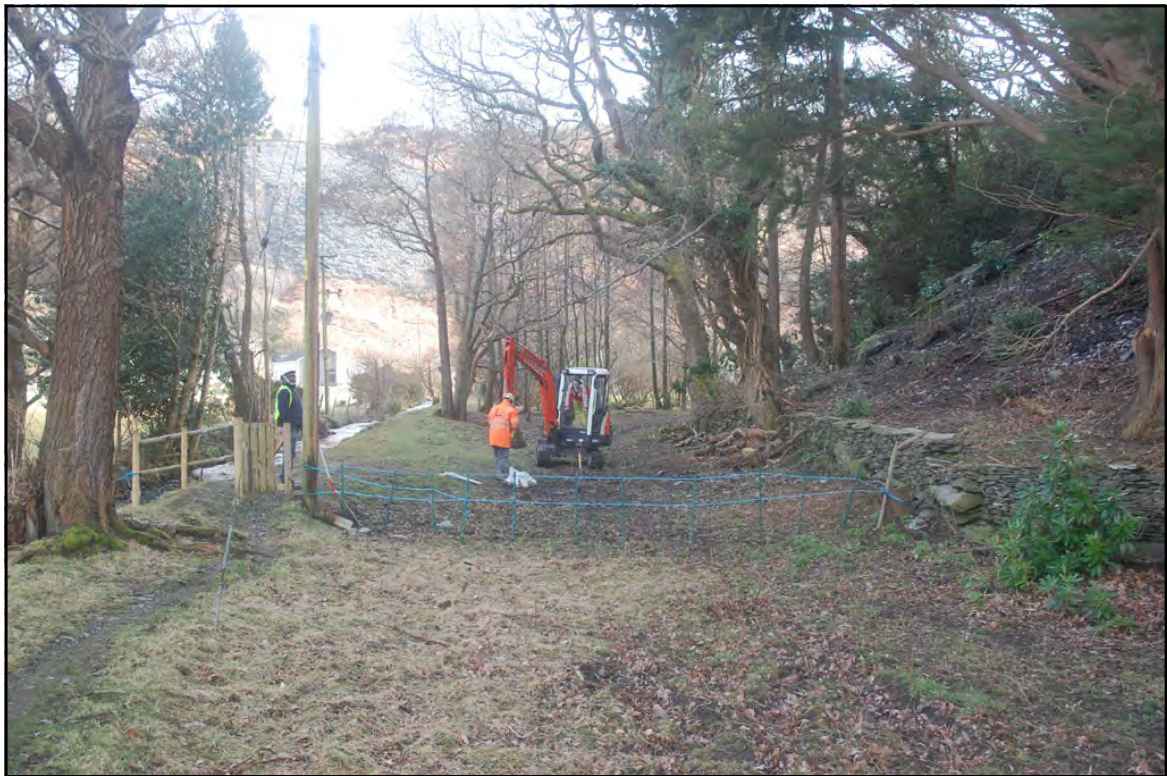
Plate 07 - location of test pit 04. The test pit included organic-rich deposits and shale fragments at the limit of excavation

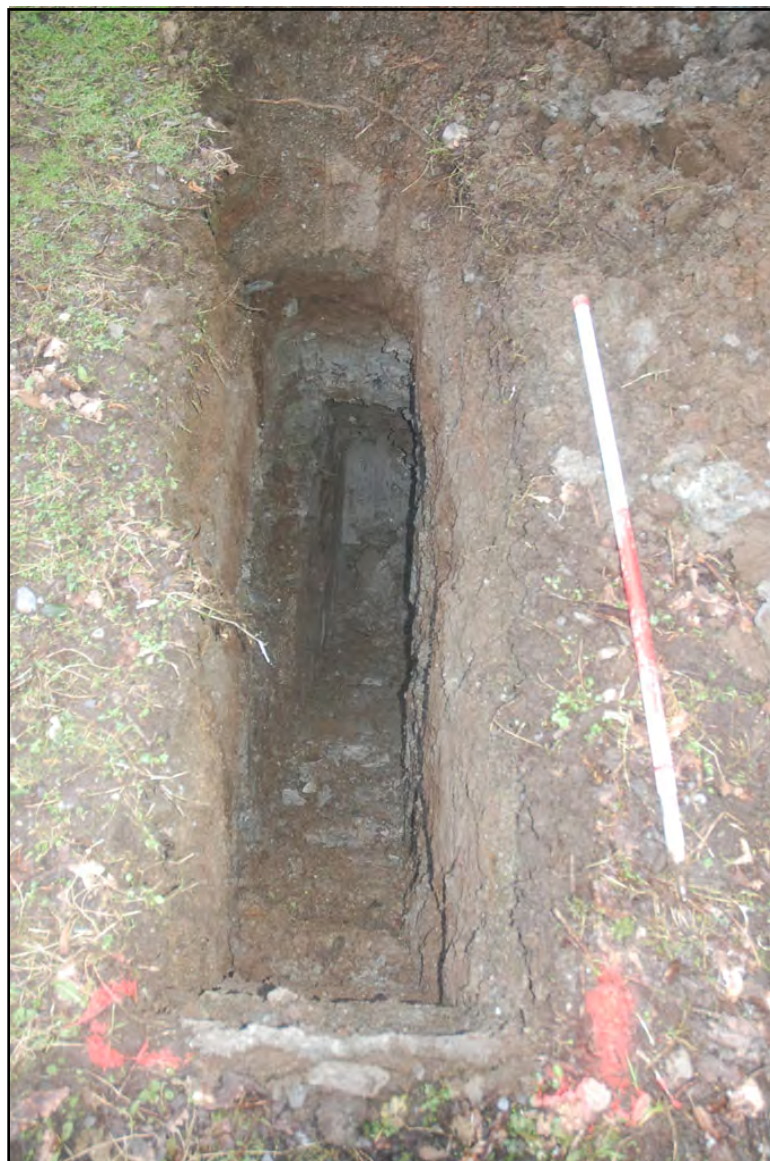
Upper layer was a mid greyish brown, soft sandy silt with a depth of 0.15m. Upper subsoil a mid brownish grey shaley sandy silt with a depth of 0.40m. Underlain by a dark greyish brown silty sand. All the above layers were fairly organic.

The lowest deposit in the test pit was a mid greyish brown with an orange tint, silty clay, containing large amounts of slaty or shaley fragmentary rock.

No archaeology, the fragmentary rock is bedrock from the outcrop Ynys y Bugail as previously mentioned in TP02.

Plate 08 - test pit 04: detail of limit of excavation. The organic-rich deposits and the shale-rich deposit at the base of the test pit (3.00m below ground level), are visible

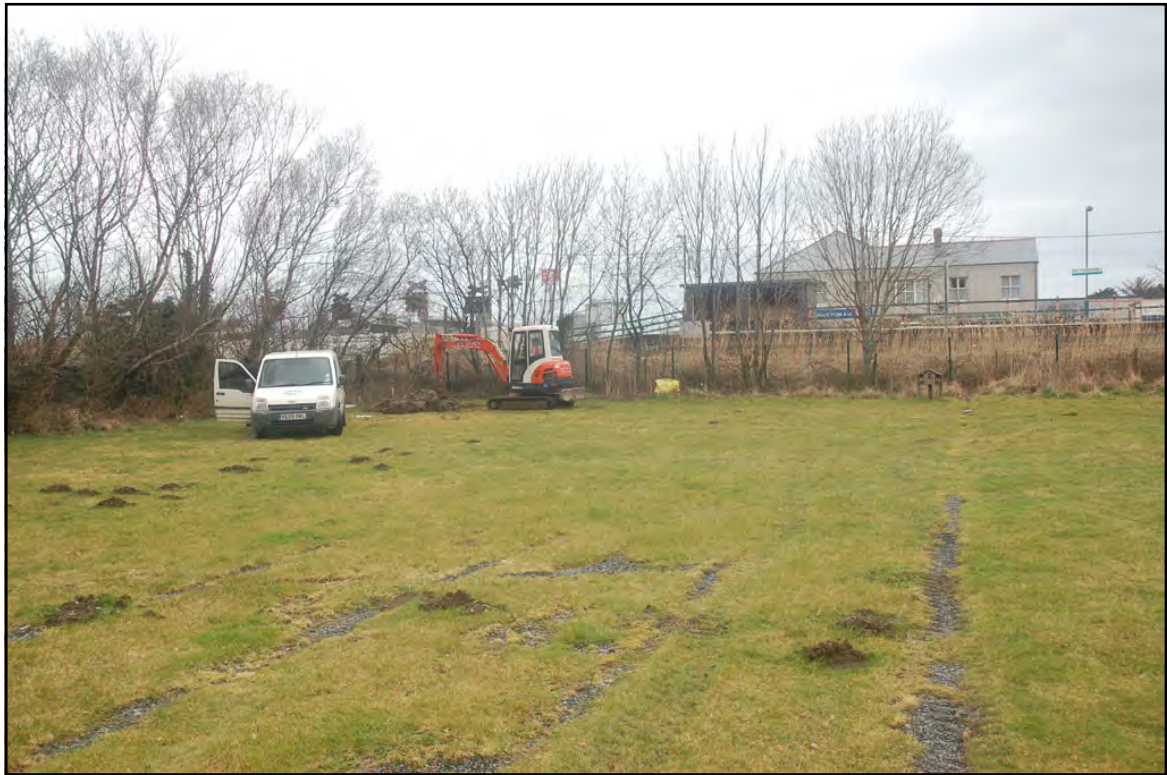
Plate 09 - test pit 10. Located on the southeastern outskirts of Fairbourne within a small caravan park., close to the former railway line

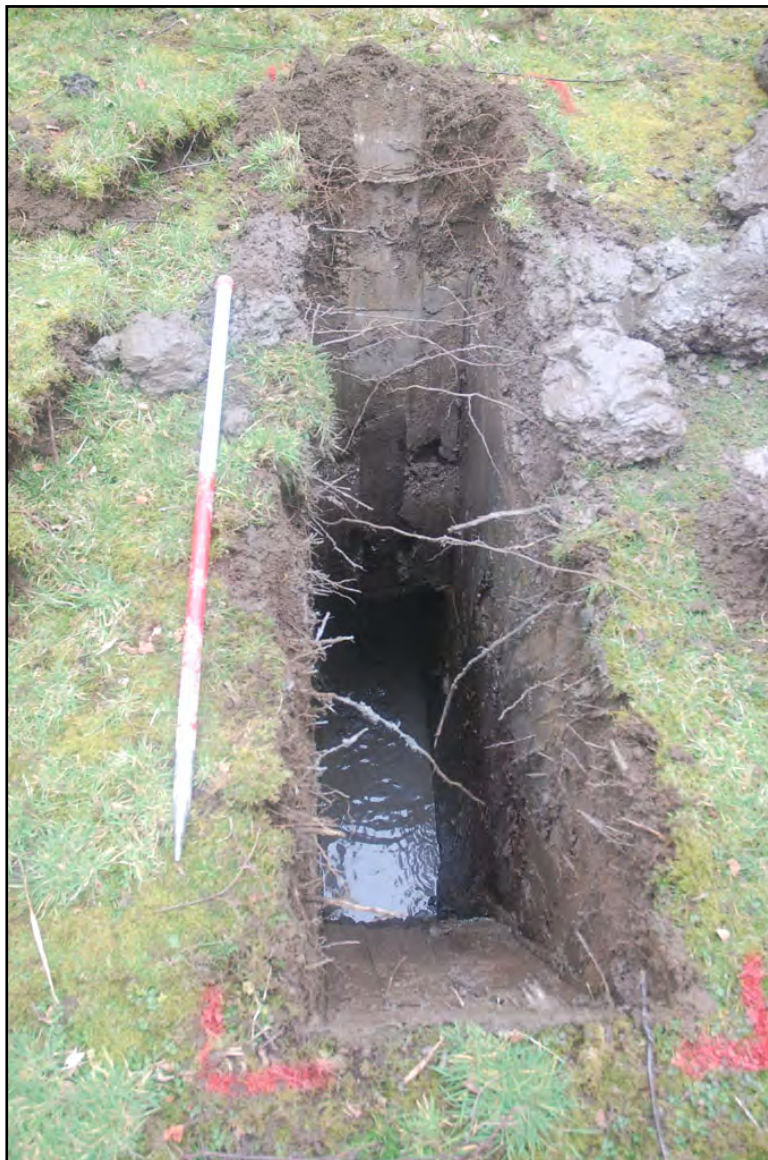
Very rooty dark greyish brown topsoil with depth of 0.20m, below which was a mid orangey grey silty clay with depth of 1.50m. The lower layer was a slightly orange grey clay, plastic. Water seepage at the top of this layer at the horizon with previous layer.

Plate 10 - test pit 10 on completion, detailing limit of excavation and water ingress @1.50m below ground level

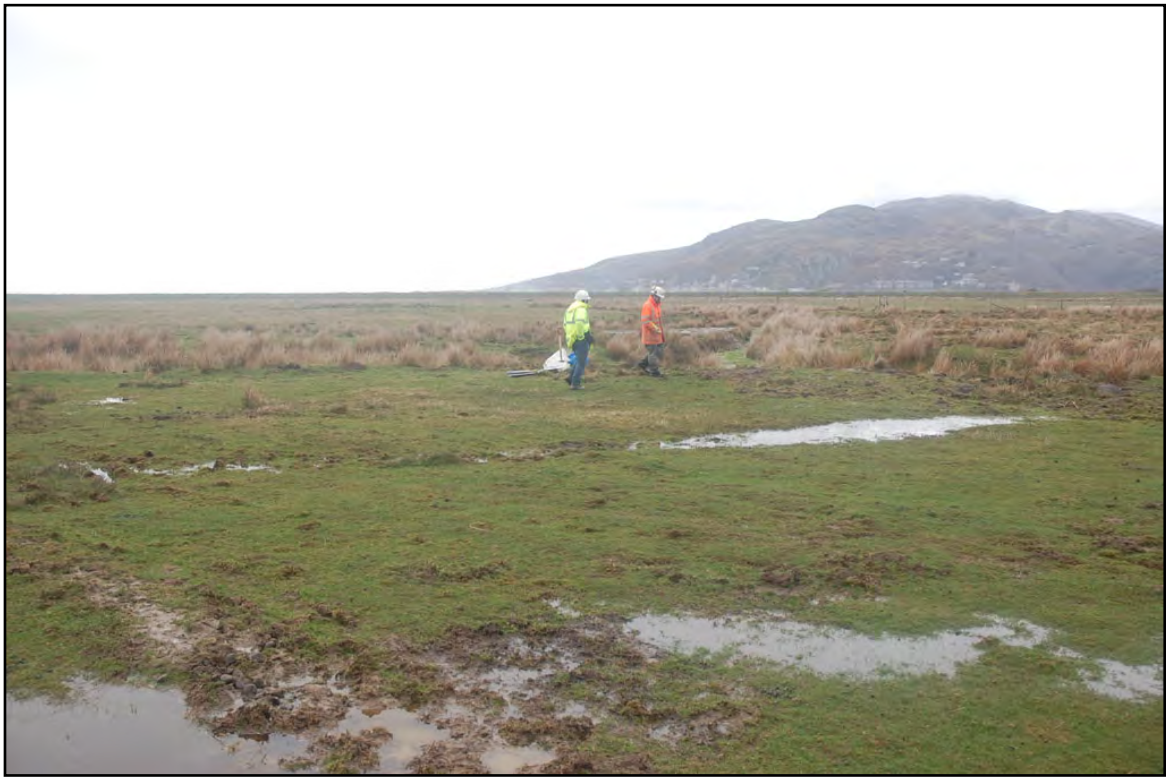
Plate 11 - location of test pit 19, located to the northeast of Fairbourne within the coastal floodplain

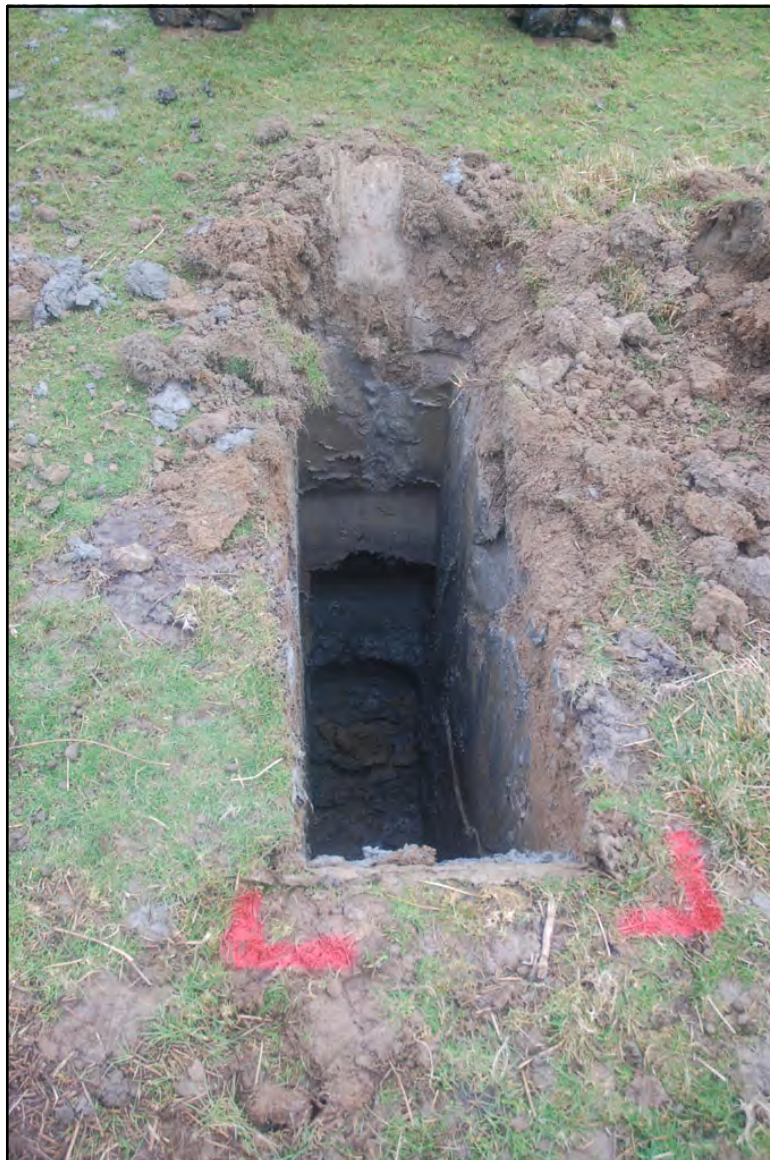
Mid orangey grey silty sand with some clay content, depth of 0.25m. Orangey grey silty clayey sand, soft texture with a depth of 1.25m. The lower layer was an orangey grey silty clay, although less clay and more sandy as the trench progressed downwards.

Plate 12 - test pit 19 at limit of excavation, detailing a succession of sand-rich layers. No archaeological activity was identified within the confines of the test pit

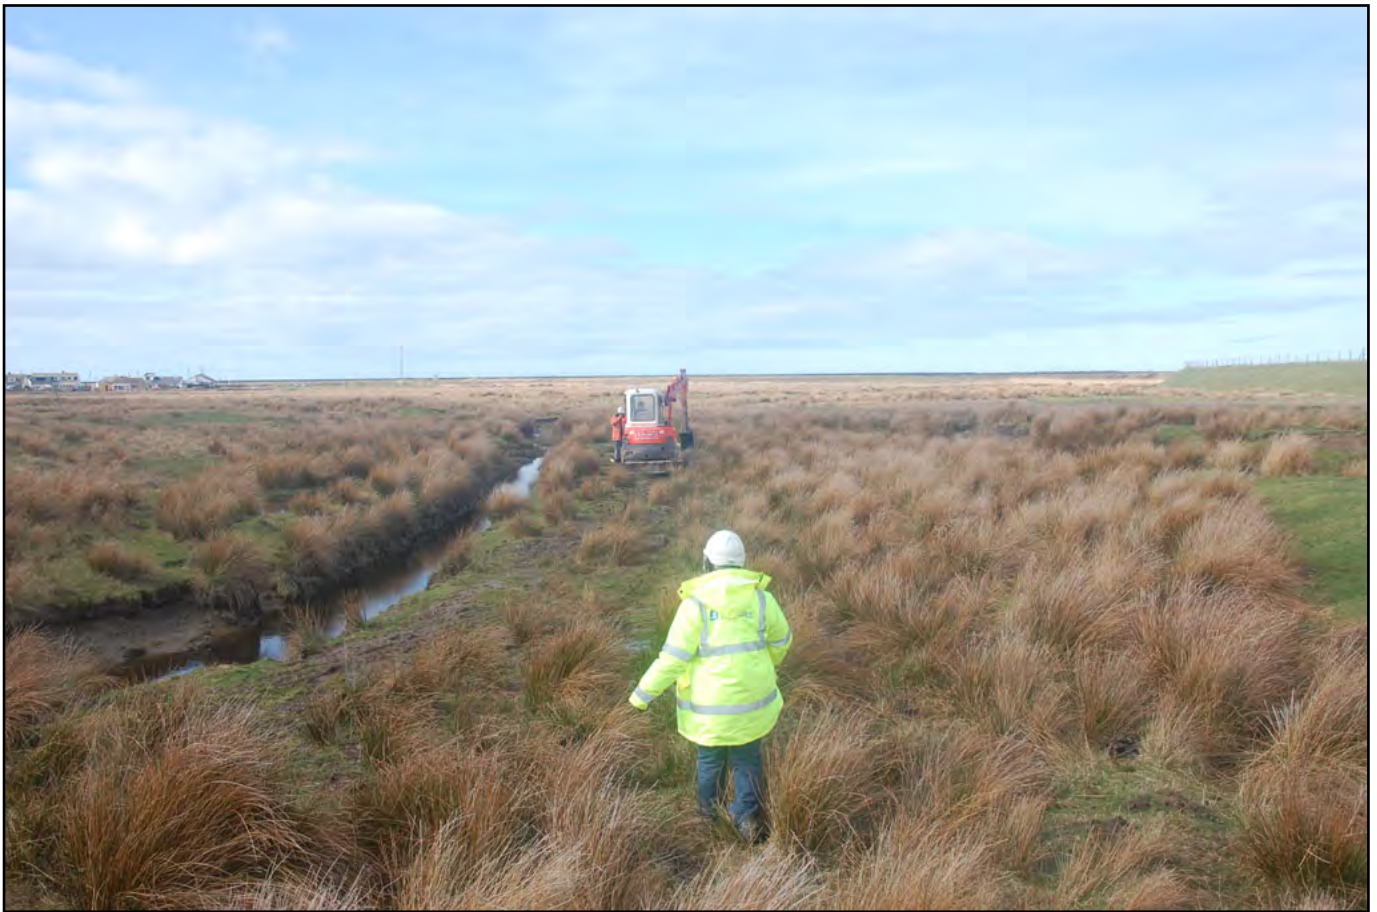
Plate 13 - location of test pit 22, positioned within the coastal flood plain to the northeast of Fairbourne. Test pit 22 was the final test pit excavated as part of the GI programme.

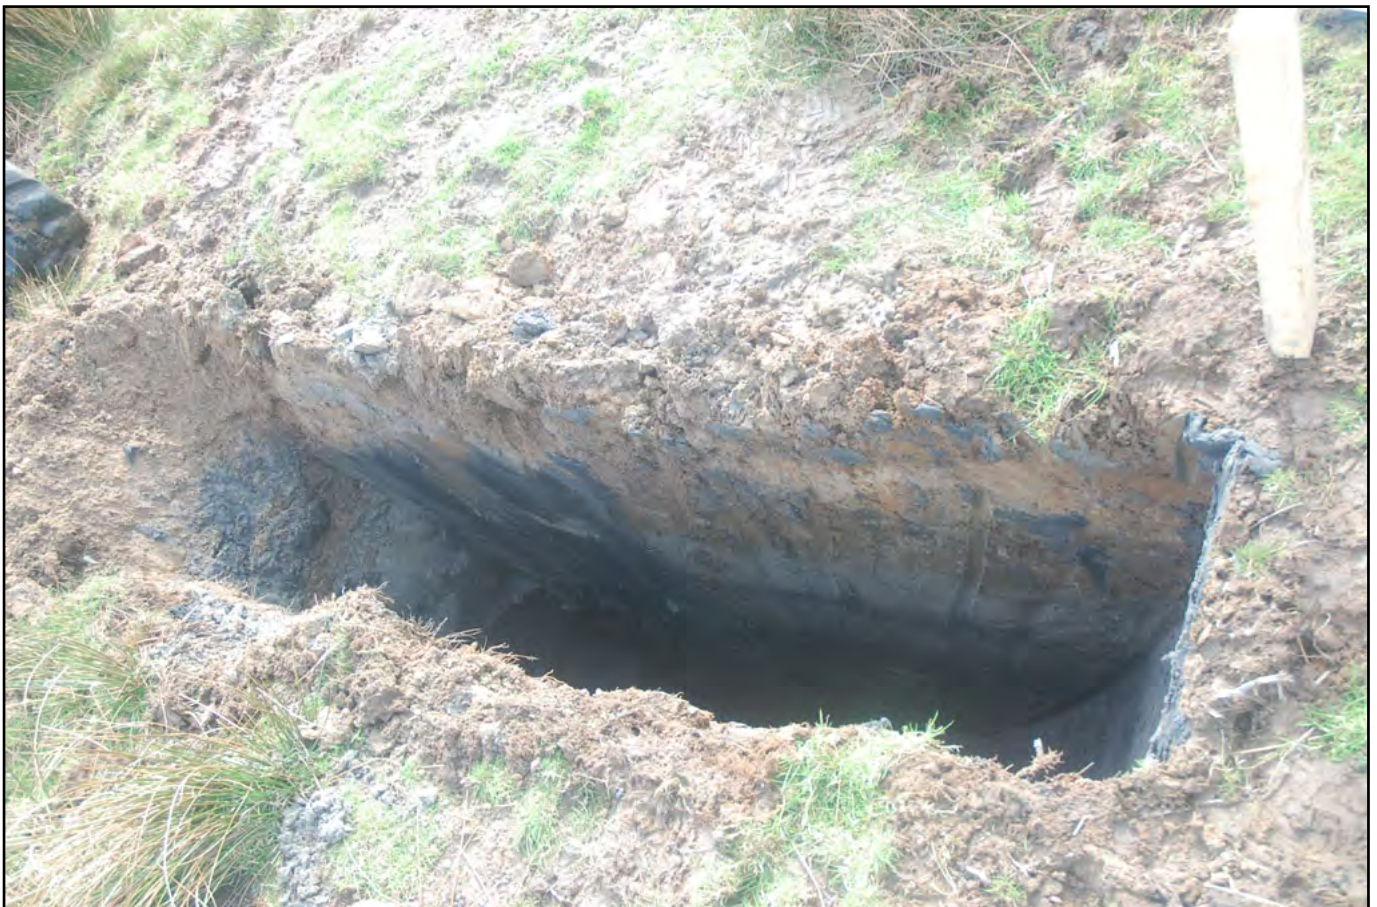
Plate 14 - test pit 22 at limit of excavation. The test pit contained sand-rich deposits; no archaeological activity was identified within the confines of the test pit

Very degraded brownish grey sandy silt topsoil with a depth of 0.10m, underlain by a subsoil of a mid orangey grey silty sand with a soft texture and depth of 0.40m. The bottom layer in the trench was a dark grey sandy silt with a small clay content.

Plat□
within the confines of the test pit
