## CONWY QUAY REDEVELOPMENT PROGRAMME: INTERIM SCHEME WATCHING BRIEF - BOAT RESTORATION AREA, OAK BOLLARDS & ZONE 3 INTERPRETATION AREA

GAT Project No. 2070

Report No. 878

July 2010

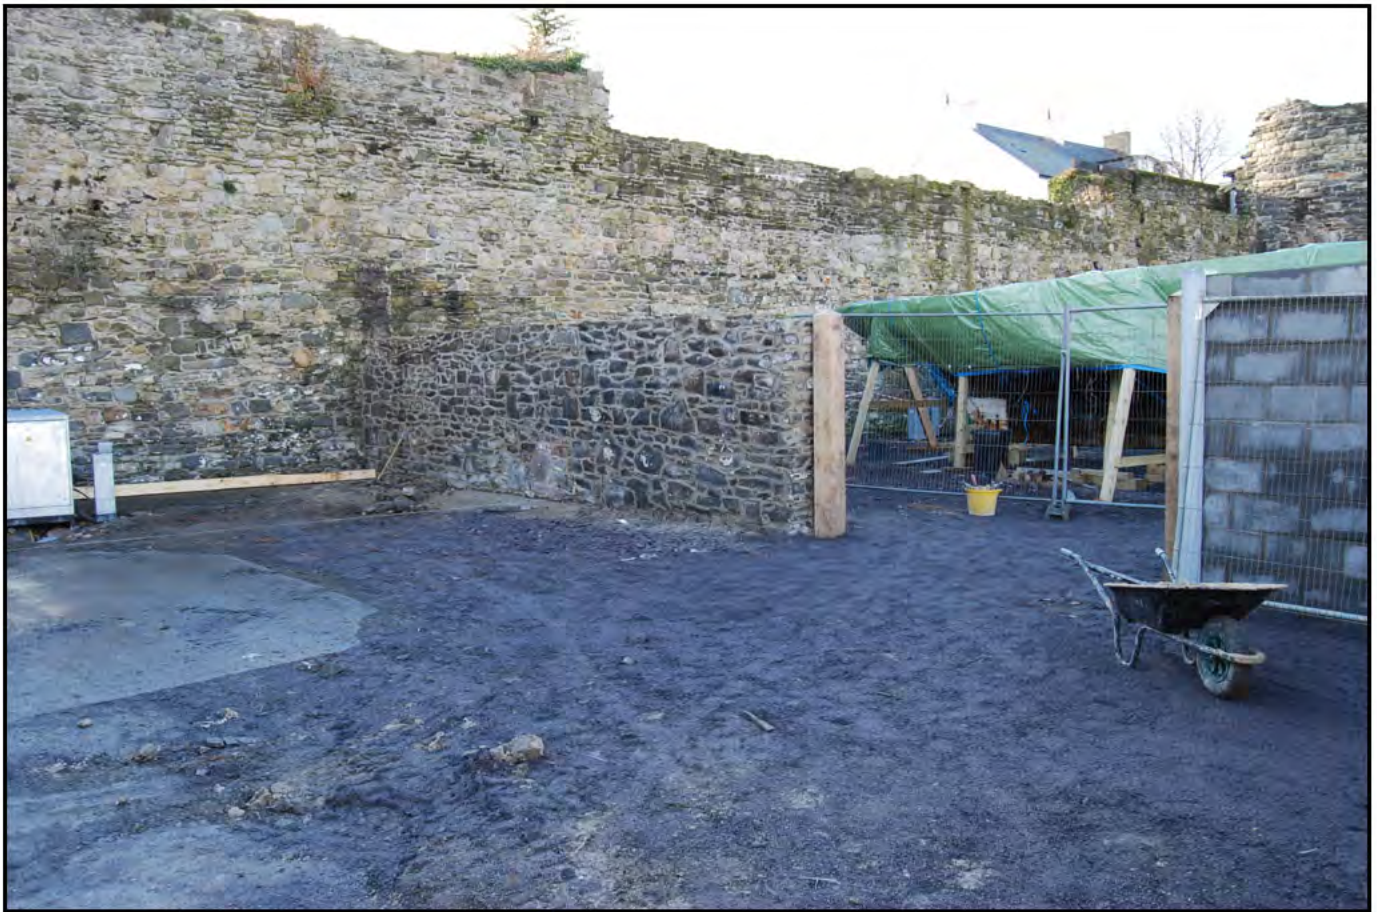
Plate 01: Zone 1/Yard 1 (PRN 30451): view west of Zone 01 during repointing of former Cross Wall A (cf. Fig. 02) and construction of a block wall joining Cross Wall A to Enclosure Wall A (not visible). A new entrance linking Zones 01 and 02 is also visible. The Nobby boat is also visible in the background (Zone 02), supported on wooden posts and covered with tarpaulin. Zone 01 was the former location of Buildings 01 and 18 (see appendix I for PRN numbers).

The extant portion of Cross Wall A (Figure 01) was repointed as part of the interim scheme and a block wall linking the line of this wall to Enclosure Wall A was also built (plate 01). An entrance linking zones 01 and 02 was also created between the original portion of Cross Wall A and the block-built portion (plate 01).

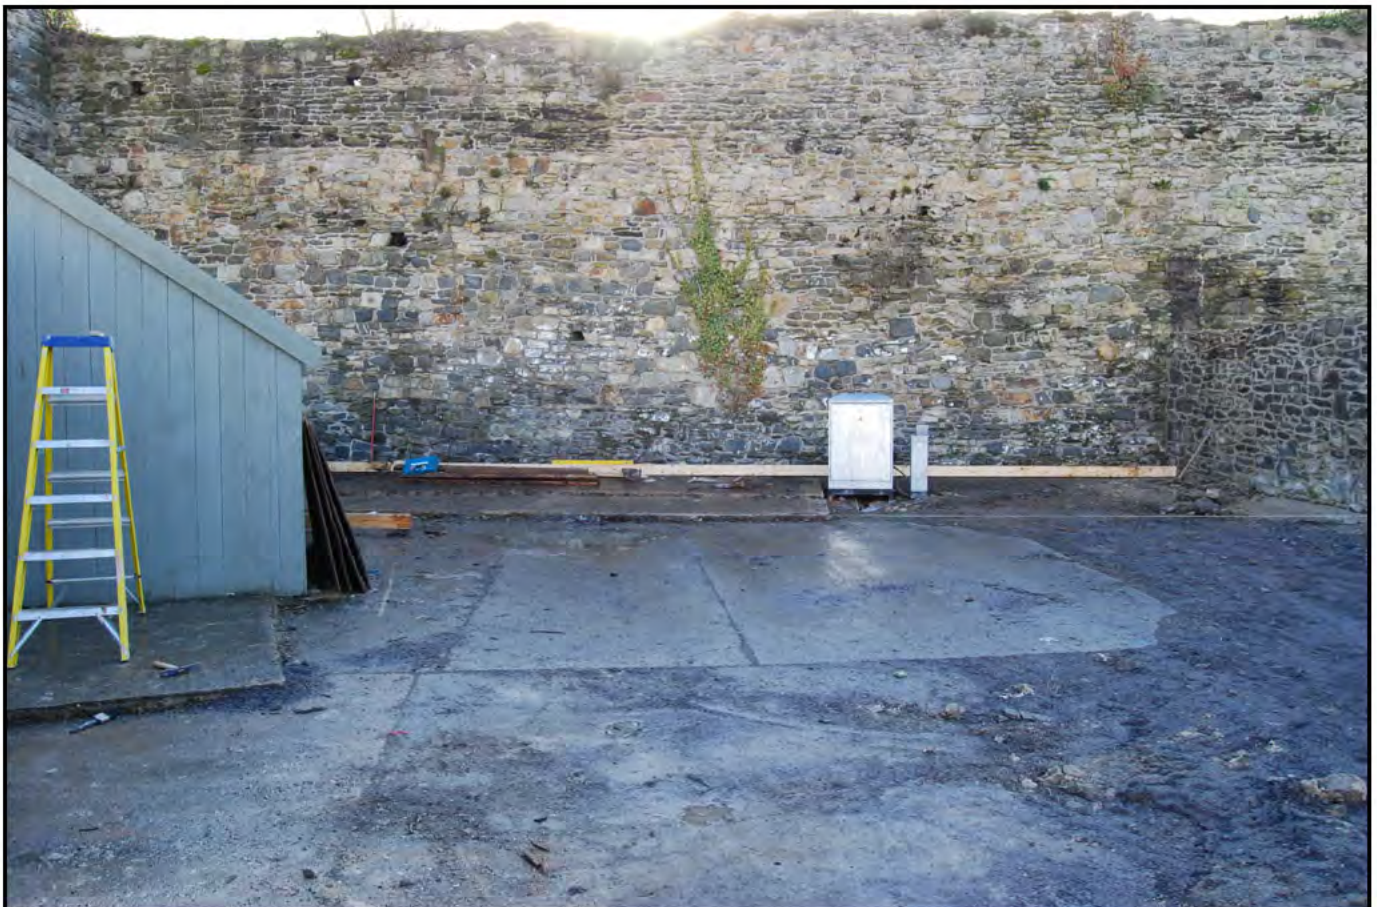
Plate 02: Zone 1/Yard 1 (PRN 30451): view southwest prior to the placement of two refurbished steel containers. The concrete pad visible was laid in the twentieth century, atop the foundations/demolition layers of Building 18 (PRN 30453). A bat roost is visible to the left of image.

Two refurbished steel storage containers were also added to zone 01 as part of this phase (not monitored by GAT).

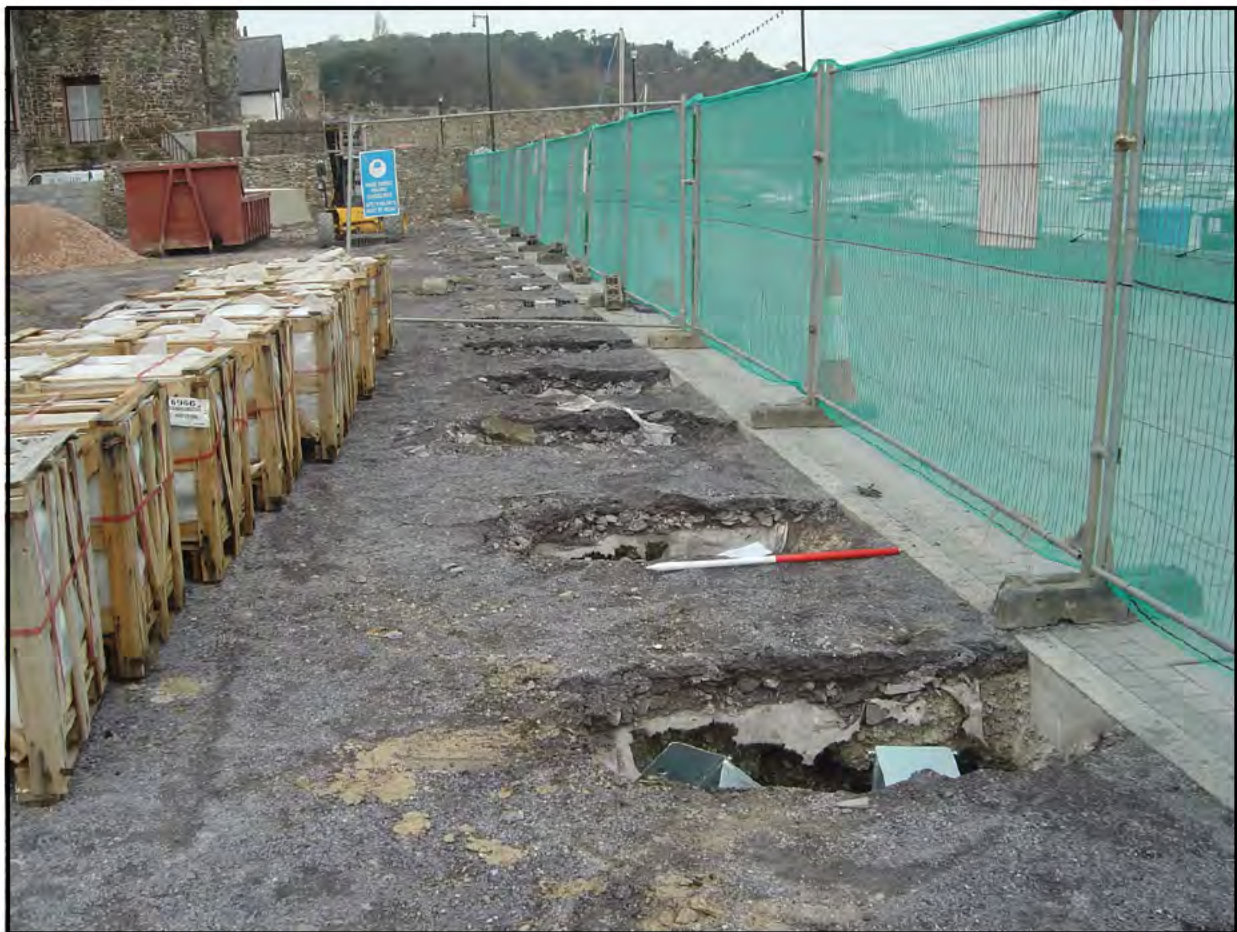
Plate 03: Zone 2/Yards 2 (PRN 30454), 3 (PRN 30457) & 4 (PRN 30463): view northwest of oak bollard foundation cuts (depth 0.75m). The oak bollards were set 2.0m apart and to be connected by chain links that segregate the paved road and the eventspace in Zone 02. A total of 31 foundation cuts were made. (Scale 1 x 1.0m)

The oak bollards were set 2.0m apart (plate 03) and were excavated to an average depth of 0.75m (plate 04). All oak bollard excavations contained evidence for the recent consolidation stage (grey crushed slate atop *Terram* membrane), followed by infill deposits associated with the construction of the quay in the 1830s (Plate 04). No specific structural activity associated with the former quay buildings were identified.

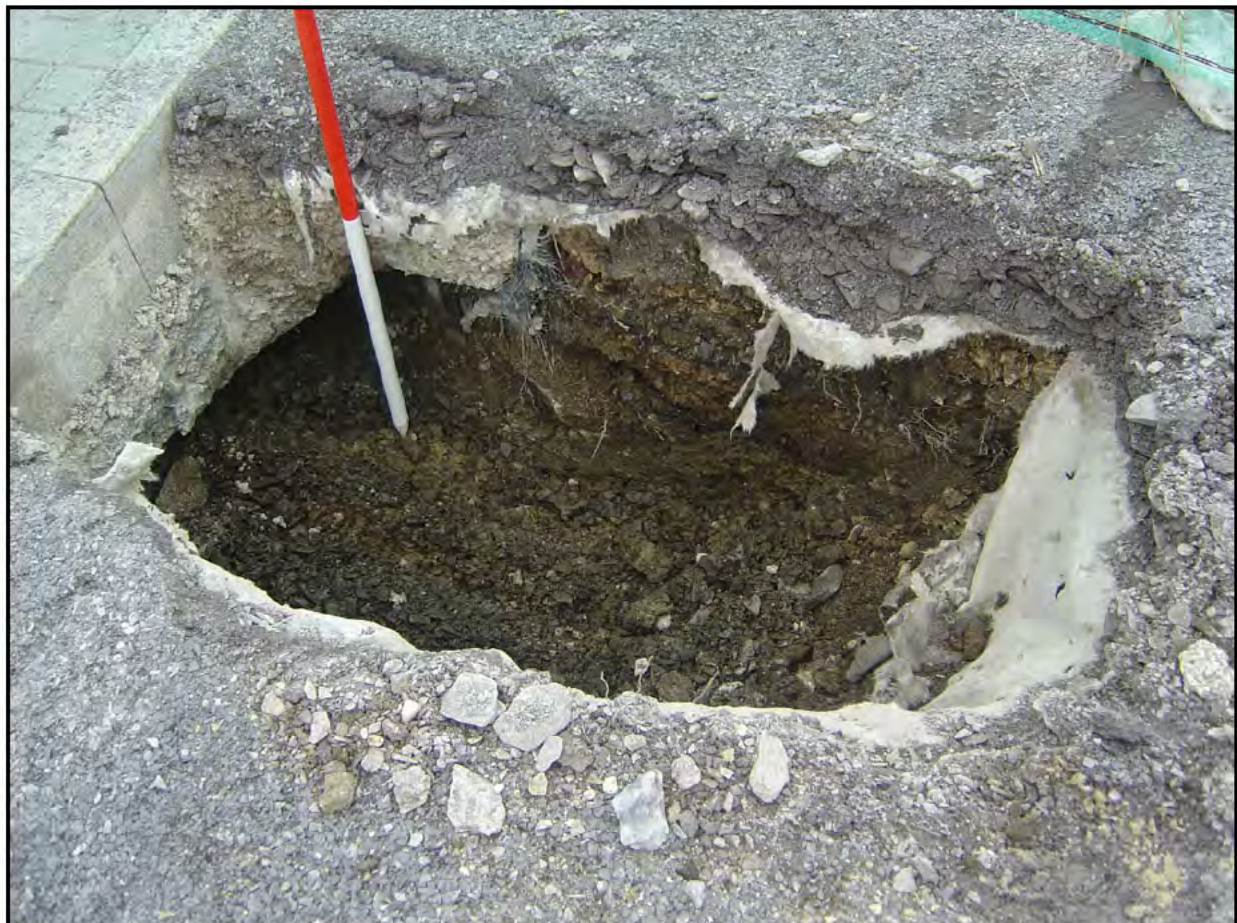
Plate 04: Zone 2/Yards 2 (PRN 30454), 3 (PRN 30457) & 4 (PRN 30463): close-up of an oak bollard foundation cut (depth 0.75m), detailing stratigraphy that included dark grey crushed slate and terram deposited after the clearing of the demolition of the quay buildings in 2009, atop a mixed yellow-clay silt soil matrix with crushed slate and gravels followed by a mixed brownish sand to limit of excavation. The latter two deposits were previously identified in the service trench installation watching brief and were interpreted as evidence for the construction and infilling of the quay in the 1830s. (Scale 1 x 1.0m)

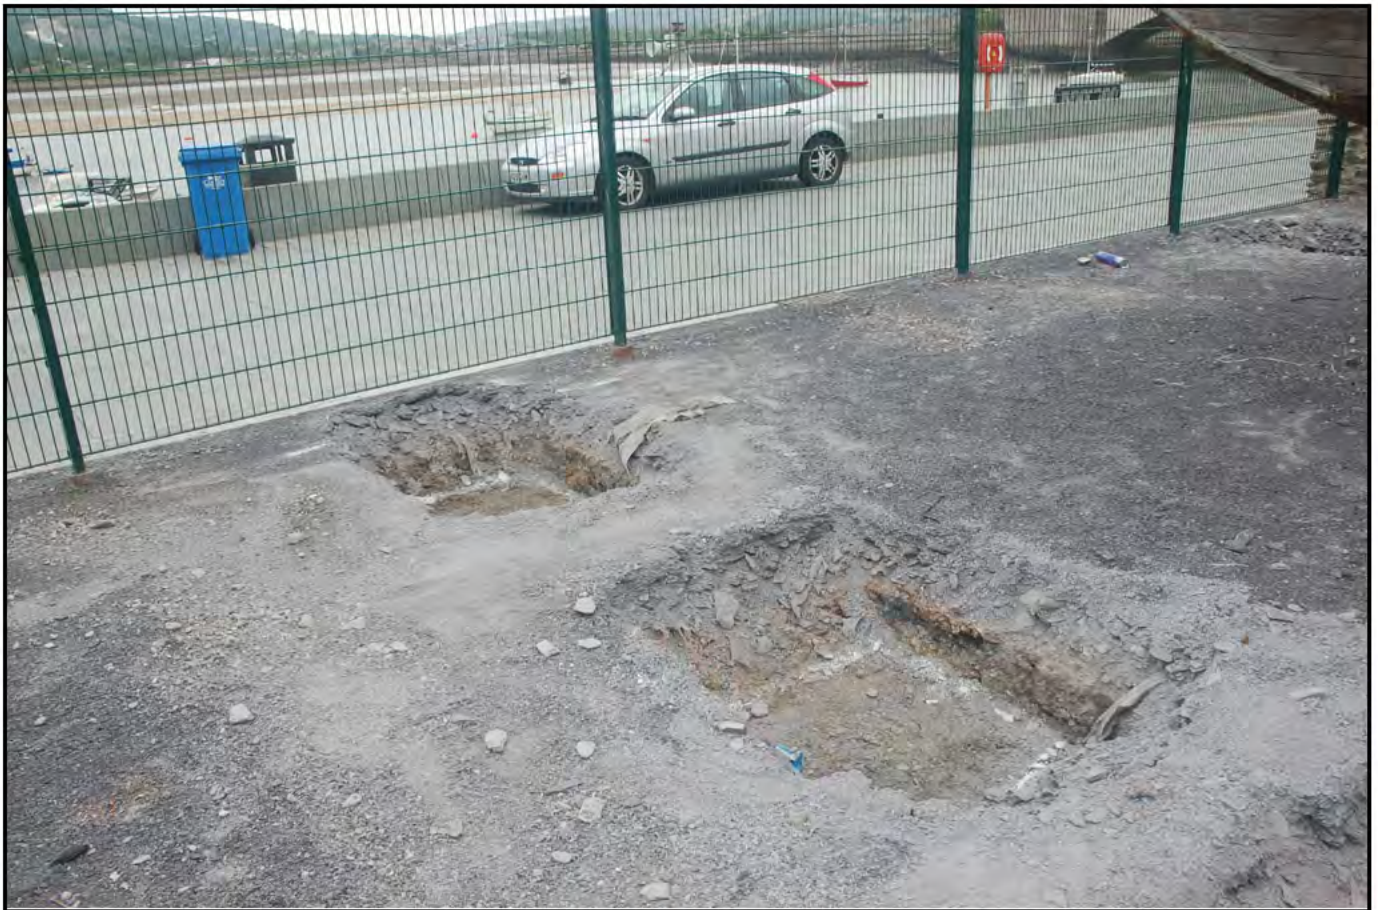
Plate 05: Zone 2/Yards 2 (PRN 30454), 3 (PRN 30457) & 4 (PRN 30463): View northwest of Zone 2/Yard 2 during the excavation of the Nobby boat support posts. Limit of excavation was 0.40m below ground level. The stratigraphy included the crushed slate/terram associated with the 2009 demolition phase, atop the mixed clay-silt associated with the infilling/construction of the quay in the 1830s.

The excavations for the Nobby shelter supports were set c.0.35m apart (plate 05) and excavated to an average depth of 0.40m. The stratigraphy included the crushed slate/*Terram* associated with the 2009 demolition phase, atop the mixed clay-silt associated with the infilling/construction of the quay in the 1830s. No specific structural activity associated with the former quay buildings were identified.

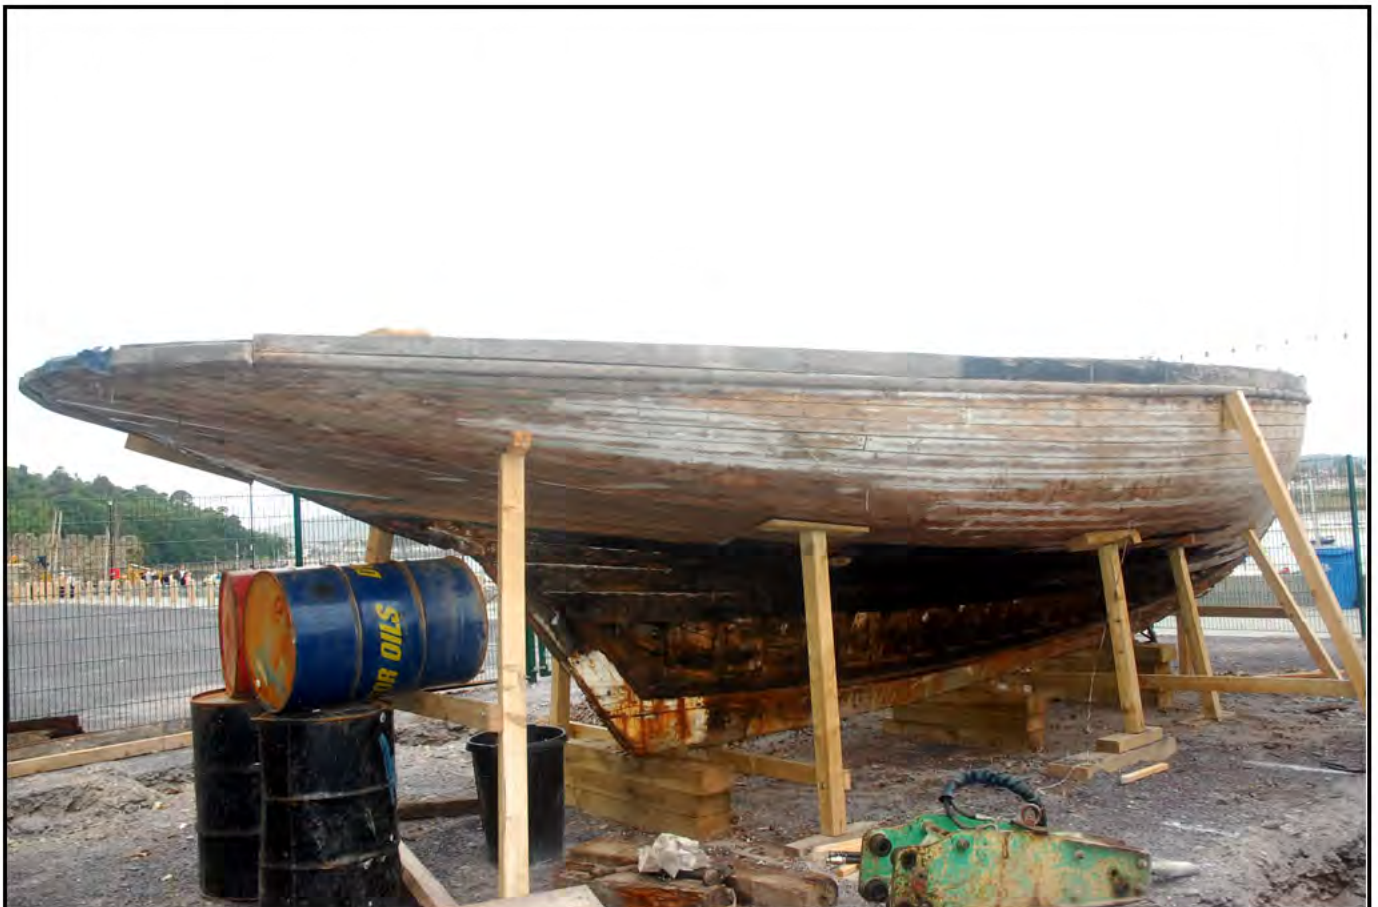
Plate 06: Zone 2/Yard 2 (PRN 30454): View northeast of the boat restoration area/Nobby boat during the interim scheme works. The oak bollards that segregate the quayside road and the event spaces can be seen in the background (cf. Plates 03 and 04 for the excavation of the oak bollard area).

Zone 02 was used as the location for the Boat Restoration Area/"Nobby" Boat emplacement (plate 06) and for the majority of the oak bollard settings that segregated the quayside road and the event space represented by the three zones.

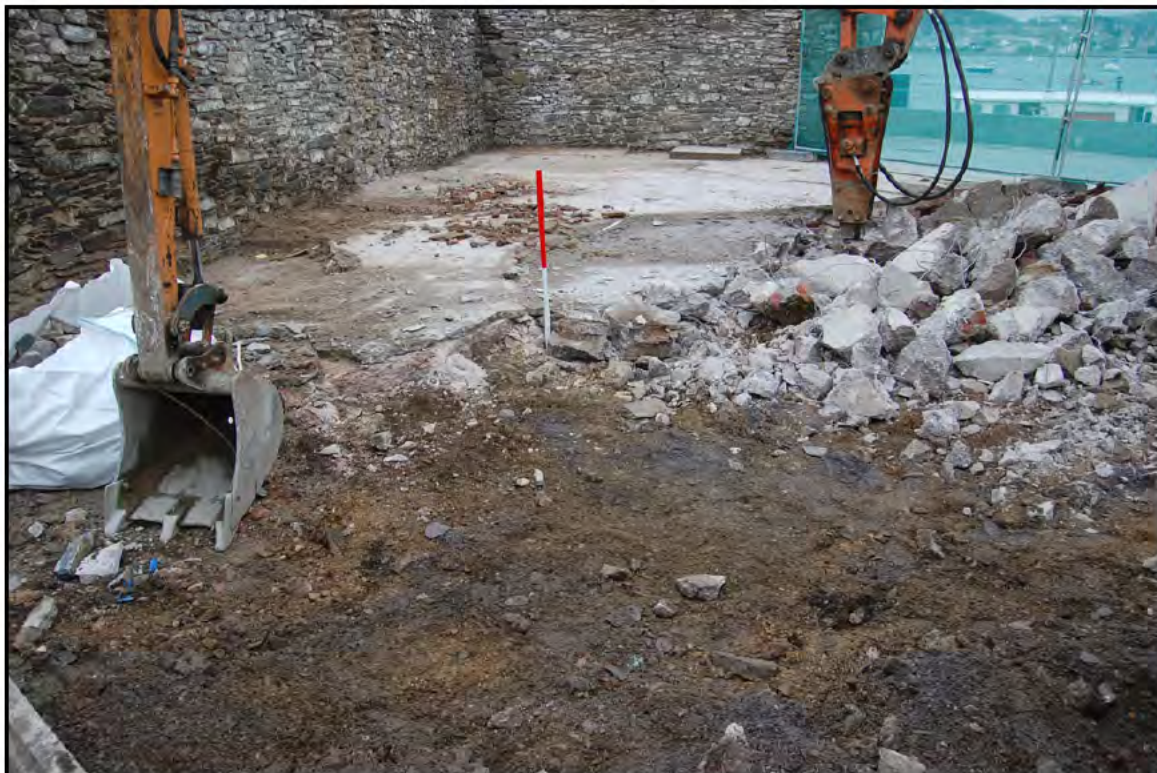
Plate 07: Zone 3/Yards 5 (PRN 30469) & 6 (PRN 30474): excavation of the former ground levels of Buildings 7 (PRN 30475) and 8 (PRN 30476): both floors were built from concrete atop redundant (brick) building material sub-base. Beneath the sub-base was the construction layer for the quayside previously identified during the service trench installation. Zone 03 became the location for the new interpretation area. Scale: 1 x 1.0m

remained intact at the start of the watching brief. The floor levels were removed as part of the latest phase to accommodate a new paved area (plates 07 to 09).

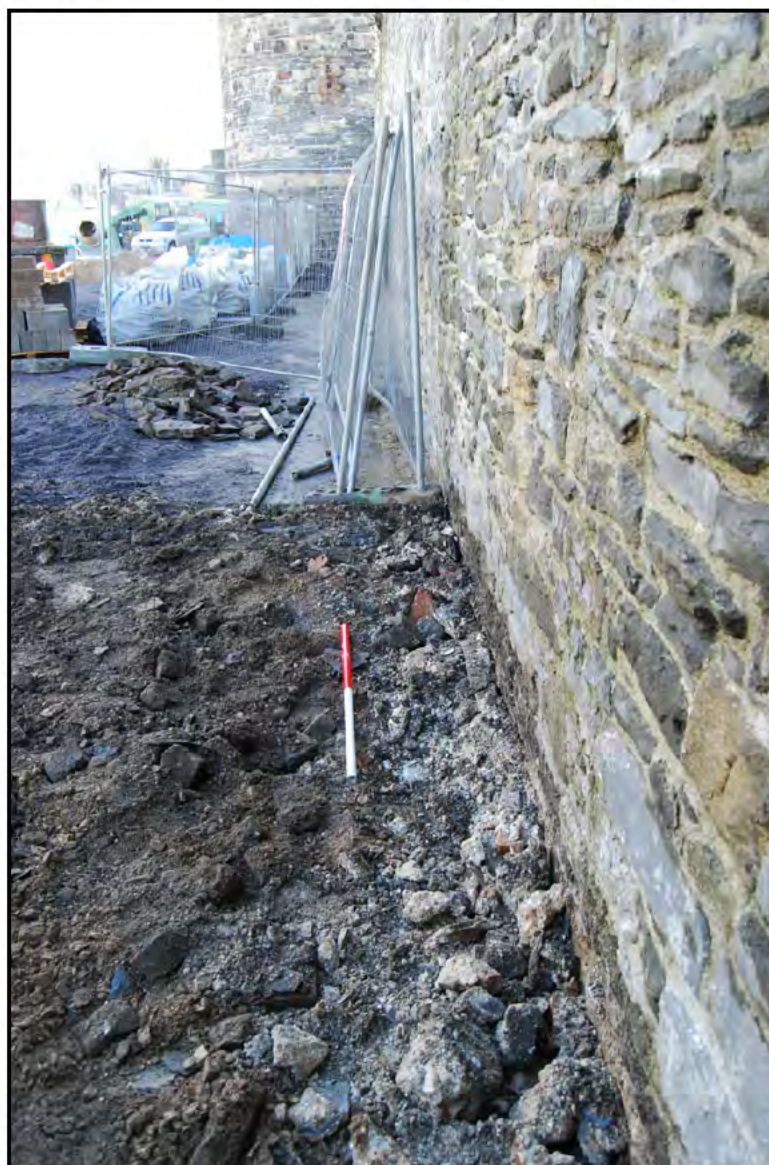
Plate 08: Zone 3/Yards 5 (PRN 30469) & 6 (PRN 30474): View southeast of after removal of Building 08 (PRN 30476) floor surface. The foundation footing for Building 08 can be seen running parallel to the town wall. This footing had originally been identified during the initial watching brief (GAT Report 815). Scale: 1 x 1.0m

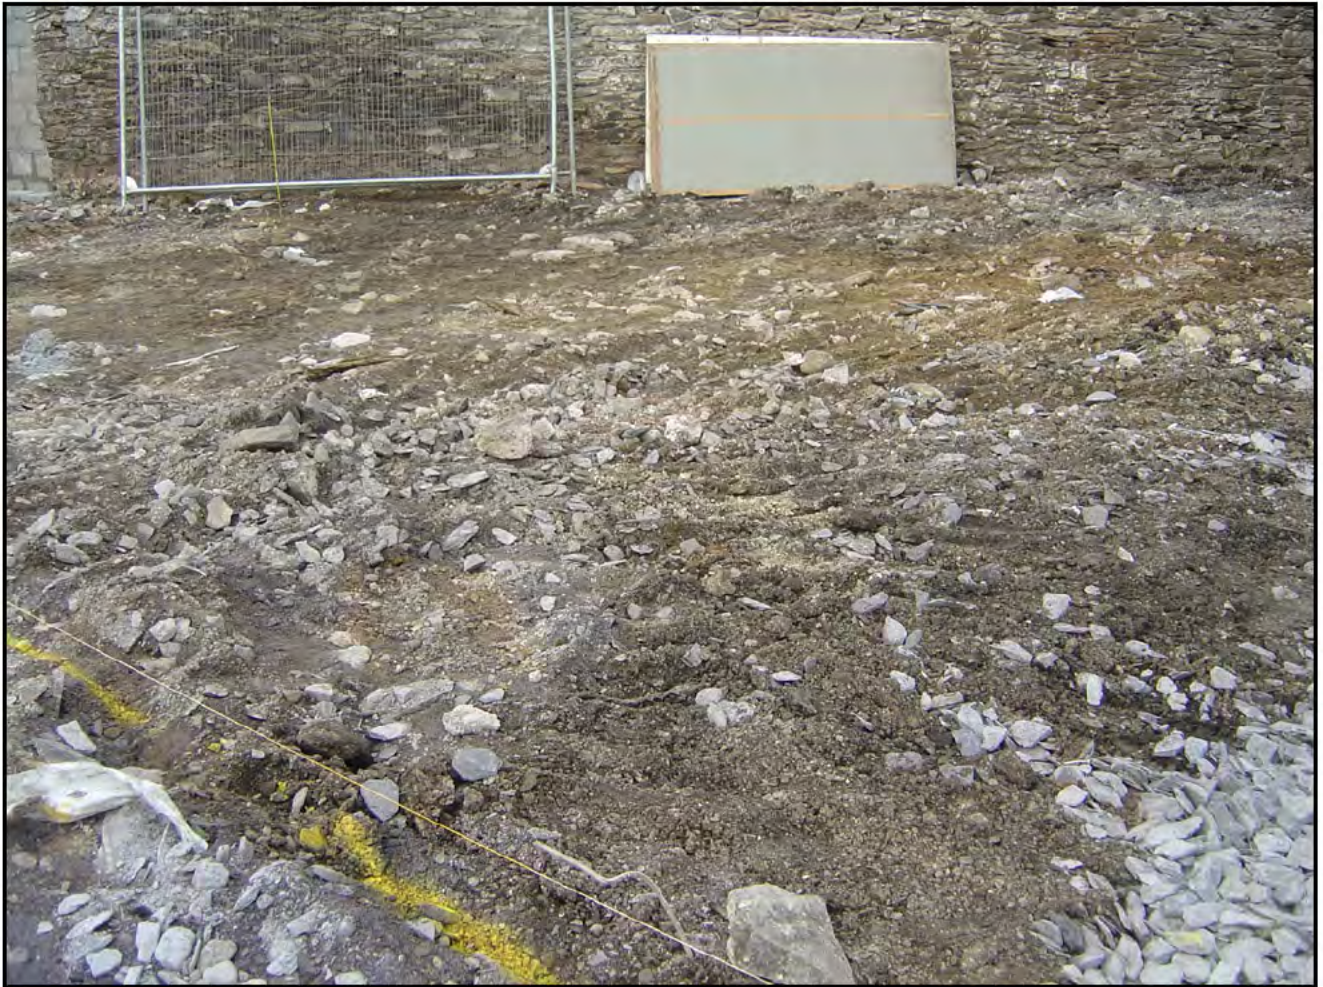
Plate 09: Zone 3/Yards 5 (PRN 30469) & 6 (PRN 30474): excavation of the former ground levels of Buildings 7 (PRN 30475) and 8 (PRN 30476), detailing limit of excavation prior to construction of the interpretation area

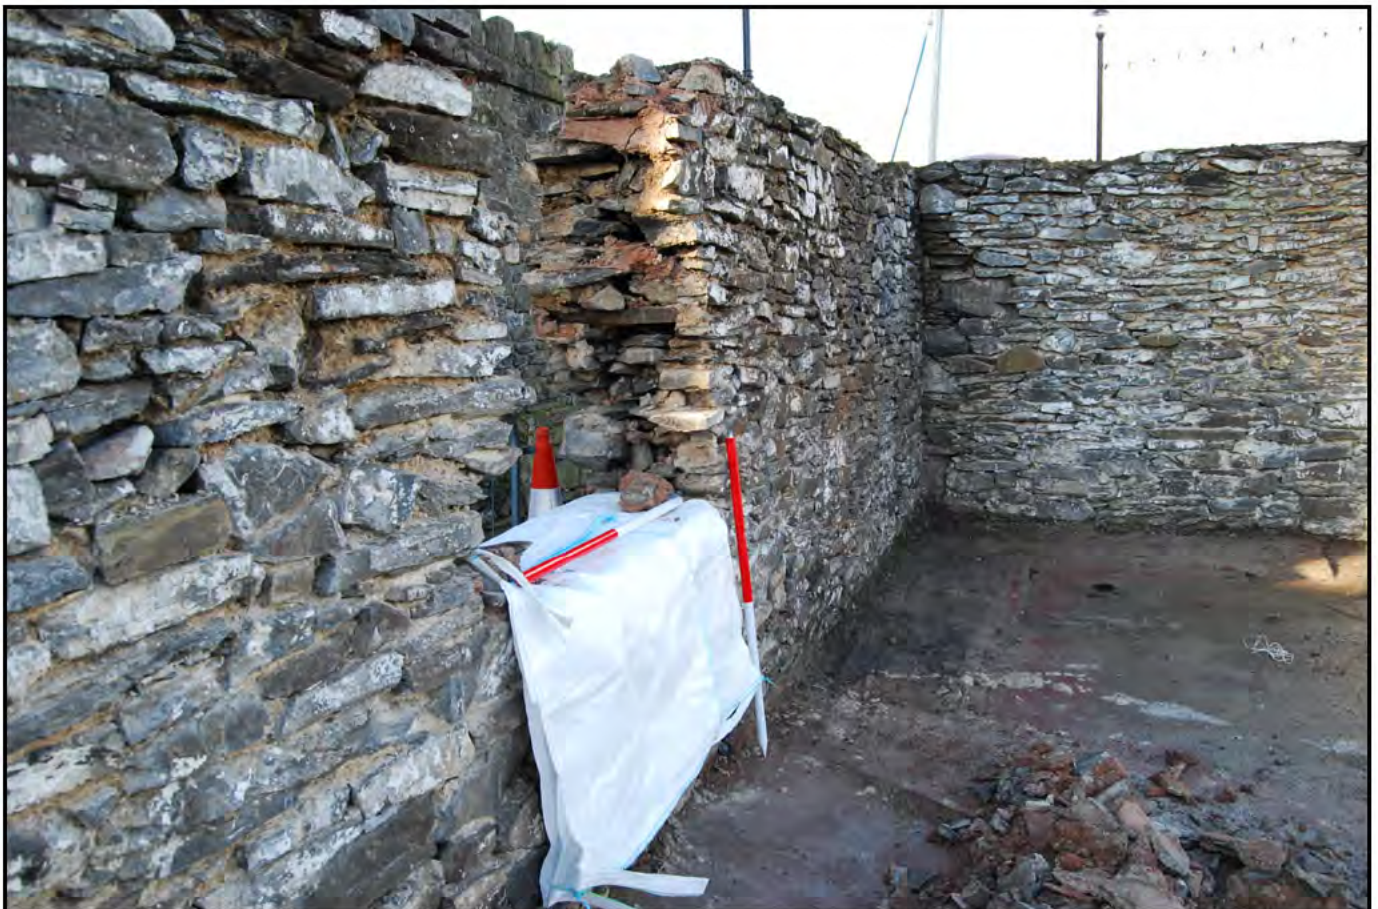
Plate 10: Zone 3/Yards 5 (PRN 30469) & 6 (PRN 30474): Enclosure Wall A repair; former aperture for Building 07 (PRN 30475), detailing wall thickness and construction (0.40m thick). Scale (2 x 1.0m)

In addition to the excavation of the extant floor levels, a former breach in Enclosure Wall A was repaired (plate 10). The cavity in Enclosure Wall A left by the demolition of **Building 08** (plate 11) was also repaired: a block wall was constructed with an outer face of salvaged stone material (plate 12) to match the existing wall.

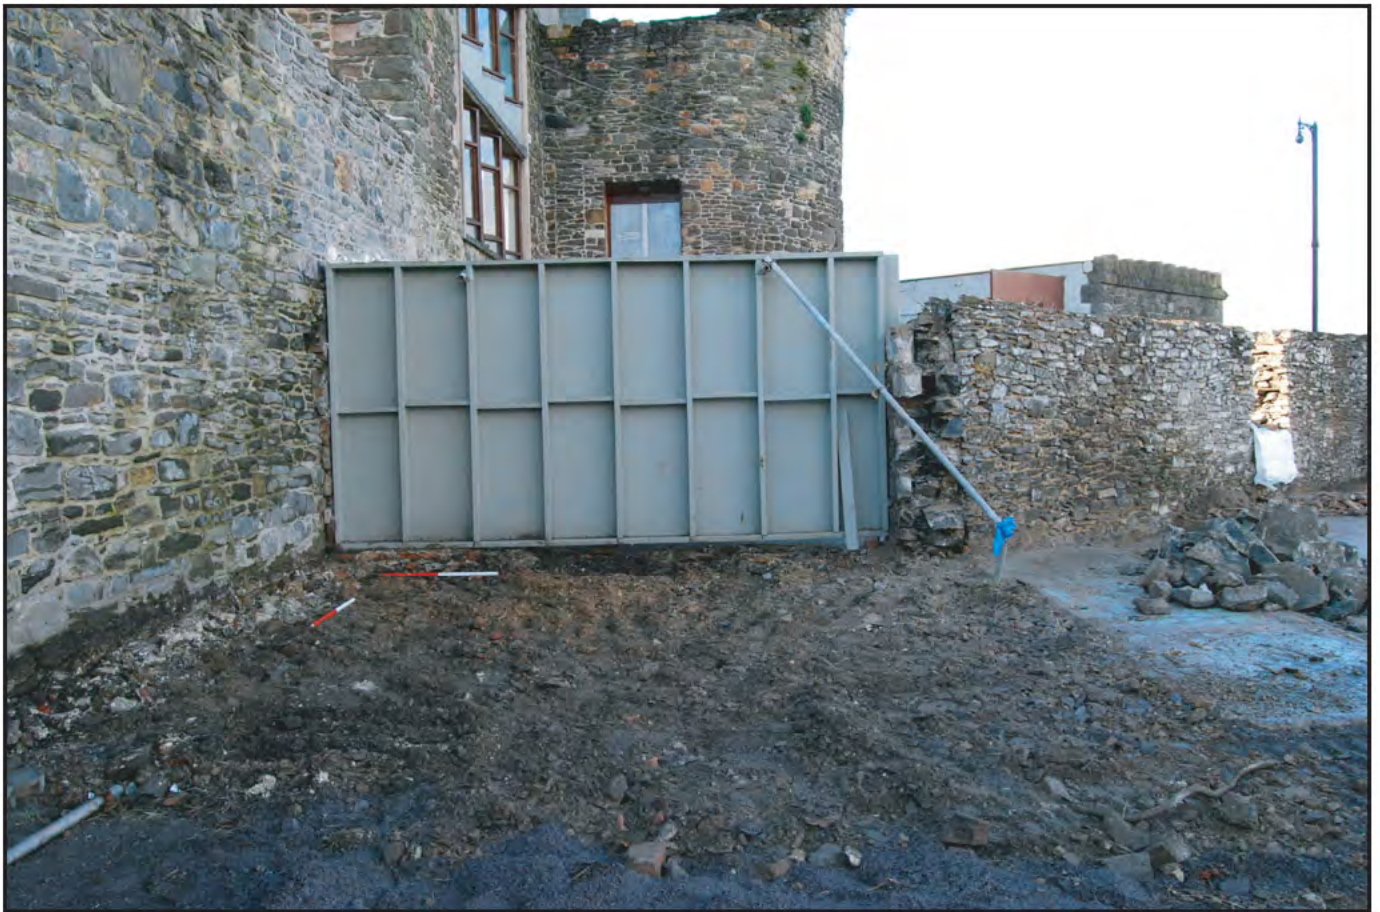
Plate 11: Zone 3/Yards 5 (PRN 30469) & 6 (PRN 30474):: View northwest of temporary timber screen positioned along Enclosure Wall A at the former location of Building 08 (PRN 30476) (Building 08 truncated return wall is visible to the left of the timber screen). This screen was replaced by a wall built from salvaged stone (cf. Plate 12). The limit of excavation for the interpretation area can be seen in the foreground. Scale: 2 x 1.0m

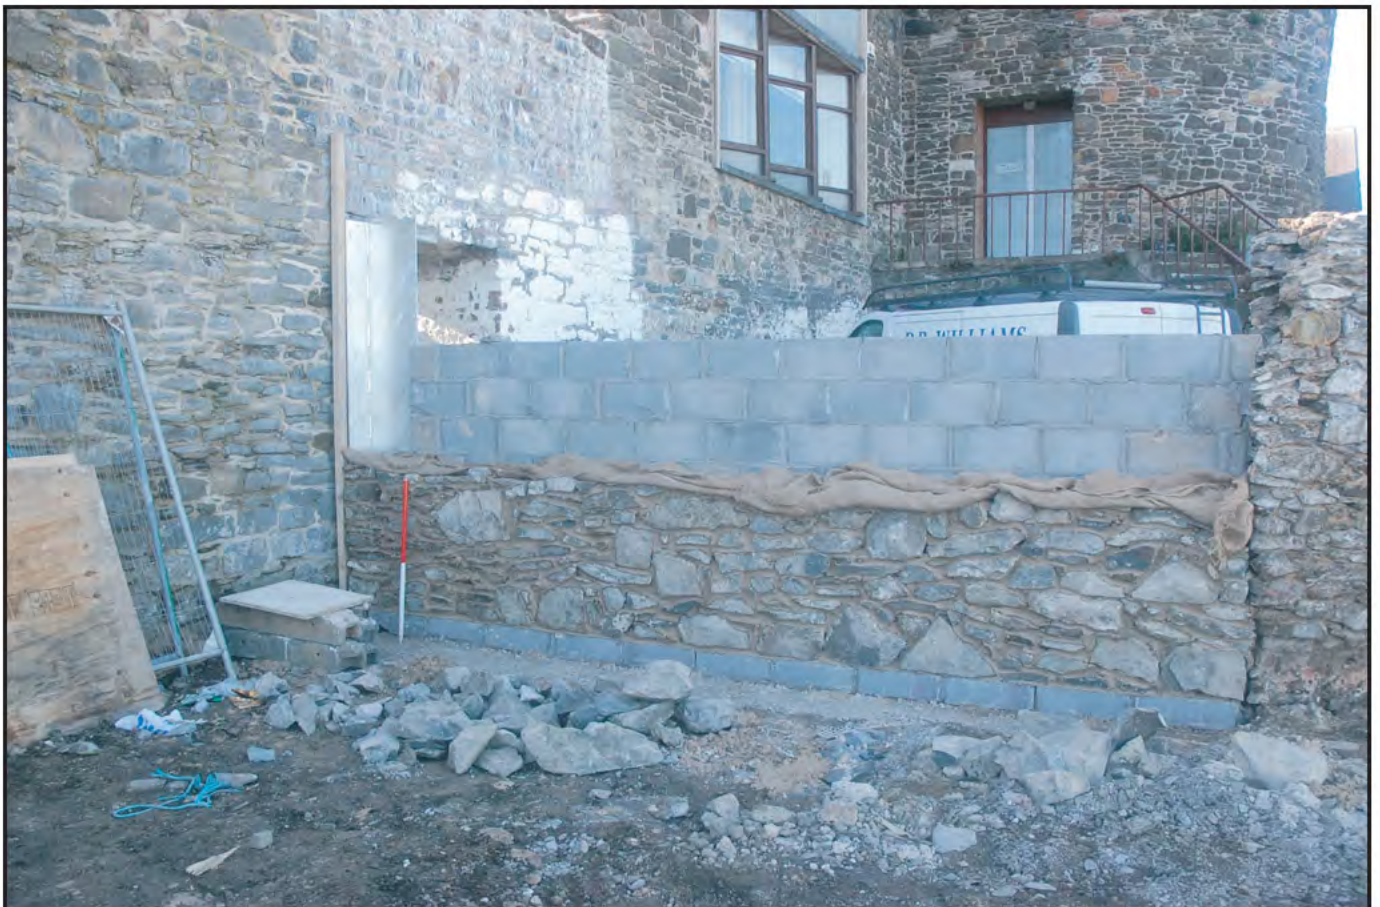
Plate 12: Zone 3/Yards 5 (PRN 30469) & 6 (PRN 30474): view northwest of salvaged stone wall during construction, designed to replace the timber screen visible in Plate 11. Scale: 1 x 1.0m.
