# Cilfor Water Treatment Works: **Talsarnau, Gwynedd**

# **Archaeological Assessment**

GAT Project No. 2145 Report No. 886 September, 2010

# G2145 CILFOR WATER TREATMENT WORKS, LLANDECWYN

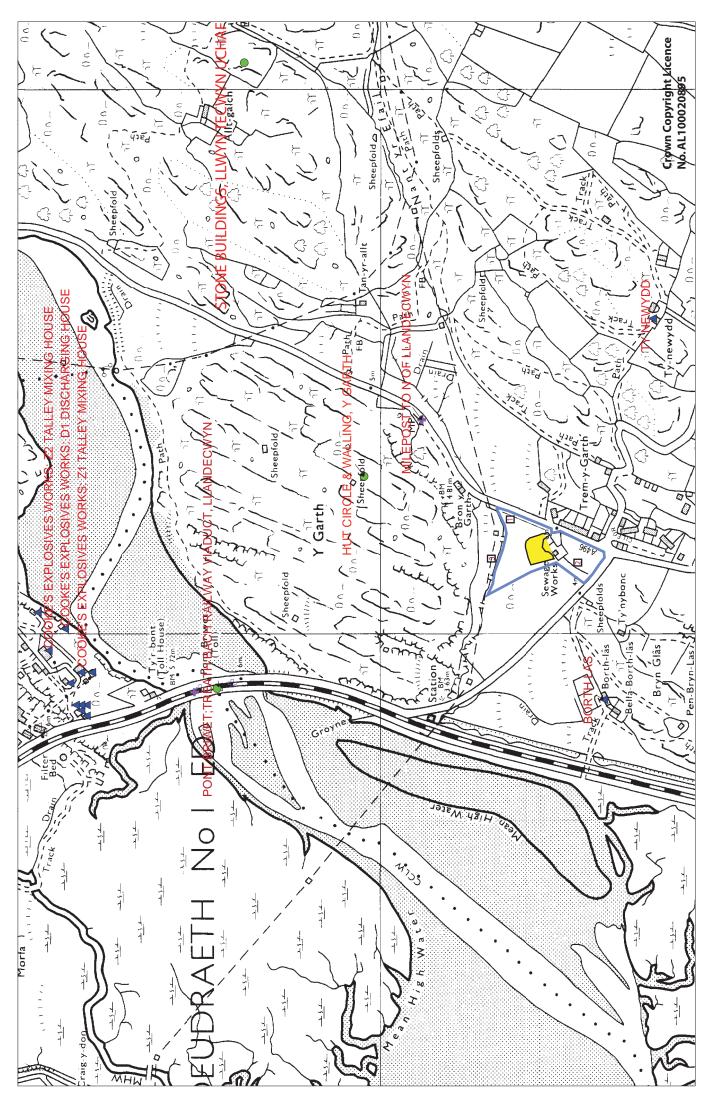
Fig. 2 Location of sites on the Gwynedd HER (Green dots), RCAHMW CARN database (Blue triangles) and listed buildings (Pink cross). The study area is outlined in blue, the development area in yellow and the sites referred to in the text are numbered in pink. Base map taken from OS1:10 000 sheet SH63NW. Scale 1:5000.

Three features were identified directly within or contiguous with the proposed development area, defined as the outline shown on Fig. 2 and within 30m of it; the features are located on Fig. 2. These are initially described listed below with recommendations for further assessment and mitigatory measures, where appropriate. The recommendations reflect the information currently provided by Dwr Cymru Welsh Water, and assume impact only within the defined proposed development area (as outlined on fig. 2). Any change to the boundary of the proposed development area will require the recommendations below to be changed also.

Sites within 500m of the study area on the Gwynedd HER are noted on Fig. 2 and in Appendix 1. The proposed development area, taken from Black and Veatch drawing no. 167975-00-3006, consists of 2927 m<sup>2</sup> and is shown on Fig. 2, with 5161m<sup>2</sup> to be used for temporary works, such as the compound area.

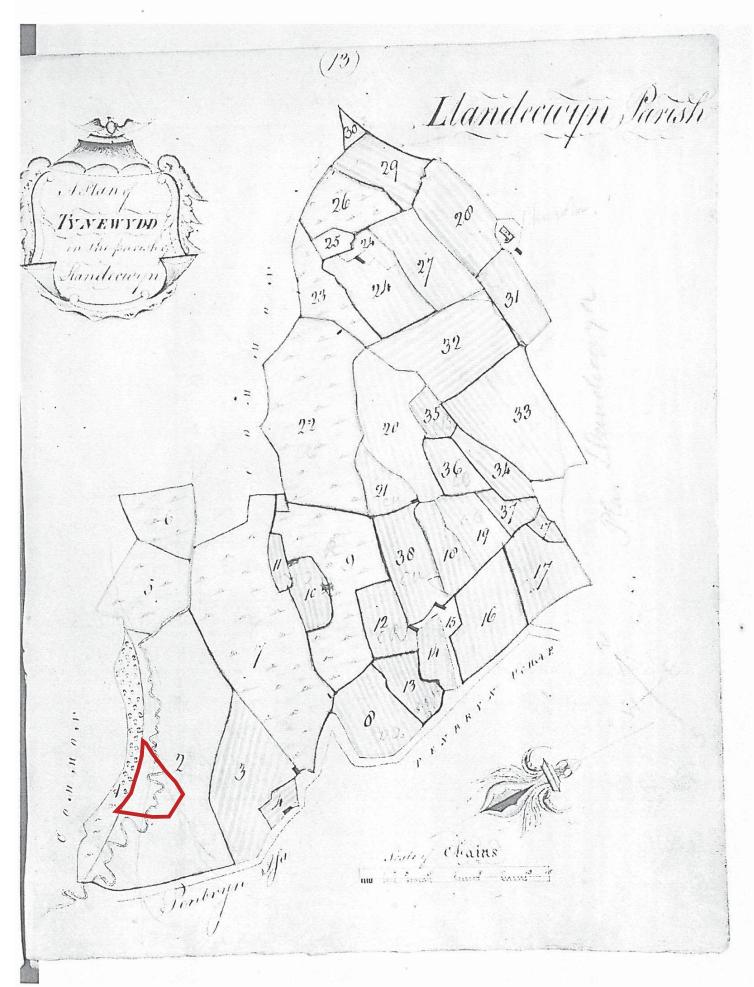
Fig. 3 Approximate location of study area, overlain in red on 1770 Survey of Pencraig and Cae Nest Estates ...the Property of Owen Anthony Poole Esq. (NLW Maps Vol.2 094/8/3)

In 1770 the study area was part of the Cae Nest Estate, which was the property of Owen Anthony Poole Esq. and formed part of Ty Newydd farm (NLW Maps Vol. 2 094/8/3; Fig. 3), located in an area of salt marsh on the edge of Traeth Bach (Field 2, Fig. 3). Before the beginning of the 19<sup>th</sup> century, the high tides washed the cliffs, which would have included Y Garth (Lloyd 1958, 137). Small boats were said to be able to reach Y Garth on the high tides.

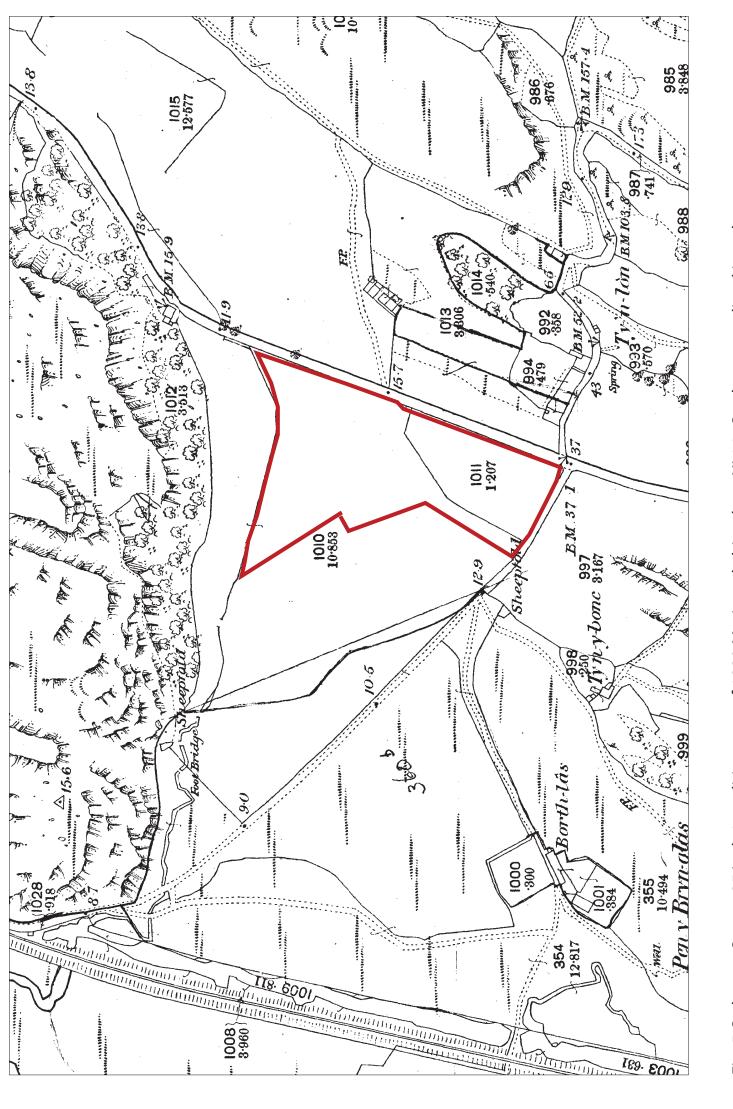
Fig. 5 Ordnance Survey 25 inch 1st edition map of 1889 Merionethshire sheet XI.14 . Study area outlined in red

The field patterns around the study area remain largely unchanged from the time of the 1<sup>st</sup> edition 25 inch Ordnance Survey map of 1889 (Fig. 5) until the present time, although housing has subsequently been built nearby at Trem y Garth and the Water Treatment Works was added in the mid-20<sup>th</sup> century. Significant amounts of land drainage works have also been carried out in recent times (Fig. 7).

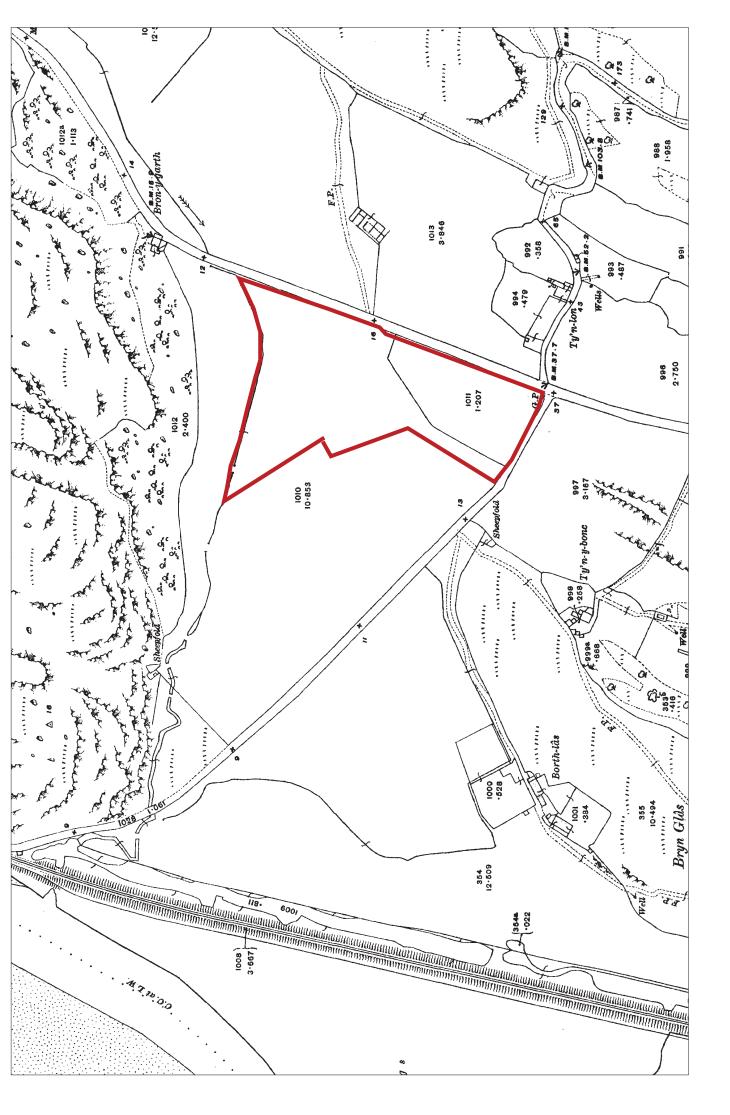
Fig. 6 Ordnance Survey 25 inch 3rd edition map of 1916 Merionethshire sheet XI.14 . Study area outlined in red

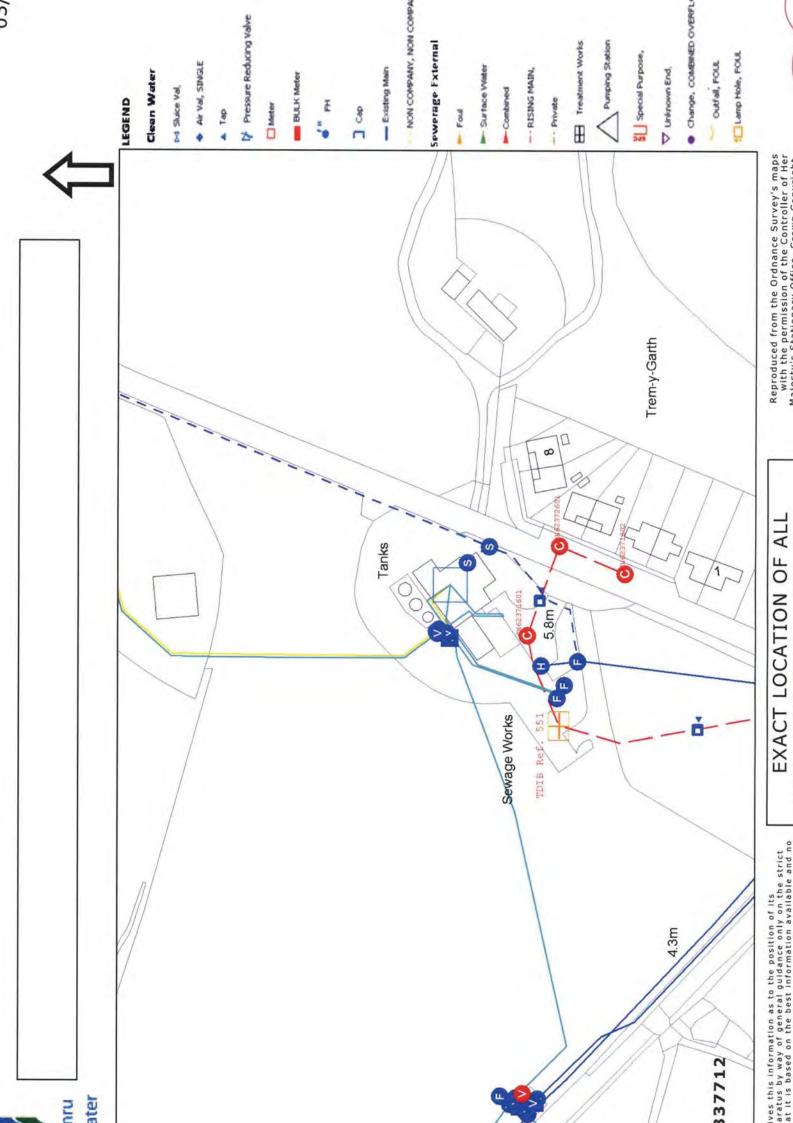
Fig. 7 Plan of 20th century land drainage at Cilfor (plan provided by Dwr Cymru)

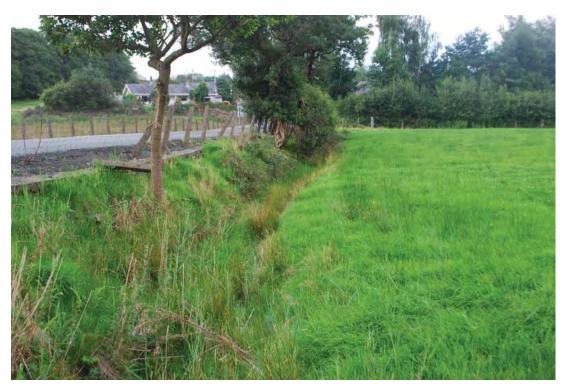
Feature 1 Drainage channel and embankment (Fig. 2; Plates 2-3)

SH 62253780-SH62213773 Period: Post-medieval Category: B Impact: None

A ditched embankment, with drainage ditch parallel to a slate embankment, which formed the sub base for the 1833 Turnpike Road leading from Harlech to Maentwrog. It was created owing to the need to create a secure base as the road crossed the former salt marsh area on the edge of Traeth Bach.

Plate 2 Feature 1, the embanked Turnpike road of 1833, from the north

Recommendations for further assessment: None Recommendations for mitigatory measures: Avoidance

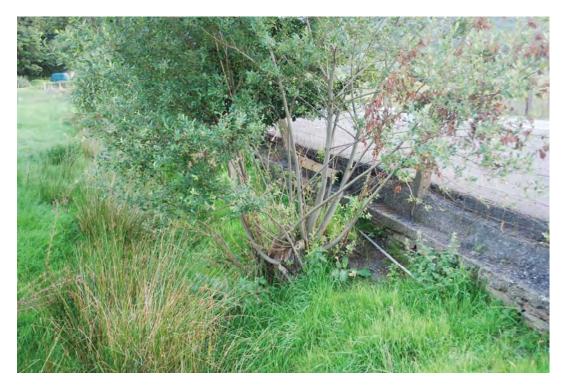
Plate 3 Detail showing slate sub-base for the Turnpike Road (Feature 1), from the south west

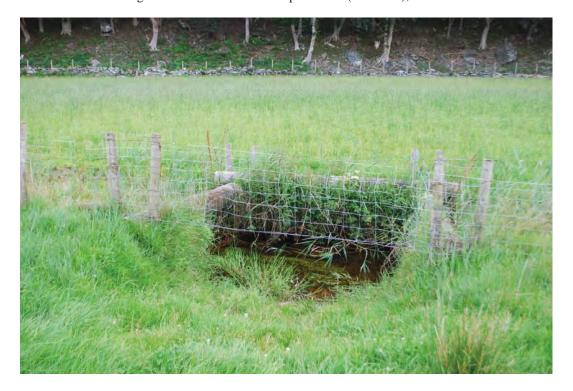
# Feature 2 Channelled Stream Course (Fig. 2; Plate 4)

SH 62233779-SH62083780 Period: Post-medieval Category: C Impact: None

The Nant yr Efail, flowing westwards towards the Afon Dwyryd has been channelled at this point, with a simple crossing point created at SH62163778. This would appear to have taken place before 1842, as the land is shown in its current form on the tithe map of 1842 (Fig. 4). On the 25 inch 1<sup>st</sup> edition Ordnance Survey map the channelled strean is shown as it is now (Fig. 5). It would seem to have been carried out as part of land improvement, to improve the land from salt marsh to good quality pasture land. The stream appears in its original meandering course in the 1770 estate map (NLW Vol. 2 094/8/3; Fig. 3), so the work must is likely to have been carried out between 1770 and 1840.

Plate 4 Feature 2, detail of channelled stream course, view from the south

Recommendations for further assessment: None Recommendations for mitigatory measures: Avoidance

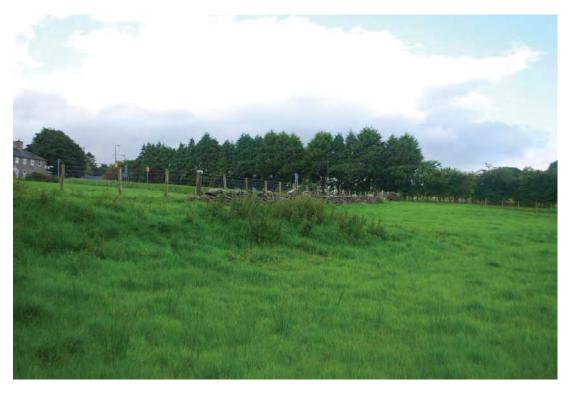
# Feature 3 Field Boundary (Fig. 2; Plate 5)

Category: C Impact: Possibly Considerable

A dry stone wall forming a field boundary, which extends for 48m northwards from its junction with the road to the south west. It appears to have been truncated at its northern end by the construction of the original Water Treatment Works. The original line ran north eastwards and met the 1833 Turnpike Road under the current works (Fig. 5). It is unlikely to be earlier than 19<sup>th</sup> century in date as it is on the reclaimed land.

$\textbf{Plate 5} \ \text{Feature 3, the truncated dry stone wall, from the north-east}$

Recommendations for mitigatory measures: Avoidance, or basic recording if this is not possible

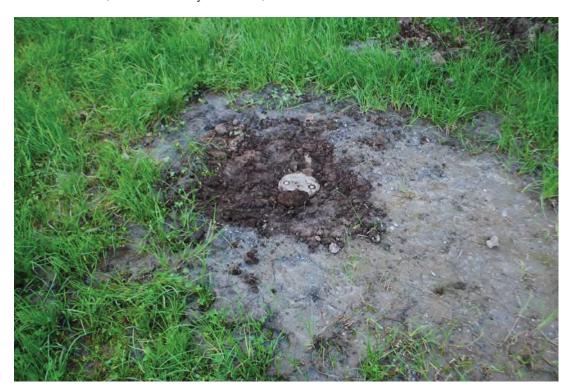
It appears that services, associated with the Water Treatment Works and adjacent Sewage Treatment Works, are located within the proposed development area, and these are shown on Dwr Cymru Welsh Water Drawing dated 3/9/2010 (Fig. 8, Plate 6). These may result in any potential archaeological deposits having been previously disturbed in places. The ground within the current Water Treatment Works is completely landscaped and disturbed, and there is no prospect of any archaeological remains surviving within this area. Extensive land drainage and deep ploughing (Fig. 7) has also been carried out by the landowners in the study area over a number of years, which may have a detrimental effect on the survival of archaeological remains.

Plate 6 Detail of services within development area
