GAS PIPELINE REPLACEMENT: PWLLHELI CITY GATE PRI TO BLAENAU FFESTINIOG PRI

Archaeological Evaluation

GAT Project No. 2148

Report No. 893

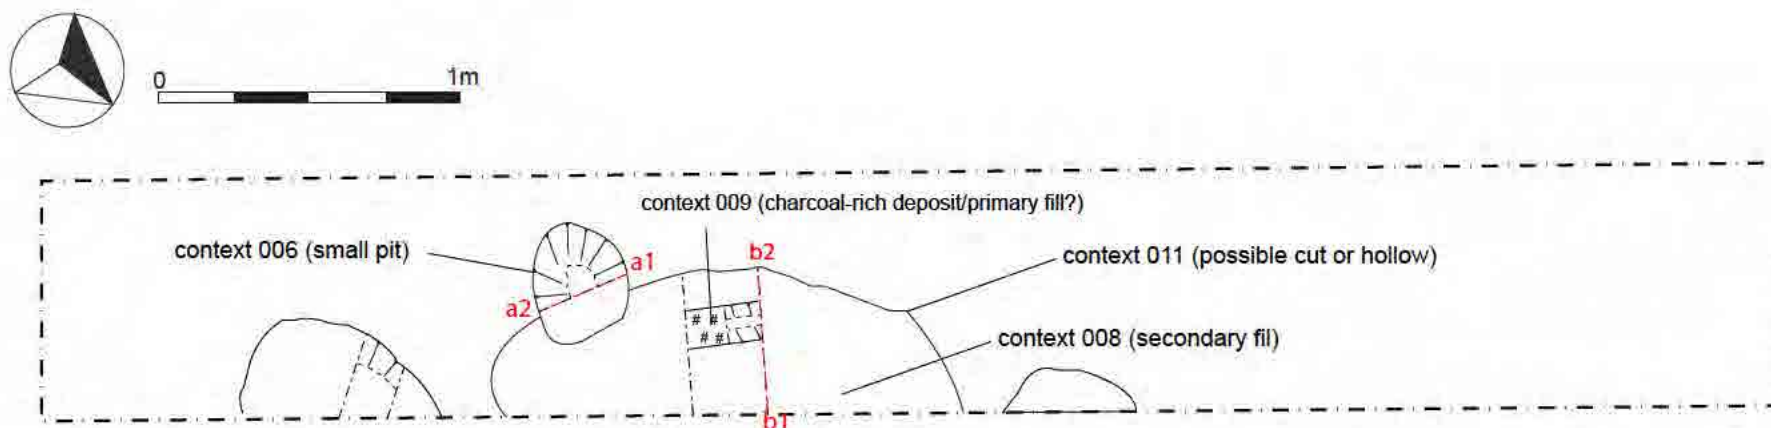
Figure 14a: Trench 17 - Plan (Scale: 1:50@A4)

(some of which were burnt). The silt-rich pit or hollow (context 011) measured 1.10m in width and 0.15m in depth and was filled by a semi-circular deposit of a brown silt containing stones and charcoal; the pit/hollow and associated fill were only partly extant within the trench. A 0.50m wide slot was cut through the fill, identifying a sealed band of charcoal-rich silt (context 009), which was atop the natural. It could not be determined within the confines of the trench whether the larger feature was a deliberately cut pit or a natural scoop or hollow.

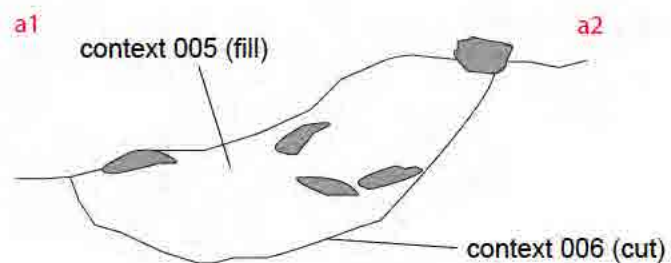
Figure 14b: Trench 17 - Pit (Context 006): south facing section (Scale: 1:10@A4)

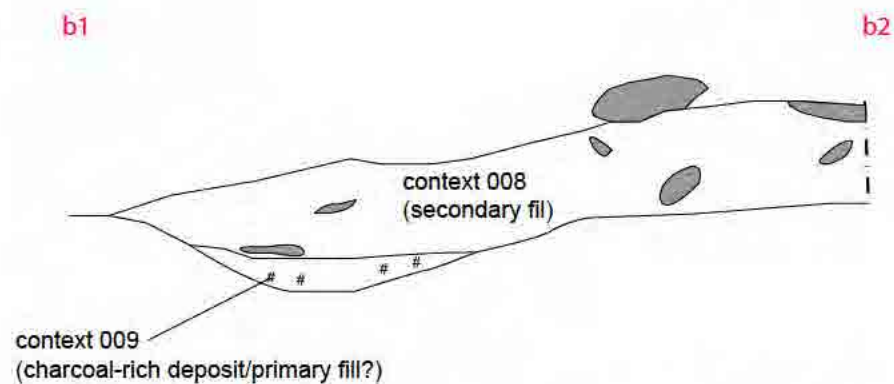
Figure 14b: Trench 17 - possible cut or hollow (Context 011): southeast facing section (Scale: 1:10@A4)

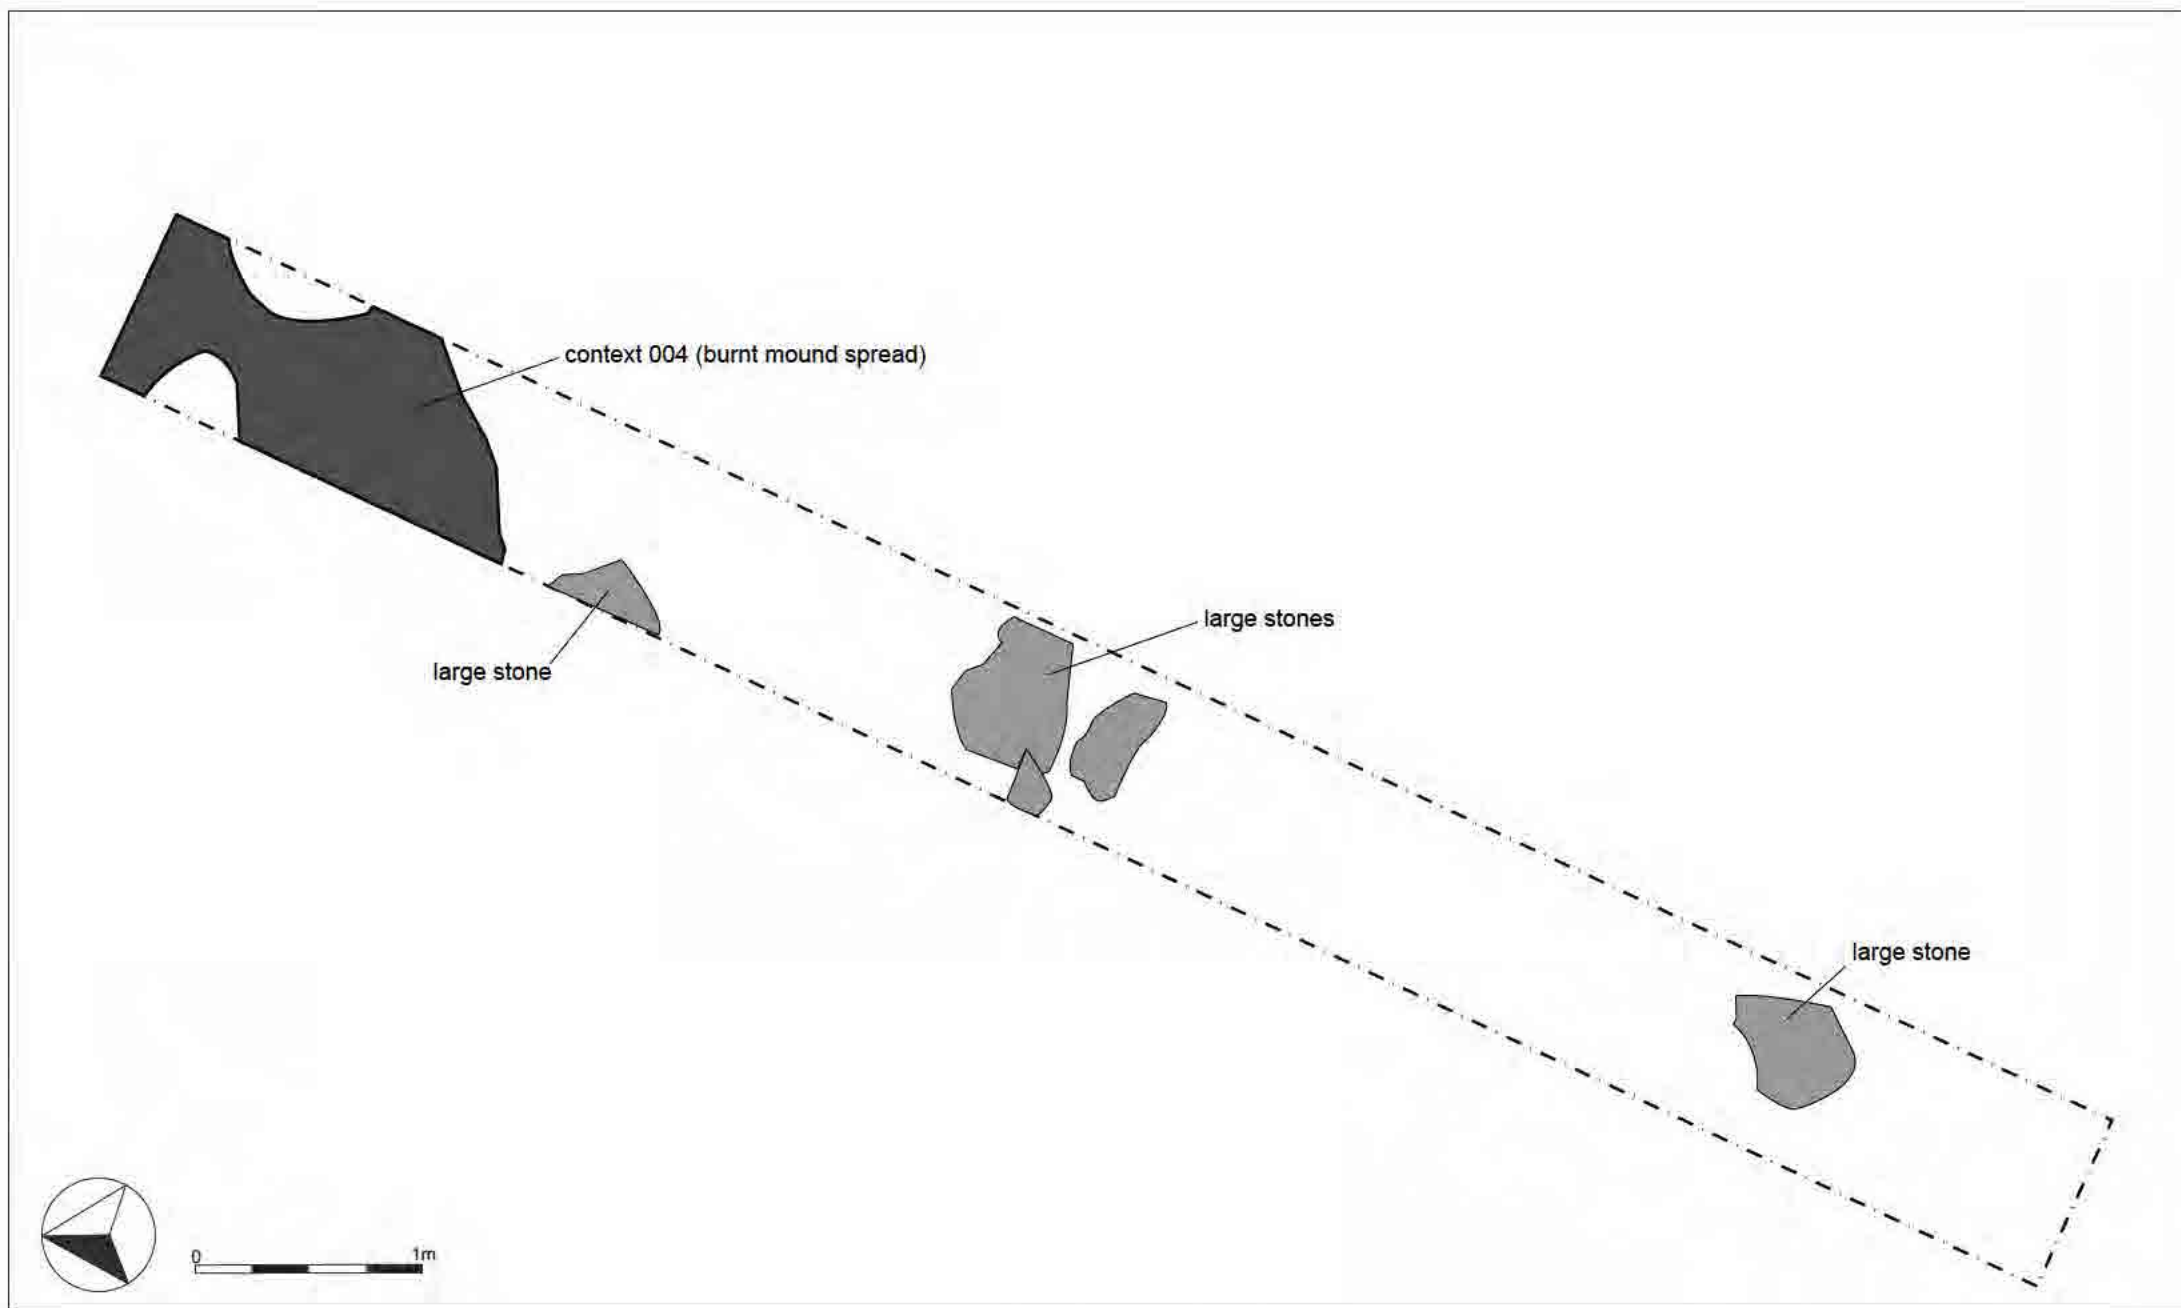
Figure 15: Trench 24 - Plan with associated archaeological features (For the location of trench 17, cf. RSK Archaeological Monitoring Locations Map 16; Reproduced as Figure 10). Scale: as indicated

The trench was located to target “geological and uncertain/unknown” geophysics and was positioned near a gate in the stone wall at the top of the slope above a boggy and marshy area. A large boulder was encountered near the SSW end of the trench which we were unable to remove as it would damage the trench sides. The natural in this trench comprised of a grey and orange gravel and fractured rock. Large flat slabs were found at 10.0m along the trench and seem to be natural, although this could not be confirmed. Further towards the NNE a deposit of burnt stone and charcoal was found which continued to the end of the trench. This deposit is typical of burnt mound material. The total exposed area within this trench was 5.0m x 1.60m (trench width), although it is very likely to continue for an unknown distance down the slope and the exterior edges of the trench, the depth of the material at the outer edge of the mound was 0.20m.

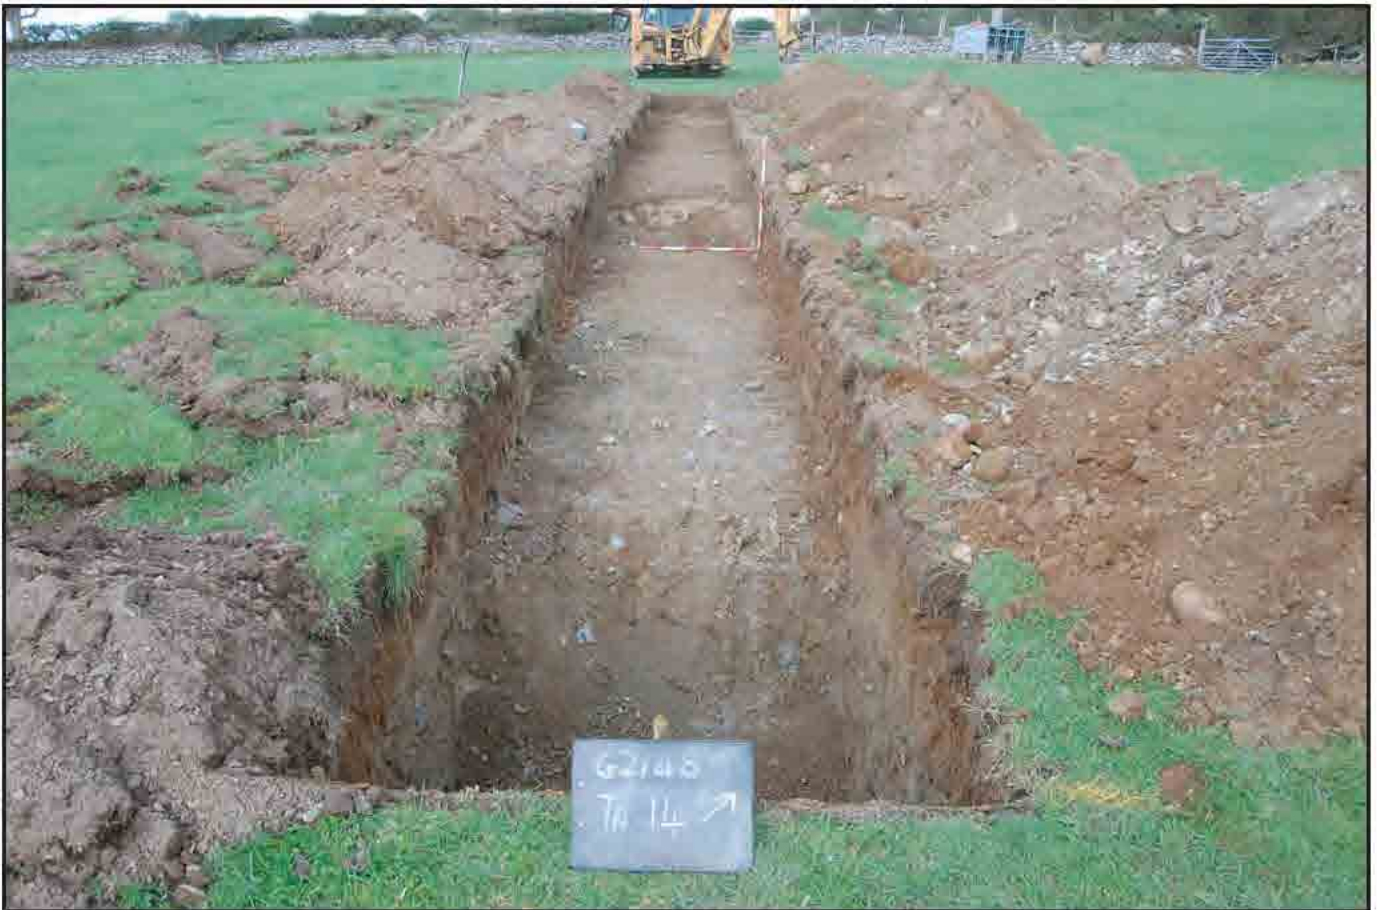
Plate 1: Trench 14 - This trench was positioned to target "uncertain/unknown" geophysics and was located on the lower area of field 6/1. At the centre of the trench there was a deposit of large stones, initially thought to be the remains of a field boundary, within a matrix of grey clay with orange mottling. Further investigation showed voids in the stones and edges indicating that this feature was quite a large stone filled drain. (cf. Plate 2). Scales: 2 x 2.0m

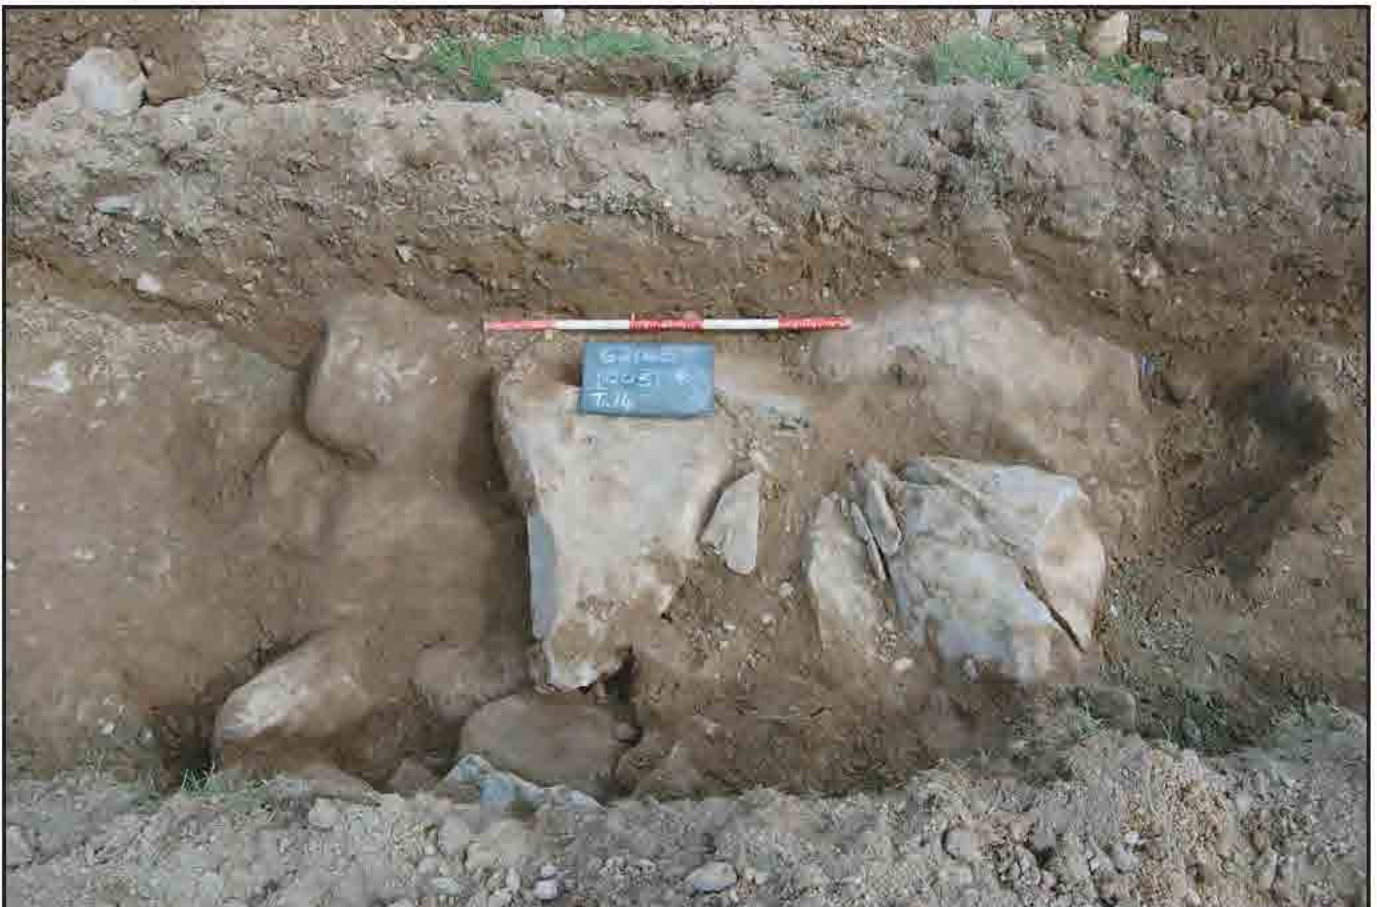
Plate 2: Trench 14 - Detail of large stone filled drain: interpreted as post-medieval. (cf. Plate 1). Scales: 1 x 2.0m

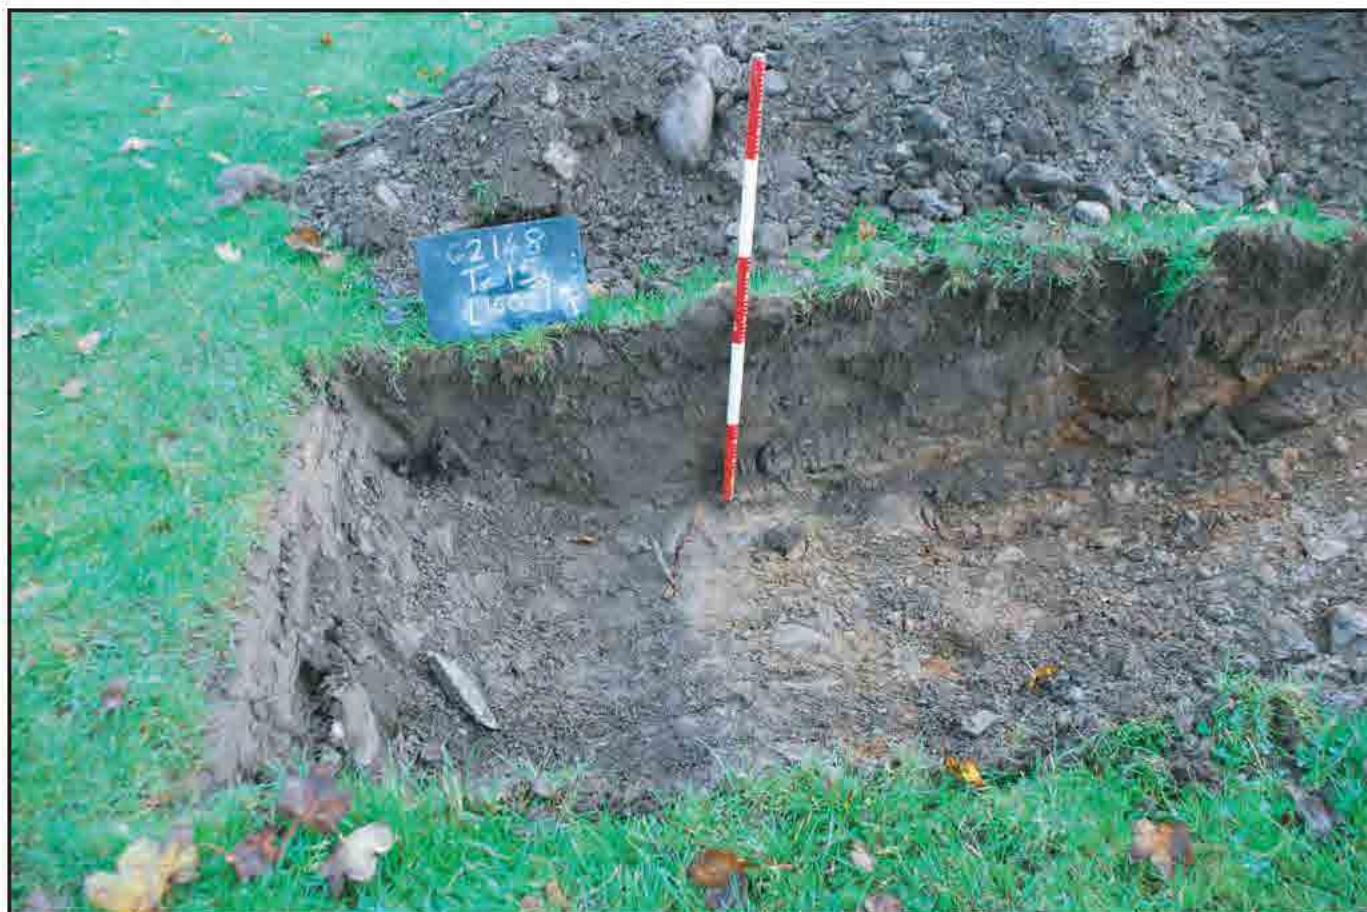
Plate 3: Trench 15a - This trench was positioned to target “mainly geological” geophysics on a relatively steep SE-NW slope. At the NW end of the trench a possible field boundary ditch was identified, filled by a light orange brown sand-rich clay silt. This ditch appeared just below the topsoil and matched the alignment of a modern boundary wall located on the other side of the field wall, suggesting the feature was part of a modern boundary alignment.

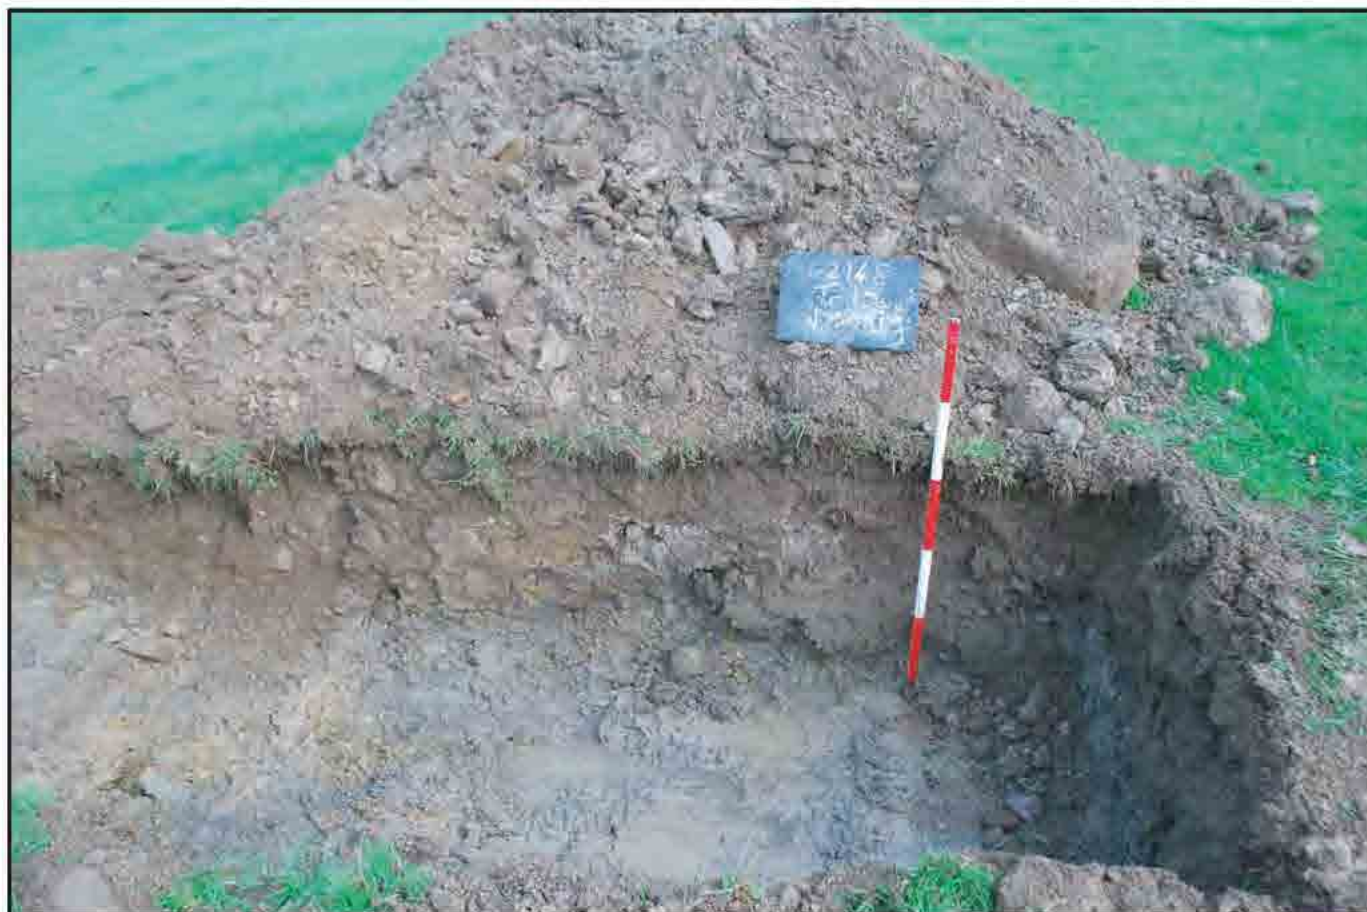
Plate 4: Trench 15a - This trench was positioned to target “mainly geological” geophysics on a relatively steep SE-NW slope. At the SE end of the trench a former field boundary was noted, although its full width was not assessed as it was outside of the investigative area (about 0.50m was visible), running at a right angle to the trench. Visible on the 1st Edition 25” Ordnance Survey Map of the area

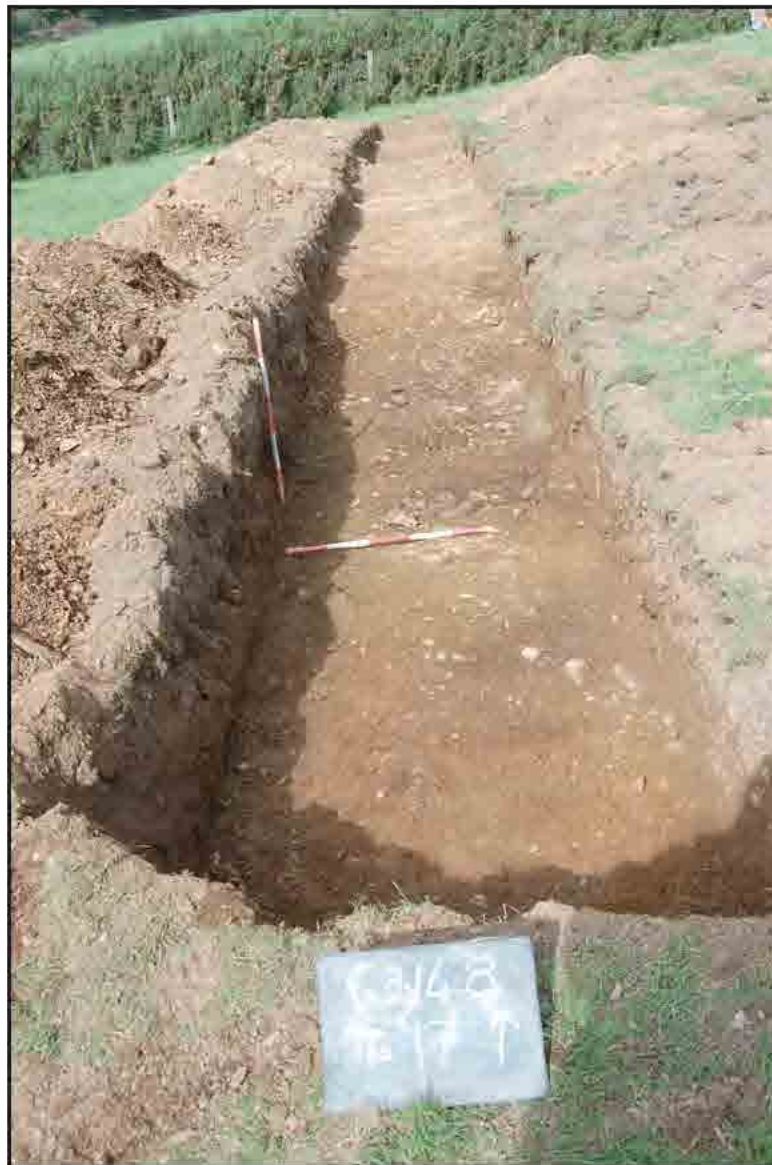
Plate 5: Trench 17. This trench was positioned across the steep west-facing slope of field 6/11 and targeted "geological and uncertain/unknown" geophysics. Two archaeological features were identified within the confines of the trench: a small pit and a larger pit or hollow.

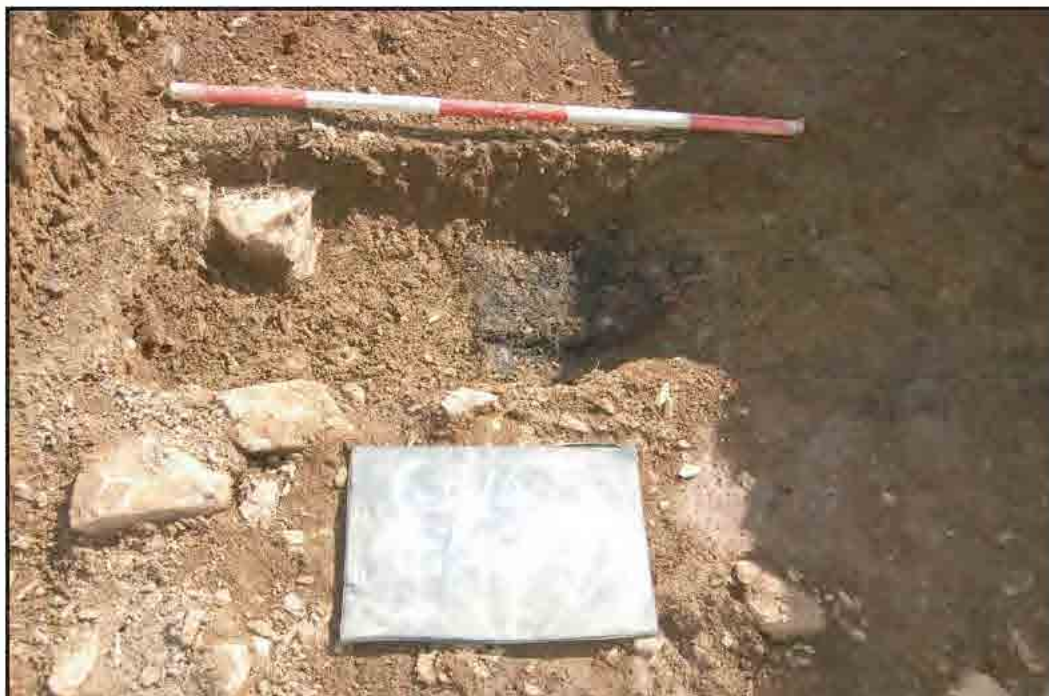
Plate 6: Trench 17 - detail of the silt-rich pit or hollow (context 011). The feature measured 1.10m (w) and 0.15m (d) and was filled by a semi-circular deposit of a brown silt containing stones and charcoal; the pit/hollow and associated fill were only partly extant within the trench. A 0.50m wide slot was cut through the fill, identifying a sealed band of charcoal-rich silt (context 009), which was atop the natural. It could not be determined within the confines of the trench whether the larger feature was a deliberately cut pit or a natural scoop or hollow.

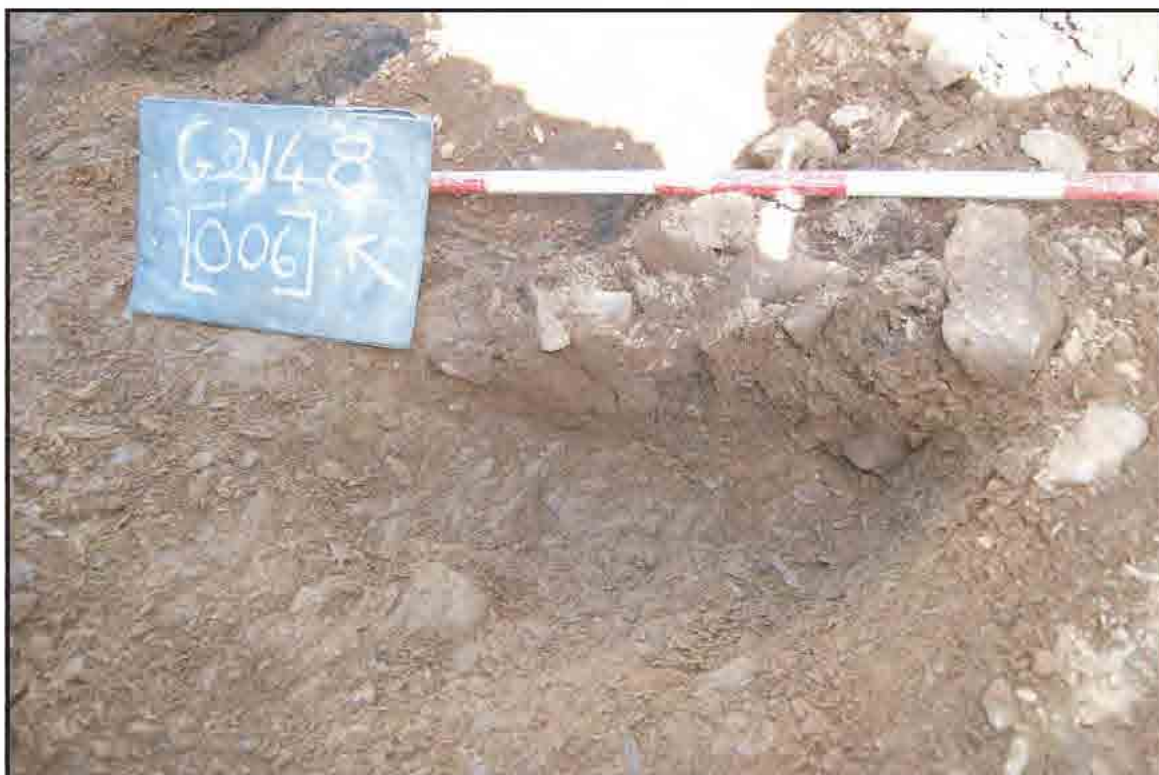
Plate 7: Trench 17 - detail of the small pit (context 006); the pit measured 0.60m (w) and 0.20m (d) and cut both the natural (context 003) and a larger silt-rich pit or hollow (context 011). no datable artefacts were identified within this feature or the larger pit/hollow

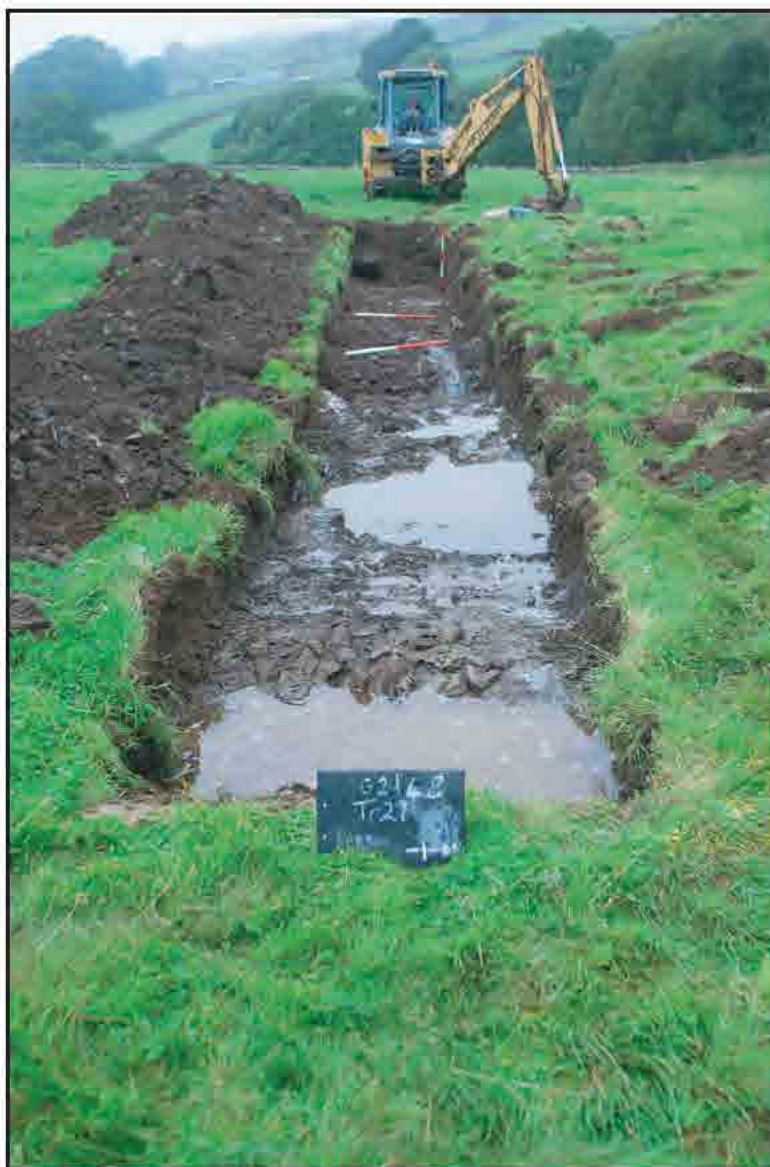
Plate 8: Trench 21- this trench was located to target "mainly geological" geophysics and was positioned at the edge of a boggy patch of ground. Two post-medieval stone-filled field drains were noted cut into the subsoil.

The trench was positioned at the edge of a boggy patch of ground. Depth of the mid orange brown clay-silt topsoil varied considerably but had a maximum depth of 0.60m. Below was a mid grey-brown silt-rich clay subsoil with a depth of 0.20m containing some very large stones. This overlay a glacial clay which in turn overlay a shale bedrock which was exposed through the glacial clay in places. The area was very waterlogged and two stone filled field drains were noted cut into the subsoil. The

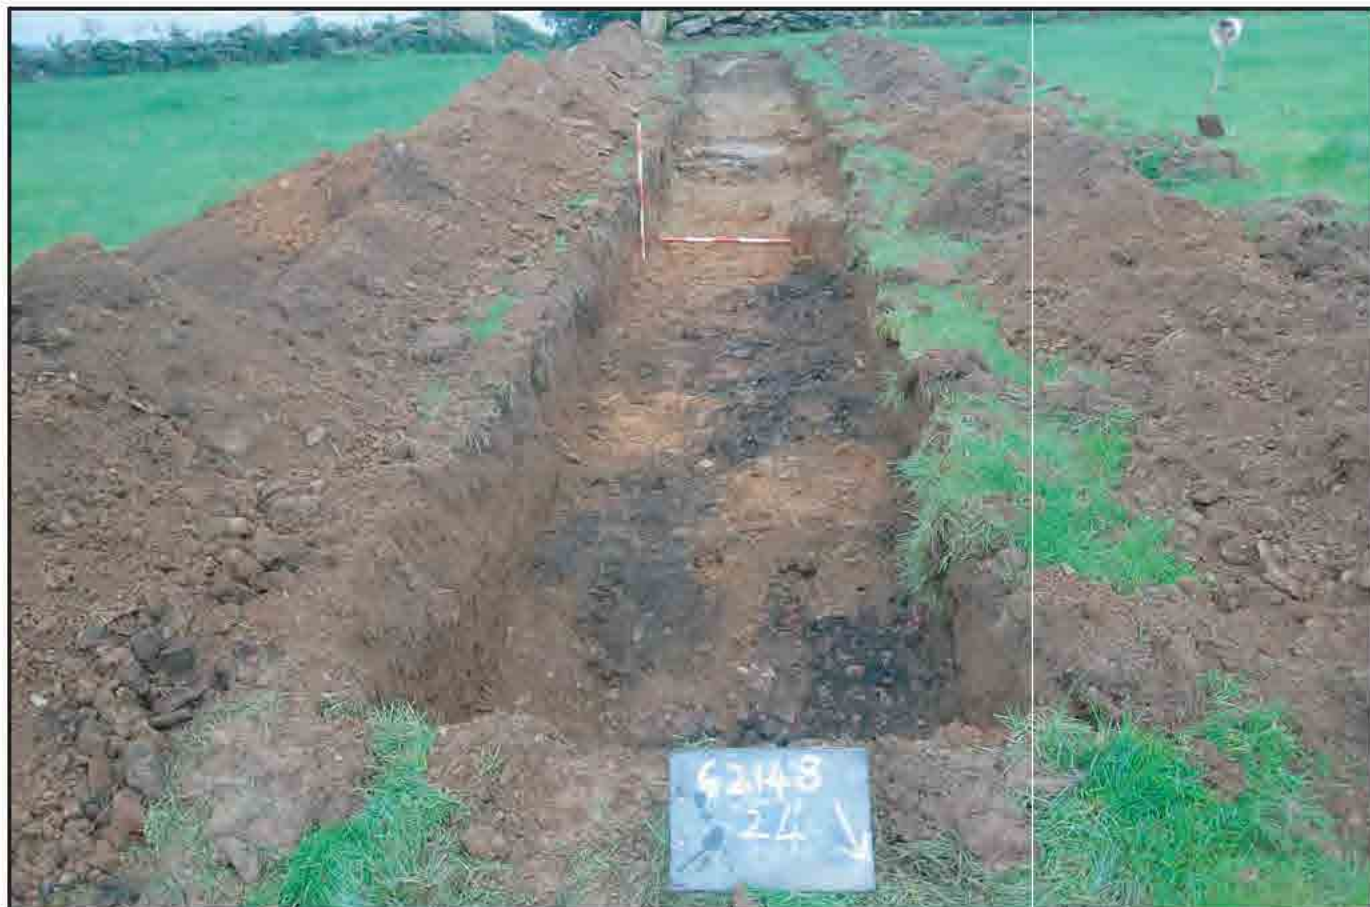
Plate 9: Trench 24 - The trench was located to target "geological and uncertain/unknown" geophysics and was positioned near a gate in the stone wall at the top of the slope above a boggy and marshy area. Large flat slabs were found at 10.0m along the trench and seem to be natural, although this could not be confirmed. Further towards the NNE a deposit of burnt stone and charcoal was found which continued to the end of the trench. This deposit is typical of burnt mound material.

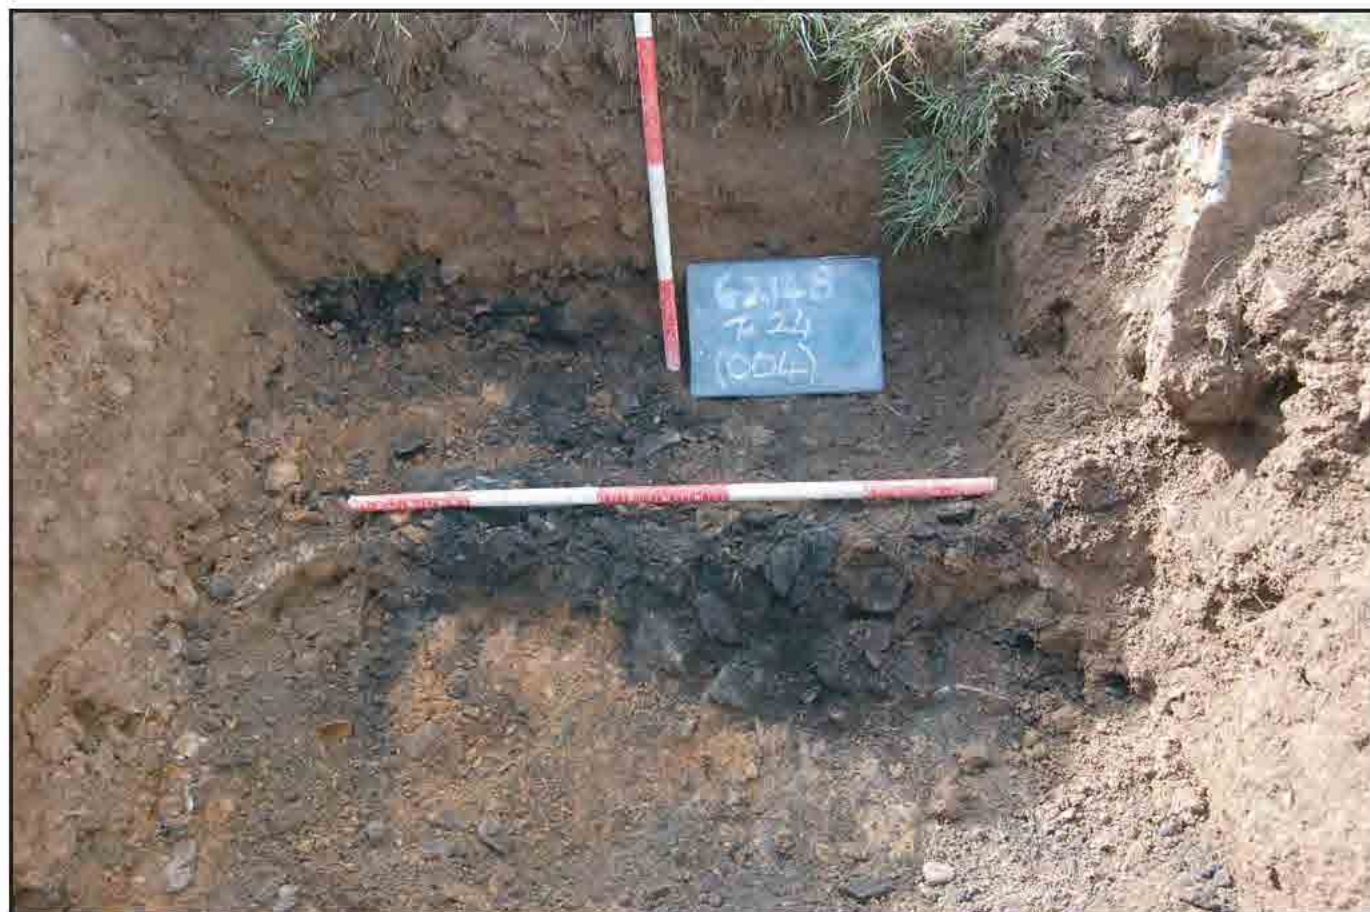
Plate 10: Trench 24 - detail of burnt mound during initial exposure and investigation. The total exposed burnt mound area within the trench was 5.0m x 1.60m (trench width). The mound appeared to continue outside the trench. No associated trough or hearth were identified within the confines of the trench. The depth of the material at the outer edge of the mound was 0.20m. Scale: 2 x 1.0m

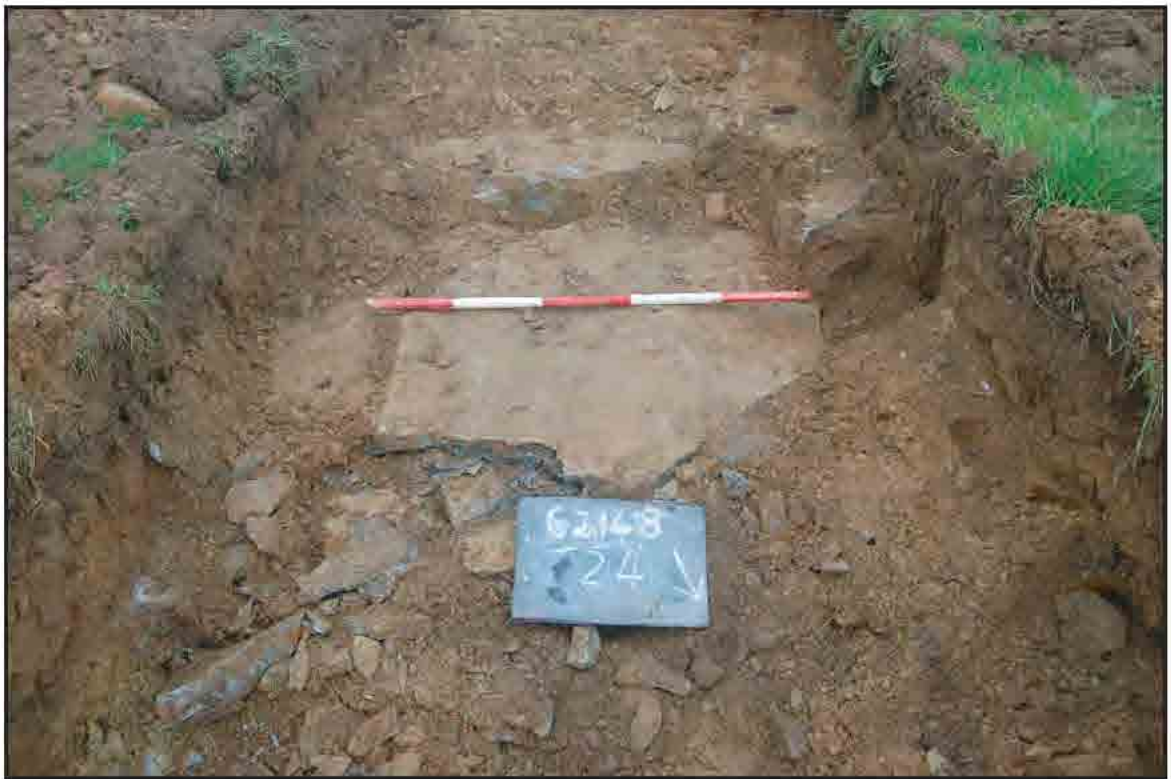
Plate 11: Trench 24 - detail of large flat slabs located at 10.0m along the trench. Interpreted as a natural formation. Scale: 1 x 1.0m.

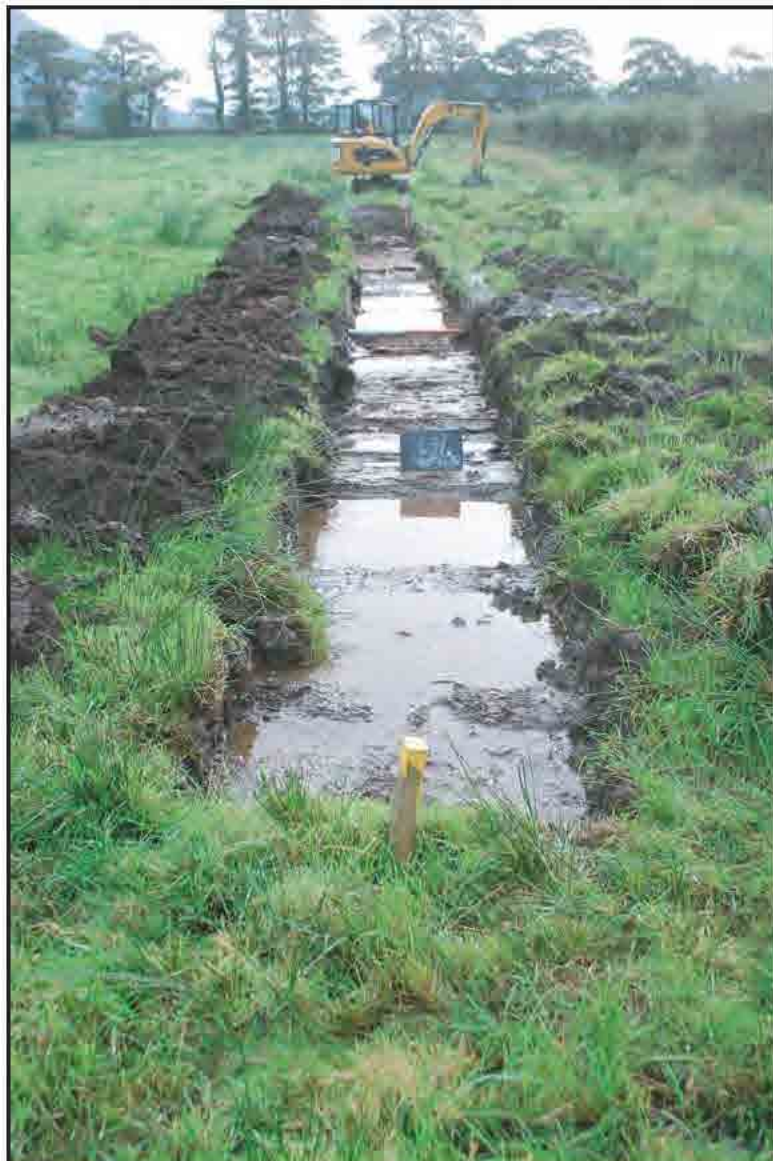
Plate 12: Trench 27 - this trench was located to target "mainly geological" geophysics and was positioned on the re-claimed land of Traeth Mawr. Evidence for localised drainage was indicated by a series of 5 ceramic field drains within the trench. Scale: 2 x 1.0m

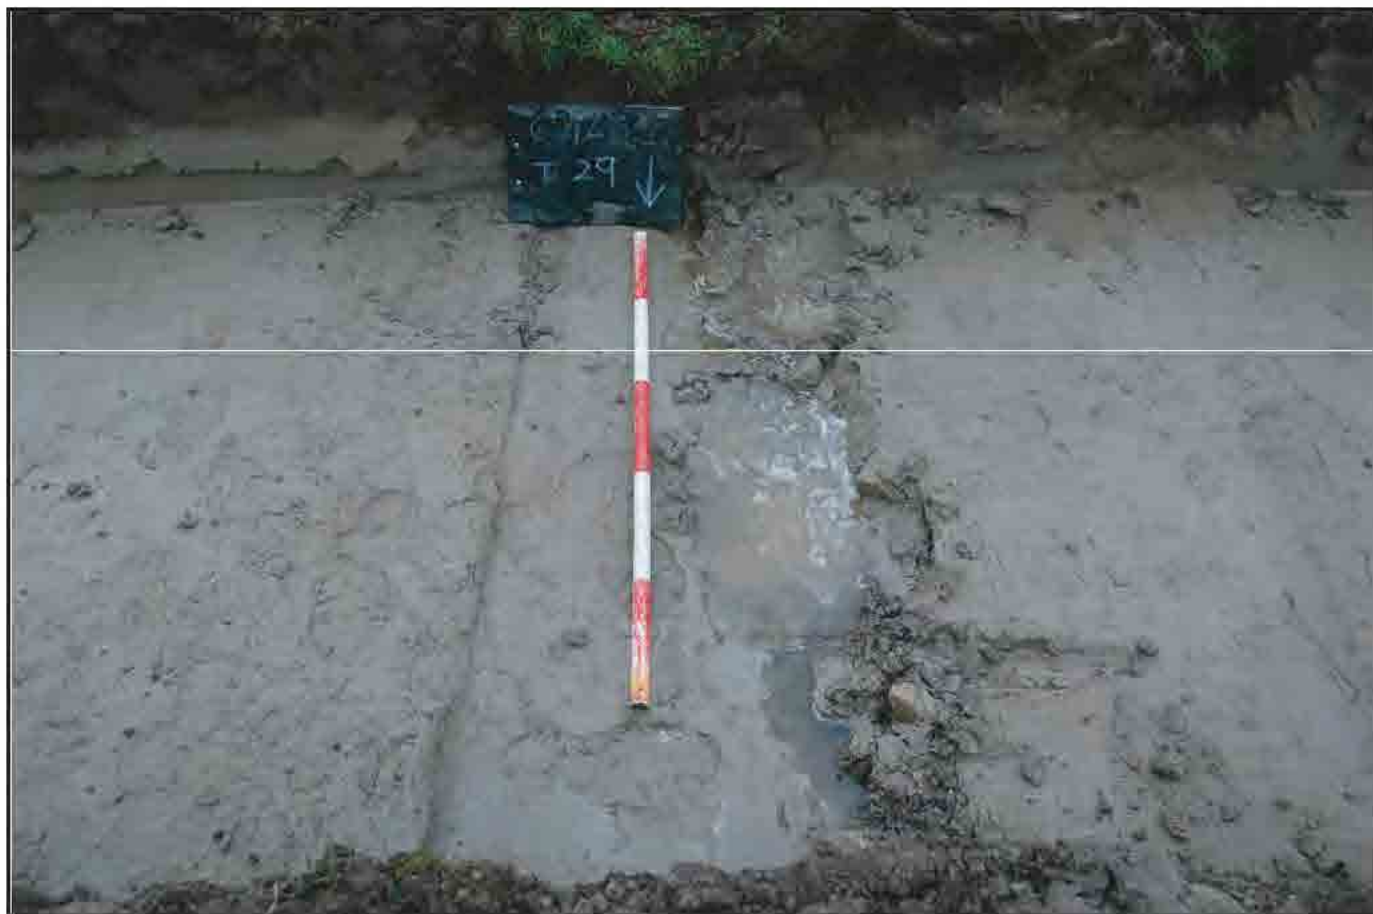
Plate 13: Trench 29 - this trench was located to target “possibly geological” geophysics. The trench was cut into soft and wet ground, with a dark brown topsoil with a depth of 0.20m overlying a pale grey sand with a depth of 0.10m. A ceramic field drain was found within the trench, which was blocked with silt and not working, and also a stone filled field drain was exposed which began to fill the trench with water. Scale: 1 x 1.0m.

This trench was cut into soft and wet ground, with a dark brown topsoil with a depth of 0.20m overlying a pale grey sand with a depth of 0.10m. The natural alluvial deposit was a very sand-rich grey clay, this was tested to a depth of 0.90m before flooding occurred. A ceramic field drain was found within the trench, which was blocked with silt and not working, and also a stone filled field drain was exposed which began to fill the trench with water. No archaeological activity was identified within the confines of the trench, apart from the drainage activity.

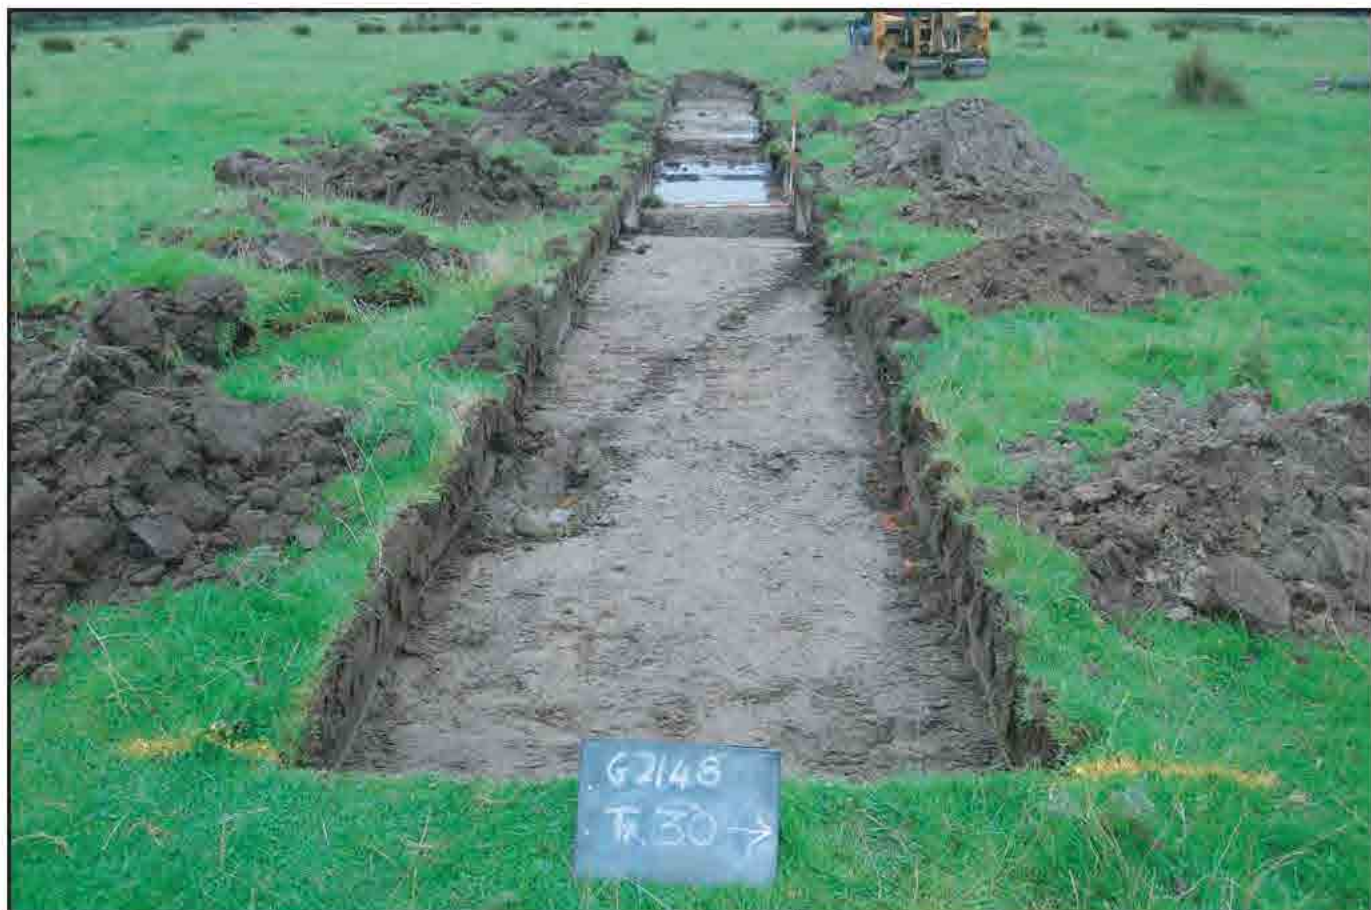
Plate 14: Trench 30 - this trench was positioned across a low lying channel between two higher areas. The topsoil had a depth of 0.20m and overlay a subsoil of pale grey sand that reached a maximum depth of 0.20m. Two ceramic land drains found within the first 6.60m from the east and another just over half way in the trench. A test pit was excavated to confirm the nature of the natural: a narrow band of a natural peaty organic material was seen in this area, but the trench began to flood and the excavation discontinued. Scale 2 x 1.0m.

This trench was positioned across a low lying channel between two higher areas. The topsoil had a depth of 0.20m and overlay a subsoil of pale grey sand that reached a maximum depth of 0.20m. The natural was a grey very sand-rich clay-silt. Two ceramic land drains found within the first 6.60m from the east, and another just over half way in the trench. A test pit was excavated to confirm the nature of the natural: a narrow band of a natural peaty organic material was seen in this area, but the trench began to flood and the excavation discontinued.
