# Proposed Quarry Realignment, Penrhyn Quarry, Bethesda

## Archaeological Evaluation

**Report No. 899**

**PROPOSED QUARRY REALIGNMENT, PENRHYN QUARRY, BETHESDA:  
ARCHAEOLOGICAL EVALUATION**

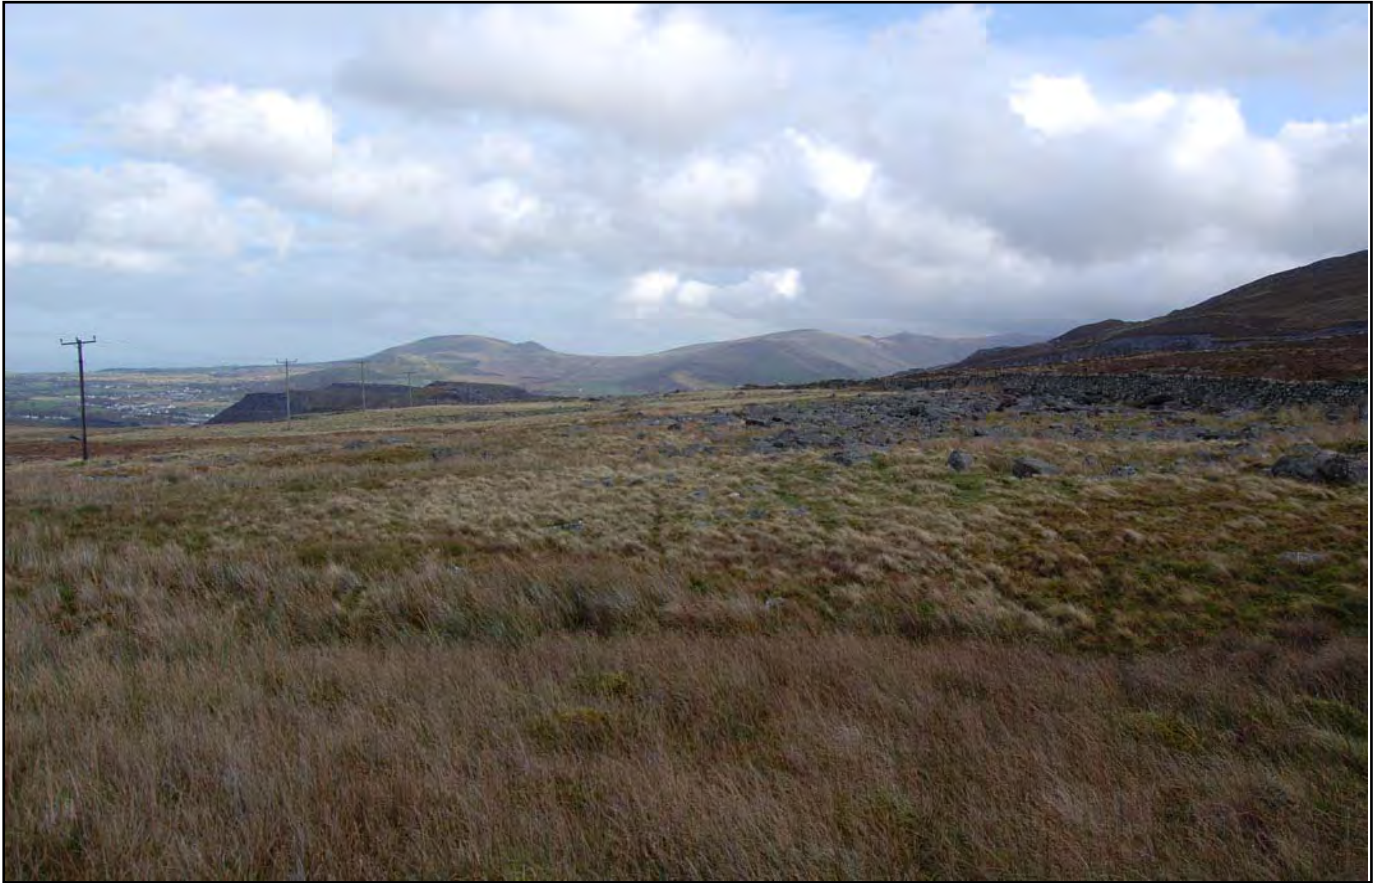
**Plate 1 Pre-ex shot of site 20 (cleared area).**

No evidence of any form of archaeological activity was observed in either of the 2m x 20m trenches. They revealed soft, dark humic soil which ranged from 0.2m – 0.3m in depth, and this lay directly over a very stony and clayey natural glacial till. The lack of subsoil and shallow topsoil combined with poor drainage suggested the area had never been ploughed, and the exposed location would certainly make such an activity difficult.

As this site revealed no evidence of archaeological activity, no further action is recommended.

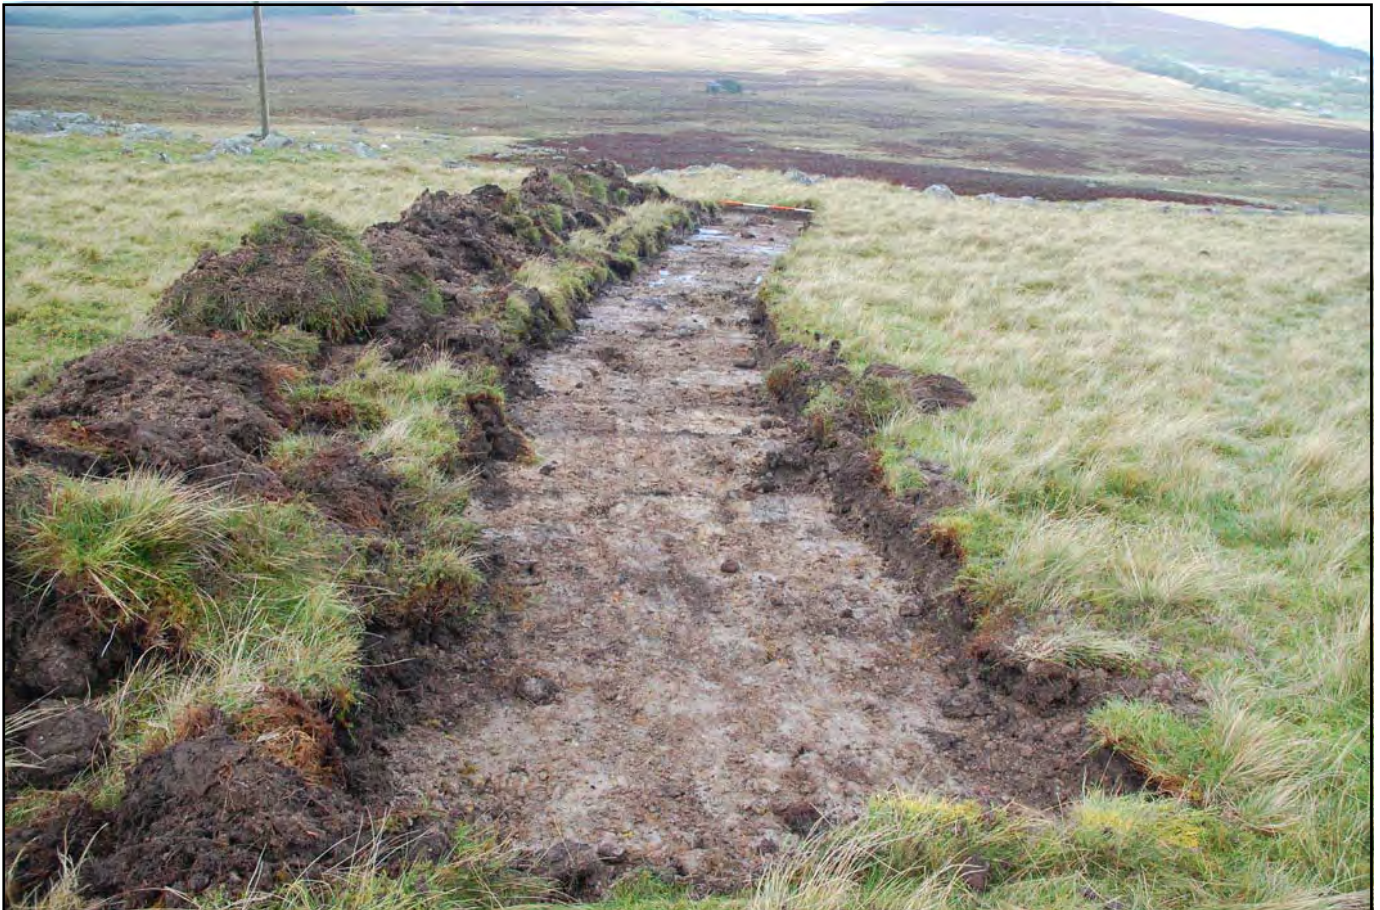
**Plate 2 Post-ex shot of trench 1, site 20 (cleared area).**

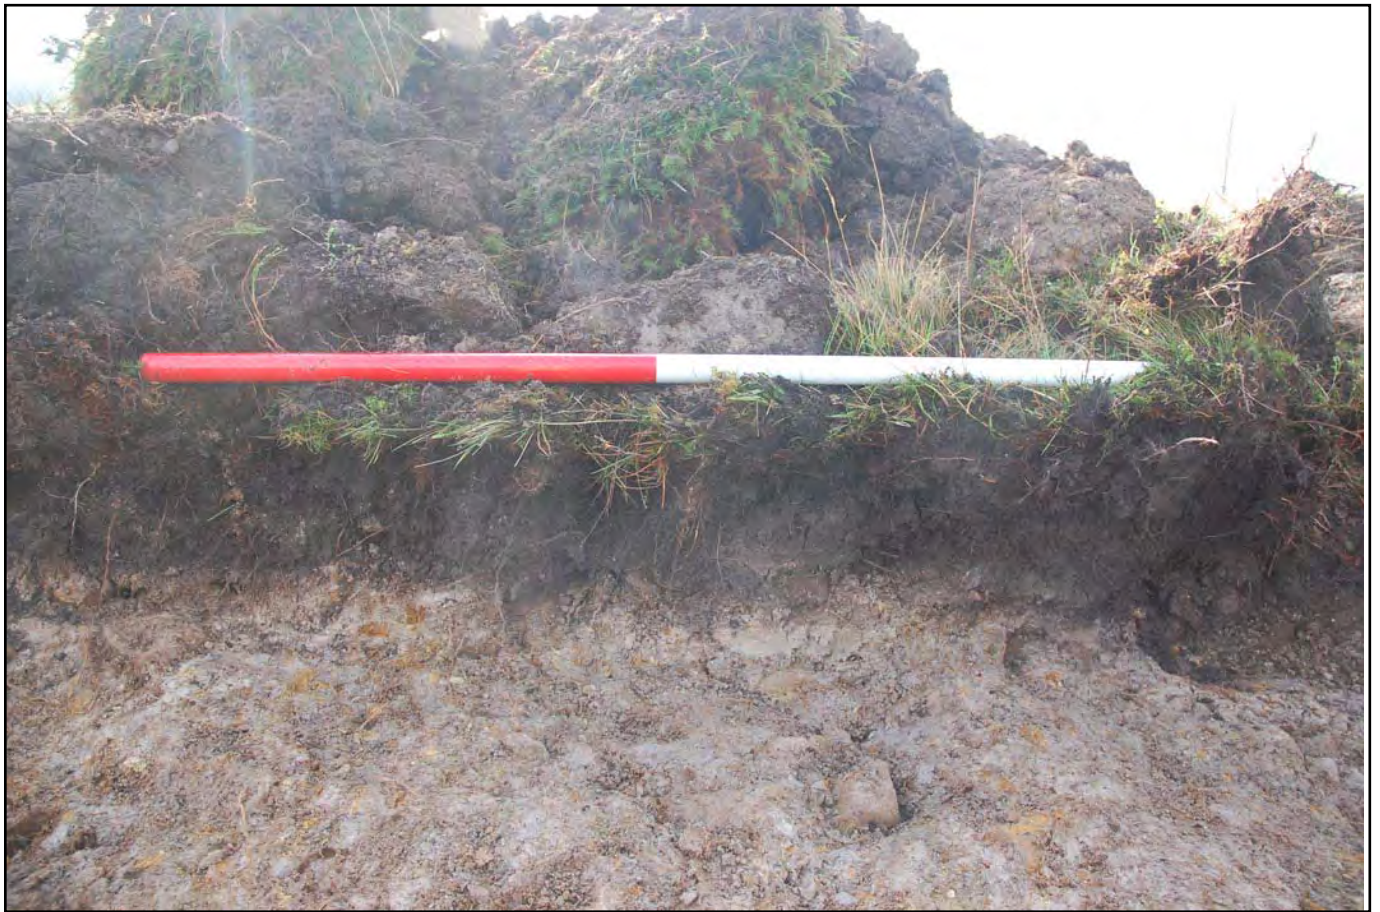
**Plate 3 Close-up of west facing section in trench 2, site 20 (cleared area).**

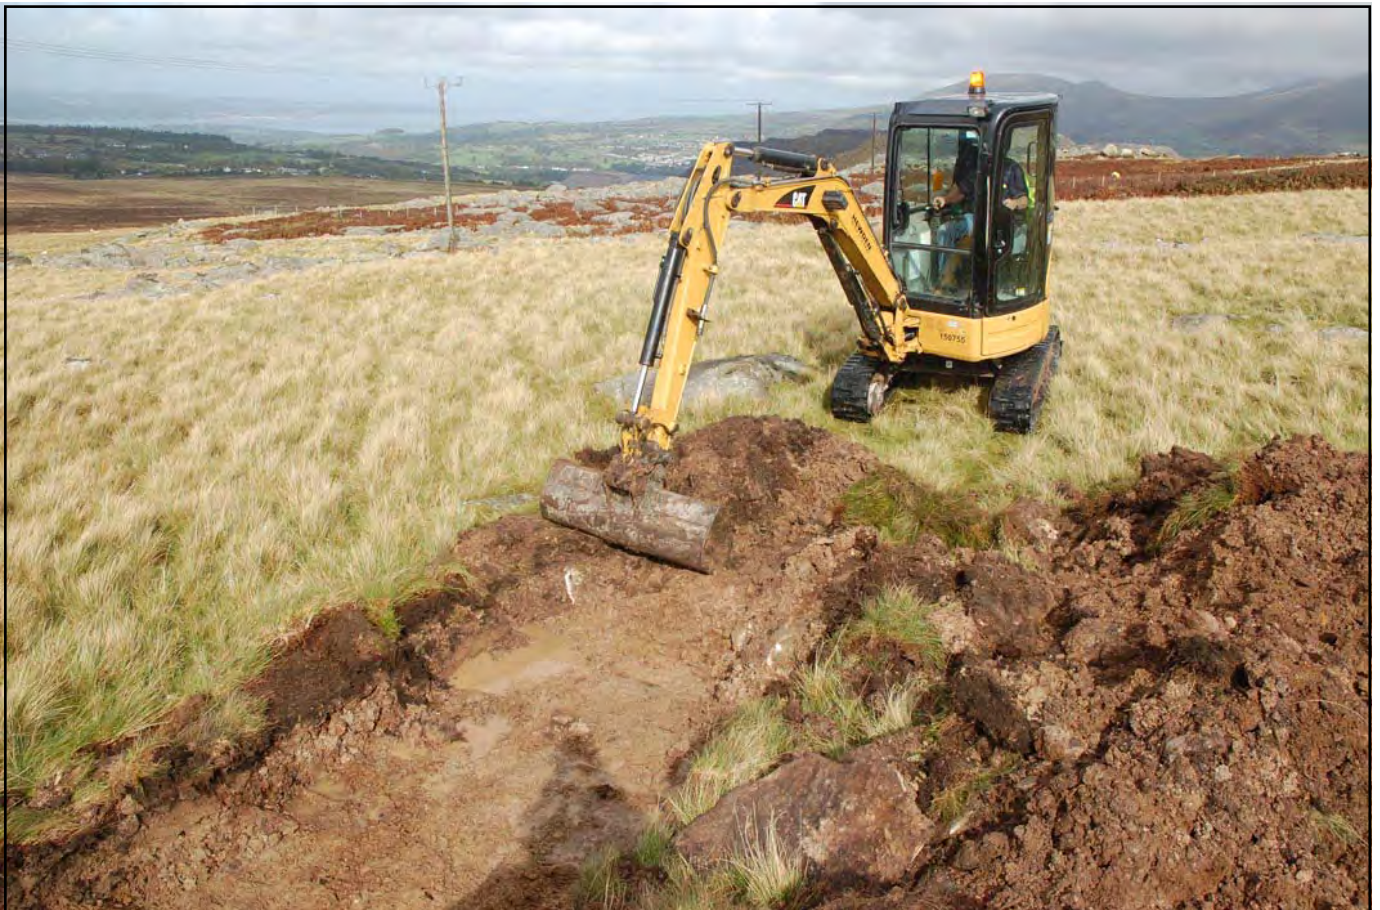
**Plate 4 Working shot, trench 2, site 20 (cleared area).**

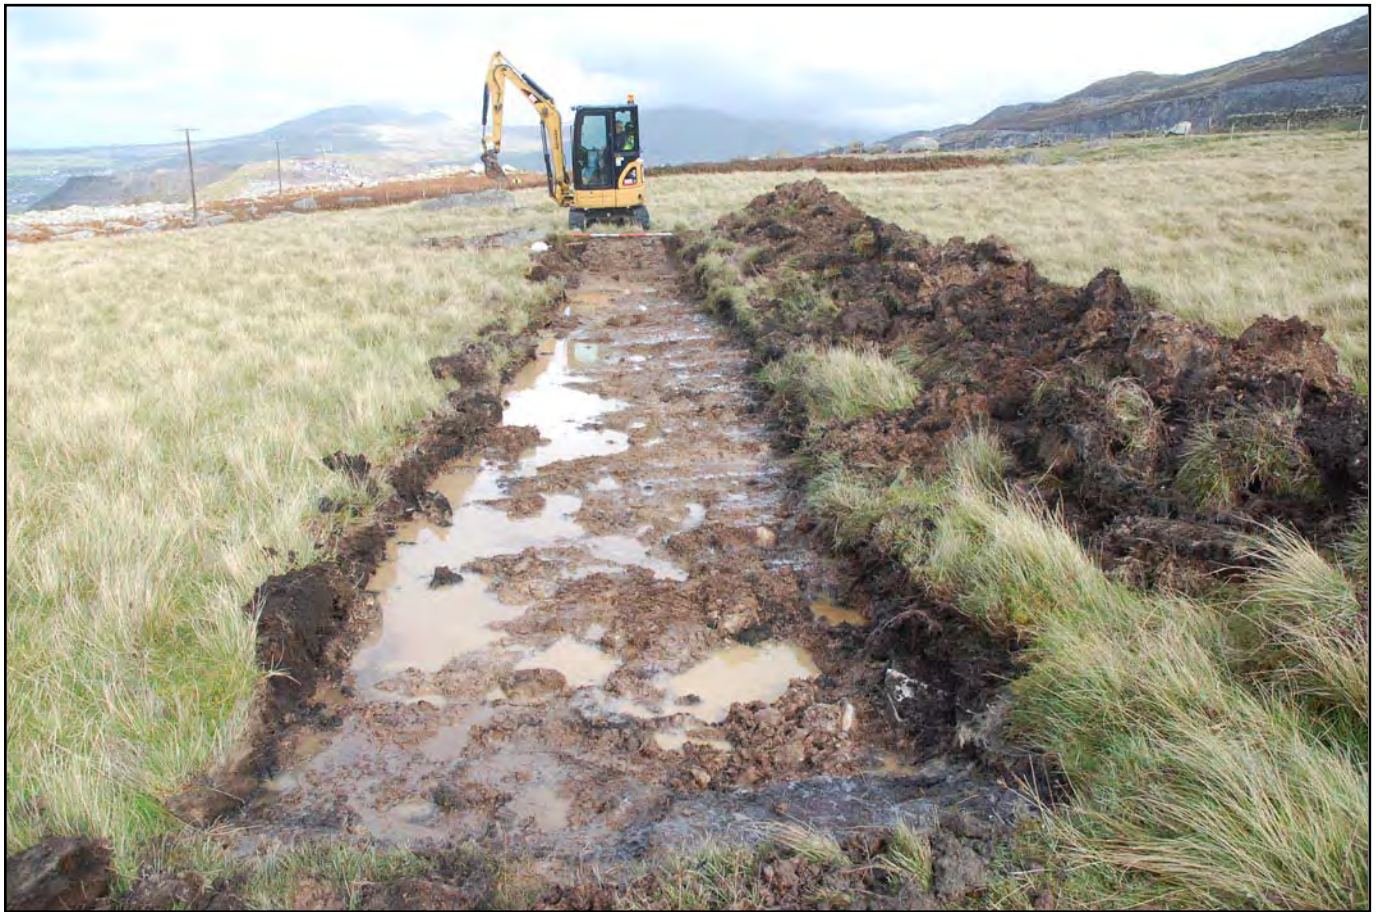
**Plate 5 Post-ex shot of trench 2, site 20 (cleared area).**

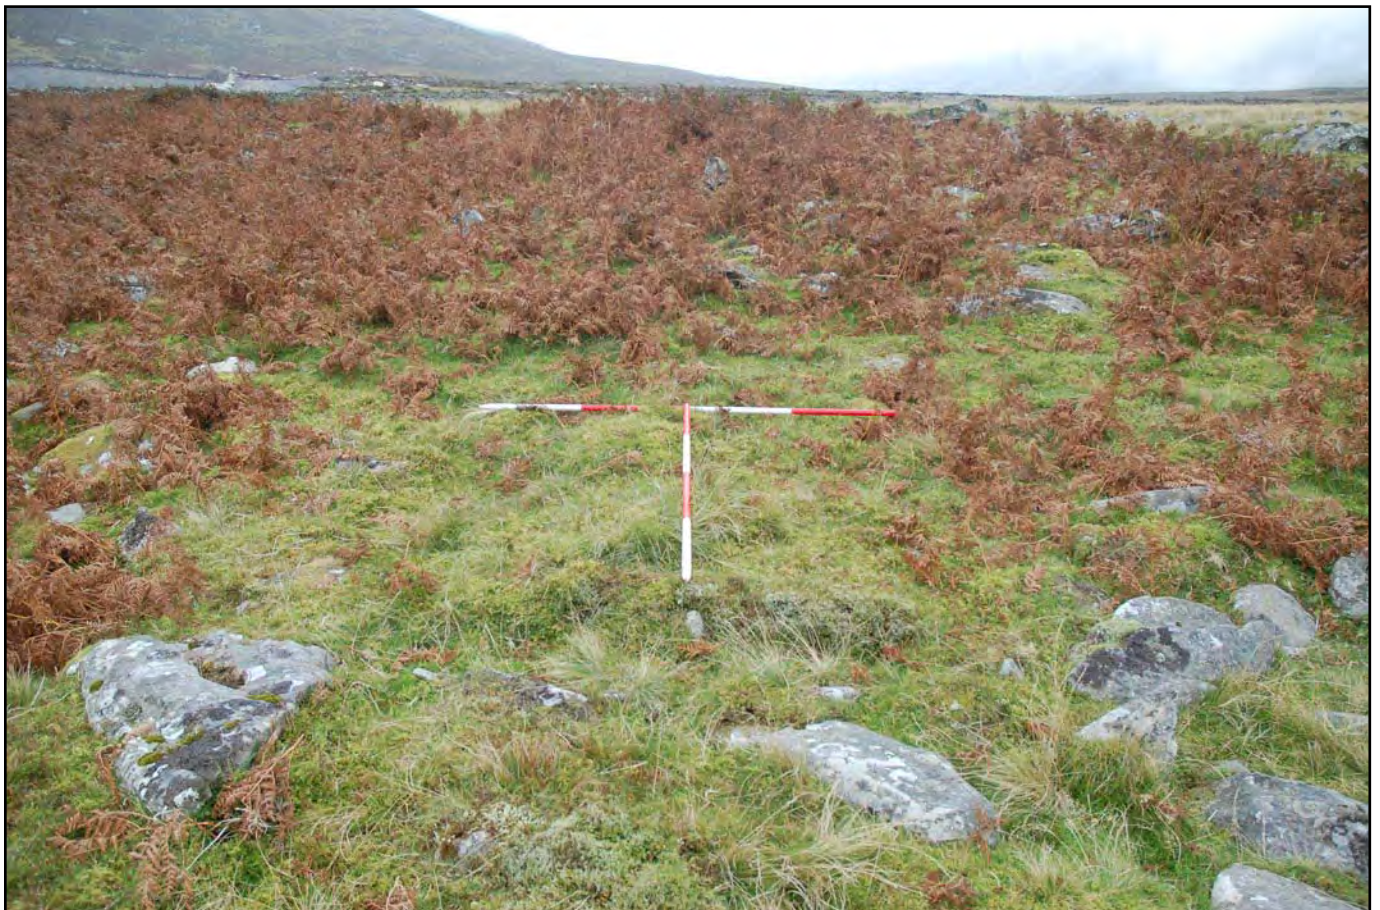
**Plate 6 Pre-ex shot of site 16 (suspected prehistoric structure).**

On the surface this site appeared to be a small, low sub-circular structure, entirely covered by vegetation. However the 2m x 1m, east-west aligned trench revealed bed rock or large glacial erratic boulders protruding from the natural glacial till. Once fully revealed the stones were much larger and more irregular than initially supposed. There was no evidence of deliberate human construction, and there were no associated archaeological deposits.

As this site revealed no evidence of archaeological activity, no further action is recommended.

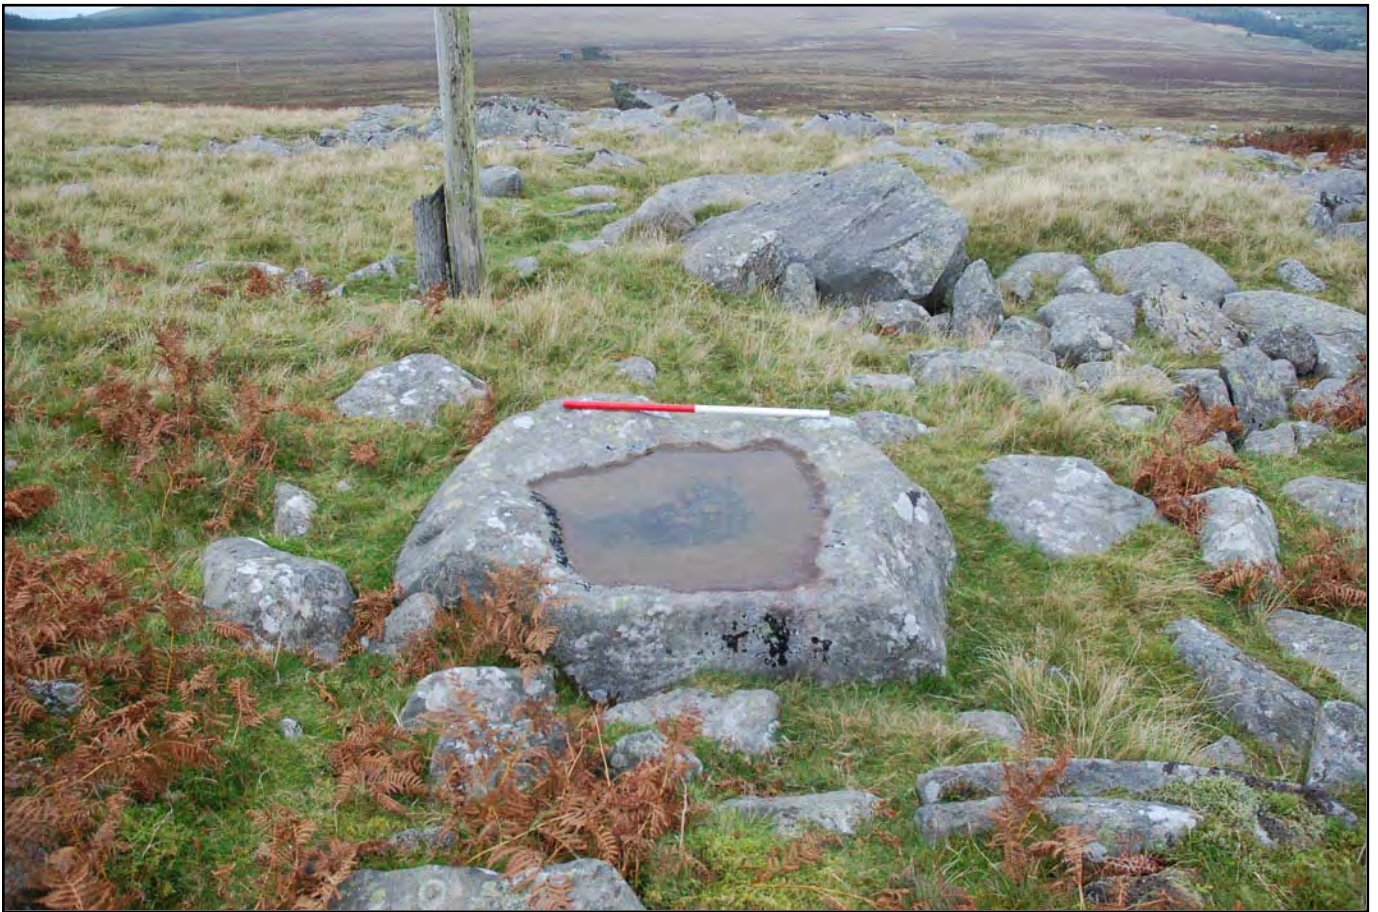
Adjacent to this suspected structure was a large sub angular boulder, approximately 1.5m in diameter and 0.5m in height, with a concave surface which generally held a pool of rain water. This stone bore no evidence of modification or use.

**Plate 7 Large concave stone associated with site 16 (suspected prehistoric structure).**

It has been established that the suspected prehistoric structure was simply the coincidental formation of naturally occurring boulders or bed rock. The formation of the large associated concave boulder was again almost certainly due to natural processes. This does not mean that it has not been utilised at any point during the human occupation of this area, it would for example prove a very useful water trough for livestock and humans alike, or a quenching trough for smithing. However with no evidence of modification this can not be proven.

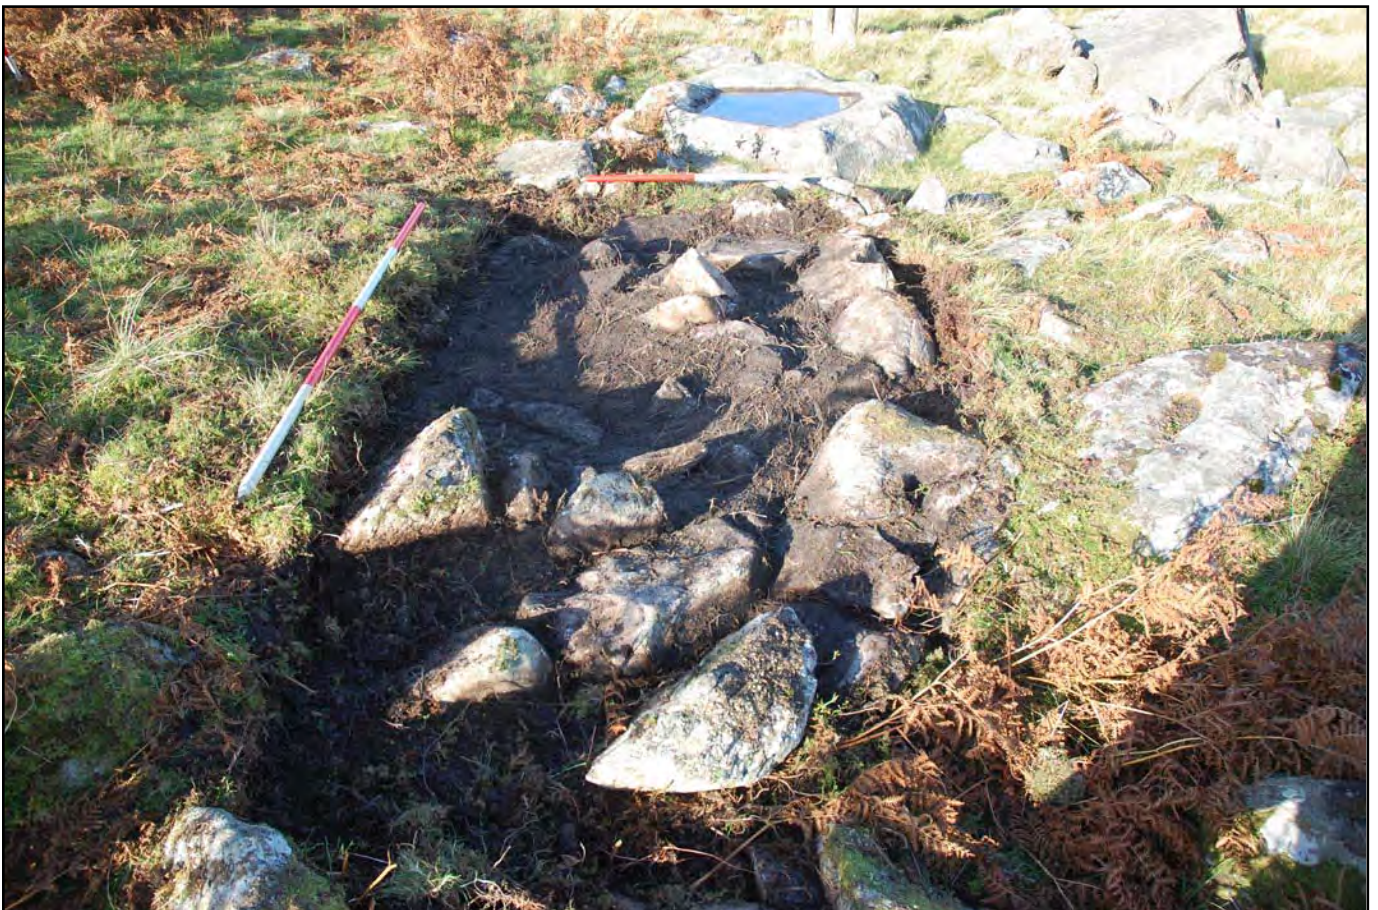
**Plate 8 Post-ex shot of trench 1, site 16 (suspected prehistoric structure).**

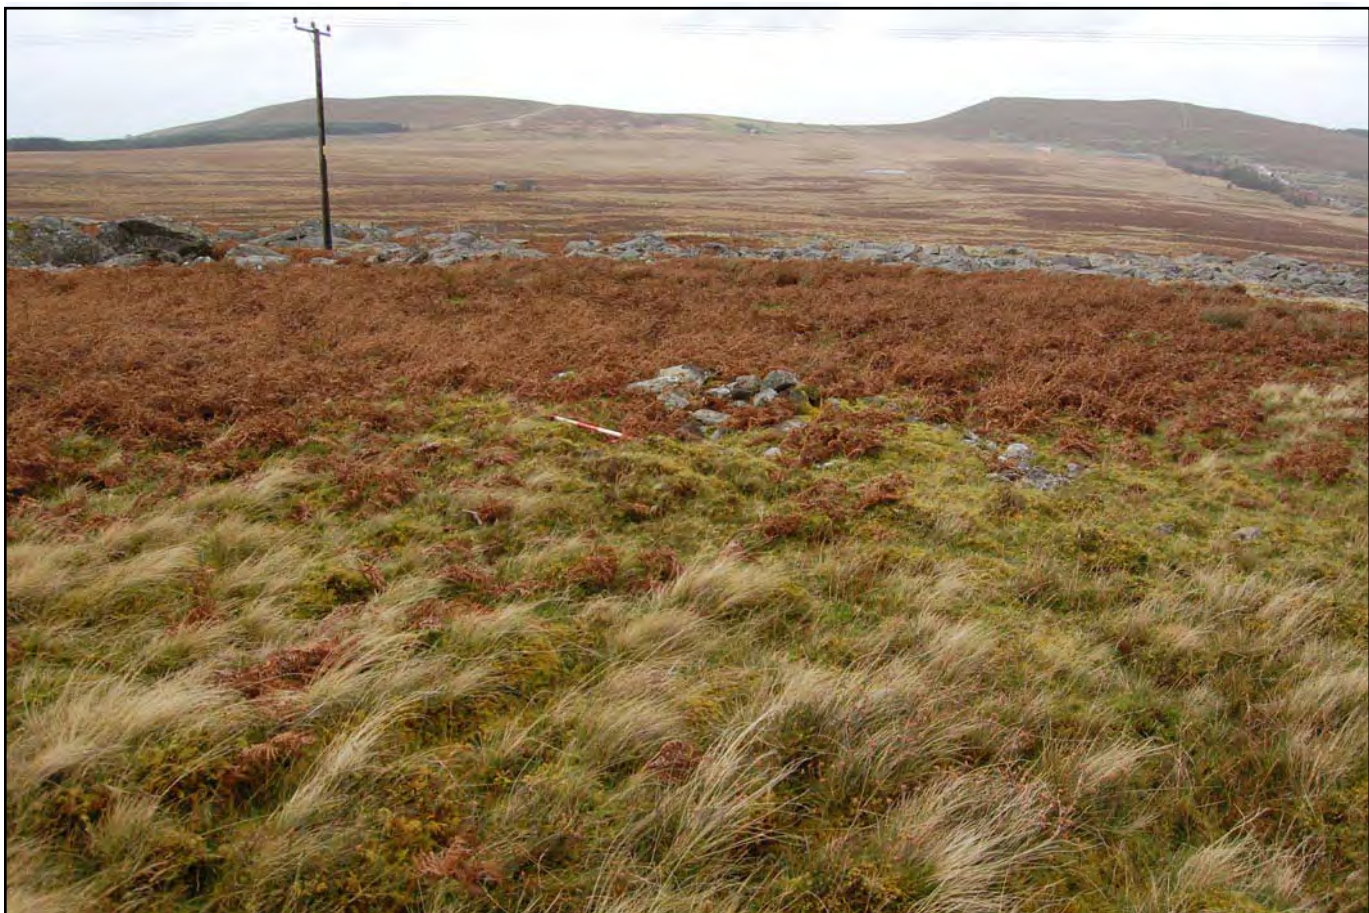
**Plate 9 Pre-ex shot of site 15 (possible burial cairn).**

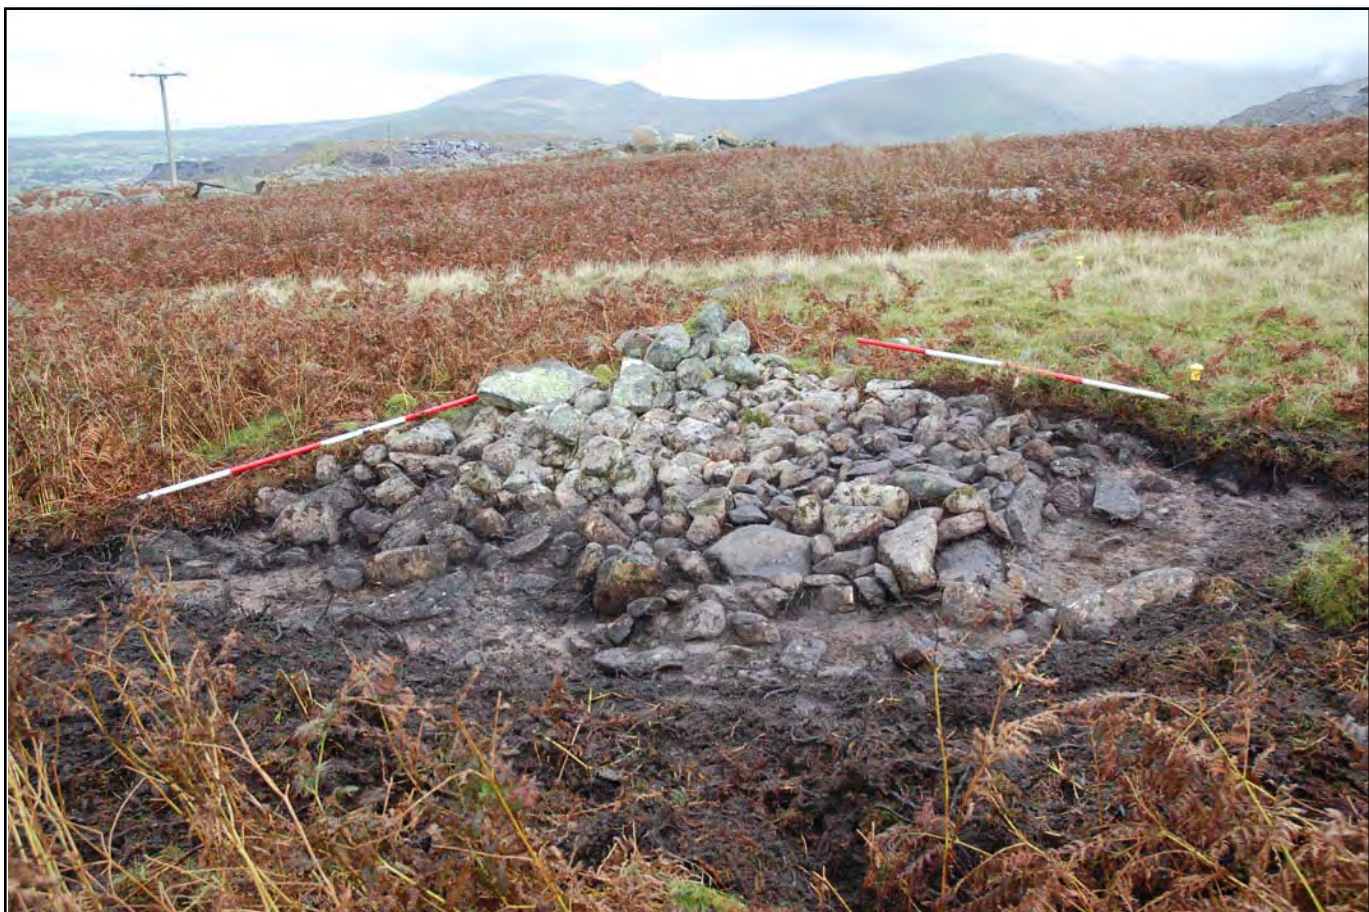
The removal of the thin deposit of topsoil and turf at this site revealed a large, though not very high cairn with a radius of 3.5m. The feature appeared to consist of a single deposit (004), made up of jumbled, poorly sorted sub-rounded and angular stones. The stones rose up in the middle to a slight point, approximately 0.5m high, and there was a slight hint of curb stones at the outer limits, but in general no coherent structure. There was no evidence of separate phases within in this deposit, as suggested in the 1989 Upland Survey. However as there was little matrix surrounding the stones, it is entirely possible that the cairn has been added to in the fairly recent past. No datable evidence was found.

**Plate 10 Deposit (004) within the south-west quadrant of site 15 (possible burial cairn).**

A relatively complex level of archaeology was revealed at this site, and the evaluation excavations, though they have not allowed the nature of the structure to be identified with any certainty, do indicate the presence of archaeological remains. Full excavation of this site is therefore recommended.

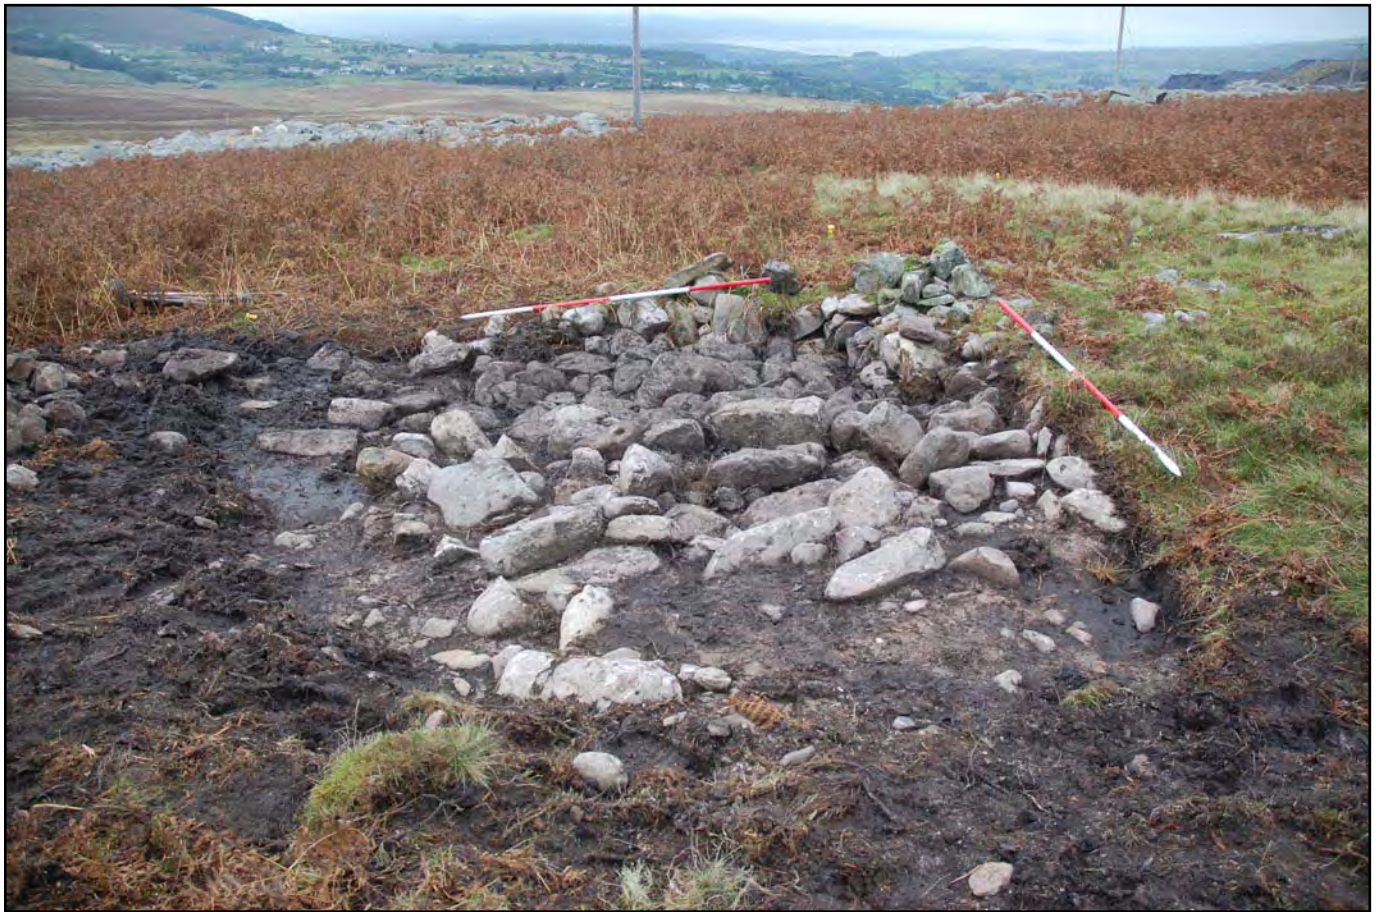
Following the removal of deposit (004) a more complex, structured layer of activity was revealed. The exact nature of this is unclear, however it appeared to consist of three main elements: a fairly even, level surface made up of generally large stones (007); a linear arrangement of stones running east-west (008); and an area containing stones of various sizes (009), apparently deliberately positioned, some set on end, but the purpose of which was unclear. There did not appear to be a direct link

**Plate 11** South-west quadrant of site 15 (possible burial cairn) following the removal of deposit (004).

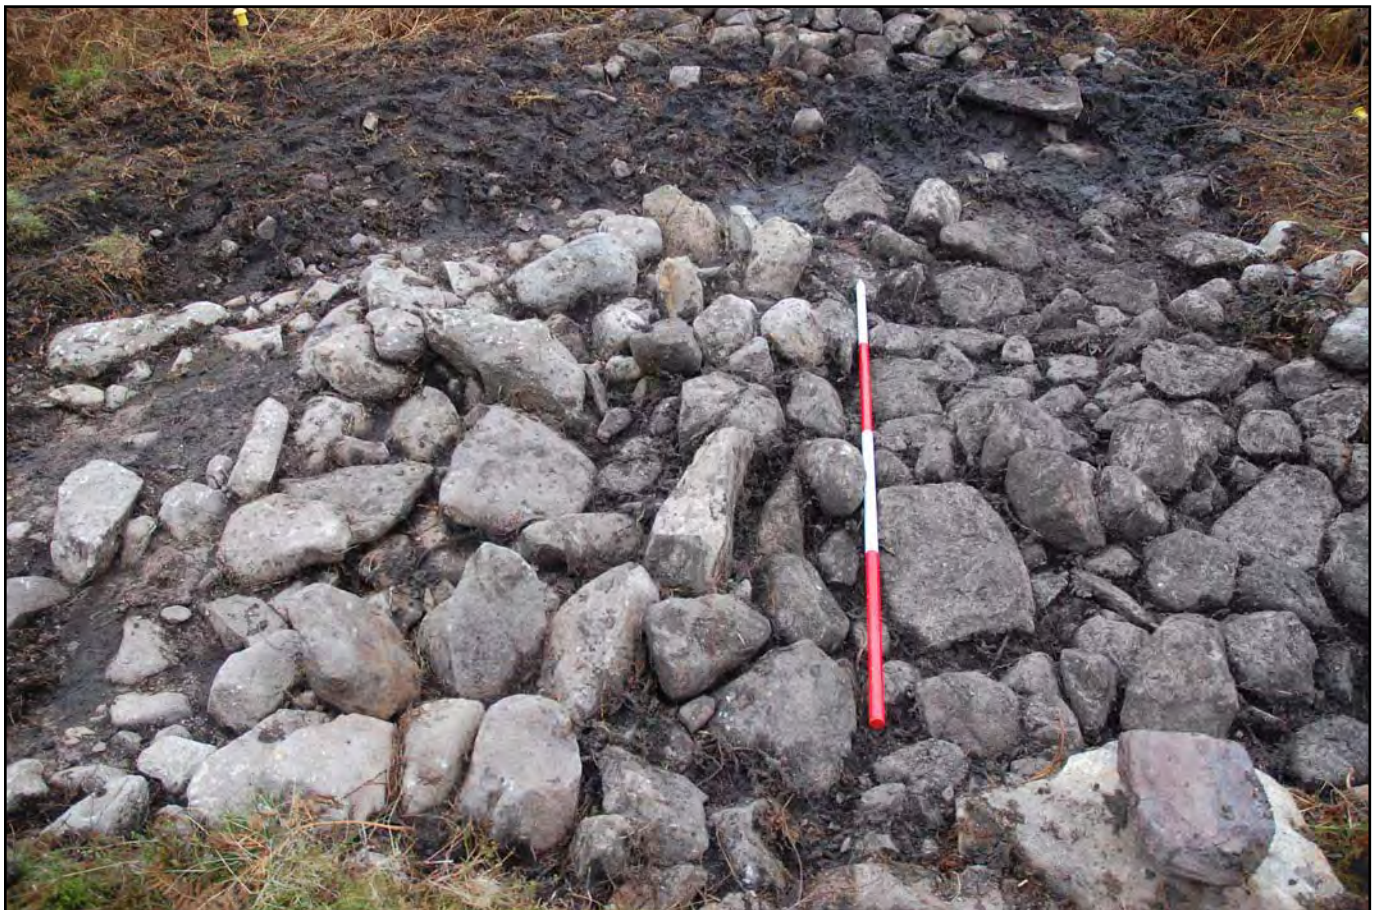
between the apex in the upper deposit of stones, (004) and the features lying beneath. Again no datable evidence was found.

**Plate 12** Features (007), (008) and (009) within the south quadrant of site 15 (possible burial cairn). Features (007), (008) and (009) (Site 15).

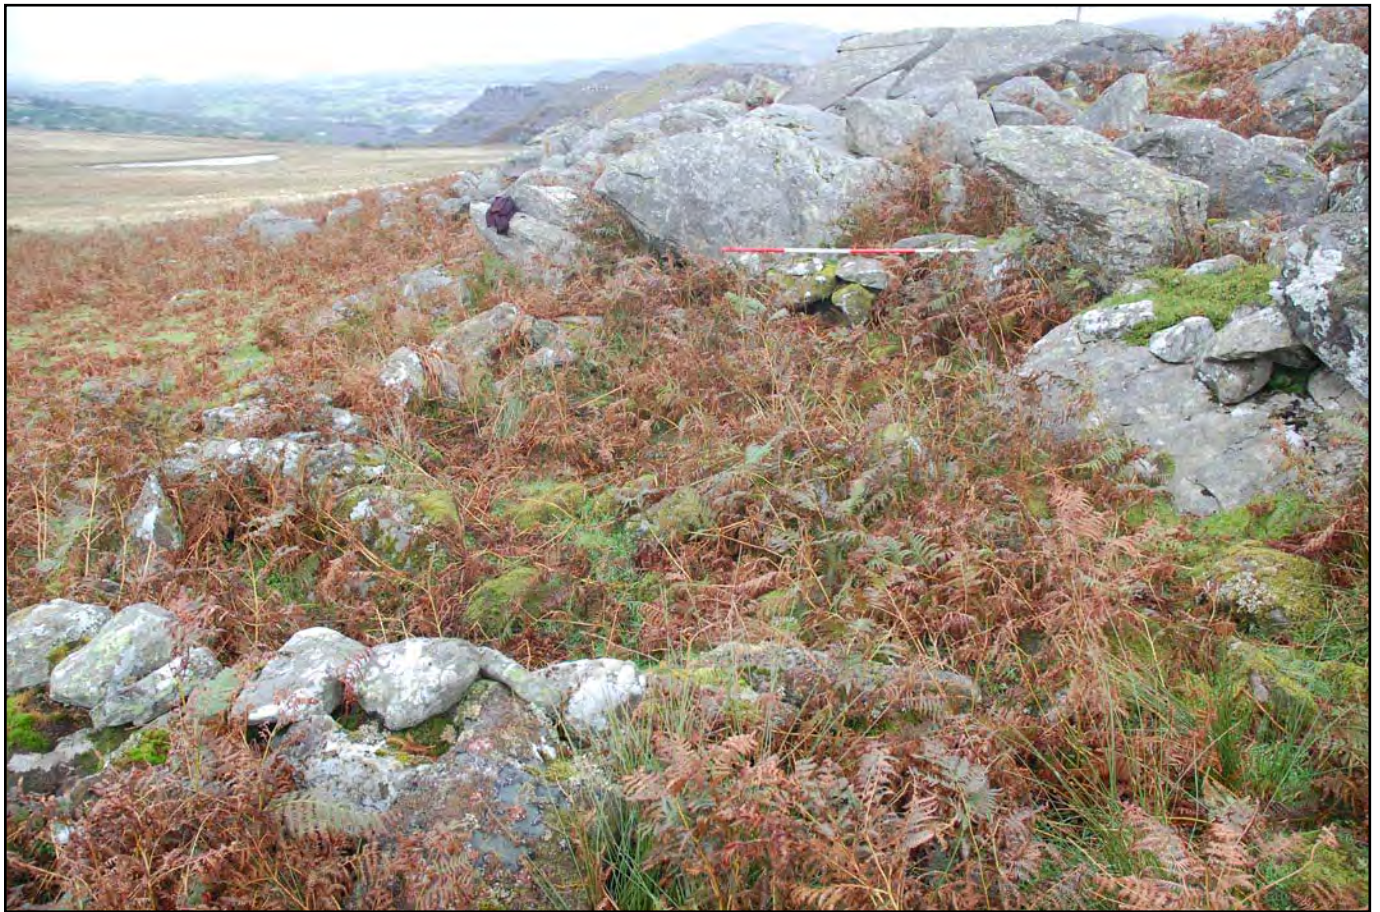
**Plate 13 Pre-ex shot of site 14 (possible ruined hut circle with sheepfold rebuild).**

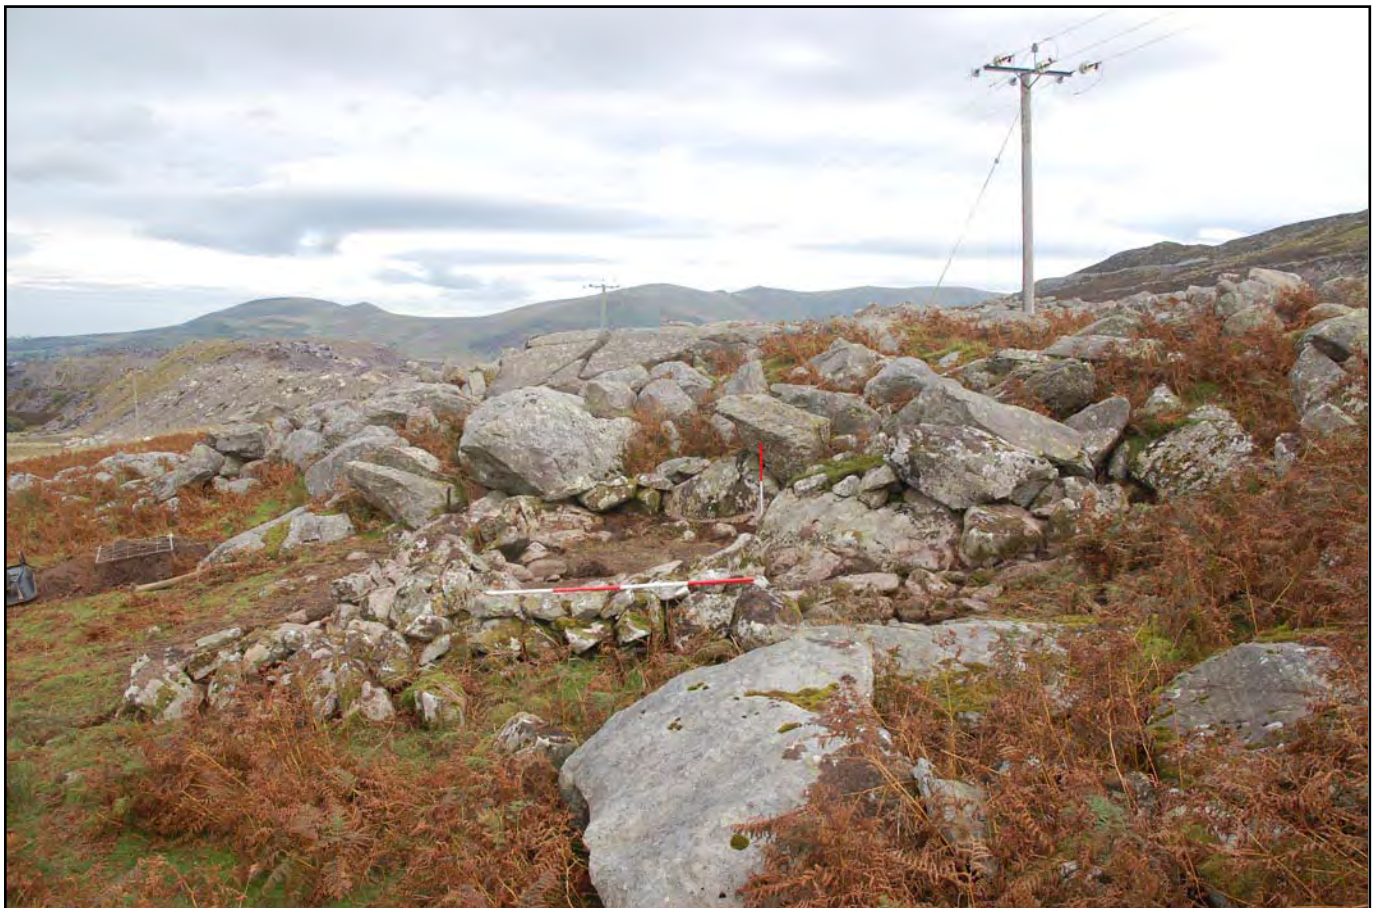
The initial cleaning of this site provided clarification of the layout and construction of this structure, and allowed for detailed planning. However no further walls or other features were identified. Also no evidence of an earlier structure was found.

**Plate 14 Site 14 (possible ruined hut circle with sheepfold rebuild) following the removal of vegetation.**

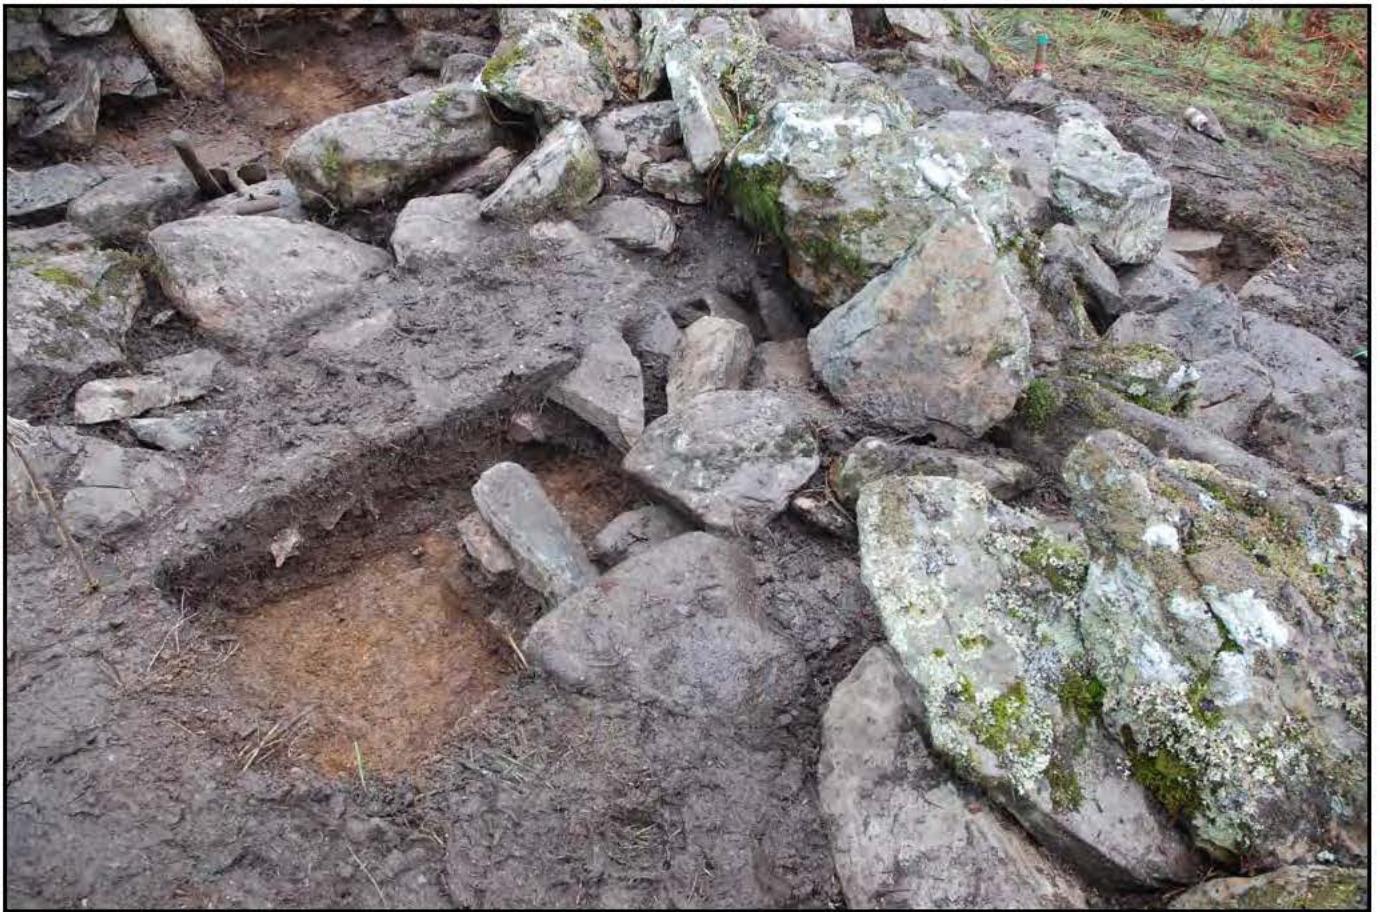
Excavation was undertaken in the interior in order to examine the floor deposits and observe more closely the alignment of the walls. Below the topsoil possible floor deposits were observed in both cells. Trench 1 in the north-eastern cell revealed deposit (005), a firm medium greyish brown silt containing some grit, small stones and slate fragments. This deposit was on average about 0.1m thick, though was fairly uneven. This deposit does not appear to be of deliberate construction, but is more likely to have built up over time. Trench 2 contained deposit (010) a firm dark reddish brown clay-silt with occasional fairly large flat slabs of stone and slate pressed into the top. It is possible that this deposit is the result of deliberate construction.

**Plate 15 Trench 1 in the north-eastern cell of site 14 (possible ruined hut circle with sheepfold rebuild).**

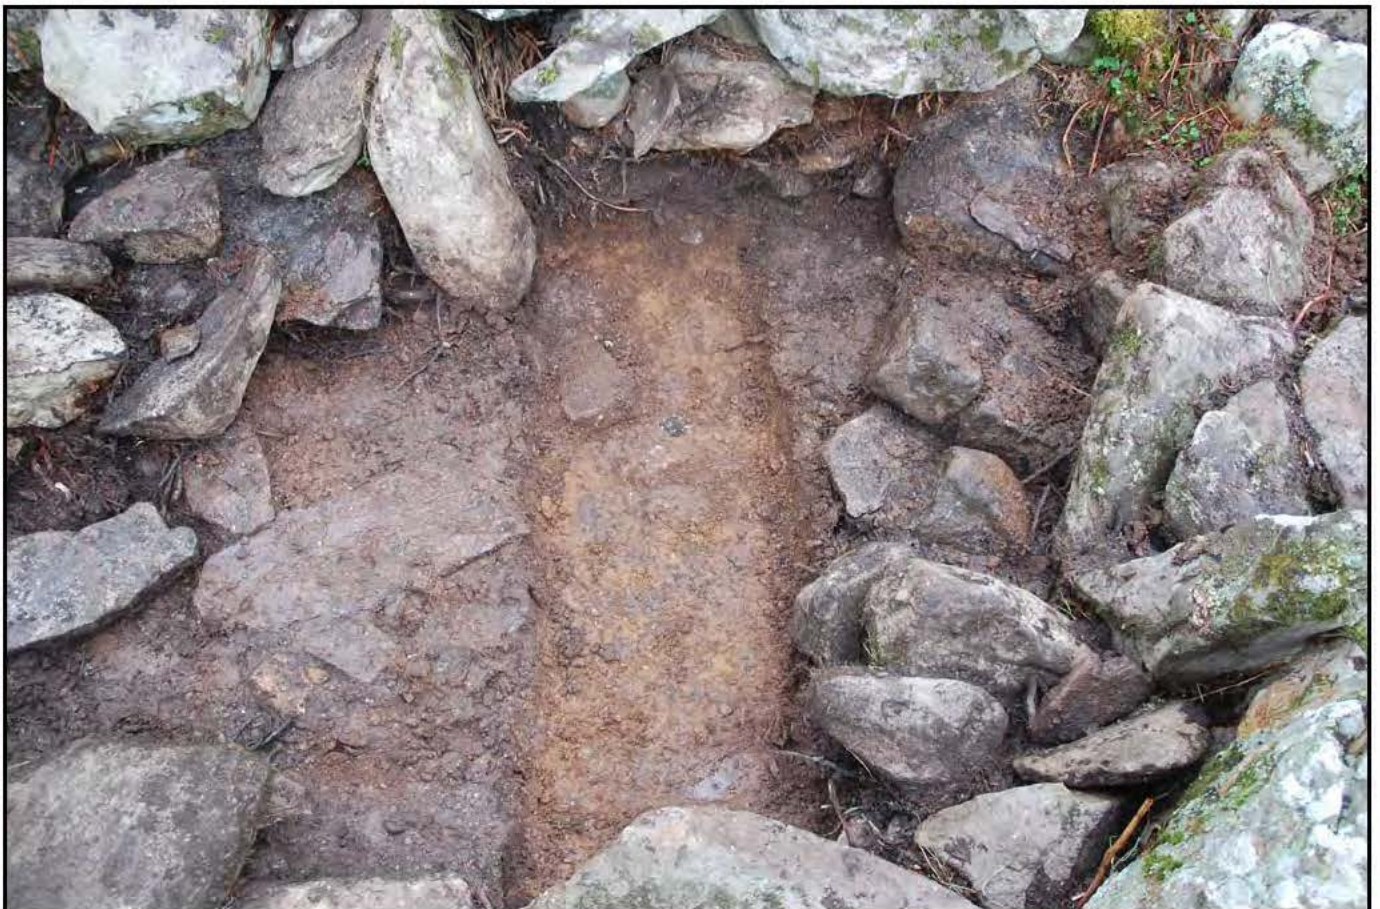
**Plate 16 Trench 2 in the north-western cell of site 14 (possible ruined hut circle with sheepfold rebuild).**
