# Proposed Quarry Realignment, Penrhyn Quarry, Bethesda

## Archaeological Evaluation

**Report No. 899**

**PROPOSED QUARRY REALIGNMENT, PENRHYN QUARRY, BETHESDA:  
ARCHAEOLOGICAL EVALUATION**

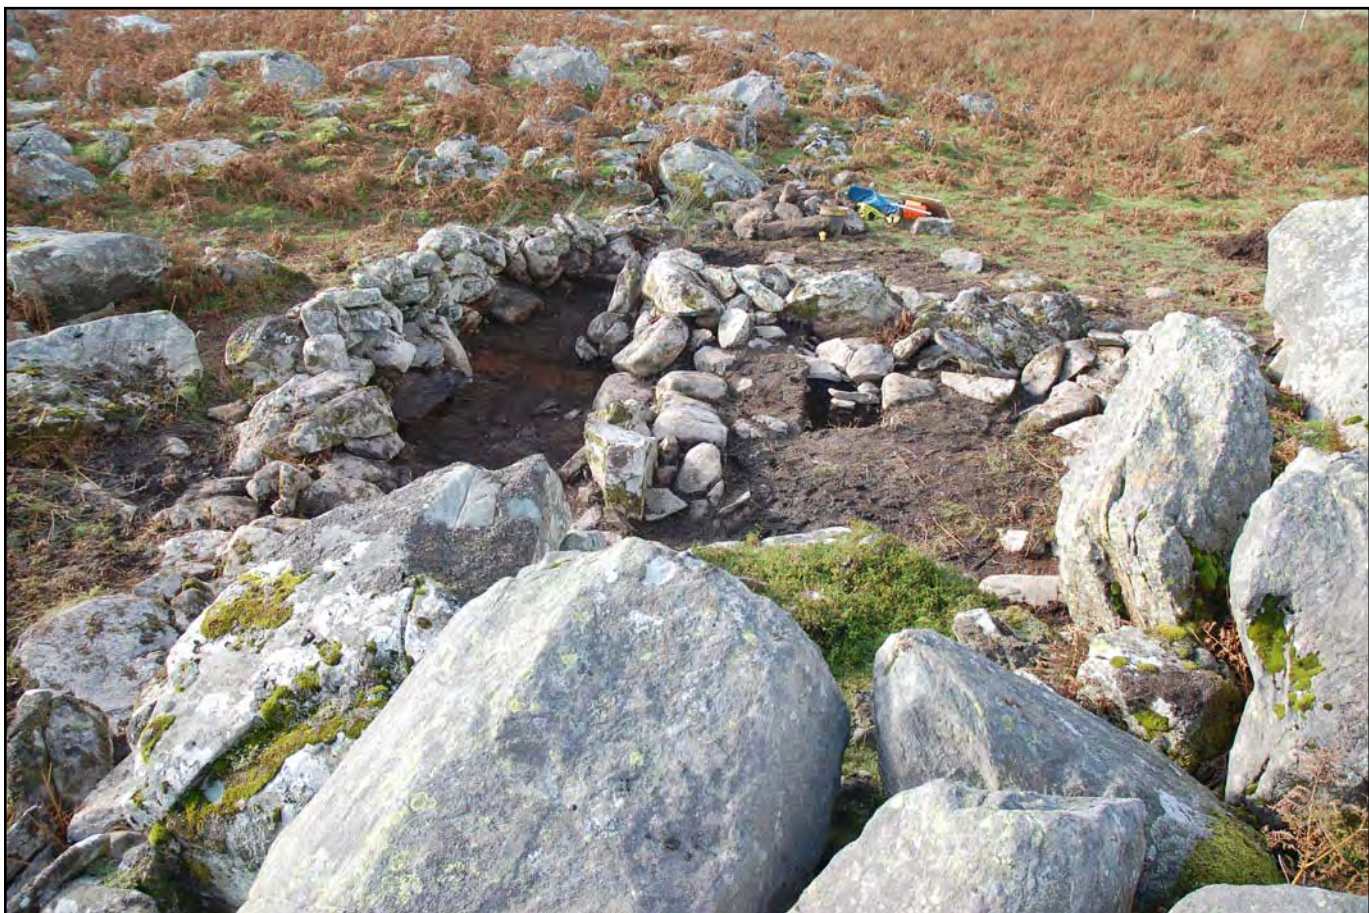
Following the removal of the tumble (011) in the western corner of the enclosure, a narrow entrance was clearly revealed leading into cell 2. As originally suspected the south-western wall created a curved extension around the western side of this entrance, whilst several large slabs set on edge on the eastern side formed a slight funnelled effect. The entrance was as little as 0.6m wide in places. The extension of the wall may have had two functions, firstly to facilitate the herding of livestock into the structure, and secondly to provide some protection against the elements.

**Plate 17 Site 14 (possible ruined hut circle with sheepfold rebuild) following the removal of tumbled stone deposit (001).**

The evaluation of this site has resulted in a full record being made of the structure, and a high percentage of excavation of the interior. It is considered unlikely that further work will produce any additional results, and therefore no further work is recommended other than the publication of the findings in Archaeology in Wales.

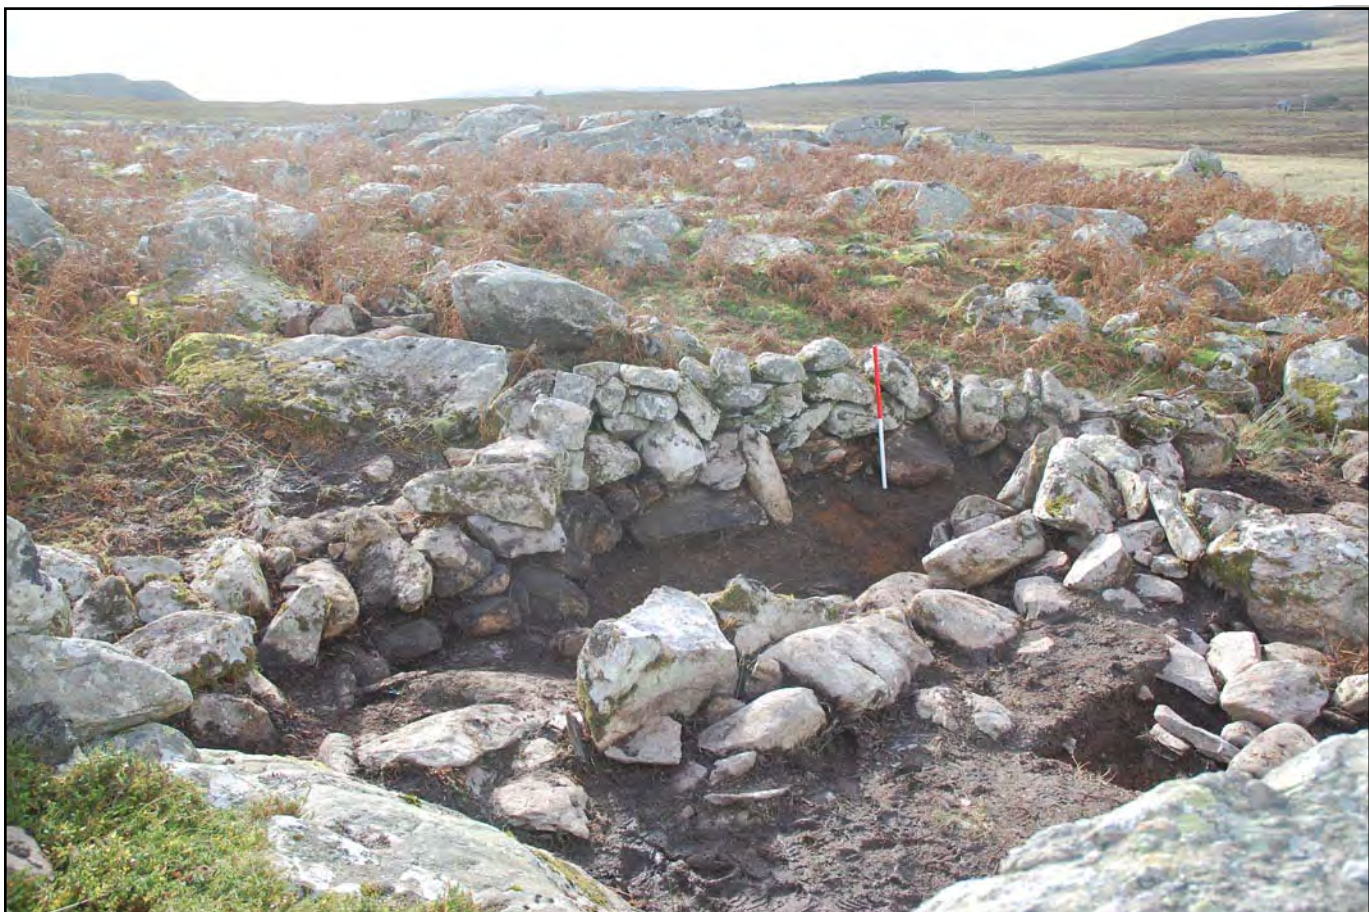
**Plate 18 Close-up of the north-western cell of site 14 (possible ruined hut circle with sheepfold rebuild) following the removal of tumbled stone deposit (001).**

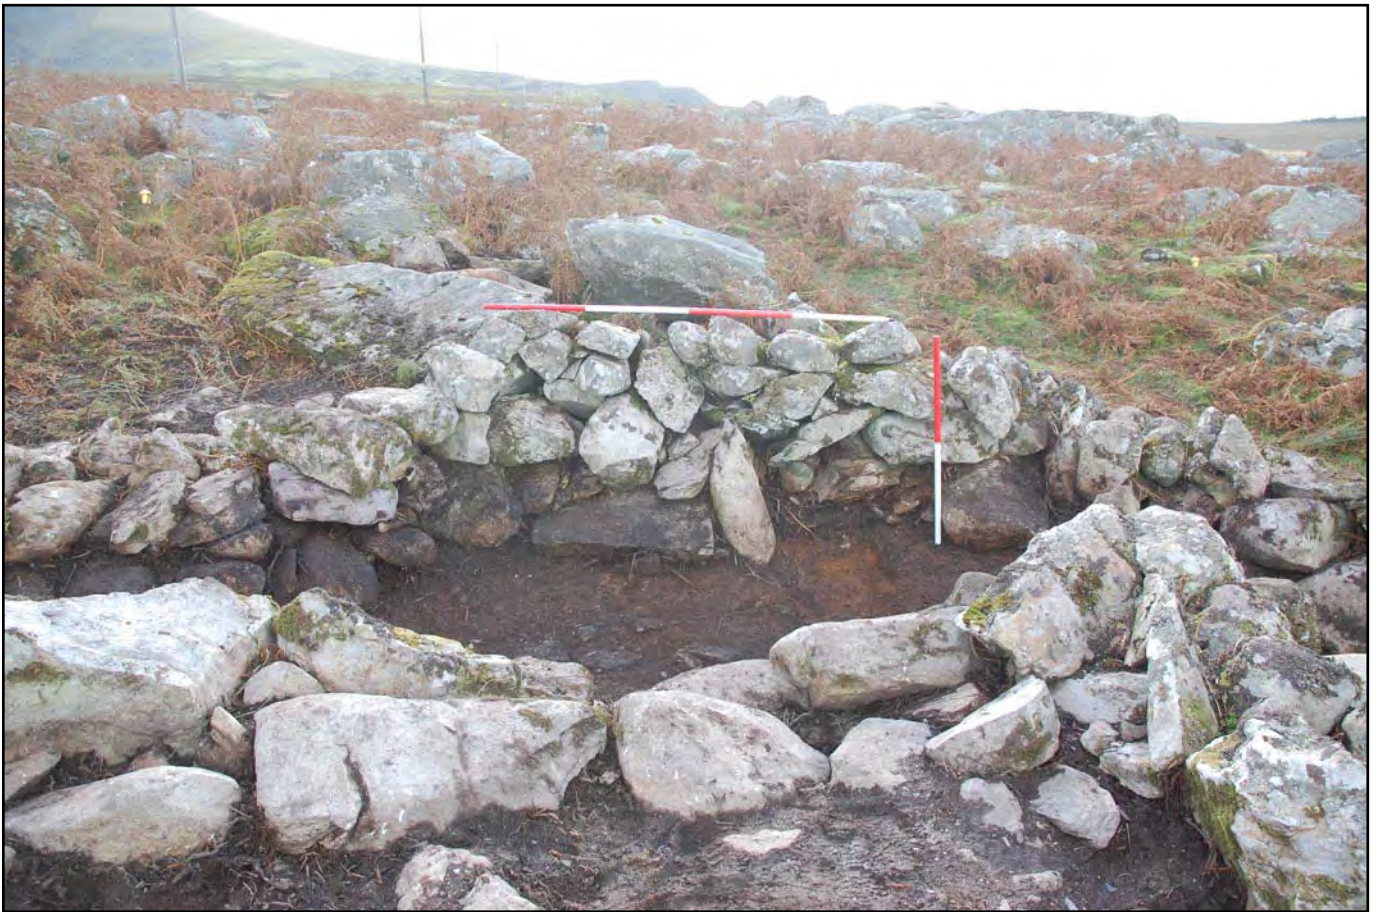
The south-west wall was about 10m in length, and was the best constructed of all the walls. In the middle it stood about 1m high, and was made up of about 4 courses. However towards the south eastern end it slumped inwards, and all that was visible was a large area of tumble deposit (011), with no clear structure. The north-western end of this wall was fairly intact, and extended out, beyond the main body of the enclosure to curve round, creating an extension around the entrance. This wall also extended out slightly at the south-eastern end, which created a slight annex in conjunction with the surrounding boulders.

**Plate 19** Possibly reconstructed south-western wall of site 14 (possible ruined hut circle with sheepfold rebuild).

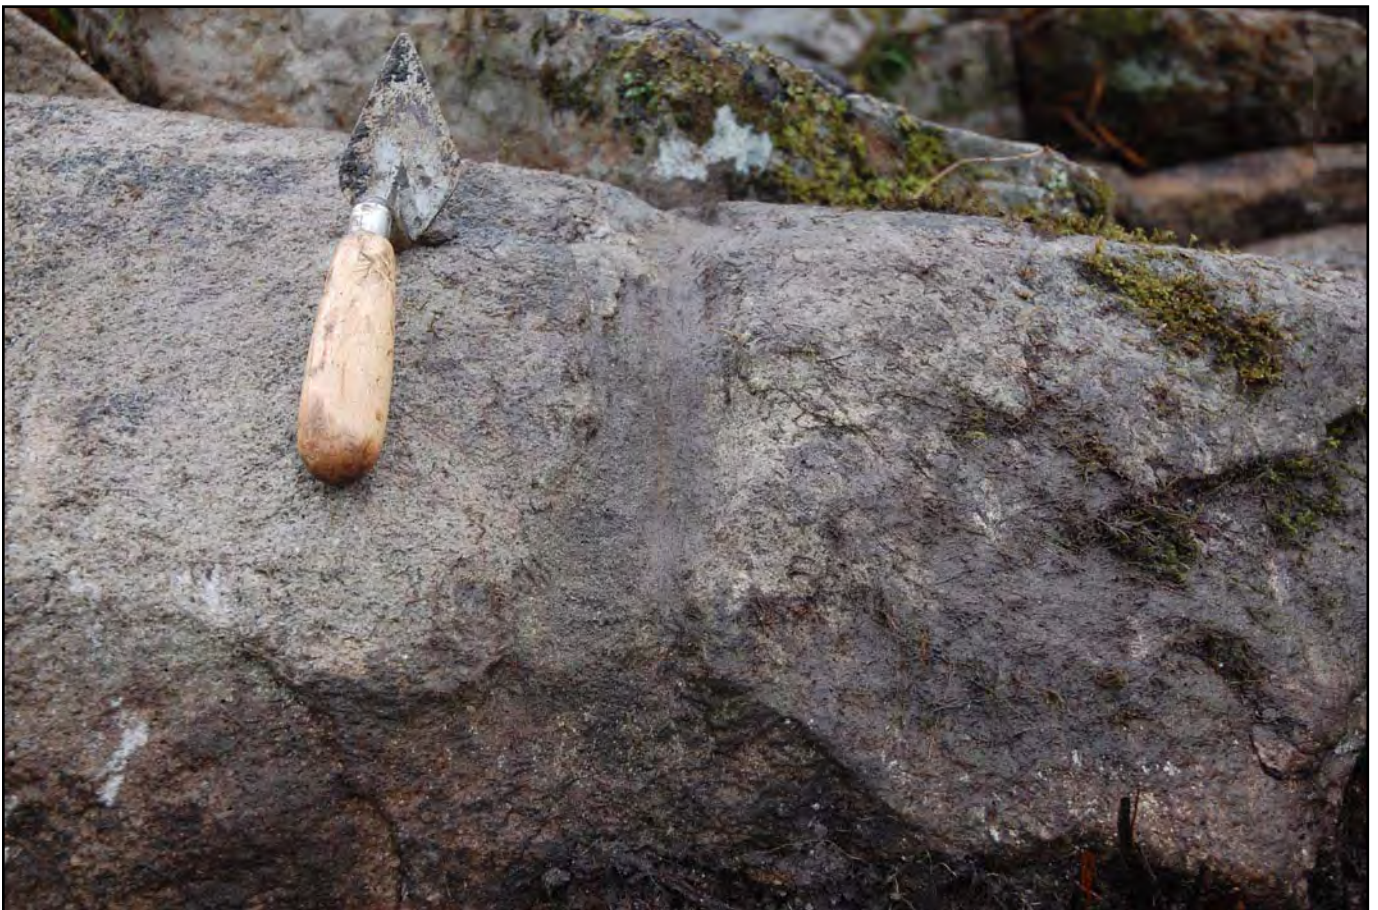
The only other finds from this site were two large stones, each with similar cut marks, visible as shallow, slightly irregular grooves approximately 0.5m in width. One stone was located in the internal wall, and had a groove about 0.3m in length, the other was in the south-western wall and had a groove that ran the width of the stone, approximately 0.6m. In their present location these did not appear to serve any obvious purpose, and when examined closely do not appear to have been made by hand drilling. They are probably, therefore, natural grooves caused by water erosion.

**Plate 20** Close-up of stone A with possible groove cut within site 14 (possible ruined hut circle with sheepfold rebuild).

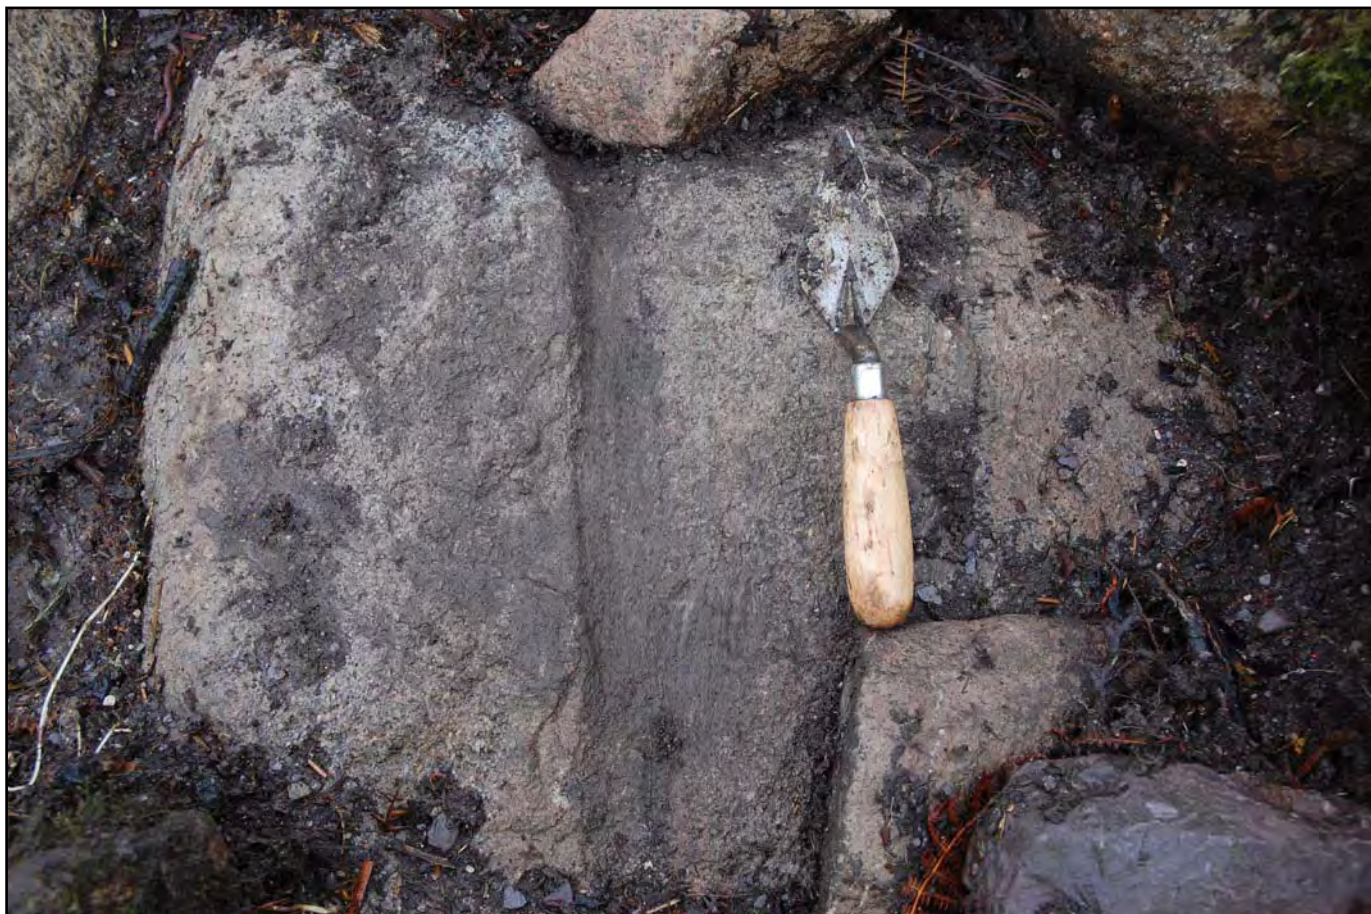
**Plate 21 Close-up of stone B with possible groove cut within site 14 (possible ruined hut circle with sheepfold rebuild).**
