# Bala WTW, Ty'n y Cae: **Bala, Gwynedd**

## Archaeological Assessment

GAT Project No. 2173

# Bala Water Treatment Works

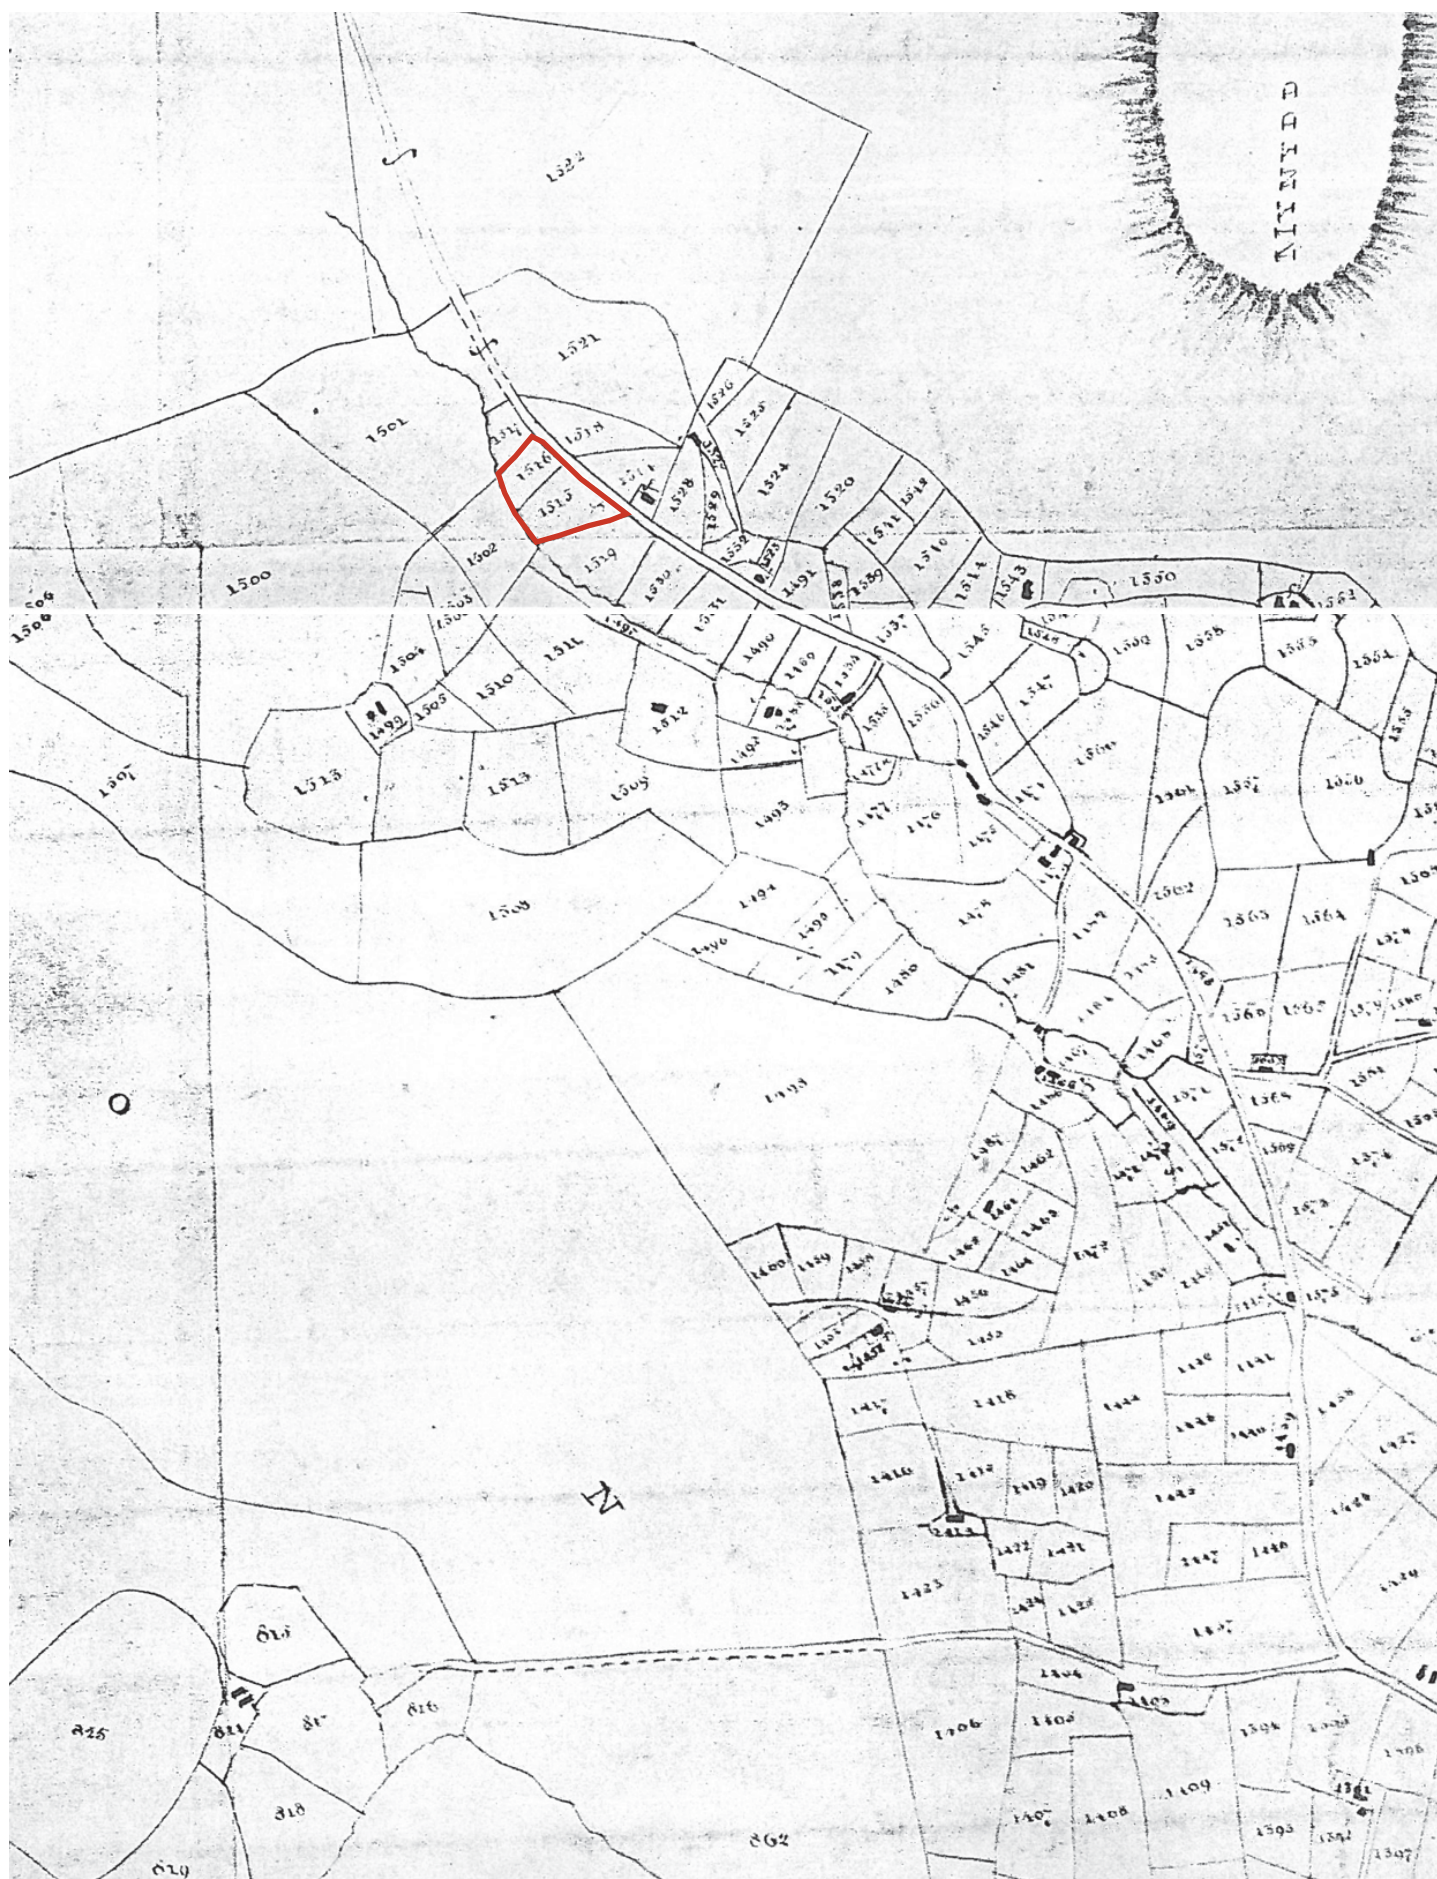
**Fig. 3** Tithe Map of the parish of Llanycil of 1839, with the study area outlined in red (Gwynedd Archives)

The site of the Water Treatment works formed part of the small farm of Ty’n y Cae, which was part of the larger Fronheulog estate. The first known reference to the property dates from 1724, when the title of the property is established to William Hanmer and his wife, and it clearly forms part of the estate from that date (NLW Fronheulog MSS 172). In 1814 the estate was in the hands of John Davies, the son of Gabriel Davies of Messrs Davies and Anwyl, a firm of Bala solicitors. The property of Ty’n y Cae is described below, as shown on the Tithe Apportionment for the parish of Llanycil of 1839. The plan numbers refer to the fields noted on the tithe map (Fig. 3), and the field currently containing the WTW is highlighted in bold.

The study area consists of two fields, clearly indicated on the tithe map and OS maps (fig's 3 and 5) with an additional small triangle of land on the west side created by the alignment of a track (fig 5). The Afon Bleiddyn forms the southern boundary, and the road the northern boundary. The dividing field boundary (feature 3 below; fig 2) is of a different character to the eastern boundary (feature 1), being 'wandering' in character as opposed to straight, and from its character it is likely to pre-date feature 1. The dividing wall is partially ruinous, and the two fields are now essentially one single field, with the water treatment works occupying the north-east corner.

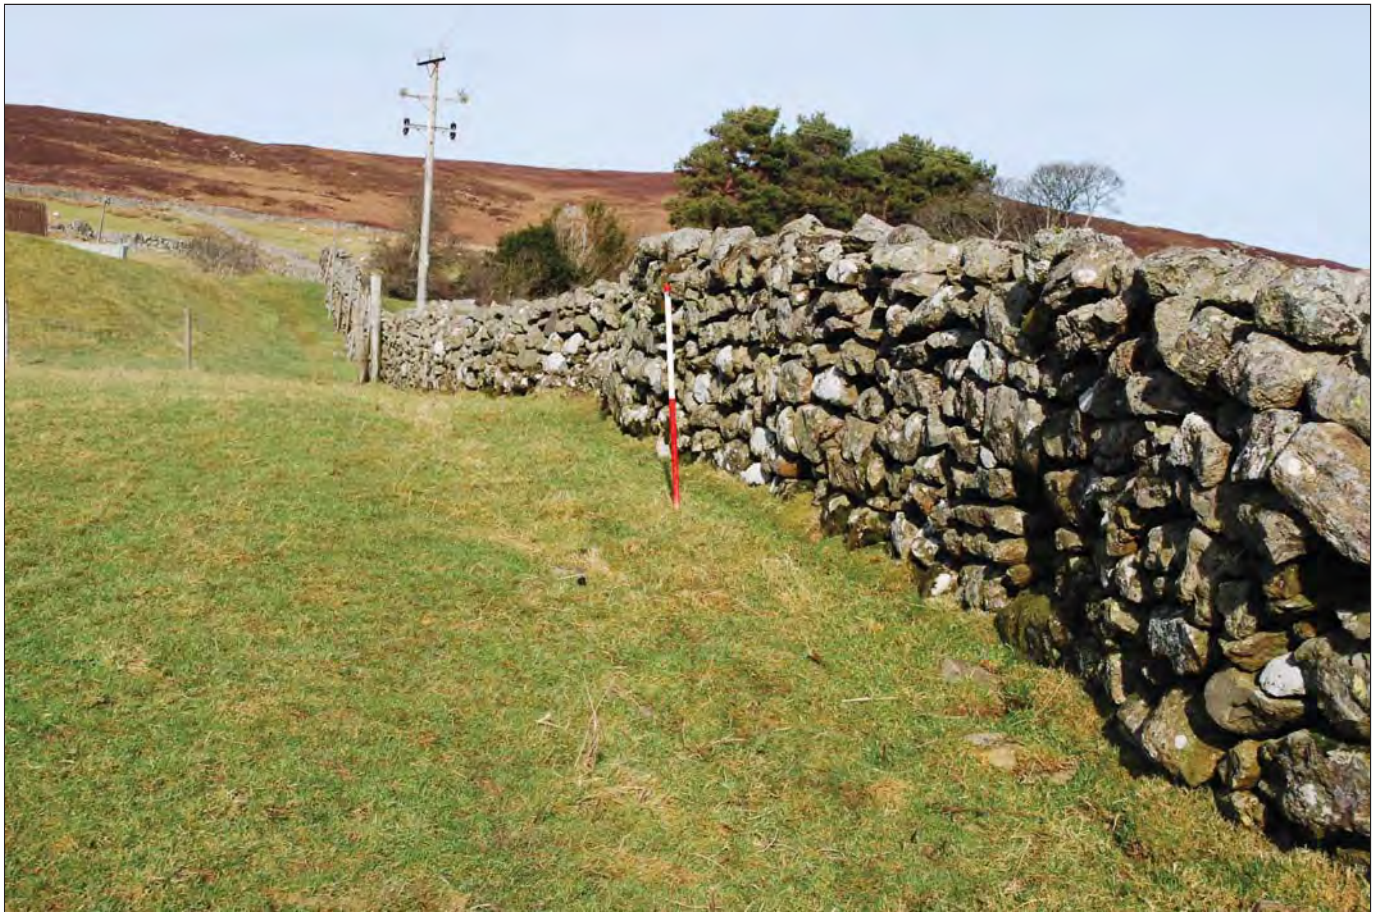
#### **Feature 1            Dry Stone Wall (Plate 1)**

A dry stone wall 1.3m high, consisting of rough field stones up to 0.5m by 0.3m and bowing in places. The wall terminates when it reaches the stream to the south. It appears to be of 19<sup>th</sup> century date, and is shown on the 1<sup>st</sup> edition 25 inch Ordnance Survey map of 1889 (Fig. 5)

**Plate 1** Drystone wall (Feature 1) from the south. Scale 1m

**Recommendations for mitigatory measures:** Avoidance or Basic Recording

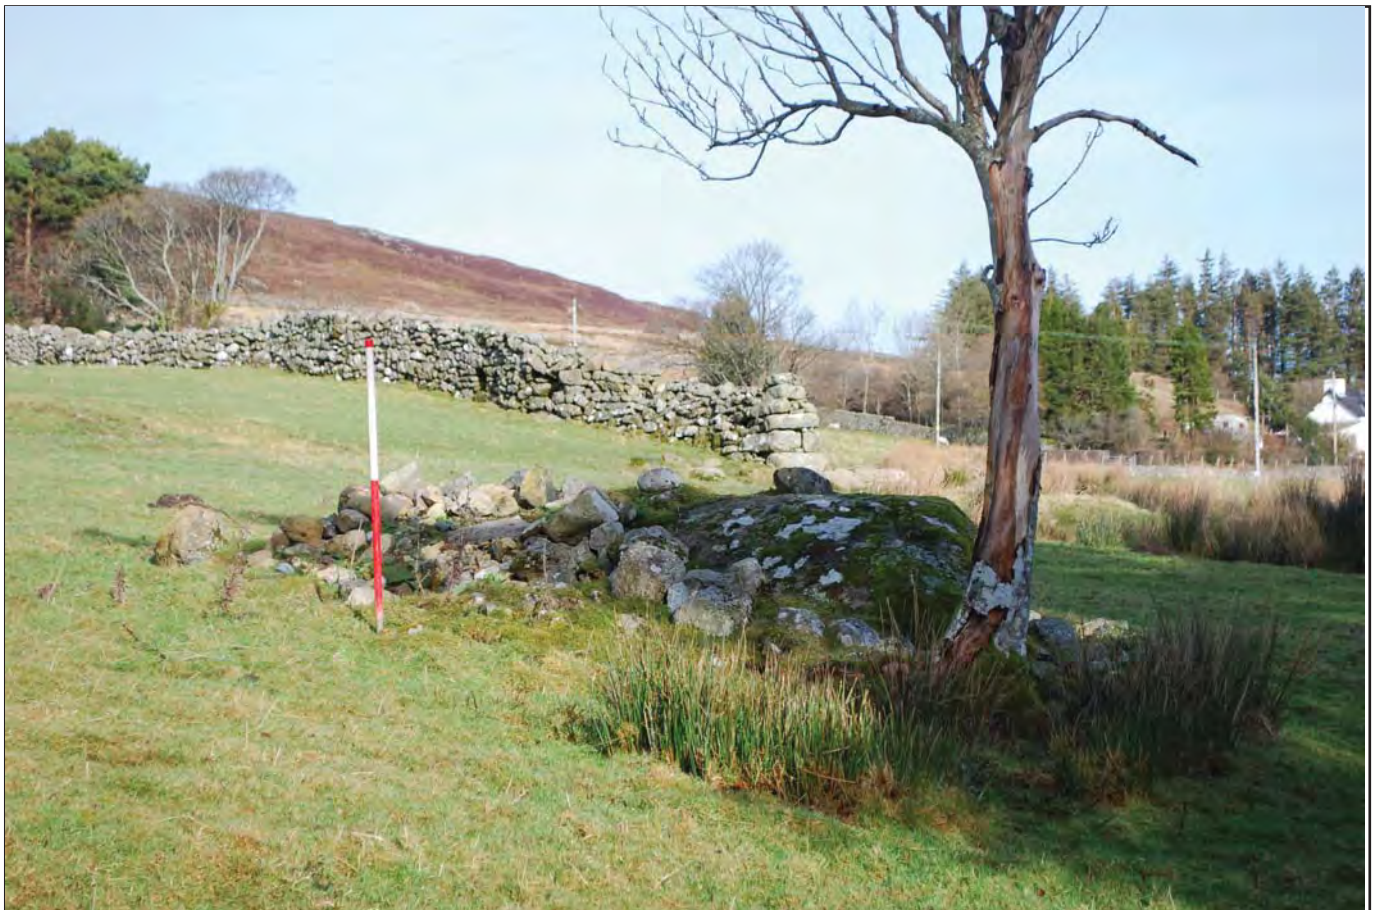
#### **Feature 2            Clearance Cairn (Plate 2)**

Probable clearance cairn, 4.5m by 2.8m, with the stones appearing to have been placed around a natural rock outcrop. This strongly suggests clearance rather than any other archaeological feature. It also appears to contain modern material including two sherds of Buckley ware pottery, and there appears to be no evidence for burnt stone.

**Plate 2** Clearance Cairn (Feature 2). Scale 1m

**Recommendations for mitigatory measures:** None

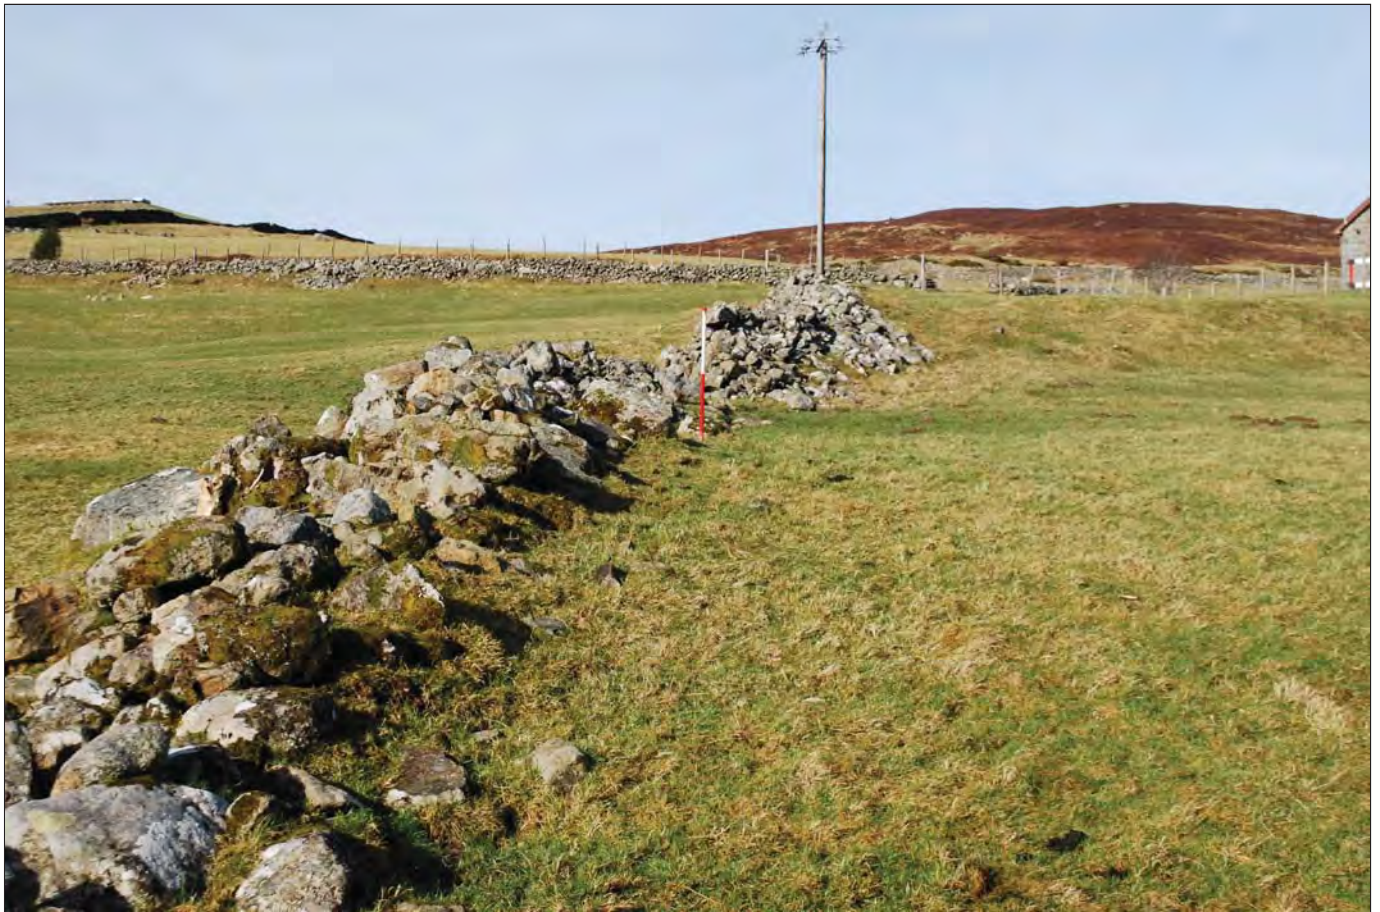
**Feature 3 Relict Dry Stone Wall (Plates 3, 5)**

A relict dry stone wall, approximately 1.8m wide, and surviving to a height of 0.8m in places, but significantly tumbled. It is constructed of small to large field stones, and wanders more than the neighbouring walls. It turns noticeably west at the bottom of the slope close to the river. It has a gate opening 1.6m wide about half way along its length. It may be 18<sup>th</sup> century or earlier in date and appears to have formed part of a pre 19<sup>th</sup> century field system. It is shown on the 1<sup>st</sup> edition 25 inch Ordnance Survey map of 1889 (Fig. 5).

**Plate 3** Collapsed dry stone wall (Feature 3) from the south. Scale 1m

**Recommendations for mitigatory measures:** Basic record and excavation across the line of the wall

- Evaluation excavations are recommended for the area of direct impact around the present works (as shown on fig. 6). This would include trenching across feature 3.
- A mitigation strategy for this area would be agreed following the results of the evaluation.
- A watching brief is recommended during top soil stripping within the compound area.

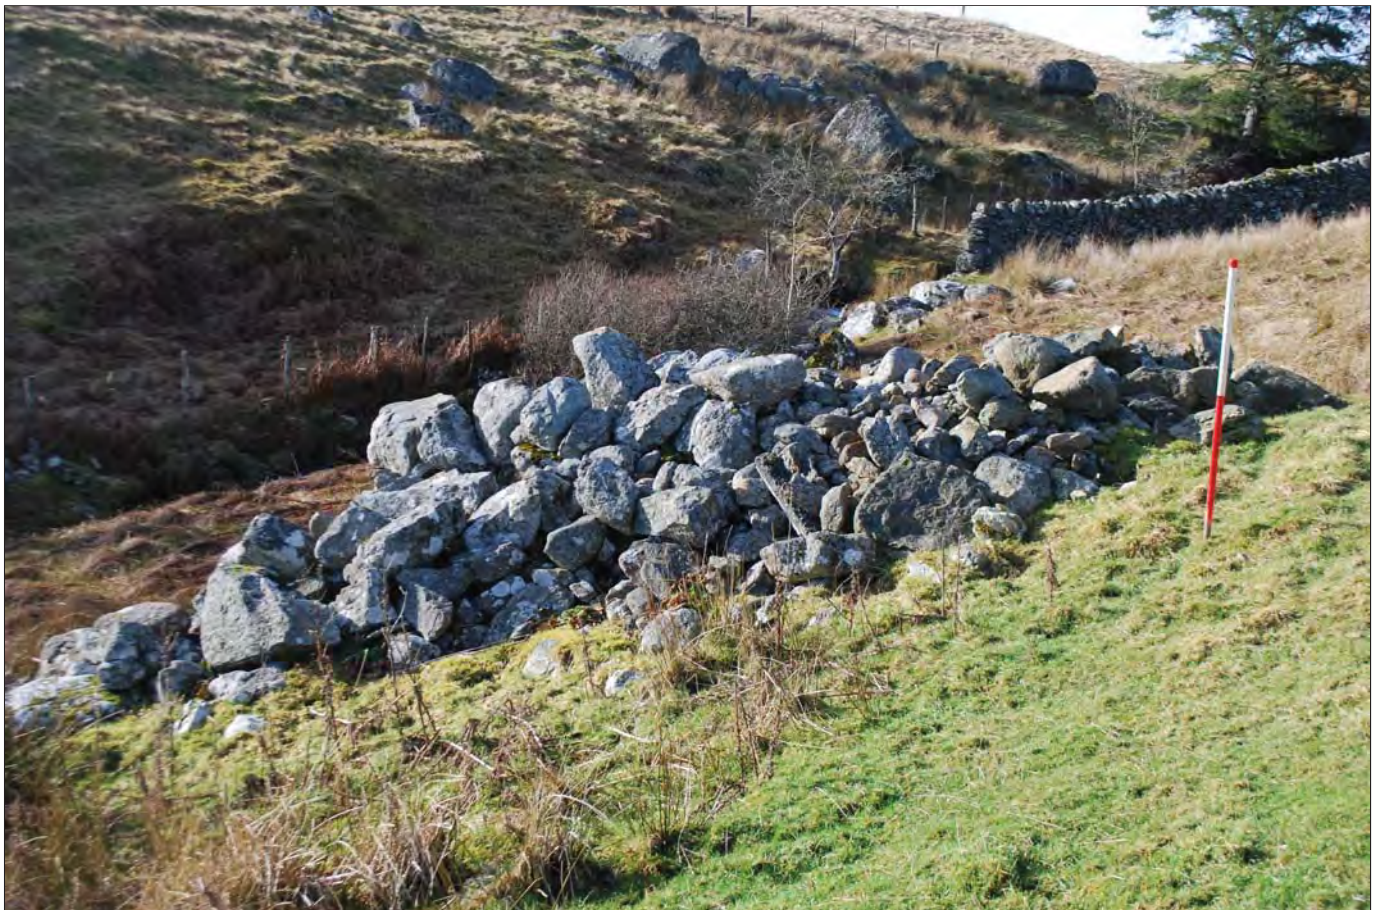
**Feature 4 Clearance Cairn (Plate 4)**

A recent clearance cairn, approximately 6m in diameter, consisting mainly of field stones, but also some Macadamised material. It possibly consists of cleared dry stone wall material, possibly the demolished remains of part of Feature 5.

**Plate 4** Recent clearance cairn (Feature 4), from the east. Scale 1m

**Recommendations for mitigatory measures:** None

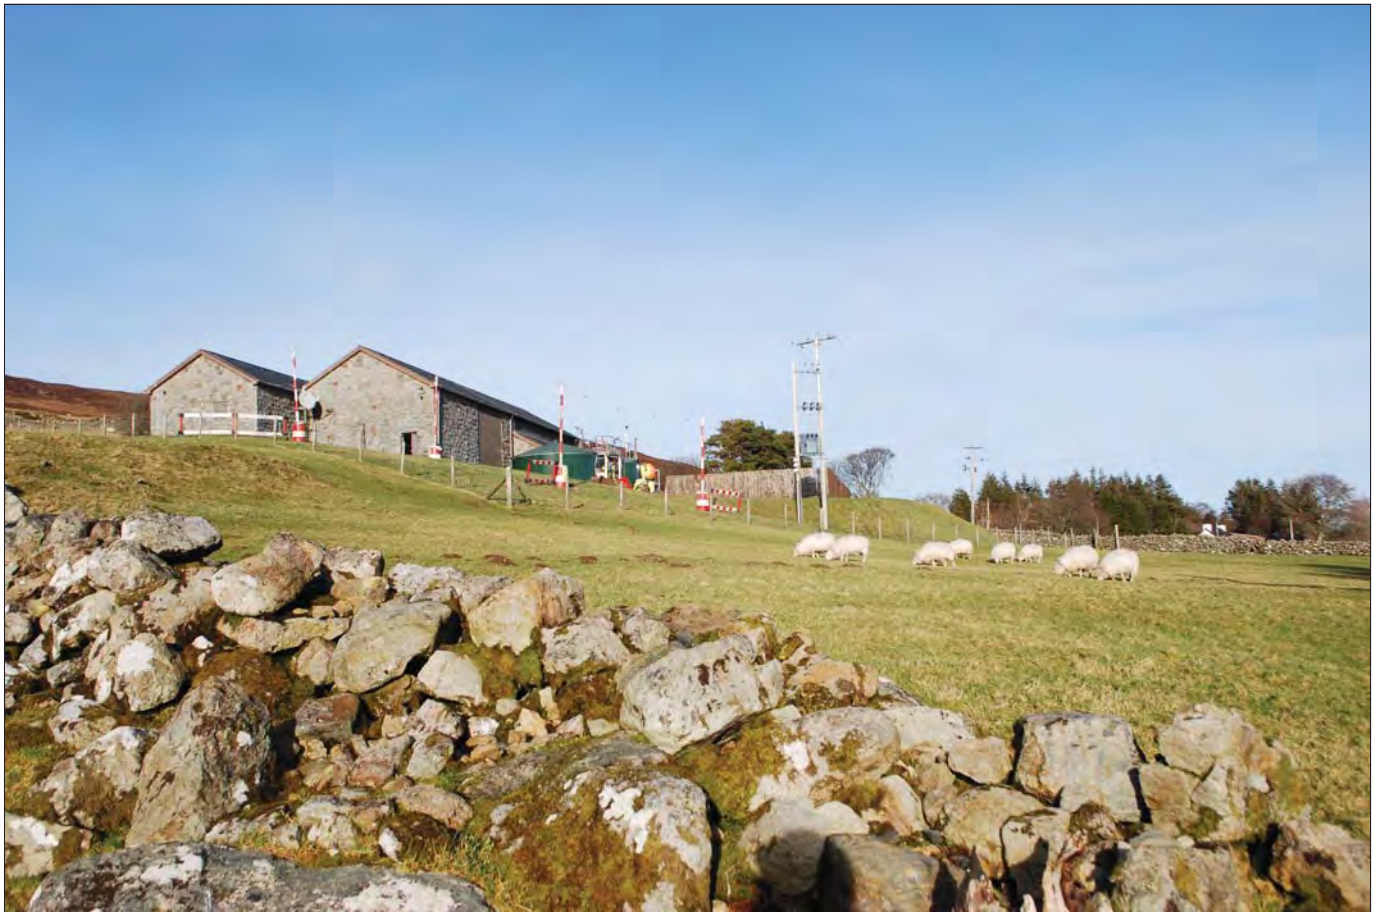
**Plate 5** View of the Water Treatment Works from the west showing north-south slope and terracing, with Feature 3 in the foreground. Scale 1m

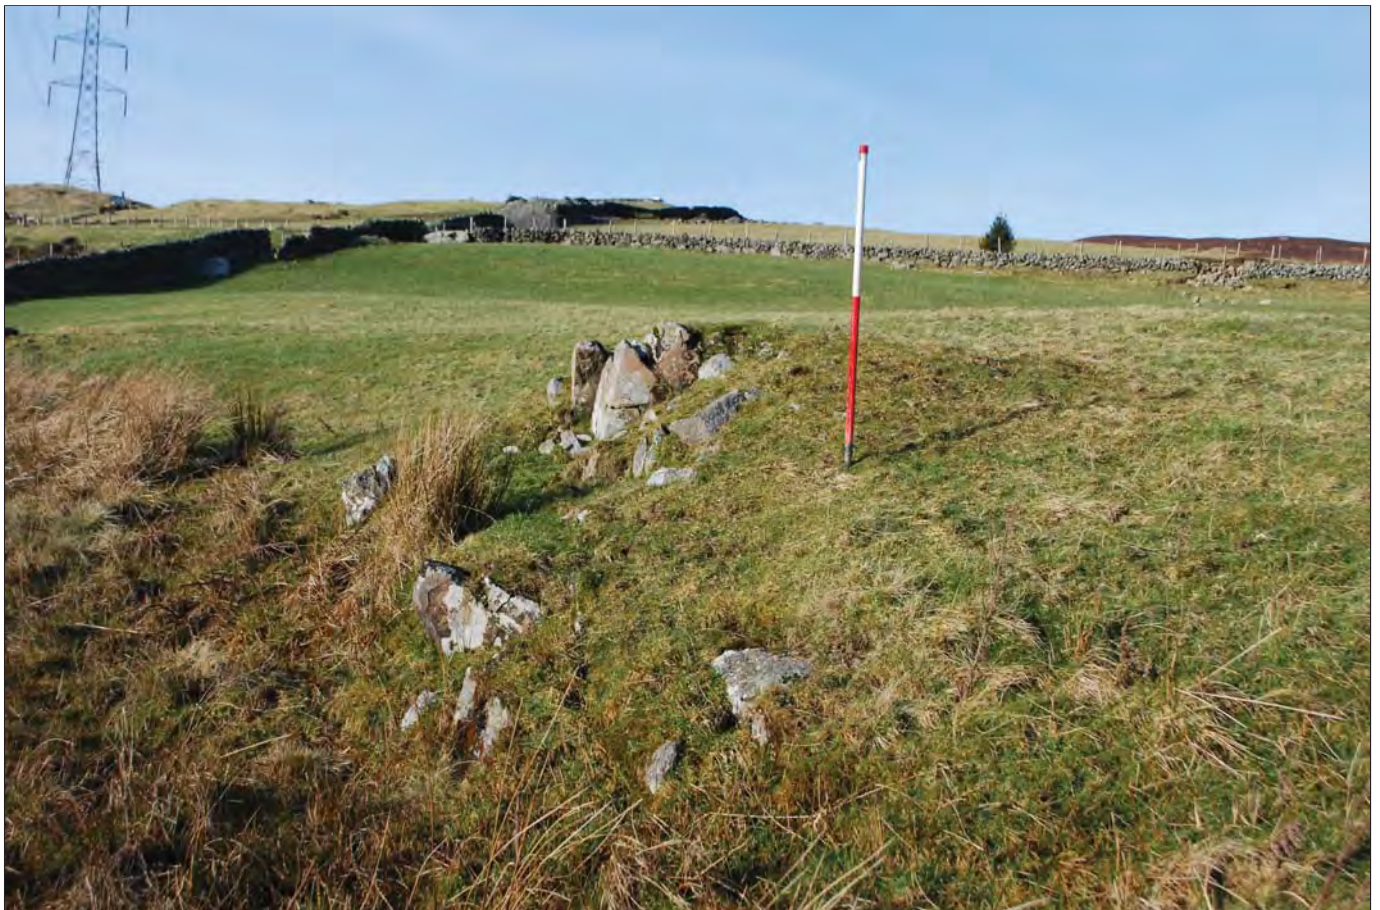
### **Feature 9      Probable Rock outcrop (Plate 6)**

A probable rock outcrop with a small amount of stone clearance associated with it. It is however close to the stream and appears to be a discrete feature with no evidence of modern activity, and may indicate a focus for earlier activity.

**Plate 6** Feature 9 from the south east. Scale 1m

**Recommendations for mitigatory measures:** Avoidance- it lies outside the area of proposed works
