# **Tomen y Mur, medieval motte**

## Archaeological survey and record

Report No. 949

Prepared for  
the Snowdonia National Park Authority

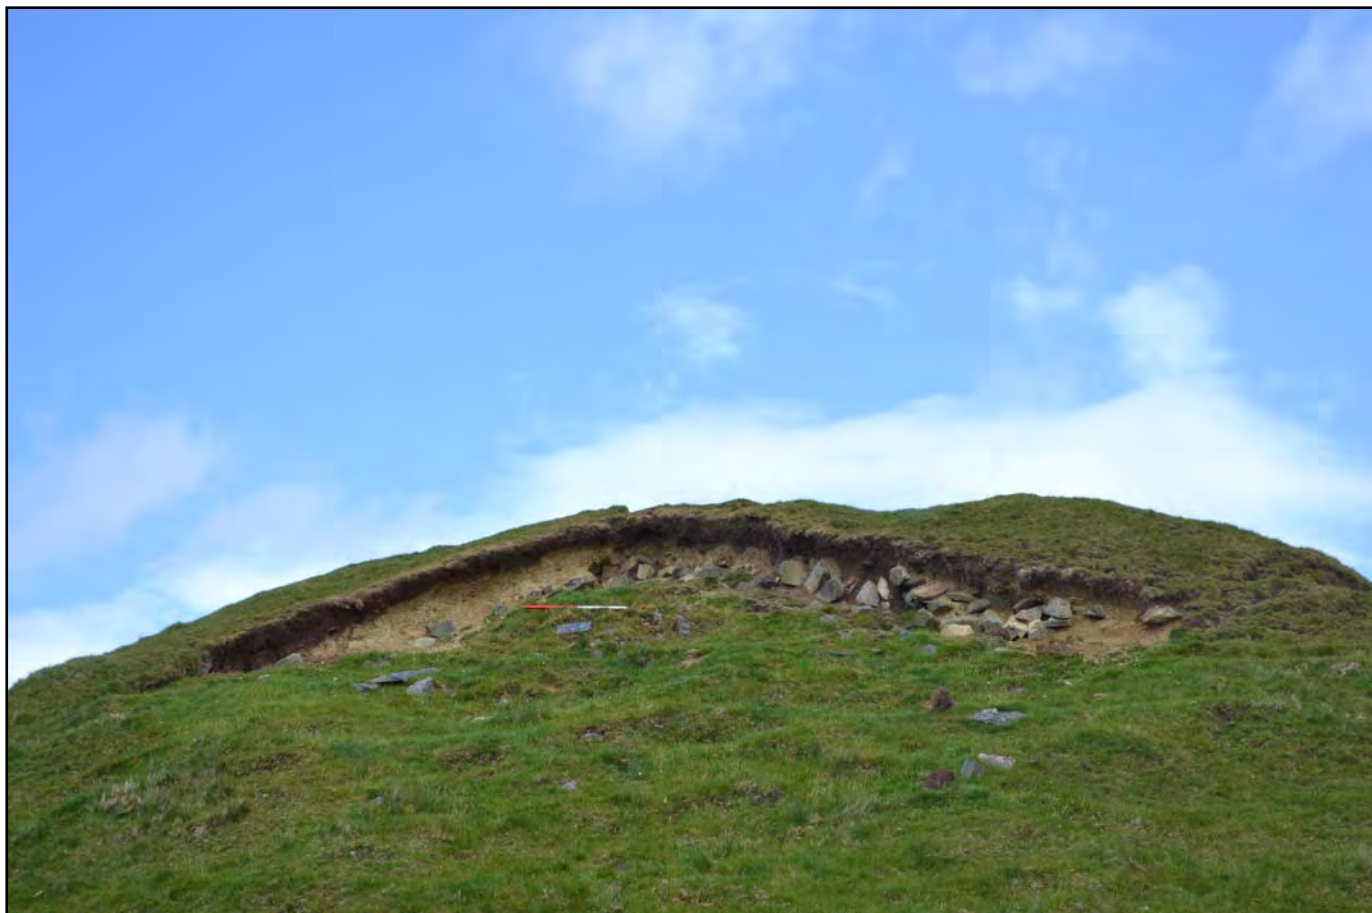
The first erosion scar was located on the south slope of the motte near the summit. The scar measured 10.60m in length, an average of 0.60m in depth, and approximately 0.50m in width. The eroded area had formed at a right angle, orientated southwest to northeast and then northwest to southeast. The erosion processes had caused an overhang to develop towards the centre of the scar measuring some 0.36m in width. Once the area had been cleaned it became clear that the core of the motte was constructed from a very firm, yellow clay (002) with frequent large, angular stone inclusions. This deposit constituted the main bulk of the motte, with a layer of moderately soft, dark-brown silt-clay topsoil (003) covering the core, upon which a layer of turf was established. Almost certainly the stone included within the core would have been robbed from the Roman fort, and the topsoil deposit was most likely a deliberate deposition to pin the clay core in place.

**Plate 1: Erosion scar [001] from the south**

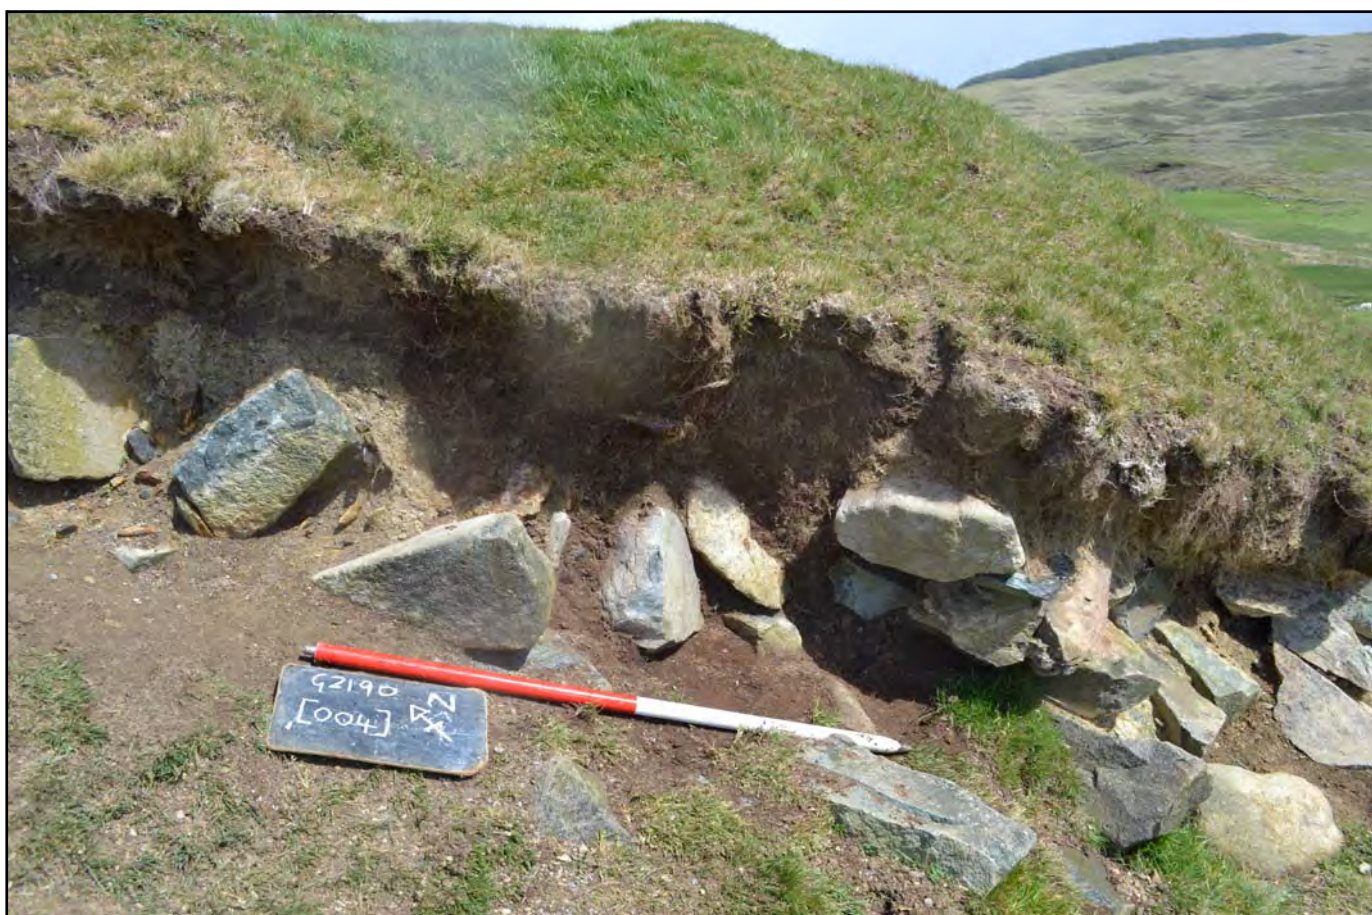
Upon cleaning of the southwest facing eroded section, a large feature, probably a post-hole (004), was discovered. It measured 0.80m in width and 0.55m of its depth had been revealed by the erosion. The exact depth and length of the feature was not discernable due to the limits of the erosion scar, however, the feature appeared to cut into the clay and stone core (002) of the motte and was filled by the topsoil layer (003). Upon further investigation, it became clear that the large angular stones to the immediate southeast of the feature and included within the clay and stone core (002), were in fact running over the post-hole, meaning that it had not been cut into the core per se, but rather incorporated into the motte during the deposition of

the core. The fill of the post-hole was identical to the topsoil layer (003) with no obvious inclusion of post packing or post removal. Thus it can be surmised that either the post had rotten in-situ and thus the post-hole (004) became filled with the layer immediately above it, topsoil (003), or that the post-hole was filled and packed with the same topsoil layer as was deposited over the motte core (002). The incorporation of the post-hole (004) into the motte core (002) suggests that whatever the post-hole was utilised for, its purpose was integral to the motte construction and was envisioned as a single construction event. In short, the majority of the motte was constructed, a large post was put in place almost at the summit of the mound, and then more clay and stone material was added to secure the post in place and complete the motte. The location on the summit edge of the motte and the large size of the post-hole suggests that it may be part of a wooden defence wall, possibly a palisade encircling the summit of the motte.

**Plate 2: Probable post-hole [004] in erosion scar [001] from the southwest**

The large post-hole feature may represent part of a defended enclosure or palisade encircling the summit of the motte. The post-hole was incorporated into the motte rather than having been cut into it, suggesting that the post was put in place while the core of the motte was being deposited.

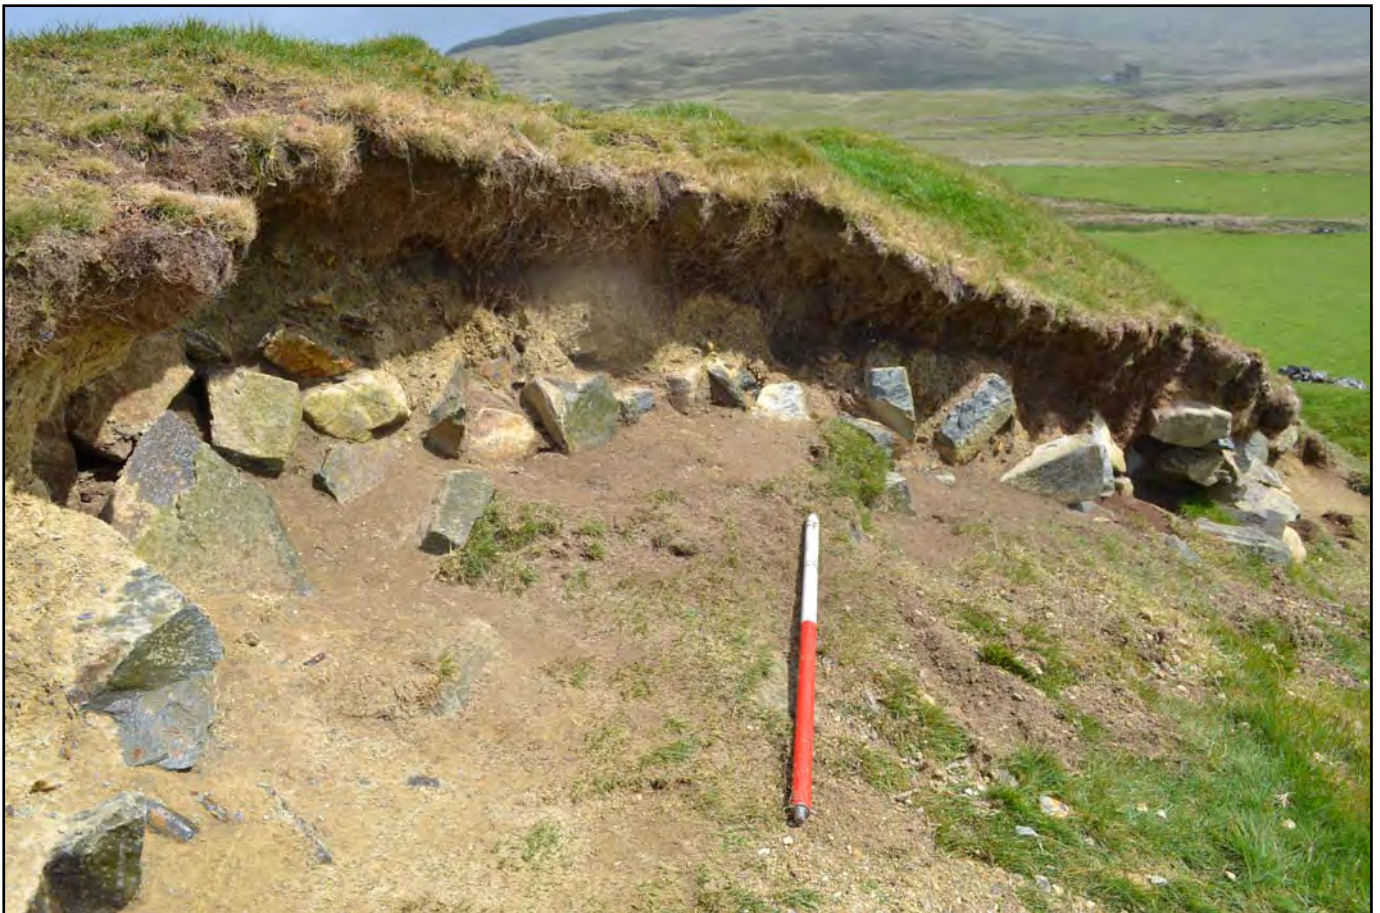
Upon inspection of the southwest facing eroded section, three stepped features were seen 'cut' into the top of the clay core (002). The features were filled with a dark brown silt-clay, identical to the topsoil layer (003) immediately above and most likely the same deposit. It is not clear whether these features are stone-holes, created as stones have fallen out of the eroded section, or whether they are actually part of a stepped profile to the motte, which can be seen faintly on all of its slopes. Indeed, if the features do represent a deliberate stepped profile, it appears that this was created during the deposition of the clay and stone core (002) material, with the topsoil layer (003) consequently being laid over it.

**Plate 3: Erosion scar [001] from the west**

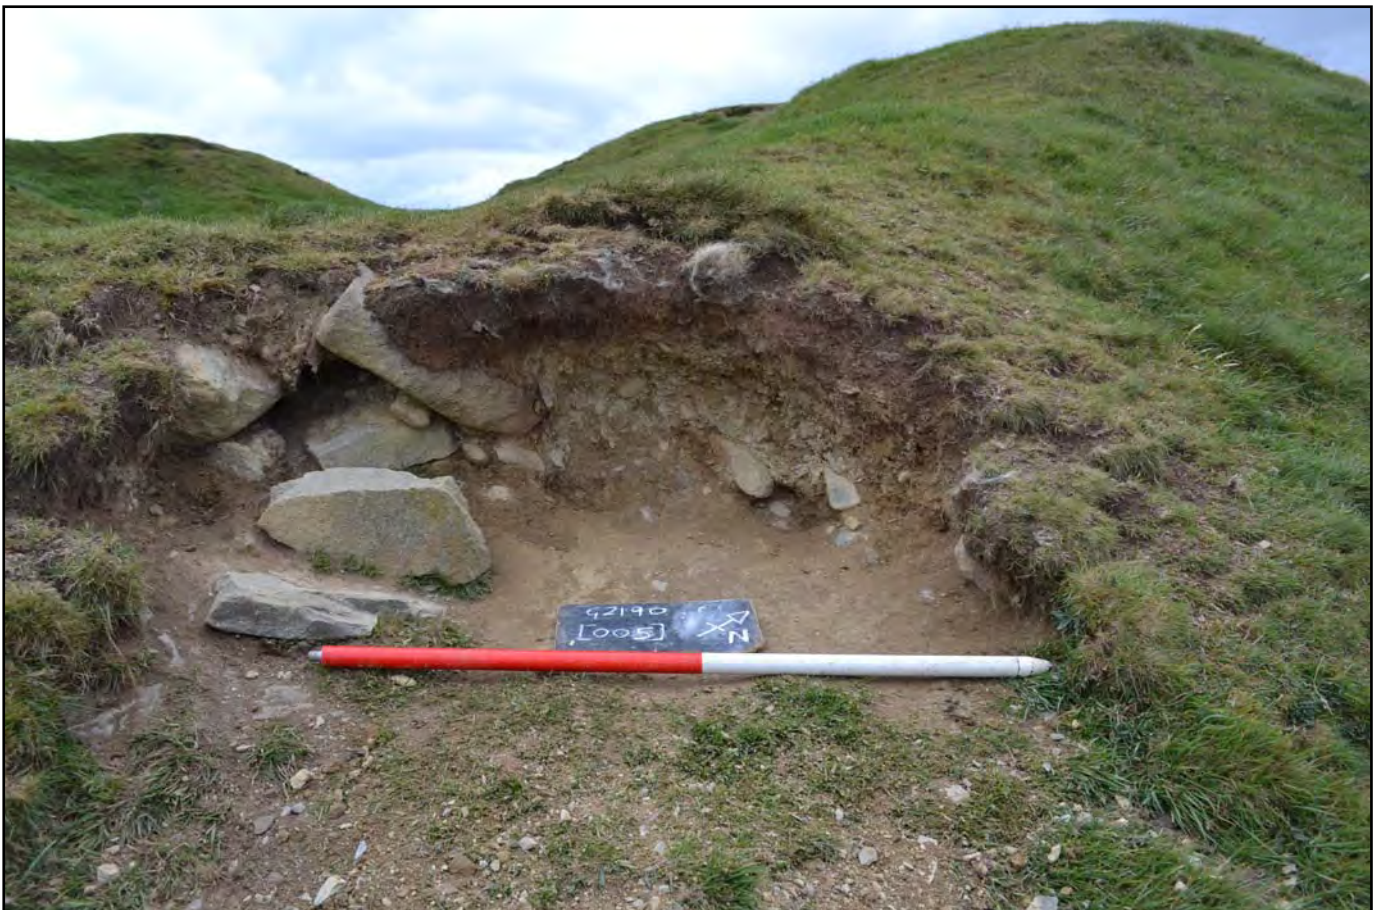
The second erosion scar (005) was located on the southeast facing slope, again close to the summit of the motte. The eroded area was much smaller than the first, measuring 1.30m in length, a maximum of 0.50m in depth, and 0.40m in width. Like the first eroded area, this scar had a clear overhang measuring some 0.20m in width and was linear in plan, orientated northeast to southwest. Once cleaning of the scar was complete, it became clear that the same arrangement of clay and stone core (002) covered with topsoil (003) had been used on this part of the motte. No archaeological features were observed within the cleaned section.

**Plate 4: Erosion scar [005] from the southeast**
