Wig Bach: Abergwyngregyn, Gwynedd

Level II Archaeological Building Record

GAT Project No. 2190

Report No. 951

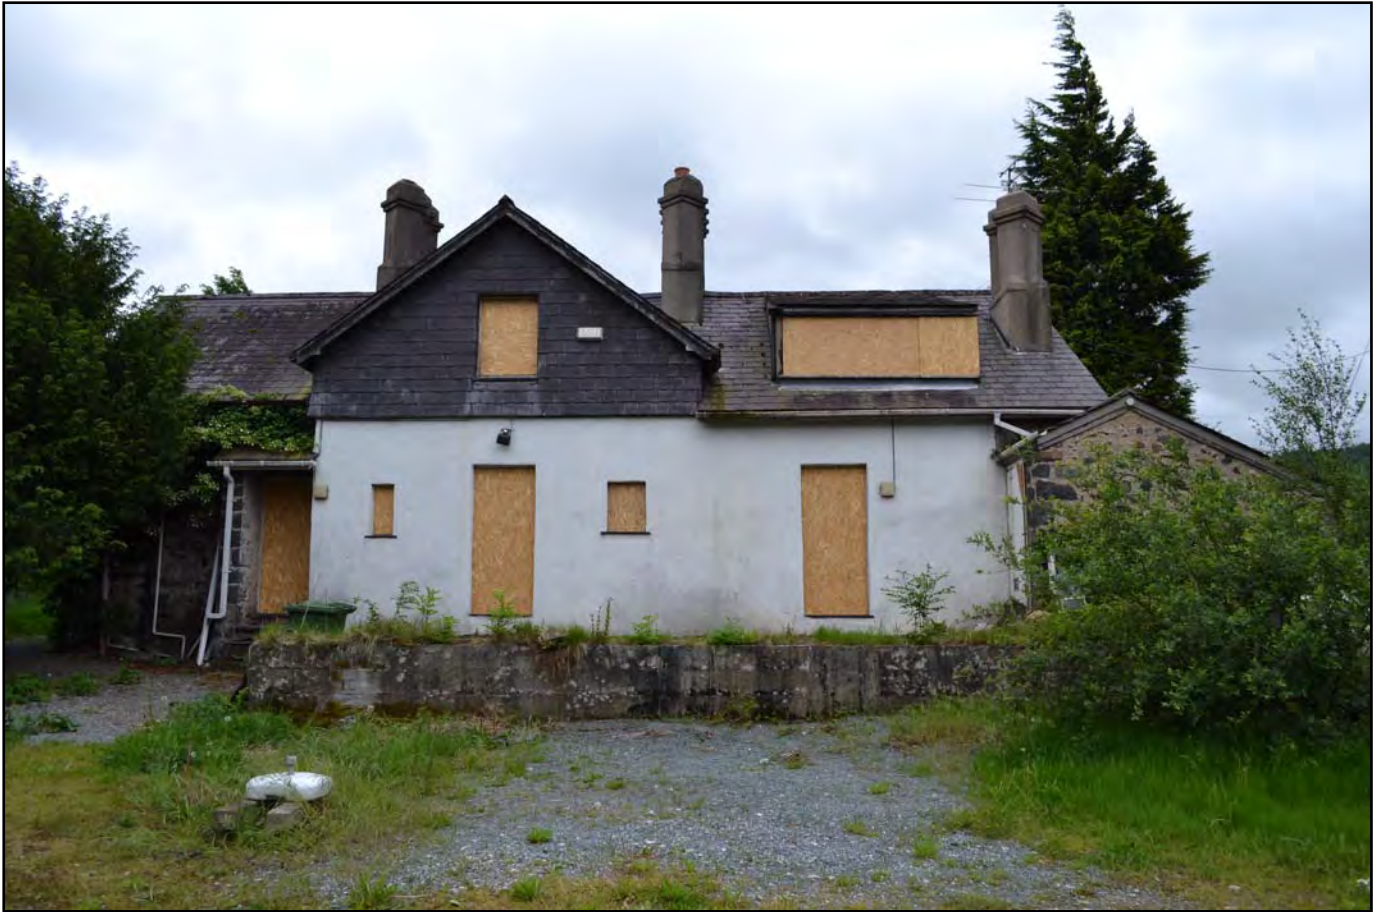
Plate 1: Northern external elevation from the north

The east facing gable has three twelve pane fixed windows, and is very overgrown. The west facing gable has two six pane fixed windows in the roof space, and a twelve pane fixed window in the downstairs lean-to extension. The north facing elevation has two doors, one leading to the kitchen and one to the living room of cottage B, situated on the eastern side of the elevation. Two further doors are situated to the west of the northern elevation and give access to the living room and lean-to kitchen of cottage A, although the latter was blocked presumably during the improvements in 1920. Two small, two-pane fixed windows are located either side of the door to the living room of cottage B. There is a large dormer window in the eaves, and a twelve pane cat-slide dormer window in the north facing gable, all replacements. The ground storey has been rendered and painted white.

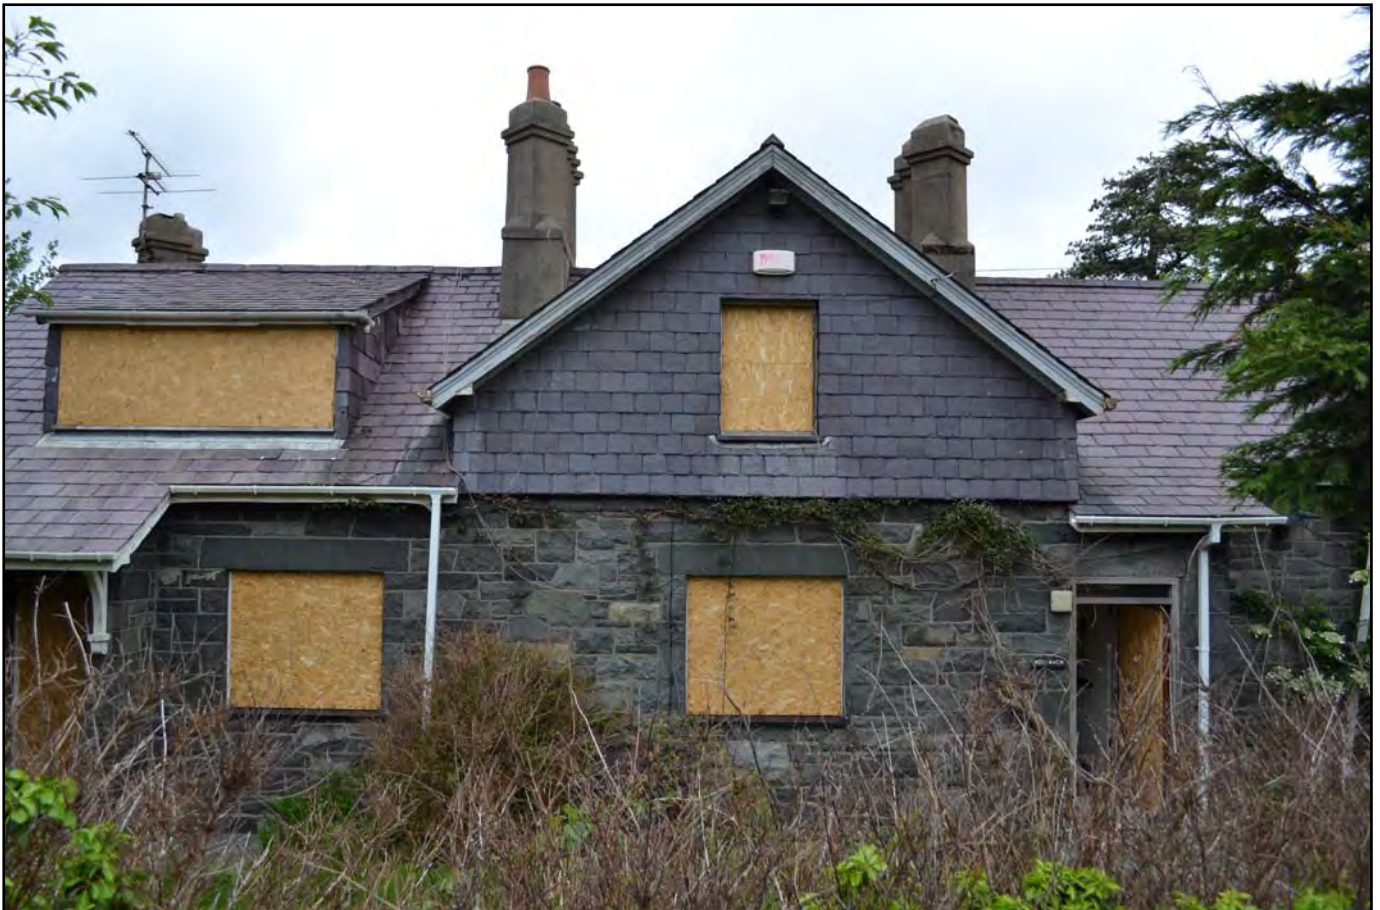
Plate 2: Southern external elevation from the south

The southern elevation of the property has an original porch on the west side, constructed from the same granite as the property proper and leading into what would have been the traditional entrance into cottage A. The entrance was made into a walk in window when the properties were amalgamated. On the eastern side of the southern elevation a recessed internal porch gives access to cottage B, with a slate plaque alongside bearing the name 'Wig Bach'. There are two horizontal twelve pane fixed windows on the ground storey, a large dormer window in the eaves, and a twelve pane cat-slide dormer window in the south facing gable, all having replaced the original windows probably when the cottages were combined.

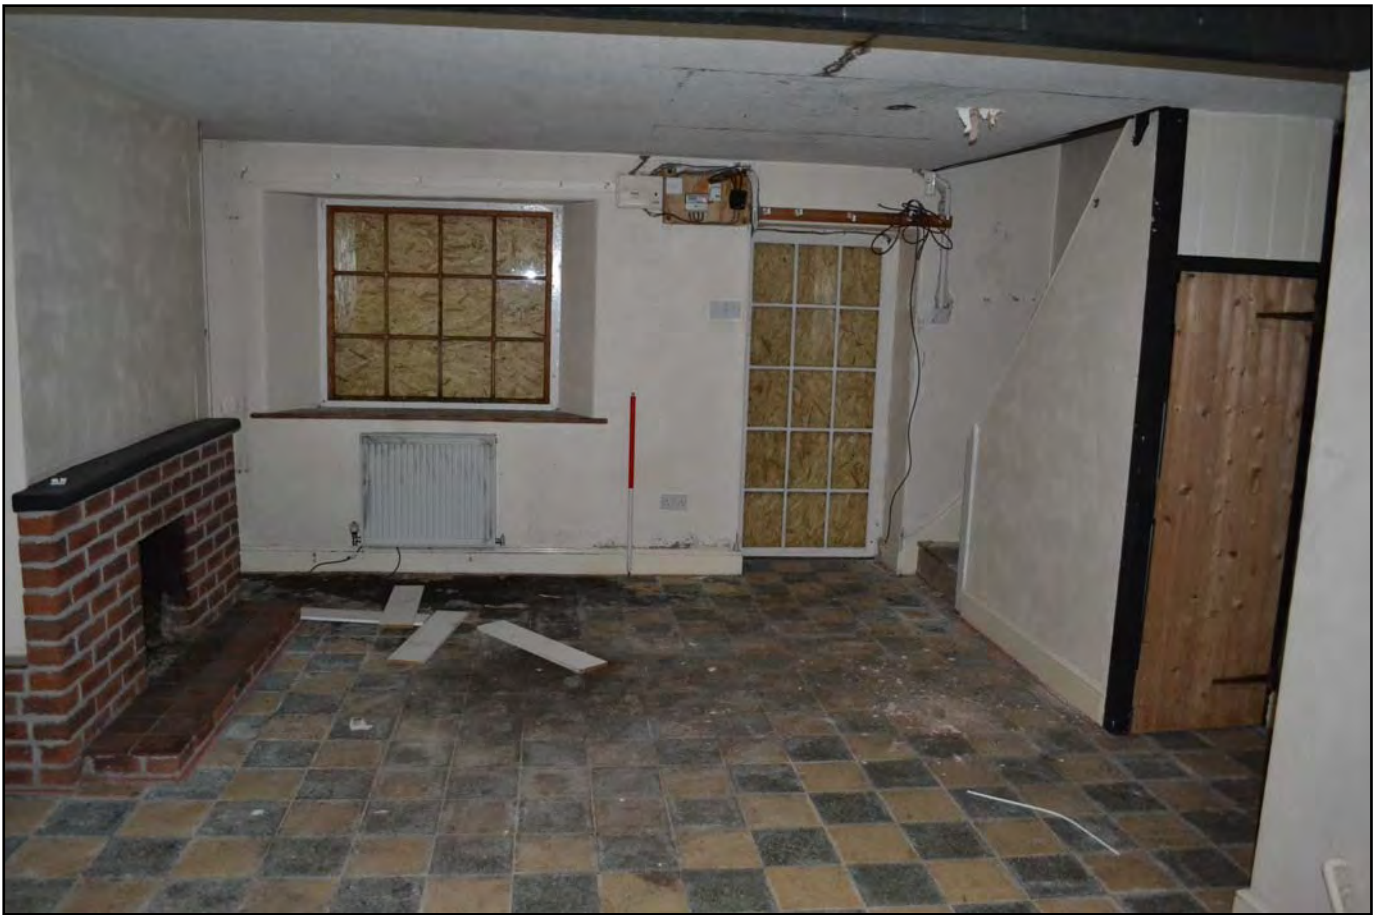
Plate 3: Cottage A Living Room from the north

Cottage A was originally accessed by the porched entrance (described above) located on the western side of the southern elevation. This external doorway was blocked up with a twelve-pane fixed walk in window during the improvement works *circa* 1920. The entranceway would have originally led into the main living room of cottage A. This room exists today as a rectangular room some 6.10m in length and 4.0m wide living room orientated north to south, with a wooden staircase on the west side leading upstairs. An eight-pane wooden door leads from the northern wall of the living room out into the rear of the property, and a fifteen-pane wooden door leads through the eastern wall into the traditional living room of cottage B. A chamfered ledged tongue and groove door in the west wall leads into the kitchen of cottage A, and may be original. An architect's plan of proposed improvements to the property *circa* 1920, shows that this room was used as a living room but was originally divided in two by an east-west internal wall at its northern end. This extra room was utilised as a downstairs bedroom. The plan depicts a window in the northern wall of this bedroom where the eight-pane door leading to the outside rear is now located.

The living room has an open fire on the eastern wall with modern red-brick surround and slate hearth. The floor is tiled in alternating black and beige tiles, and the walls are plastered and painted white. A blocked up fireplace is located in the north part of the eastern wall and would have originally served the downstairs bedroom.

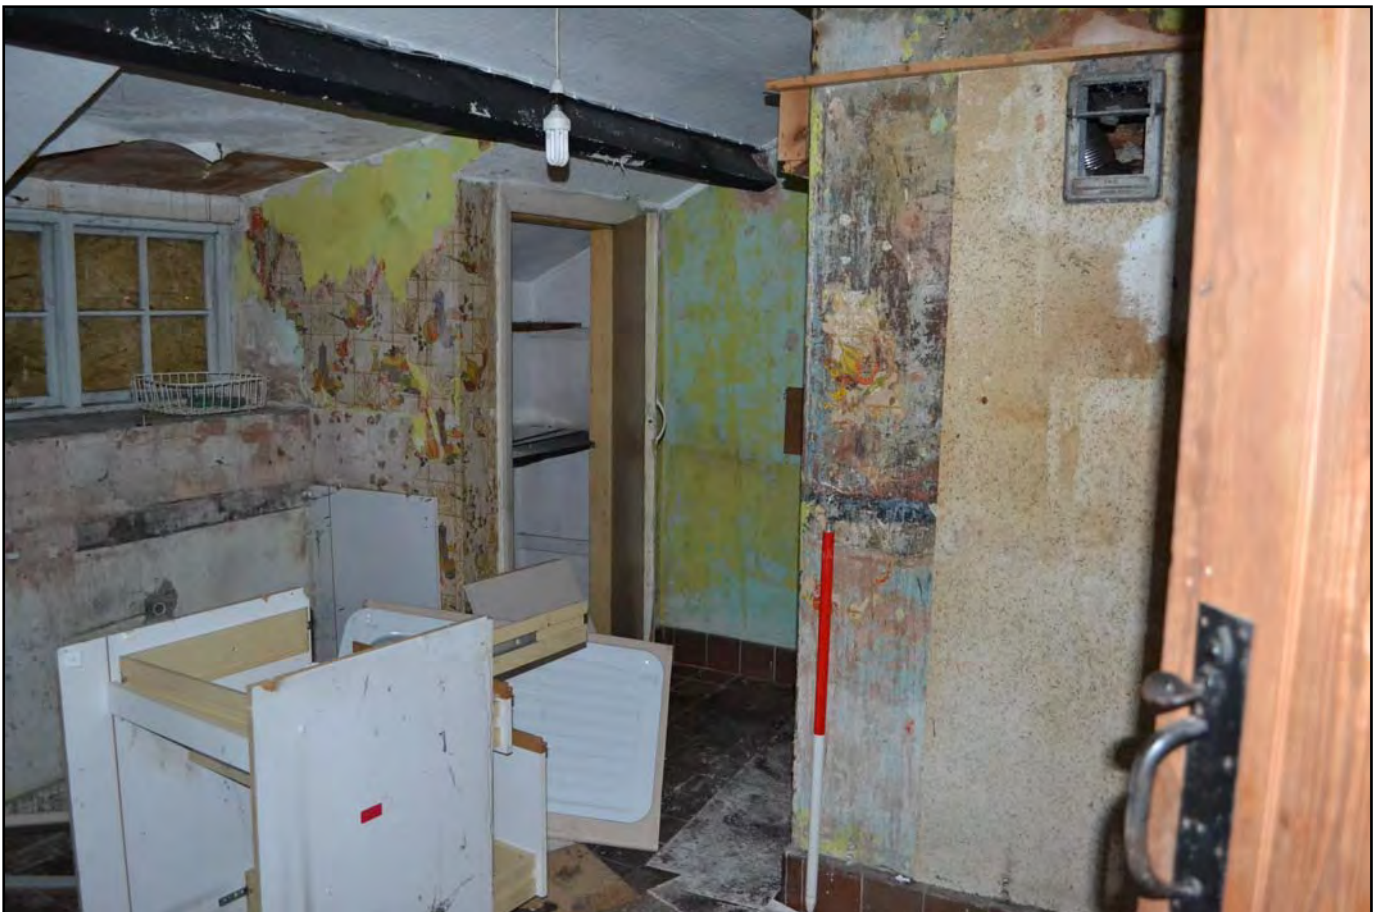
Plate 4: Cottage A Kitchen from the southeast

The kitchen of cottage A exists today as a rectangular room measuring 3.70m in length and 3.40m in width orientated north-south and occupying the single-storey lean-to structure on the west of the property. The room has the remains of wooden kitchen units and a plastic sink, ripped from the wall and strewn across the floor. There is a large cupboard in the northwest corner, probably having functioned as a larder, and a doorway leads through the southern wall

into a downstairs bathroom. The floor is entirely tiled in brown-red ceramic tiles, and there survives the traces of at least five different types of wallpaper on the walls. The 1920s architect's plan also depicts the room as a kitchen scullery and little change has seemingly occurred to the layout of the room, aside from the room could originally be accessed via an external door in the north end of the east wall. This doorway must have been blocked up during the house improvements, and the part of the entranceway made over to an external storage shed.

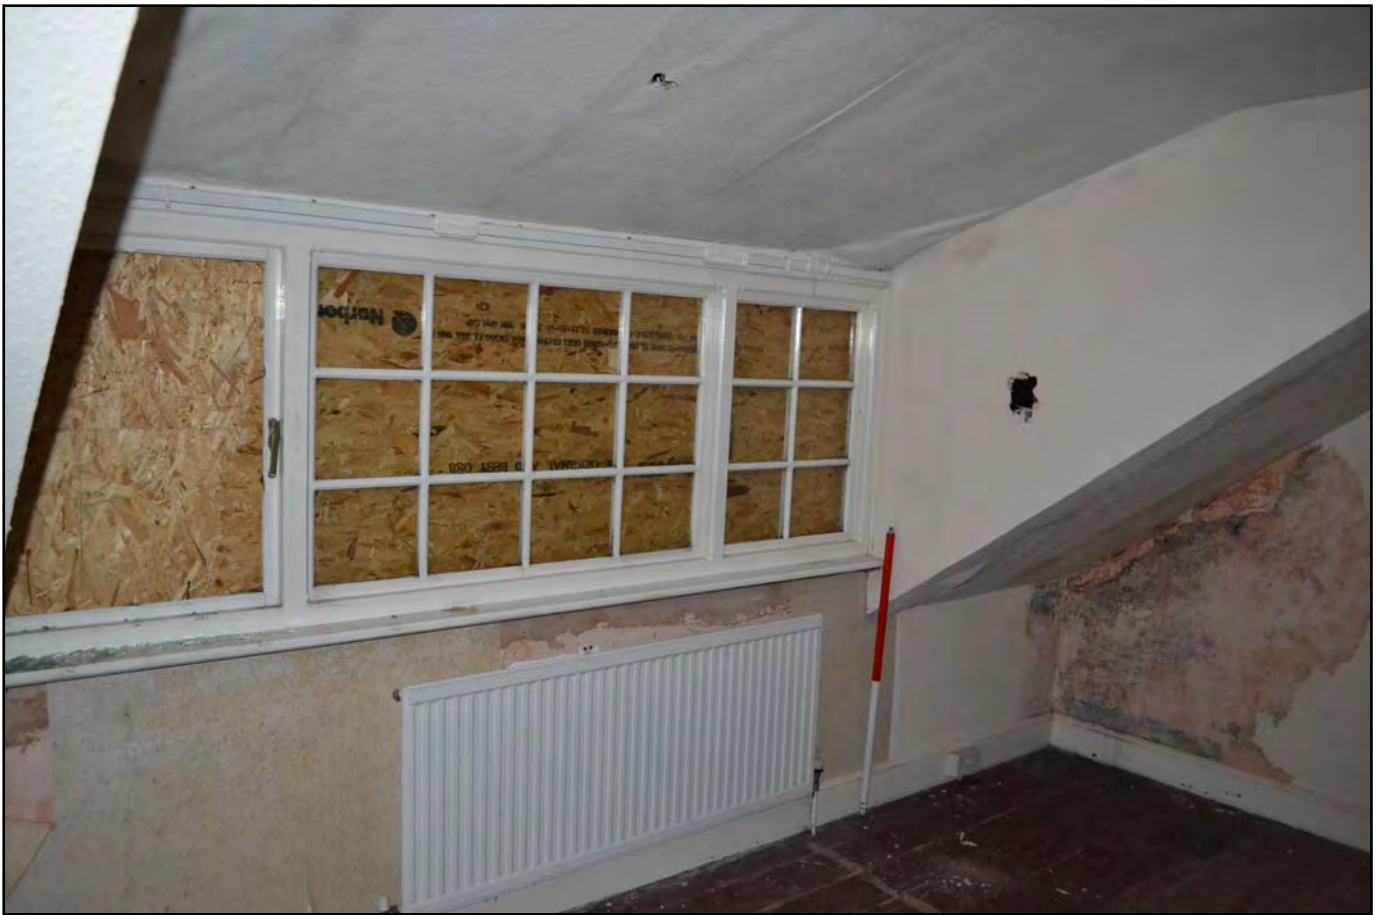
Plate 5: Cottage A Bedroom 1 from the southwest

The first and largest bedroom of cottage A is located to the rear (north) of the property and exists as a rectangular room measuring 7.25m in length and 2.60m in width, orientated east-west. The floor is of wooden floor boards and the walls are wallpapered in plain white. A large dormer window is located in the northern wall, with a small two-pane fixed window in the western wall. The 1920s architect's plan also depicts the room as a bedroom, however the dormer window was originally much smaller and an open fireplace was located on the western wall, presumably blocked up during the improvement works.

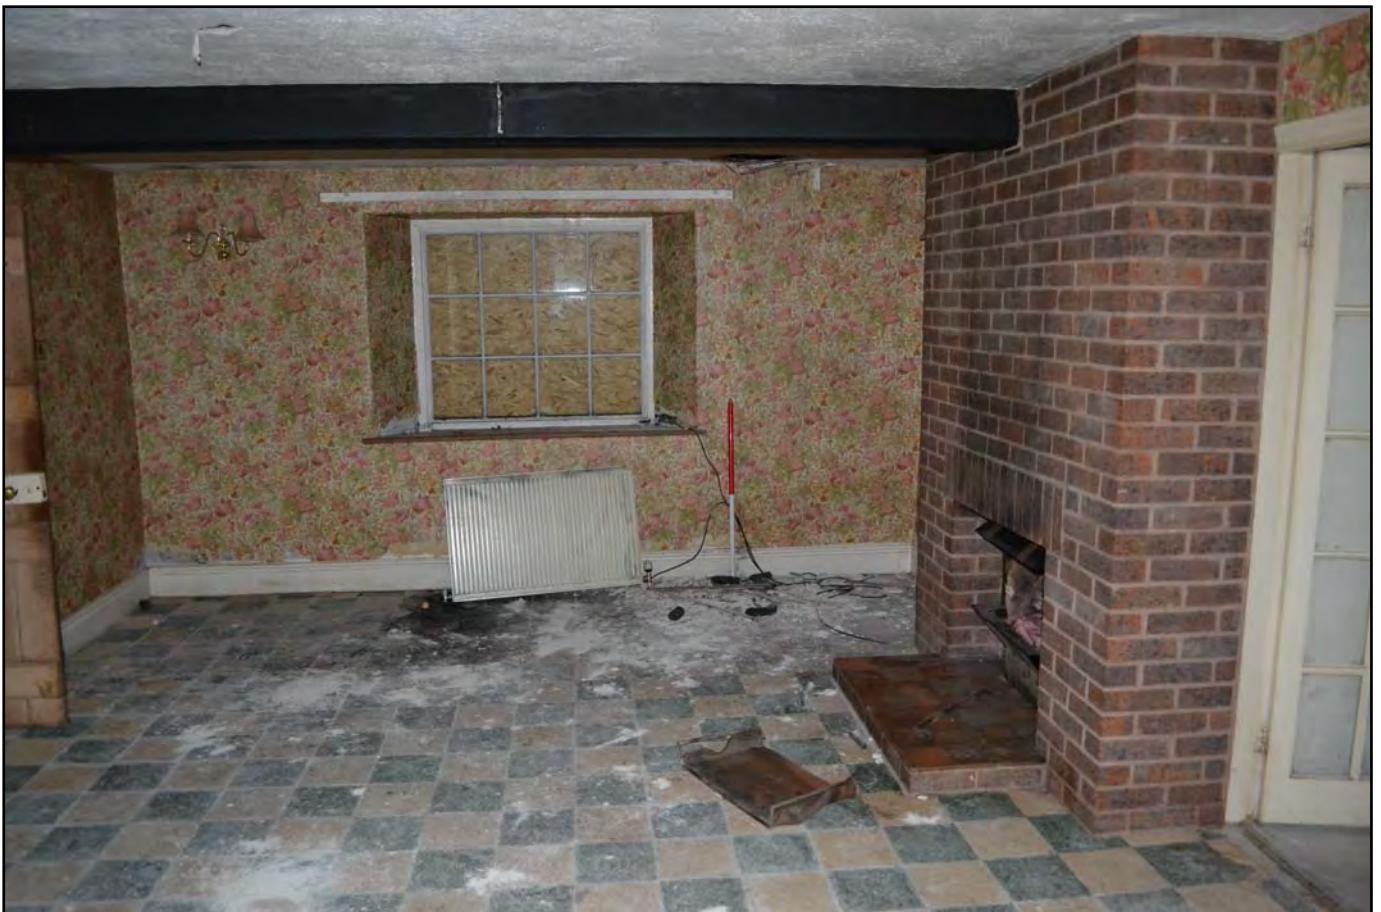
Plate 6: Cottage B Living Room from the north

Cottage B was originally accessed by the internal recessed porch on the eastern side of the southern elevation. The main entrance leads into a small hallway which gives onto a rectangular living room measuring 6.00m in length and 4.00m in width orientated north-south. An eight-pane wooden door leads through the northern wall into the rear of the property, and a fifteen-pane wooden door leads through the eastern side of the northern wall into the kitchen of cottage B. A chamfered ledged tongue and groove door separates the living room from the hallway/ main entrance to the west, and a fifteen-pane wooden door leads from this living room west into the living room of cottage A. A large twelve-pane fixed window is located in the southern wall, and a modern red-brick fire hearth contains a multi-fuel burner on the western wall. The walls are decorated with a yellow and pink floral paper, and the floor is tiled with alternating black and yellow ceramic tiles. The northern part of the room is tiled with smaller brown-red ceramic tiles and the traces of a demolished internal wall can be seen. The 1920s architect's plan depicts the room as a living room, but also shows that the northern part of the room was sub-divided by an internal partition. This room is unnamed on the plan but appeared to be a walk in larder. The plan also shows that like cottage A, the door leading

from the living room through the northern wall to the rear of the property was originally a window.

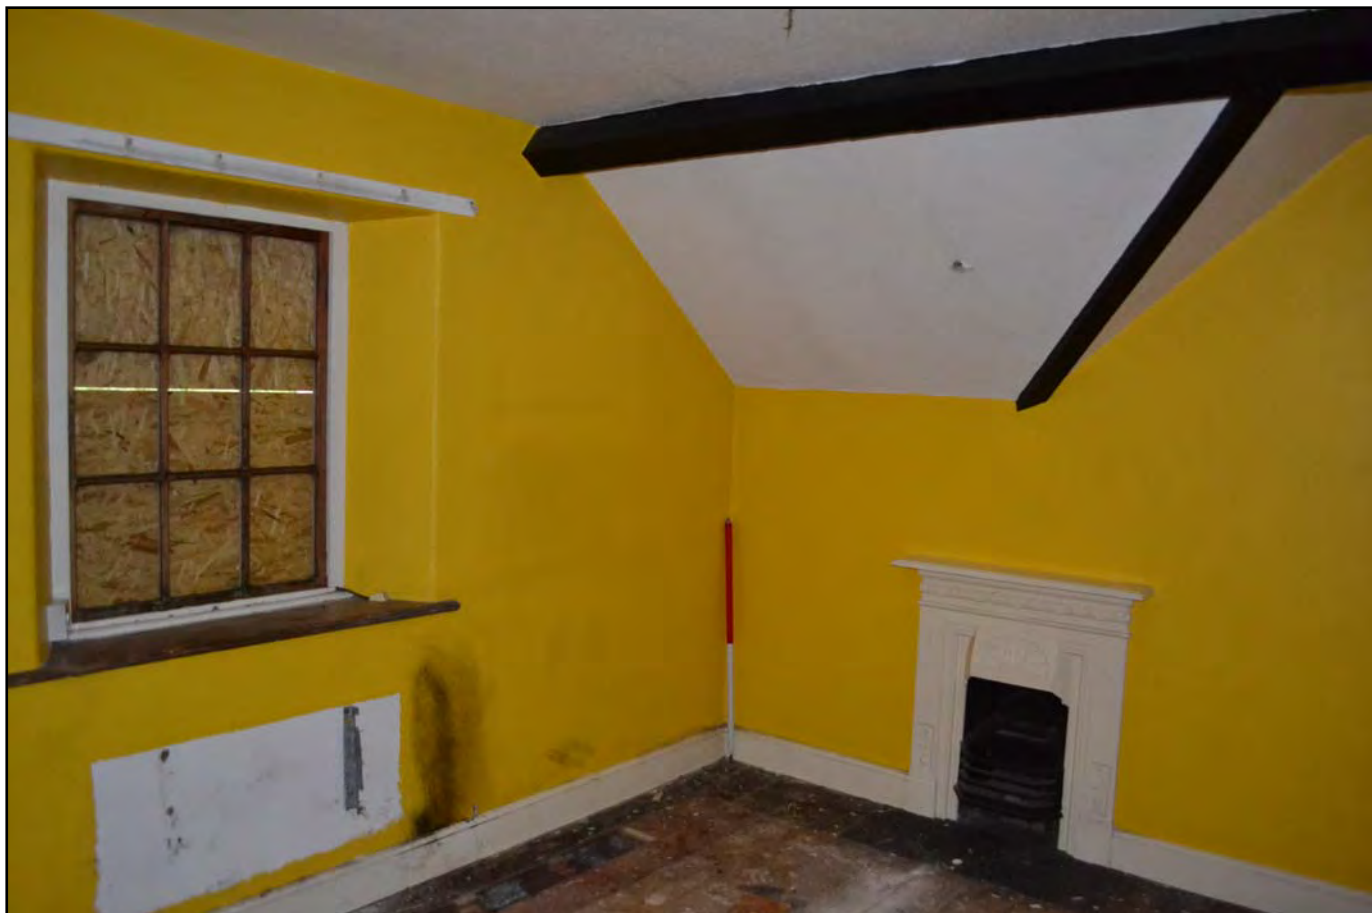
Plate 7: Cottage B Bedroom 1 from the southwest

The first and largest bedroom of cottage B is located upstairs and at the rear (north) of the property. The room is rectangular and measures 4.10m in length and 2.85m in width, orientated east-west. The room has a nine-pane fixed window in the northern wall, and a white painted iron fire-surround is located on the eastern wall. The surround has formalised floral designs and depicts two doves around a centralised arabesque motif. The floor has wooden floorboards and the walls are covered in plain pattern wallpaper painted bright yellow. The door leading to the landing is a chamfered ledged tongue and groove door. The 1920s architect's plan also depicts the room as a bedroom.
