Plas Y Coed, Bangor, Gwynedd, North Wales

Archaeological Assessment

Project No. G2210

Report No. 974

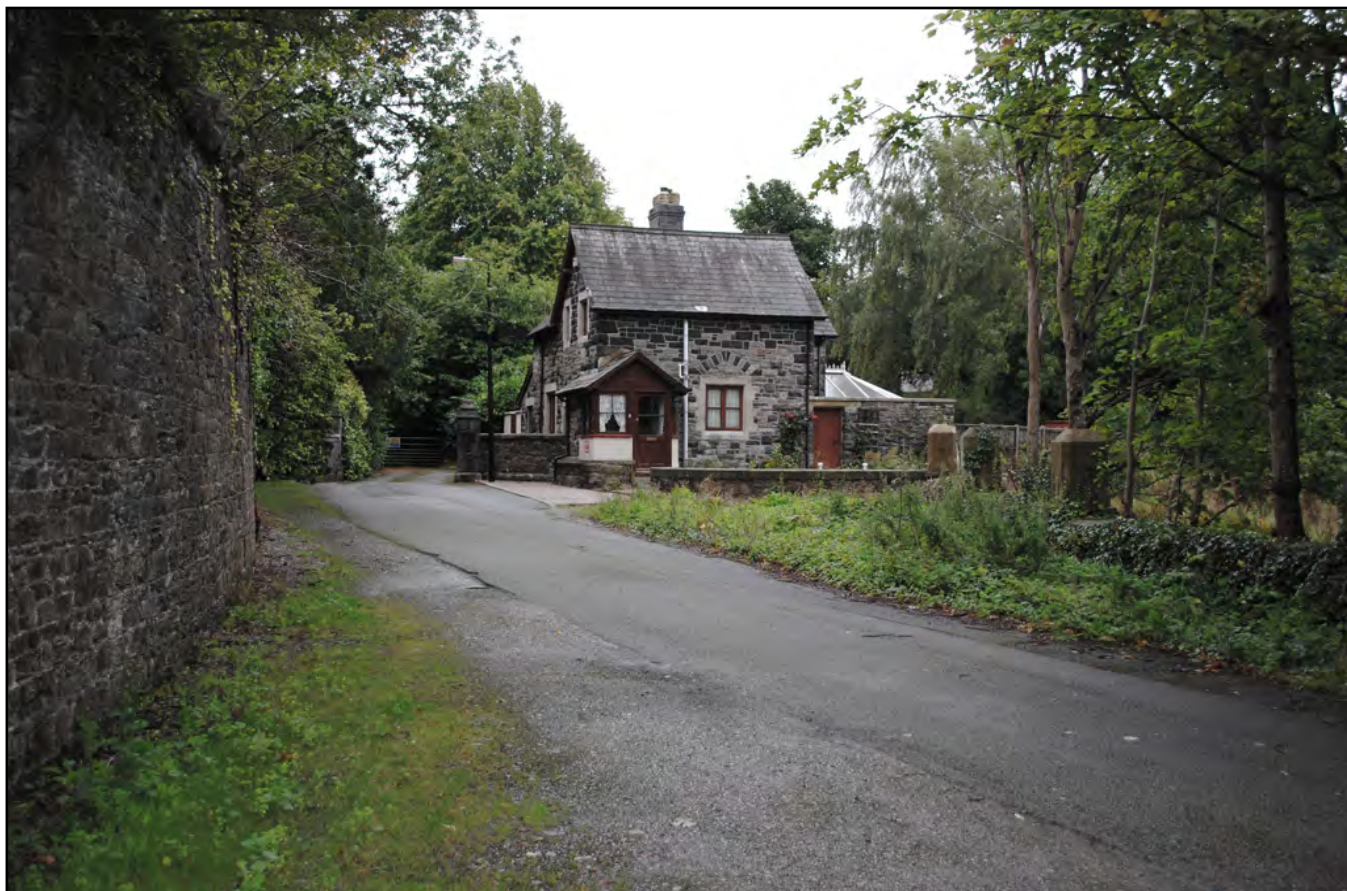
Plate 01: View of Plas Y Coed lodge. Photograph taken from the north east

The proposed development is not expected to have a direct physical impact upon the kitchen garden (site 3) or Lodge (site 5) and thus *avoidance* of these sites has been recommended. It is the responsibility of the client to avoid these sites during enabling works and construction, and provide any protection required prior to the commencement of works.

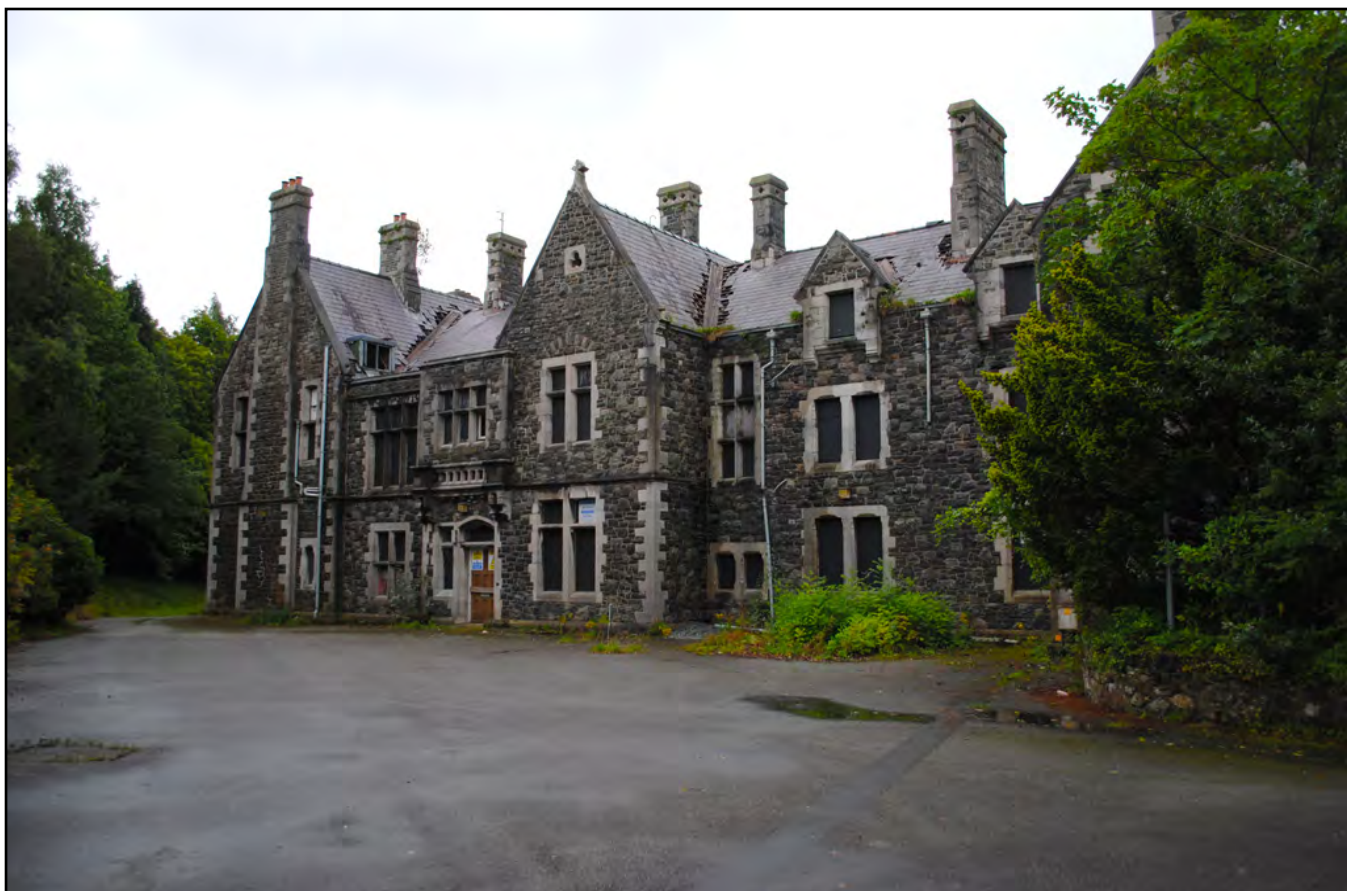
Plate 02: Rear elevation of Plas Y Coed house. Photograph taken from the north east

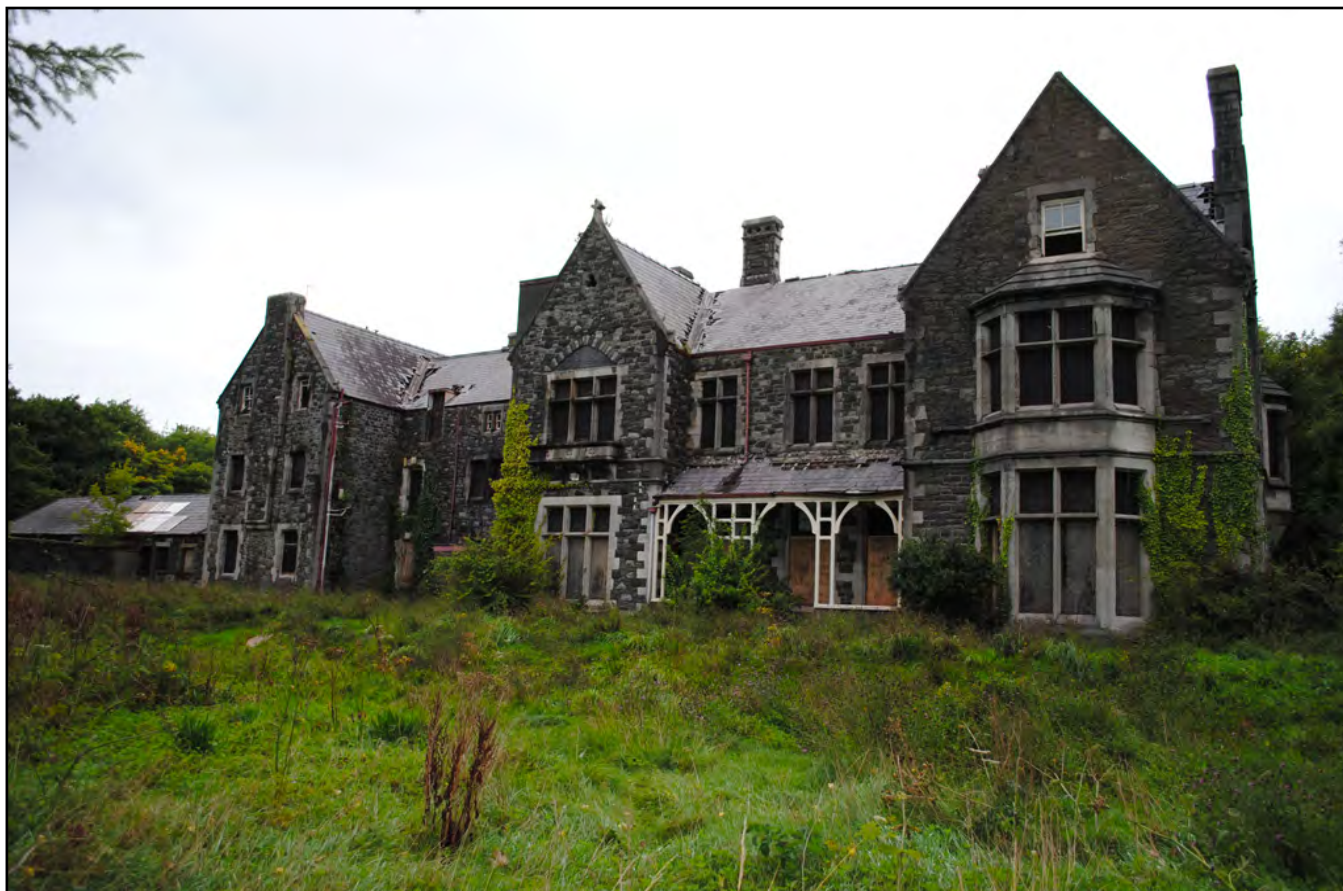
Plate 03: Front elevation of Plas Y Coed house. Photograph taken from the south east

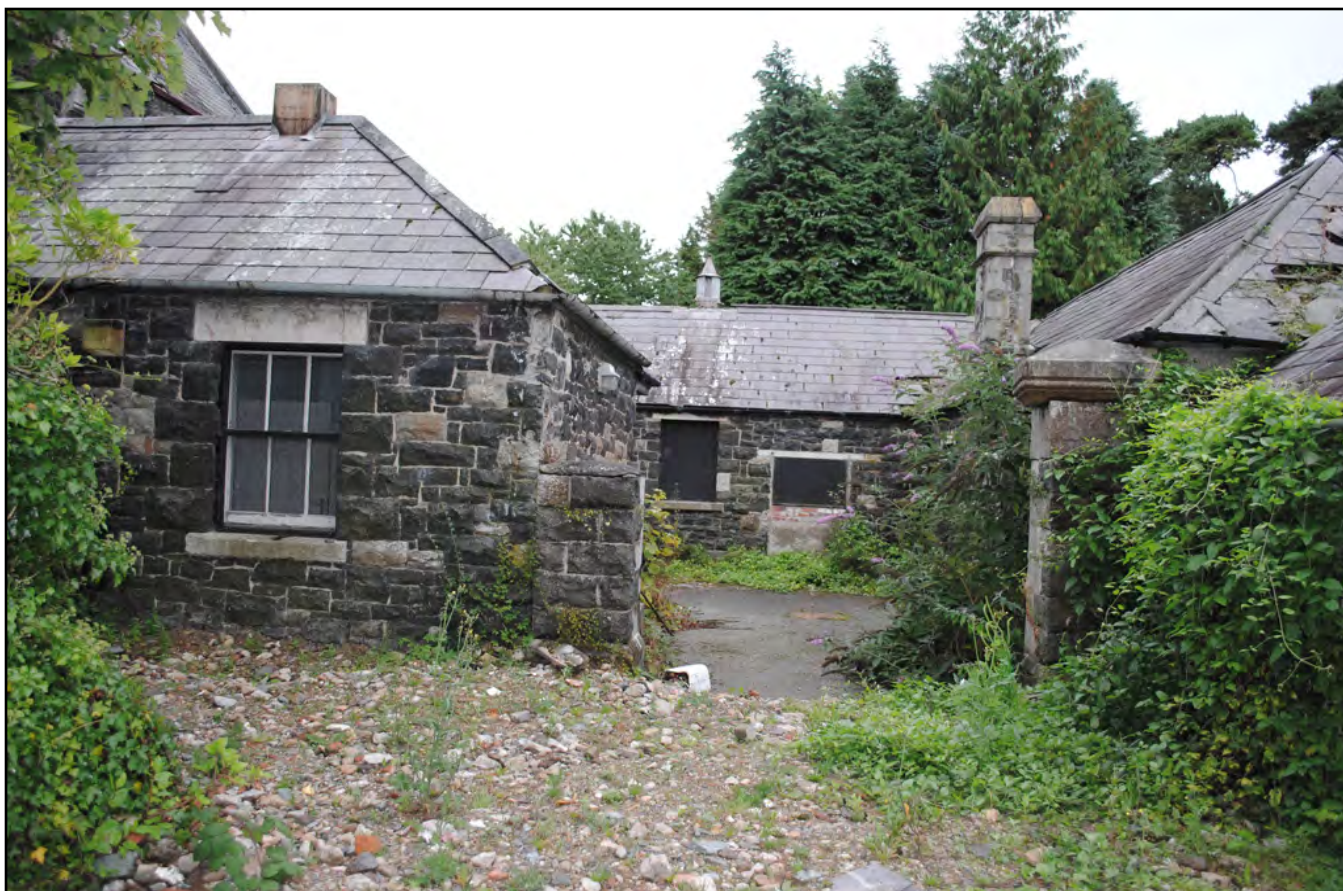
Plate 04: View of entrance to service range. Photograph taken from the north

NGR: SH 59387247		
Recommendations for further assessment: None		
Mitigation Recommendations: Detailed recording (commensurate with level 3/4 building record)		
SITE 2: STABLES AT PLAS Y COED (Plate 4)		PRN: 34779
Assessment of Importance: B	Physical Impact: Moderate	Site Status Reference: LB II Ref: 23371
<p>The stables are attached to west end of the house at Plas y Coed forming a small U-shaped courtyard. They were built contemporaneously with the house at Plas y Coed. The range in front of the courtyard on the west side was added in the late 20th century. The buildings consist of a</p>

Recommendations for further assessment: None

Mitigation Recommendations: Detailed recording (commensurate with level 3/4 building record)

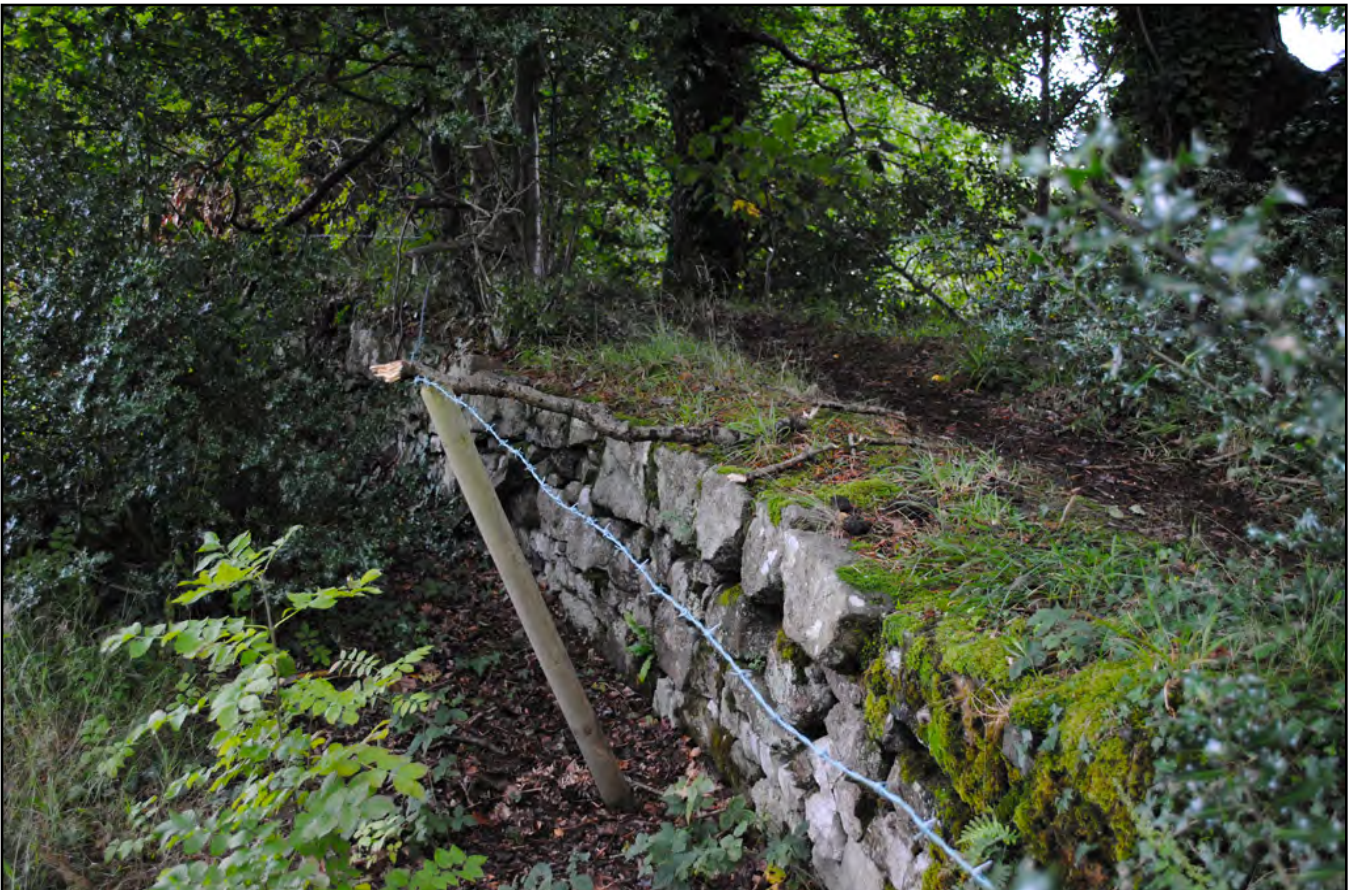
Plate 06: View of raised walkway heading south from the south east corner of the kitchen garden. Photograph taken from the south

The proposed development is expected to have a *minor* impact upon the raised walkway (site 6). The development will avoid the southern and raised section of the feature but will impact upon the eastern section which connects with the kitchen garden. A *basic record* of the trackway is recommended prior to the commencement of groundworks, and *avoidance* of the raised section of trackway is recommended.

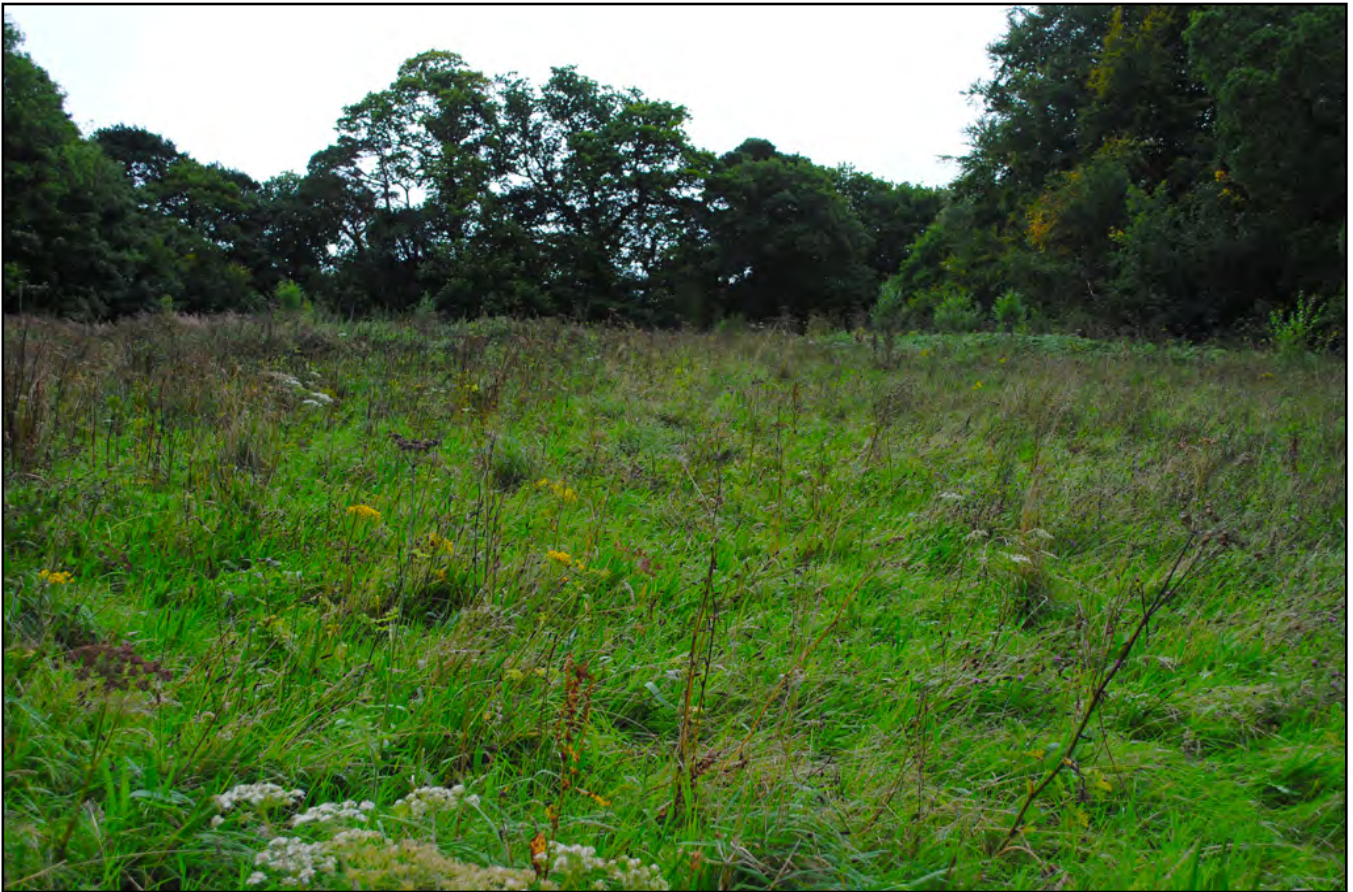
Plate 07: View of the pasture field from the west. Photograph taken from the west

The proposed development is expected to have a *major* impact upon any unknown buried archaeological sites within the proposed development field to the west. The exact nature of these deposits is currently unknown, however it is recommended that a programme of geophysical survey and trial trenching is undertaken to help inform this.

A programme of archaeological evaluation is recommended across the open areas of the site where this is practicable, which would include the kitchen garden area and the pasture field. This should be a phased programme of evaluation, of which the first phase would be **geophysical survey** across the entire site. This may be followed by **trial excavation** at a density to be confirmed once the results of the geophysical survey

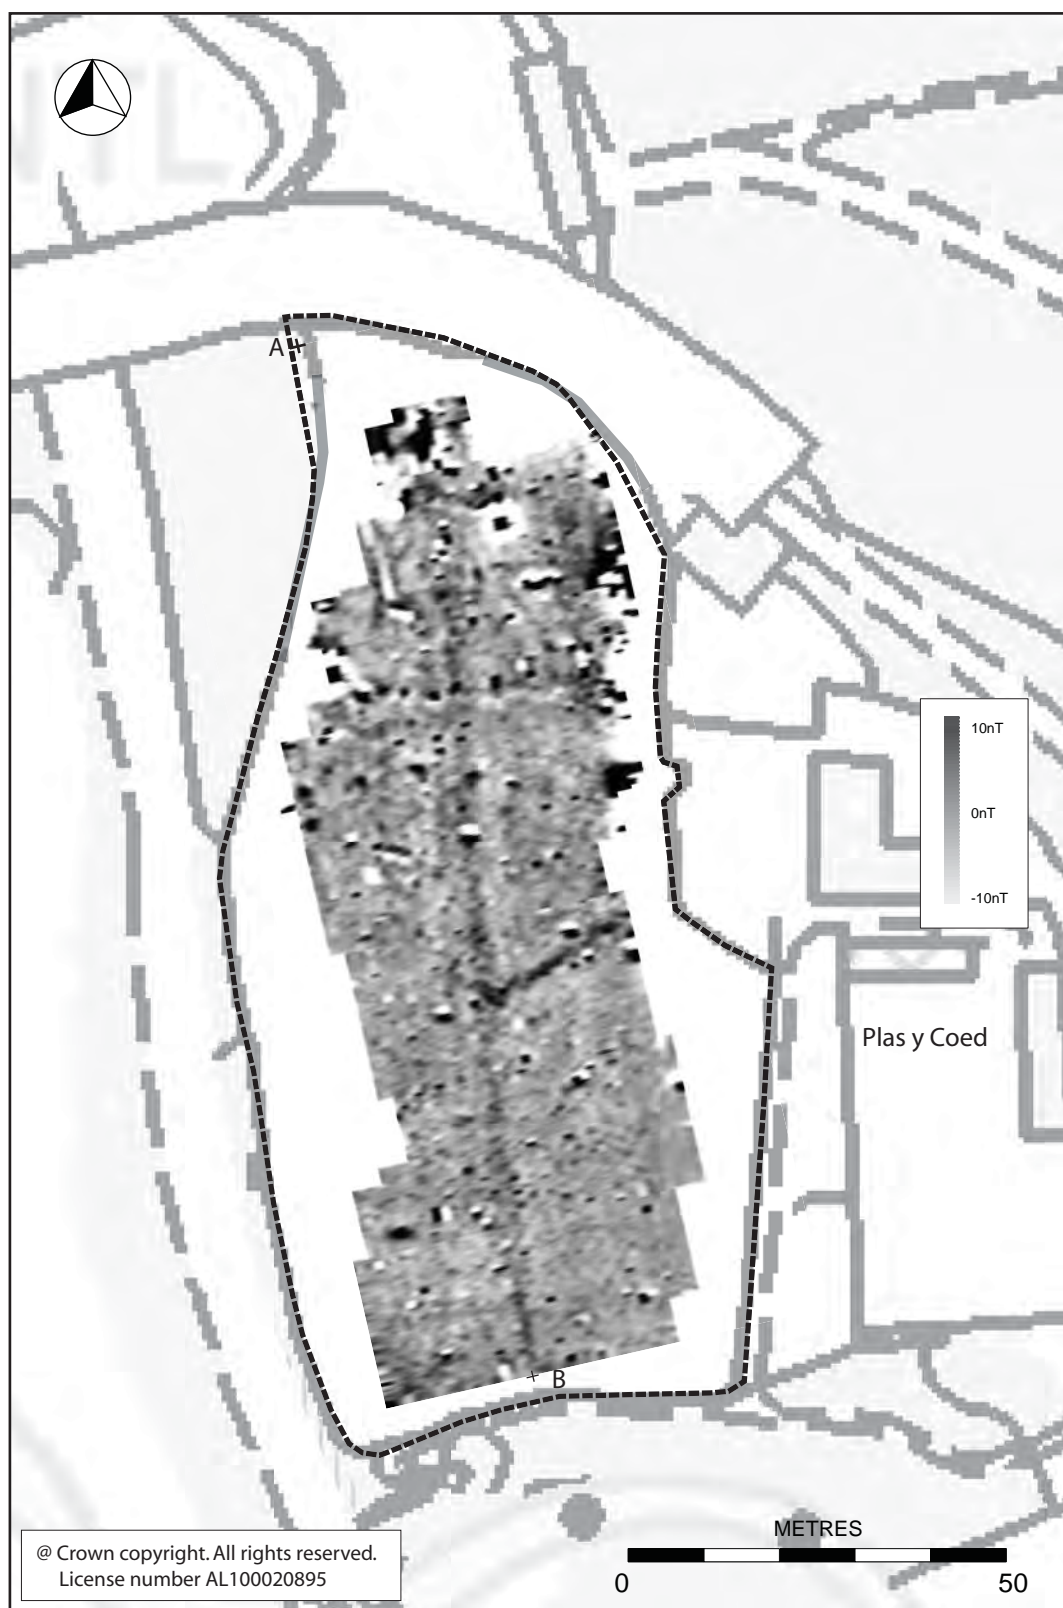
The survey produced good results with low to moderate levels of background noise. There was a scatter of ferrous anomalies caused by stray pieces of iron such as nails and other rubbish in the soil. These are visible as small half black and half white anomalies representing magnetic dipoles on the grey-scale plot. Other anomalies are listed below and numbered on the interpretation plan (Fig. 2).

Fig. 1 Fluxgate gradiometer survey, grey-scale plot

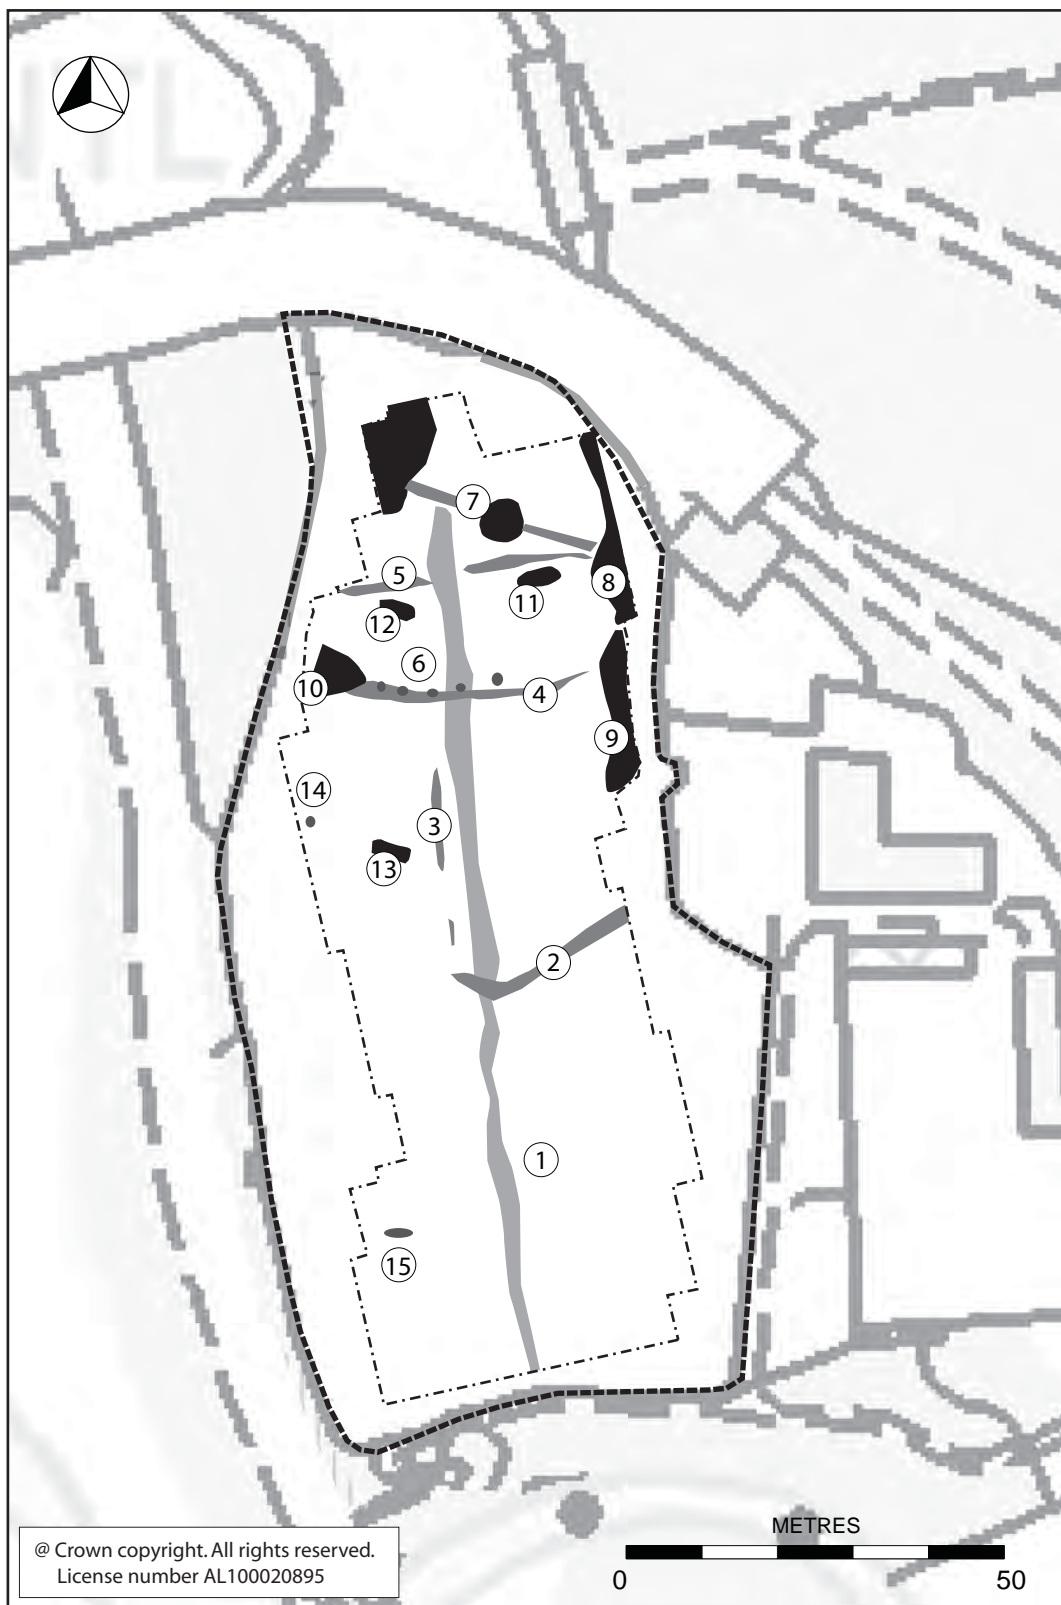
6. A row of small discrete anomalies that do not obviously appear to be ferrous and may be pits or post holes associated with possible boundary 4.
7. A large ferrous anomaly caused by an iron manhole cover. The associated linear anomalies on either side presumably indicate a pipe. A large ferrous anomaly on the western side is probably another manhole.

- 8 and 9. Ferrous anomalies caused by a fence.
10. Ferrous anomaly, probably buried rubbish.
- 11, 12 and 13. Three similar ferrous anomalies. All are longer than the usual pieces of scrap iron or steel producing anomalies in the topsoil. They are almost certainly scrap but may be larger items possibly associated with the railways or docks.

Fig. 2 Fluxgate gradiometer survey, interpretation

The exact nature, date and phasing of the anomalies cannot, however, be determined by geophysical survey. It is therefore recommended that a programme of trial trenching should be undertaken prior to

the commencement of development in order to further investigate the features identified in the geophysical survey.
