Dolgarrog Hydro-Electric Works: **Dolgarrog, Conwy**

GAT Project No.2158
Report No. 978
May 2011

HYDRO-ELECTRIC PIPELINE, DOLGARROG, CONWY

**ARCHAEOLOGICAL WATCHING BRIEF ON
GROUND INVESTIGATION PROGRAMME**

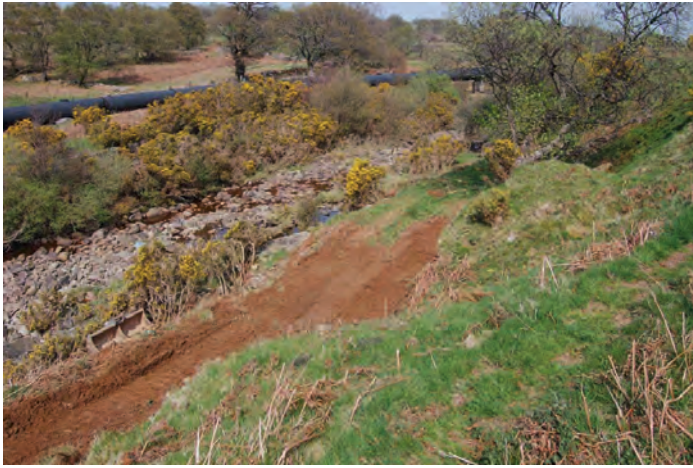
Plate 9. Widened track for access to TP 07 and 08 and boreholes 03 and 04, from S

Trial pit 08 was at the base of a river cliff and trial pit 07 was in the middle of the river. Boreholes 03 and 04 were also in this area. There was no access down the very steep bank but a track had previously been created along the river bank. This track was probably dug in the 1950s and formed a branch from the track recorded as

feature 70. The original creation of this track had resulted in the dumping of a conical mound of spoil, now entirely overgrown, at the base of the river cliff. The existing track was not wide enough so this was widened by the mechanical excavator cutting through the conical mound of spoil and other dumped material (approximately located at (e) on figure 2) (plate 9). This area had previously been disturbed by the river and by the creation of the track and the widening of this track revealed no archaeological features or deposits.

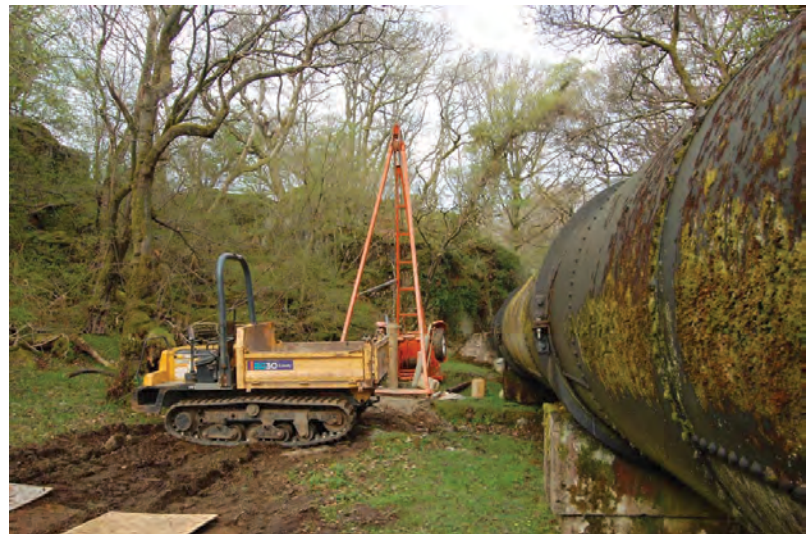
Plate 10. Cable percussive borehole rig in place on BH 15

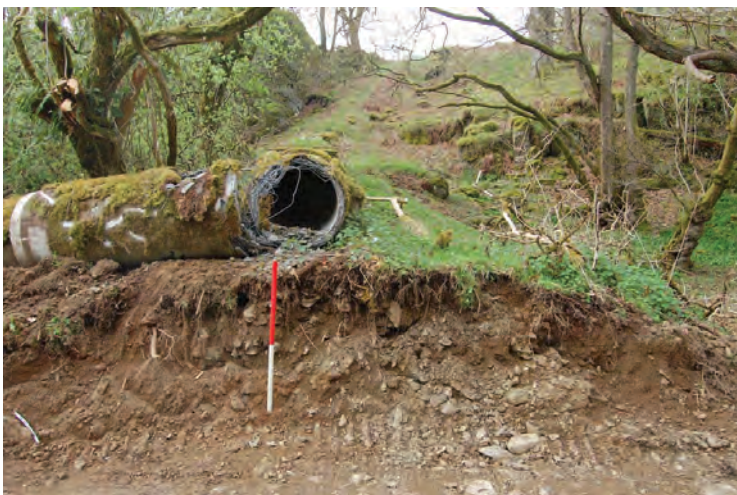
Plate 11. Disused surge pipe (F90) broken through to allow access to borehole 15

Borehole 15 lay to the west of features recorded in the assessment as F90. These include a stone-lined drainage feature and a disused surge pipe. The drain had to be infilled with soil, but was emptied again after the rig had been removed (plate 10). The end of the concrete surge pipe had to be broken through and the earth bank on which it rests was also breached (plate 11). The majority of the pipe remains intact.

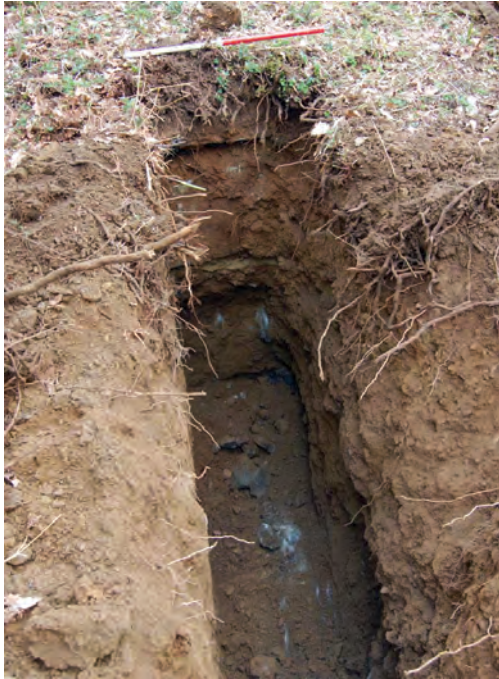
Plate 1. TP 20 showing large stones in NE end, from SW

The only archaeological deposit identified was a thin layer of stones just beneath the topsoil in TP20. This may be rubble from structures relating to the track to Coed Sadwrn (feature 09, also see feature 73 and 74), but it is possible that it represents a very disturbed stone surface. No dating evidence was recovered. A large horizontal stone was seen close to the surface in the end of the trial pit but this directly overlaid a larger stone that seemed to be securely embedded in the natural, so it is possible that both were natural boulders (plate 1).

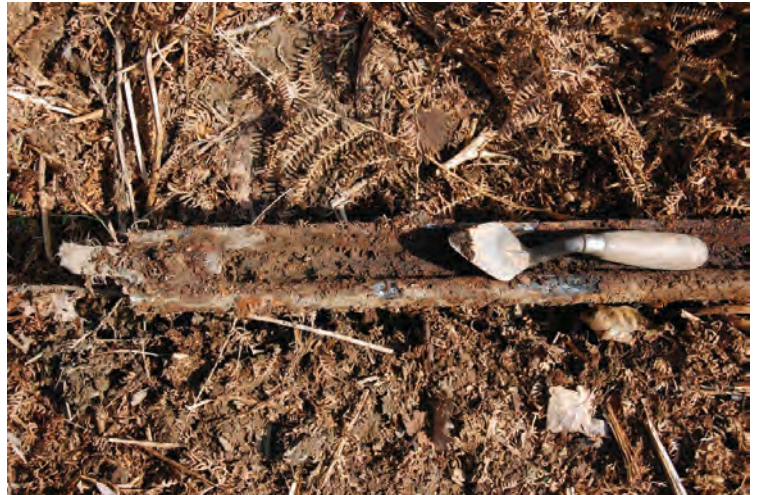
Plate 2. Rail found near TP20

A length of rail was exposed when the mechanical excavator tracked back from trial pit 20. This rail (plate 2) is almost certainly a piece of contractor's flat-bottom rail from the 1920s probably from one of the sidings used during the pipe construction. It is not part of the original Cwm Eigiau railway, as this used T-section rails in chairs. The rail is of no particular interest as these rails were mass-produced and sold all over the world (Dr D Gwyn pers com). At present the rail remains where it was found and it is not recommended that it is recovered and retained.

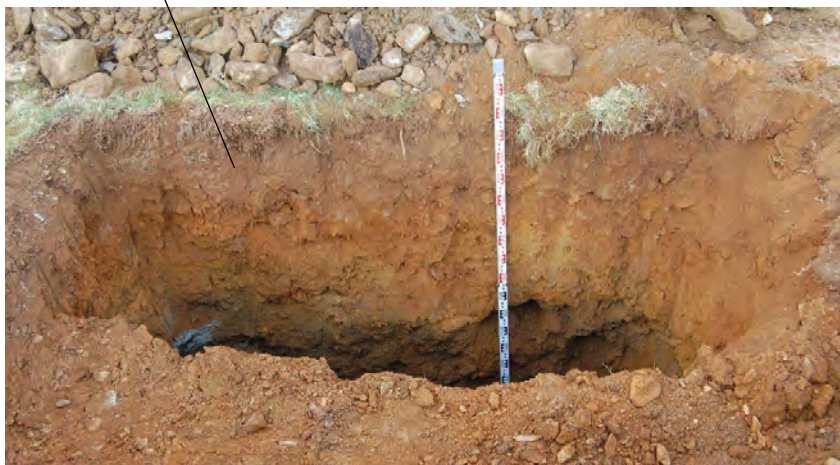
ploughsoil

Plate 3. Section of TP 23 showing layer of ploughsoil and typical natural

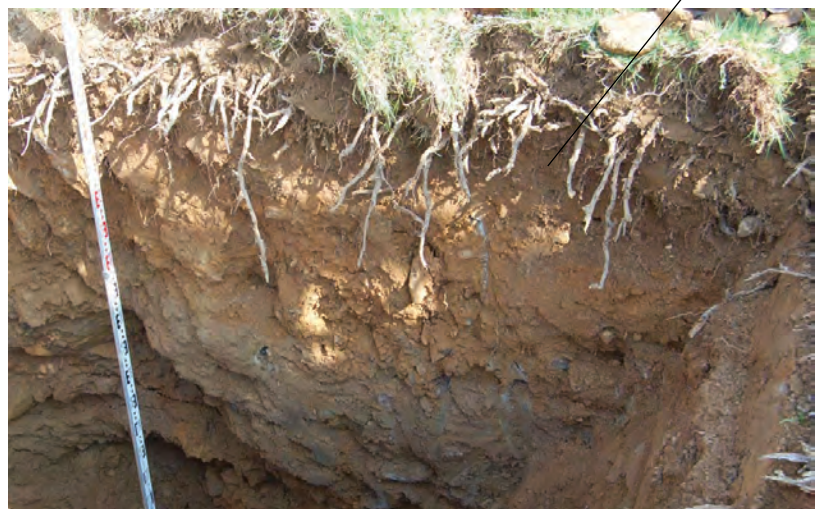
A horizon

Plate 4. Section of TP 10 showing developed A horizon, bracken roots and typical natural

Feature 69 was interpreted as the possible corner of a prehistoric field. However trial pit 10, which lay within this area, had the same depth of A horizon as TP 11, just outside the projected field. The trial pits suggested that the scarp visible on the ground surface was not caused by a build-up of ploughsoil and that it is probably of glacial origin.

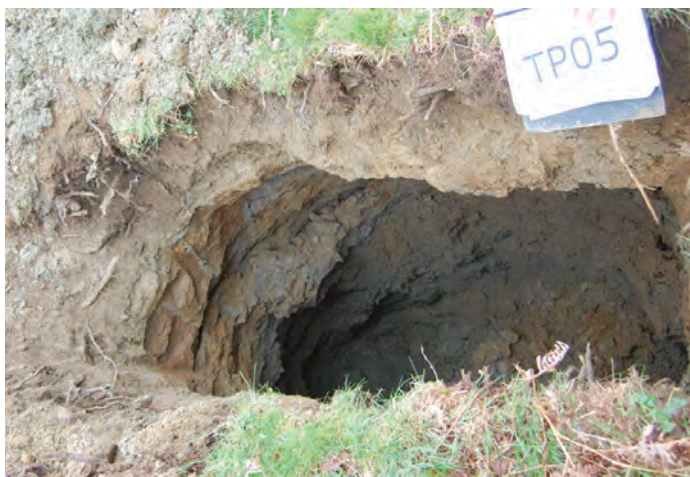
Plate 5. TP 05 showing alluvial deposit

In trial pits 03 and 04 water-logged sandy deposits were found buried under recently dumped material from the creation of the present pipeline. These deposits appear to be river deposits but the trial pits lie significantly to the north-west of the river as shown on the 1889 OS map; TP 04 was within the area of a former field. These deposits are therefore probably related to a much earlier phase of the river when it ran along a slightly different route or possibly to glacial outwash. Trial pit 05 was about 30m north-west of the bank of the former river, but it had a deep deposit of what appeared to be alluvial silt over a silty sand (plate 5). In the top of the deposit were boulders. Some of these may have originated from a former field boundary no longer visible on the ground but indicated by a row of trees on the 1889 map. However the presence of many boulders at this level in the adjacent field shows that most of these were natural. The boulders were presumably deposited shortly after the valley glacier retreated, perhaps moving downslope due to freeze/thaw action. The alluvial deposits must therefore pre-date this and be due to either glacial outwash or the retreat of the glacier. The fine silts suggest much slower flowing water than is usually associated with fluvio-glacial deposits, so perhaps some ponding occurred in this area.

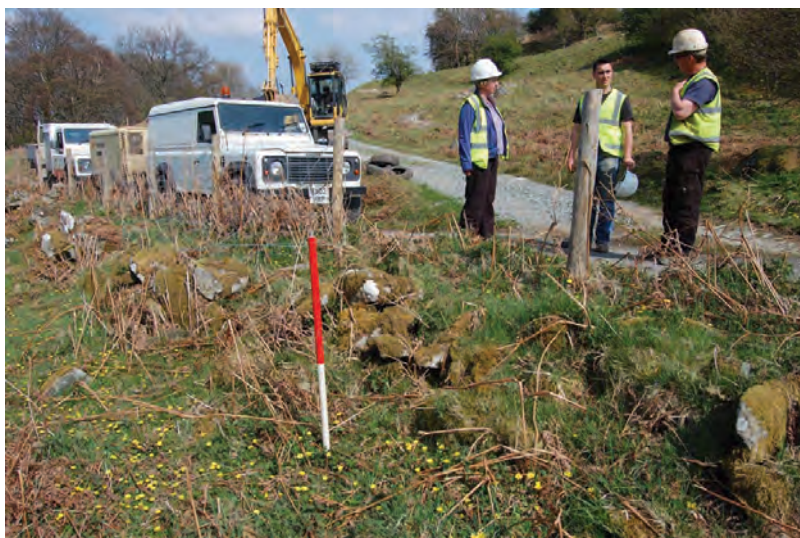
Plate 6. Section of boundary wall feature 82 to be breached for access, from SW

Four field boundaries dated to the late 18th century or earlier had to be crossed or breached during the works (shown on figure 2). Of these only one (F82) was significantly disturbed for a 4m section (at (a) on figure 2) to allow access for the borehole rig. The wall at this point was little more than a revetment surviving to a height of 0.5m on the western side but hardly projecting above ground level next to the road (plate 6). The stones of the wall were pushed towards the west to create a ramp for the rig. In the other cases (features 26, 34 and 104 for access to TP 31 (b-d on figure 2)) the walls were crossed by the tracked excavator with relatively little disturbance beyond some crushing of stones and the movement of occasional individual stones (plate 7).

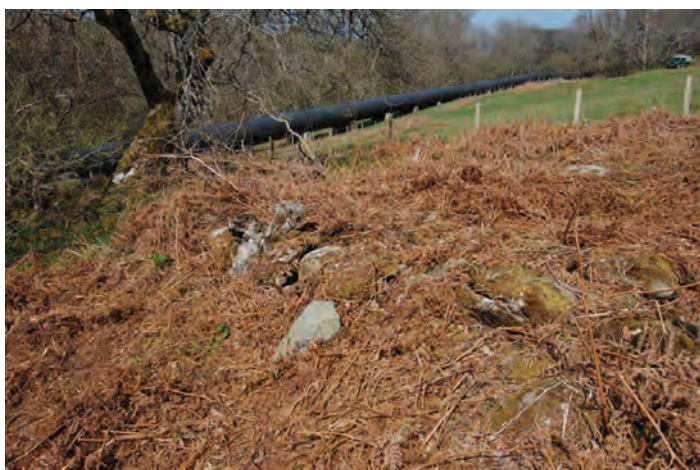
Plate 7. Wall F34 after being tracked over for access to TP 19 and 20

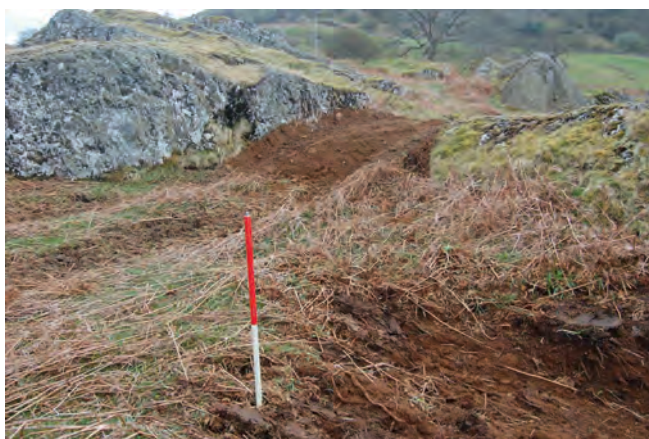
Plate 8. Ramp over rock outcrop to allow access to borehole 14, with soil pit in foreground, from NW

To gain access to TP 33, 35, 35 and borehole 14 a rock ridge had to be crossed. In order for the borehole rig to cross the ridge a ramp had to be built (approximately located at (e) on figure 2). This was made of soil taken from a shallow pit close to the crossing point (plate 8). The removal of the soil from the pit was monitored by the archaeologist and no archaeological features were exposed or damaged.
