# Coed Dolwyd Service Reservoir and Associated Pipework, Glan Conwy

## Archaeological Evaluation & Mitigation

# COED DOLWYD SERVICE RESERVOIR AND ASSOCIATED PIPEWORK: ARCHAEOLOGICAL WORKS

Prepared for Dŵr Cymru, September 2011

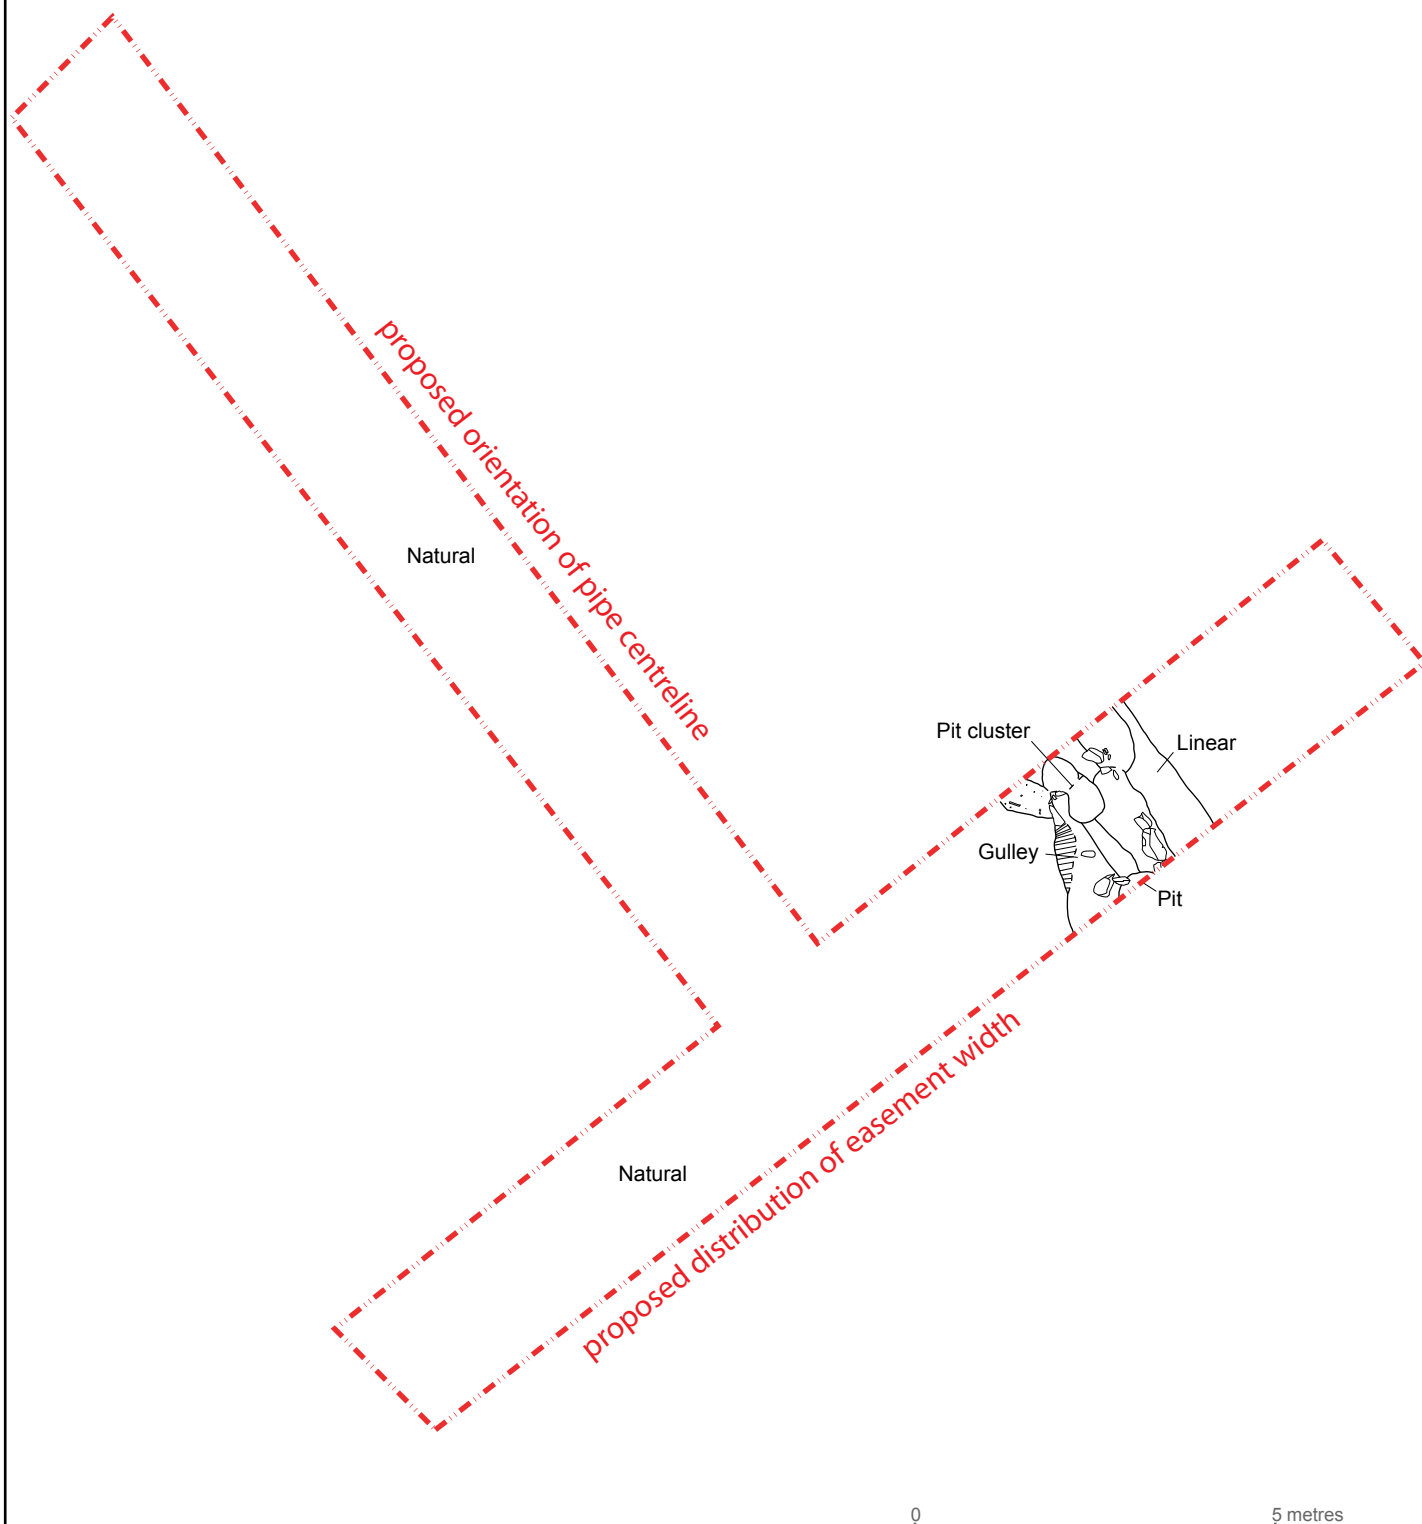
**Figure 03:** Trench 15 - Pre excavation detailing the distribution of features, for specific detail see **Figure 04**

Two slightly irregular gullies, a maximum of 0.7m wide, were cut into either side of the main feature, later in date, but apparently running parallel to it. The gullies contained fairly frequent sub-rounded cobbles (<0.3m diameter), along with lumps of charcoal and burnt clay, and very small fragments of burnt bone (Figures 3 and 5).

In turn the gullies were truncated by a total of five small sub-circular pits (Figures 3 and 4). These pits appeared to intercut each other slightly, indicating that they were not all contemporary, however exact relationships proved difficult to ascertain due to truncation. Again lumps of charcoal and burnt clay were evident within the fills of some of these pits. No obvious function for these pits was evident, they were small for waste pits, and there was no obvious evidence of them being post holes (e.g. in the form of packing or post pipes).

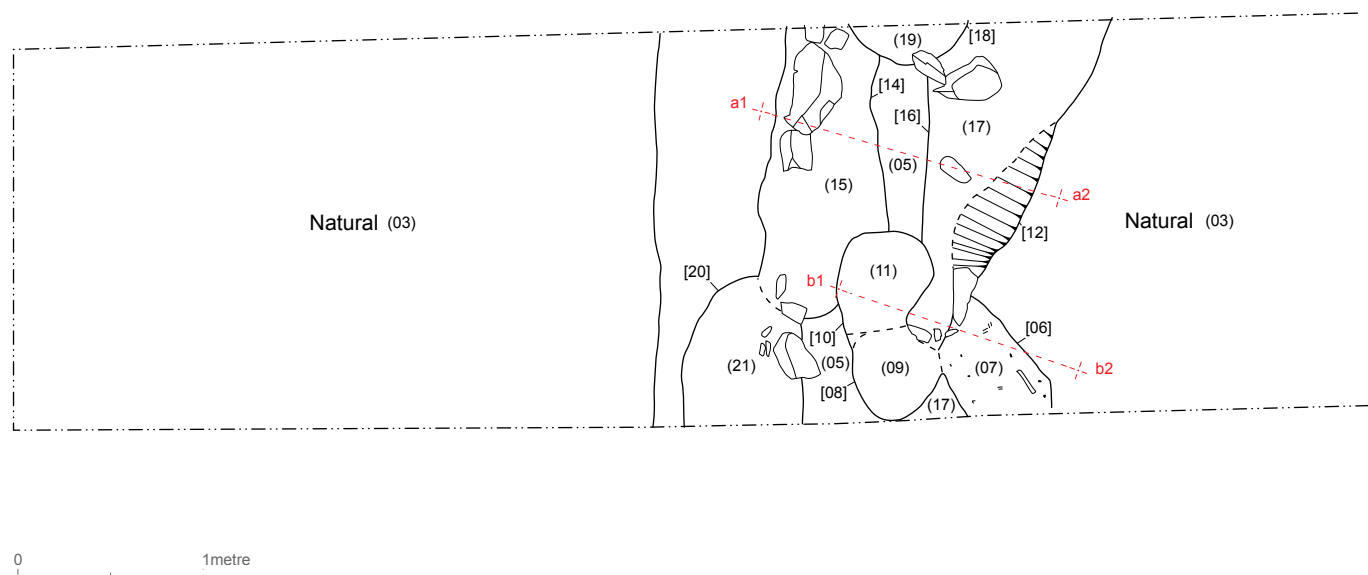
**Figure 04:** Trench 15 - Pre excavation plan detail detailing the distribution of features  
(cf. Figure 03 for locaiton of features within trench and Figures 07 and 08 for assoc. sections).

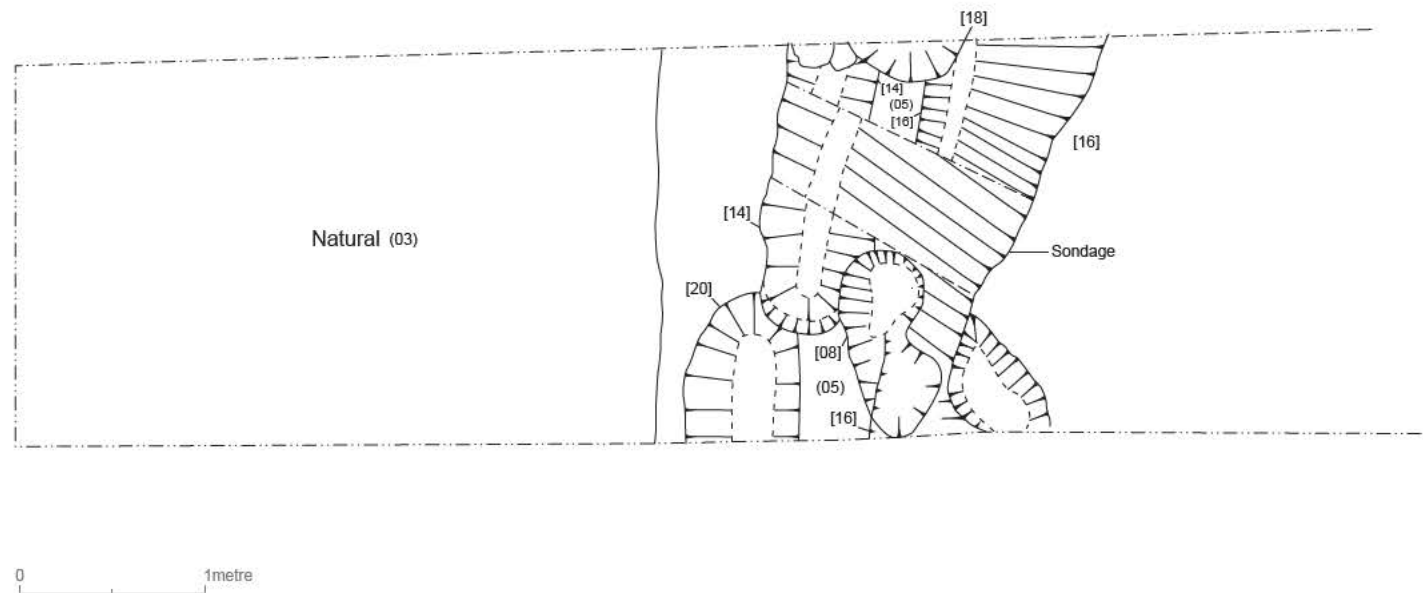
**Figure 05:** Trench 15 - Plan during excavation of multiphase activity detailing excavation of pit clusters and sondage through gullies/linear feature (cf. Figure 03 for locaiton of features within trench and Figures 07 and 08 for assoc. sections).

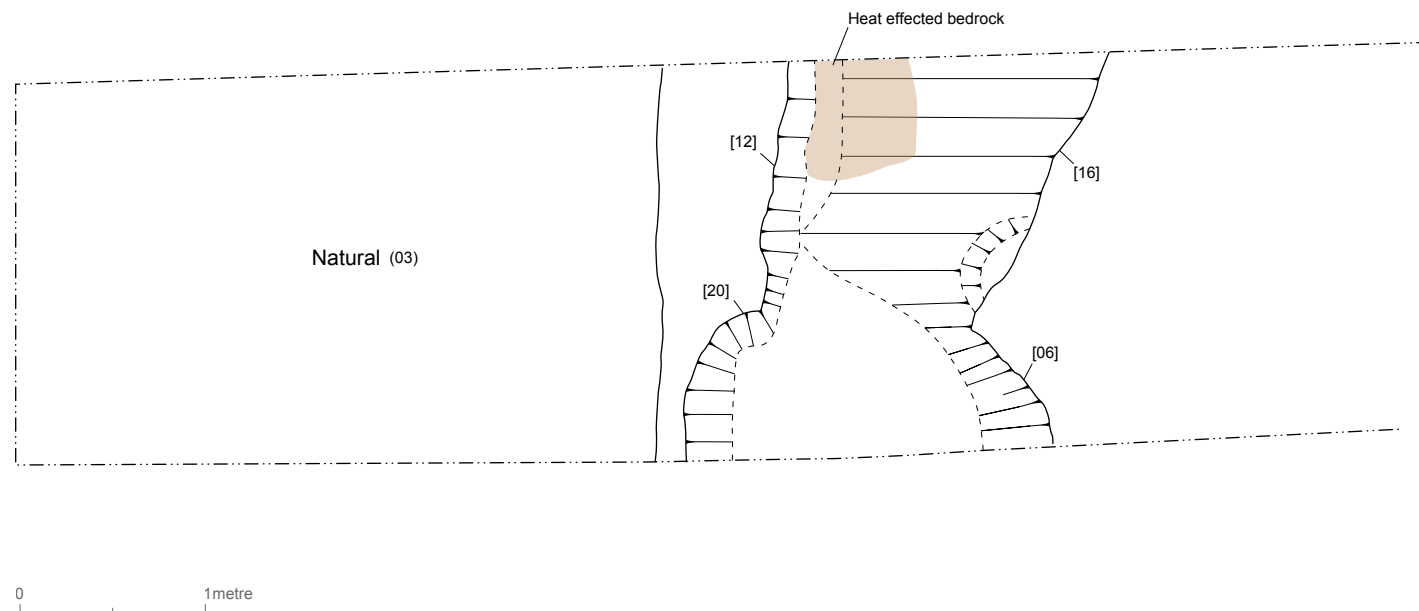
**Figure 06:** Trench 15 - Post excavation plan of multiphase activity  
(cf. Figure 03 for locaiton of features within trench and Figures 07 and 08 for assoc. sections).

The feature measured c.2.0m wide, running off the edge of excavation to the north-west and south-east. The feature was cut into the bedrock (fractured, fine silt stone), which had moderately sloping sides and a flat base (Figure 06). The natural fault lines of the bedrock had informed the shape of the cut. The rock displayed evidence

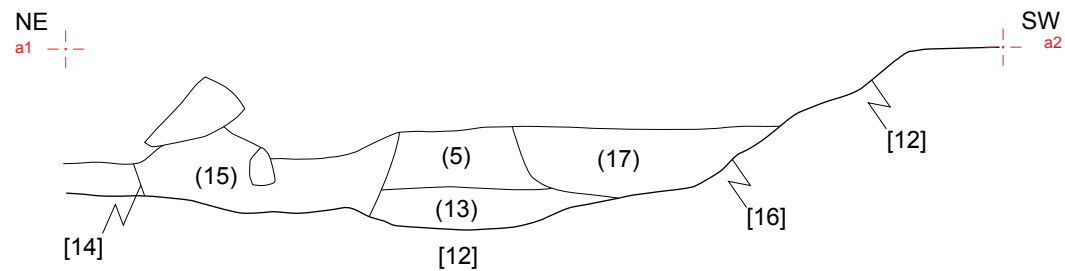
**Figure 07:** Trench 15 - North west facing section of features 12, 14 & 16

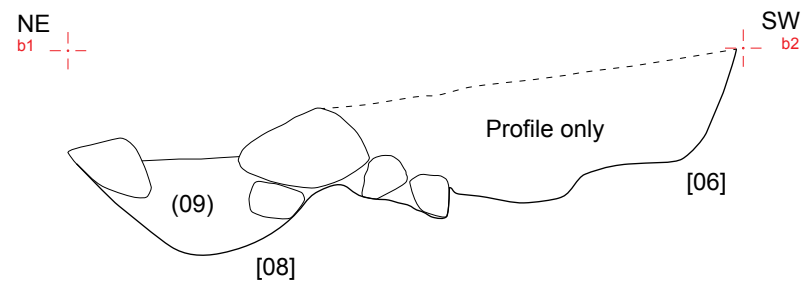
**Figure 08:** Trench 15 - North west facing section of features 08 & 06

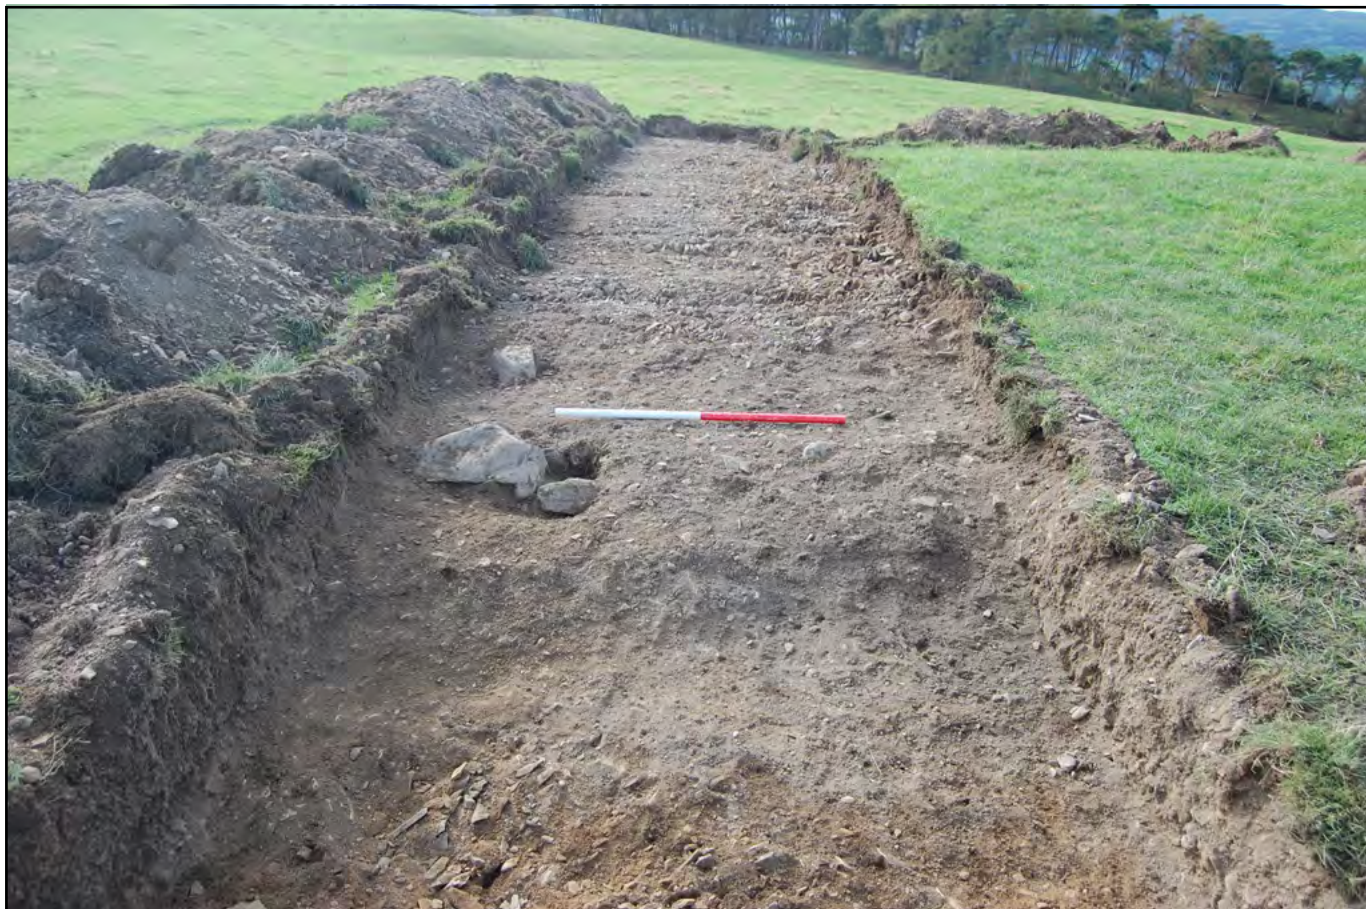
Plate 17 - Trench 15 general shot

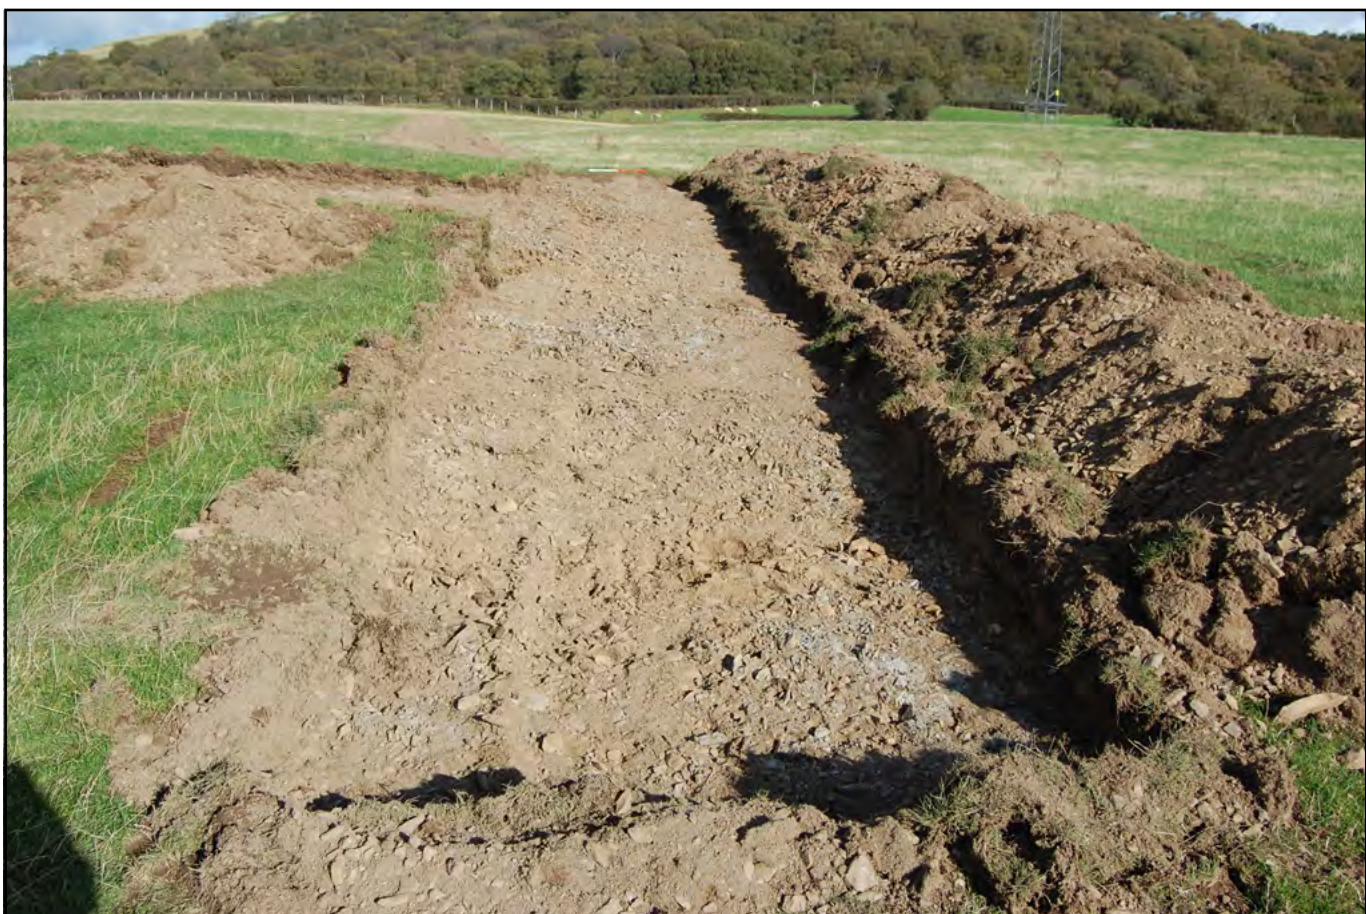
Plate 18 - Trench 15 general shot

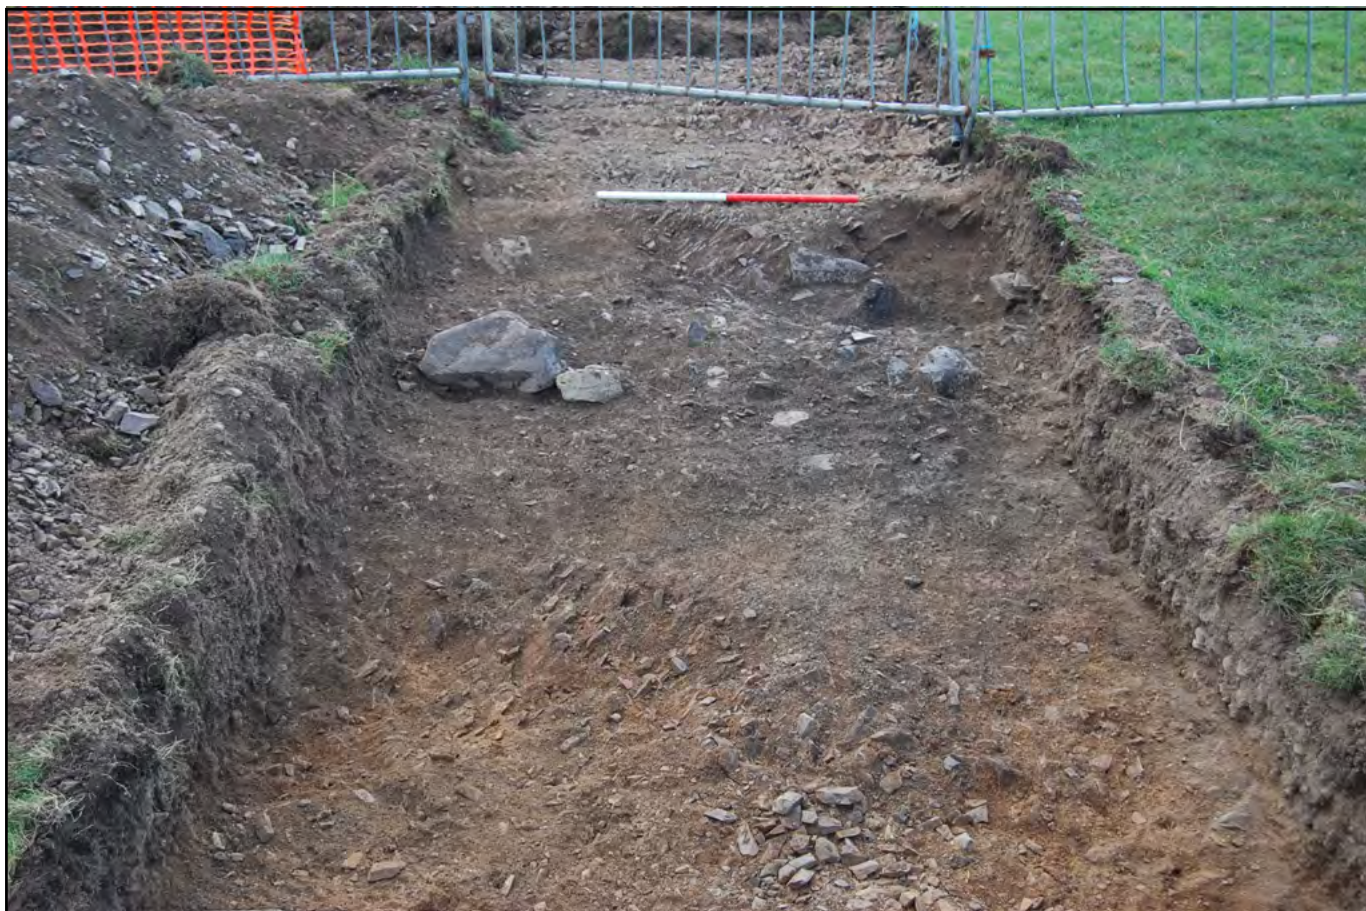
Plate 19: Trench 15 - detailed shot of linear feature/gully prior to cleaning and excavation

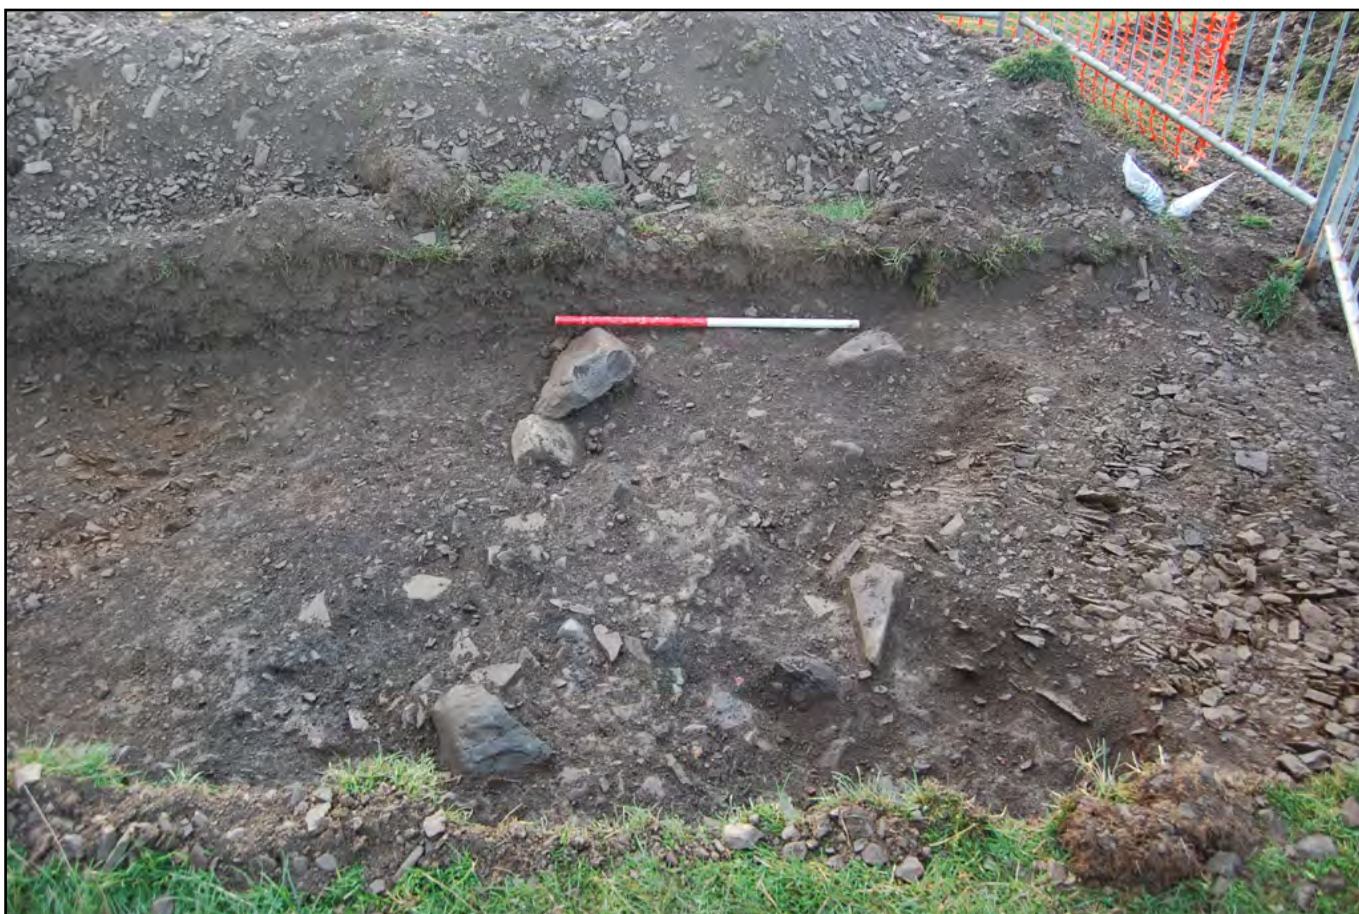
Plate 20: Trench 15 - detailed shot of linear feature/gully prior during cleaning and excavation; note pit cluster in foreground

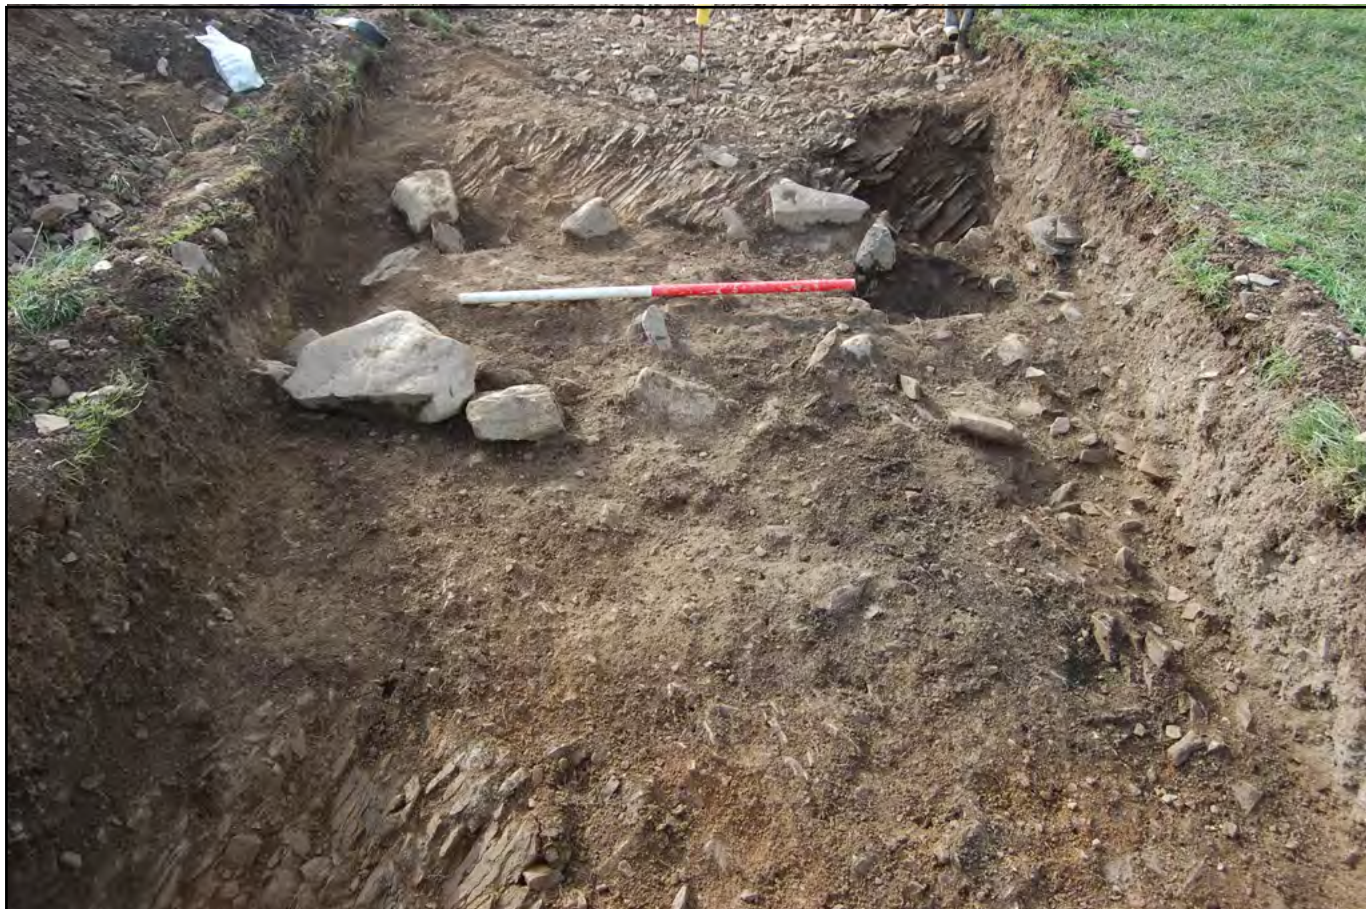
Plate 21: Trench 15 - detailed shot of linear feature/gully area during excavation of the later pit cluster

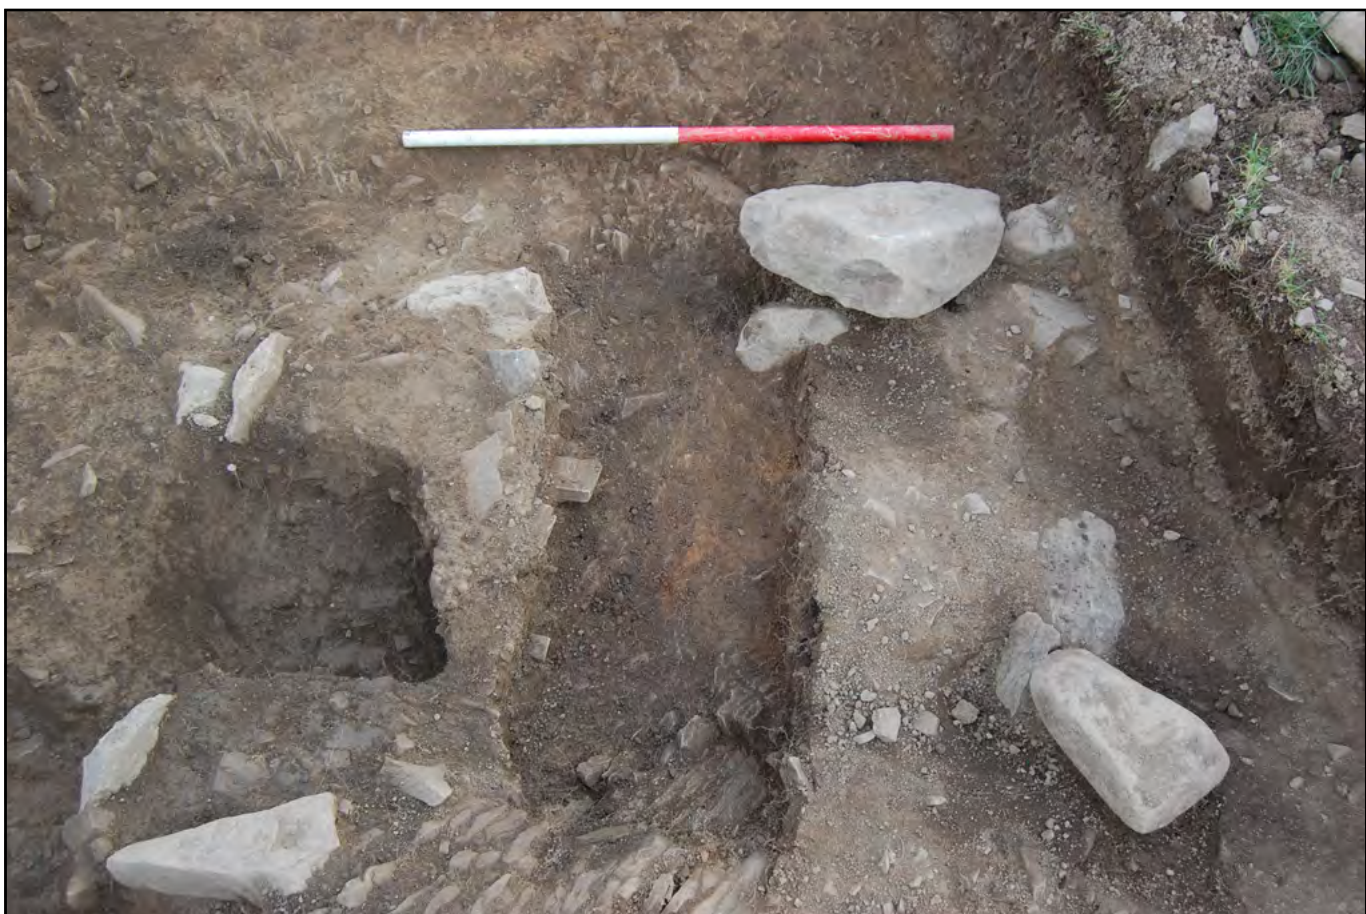
Plate 22: Trench 15 - detailed shot of gully fill during excavation and fully excavated pit cluster

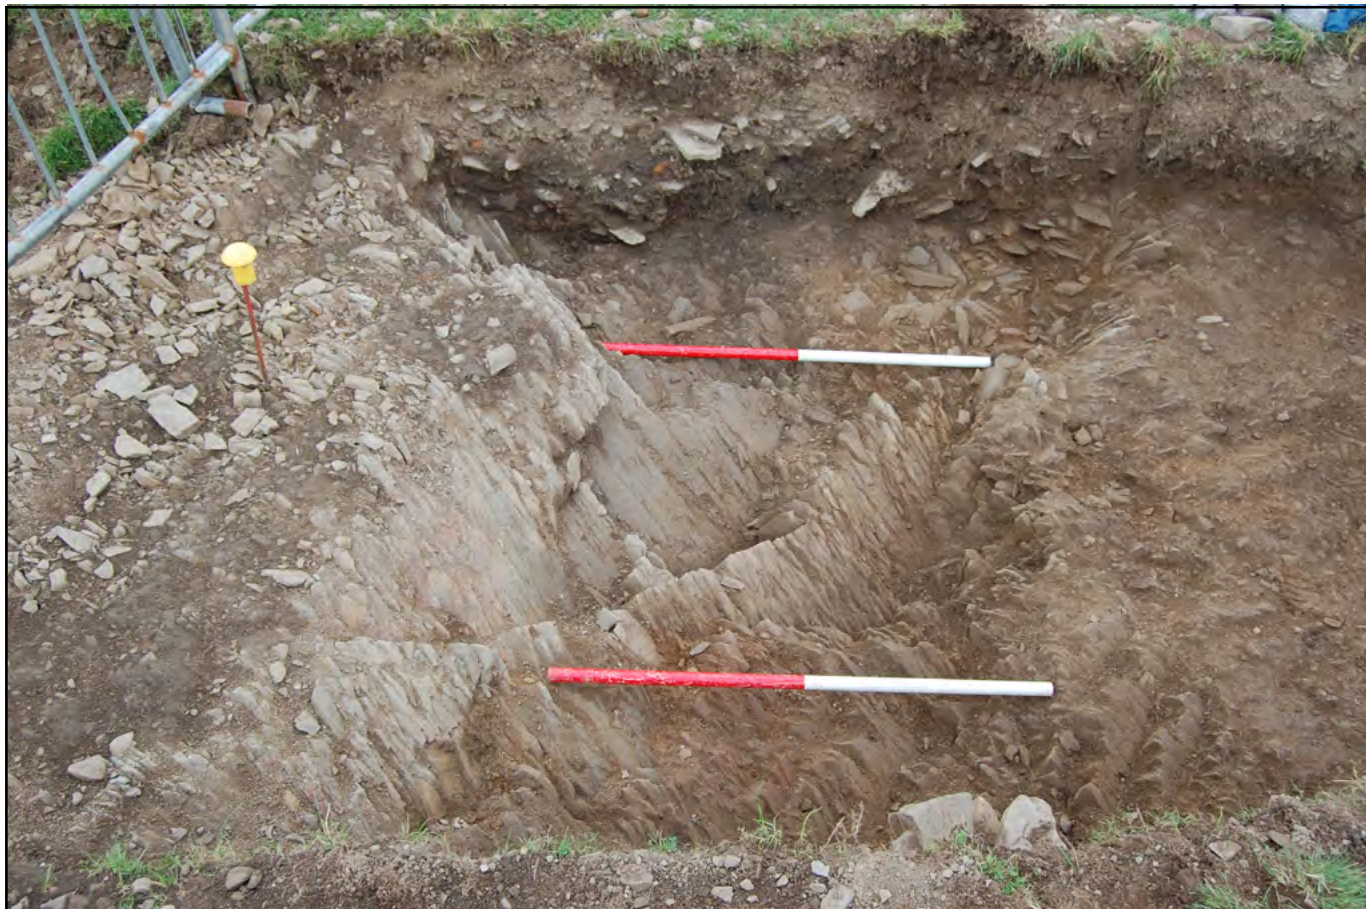
The three distinct phases, the rock cut linear, the parallel running gullies and the intercutting pits indicate a fairly lengthy period of activity, and the large quantity of burnt clay suggests possible industrial processes.

Plate 23: Trench 15 - detailed shot of linear feature after excavation; this feature had utilised an existing fissure in the bedrock, which was then expanded. The date of the feature was not determined during the excavation; samples for possible C14 dating were recovered from all main features including the pit cluster.

At the location of Trench 15 (centred on NGR SH81357620) it is recommended that further evaluation and/or mitigation of a larger area within the easement is undertaken in advance of main works (or in tandem if a strategy of controlled strip is agreed). It is also recommended that the charcoal samples recovered from the identified features during the current evaluation are assessed for palaeoenvironmental potential, which could provide dating and/or phasing for the multi-phase activity within this location. The dating of these features could be completed prior to main works to inform the mitigation strategy.
