# Cefn Coed Ucha, Eglwysbach, Conwy, Wales

## Archaeological Building Record

Report No. 992

Project No. 2222

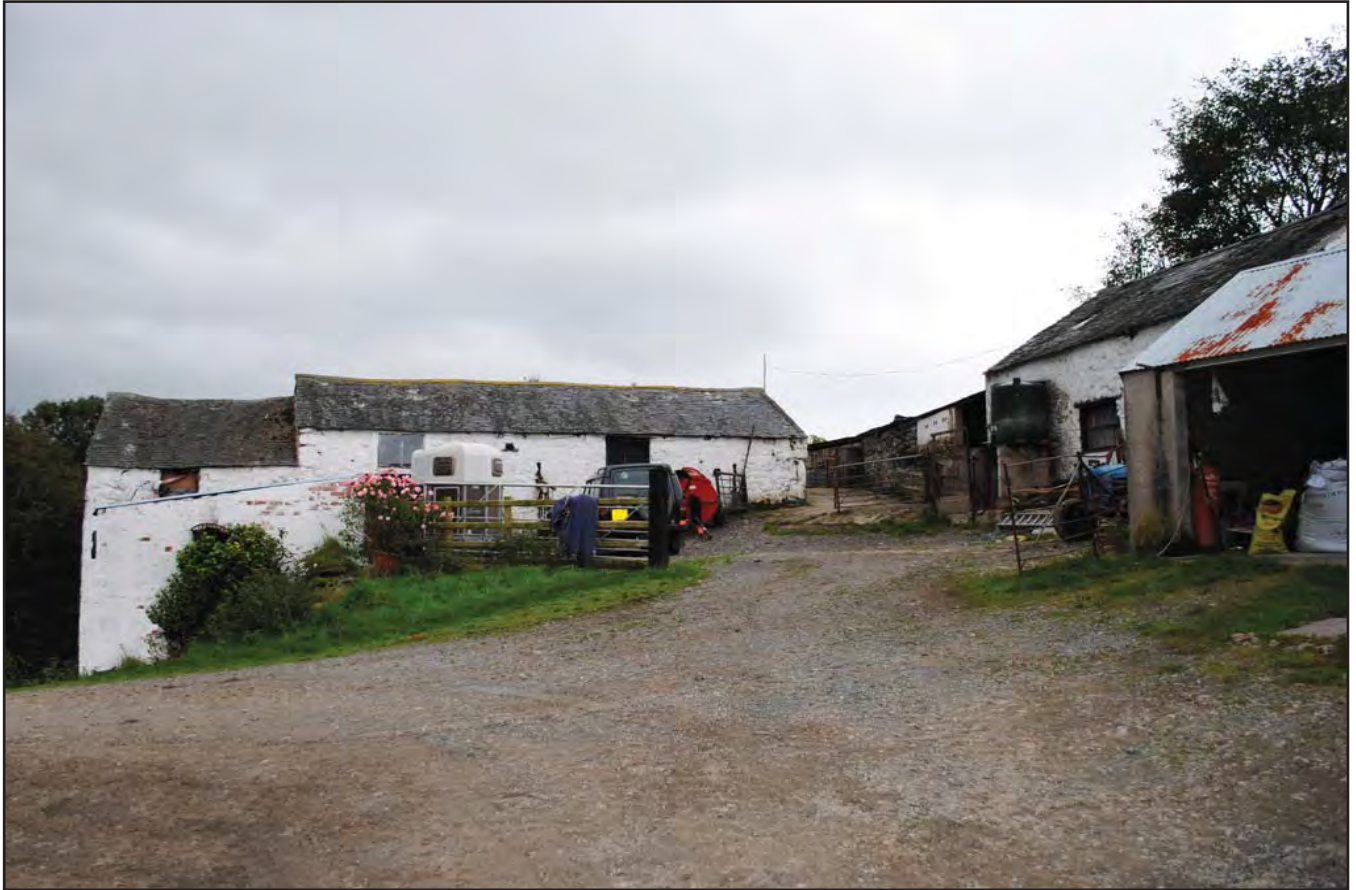
**Plate 01:** Historic farm outbuildings. Photograph taken from the north east

The main dwelling, which appears to have always had two storeys, was divided into two rooms downstairs by panelling north of the entrance creating a division between the main living room with a substantial hearth to the south and a parlour or bedroom (Smith 1991, 174-5). The first floor was subsequently subdivided into three rooms by wooden partitioning on the main trusses. The roof trusses, consisting of tie-beams and two raking struts connecting to the principal rafters are unlikely to be earlier than 18<sup>th</sup> century in date (Alcock *et. al.* 1996). The rubble stone addition to the south of the main house is probably a former outbuilding converted into a kitchen when access to it from the main house was cut through the south end wall at ground and first floor level in the 20<sup>th</sup> century. The former presence of a large hearth suggests it was possibly formerly used for industrial purposes, maybe as a forge. The farm yard and outbuildings to the south of the house have surviving buildings of post-medieval origin, which include a substantial barn (Plates 1, 6; NGR SH80236883; NPRN 31701).

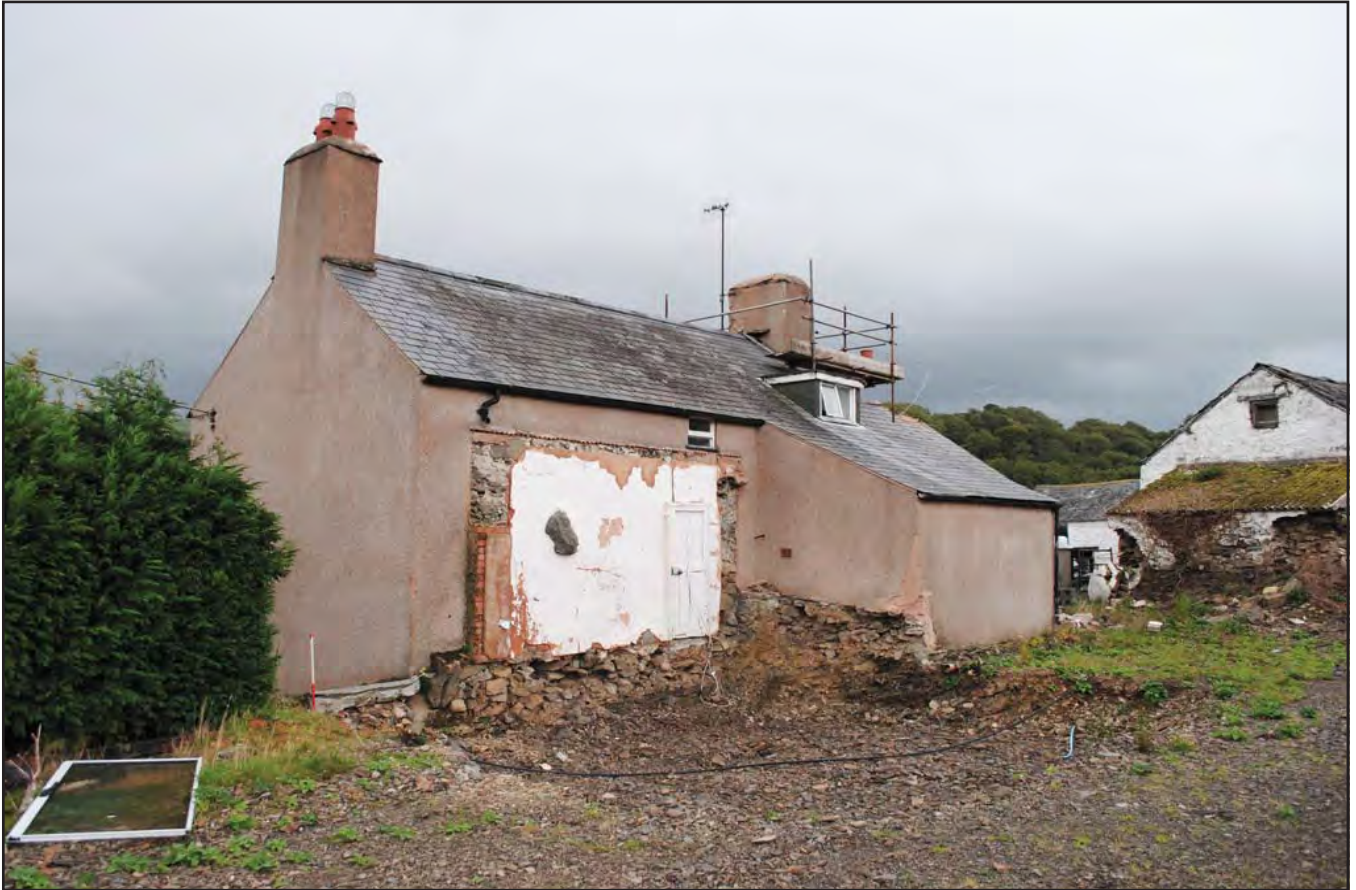
Plate 04: Rear elevation of Cefn Coed Uchaf. Photograph taken from the east

Cefn Coed Uchaf is an east facing 3 bay farm house with gable chimneys, built into a shale slope. There are a number of later additions to the building. The exterior of the building is currently covered in a pebble-dashed render (Plates 2-7), although where areas of stonework are exposed due to demolition the wall can be shown to be of uncoursed rubble construction (Plate 4). A kitchen block to the south of the main farmhouse has a lower pitched roof than the main building, although it is still of two storeys, with a substantial chimney breast against the southern gable wall (Plates 2,5). There is a small porch on the east façade of the building that is probably 19<sup>th</sup> century in date (Plate 2), and a western extension that may be of similar date (Plate 4). Further extensions to the west and east are of 20<sup>th</sup> century date (Plate 2, 7; Fig. 5), and there is a very recent garage built of breeze block construction (Plate 2, 7). Excavation to the rear of the property, which has removed a modern rear extension to the north-west shows that is built directly on the shale bedrock, with about five courses of rubble foundation (Plate 4).

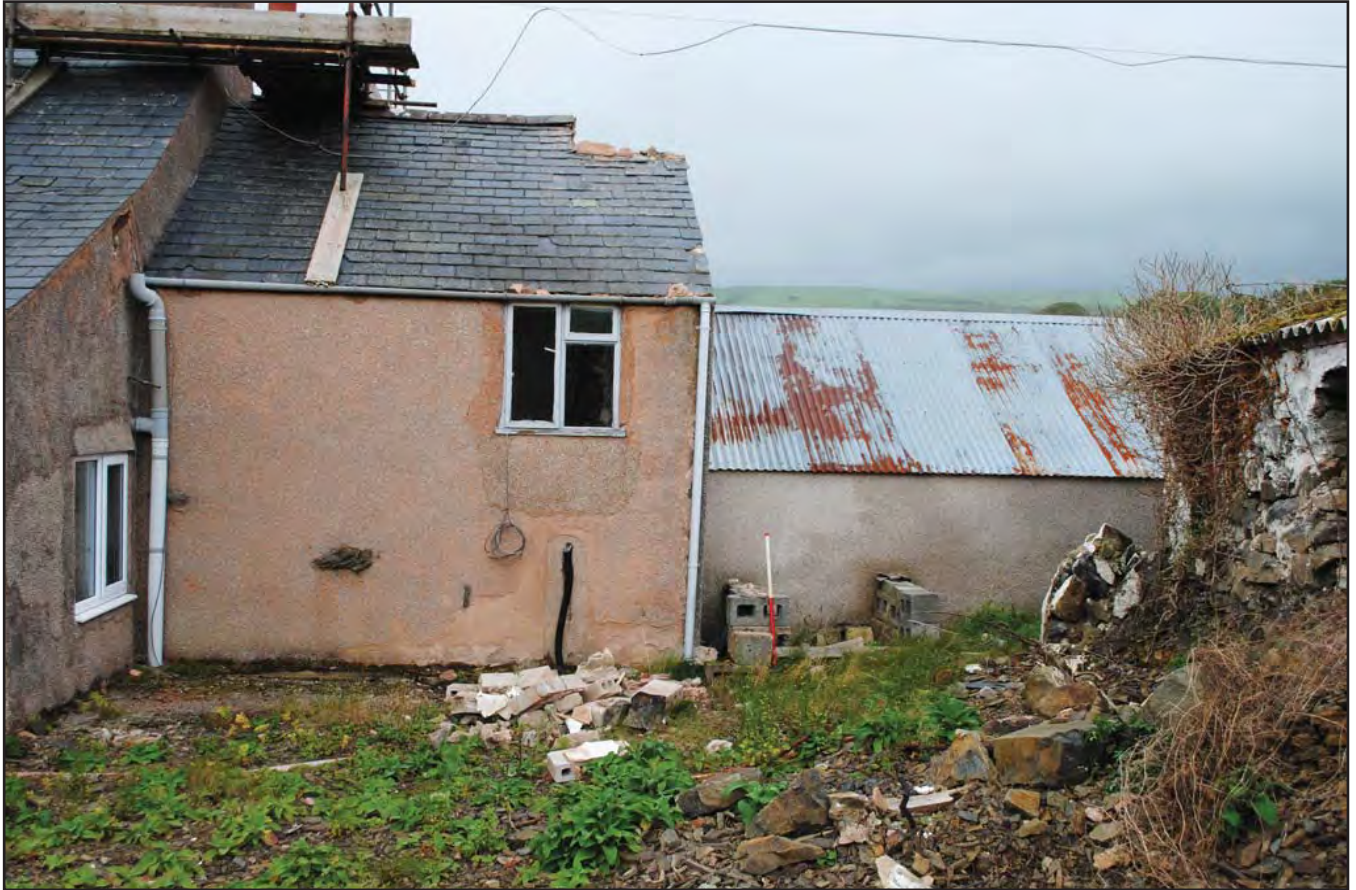
Plate 07: Kitchen extension & garage, note the missing chimney. Photograph taken from the east

The main east elevation has an off-centre door flanked by two windows lighting the kitchen and parlour. Three windows, possibly enlarged in more recent times, light the three bays in the first floor. All openings now contain modern pvc windows. A gabled porch, possibly 19<sup>th</sup> century, protects the door (Plate 2). To the rear there is a small single light in the western elevation and one each to the kitchen and utility room extensions, the utility room one at ground floor level. There is a wooden casement window at 1<sup>st</sup> floor level in the kitchen extension (Plate 5). A fire in the kitchen extension has resulted in the loss of the southern chimney, although a modern flat-roofed dormer window survives (Plate 7).

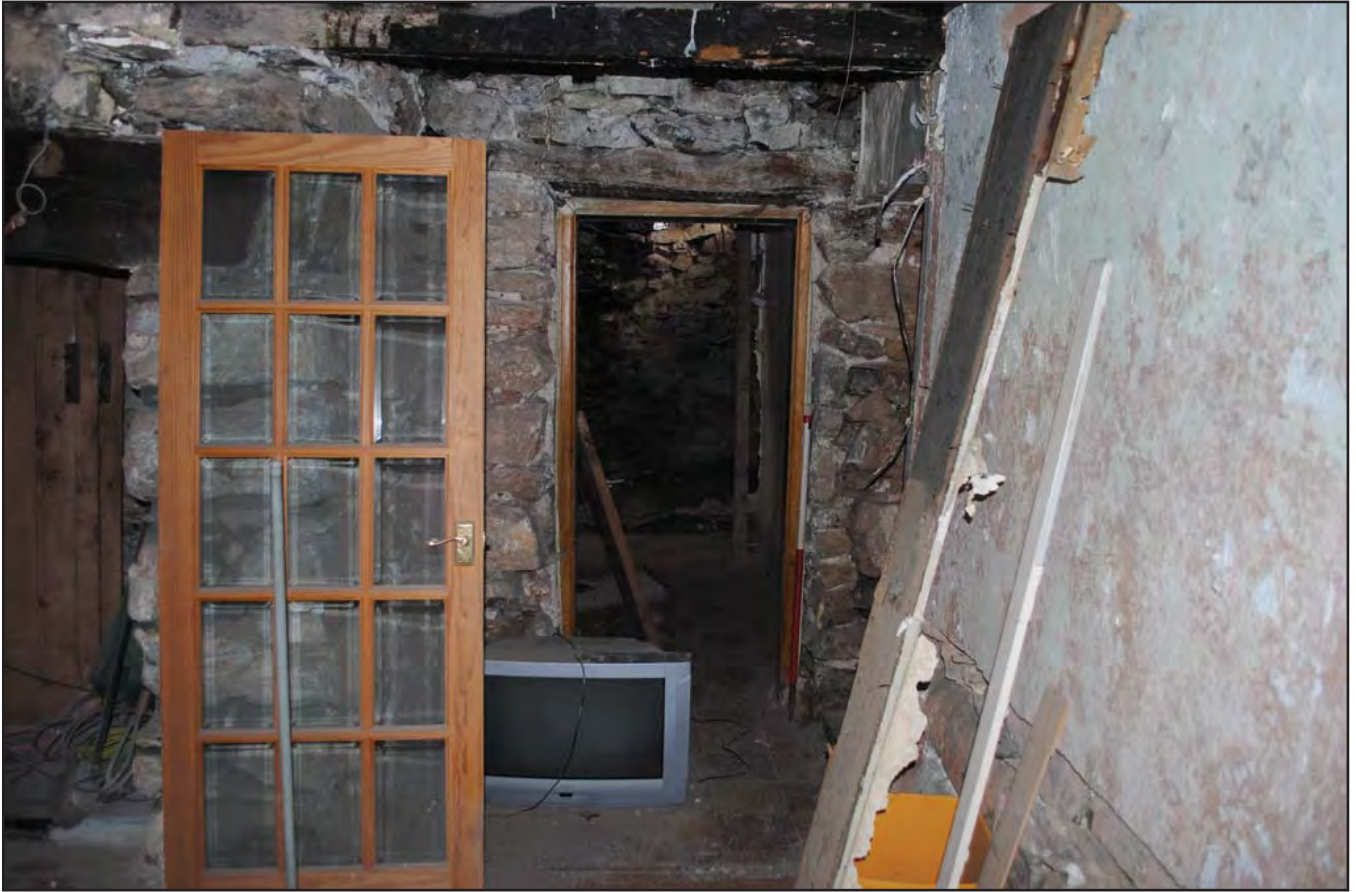
Plate 16: Doorway between main room and kitchen extension, to north of the fireplace. Photograph taken from the south east

An entrance to the kitchen extension was cut through the substantial (0.7m thick) southern gable wall west of the main fireplace wall, probably during the late 19<sup>th</sup> or early 20<sup>th</sup> centuries (Plate 16). This resulted in modifications to the joists above this area. The room is thought to be originally for agricultural or industrial use, with an entrance on the east side (Fig. 5). The open hearth area is exposed due to a recent fire (Plate 8), although some modern brick infill was noted, much material, including the former fire surround, has been lost here (Plate 15). The original external door now leads eastwards to a modern porch and WC extension (Plates 12-14). The porch has a lean-to shallow pitched timber-clad roof and plate glass windows. There is a single modern casement window to the WC to the east. The kitchen and extensions have tiled floors of 20<sup>th</sup> century date.

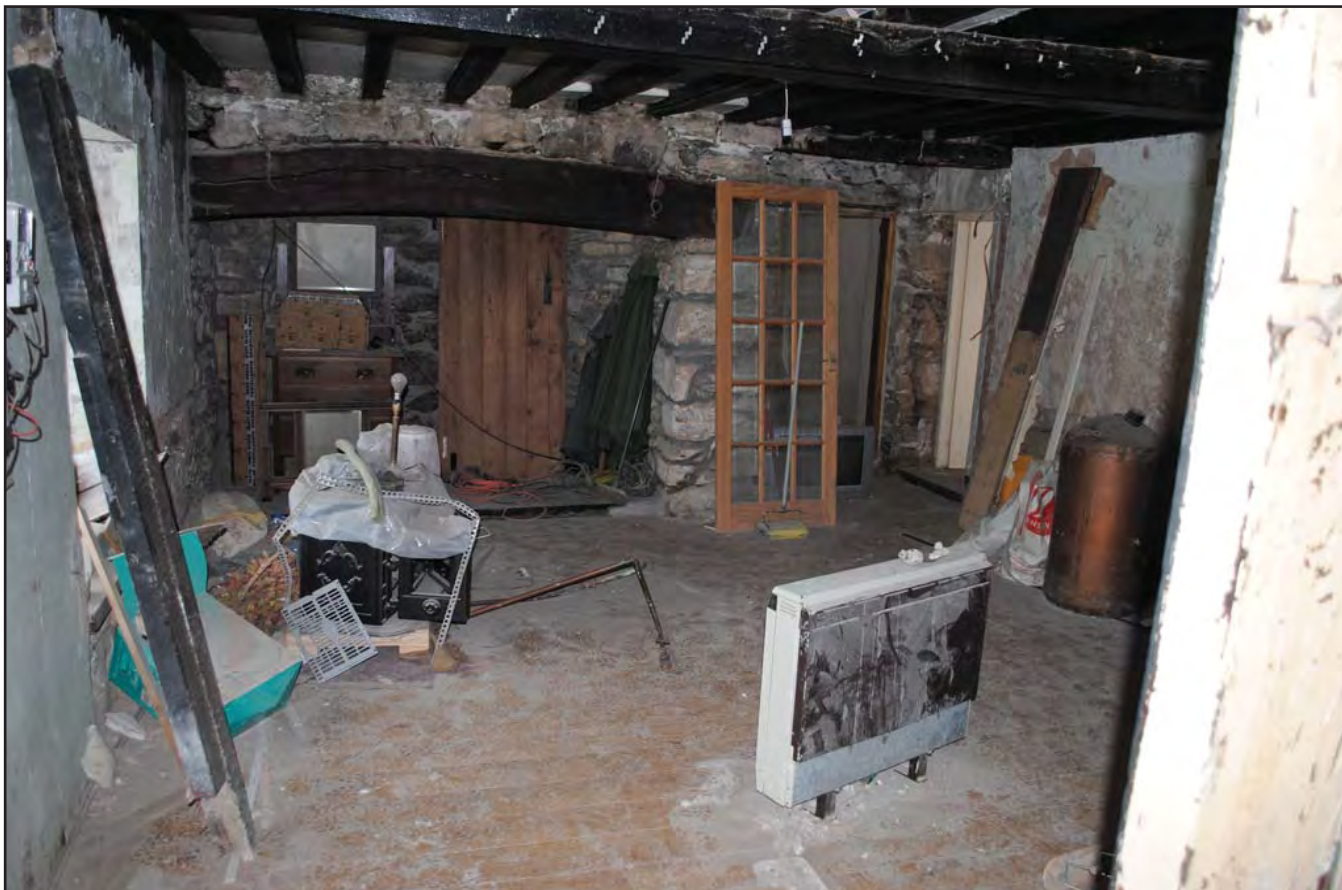
Plate 19: Inglenook fireplace in main room. Photograph taken from the south

out. The fireplace has undergone some modification with a brick surround, now partially removed, but the large lintel stone is still present (0.9m high and 0.7m wide). Small recesses on either side of the fireplace are of uncertain date, but are possibly modern (Plate 18). The roof joists are of a mixture of modern and 19<sup>th</sup> century date.

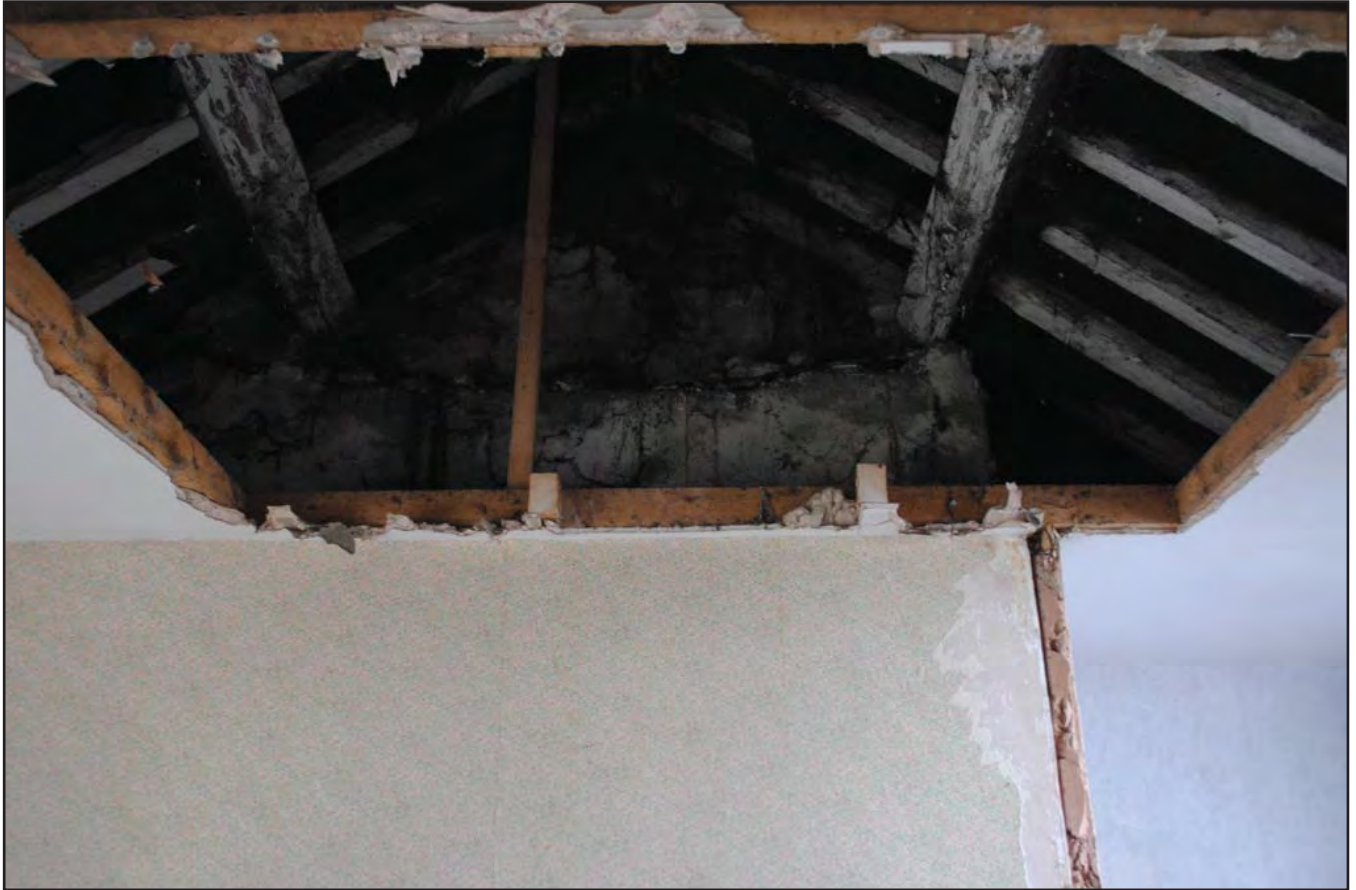
**Plate 21:** Upper part of chimney breast (partially hidden by plater board) in bedroom 2. Photograph taken from the north west

Bedroom 2 is considered as one space, though consists of two rooms divided by the southern truss. The latter is a tie beam truss with raking struts, which supports purlins and common rafters. The truss has been infilled with studs to support a lath and plaster partition. Below the truss, down to first floor level, are the remains of a post and panel partition with five original posts and later insertions including fragmentary remains of a recent door frame (Plate 20, 22, 24). The room contains a fireplace, 0.9m by 0.7m in the chimney breast on the southern gable

wall of the farmhouse (Plate 21, 31). It is topped by a massive stone lintel, 1.1m by 0.3m. Much of the detail in the surrounding area is obscured by render. There was a modern partition to separate off the bedroom from the bathroom to the west. A single window light faced east, with no surviving historic detail.

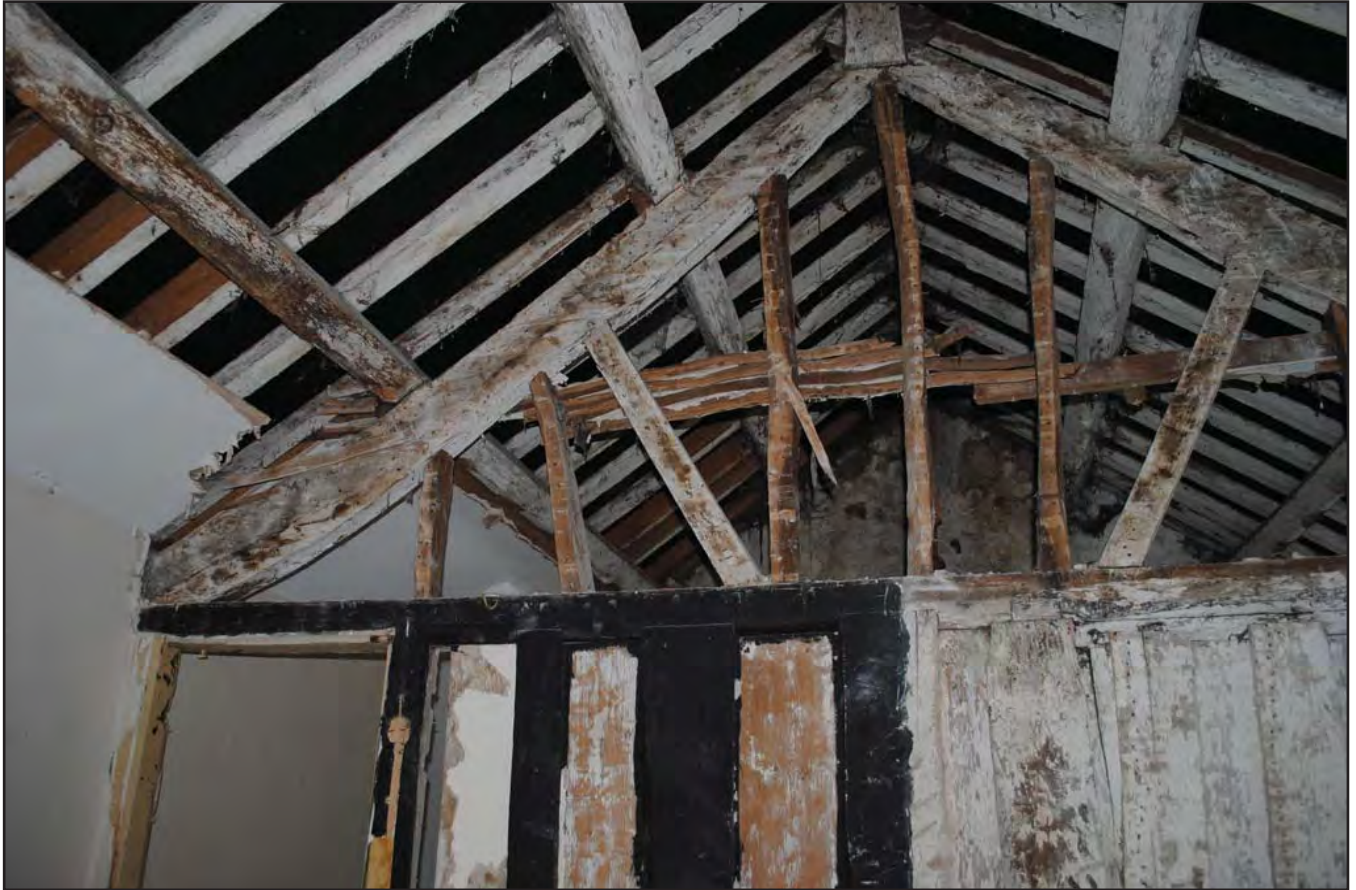
Plate 27: Roof truss and stud panelling between bedrooms 2 & 3. Photograph taken from the north west

The north bedroom, above the parlour, is separated by a second truss, similar in construction to the southern one, that is, a tie beam truss, of pegged construction, with two raking struts between the tie beam and the principal members. This truss was also infilled with lath and plaster. Below the truss is a post and panel partition reaching down to first floor level, and not in-line with the post and panel partition that divides the ground parlour from the kitchen. The posts to the east are of a different character to, and possibly later than, the posts to the west. The eastern posts are rougher and designed to be plastered over, and perhaps this was so from the beginning, though they do not fit the horizontal rail in the expected manner if this were the case, and they are more likely to be a later insertion. A doorway is located at the western end, with a replacement post used as a door jamb. The posts are 1.6m high and up to 0.35m wide. There are no other surviving architectural details within the room.

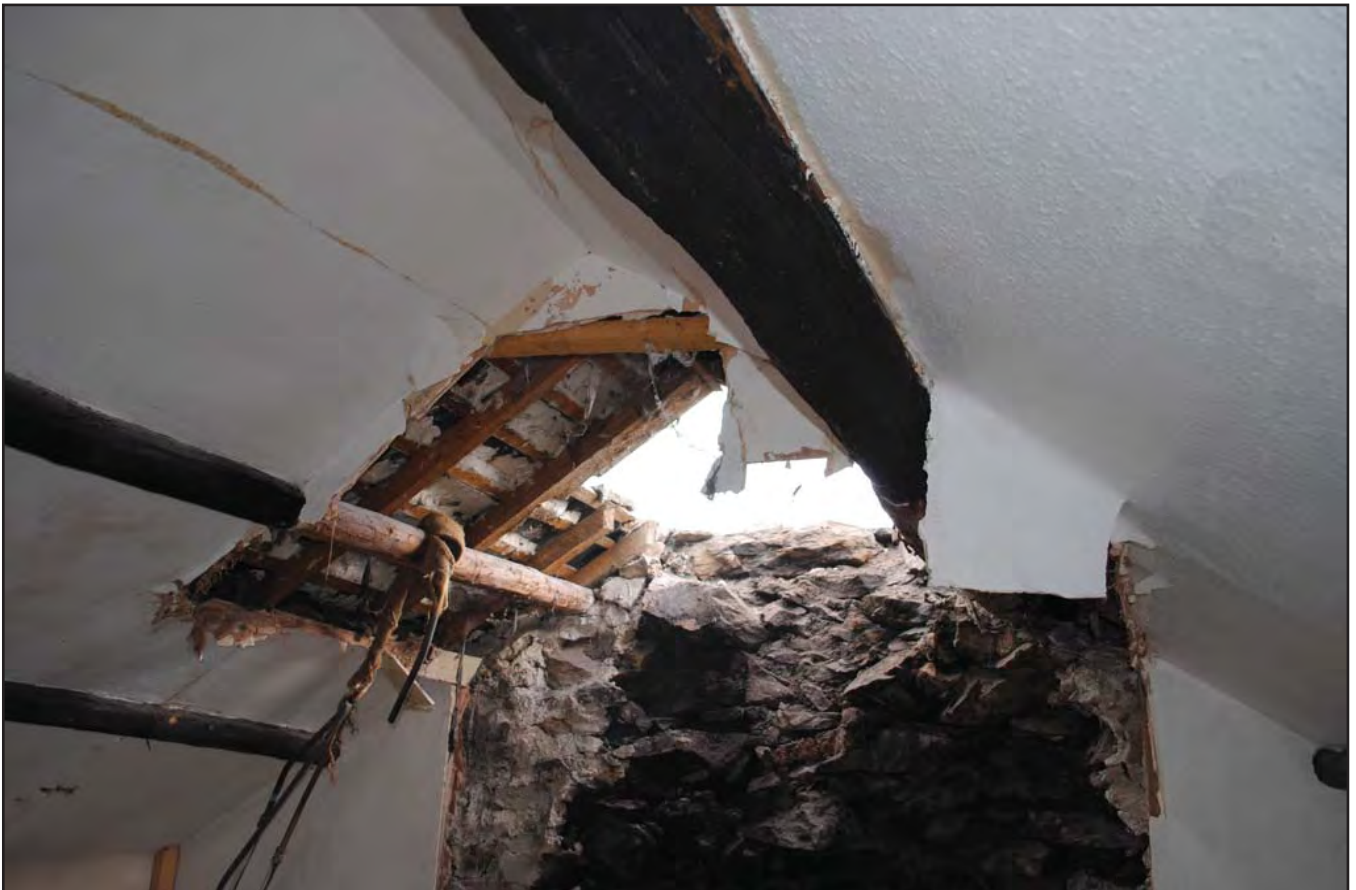
Plate 32: Open roof structure with chimney removed in bedroom 1. Photograph taken from the east

The room took up the entire roof space above the kitchen extension (Plate 34). Fire damaged purlins were noted, with tiles nailed on laths above the modern plasterboard roof (Plate 32). There was probably a fireplace in the south gable (Plate 33), but that has now been lost as a result of the fire. No other architectural detail was noted. A narrow opening, 0.6m wide, was cut into the southern gable west of the chimney breast to allow access to the room from bedroom 2 in relatively recent times.
