# Holyhead to Cwm Reservoir

## Archaeological Assessment

Prosiect Rhif / Project No. G2449

Adroddiad Rhif / Report No. 1303

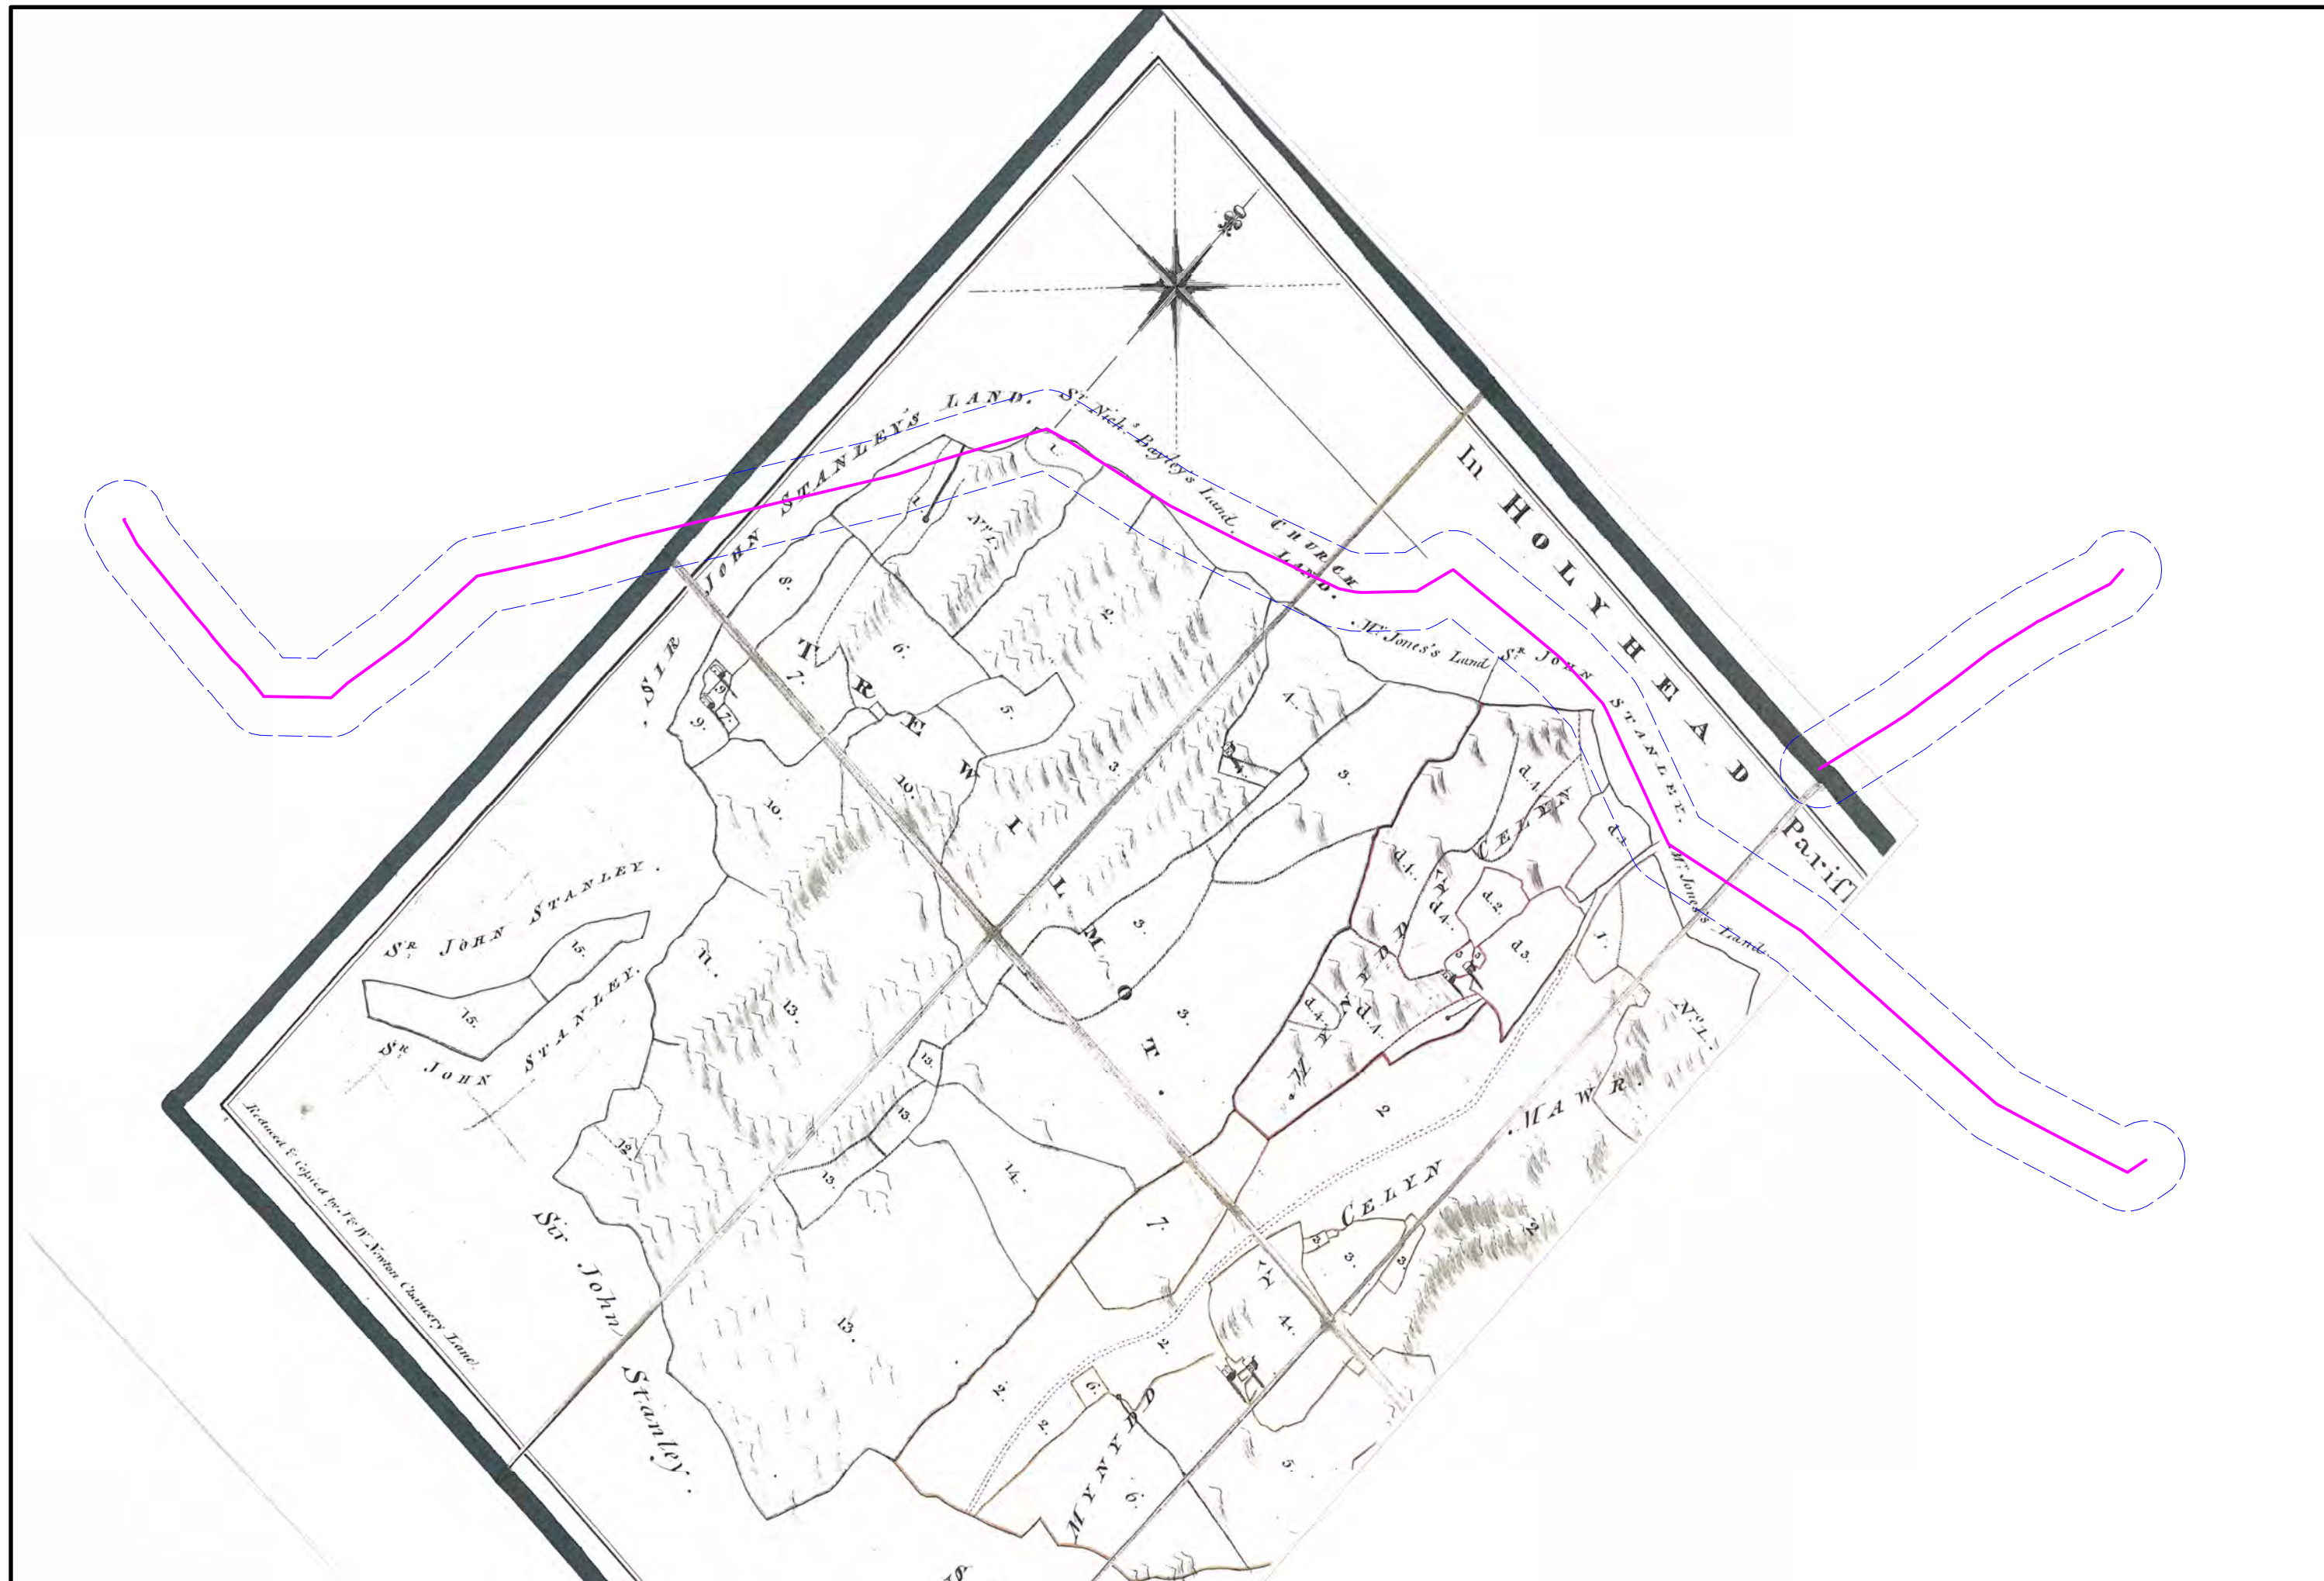
Figure 08: Reproduction of a 1783 map denoting lands belonging to the Lligwy Estate in the Parish of Holyhead (Bangor University Archives MSS 1420). The proposed route is superimposed as a pink line, with the 100m assessment buffer outlined in blue. Scale: 1 to 7500@A3.

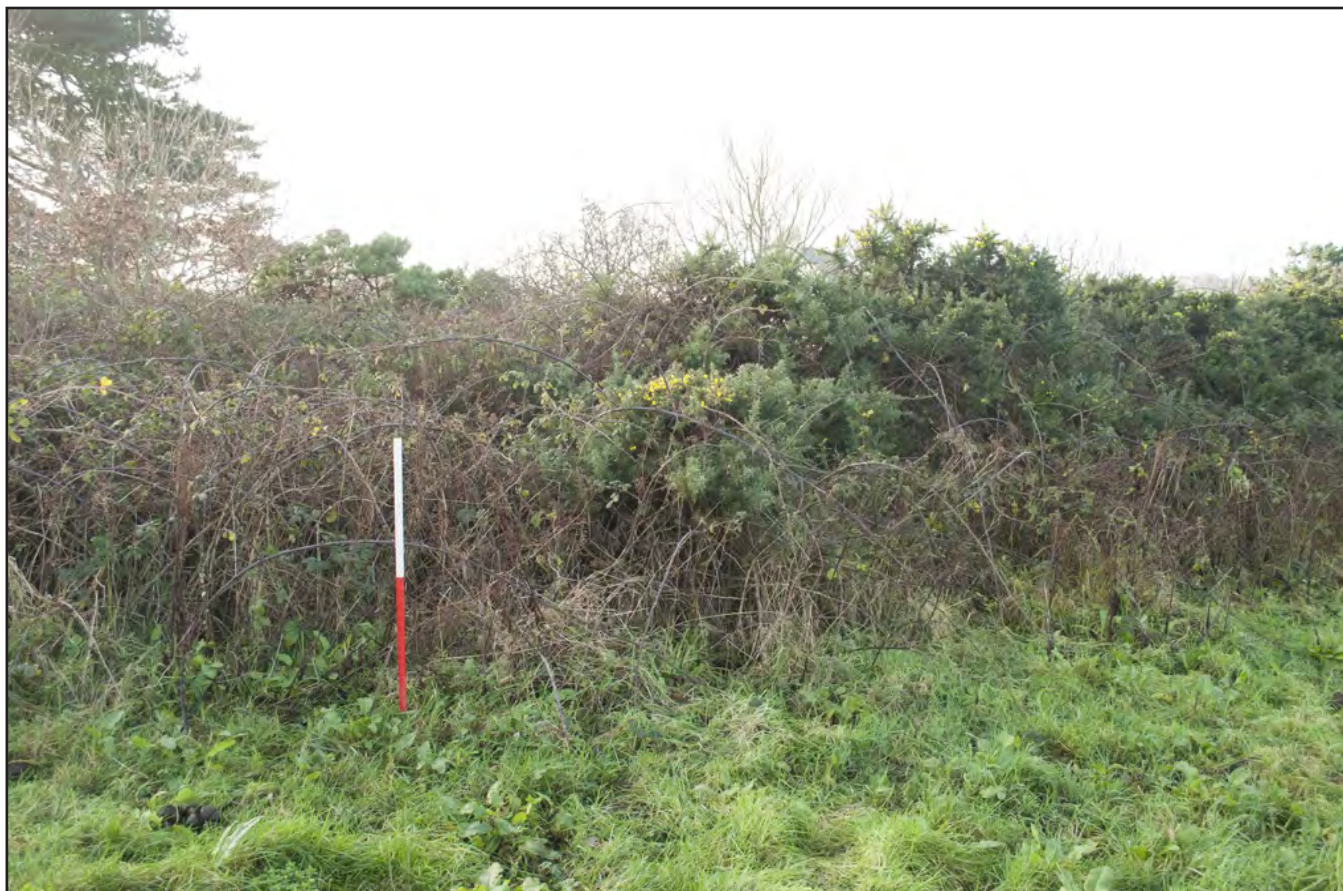
Plate 01: Section A to B - view from the southwest of bracken and thorn preventing access to Field 14 (Scale: 1 x 1.0m; archive image: G2449\_037).

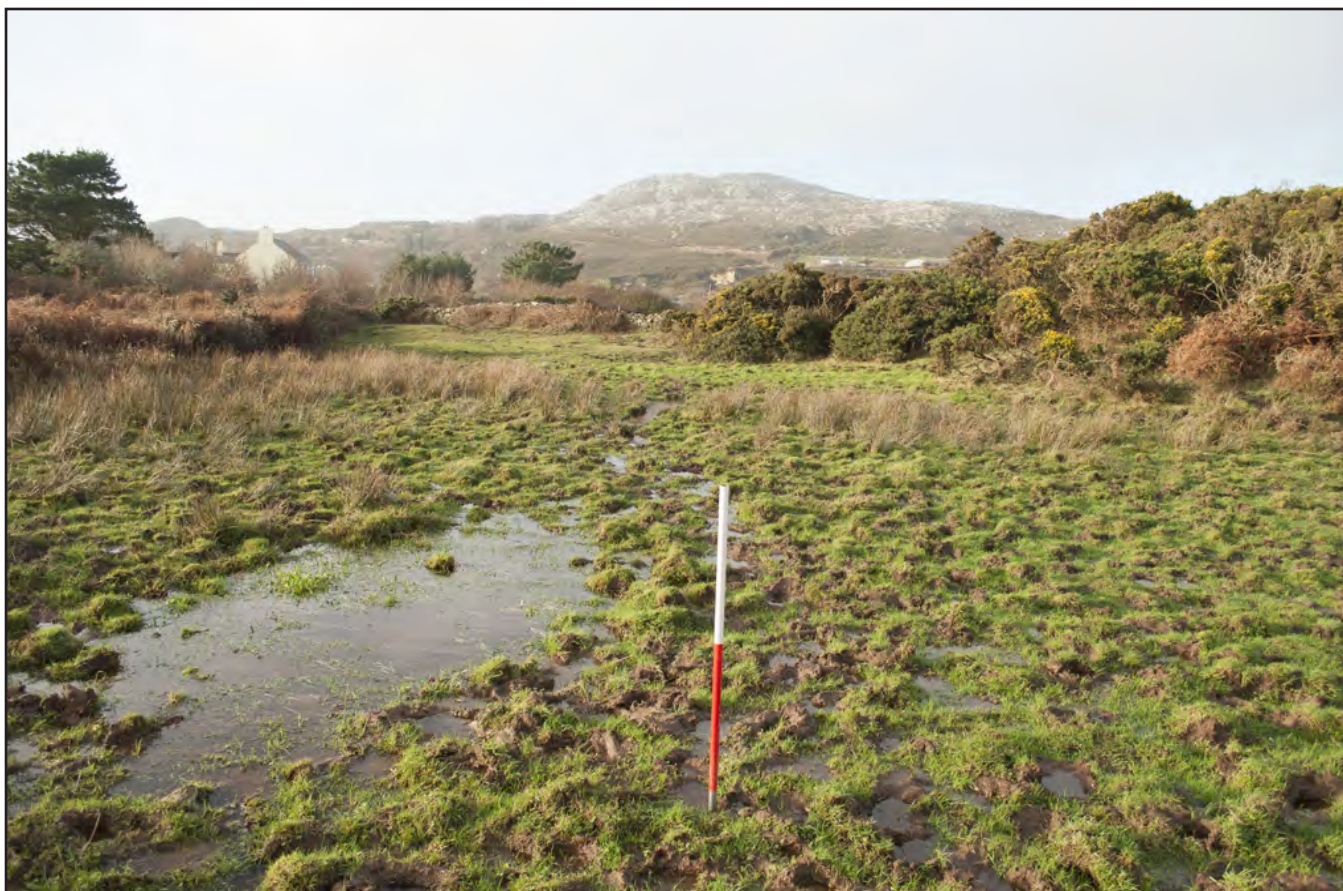
Plate 02: Section A to B - view northwest across Field 16 Scale: 1 x 1.0m; archive image: G2449\_034).

The majority of the fields comprised rough upland pastures that were boggy and wet with frequent, large outcrops of gorse covered bedrock (Plate 02). This was particularly the case with the land between Fields 12 and 13 and Plas Road. The land between the South Stack Road and Fields 12 and 13 was better maintained, in particular Fields 5 and 6 (Plate 03), with a large, water filled drainage channel/ditch (Plate 04) that separated Fields 6 and 7, with a northeast by southwest orientation. In contrast, Field 4 was badly overgrown with dense bracken (Plate 05) and appears not to have been maintained in recent years.

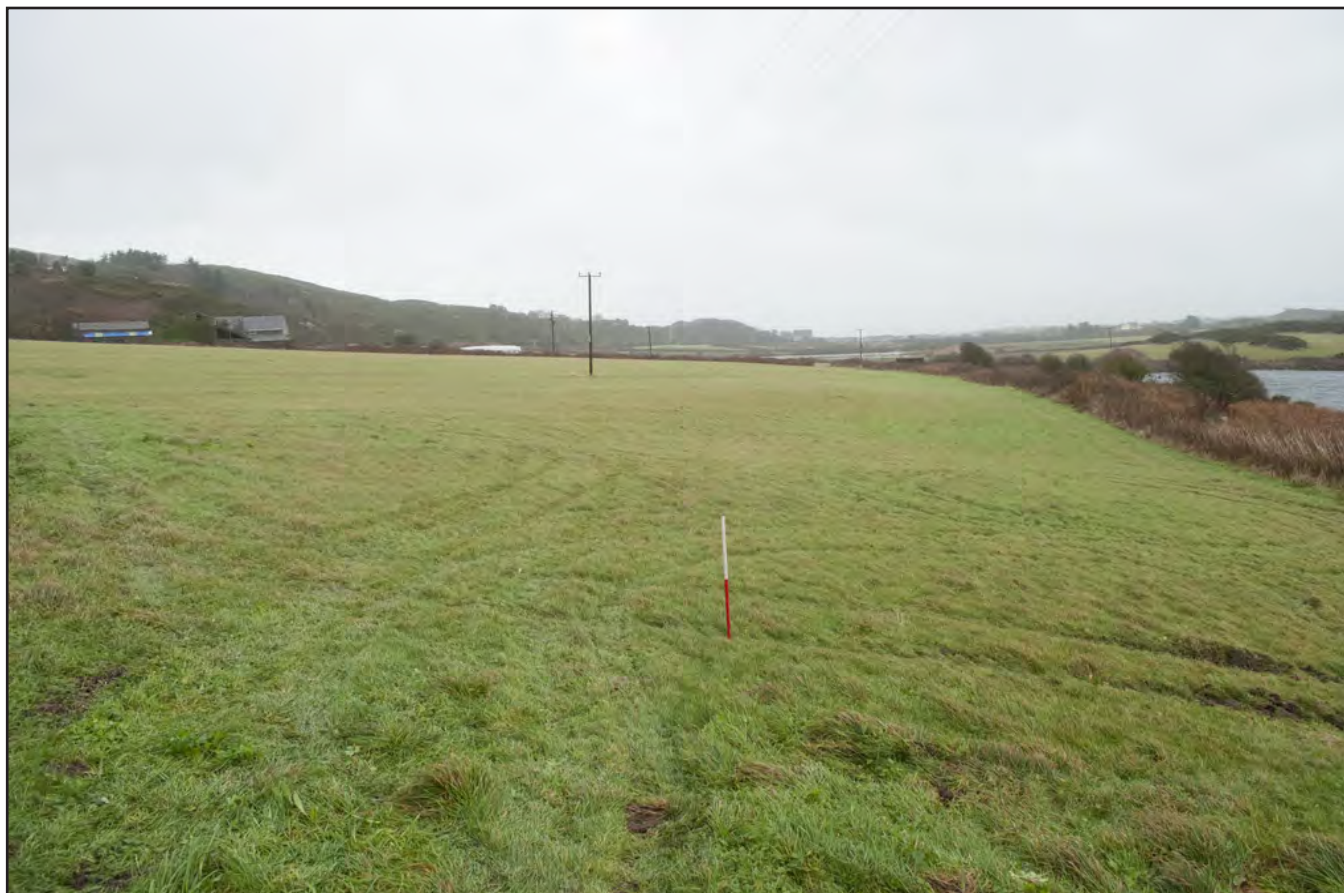
Plate 03: Section A to B - view northeast across Field 5 (Scale: 1 x 1.0m; archive image: G2449\_005).

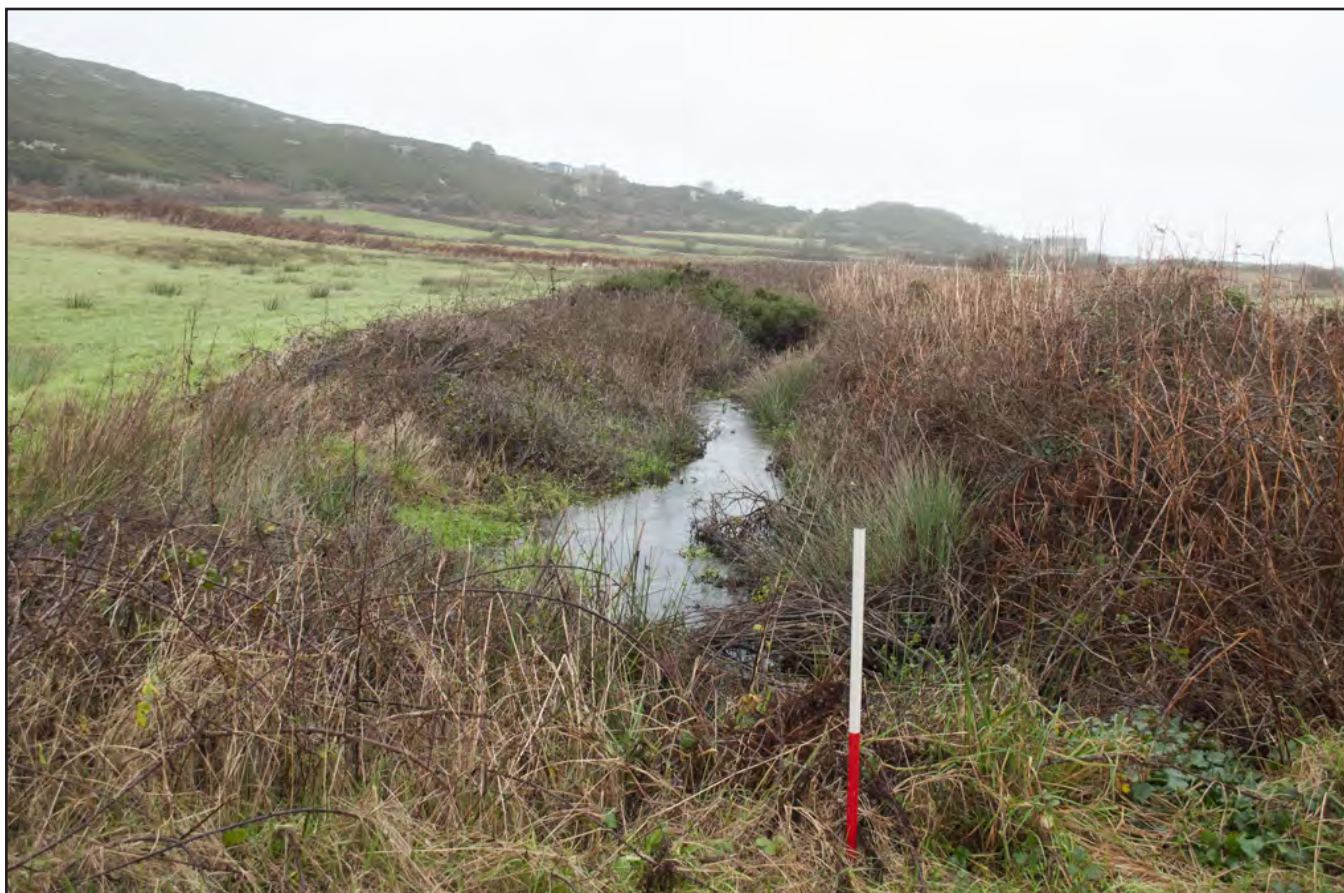
Plate 04: Section A to B - view north of drainage ditch running along the eastern boundary of Field 6 (Scale: 1 x 1.0m; archive image: G2449\_008).

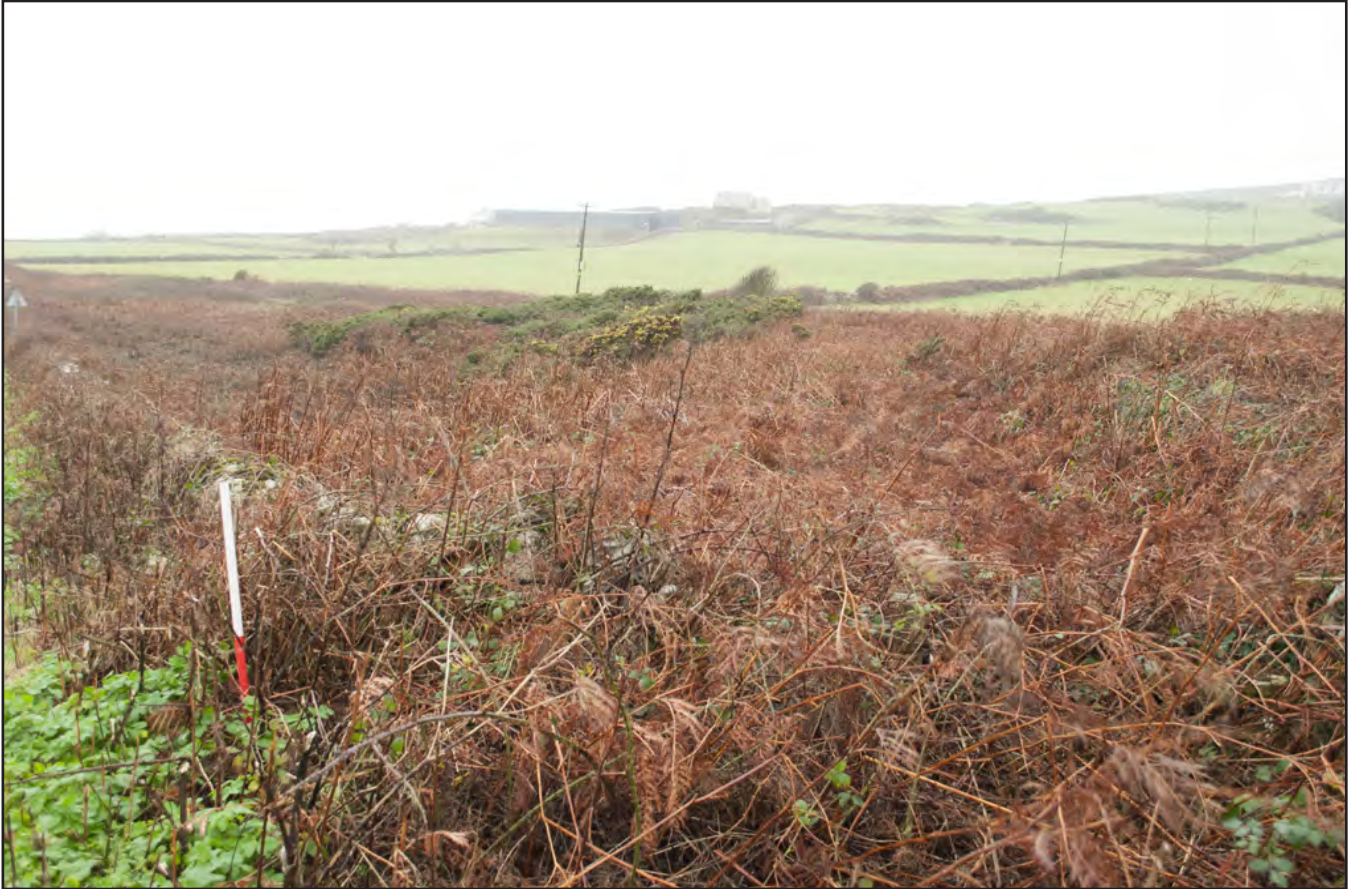
Plate 05: Section A to B - view southwest of bracken within Field 4; the field was inaccessible and the walkover was not completed (Scale 1 x 1.0m; archive image: G2449\_001).

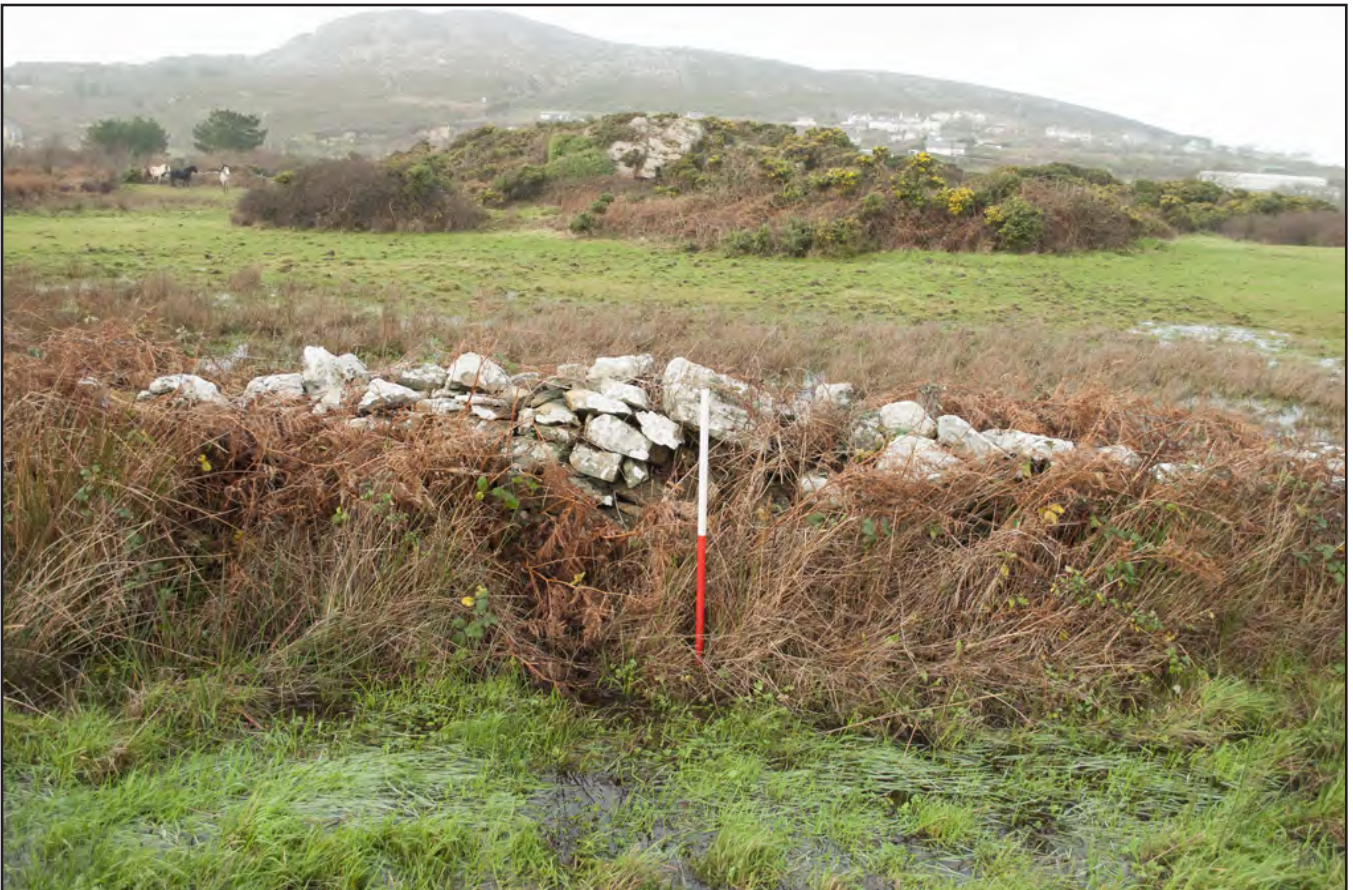
Plate 06: Section A to B - view northwest of drystone wall between Fields 16 and 17 (Scale: 1x1.0m: archive image: G2449\_032).

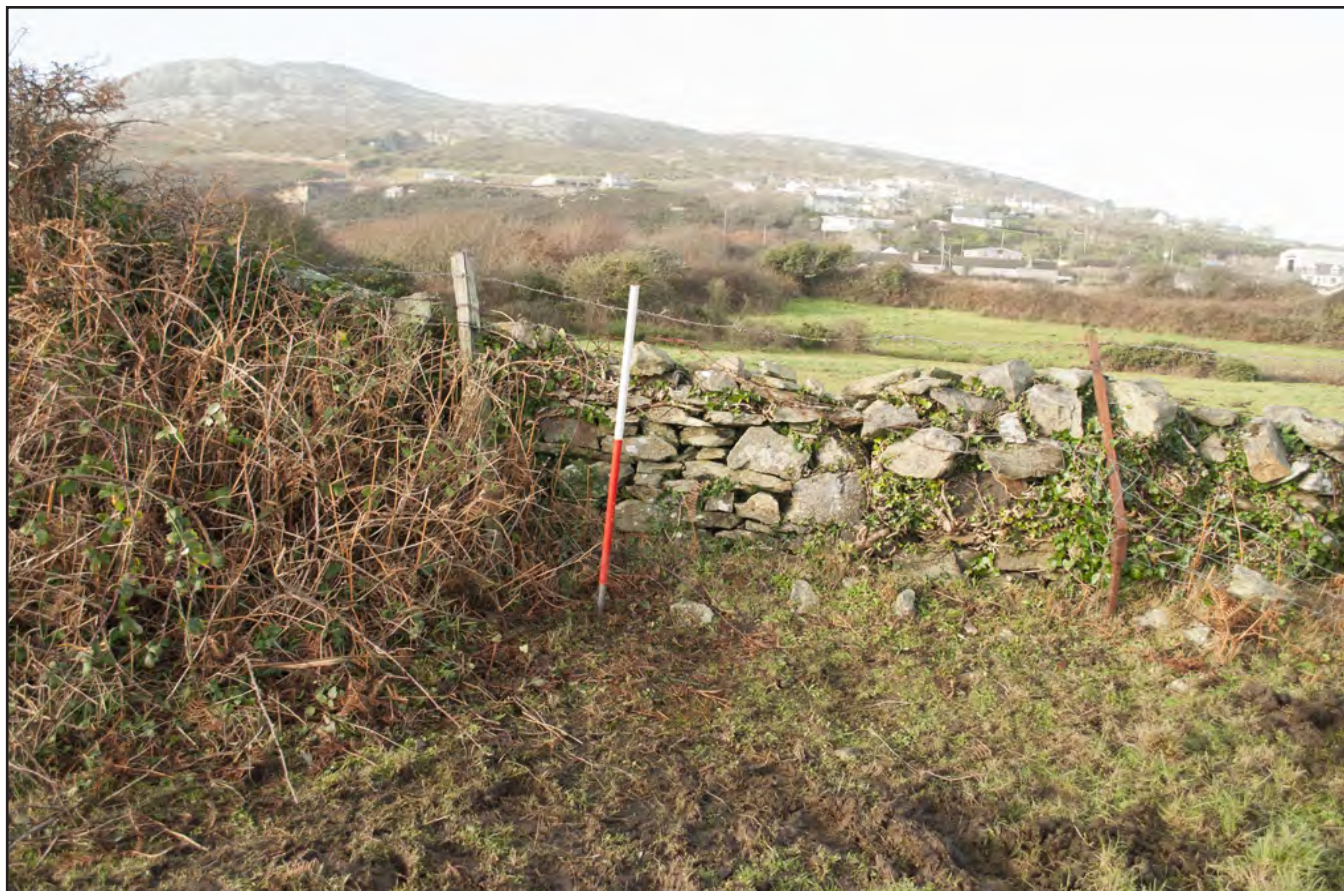
Plate 07: Section A to B - view northwest of drystone wall and wire fence separating Fields 15 and 16 (Scale 1 x 1.0m; archive image: G2449\_035).

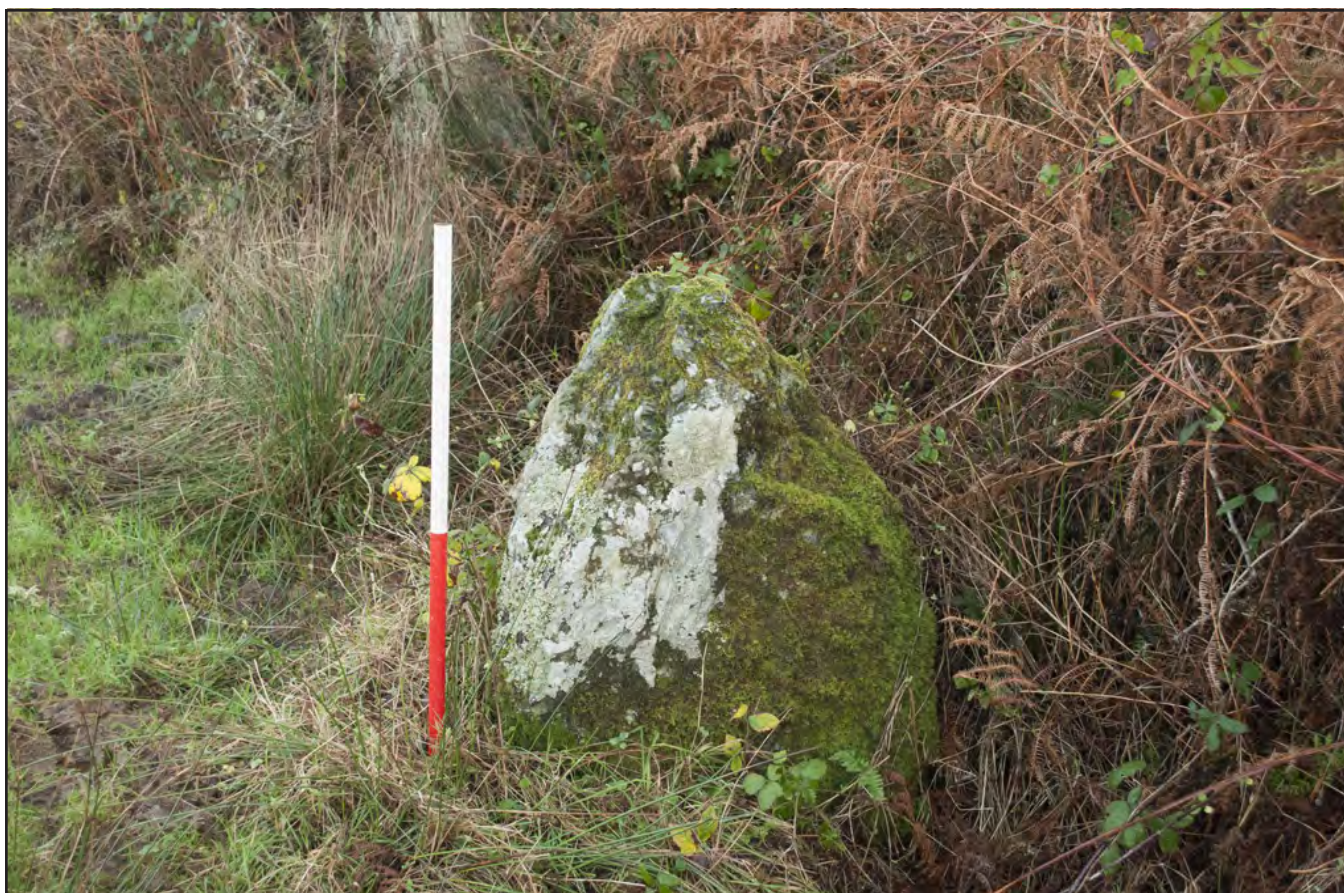
Plate 08: Section A to B - view southeast of possible standing stone (Primary Reference Number 61261; NGR SH23338205) located in Field 17 (Scale: 1x1.0m; archive image: G2449\_027).

**Recommendations for mitigatory measures:** Fenced off prior to groundworks to ensure Avoidance

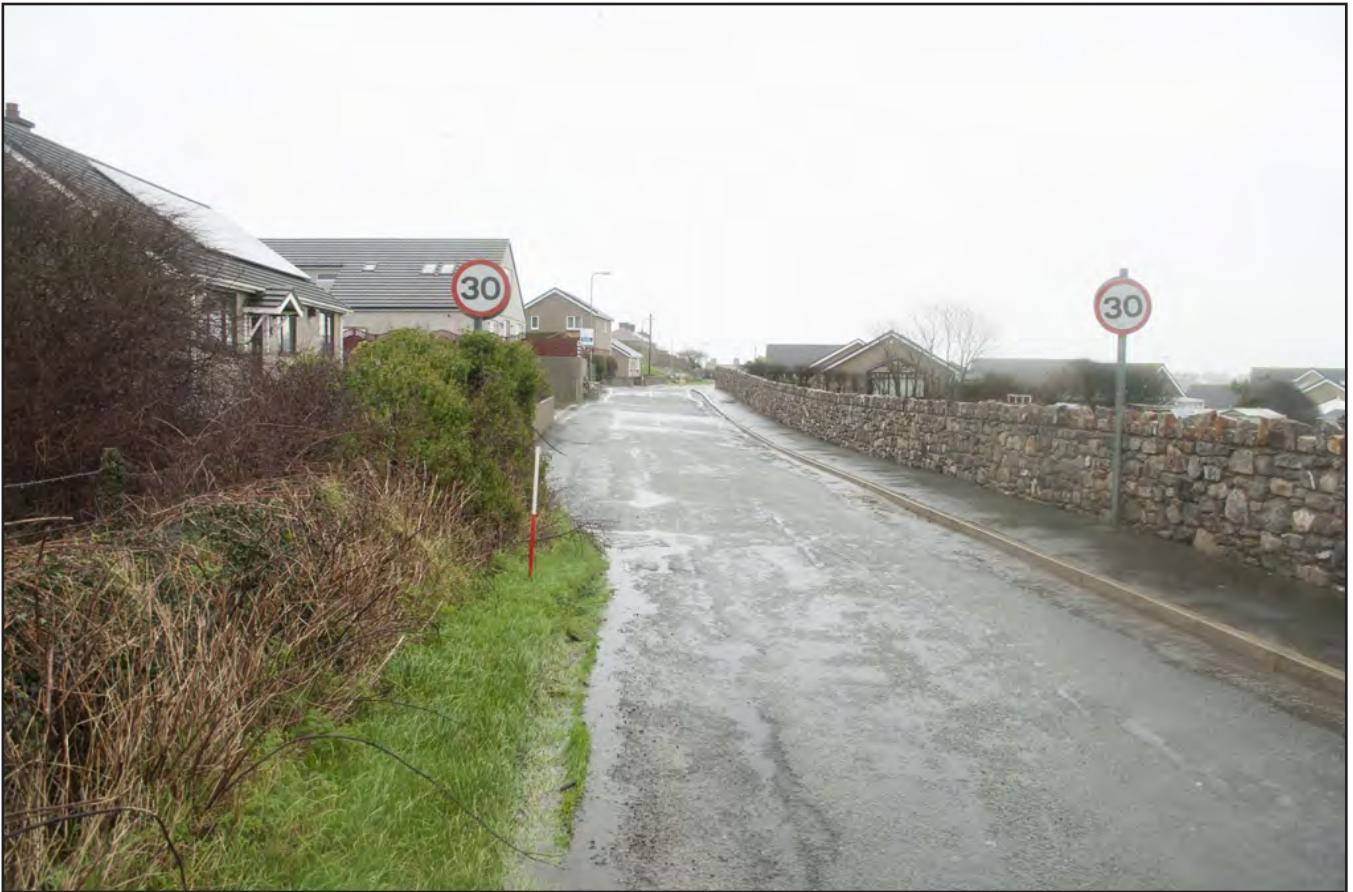
Plate 09: Section B to D - view northeast along Plas Road (Scale: 1 x 1.0m; archive image: G2449\_072).

Section B-D comprised three fields along the southern edge of the Plas Road and then further east along the Plas Road (Plate 09) until Plas Hyfryd Terrace (Figure 01). Fields 1 and 2 are rough fields of pasture with sporadic outcrops of gorse covered bedrock (Plate 10) that are enclosed by low dry stone walls that have been supplemented with post and wire fencing (Plate 11). Field 3 is currently in use as allotments (Plate 12). No upstanding archaeological remains were identified along this section of the route. A more in-depth description of the fields accessed for Section B-D is detailed in Table 2.

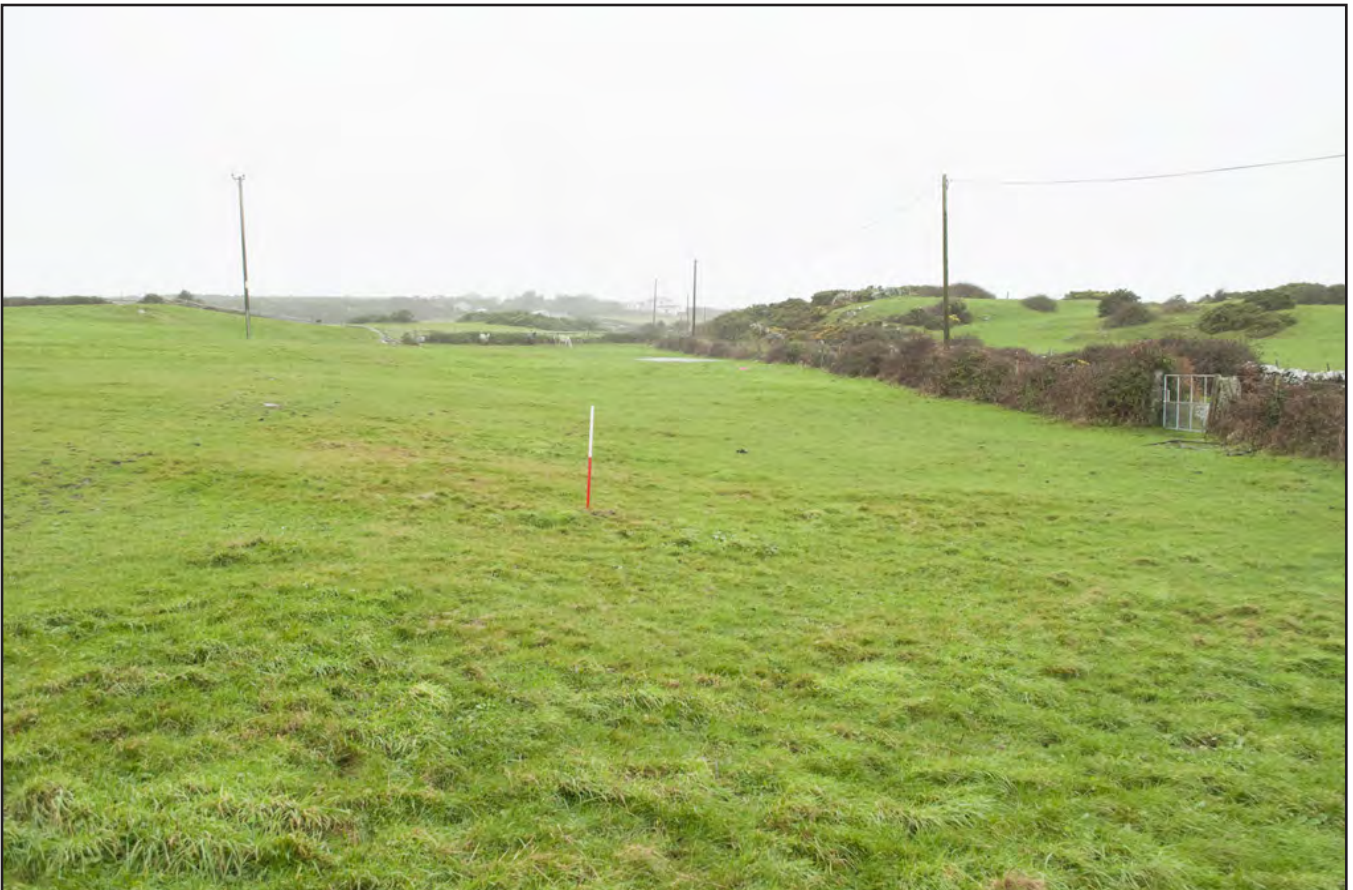
Plate 10: Section B to D - view southwest along Field 2 (Scale: 1 x 1m; archive image: G2449\_069).

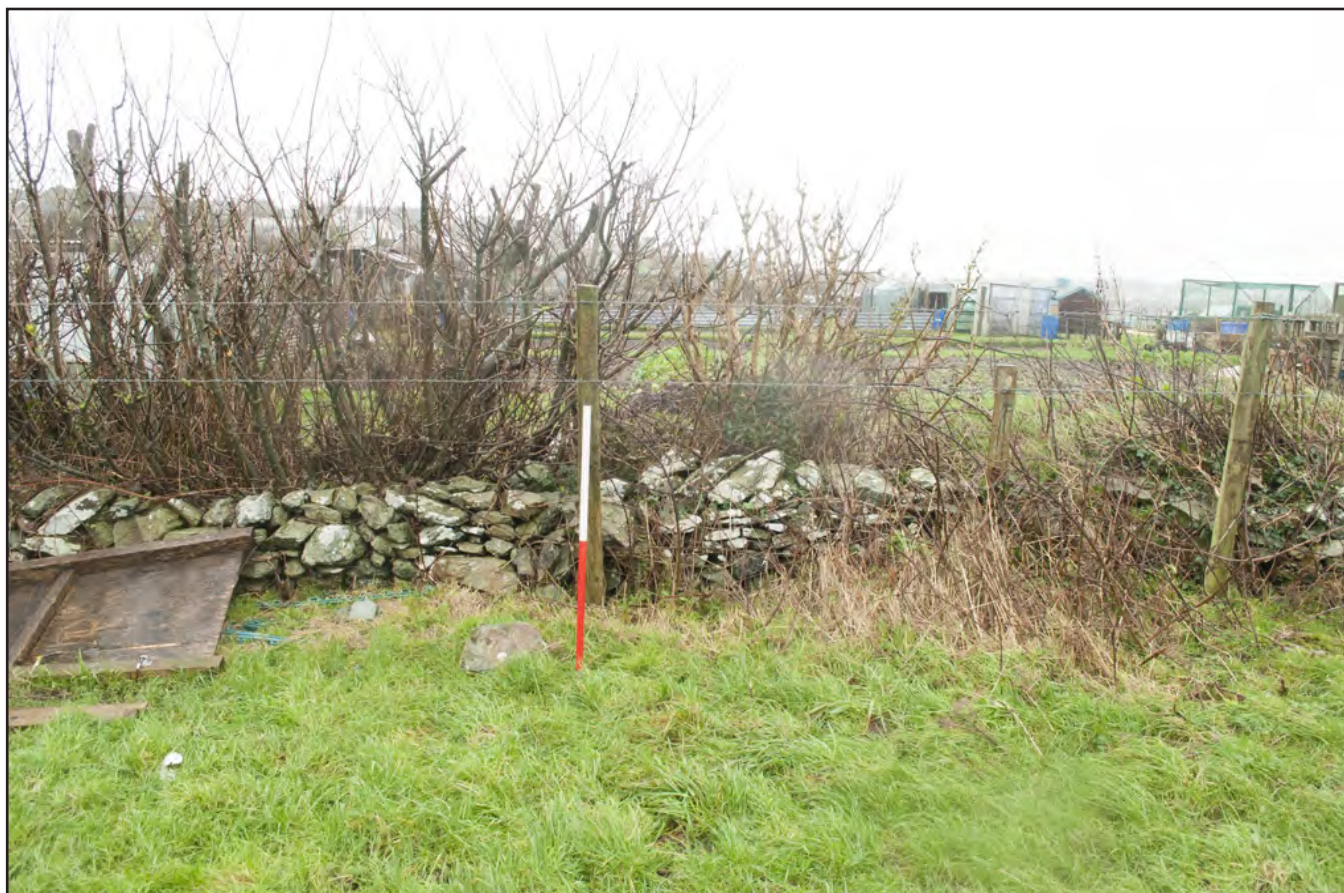
Plate 11: Section B to D - view northeast of drystone wall boundary separating Fields 2 and 3 (Scale 1 x 1.0m: archive image: G2449\_070).

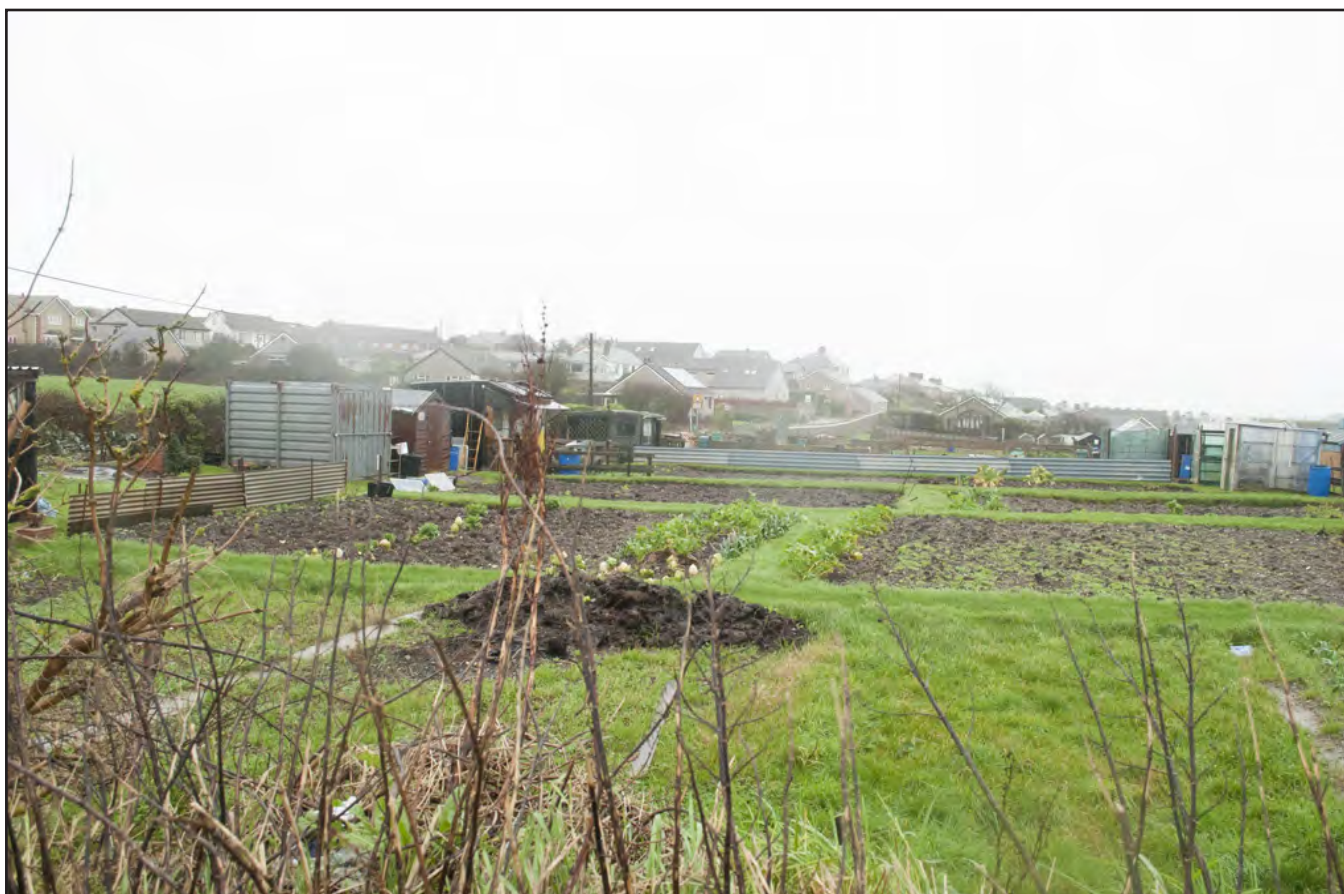
Plate 12: Section B to D - view northeast of Field 3, in use as an allotment (archive image: G2449\_071).

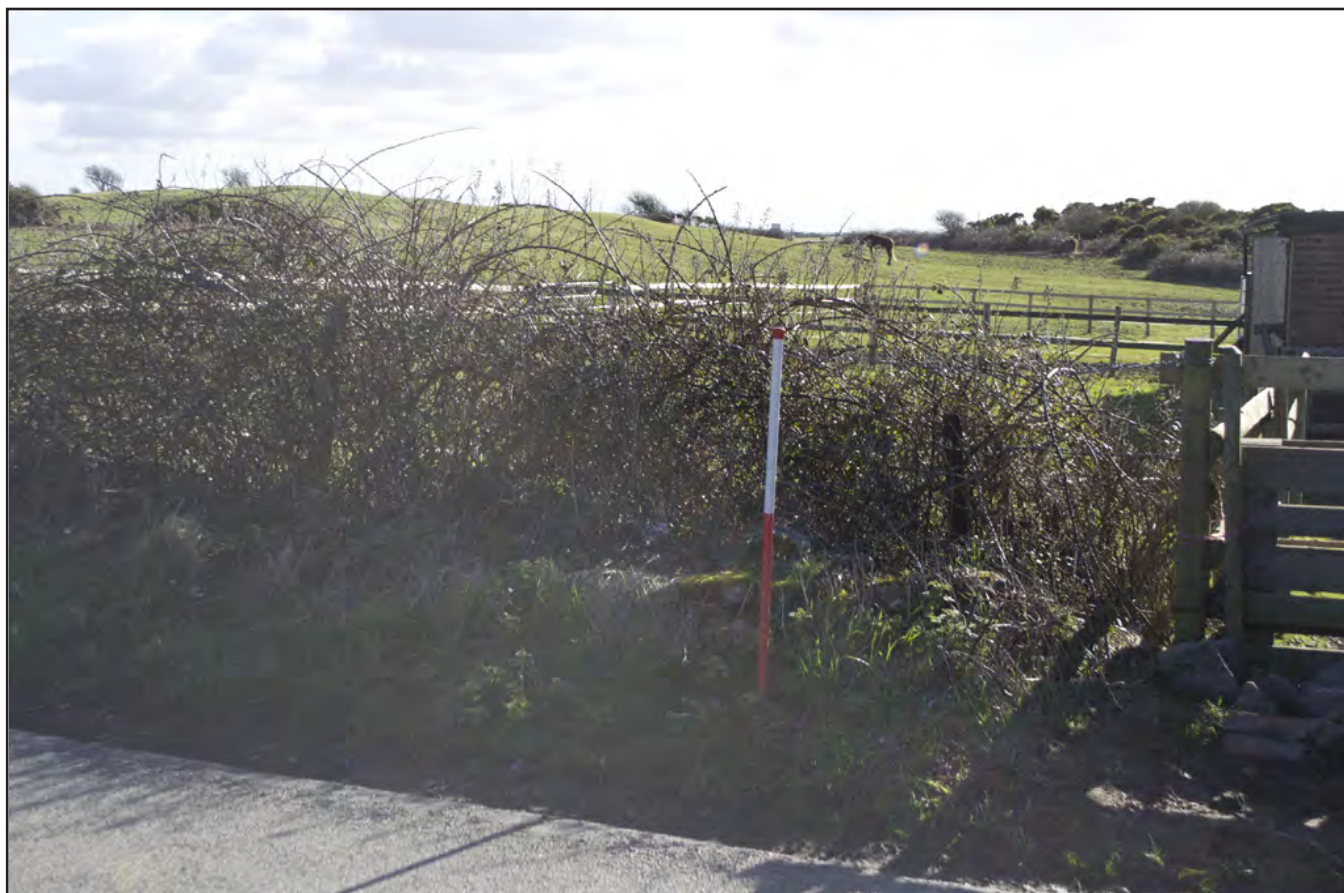
Plate 13: Section B to E - Field 1, view southwest of boundary off the Plas Road (Scale 1 x 1.0m: archive image: G2449\_073).

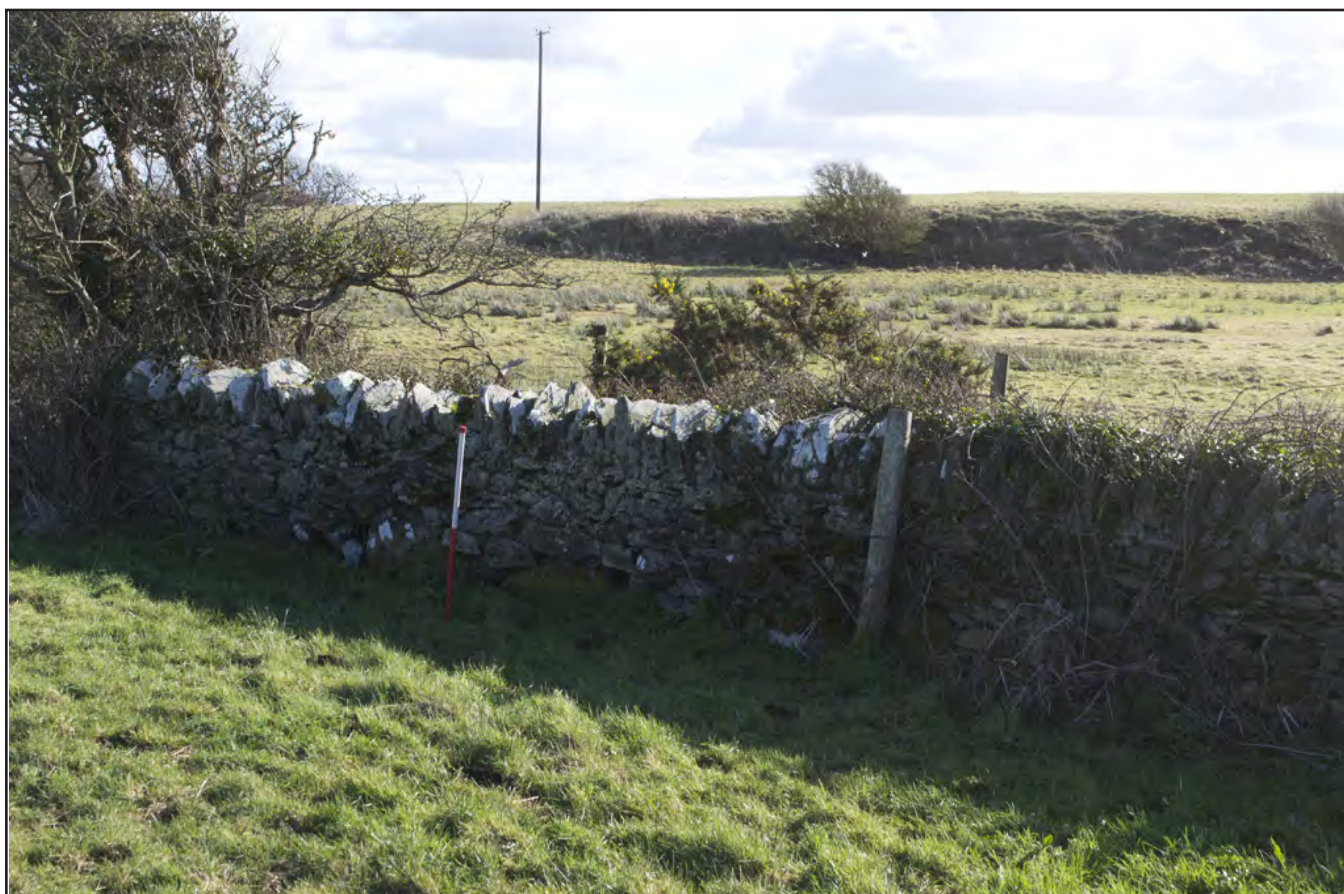
Plate 14: Section B to E - Field 1, view southeast stone wall field boundary between Fields 2 and 3 (Scale 1 x 1.0m: archive image: G2449\_080).

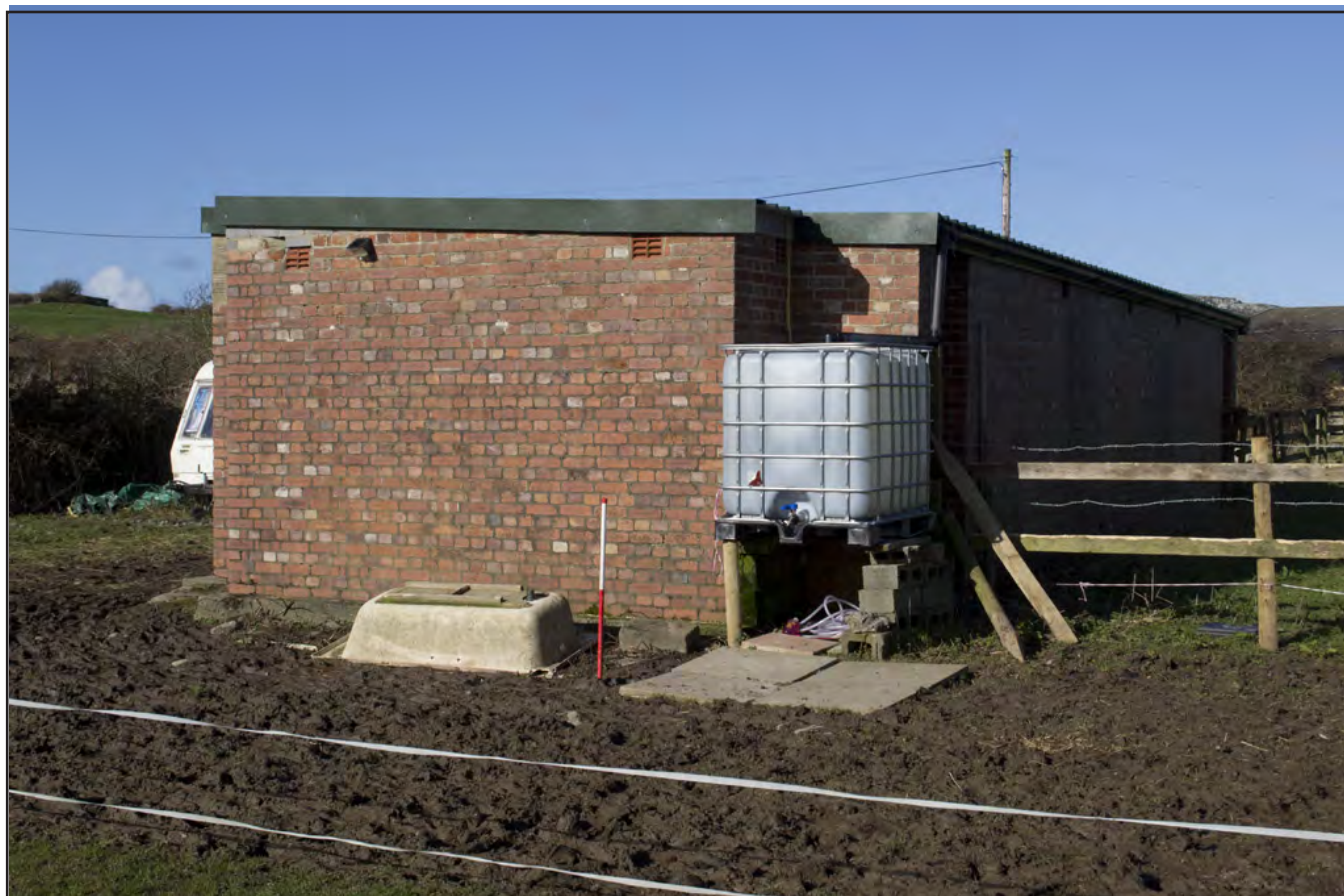
Plate 15: Section B to E - Field 1, view west of stables (Scale 1 x 1.0m: archive image: G2449\_074).
