# Holyhead to Cwm Reservoir

## Archaeological Assessment

Prosiect Rhif / Project No. G2449

Adroddiad Rhif / Report No. 1303

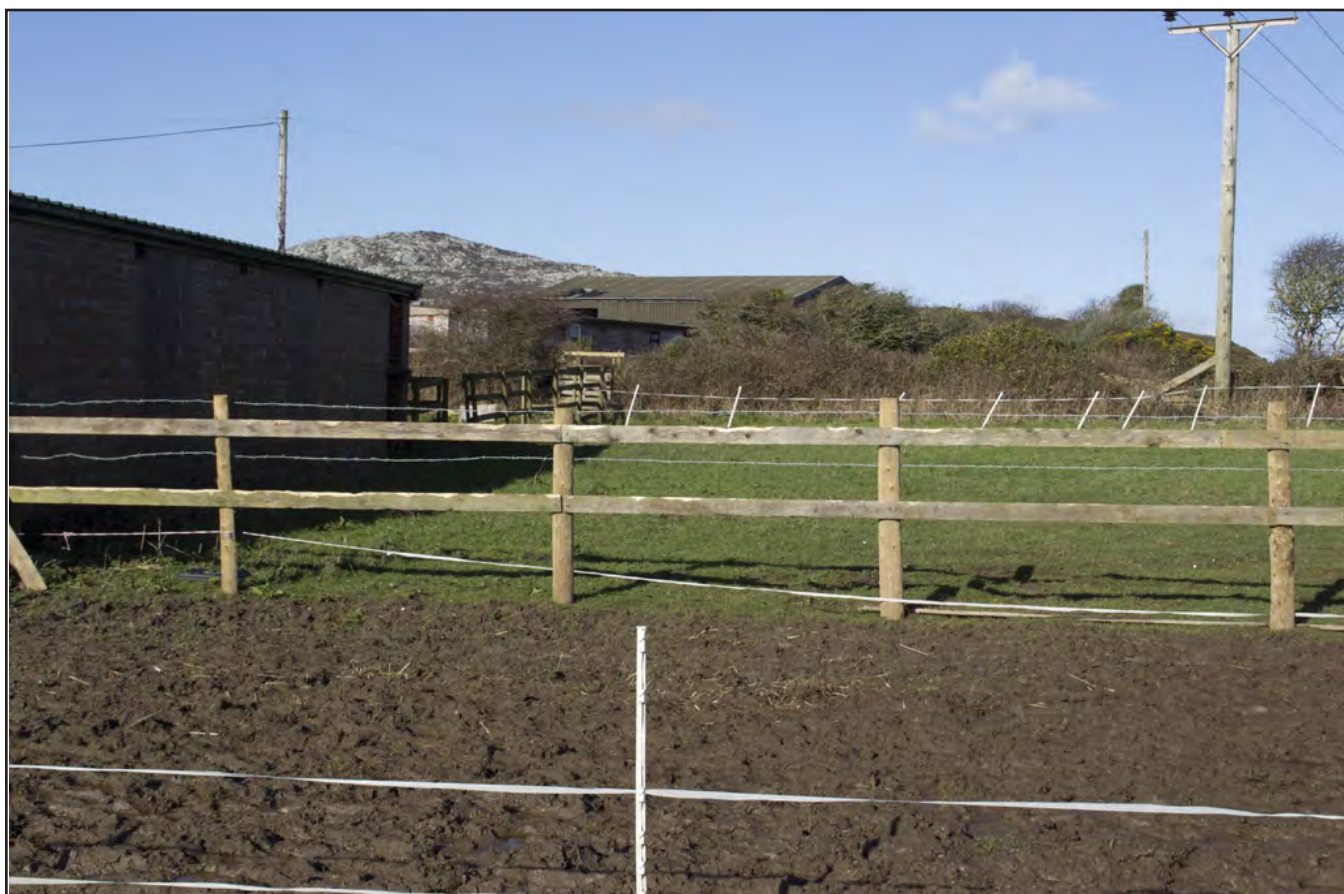
Plate 16: Section B to E - Field 1, view northwest of stables and proposed location of opencut (Scale 1 x 1.0m: archive image: G2449\_075).

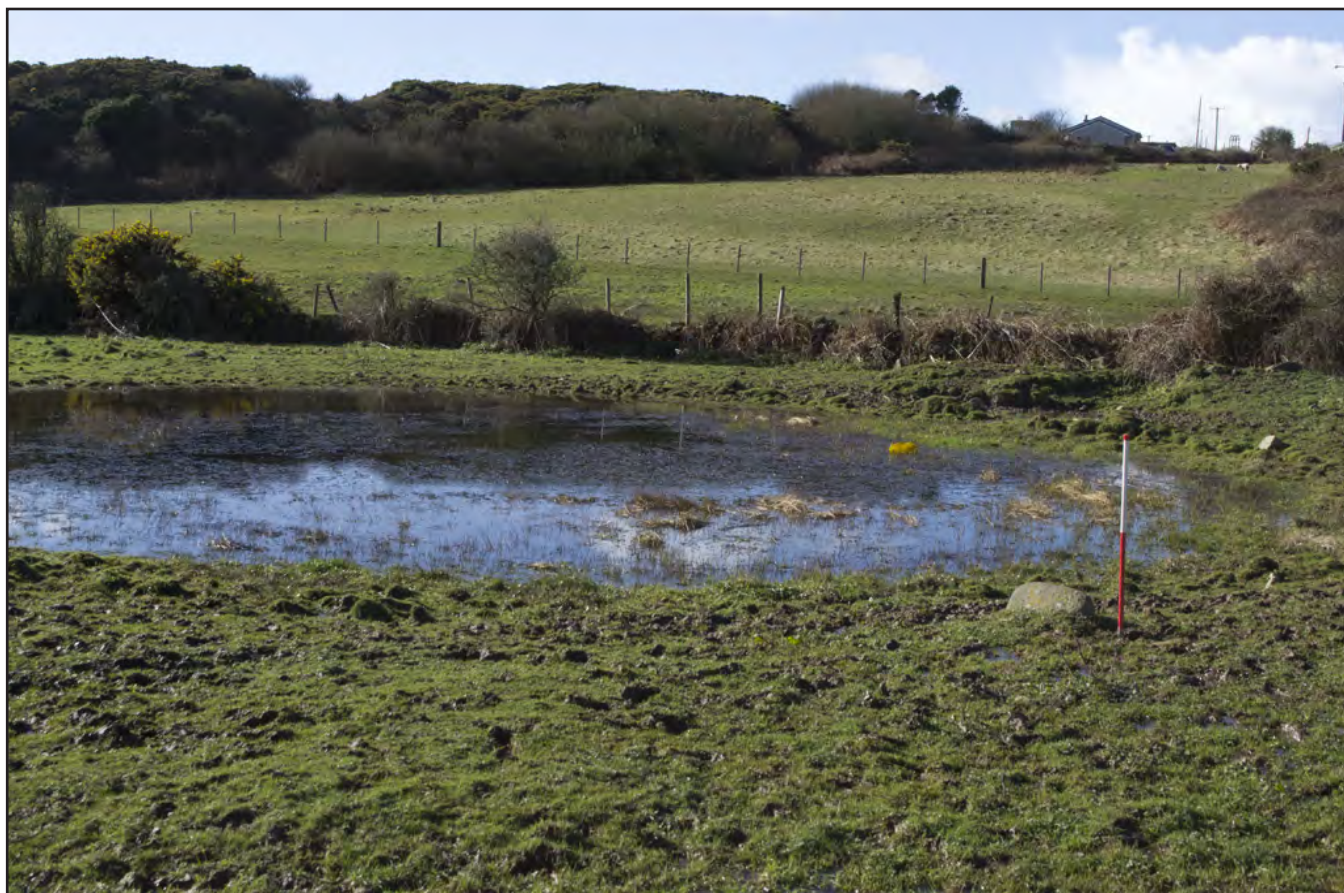
Plate 17: Section B to E - Field 1, view southwest of pond (Scale 1 x 1.0m: archive image: G2449\_076).

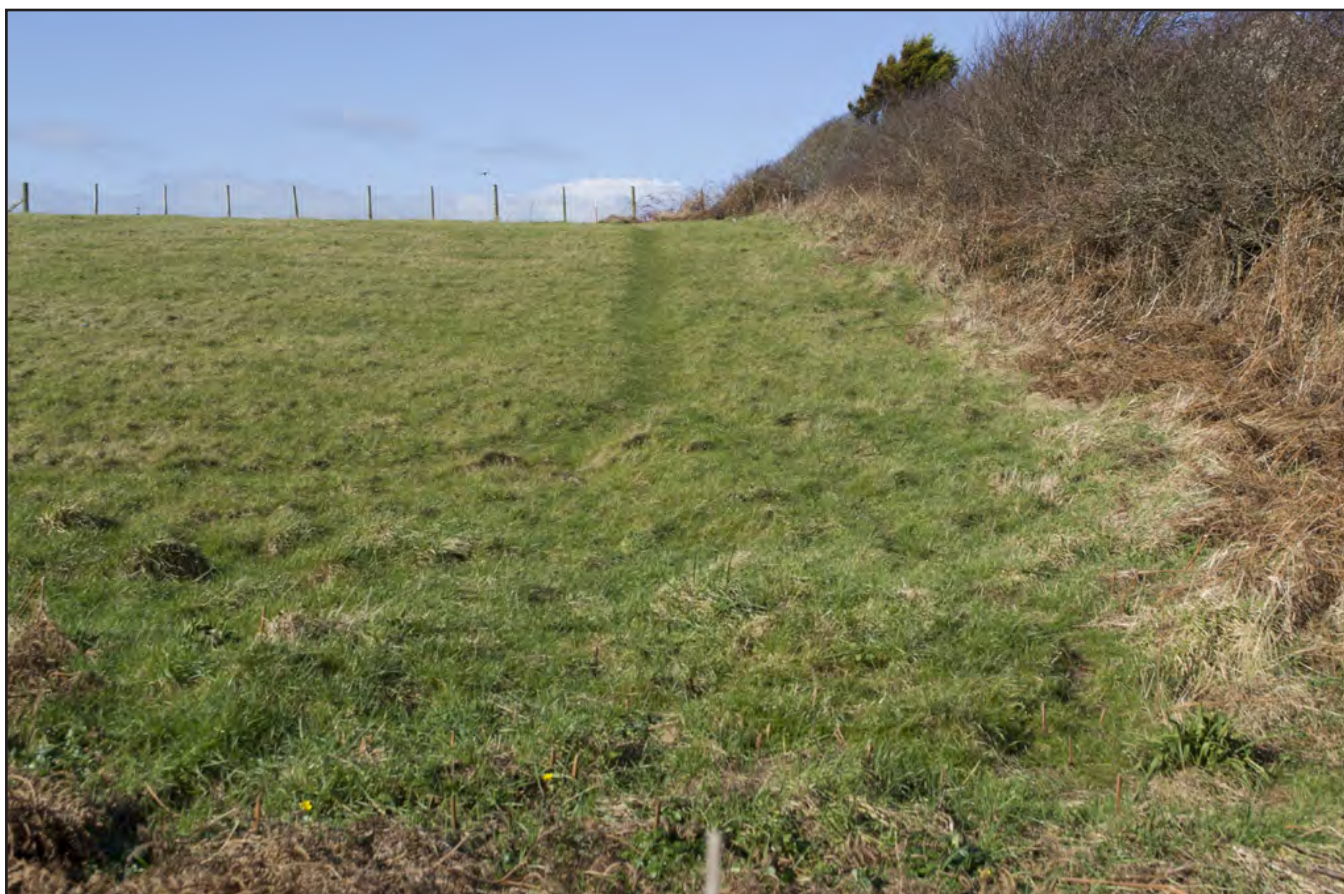
Plate 18: Section B to E - Field 5, view northwest of proposed route (Scale 1 x 1.0m: archive image: G2449\_082).

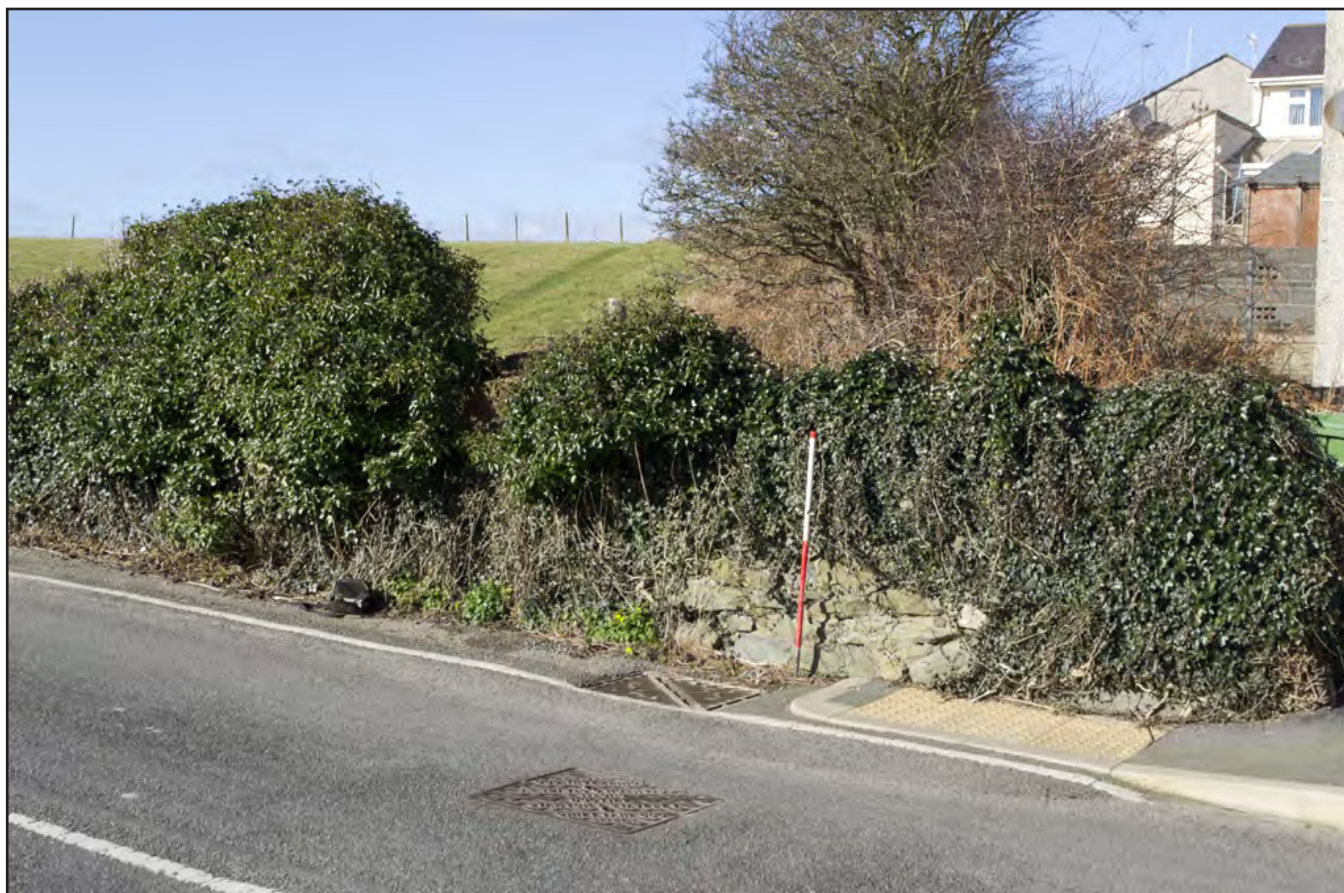
Plate 19: Section B to E - Field 5, view northwest of proposed exit point for pipe at boundary of field five (Scale 1 x 1.0m; archive image: G2449\_081).

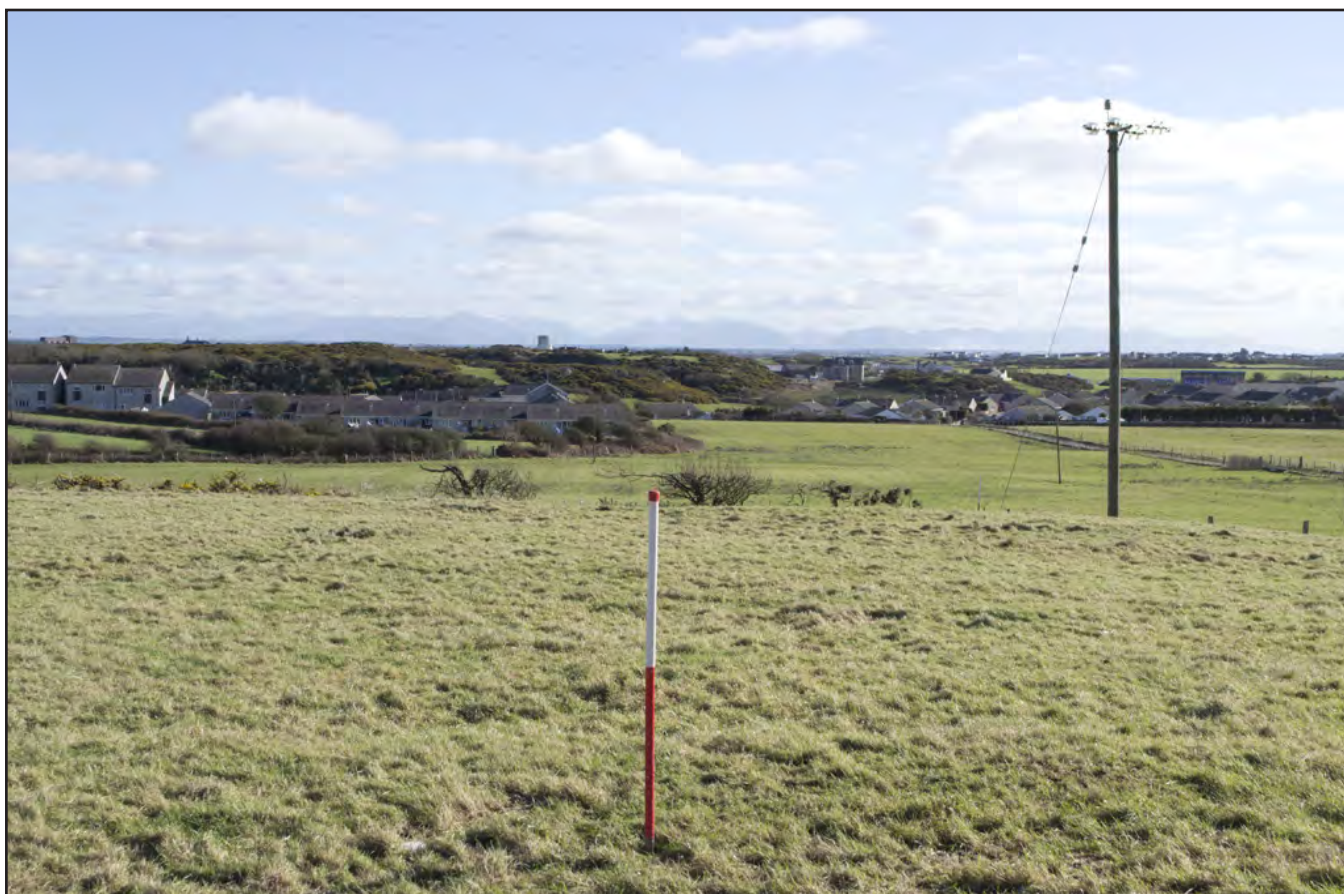
Plate 20: Section B to D - view southeast of Field 3 of proposed opencut route from road (Scale 1 x 1.0m; archive image: G2449\_071).

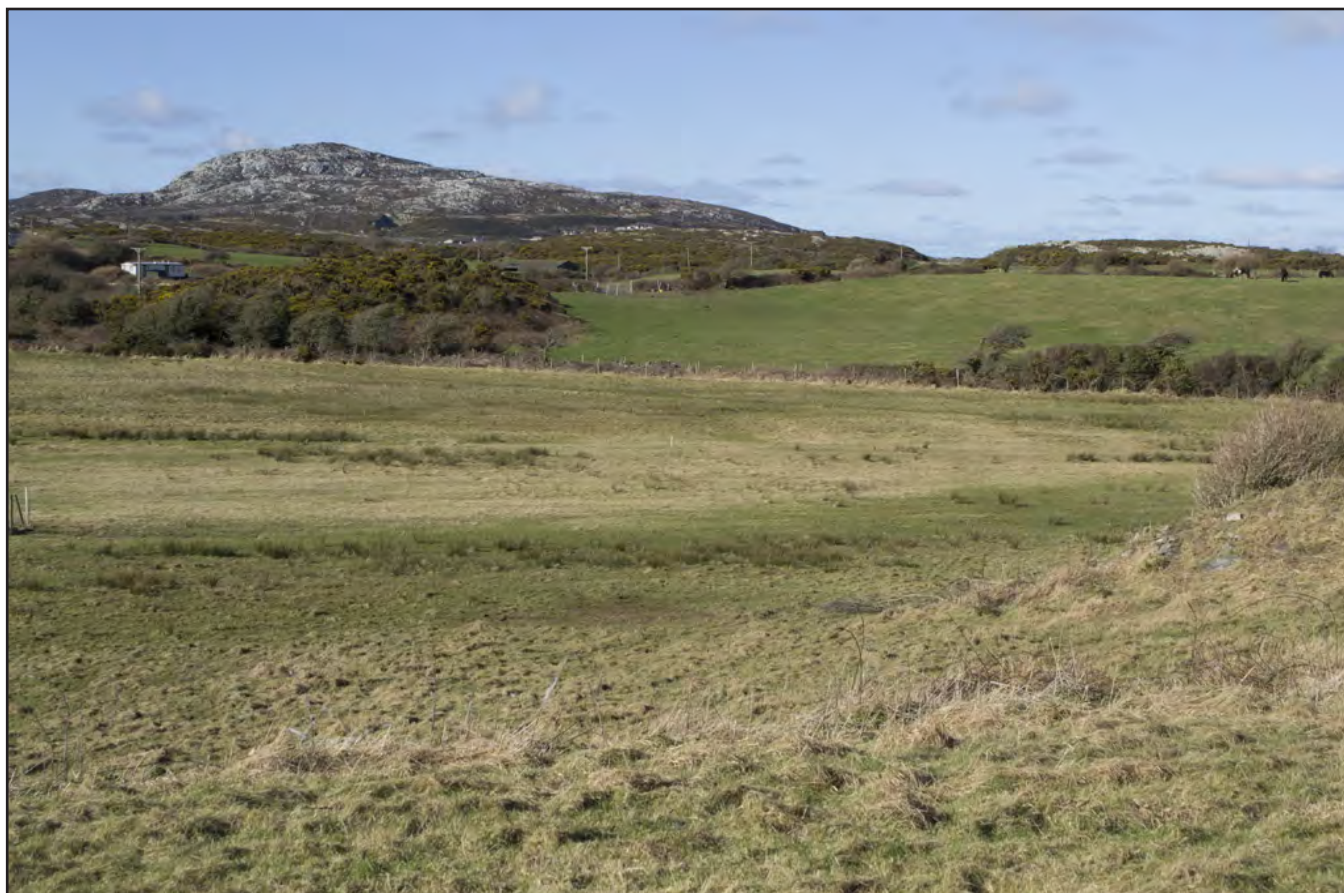
Plate 21: Section B to E - Field 3, view northwest along of proposed opencut route from Plas Road (archive image: G2449\_088).

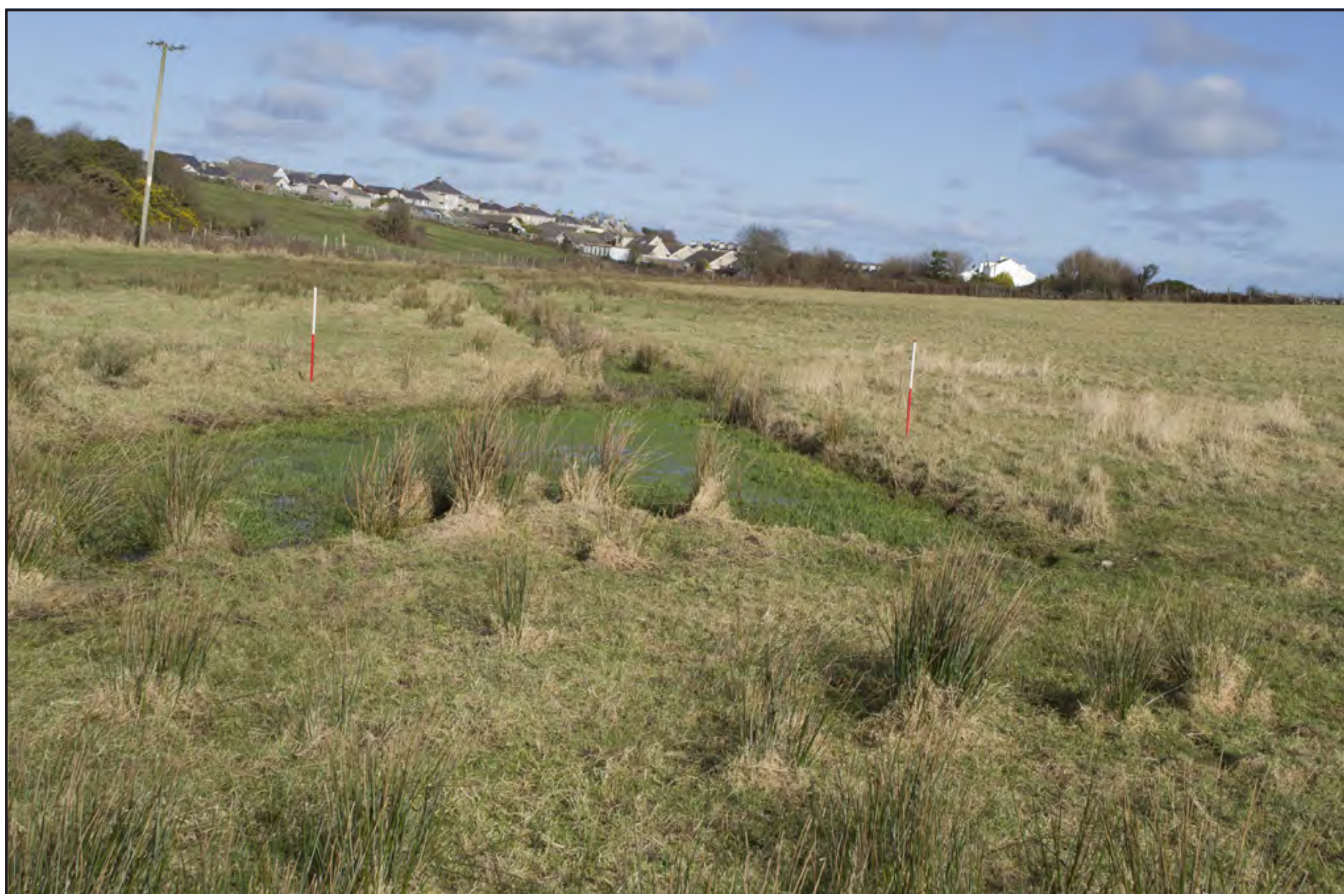
Plate 22: Section B to E - Field 3, view north of terminus for the water channel (archive image: G2449\_090).

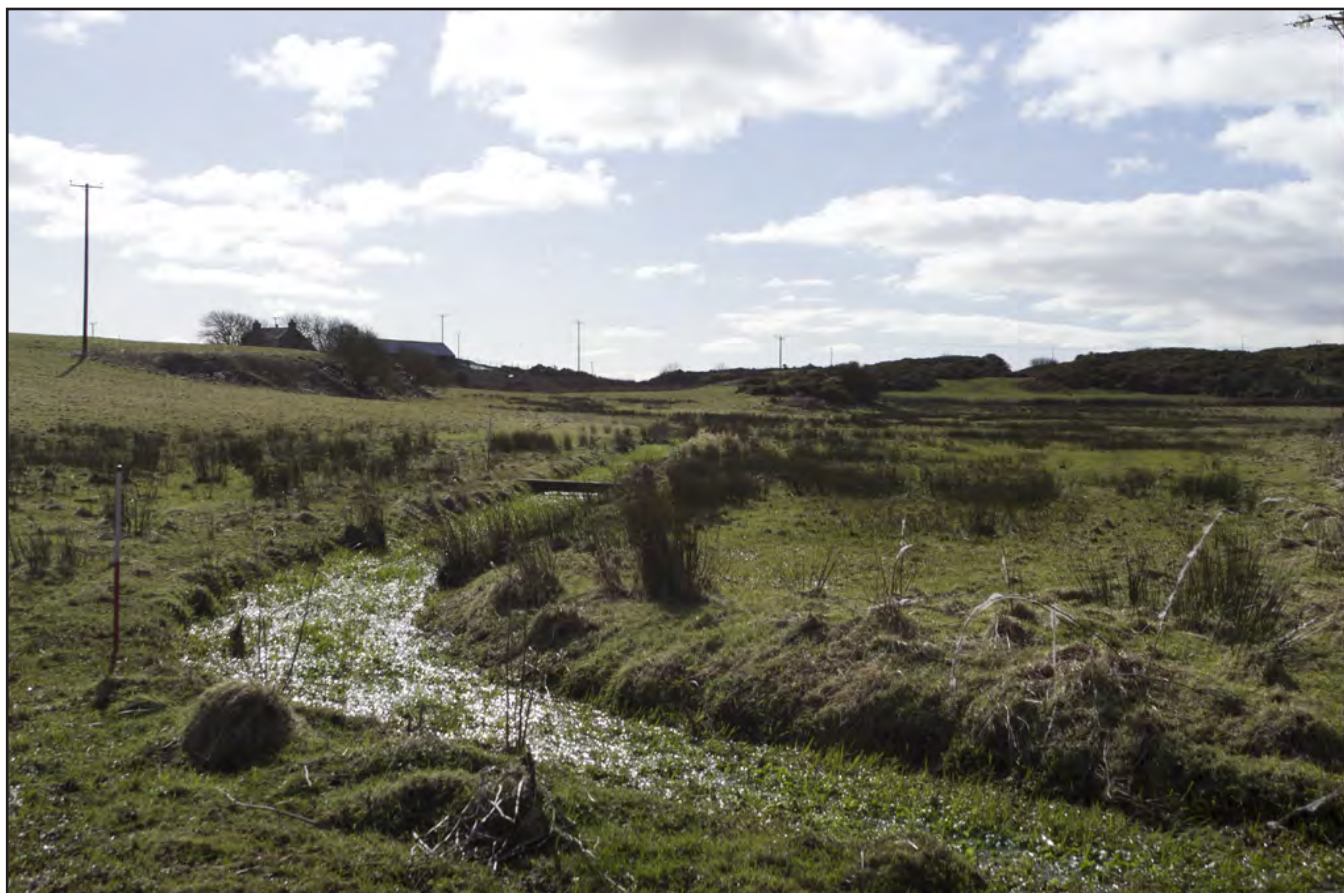
Plate 23: Section B to E - Field 3, view south along water channel (archive image: G2449\_089).

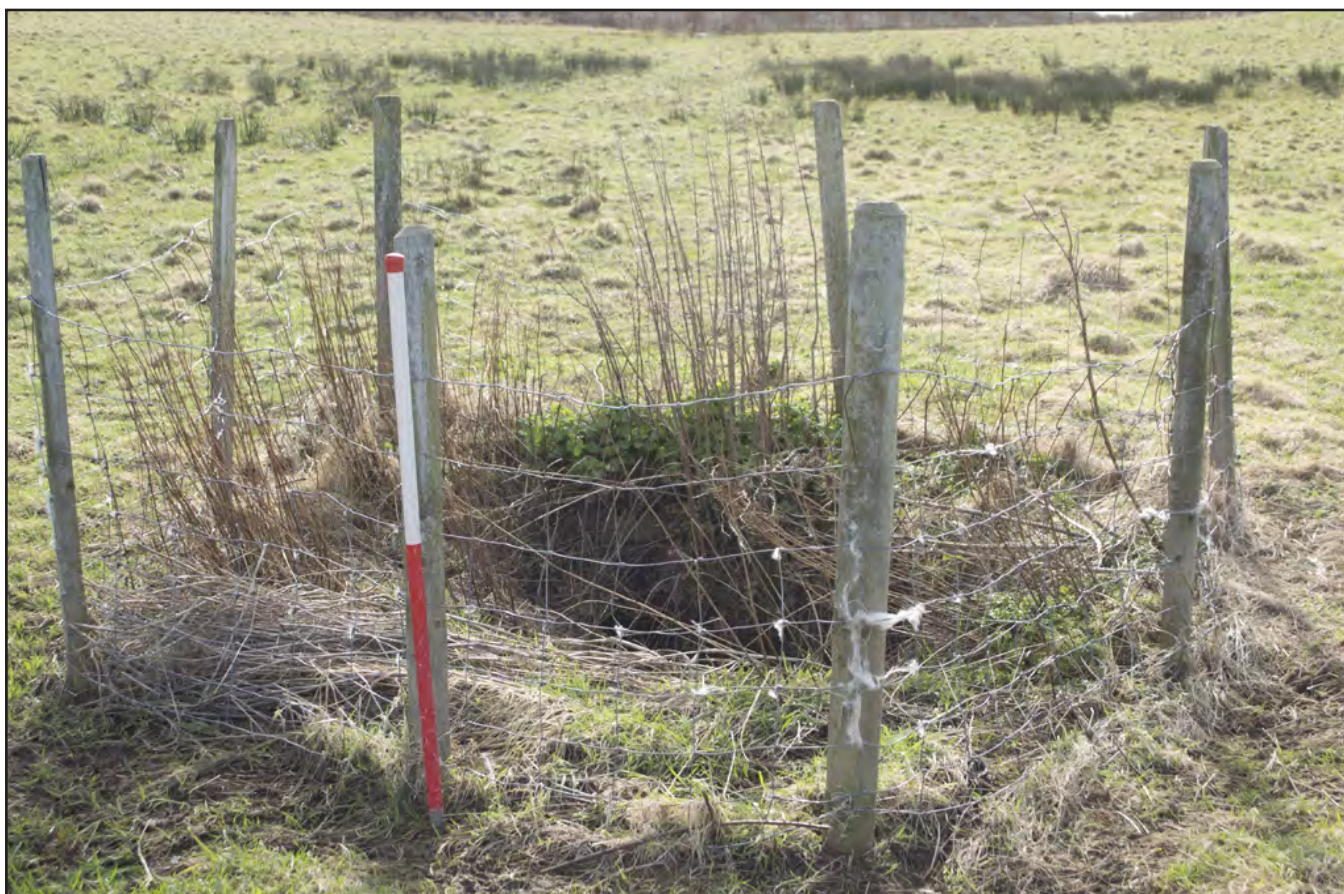
Plate 24: Section B to E - Field 3, view south of drain/issue associated with open water channel (Scale 1 x 1.0m: archive image: G2449\_091)

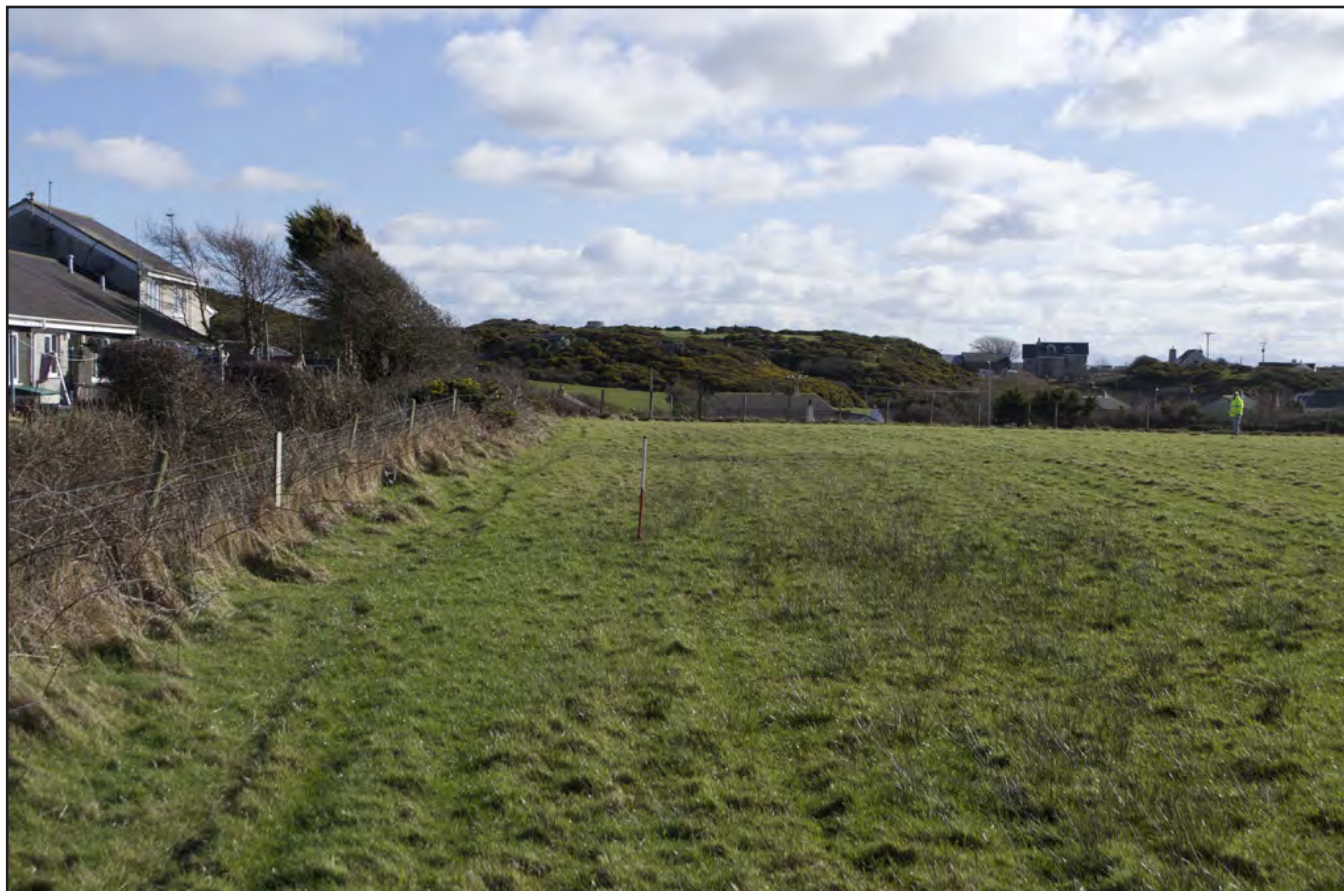
Plate 25 Section B to E - view southwest of Field 4, view southwest along proposed route of opencut.  
(Scale 1 x 1.0m: archive image: G2449\_083).

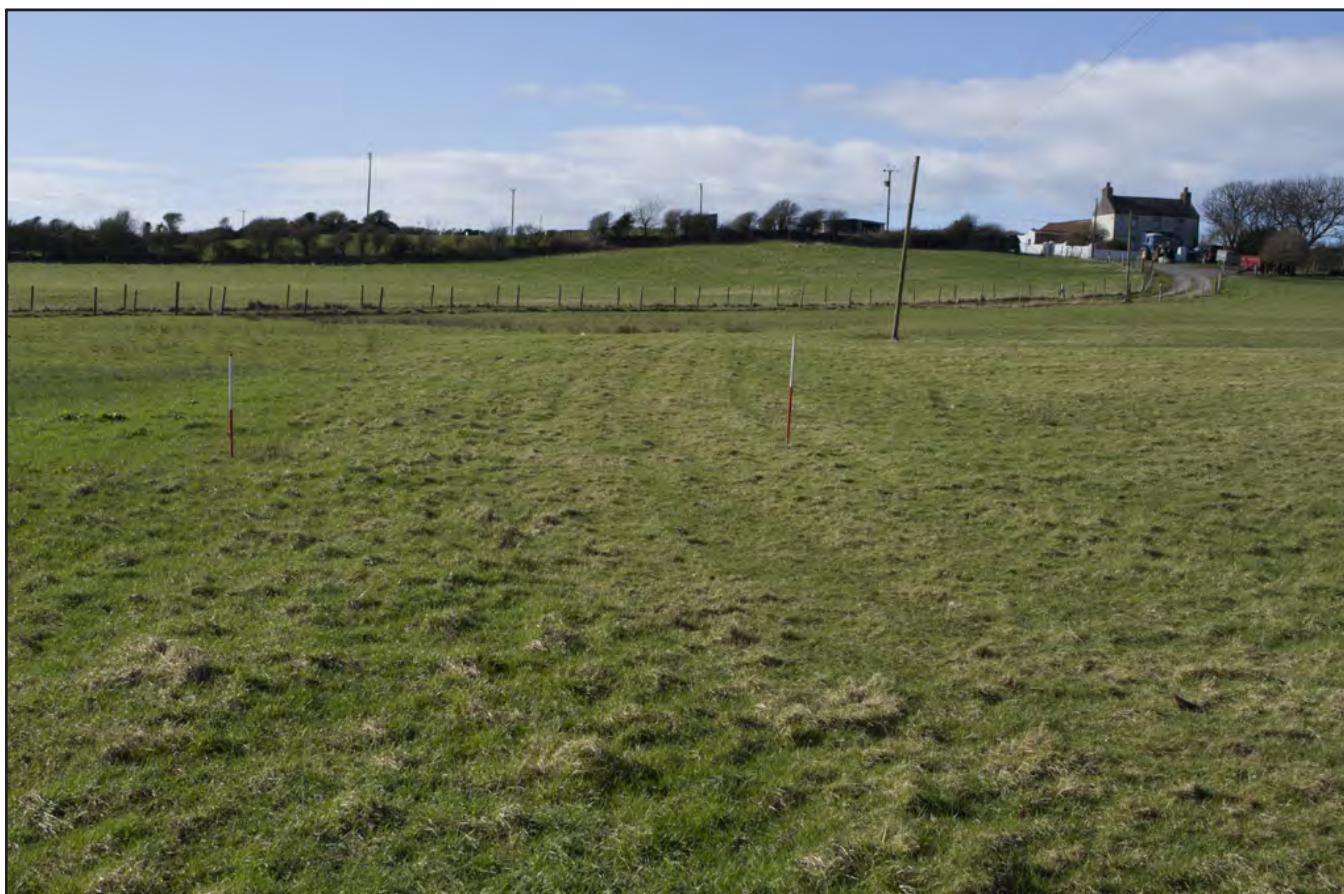
Plate 26: Section B to E - view southwest of Field 4, detailing possible causeway (Scale 2 x 1.0m: archive image: G2449\_084).

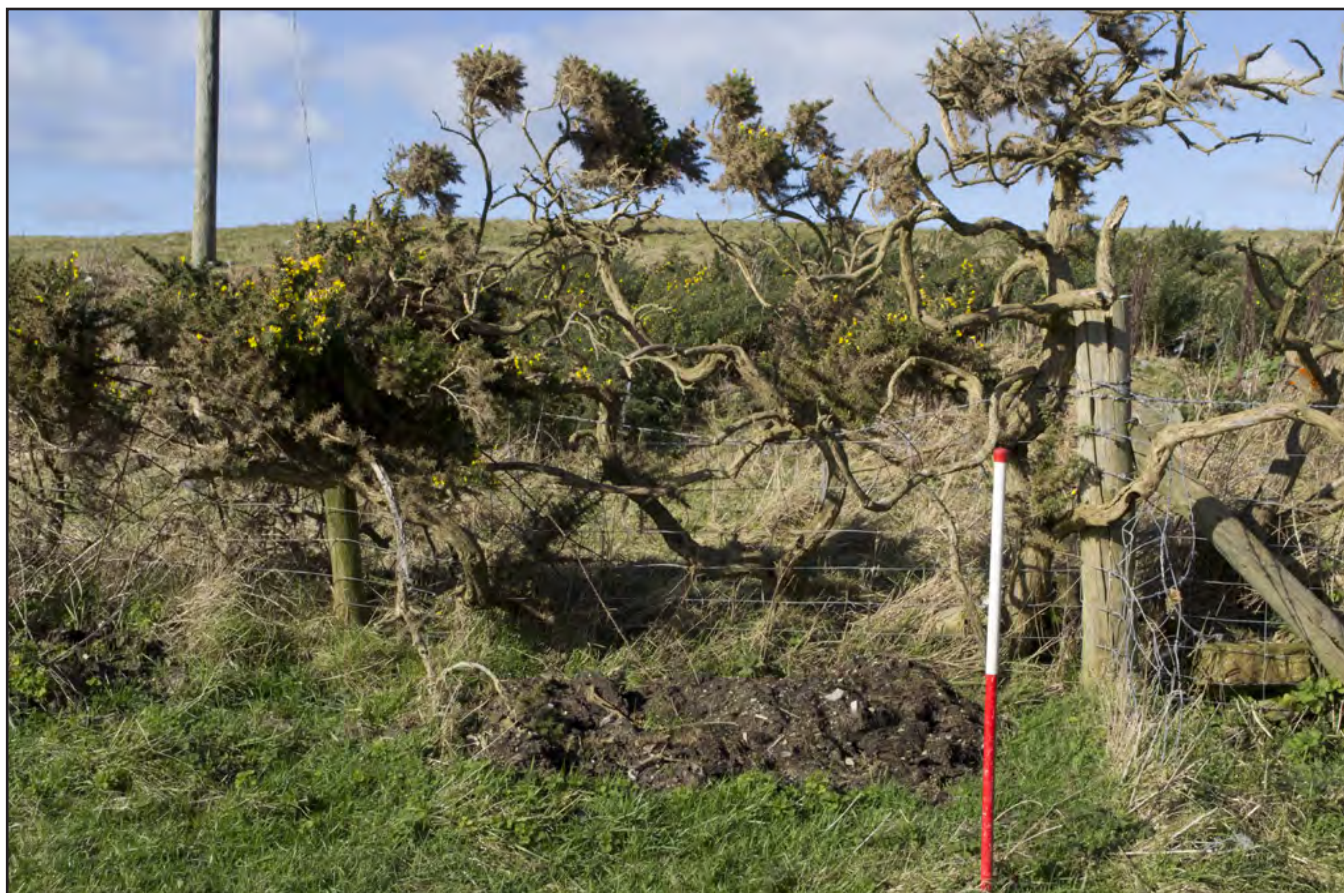
During the walkover of Fields 3 and 4 at least three backfilled geological trial pits were identified, positioned along the proposed route of the open cut trench. The pits were located just north of the causeway in Field 4, at the boundary between Fields 4 and 3 (Plate 27) and on top of the ridge in Field 3 (Plate 28). A more in-depth description of the fields accessed for Section B-E is detailed in Table 3.

Plate 27: Section B to E - field boundary between fields four and three with geological trial pit.  
(Scale 1 x 1.0m: archive image: G2449\_085).

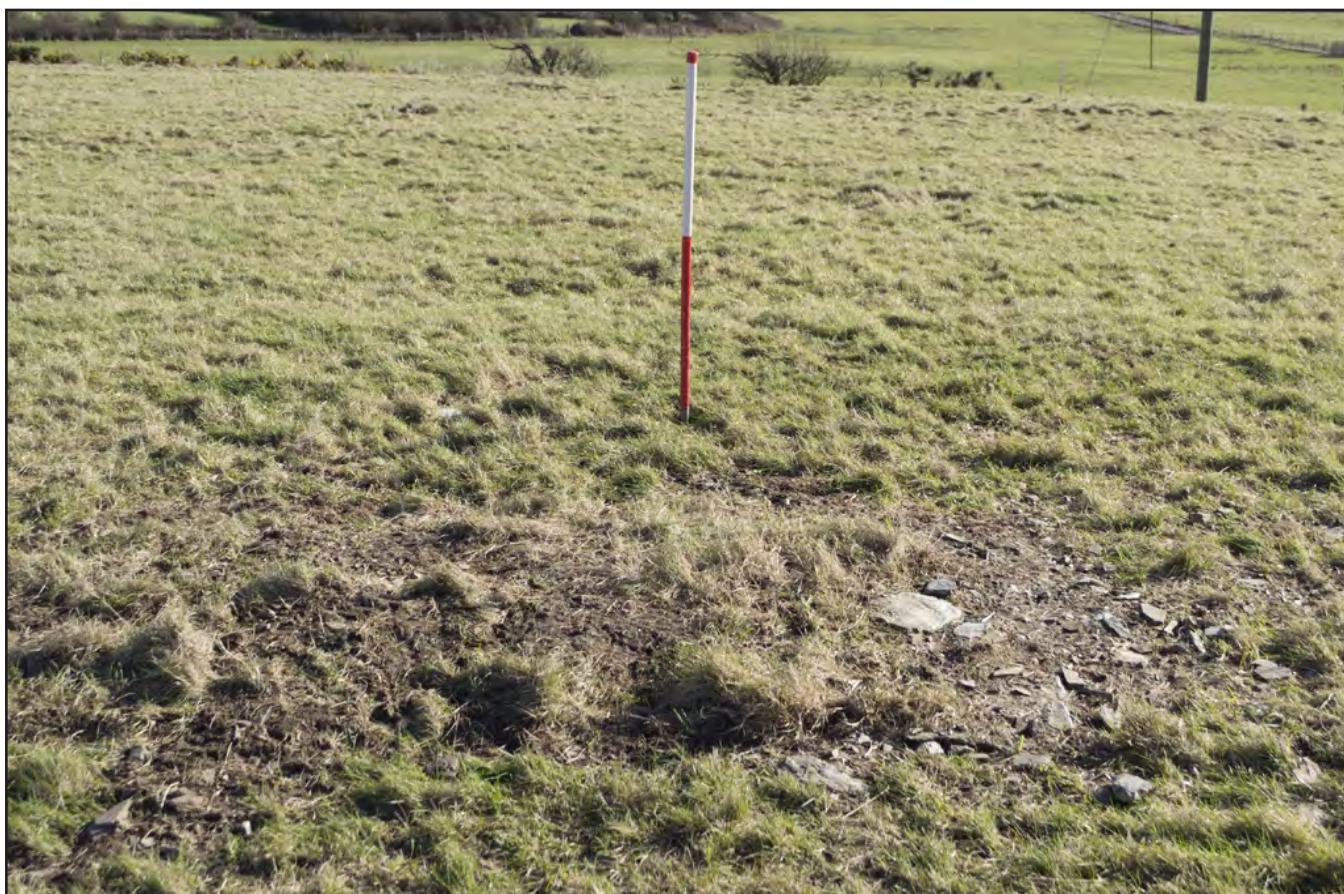
Plate 28: Section B to E - view northeast of Field 3, geological trial pit on top of ridge.  
(Scale 1 x 1.0m: archive image: G2449\_086).

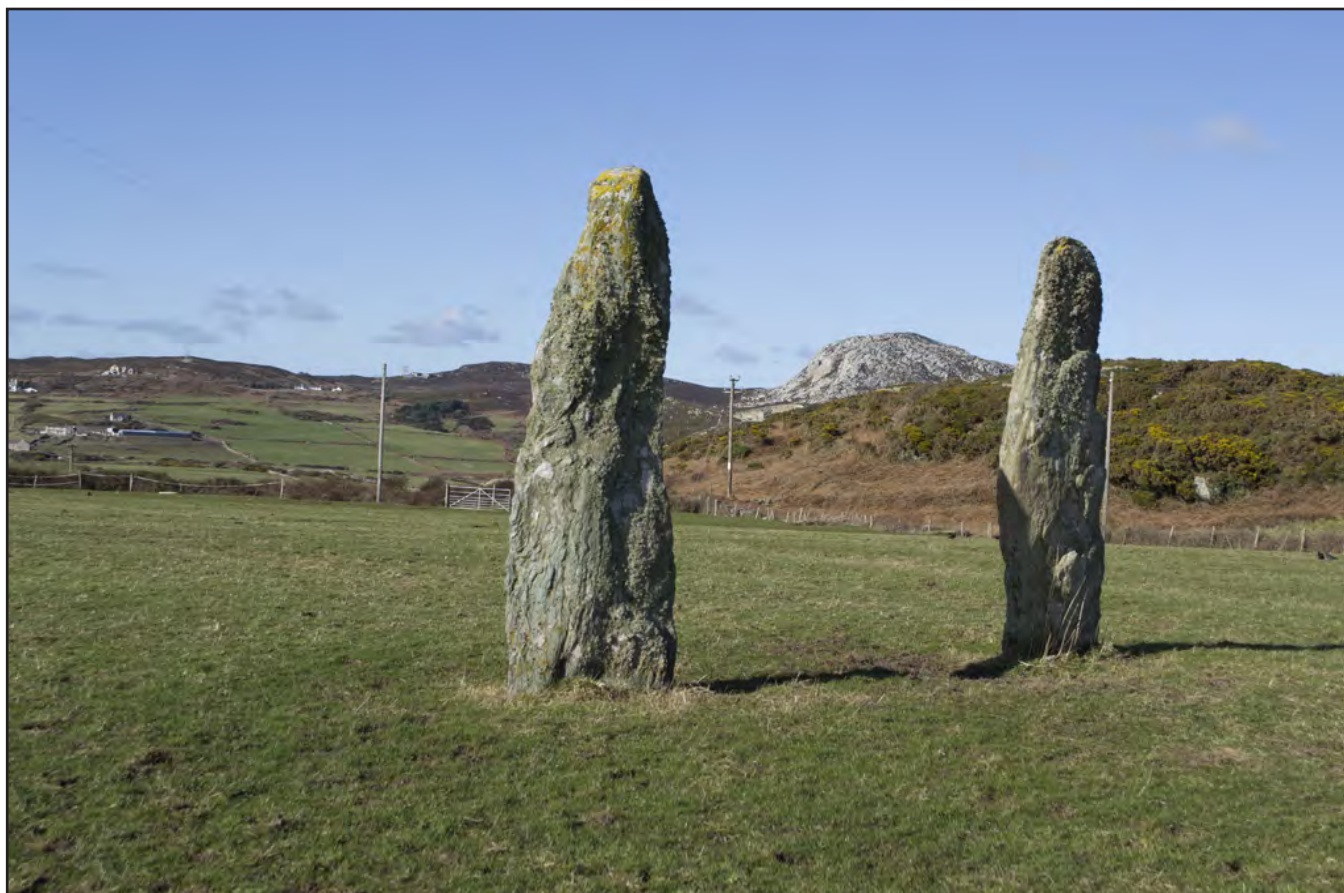
Plate 29: View from AN017 to the north-east and direction of open-cut trench (archive image: G2449\_093).

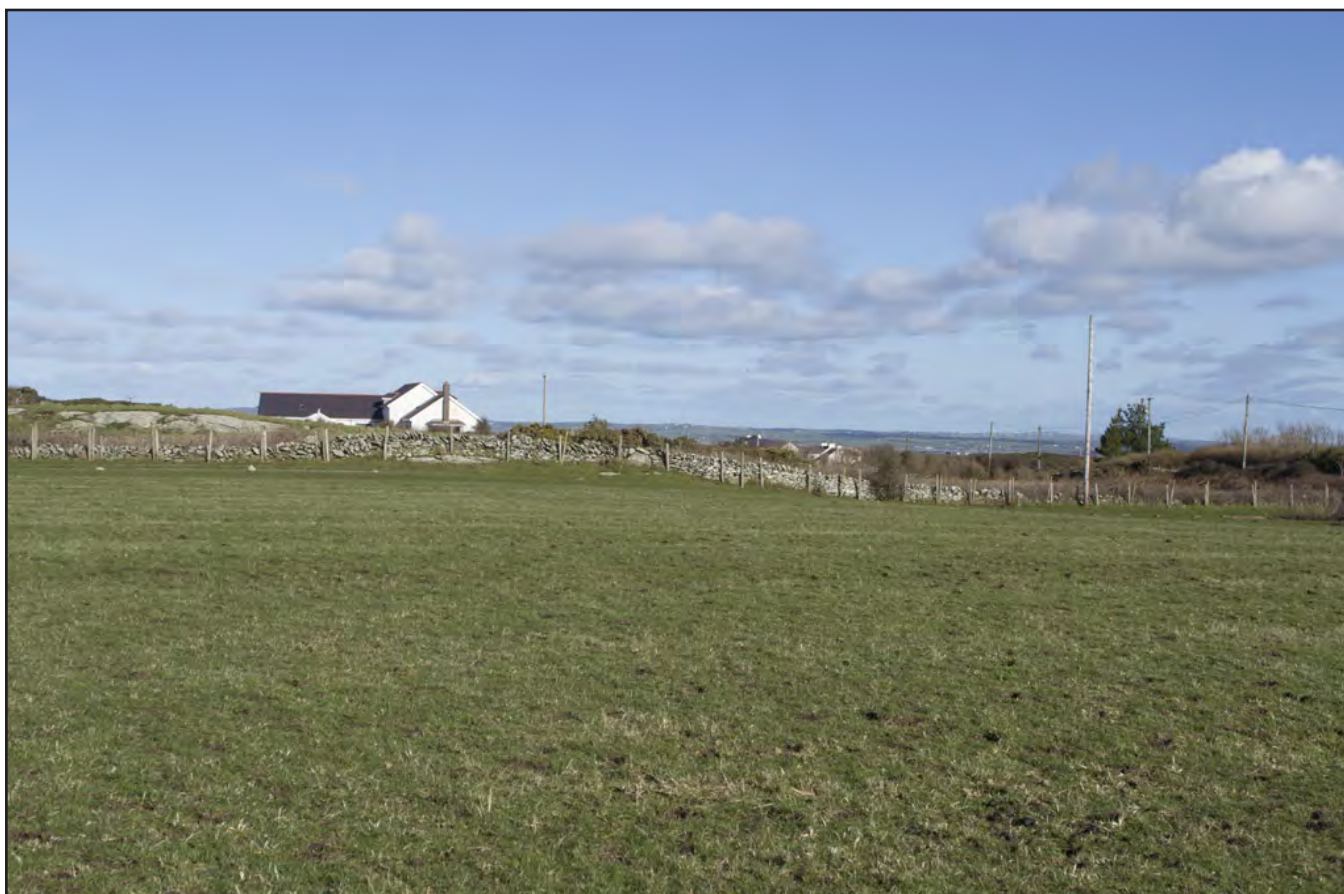
Plate 30: View from Plas Road, adjacent to AN033 to the north-east and direction of open-cut trench (archive image: G2449\_094).

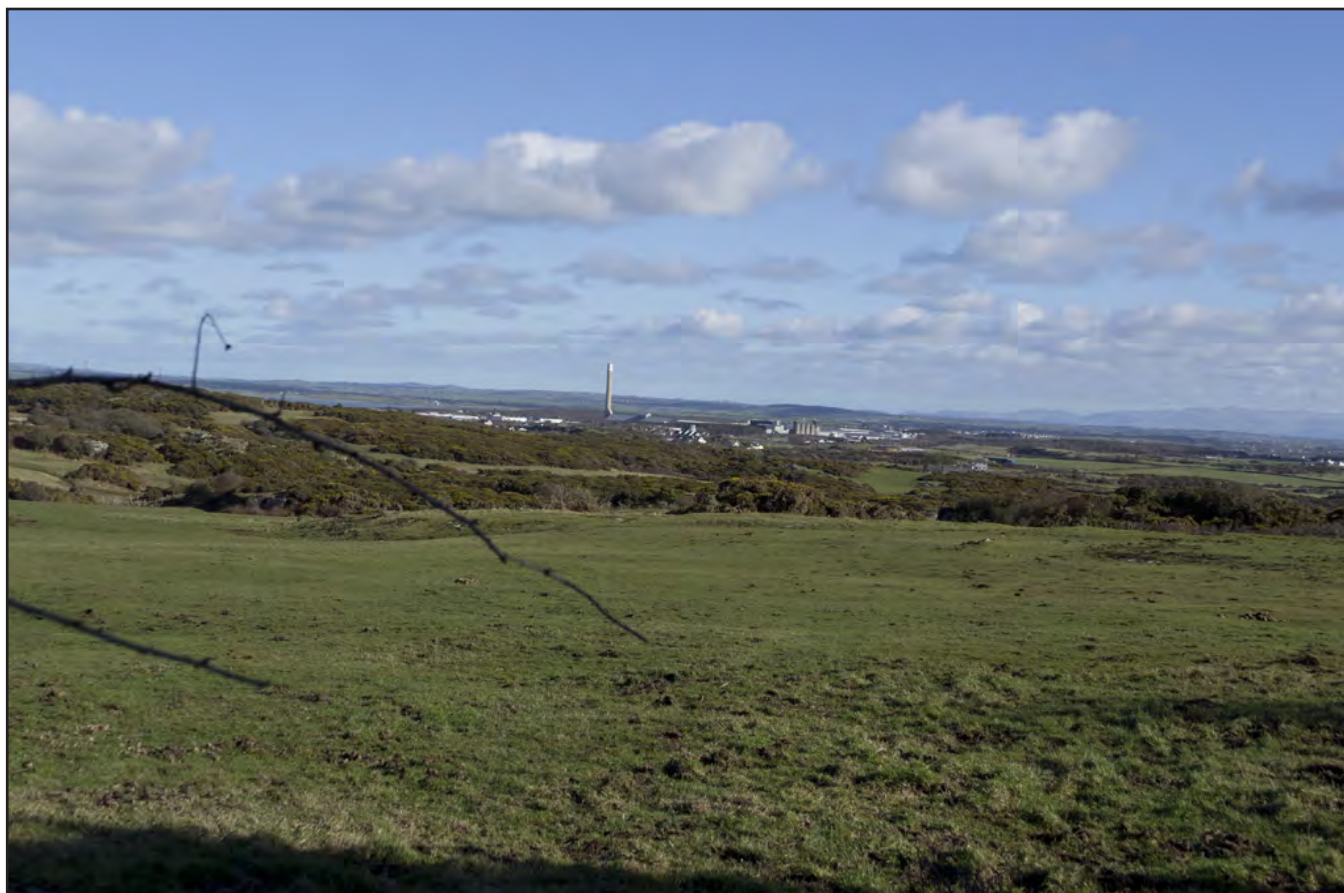
Plate 31: View from Plas Road, adjacent to AN033 to the north-east and direction of opencut trench (archive image: G2449\_095).

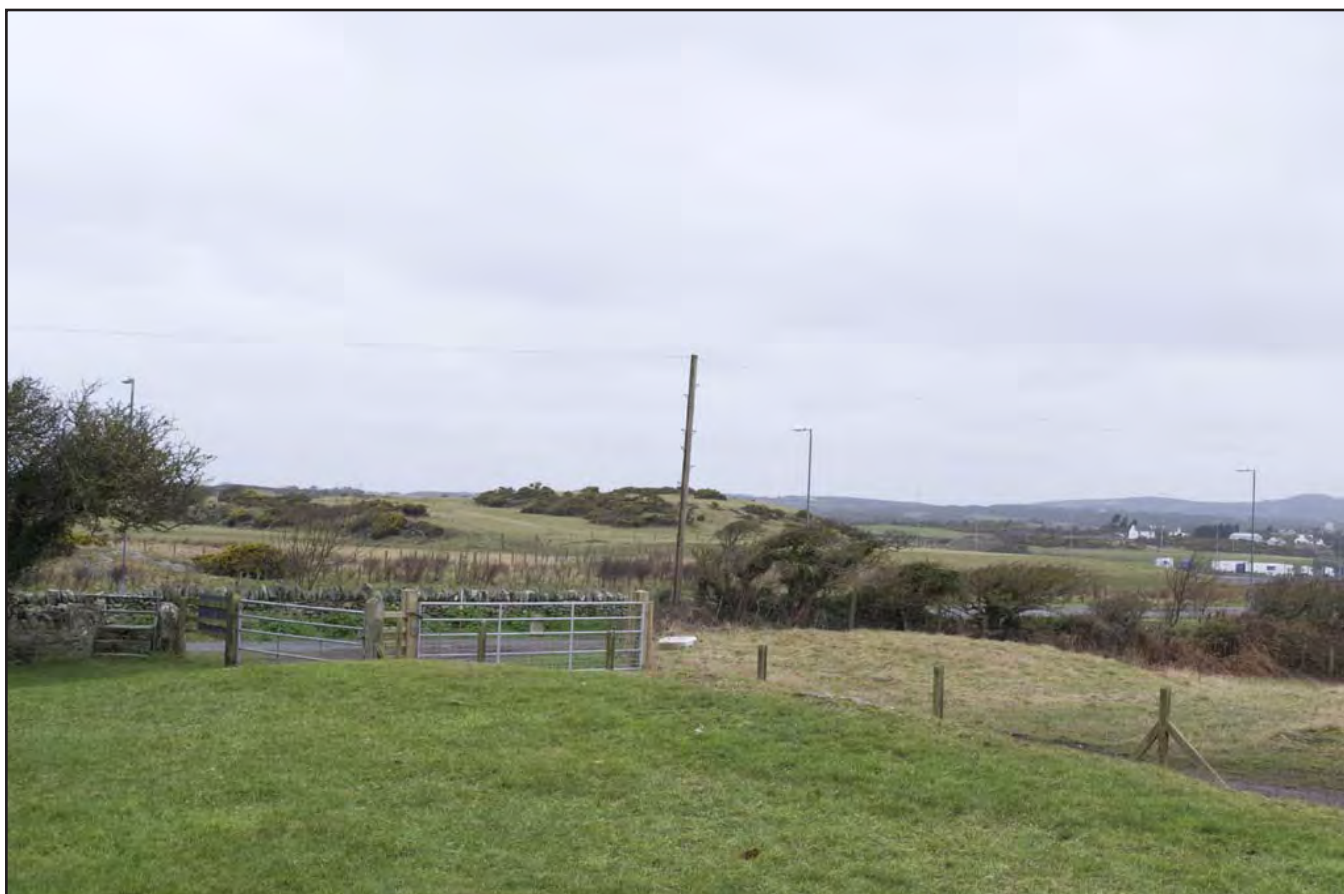
Plate 32: View from AN011 looking west-southeast (archive image: G2449\_096).

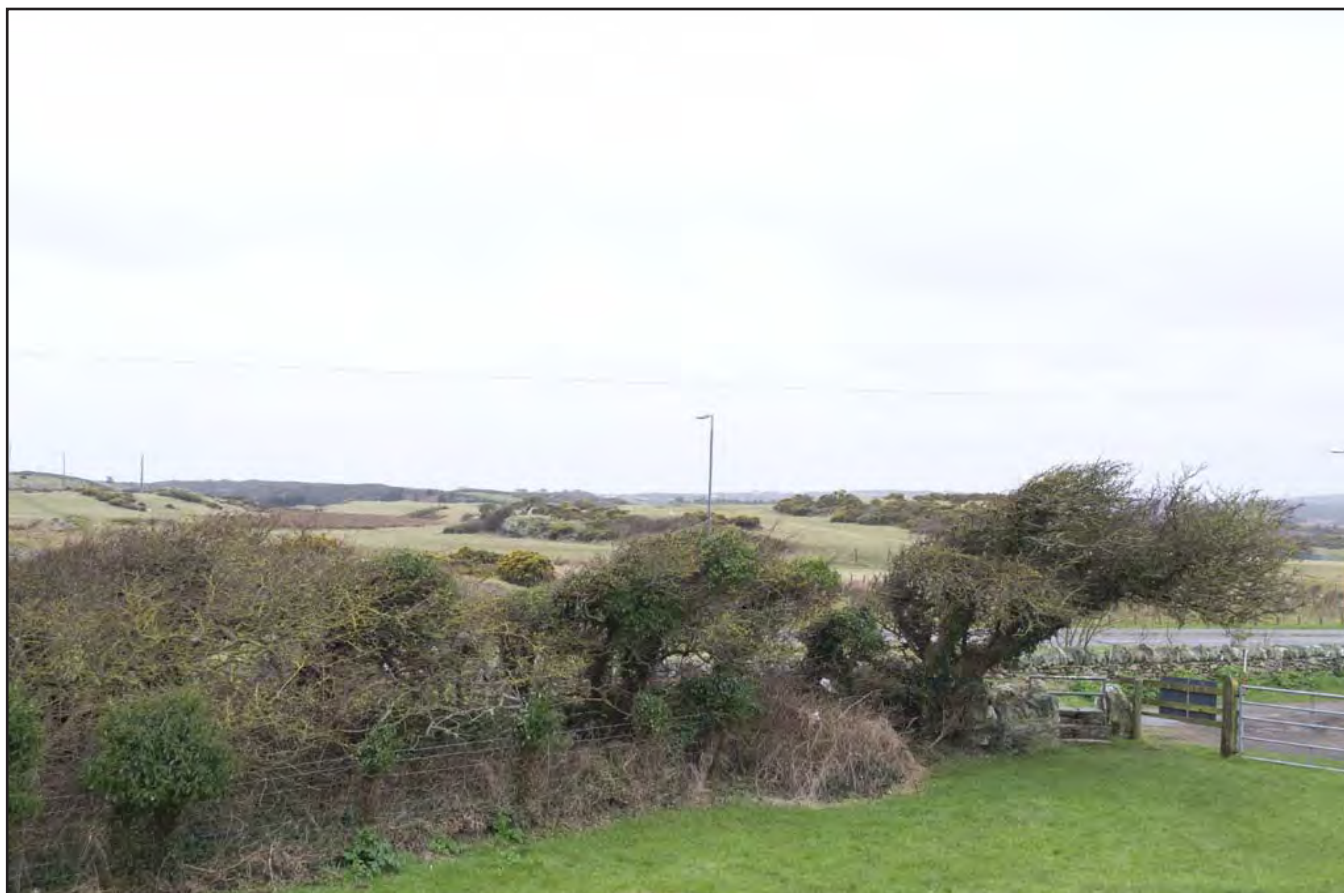
Plate 33: View from AN011 looking southwest (archive image: G2449\_097).
