# Holyhead to Cwm Reservoir

## Archaeological Assessment

Prosiect Rhif / Project No. G2449

Adroddiad Rhif / Report No. 1303

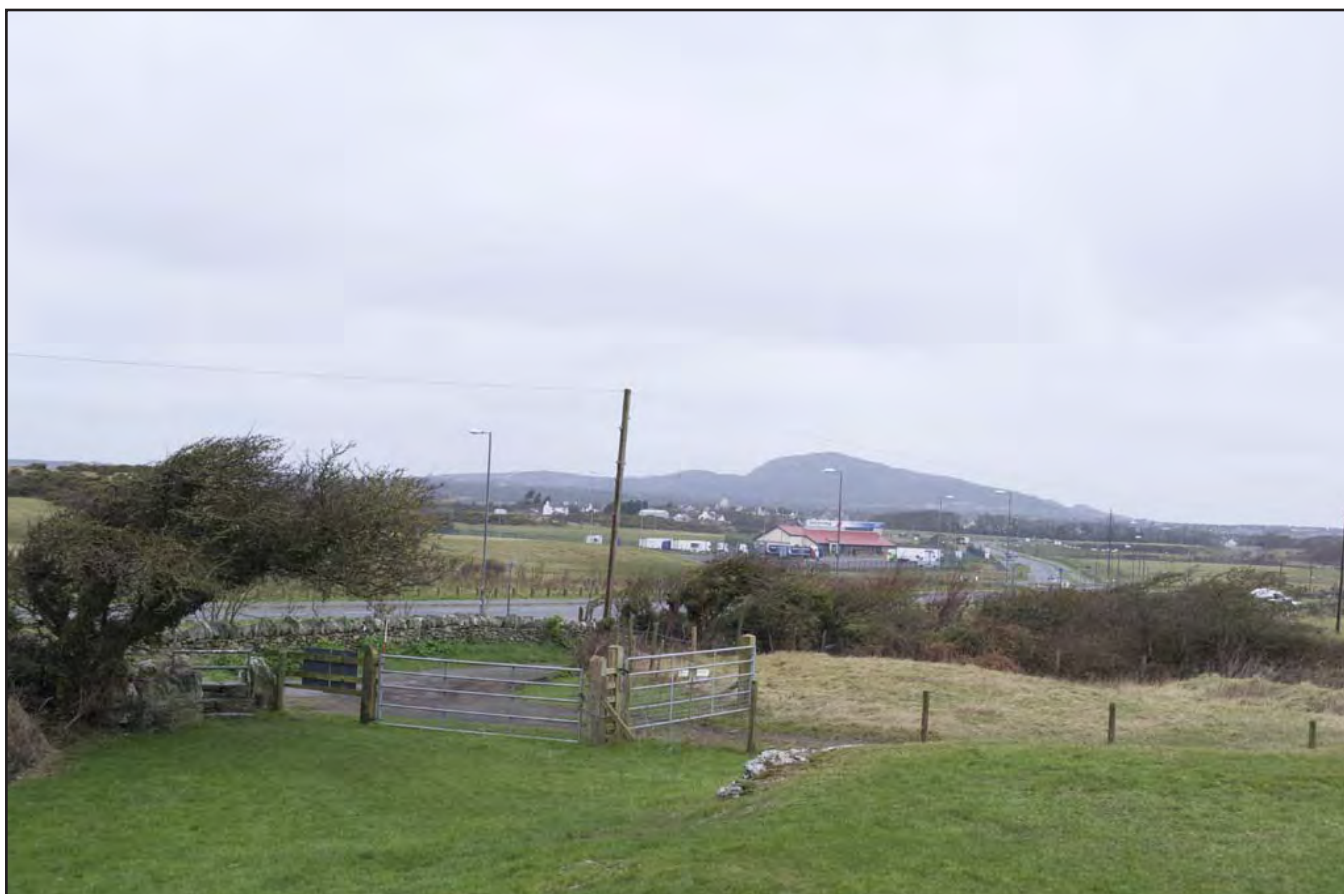
Plate 34: View from AN011 looking northwest (archive image: G2449\_098).
