Pandora Reservoirs, Trefriw, Conwy

Briff Gwyllo Archeolegol / Archaeological Watching Brief

Rhif Prosiect / Project No. HD24 -025

Rhif Adroddiad / Report No. 1776

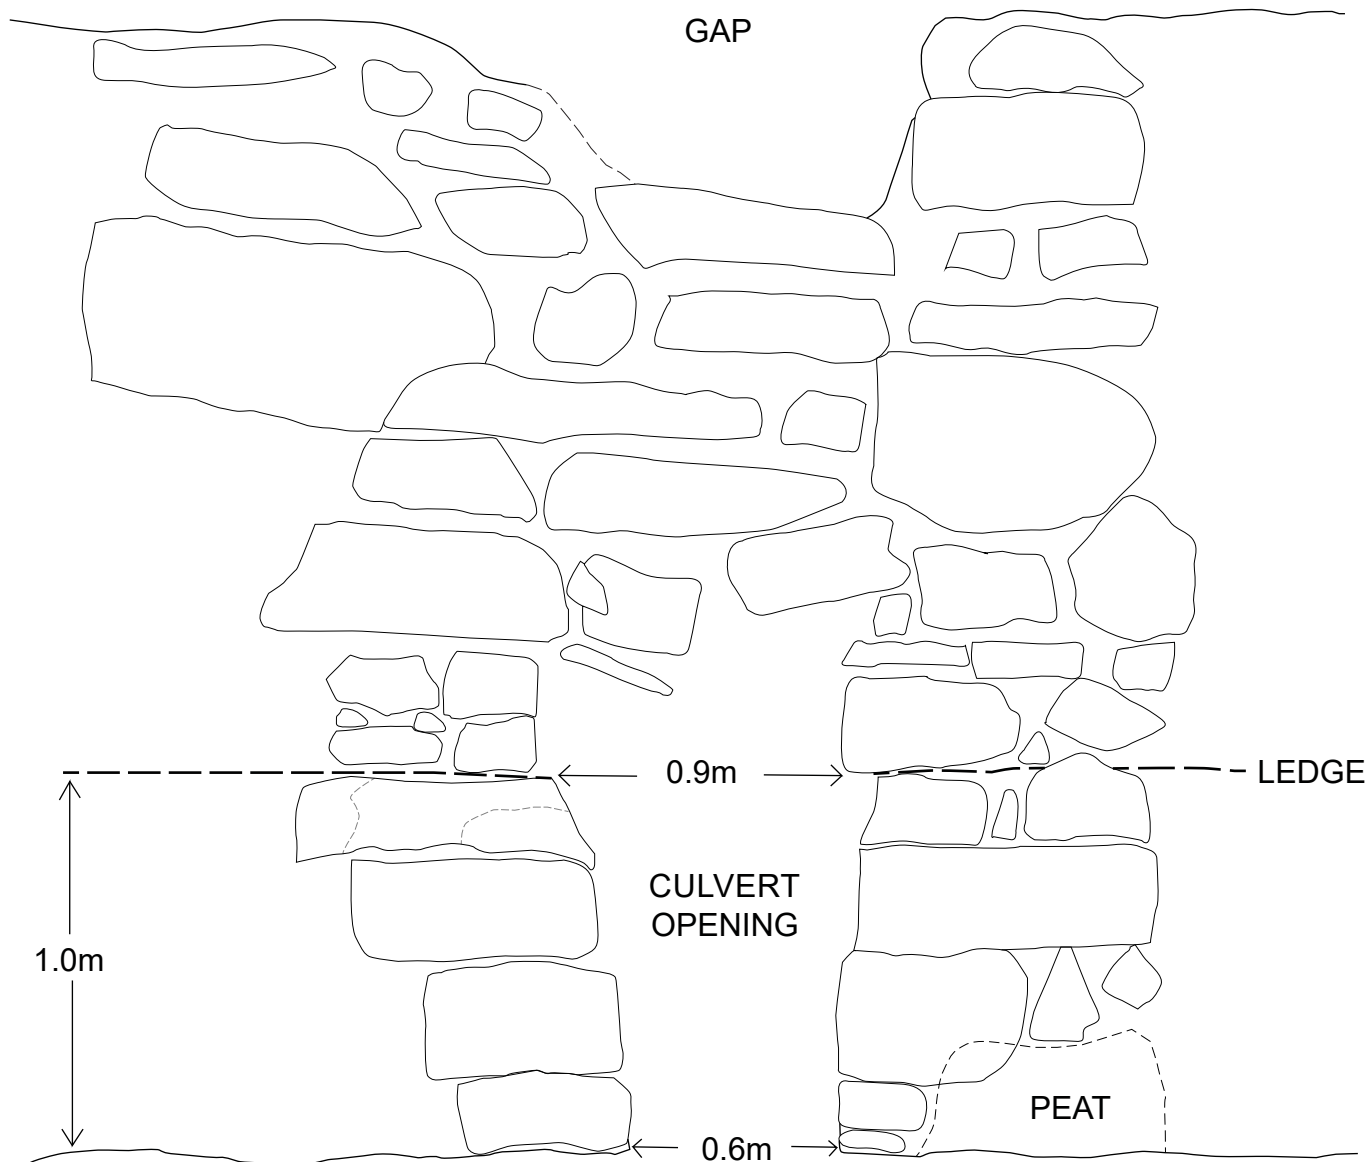
FIGURE 06

West-Northwest facing elevation of sluice in Upper Embankment. Not to scale sketch drawing@A4.

FIGURE 06:
West-Northwest facing
section of culvert;
Scale: Not to scale
(Sketch Section)@ A4.

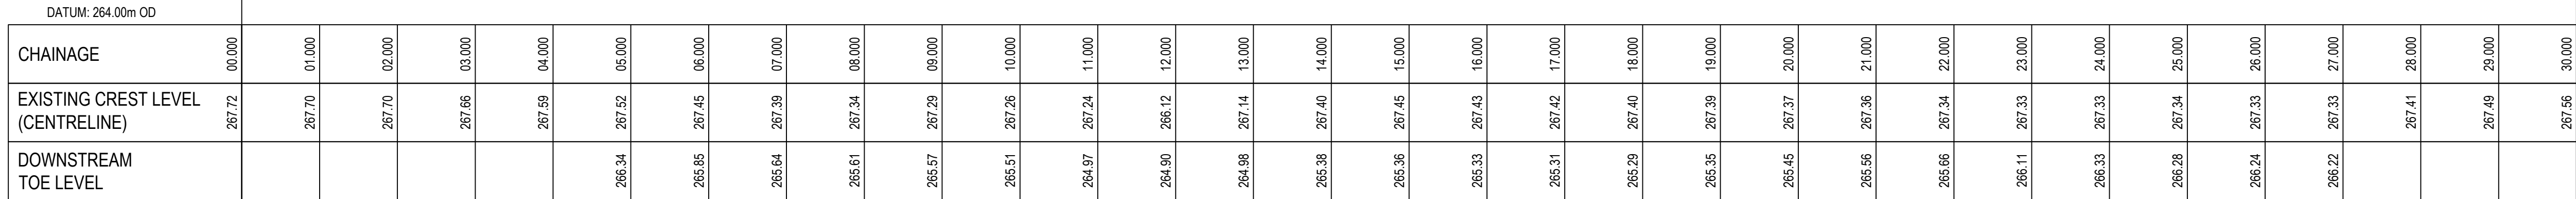
FIGURE 07

**Reproduction of Drawing No. 4020829-BUK-ZZ-00-DR-C-00007, Pandora
Lower Breach Formalisation Plan and Sections.**

LONGITUDINAL SECTION (SECTION JJ)

CROSS SECTION (SECTION KK)

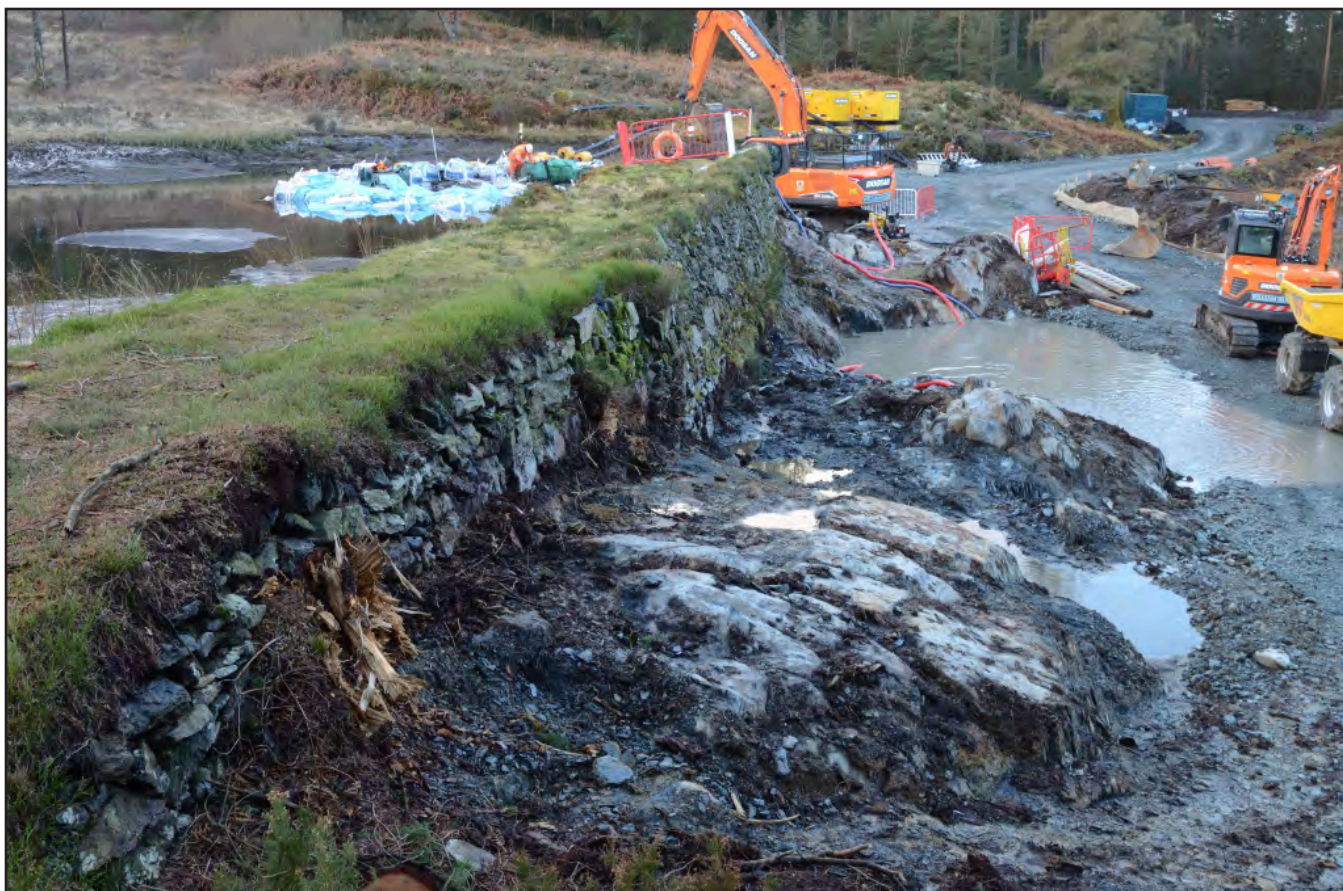
Plate 4: Exposed bedrock along northwest side of upper embankment; Scale: Not used; view from NNE (archive reference: G2826_047).

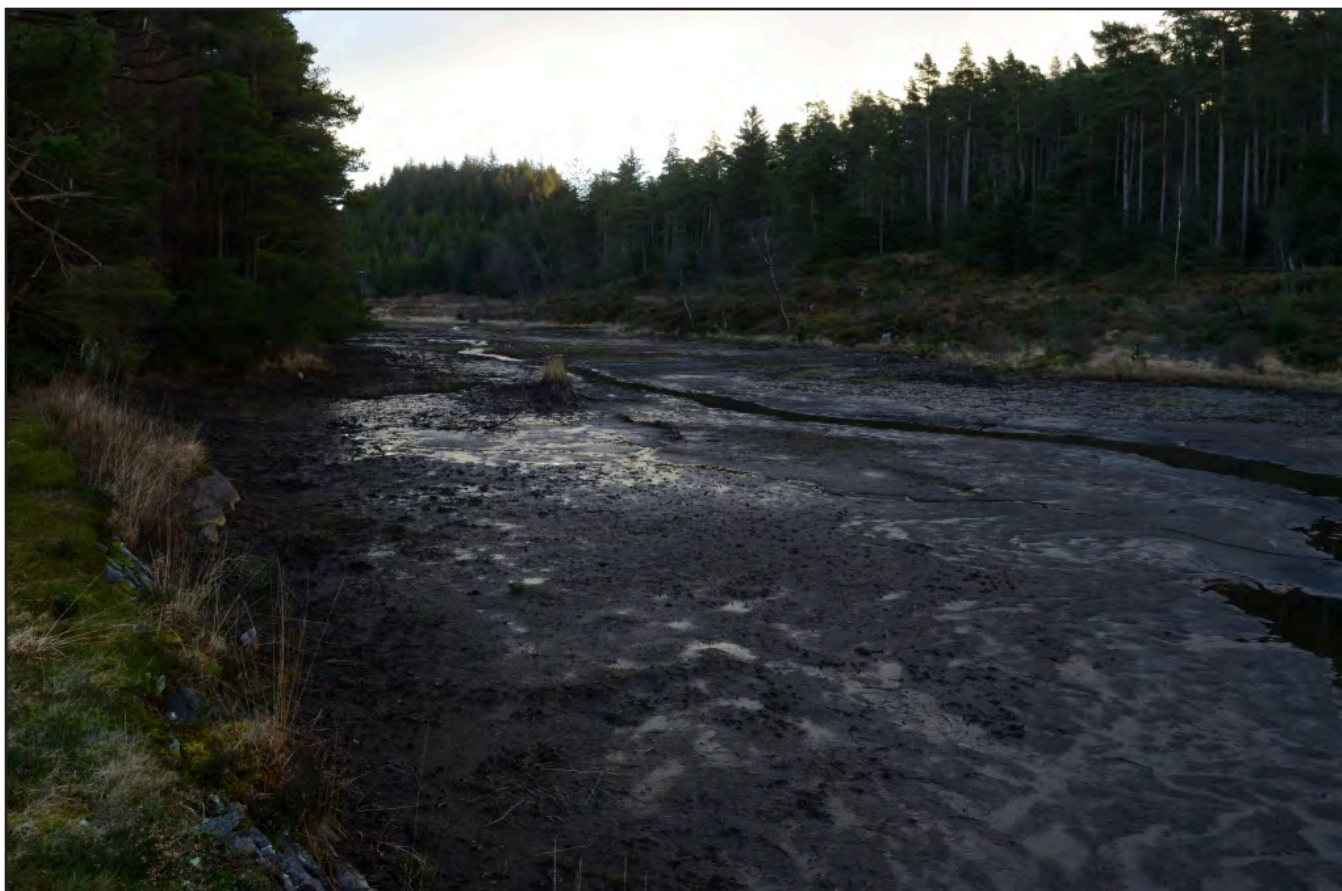
Plate 6: View of silted up, de-watered upper reservoir; Scale: Not used; view from W
(archive reference: G2826_049).

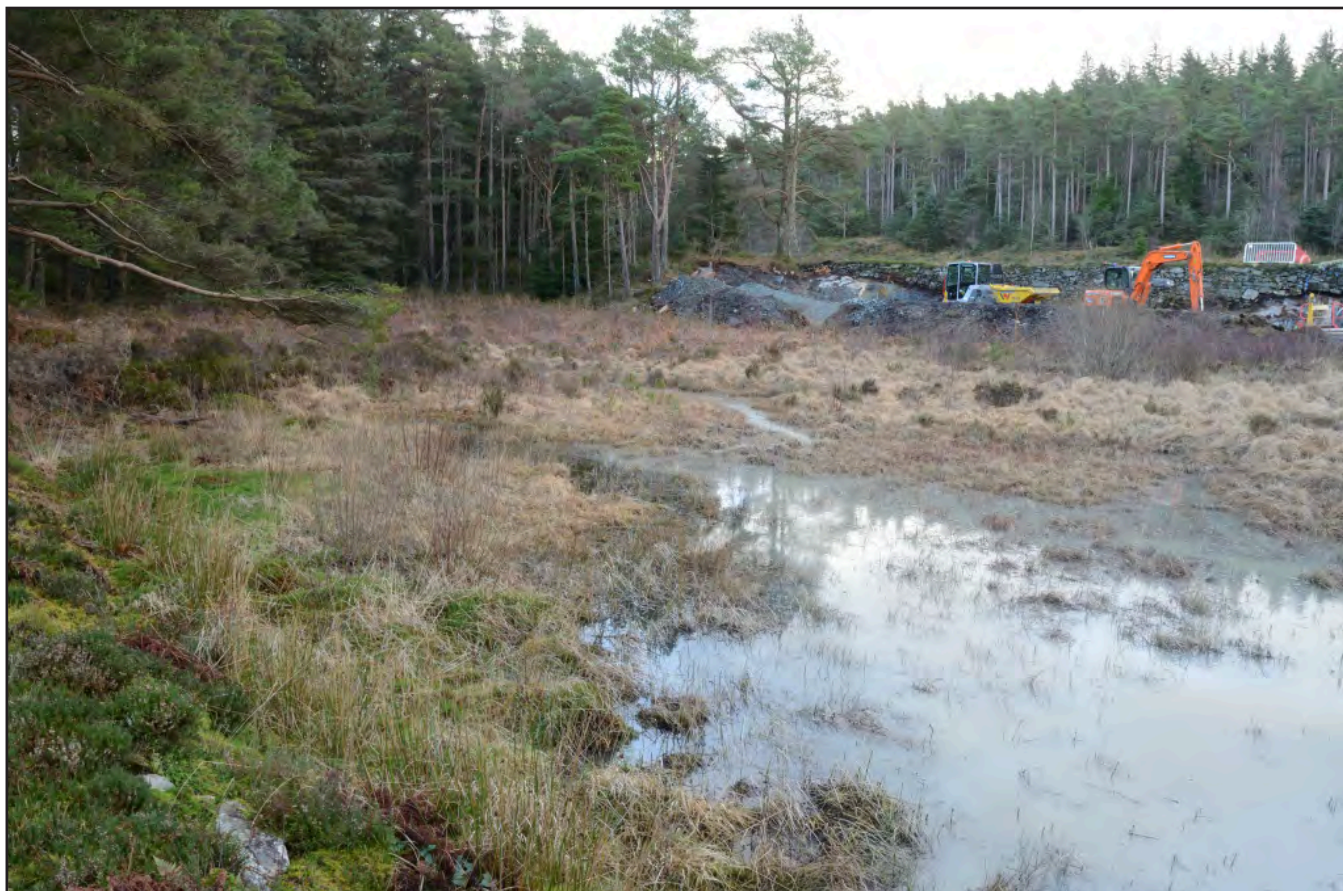
Plate 7: Silted lower reservoir with site works in background; Scale: Not used; view from W
(archive reference: G2826_057).

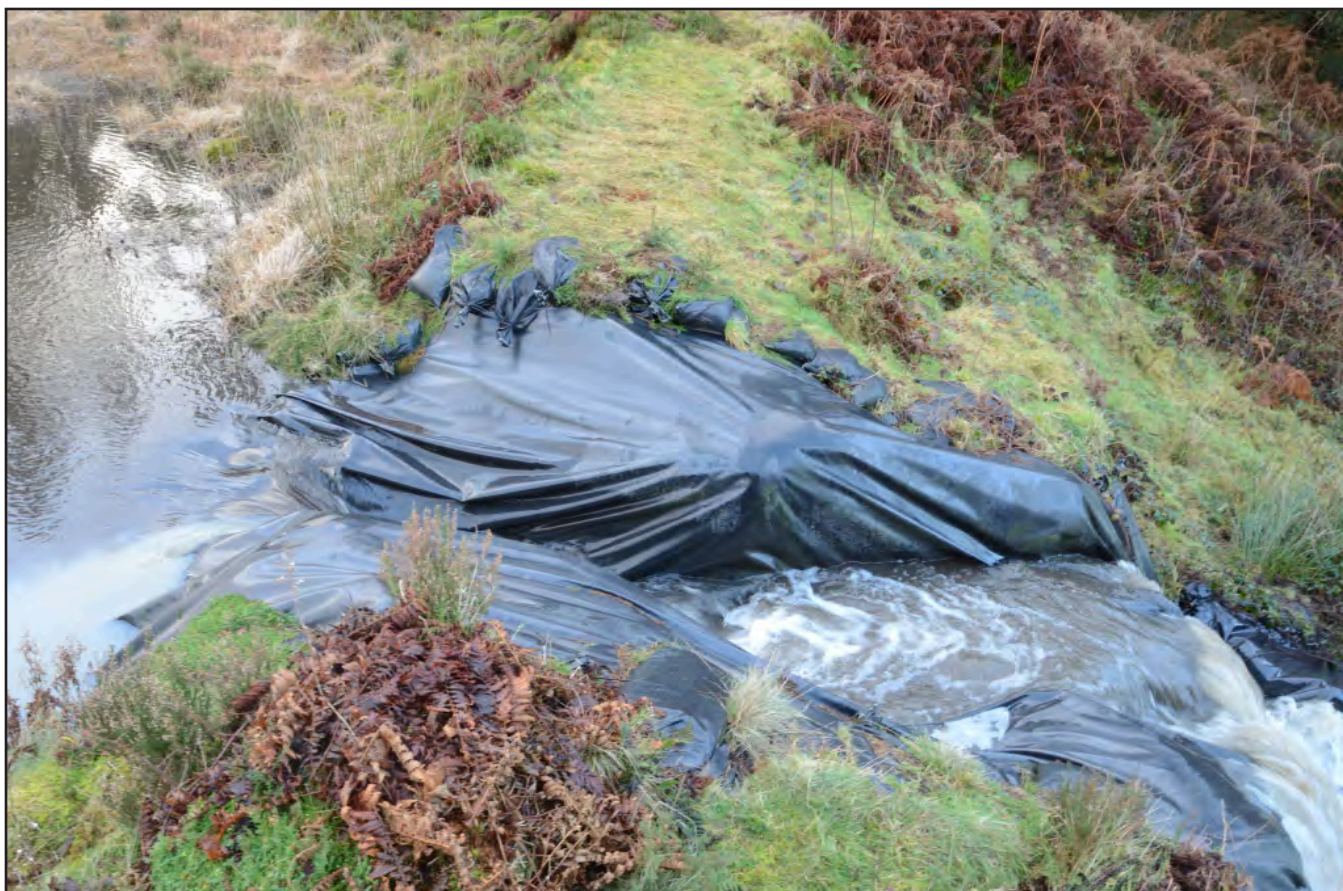
Plate 8: Tarpaulin covered breach through lower embankment; Scale: Not used; view from NNE
(archive reference: G2826_058).

The lower reservoir of Pandora, in comparison, was also heavily silted, but had large concentrations of moss, rushes (*Juncus*) and grass, along with sporadic wild seeded tree saplings at the sides of the reservoir and close to the southeastern face of the embankment (Plates 7 & 10). The breach at the lower embankment was covered with a thick black plastic tarpaulin to try to prevent further water damage to the structure (Plates 8 & 9).

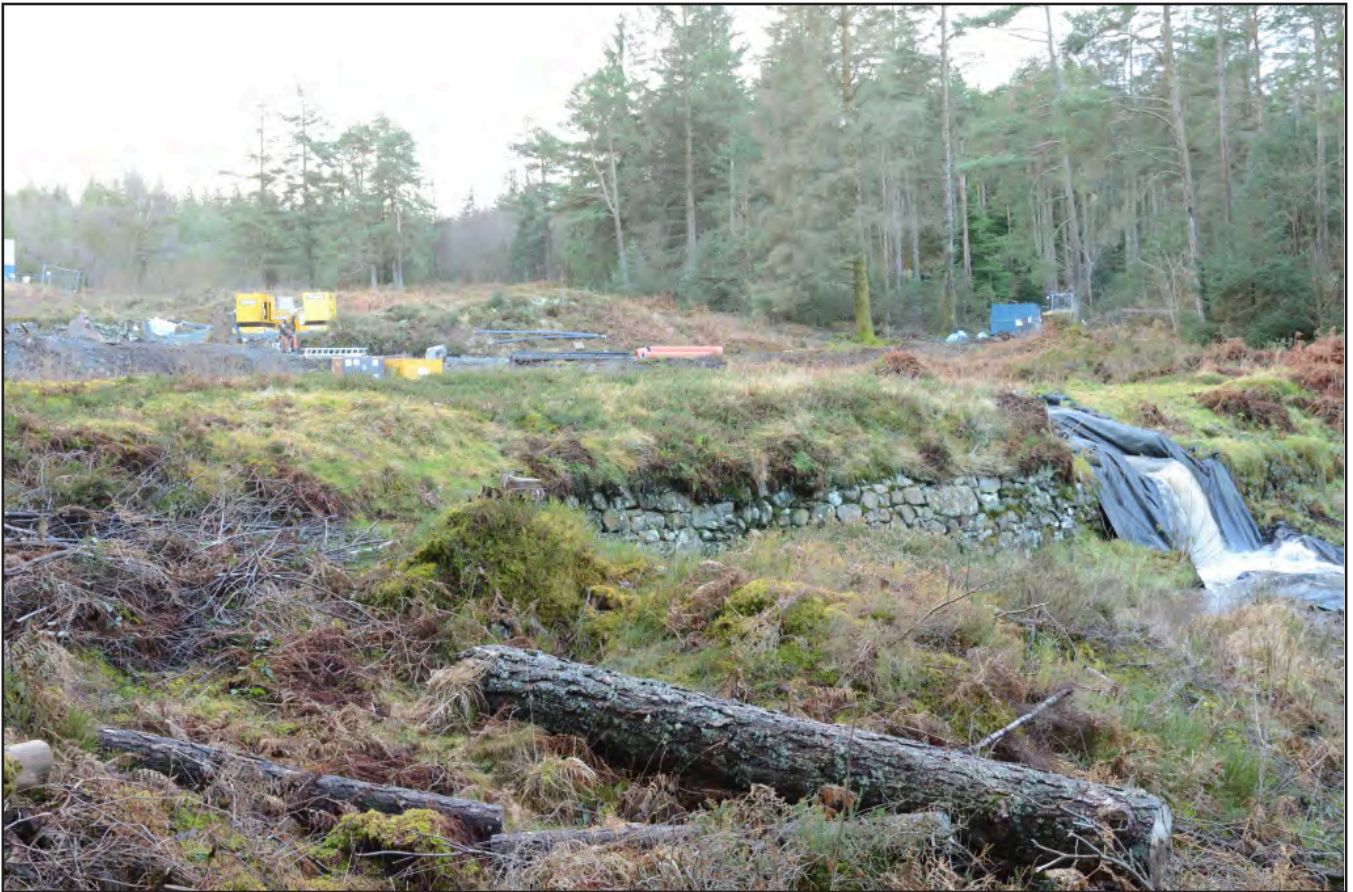
Plate 9: Western face of lower embankment; Scale: Not used; view from NNE (archive reference: G2826_059).

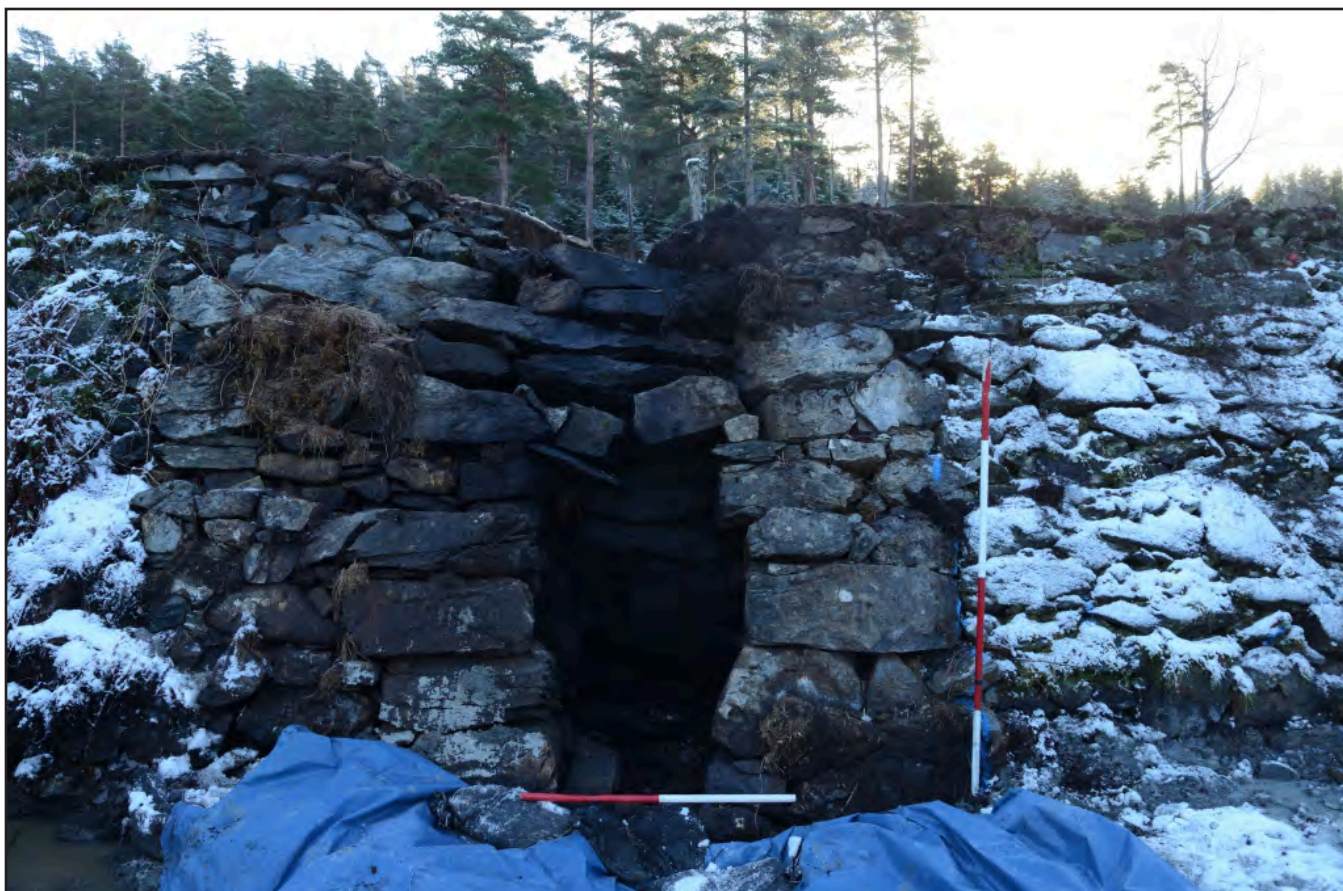
Plate 14: Close-up view of west face of sluice opening; Scale: 1x1m; view from WNW (archive reference: G2826_002).

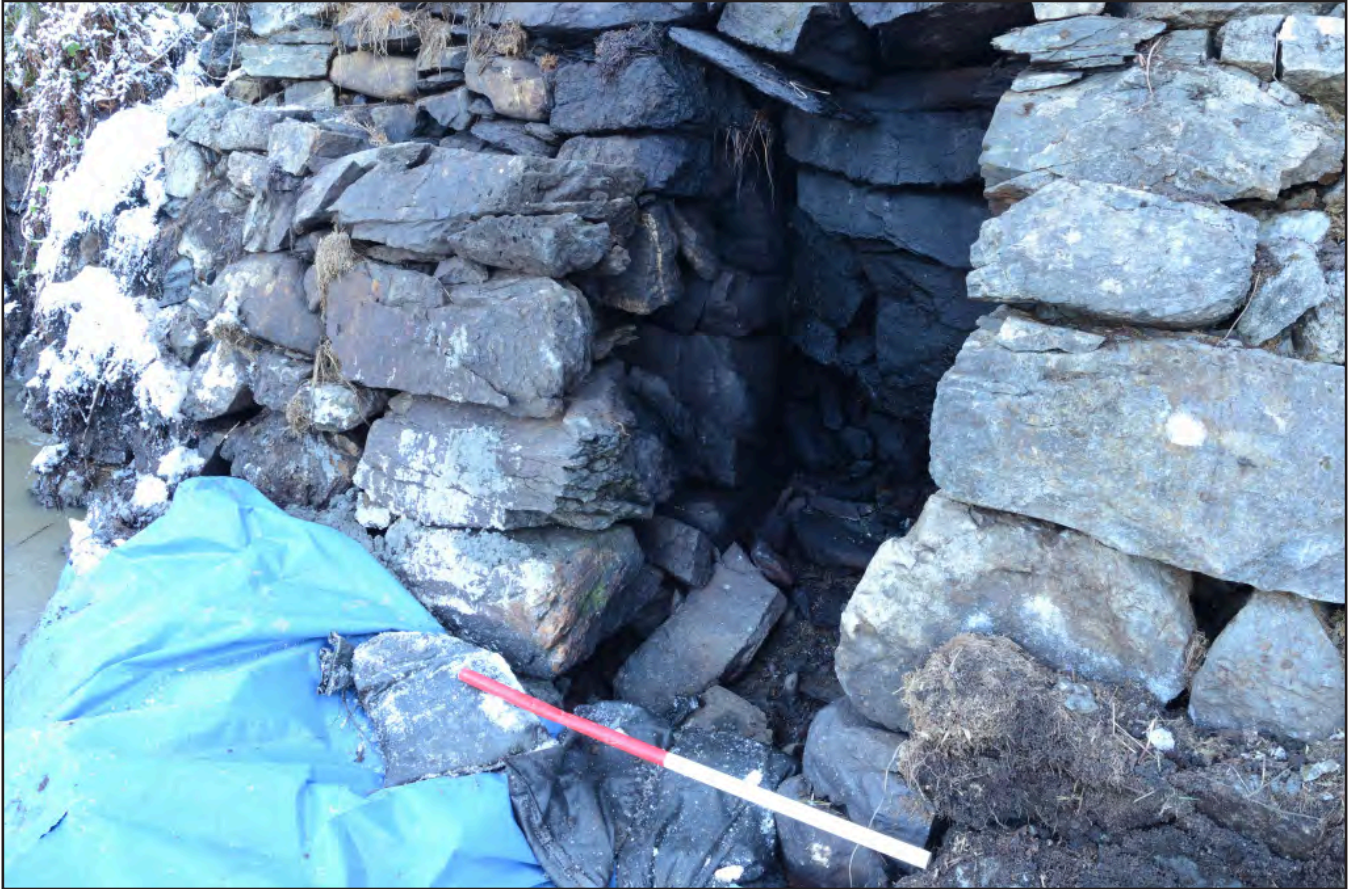
Plate 15: Close-up of interior of sluice opening; Scale: 1x1m; view from W (archive reference: G2826_003).

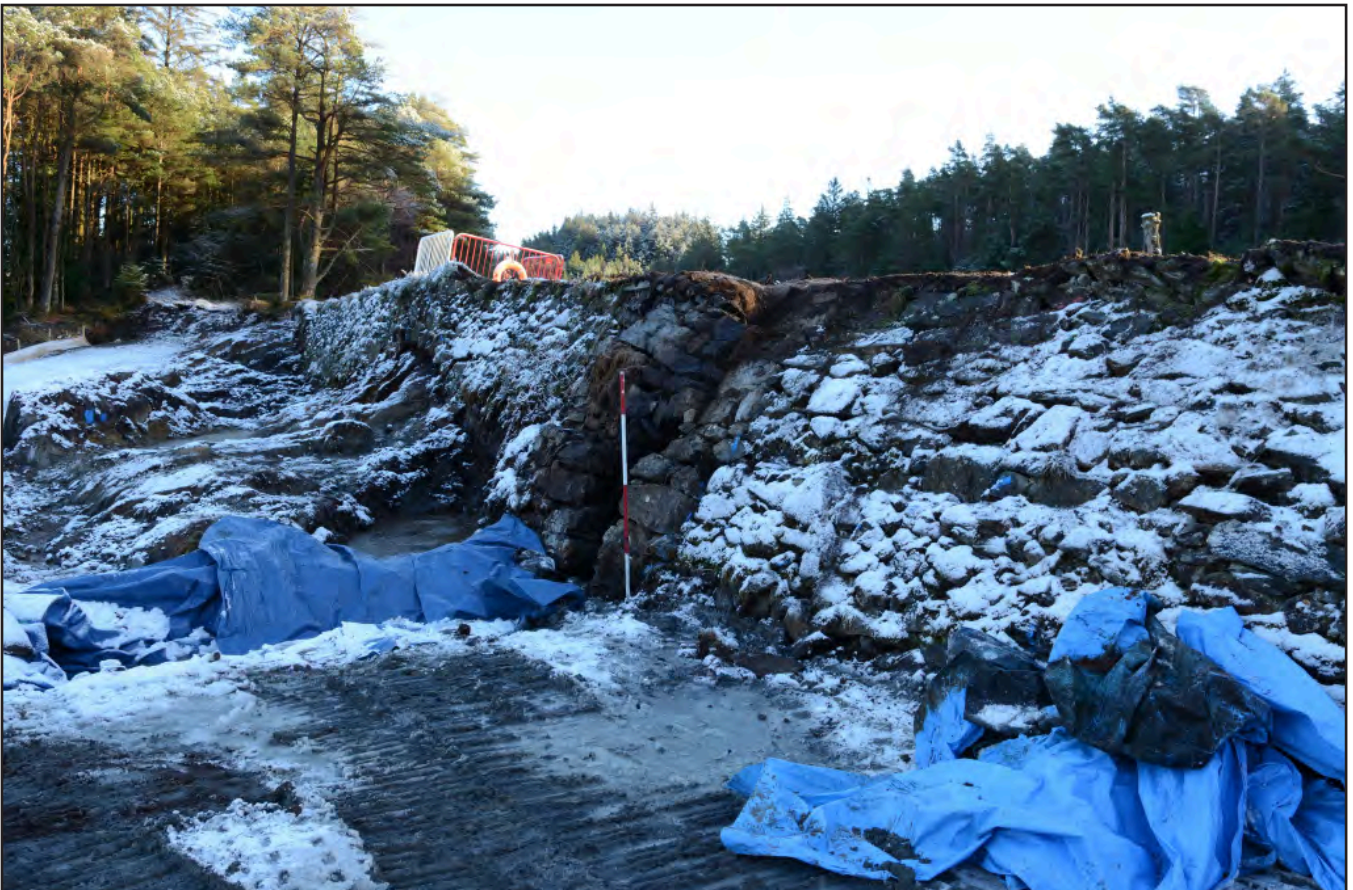
Plate 16: Location of breach and sluice opening in embankment; Scale: 1x2m; view from SW (archive reference: G2826_005).

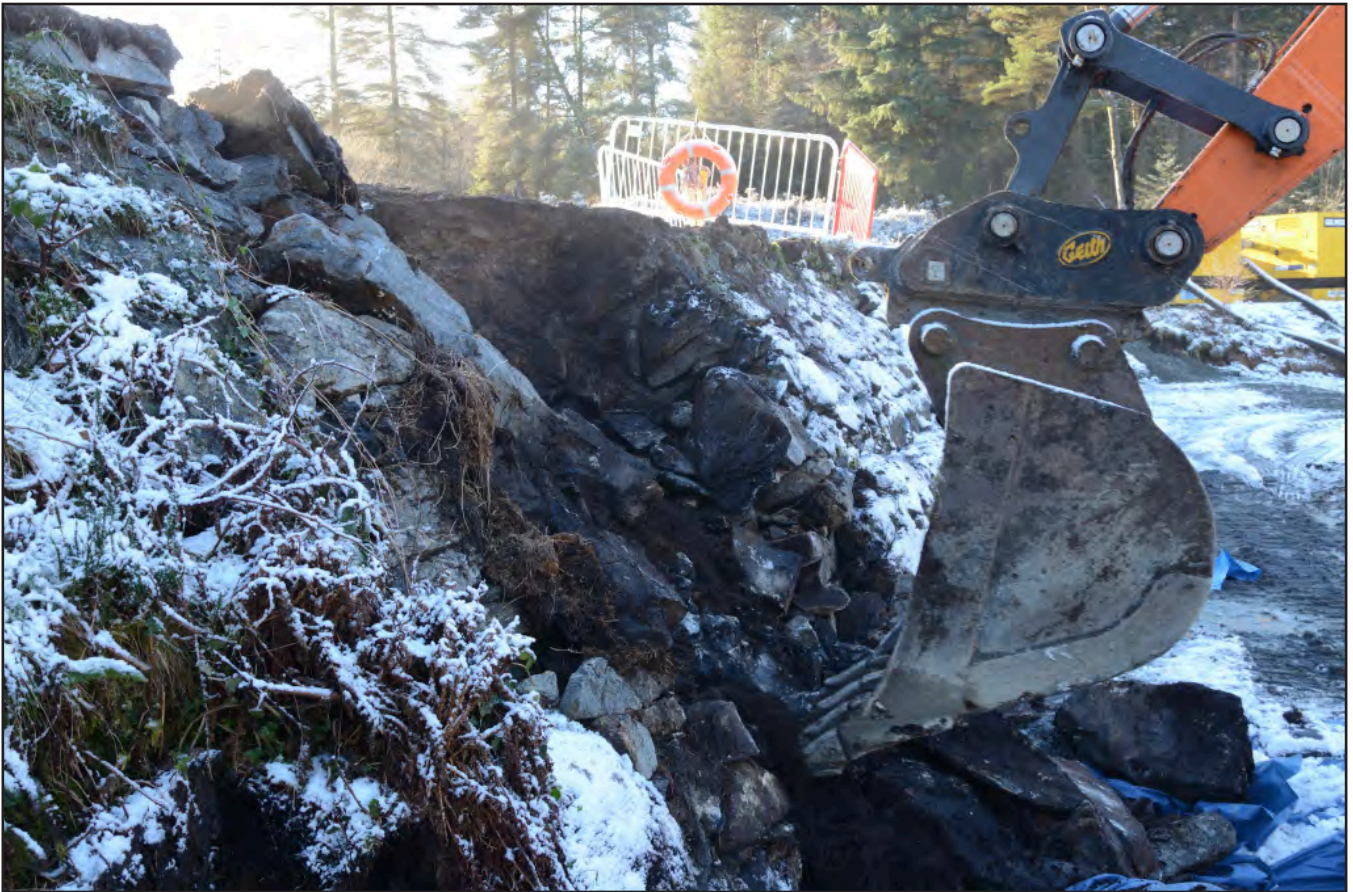
Plate 17: Excavation of spillway break of embankment wall; Scale: Not used; view from NNE (archive reference: G2826_011).

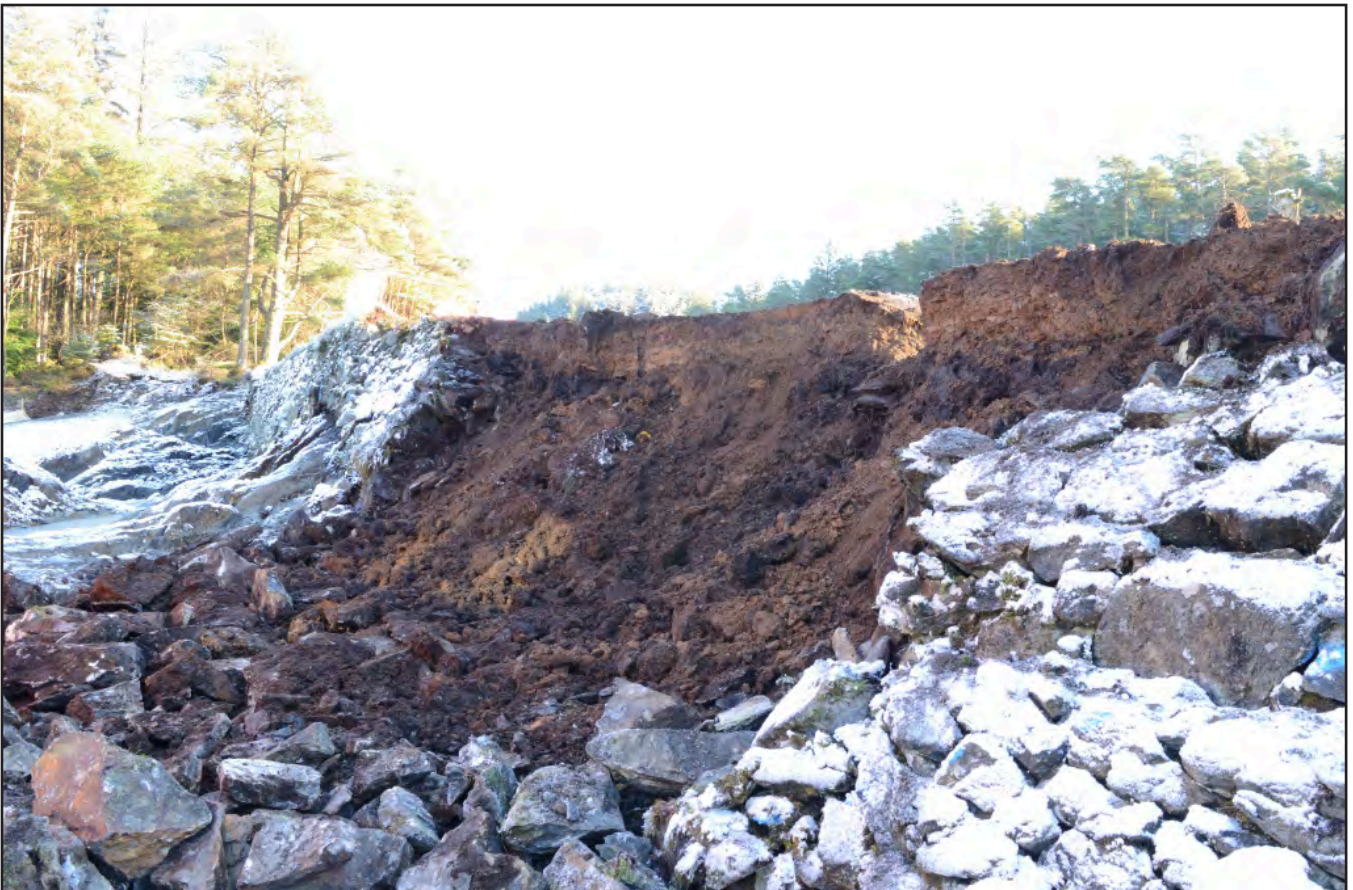
Plate 18: View of earth core of embankment exposed; Scale: Not used; view from SSW (archive reference: G2826_018).

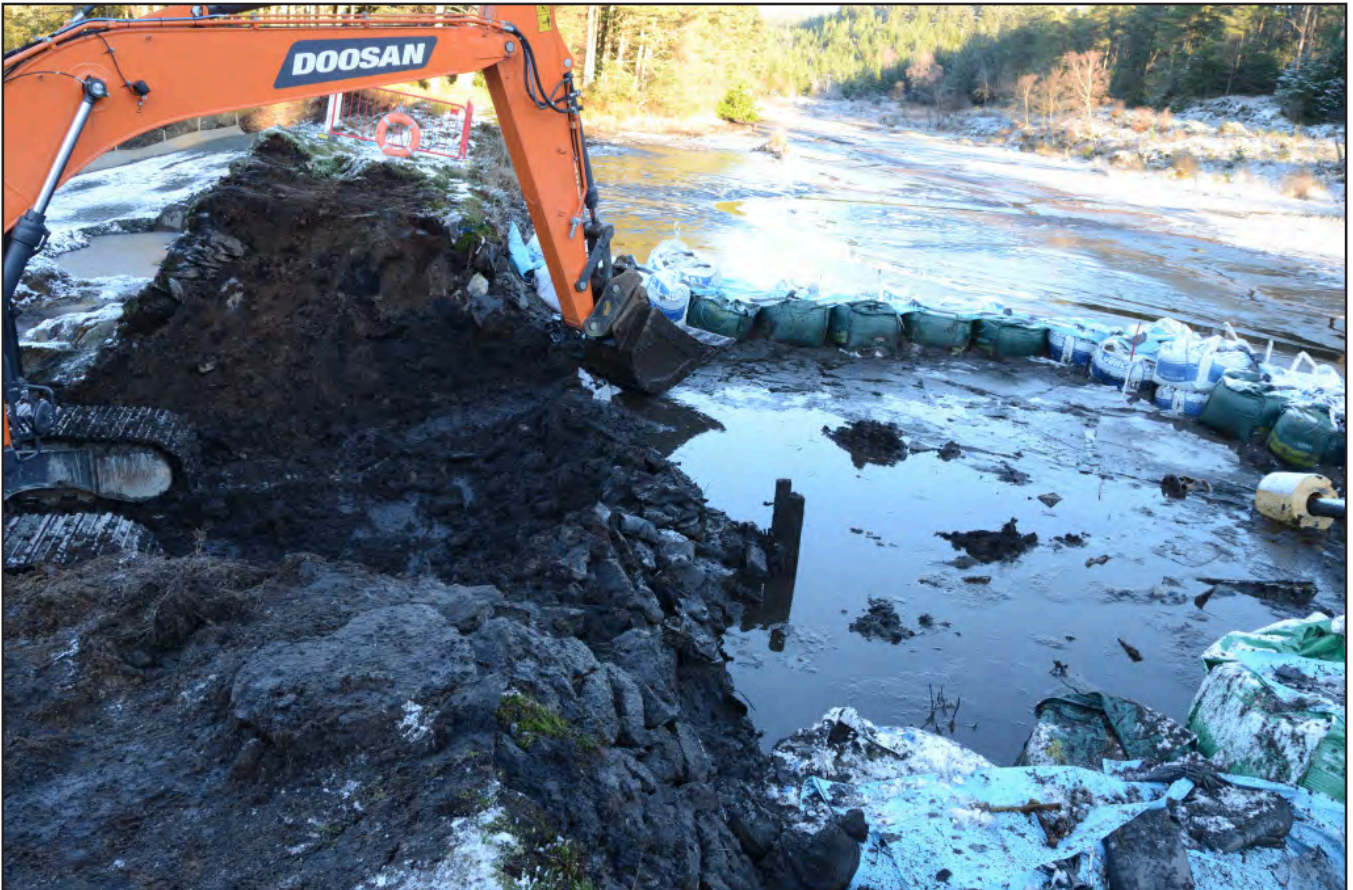
Plate 21: Excavation area of spillway within embankment and collar dam; Scale: Not used; view from SW (archive reference: G2826_041).

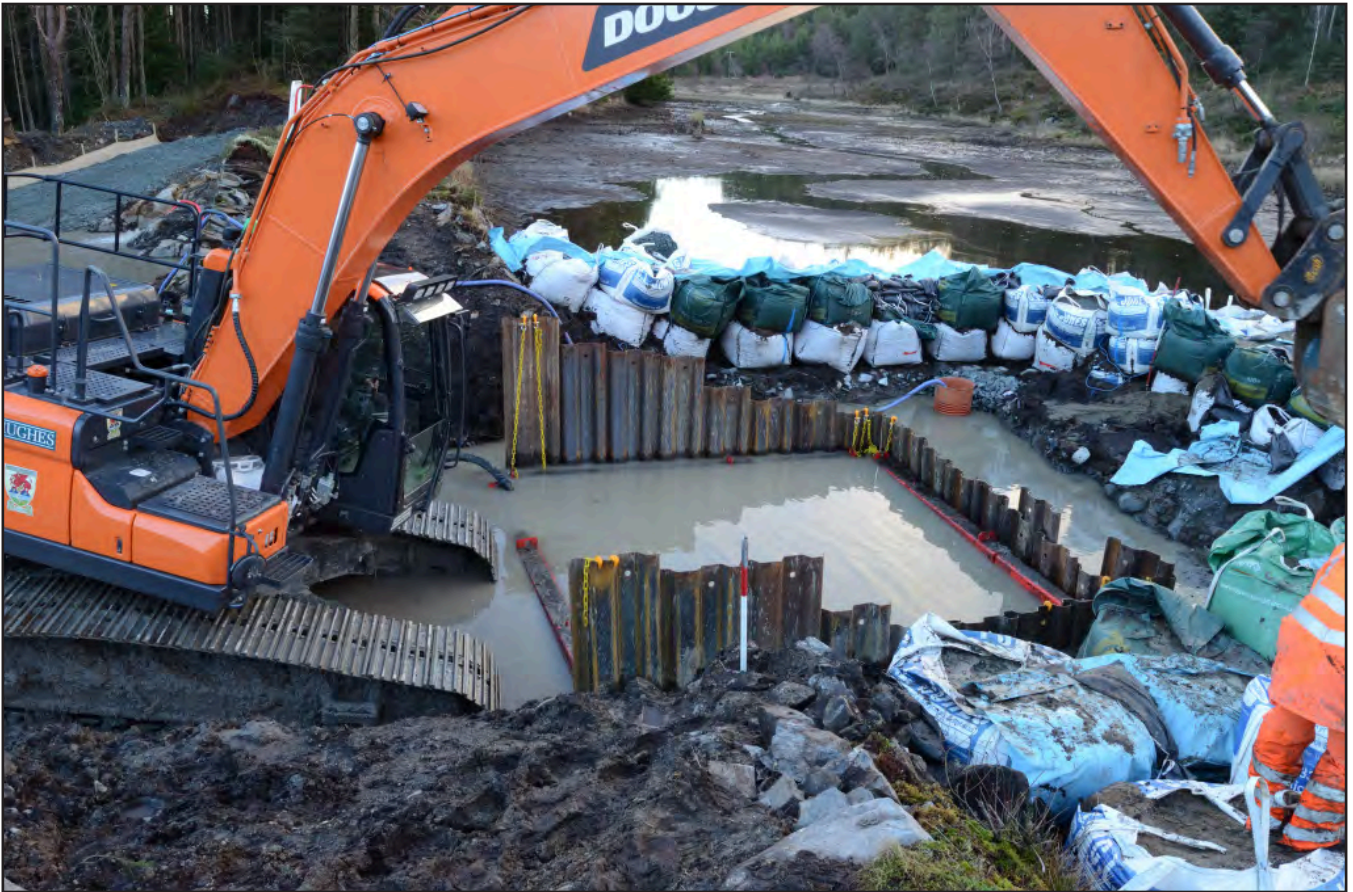
Plate 23: Steel coffer dam in place within spillway dig; Scale: Not used; view from SW (archive reference: G2826_044).

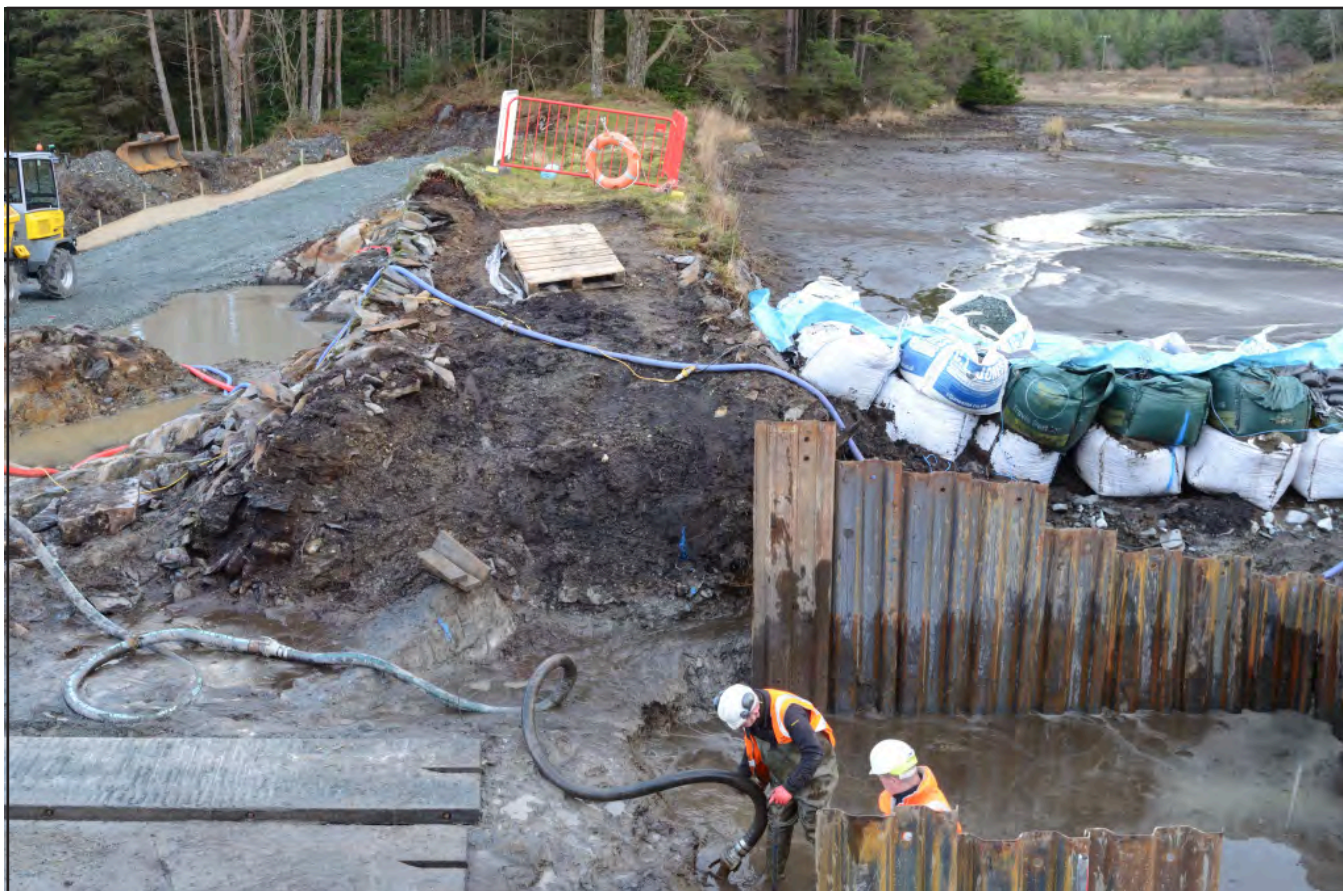
Plate 25: Slipway excavation, with exposed natural clay visible; Scale: Not used; view from SW (archive reference: G2826_061).

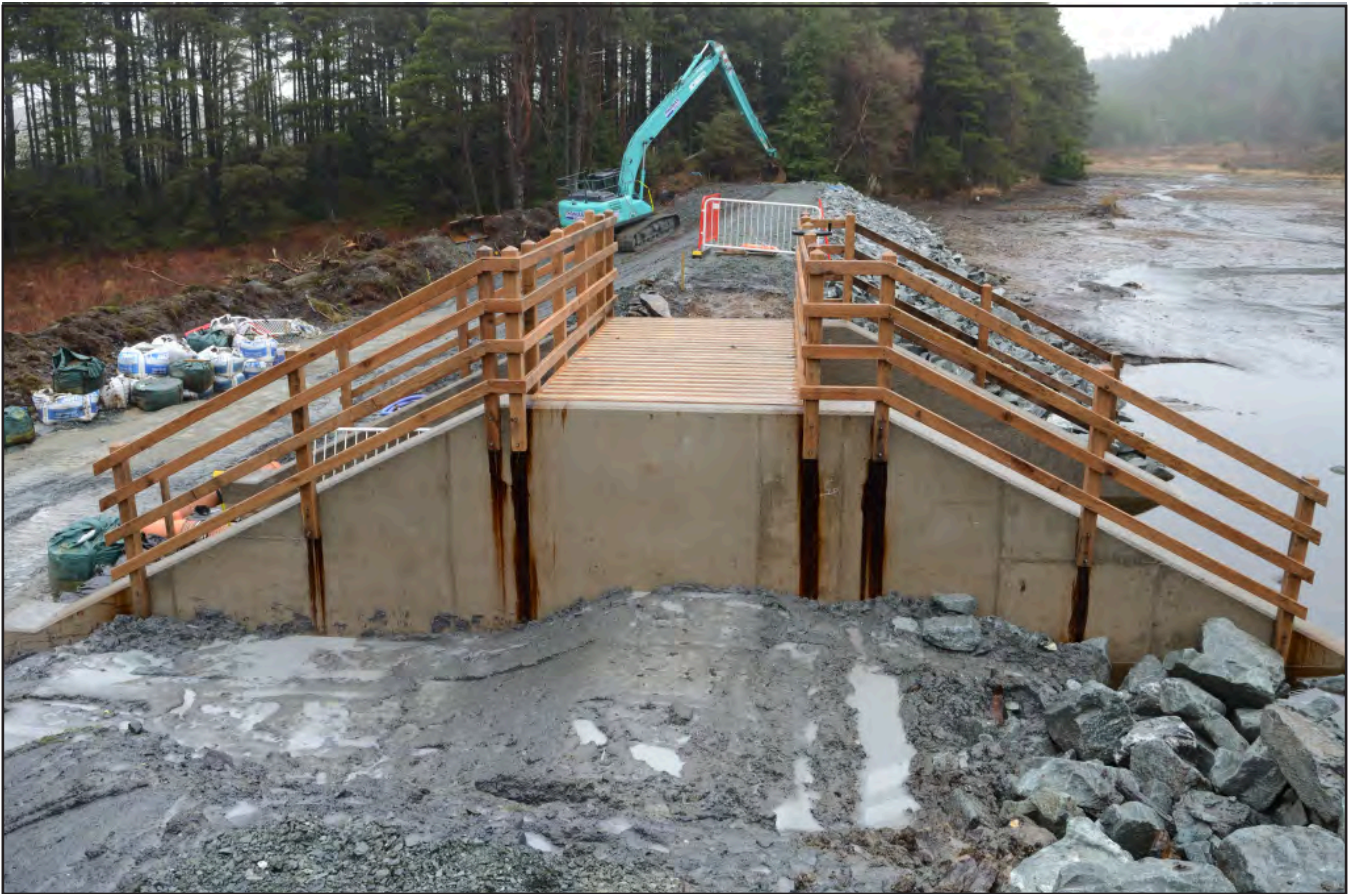
Plate 29: Completed spillway and bridge inserted within upper embankment; Scale: Not used; view from SW (archive reference: G2826_071).

Further to the completion of the excavation and construction of the reinforced concrete spillway with broad crested weir, the sides of the spillway were enclosed with timber fencing and a timber footbridge was inserted. The upper embankment was raised and re-profiled, with imported mid-grey clay placed along the downstream (western) face of the embankment, rip rap (loose quarried stone) placed along the upstream (eastern) face and the top of the embankment was levelled with fine gravel (Plates 27-32).

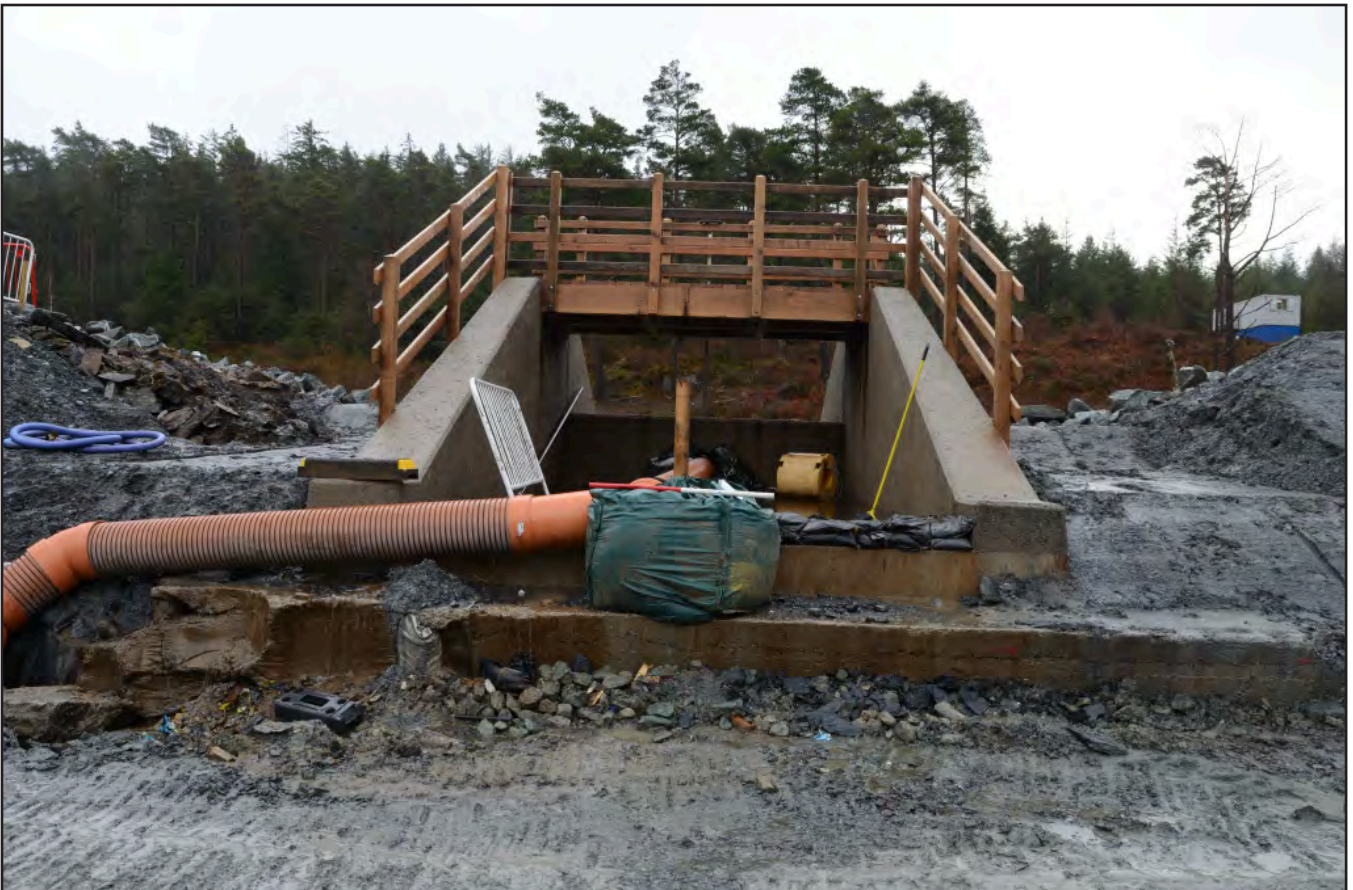
Plate 30: Completed spillway face-on within embankment; Scale: Not used; view from WNW (archive reference: G2826_072).

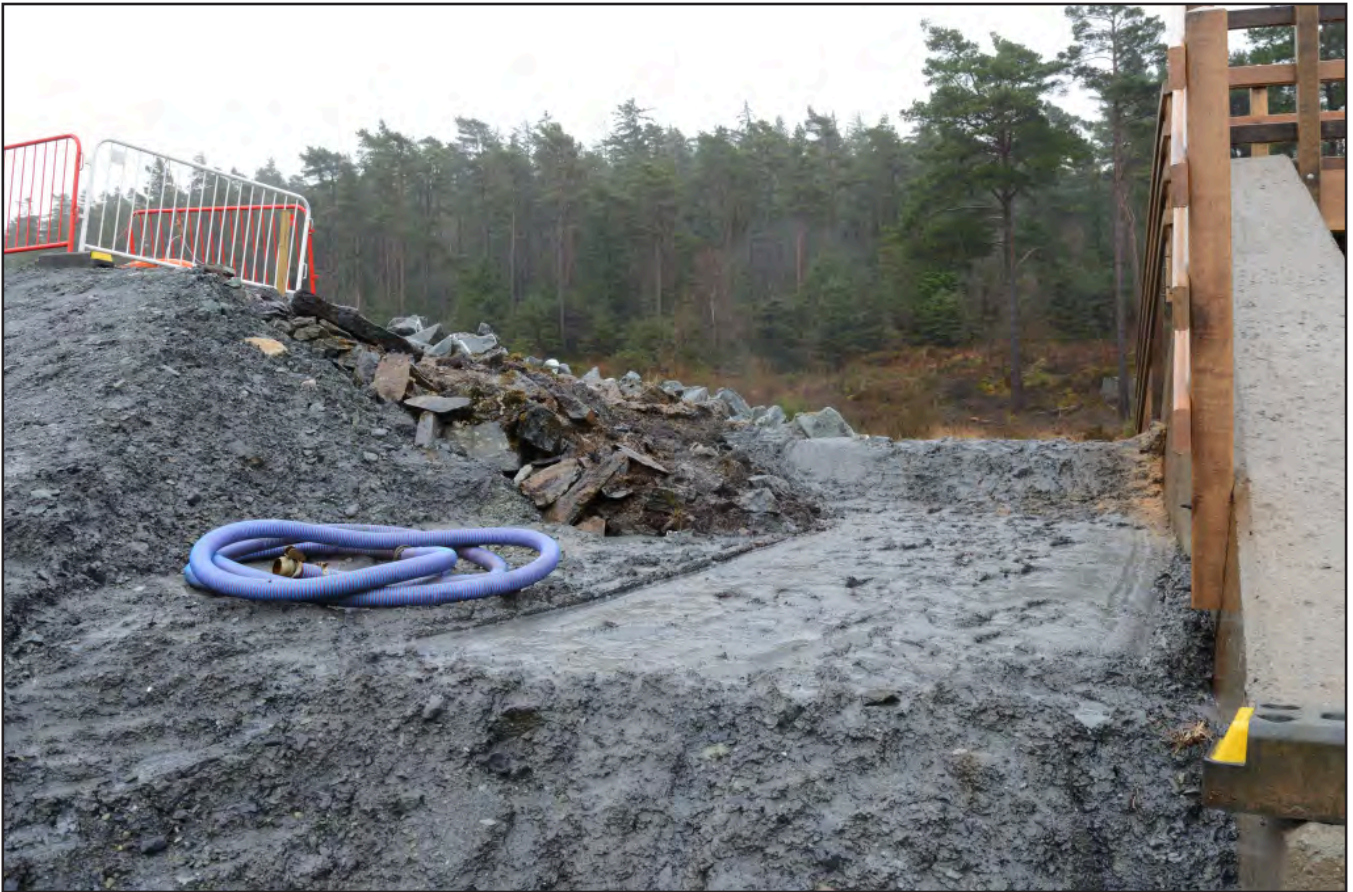
Plate 31: Imported clay over original embankment and next to spillway; Scale: Not used; view from W (archive reference: G2826_073).
