Pandora Reservoirs, Trefriw, Conwy

Briff Gwyllo Archeolegol / Archaeological Watching Brief

Rhif Prosiect / Project No. HD24 -025

Rhif Adroddiad / Report No. 1776

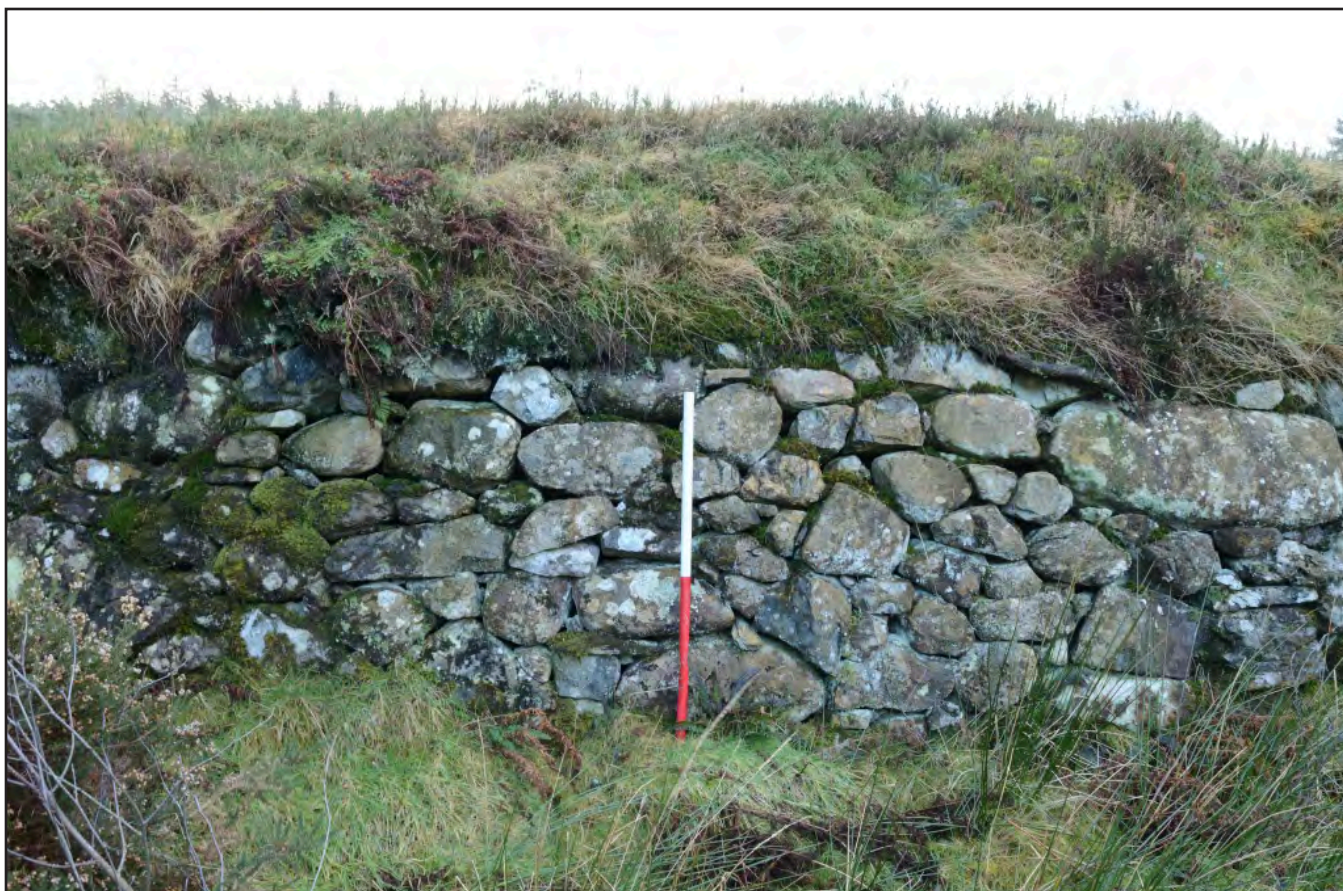
Plate 34: Face of stone wall façade lower embankment; Scale: 1x1 m; view from NW (archive reference: G2826_054).

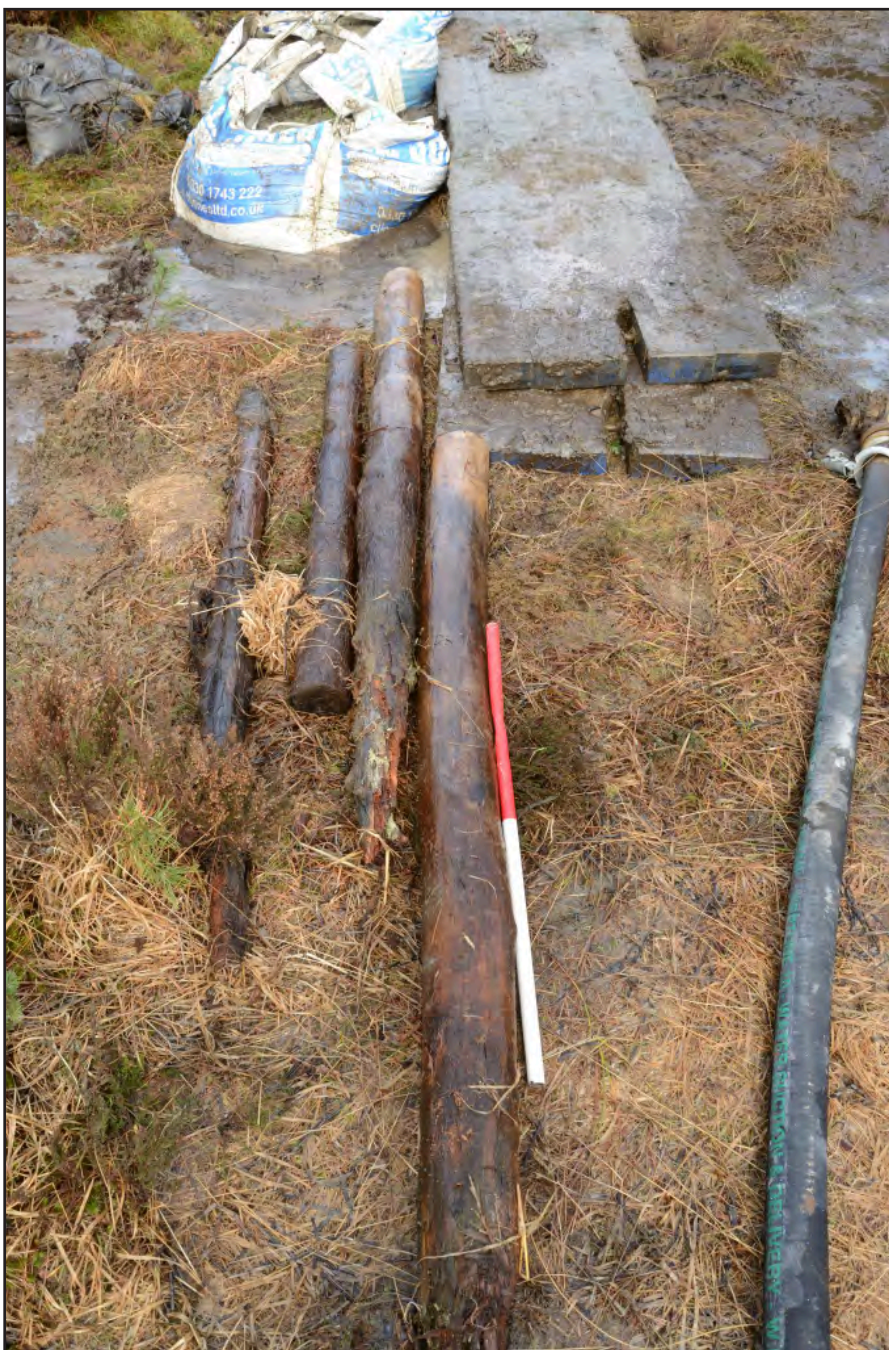
Plate 43: Timbers that formed the penstock; Scale: 1x1m; view from S (archive reference: G2826_090).

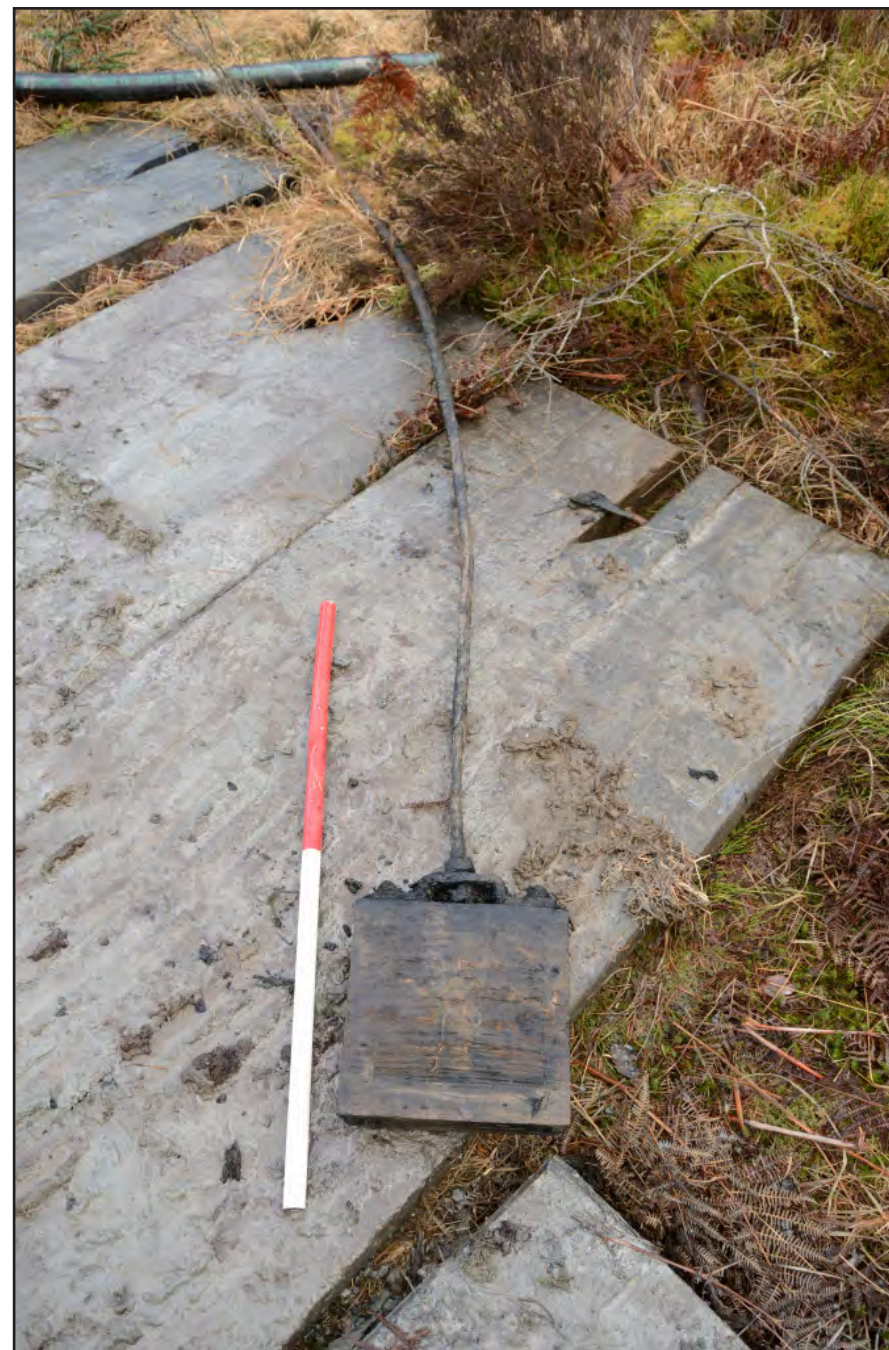
Plate 44: Penstock paddle and metal rod; Scale: 1x1m; view from S (archive reference: G2826_093).

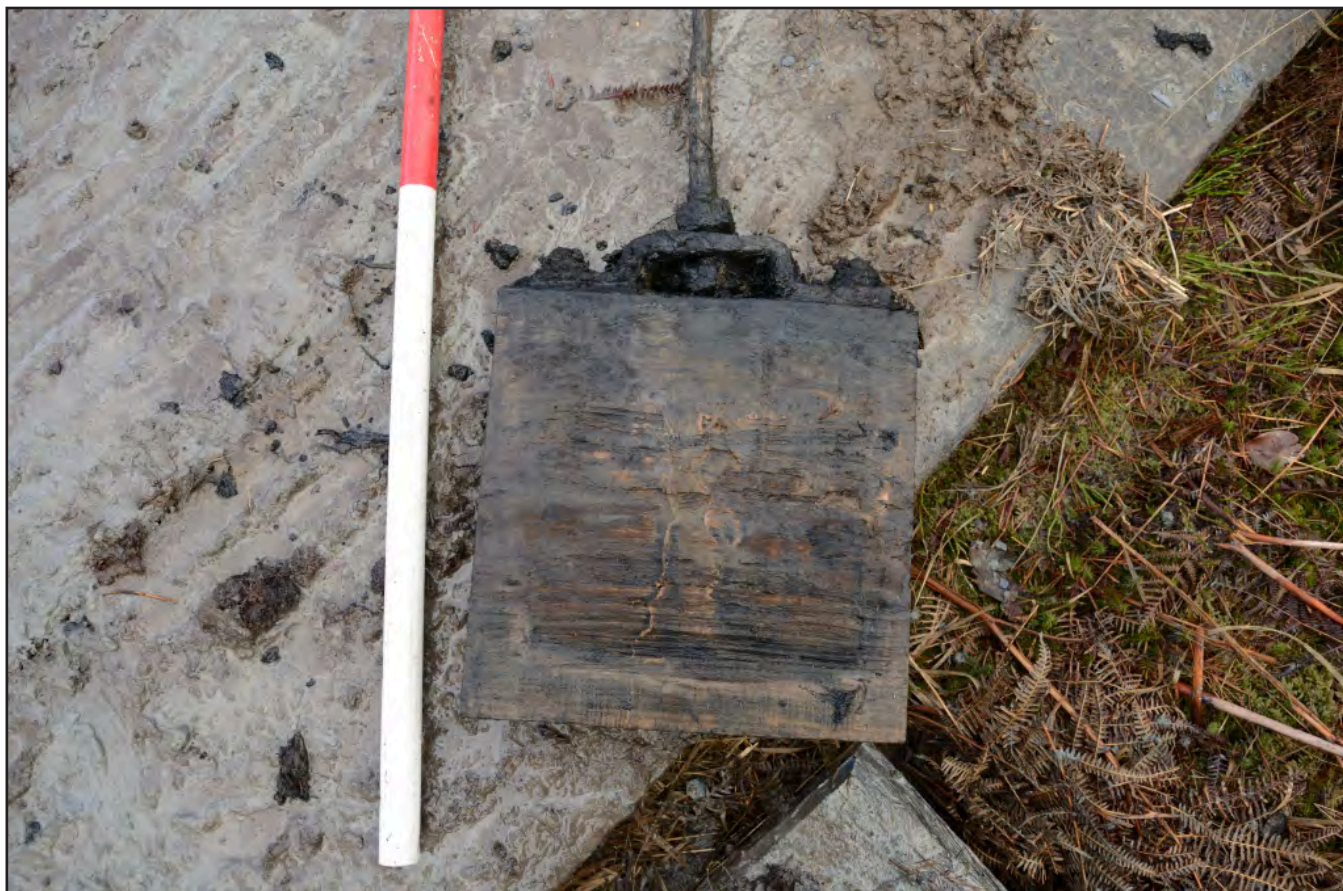
Plate 45: Penstock paddle and metal rod; Scale: 1x1m; view from S (archive reference: G2826_094).

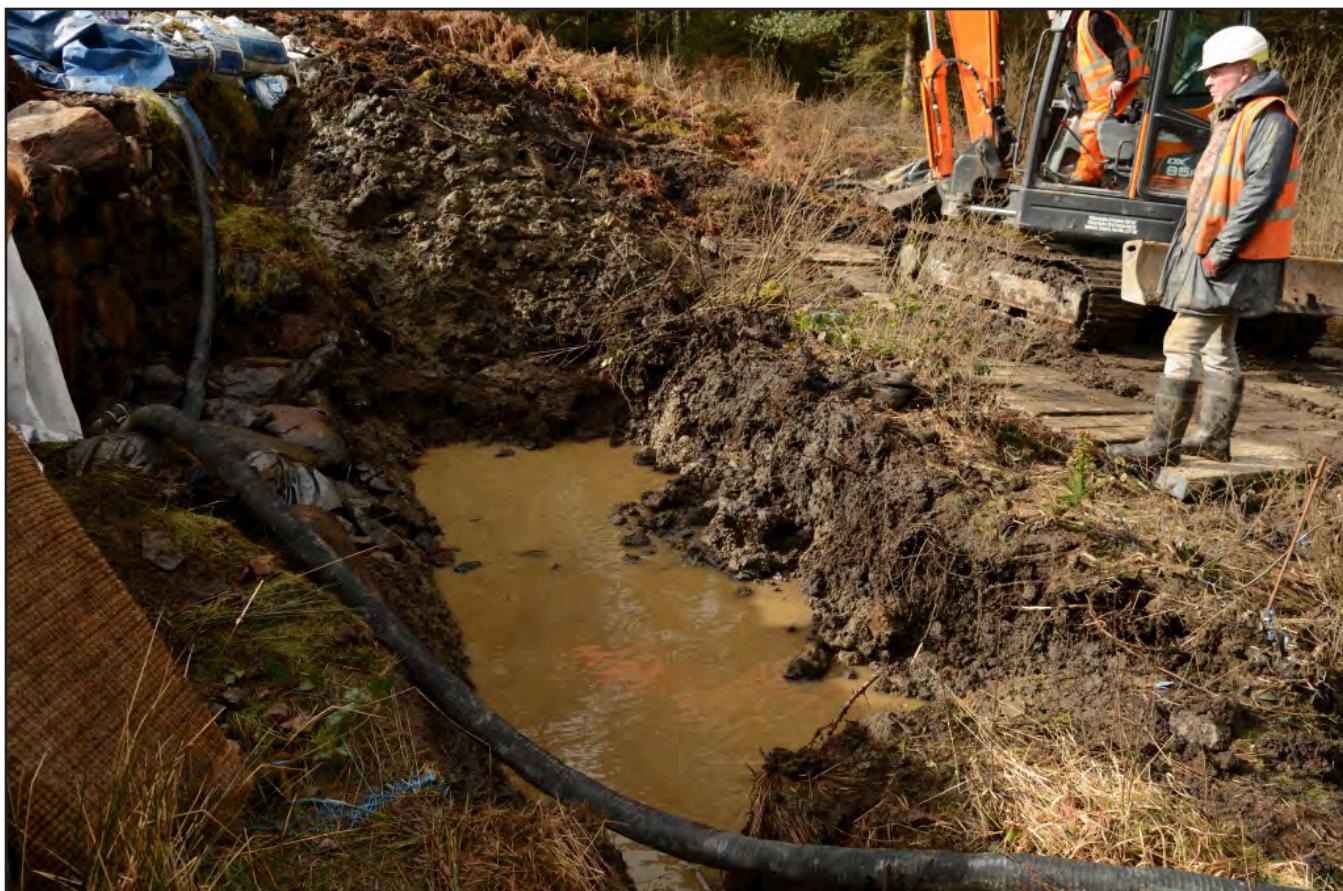
mixed with loose light grey clayey gravel (Plate 46). A channel was excavated off the trench, for a distance of 3.0m, with a width of 1.50m and depth of 0.9m (Plate 47). No archaeological deposits or material associated with the reservoir was uncovered during the excavation and the peat was not sampled.

Plate 46: Excavation below lower embankment; Scale: Not used; view from NE (archive reference: G2826_103).

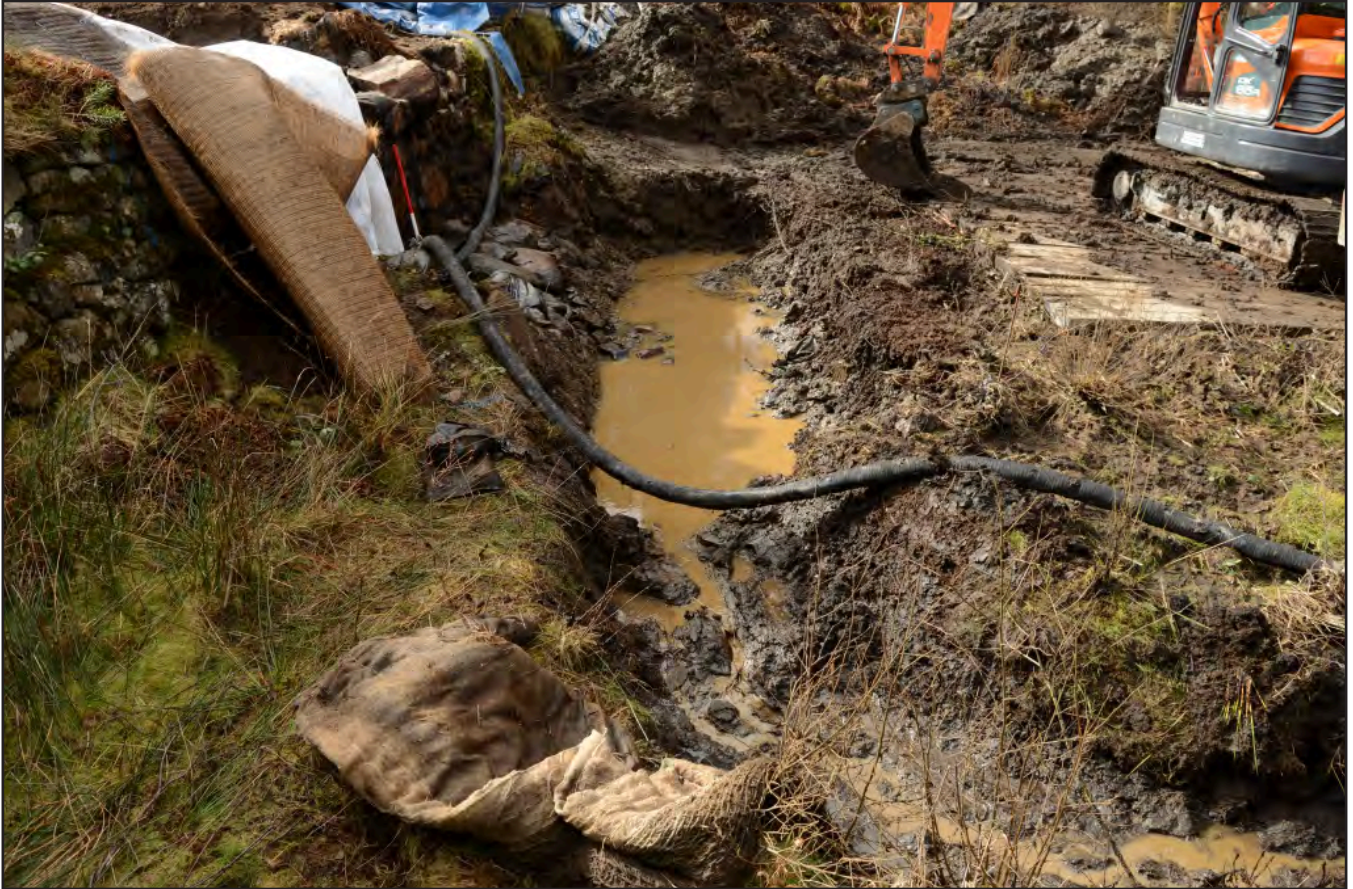
Plate 47: View of area excavated below lower embankment; Scale: Not used; view from NE (archive reference: G2826_106).

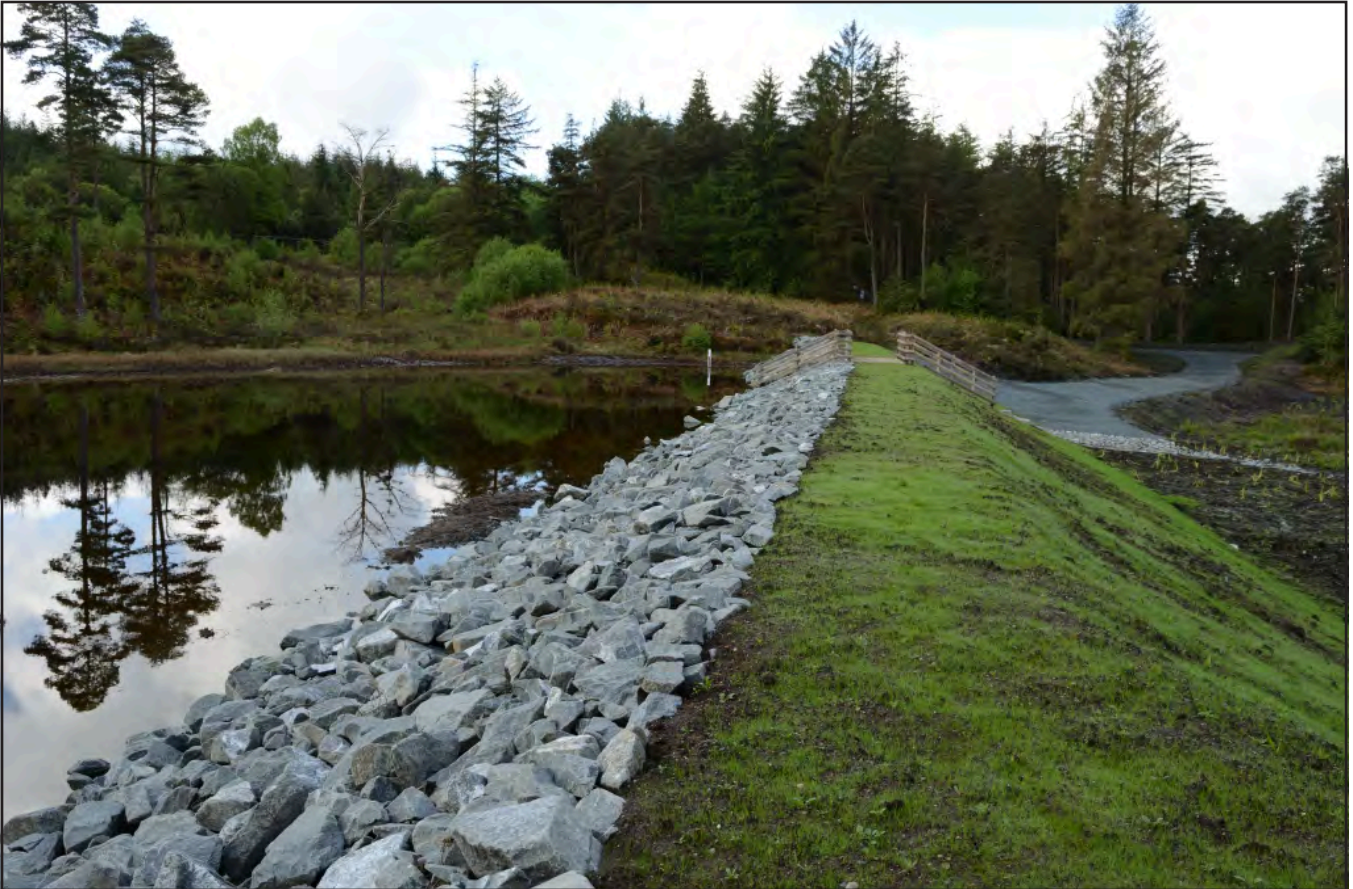
Plate 52: Post completion view of upper reservoir and embankment; Scale: Not Used; view from N (archive reference: G2826_116).

At the lower embankment, the breach had been covered over with composite turf reinforcement matt and loose quarry stones (Plate 52). The trench had been backfilled as planned with rip rap (loose quarry stones) and the embankment sealed by restored soil and peat, this also partially covered the western stone façade (Plate 53).

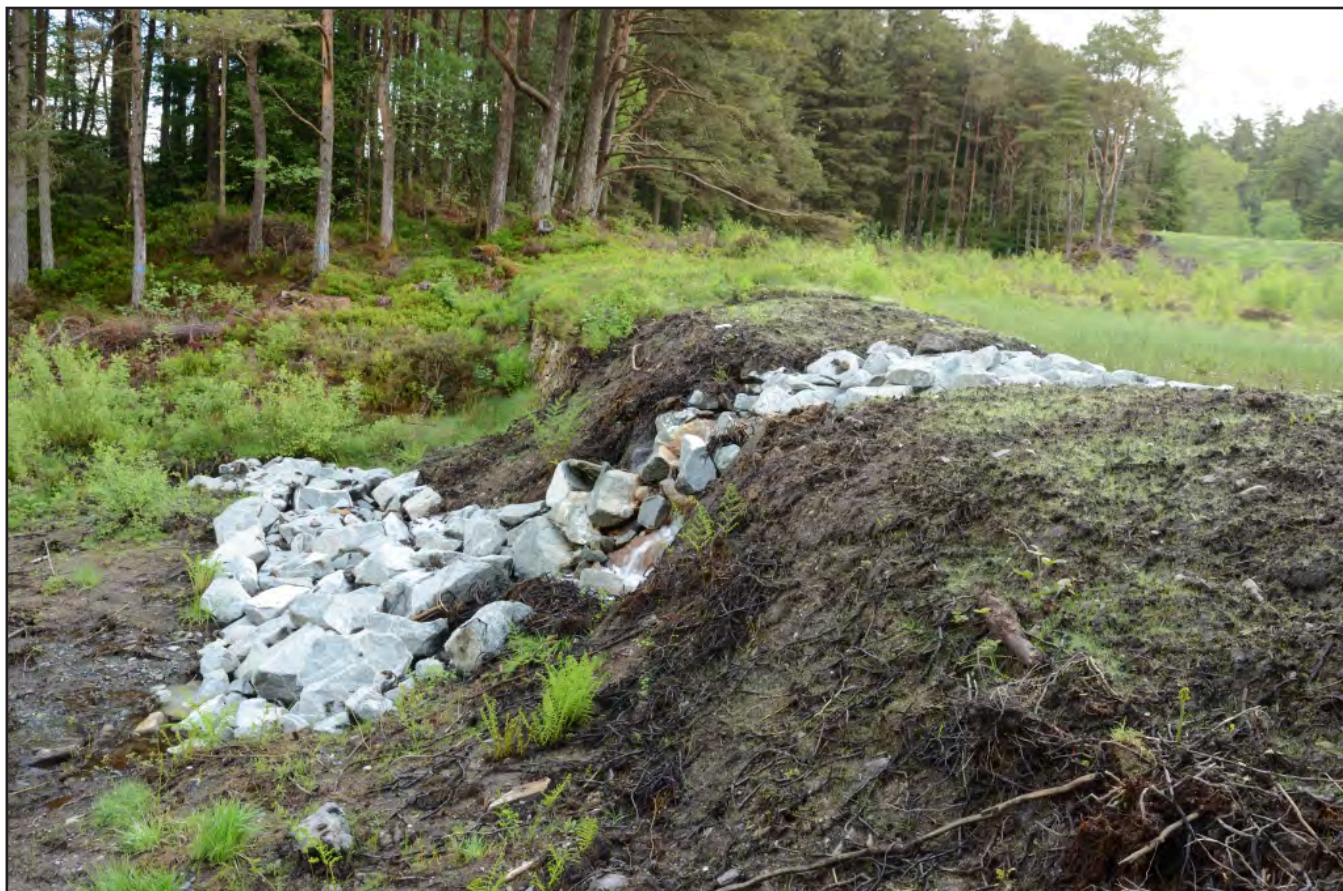
Plate 53: Post completion view of lower embankment and breach; Scale: Not used; view from SW (archive reference: G2826_121).
