St David's Church, Caernarfon Road, Bangor, Gwynedd

Cofnod Adeilad Lefel 2/3 Archaeolegol /
Archaeological Level 2/3 Building Record

Rhif Prosiect / Project No. HD29-019 / G2827

Rhif Adroddiad / Report No. 1778

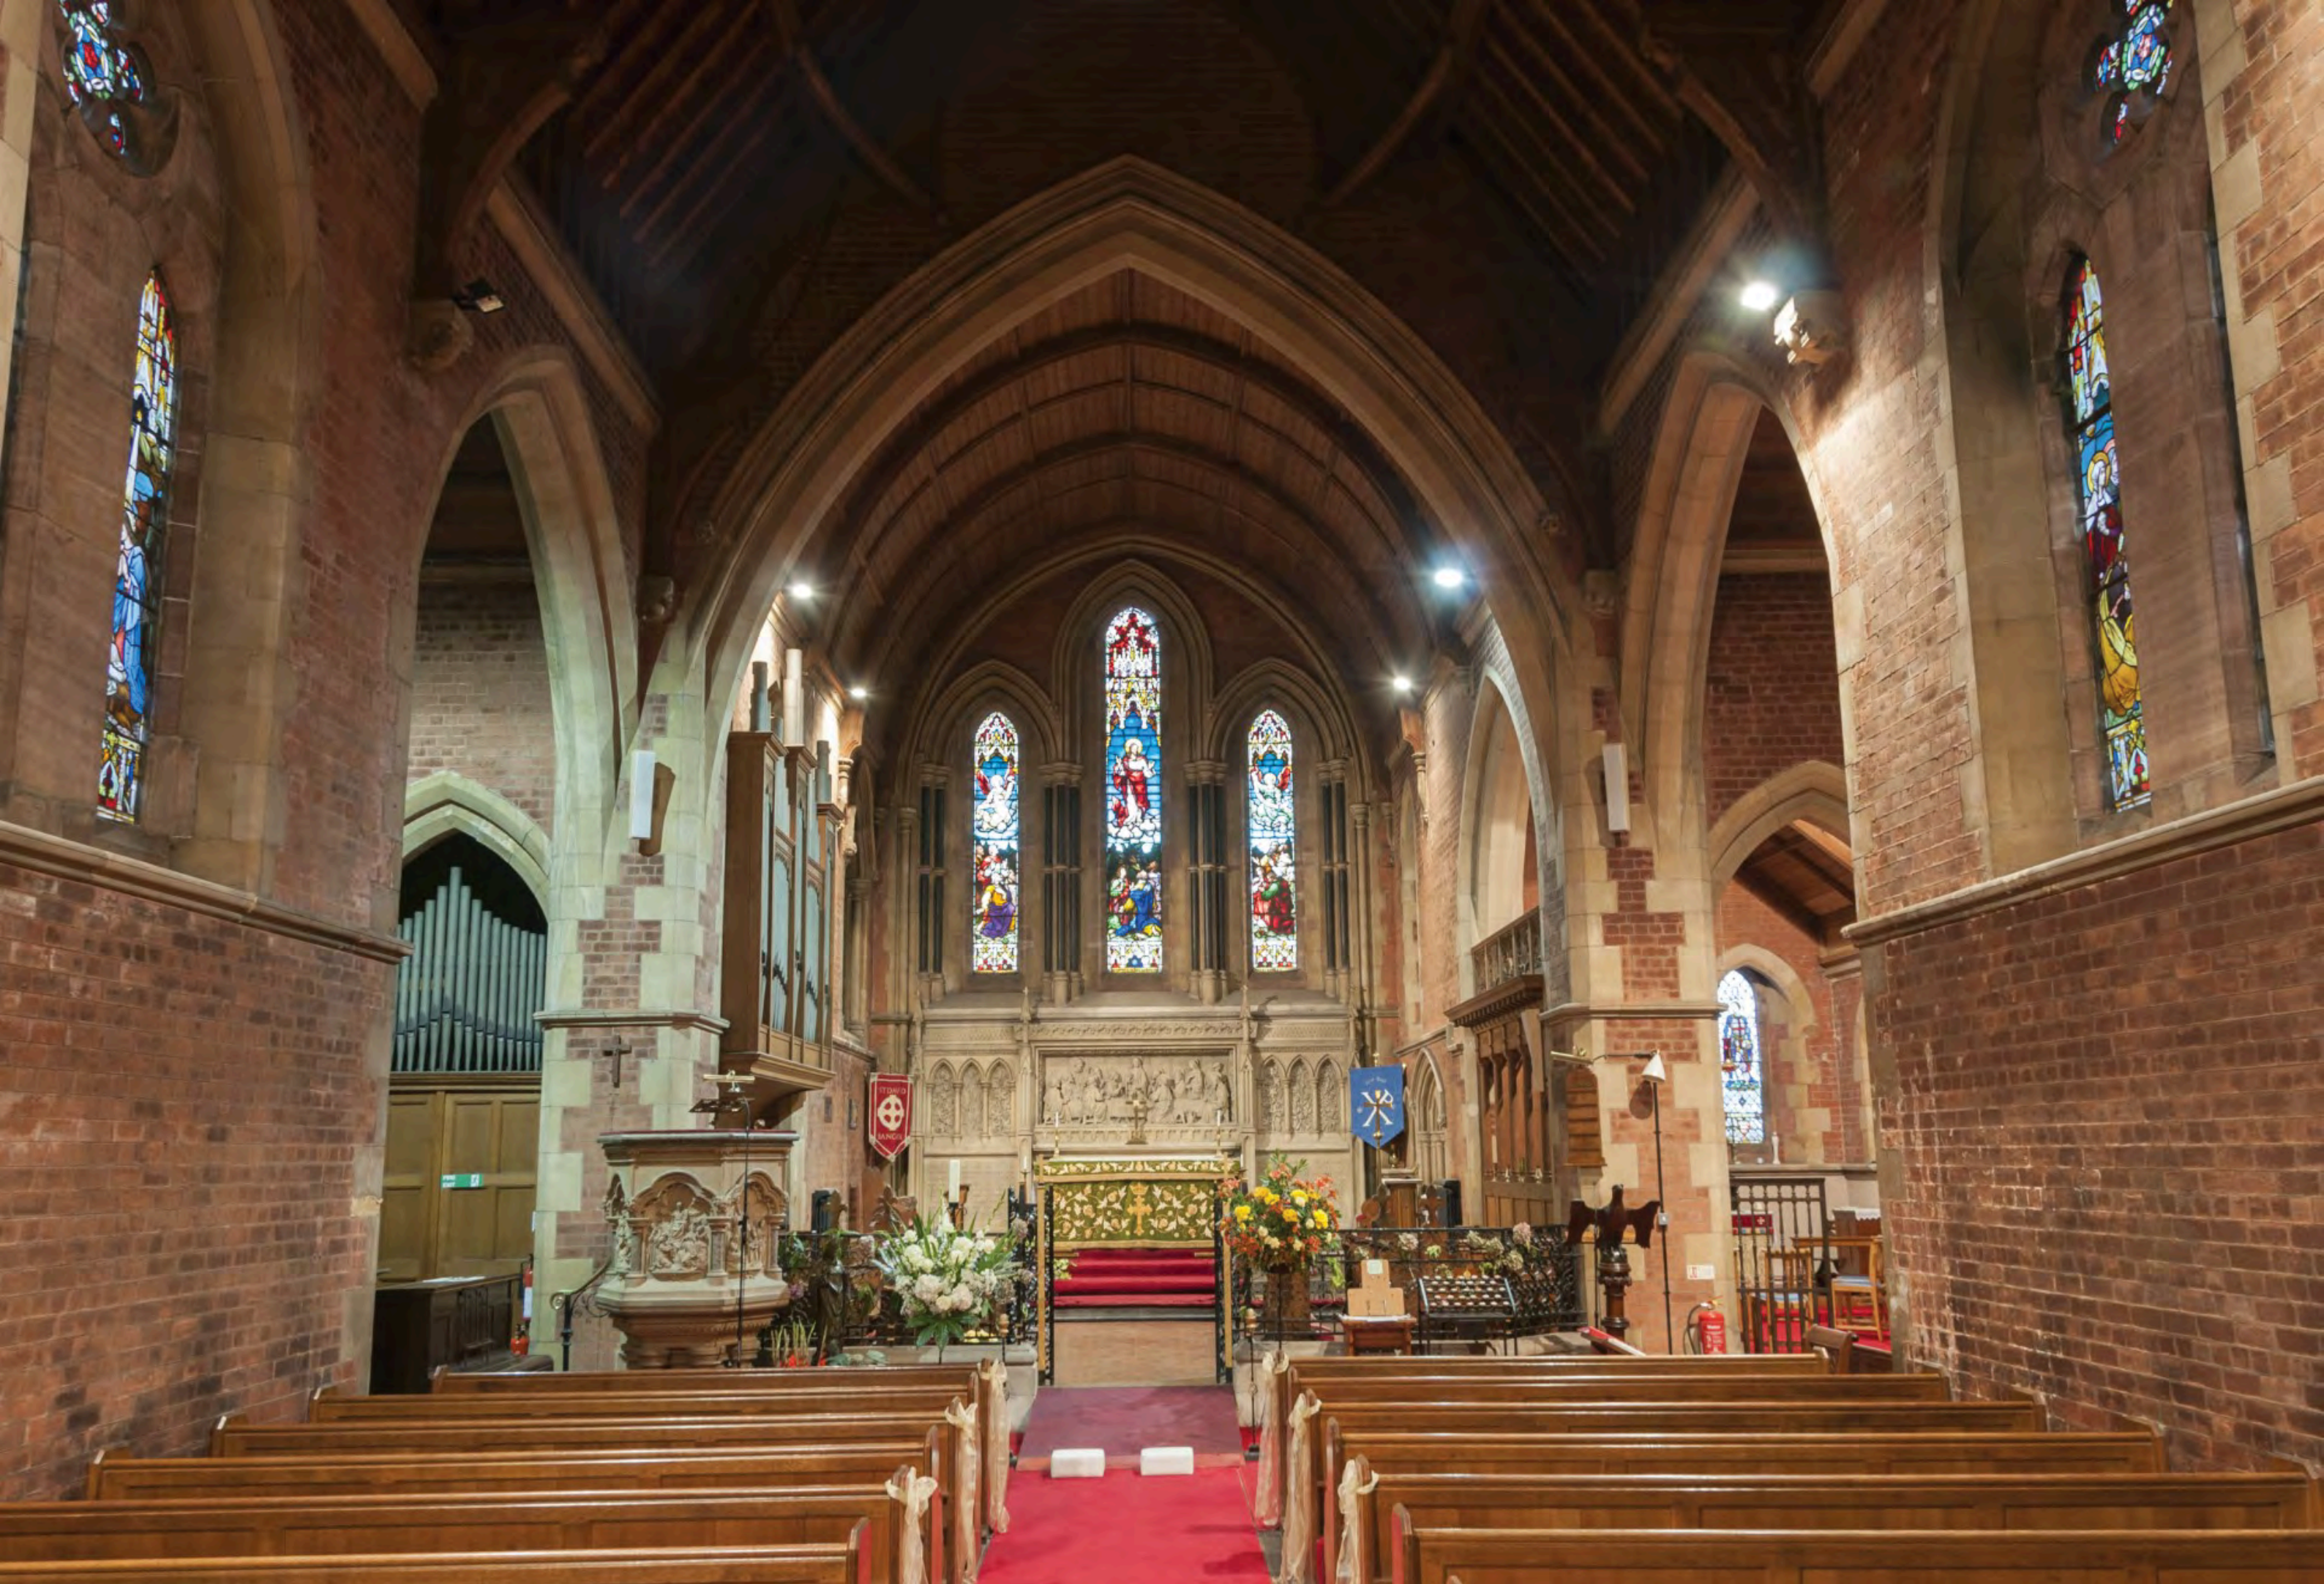
FIGURE 06

Reproduction of modern photograph of St Davids Church interior, prior to removal of interior. View from nave towards chancel. Source: John Nicholson, 2023. Size: A3.

Figure 06: Reproduction of modern photograph of St Davids Church interior, prior to removal of interior. View from nave towards chancel. Source: John Nicholson, 2023. Size: A3.

Directly behind all the ecclesiastical features and separates the nave from the chancel is a set of black ornate wrought iron and bronze choir screen / railings with multiple scrolls along with a set of square gates which also include multiple scrolls and the St Davids emblem on each one. The gate pillars on each side are painted gold with a cross on top of each one. The railings are imbedded into a raised wall, square with a rounded top. The wrought iron and bronze choir screen were erected in 1936 (HIA) and is visible in ([Figure 06](#)) but not in the 1933 archival photo ([Figure 09](#)).

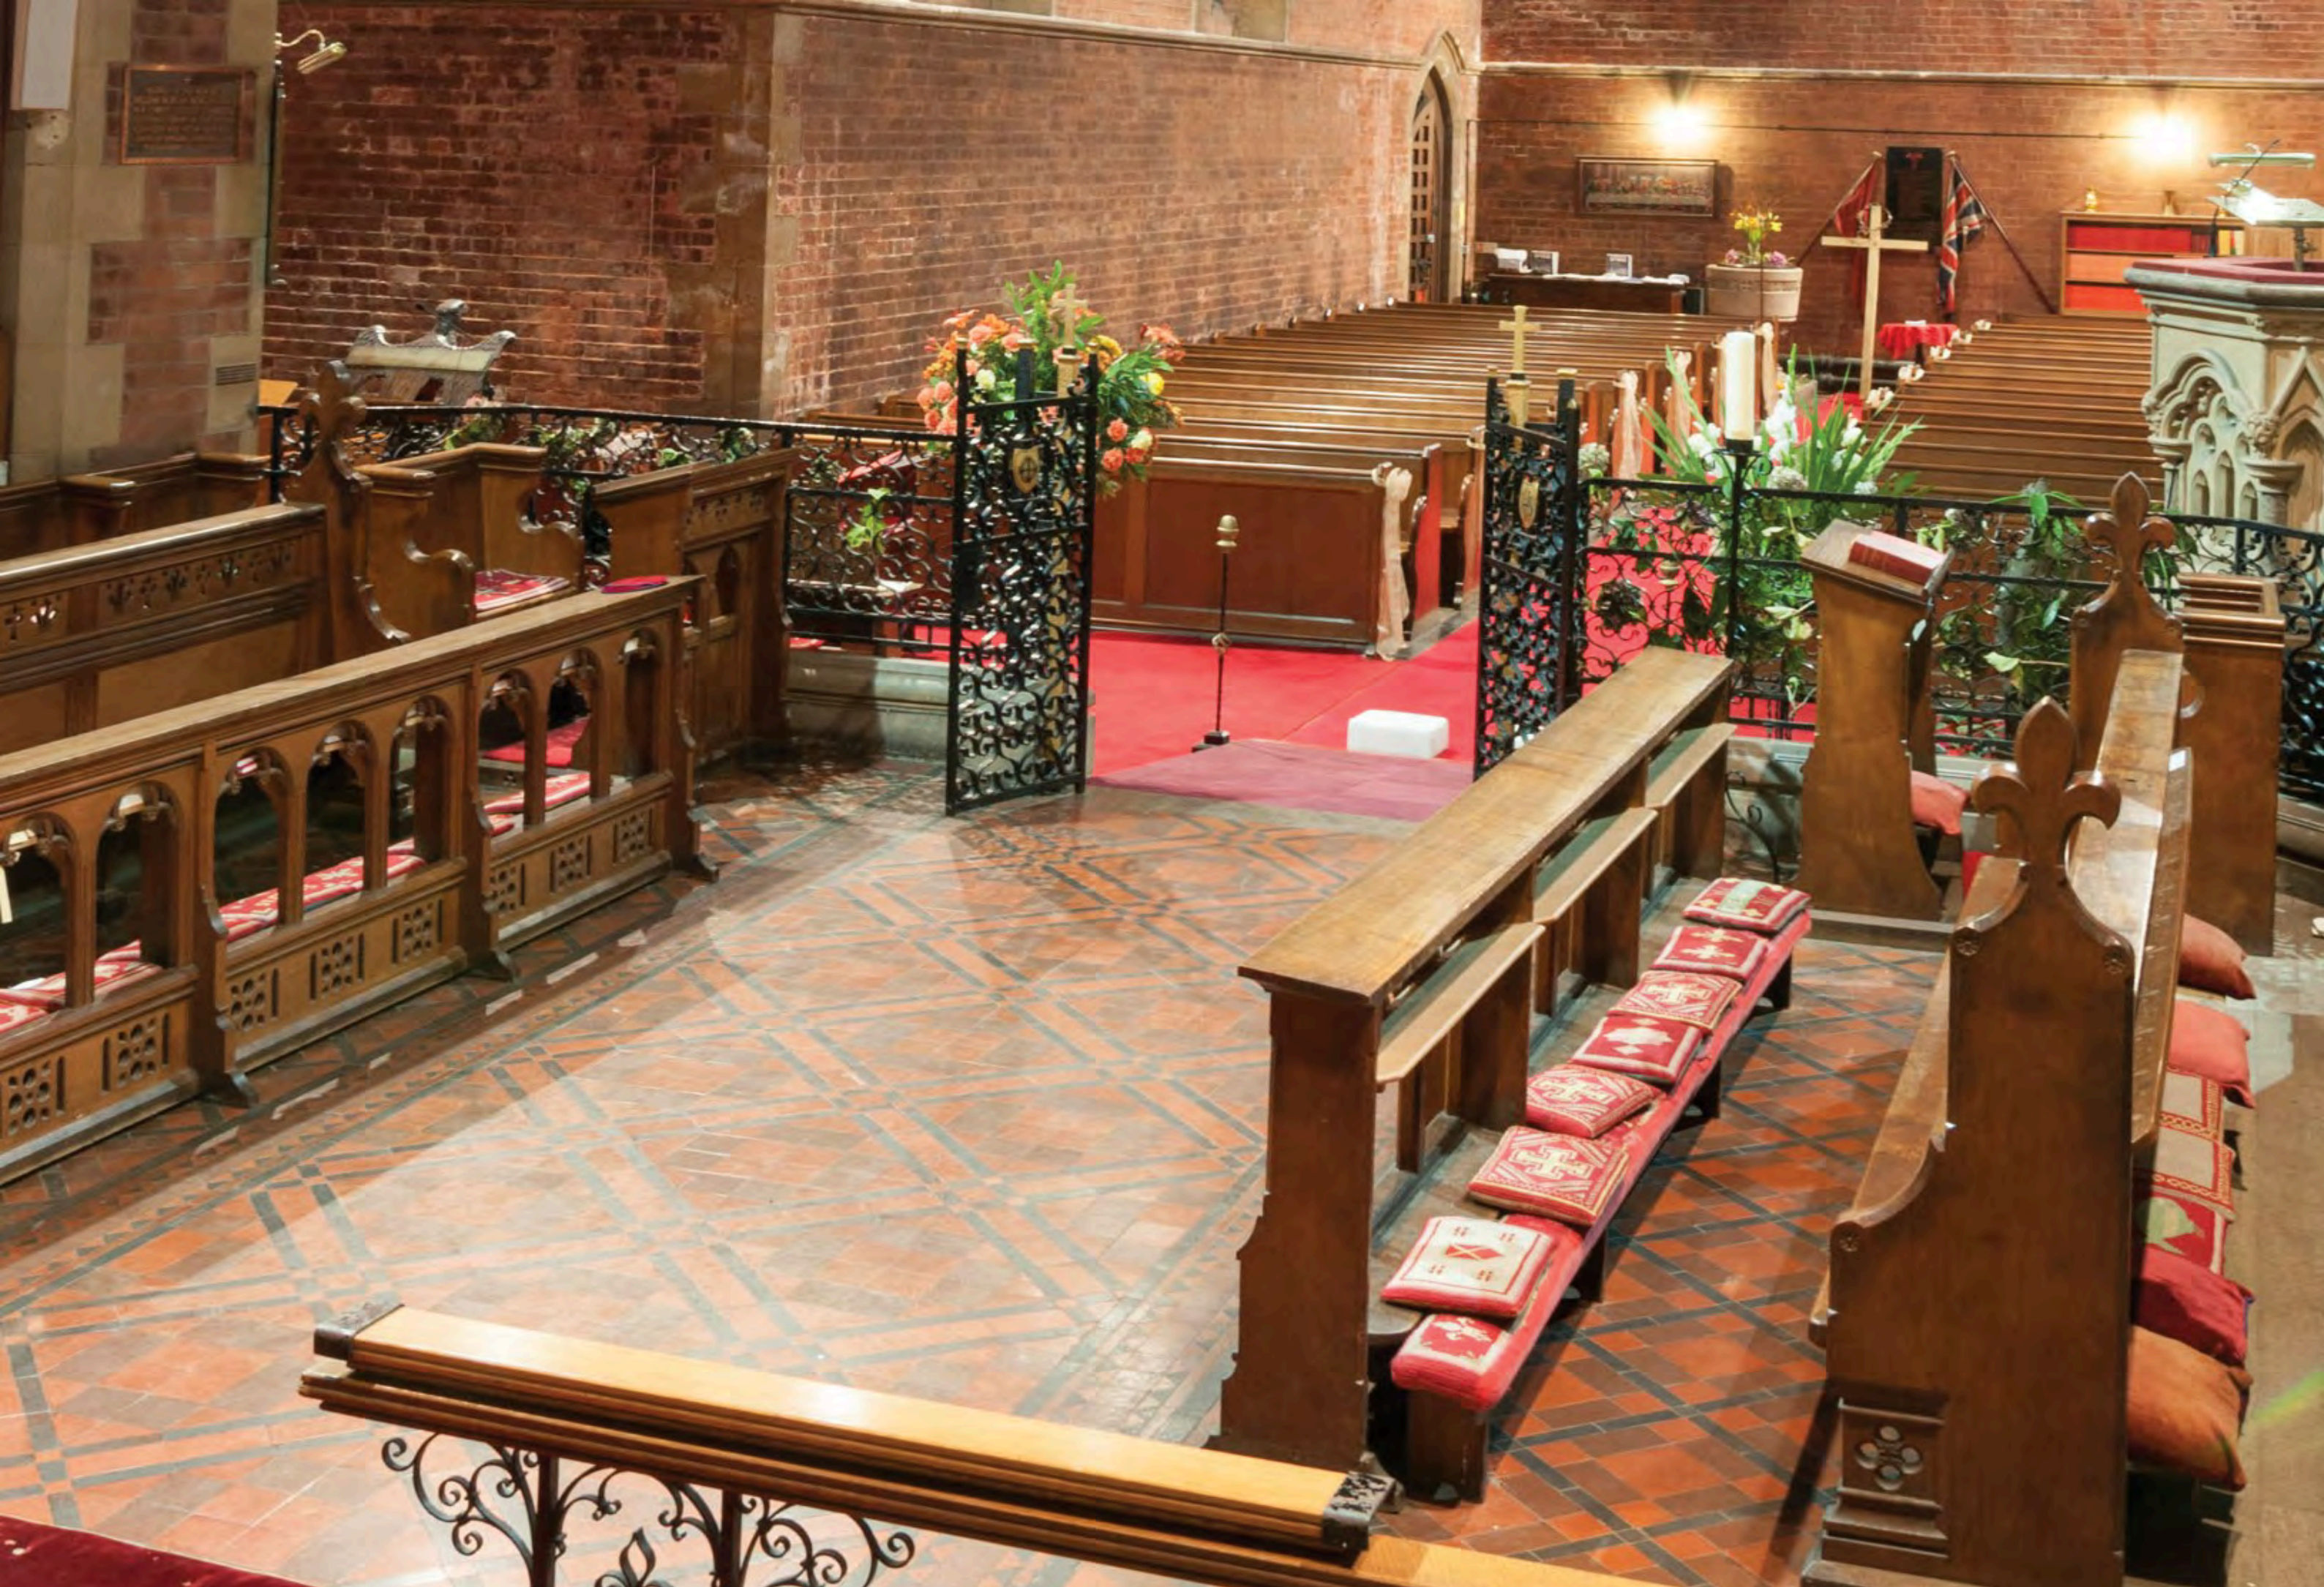
FIGURE 07

Reproduction of modern photograph of St Davids Church interior, prior to removal of interior. View from within chancel. Source: John Nicholson, 2023. Size: A3.

Figure 07: Reproduction of modern photograph of St Davids Church interior, prior to removal of interior. View from within chancel. Source: John Nicholson, 2023. Size: A3.

The Chancel has a pair (each side) of choir pews enough for 26 singers ([Figure 07](#)). The pews face inwards within the chancel. The chancel floor is exposed decorated tiles laid out in concentric square patterns similar to the nave. Positioned on the NW wall is the William & Hill organ built in 1906 and removed in 2021 under Listed Building Consent C20/0862/11/CR. The organ pipes are present on the left-hand side above the choir pews and on the north-northeast of the northern transept. Next to the railings on either side there is a pair of smaller pews for an individual. Above the individual pew on the right-hand side (chapel side) there is a bronze plaque with unknown details written on it. On the organ side there is a tall candle stand. Also, blacksmith made with scrolls and to hold a large candle.

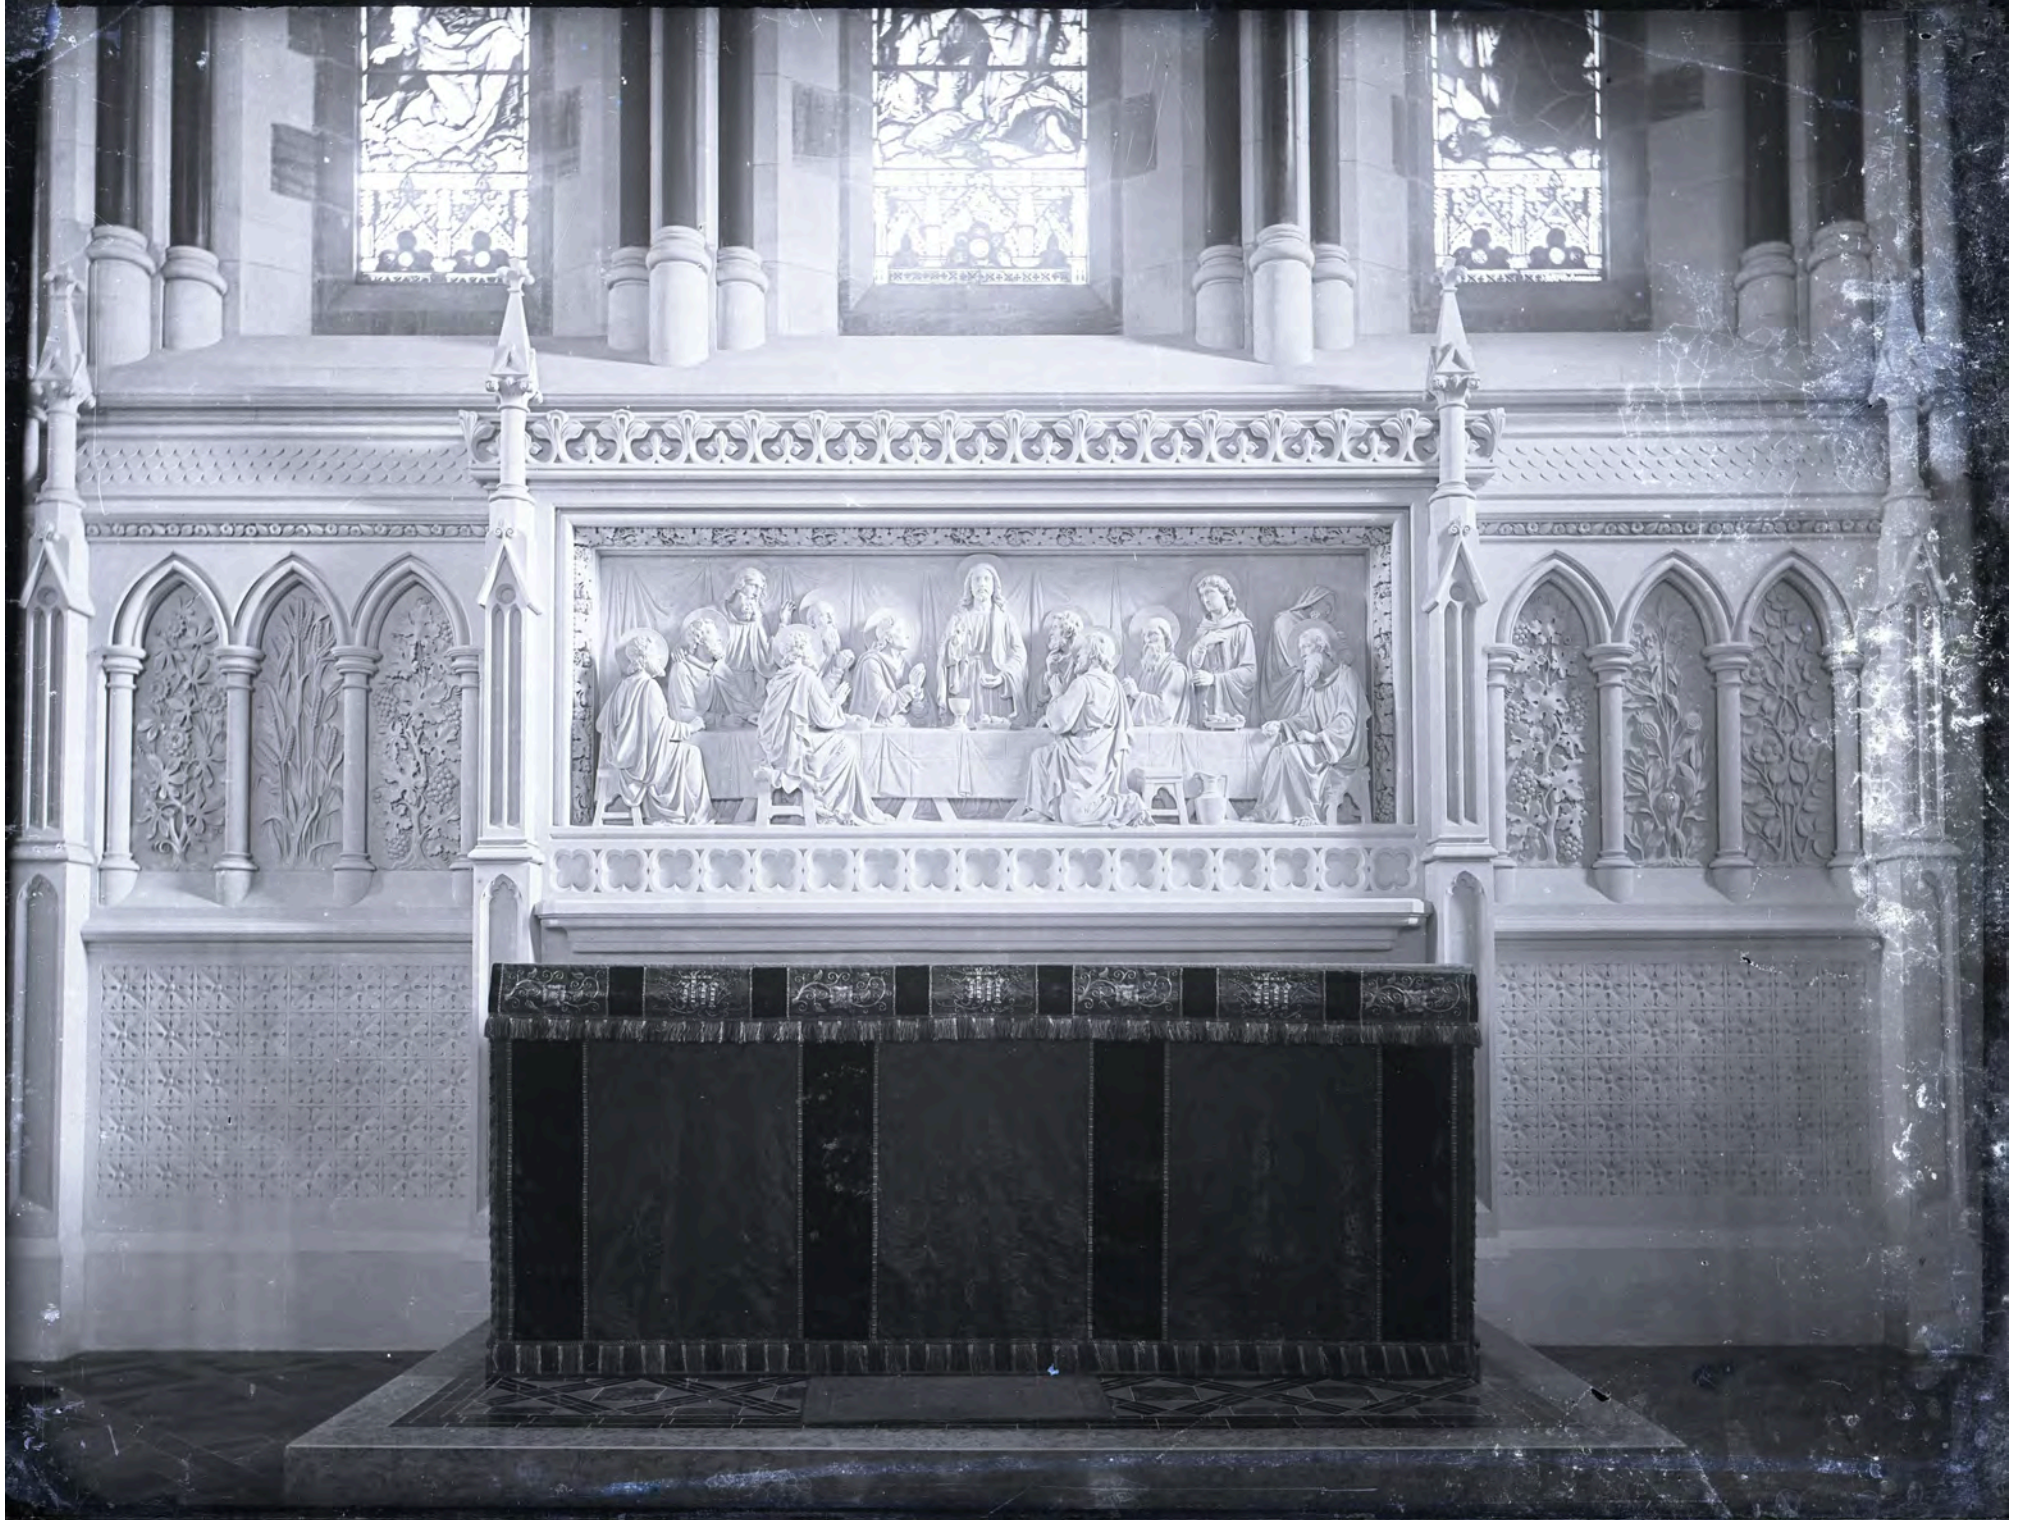
FIGURE 08

Archival photograph from 1936 of the newly erected altar with the reredos displayed directly behind. Source: Gwynedd archive, XS/1077/14/5/9.

Figure 08: Archival photograph from 1936 of the newly erected altar with the reredos displayed directly behind. Source: Gwynedd archive, XS/1077/14/5/9.

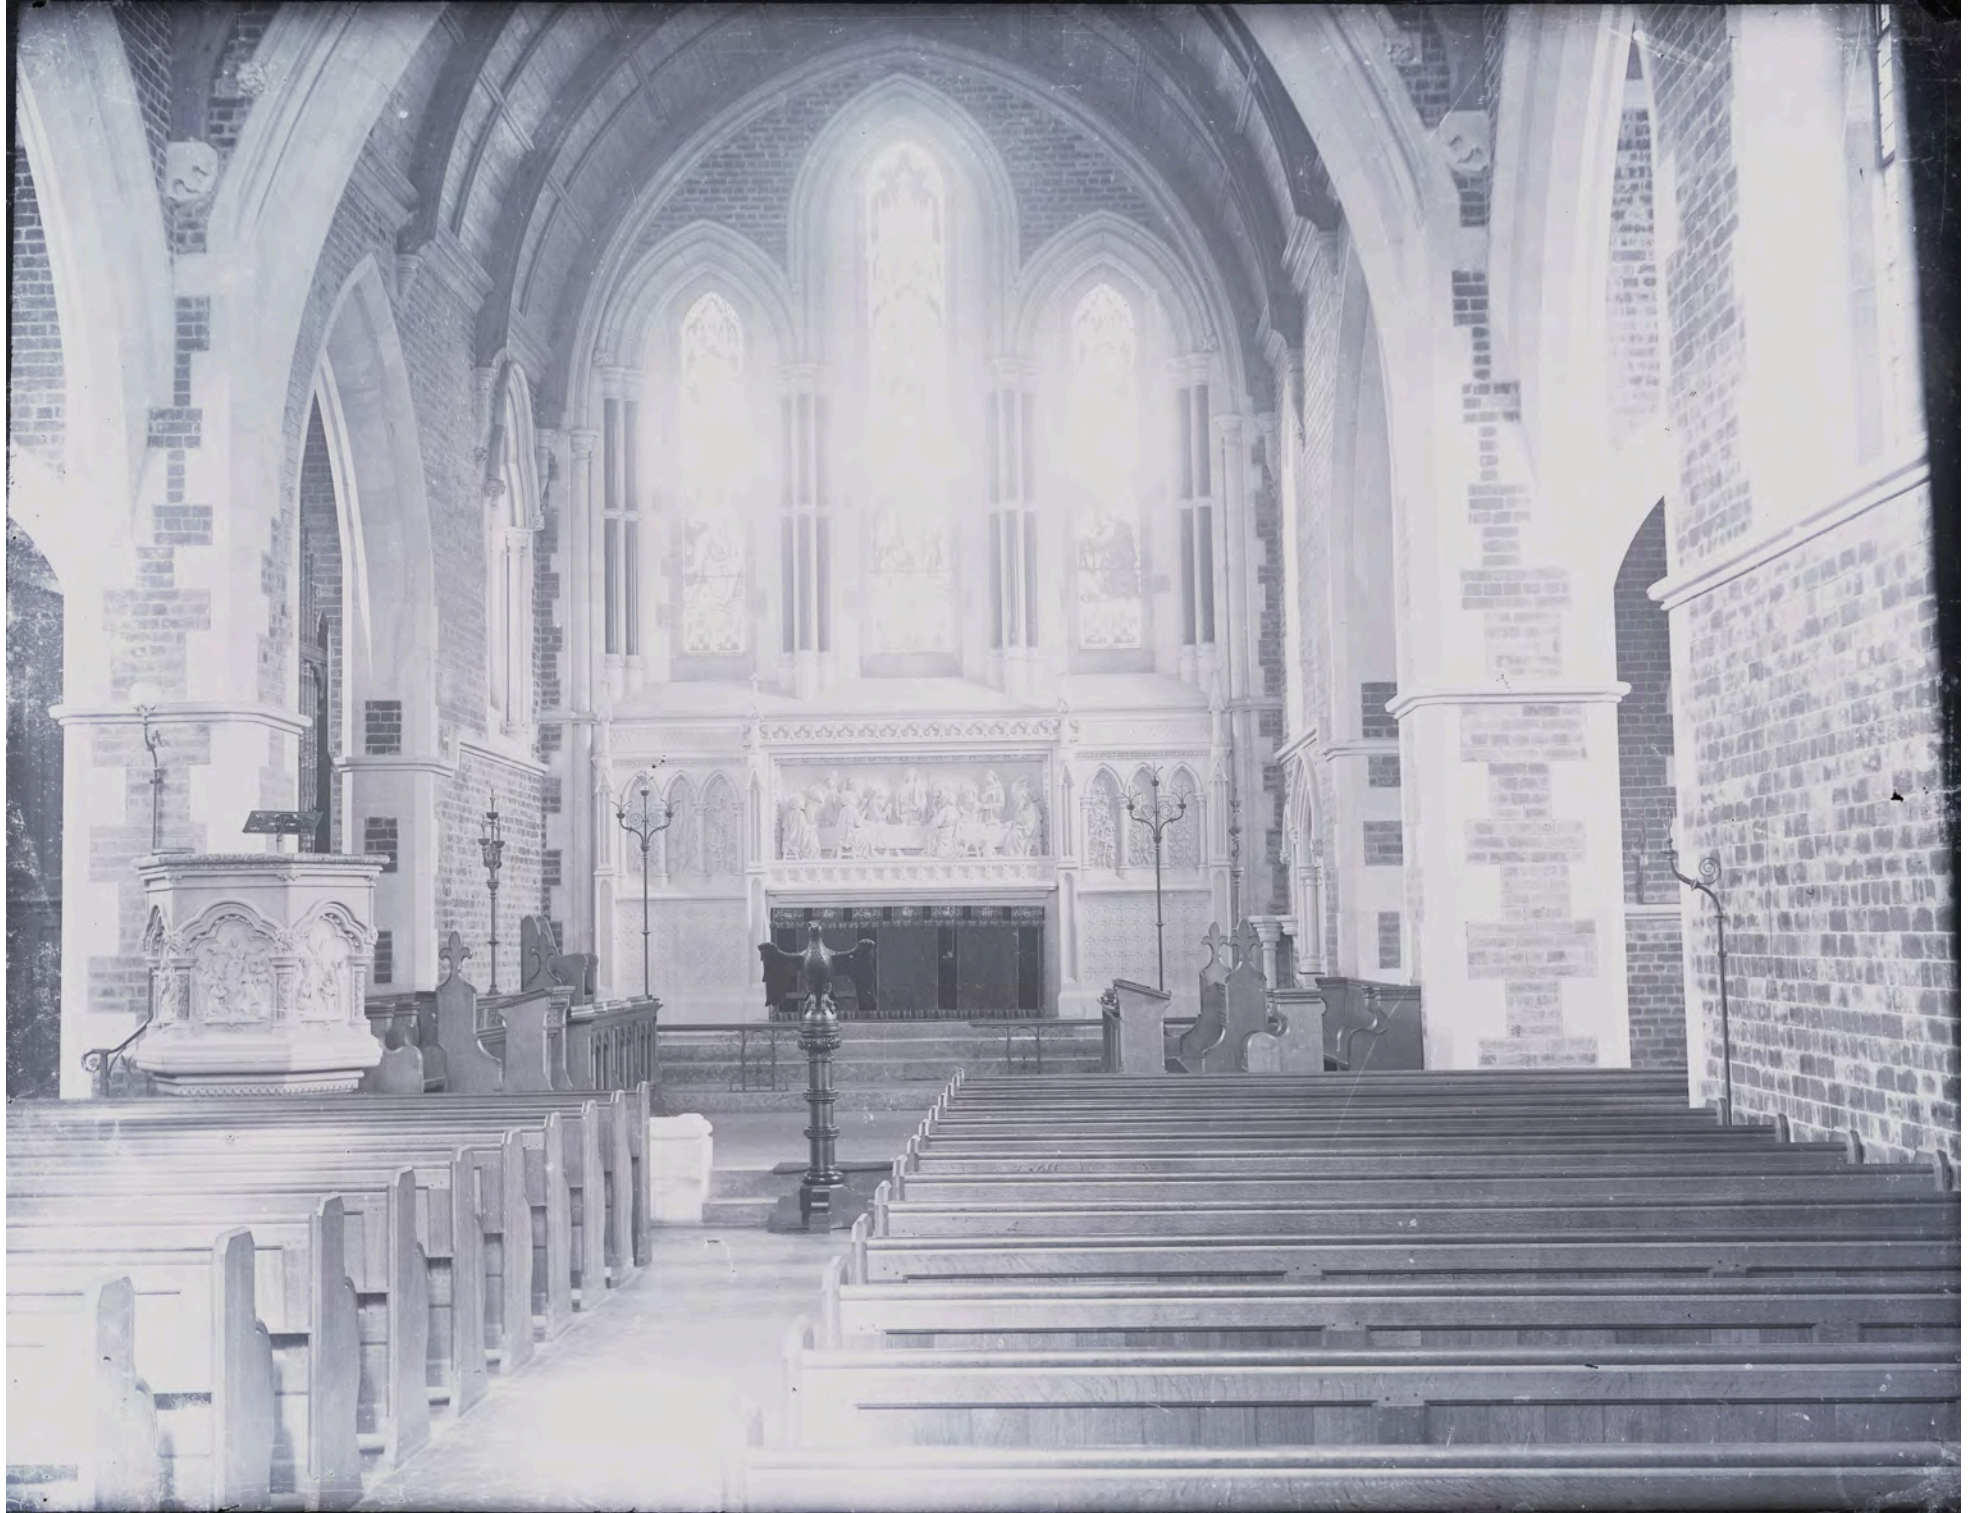
FIGURE 09

Archival photograph from 1933 from within the centre of the nave towards the chancel. Source: Gwynedd archive, XS/1077/14/5/9.

Figure 09: Archival photograph from 1933 from within the centre of the nave towards the chancel. Source: Gwynedd archive, XS/1077/14/5/9.

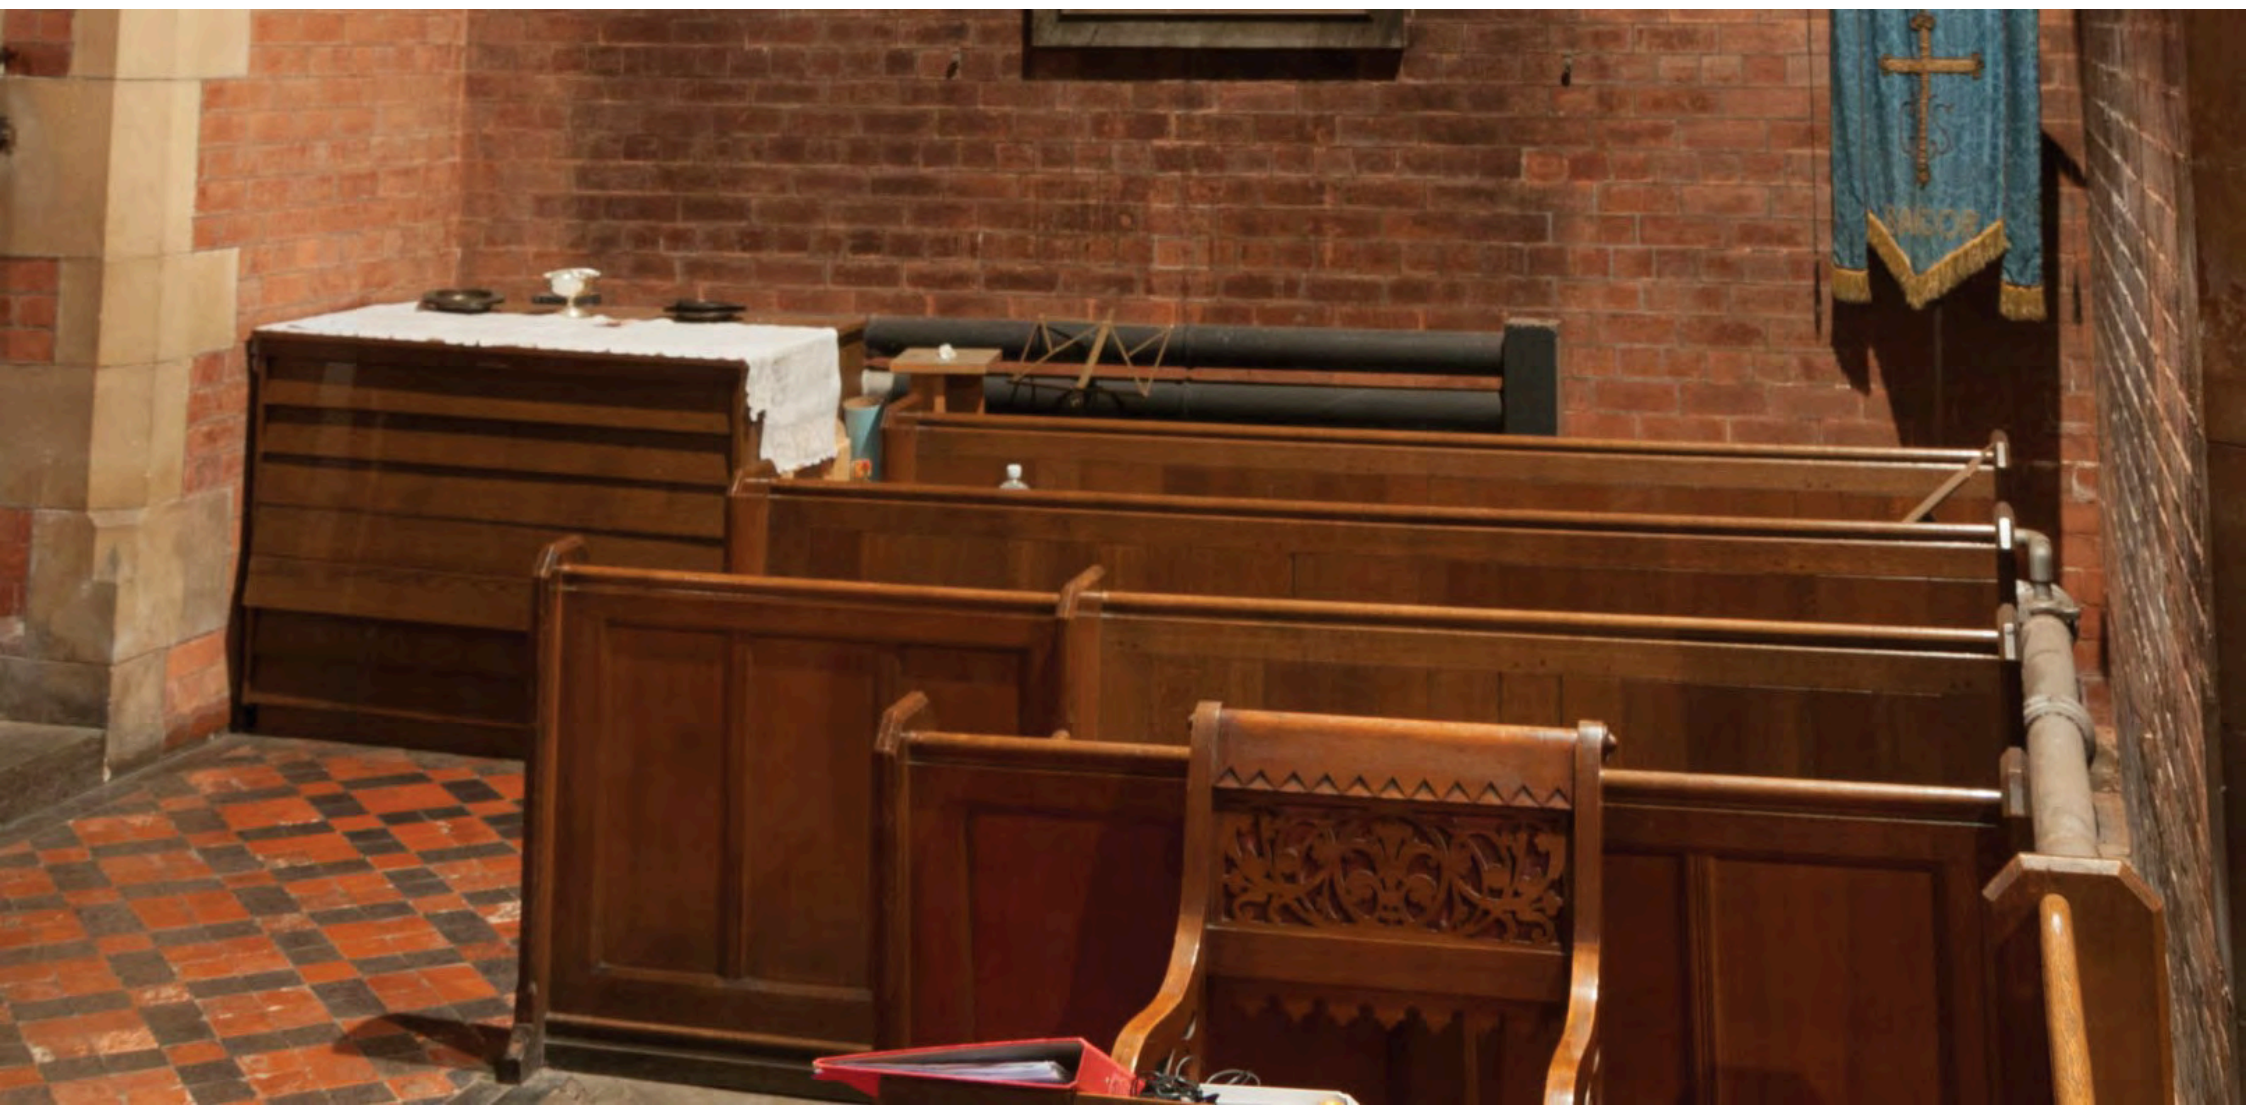
FIGURE 10

Reproduction of modern photograph of St Davids Church interior (Southern transept), prior to removal of interior. Source: John Nicholson, 2023.

Figure 10: Reproduction of modern photograph of St Davids Church interior (Within southern transept), prior to removal of interior. Source: John Nicholson, 2023.

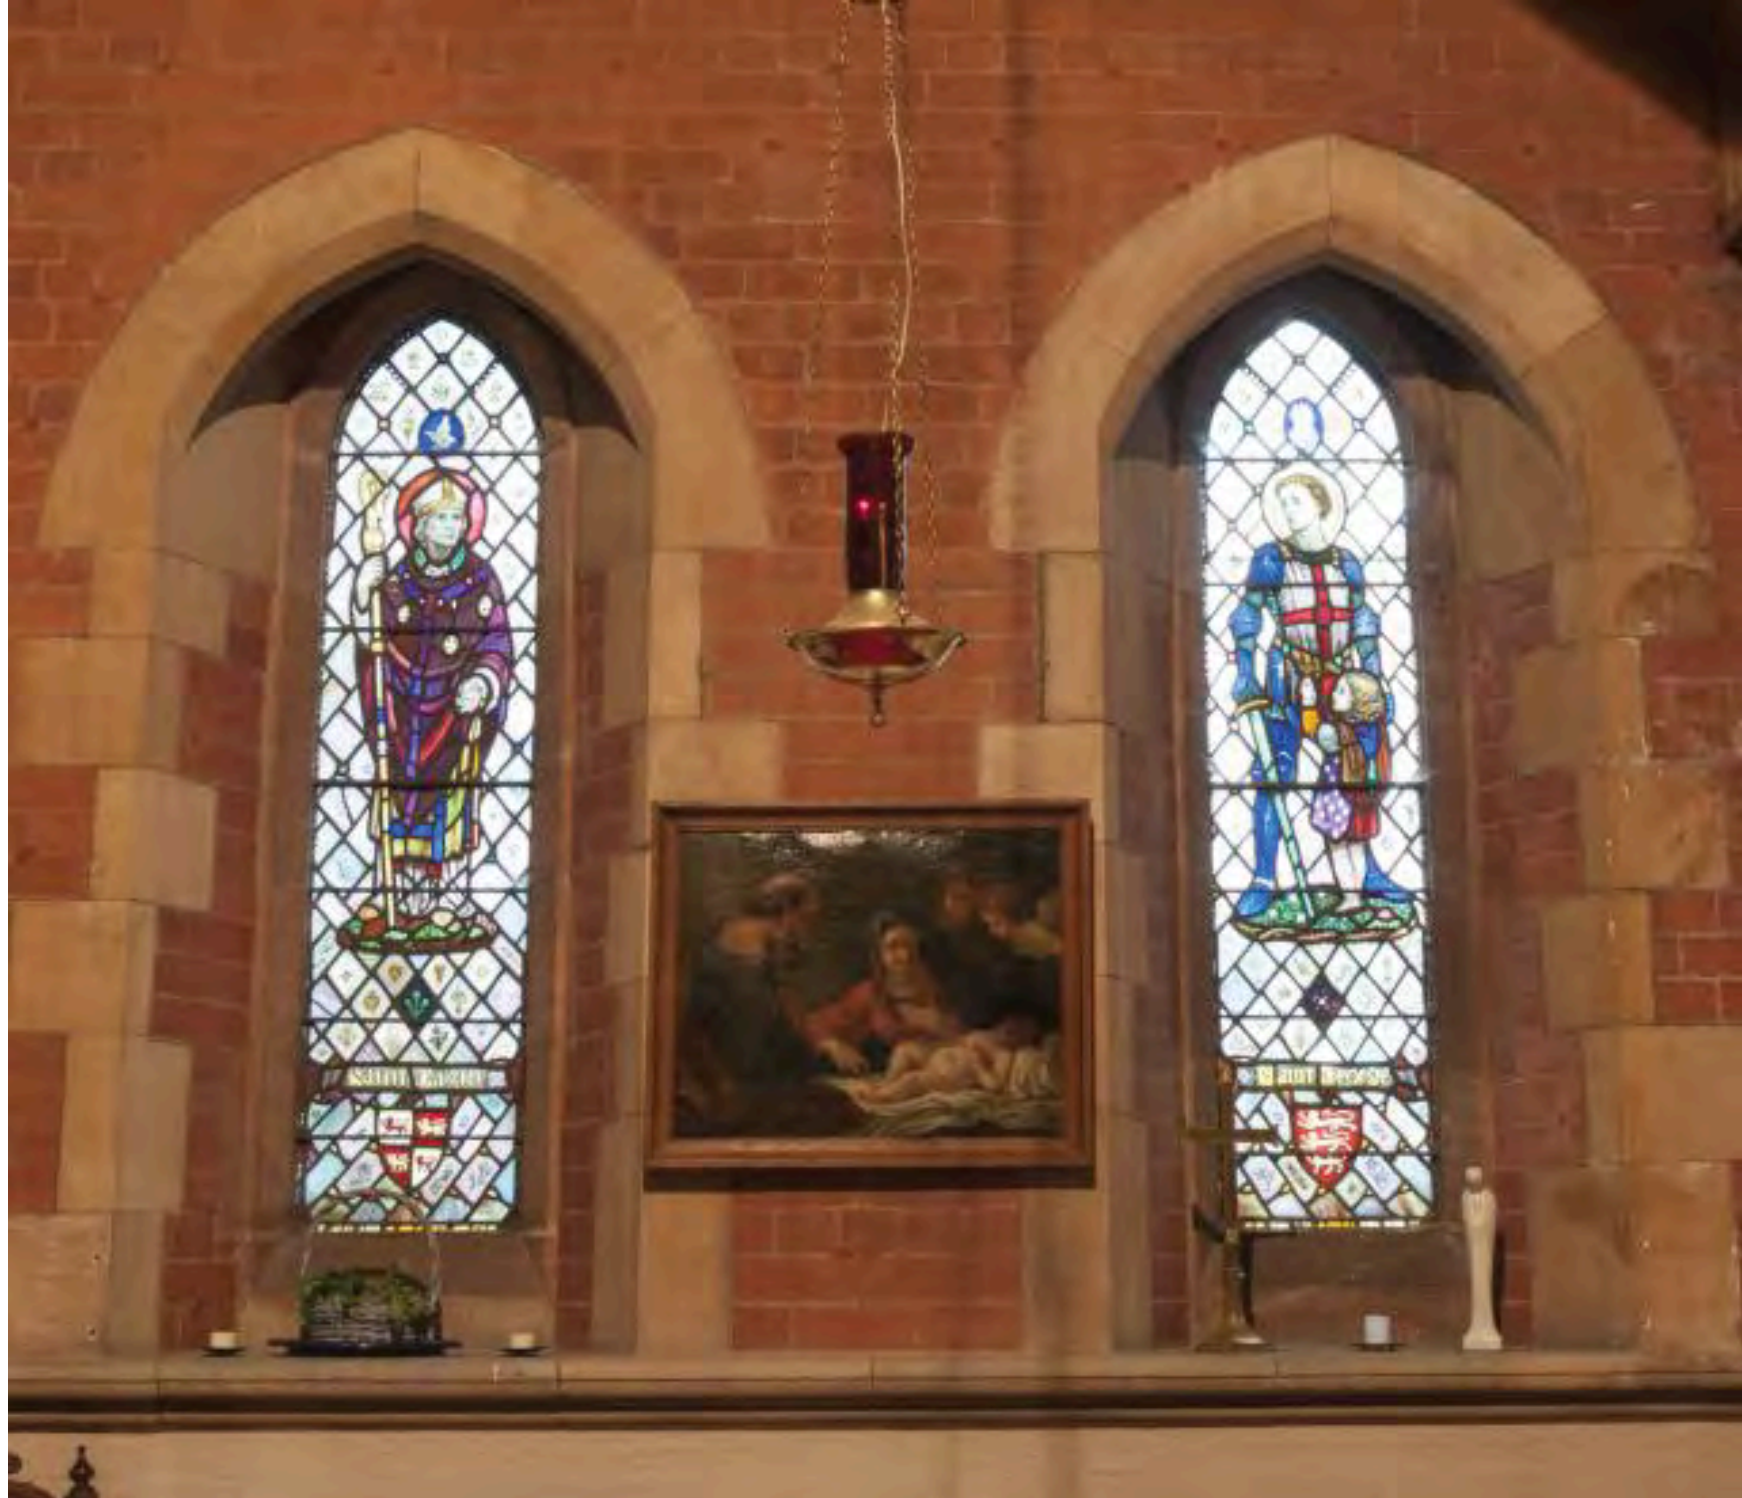
FIGURE 11

Reproduction of modern photograph of St Davids Church interior (Within Lady Chapel), prior to removal of interior. Source: John Nicholson, 2023.

Figure 11: Reproduction of modern photograph of St Davids Church interior (Within Lady's Church), prior to removal of interior. Source: John Nicholson, 2023.

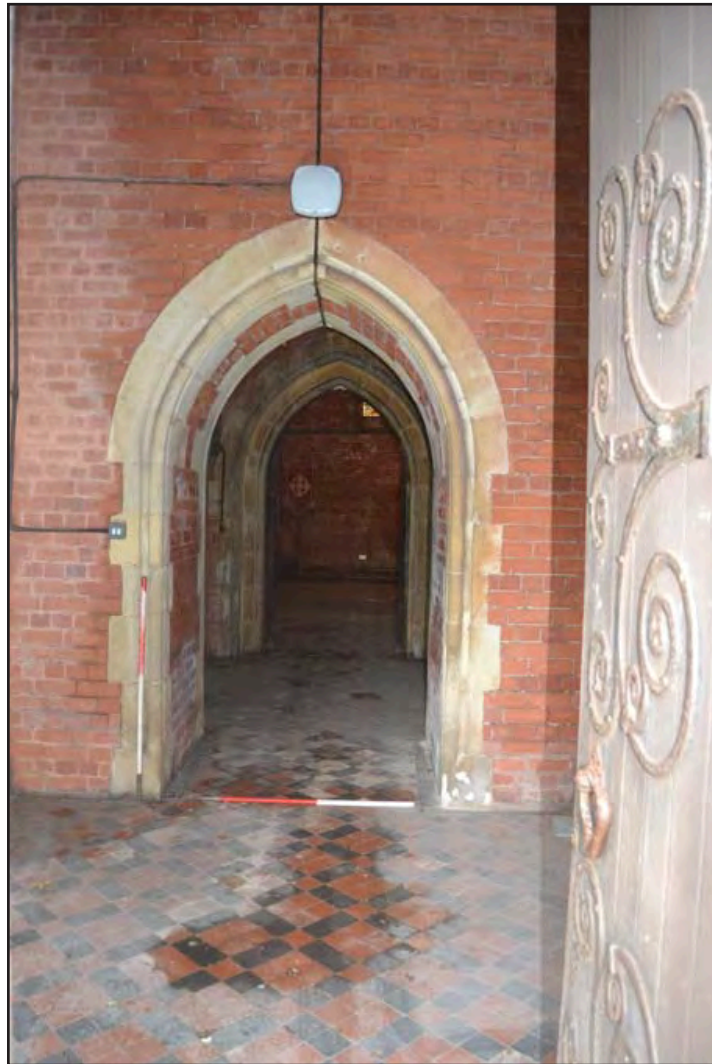
Plate 01: View of entrance room classified as 'bell tower' on plan from doorway into St Davids Church, from southeast; scale: 2x1m (archive reference: G2824_023).

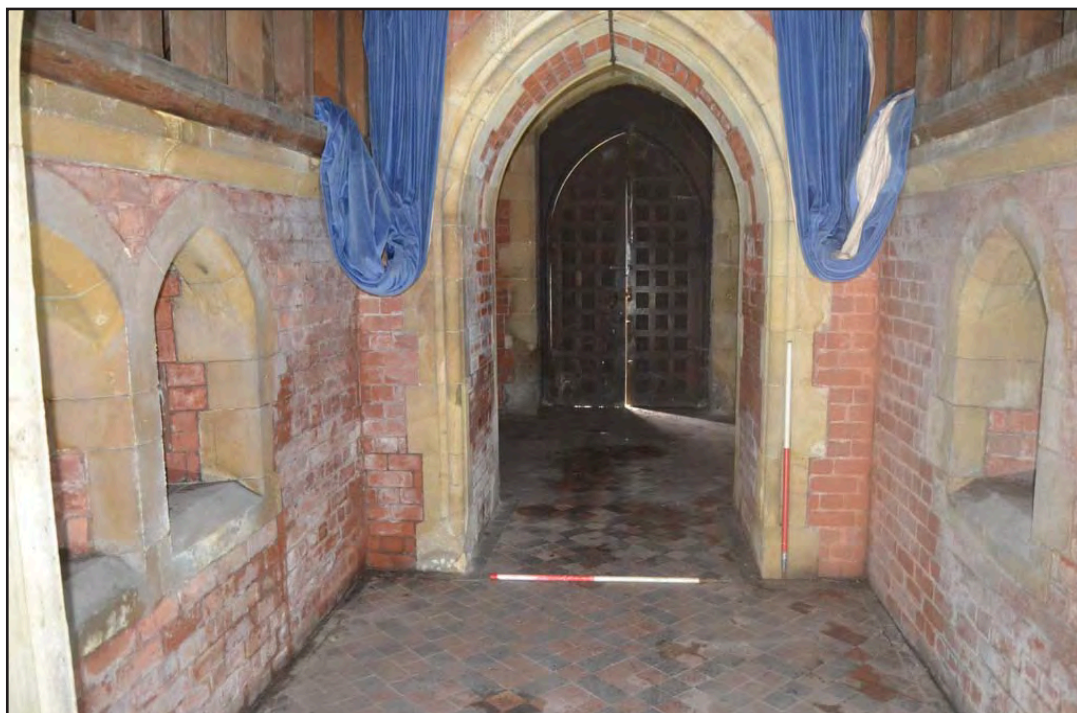
Plate 02: View of small entrance room situated between nave and bell tower, from northwest; scale: 2x1m (archive reference: G2824_024).

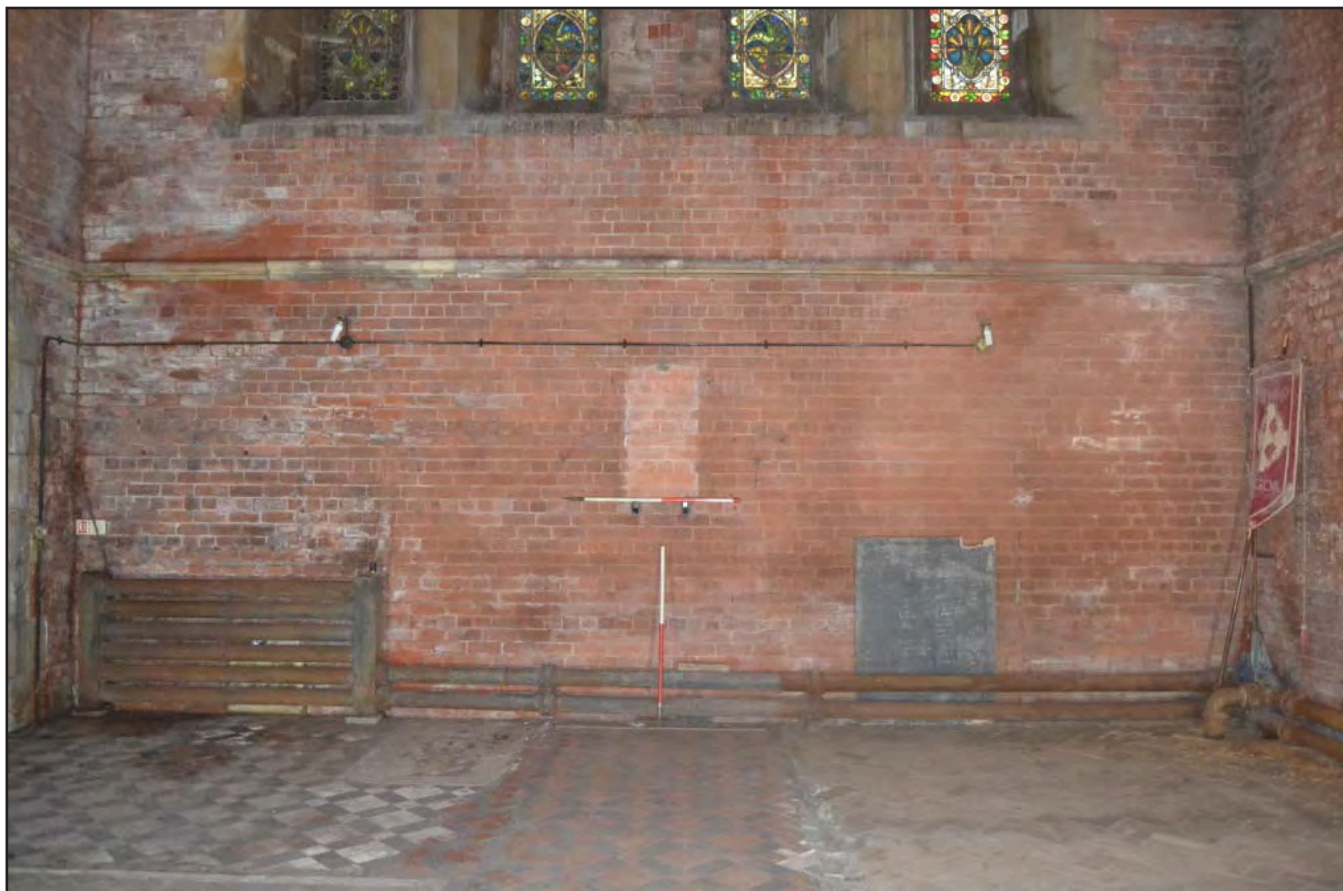
Plate 03: View of southwest wall of nave showing font, cabinet, last supper painting, war memorial, flags and bible book stand removed, from northeast - ; scale: 2x1m (archive reference: G2824_25).
