St David's Church, Caernarfon Road, Bangor, Gwynedd

Cofnod Adeilad Lefel 2/3 Archaeolegol /
Archaeological Level 2/3 Building Record

Rhif Prosiect / Project No. HD29-019 / G2827

Rhif Adroddiad / Report No. 1778

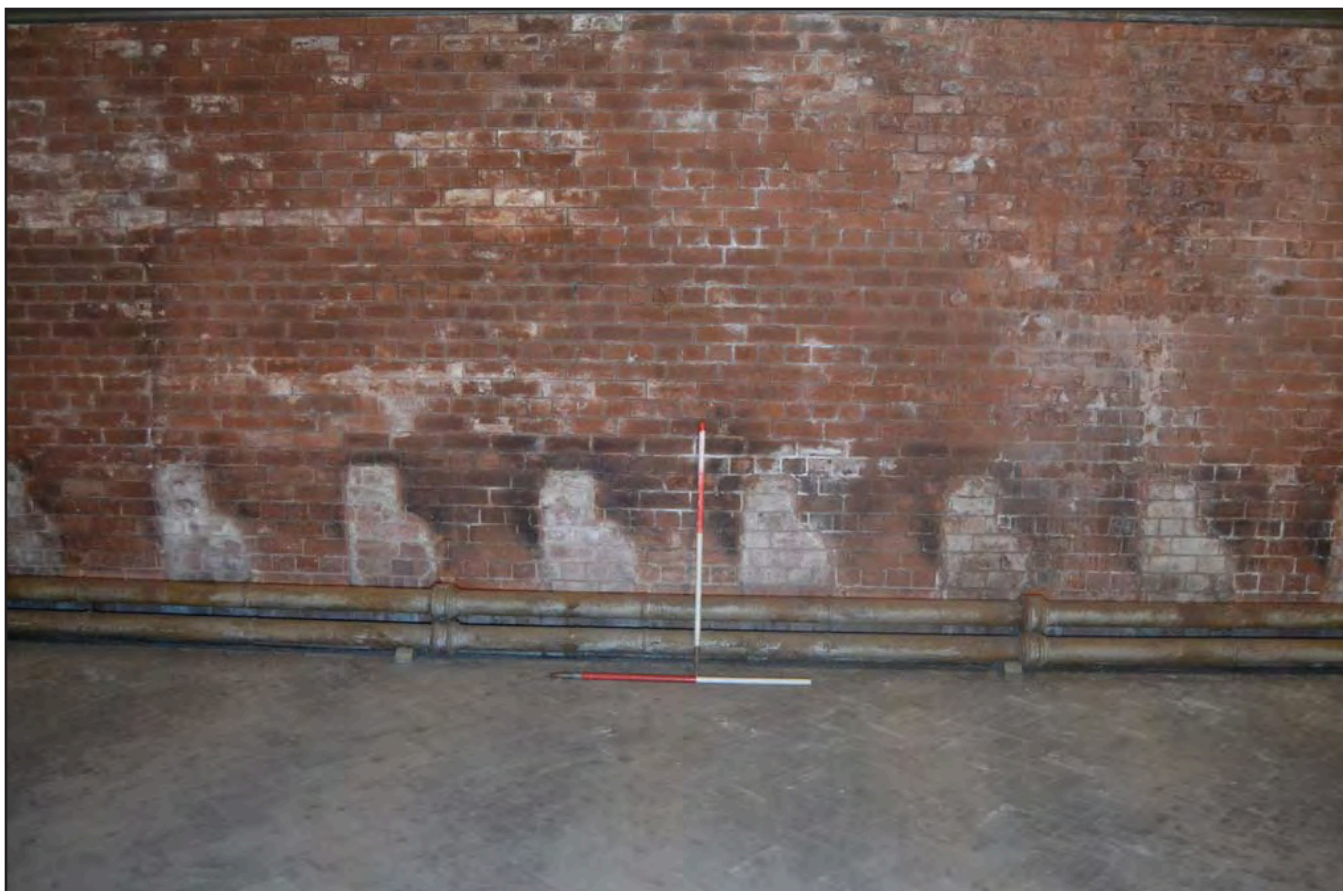
Plate 06: View from centre of nave showing pew outline (now removed) along northwestern wall, from southeast- ; scale: 2x1m (archive reference: G2824_28).

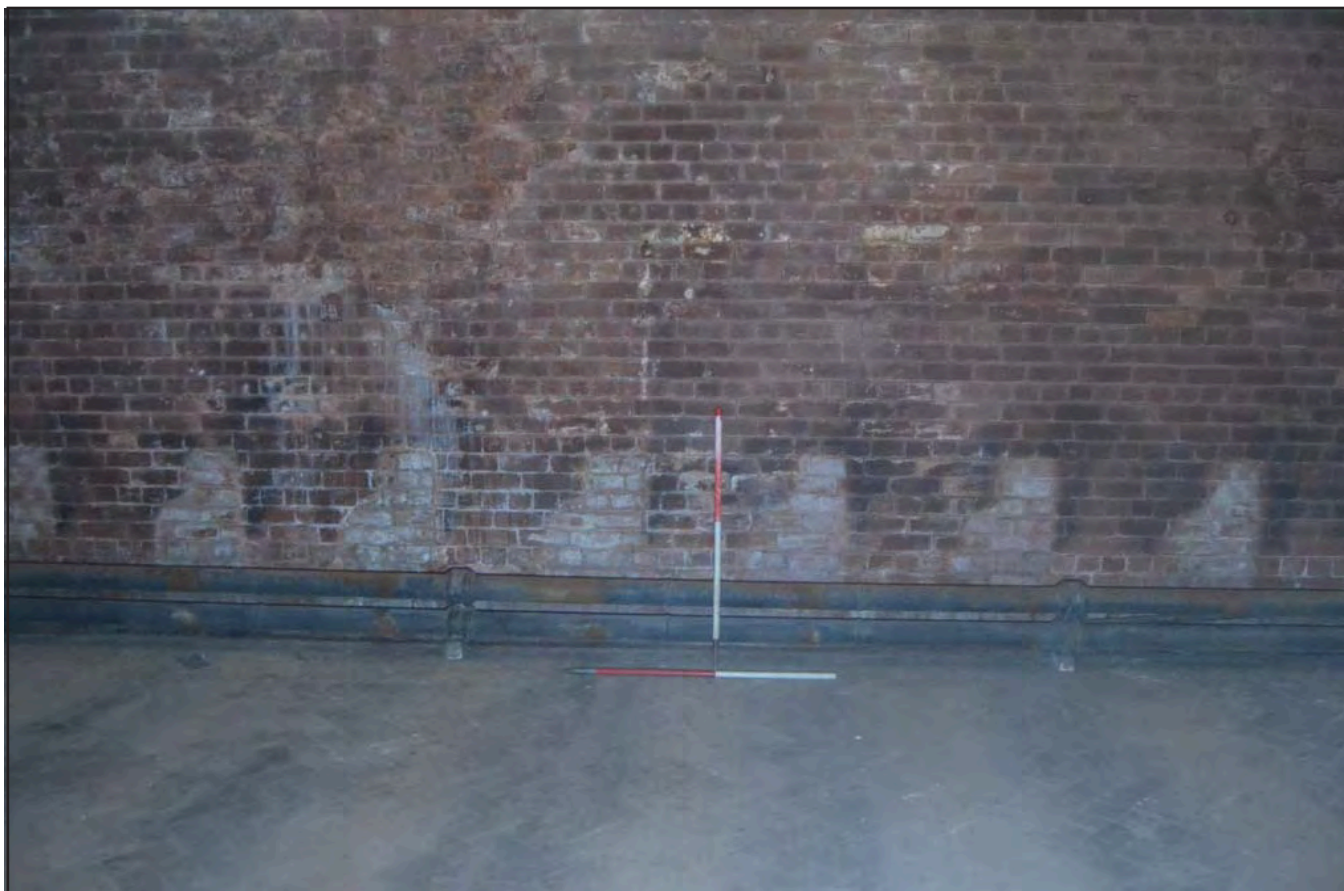
Plate 07: View from centre of nave showing pew outline (now removed) along southeastern wall, from northwest- ; scale: 2x1 m (archive reference: G2824_29).

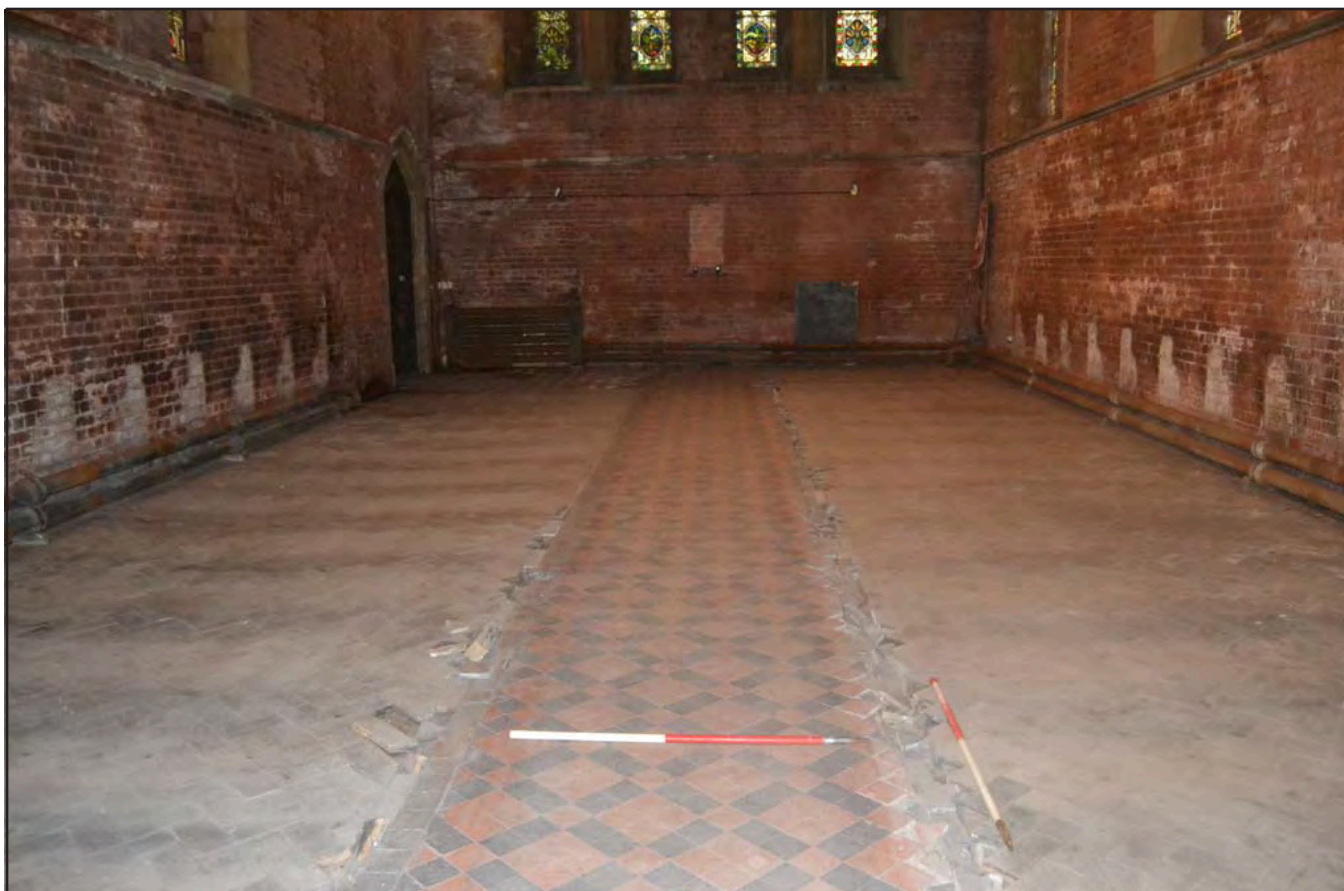
Plate 08: View of Parquet floor placed each side of nave and beneath the pews with a tiled centre (red carpet removed) leading up to the chancel, from northeast- ; scale: 2x1 m (archive reference: G2824_30).

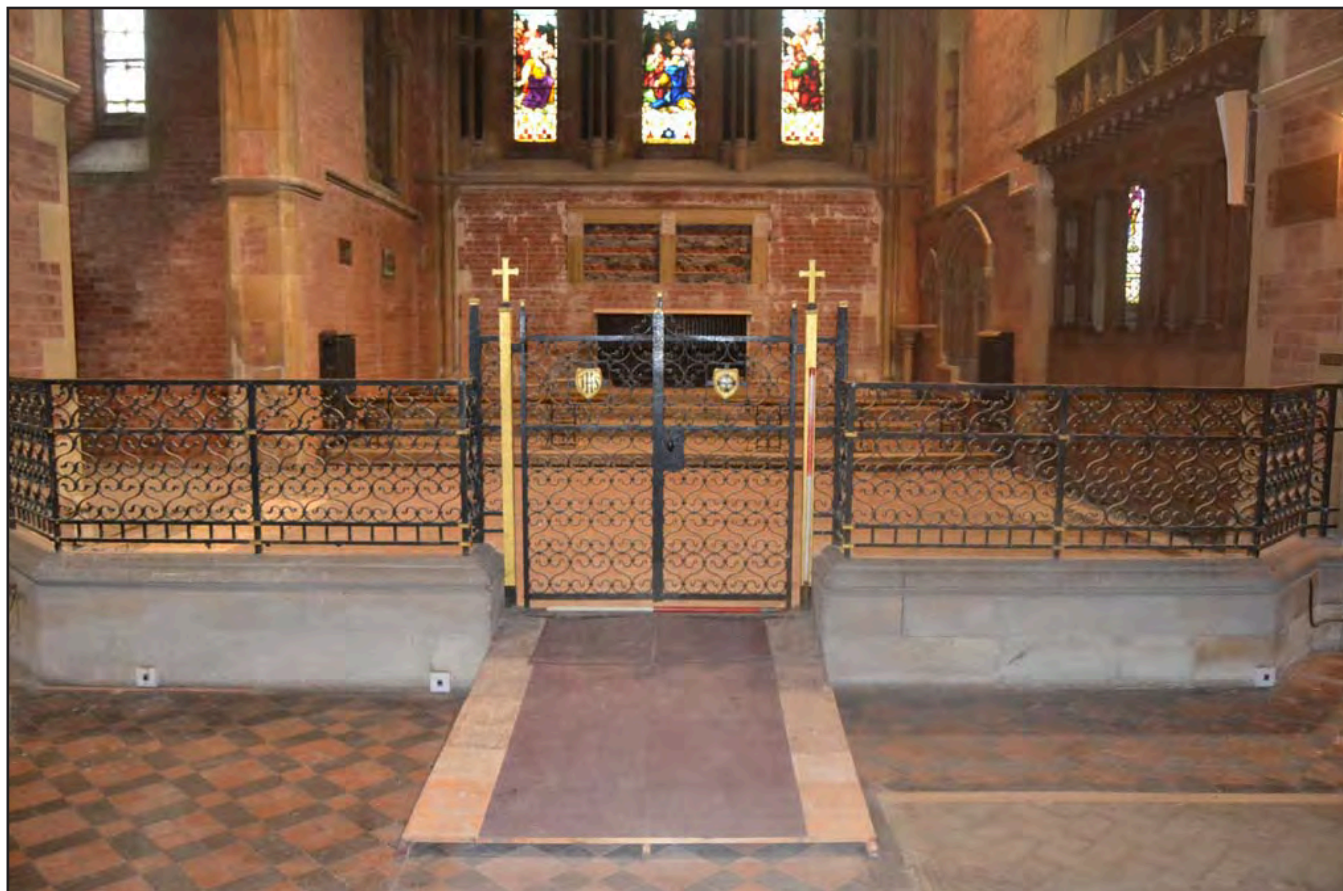
Plate 09: View of chancel and choir screen from end of nave (centre), from southwest- ; scale: 2x1m (archive reference: G2824_31).

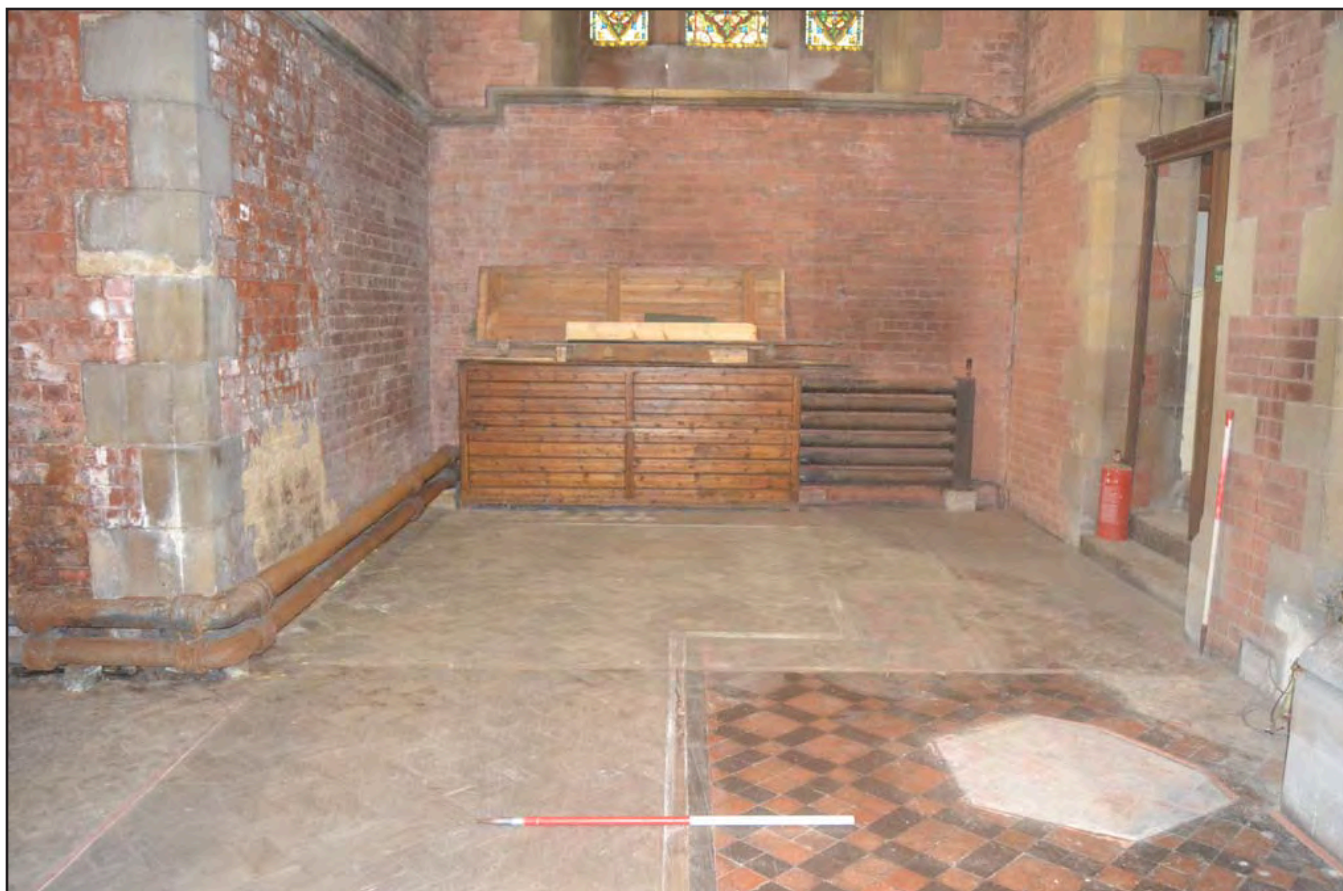
Plate 10: View of northern transept along with imprint of removed pulpit, from south east- ; scale: 2x1m (archive reference: G2824_32).

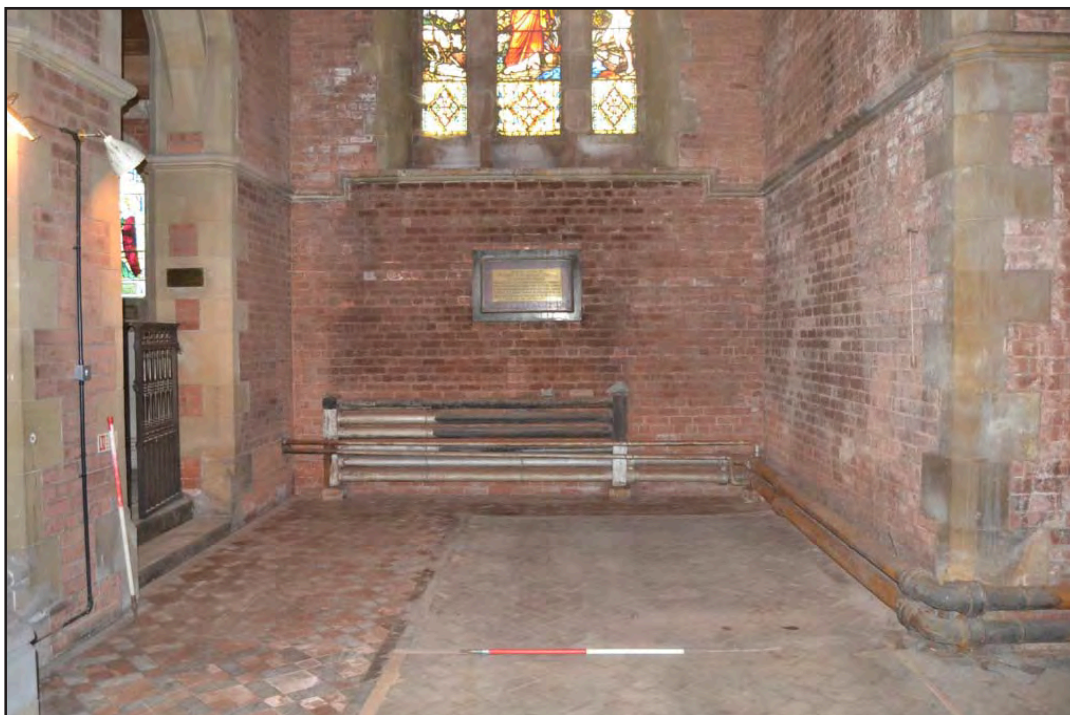
Identically to the northern transept, the Parquet floor continued round from the nave and had a portion of the floor in terracotta and black rectangular shaped tiles (Plate 11). Remnants of old nails and ripped pieces of wood were noted still attached to the wooden floor which once held pews. On the southeast wall the plaque in memory of Elizabeth Atcherley Symes who endowed the Church on her death (c.1890) was still in situ (Plate 14). Beneath the plaque there was a series of large heating pipes attached to the wall. Positioned on the northeast wall was the entrance to the Lady Chapel with the gates x2 still in situ. In comparison to the other iron work found in the church, the gates to the Lady Chapel were modern factory mass

Plate 11: View of southern transept and memorial plaque of Elizabeth Symes still in situ along with entrance to Lady Chapel, from the northwest; scale: 1x1m (archive reference: G2824_33).

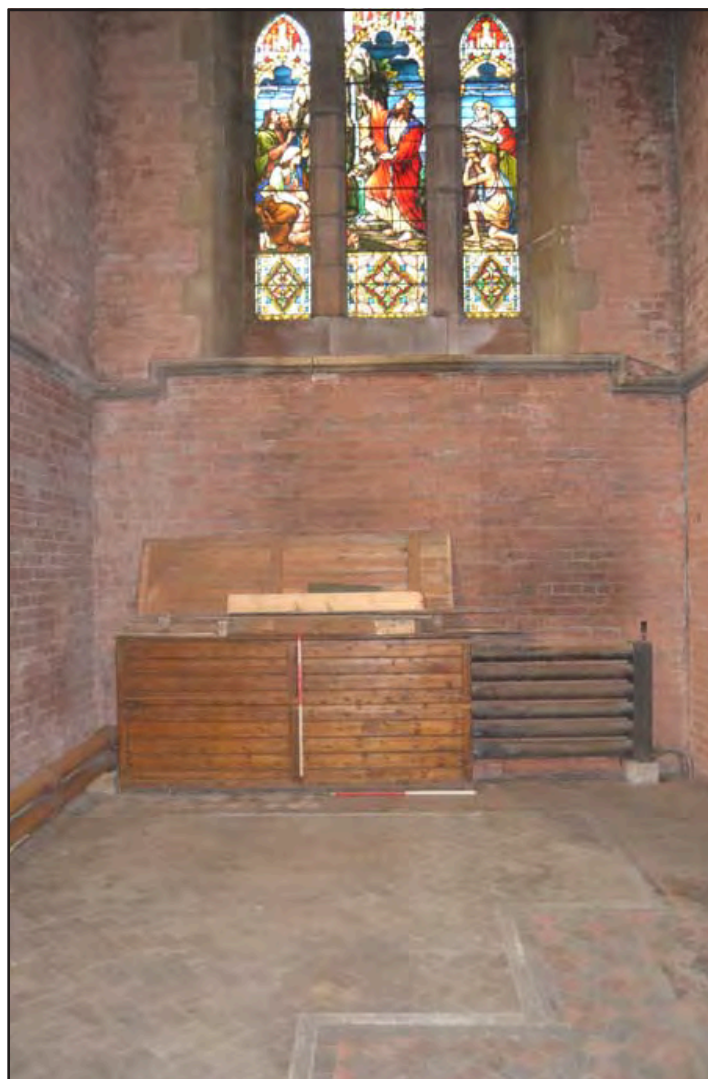
Plate 12: View of Northern transept (Portrait) showing demolition material in the form of broken wooden panels and cabinets on northwest wall, from the southeast; scale: 1x1m (archive reference: G2824_34).

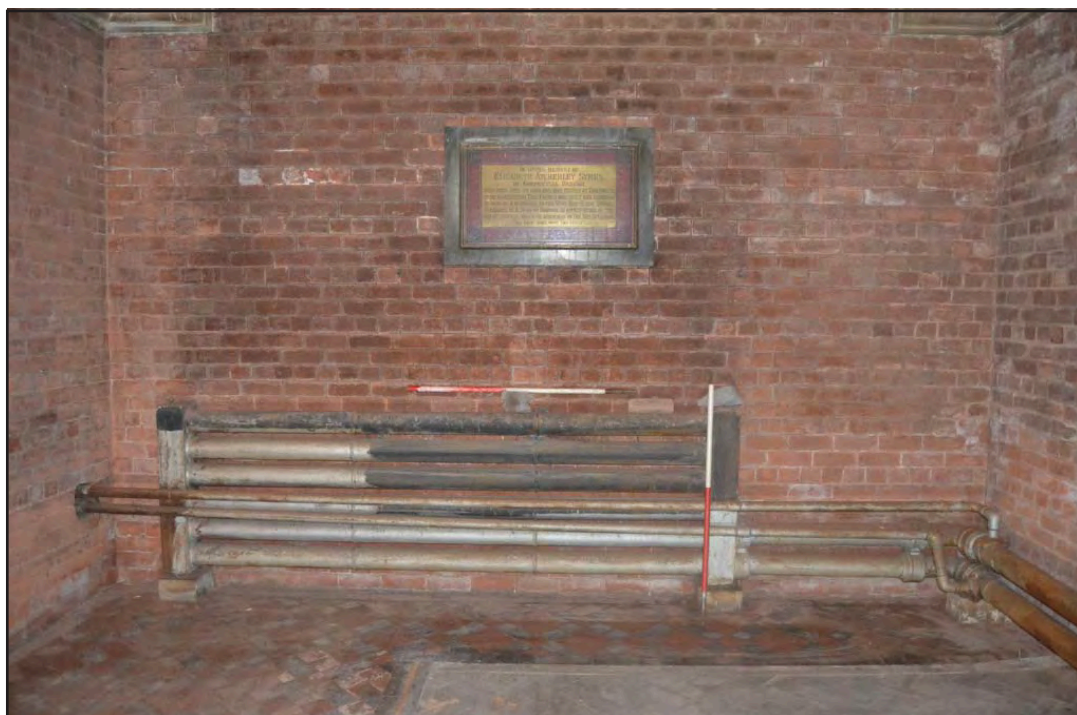
Plate 14: View of southern transept showing cast iron piping and memorial plaque to Elizabeth A. Symes still in situ, from the northwest; scale: 2x1m (archive reference: G2824_036).

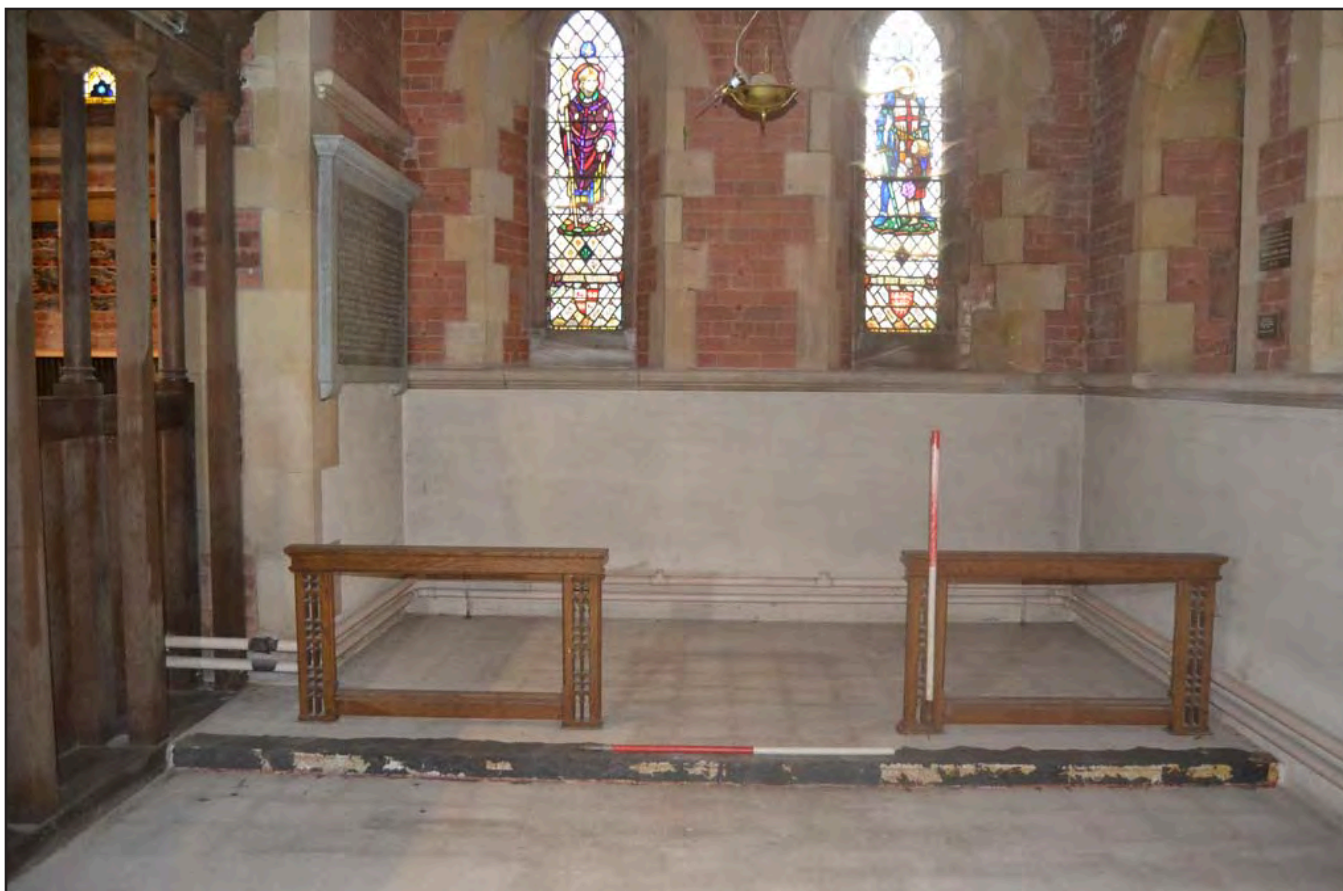
Plate 16: View within Lady Chapel of small chancel against north east wall along with windows, First World War memorial plaque and railings still in situ, from the southwest- ; scale: 2x1m (archive reference: G2824_38).

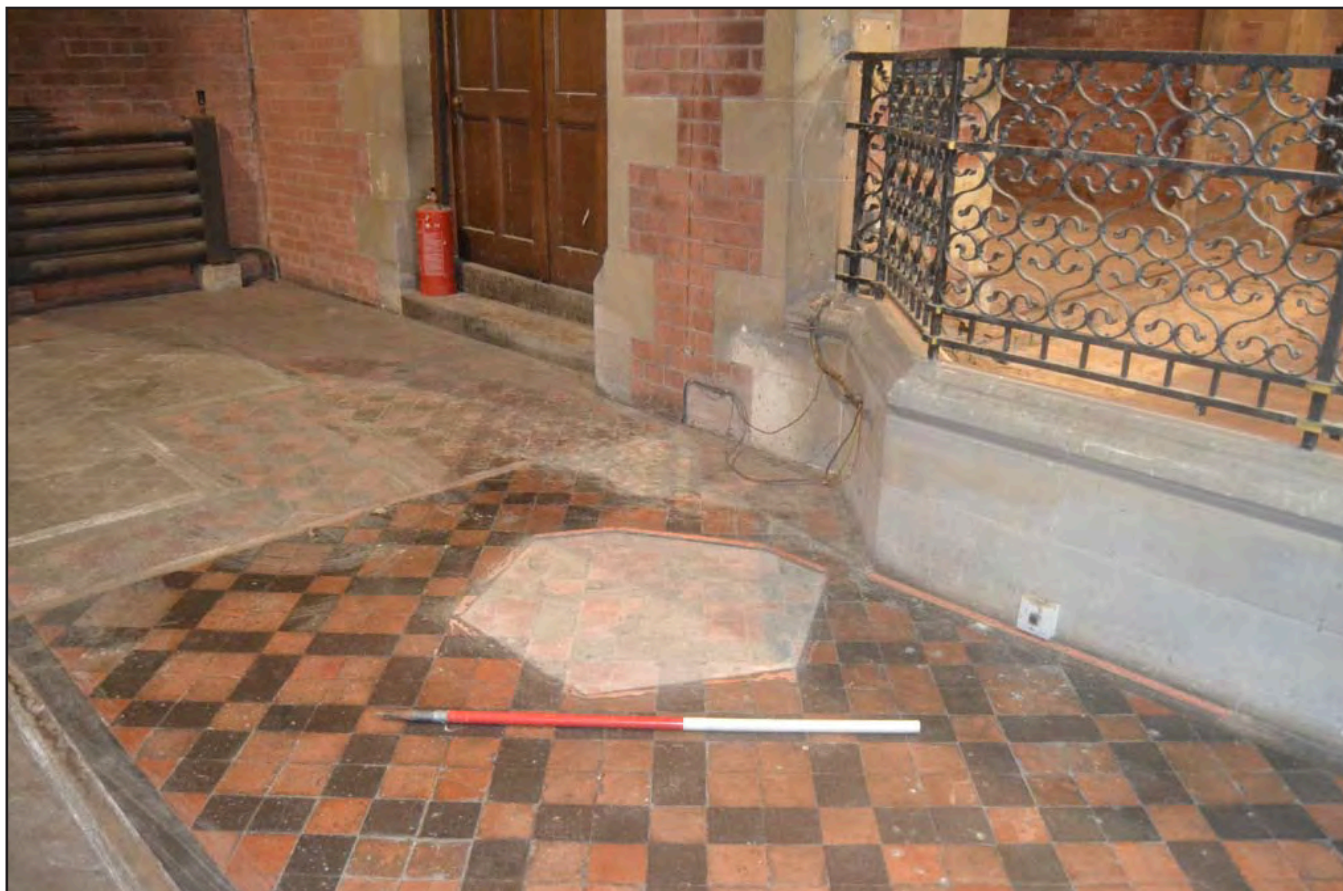
Plate 17: View of removed pulpit imprint on floor situated next to northern transept, from the south- ; scale: 1x1m (archive reference: G2824_39).

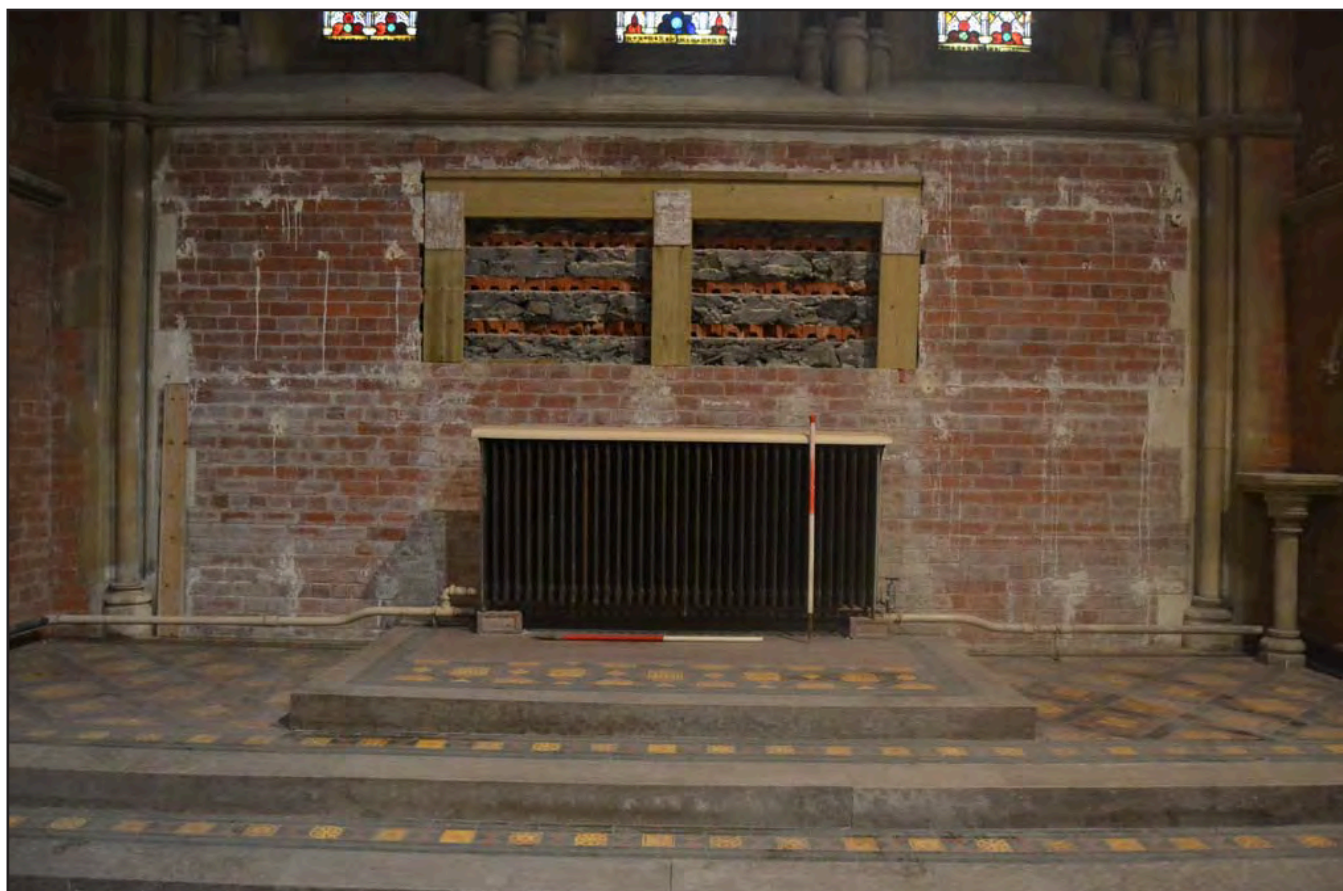
Plate 19: Close-up view of removed alter and Reredos in sanctuary, from the southwest- ; scale: 2x1m (archive reference: G2824_41).

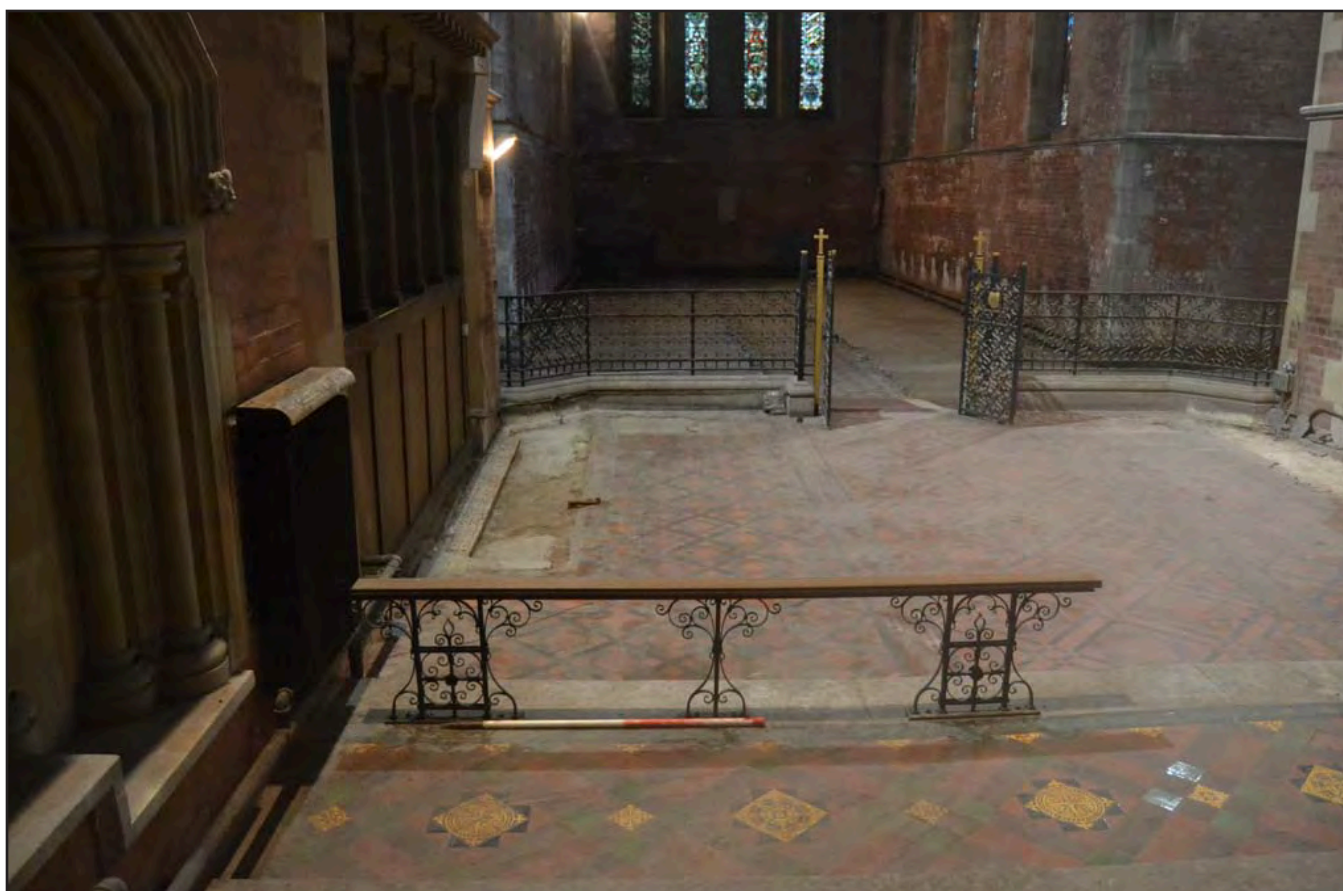
Plate 20: View along chancel towards nave (southeast side) showing former location of choir pews, choir screen and communion rail still in situ, from the northeast- ; scale: 1x1m (archive reference: G2824_42).

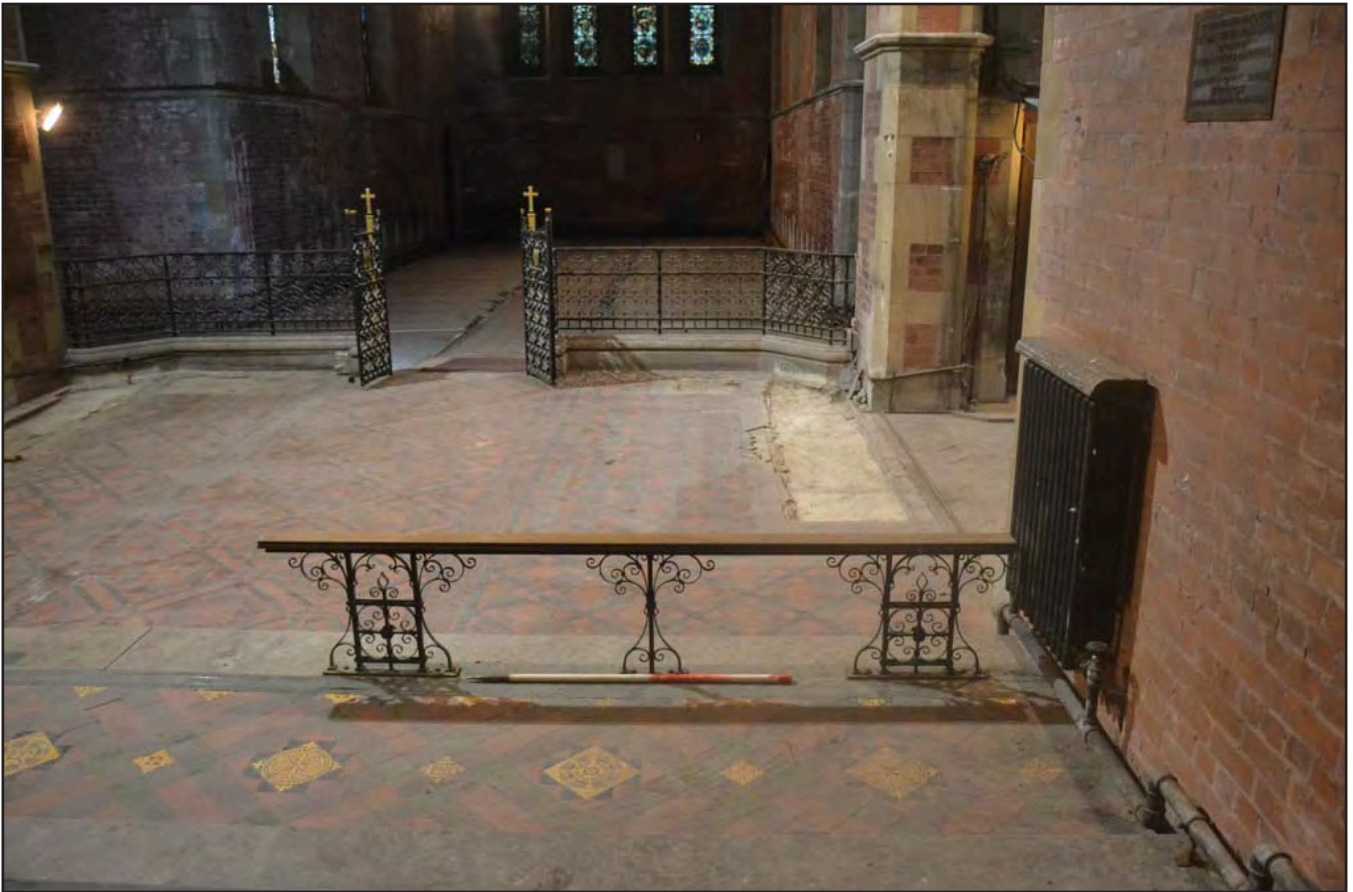
imprint is still present (Plate 21 and 22). The Chancel and Lady Chapel is separated by an oak columned screen with shield cresting which is in excellent condition and remains in situ. The shield crests depict Wales and England with a central crest depicting Cristo and the last two being Scotland and Ireland (Plate 22). The wooden screen was erected in memory of William Morgan-Jones Canon of Bangor Cathedral 1930 by his brother Reverend T.A Morgan Jones in c. 1923 with the Welsh scripture: *GWIR ORPHWYSFA GÂNT MEWN GWYNFYD*.

Plate 21: View along chancel towards nave (northwest side) showing former location of choir pews and organ, with communion and choir screen still in situ, from the northeast- ; scale: 1x1m (archive reference: G2824_43).

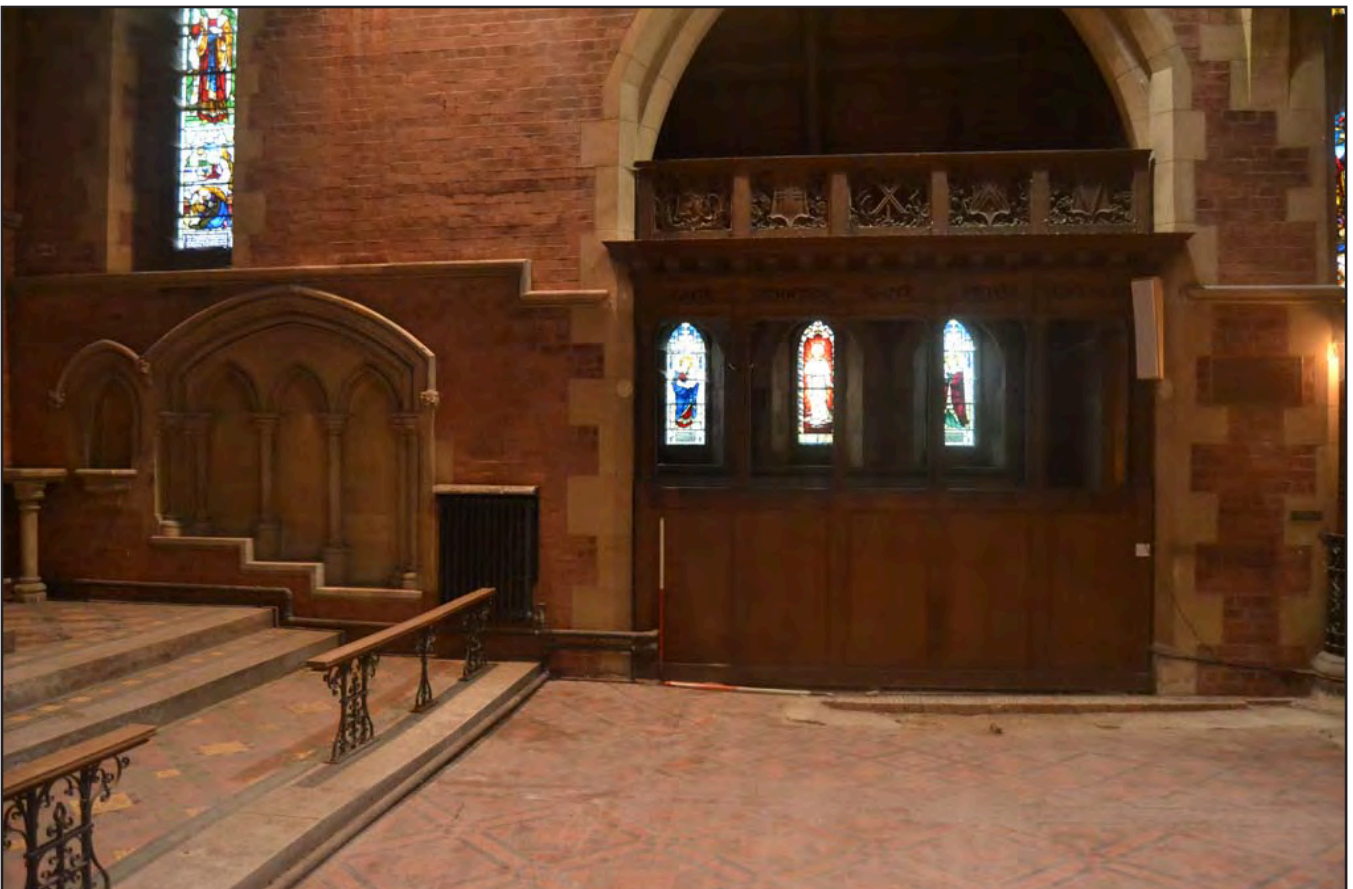
Plate 22: View of oak columned screen with shield cresting to Lady Chapel, from the northwest- ; scale: 2x1m (archive reference: G2824_44).

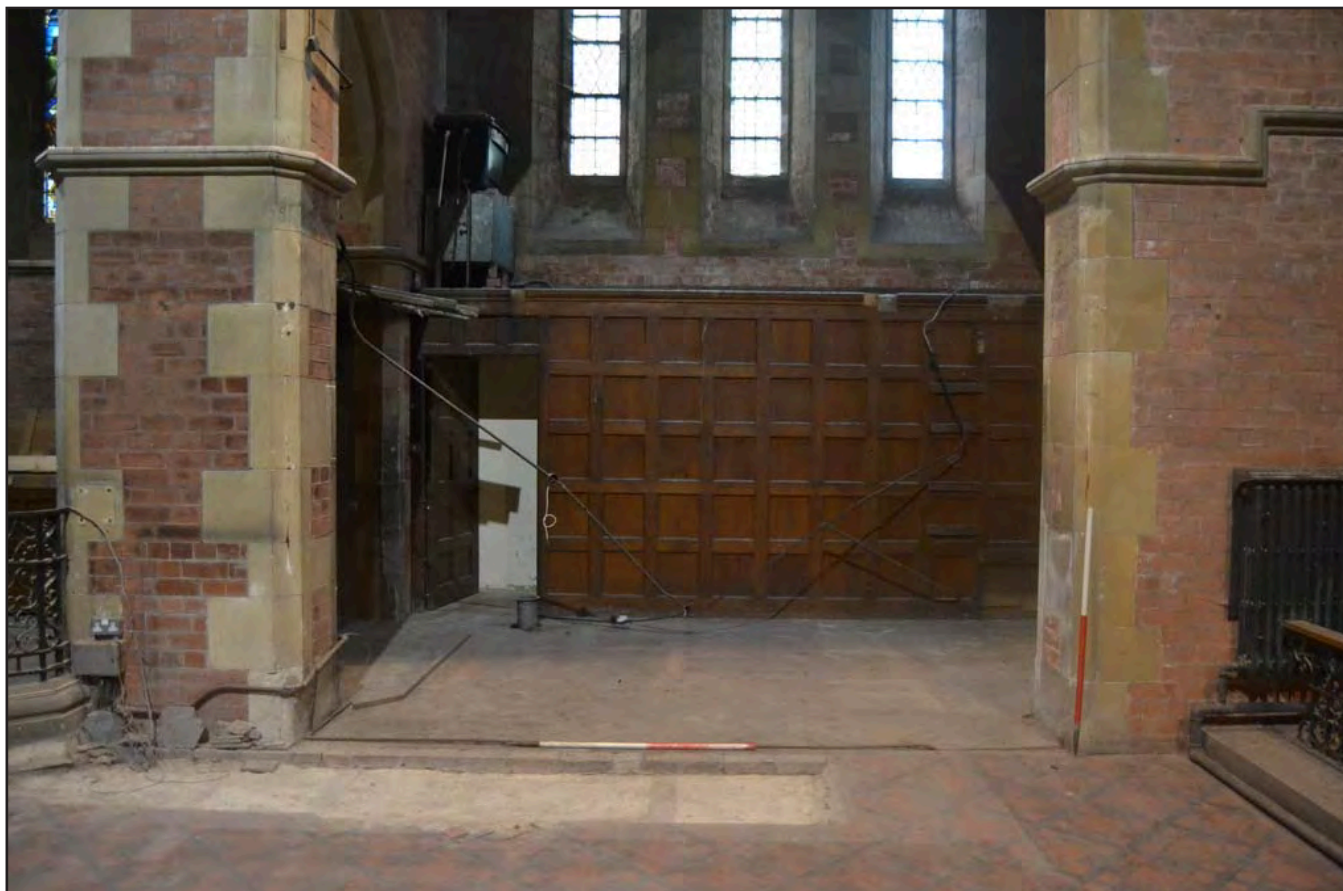
Plate 23: View through to organ room with organ removed, from the southeast- ; scale: 2x1m (archive reference: G2824_45).

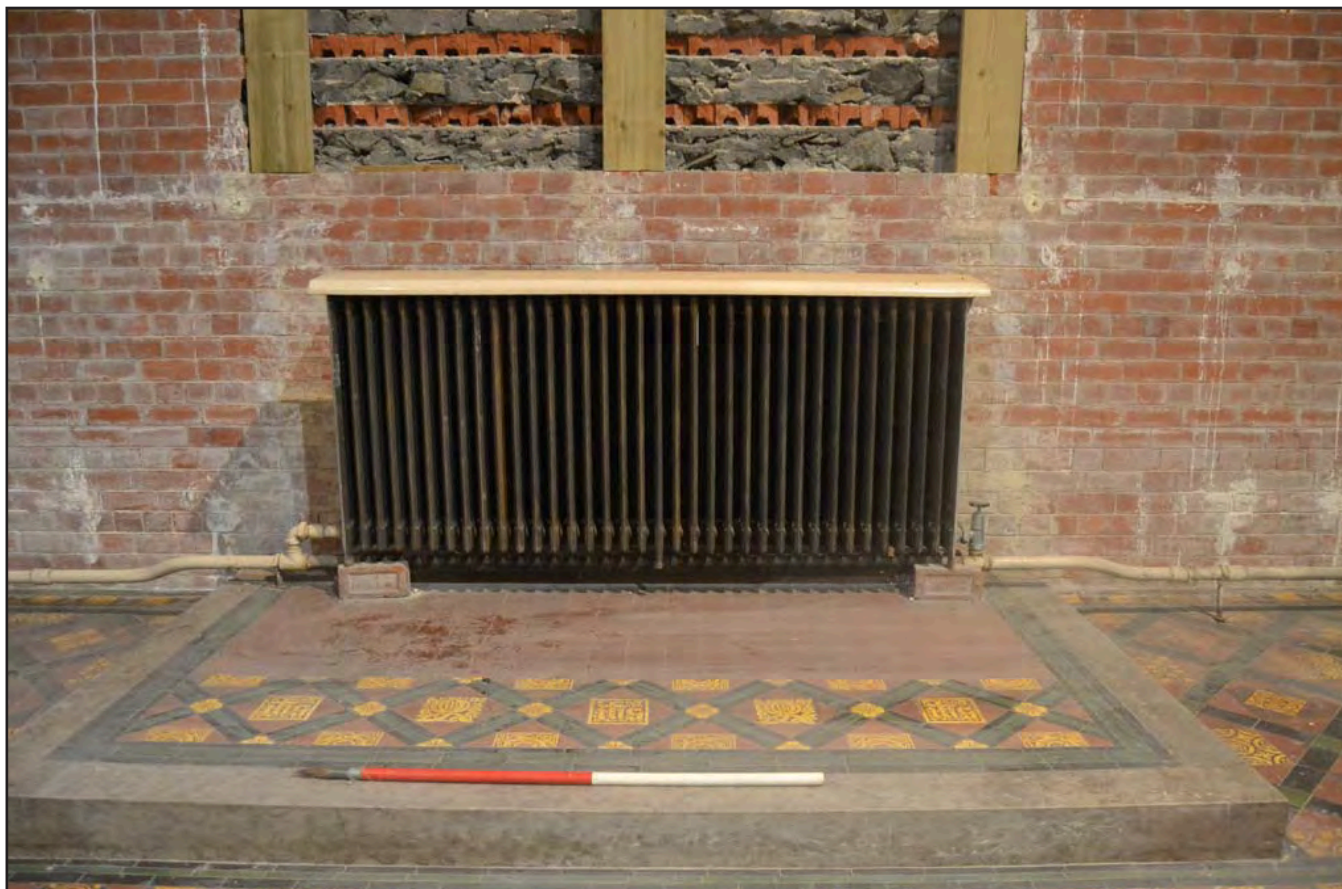
Plate 25: View of former altar location (predella), from the northeast- ; scale: 1x1m (archive reference: G2824_47).

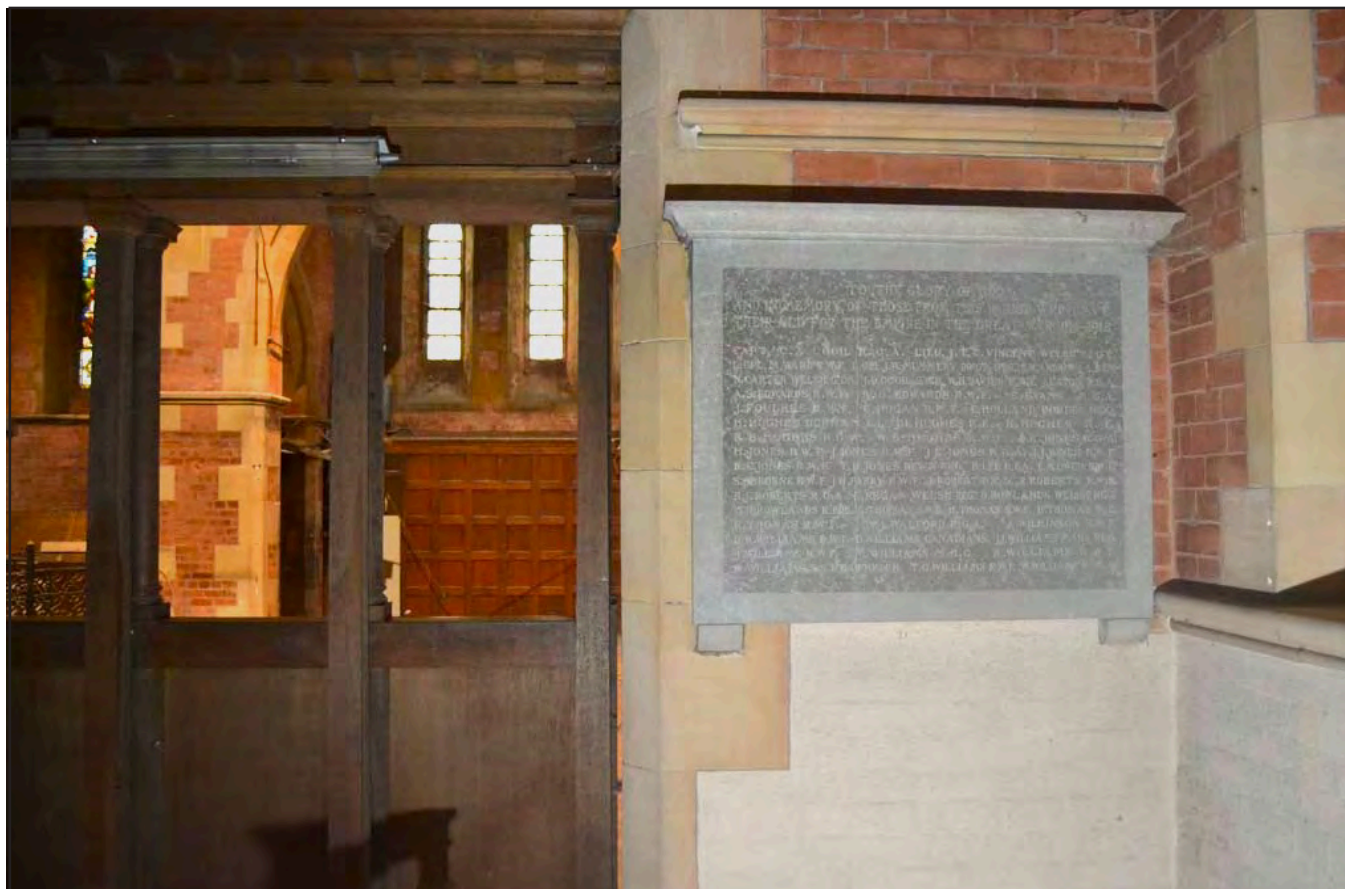
Plate 26: View of memorial plaques still in place within sanctuary on northwest wall, from the southeast- ; scale: not used (archive reference: G2824_48).

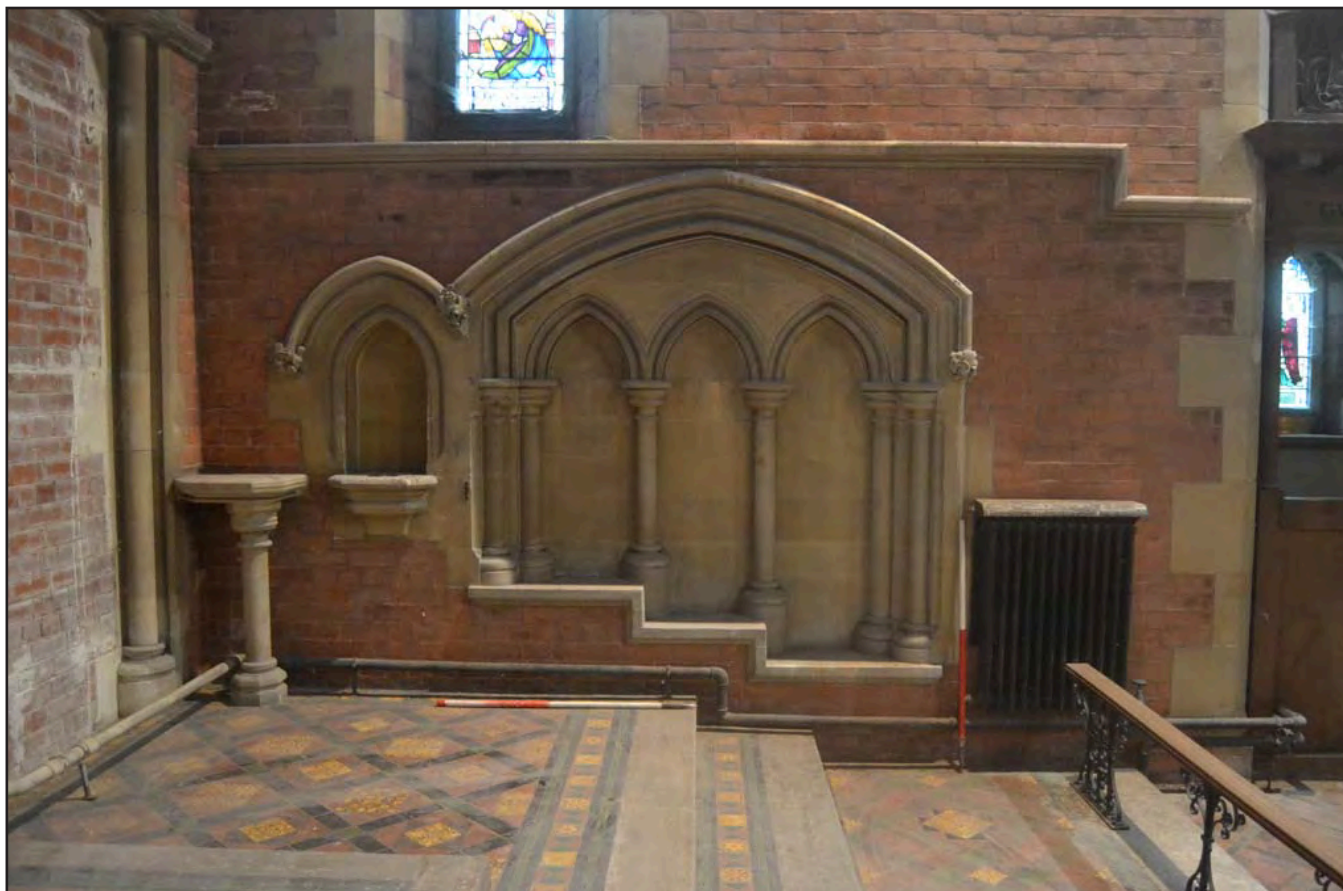
Plate 29: View of carved sandstone art in the form of columns, arches and elaborate borders with carved leaves and berries, from the northwest- ; scale: 2x1m (archive reference: G2824_51).

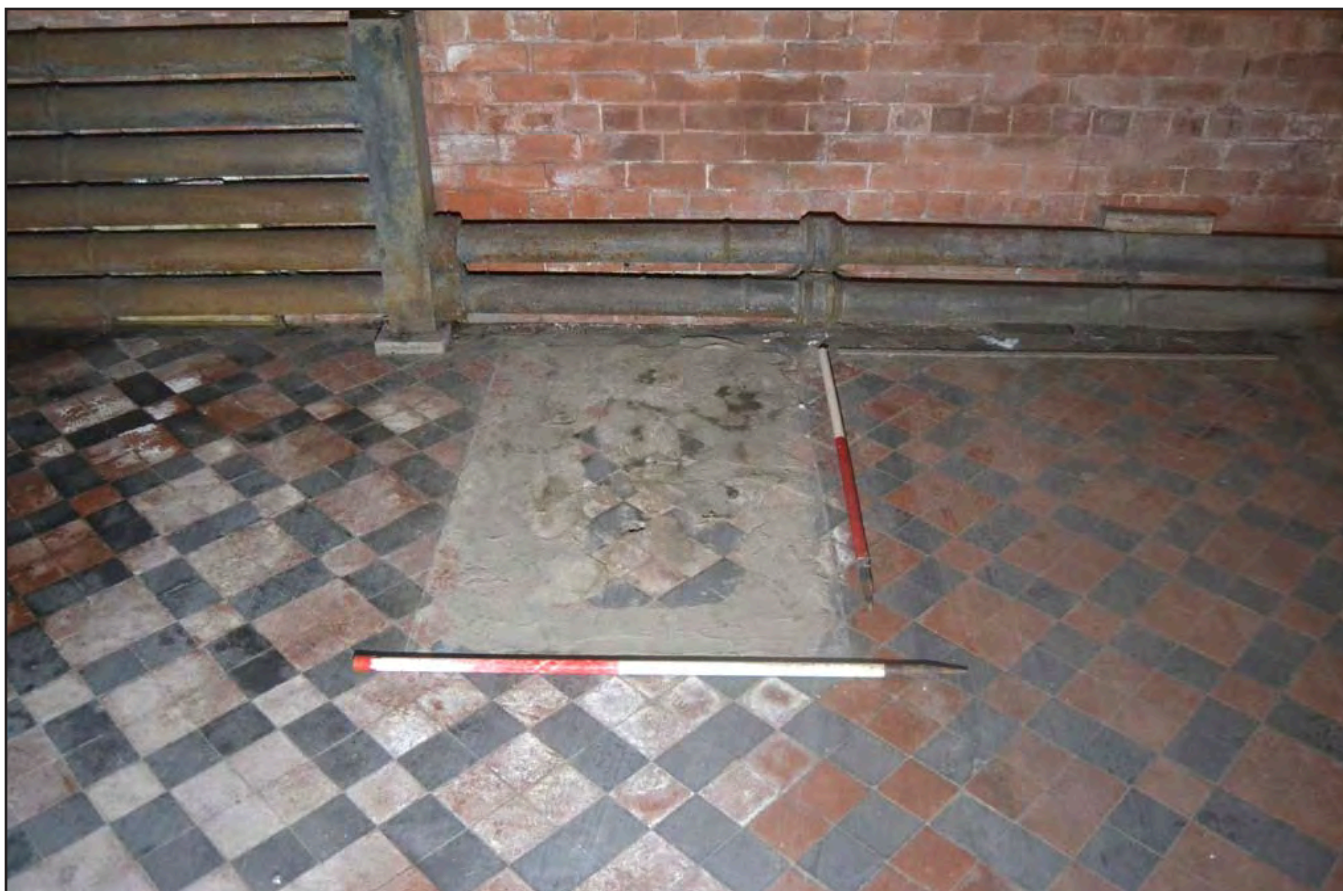
Plate 30: View of previous location of font seen by footprint on floor next to door into nave, from the northeast- ; scale: 2x1m (archive reference: G2824_52).
