St David's Church, Caernarfon Road, Bangor, Gwynedd

Cofnod Adeilad Lefel 2/3 Archaeolegol /
Archaeological Level 2/3 Building Record

Rhif Prosiect / Project No. HD29-019 / G2827

Rhif Adroddiad / Report No. 1778

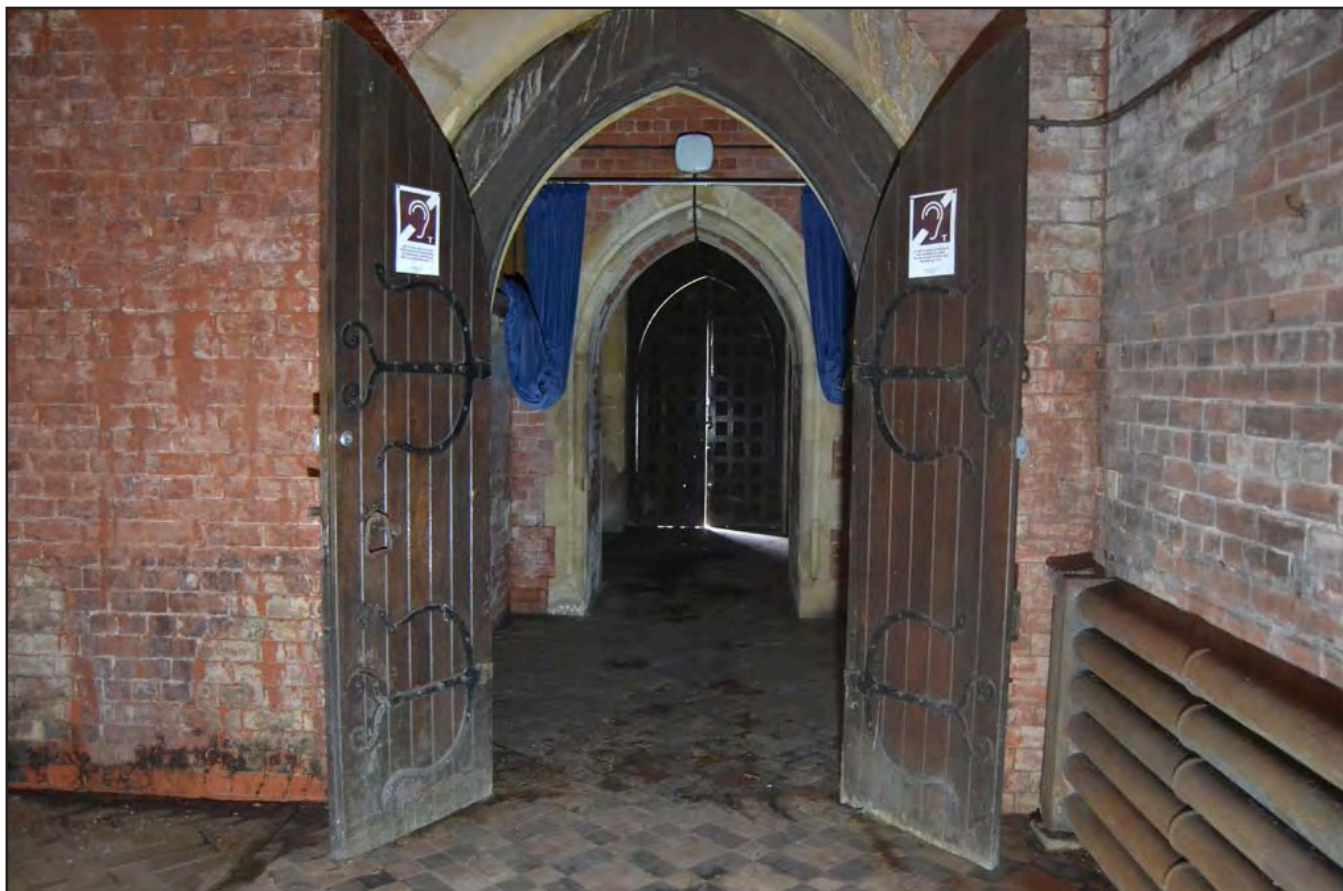
Plate 31: View of entrance door to nave showing heavy cast wooden door supported by blacksmith made elaborate and large scroll hinges, from the northwest - ; scale: not used (archive reference: G2824_53).
