Parc, Talwrn, Ynys Môn

Cofnod Adeilad Lefel 2/3 Archaeolegol
Archaeological Level 2/3 Building Record

Rhif Prosiect Heneb Archaeoleg Gwynedd / Heneb Gwynedd Archaeology Project No. HD24-116

Rhif Adroddiad / Report No. 1817

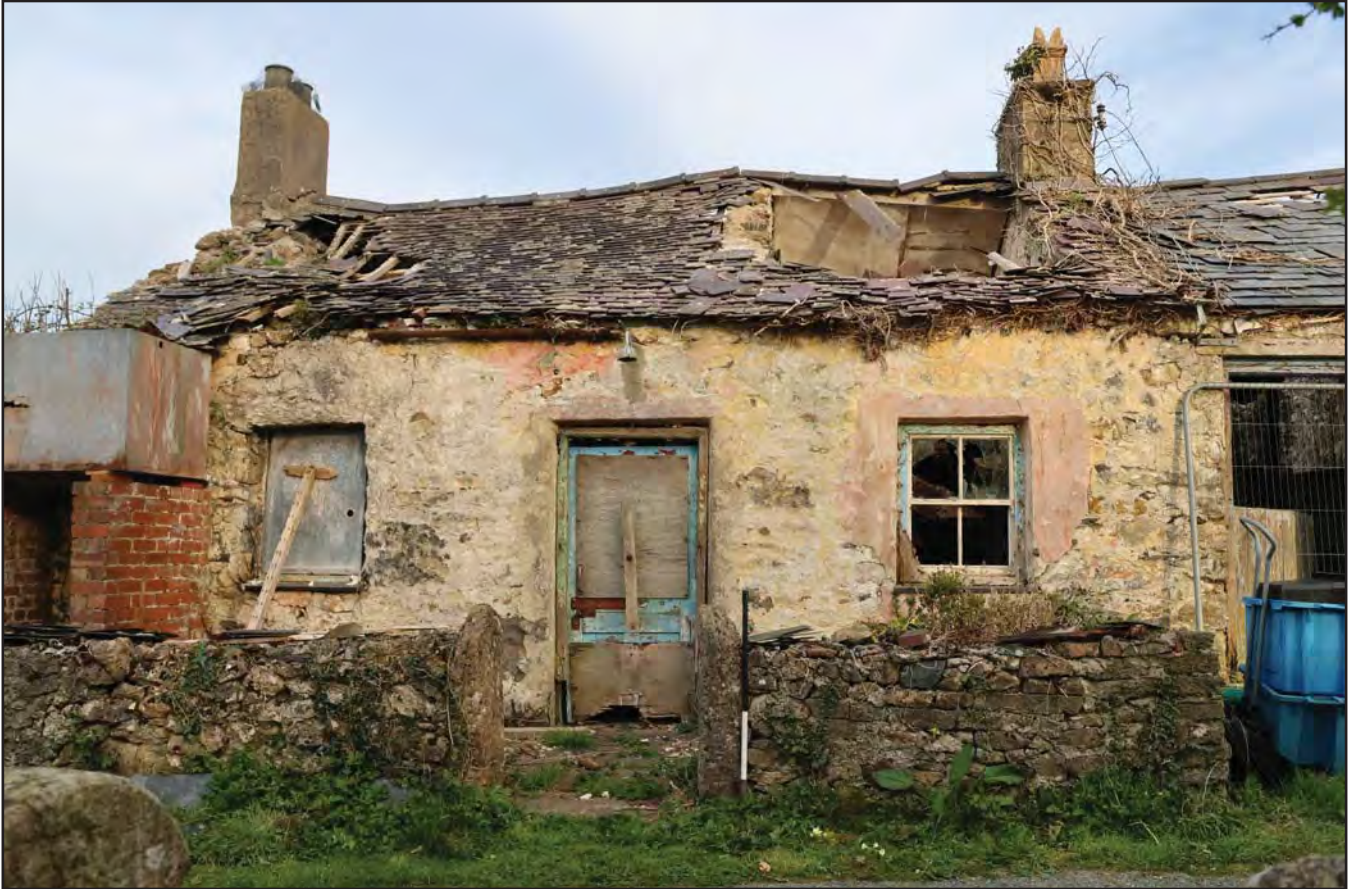
The main house consists of Rooms 1 and 2 and a croglift on the first floor above Room 2 and is of a rubble stone construction which has been rendered over (Plate 1). The southeast facing elevation forms the front of the house and has a central doorway, and two wooden framed windows positioned each side. The front door is a blue, constructed of wood and presumably had a frosted glass top half which is now boarded over. On further examination, the door is not original as it does not align with the frame, therefore a later addition, presumably to deter access whilst the house was in a poor state of repair. The window frame is completely missing from the window to the left of the front door; however, the worked slate windowsill still remains. The window to the right of the front door is still in place and has a wooden frame in place that appears to be original in addition to a worked slate windowsill (Plate 1). The external walls have been rendered with stonework visible where the mortar has fallen off. A small garden wall standing approximately a 1m high forms a small, enclosed yard in front of the house.

Two Chimneys remain standing, one in the southwest gable end and the other in the northeast gable end. The chimney pots and stacks do not match each other, suggesting they have been replaced at some time (Plate 1, 2, 5 and 49).

Plate 1: Exterior - View of main house SE facing elevation (front); scale 1x1m;
view from SE (archive reference: E49216_01).

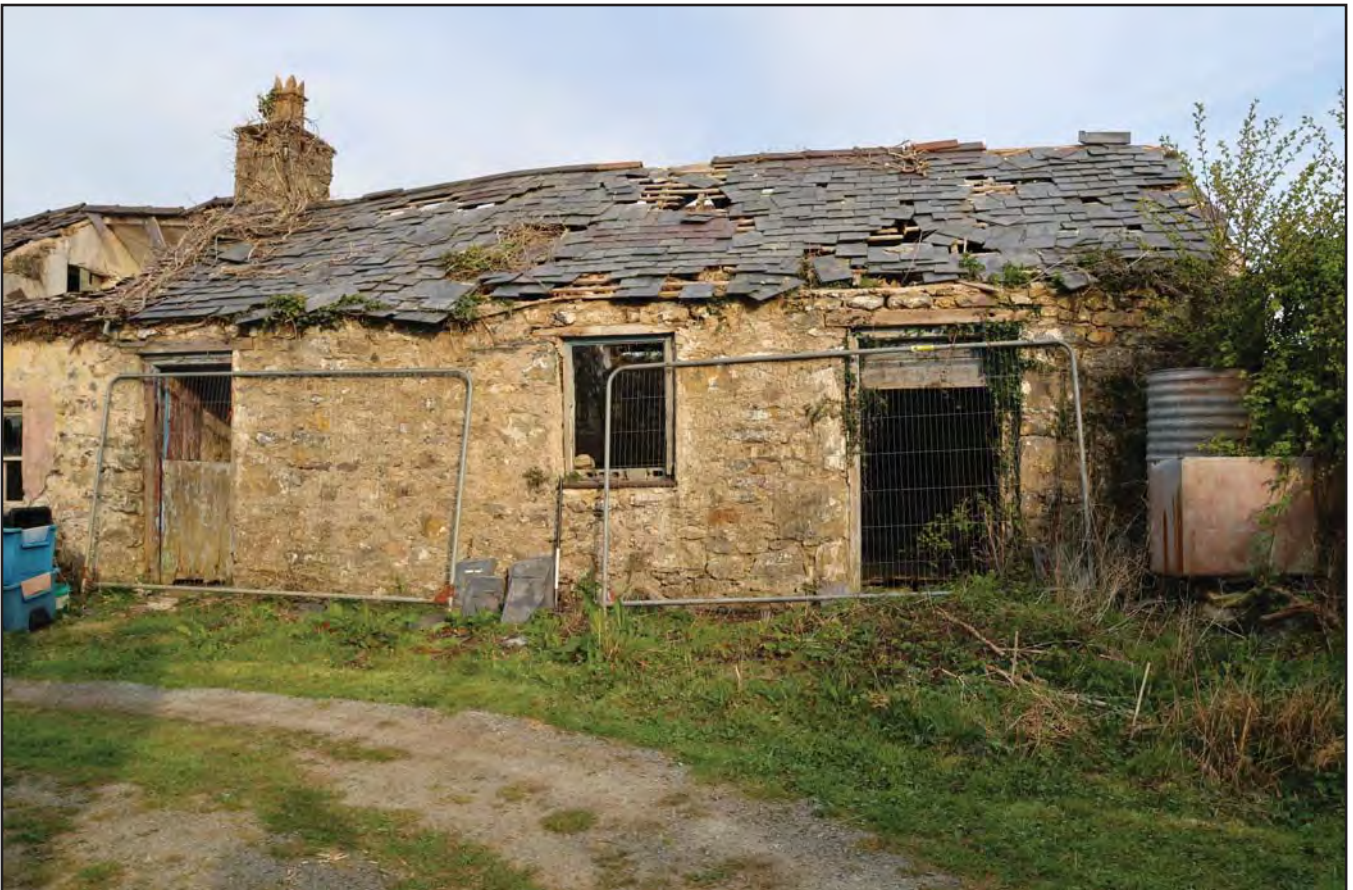
The southeast elevation has two doorways and one window (Plate 2). The window is positioned with views into the Cowshed with only the wooden frame remaining, and two entrance doors, one positioned either side (Plate 2). Furthermore, an additional two doors are positioned on the northwestern elevation wall, one into the Calving Shed and to the exterior into a narrow corridor besides the barn, house and outbuildings and one into the Cowshed from the Barn (Plates 12, 70 and 84), both doors positioned almost adjacent to the ones found on the south east elevation front wall.

The external walls may have one time been mortared, however, at present the stonework is visible, large quoin stones can be seen either side of both the doorways and on the northeast corner (Plate 2). The roof is made up of Welsh slate, however, at present it is slowly in decline with slates dislodged and missing (Plate 2). The slates on this roof are of a different colour to the main house and there is no evidence of mortar suggesting this roof was replaced at some point.

Plate 2: Exterior - View of cow and calving Shed (R4 & R5); scale 1x1m;
view from ESE (archive reference: E49216_02).

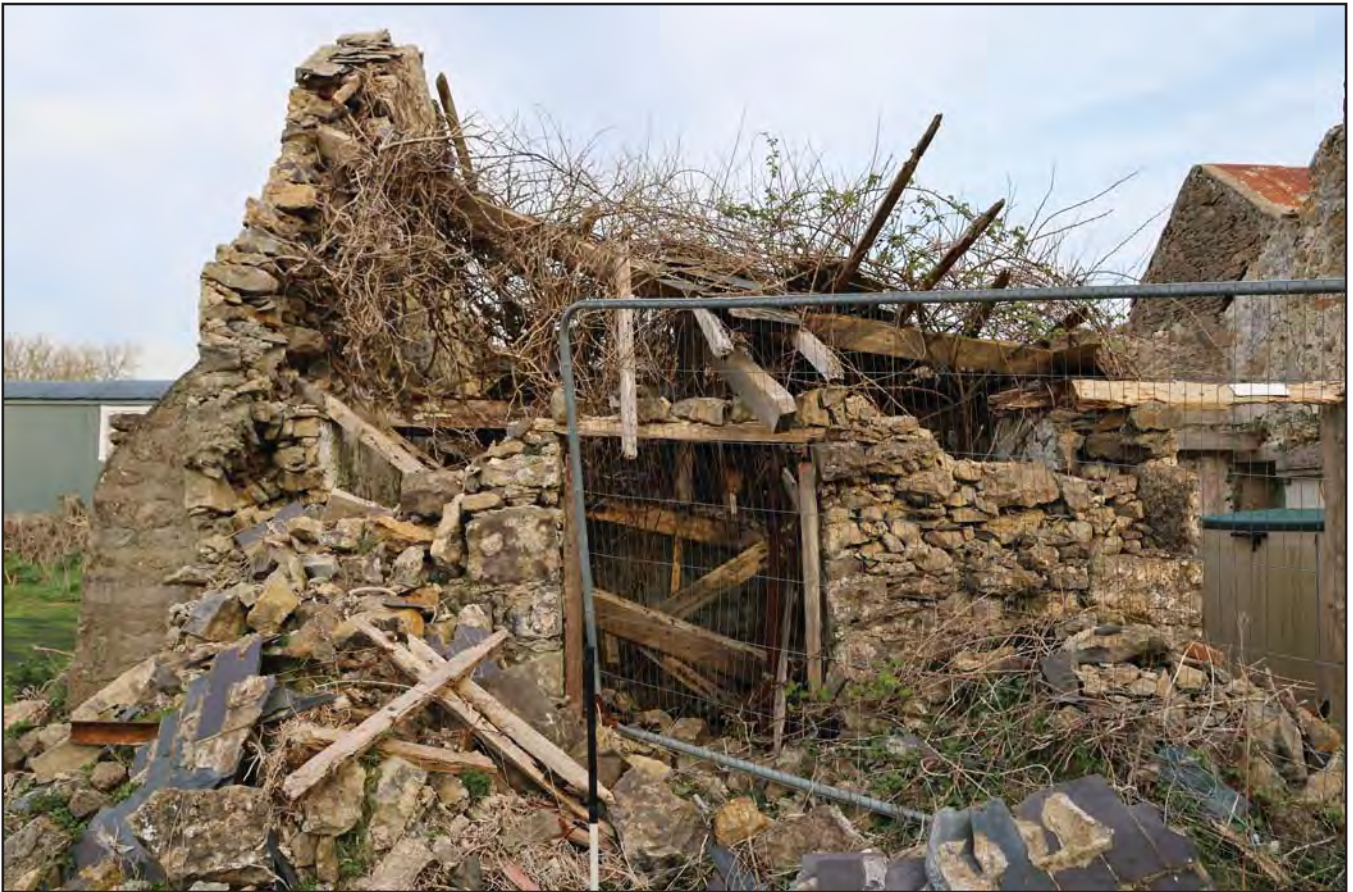
This building is of stone construction with quoin stone corners and are of random coursed construction, it is in very poor condition with the roof totally collapsed (Plate 3). The southeast elevation contains two doorways, one leading into Room 6 (Store room) and one with a window next to it leading into Room 3 (Kitchen). The doorway leading into the store room has a wooden lintel and part of the wooden door frame still present, while the wooden lintel only survives leading into the kitchen (Plate 4). The southeast wall of the storeroom has almost completely collapsed.

Plate 3: Exterior - View of storeroom (R6); scale 1x1m; view from SE (archive reference: E49216_04).

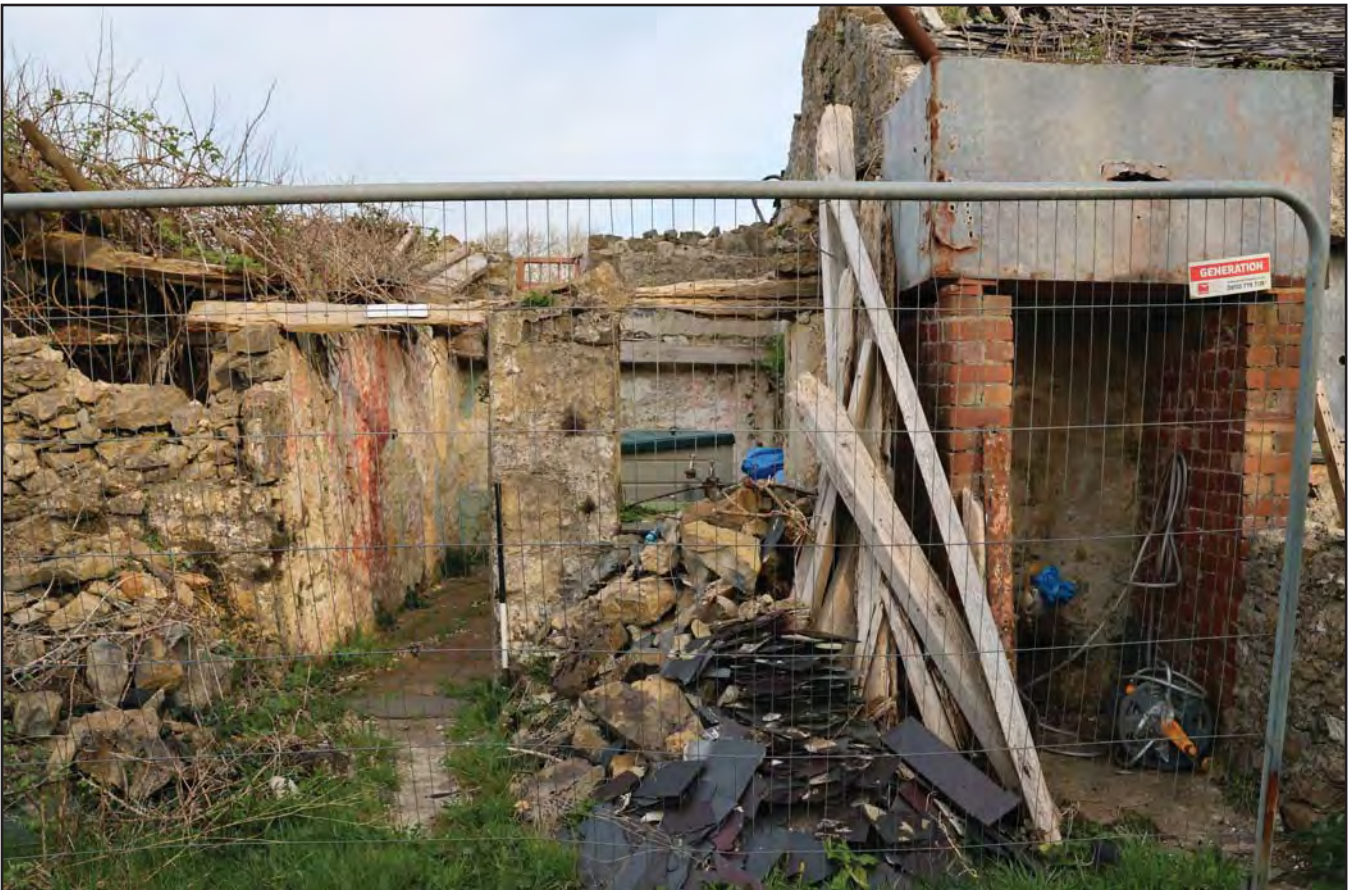
Plate 4: Exterior - View of kitchen (R3); scale 1x1m; view from SE (archive reference: E49216_05).

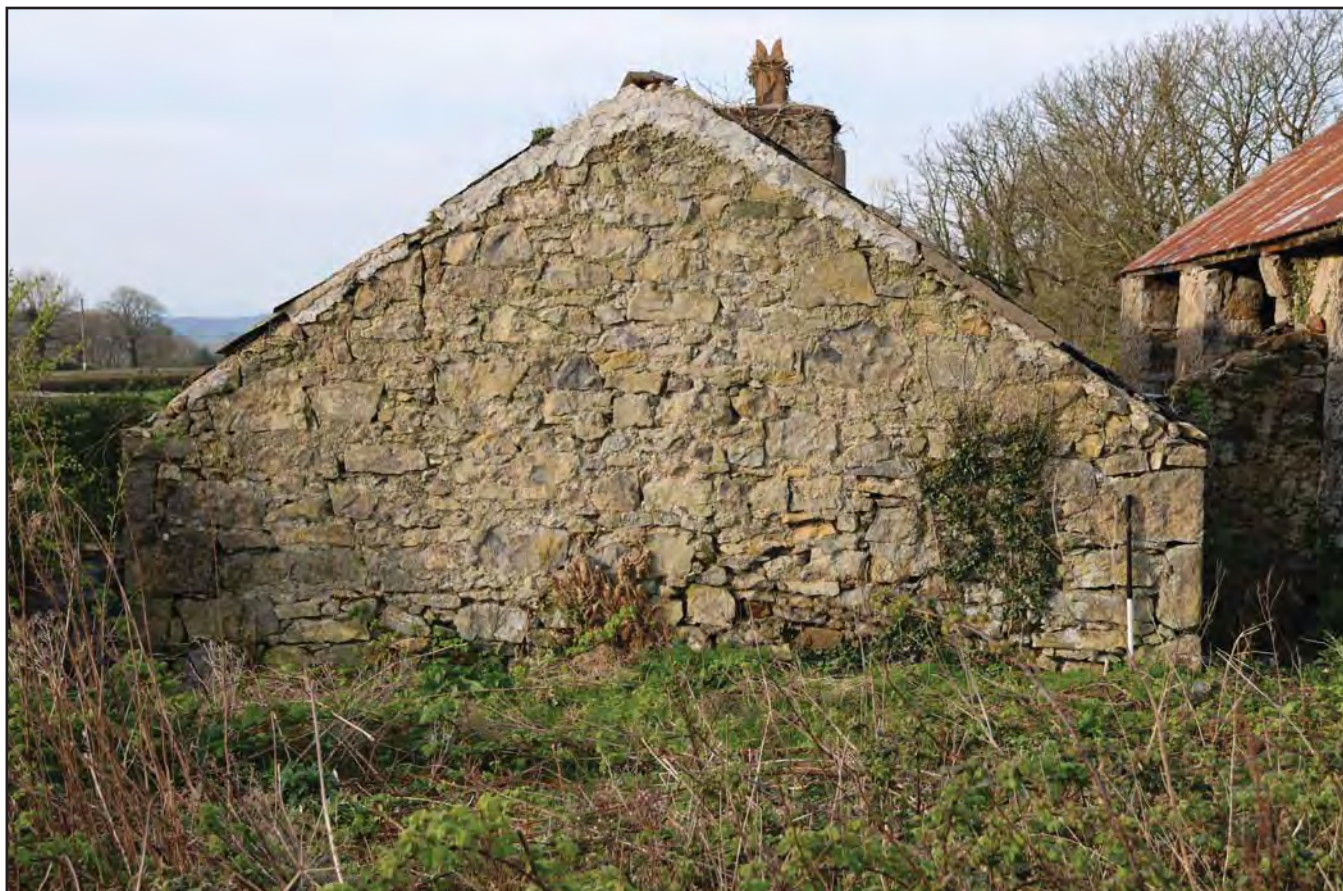
The northeast facing gable end of the cow shed has large quoin stones on both the northwest and southeast corners, and the wall is of a random coursed construction with some mortar remaining, the roof shows signs of previous repairs to the ridge of the wall (Plate 5).

Plate 5: Exterior - NE elevation of the cow shed (R5); scale 1x1m;
view from NE (archive reference: E49216_06).

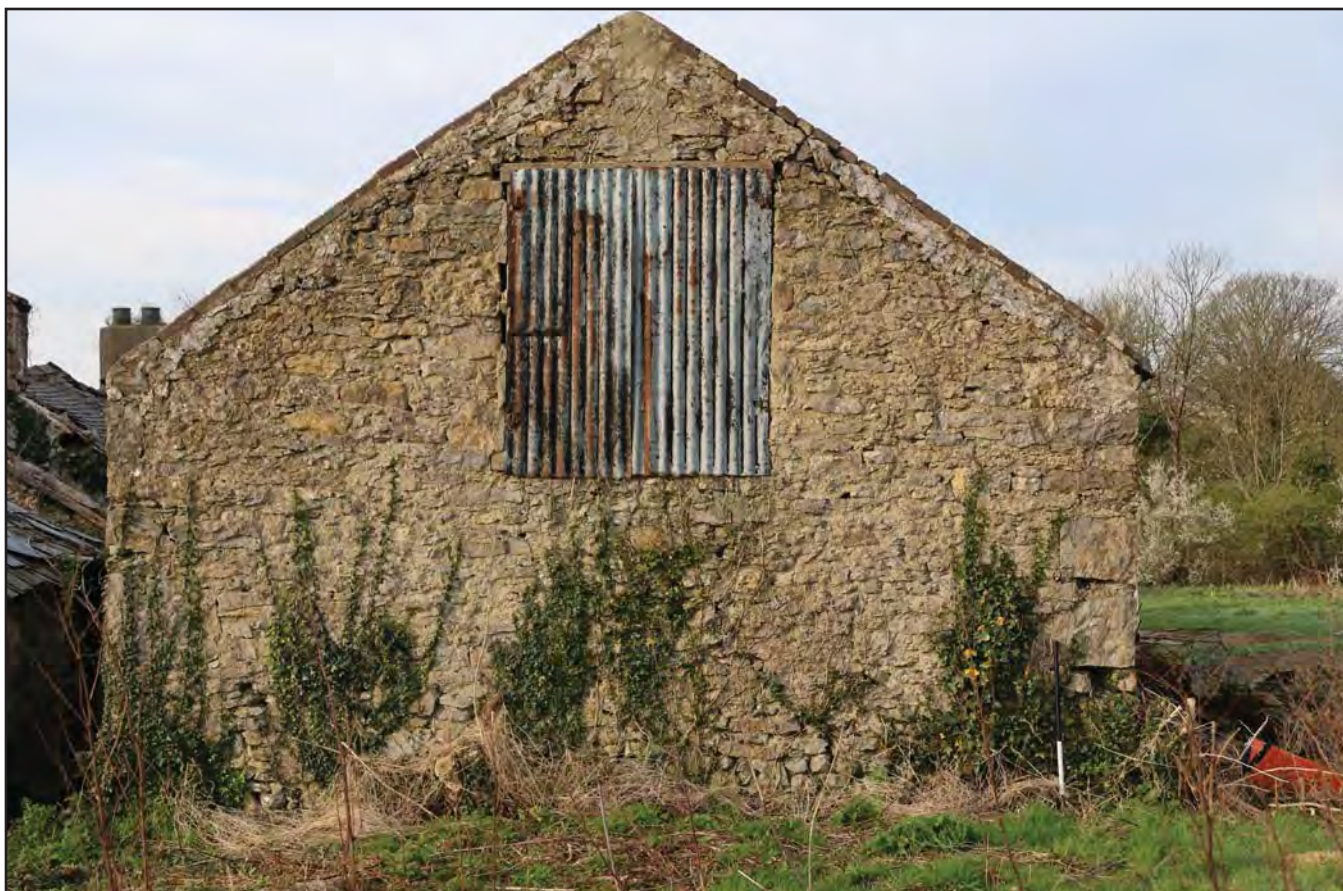
Plate 6: Exterior - NE elevation of the barn (OB8); scale 1x1m;
view from NE (archive reference: E49216_07).

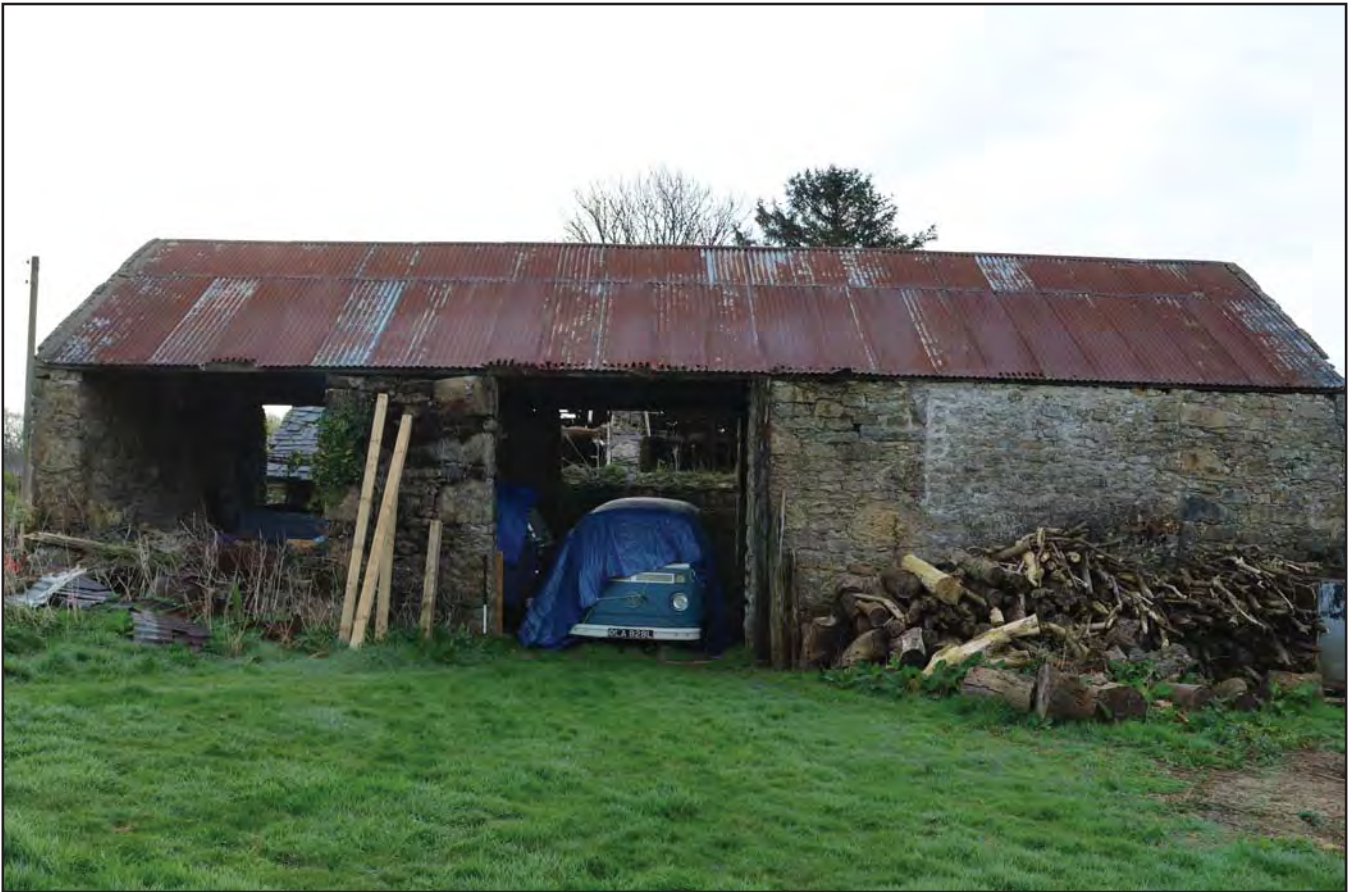
Plate 7: Exterior - NW elevation of the barn (OB8); scale 1x1m;
view from NW (archive reference: E49216_08).

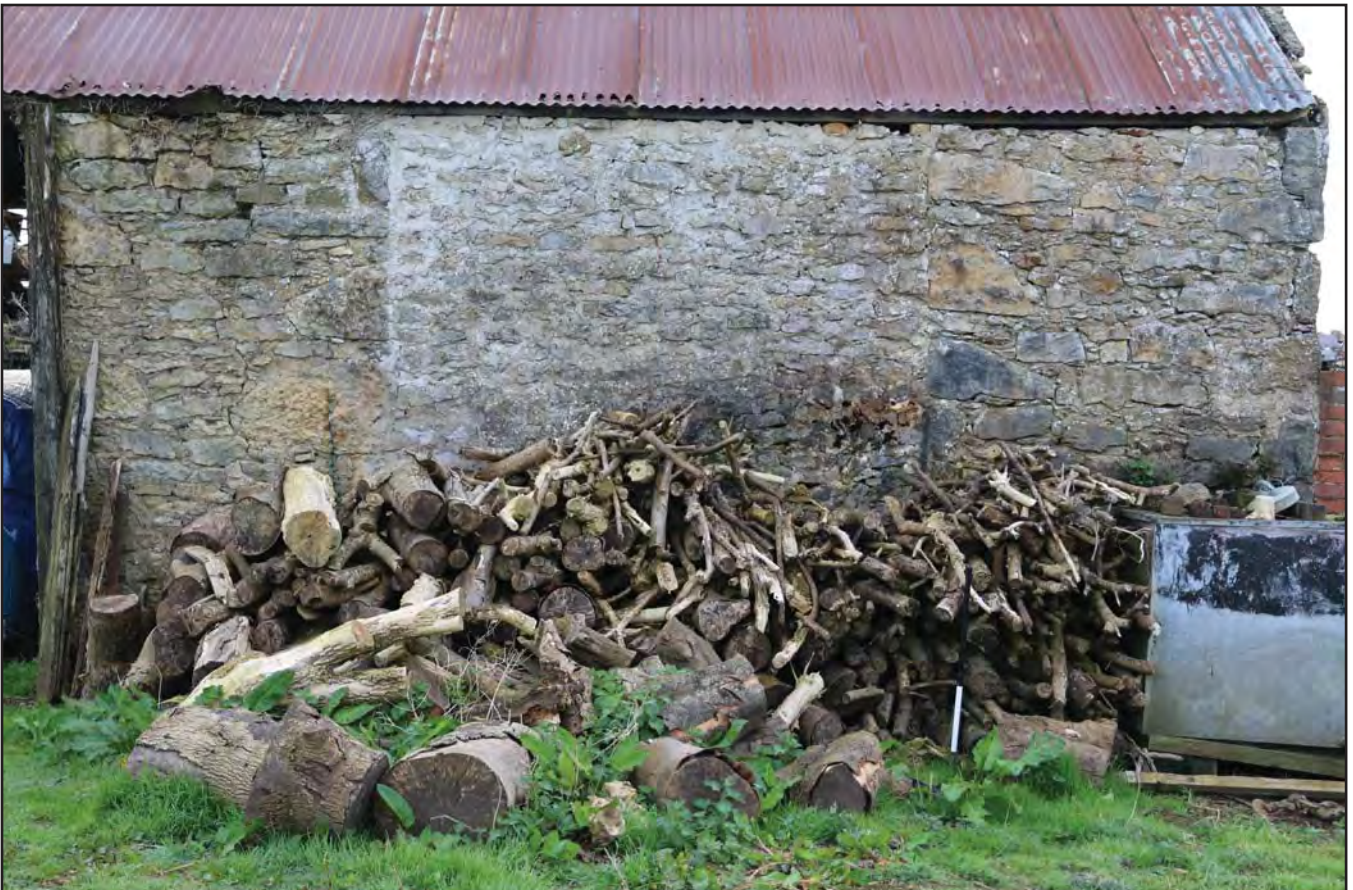
Plate 8: Exterior - NW elevation of the barn showing blocked up opening (OB8); scale 1x1m;
view from NW (archive reference: E49216_09).

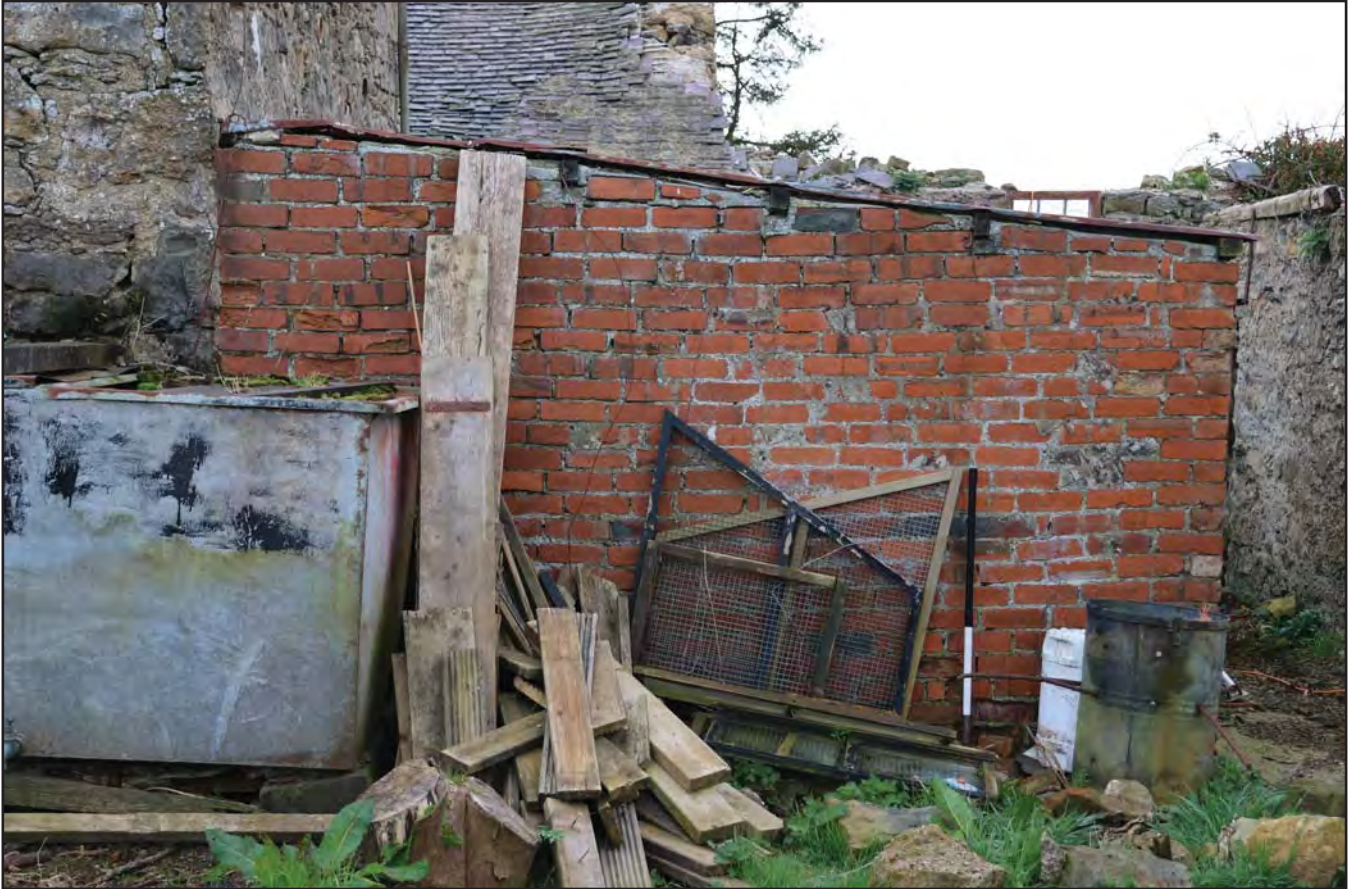
Plate 9: Exterior - NW elevation of storeroom (OB7); scale 1x1m;
view from NW (archive reference: E49216_10).

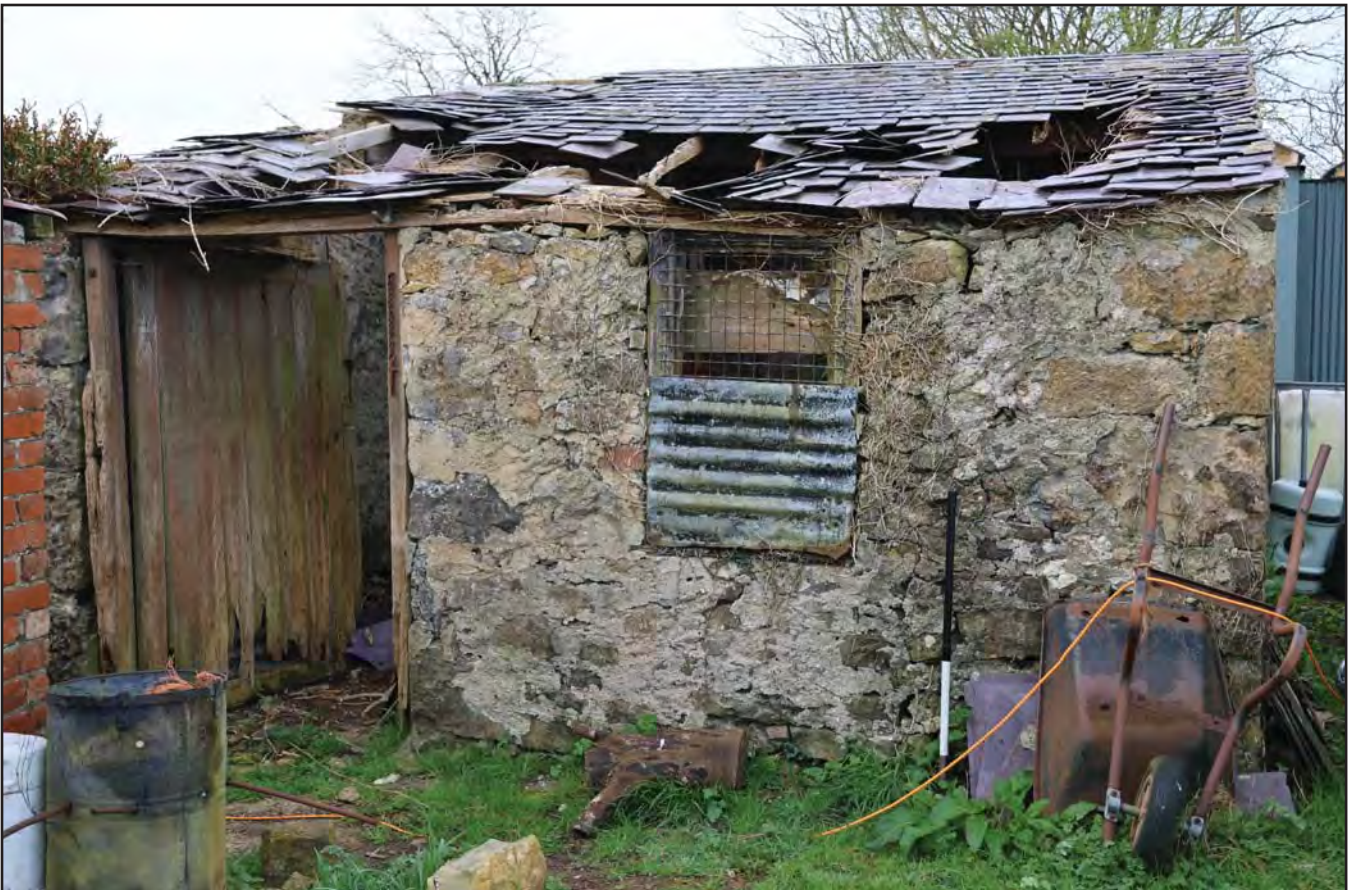
Plate 10: Exterior - NE elevation of storeroom (OB6); scale 1x1m;
view from NE (archive reference: E49216_11).

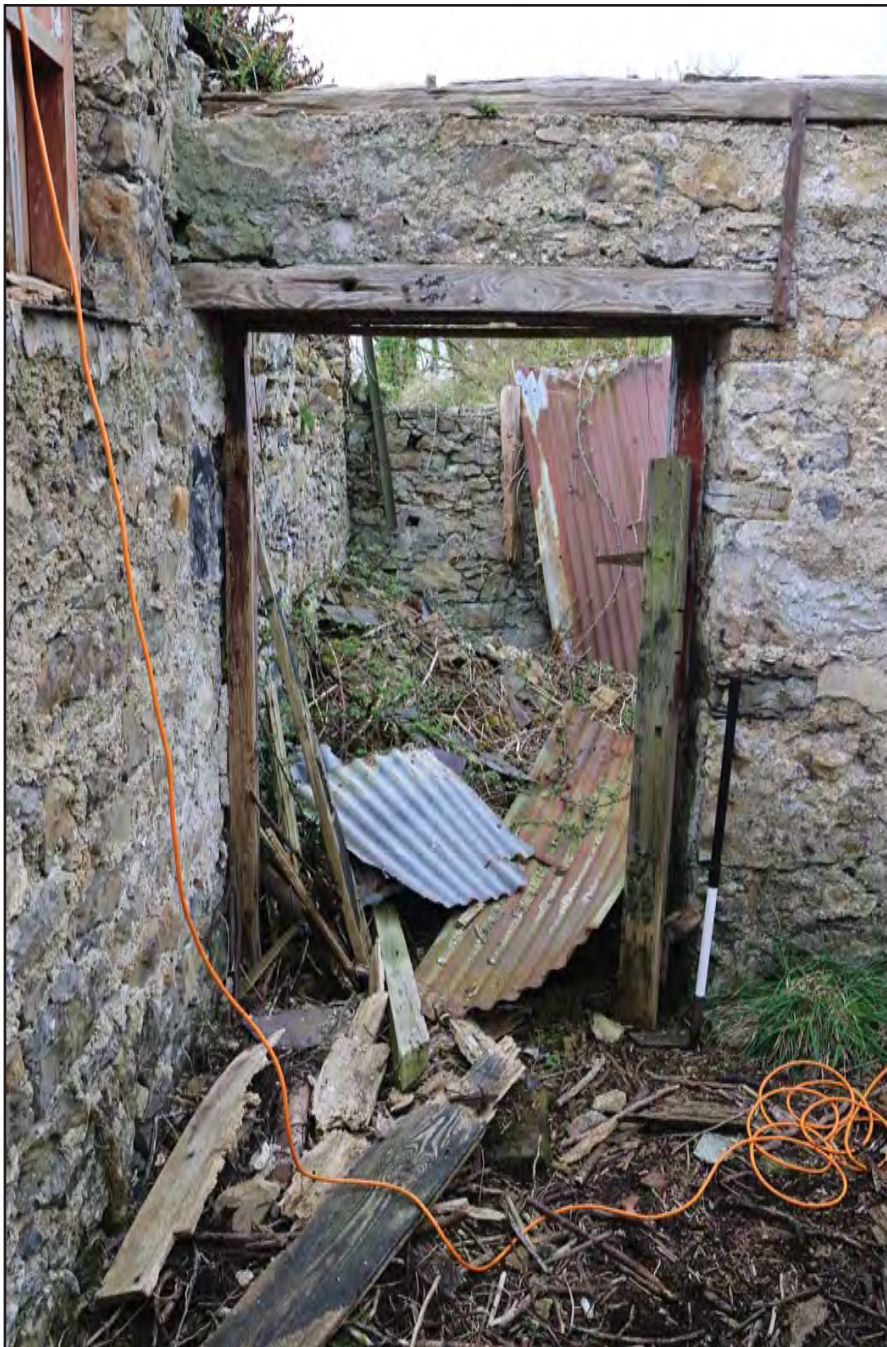
Plate 11: Exterior - View of N facing elevation storeroom showing doorway and wooden lintel (OB5); scale 1x1m; view from NE (archive reference: E49216_13).

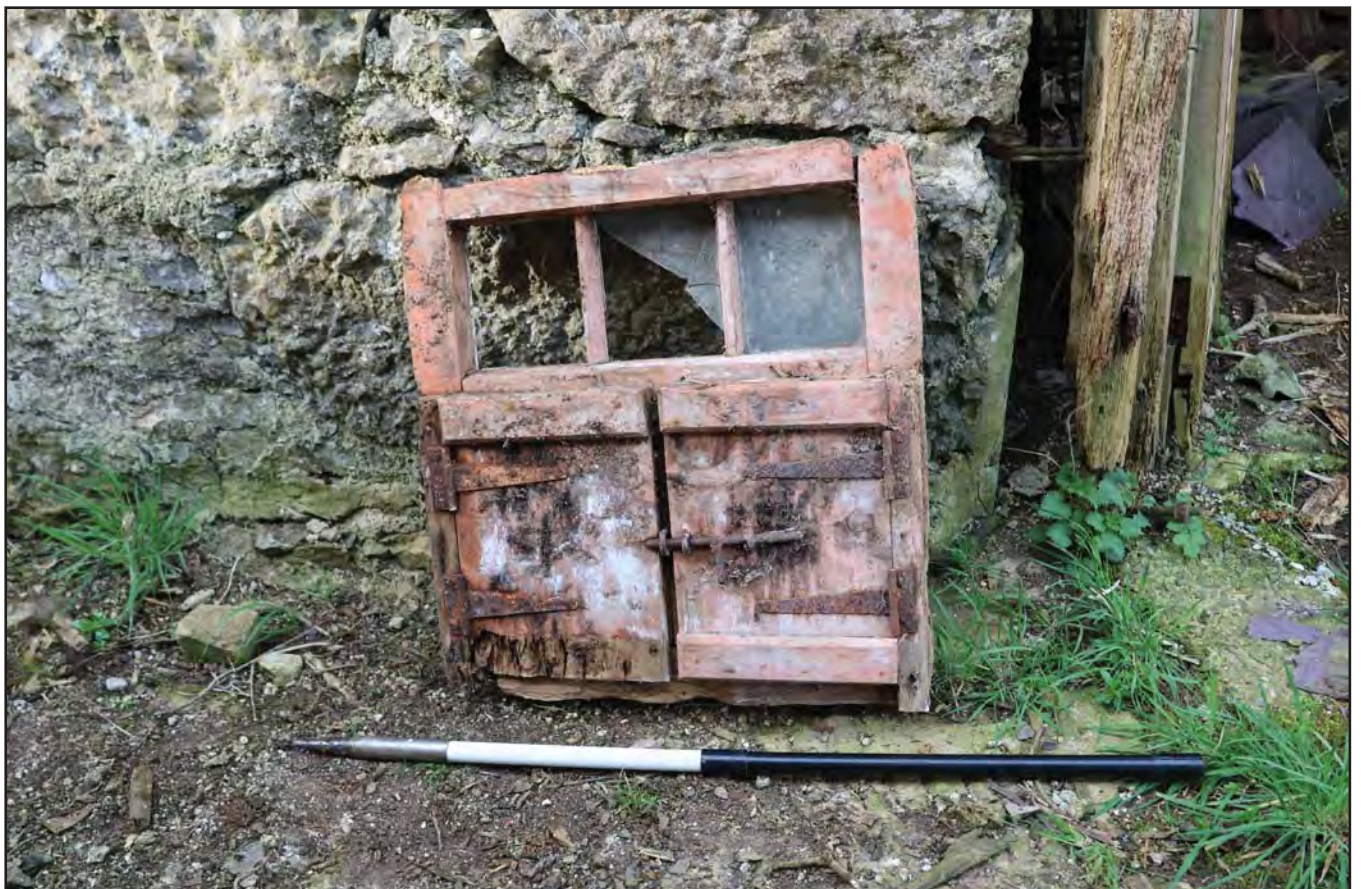
Plate 14: Exterior - View of an original window with wooden frame, 3 panes of glass above a shuttered bottom opening previously removed (rear); scale 1x1m; view from NE (archive reference: E49216_20).

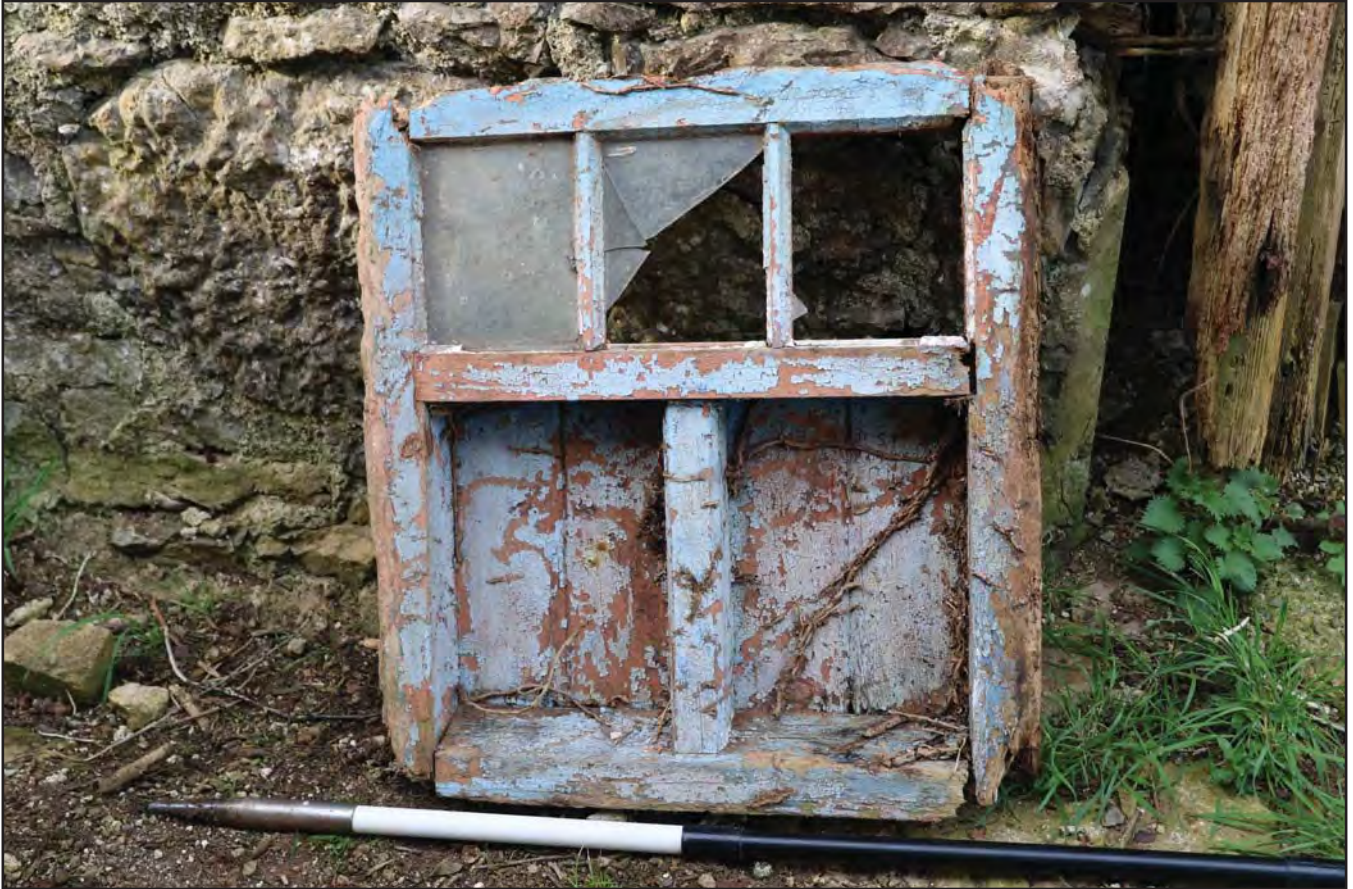
An unusual window is present within the northwest wall; this window has three panes of glass which sit above a bottom opening that is divided into two and has wooden shutters instead of glass this would appear to be an original window (Plate 46). The window would have originally been situated above the kitchen in the Grain Store (Room 7)

Plate 15: Exterior - View of an original window with wooden frame, 3 panes of glass above a shuttered bottom opening previously removed (front); scale 1x1m; view from NE (archive reference: E49216_22).

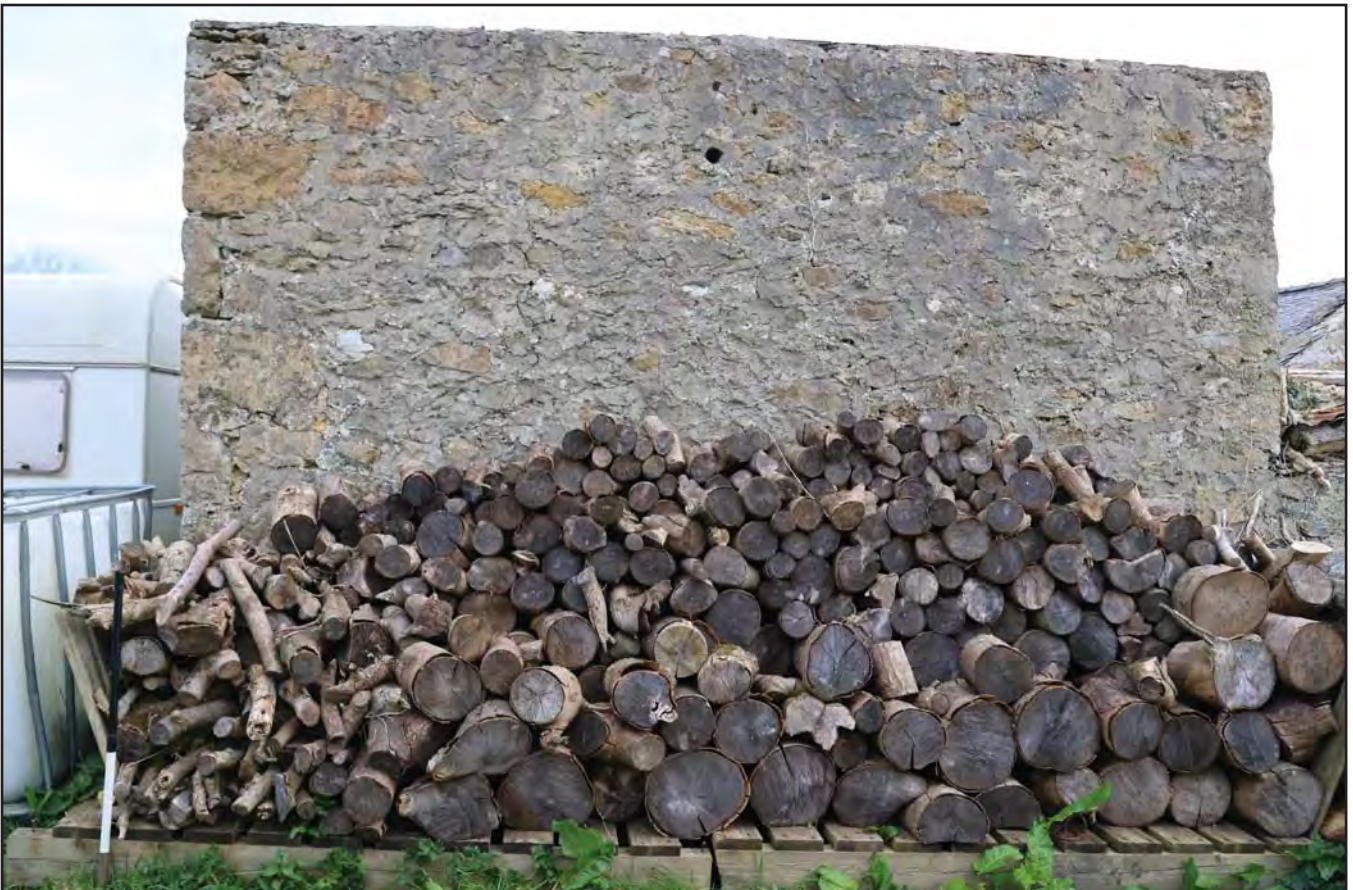
A random coursed square rubble stone-built building marked as Storeroom on the plans (Plate 16). The building has large quoin stones on the corners, a single door and window (Plate 10). The entrance is via the door located on the northeast elevation wall with the wooden lintel and frame still in place, with a wooden latch on the located on the inside (Plate 85). The window is present next to the door, of which only the frame survives (Plate 10). The roof consists of Welsh slate and is currently in poor condition, with many slates missing and roof collapse present in patches. The building has a single slanting roof design (Plate 19).

Plate 16: Exterior - View of SSW facing elevation of OB 6; scale 1x1m; view from SW (archive reference: E49216_23).

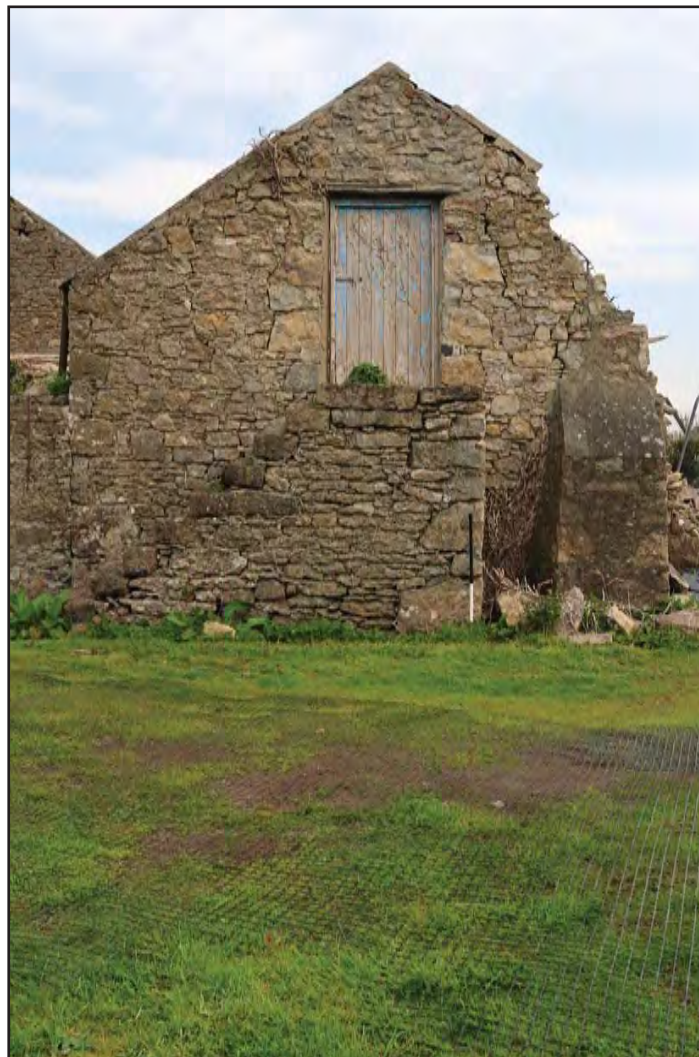
On the southwest elevation of the Store room (Room 6) is a stone staircase that leads up to a centrally located doorway that opens into the first-floor grain store, the staircase is constructed with course layers of stone and the south-southeast corner is of a quoin construction, the steps are large stone slabs, there is a recess built-in under the stairs this could possible of been a dog kennel (Plates 18, 19, 20 and 22).

The room was a crog loft which covered the span of the Store Room (Room 6) and Kitchen (Room 3) below. The room was accessed by a series of stone steps present along the exterior of the southwest facing wall (Plates 18 and 19). Unfortunately, only the gable wall survives along with the stone steps and a wooden entrance door as the main roof has completely collapsed down into the rooms below (Plate 3).

Plate 18: Exterior - View of SW elevation of storeroom (R6) and stairs lead up to storeroom (R7); scale 1x1m; view from SW (archive reference: E49216_26).

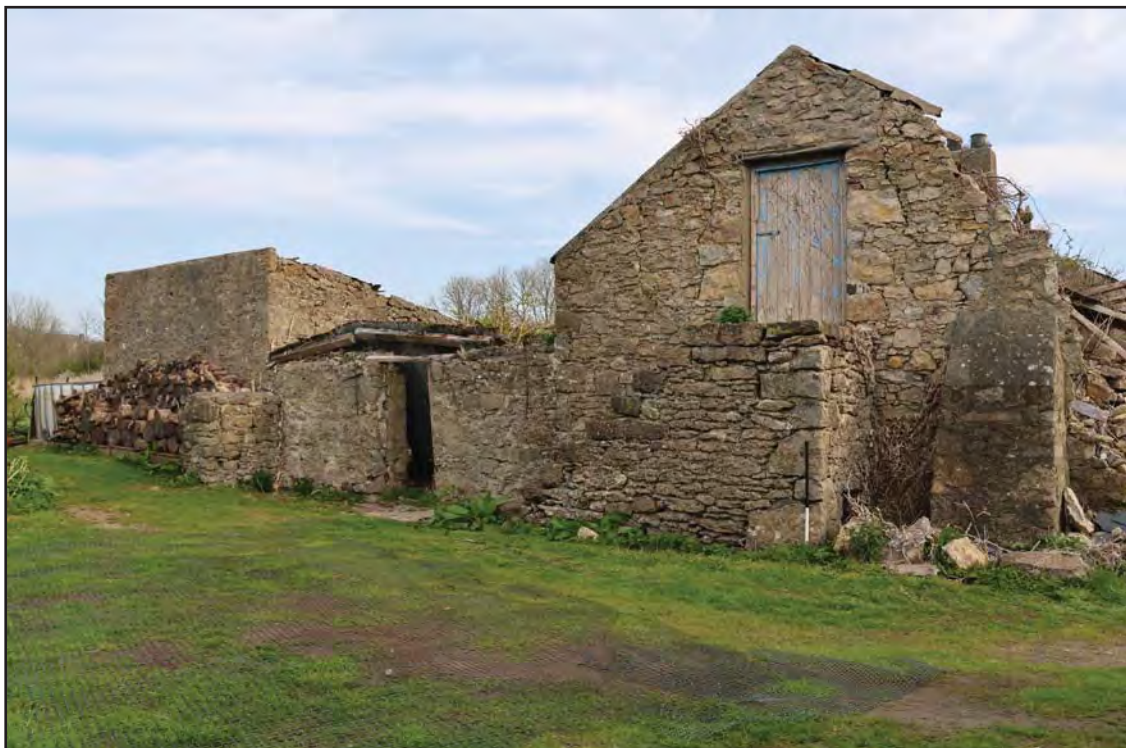
Plate 19: Exterior - View showing entire south facing elevation of OB5, OB6, Store Room and Grain Store (archive reference: E49216_27).

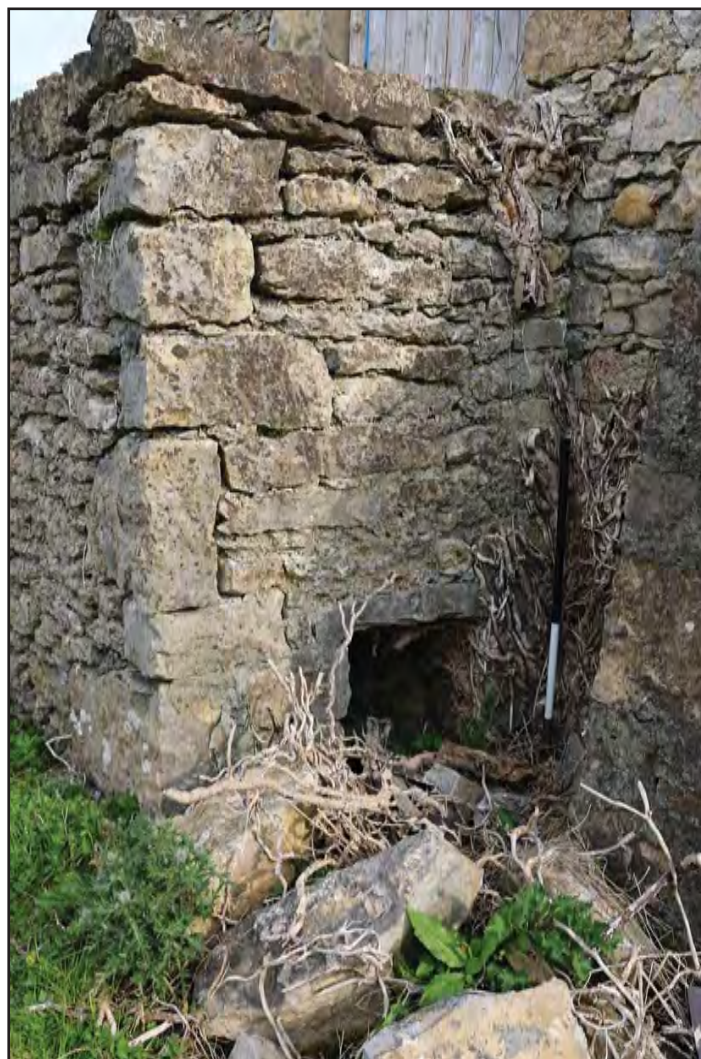
Plate 20: Exterior - Possible dog kennel built into the stairs leading up to (R7); scale 1x1m; view from S (archive reference: E49216_28).

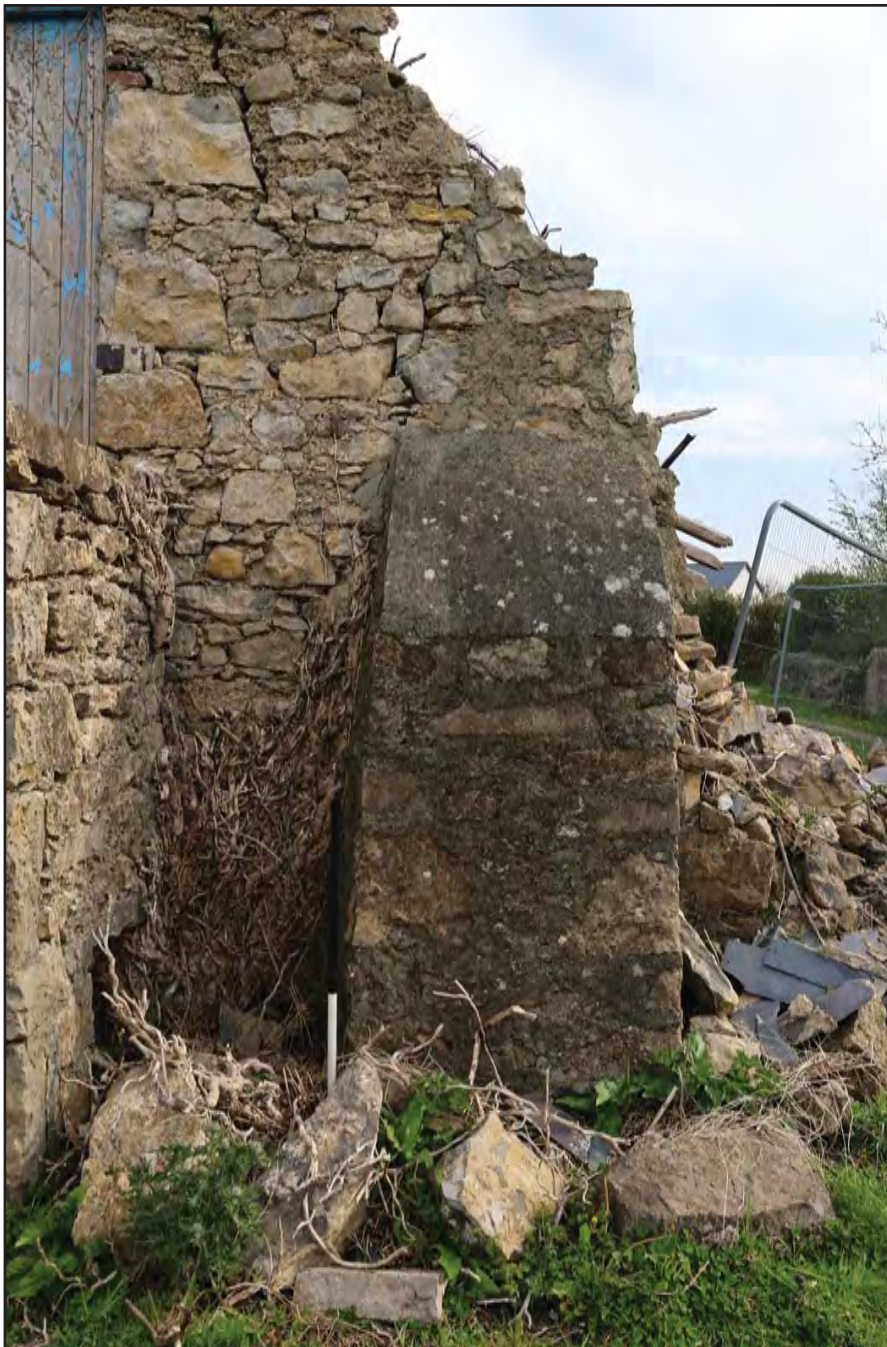
A modern buttress has been built on the south-southeast corner of the southwest gable end to prevent the collapse of this wall (Plate 21).

Plate 21: Exterior - View of modern buttress built to support SW gable end of R6 and R7; scale 1x1m; view from SW (archive reference: E49216_30).
