Parc, Talwrn, Ynys Môn

Cofnod Adeilad Lefel 2/3 Archaeolegol
Archaeological Level 2/3 Building Record

Rhif Prosiect Heneb Archaeoleg Gwynedd / Heneb Gwynedd Archaeology Project No. HD24-116

Rhif Adroddiad / Report No. 1817

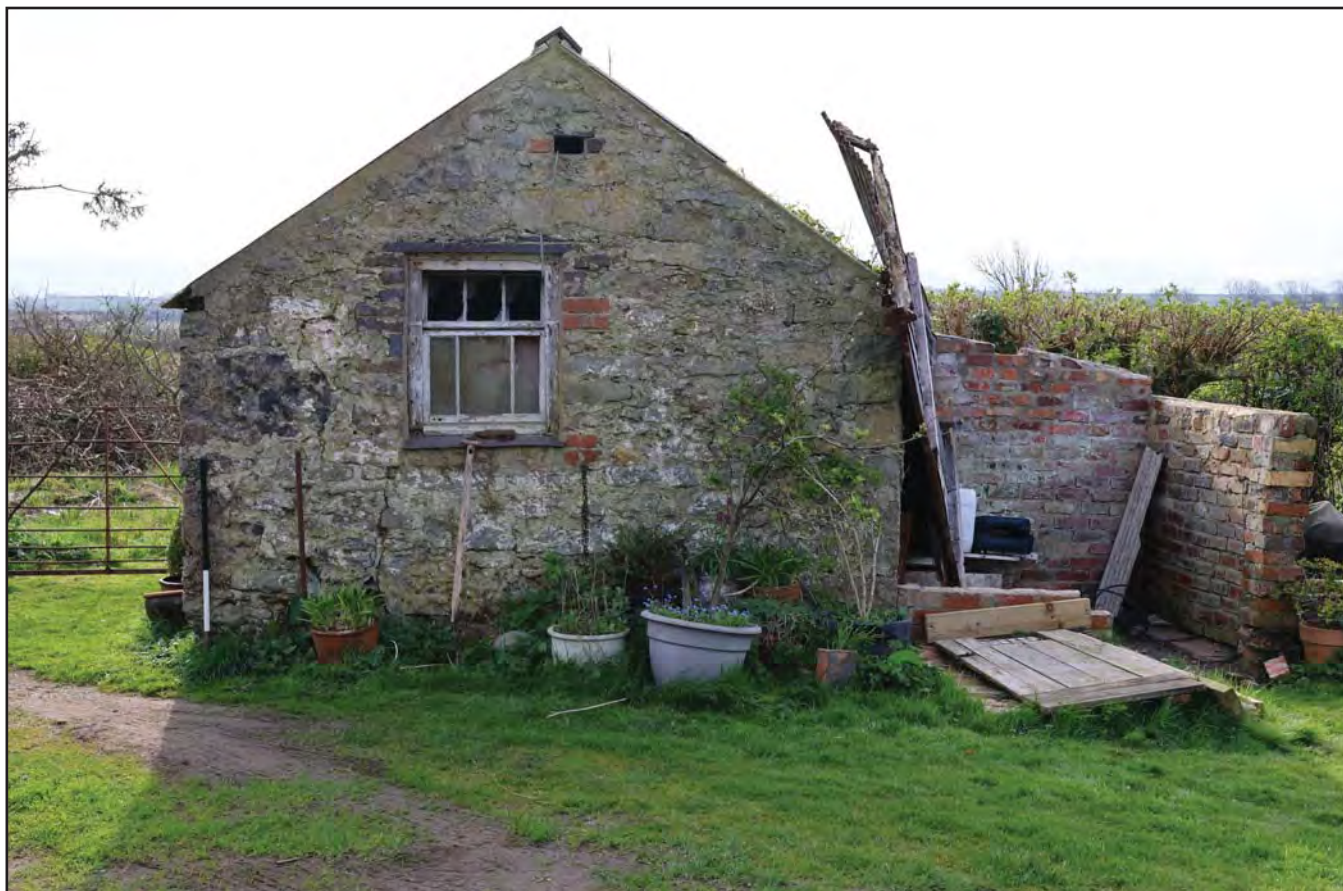
A random coursed rubble stone with red brick inclusions building with quoin stone corners currently being used as a storeroom (Plate 23). The building has modern patches of cementitious mortar repairs. The doorway is positioned within the northwestern elevation wall and consists of a wooden lintel, frame and panelled door in-situ (Plate 28). A wooden window and frame with six lights are present within the southwest elevation wall, with accompanying slate lintel and sill (Plate 27). The northeast elevation has a small slate grate inclusion (Plate 29 and 30).

Plate 23: Exterior - View of NW elevation of OB3; scale 1x1m; view from W (archive reference: E49216_33).

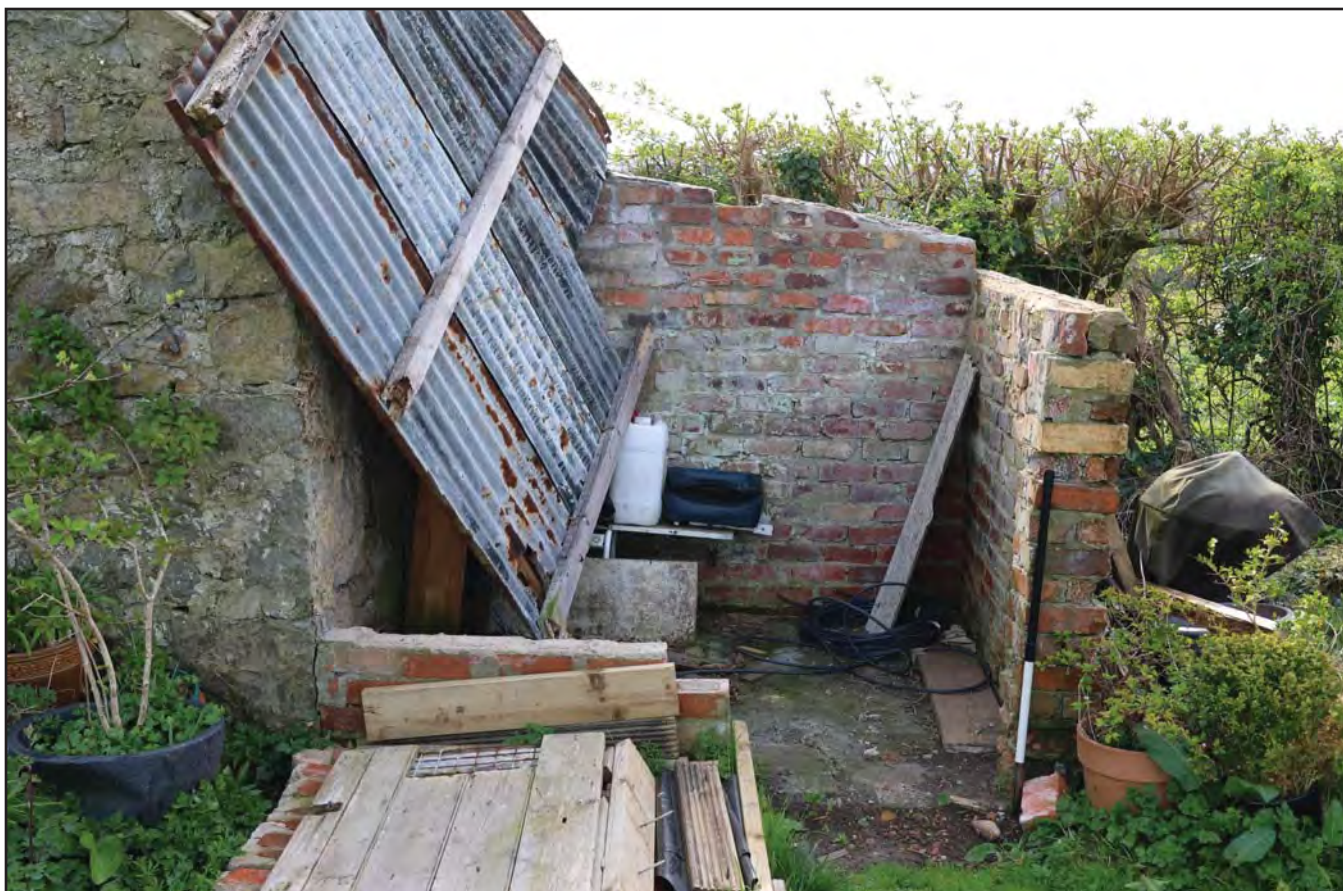
Plate 24: Exterior - View of NW elevation of OB 4 showing roof collapsed into R17; scale 1x1m; view from NW (archive reference: E49216_34).

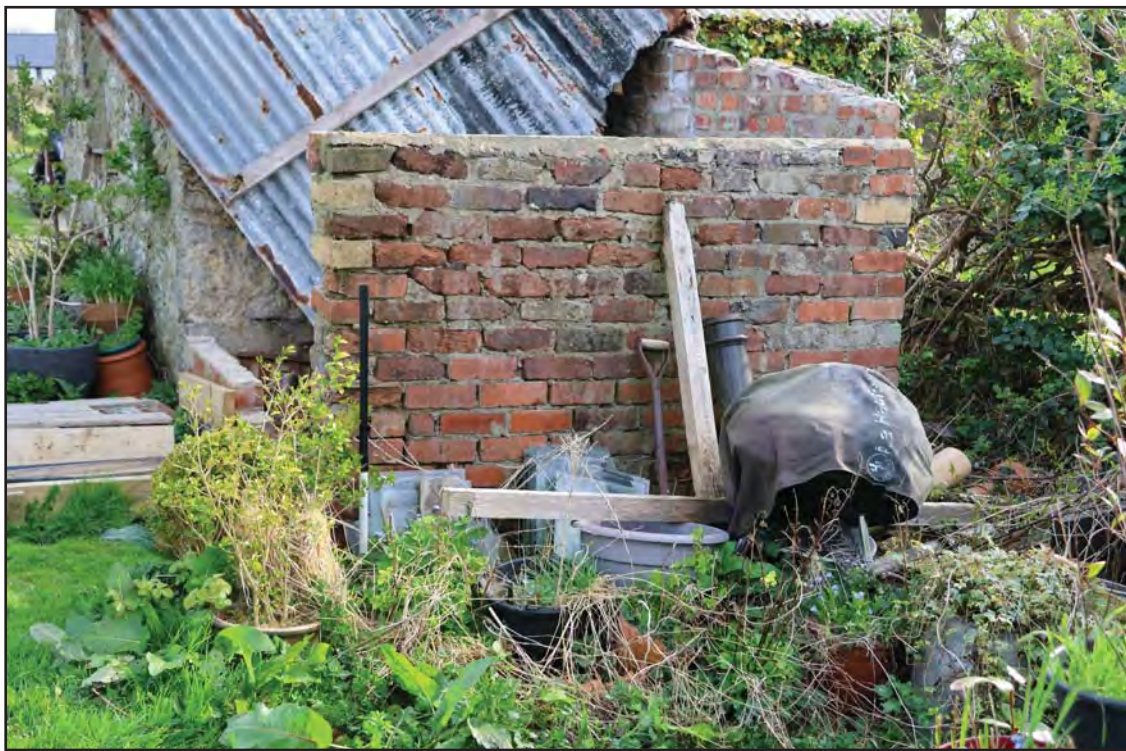
Plate 25: Exterior - SW facing elevation of OB4; scale 1x1m; view from SW (archive reference: E49216_35).

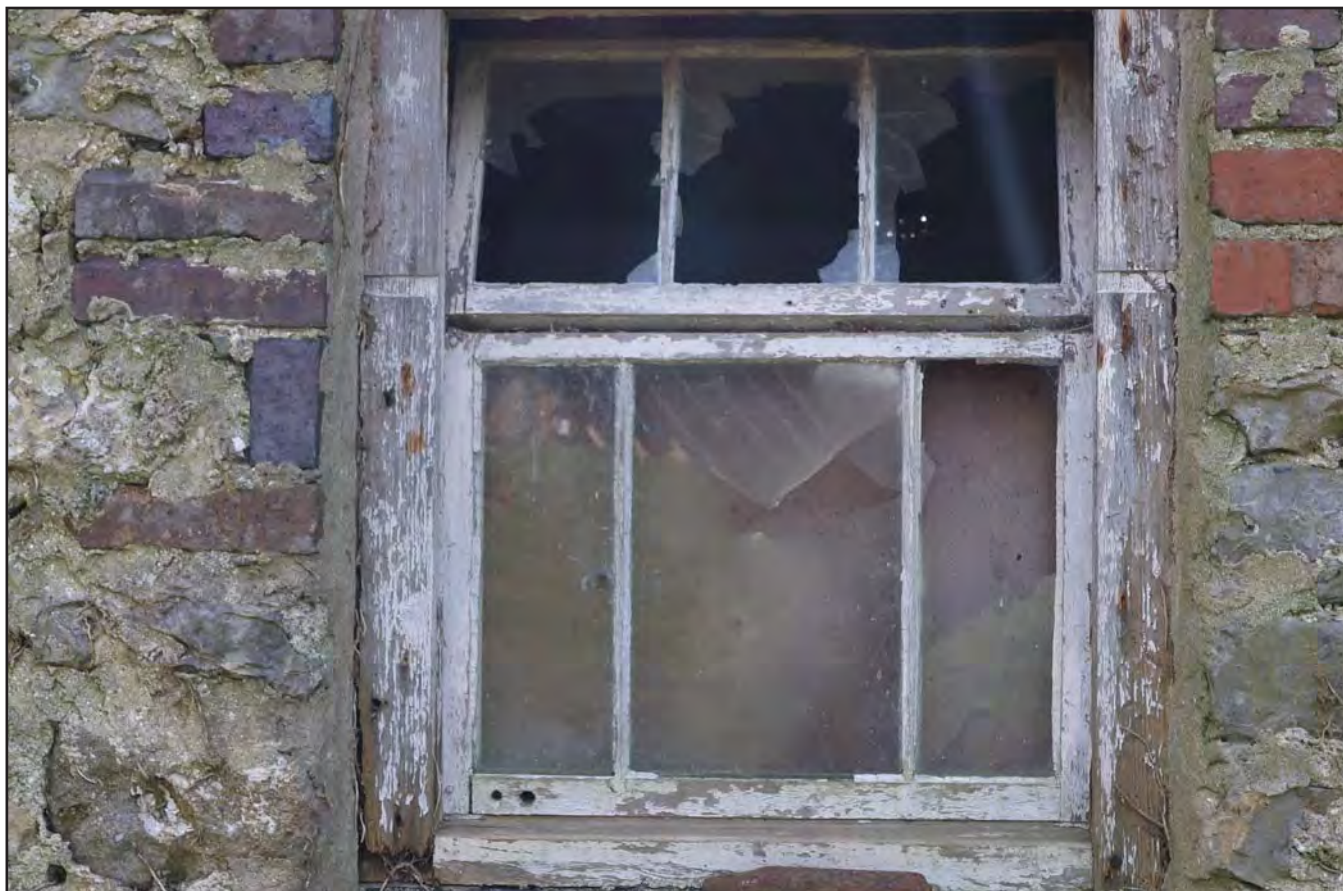
Plate 27: Exterior - Window in OB3 showing slate lintel and sill; scale not used; view from NW (archive reference: E49216_37).

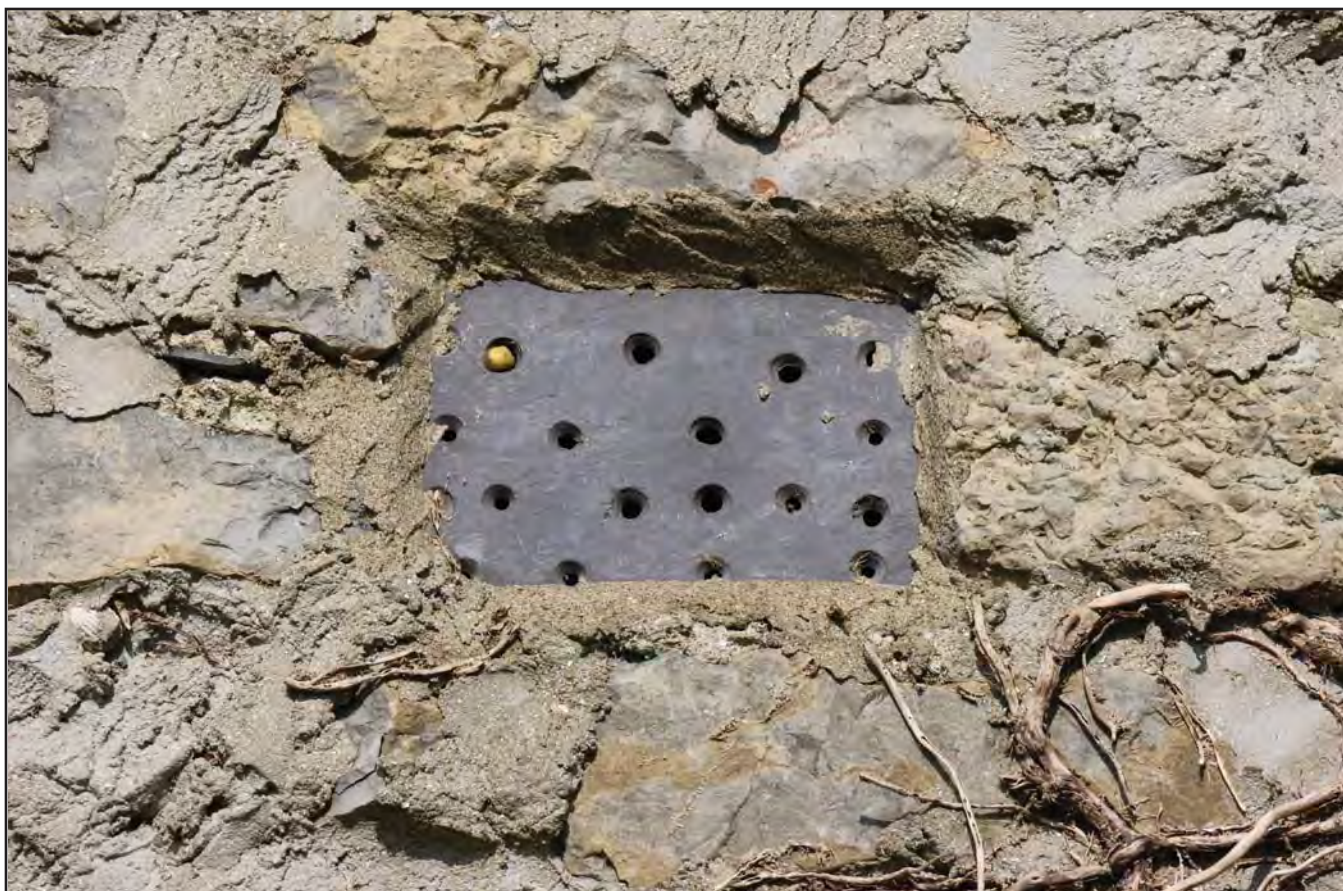
Plate 30: Exterior - Close-up shot of slate grate in E facing elevation of OB3; scale not used; view from E (archive reference: E49216_40).

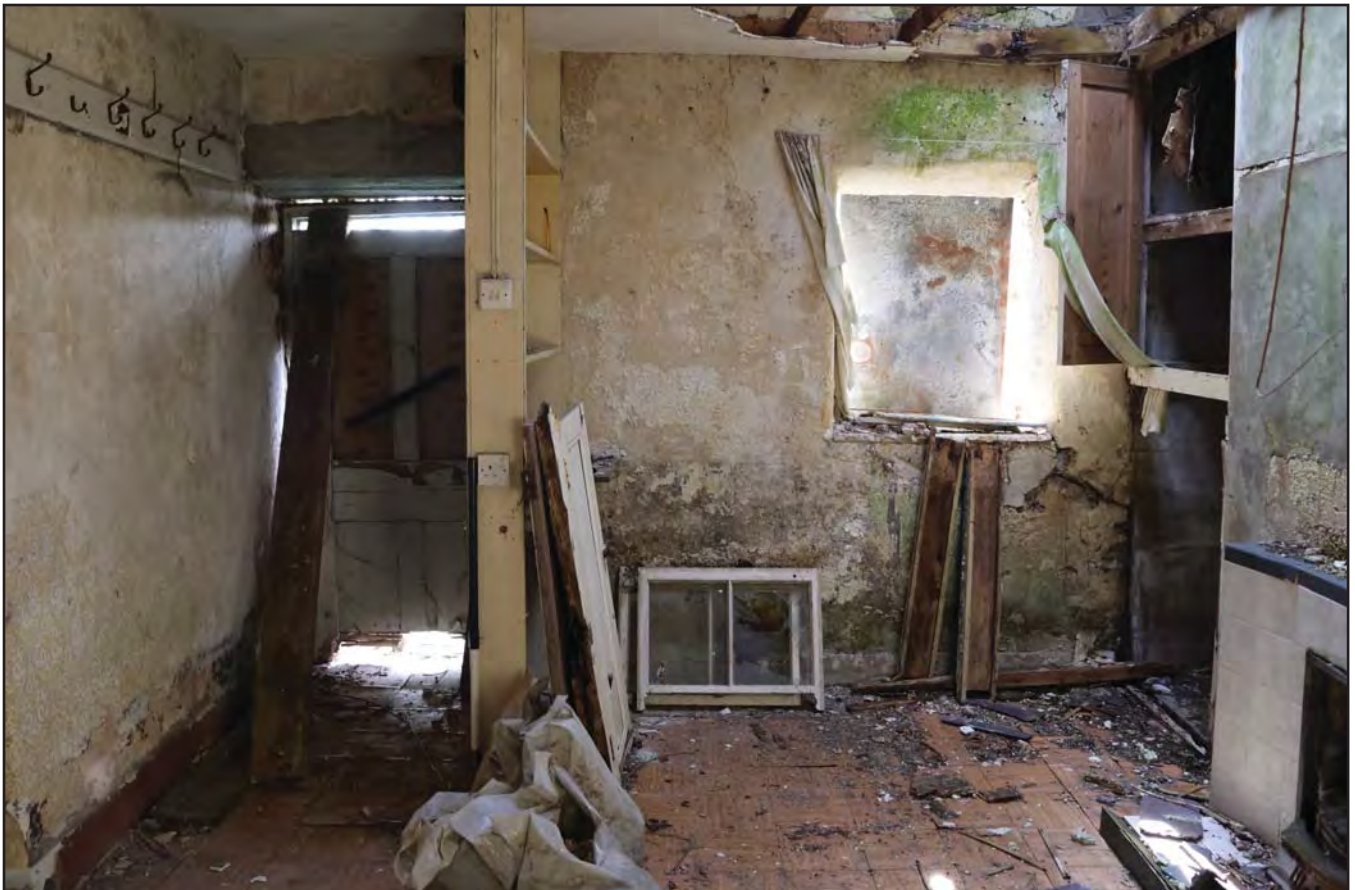
Located on the southeast wall is the main doorway and a small boarded up window, with the addition of a small partition wall with shelves separates the living space from the main doorway (Plate 34). A fireplace is located centrally on the southwest wall and is likely to date from the 1930's. The fire place composes of a white marble effect small square tile fire surround with a darker tile hearth and mantel. Located within the southern corner and next to the fireplace a small cupboard is present filling the alcove. In the western corner and on the adjacent side of the fireplace, a wooden door is present which leads into the kitchen (Room 3) (Plate 35 and 36).

Plate 34: Interior - View of SE interior wall of R1; scale 1x1m;
view from NW (archive reference: E49216_45).

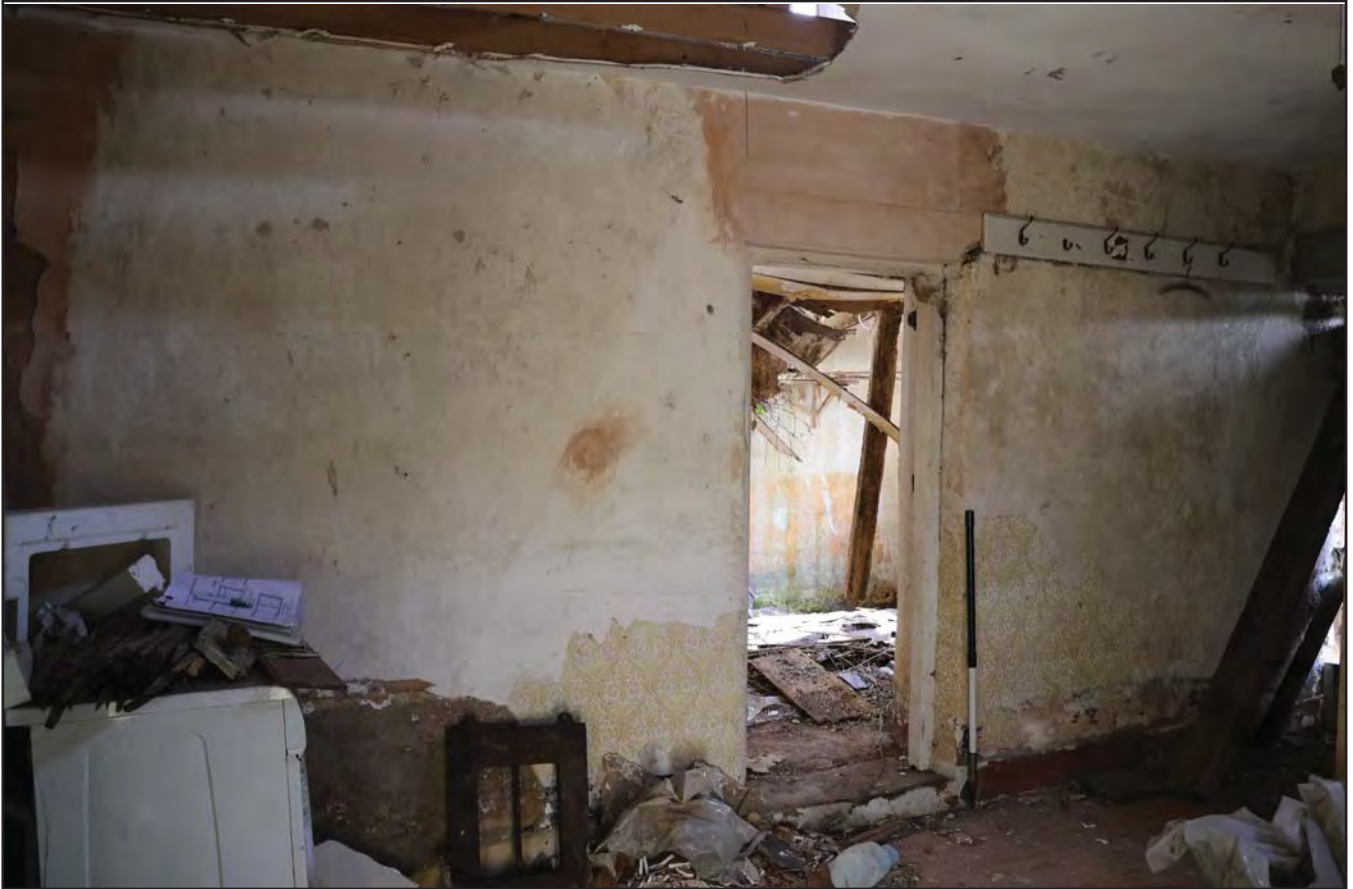
A doorway is located in the northeast wall which leads through to Room 2, to the left of this doorway is the faint outline of the stairs that would have led up to the crogloft situated above Room 2, to the right of the doorway are a row of coat hooks mounted on a wooden board (Plate 37). A window is located in the northwest wall; the window looks out to Outbuilding 7 and has an exterior stone arch lintel (Plate 39). The flooring is made up of woodgrain effect linoleum tiles, and the ceiling has been removed and damaged.

Plate 37: Interior - View of NE interior wall of R1; scale 1x1m;
view from SW (archive reference: E49216_48).

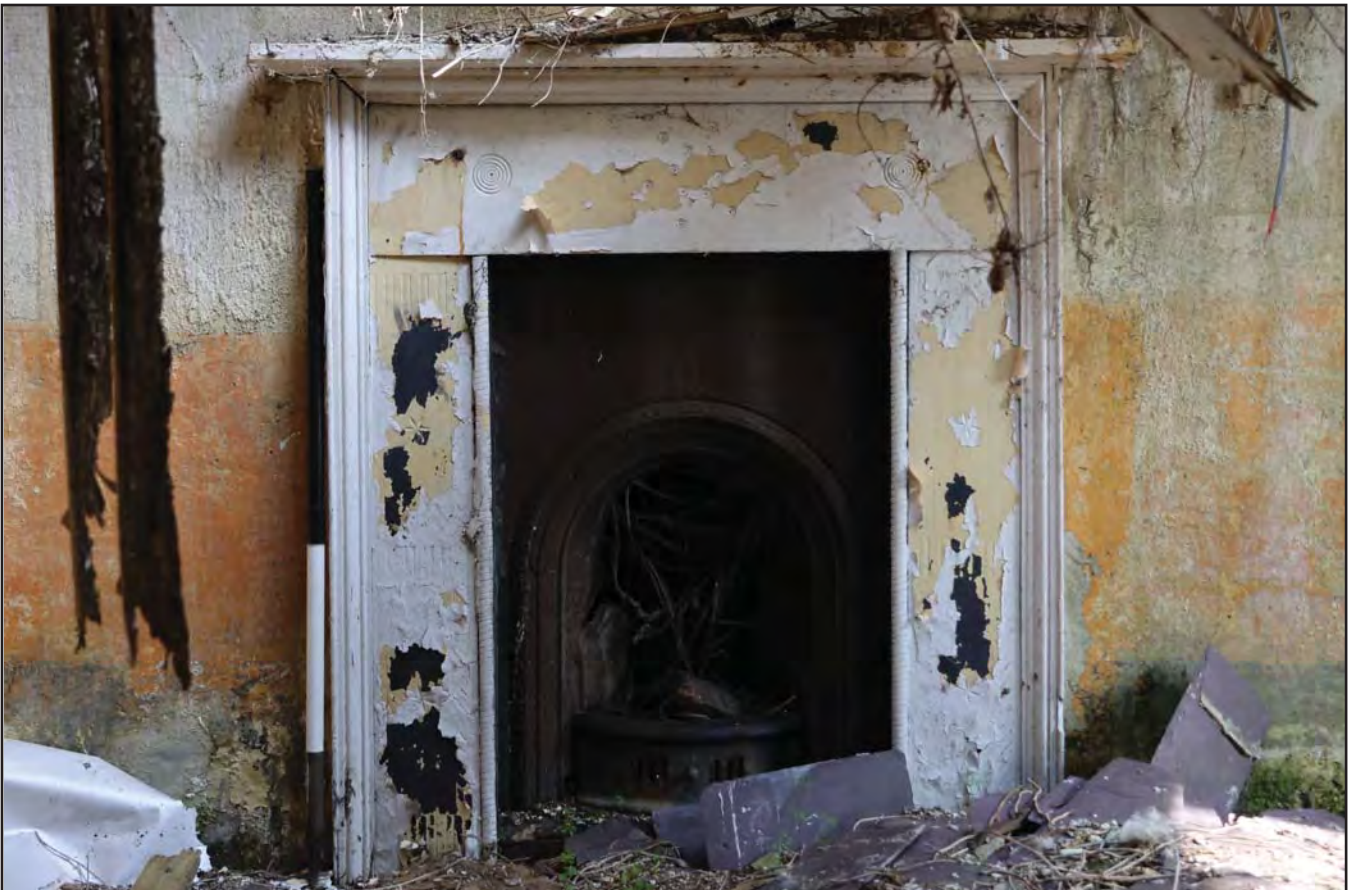
Positioned on the northeast wall is an ornate black cast iron fireplace with a slate ornate painted fire surround with a wooden mantel and surround. Some decorations can still be seen in the form of circles, lines and flowers and the former colours having been painted (Plate 38 and 40).

Plate 38: Interior - Original fireplace in NE wall of R2; scale 1x1m;
view from SW (archive reference: E49216_50).

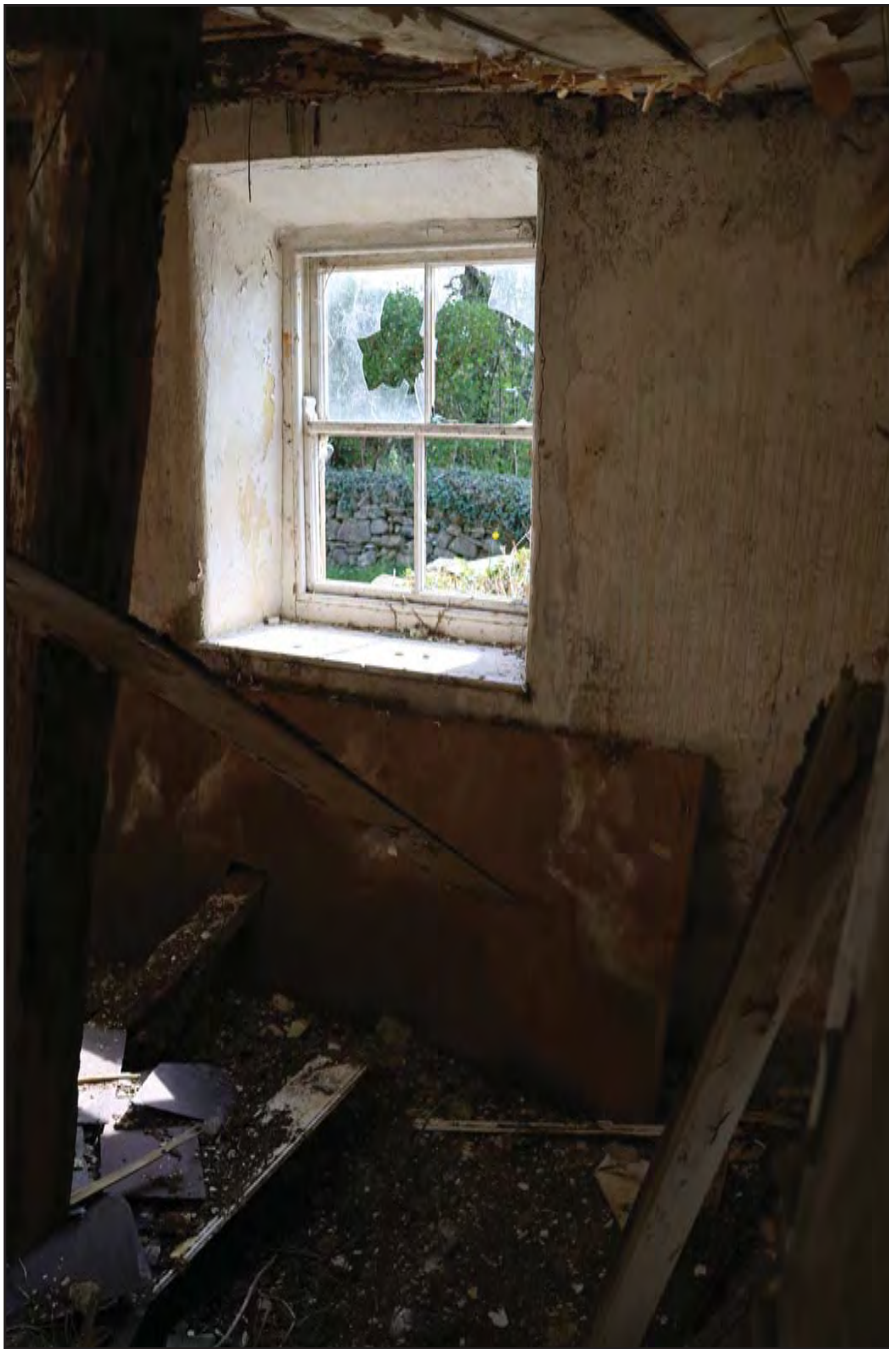
Positioned on the southeast wall and visible through the doorway is a wooden four paned window frame, two of the glass panes are broken and two are missing (Plate 39).

Plate 39: Interior - View of window in SE wall of R2; scale not used; view from W (archive reference: E49216_54).

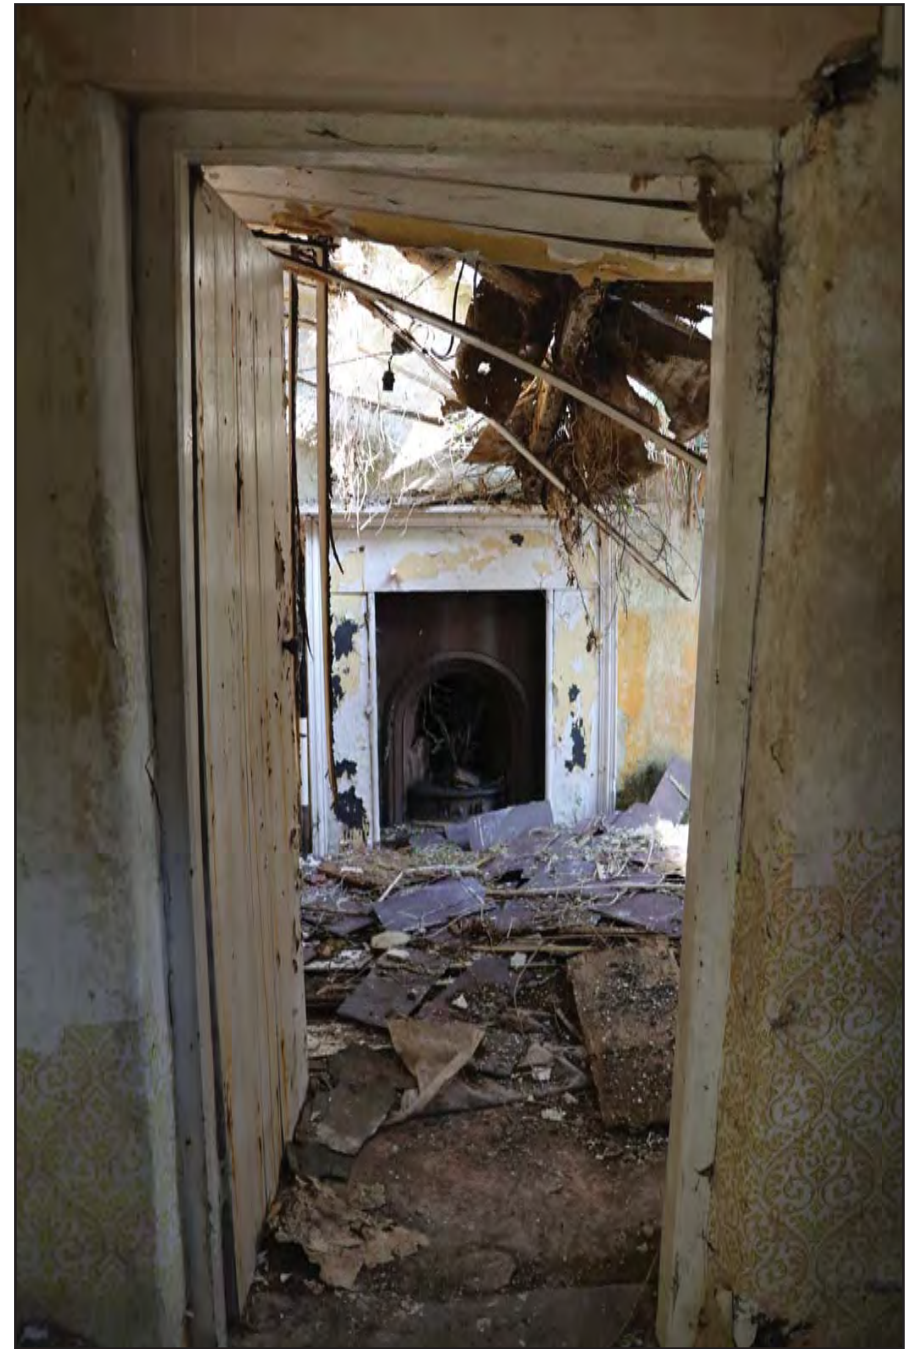
Plate 40: Interior - View showing collapsed ceiling in R2; scale not used; view from SW (archive reference: E49216_55).

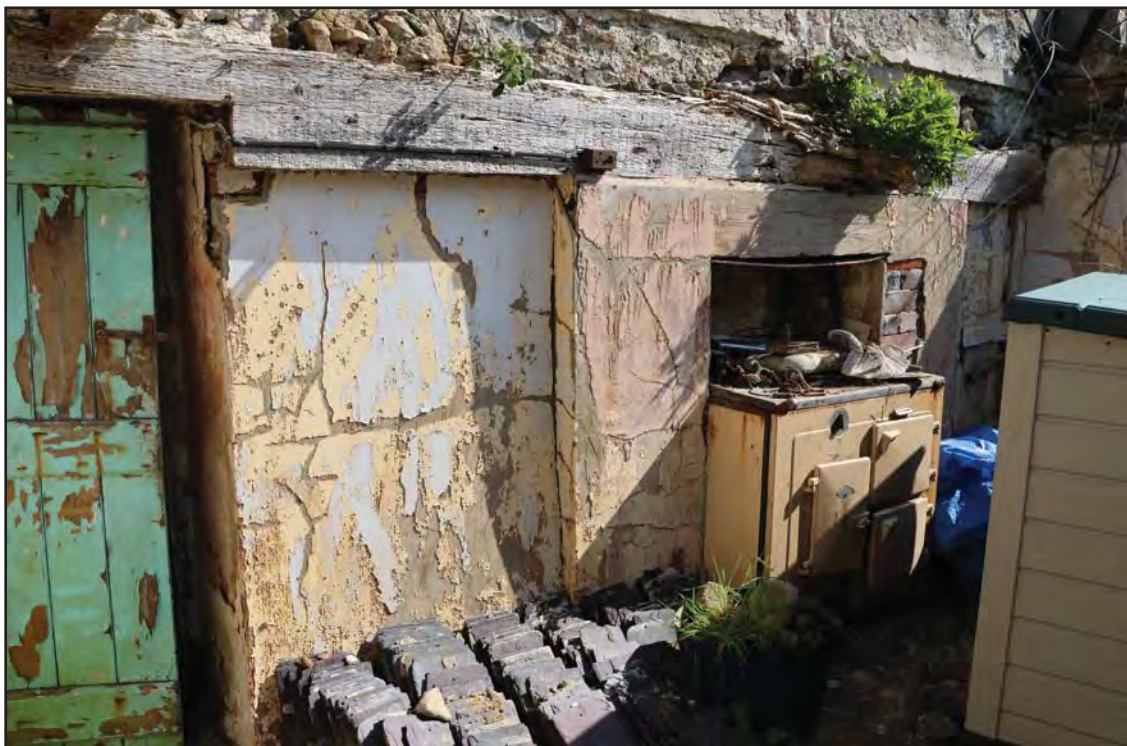
Located on the northeast wall is the doorway leading into Room 1, the door is made of wooden planks and has three horizontal planks to stabilise the door (Plates 44, 45 and 48). A cooking range is located centrally in this wall (Plates 45 and 48). A large wooden beam runs the length of this wall and has been cut where it goes over the doorway (Plate 48). On the upper section of the southwest gable end of the main house the remains of the roof line for Room 3 can still be seen.

Plate 44: Interior - View of NE wall of R3 showing cooking range; view from W (archive reference: E49216_59).

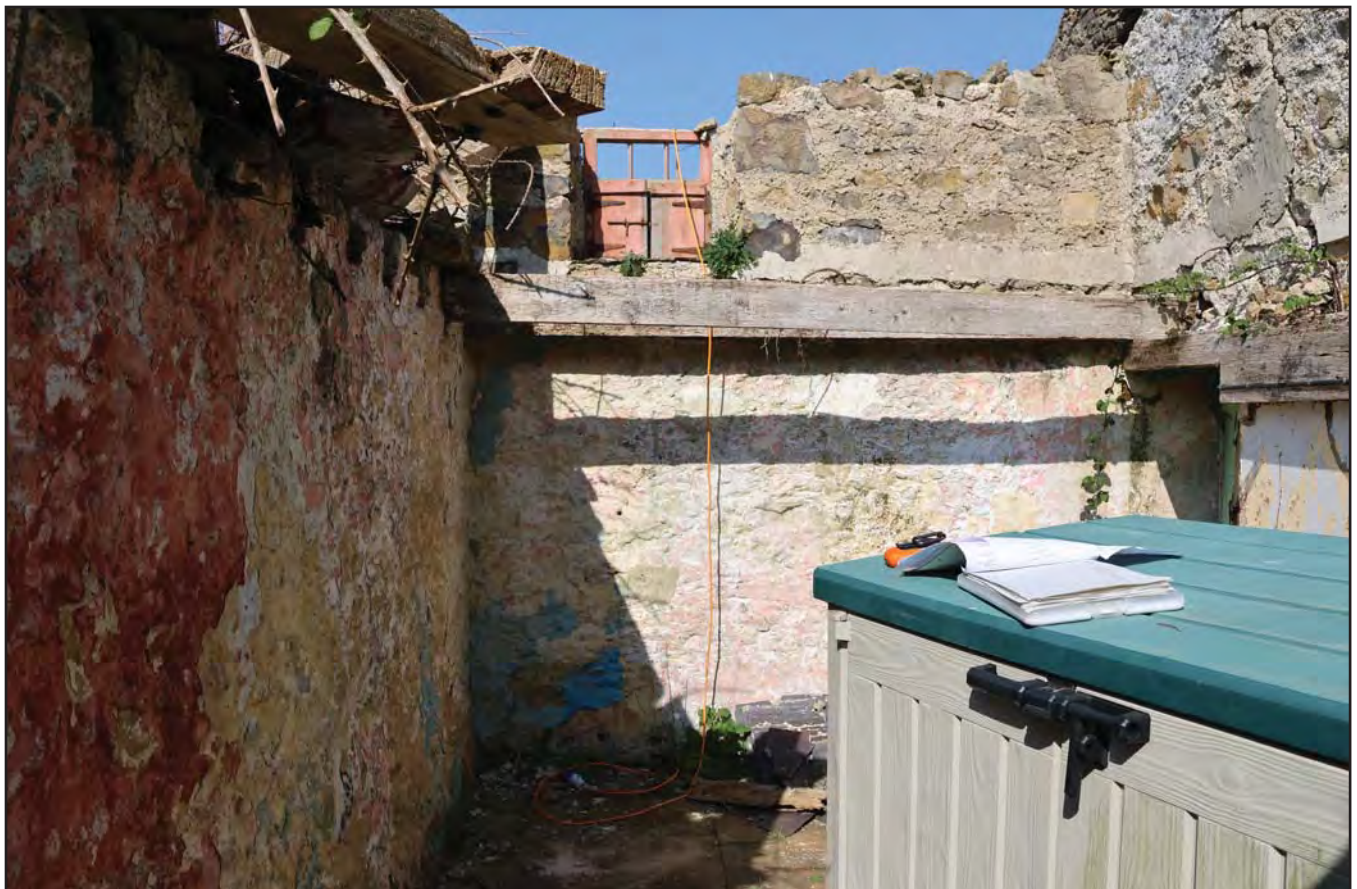
An unusual window is present within the northwest wall; this window has three panes of glass which sit above a bottom opening that is divided into two and has wooden shutters instead of glass this would appear to be an original window (Plate 46). The window would have originally been situated above the kitchen in the Grain Store (Room 7)

Visible on the southwest wall are the joist slots but only two of the joists still remain (Plate 46 and 47), furthermore, there is no roof present on the building (Plate 49).

Plate 46: Interior - View of wooden joists and NW wall of R3, also showing window of Grain Store R7; scale not used; view from SE (archive reference: E49216_61).

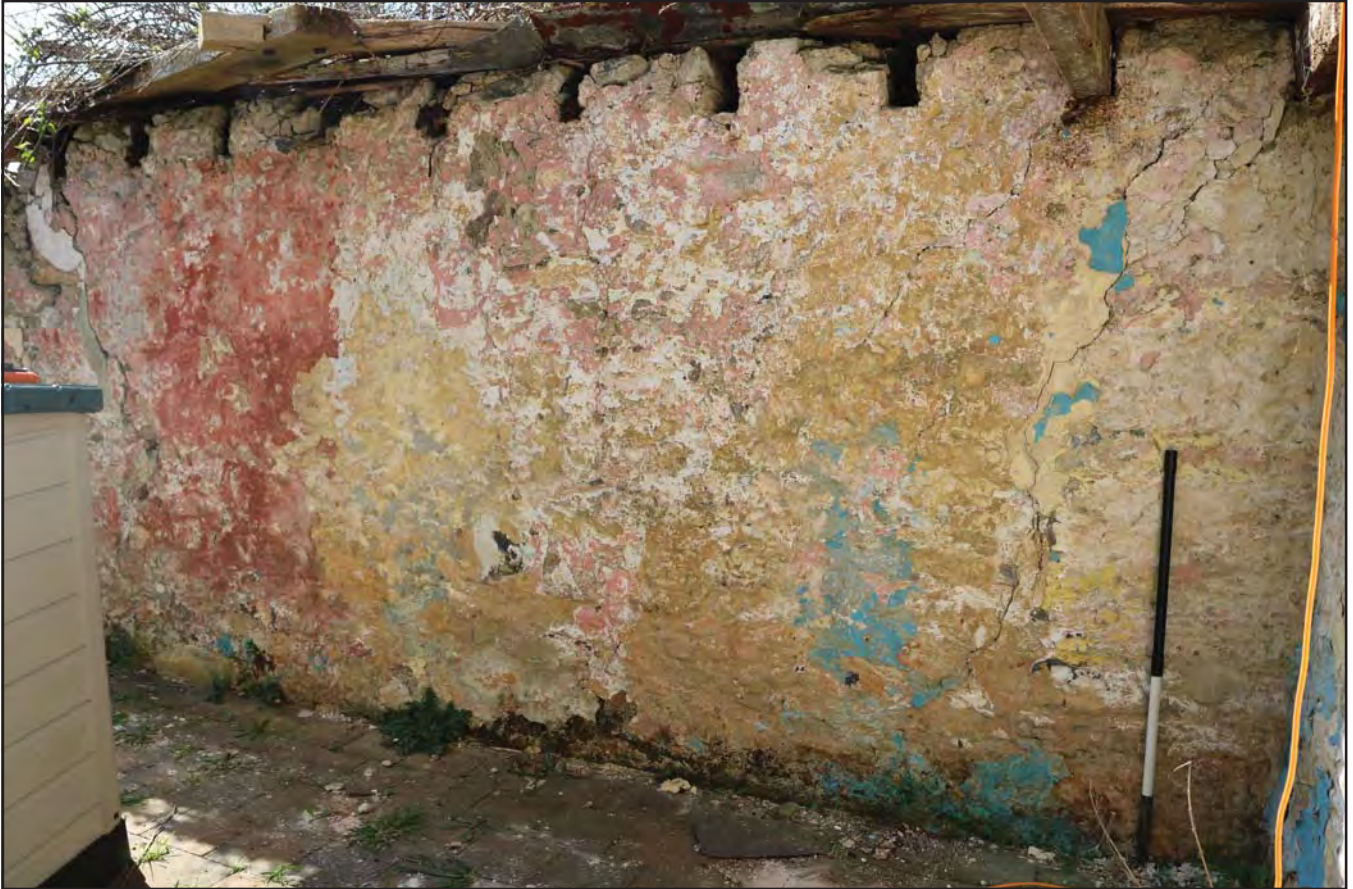
Plate 47: Interior - View of SW wall of R3 showing joist slots; scale 1x1m; view from N (archive reference: E49216_63).

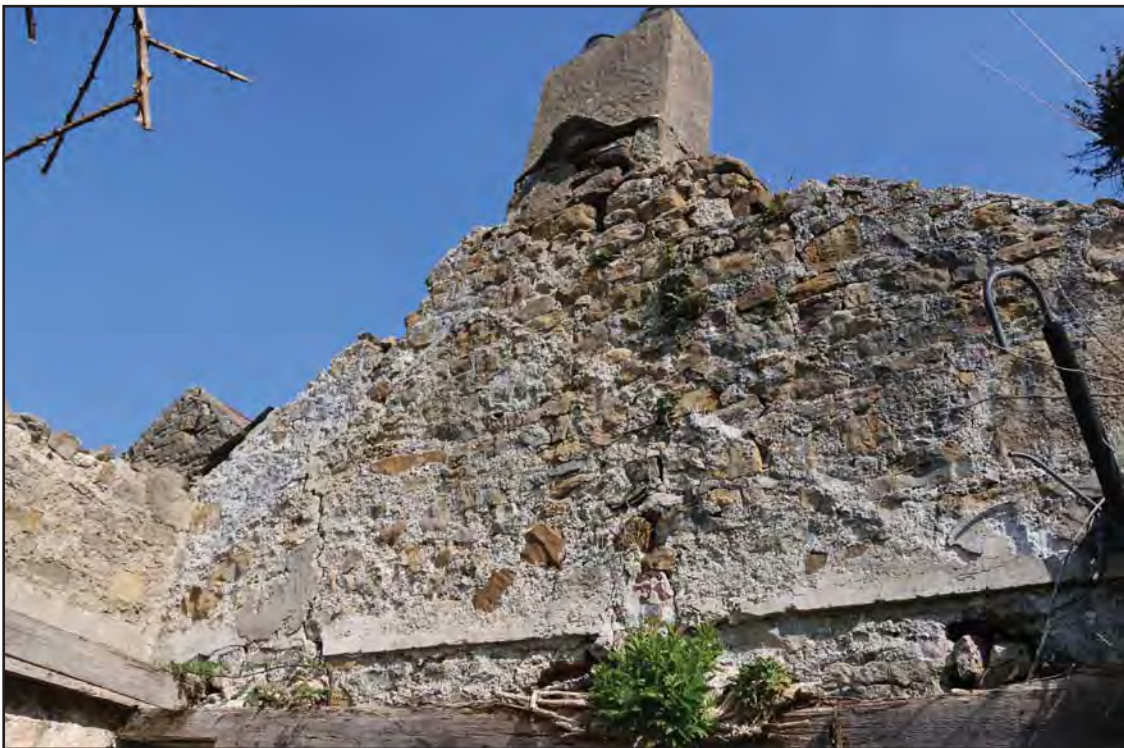
Plate 49: Interior - View of upper section of NE wall of R3; scale not used; view from SW (archive reference: E49216_65).

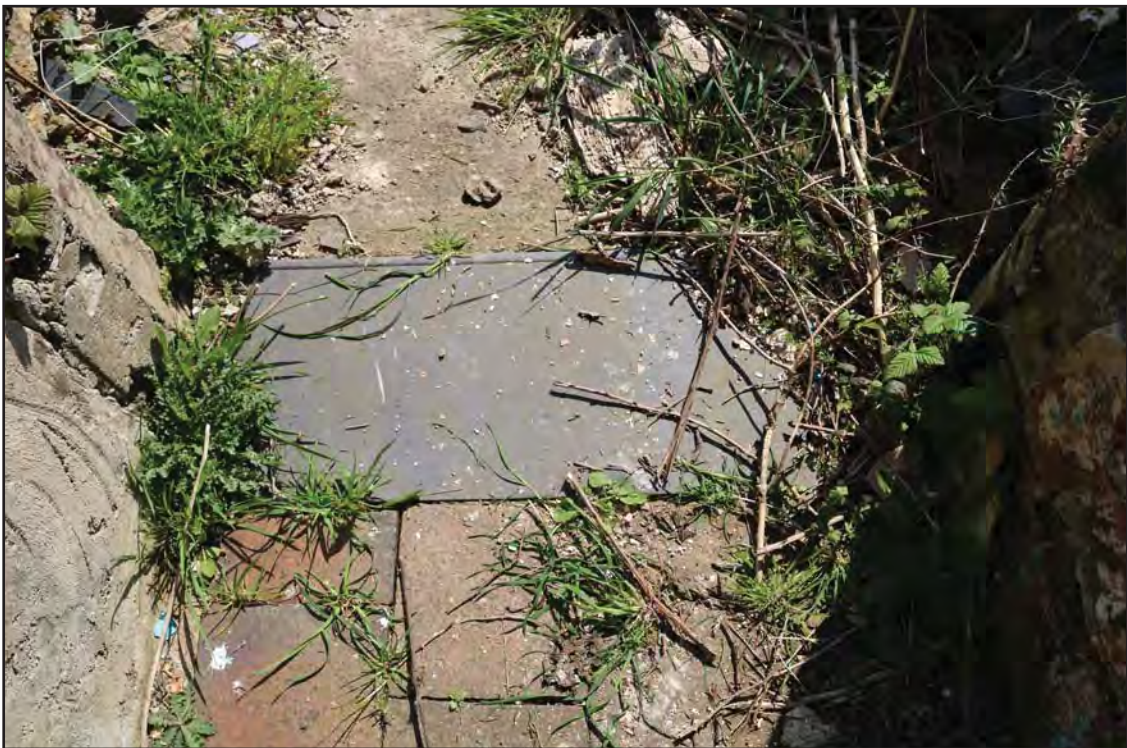
A doorway, window and a Belfast sink are positioned on the southeast wall (Plate 42 and 43). The floor consists of terracotta quarry tiles leading up to a slate threshold positioned on the exterior door (Plates 50 and 51). The Belfast sink is located under the window and is mounted on a red brick plinth with taps still present (Plate 43).

Plate 51: Interior - Slate threshold in entranceway of R3; scale not used; view from NW (archive reference: E49216_67).

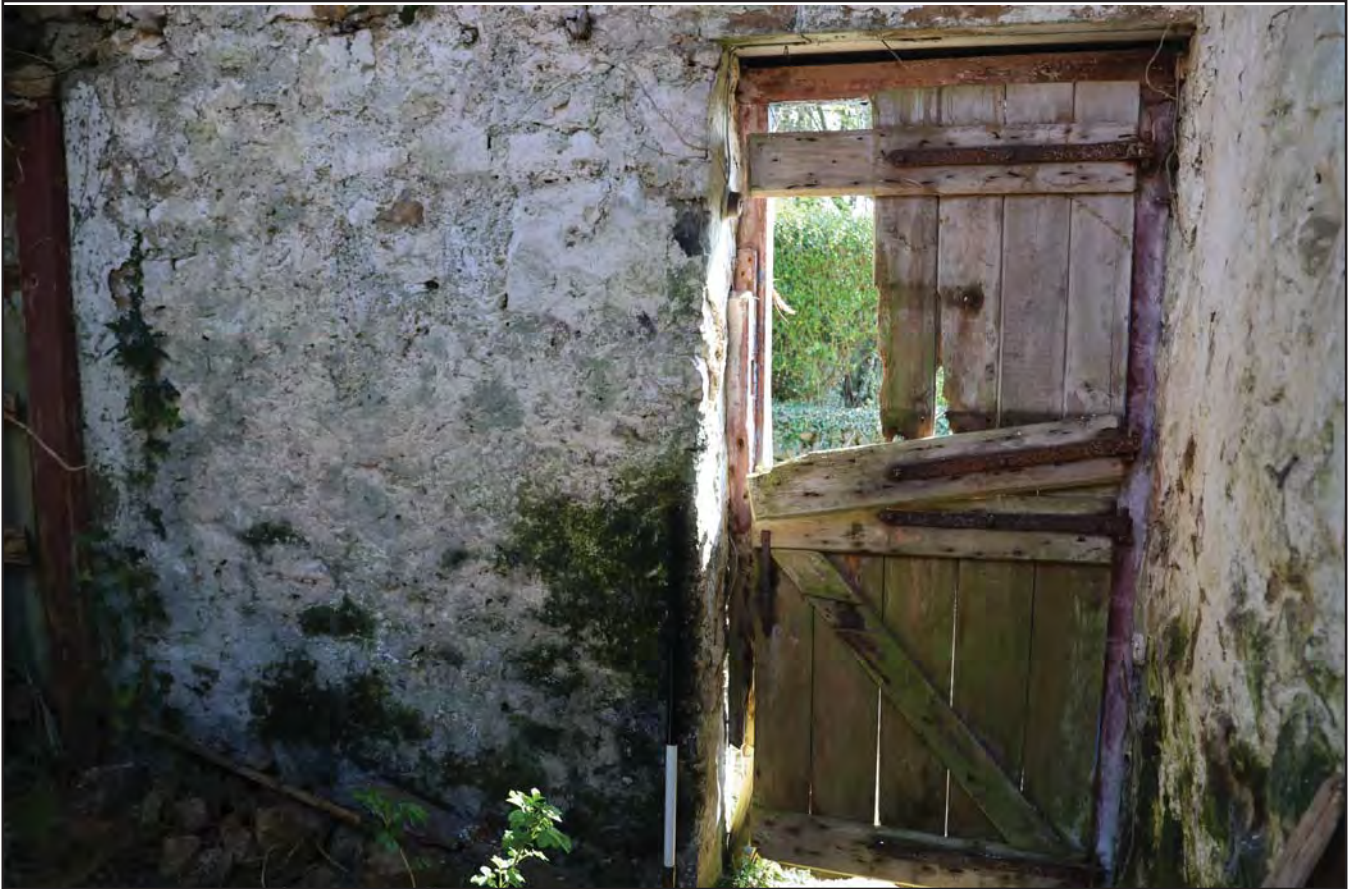
Plate 53: Interior - View of stable door and SE wall of R4; scale 1x1m; view from NW (archive reference: E49216_69).

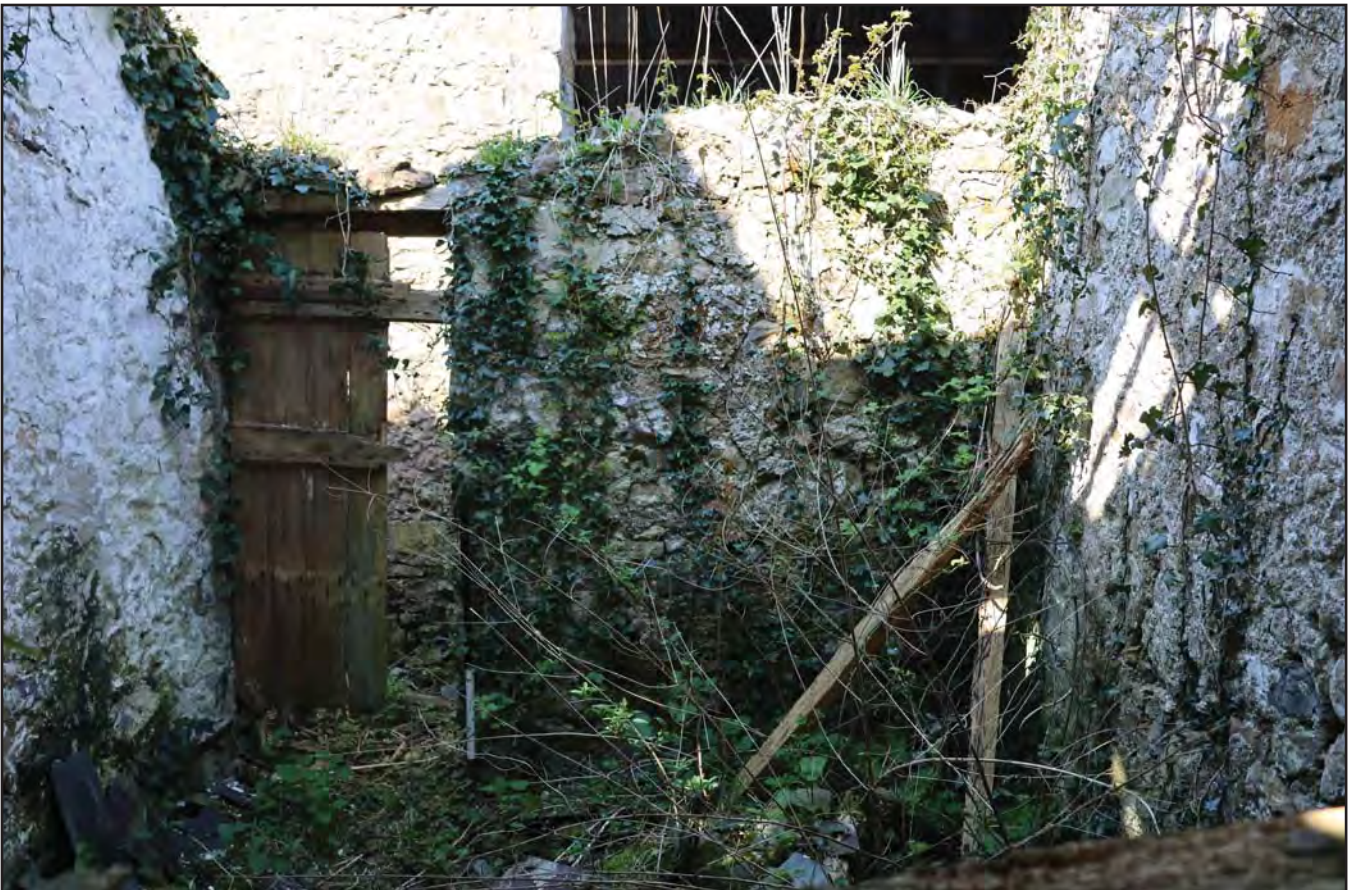
Plate 54: Interior - View of NW wall of R4 showing rear door; scale 1x1m; view from SE (archive reference: E49216_70).

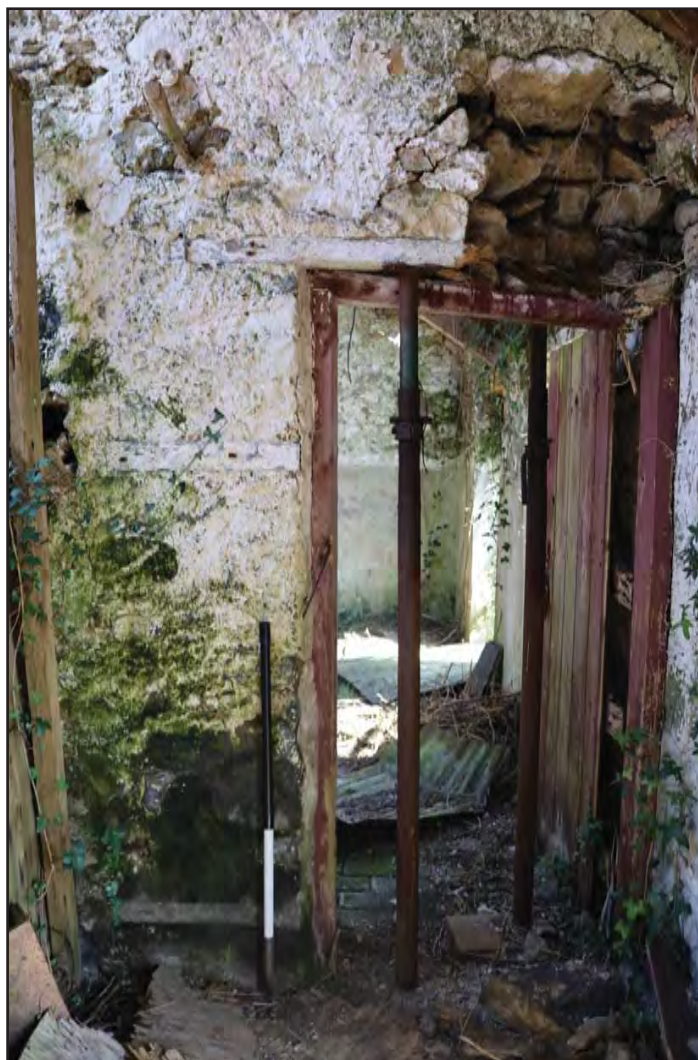
Plate 55: Interior - View of internal door leading from R4 into R5; scale 1x1m; view from SW (archive reference: E49216_71).

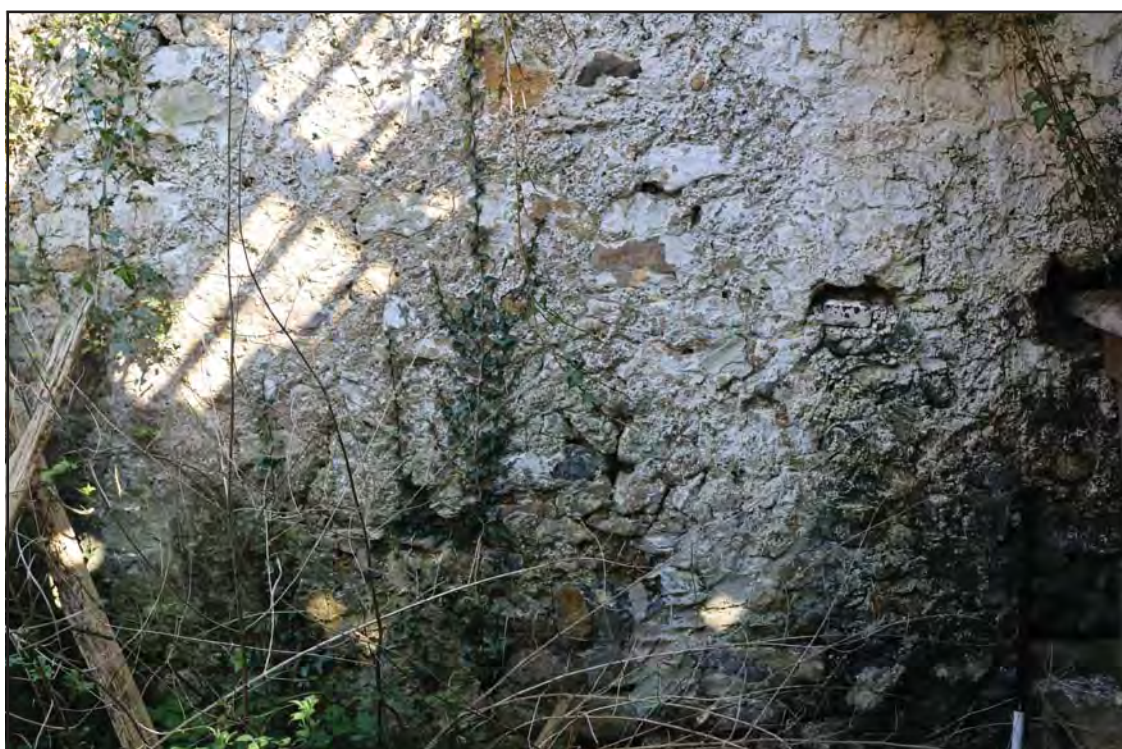
Plate 56: Interior - View of NE internal wall of R4; scale 1x1m; view from S (archive reference: E49216_72).
