Parc, Talwrn, Ynys Môn

Cofnod Adeilad Lefel 2/3 Archaeolegol
Archaeological Level 2/3 Building Record

Rhif Prosiect Heneb Archaeoleg Gwynedd / Heneb Gwynedd Archaeology Project No. HD24-116

Rhif Adroddiad / Report No. 1817

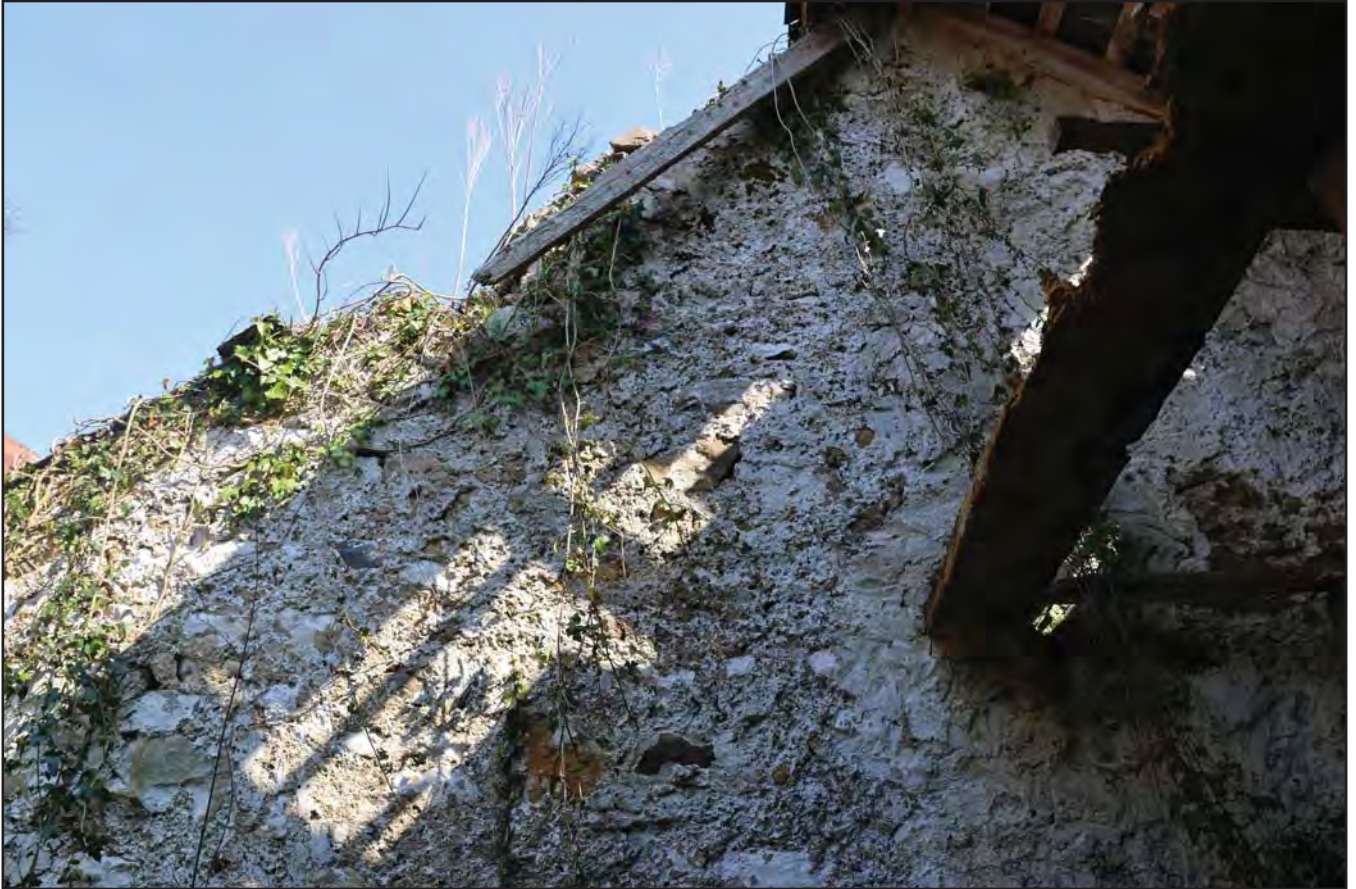
Plate 57: Interior - View of NE wall of R4 upper section; scale not used; view from SW (archive reference: E49216_73).

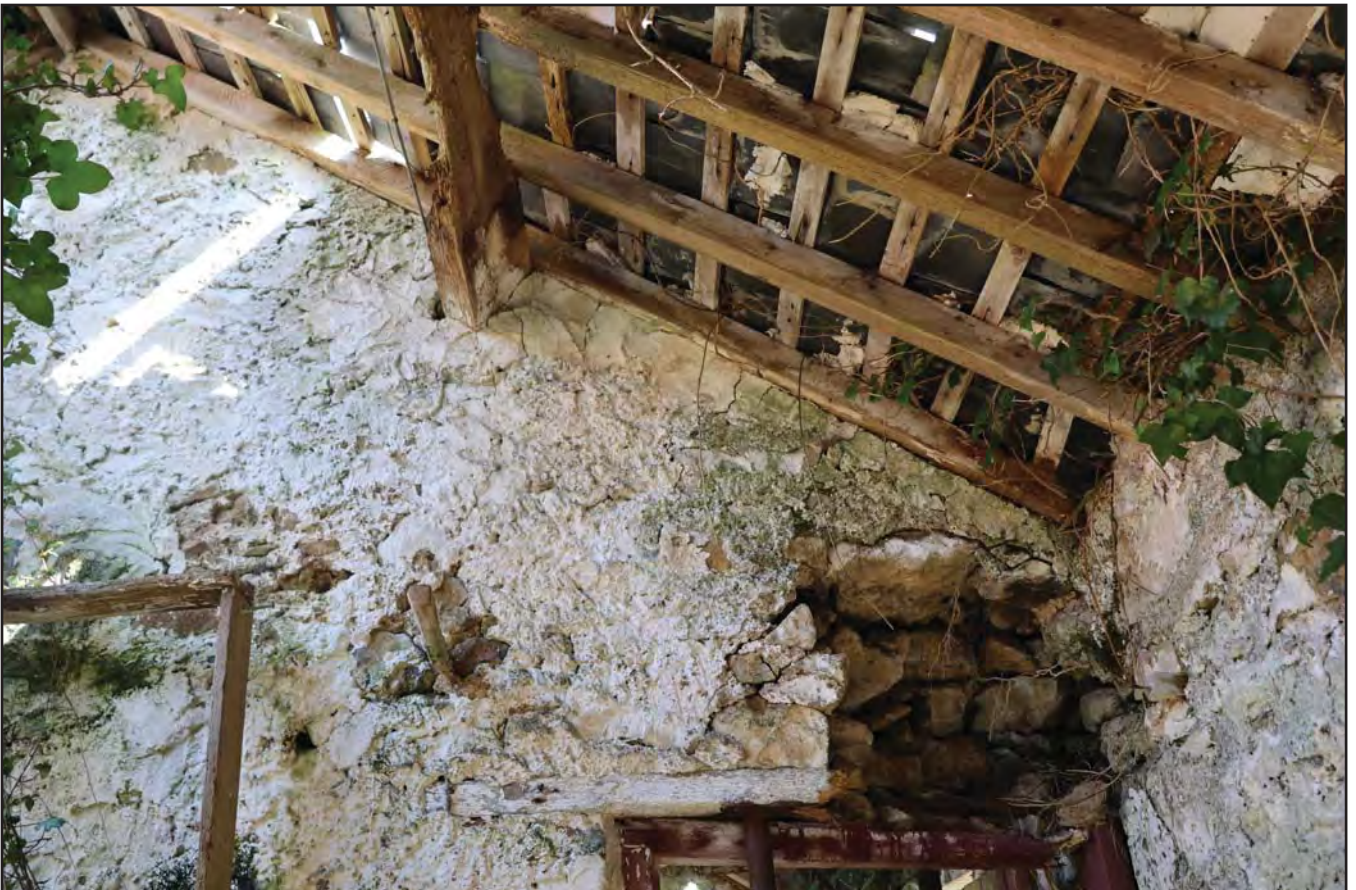
Plate 58: Interior - View of NE wall of R4 upper section; scale not used; view from SW (archive reference: E49216_74).

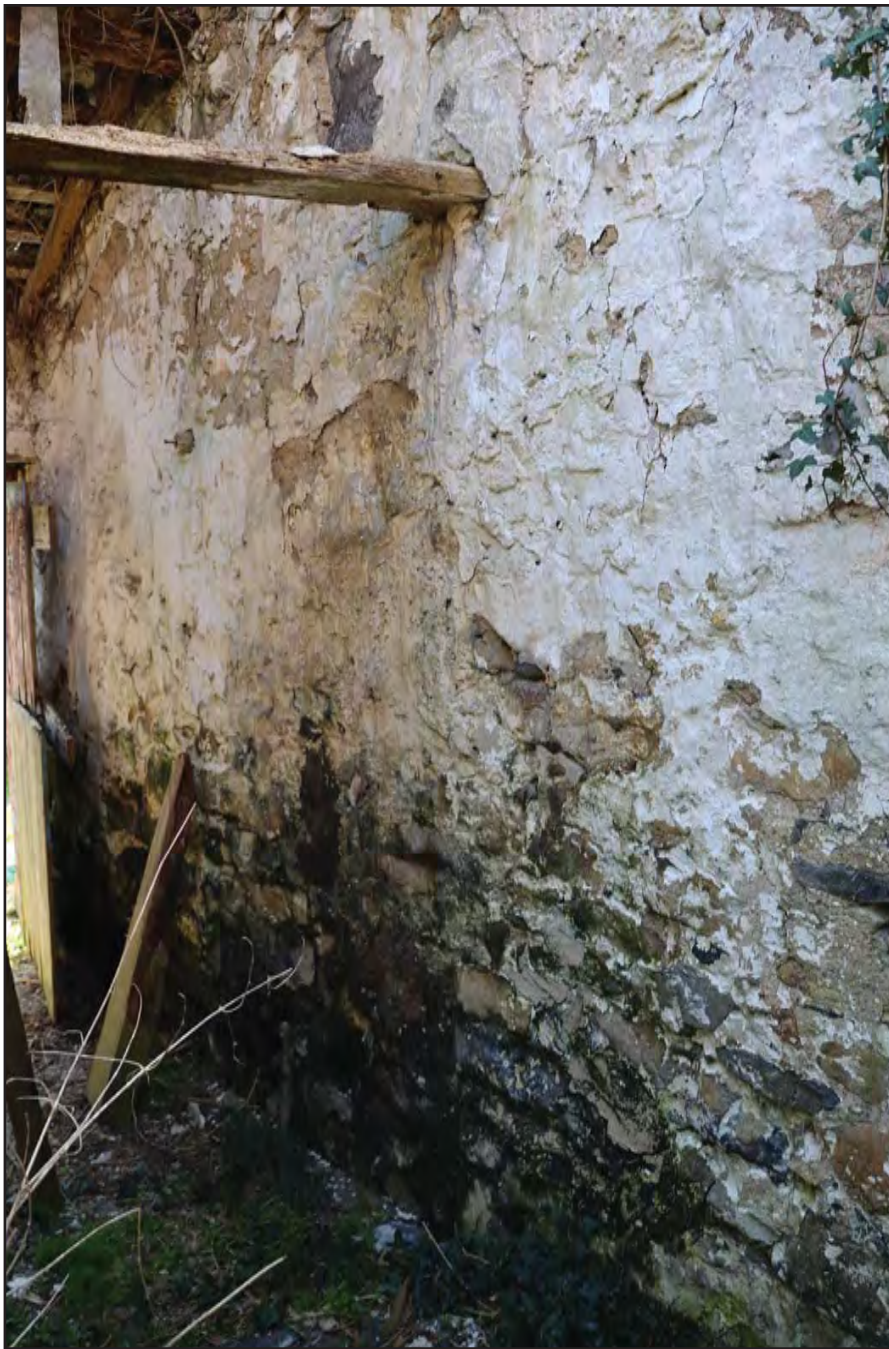
Plate 59: Interior - View of SW wall of R4; scale not used; view from N (archive reference: E49216_75).

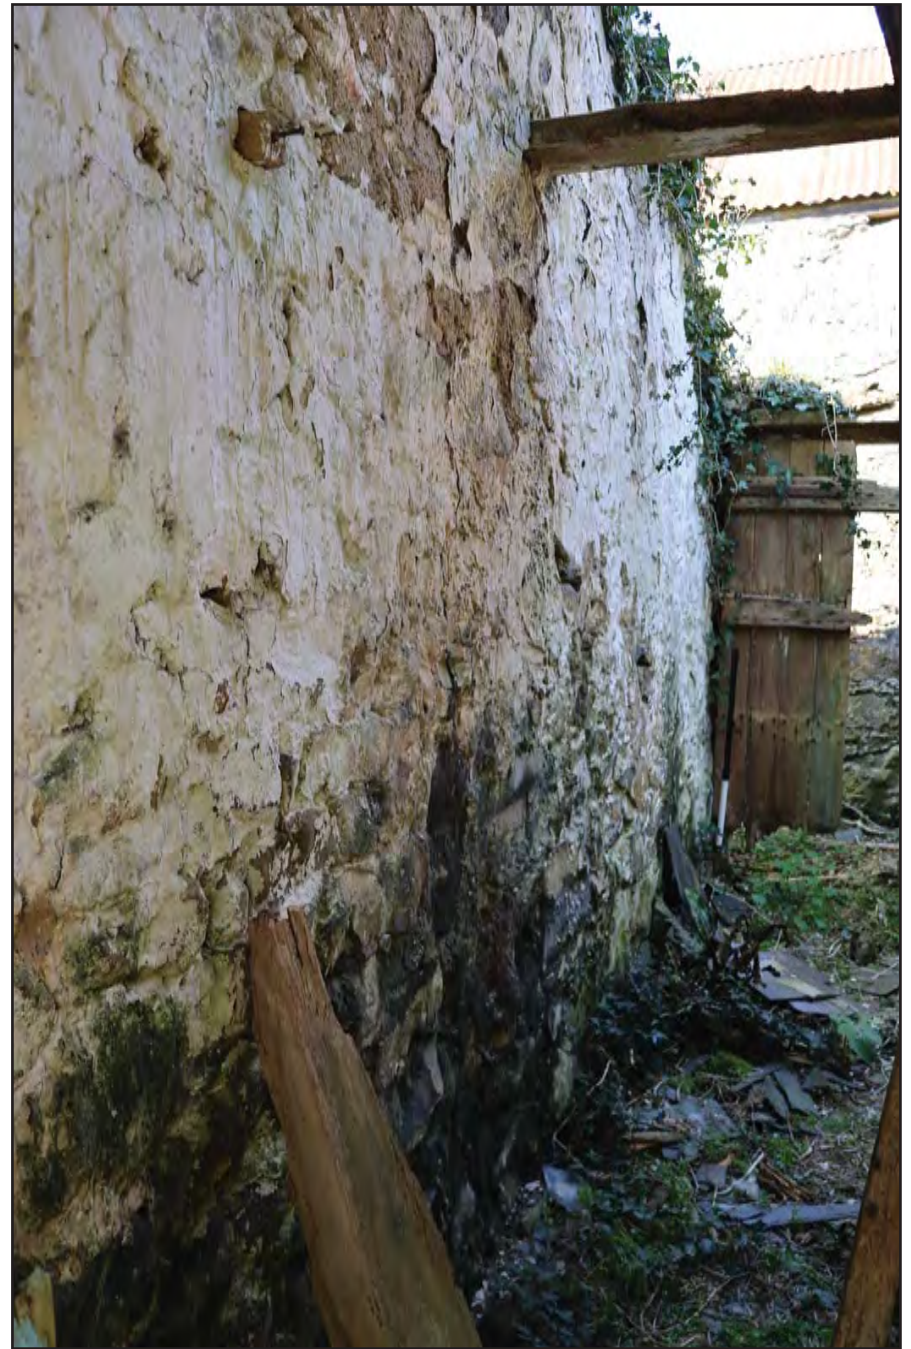
Plate 60: Interior - View of SW wall of R4; scale 1x1m; view from E (archive reference: E49216_76).

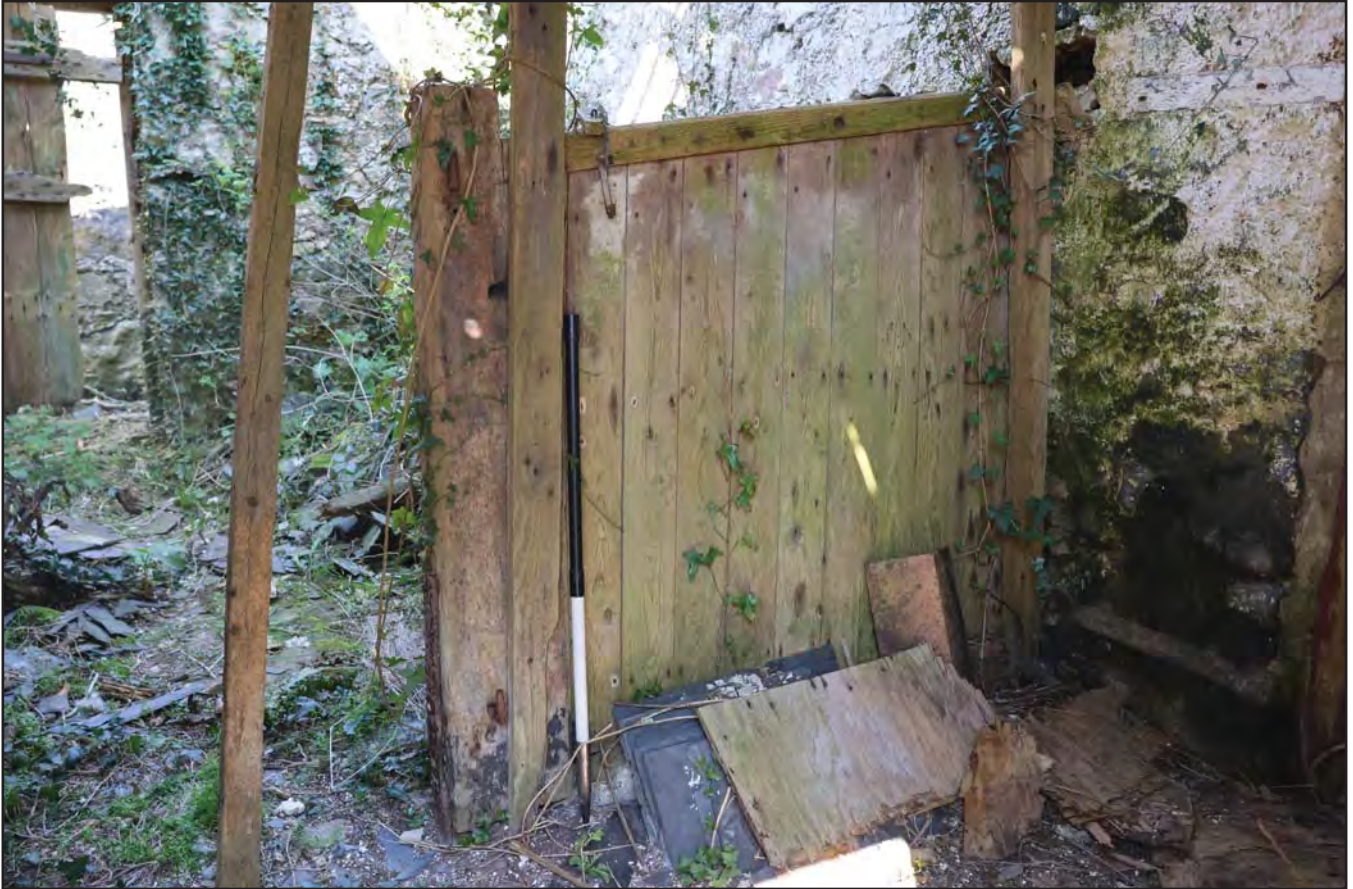
Plate 61: Interior - View of wooden partition in R4; scale 1x1m; view from SE (archive reference: E49216_77).

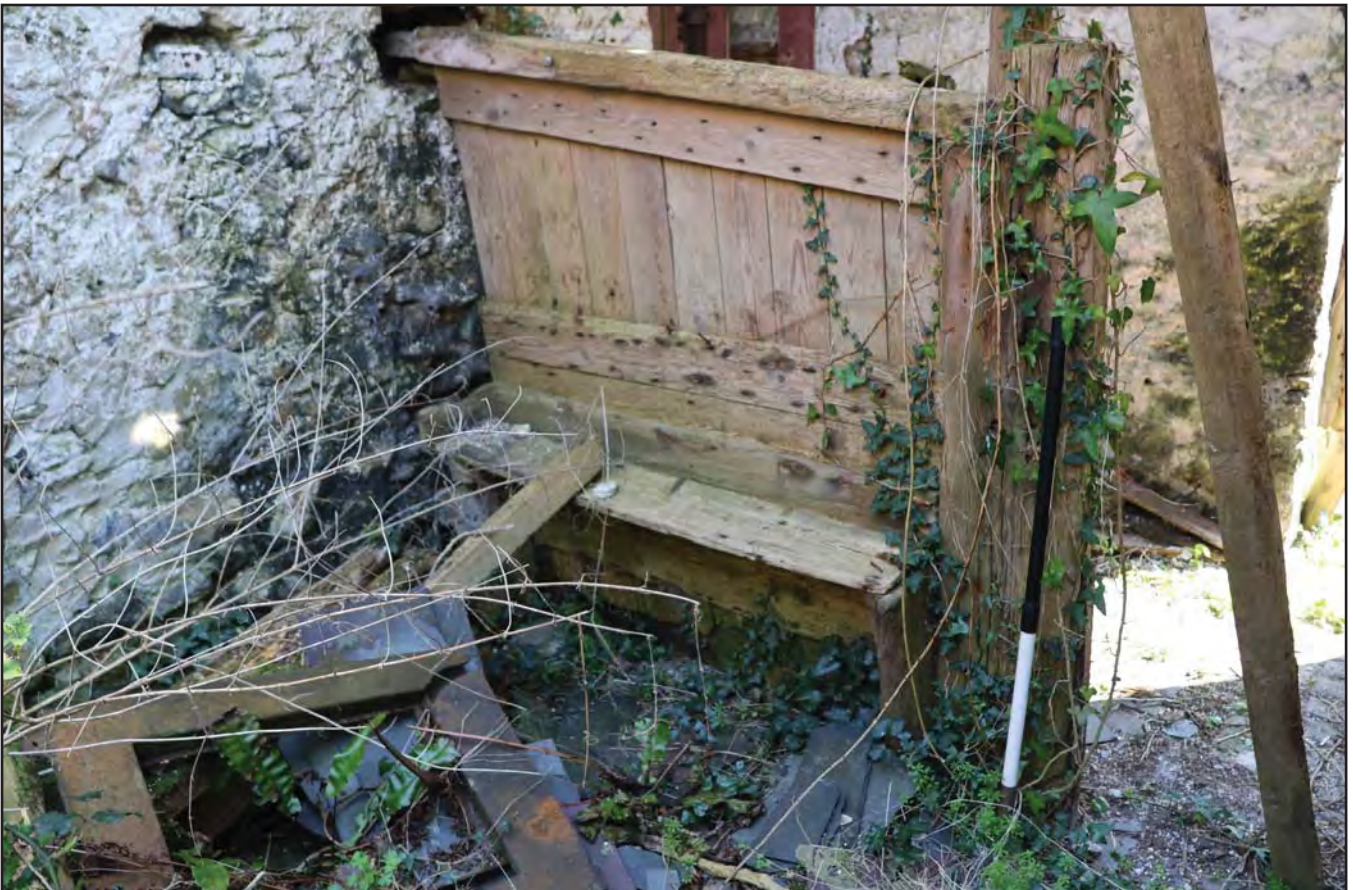
Plate 62: Interior - View of NW side of wooden partition in R4 showing a small bench; scale 1x1m; view from NW (archive reference: E49216_78).

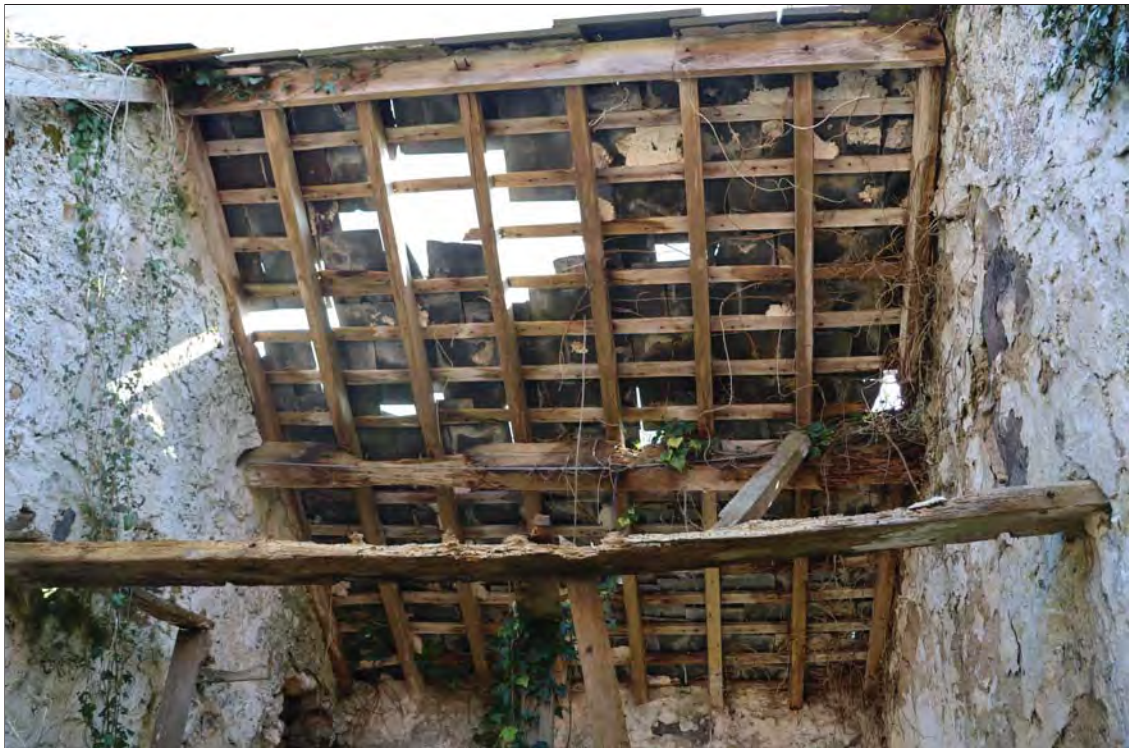
Plate 63: Exterior - Remains of the roof in R4; scale not used; view from NW (archive reference: E49216_79).

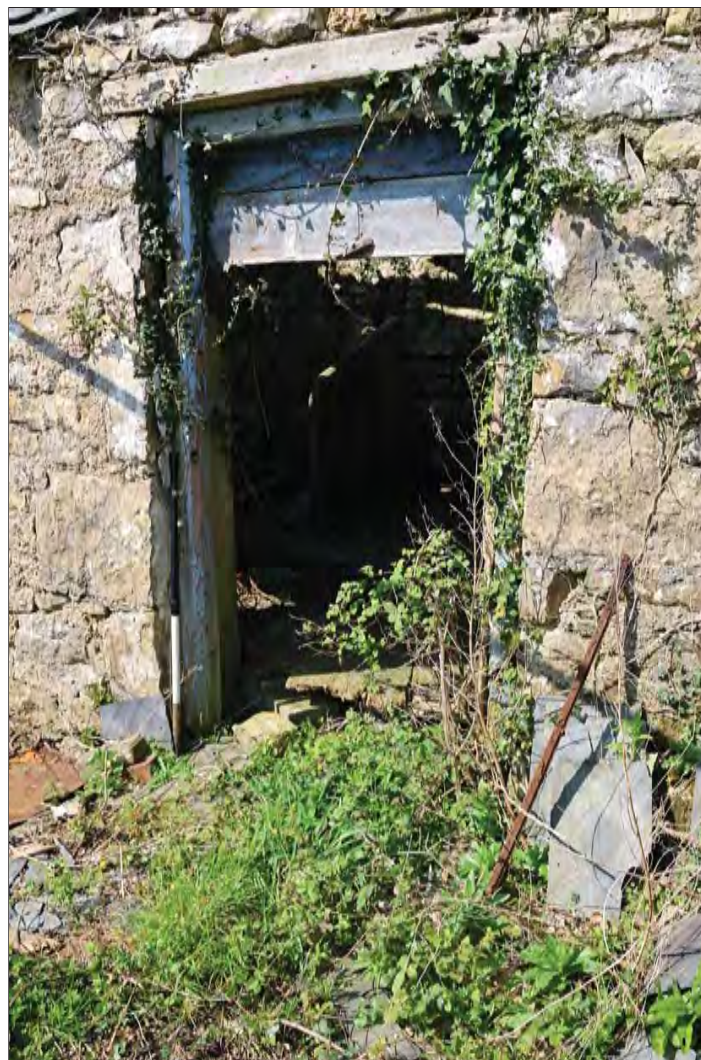
Plate 64: Interior - View of front entrance door leading into R5; scale 1x1m; view from E (archive reference: E49216_80).

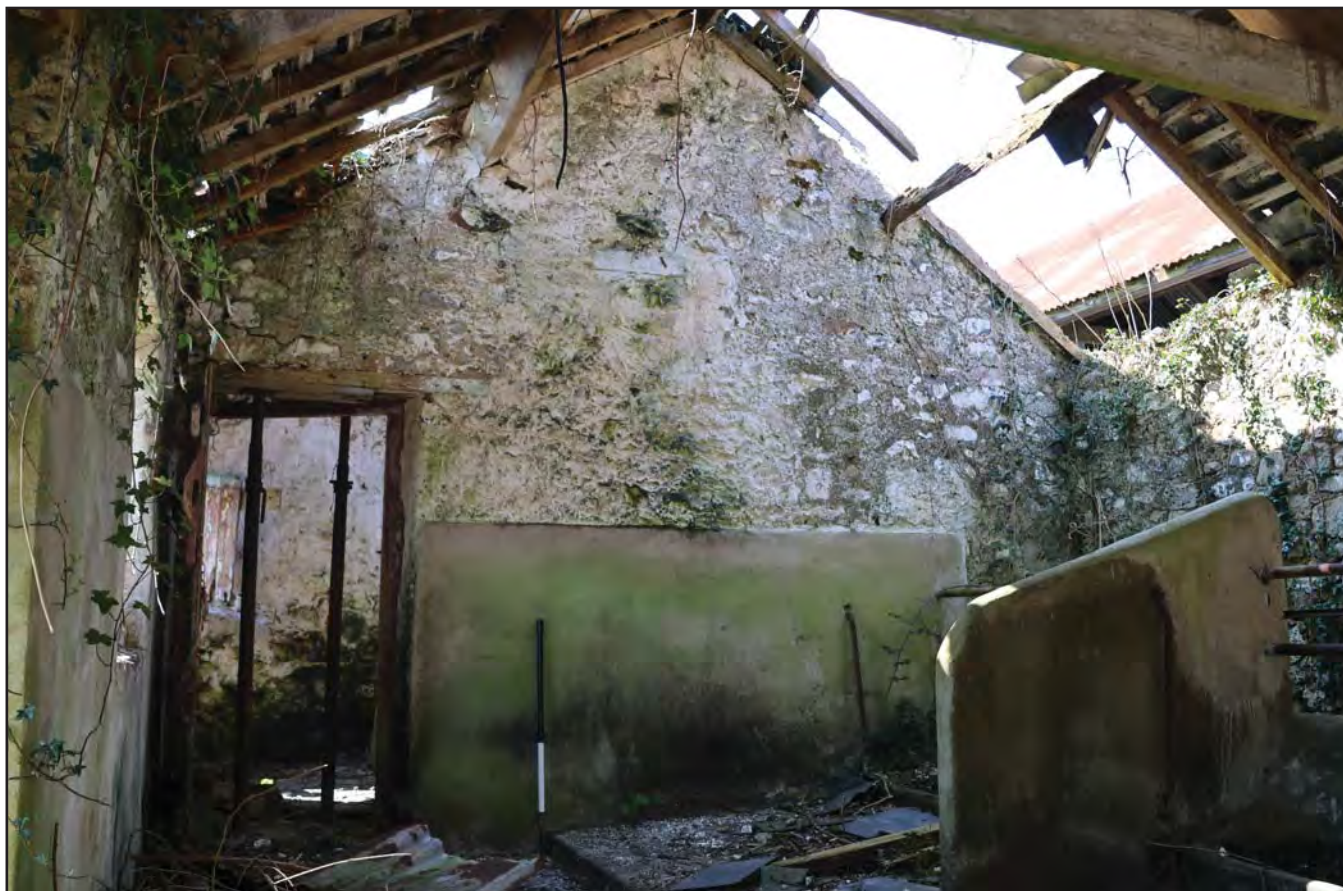
The Cow Shed has a doorway positioned on the southeast elevation along with a single window (Plate 2 and 71 and 72). On the adjacent northwest elevation wall an additional door is present leading into a narrow alleyway between the building and outbuilding 8, the wooden lintel and frame are in-situ, but the door is missing (Plate 65 to 69).

Plate 65: Interior - View of SW wall and milking stalls in R5; scale 1x1m; view from NE (archive reference: E49216_81).

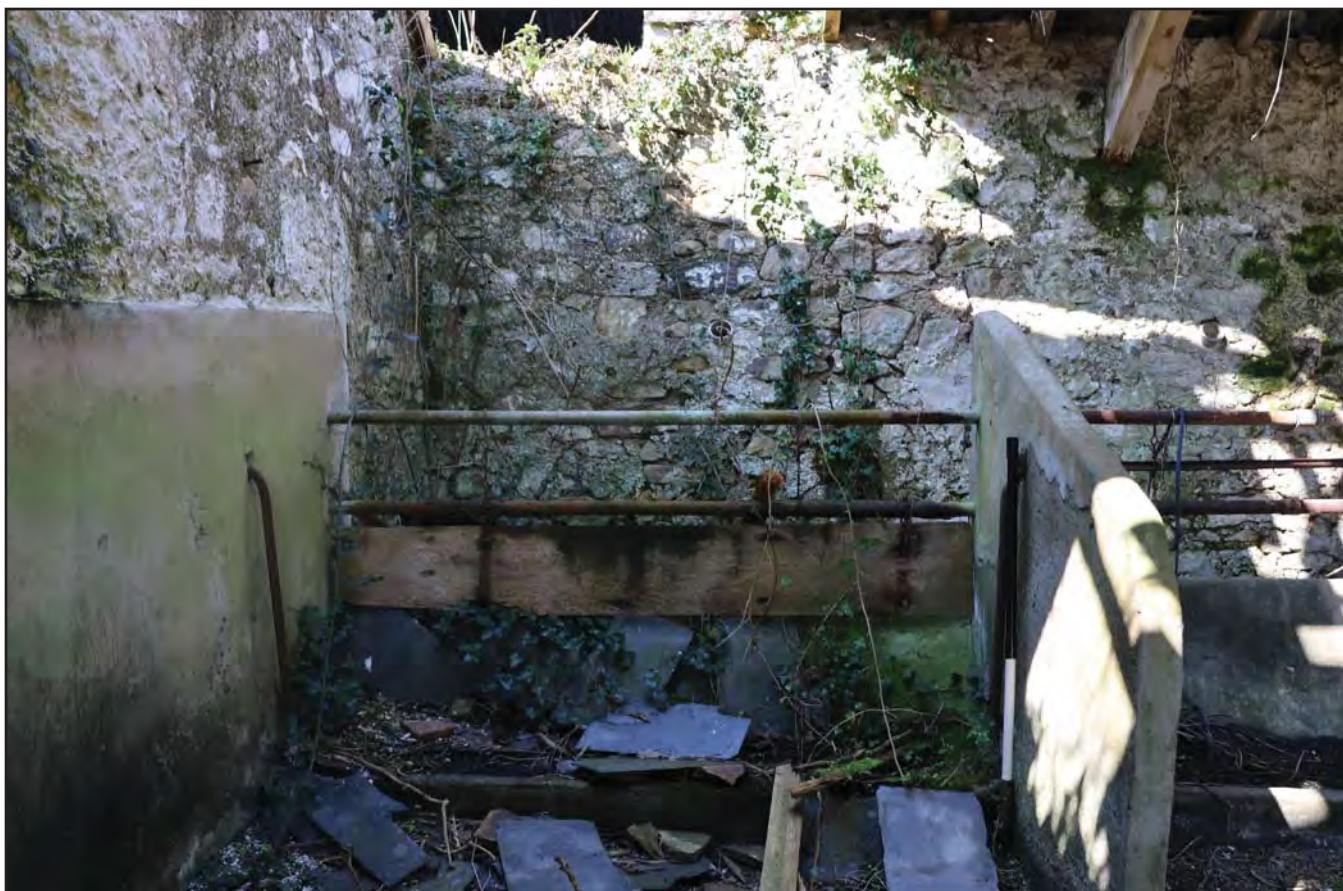
Plate 66: Interior - WNW wall of R5 showing cattle stalls; scale 1x1m; view from SE (archive reference: E49216_82).

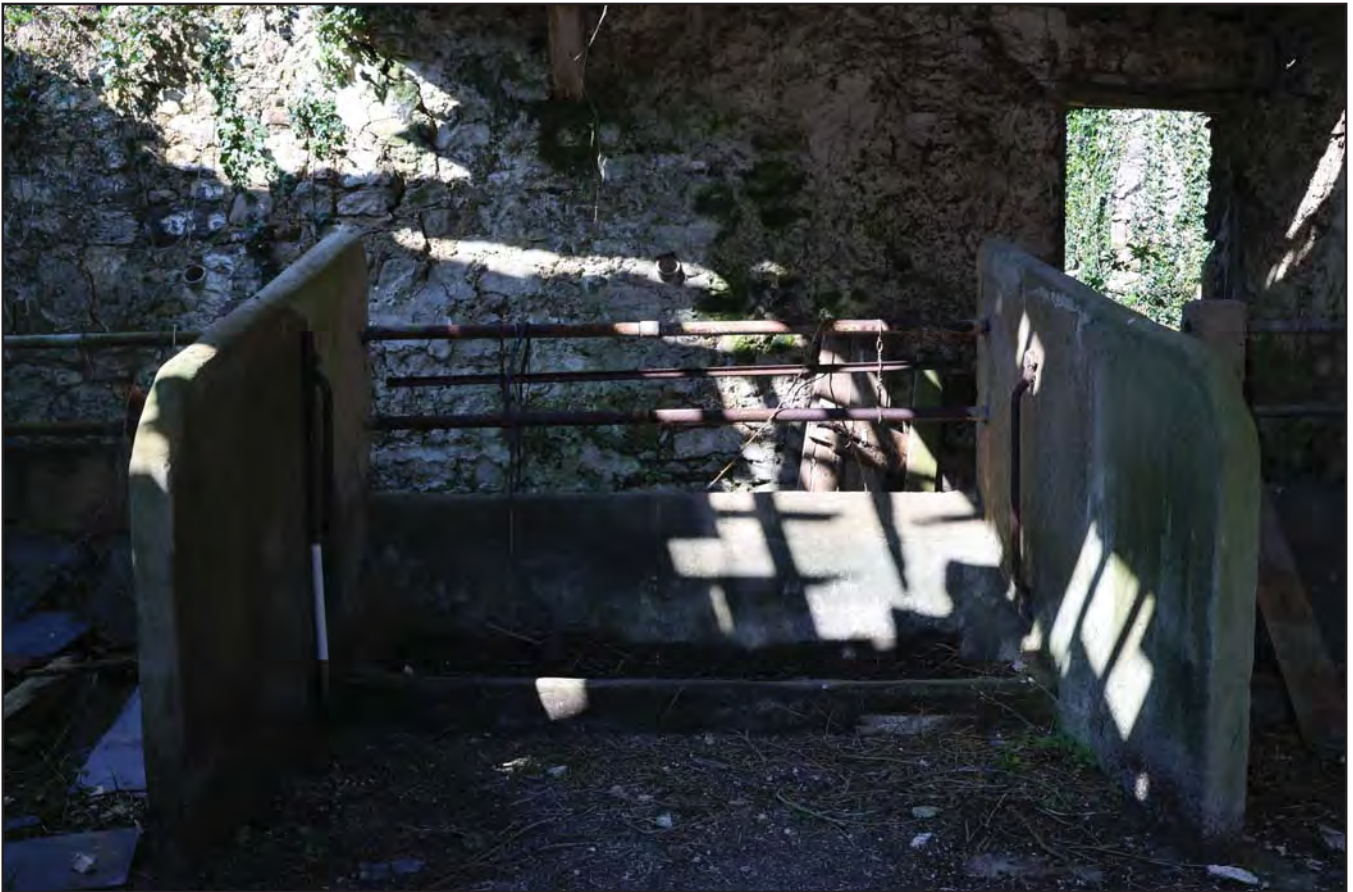
Plate 67: Interior - WNW wall of R5 showing cattle stall; scale 1x1 m; view from SE (archive reference: E49216_83).

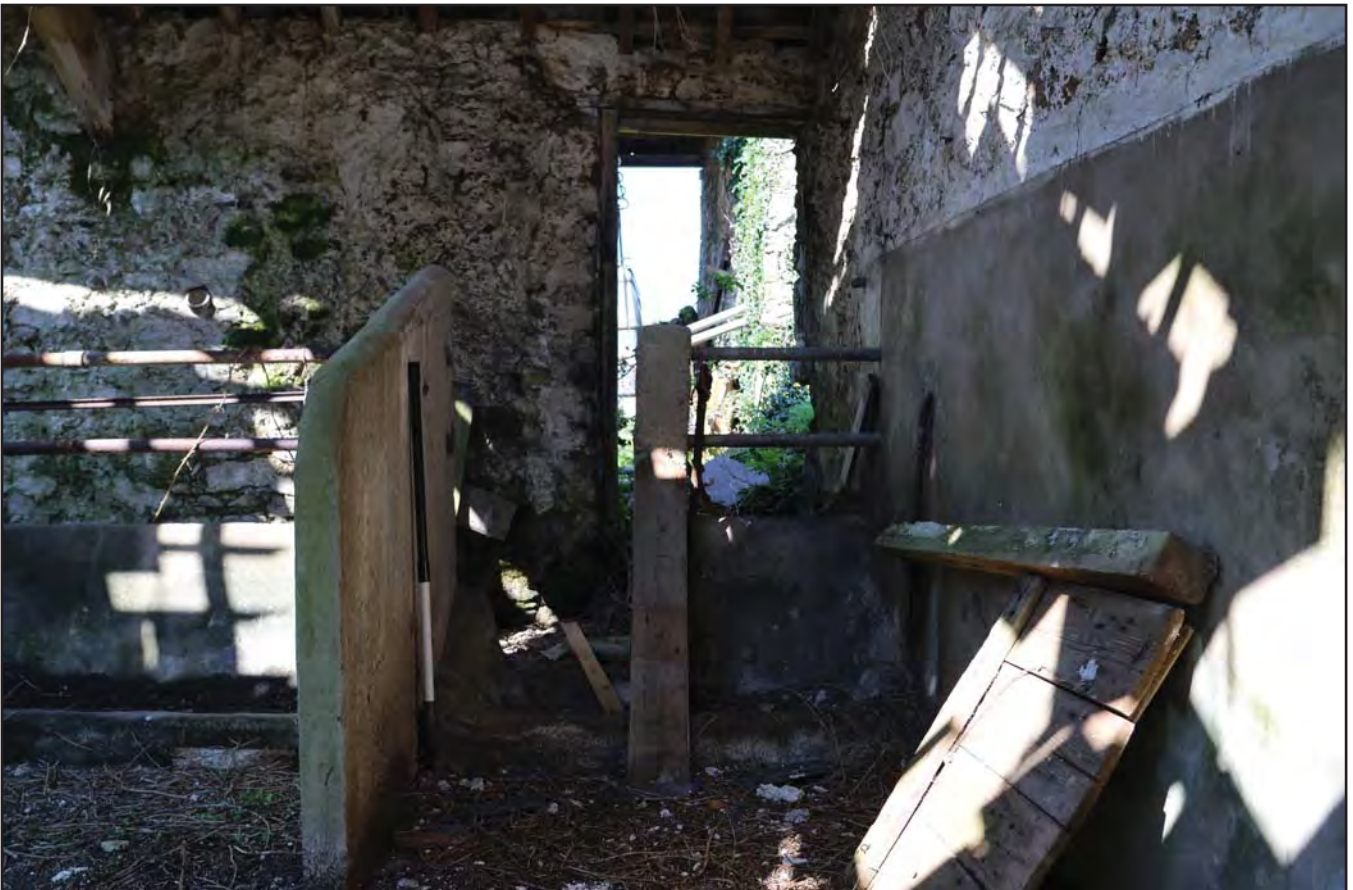
Plate 68: Interior - WNW wall of R5 showing cattle stalls and rear exit door on NW wall; scale 1x1 m; view from SE (archive reference: E49216_84).

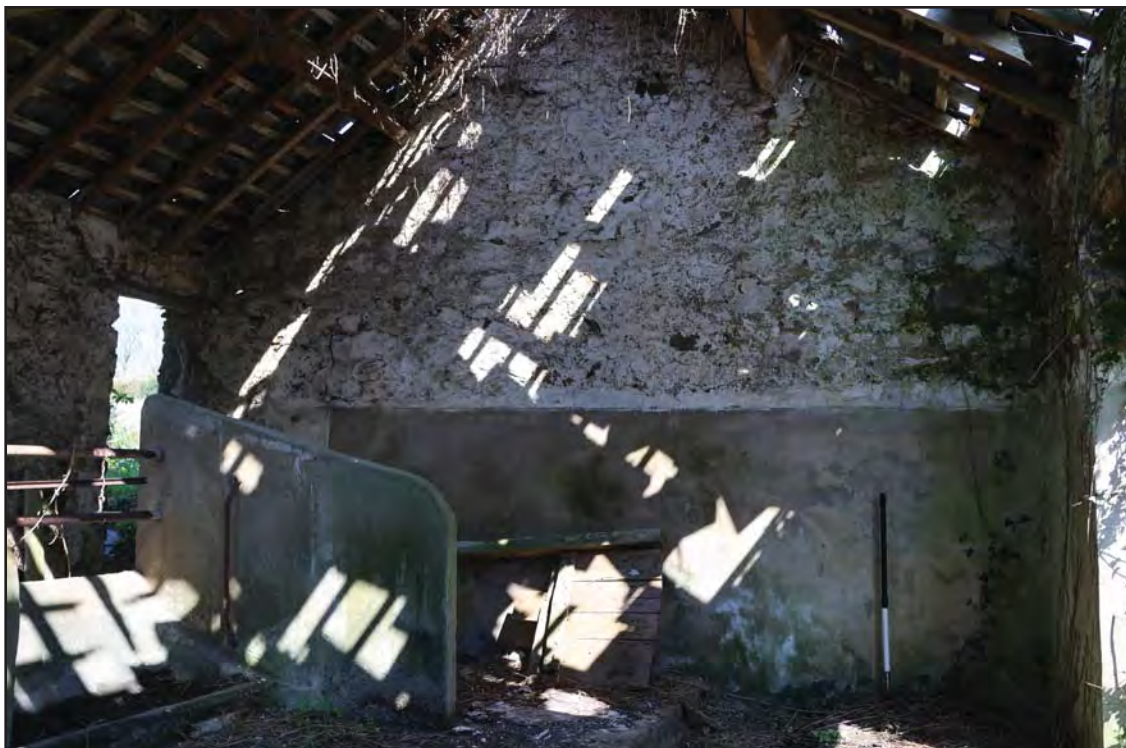
Plate 69: Interior - View of NE wall of R5; scale 1x1m; view from SW (archive reference: E49216_85).

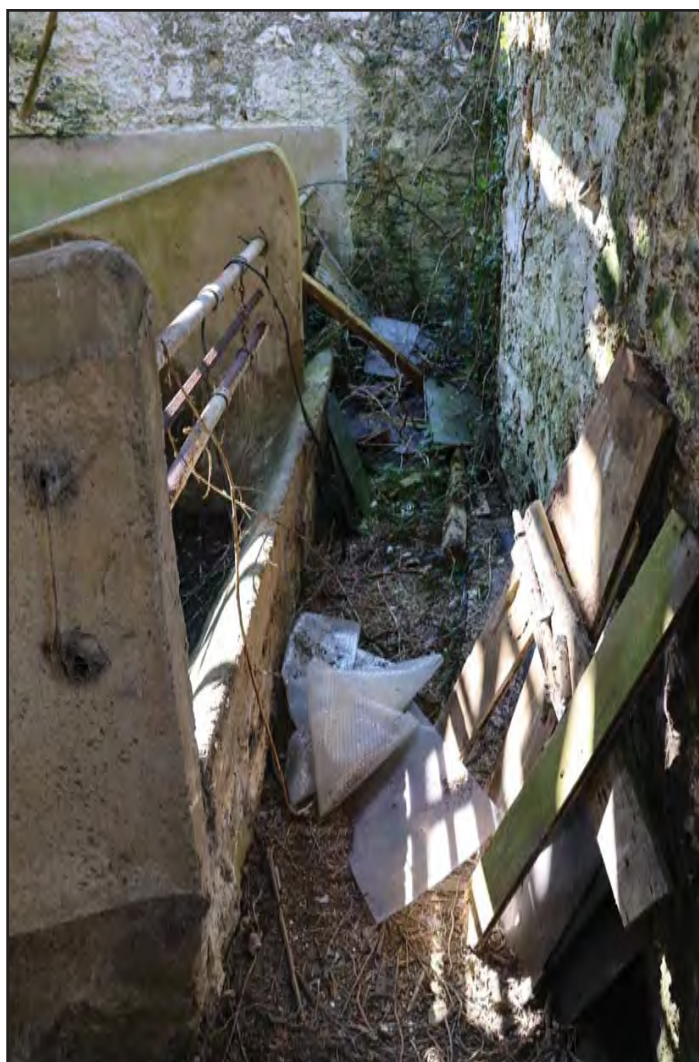
Plate 70: Interior - View looking down alley behind cattle stalls in R5; scale not used; view from NE (archive reference: E49216_86).

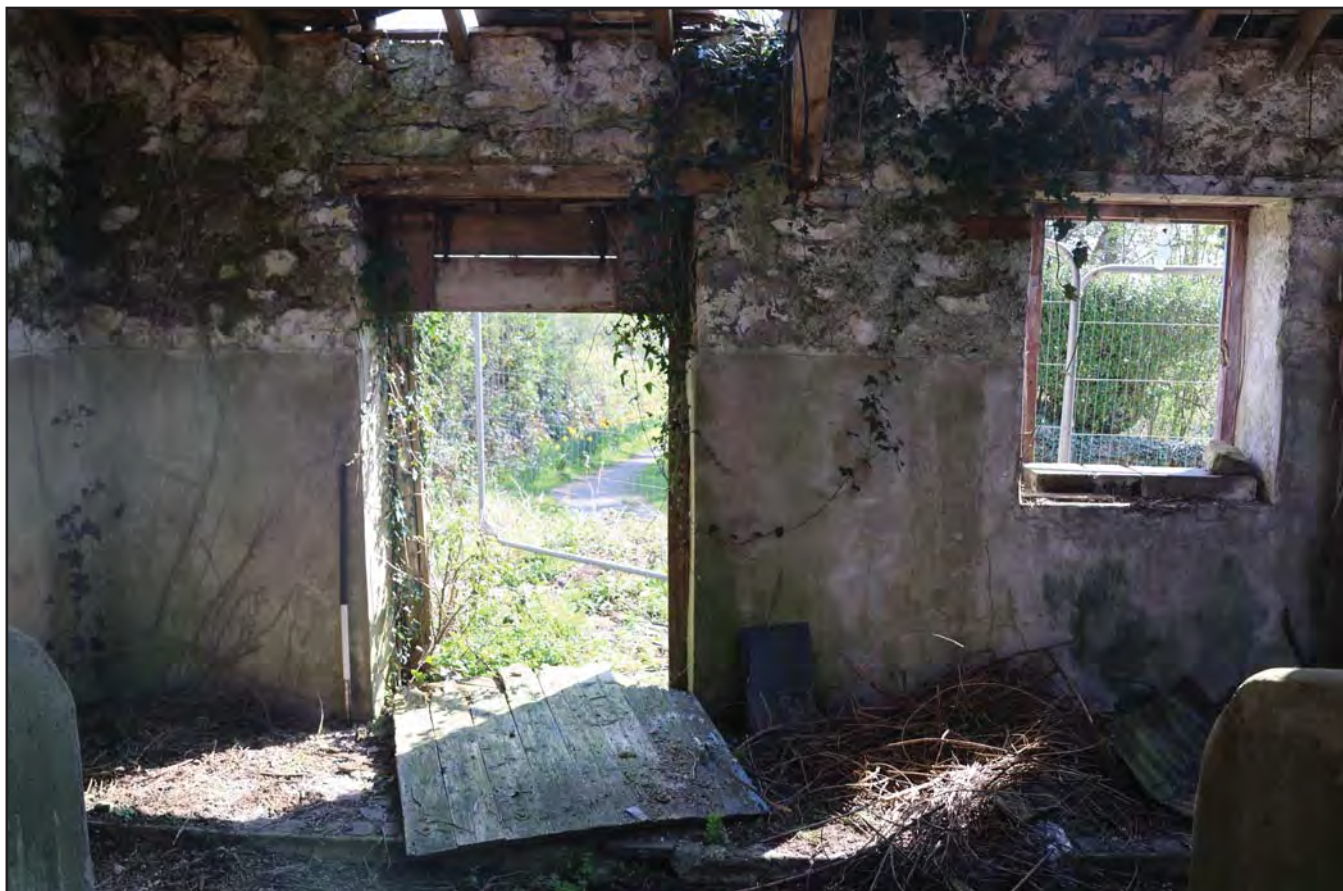
Plate 71: Interior - View of SE wall showing front entrance door and window in R5; scale 1x1m; view from NW (archive reference: E49216_87).

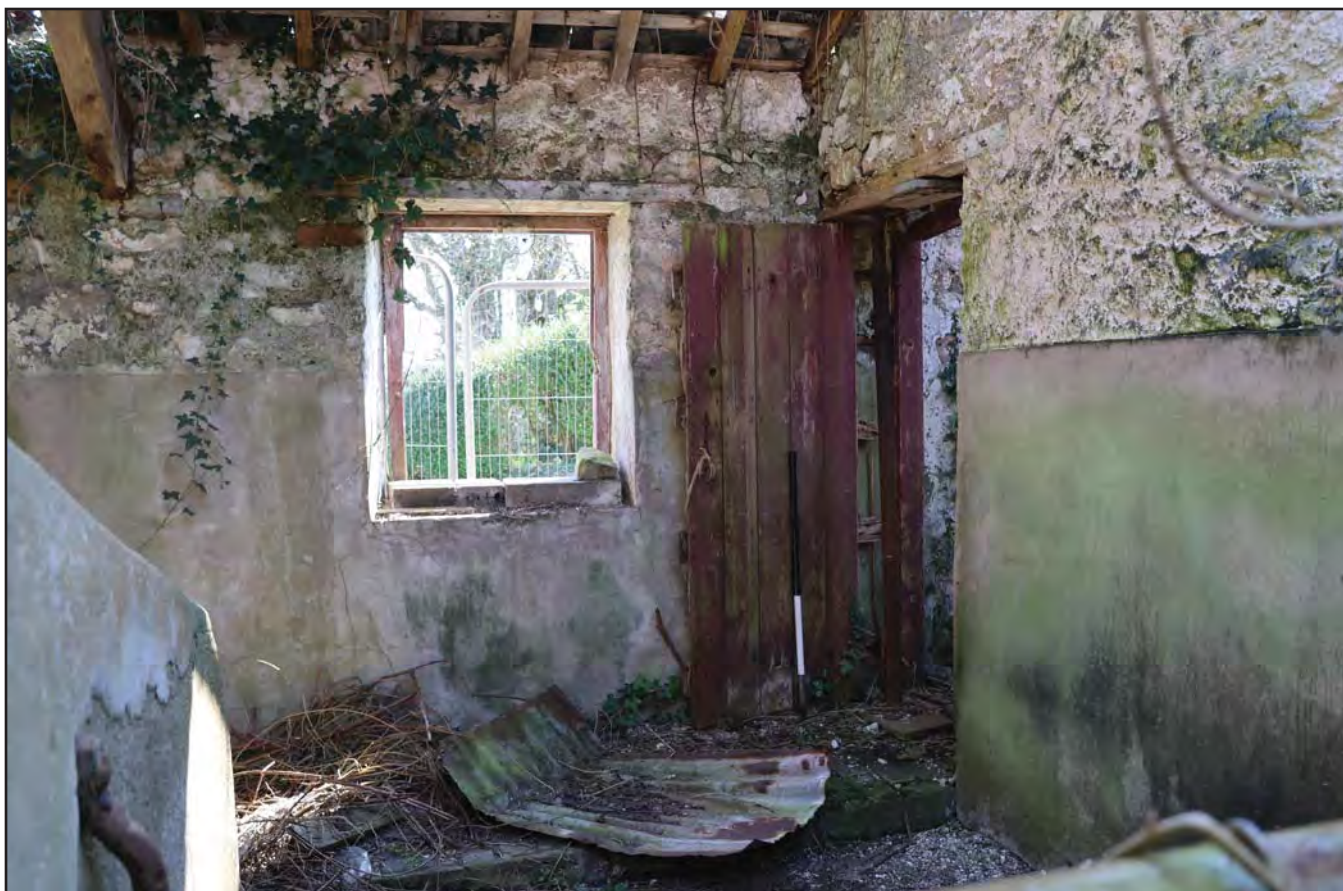
Plate 72: Interior - View of SE wall showing window and internal door through to R4 from R5; scale 1x1m; view from NW (archive reference: E49216_88).

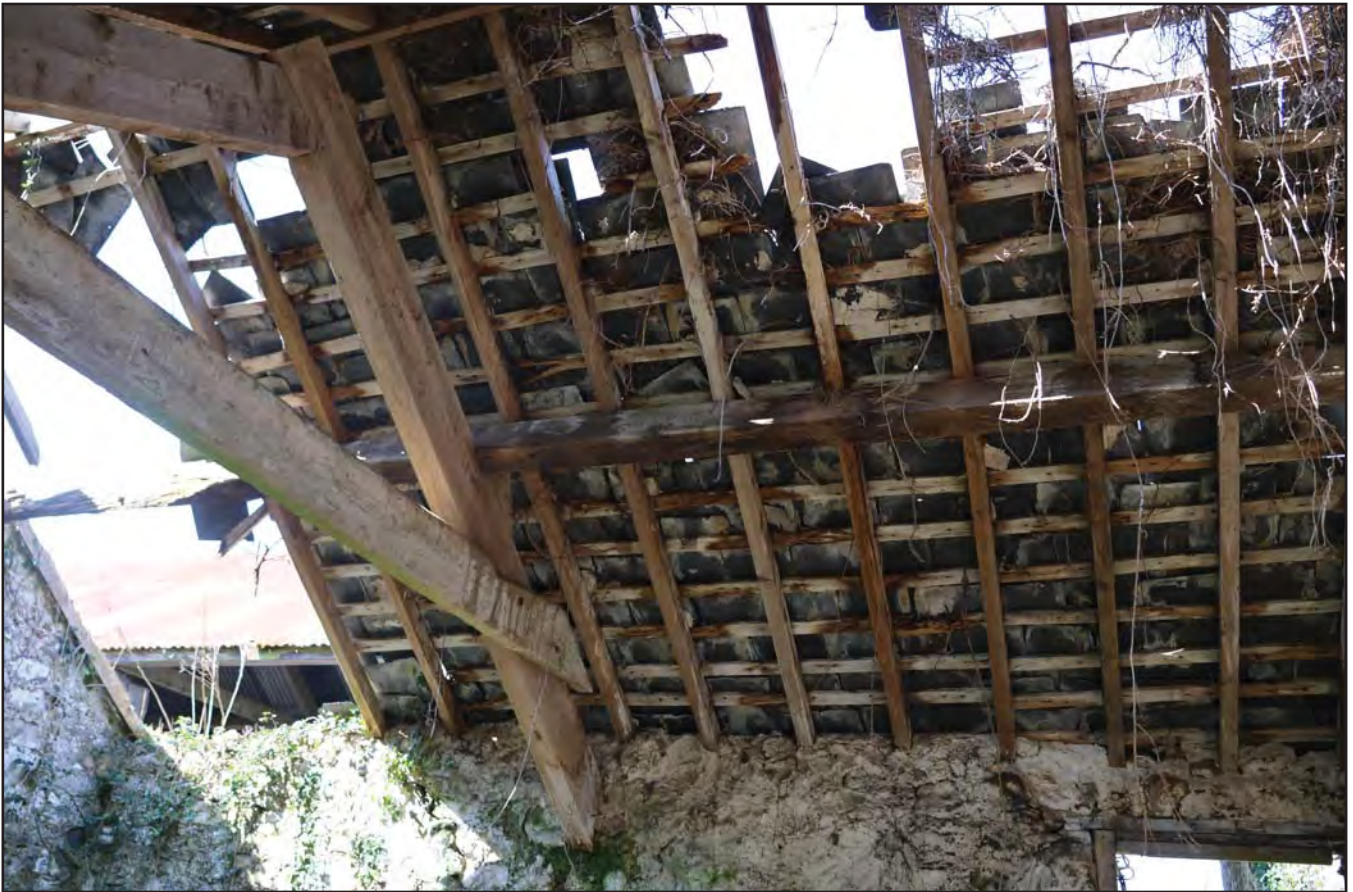
Plate 73: Interior - View of roof in R5; scale not used; view from E (archive reference: E49216_89).

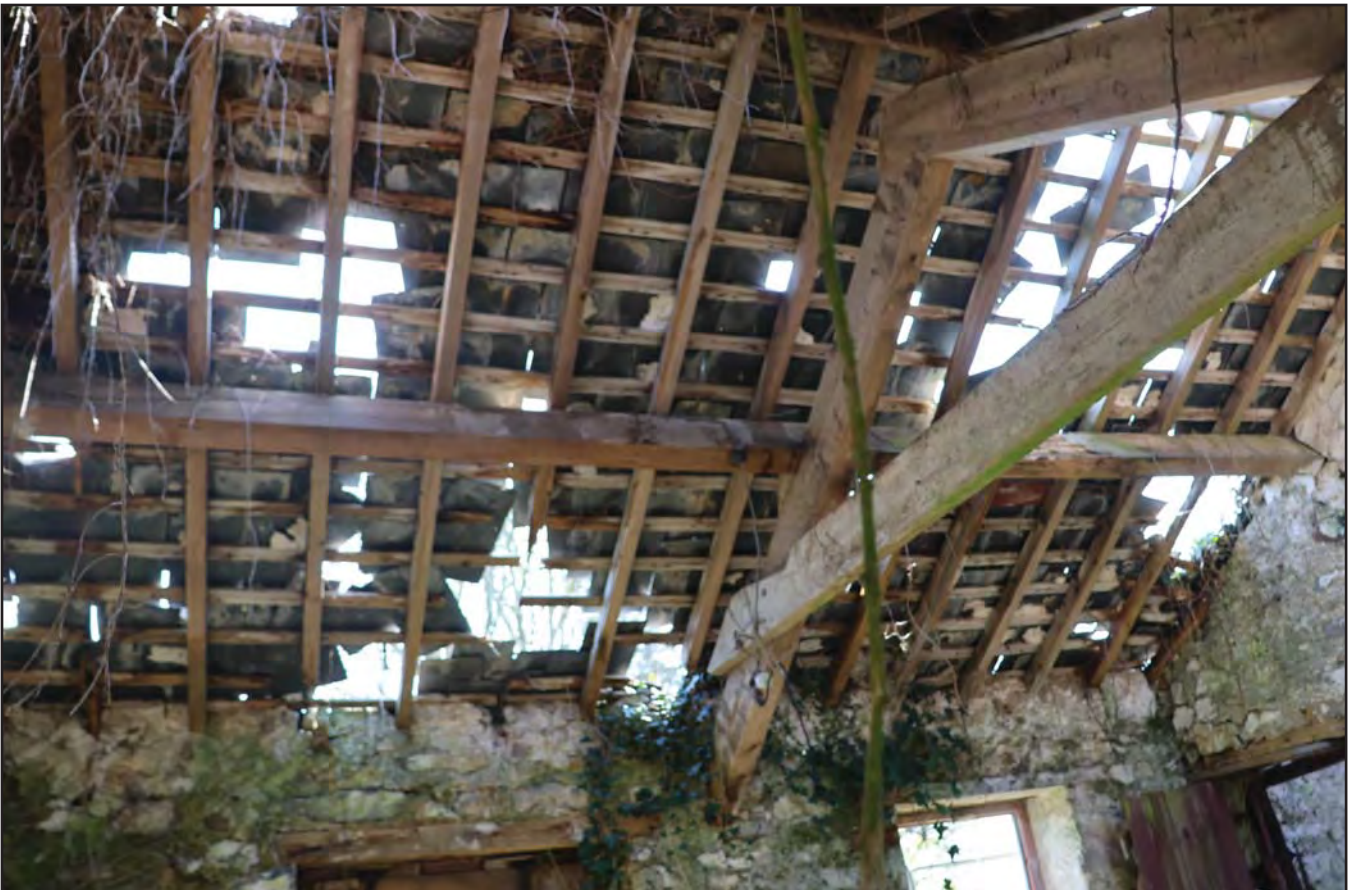
Plate 74: Interior - View of roof in R5; scale not used; view from NW (archive reference: E49216_90).

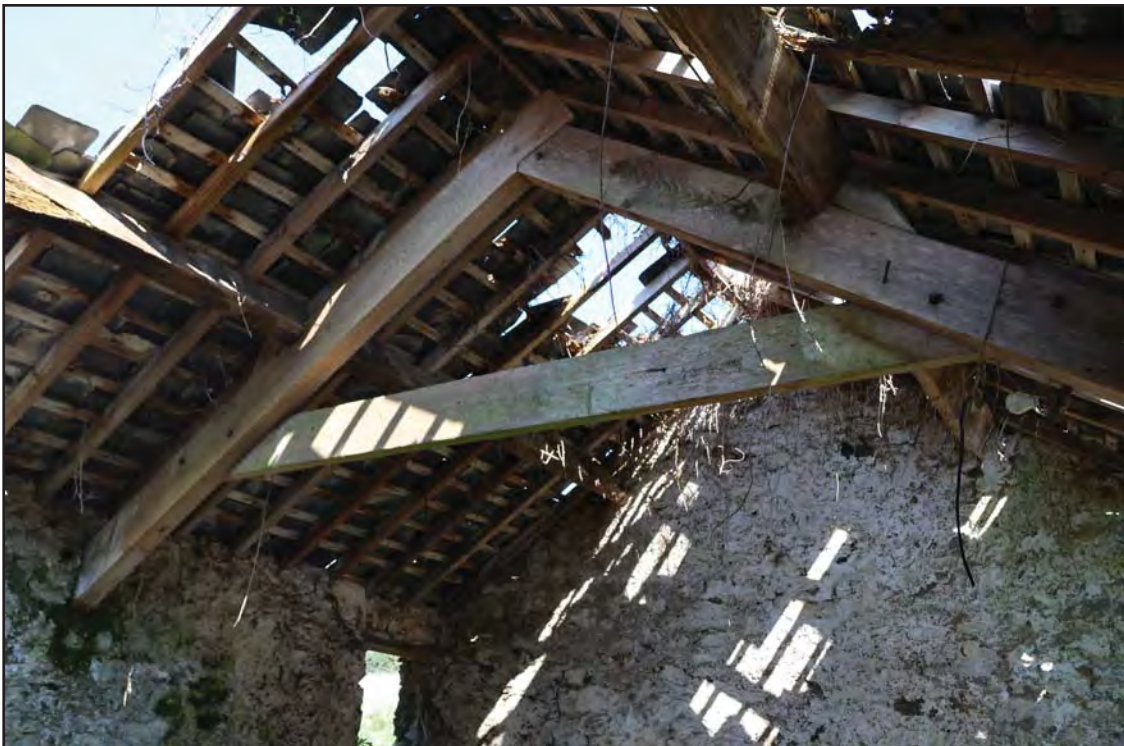
Plate 75: Interior - View of wooden A frame in roof of R5; scale not used; view from SW (archive reference: E49216_91).

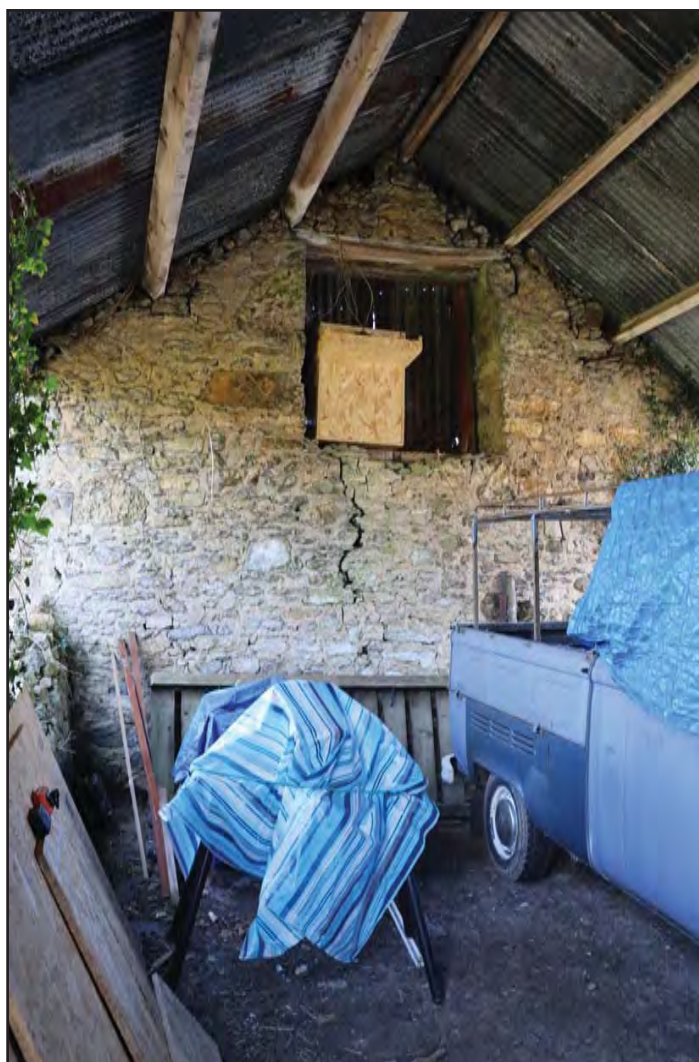
Plate 76: Interior - View of NE wall of OB8 Showing loading window; scale not used; view from SW (archive reference: E49216_92).

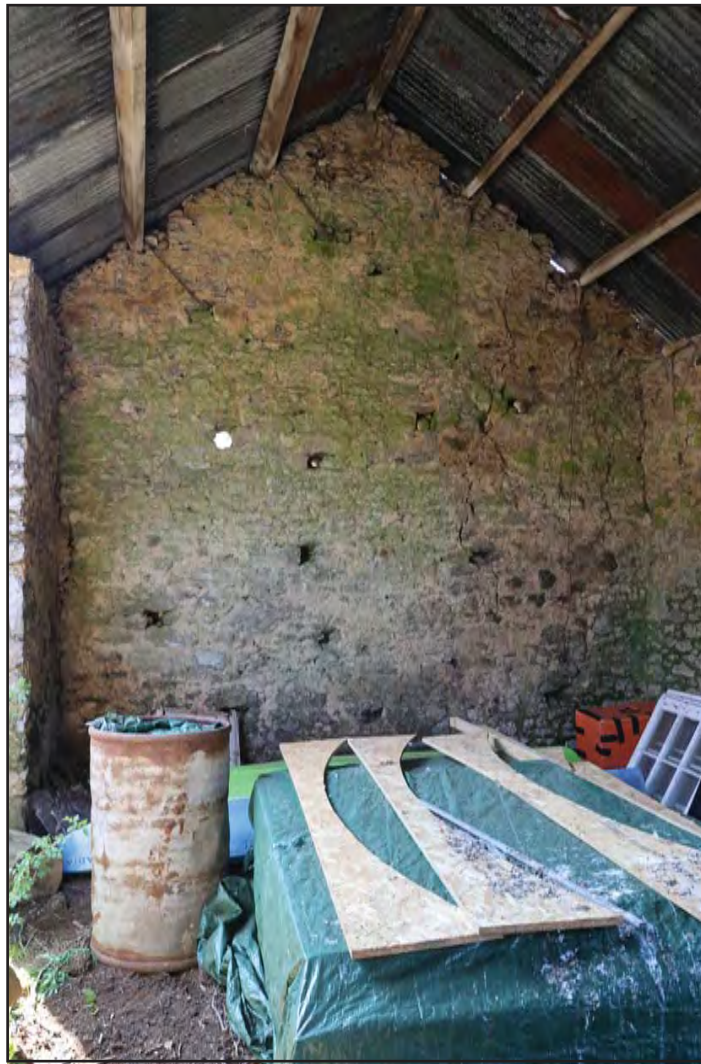
Plate 77: Interior - View of S wall of OB8; scale not used; view from NNE (archive reference: E49216_93).
