Parc, Talwrn, Ynys Môn

Cofnod Adeilad Lefel 2/3 Archaeolegol
Archaeological Level 2/3 Building Record

Rhif Prosiect Heneb Archaeoleg Gwynedd / Heneb Gwynedd Archaeology Project No. HD24-116

Rhif Adroddiad / Report No. 1817

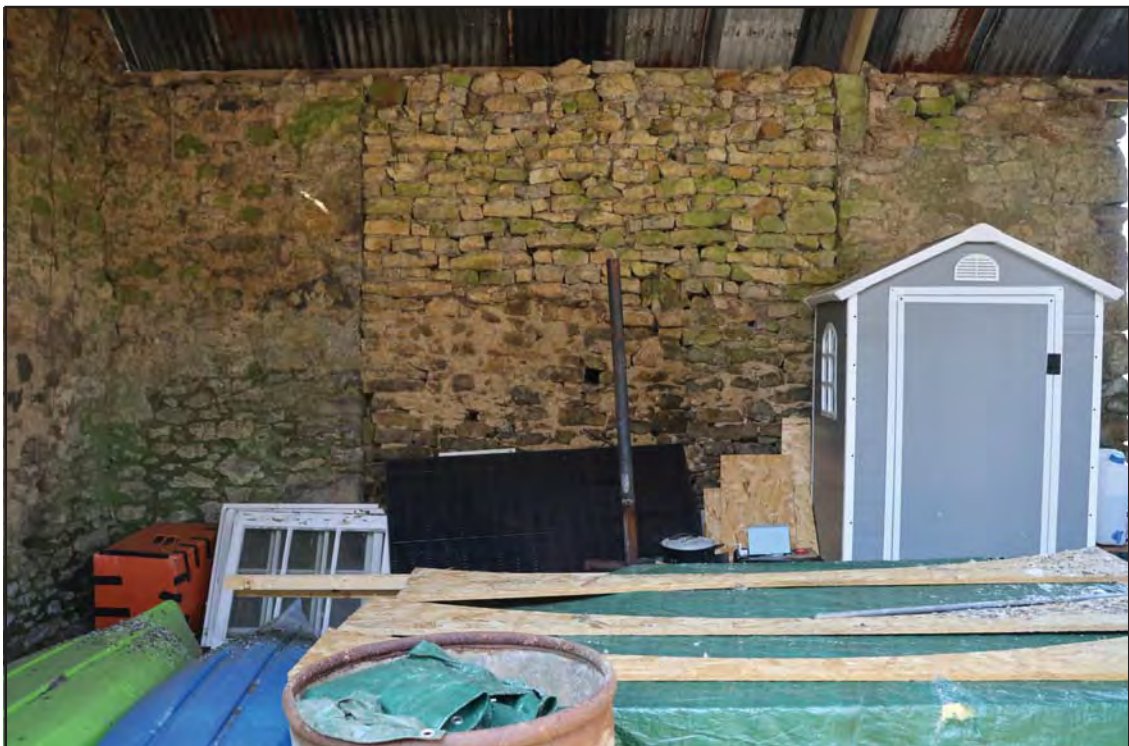
Plate 78: Interior - View showing blocked up opening in NW wall of OB8; scale not used; view from SE (archive reference: E49216_94).

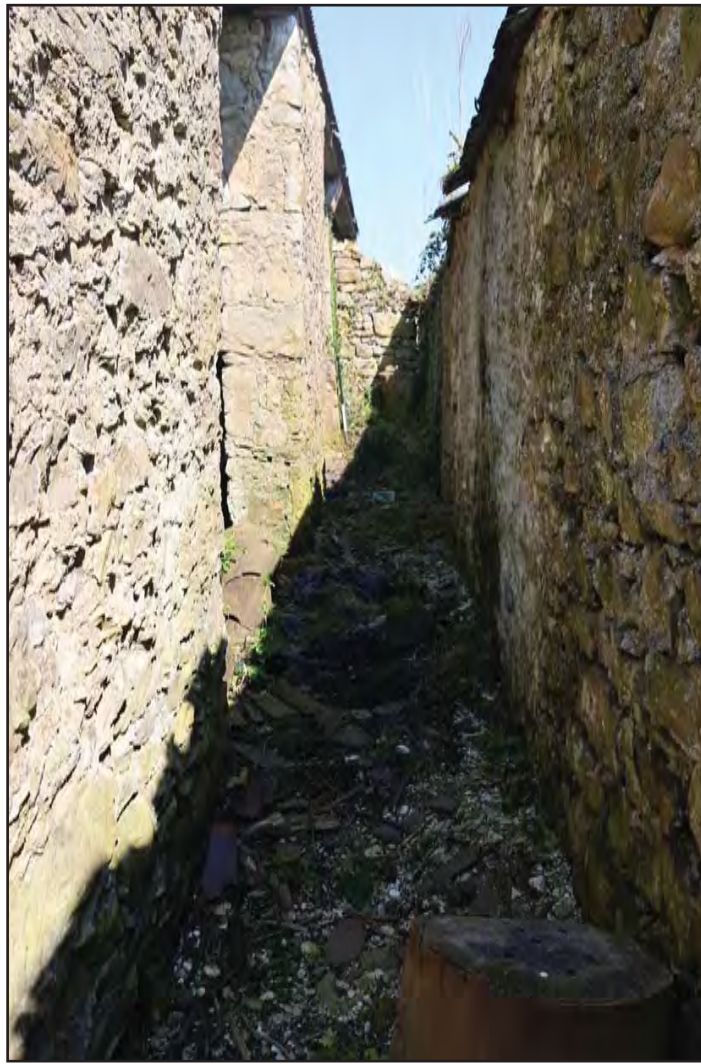
Plate 79: Exterior - View down narrow alley between main house and OB8; scale 1x1m; view from SW (archive reference: E49216_95).

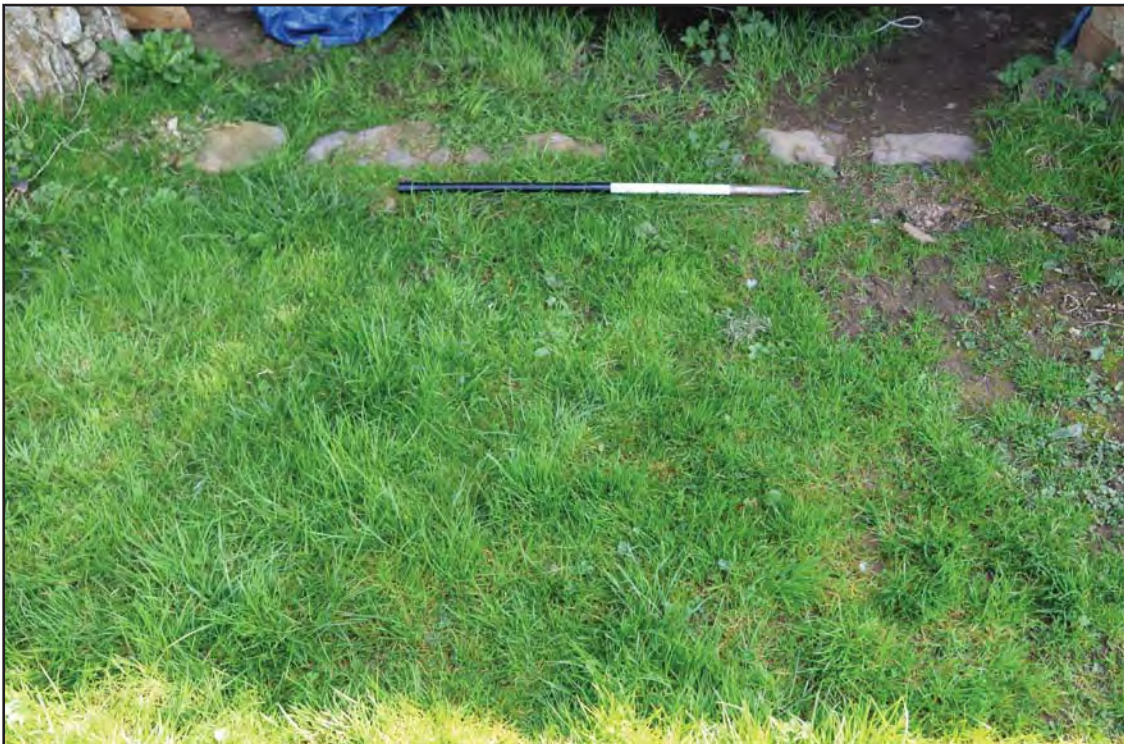
Plate 80: Exterior - Stones across central opening to OB8; scale 1x1m; view from WNW (archive reference: E49216_96).

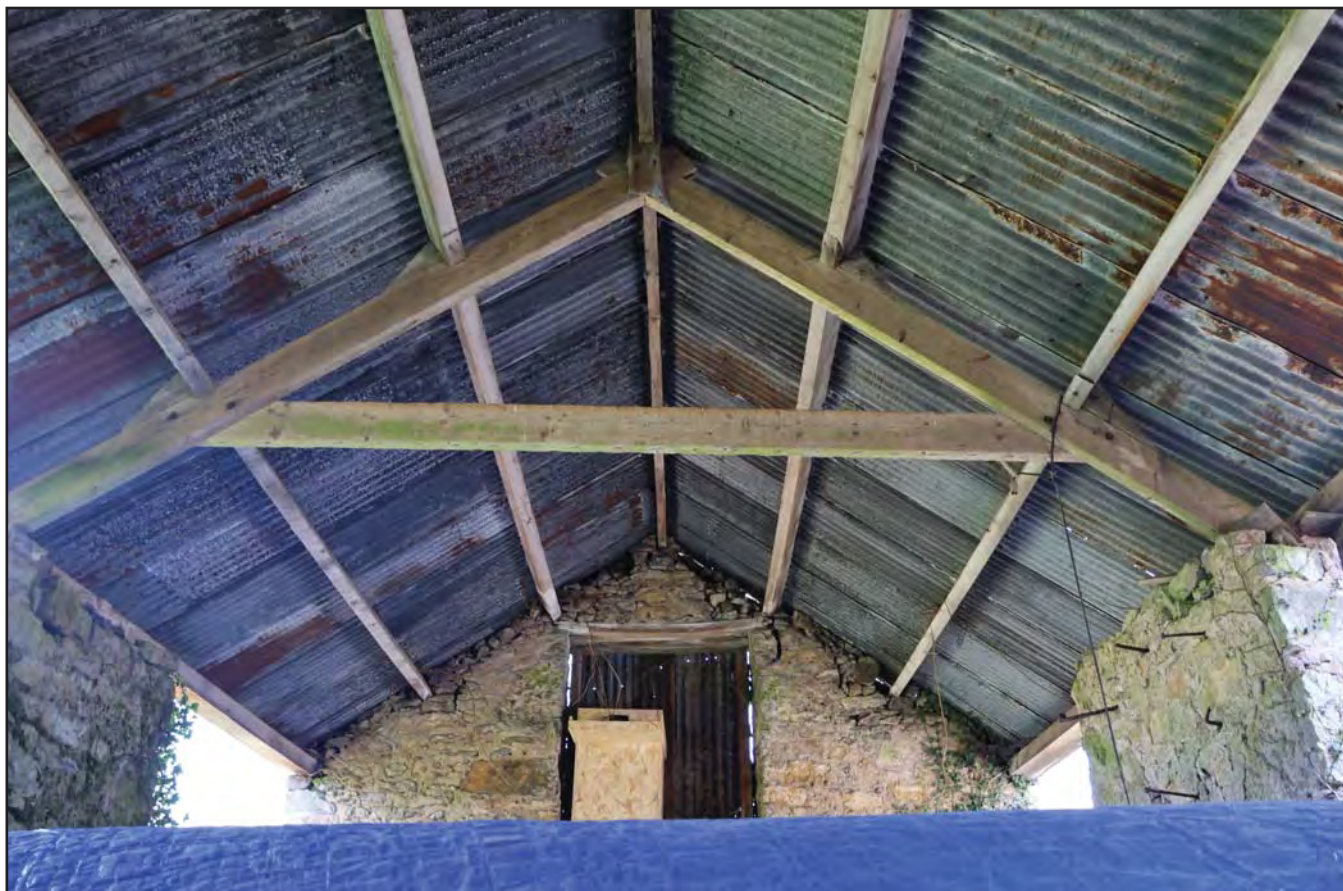
Plate 81: Interior - Roof of OB8; scale not used; view from SW (archive reference: E49216_97).

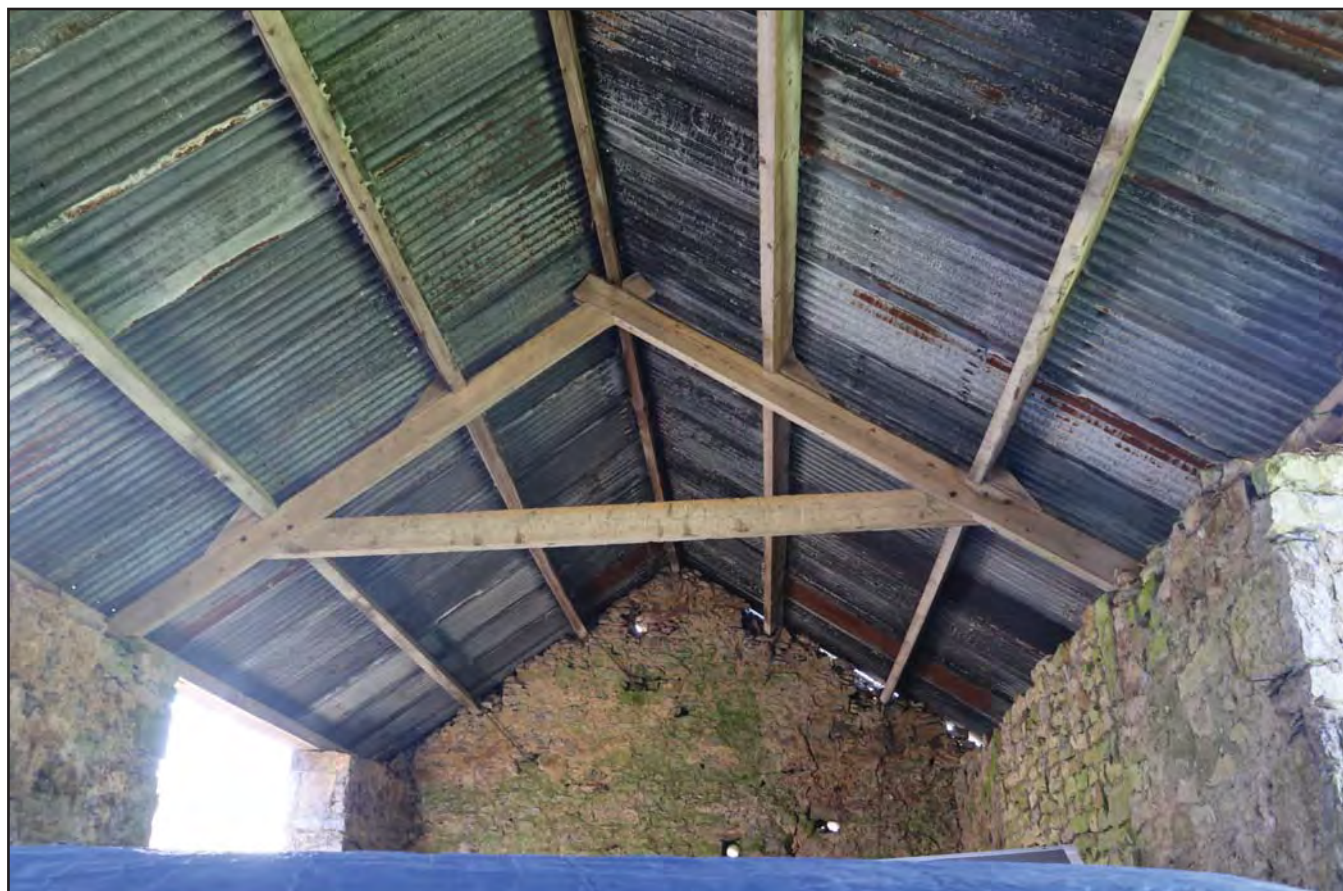
Plate 82: Interior - Roof of OB8; scale not used; view from NE (archive reference: E49216_98).

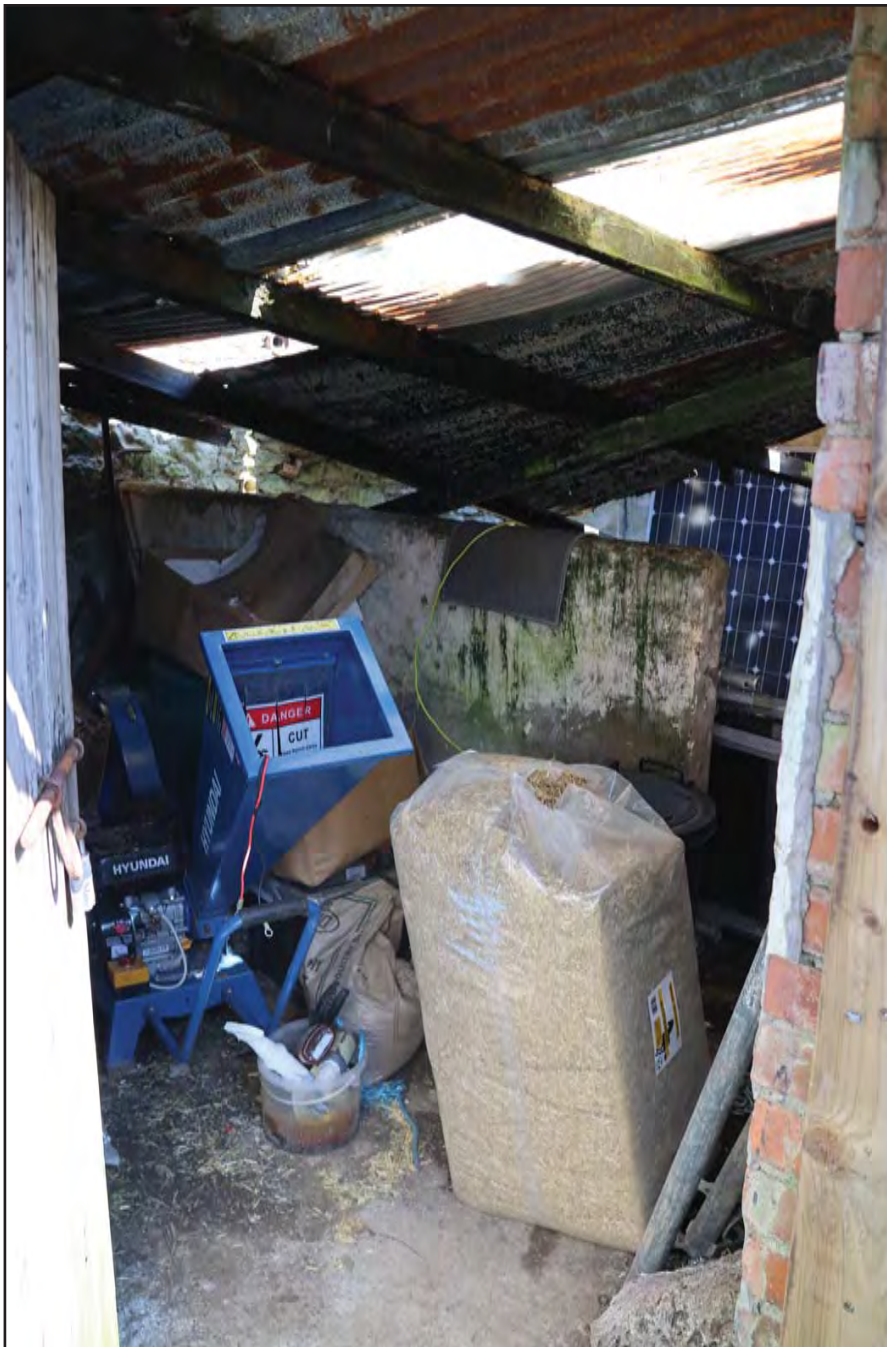
Plate 83: Interior - View through doorway looking into OB7; scale not used; view from SW (archive reference: E49216_99).

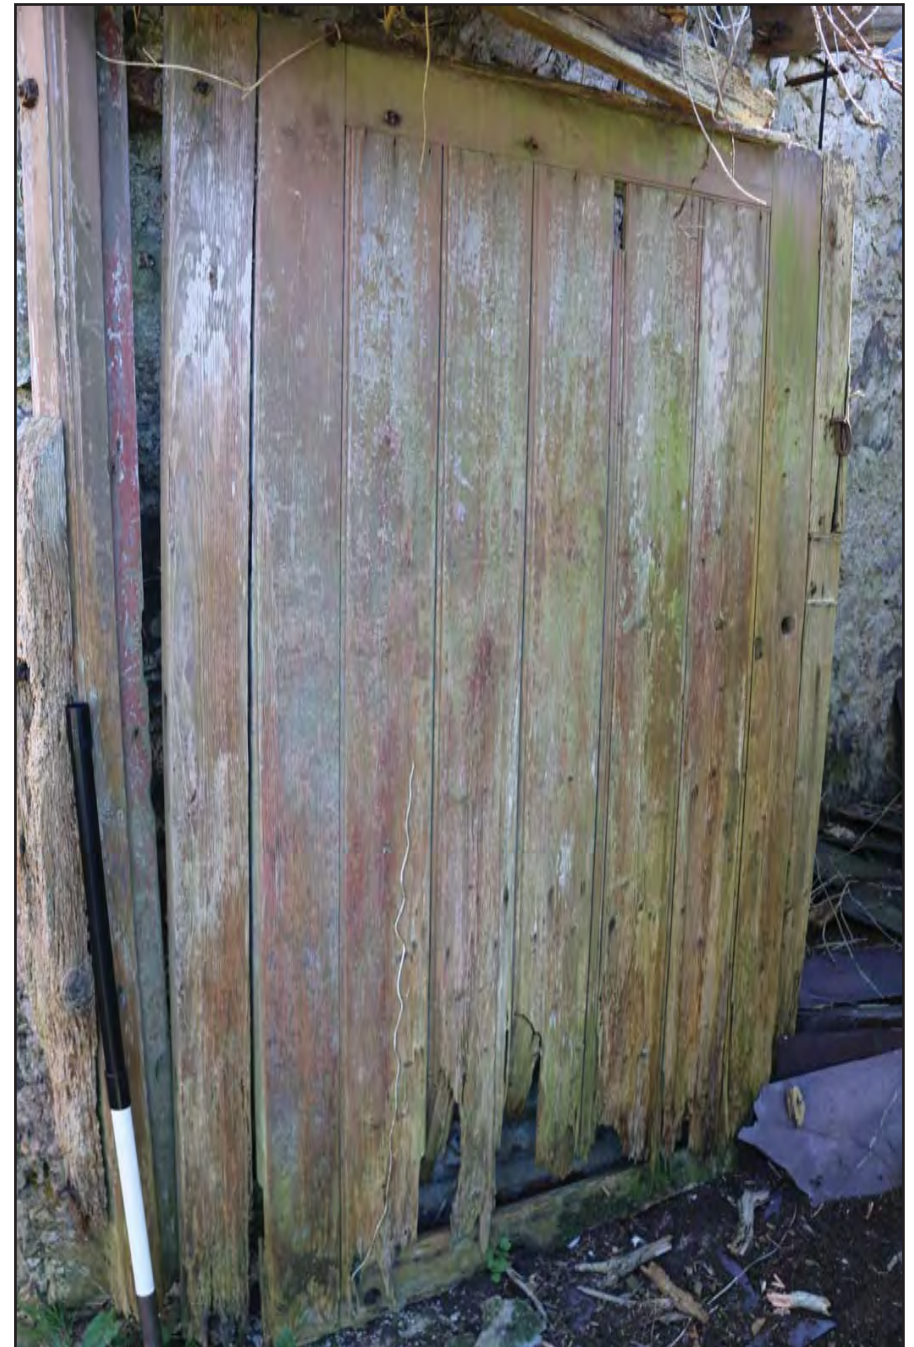
Plate 84: Exterior - View of wooden door of OB6 possible original; scale 1x1m; view from N (archive reference: E49216_100).

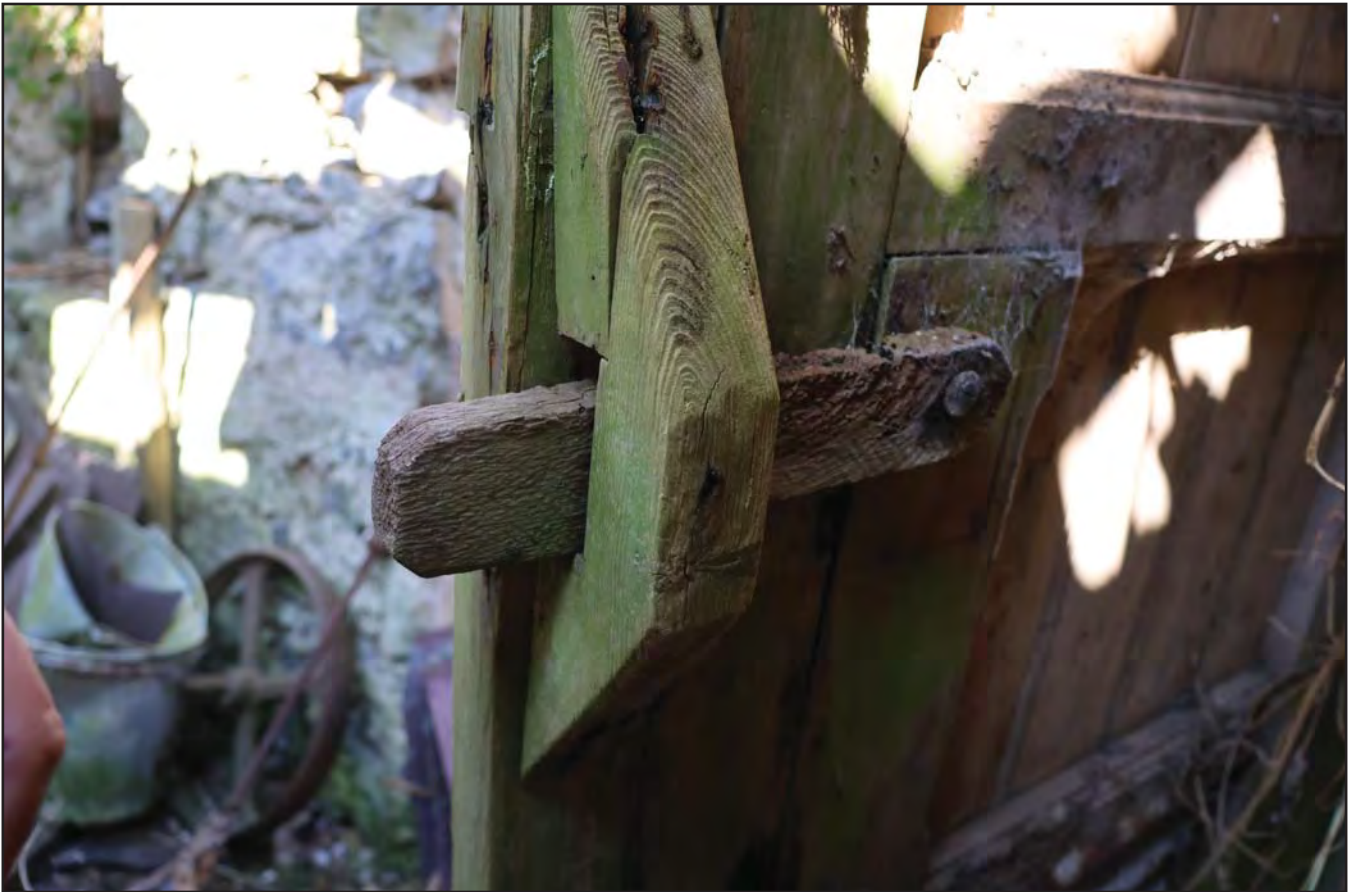
Plate 85: Interior - Wooden latch on back of door of OB6; scale not used; view from SW (archive reference: E49216_101).

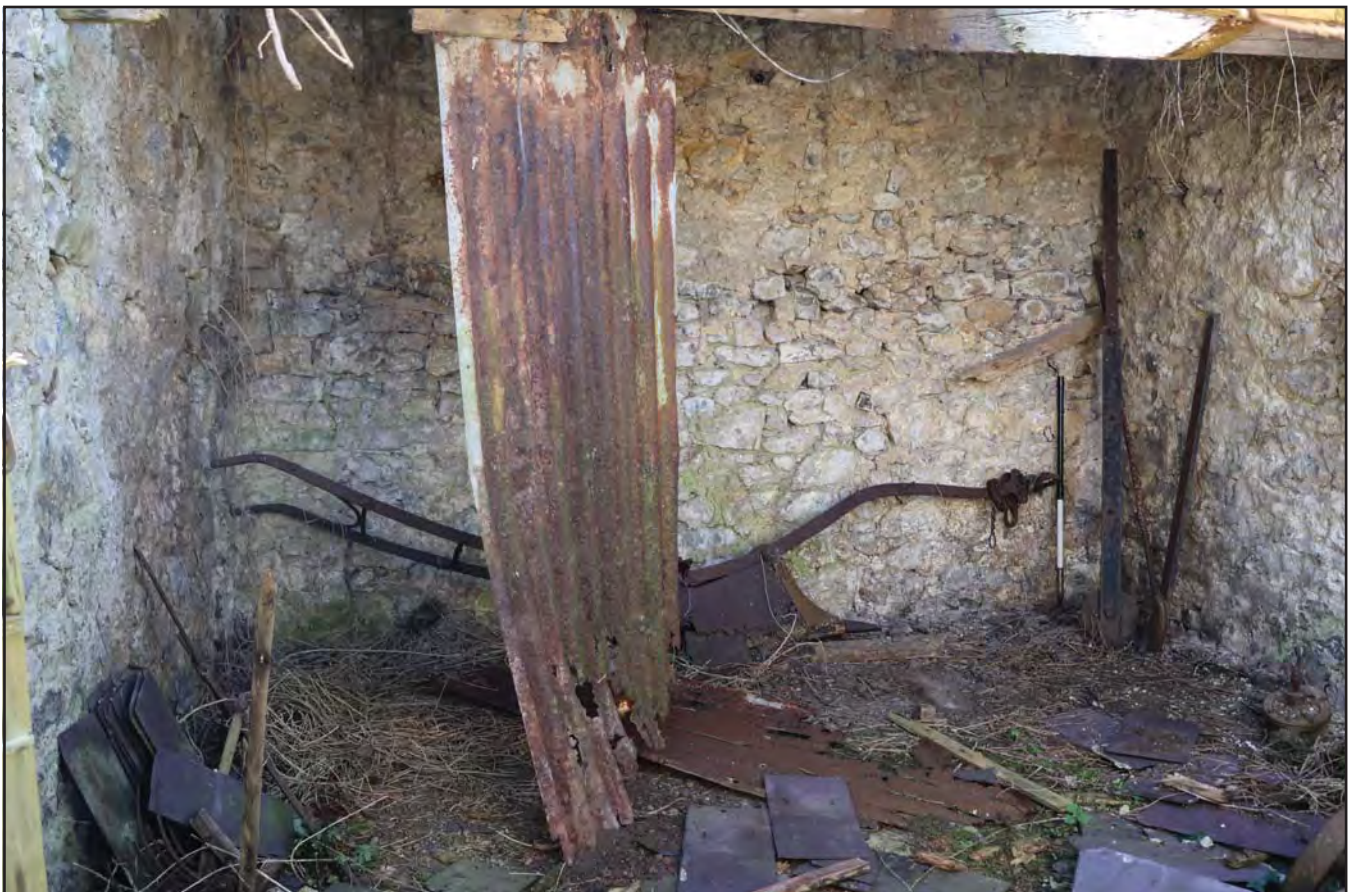
A square storeroom, the walls show evidence of once being limewashed, the roof beams are in poor condition but are probably original with the addition of an old plough that is positioned against the southwest facing elevation wall (Plates 86-92).

Plate 86: Interior - View of SW wall of OB6; scale 1x1m; view from NE (archive reference: E49216_102).

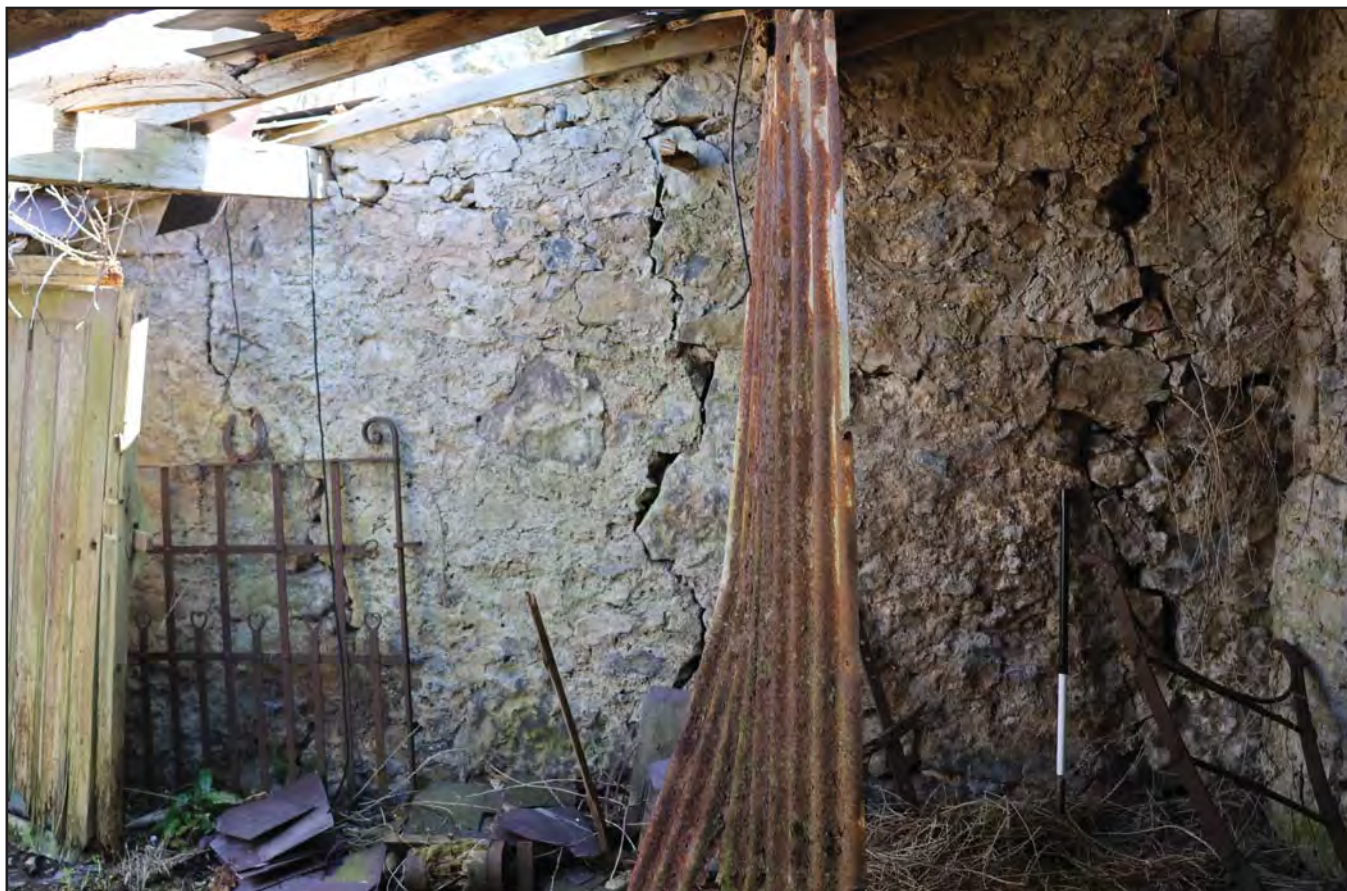
Plate 87: Interior - View of SE wall of OB6; scale 1x1m; view from NW (archive reference: E49216_103).

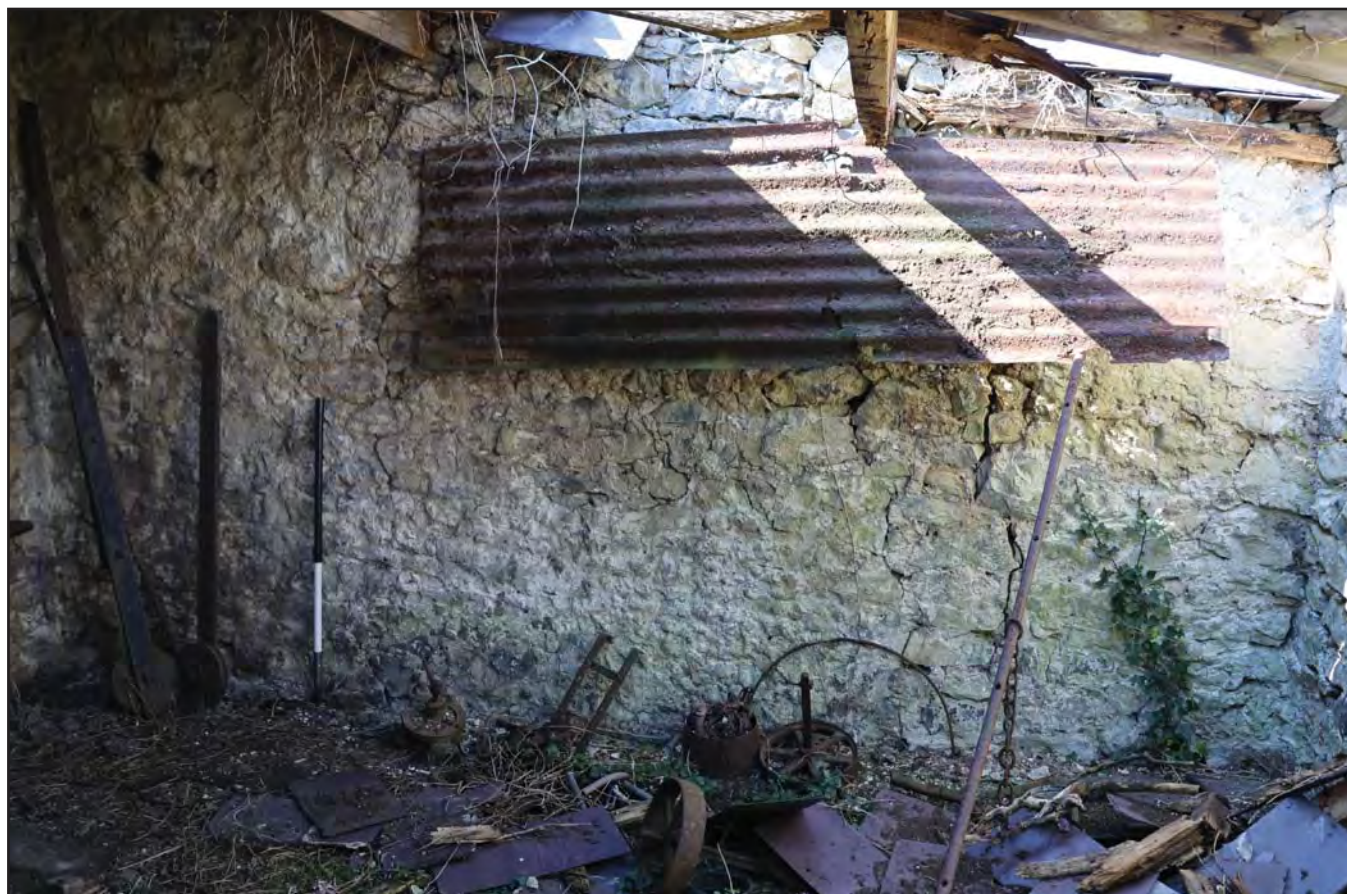
Plate 88: Interior - View of NW wall of OB6; scale 1x1m; view from SE (archive reference: E49216_104).

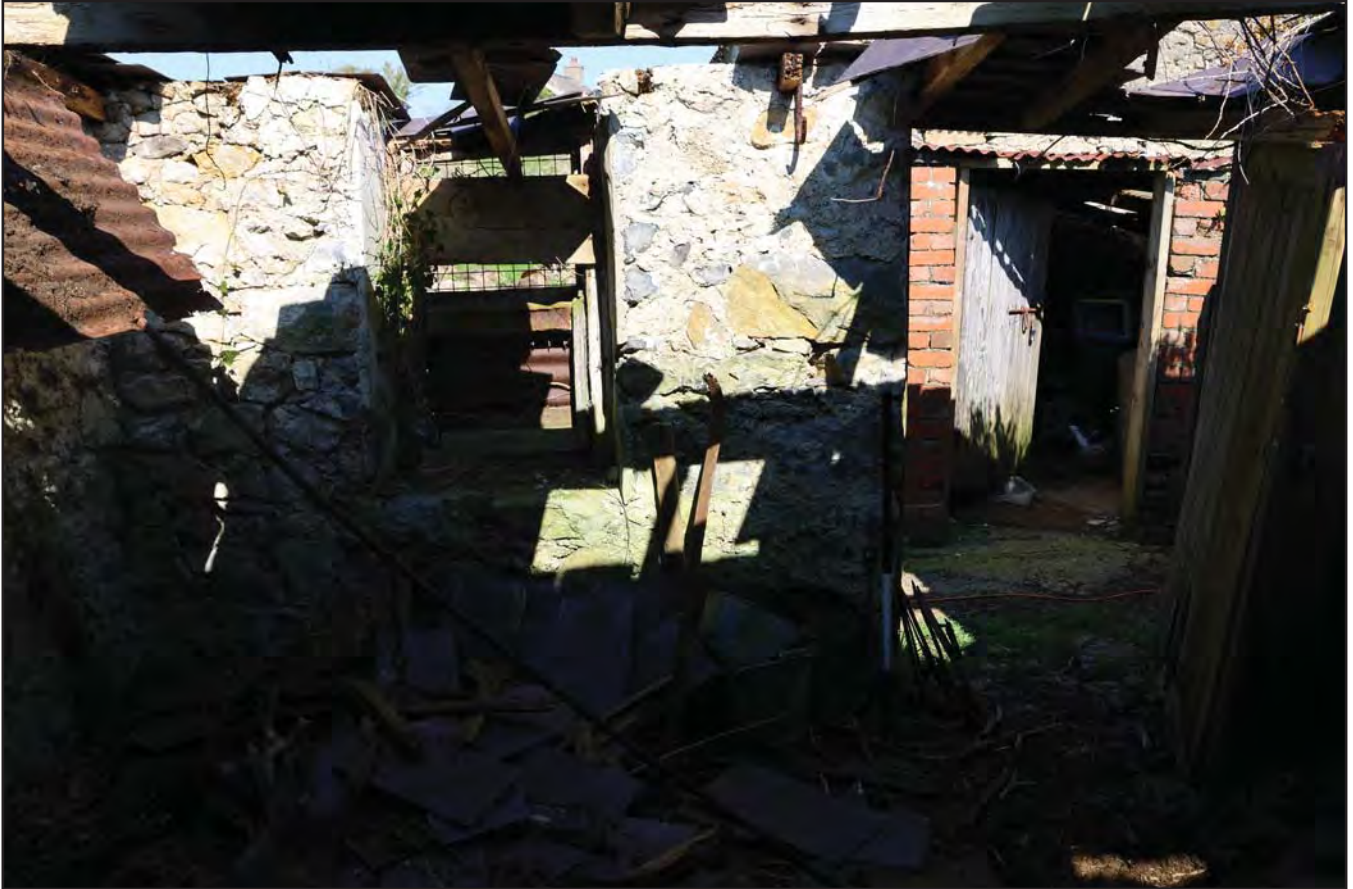
Plate 89: Interior - View of NE wall of OB6 showing window and access door; scale 1x1m; view from SW (archive reference: E49216_105).

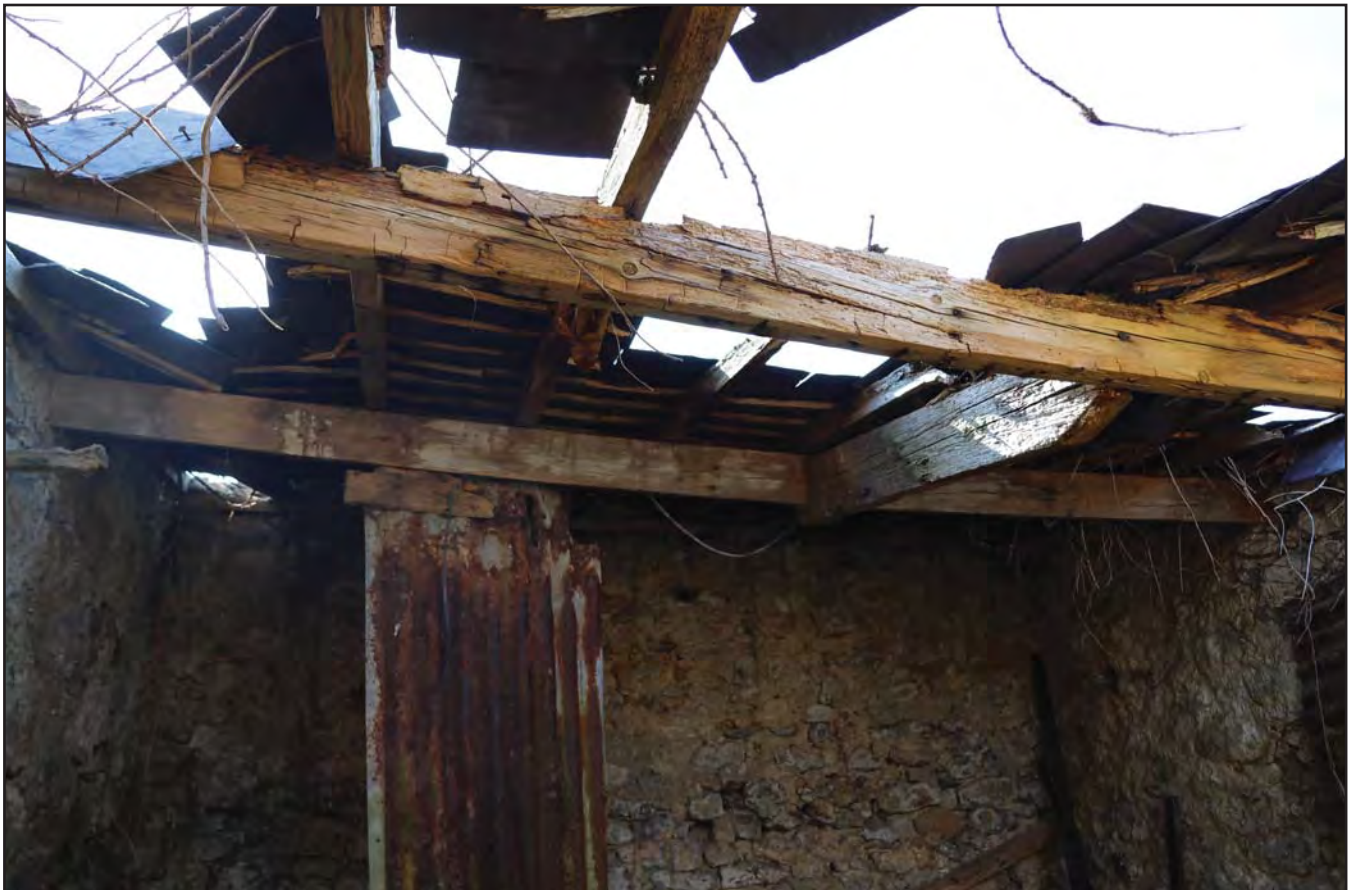
Plate 90: Interior - Roof collapse in OB6; scale not used; view from NE (archive reference: E49216_106).

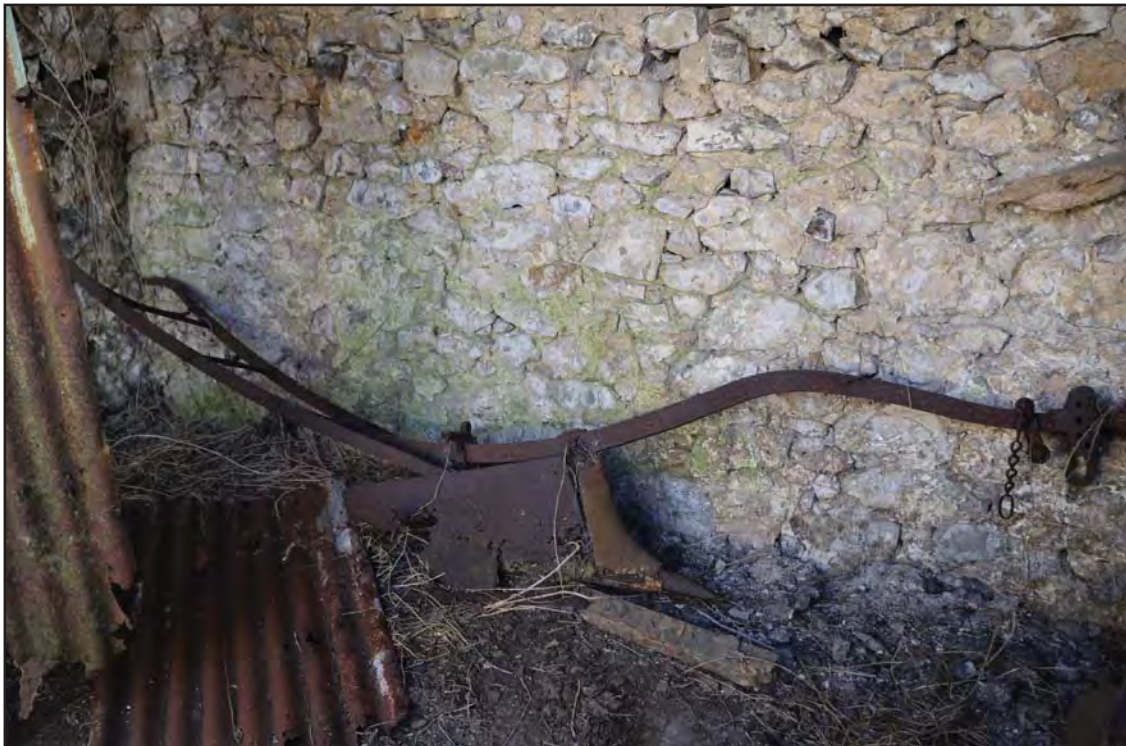
Plate 91: Interior - View of vintage plough in OB6; scale not used; view from N (archive reference: E49216_107).

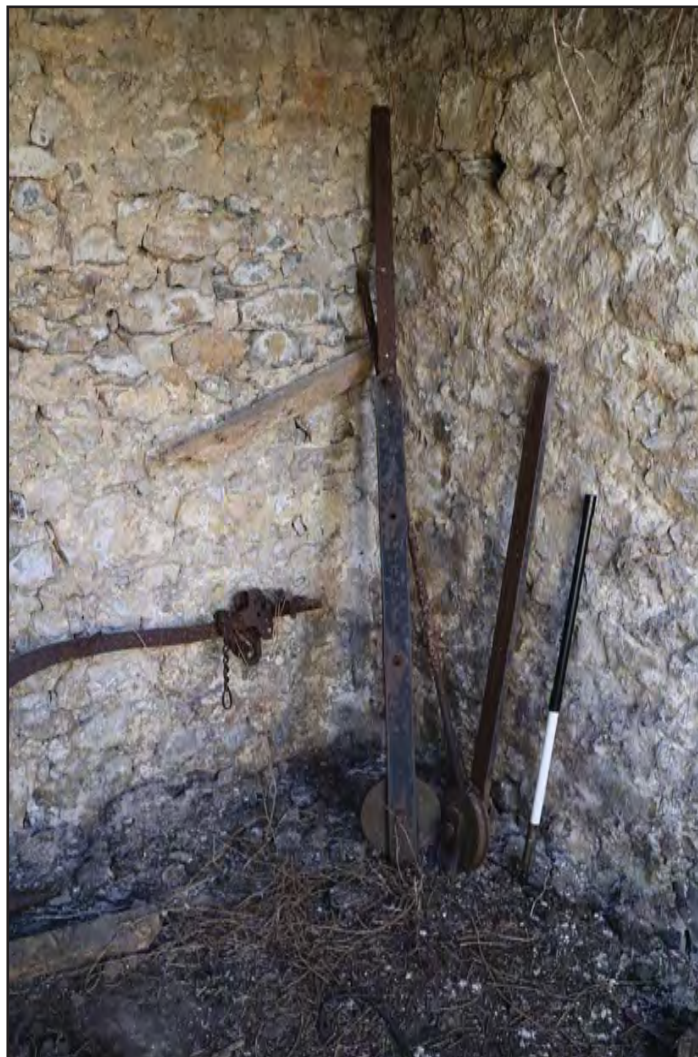
Plate 92: Interior - Pulleys in OB6; scale 1x1m; view from E (archive reference: E49216_108).

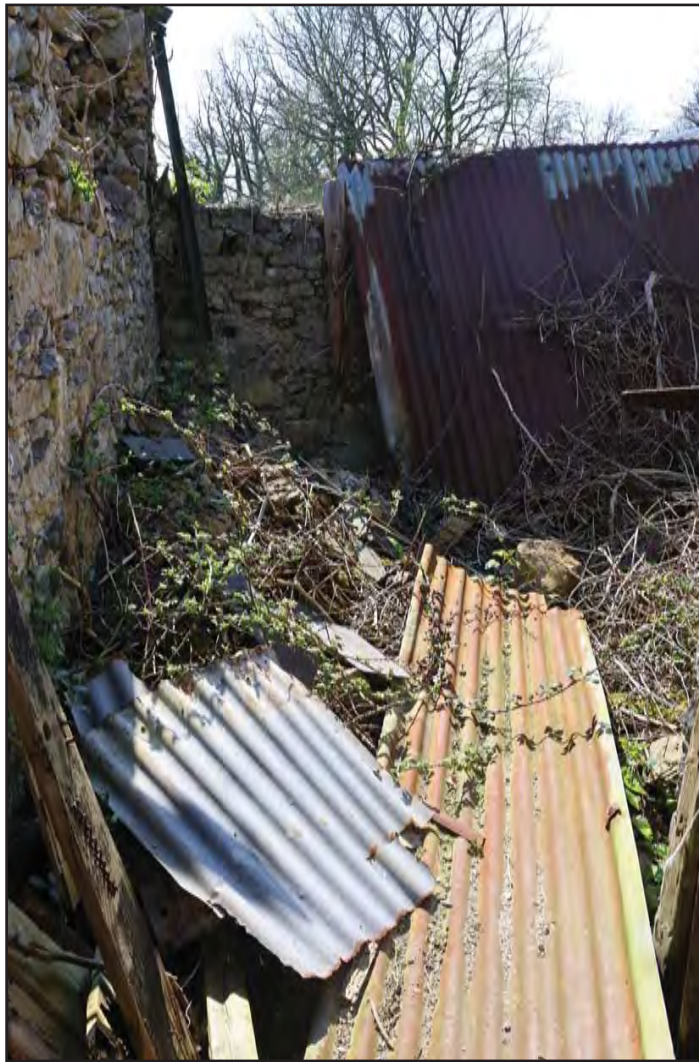
Plate 93: Interior - View inside OB5; scale not used; view from NE (archive reference: E49216_109).

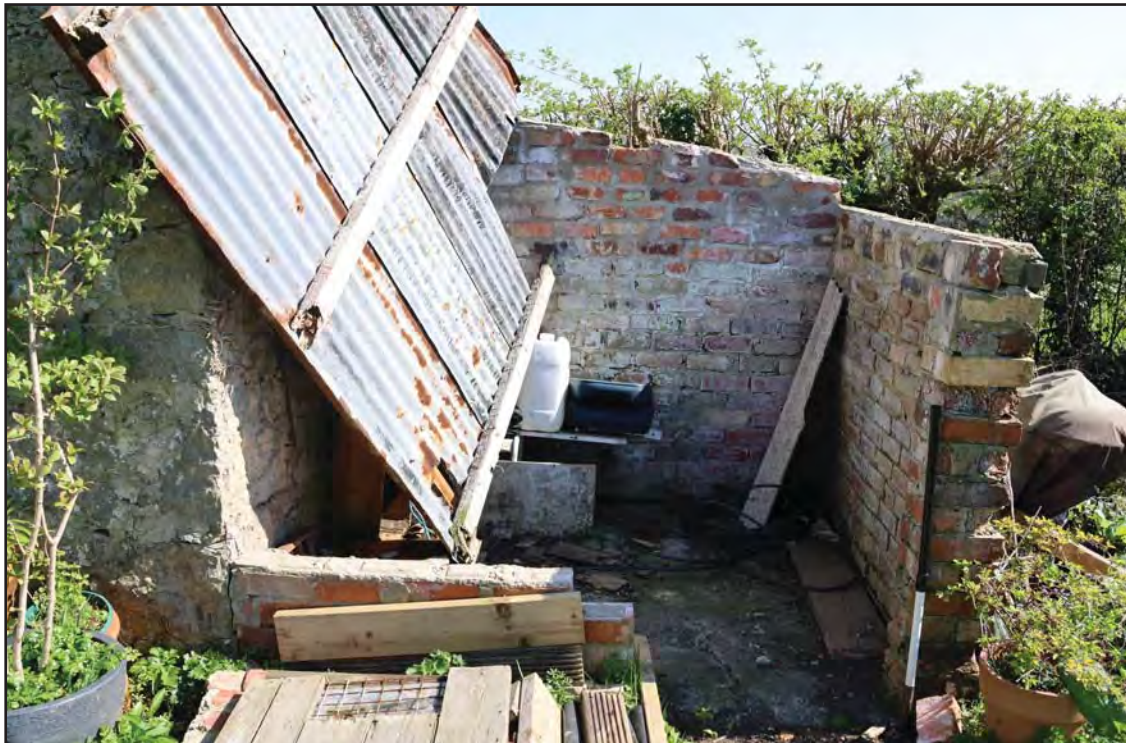
Plate 94: Interior - View of OB4, collapsed roof and wall; scale 1x1m; view from NW (archive reference: E49216_111).

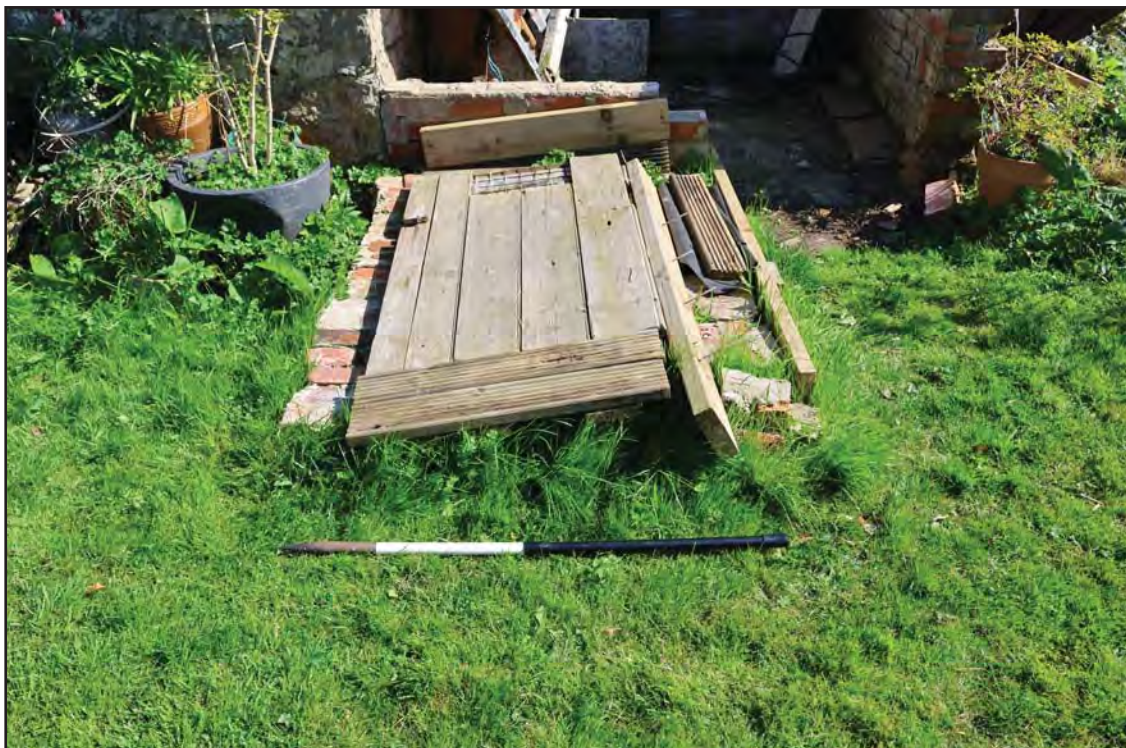
Plate 95: Interior - Collapsed wall of OB4 View through doorway looking into OB3; scale 1x1 m; view from NW (archive reference: E49216_112).

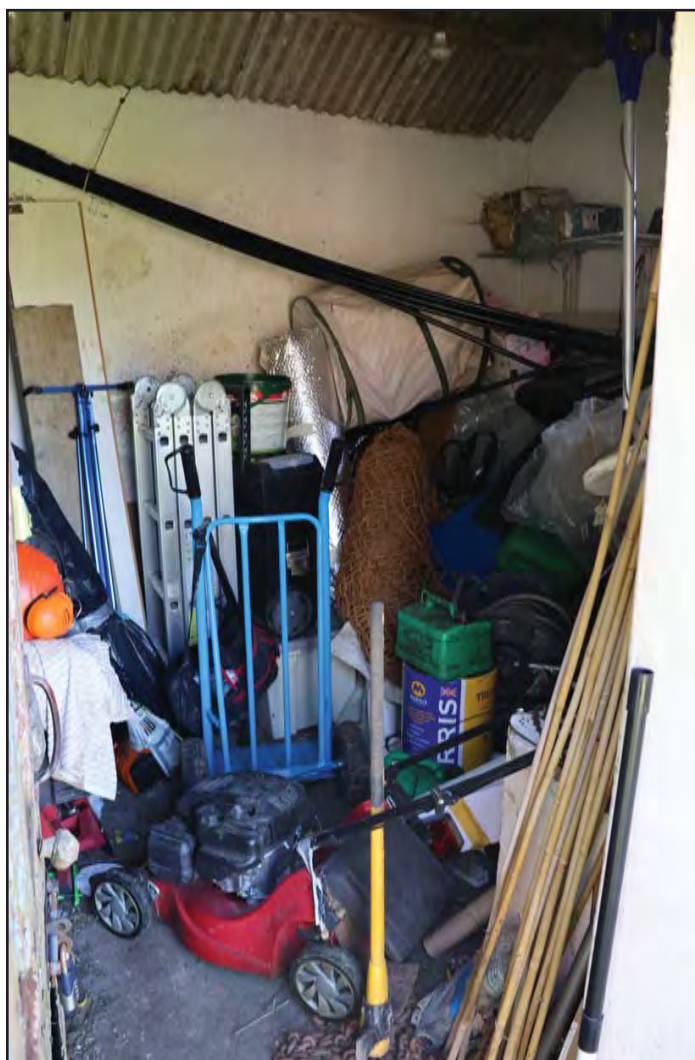
The interior walls are limewashed and the building is currently being used as a storeroom (Plates 96 and 97). The roof is constructed with corrugated fibre cement / asbestos sheeting resting onto two sets of purlins, located on each side of the eaves. The floor is made up of concrete (Plate 98).

Plate 96: Interior - View through doorway looking into OB3; scale not used; view from NE (archive reference: E49216_113).

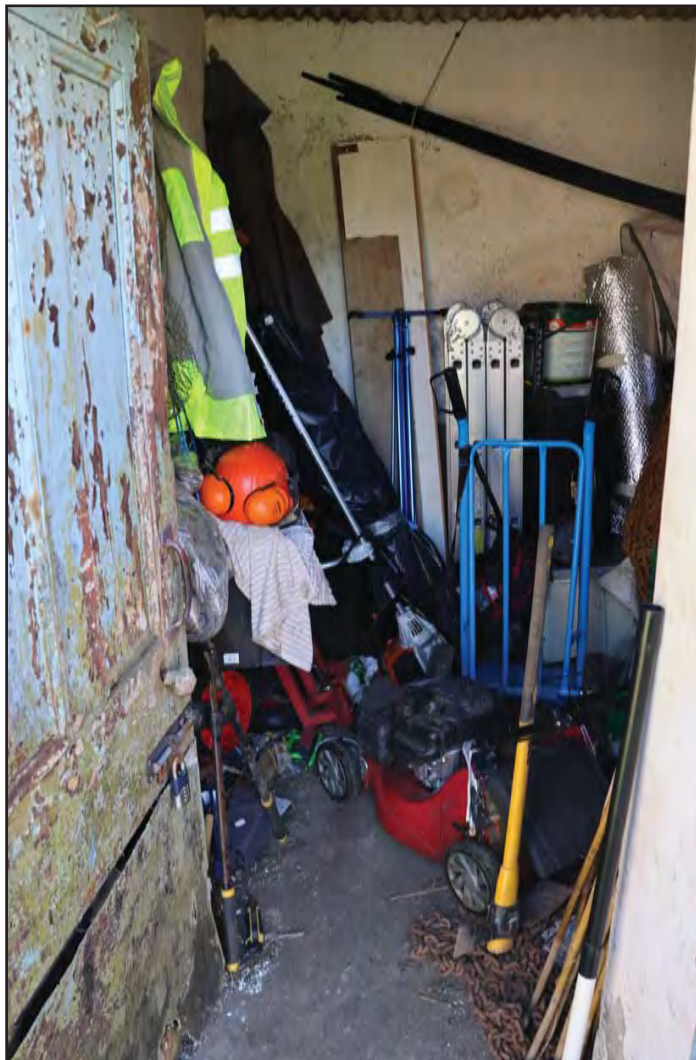
Plate 97: Interior - View through doorway looking into OB3; scale not used; view from NE (archive reference: E49216_114).

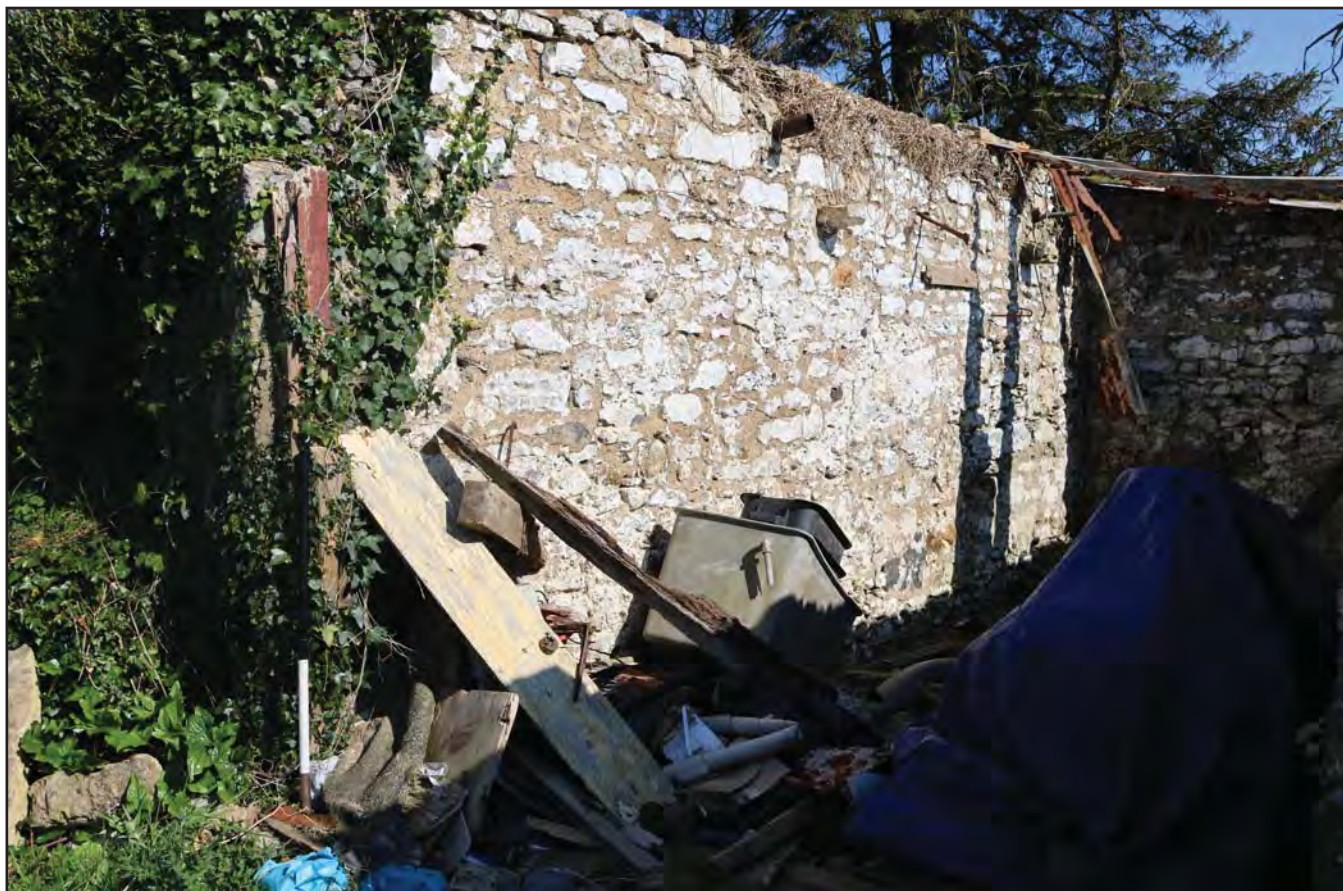
Positioned on the northwest wall, two stones which jut out (Plate 100) these are likely to support a possible former roof structure or partitions. In addition, metal fixings could also be seen attached to the wall (Plate 99 and 100). Furthermore, additional metal fixtures are present on the adjacent southwest wall (Plate 101 and 102). The walls have not been rendered

Plate 99: Interior - View of NE wall of OB1; scale 1x1m; view from W (archive reference: E49216_116).
