Parc, Talwrn, Ynys Môn

Cofnod Adeilad Lefel 2/3 Archaeolegol
Archaeological Level 2/3 Building Record

Rhif Prosiect Heneb Archaeoleg Gwynedd / Heneb Gwynedd Archaeology Project No. HD24-116

Rhif Adroddiad / Report No. 1817

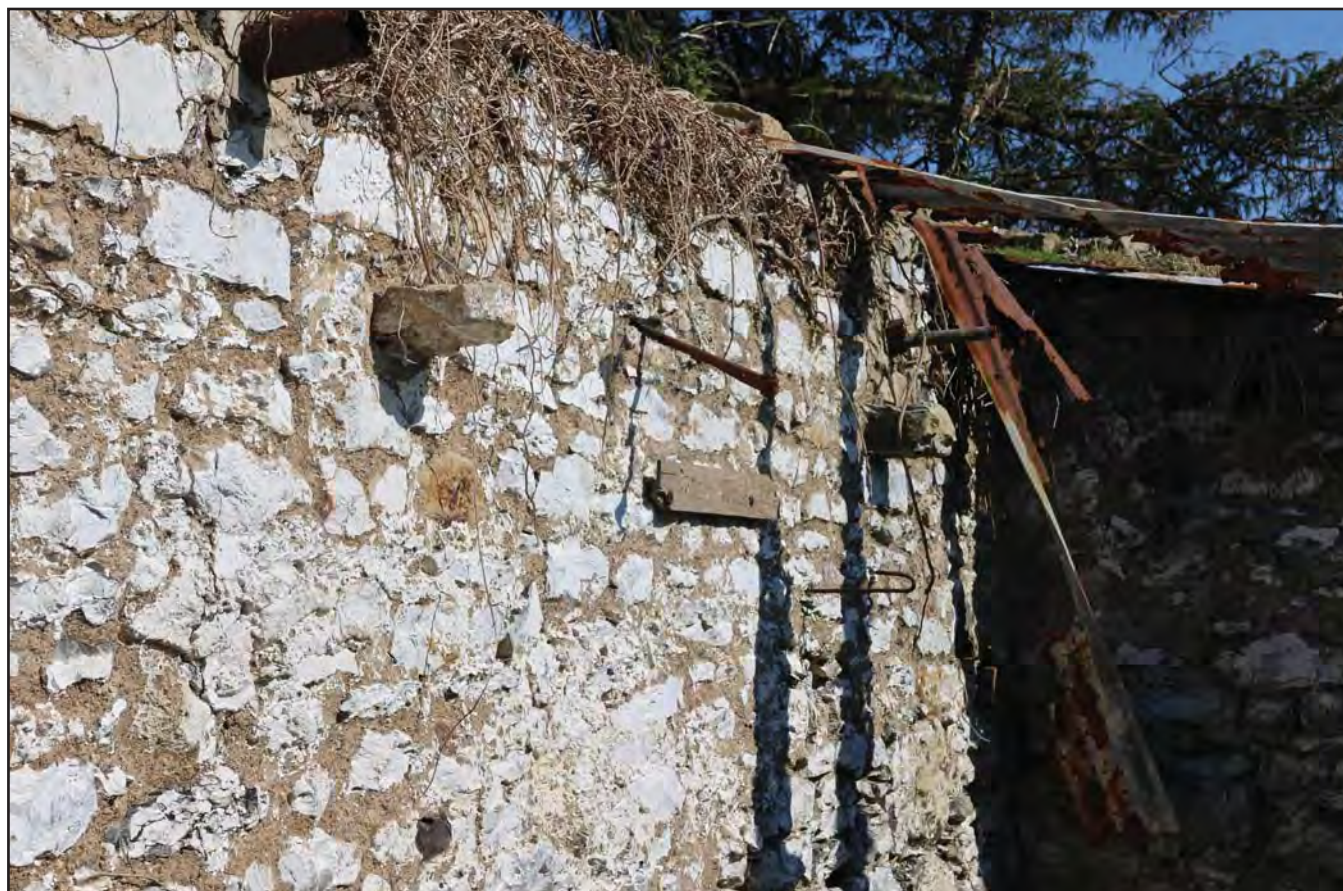
Positioned on the northwest wall, two stones which jut out (Plate 100) these are likely to support a possible former roof structure or partitions. In addition, metal fixings could also be seen attached to the wall (Plate 99 and 100). Furthermore, additional metal fixtures are present on the adjacent southwest wall (Plate 101 and 102). The walls have not been rendered

Plate 100: Interior - View of metal fittings and two stones jutting out of the NE wall of OB1; scale not used; view from W (archive reference: E49216_117).

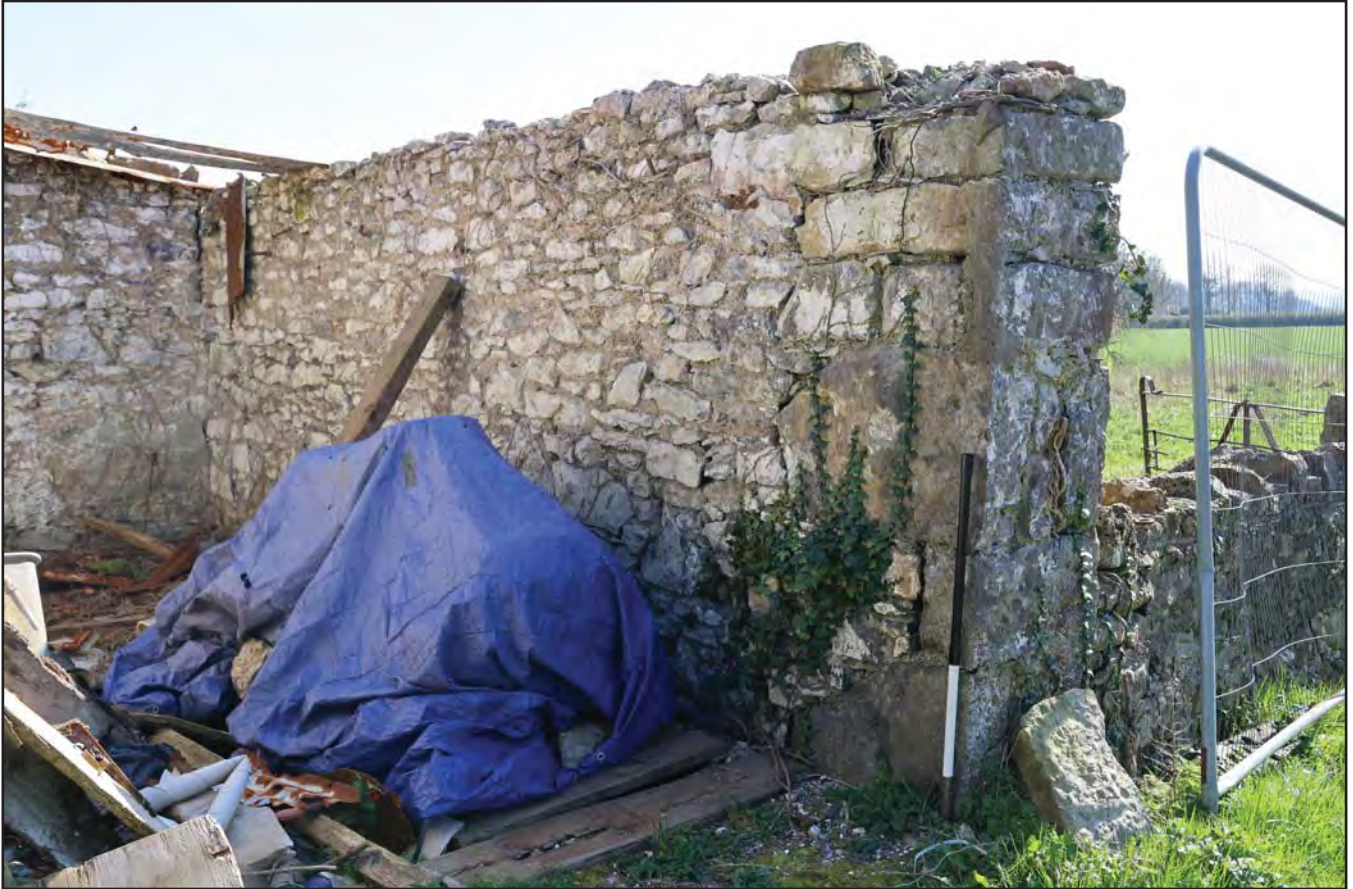
Plate 101: Interior - View of S wall of OB1; scale 1x1m; view from N (archive reference: E49216_118).

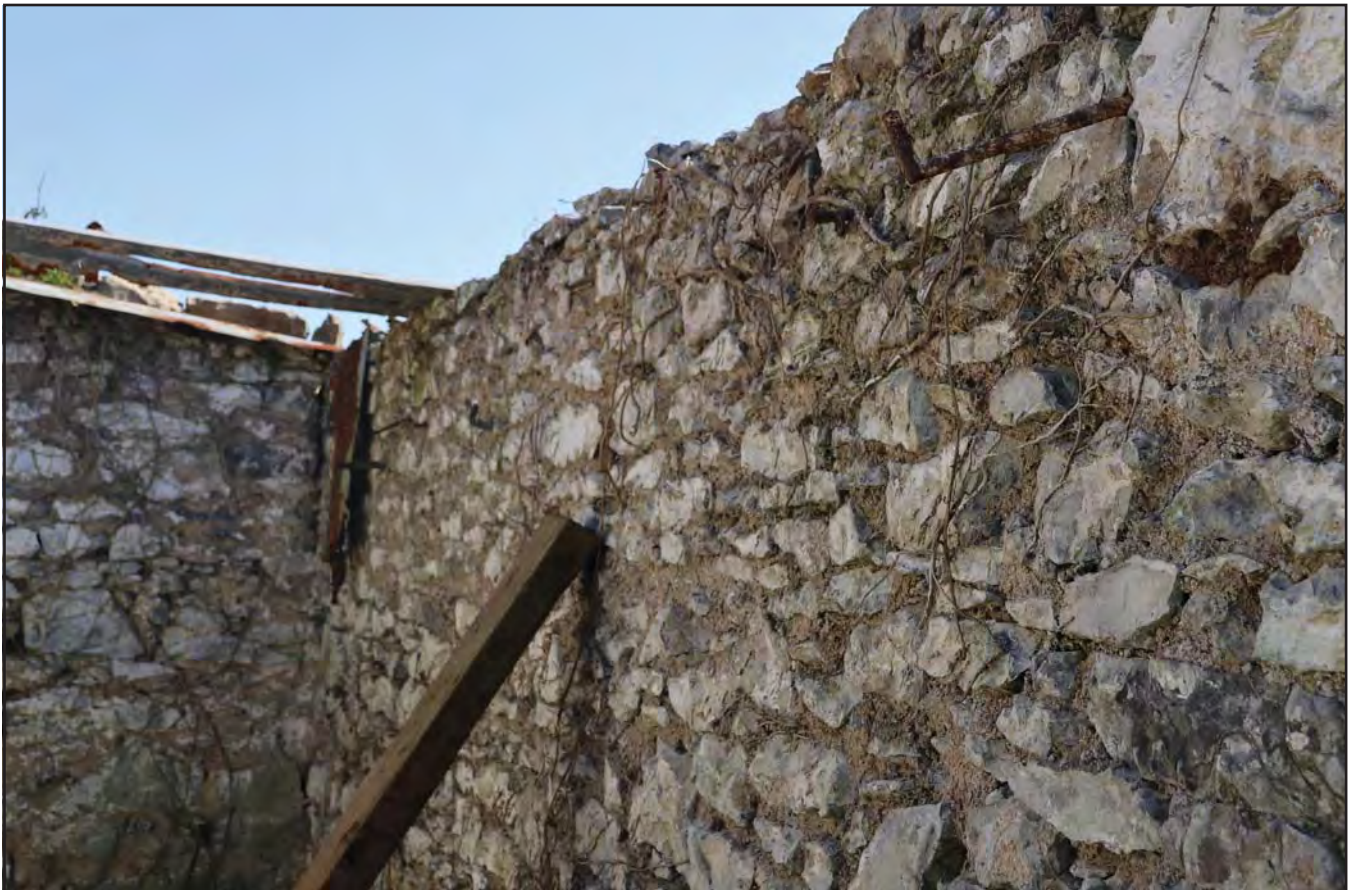
Plate 102: Interior - View of metal fittings on S wall of OB1; scale not used; view from N (archive reference: E49216_119).

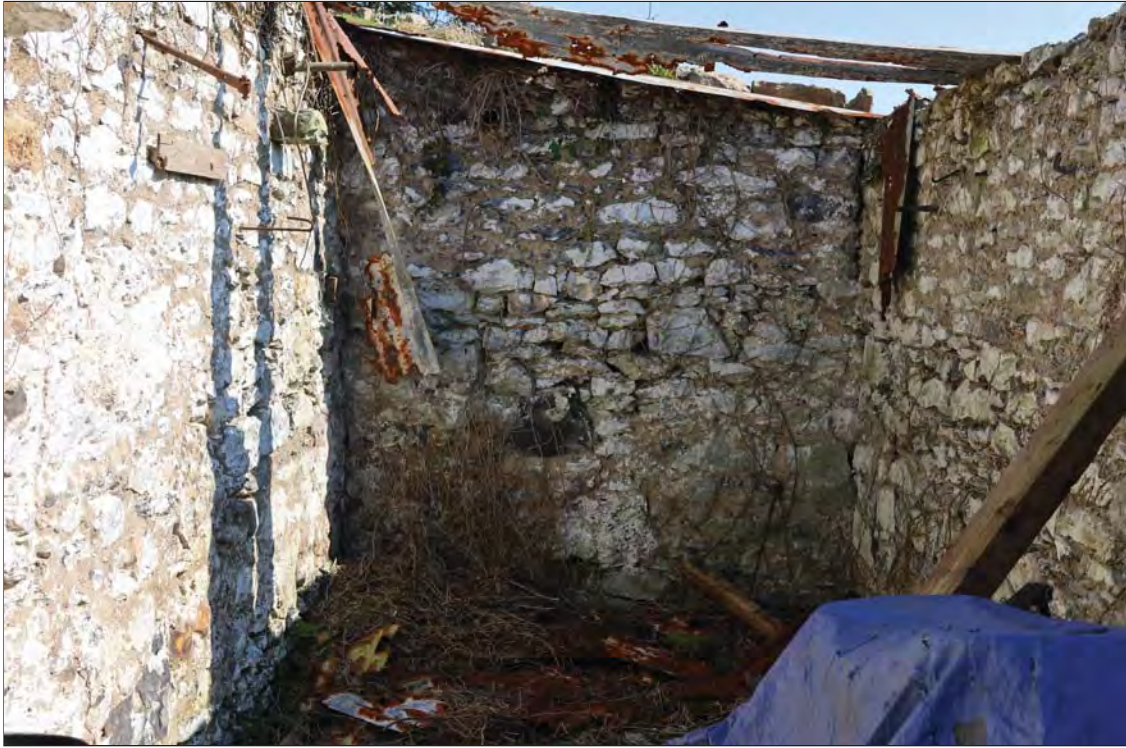
This room is long and narrow and is marked on the plans as a former Dairy, however the outbuilding was likely for other purposes, as the interior of the room is far too narrow for milking (Plate 103). The roof consisted of corrugated sheets which was likely a modern replacement for slates. The roof is no longer extant and according to the owner was damaged in a recent storm.

Plate 103: Interior - View of SE wall of OB1; scale not used; view from NW (archive reference: E49216_120).

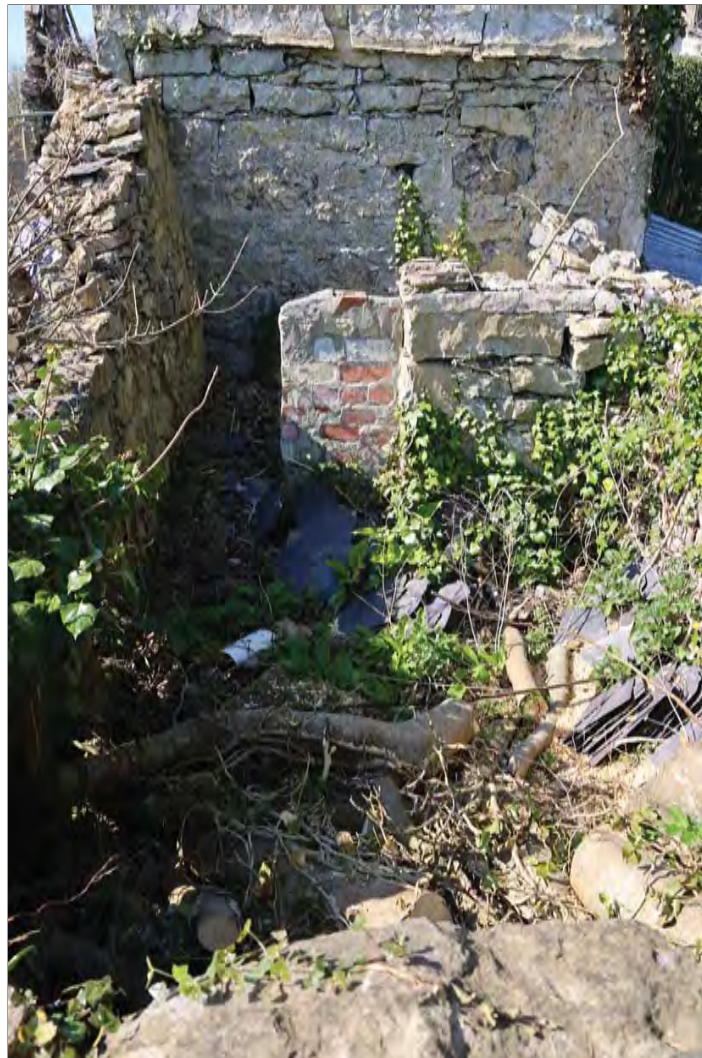
Plate 104: Interior - Interior view of OB2; scale not used; view from SE (archive reference: E49216_121).

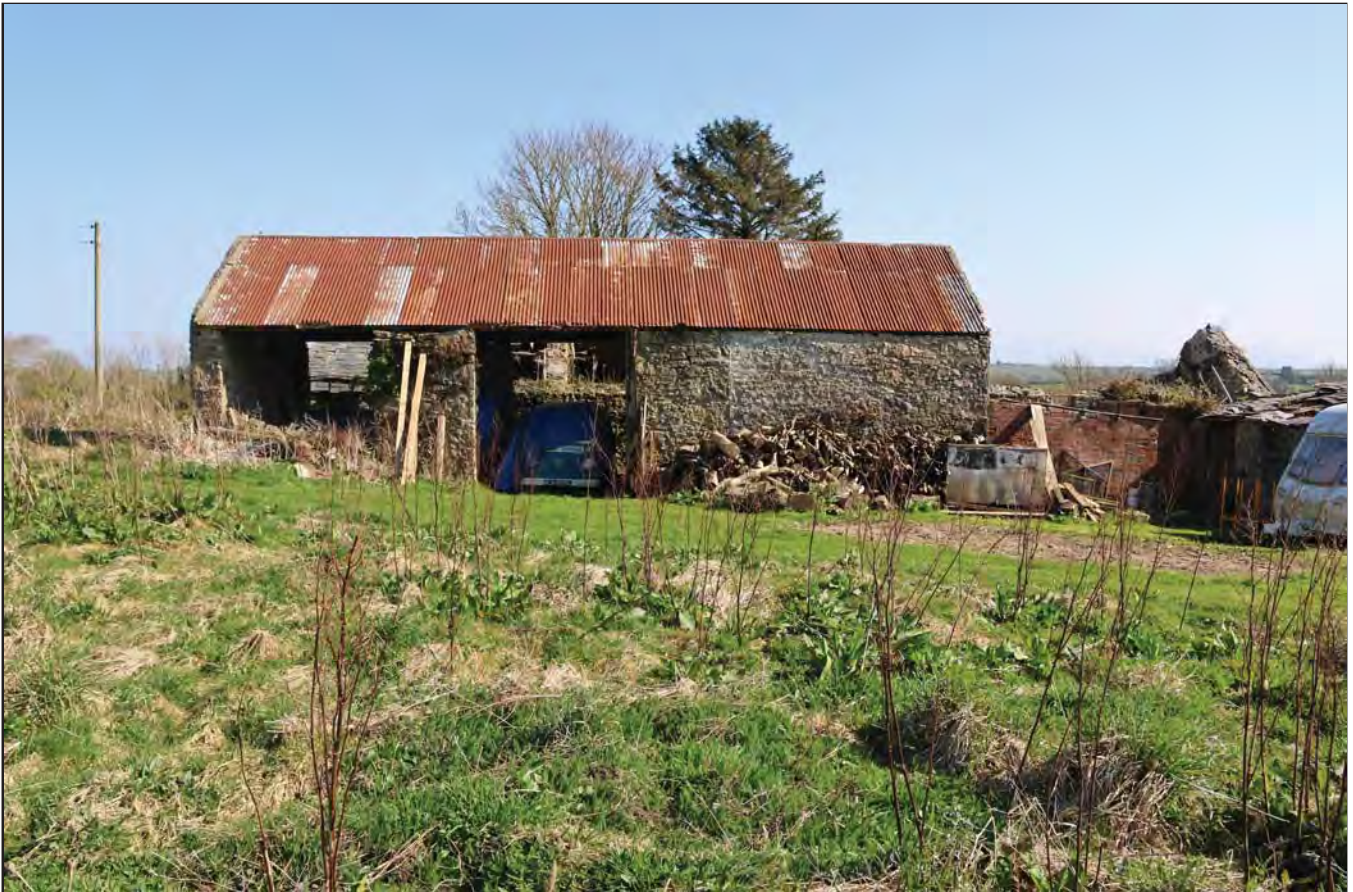
Plate 105: Exterior - Location shot showing NW facing elevation of Parc; scale not used; view from NW (archive reference: E49216_122).

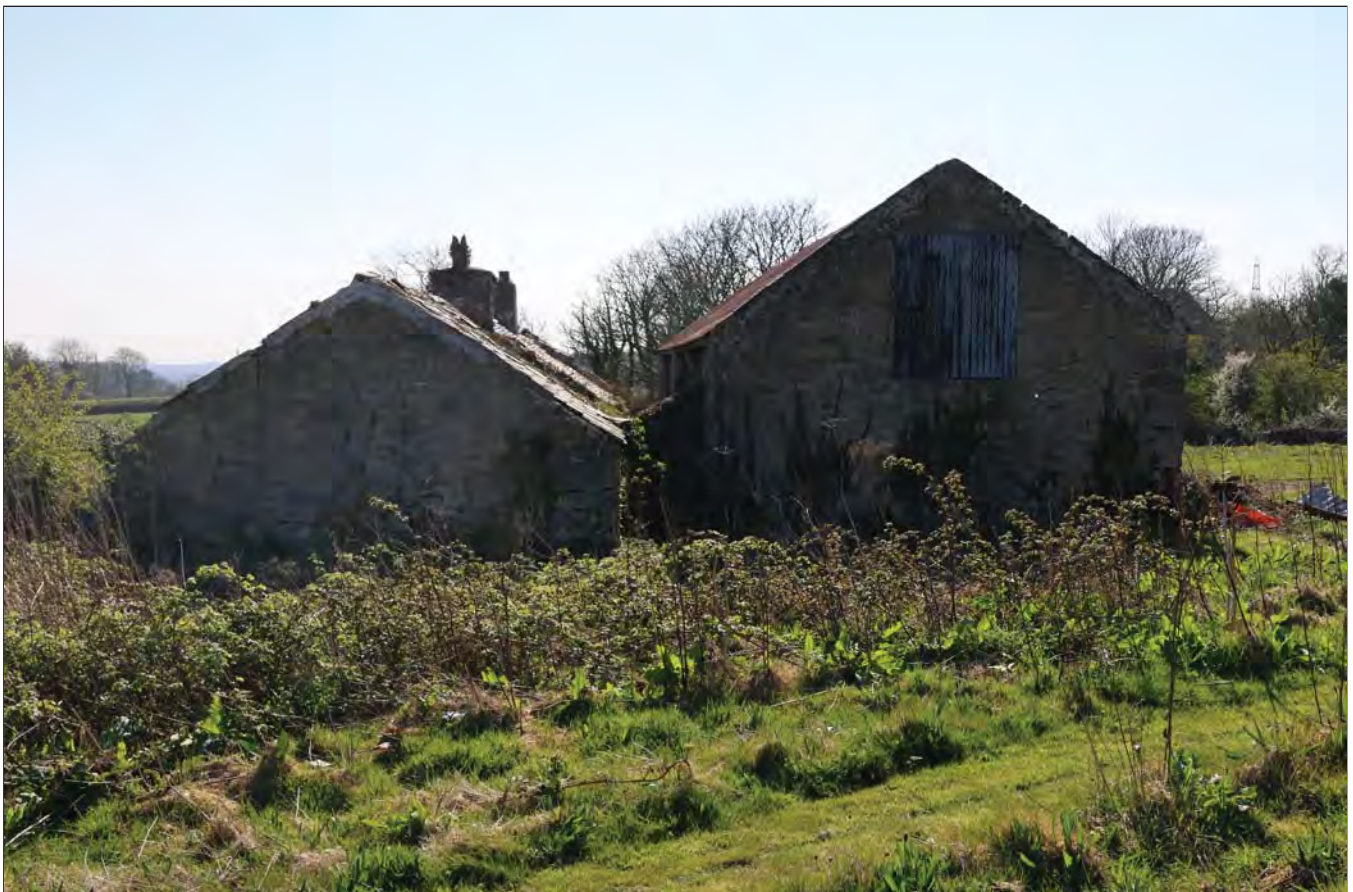
Plate 106: Exterior - Location shot showing NE facing elevation of Parc; scale not used; view from NE (archive reference: E49216_123).

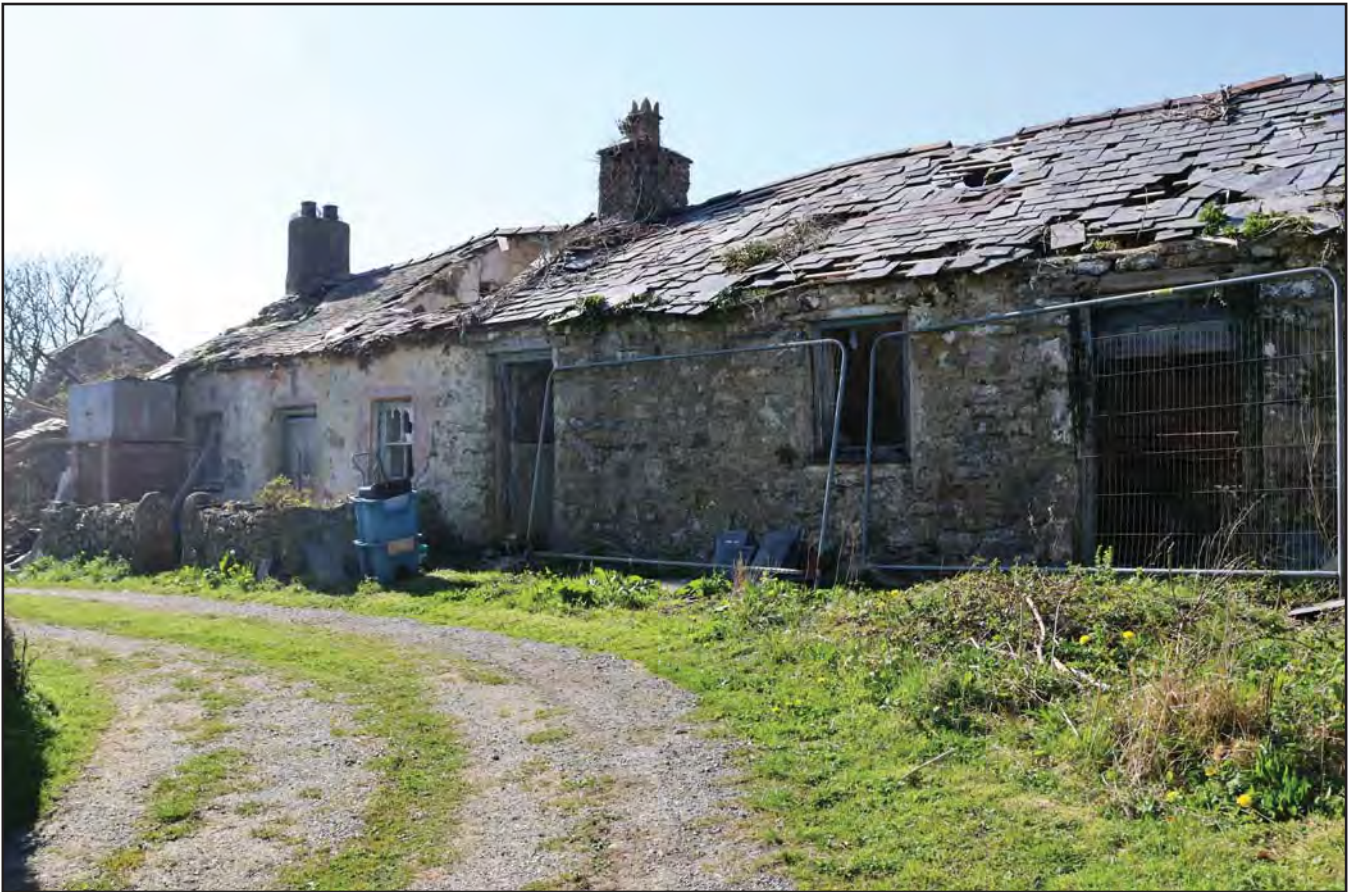
Plate 107: Exterior - Location shot showing SE facing elevation of Parc; scale not used; view from E (archive reference: E49216_124).

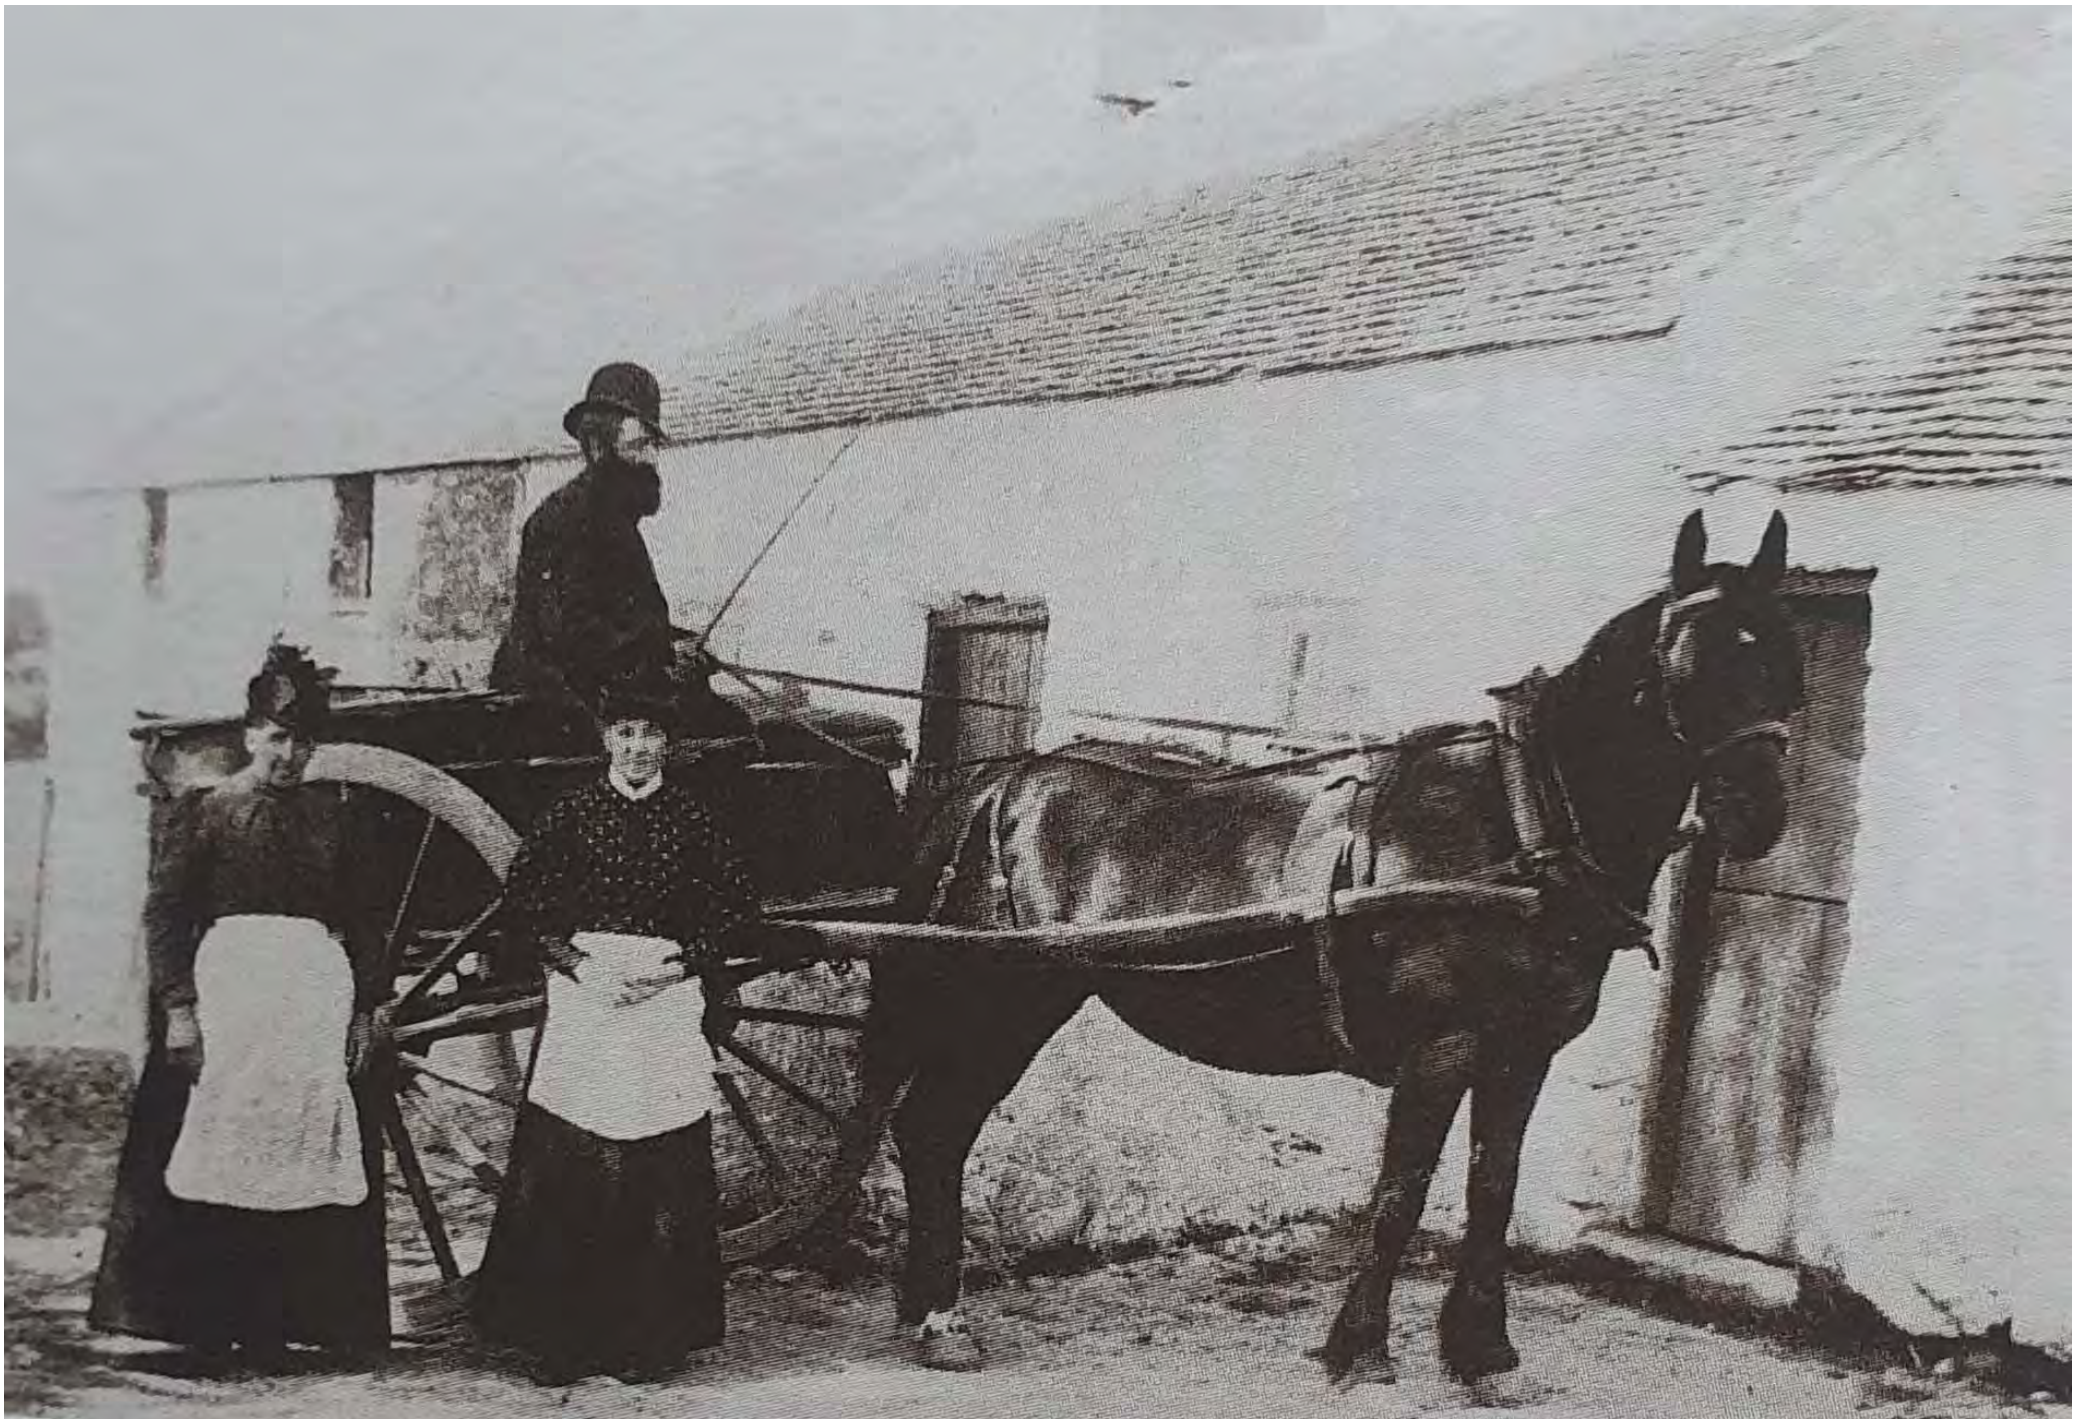
A black and white photograph from the 1890s was recovered showing part of the main house and dairy / cowshed with a gentleman astride a horse and cart with two ladies present. It shows the calving shed / cowshed's roof line much lower compared to the house, therefore the roof has been replaced at some point up to modern day (Figure 06).

Reproduction of photograph from the Book Stori'r Talwrn, showing Parc photographed in the 1890's.
