Bodior Hall, Rhoscolyn

Arolygiad Ffotograffig 2025
Photographic Survey 2025

Rhif Prosiect Heneb Archaeoleg Gwynedd / Heneb Gwynedd Archaeology Project No. HD25-012

Rhif Adroddiad / Report No. 1827

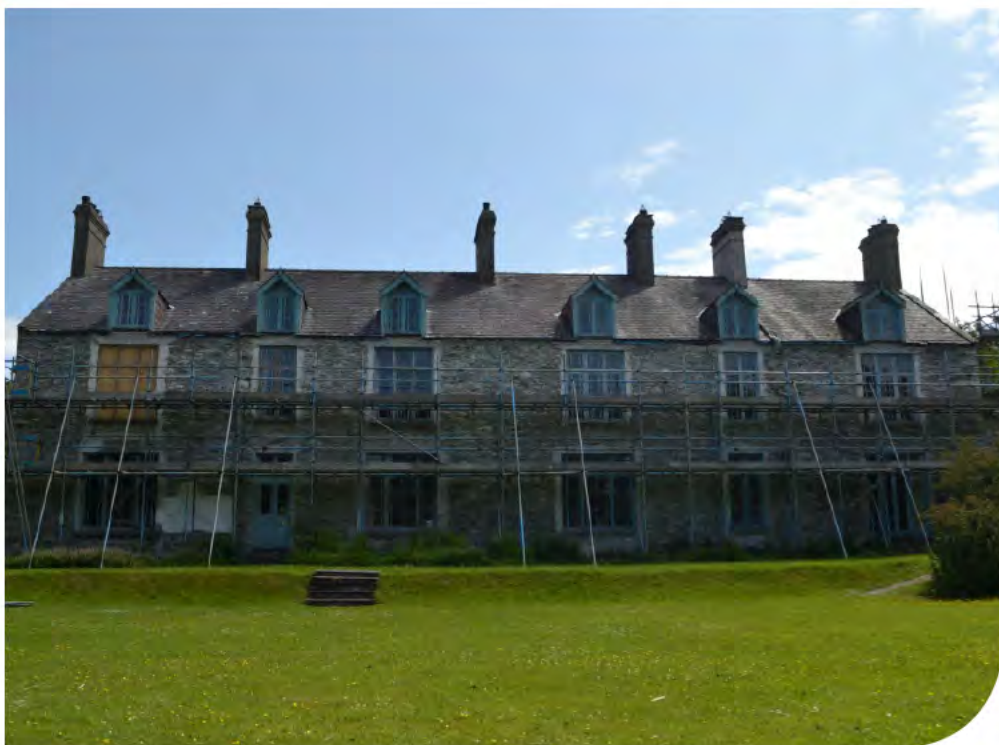
Delwedd clawr blaen / Front Cover image: View of west elevation of Bodior Hall viewed from the W; Scale: Not used (archive reference: E49291_048).

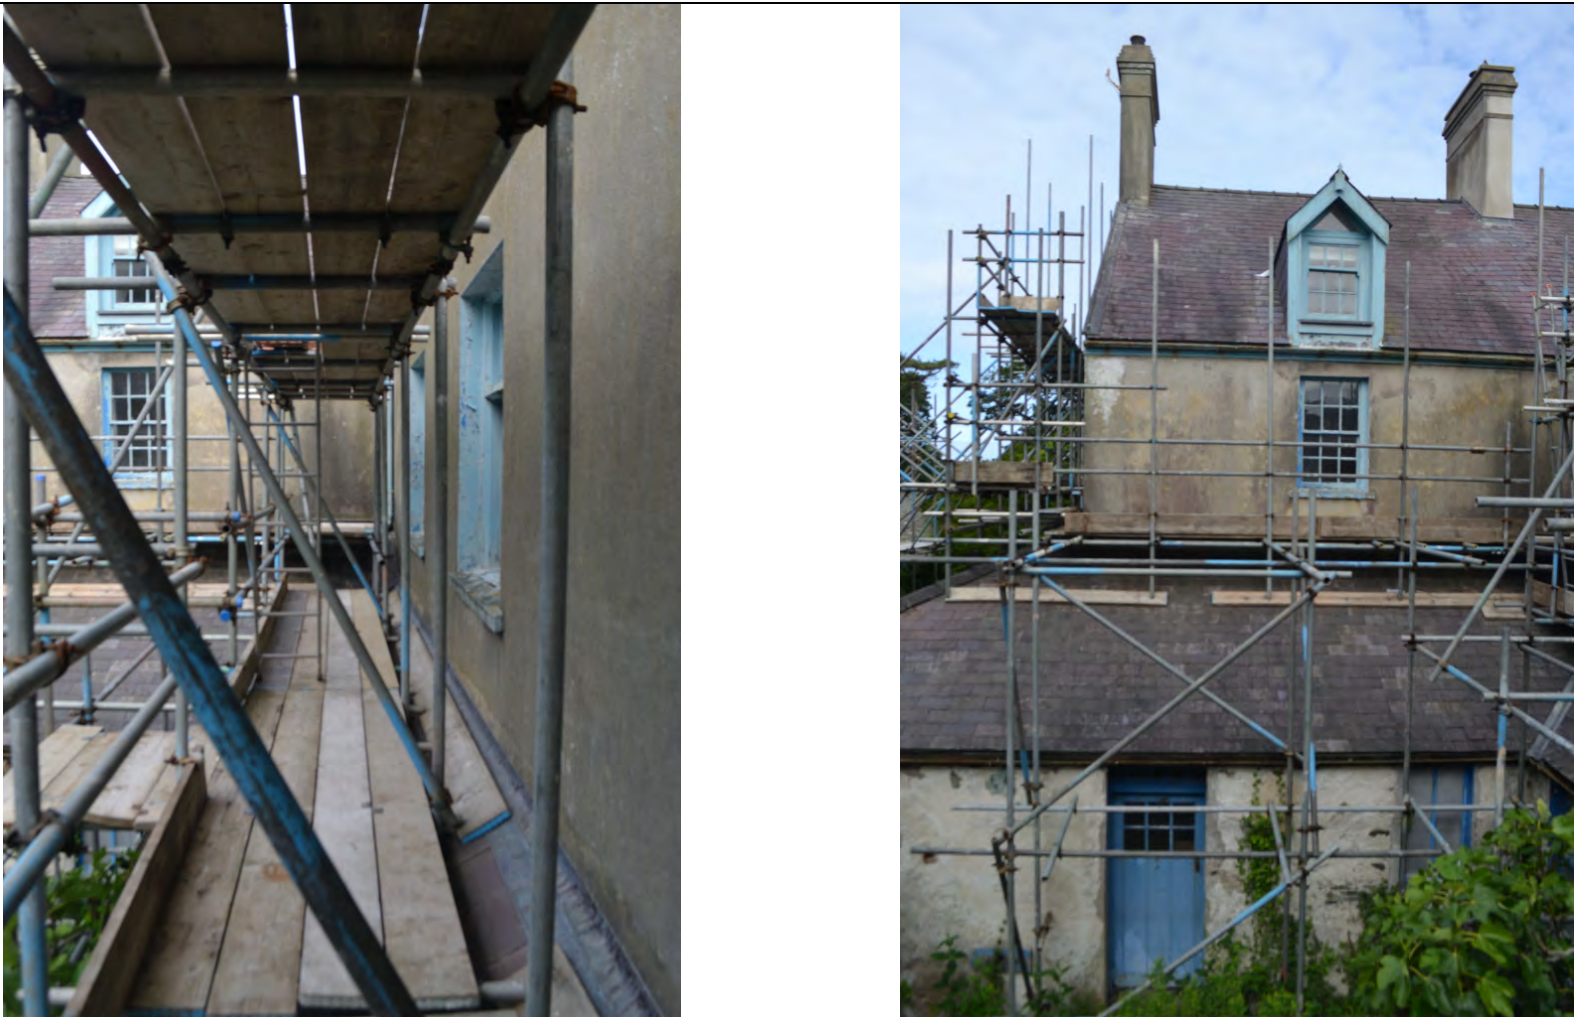
Location	Bodior Hall	Photo ID No:	E49291_011 & E49291_012
Description	View along scaffolding, south side of hall & View of back south corner showing levels 1 and 2, east elevation as viewed from the ESE; Scale: Not used		
Image

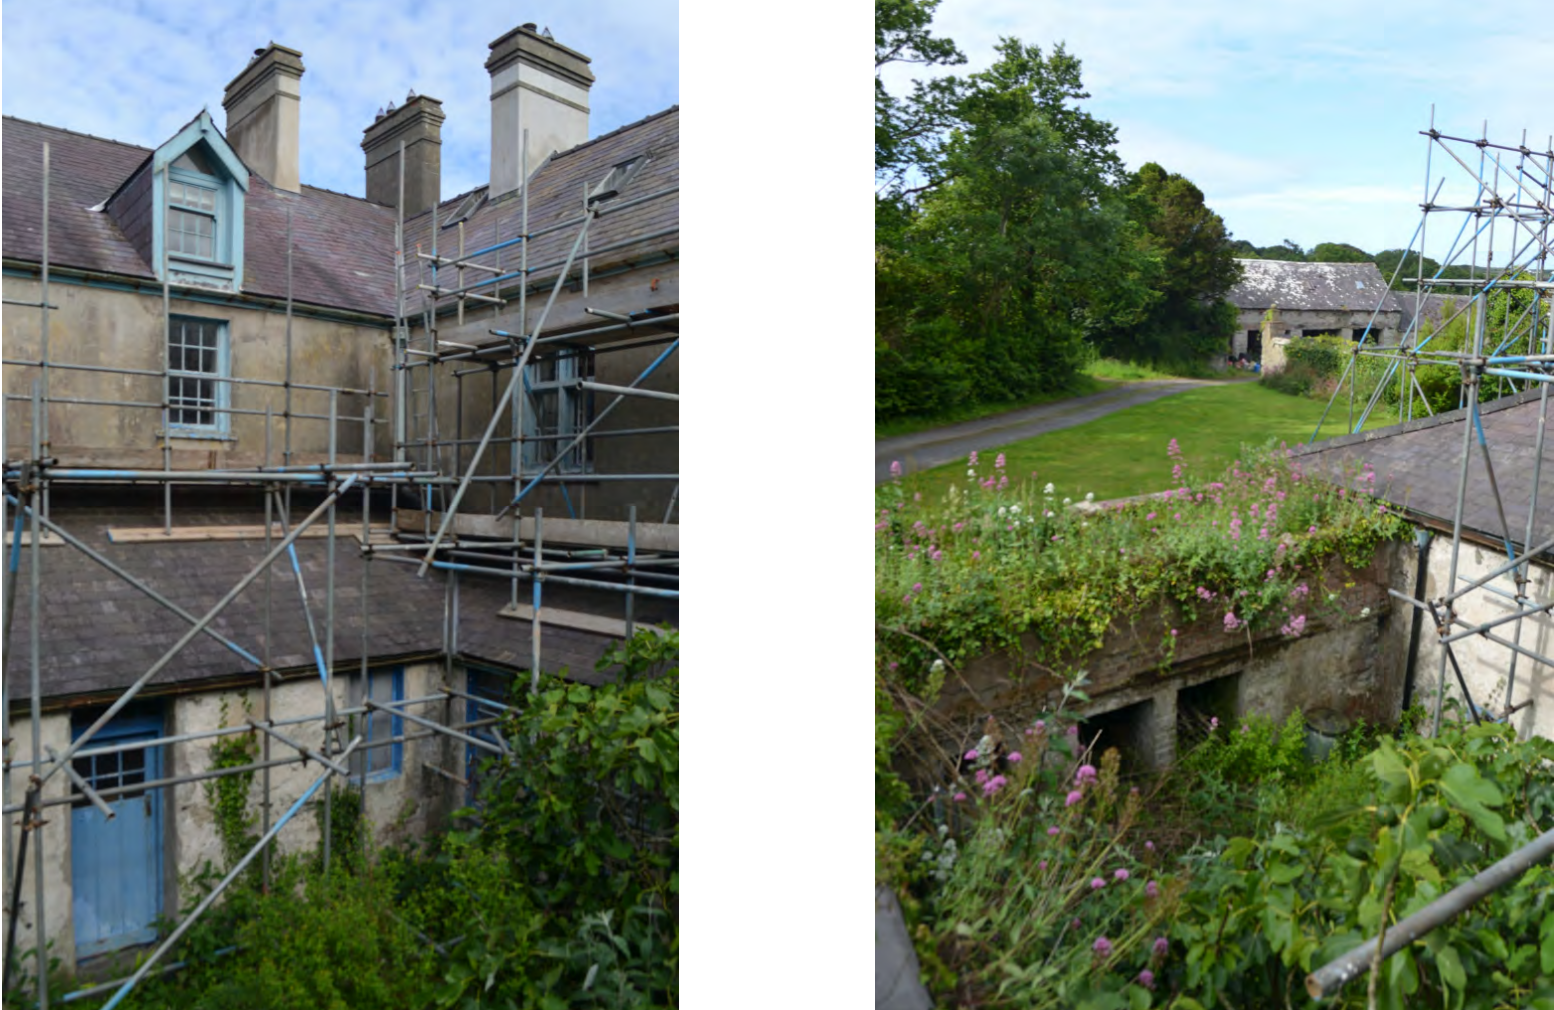
Location	Bodior Hall	Photo ID No:	E49291_013 & E49291_014
Description	Oblique view of back south corner as viewed from the SSE; Scale: Not used		
Image	View of exterior courtyard wall from within as viewed from the NE; Scale: Not used

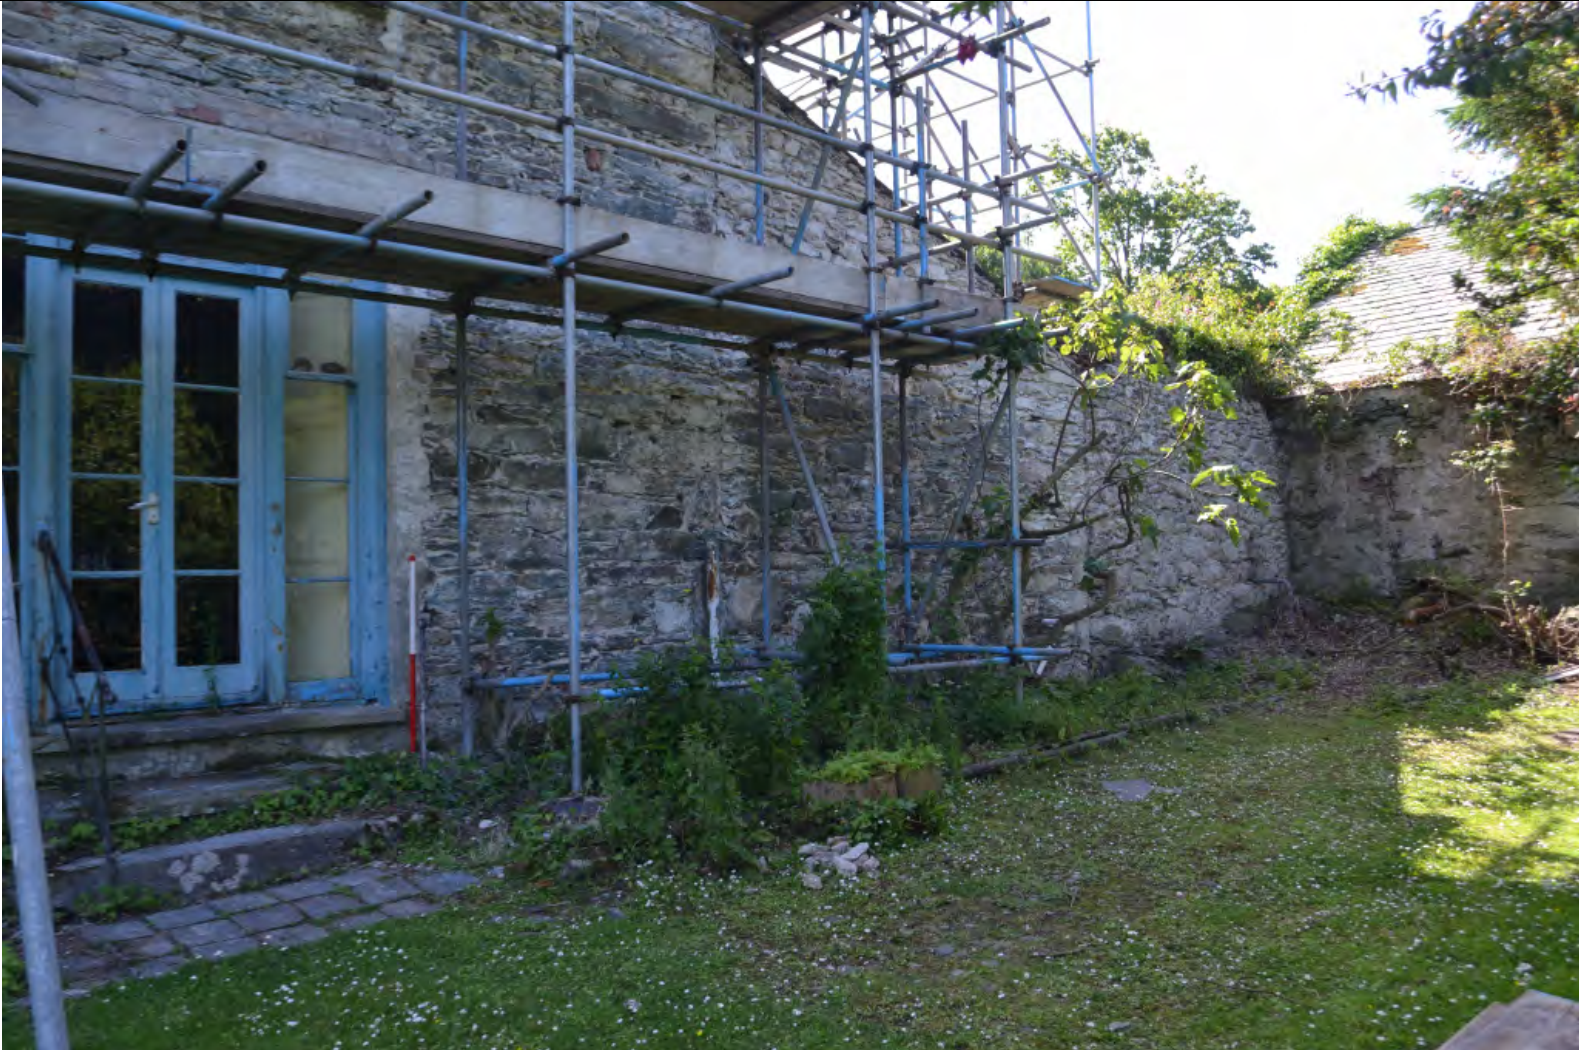
Location	Bodior Hall	Photo ID No:	E49291_020
Description	View showing south corner where hall joins outbuildings viewed from the NW; Scale: 1x1m		
Image

<p>The photograph shows the exterior of a stone building, likely a hall or outbuilding, with a blue-painted wooden door. The building is surrounded by scaffolding, indicating ongoing work or restoration. The ground in the foreground is covered with green grass and some weeds. The sky is visible in the background, and there are trees and foliage to the right of the building.</p>

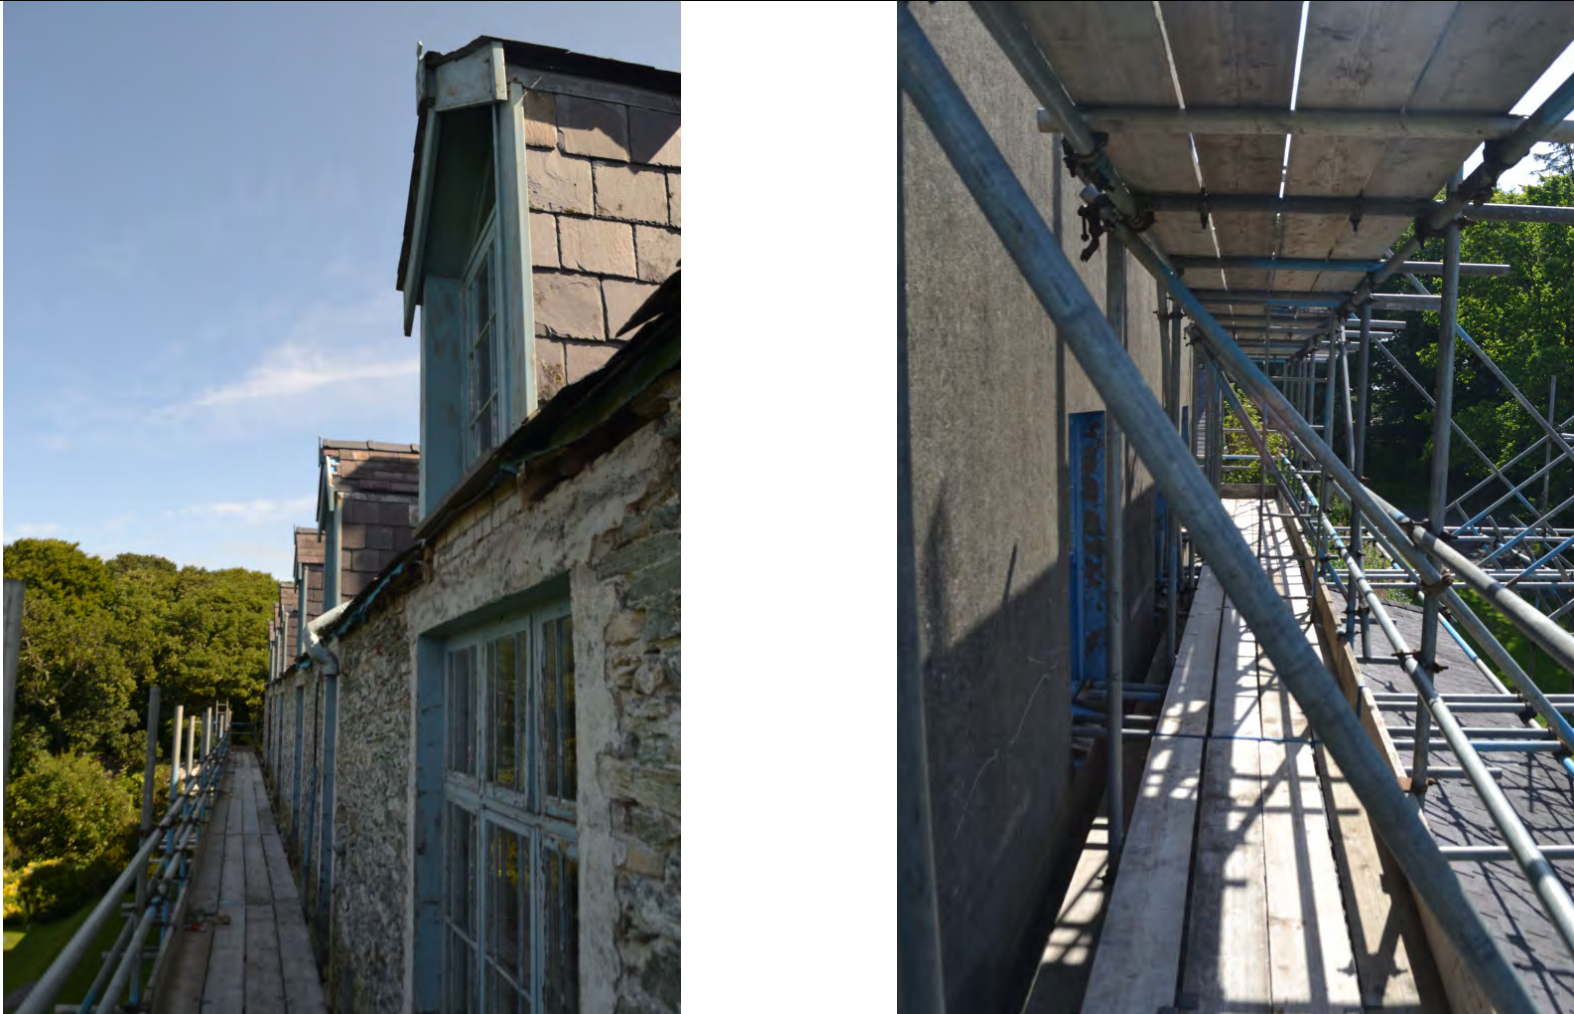
Location	Bodior Hall	Photo ID No:	E49291_023 & E49291_024
Description	View along scaffolding from first floor, west wall viewed from the S; Scale: Not used		
Image	View along south wall scaffolding from second floor viewed from the WNW; Scale: Not used

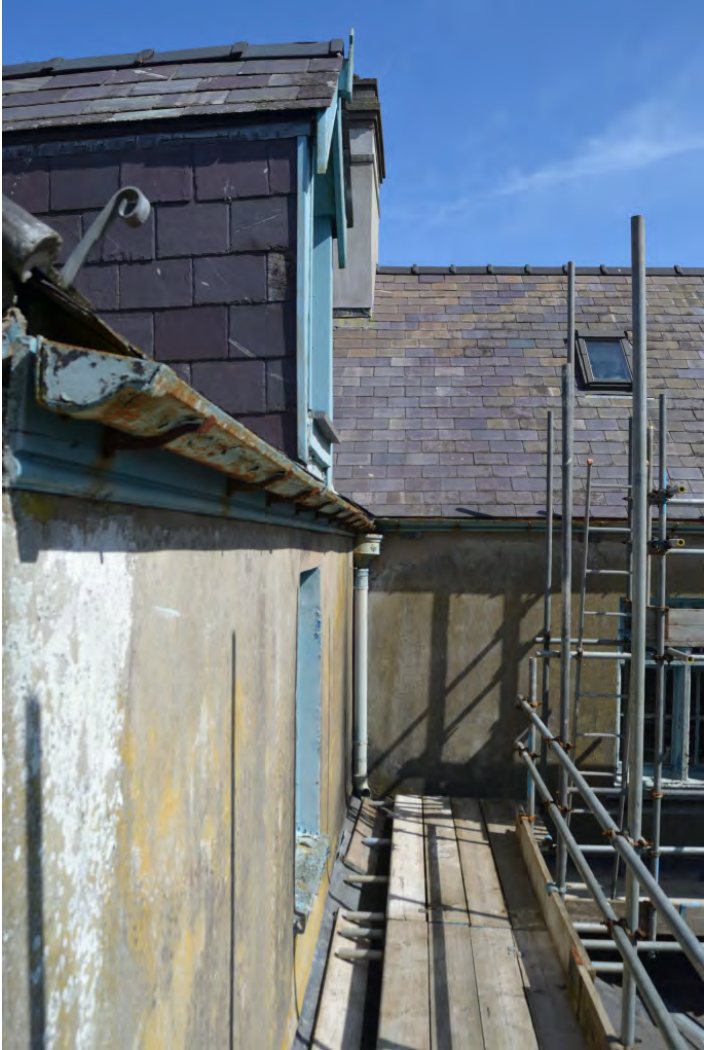
Location	Bodior Hall	Photo ID No:	E49291_025
Description	View along scaffolding 2nd floor, east wall south corner viewed from the S; Scale: Not used		
Image

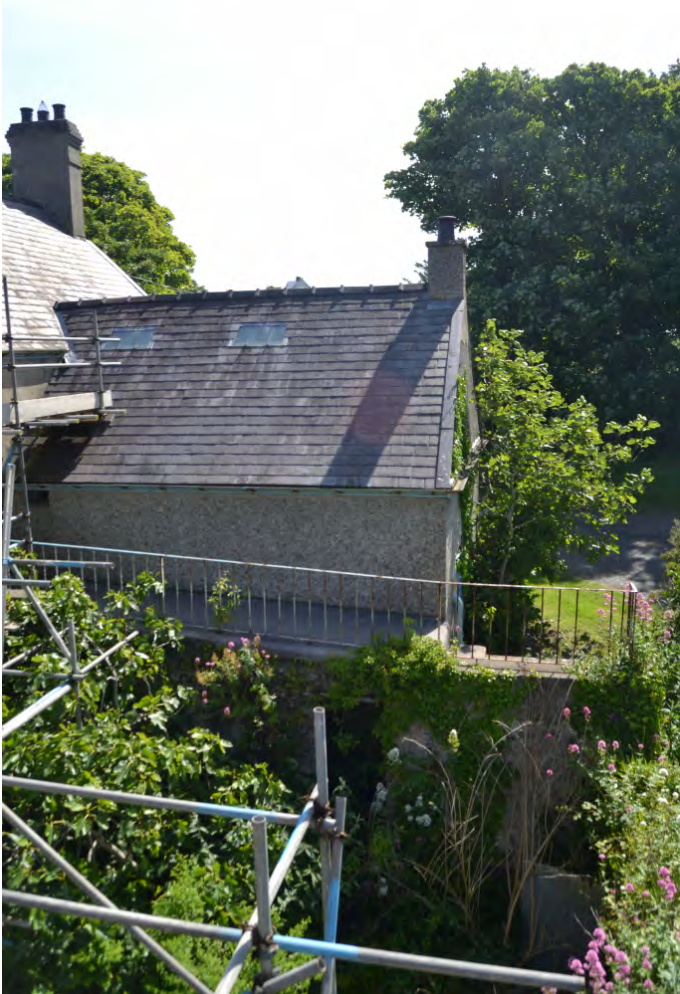
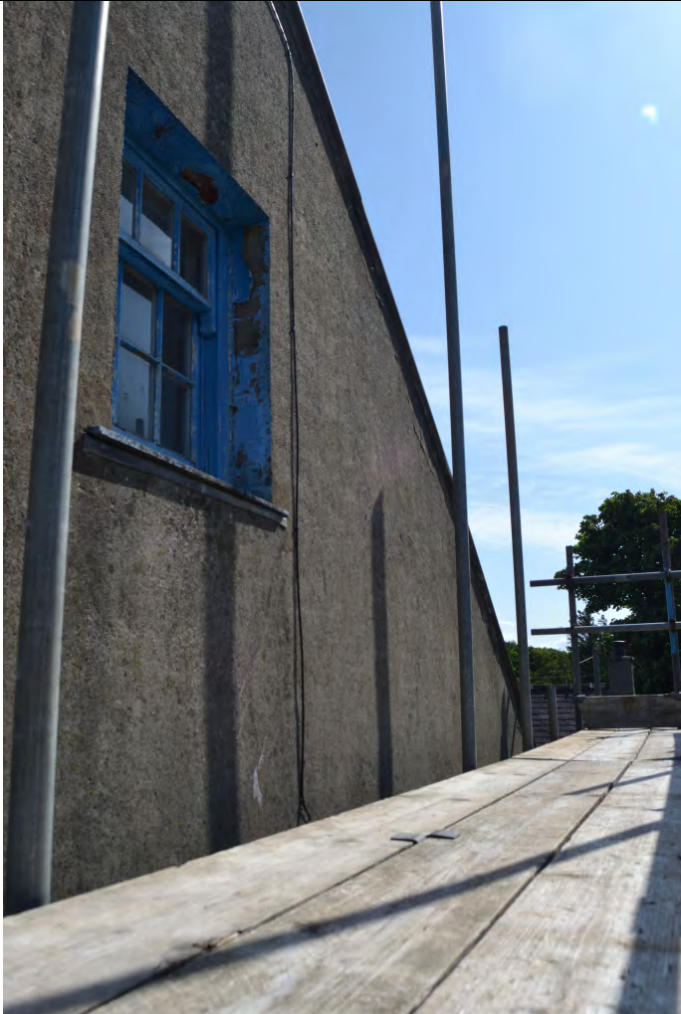
Location	Bodior Hall	Photo ID No:	E49291_027 & E49291_028
Description	View of west wall of extension showing railing to 2nd floor doorway viewed from the W; Scale: Not used		View of 3rd floor window from scaffolding viewed from the WSW; Scale: Not used
Image

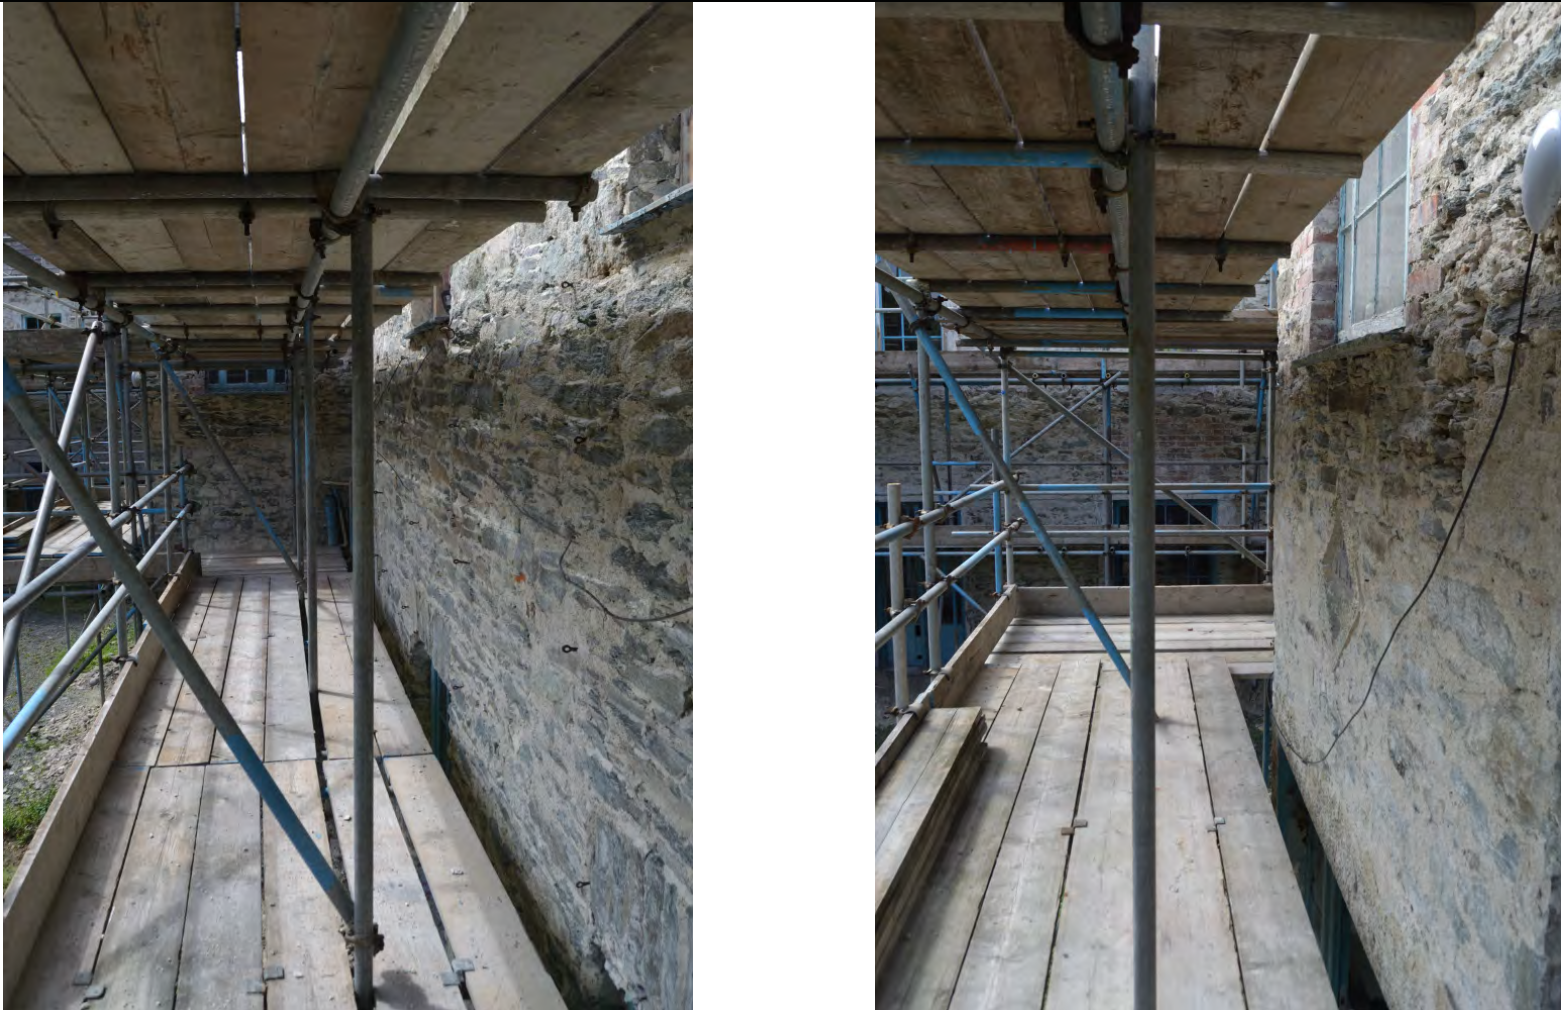
Location	Bodior Hall	Photo ID No:	E49291_033 & E49291_034
Description	View along scaffolding first floor, east wall north corner viewed from the N; Scale: Not used		
Image	View along central portion of east wall above main doorway, from scaffolding viewed from the N; Scale: Not used

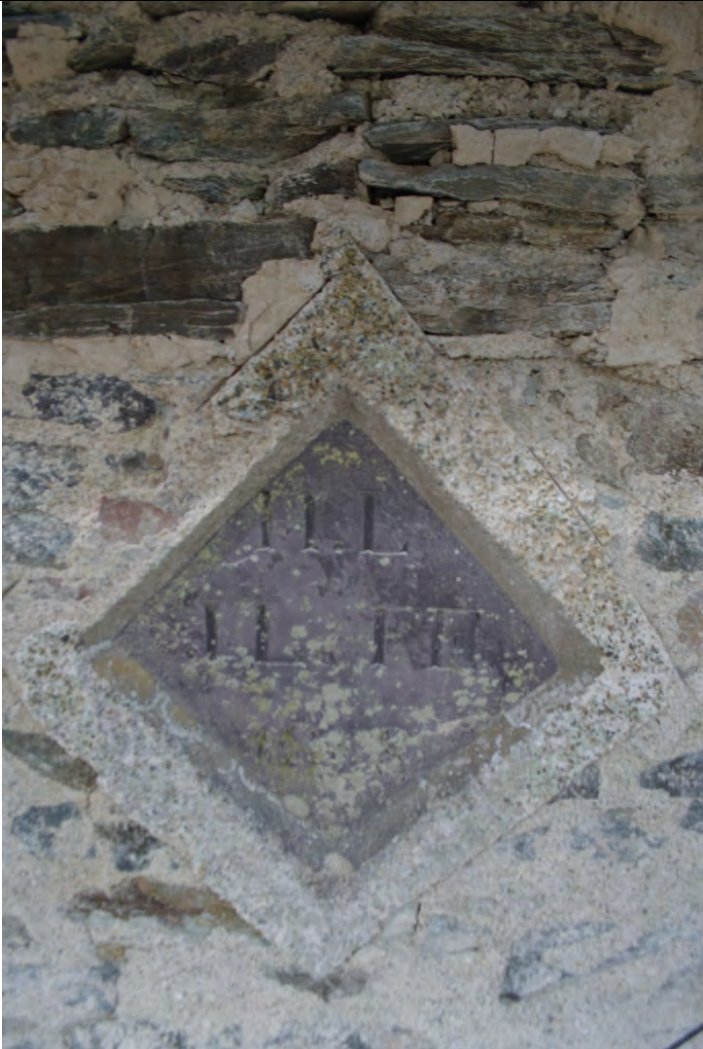
Location	Bodior Hall	Photo ID No:	E49291_035
Description	View of engraving "H.L. JL FE 1848" above main doorway viewed from the E; Scale: Not used		
Image

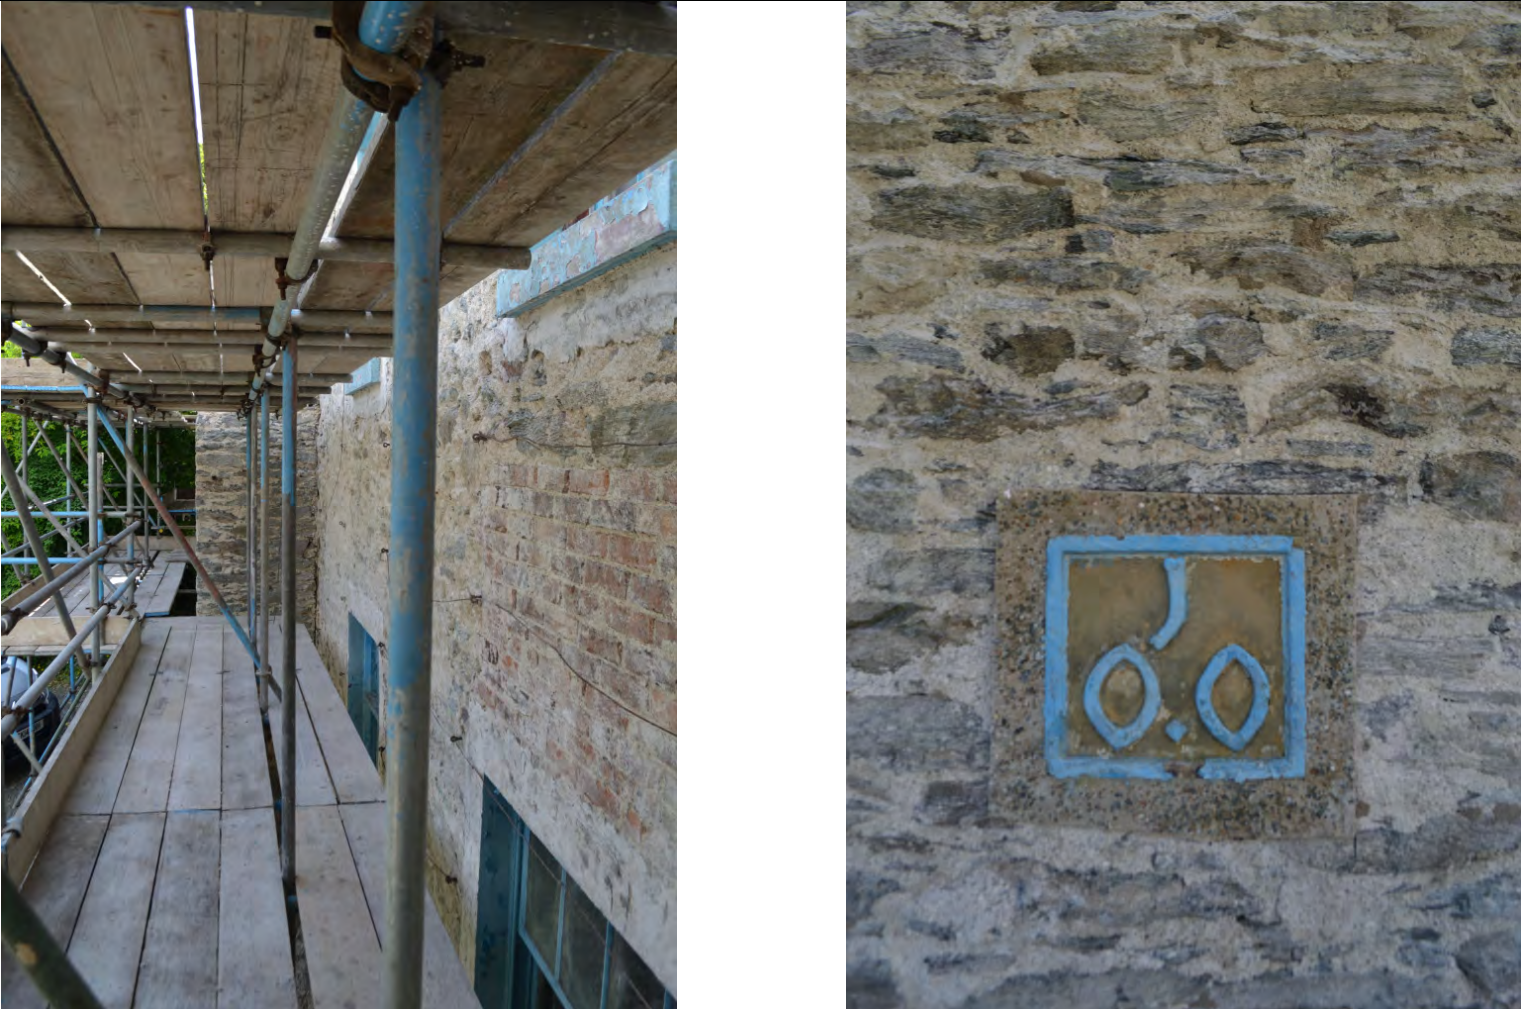
Location	Bodior Hall	Photo ID No:	E49291_037 & E49291_038
Description	View along scaffolding first floor north wall viewed from the W; Scale: Not used		
Image	View of detail "J 0.0" in center of north wall viewed from the N; Scale: Not used

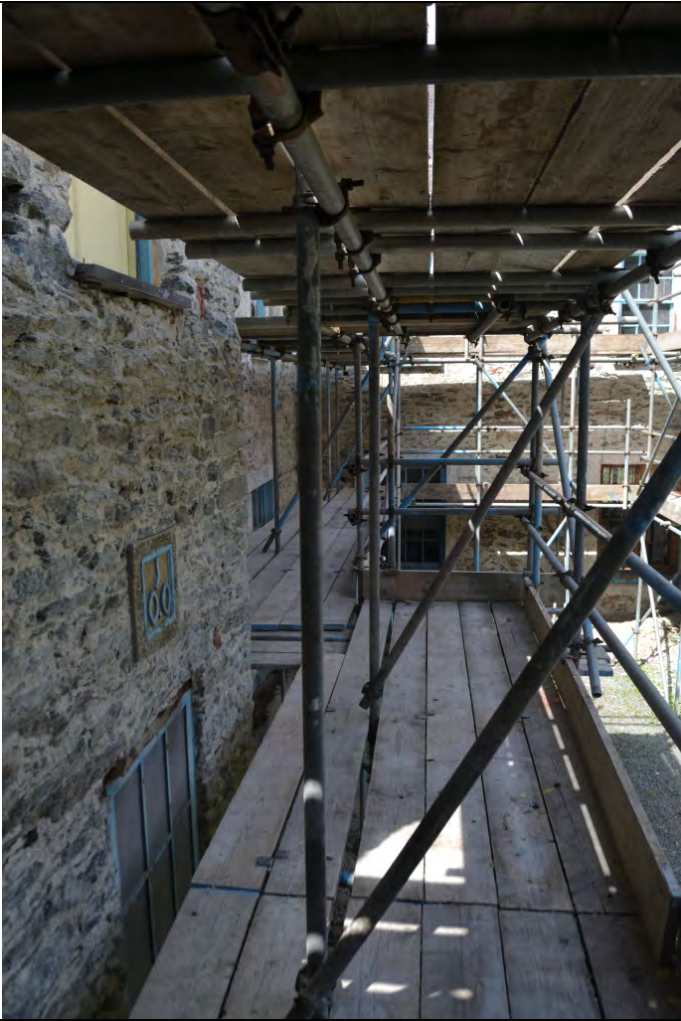
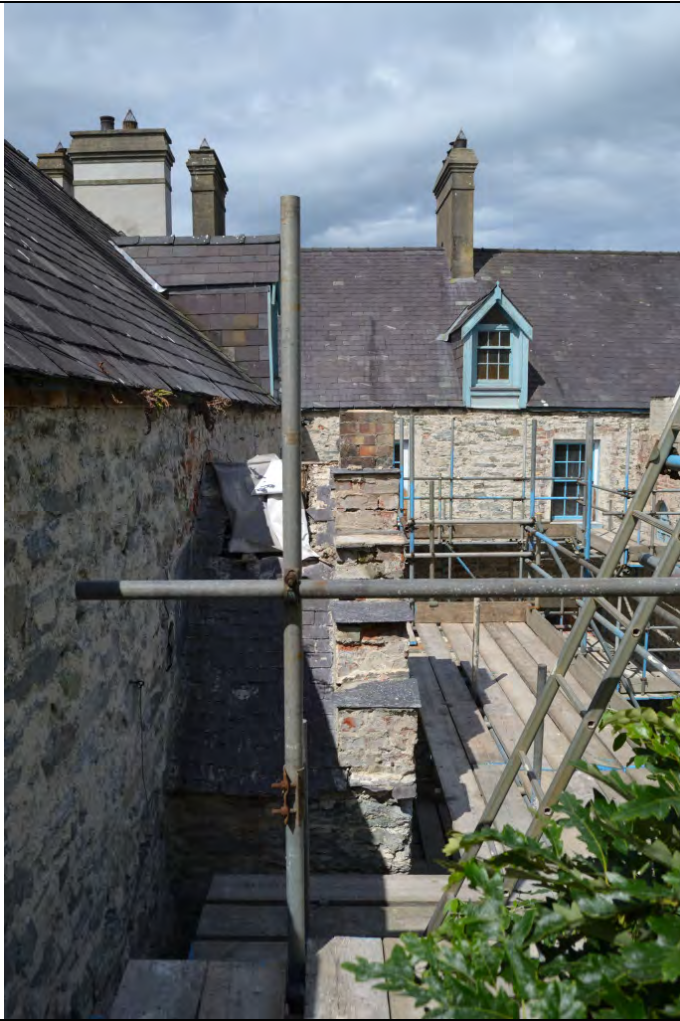
Location	Bodior Hall	Photo ID No:	E49291_039 & E49291_040
Description	View along north wall from southeast corner of hall viewed from the ENE; Scale: Not used		View along north wall from 2nd floor scaffolding viewed from the E; Scale: Not used
Image

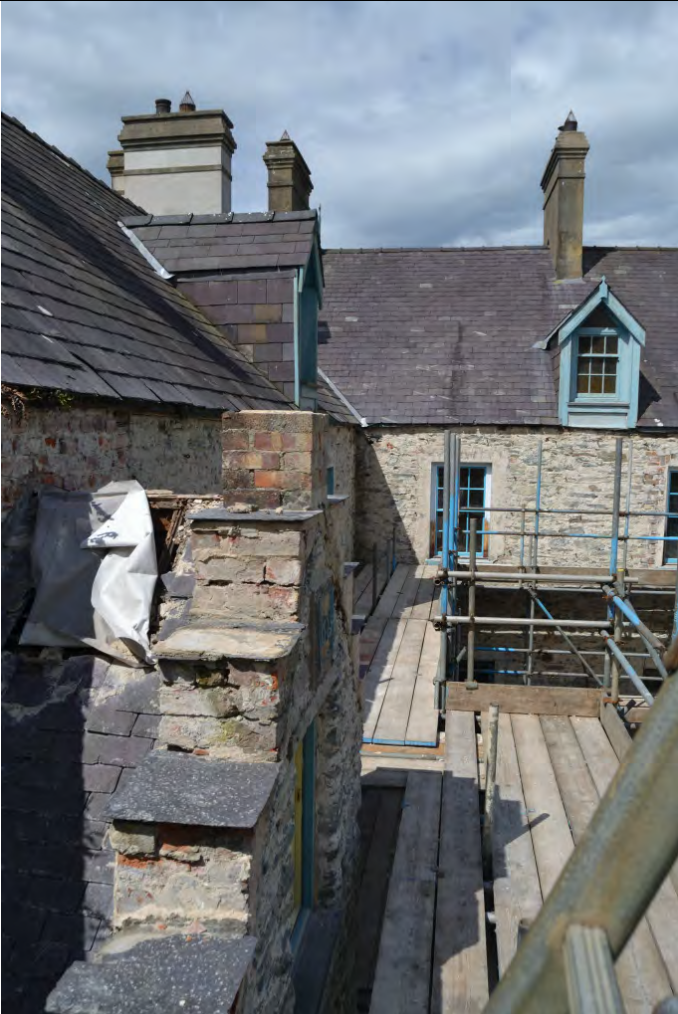
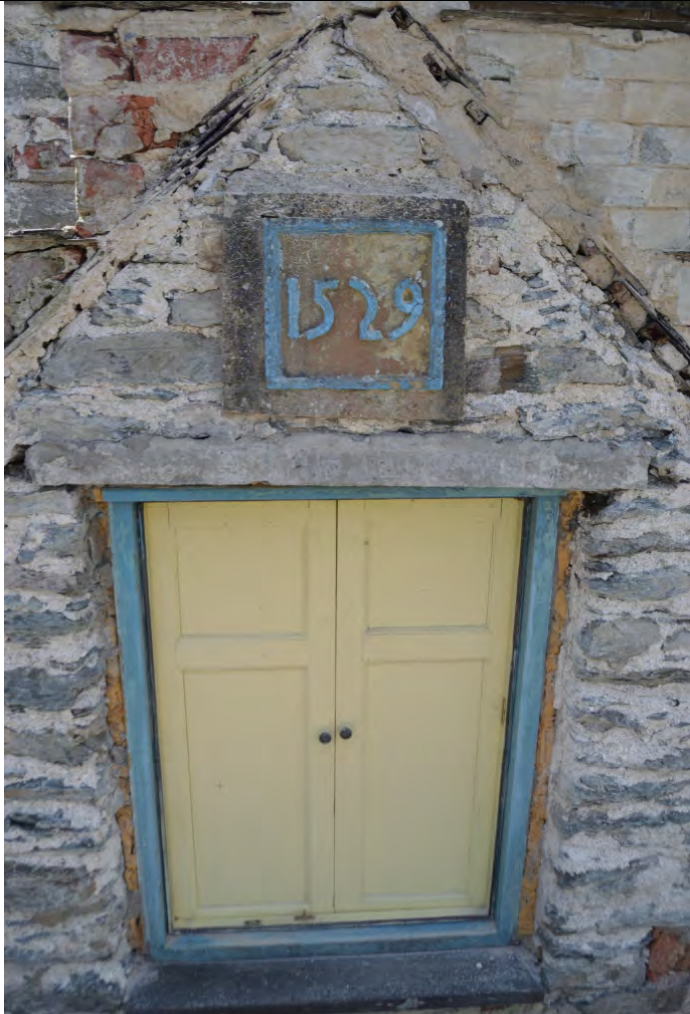
Location	Bodior Hall	Photo ID No:	E49291_041 & E49291_042
Description	View along north wall from 2nd floor scaffolding viewed from the E; Scale: Not used		Close-up view of detail "1529" and wooden window viewed from the N; Scale: Not used
Image

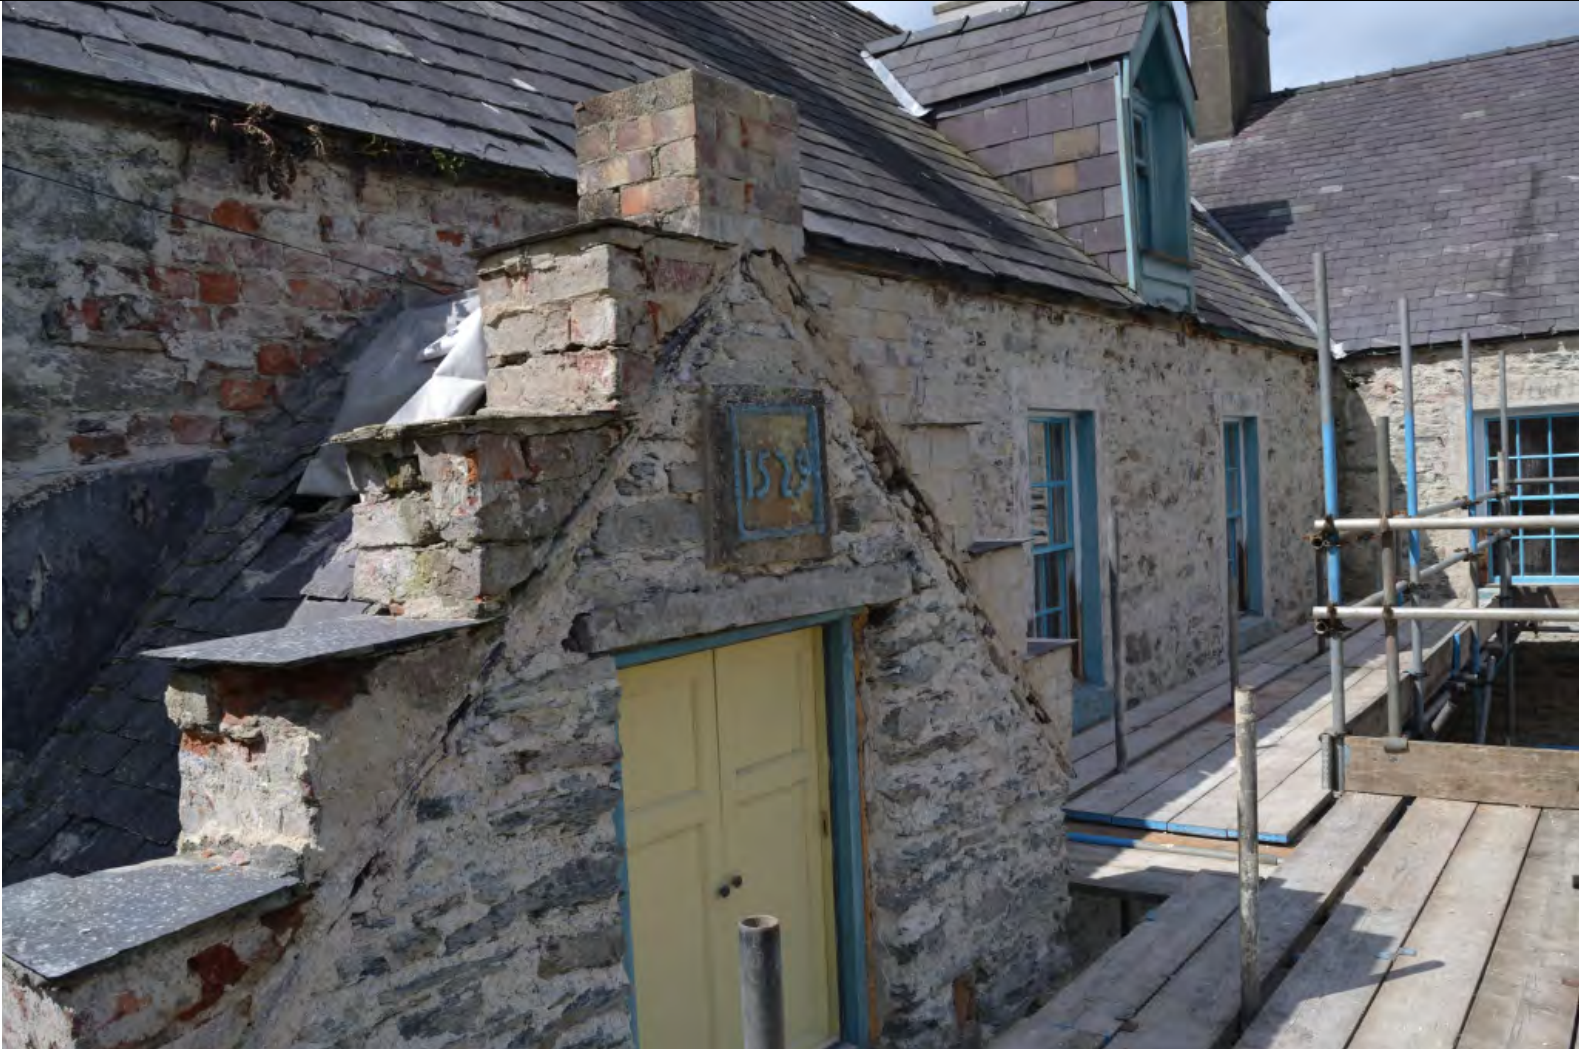
Location	Bodior Hall	Photo ID No:	E49291_043
Description	Oblique view of detail "1529" and wooden window viewed from the ENE; Scale: Not used		
Image

<p>The photograph shows a close-up, oblique view of a stone building's exterior. A prominent feature is a small, square stone detail with the number '1529' inscribed on it. To the right of this detail is a wooden window with a blue frame. The building's roof is covered in dark grey slate tiles. In the foreground, there is a wooden platform or deck with a metal railing. The overall scene is captured from an elevated position, looking down at the building's facade.</p>

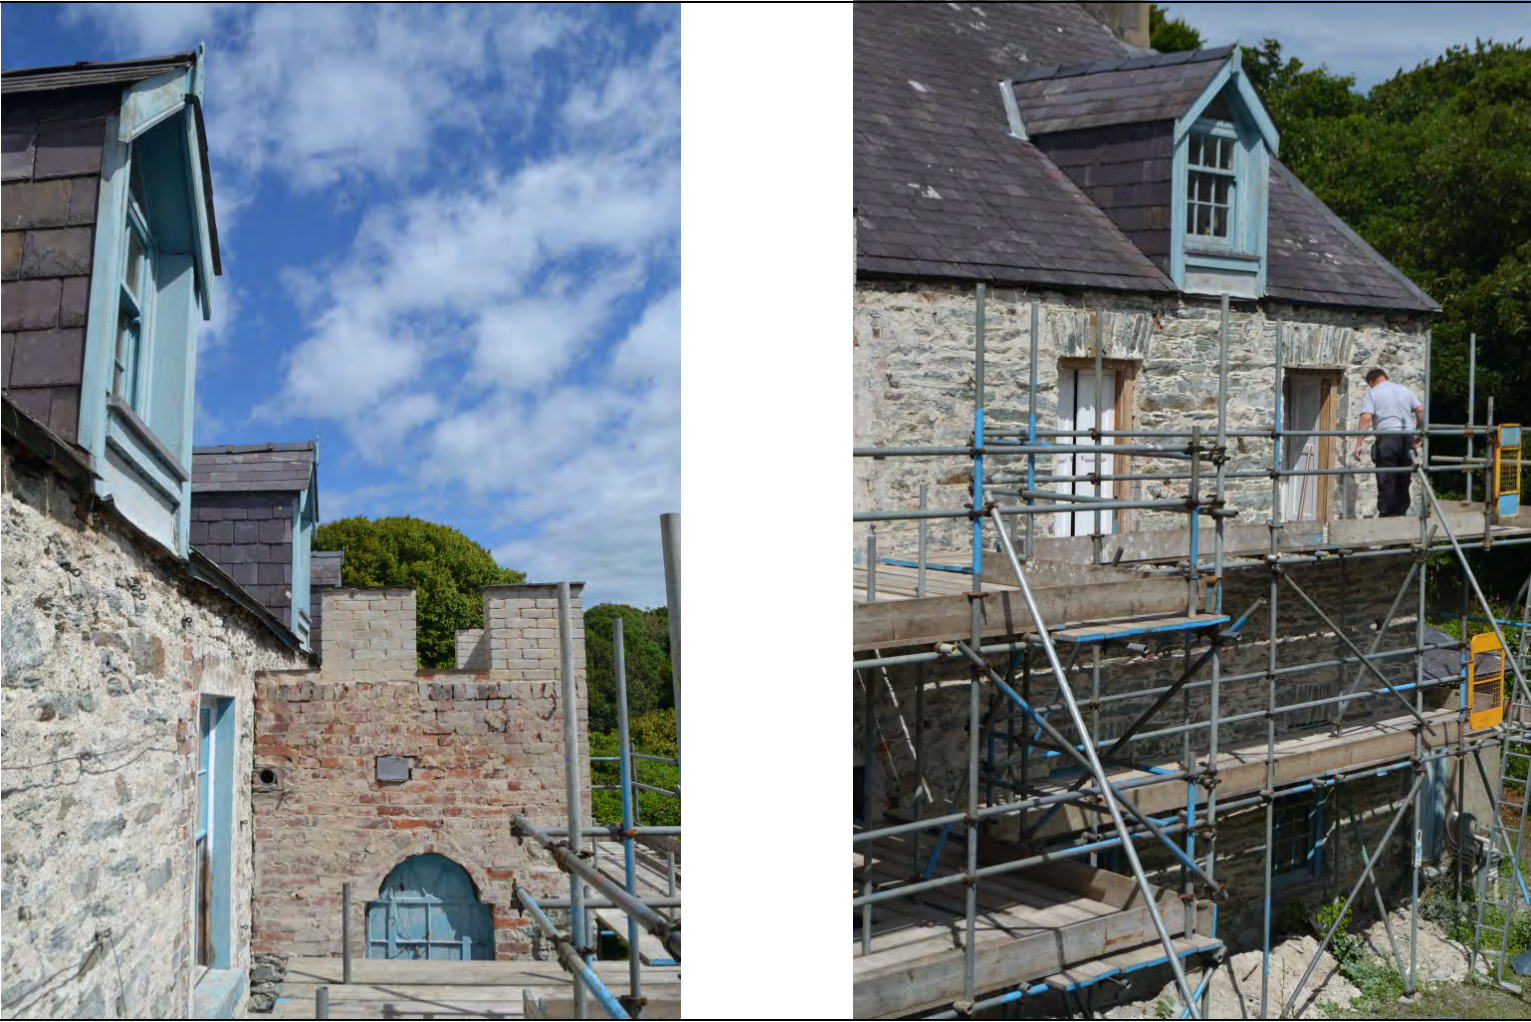
Location	Bodior Hall	Photo ID No:	E49291_045 & E49291_046
Description	View along front of hall from 2nd floor scaffolding viewed from the S; Scale: Not used		
Image	Oblique view of northeast corner from 2nd floor scaffolding viewed from the SE; Scale: Not used

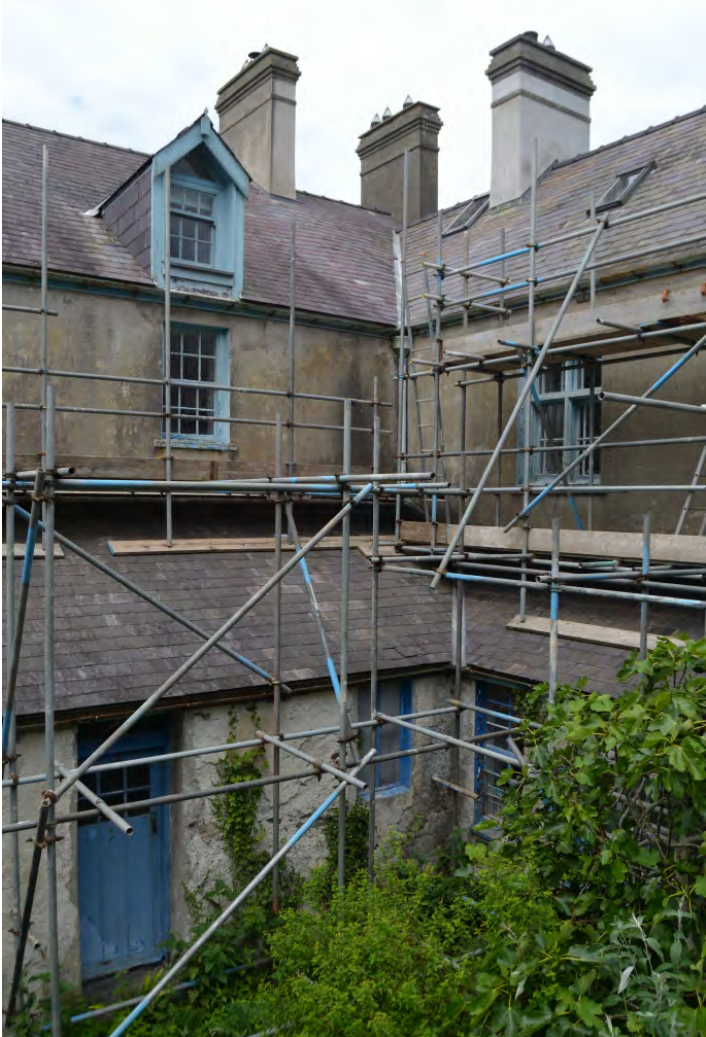
Location	Bodior Hall	Photo ID No:	E49291_052
Description	Oblique view over courtyard showing newer addition on top of 1529 house viewed from the SSE; Scale: Not used		
Image

<p>The photograph shows a multi-story stone building with a dark slate roof. Several tall, light-colored chimneys are visible against the sky. The building is partially covered in scaffolding, indicating ongoing work. A small, light blue-painted dormer window is visible on the roof. In the foreground, there are green bushes and a blue door on the ground floor. The view is from an elevated position looking down into a courtyard area.</p>

While the house dates to the 16th century, it was clear that additions had been added over the years by the way of extending upward, which could be seen as a newer addition from the southern courtyard (Plate 52). In addition, further nameplates and dates were also observed during the survey indicating some alterations (Plate 35). However, the house did hold much of its original character intact with the ground floor and first floor showing a continuation within construction methods, with wooden blue painted windows throughout, Welsh slate roof with dormers and a row of six 4 pot chimney stacks.
