Bodior Hall, Rhoscolyn

Arolygiad Ffotograffig 2025
Photographic Survey 2025

Rhif Prosiect Heneb Archaeoleg Gwynedd / Heneb Gwynedd Archaeology Project No. HD25-012

Rhif Adroddiad / Report No. 1827

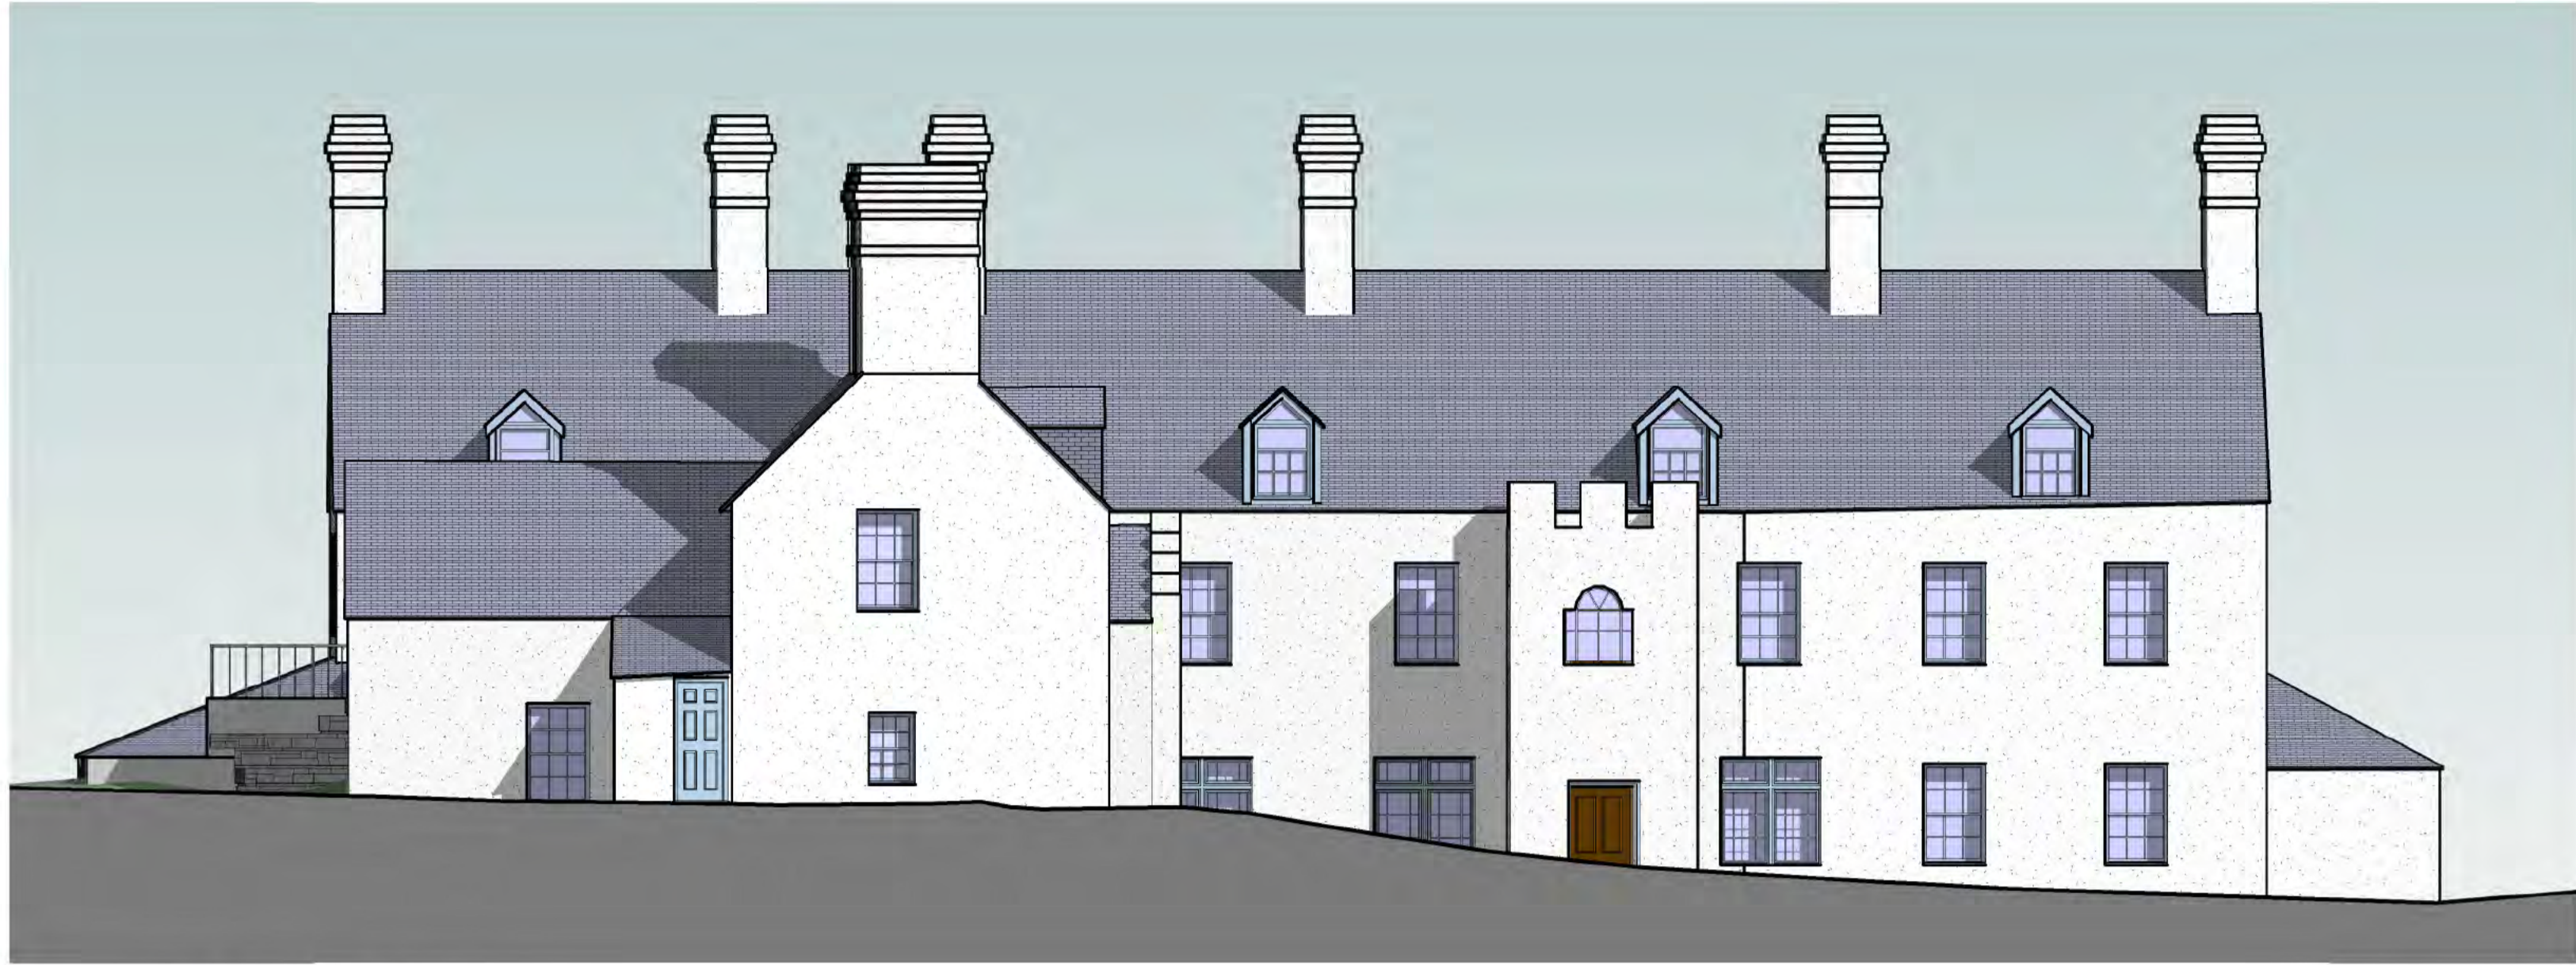
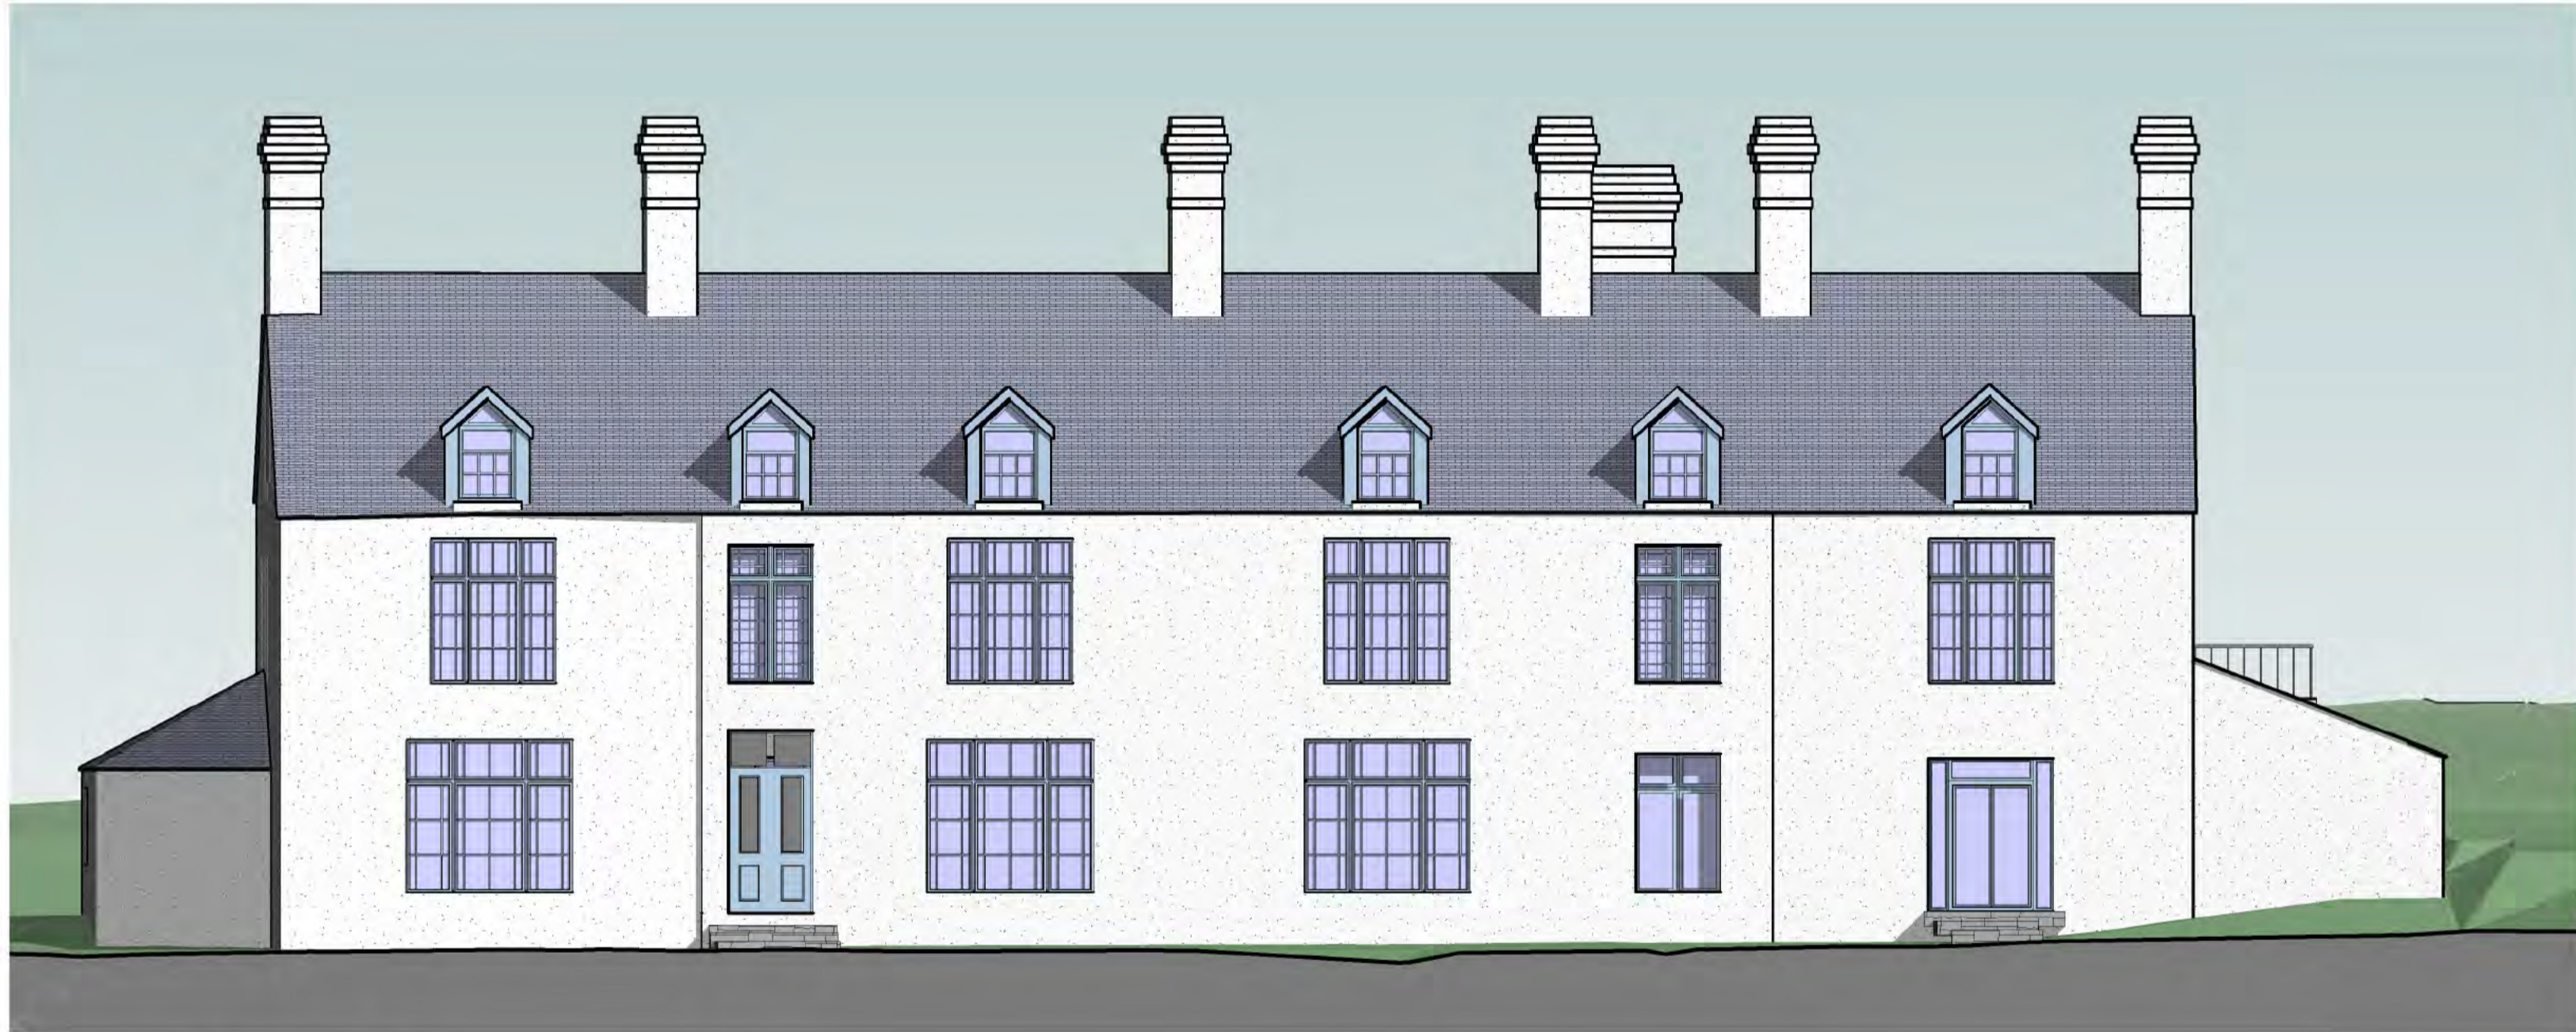
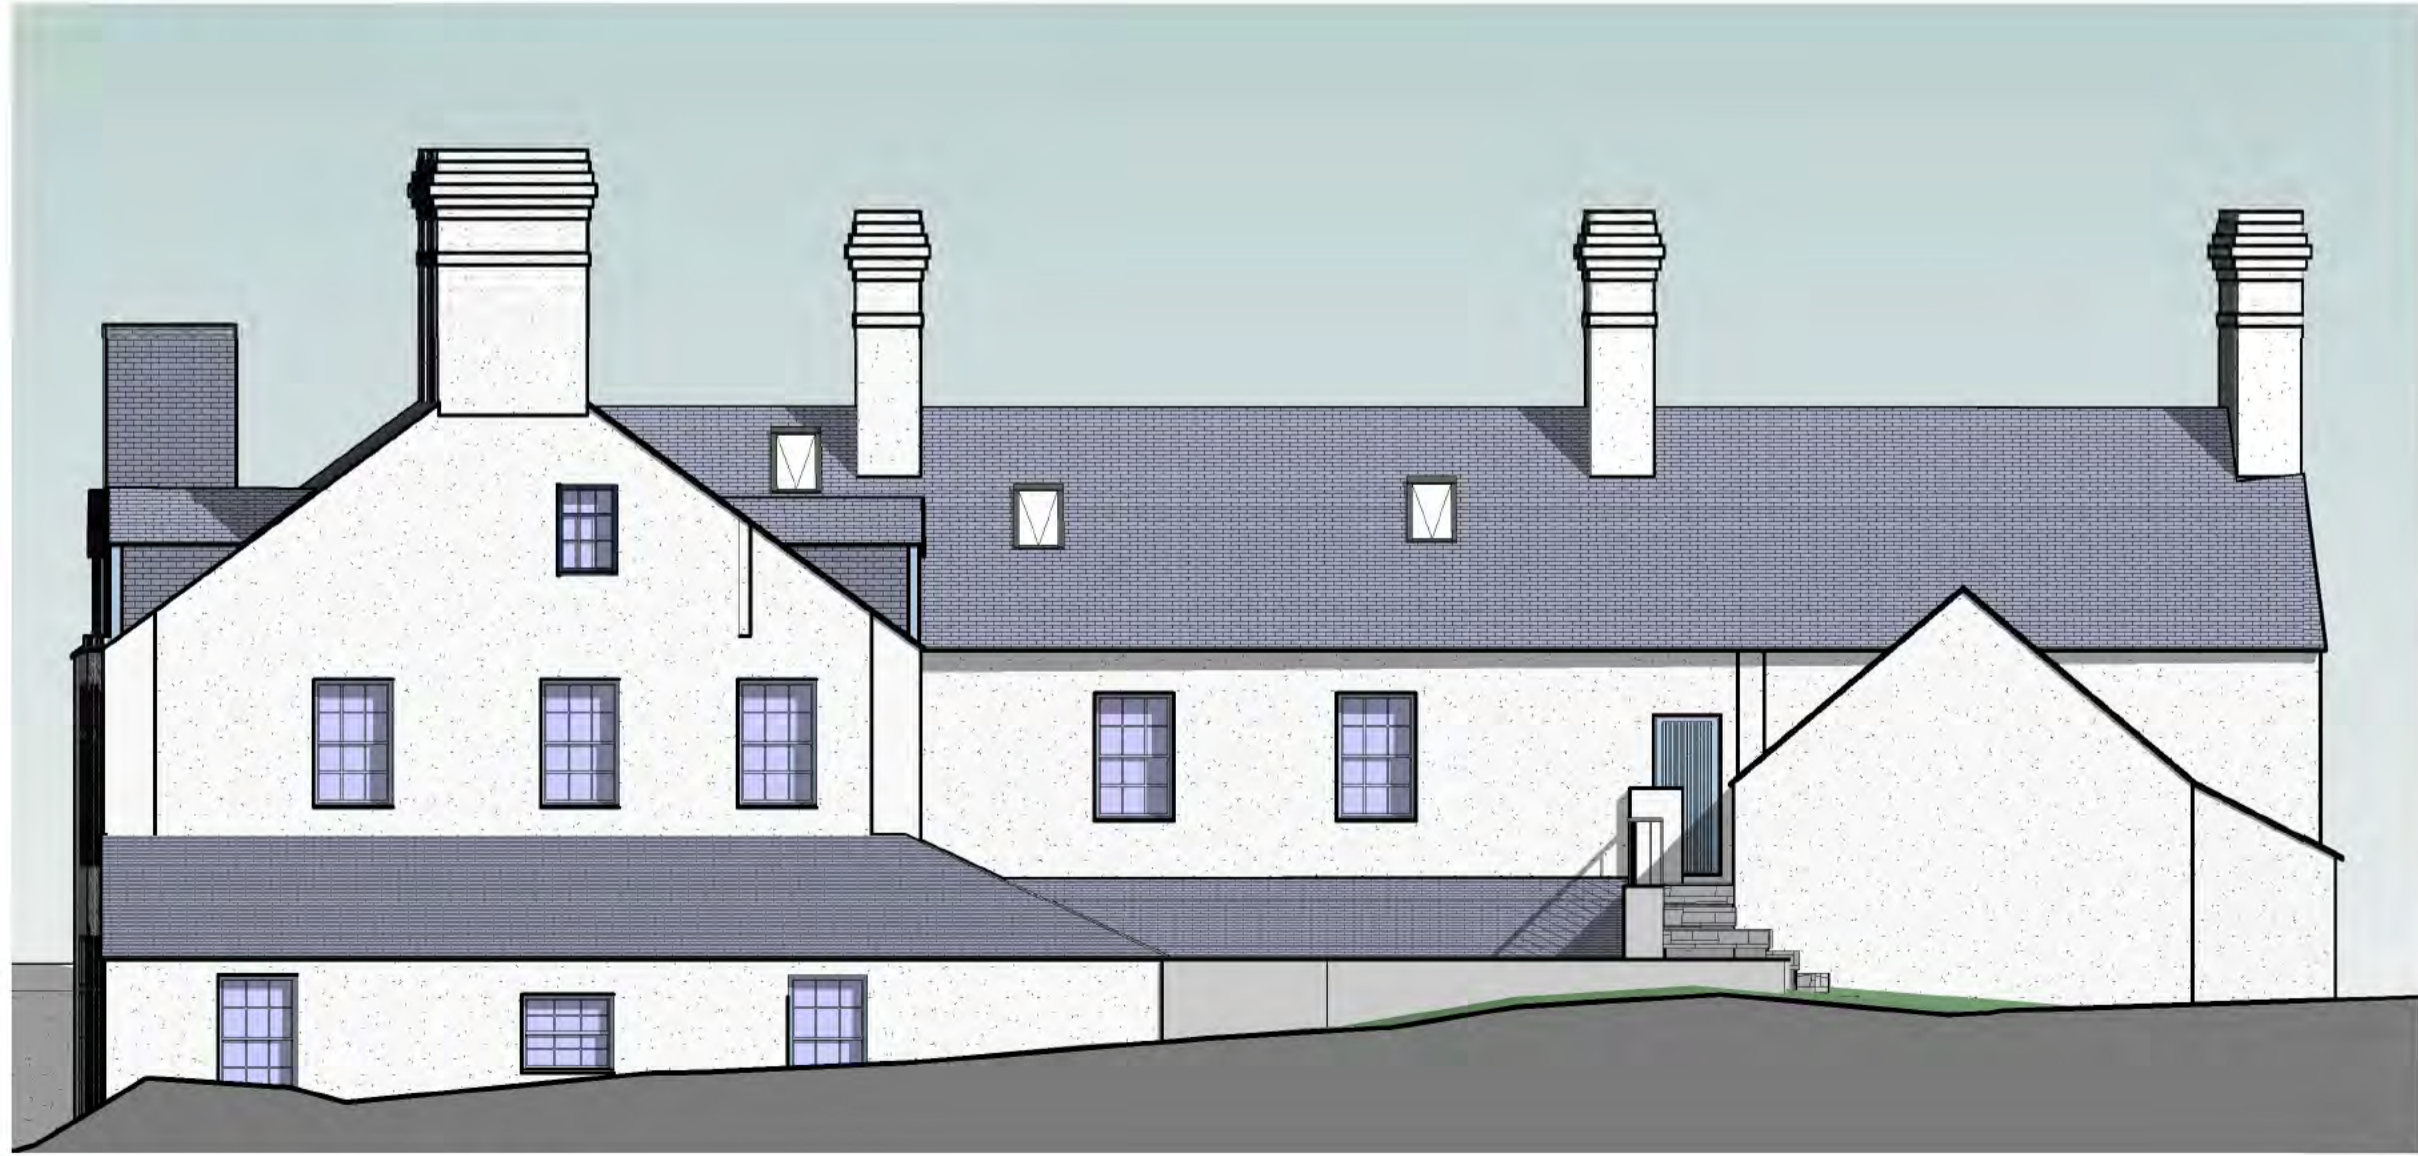
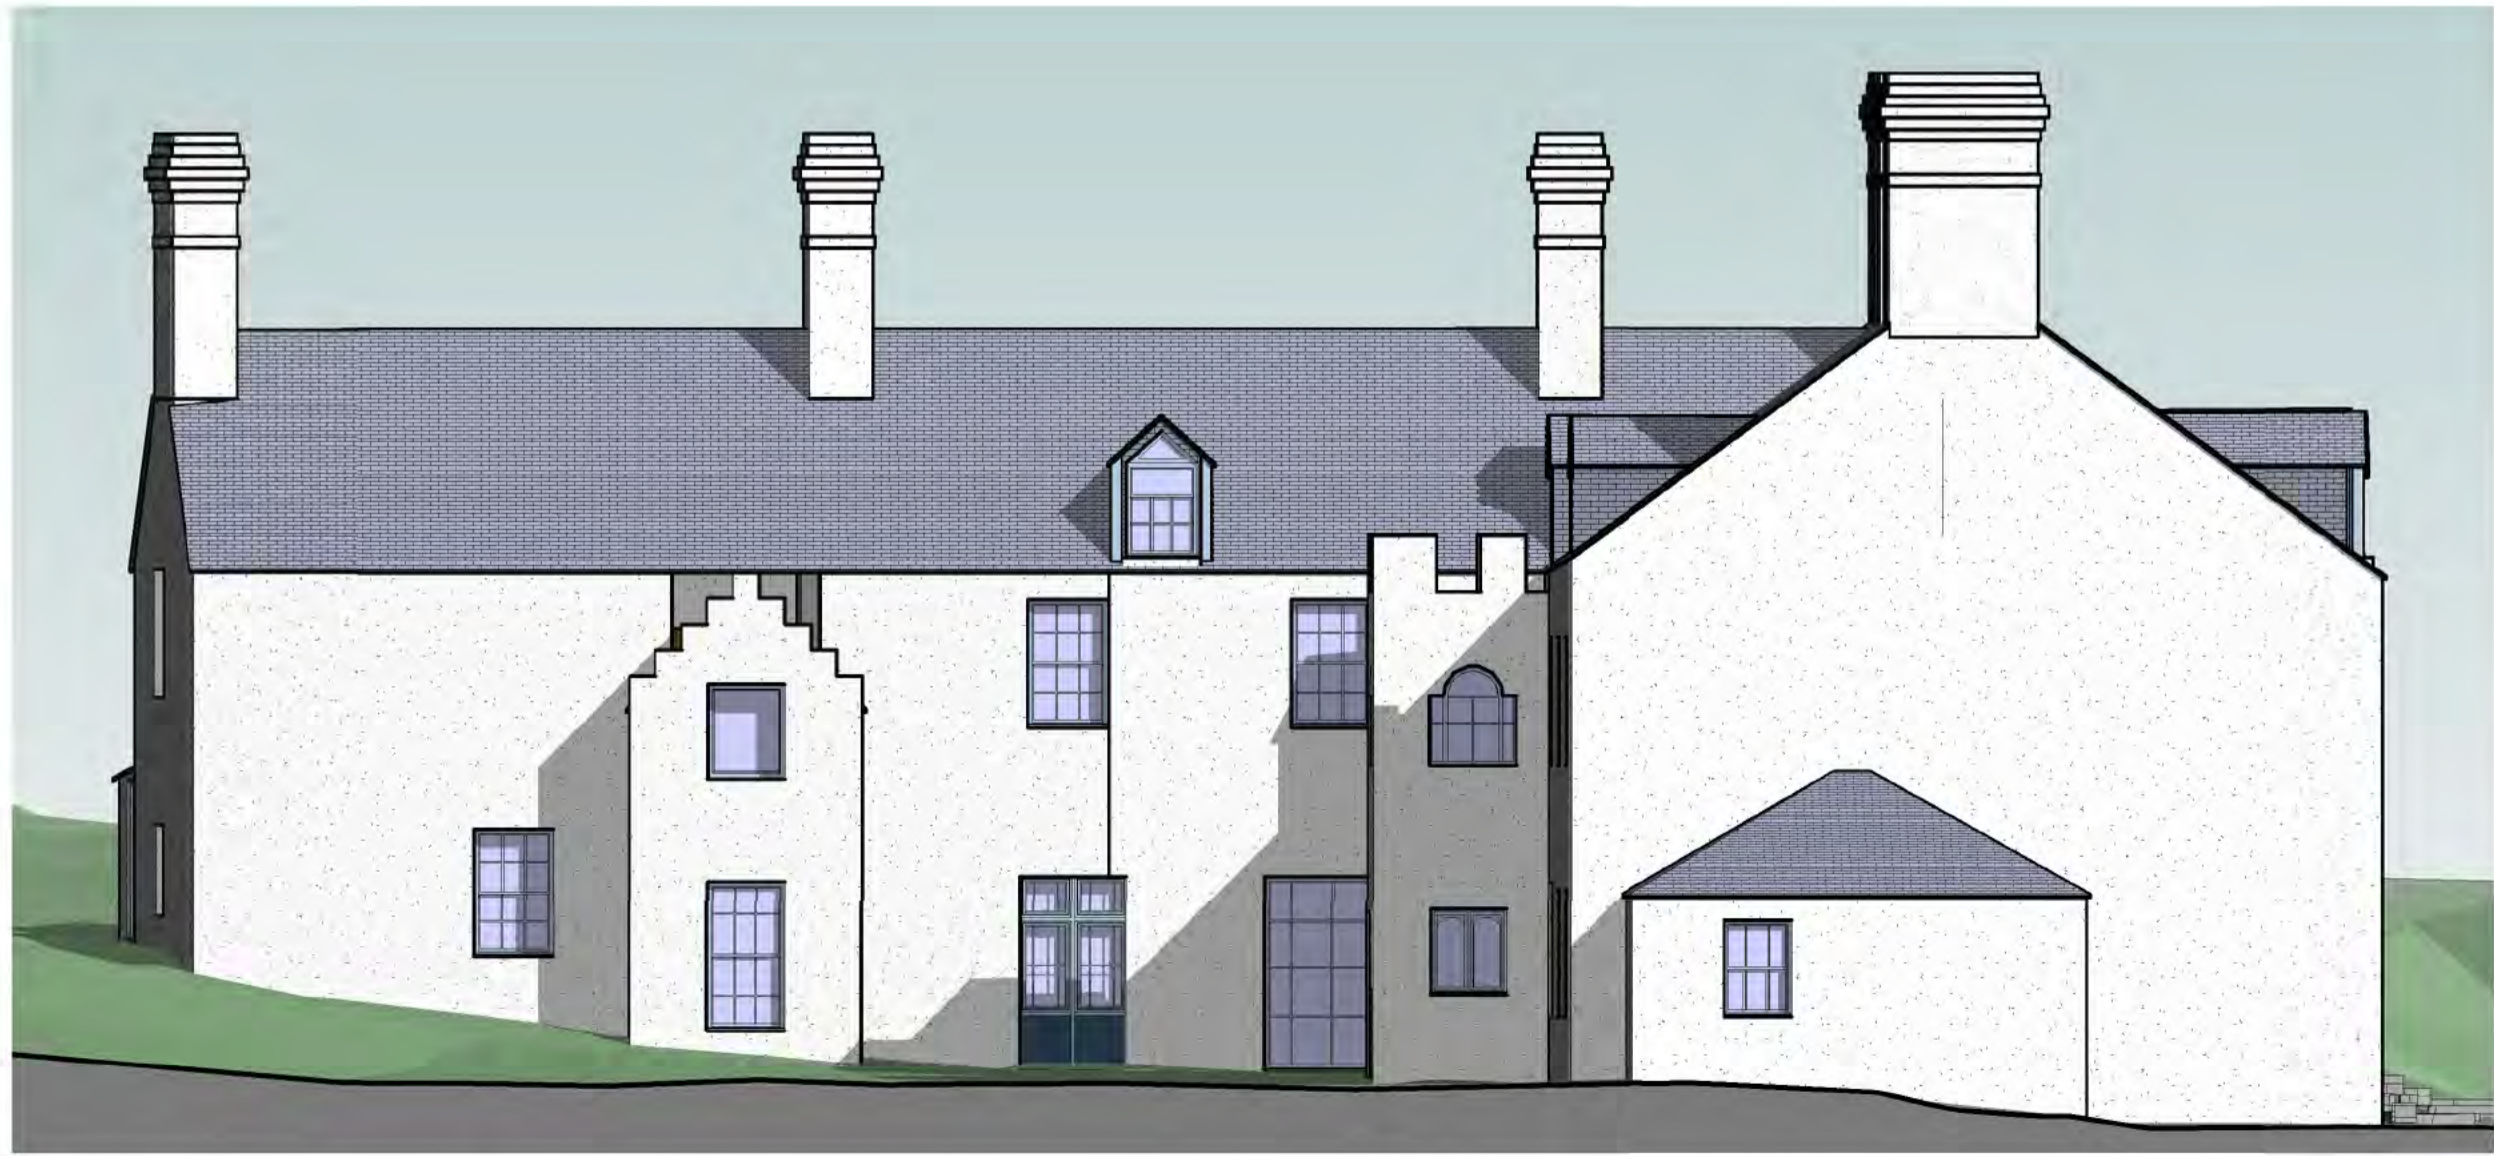
FIGURE 02

**Reproduction of client produced elevation plans of Bodir Hall. JAR
Architecture & Design LTD. Drawing No. A.300. Scale: 1:100@A1**

1 Proposed North Elevation Re-Render
1 : 100

2 Proposed South Elevation Re-Render
1 : 100

3 Proposed East Elevation Re-Render
1 : 100

4 Proposed West Elevation Re-Render
1 : 100

The removal of the existing render would be with a variable speed hammer drill to minimize damage to the existing stonework and mortar joints. The masonry would then be power washed to remove dirt and debris from original render and the render removal process.

Once this has been completed, the bare masonry can be assessed and any repairs to the stonework and mortar joints can be completed. The gauge of mix would be as per St Asier specification (two parts sand / one part NHL 2). Once the repairs have been carried out and they have been given the specified time to carbonate, the rendering process can begin.

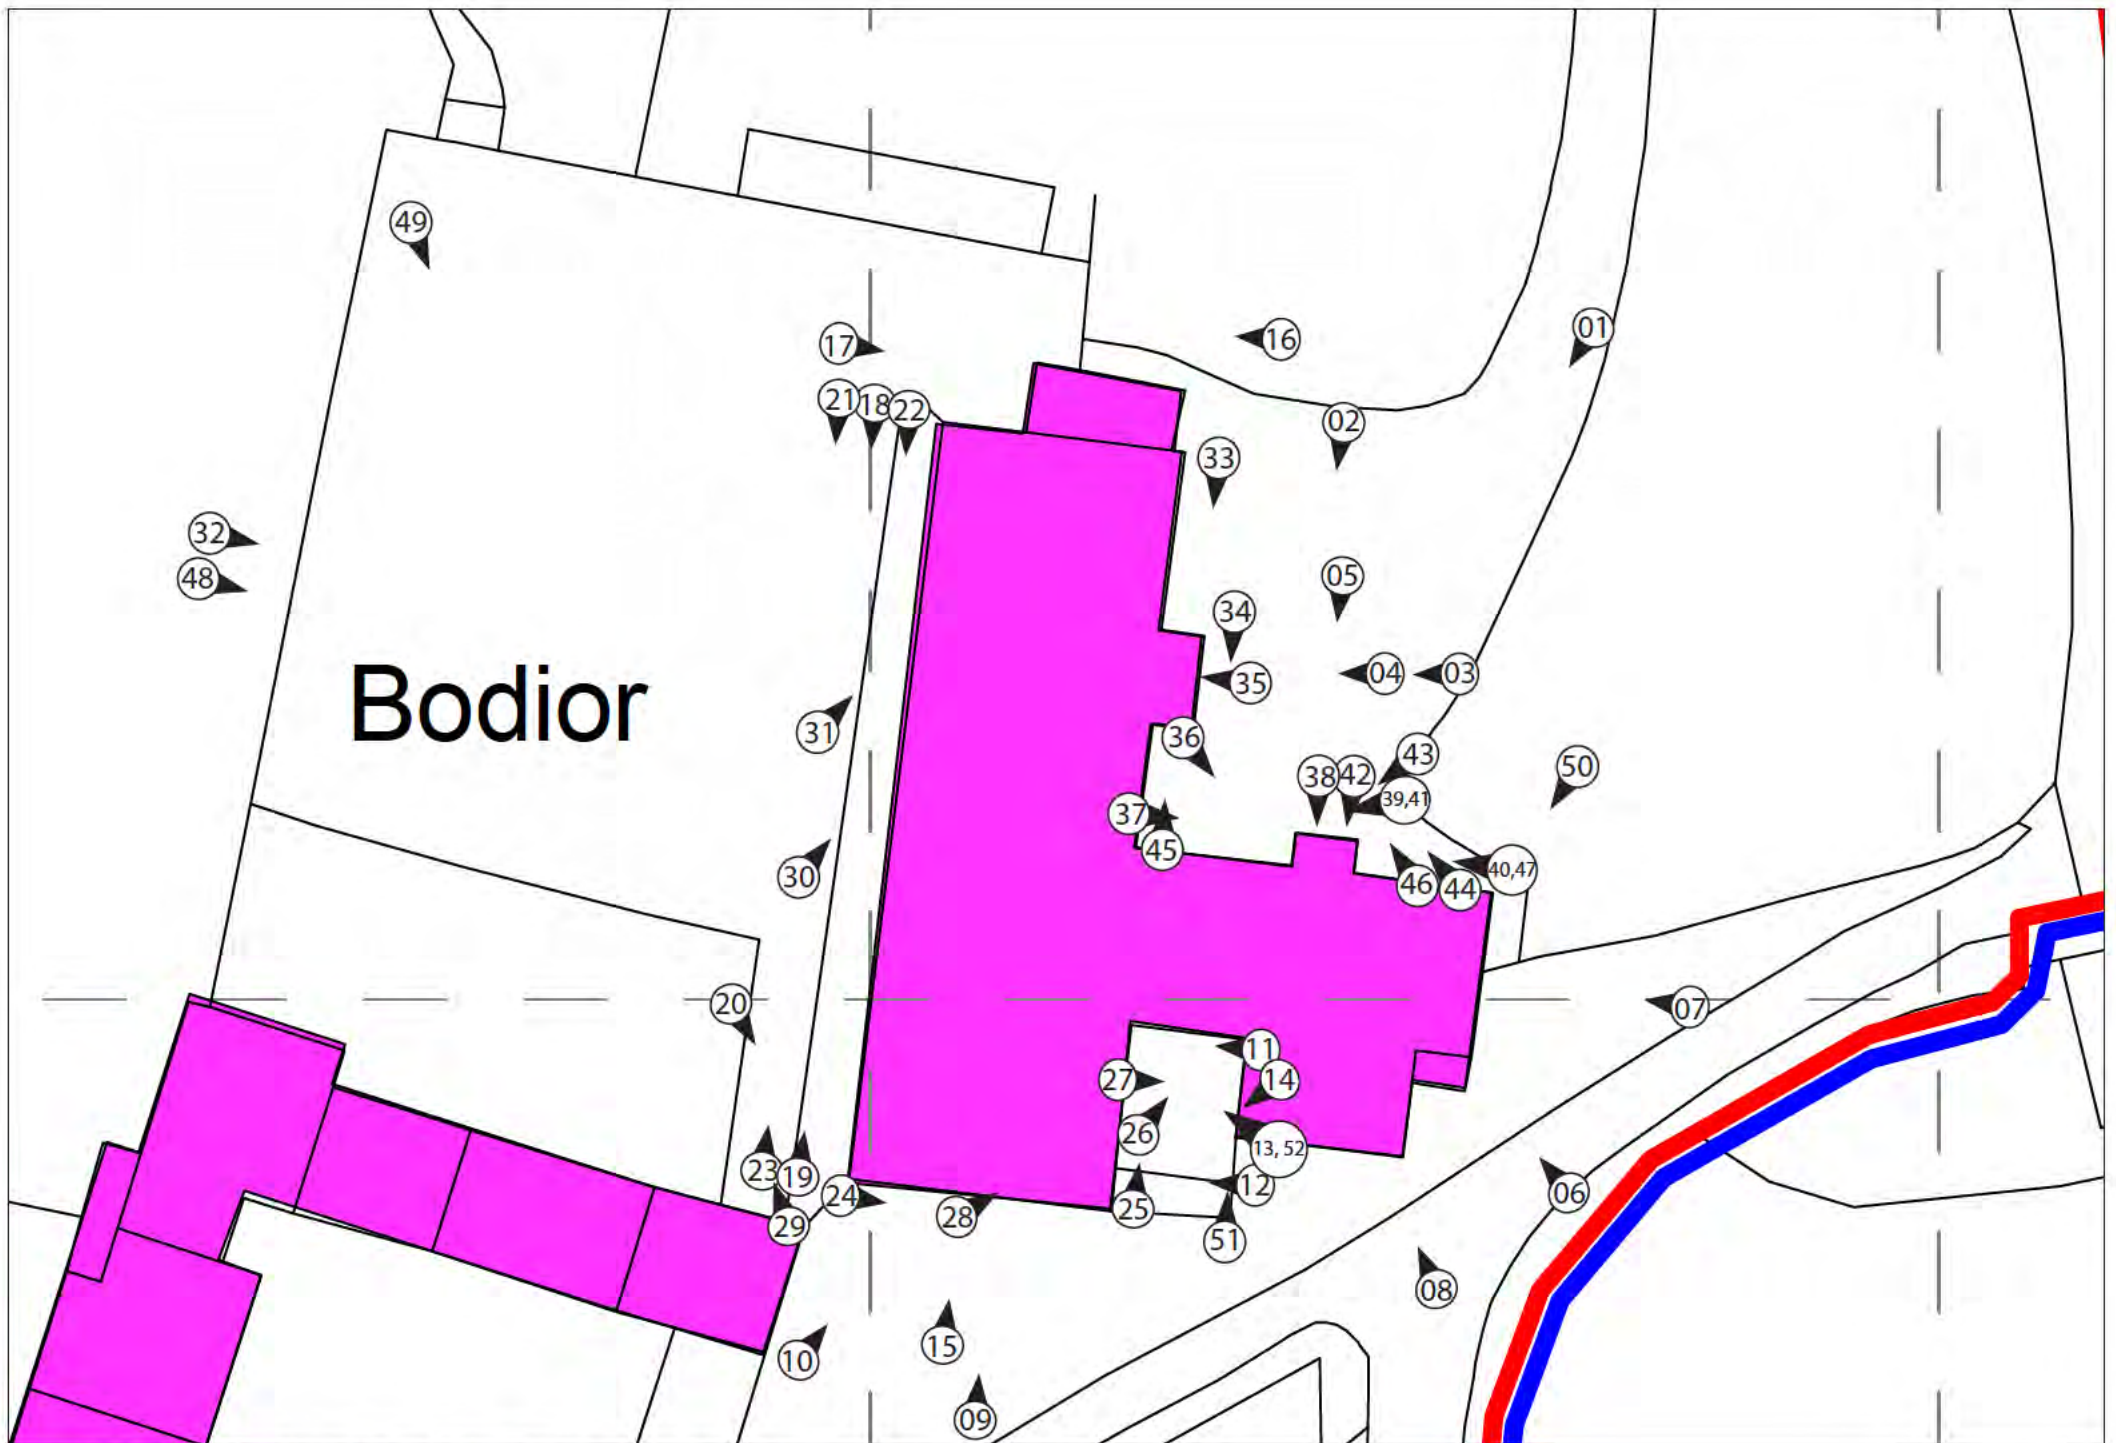
FIGURE 03

Reproduction of client plan annotated with photo directions. Scale: As shown@A4.

- Annotated plans showing the location and direction of view of each photograph. In this instance, *JAR Architecture & Design Ltd. Drawing Nos. A300* ([Figures 03](#)) were used for reference.

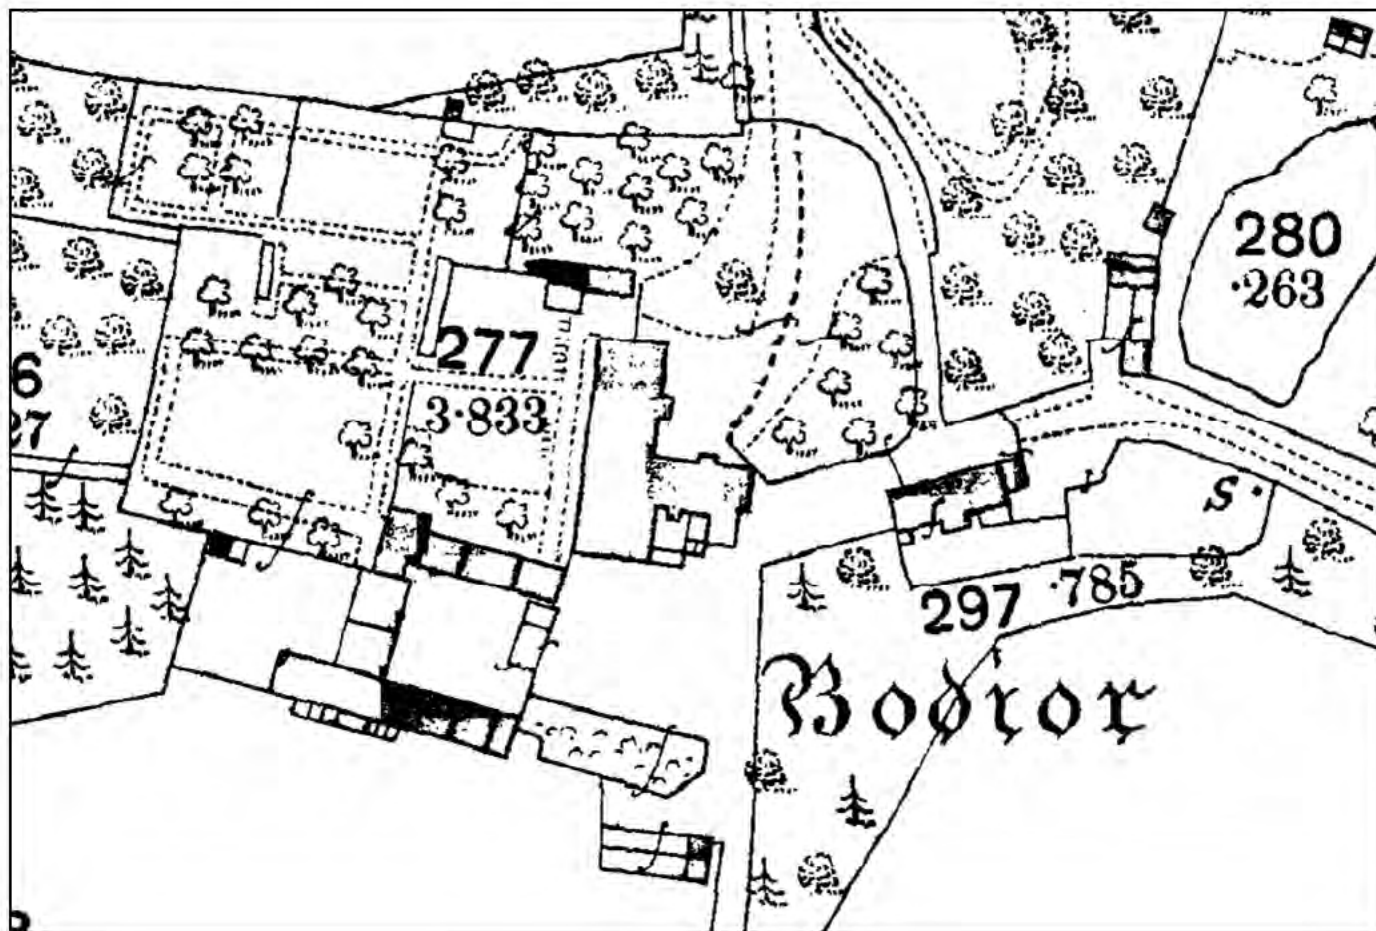
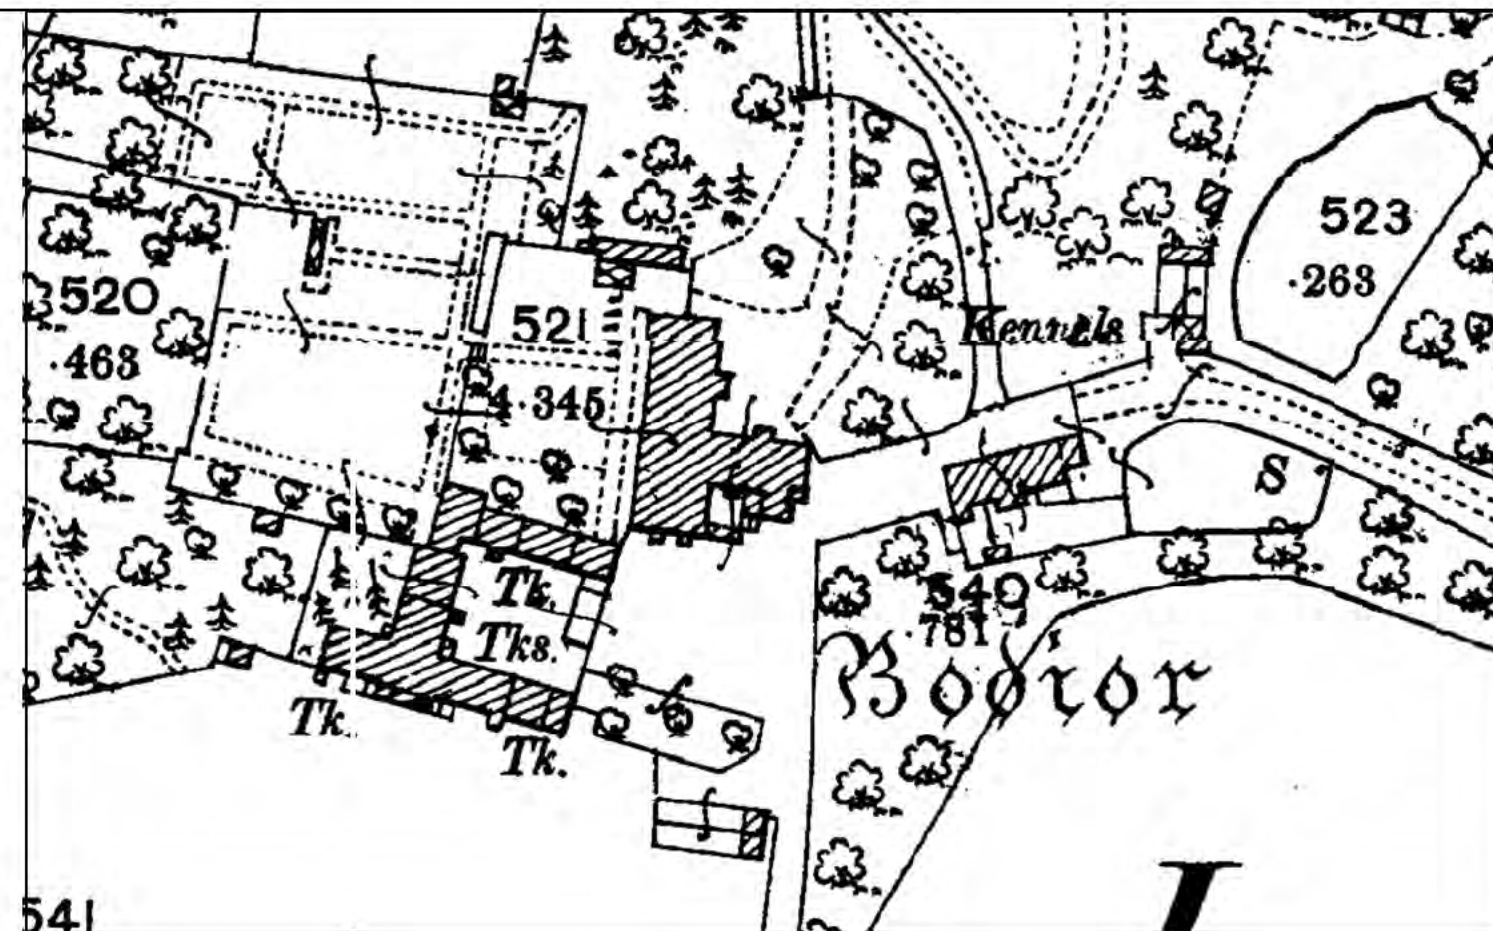
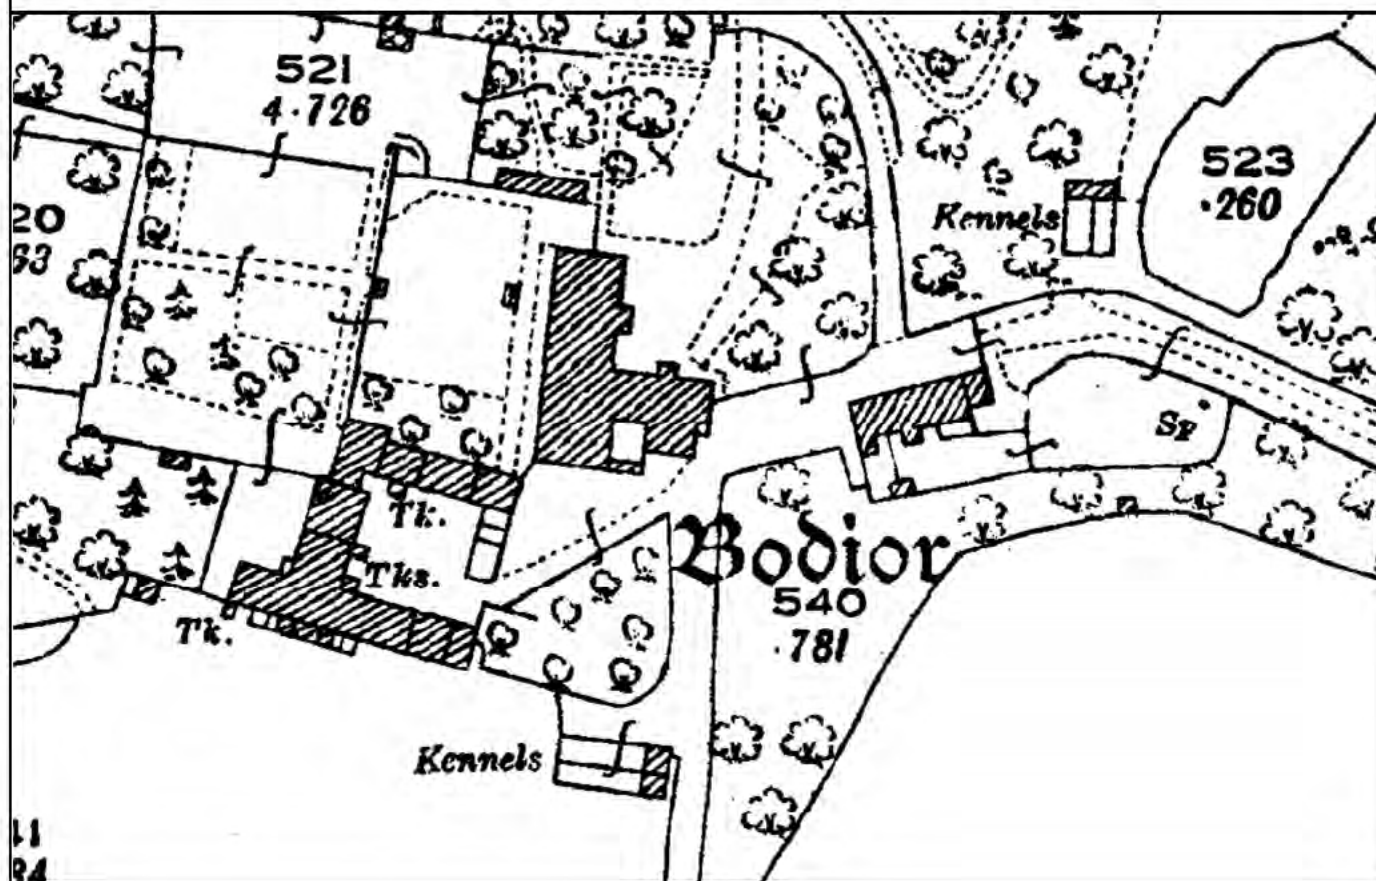
FIGURE 04

First to Third Edition 25 inch to the Mile Ordnance Survey maps (Published 1889, 1900 and 1924). Map shows slight changes in landscape over time. Scale 1:1,250@A3.
