Bodior Hall, Rhoscolyn

Arolygiad Ffotograffig 2025
Photographic Survey 2025

Rhif Prosiect Heneb Archaeoleg Gwynedd / Heneb Gwynedd Archaeology Project No. HD25-012

Rhif Adroddiad / Report No. 1827

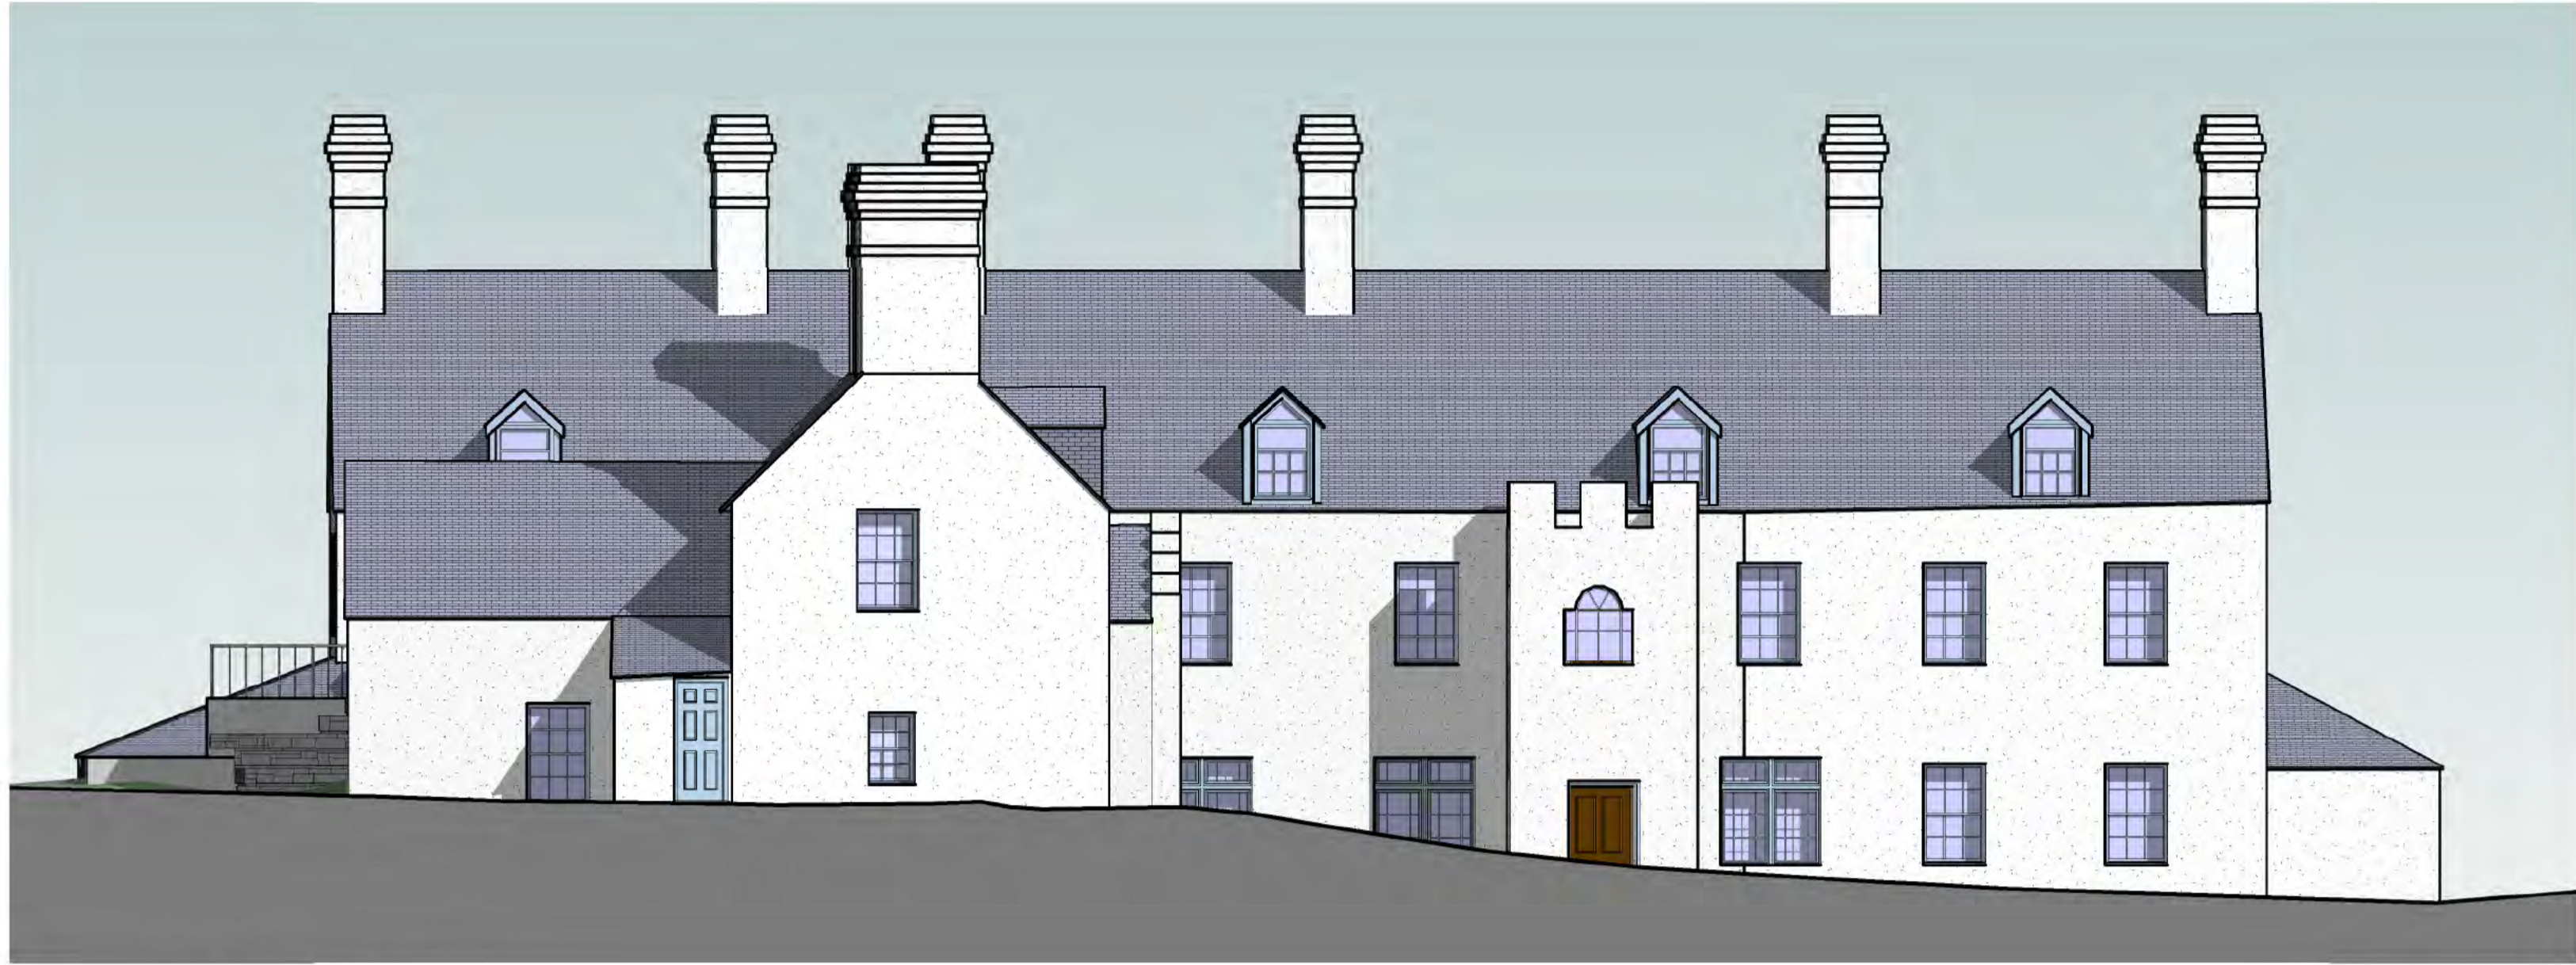
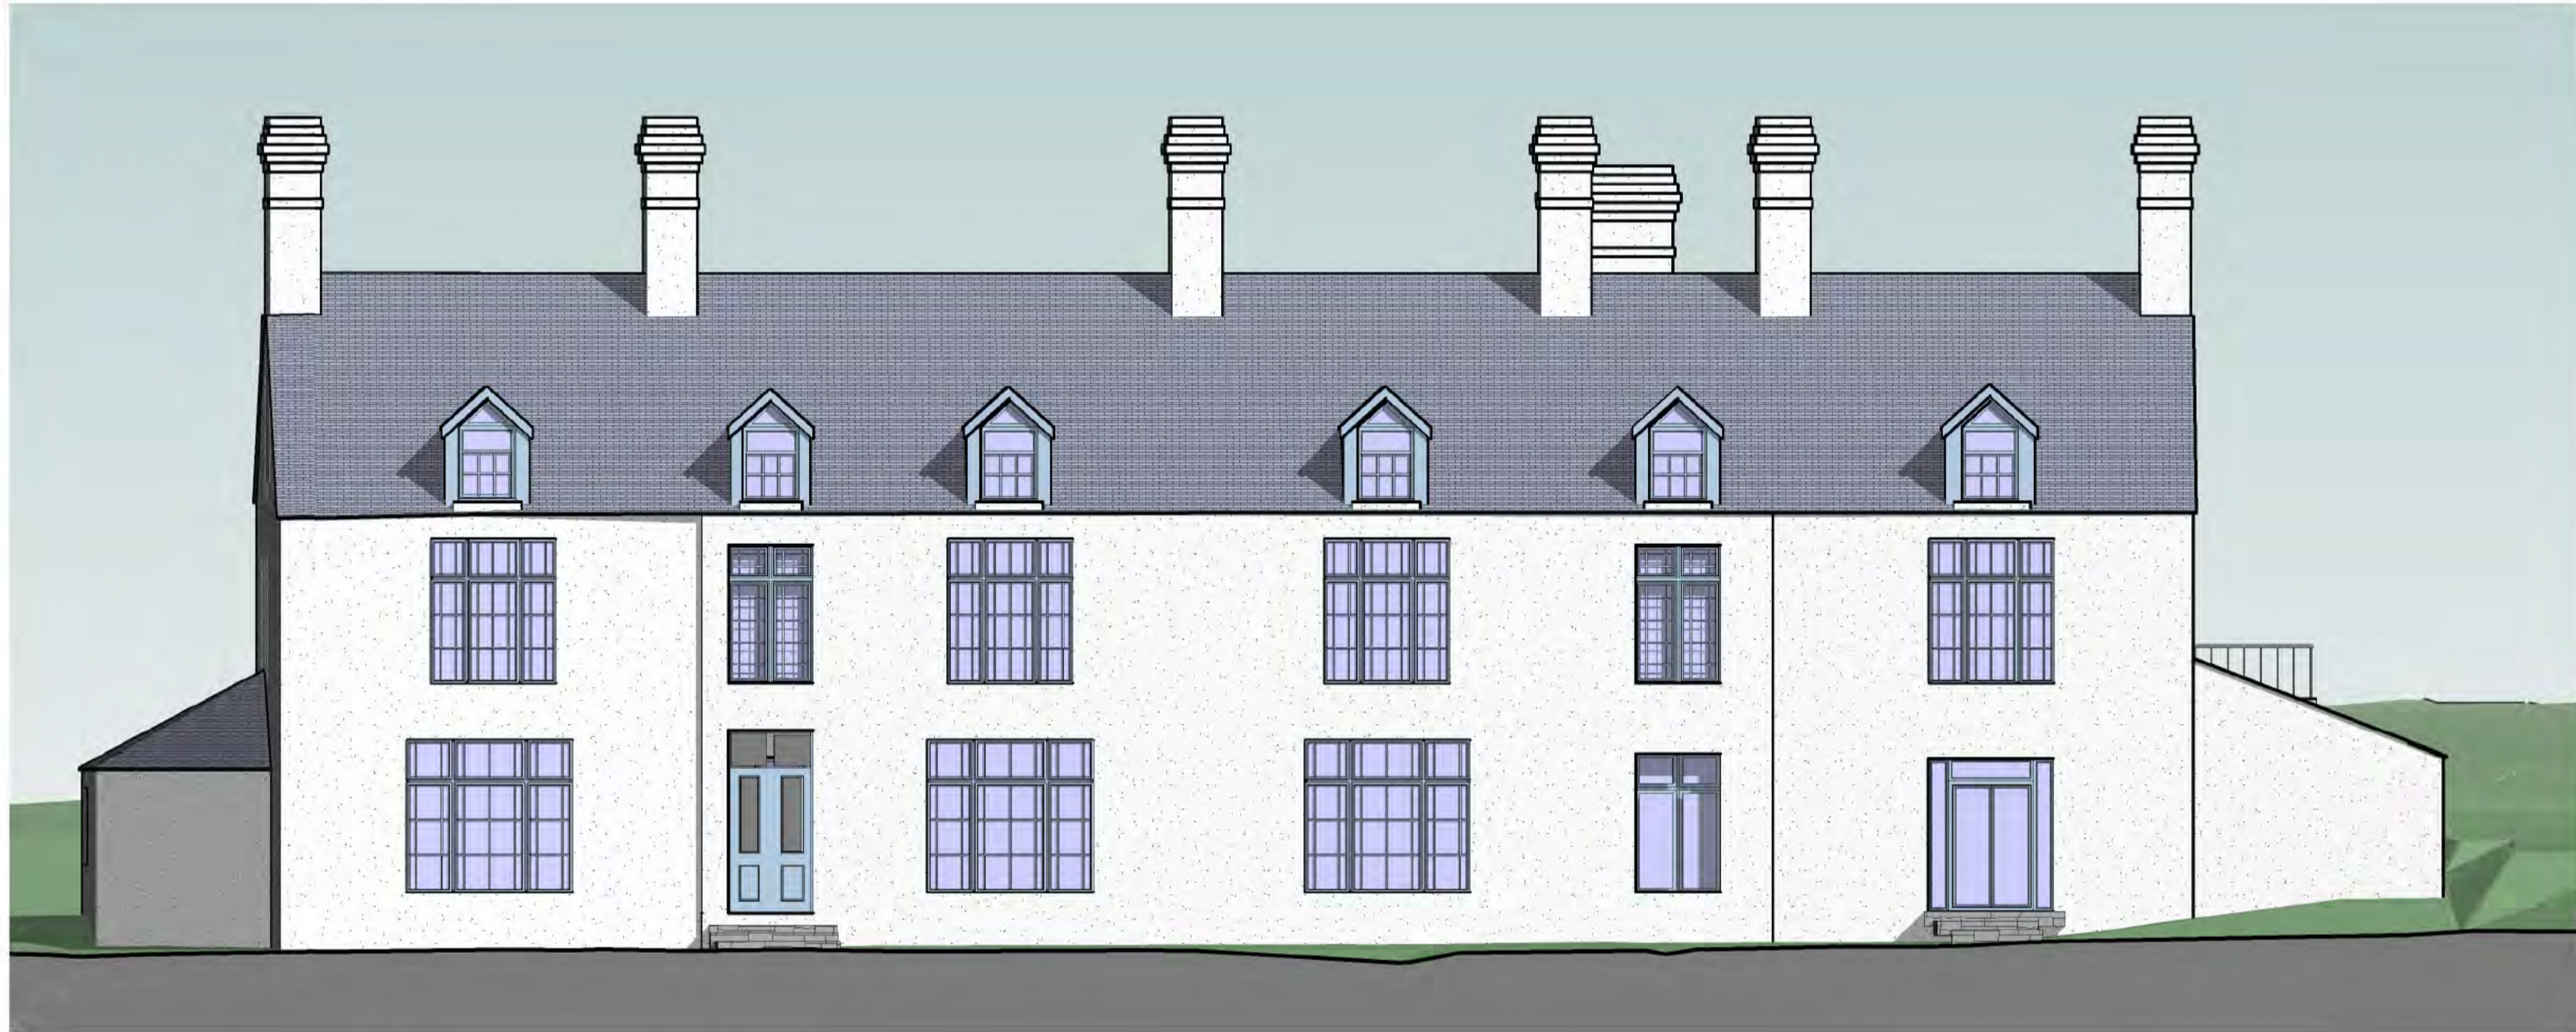
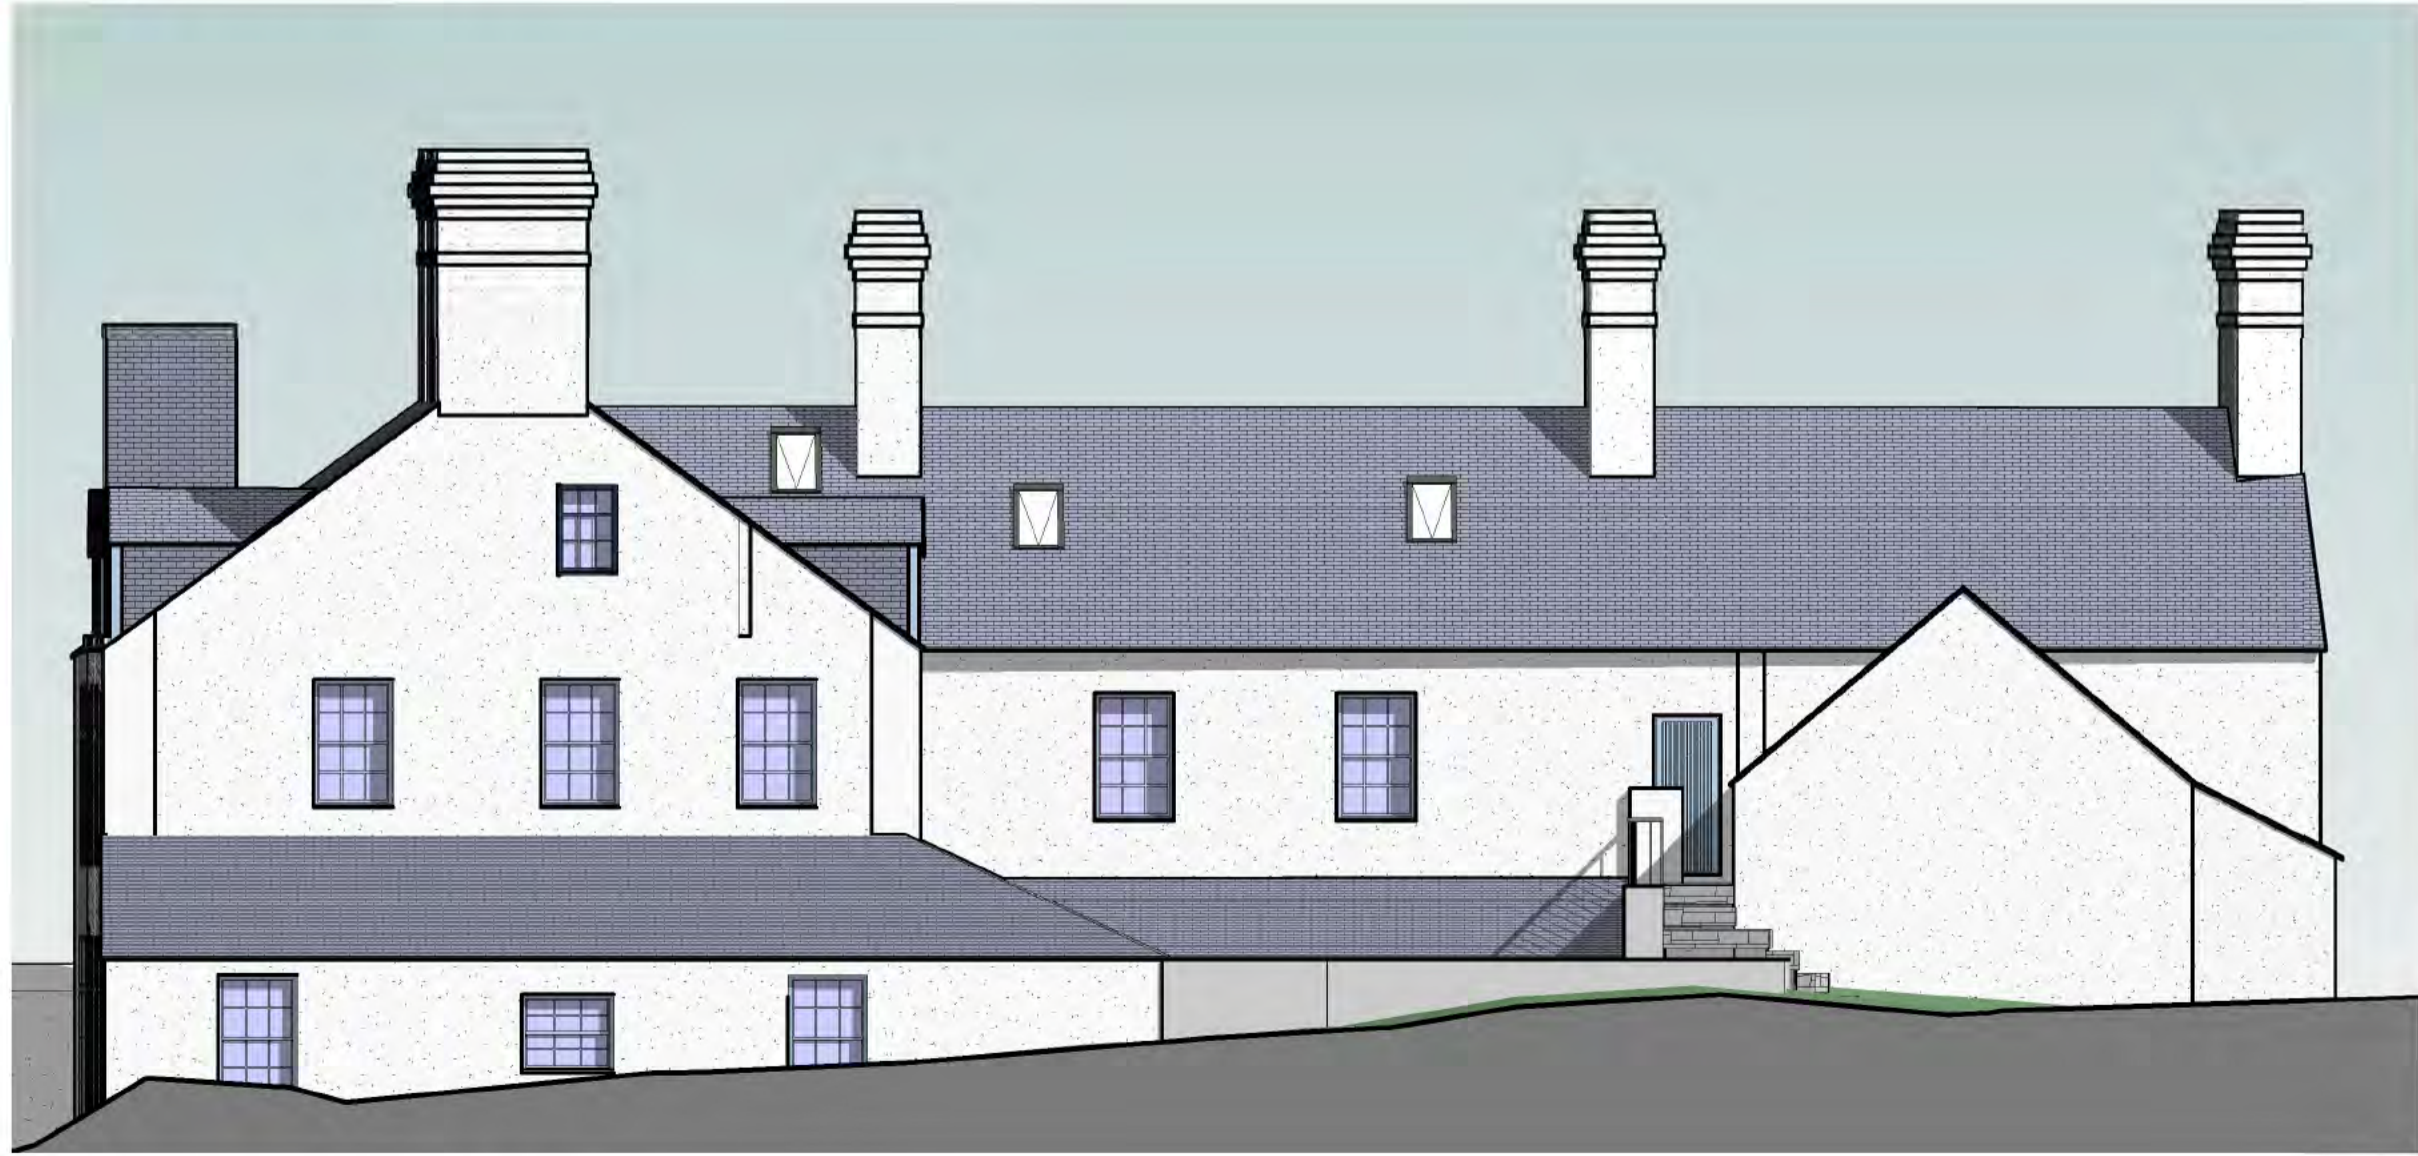
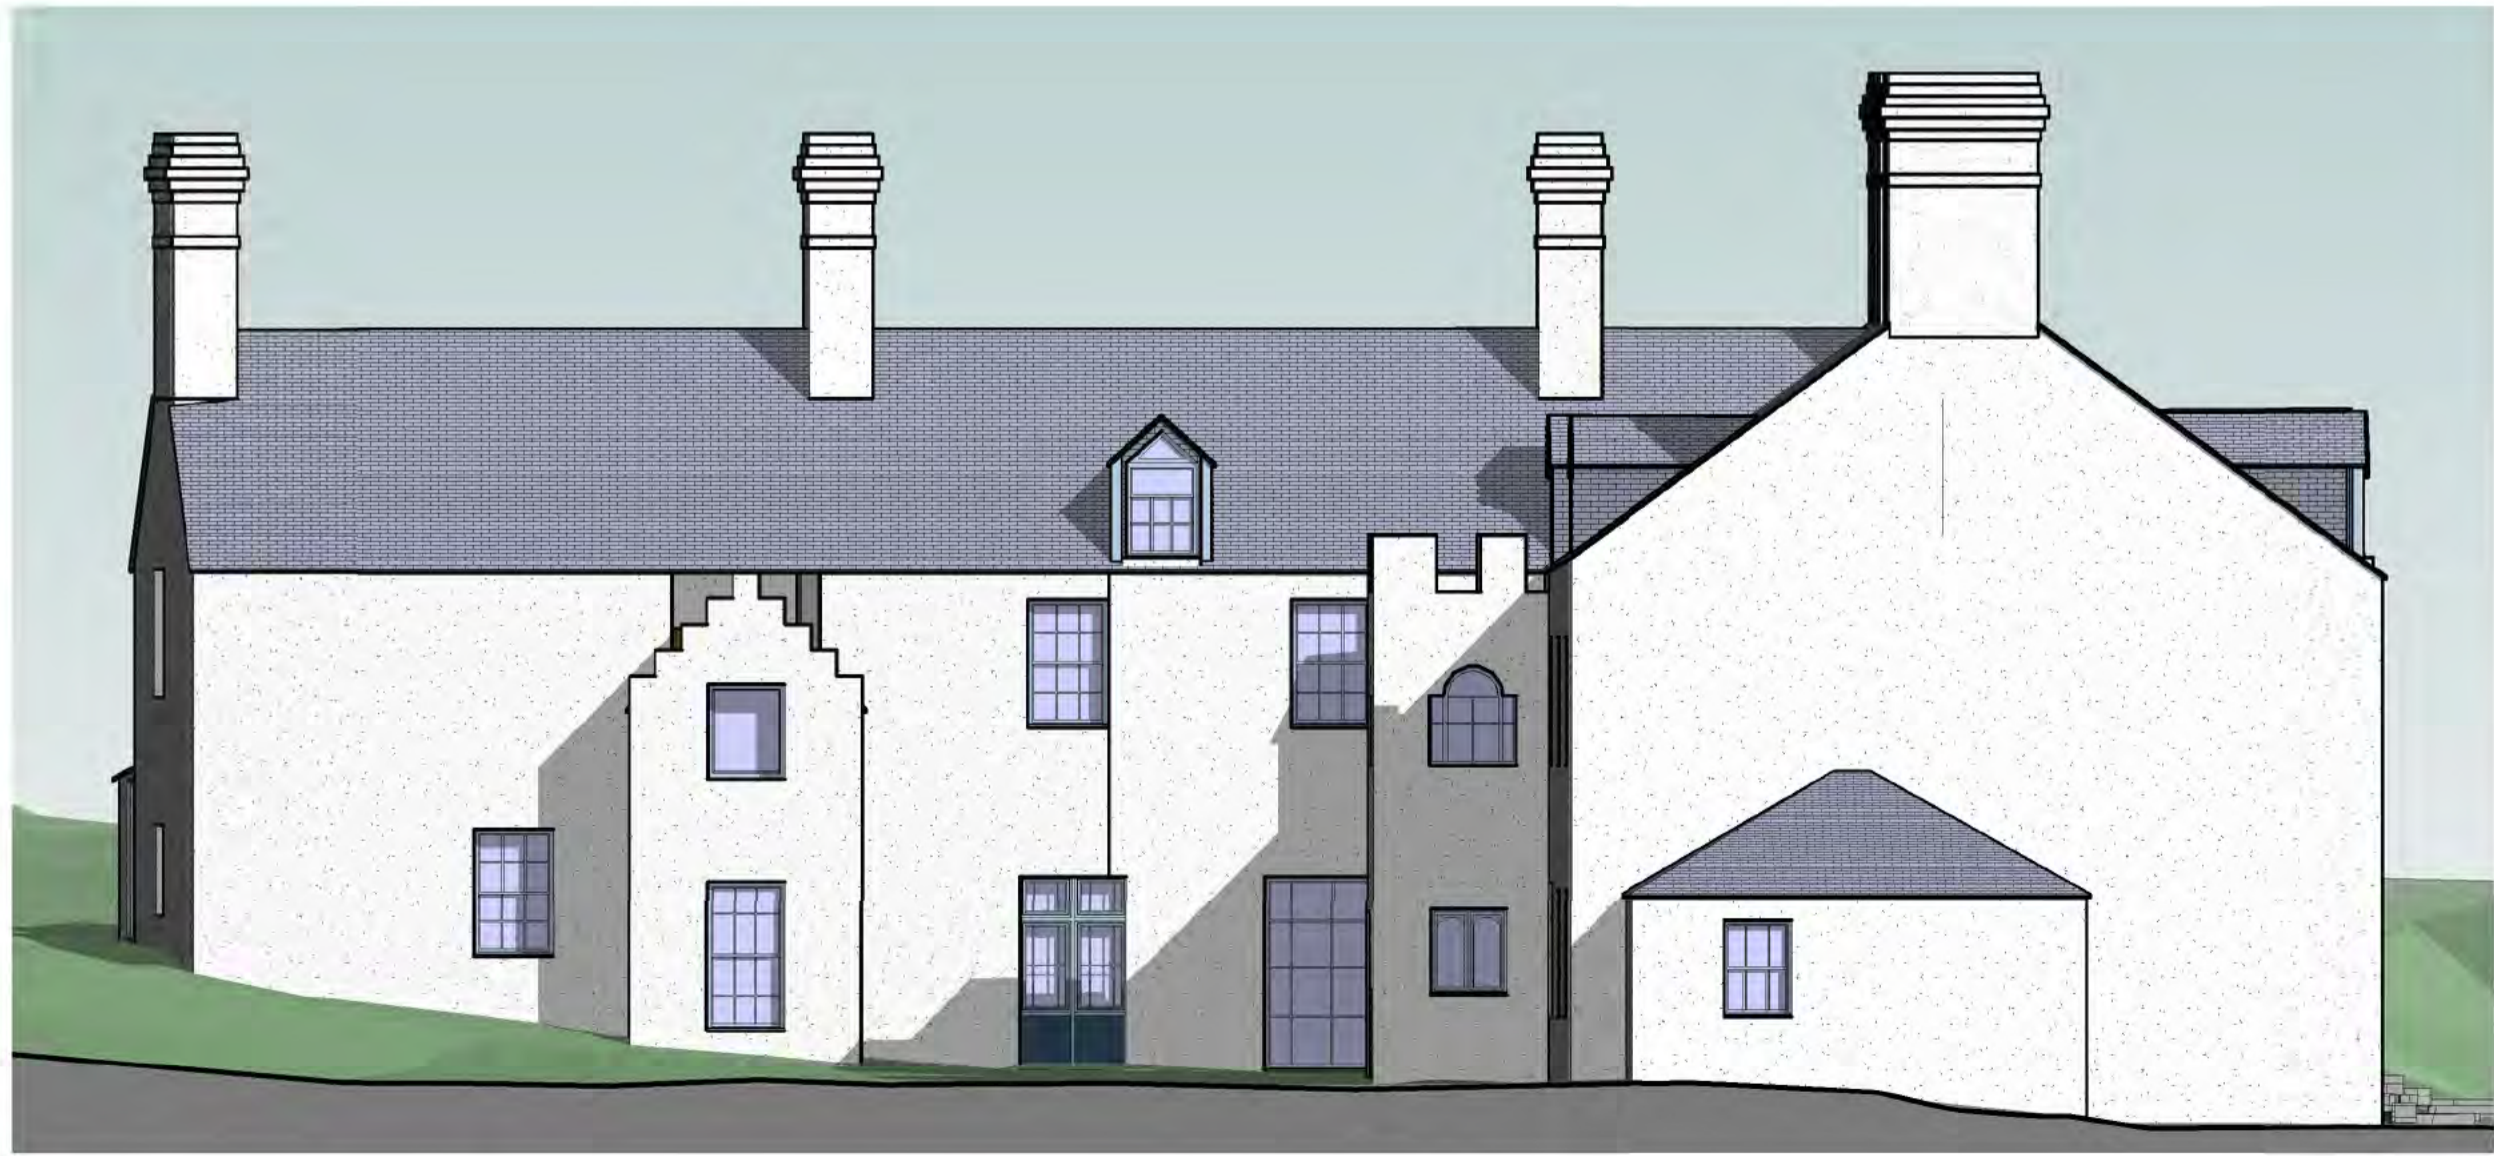
FIGURE 02

**Reproduction of client produced elevation plans of Bodir Hall. JAR
Architecture & Design LTD. Drawing No. A.300. Scale: 1:100@A1**

1 Proposed North Elevation Re-Render
1 : 100

2 Proposed South Elevation Re-Render
1 : 100

3 Proposed East Elevation Re-Render
1 : 100

4 Proposed West Elevation Re-Render
1 : 100

The removal of the existing render would be with a variable speed hammer drill to minimize damage to the exiting stonework and mortar joints. The masonry would then be power washed to remove dirt and debris from original render and the render removal process.

Once this has been completed, the bare masonry can be assessed and any repairs to the stonework and mortar joints can be completed. The gauge of mix would be as per St Asier specification (two parts sand / one part NHL 2). Once the repairs have been carried out and they have been given the specified time to carbonate, the rendering process can begin.

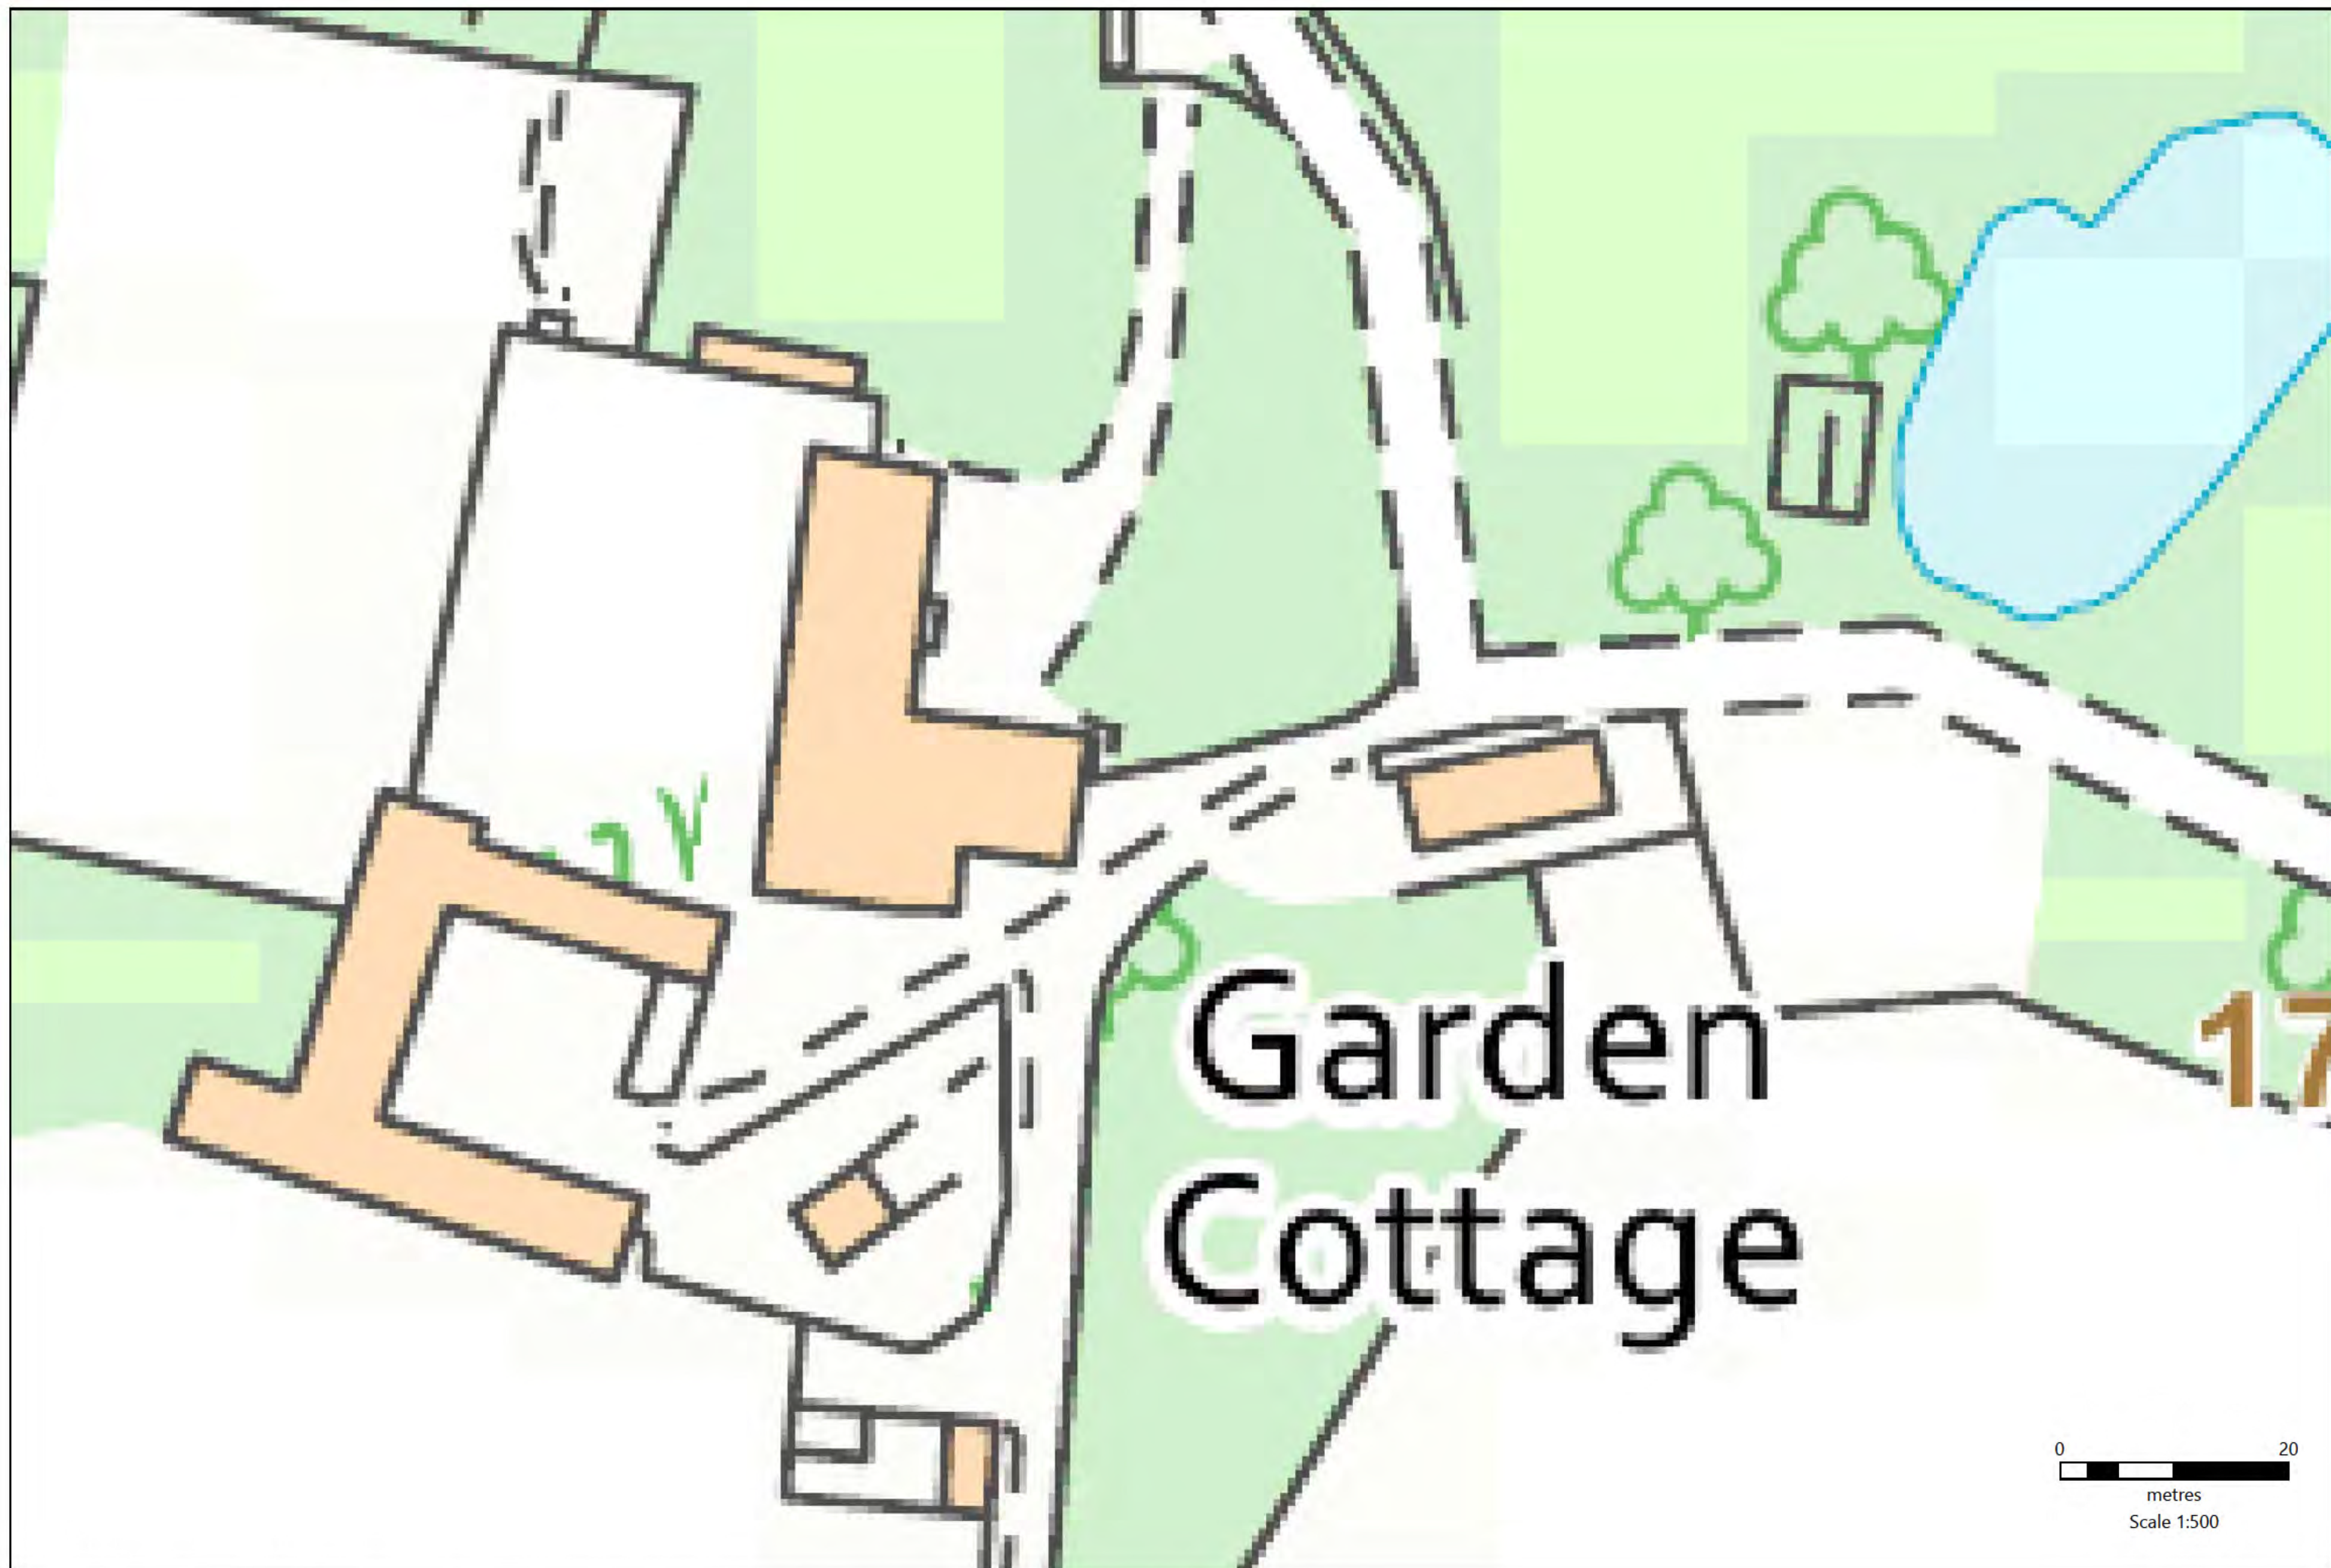
FIGURE 03

Plan of Bodior Hall with associated outbuildings. Scale:1:500@A3
