**Ddol, Bryn y Gefeiliau,
Capel Curig, Gwynedd.
July 2014
V 1.0**

Level 2 Historic Building Record
Project Code: A0042.1
Report no. 0043

Level 2 Historic Building Record
Aeon Archaeology
17 Cecil Street
Chester
CH3 5DP

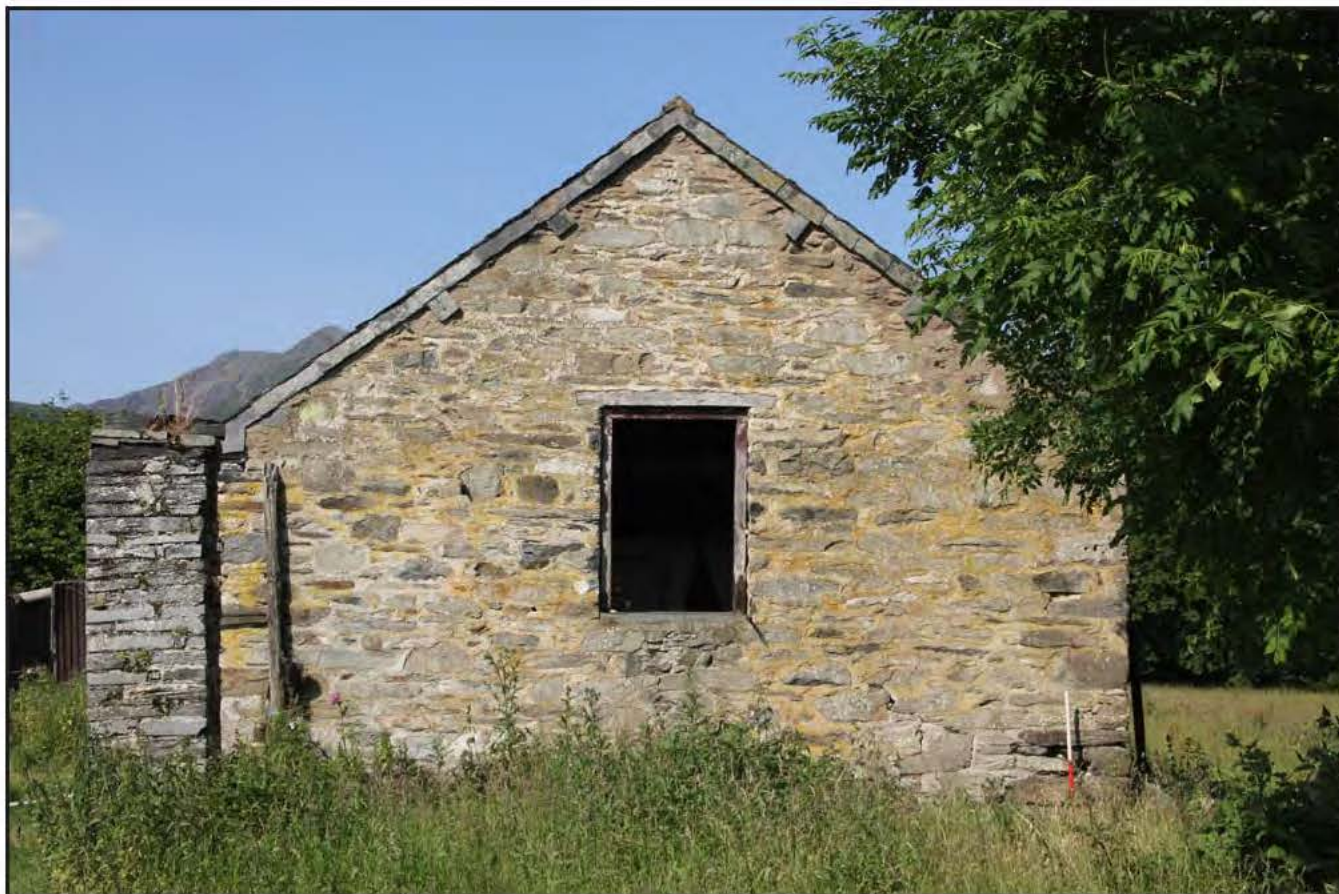
The building has a double-pitched roof of blue-grey slate and slate angular ridge tiles over the northeast barn and of grey asbestos sheet over the southwest barn. The northeast facing gable elevation is constructed from medium sized sub-angular and sub-rounded stone rubble bonded by lime mortar. Otherwise the northeast facing external elevation is featureless.

Plate 01: Northeast facing external elevation, from the northeast. Scale 1.0m.

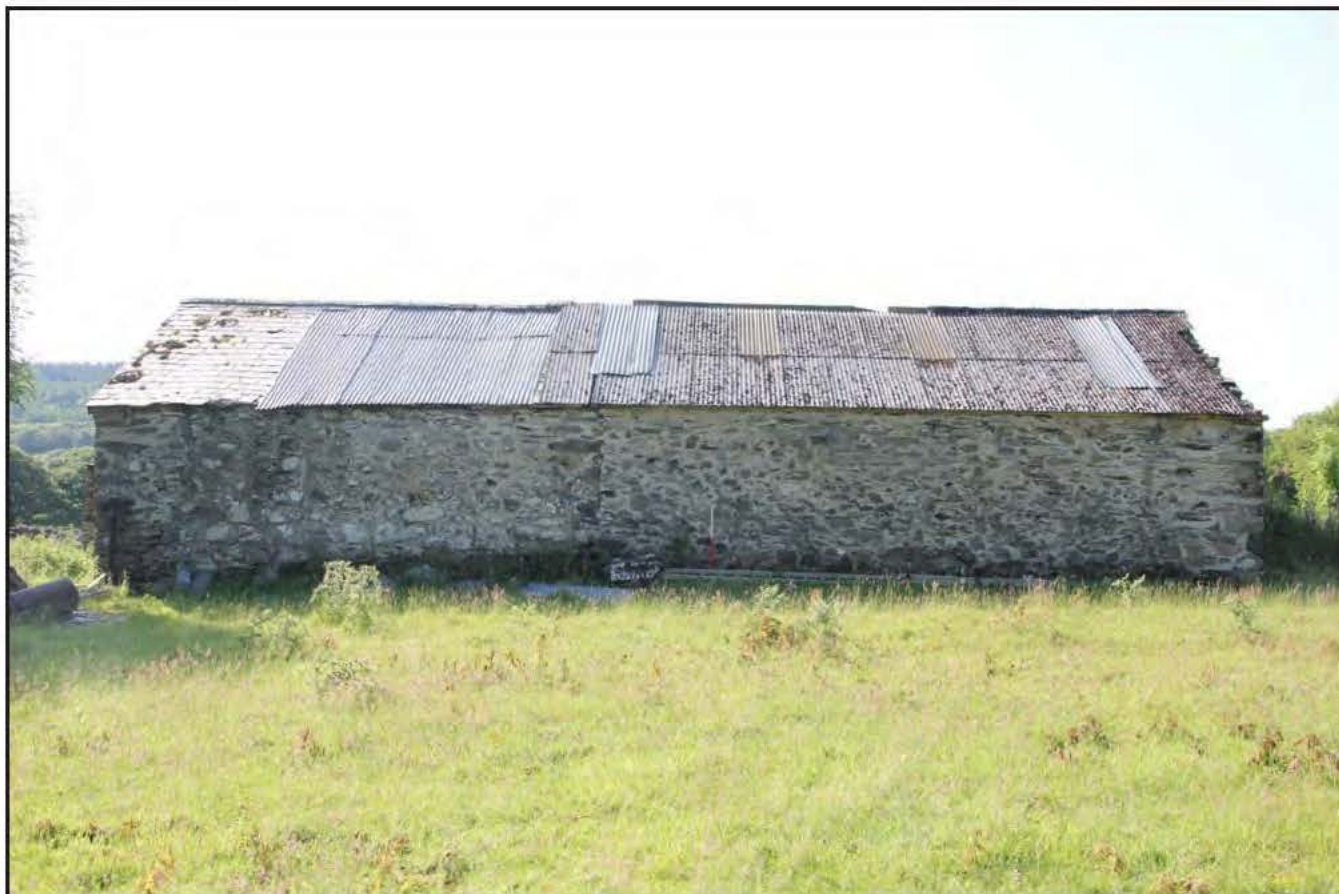
The northwest facing external elevation is also constructed from medium sized sub-angular and sub-rounded stone rubble bonded by lime mortar. There is a clear and visible division in the masonry between the northeast and southwest barns, although the size and type of rubble and mortar utilised in both constructions appears to very similar. The northwest facing external elevation of the southwest barn appears to butt up against the northwest facing wall of the northeast barn, and it is probable that the northeast barn is earlier in date.

Plate 02: Northwest facing external elevation, from the northwest. Scale 1.0m.

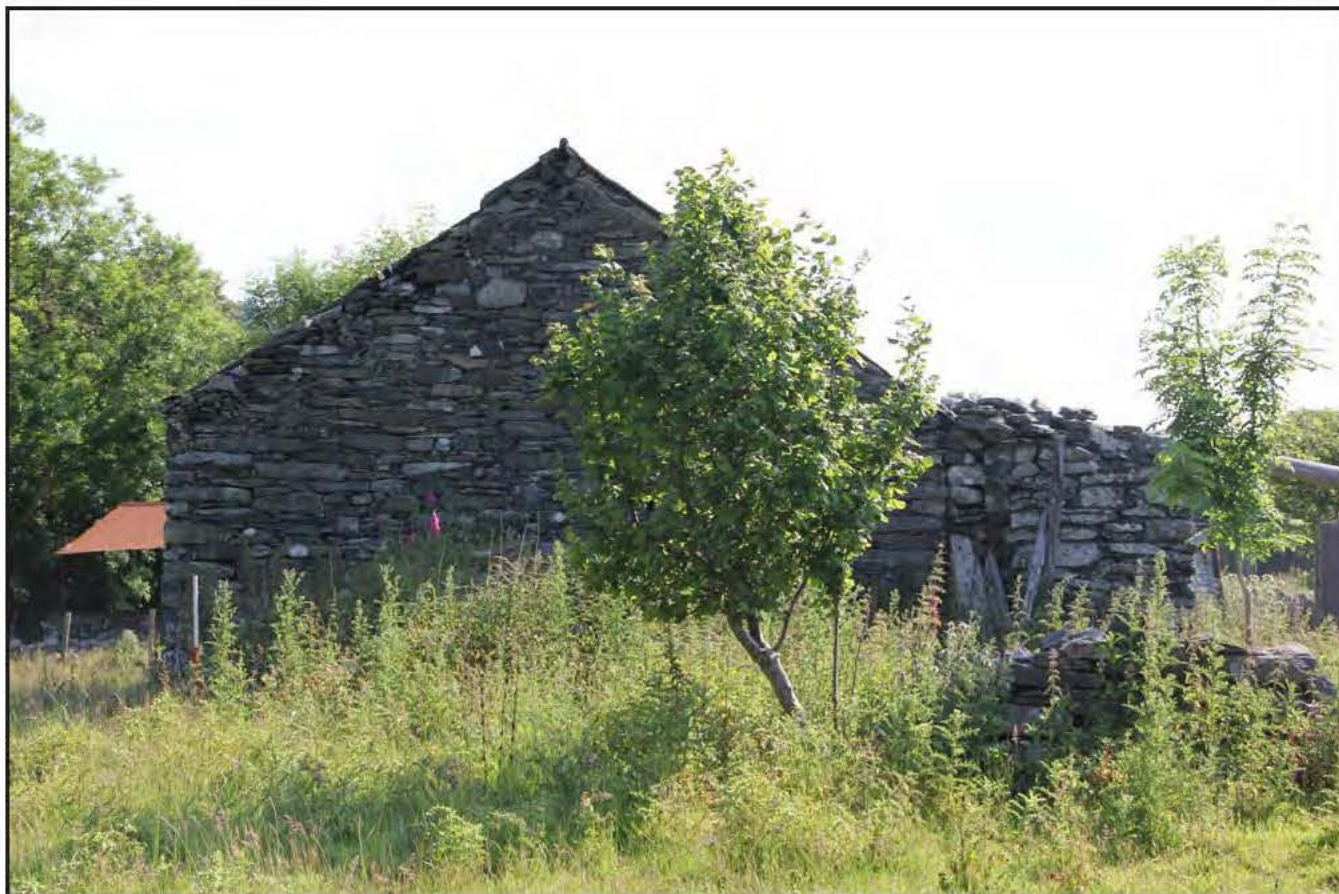
The southwest facing gable elevation is constructed from medium sized sub-angular and sub-rounded stone rubble bonded by lime mortar, but is otherwise featureless aside from a rubble stone pile lying to the immediate southwest and described below.

Plate 03: Southwest facing external elevation, from the southwest. Scale 1.0m.

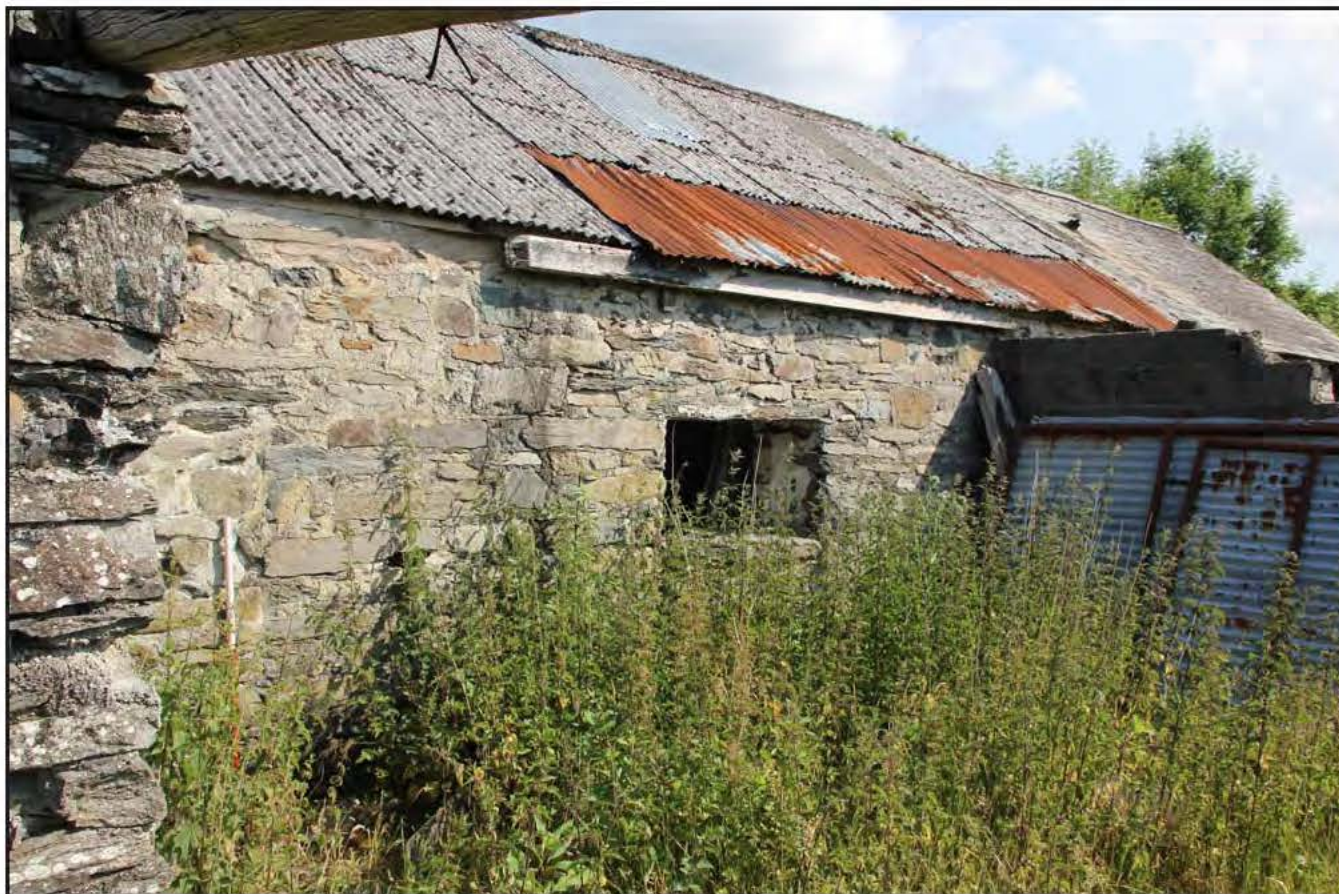
The southeast facing elevation has had a later lean-to outbuilding structure constructed against the outer face at the southwest end. This structure is now ruinous and is described below. The elevation is constructed from medium sized sub-angular and sub-rounded stone rubble bonded by lime mortar. At the southwest end of the southeast facing external elevation a single doorway has been blocked with medium sized sub-angular stone rubble bonded by mortar. Approximately 2.5m to the northeast is an open window with angular stone rubble lintel and sill. Towards the centre of the elevation a single doorway with wooden boarded door permits access into the southwest barn and to the immediate northeast of this a clear separation in the masonry shows that the southwest barn wall butts on to the northeast barn thus post dating it.

Plate 04: Southeast facing external elevation (southwest end), from the south. Scale 1.0m.

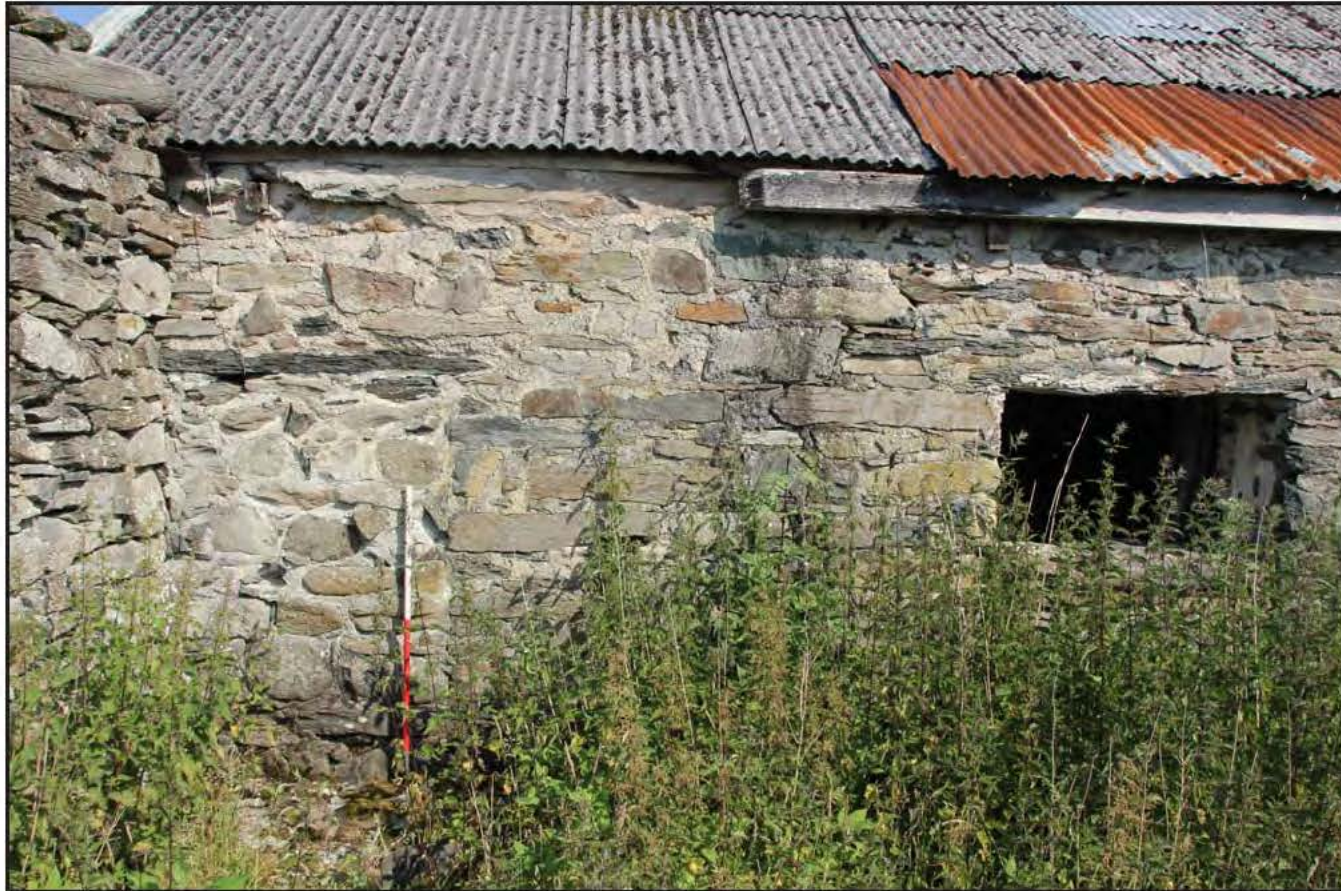
Plate 05: Southeast facing external elevation (southwest end) showing blocked doorway, from the southeast. Scale 1.0m.

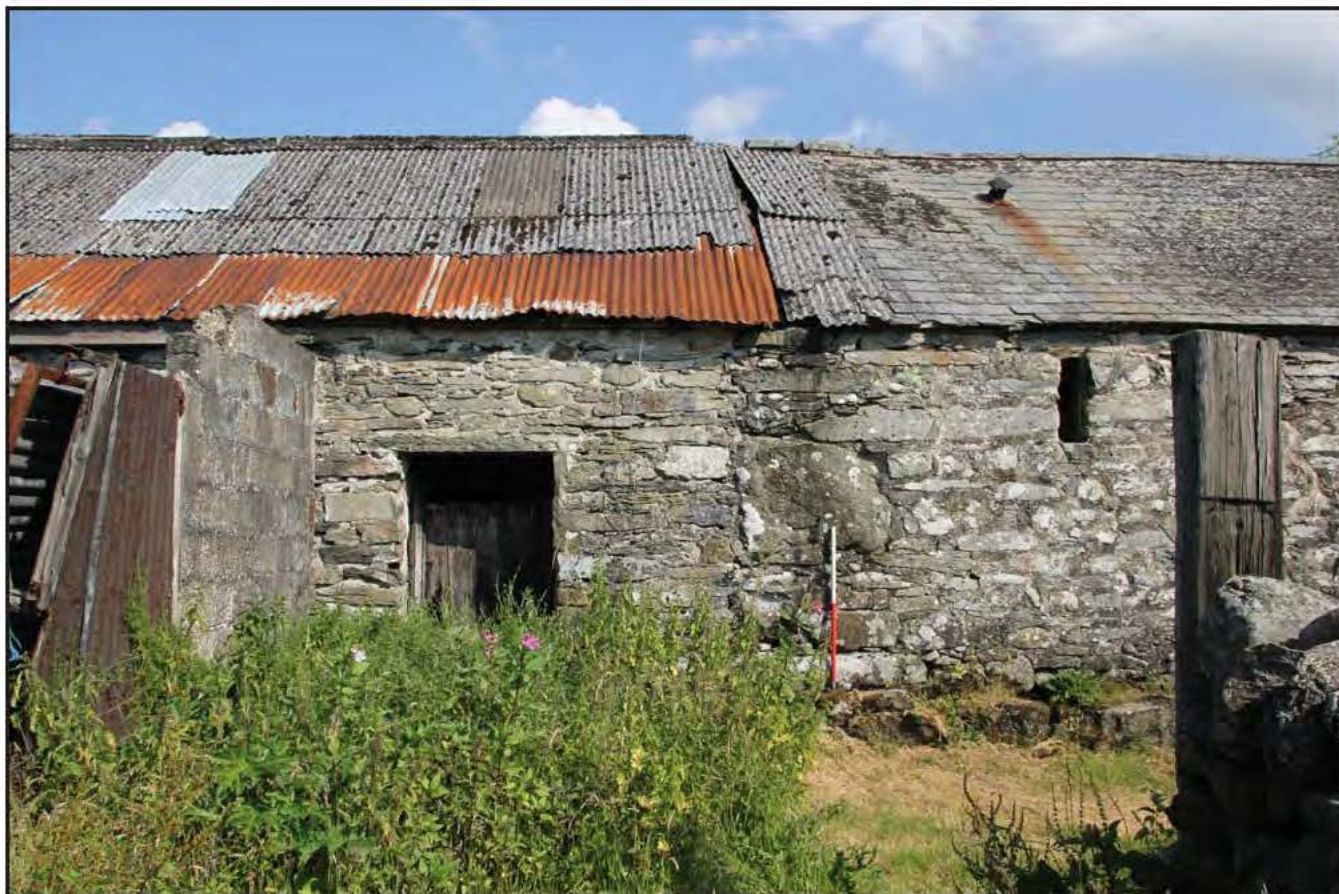
Plate 06: Southeast facing external elevation (centre), from the southeast. Scale 1.0m.

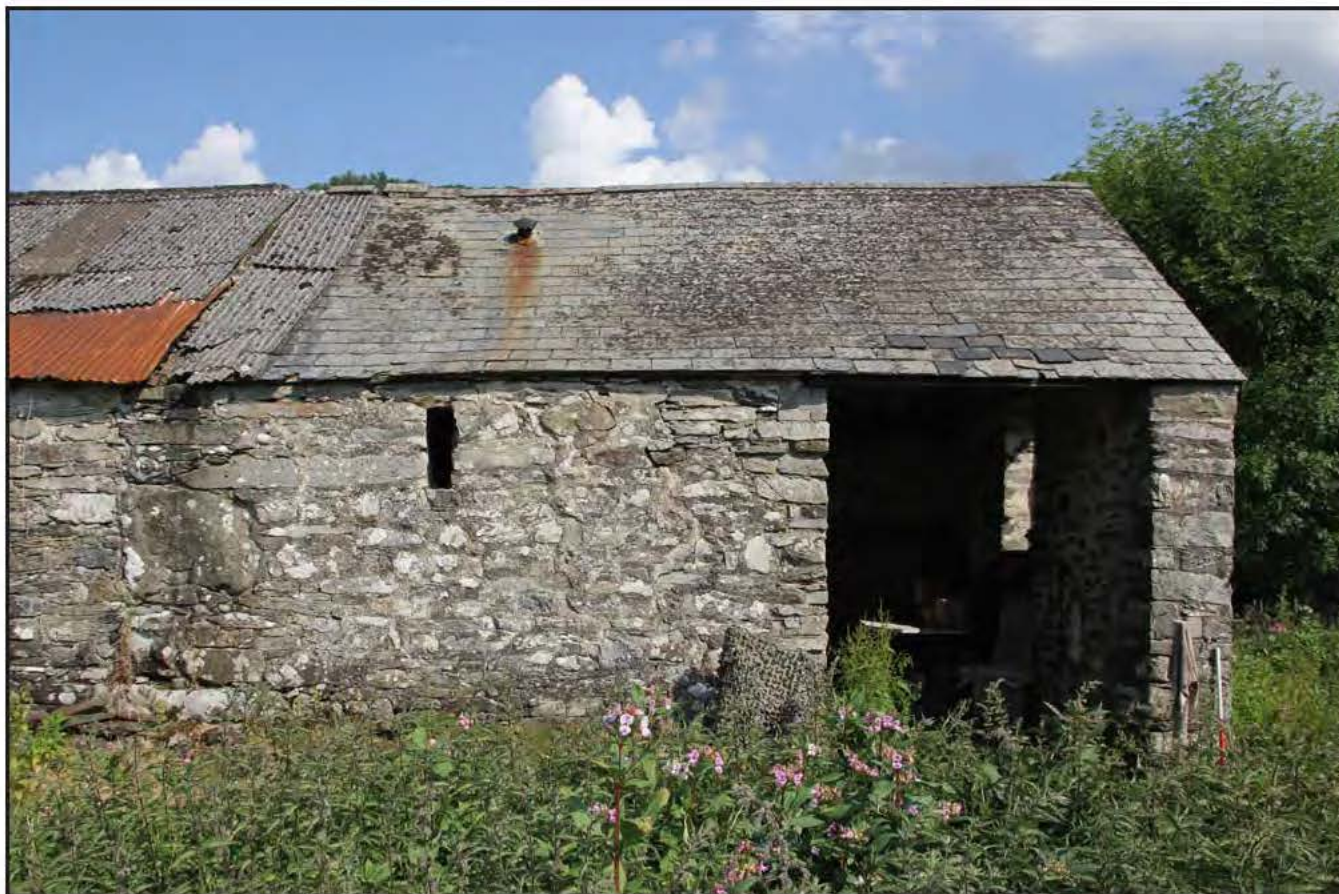
The southeast facing elevation of the northeast barn incorporates larger sub-rounded stone rubble blocks into the lower courses of the wall, and a single foundation course of very large sub-rounded and sub-angular blocks runs along the base of the southeast facing wall. These stones step out approximately 0.4m from the upstanding masonry wall and appear to be the foundation stones of an earlier structure. There is a narrow window opening at eaves height and a large opening at the northeast end that permits access into the northeast barn. This opening has clearly been inserted at a later date to enable large machinery to be stored in the barn, although it probably replaced a single doorway located at the same point.

Plate 07: Southeast facing external elevation (northeast end), from the southeast. Scale 1.0m.

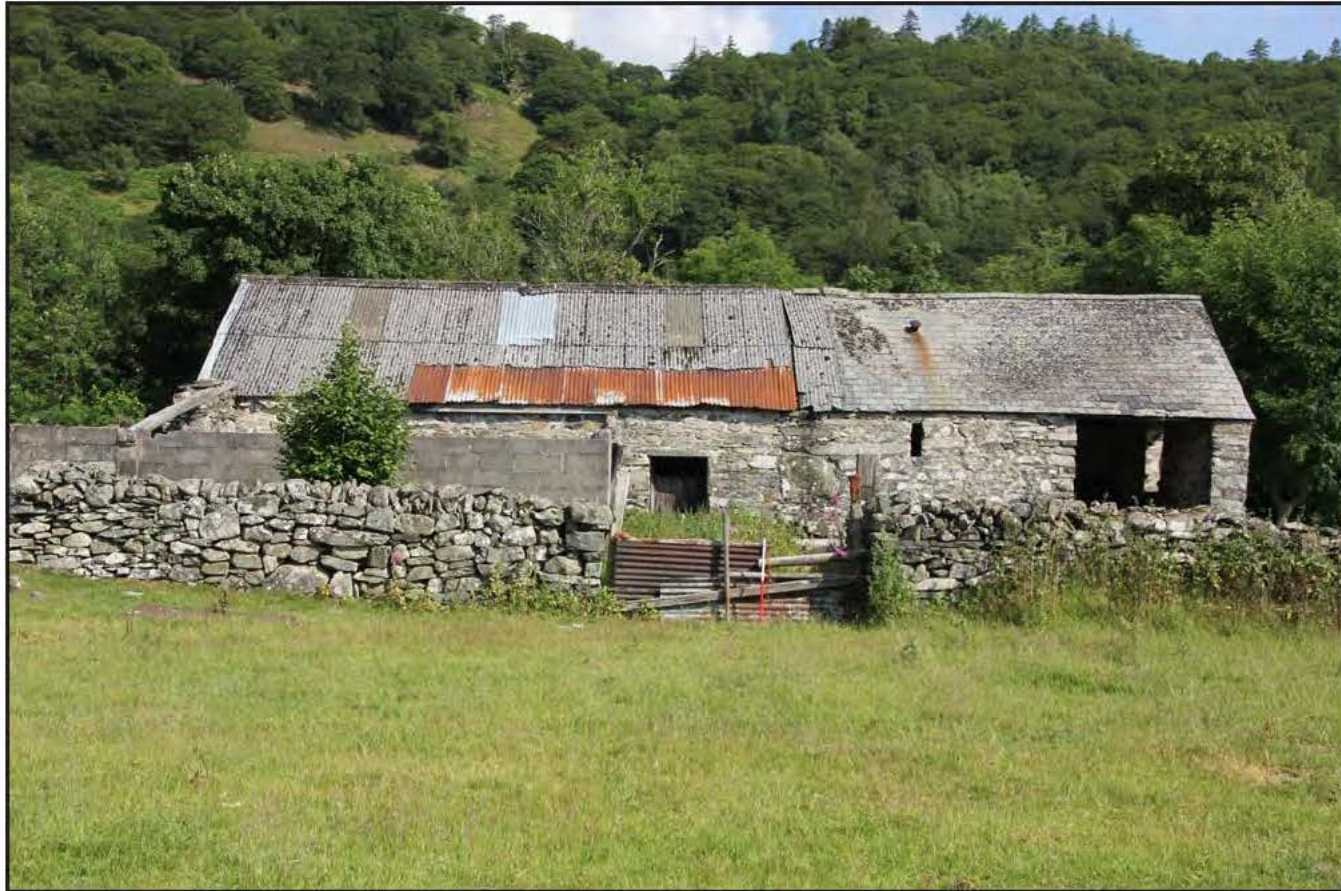
Plate 08: Southeast facing external elevation, from the southeast. Scale 1.0m.

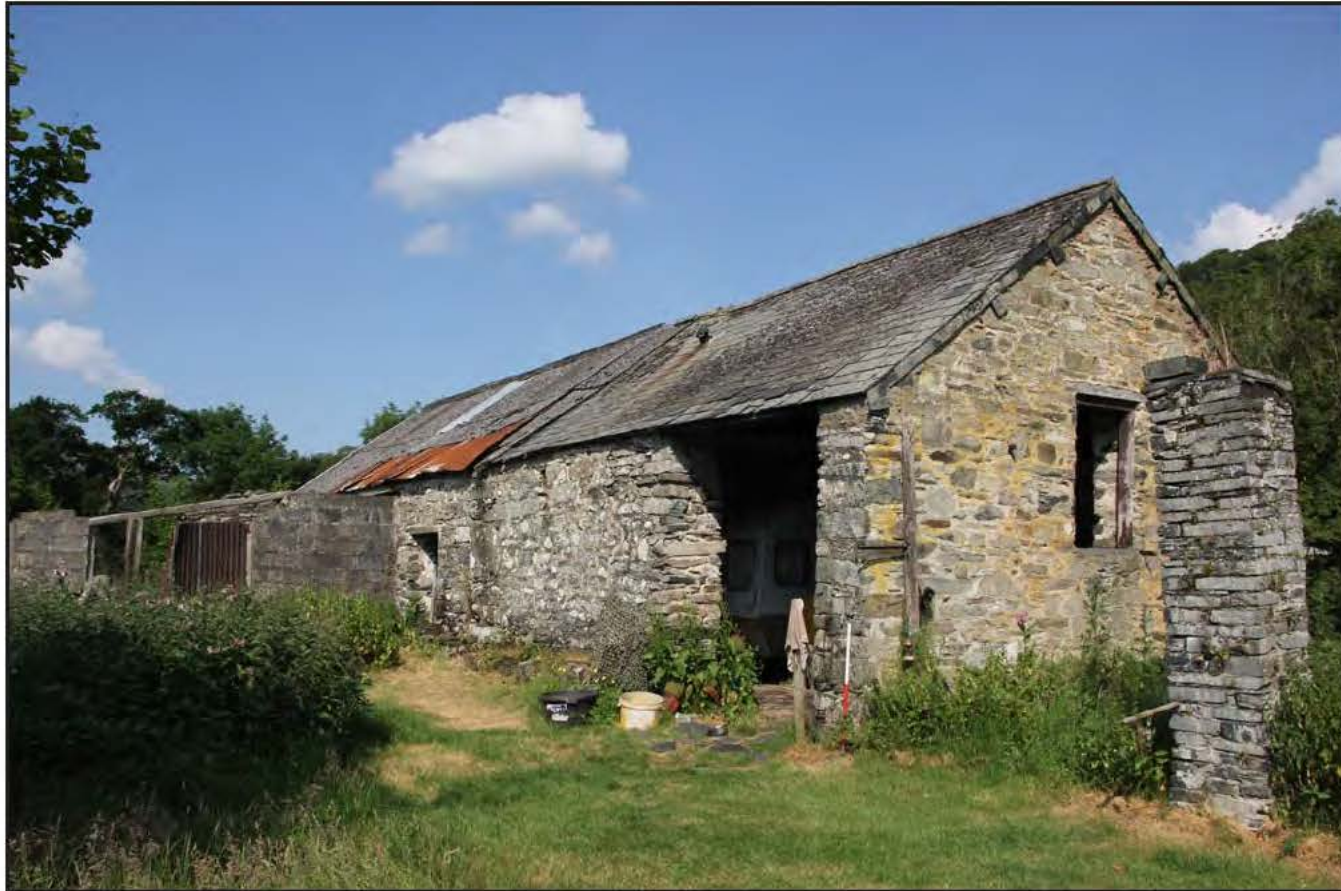
The building known as Ddol is a rectangular single-storey structure measuring 17.5m in length by 6.8m in width, orientated northeast to southwest. The building is divided into two separate barns, referred to here as the northeast barn and the southwest barn, the latter being the larger and accounting for approximately three-fifths of the structure.

Plate 09: Oblique view of Ddol, from the east. Scale 1.0m.

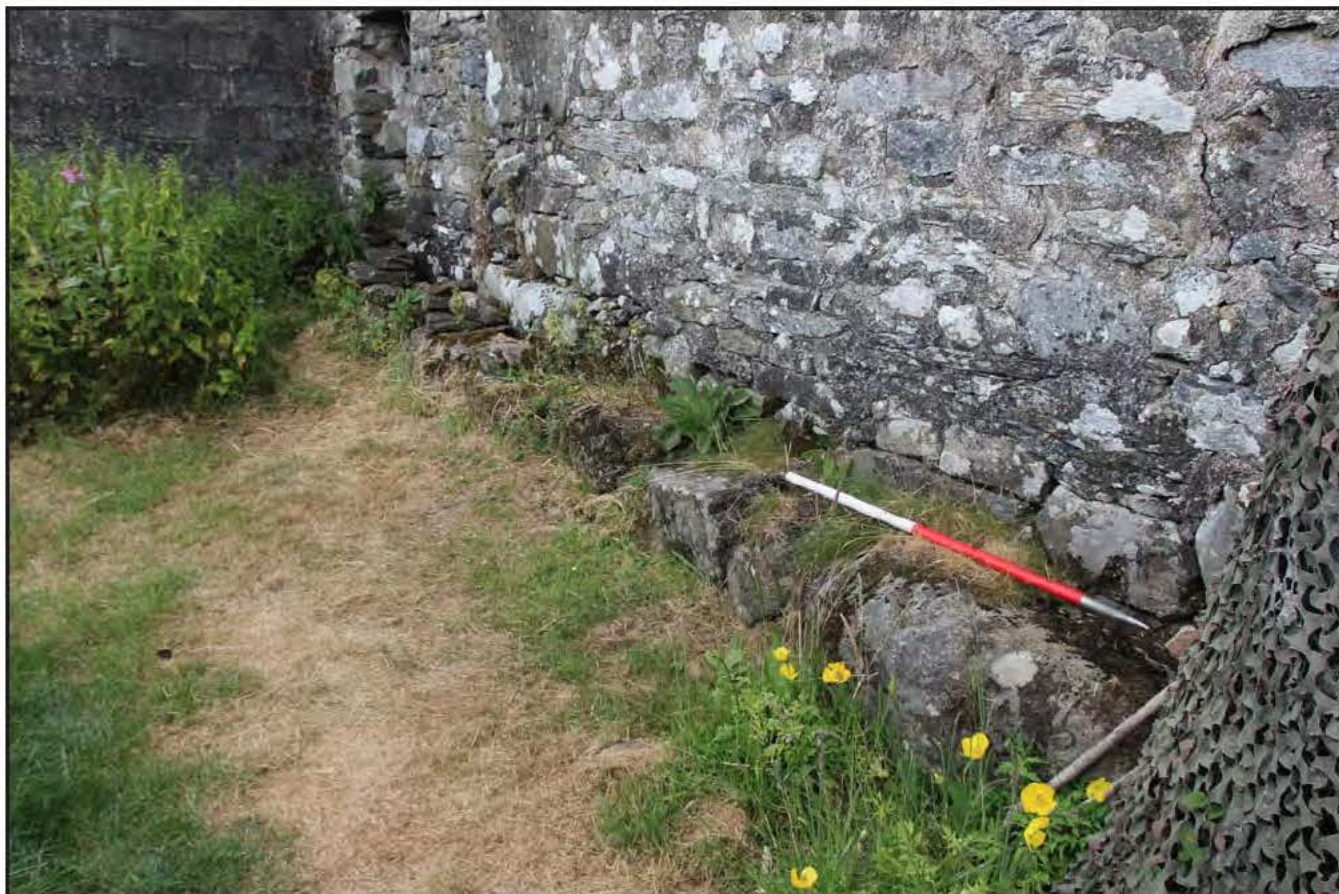
Plate 10: Southeast facing external elevation showing foundation stones, from the east. Scale 1.0m.

Of interest is the single course of very large foundation stones present in the southeast and southwest facing walls of the northeast barn. These stones are stepped out from the upstanding masonry and appear to be the footprint of an earlier structure that has been utilised as the foundations of the northeast barn. It is not clear what this earlier structure may have been, although due to the very close proximity of the Roman fortification wall to the immediate southeast it could be Roman in origin or an earlier precursor to the barn.

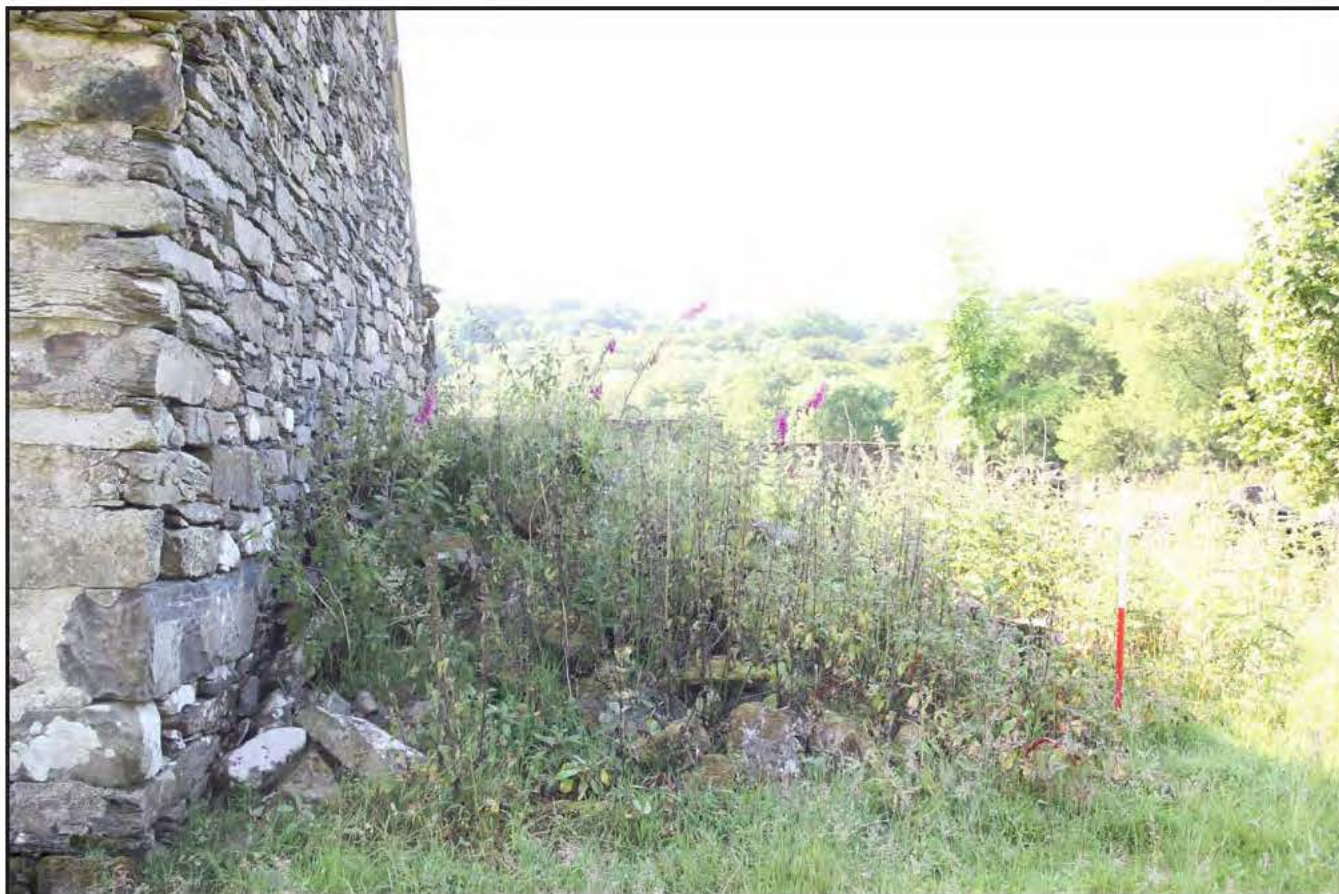
A rubble pile measuring approximately 1.0m in height and 3.0m in diameter is located to the immediate southwest of the southwest facing gable elevation. The pile is made up of medium sized sub-rounded and sub-angular stone cobbles and there is no visible structural element to any part of the pile. The pile appears to have been deposited to clear fallen stones from the lean-to structure when it was partially rebuilt using concrete breeze blocks.

Plate 11: Rubble pile, from the northwest. Scale 1.0m.

This feature will require removal as part of the renovation works.

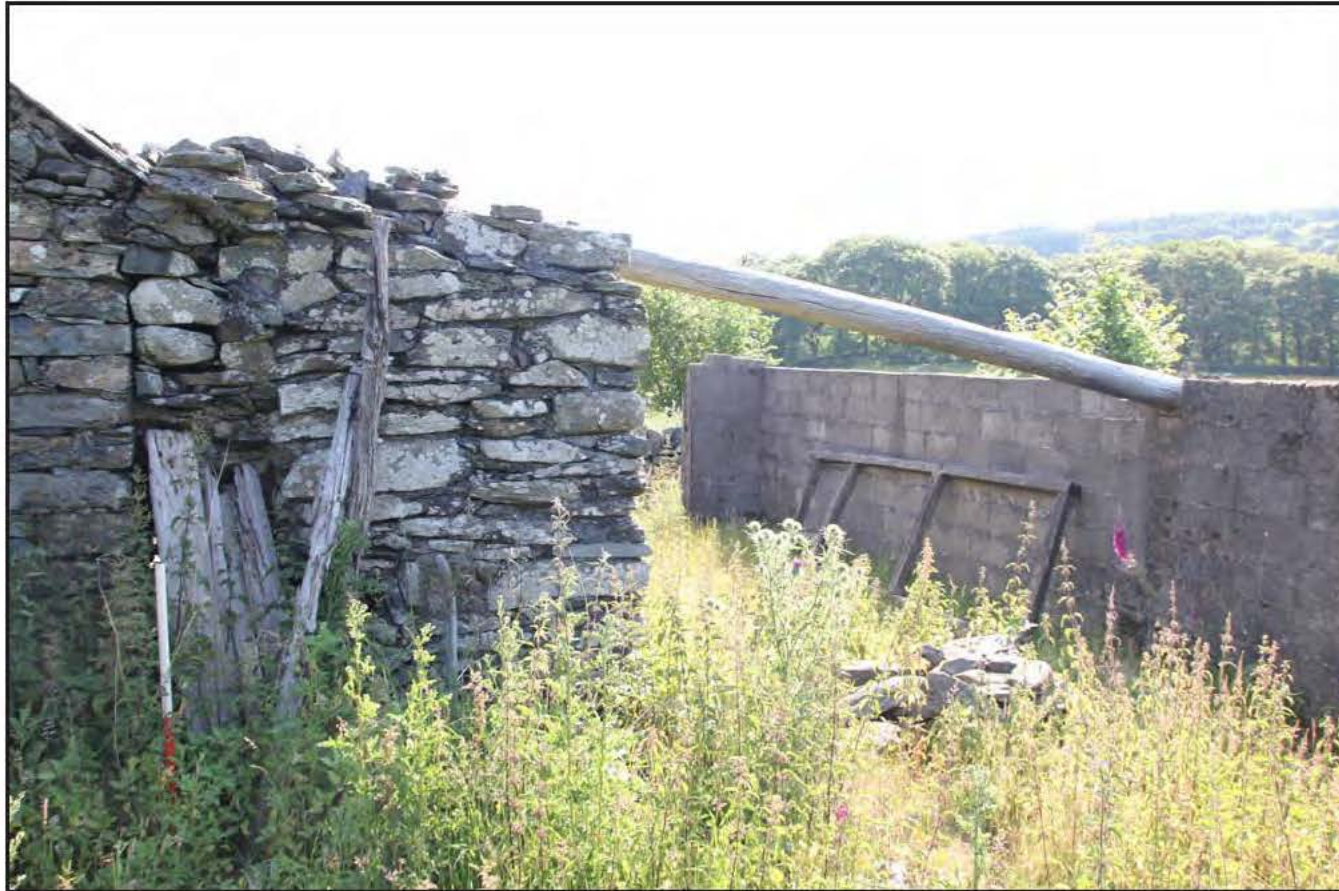
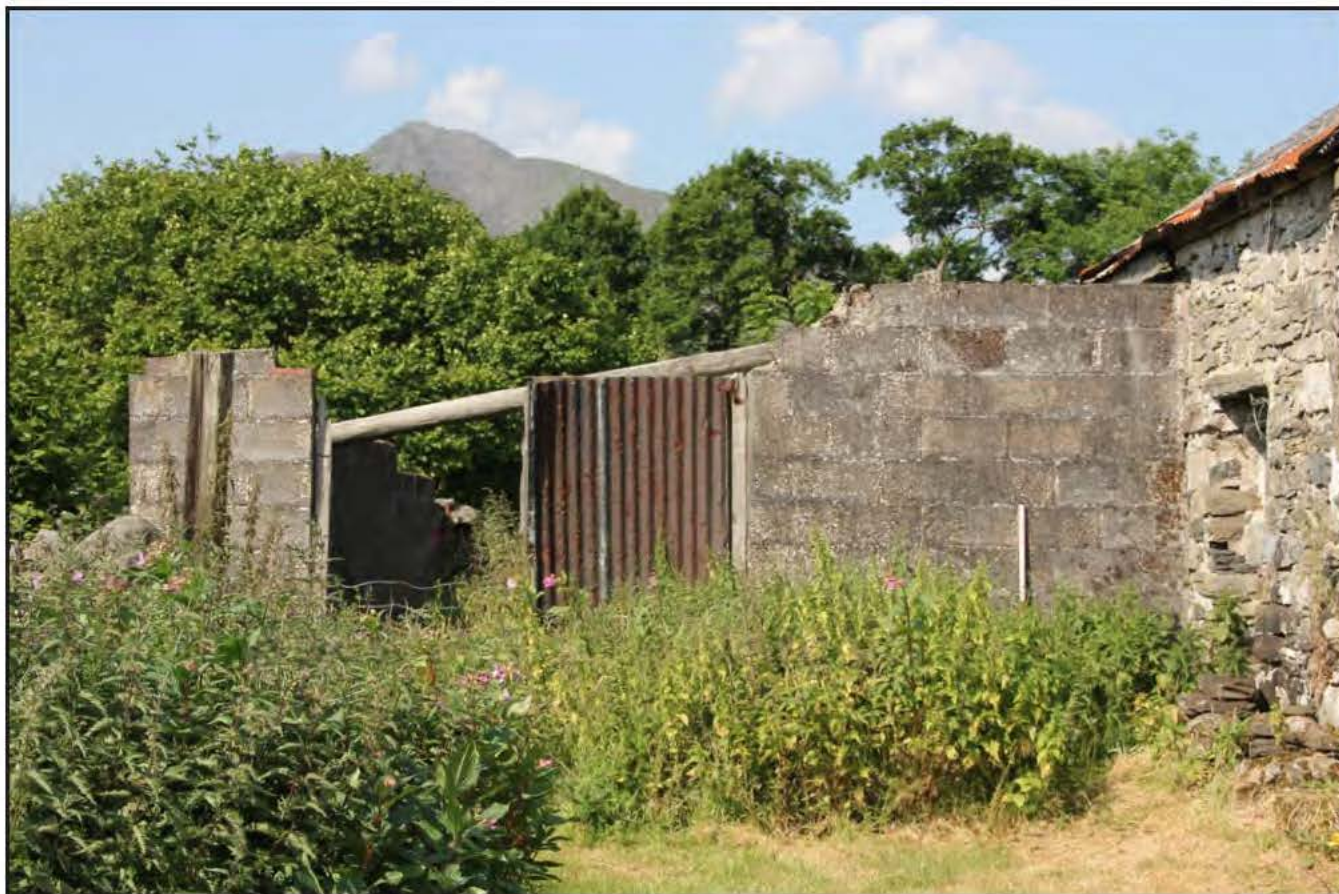
A lean-to outbuilding measuring approximately 7.0m in length by 3.0m in width and orientated northeast to southwest butts up against the southeast facing elevation of the barn at its southwest end. The lean-to is now roofless and has gone into disrepair. The southwest gable wall is constructed from medium sized angular stone rubble bonded by lime mortar and clearly butts up against the southeast facing elevation of the southwest barn thus post dating it. The lean-to appears to have been partially rebuilt at some point with the southeast and northeast facing walls being built out of concrete breeze blocks bonded by mortar.

It is probable that the breeze block walls replaced stone rubble ones and that the stone from these has been deposited as the stone rubble pile at the southwest end of the barn. The lean-to will require demolition as part of the renovation works.

Plate 12: Lean-to structure, from the southwest. Scale 1.0m.

Plate 13: Lean-to structure, from the northeast. Scale 1.0m.

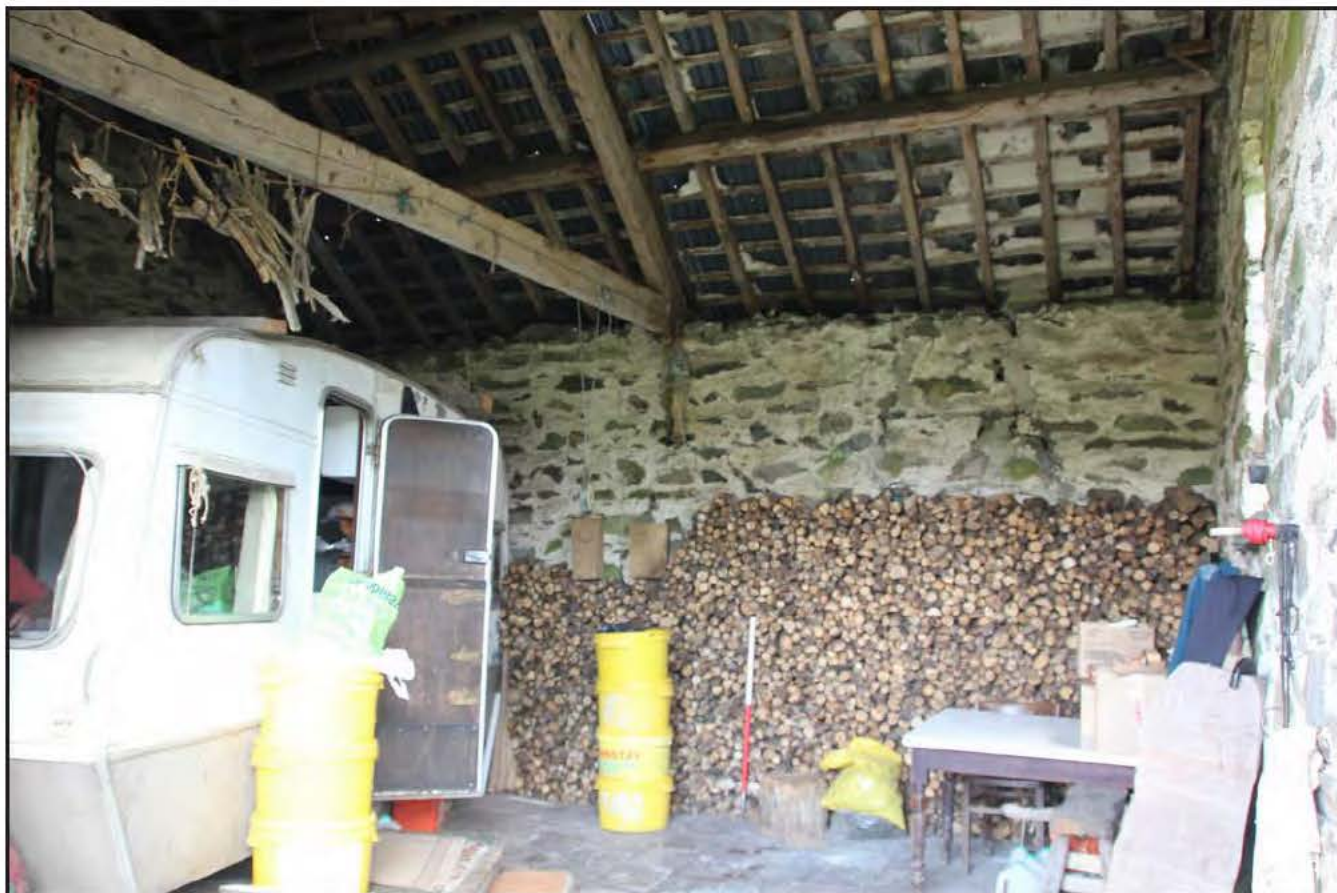
The northeast barn constitutes one large rectangular room measuring 6.4m in length by 5.4m in width and orientated northeast to southwest. The barn is open to the roof space and has a single A-frame truss supporting four purlins and the principle rafters, all of sawn timber. The internal walls are all of medium sized rubble bonded by lime mortar, and a single small open window is located in the northwest facing internal elevation along with a large opening into the barn. A second large open window is located in the southwest facing internal elevation. The floor is of laid slate slabs measuring approximately 0.25m square. The room is otherwise featureless and currently houses an occupied caravan.

Plate 14: Northeast barn, from the south. Scale 1.0m.

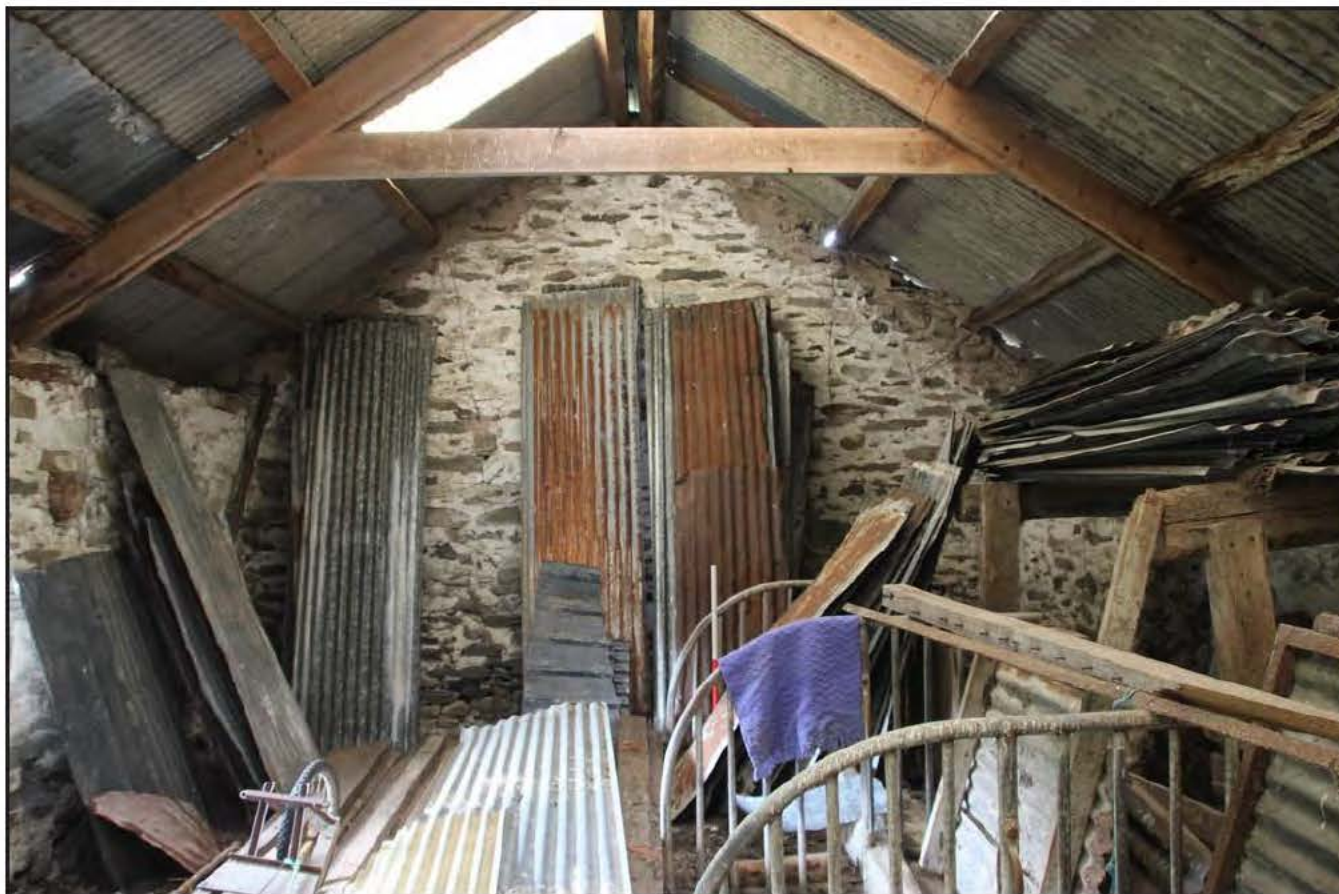
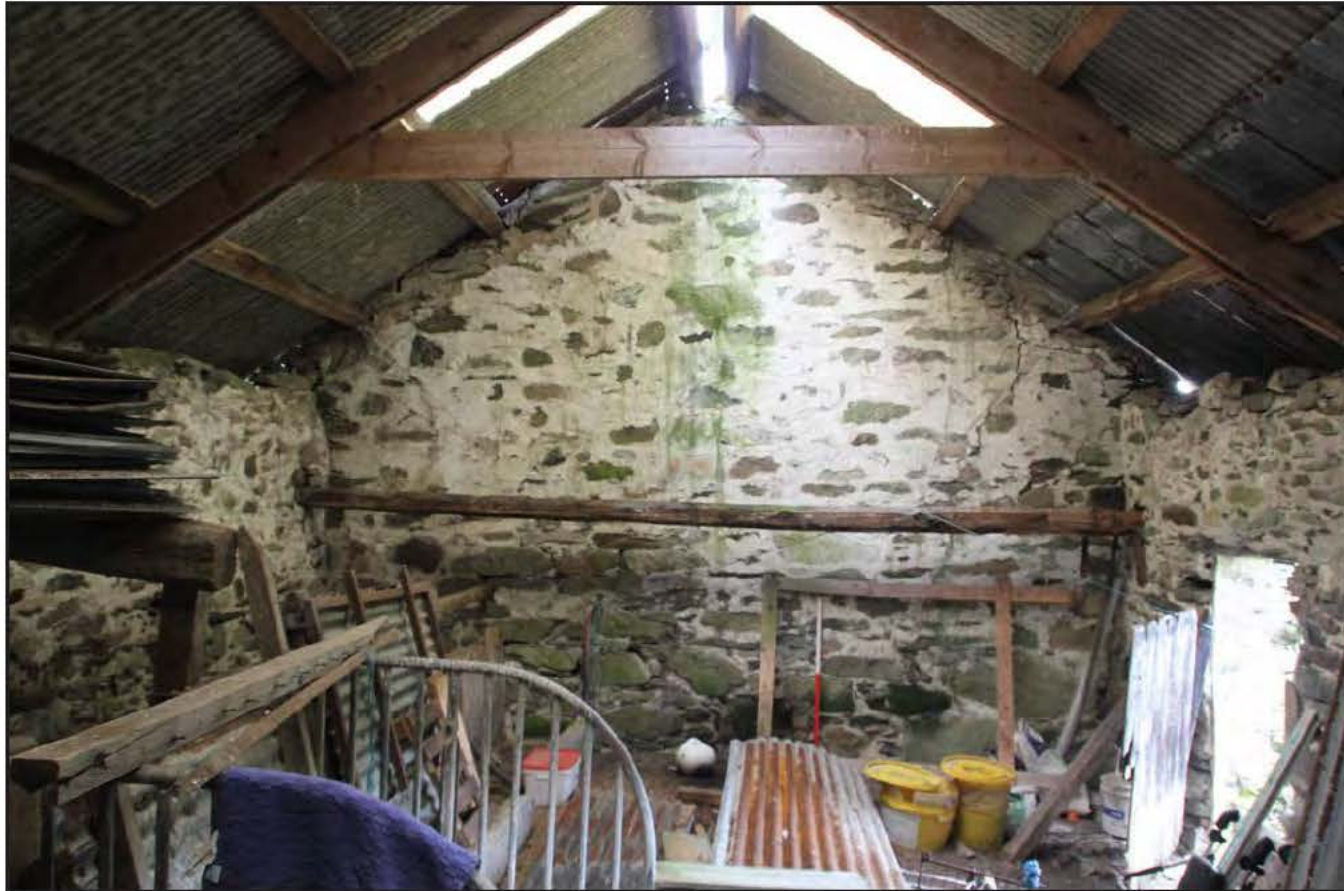
The southwest barn constitutes one large rectangular room measuring 9.0m by 5.5m and orientated northeast to southwest. The barn is open to the roof space and has two equally spaced A-frame trusses supporting six purlins and the principle rafters, all of sawn timber. The internal walls are all of medium sized rubble bonded by lime mortar, with the exception of the southwest facing internal elevation which has very large sub-angular stones at foundation level at the southeast end.

The northwest facing wall has a doorway blocked with rubble and mortar at the southwest end, and a centralised open window with stone lintel and sill. A single doorway with wooden board door is located at the northeast end of the northwest facing wall and permits access to the exterior of the building. There is a row of animal pens constructed from wooden planks, concrete foundations and metal bars along the southeast facing wall, and the floor appears to be of compacted earth. The barn is currently utilised for the storage of metal corrugated sheets.

Plate 15: Southwest barn, from the northeast. Scale 1.0m.

Plate 16: Southwest barn, from the southwest. Scale 1.0m.

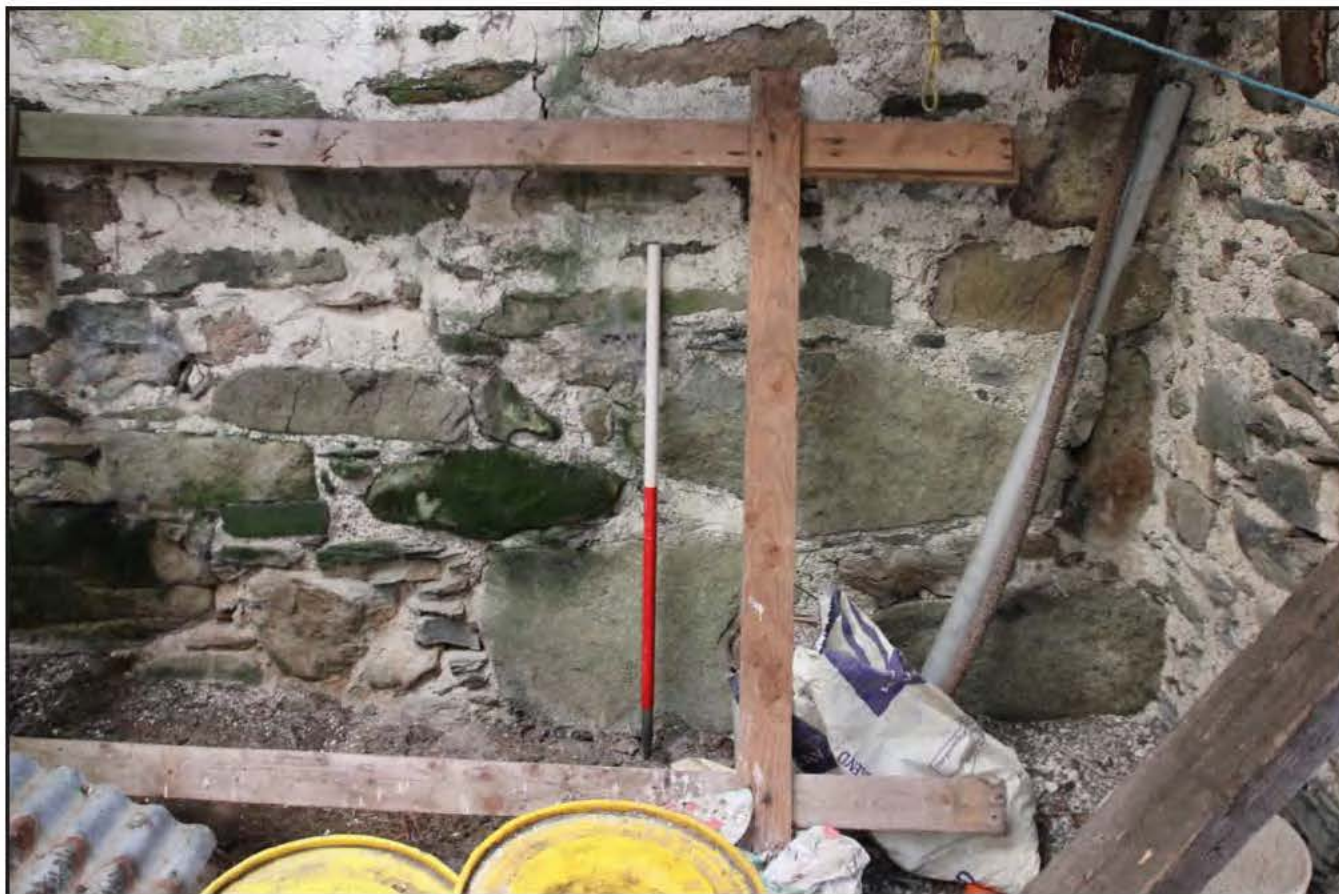
Plate 17: Southwest facing elevation of the southwest barn showing large foundation stones. Scale 1.0m.
