# **Water Mains Renewal, Penmorfa, Tremadog, Gwynedd.**

Archaeological Watching Brief

Report no. 0055

Client: Welsh Water

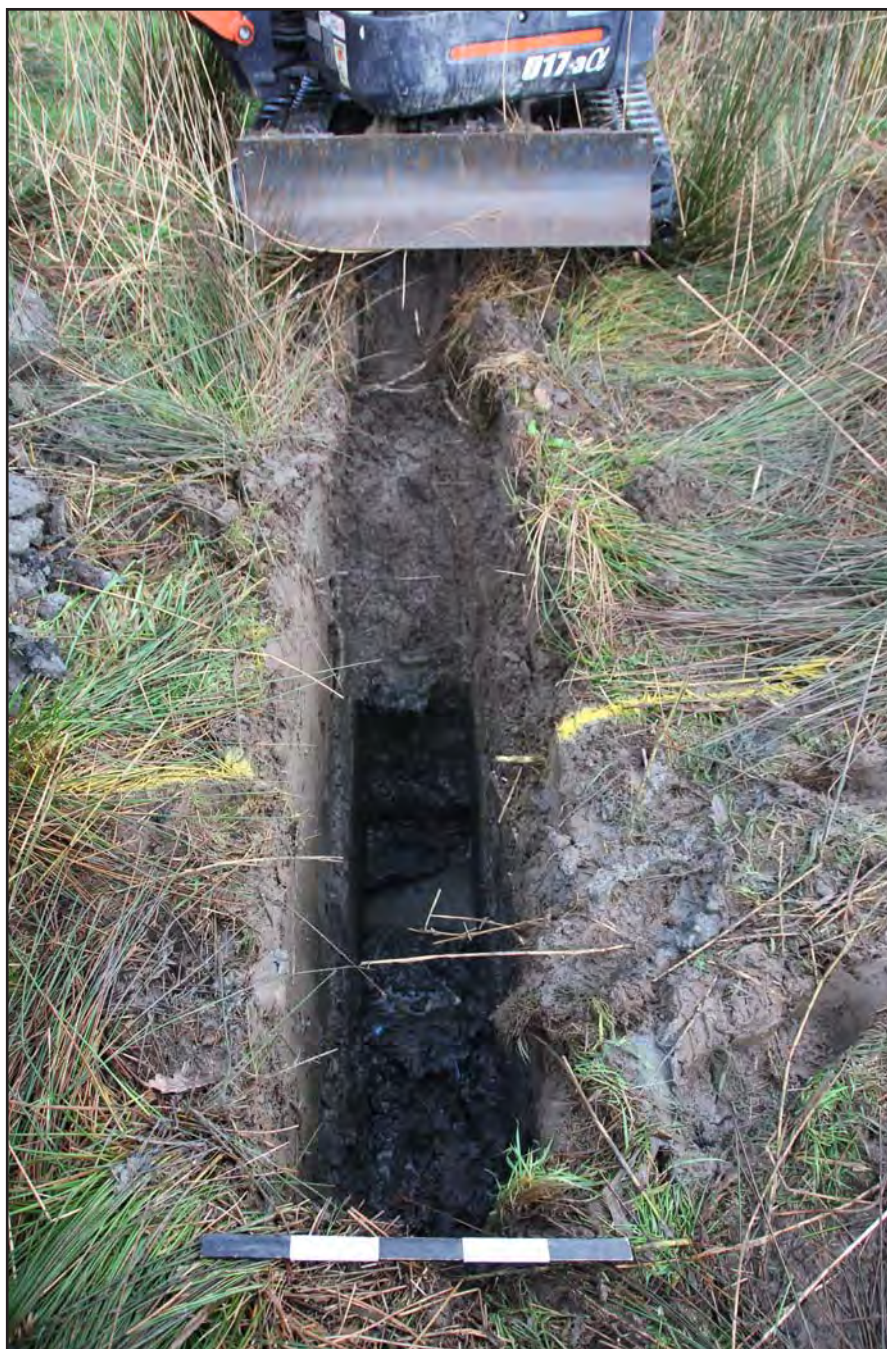
**Plate 01:** Test Pit A, from the west. Scale 0.5m.

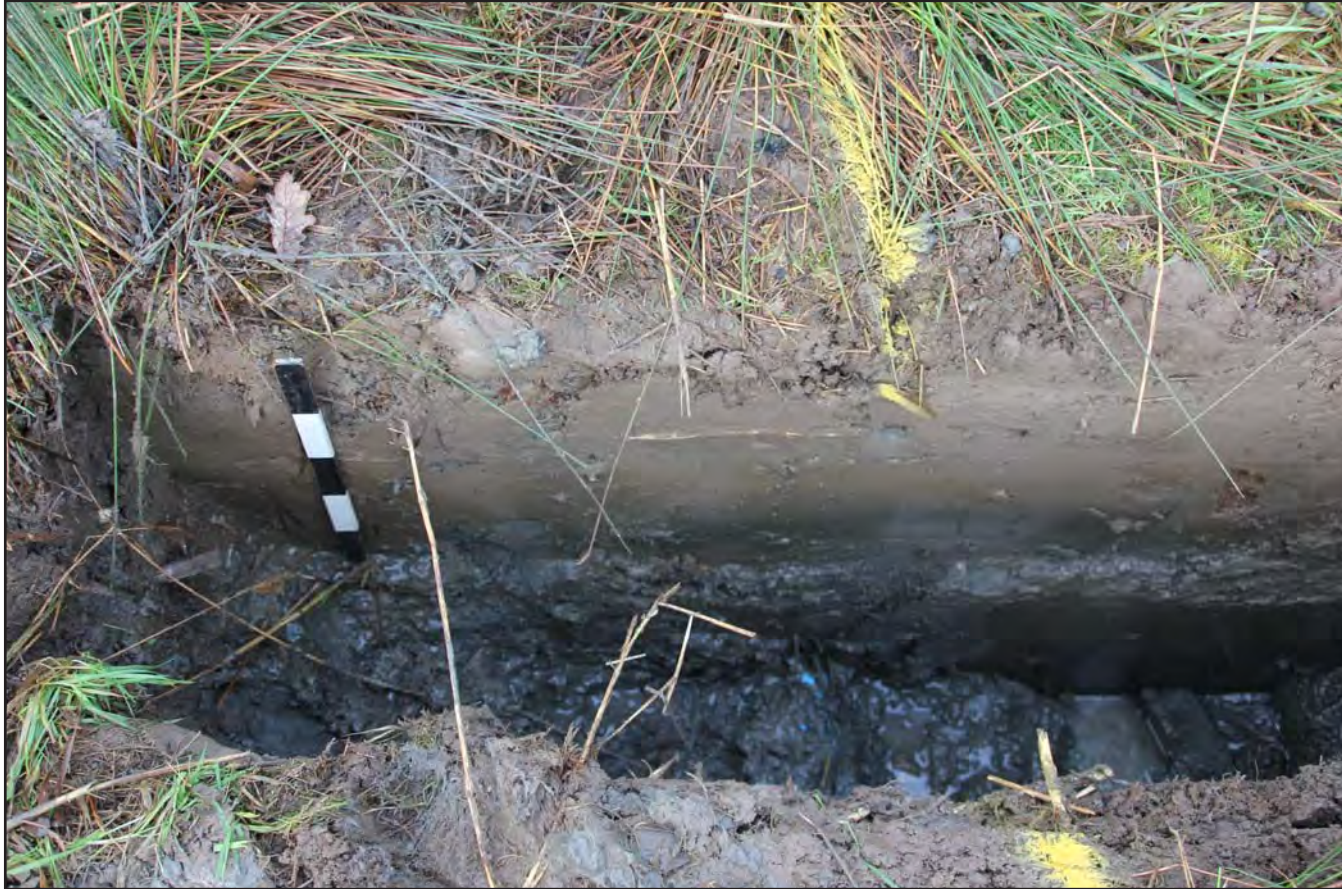
**Plate 02:** South facing section of Test Pit A, from the south. Scale 0.5m.

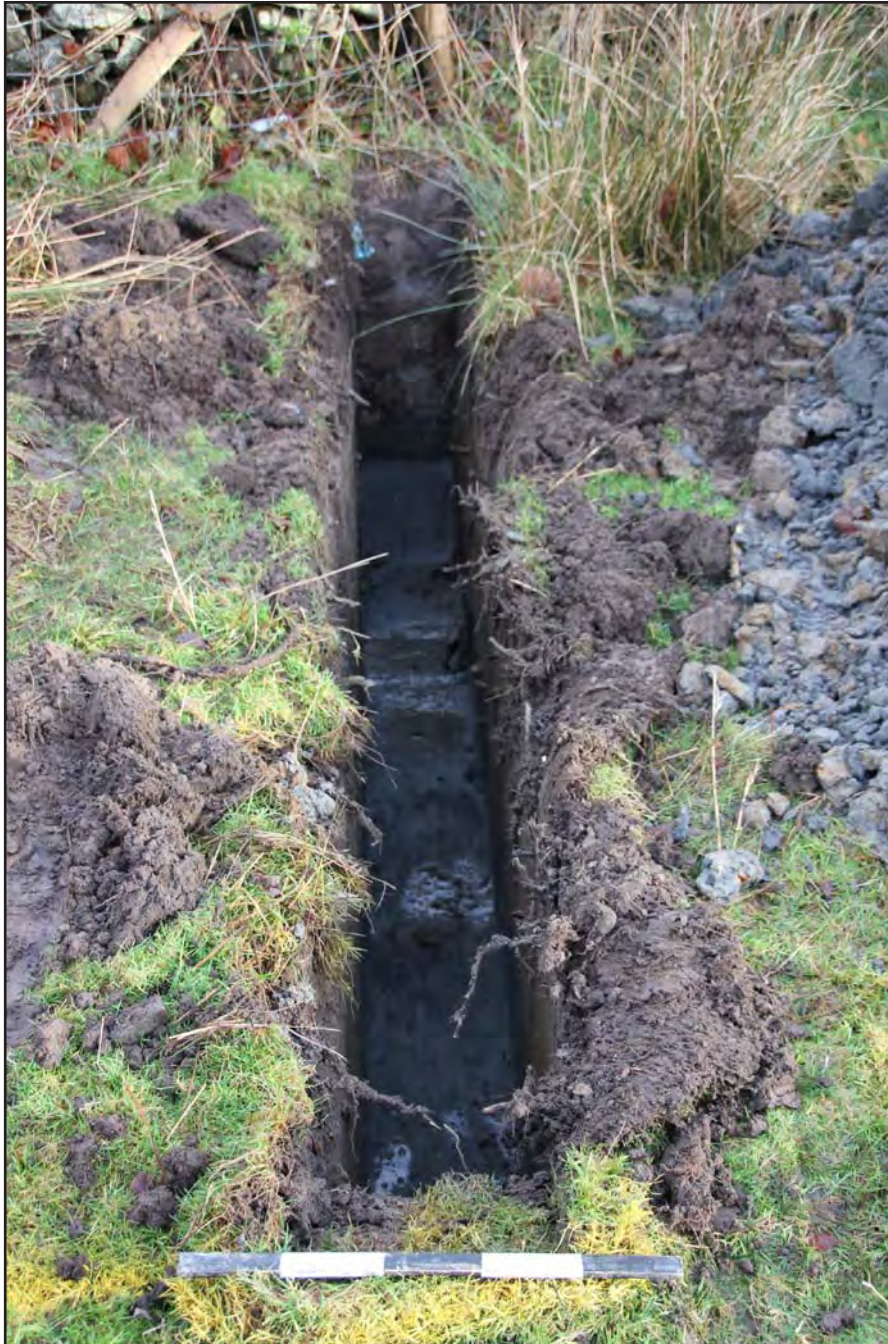
**Plate 03:** Test Pit B, from the south. Scale 0.5m.

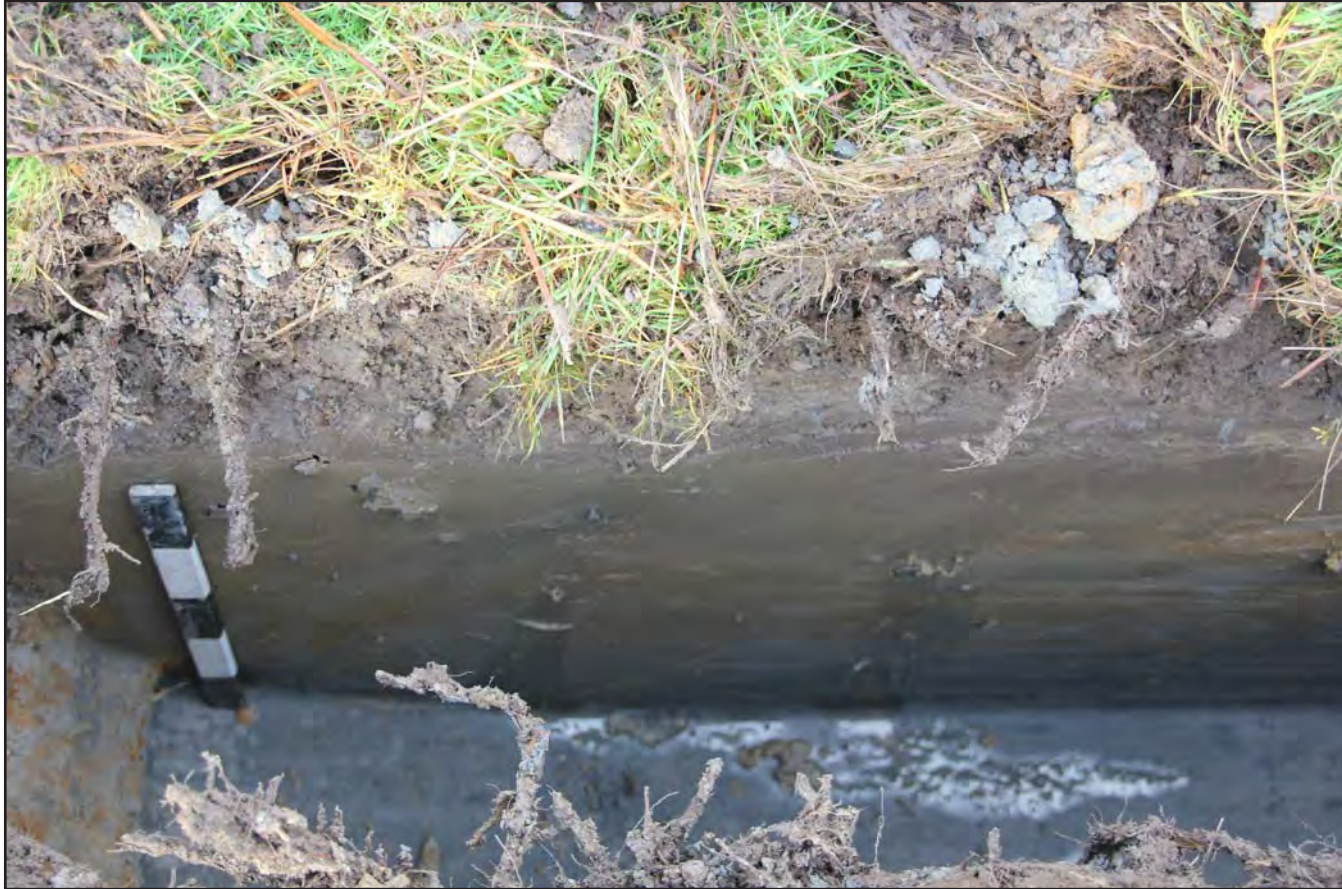
**Plate 04:** West facing section of Test Pit B, from the west. Scale 0.5m.

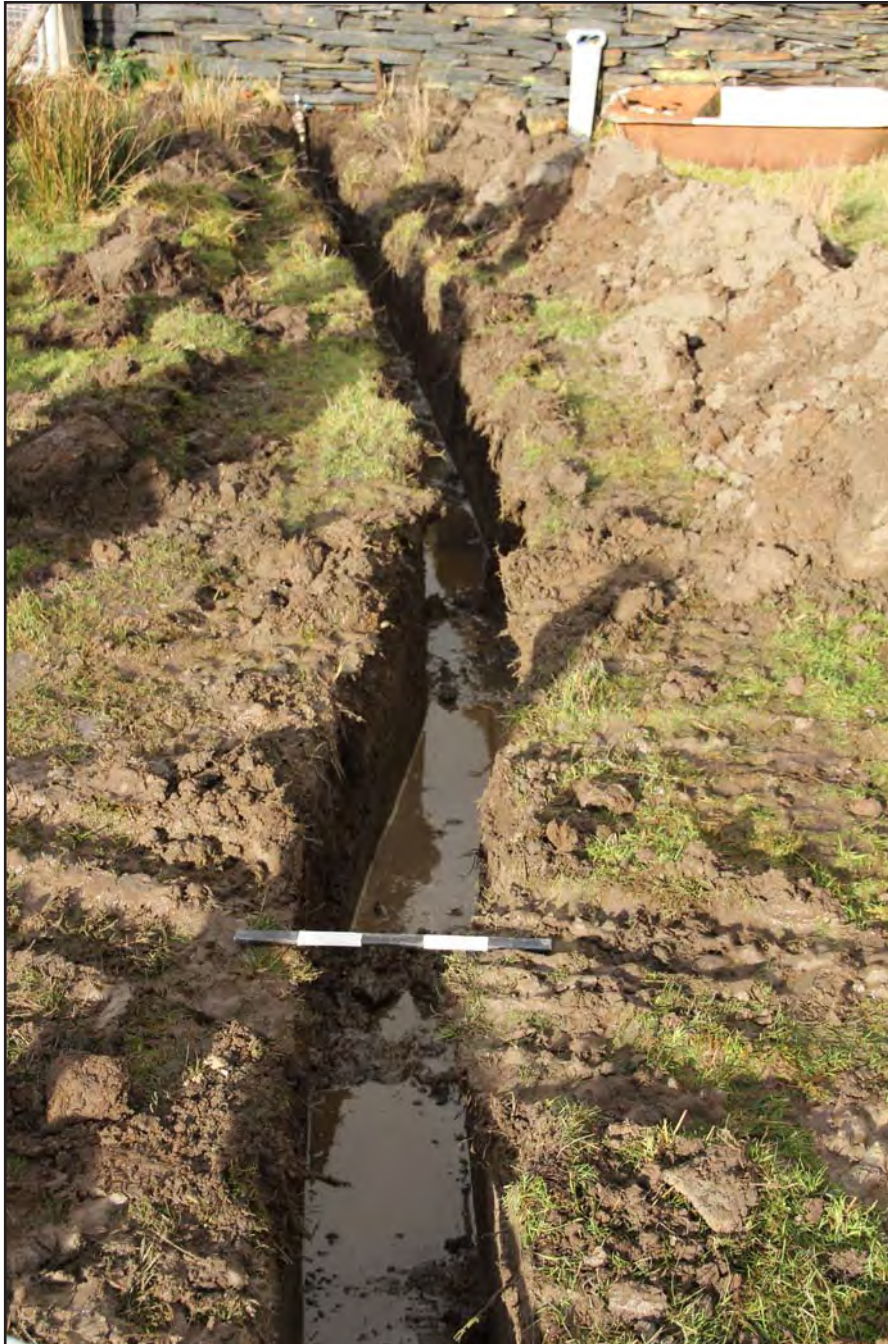
Before the replacement water main trench could be excavated an existing agricultural water pipe was required to be relocated to the south side of the 10.0m wide easement. As such a new trench was excavated from SH 55788 40123 to SH 55794 40111 towards the west of the grazing field and immediately south of the A498 Dublin Street. The trench measured 12.0m in length by 0.4m in width orientated northwest to southeast. It was excavated to a depth of 0.5m through a 0.2m deep mid grey-brown silt-clay topsoil, a 0.6m deep light yellow-brown natural clay substrata, and a >0.2m deep dark black-grey natural clay substrata.

**Plate 05:** Water pipe trench, from the southwest. Scale 0.5m.

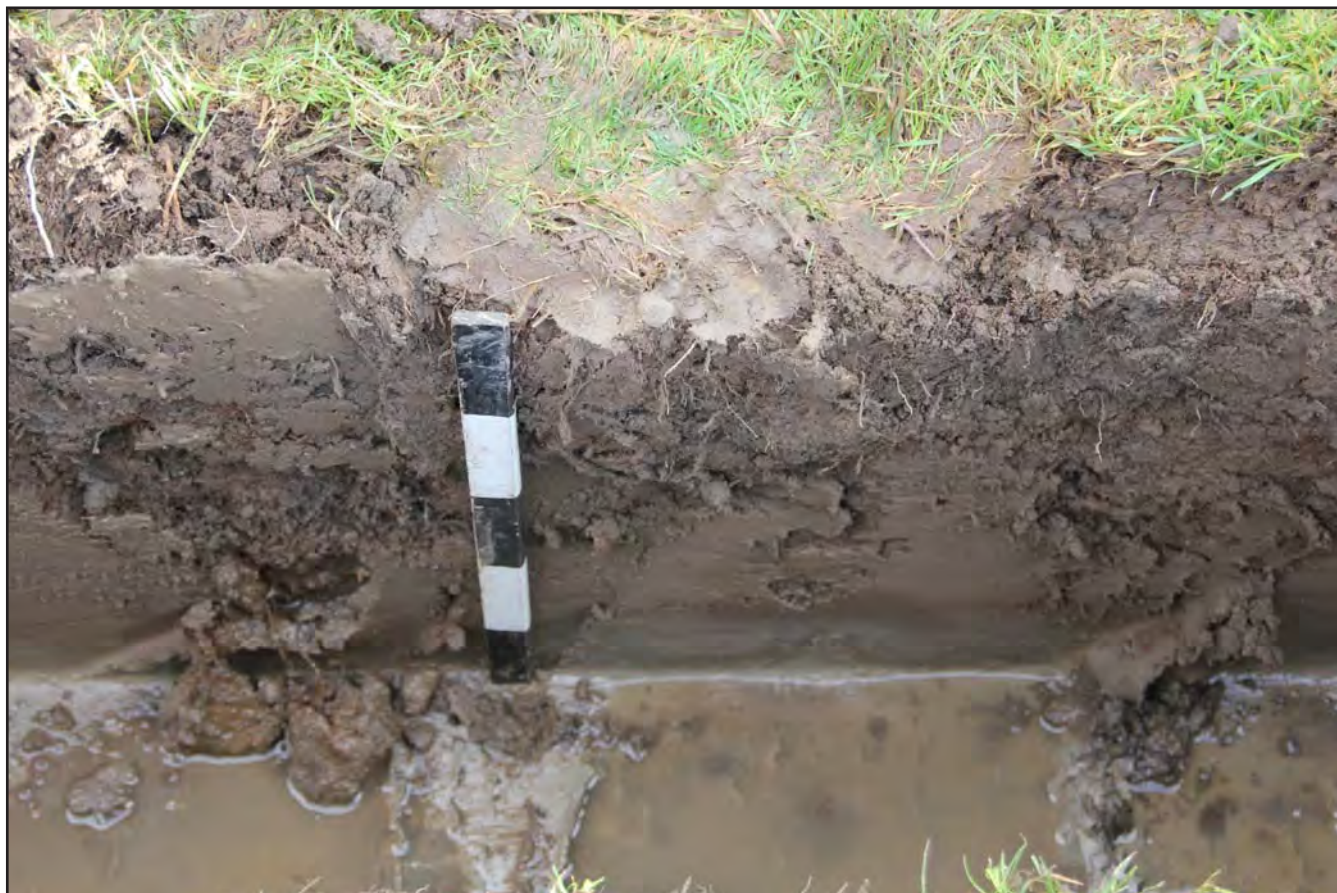
**Plate 06:** Southwest facing section of water pipe trench, from the southeast. Scale 0.5m.

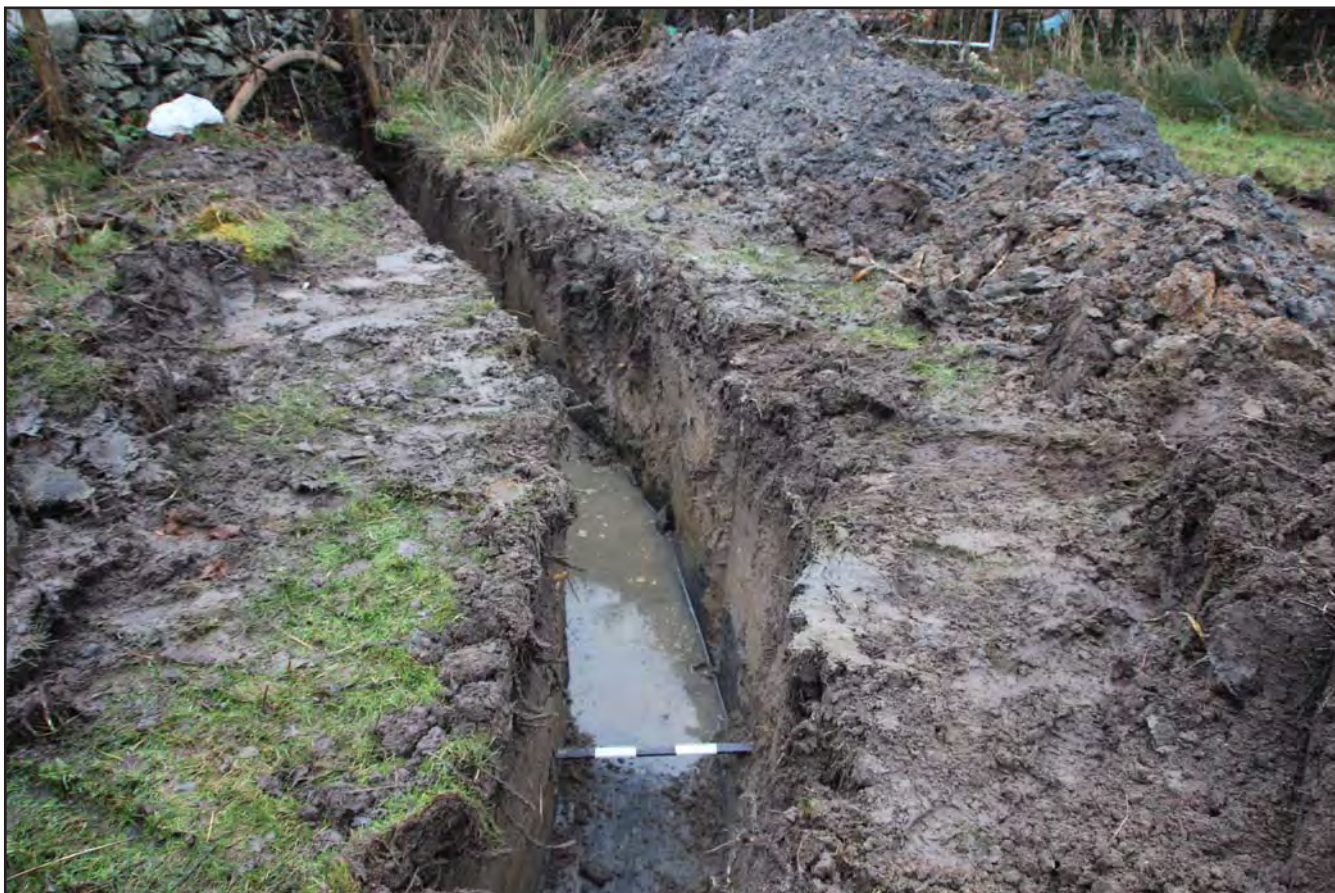
A watching brief was maintained during the excavation of the replacement water main trench from NGR SH 55880 40123 to SH 55873 40121 40111 towards the northeast of the grazing field and immediately south of the A498 Dublin Street. The trench measured approximately 12.0m in length by 0.5m in width orientated northeast to southwest. It was excavated to a depth of 0.9m through a 0.2m deep mid grey-brown silt-clay topsoil, a 0.5m deep light yellow-brown natural clay substrata, and a >0.2m deep dark black-grey natural clay substrata.

**Plate 07:** Water Main renewal trench SH 55880 40123 - SH 55873 40121, from the southwest. Scale 0.5m.

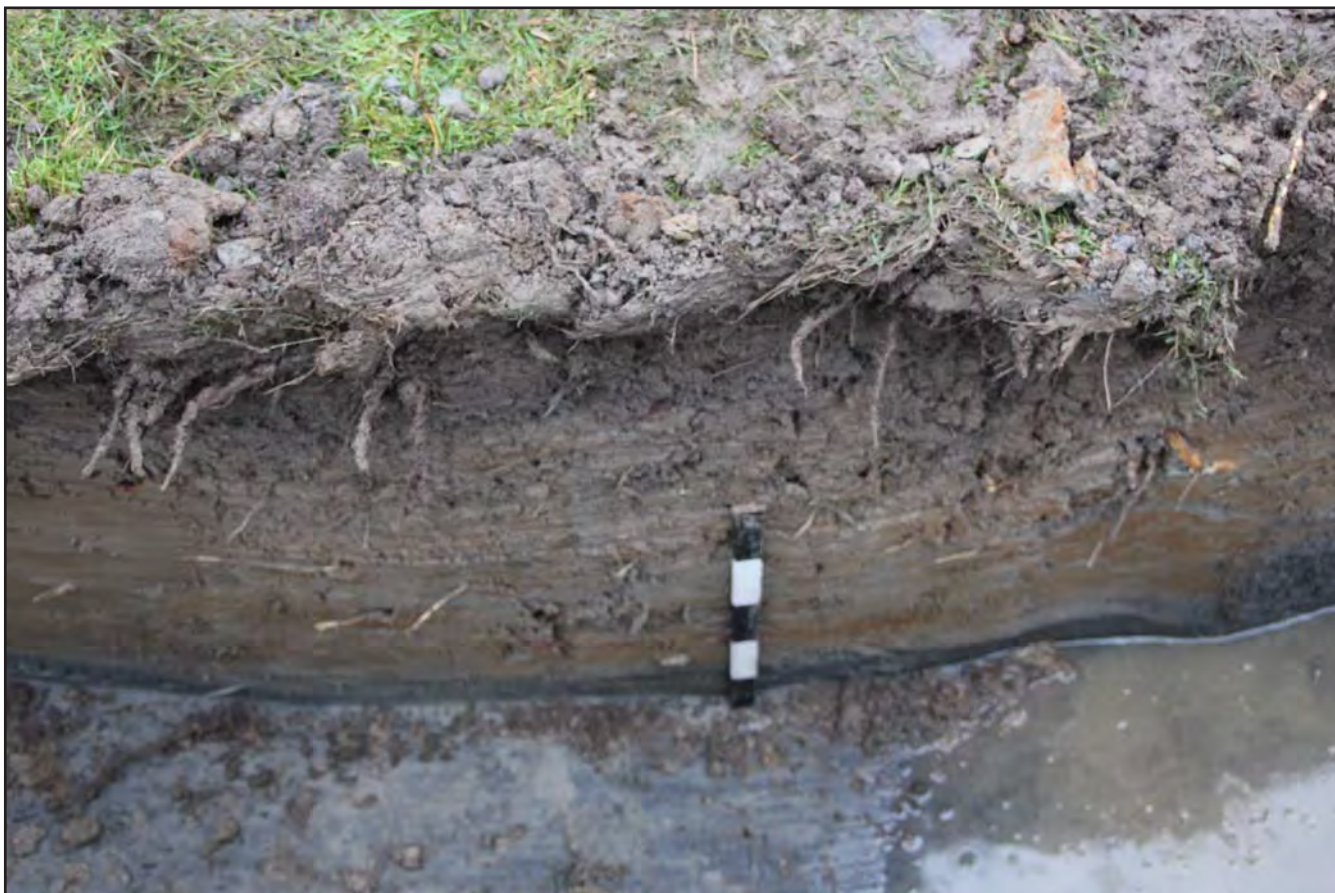
**Plate 08:** Southeast facing section of Water Main renewal trench SH 55880 40123 - SH 55873 40121, from the southeast. Scale 0.5m.

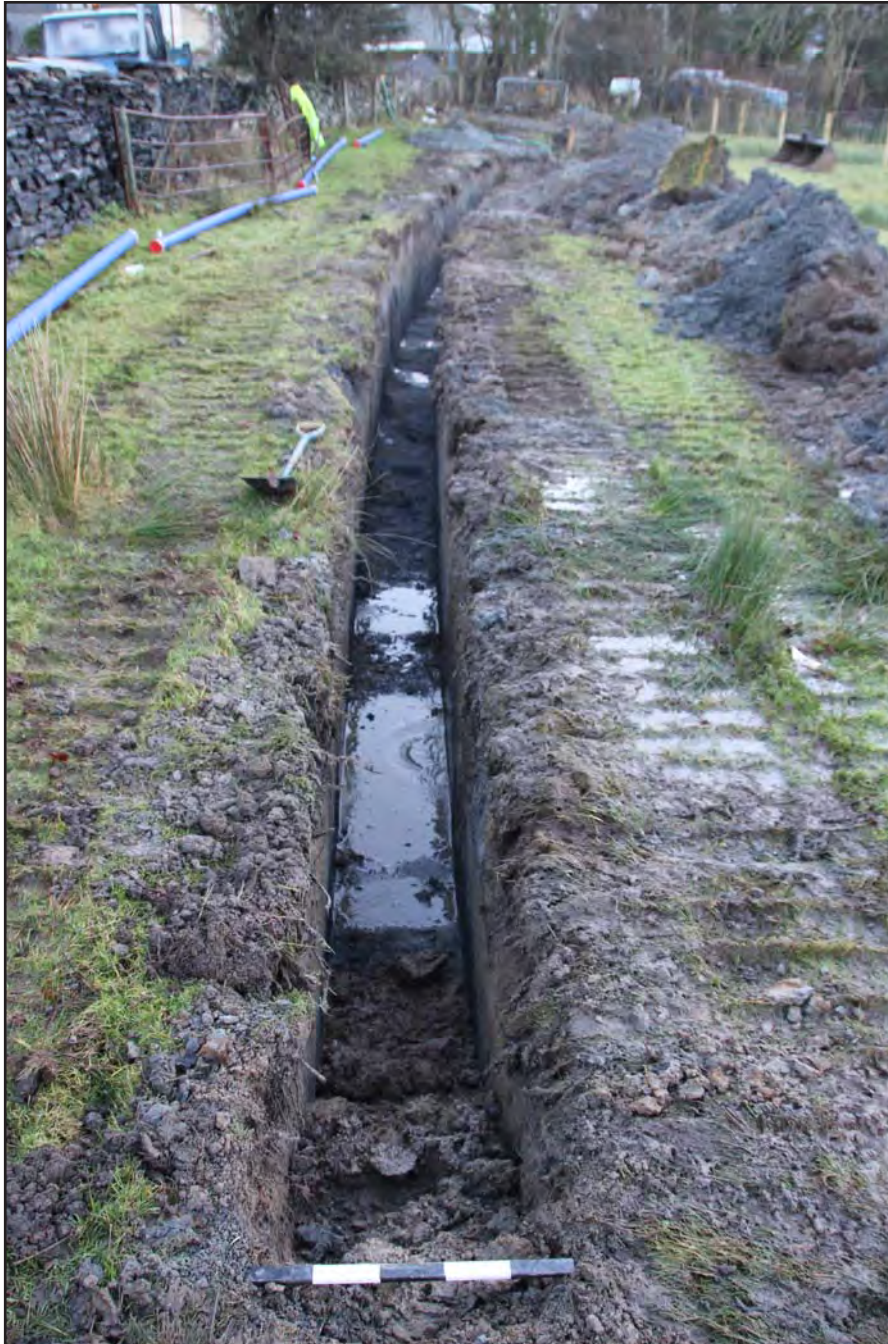
A watching brief was maintained during the excavation of the replacement water main trench from NGR SH 55873 40121 to SH 55836 40129 towards the northeast of the grazing field and immediately south of the A498 Dublin Street. The trench measured approximately 36.0m in length by 0.5m in width orientated east to west. It was excavated to a depth of 0.9m through a 0.15m deep mid grey-brown silt-clay topsoil, a 0.5m deep light yellow-brown natural clay substrata, and a >0.25m deep dark black-grey natural clay substrata.

**Plate 09:** Water Main renewal trench SH 55873 40121 - SH 55836 40129, from the west. Scale 0.5m.

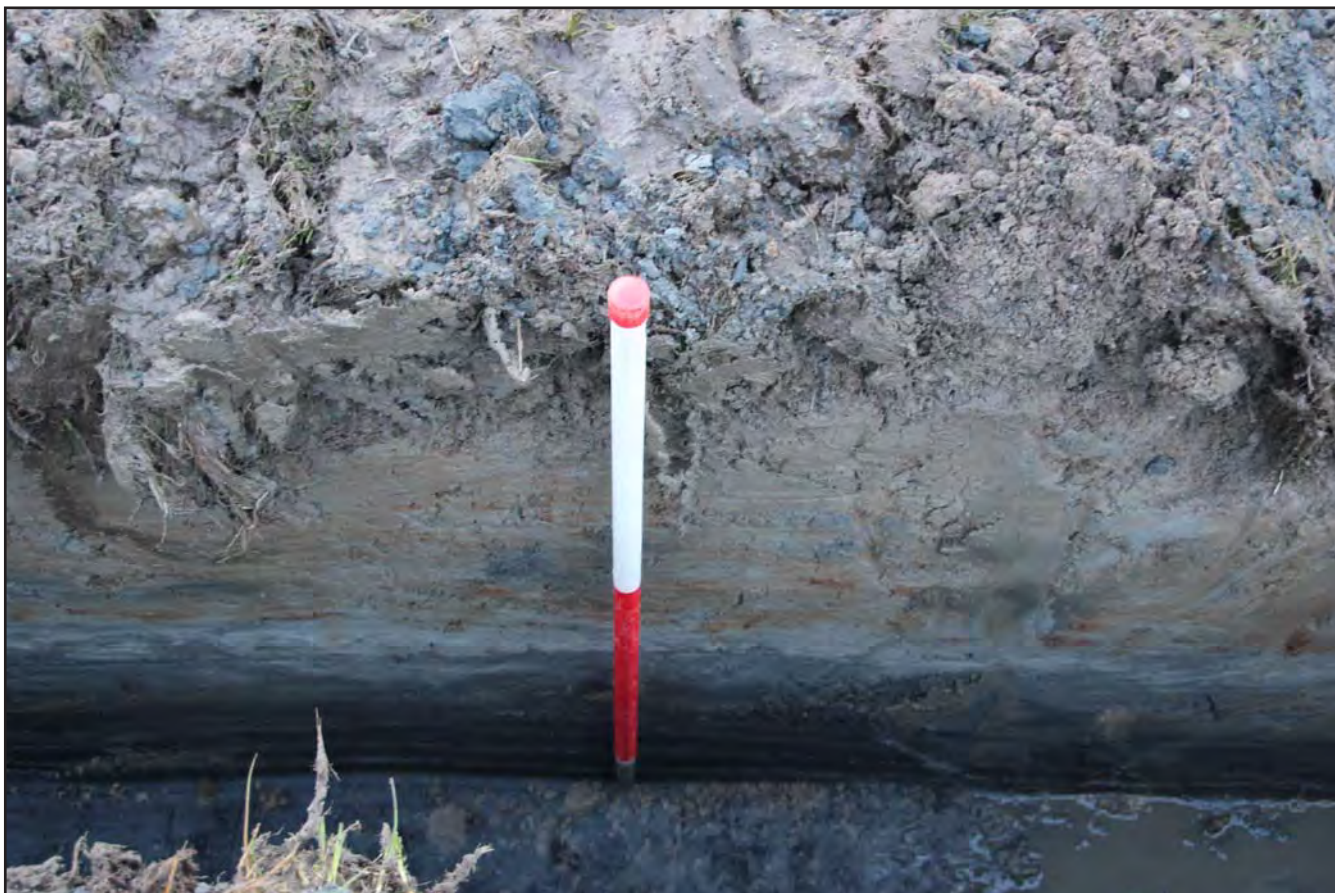
**Plate 10:** North facing section of Water Main renewal trench SH 55873 40121 - SH 55836 40129, from the north. Scale 1.0m.

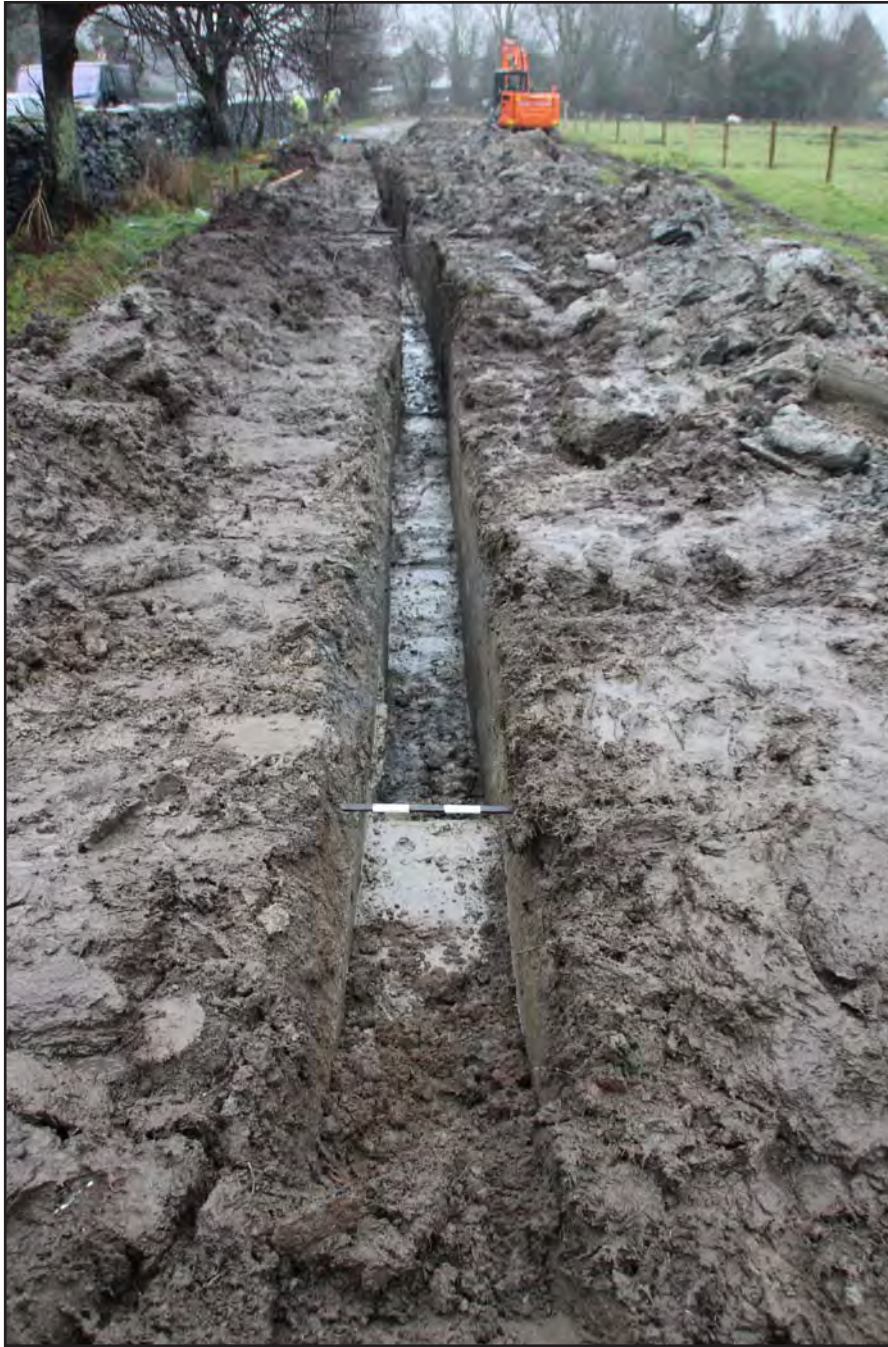
A watching brief was maintained during the excavation of the replacement water main trench from NGR SH 55836 40129 to 55785 40113 towards the north of the grazing field and immediately south of the A498 Dublin Street. The trench measured approximately 72.0m in length by 0.5m in width orientated east to west. It was excavated to a depth of between 0.7m to 0.9m although this was in fact due to the presence of broad peaks and troughs (see below). The trench cut through a 0.1m-0.3m deep mid grey-brown silt-clay topsoil, a 0.5m deep light yellow-brown natural clay substrata, and a >0.25m deep dark black-grey natural clay substrata.

**Plate 11:** Water Main renewal trench SH 55836 40129 - SH 55785 40113, from the west. Scale 0.5m.

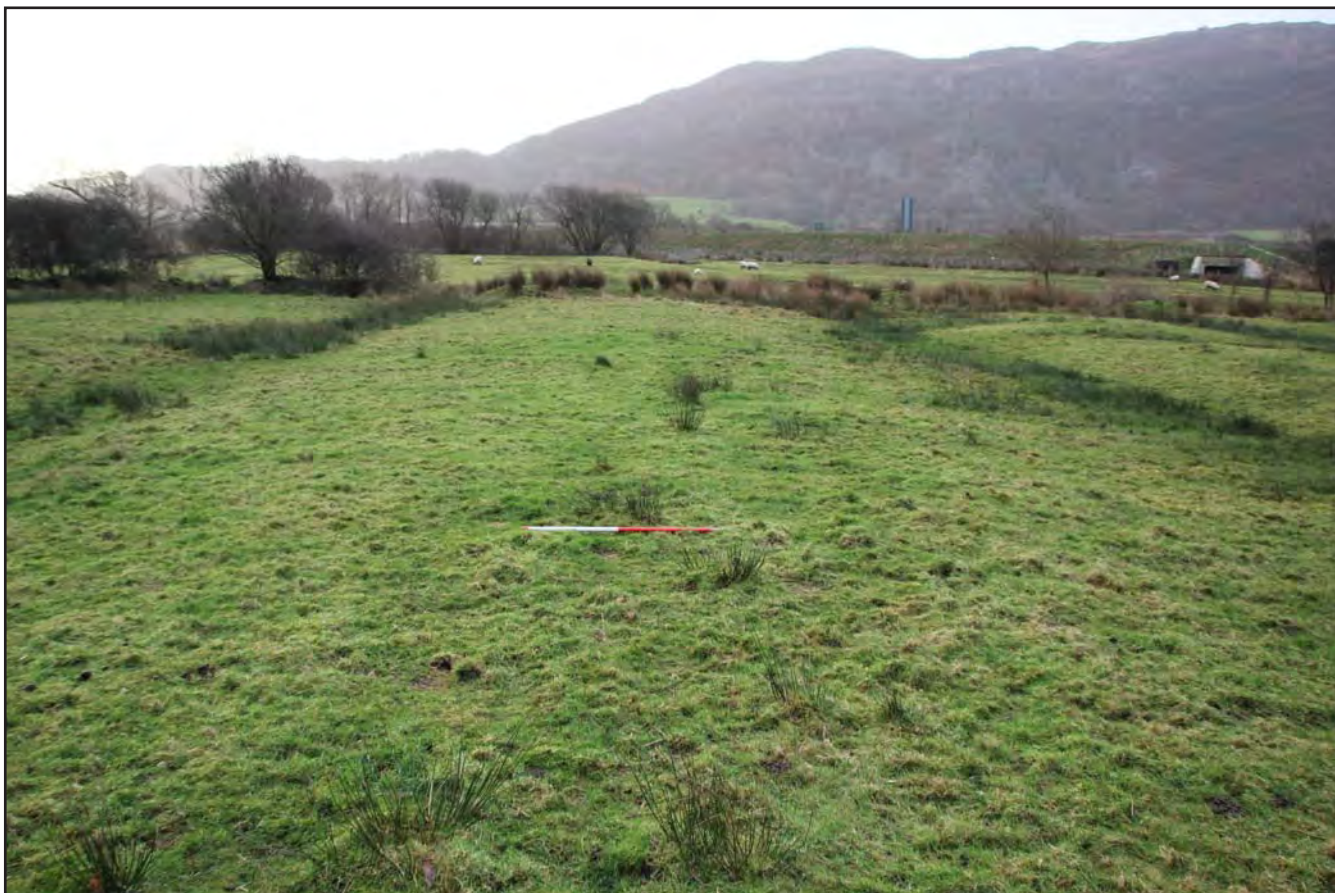
**Plate 12:** Peaks and troughs, from the north. Scale 1.0m.

The archaeological watching brief during the excavation of THA, THB, and the replacement water main trench at Penmorfa, Tremadog did not expose any archaeological remains or artefacts aside from a series of peaks and troughs thought to represent post-medieval drainage earthworks, which were visible across the surface of the northern part of the grazing field.

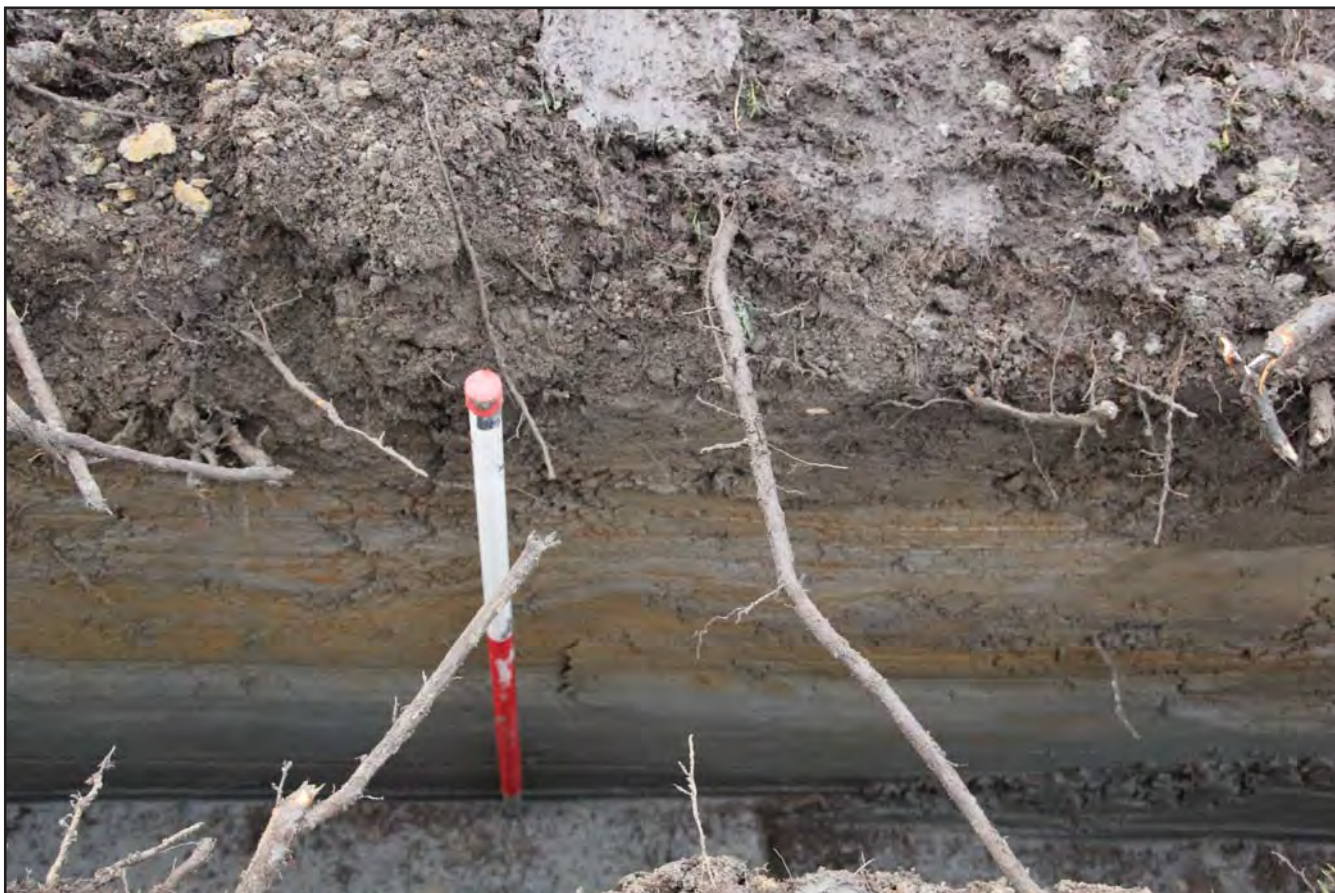
**Plate 13:** North facing section of Mains Renewal trench showing drainage peak at SH 55818 40125, from the north. Scale 1.0m.

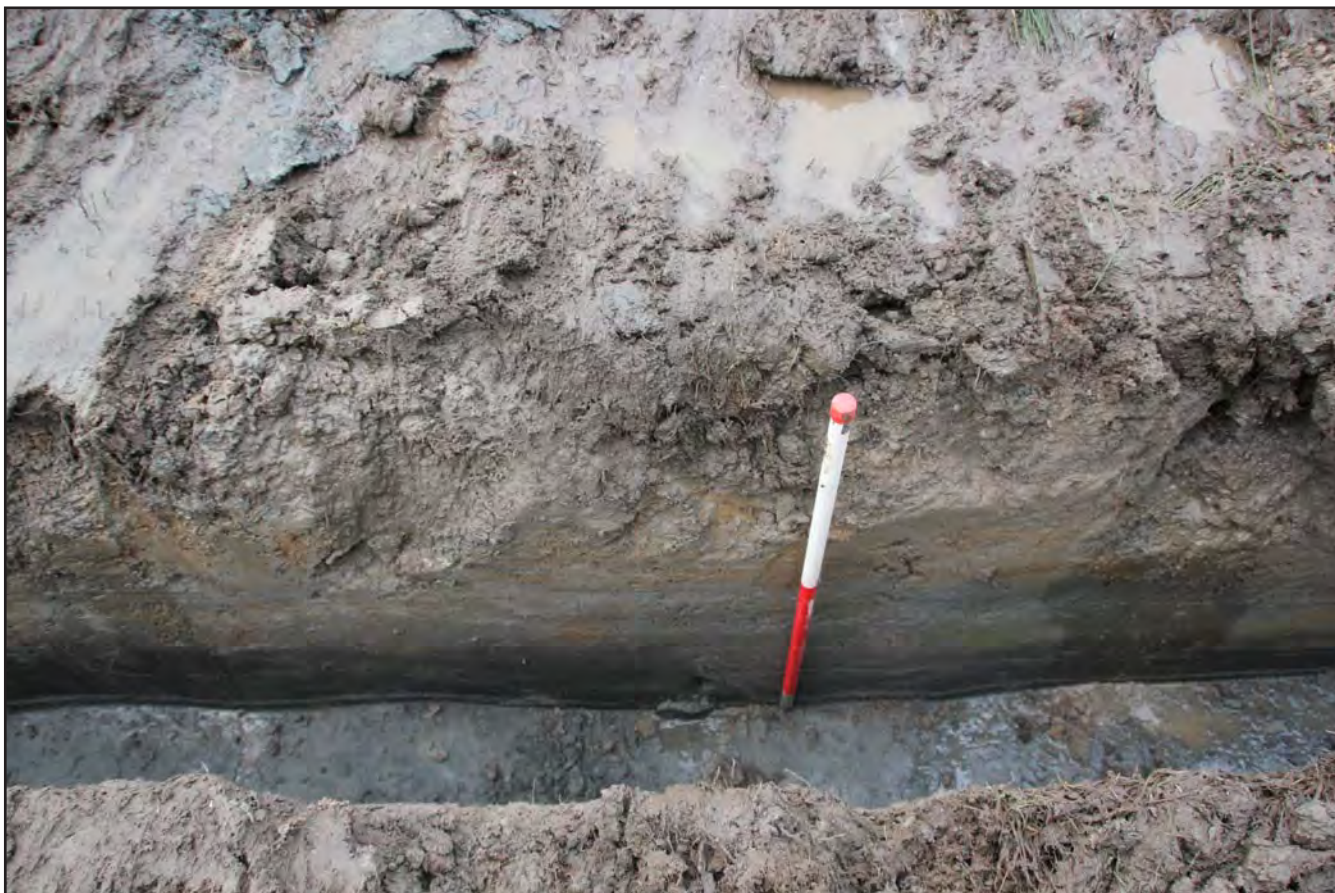
**Plate 14:** North facing section of Mains Renewal trench showing drainage trough at SH 55823 40127, from the north. Scale 1.0m.

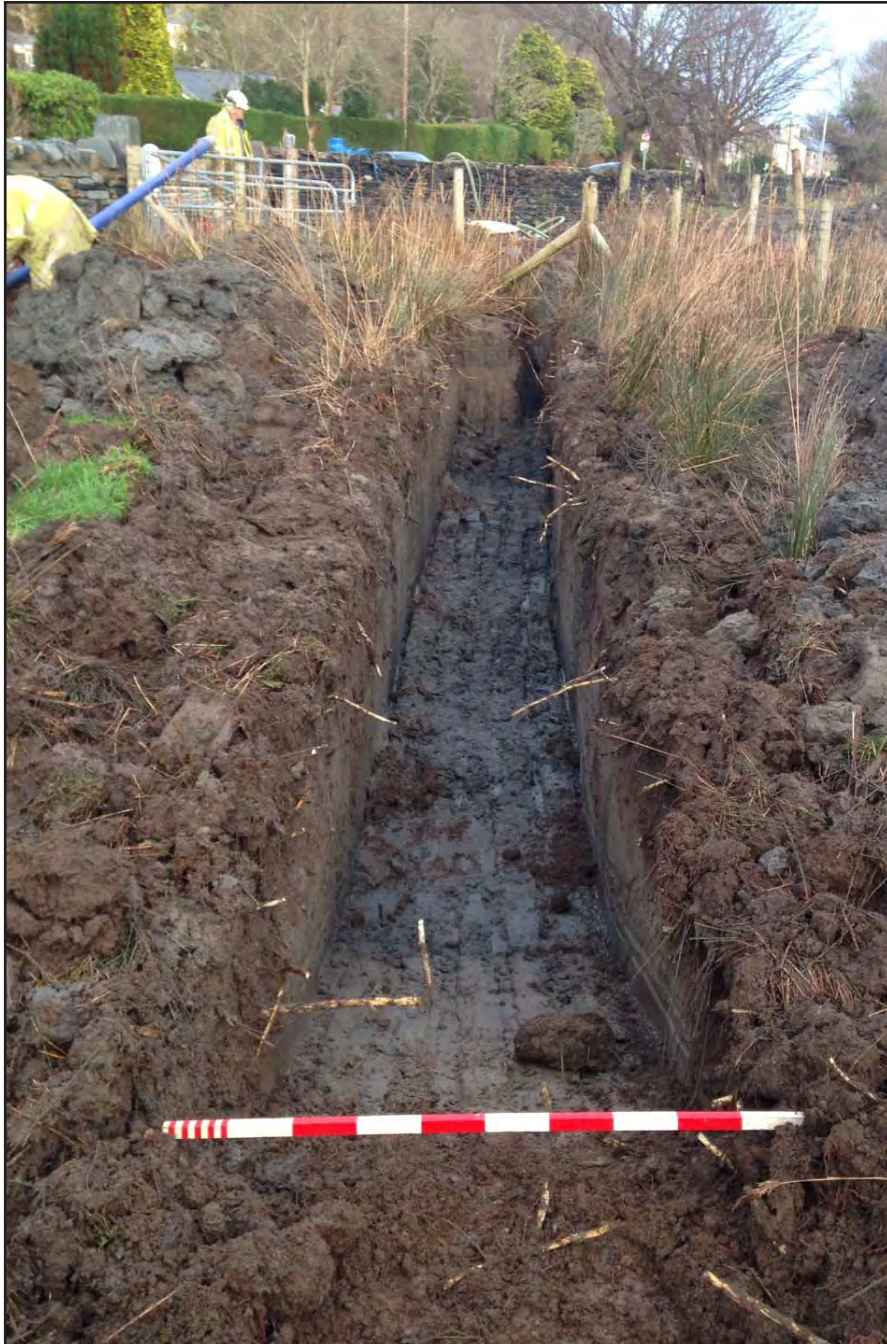
A watching brief was maintained during the excavation of the replacement water main trench from NGR SH 55785 40113 to SH 55770 40114 towards the northwest of the grazing field and immediately south of the A498 Dublin Street. The trench measured approximately 16.0m in length by 0.5m in width orientated east to west. It was excavated to a depth of 0.9m through a 0.15m deep mid grey-brown silt-clay topsoil, a 0.5m deep light yellow-brown natural clay substrata, and a >0.25m deep dark black-grey natural clay substrata.

The trench did not reveal any archaeological remains or any artefacts from any periods.

**Plate 15:** Water Main renewal trench SH 55785 40113 - SH 55770 40114, from the west. Scale 1.0m.

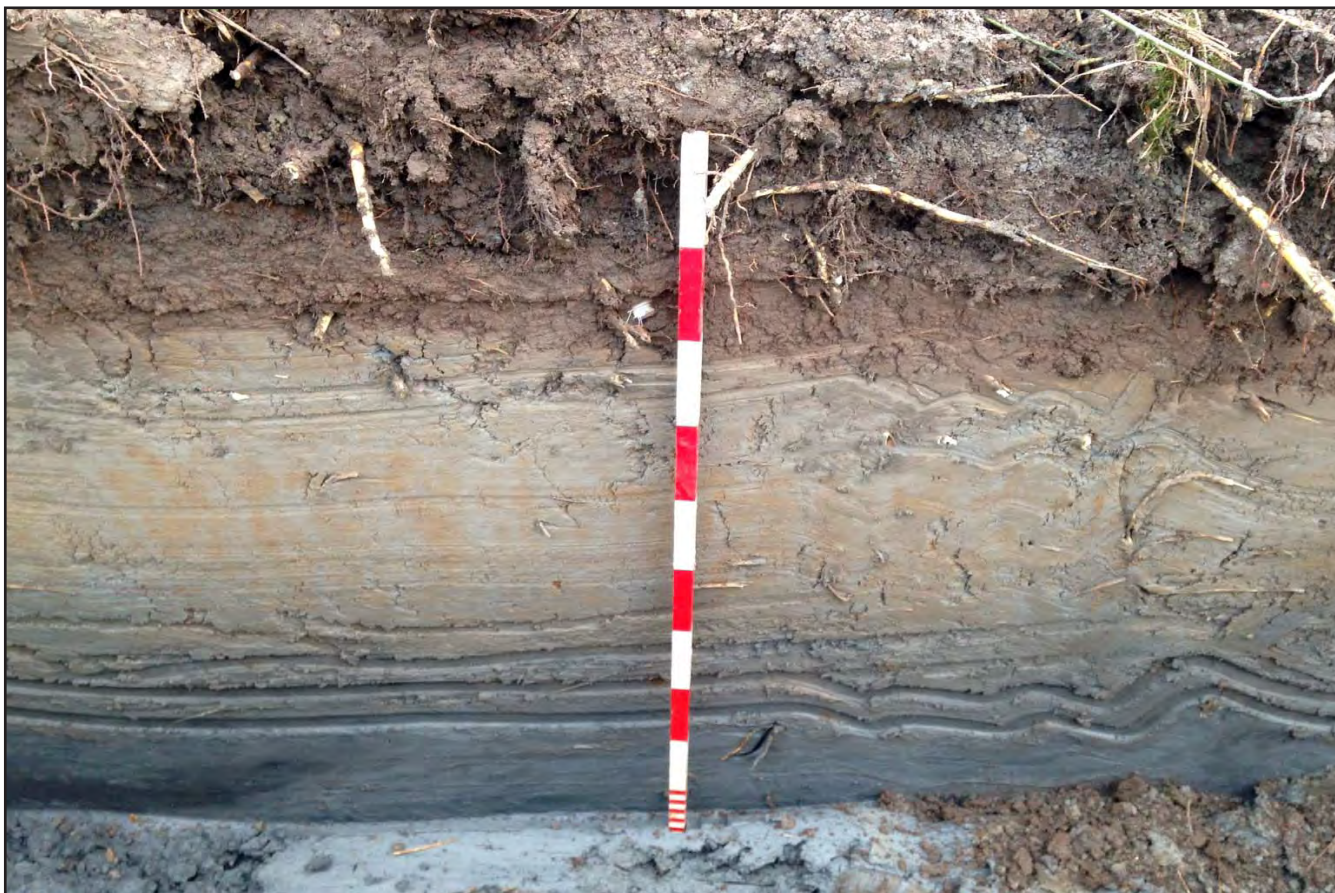
**Plate 16:** North facing section of Mains Renewal trench SH 55785 40113 - SH 55770 40114, from the north. Scale 1.0m.

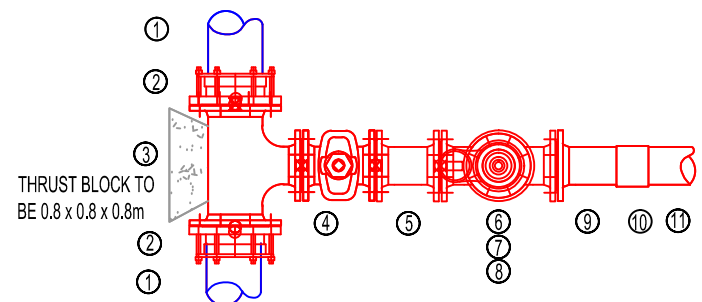
DETAIL 'B'

1.	EXISTING 5" DIA CI MAIN	-
2.	150-5" CI VJ FLANGED ADAPTOR	2
3.	100*150*150 MM AF TEE	1
4.	100 MM SLUICE VALVE C.C.	1
5.	100mm DIA AF DISTANCE PIECE 300MM LG	1
6.	80*100*100MM AF TEE	1
7.	80 MM AF DISTANCE PIECE 250 MM LG	1
8.	WASHOUT HYDRANT	1
9.	110 mm OD PUPPED FLANGED	1
10.	110mm OD ELECTROFUSION COUPLING	1
11.	110 MM OD 16 BAR HPPE PIPE	-

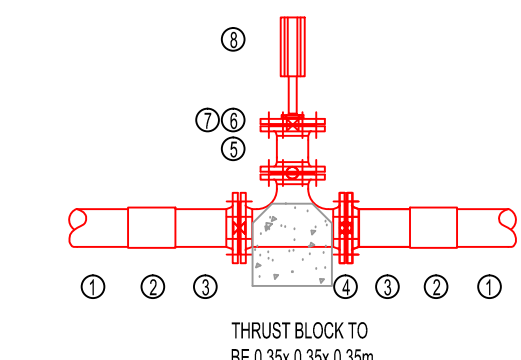
DETAIL 'C' x 2

1.	110mm od 16 BAR PROFUSE PIPE	-
2.	110mm od ELECTROFUSION COUPLER	2
3.	110mm od PUPPED FLANGE	2
4.	80mm OFF 100mm DIA ALL FLANGE TEE	1
5.	80mm DIA DISTANCE PIECE 150mm LONG	1
6.	80mm DIA BLANK PLATE D&T	1
7.	1" CHECK VALVE	1
8.	1" AIR VALVE	1
